# New Oakleigh Normanton Pit and East and North Drains

Summary Design Report

BEN862-TD-EV-REP-0001 Rev. 0

The sole purpose of this document and the associated services performed by Kellogg Brown & Root Pty Ltd (KBR) is to provide a Design and Documentation for the final landforms for the Normanton Pit and East and North Drains components of former New Oakleigh mine.

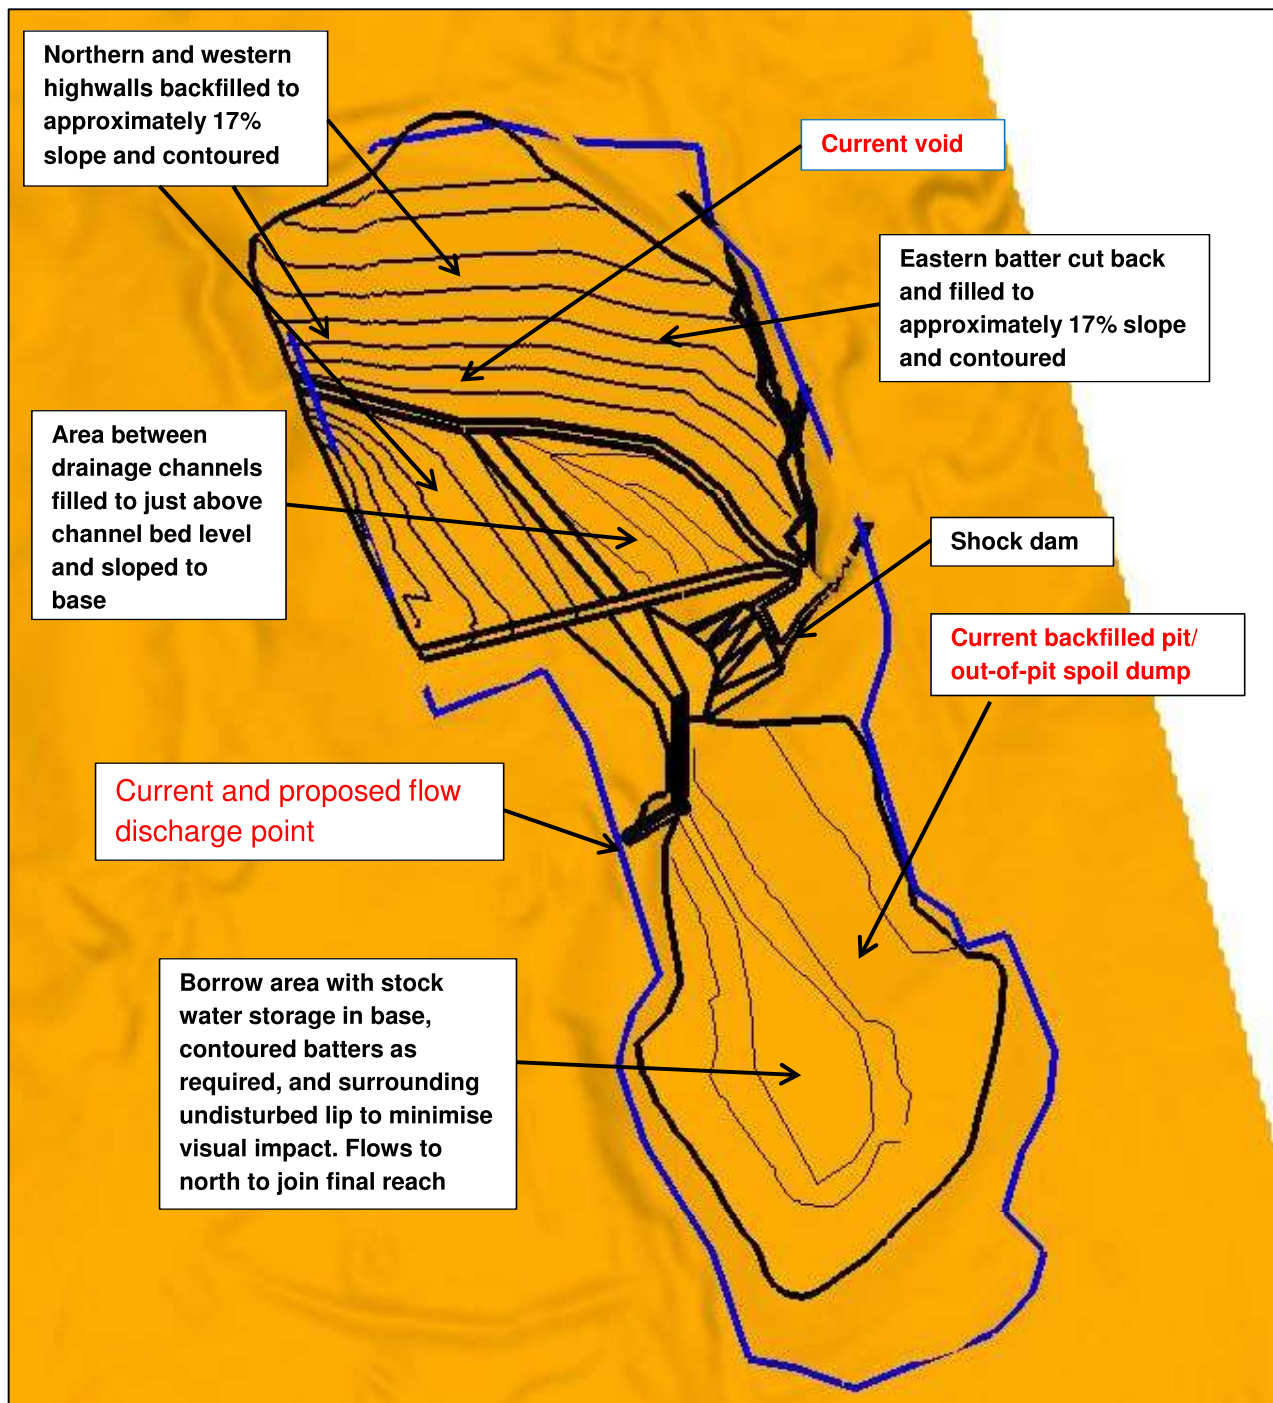
Figure 4.6 Key features of the landform under proposed concept design

Key features of the landform proposed under this concept design are illustrated in Figure 4.6 and summarised as follows:

- the area within the current pit that lies in the triangular area between the channels and the shock dam will be filled and shaped to drain directly to the channel segment leading to the last of the drop structures to avoid the need for additional banks and/or structures

- a drain from the southern borrow pit area that discharges at <1% to a point just below the last of these drop structures
- a final reach that discharges all site water into neighbouring land from where it flows to the Council constructed bund and ultimately discharges to Masons Gully

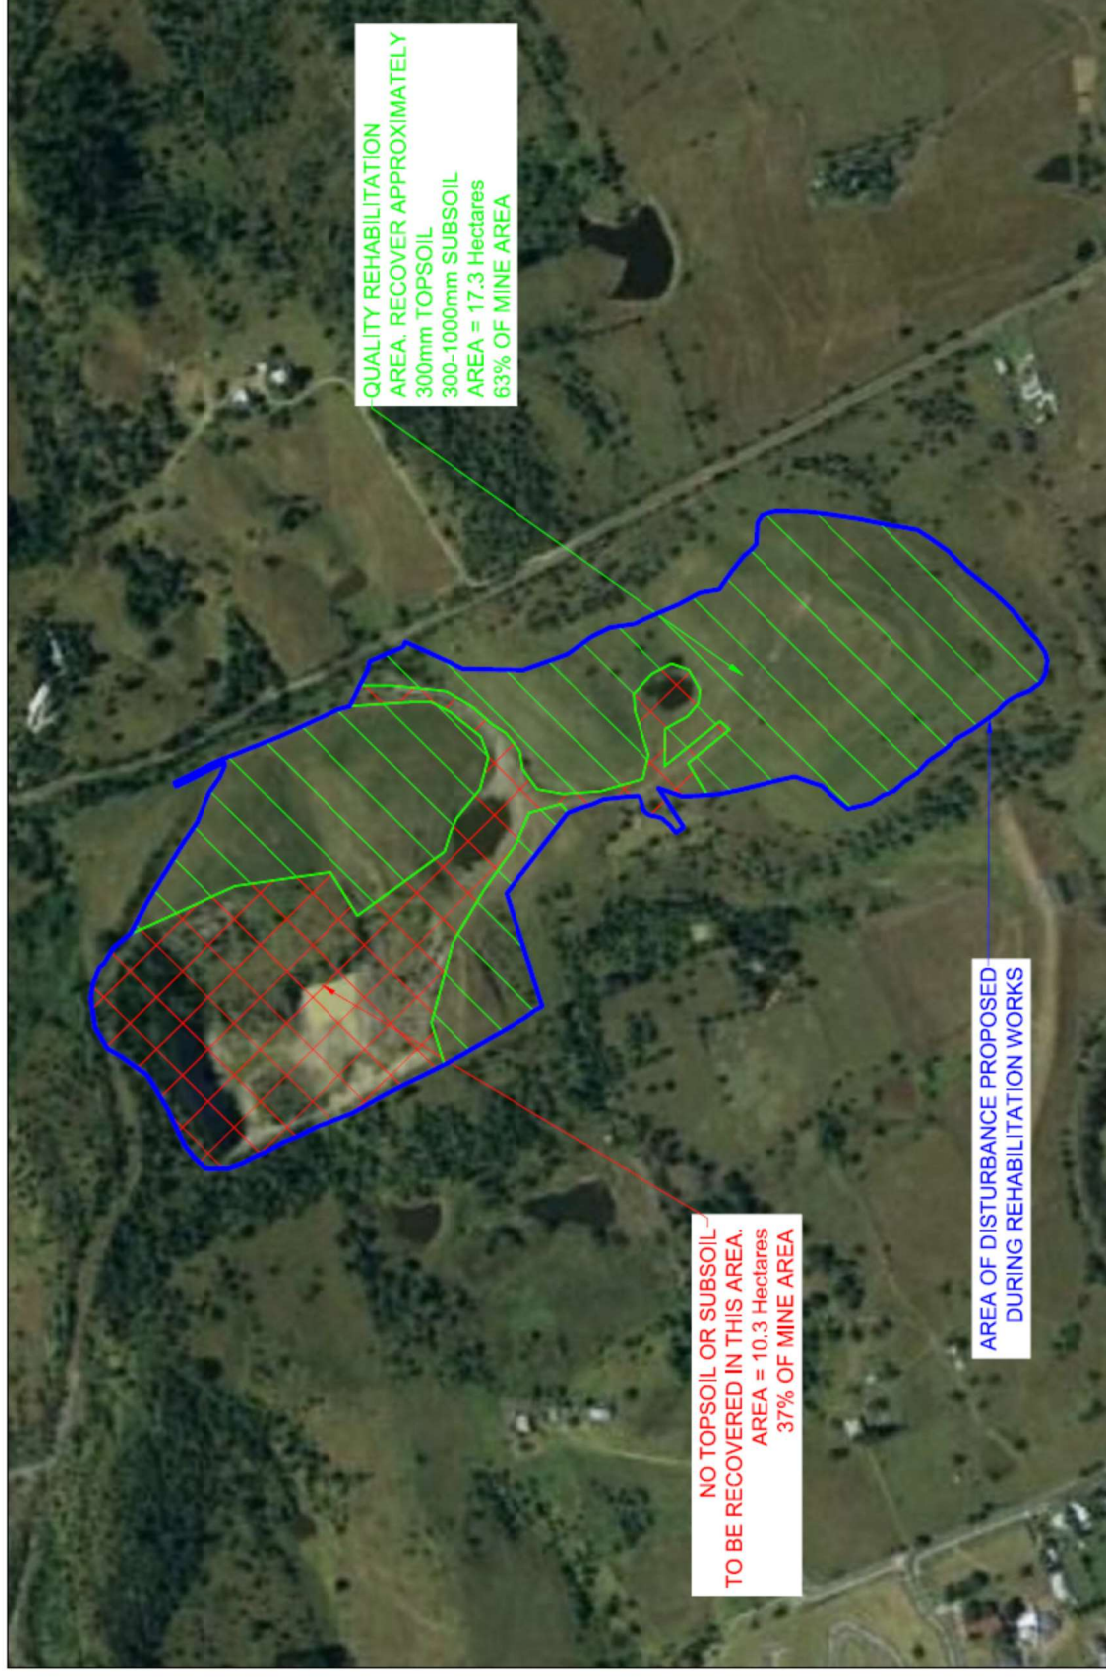
**Figure 4.7 Disturbed area that will require rehabilitation and areas where soil material can be sourced**

The total area to be disturbed by the rehabilitation works is approximately 27.6 ha comprising approximately 17.3 ha of currently rehabilitated land and 10.3 ha of abandoned pit and associated areas (Figure 4.7). This figure is for illustrative purposes only and is not a basis for calculations.

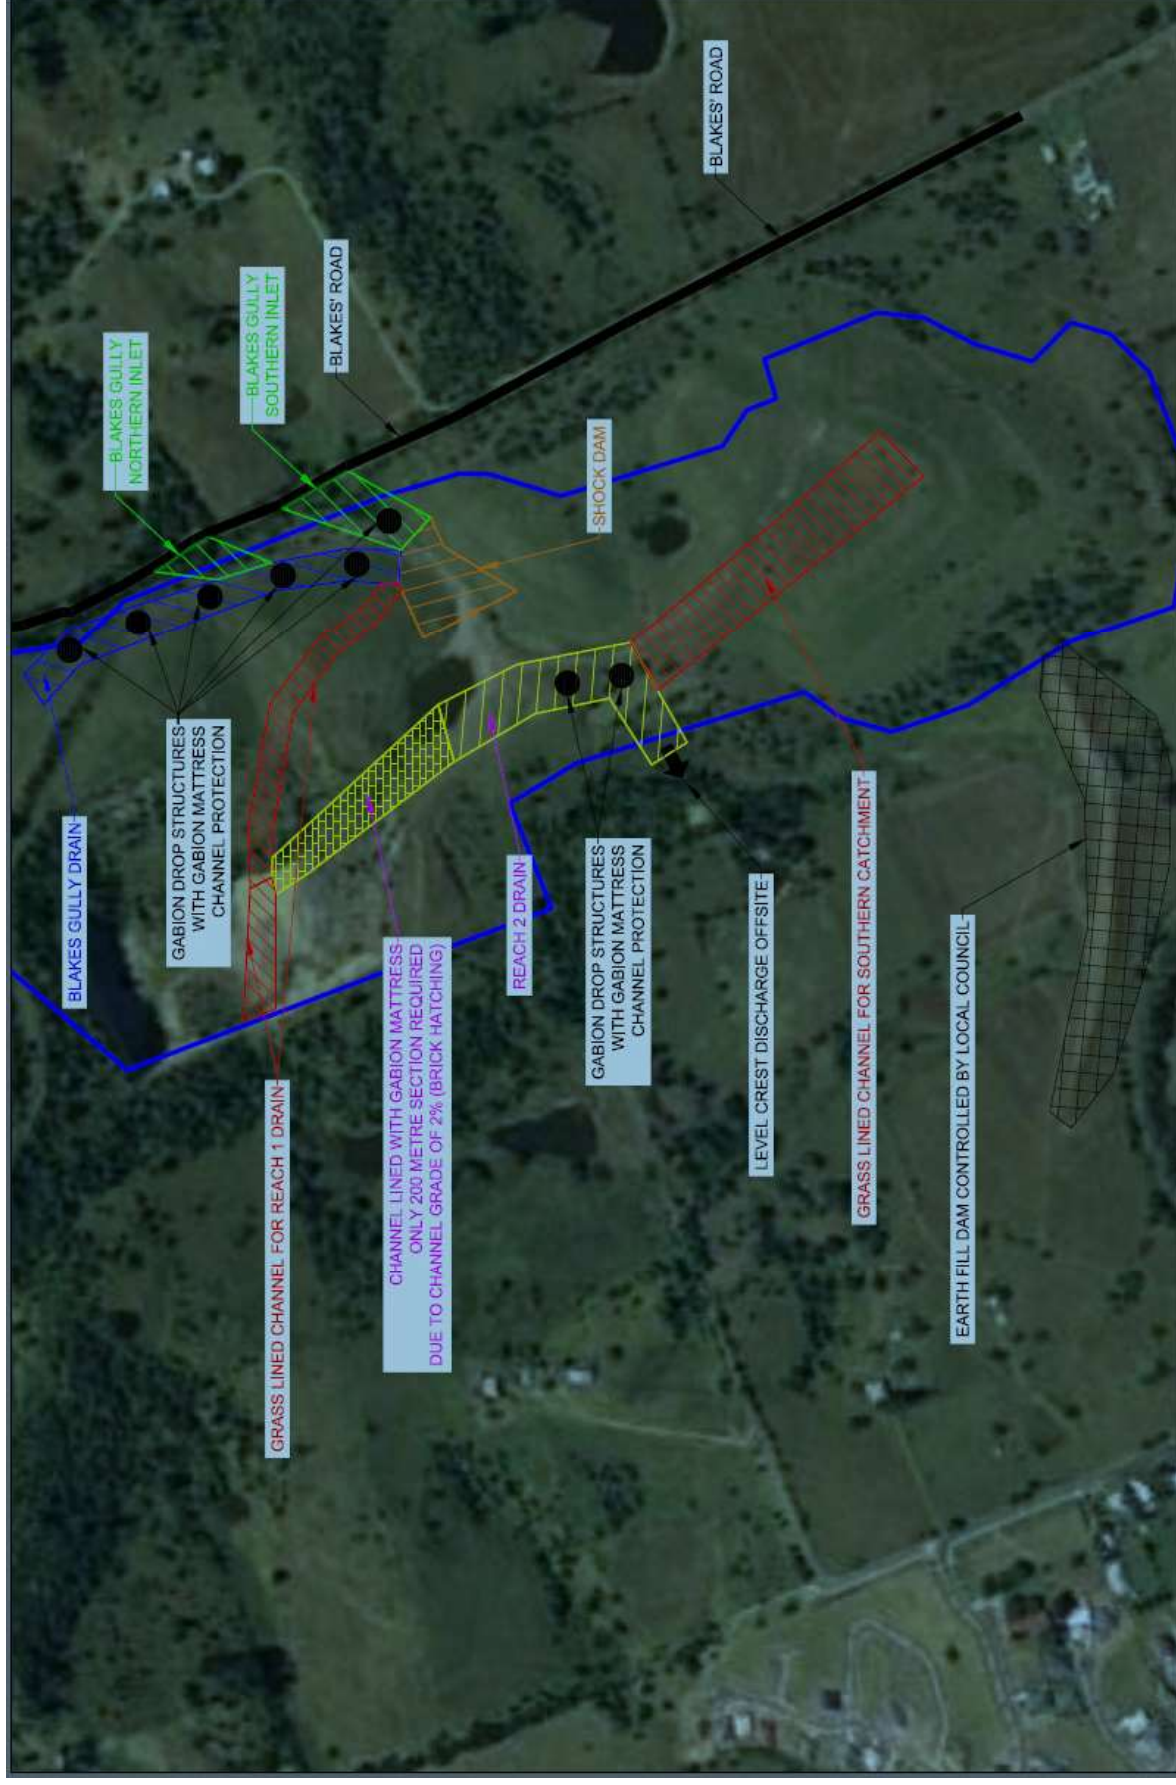
Figure 4.8 Overview of main drainage structures to be implemented (not to scale)

An overview of key components of the site redevelopment is provided in Figure 4.8.

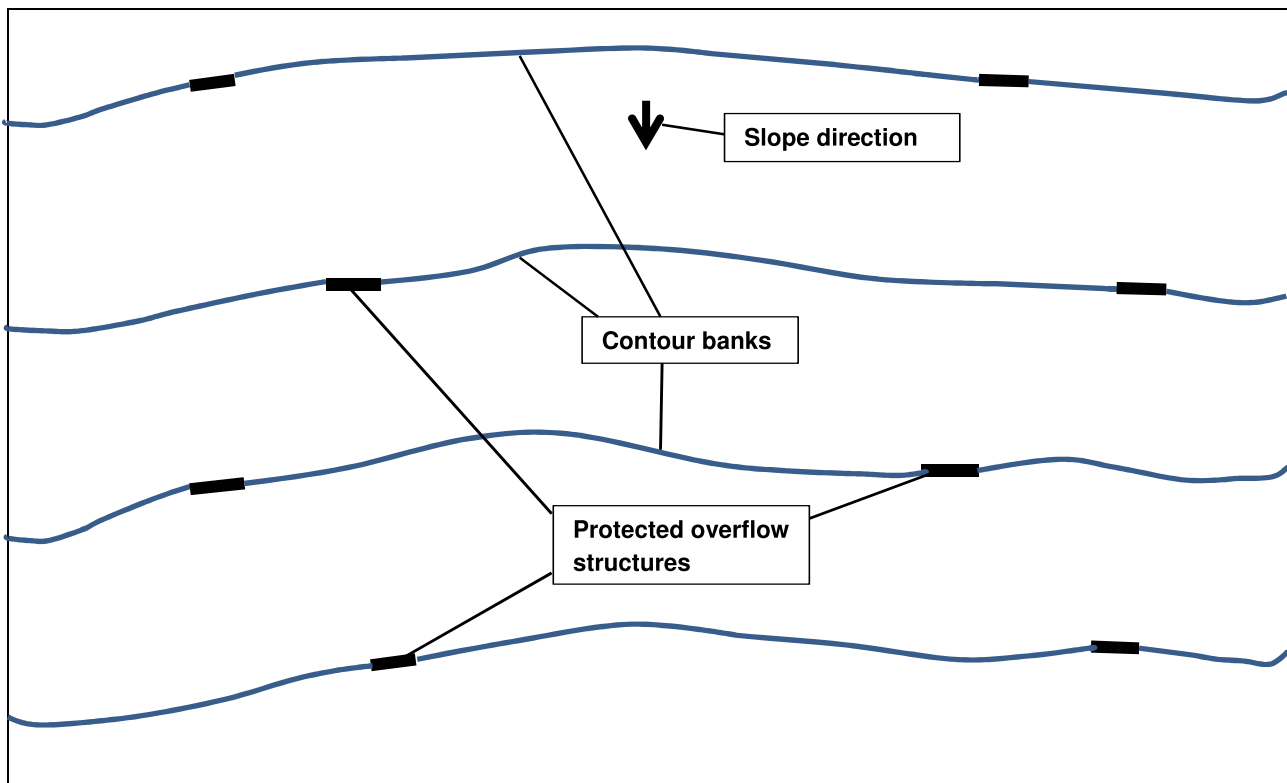
**Figure 5.1 Schematic of contour discharge system with offset protected discharges downslope**

(Figure 5.1). One option to stabilise spillways would be to have discharge over a half section of almost-buried concrete pipe (concave side down).

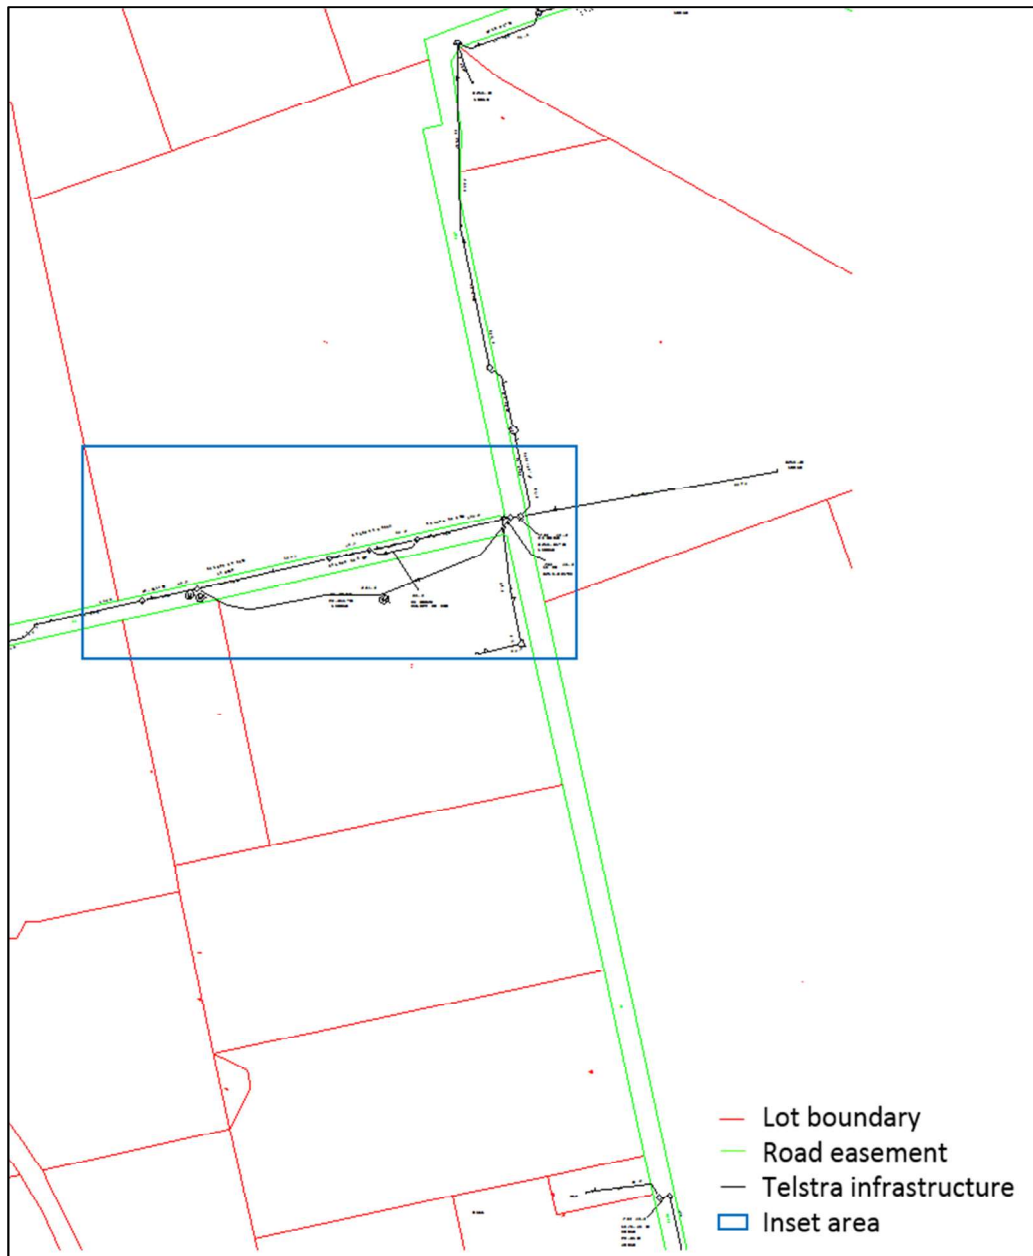
Figure A.1 DBYD overview

The location of telecommunications infrastructure on the site as indicated by DBYD is shown in Appendix A. It is understood that some, or all, of this infrastructure is non-functional but it will be necessary to liaise with Telstra to confirm status and any conditions for removal and disposal and relocation of the cables.

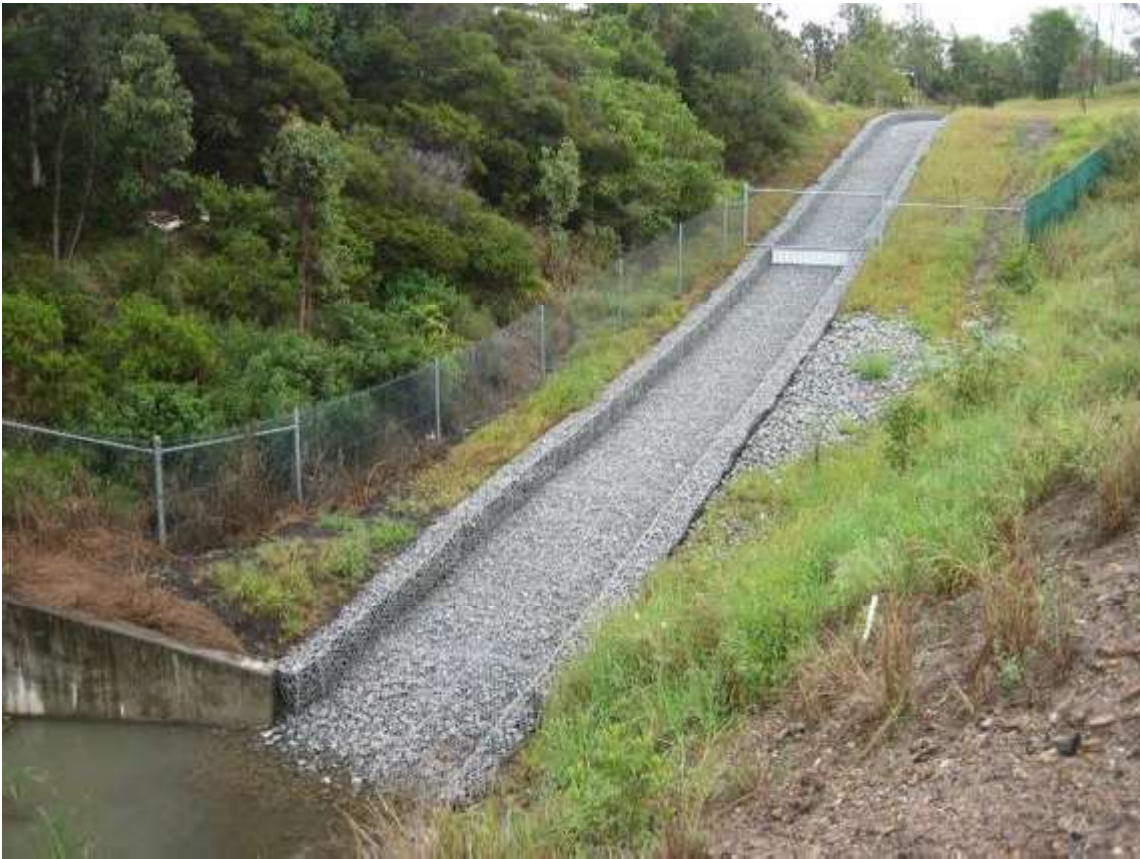
Example of gabion (Reno) mattress for discharging water safely down long steep slopes such as the internal channel

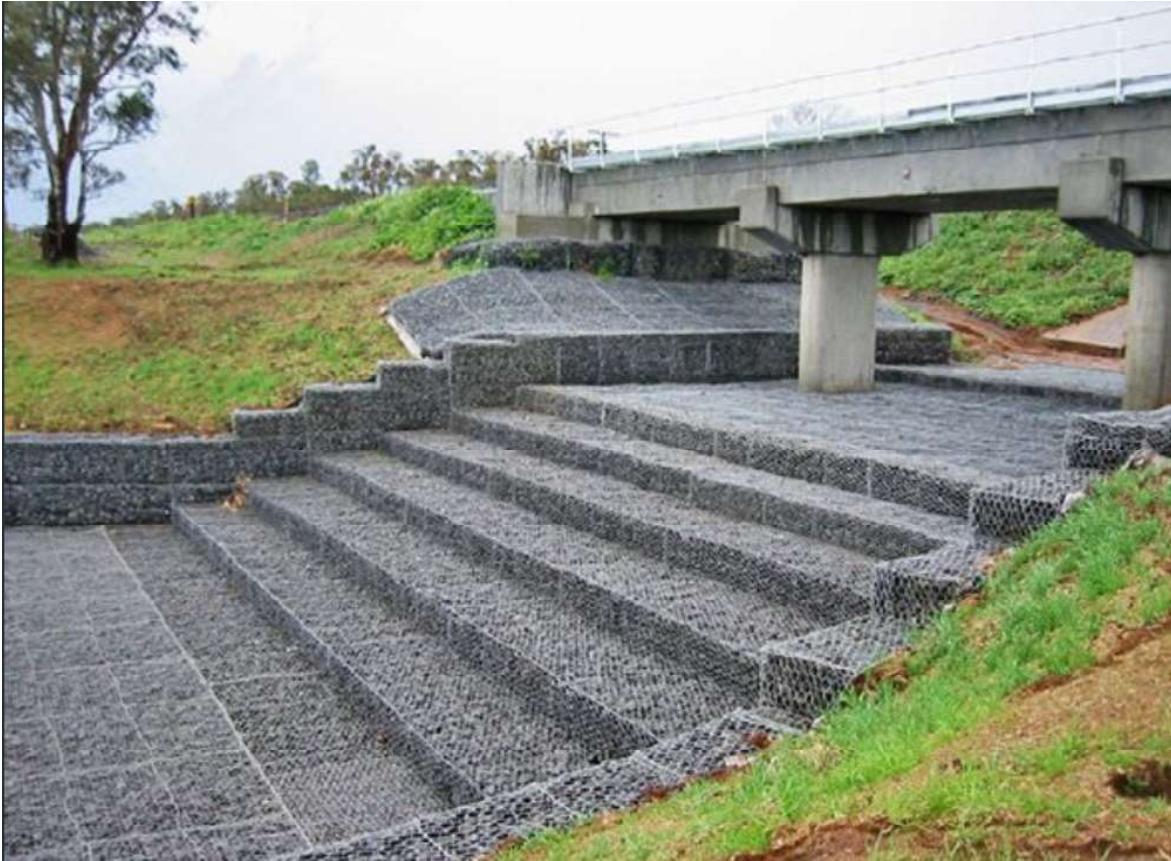
Example of drop structure using gabion baskets and mattresses at top and base of structure. In the Blakes Road instance, the structure would be near-vertical and not be associated with a bridge, but in other aspects is similar.

Gabion boxes are supplied as flat packs so that they are assembled, placed and fastened according to the final design, filled with rock, and closed with space behind backfilled and compacted progressively on site. Filling can be by machine or by hand but the rock needs to be tightly packed with the minimum of voids. Optimum rock size is 125 to 250 mm with a small percentage of smaller material allowable. Rock fill can be rounded or angular but angular rock that tends to fracture with flat sides, such as basalt or similar material has advantages because it can be packed with minimum voids and more readily be amenable to constructing flat faces within the baskets for optimum stacking of baskets. Alternative products such as permeable concrete modular units can also be used. Examples of the use of gabion baskets/mattresses are provided in Appendix B Gabion drop structure information.

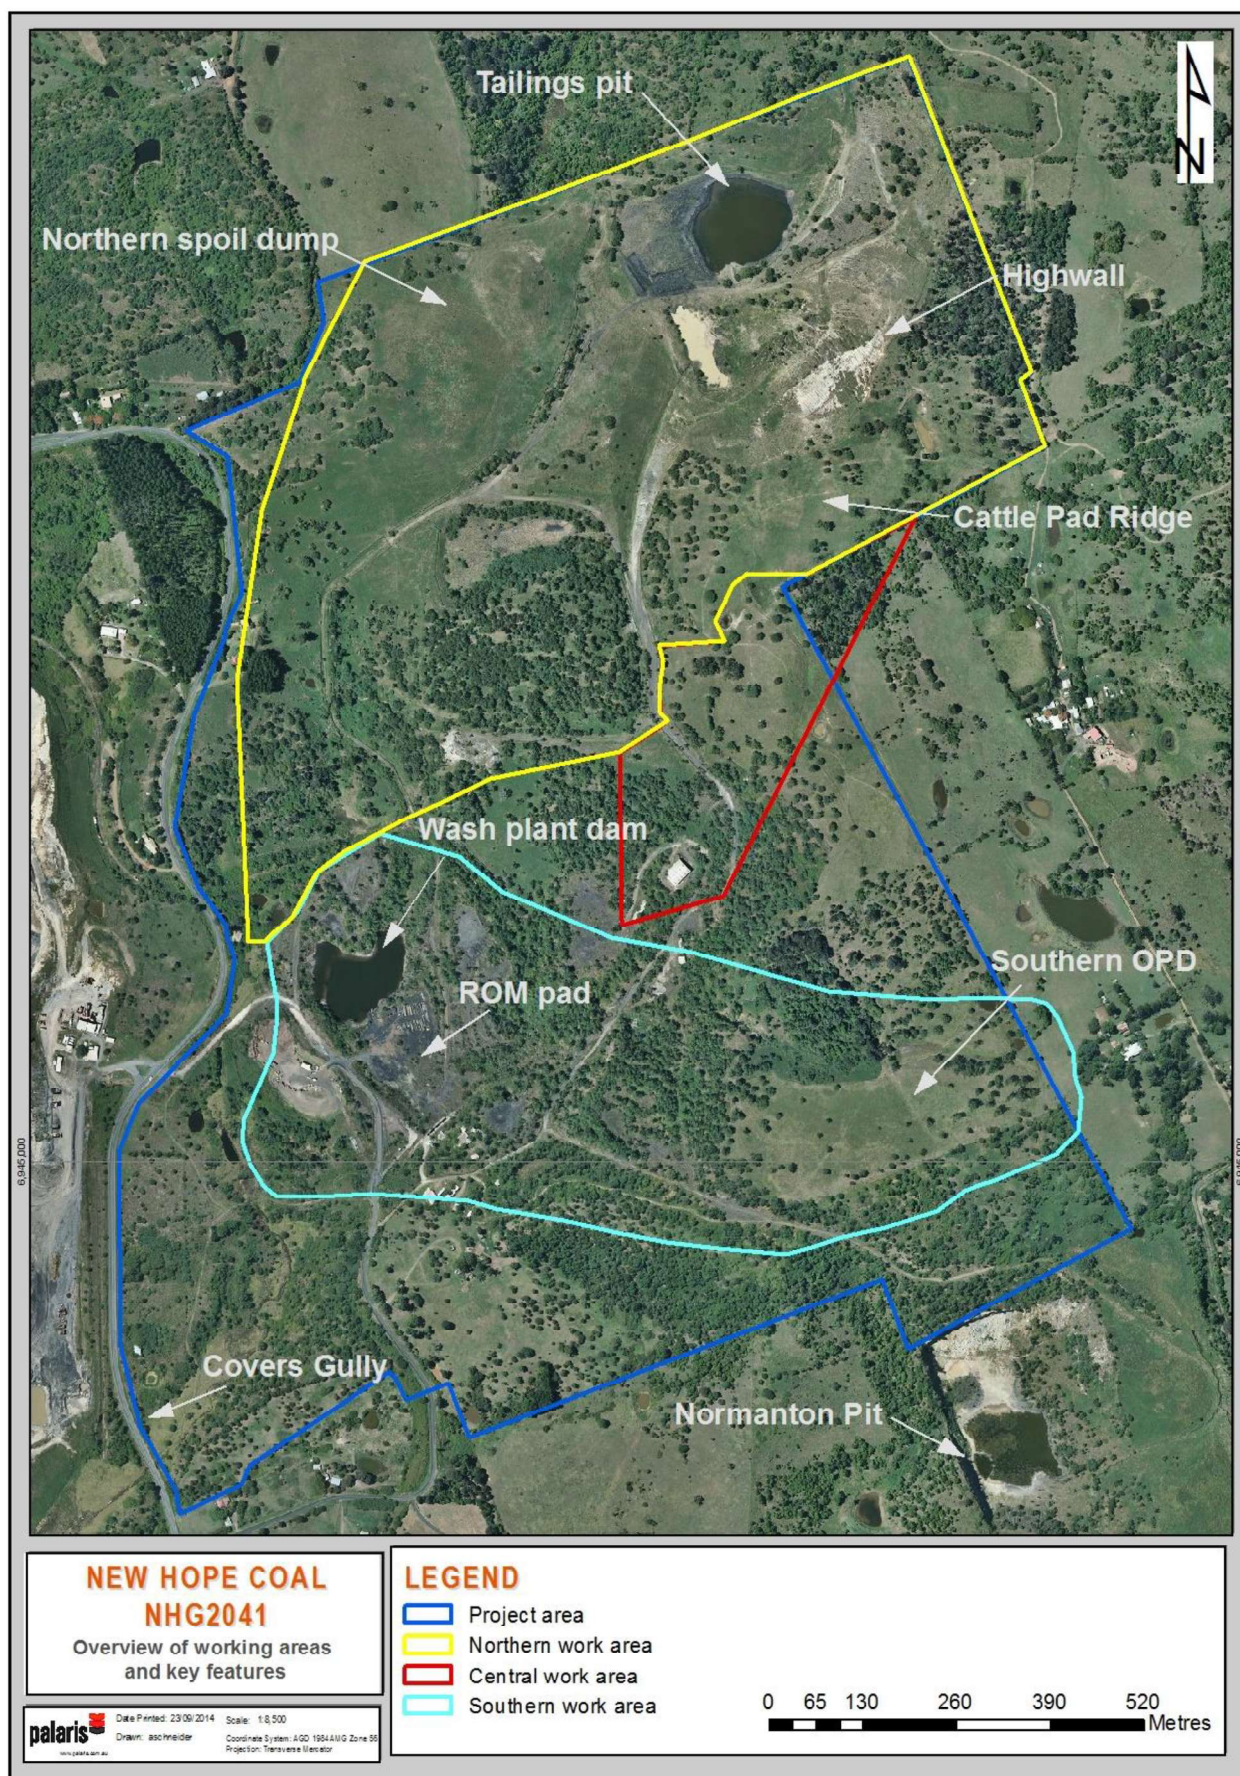
Overview of work areas and naming conventions for on-site features

The layout of the proposed work areas and naming conventions are given in the following figure:

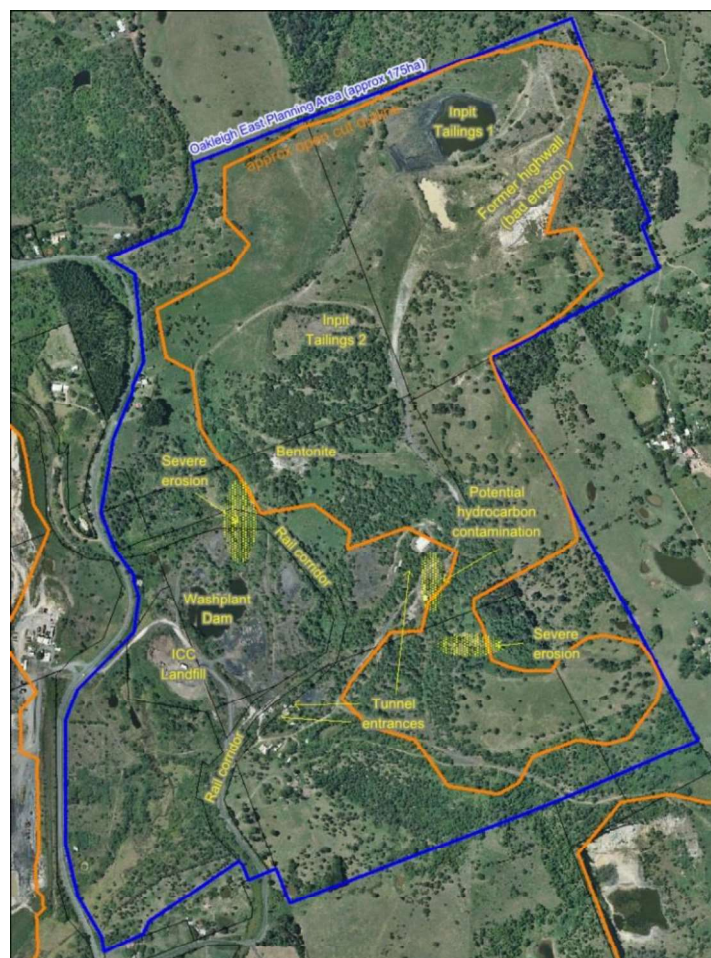
Figure 2.1 Oakleigh East area including North Pit outline and key site features of concern

The Oakleigh East area, highlighting key features of the site as shown in Figure 2.1, has been closed since mid-2000 when the last coal left the site. The open cut pit (Figure 2.1– orange outlined area) was referred to as the North Pit during those operations. Aspects requiring attention in developing the final landform and drainage system design as well as during rehabilitation include:

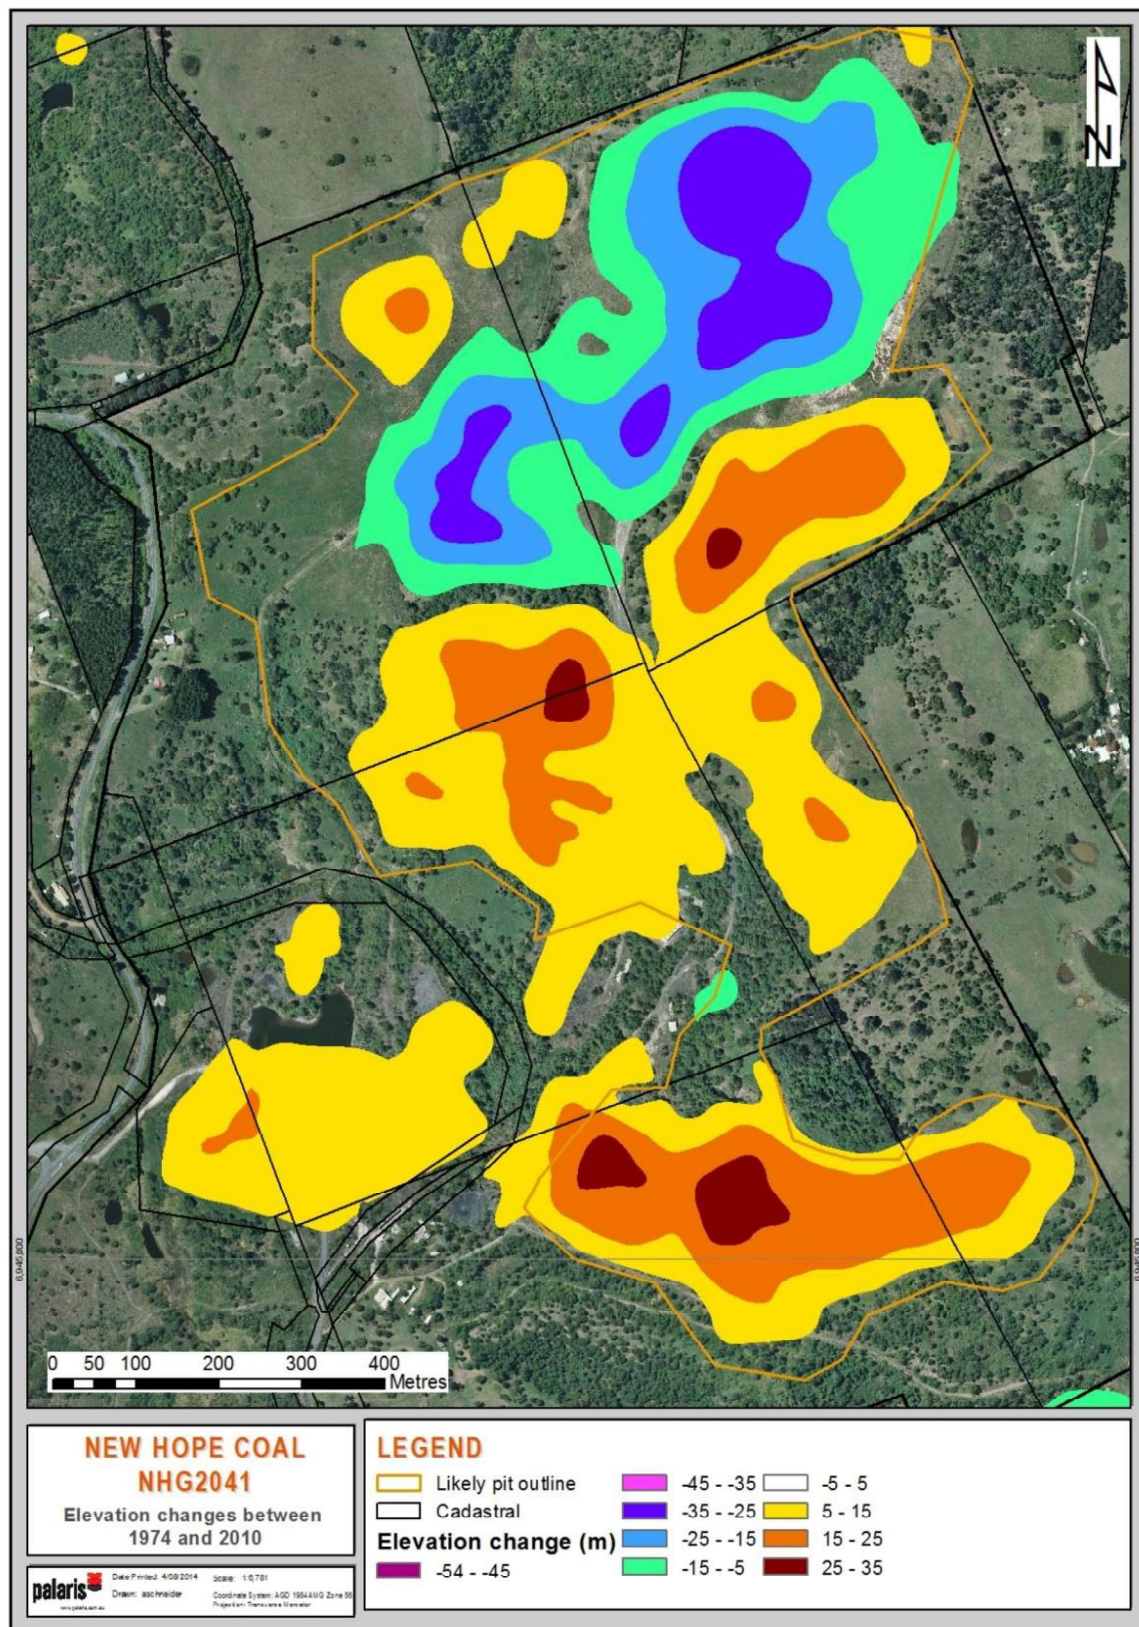
Figure 2.2 Elevation changes between the pre- and post-mining landscape

The landscape has been strongly altered through mining activities and the subsequent rehabilitation to date. The change in elevation of the pre-mining landscape in 1974 relative to the mined and reshaped landscape of 2010 is shown in Figure 2.2. It is evident that the area around the tailings pit in the north has been lowered substantially compared to the pre-mined surface as is also shown in Figure 2.2. The areas south and south-west of the northern tailings pit have gained in elevation and the surfaces today are up to 30 m above the 1974 landscape. Both of the raised areas now have steeper slopes associated with them than were present in the initial landscape. In the south-east, a former valley has been backfilled with spoil as part of the out-of-pit dump, elevating the surface up to 30 m above the pre-mining landscape (Figure 2.2) and significantly altering the drainage in this area. This dump has diverted runoff (a portion of which is sourced from outside the project area from an unmined part of the catchment) to the north where it has resulted in a deep gully forming partly in fill and partly in a natural surface hard up against a remnant area of protected vegetation.

Extensive use has been made of the data provided by NHG showing the pre-mining DEM of the site to identify where spoil has been placed throughout the life of the mine and for which no mine plan was available (see Figure 2.2). This imagery was also useful in determining some locations of probable tailings dams and former drainage lines. It is clear from the DEM that at least two of the major prior drainage lines have been buried under more than 30 m of spoil and that this has caused the remaining residual catchments that are located above the dumps and outside the project site to find new pathways for discharge. This has resulted in severe erosion that now requires attention as part of the present concept planning.

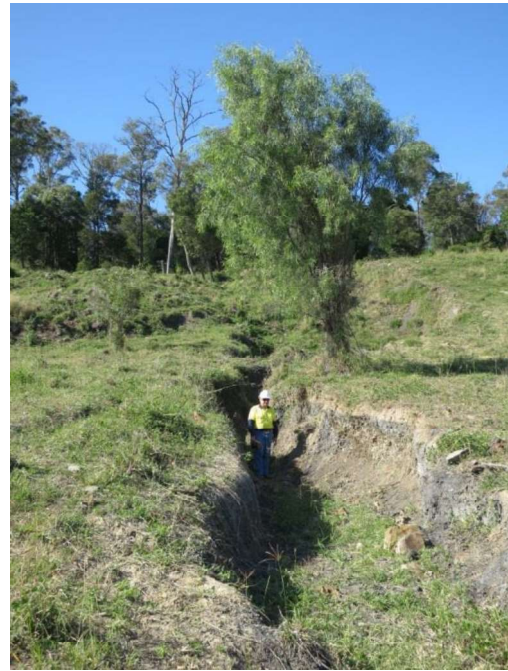
**Figure 2.4** Severe gullying close to the tailings dam in the north east

The current reshaped landscape for the area disturbed by the open cut mining, though it is sympathetic to the surrounding landscape (Figure 2.3), is unstable and showing extensive gullying on fill slopes (Figure 2.4). The final highwall in the north-east of the project area has been partially stabilised by grading the overlying slope to a gentler grade and pushing spoil against it to reduce erosion to a degree. This has been partly successful but the highwall remains unstable due to the exposure of sodic subsoil material during the reshaping of the land above the highwall. This exposure has affected vegetation establishment resulting in the formation of severe gullying (Figure 2.5 and Figure 2.6).

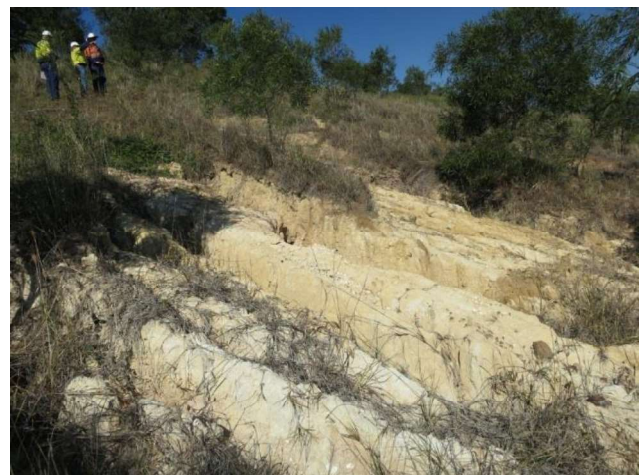
**Figure 2.6** Gullying in sodic subsoil material exposed above highwall during reshaping

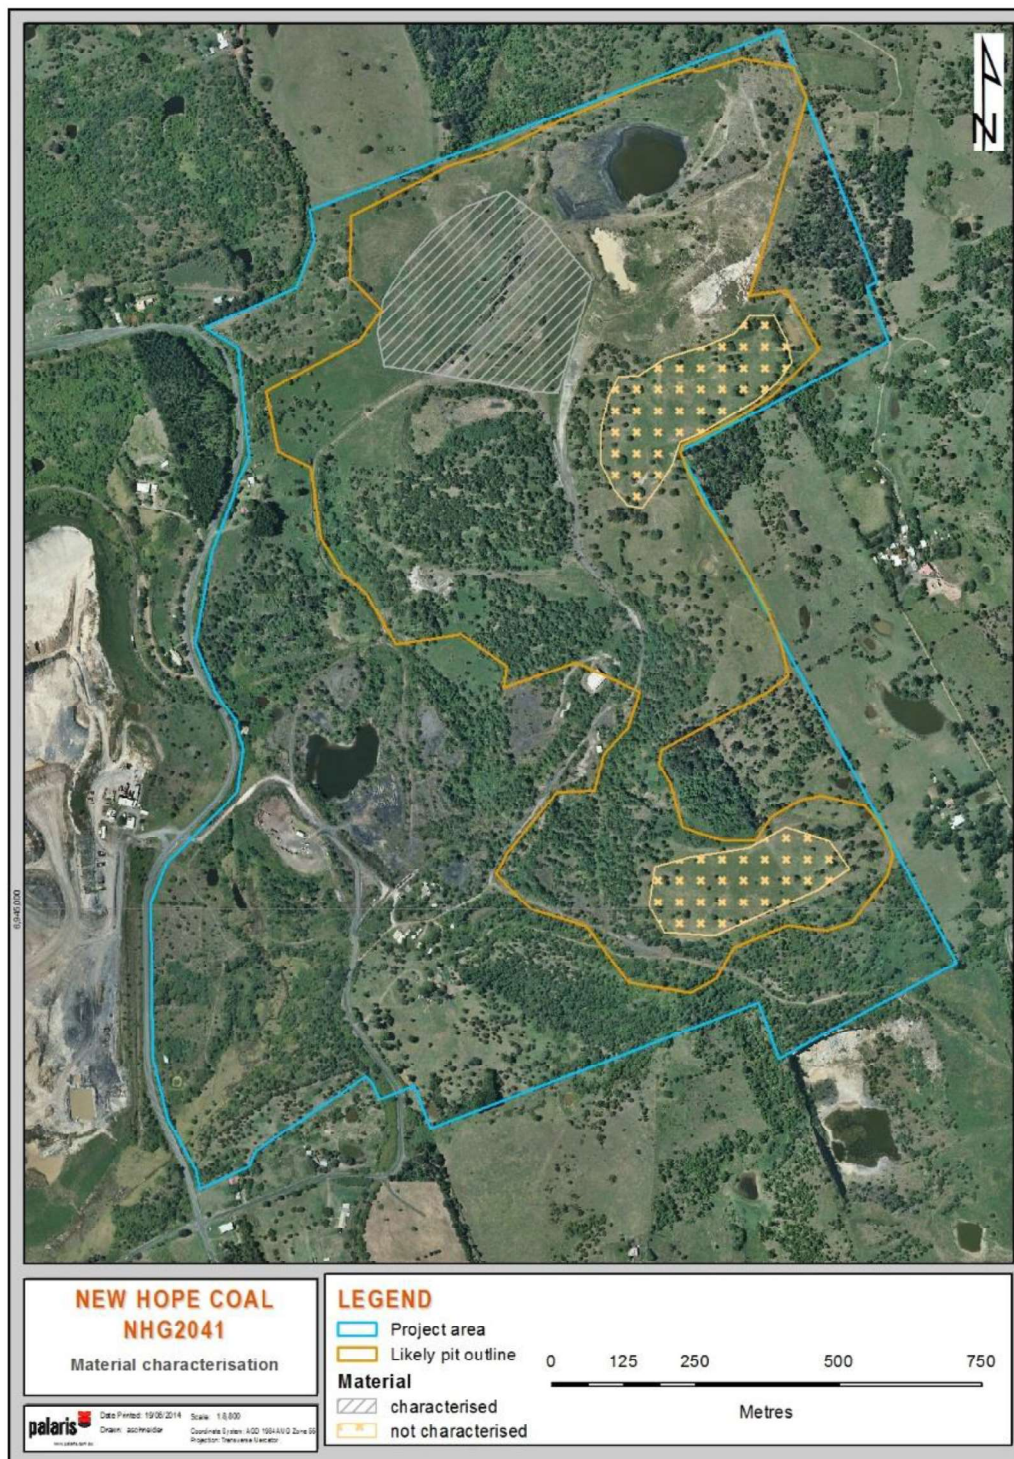
**Figure 2.7 Areas of spoil characterisation**

Samples from five sites were taken by Landloch to characterise the material in the shaded area in the north-west of Figure 2.7. The chemical properties of these samples as represented by analysis of the upper 10 cm did not show any values of concern for critical parameters. The pH of these samples ranged from 7.8 to 8.0 (slightly alkaline) and the electrical conductivity from 0.14 to 0.17 dS/m (low). Exchangeable potassium, calcium, and magnesium levels in this upper layer are acceptable. The effective cation exchange capacity (ECEC) was moderately high ranging from 28 to 31.3 meq/100g. This suggests a moderate presence of swelling clays (smectite clays) and the ability of the material to retain nutrients for rehabilitation. The total clay percentage ranged from 27% to 34%. The upper 10 cm of the sampled material is non-sodic (Landloch 2013) as exchangeable sodium percentage (ESP) was below 2% for all samples.

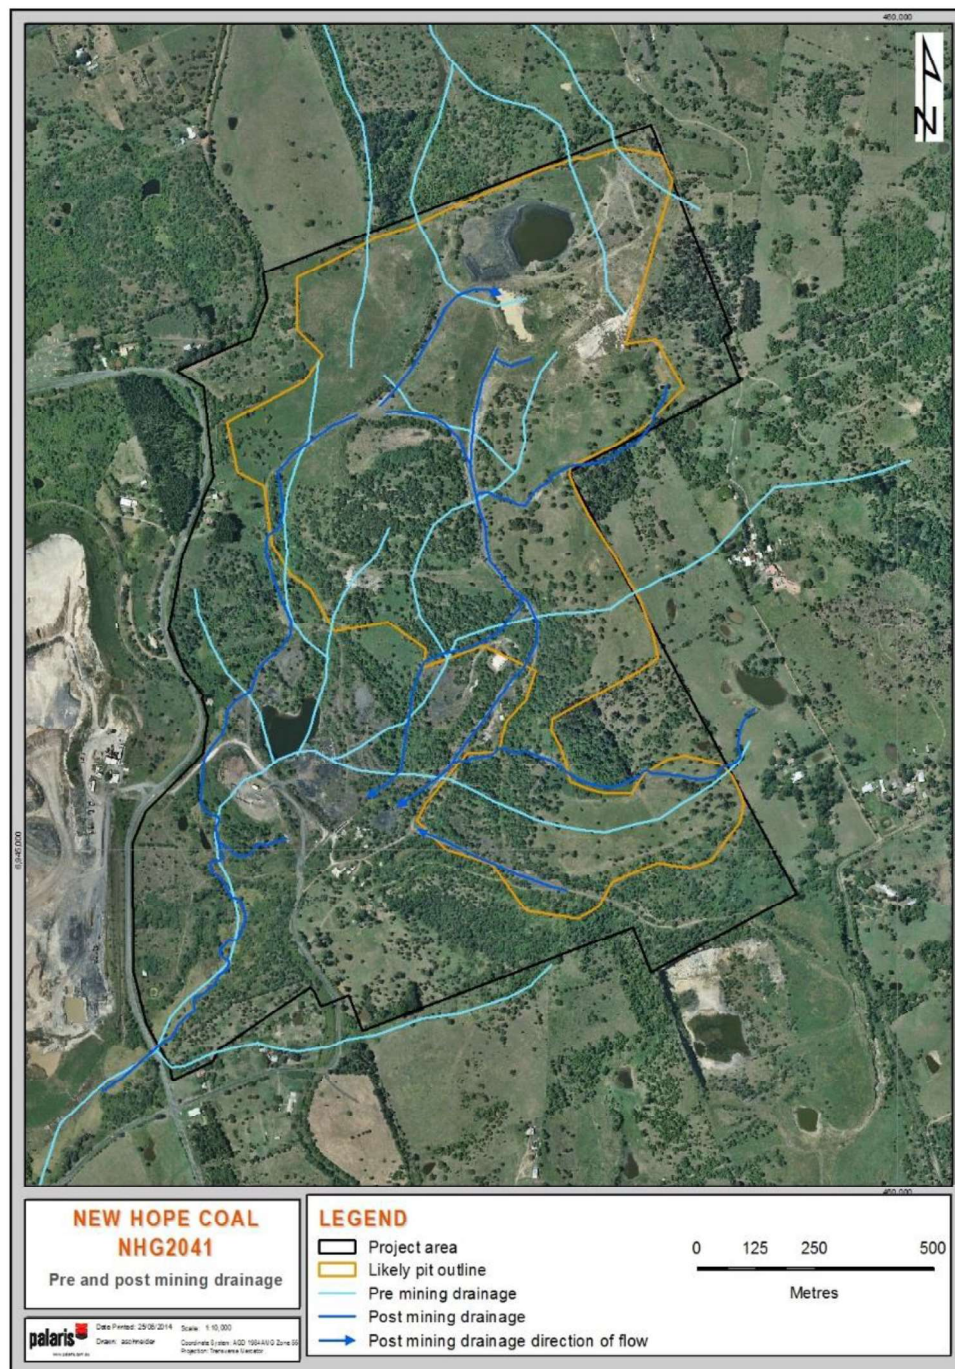
**Figure 2.8 Pre and post-mining drainage**

Pre-mining drainage of the site is no longer well-reflected in the post-mining landscape other than in the south-west and for the drainage from outside the project area in the central east of the lease area (Figure 2.8). Prior to mining activities, drainage from a small catchment in the north-east of the project site flowed north into the Blacksnake Creek system while the majority of drainage flowed to the south and south-west of the site. These southerly draining streams ultimately joined to one flow path, namely Covers Gully, which leaves the site in the south-west and flows under the Rosewood- Marburg Road (Figure 2.8), other than for a small catchment in the south-east of the mine site. This latter area originally drained via the Normanton Pit area in the north-west of Normanton Pit. It is now captured and re-directed by a bund above the residual high wall where it now flows into what has been called Blakes Gully along the eastern side of Normanton Pit.

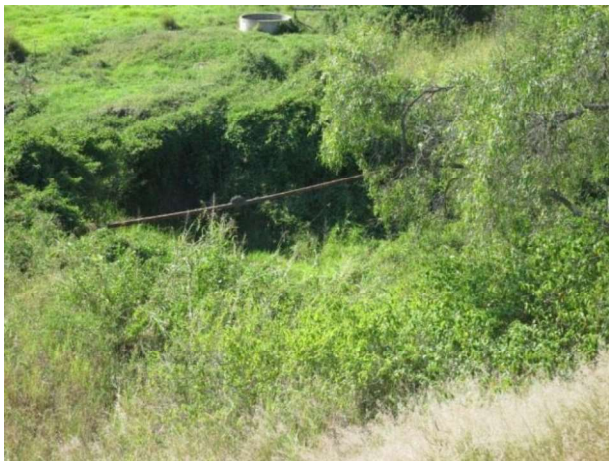
**Figure 2.11 Washed out rail bridge**

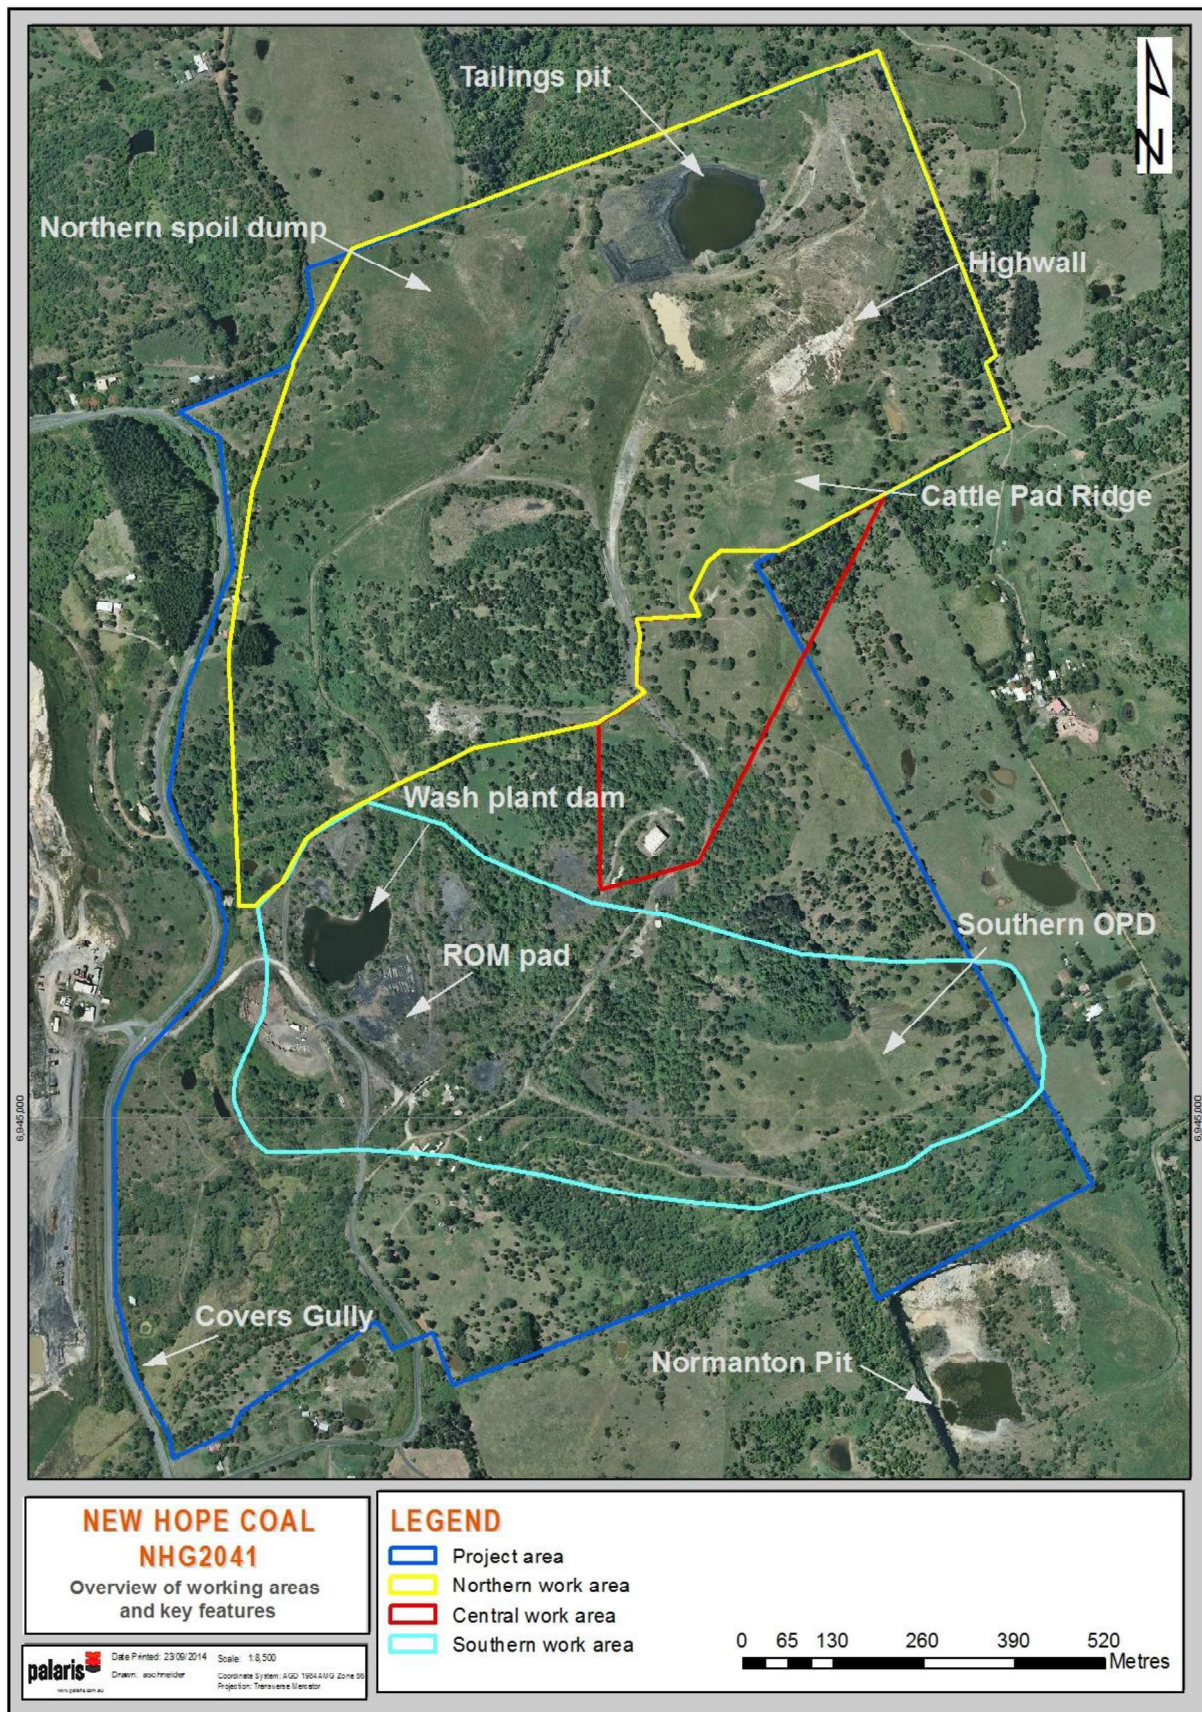
Figure 4.1 Work areas used in planning and discussing the final drainage system proposed and key locations
