# New Oakleigh Normanton Pit and East and North Drains

Summary Design Report

BEN862-TD-EV-REP-0001 Rev. 0

The sole purpose of this document and the associated services performed by Kellogg Brown & Root Pty Ltd (KBR) is to provide a Design and Documentation for the final landforms for the Normanton Pit and East and North Drains components of former New Oakleigh mine.

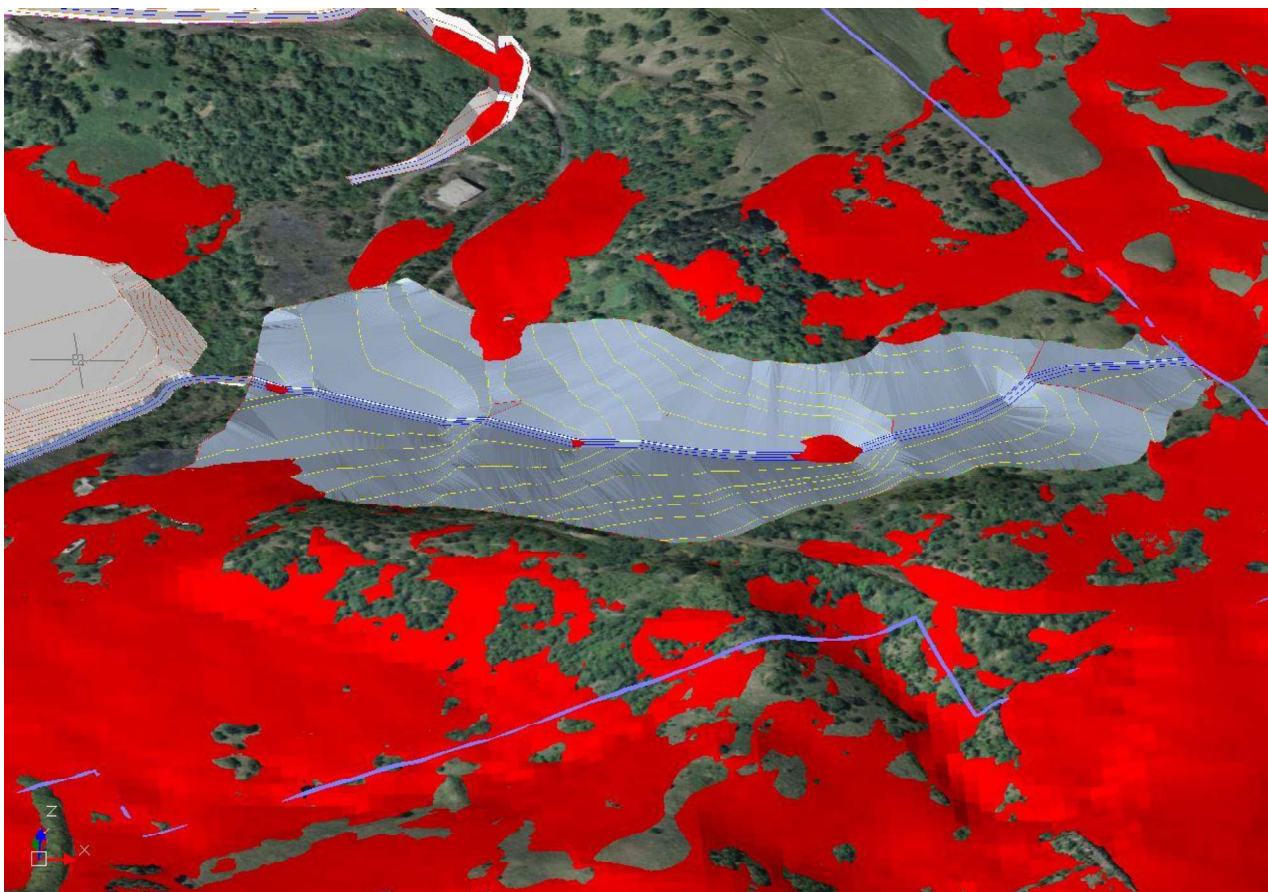
**Figure 4.2** Red areas showing the pre-mining surface in relation to the out-of-pit dump (grey). Note: three small red areas intersected by drainage line to be re-established coincide with locations of gabion drop structures meaning that they can be located on *in situ* surface

Next, various design iterations were completed to restore the OPD area to a stable drainage system. Five drop structures were required down the centre of this rehabilitated OPD area, which help limit the required movement of material as well as providing a stable flow of water to discharge at the washplant area. The new stable design requires the removal of ~1,470,000 bcm of material. NHG requested that 1,000,000 bcm of this area be kept for use in the nearby Normanton Pit rehabilitation program. This, along with the need to transport ~311,000 bcm of material to the final highwall area to meet the deficit, and to keep ~260,000 bcm of material to complete all other drains, meant ~184,000 bcm of excess material were then available to cap the washplant dam and pad area. This leaves approximately 690,000 bcm of spoil above the original surface in the southern OPD as shown in Figure 4.2, meaning that the new channel at the OPD is constructed almost entirely in fill.

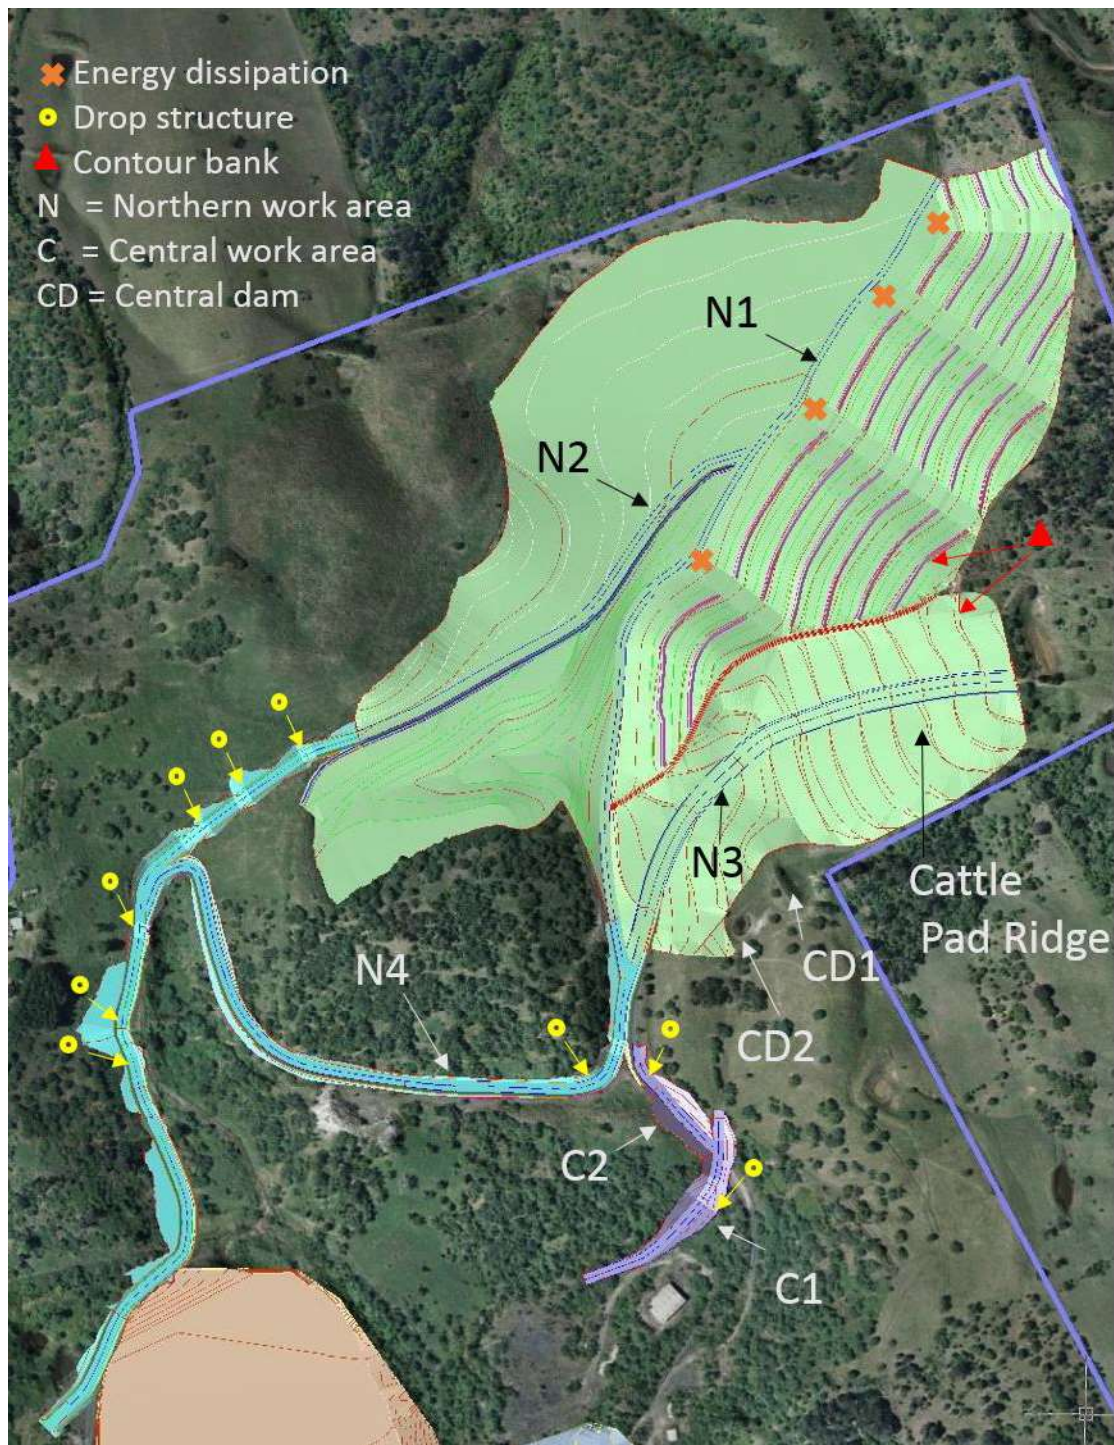
**Figure 5.1 Detailed layout of northern and central work area showing key features of surface water management in relation to final proposed landform**

The design features for the northern work area are shown in Figure 5.1.

A series of drop structures using such means as gabion baskets and mattresses is proposed at locations as shown in Figure 5.1 and Figure 5.2 for:

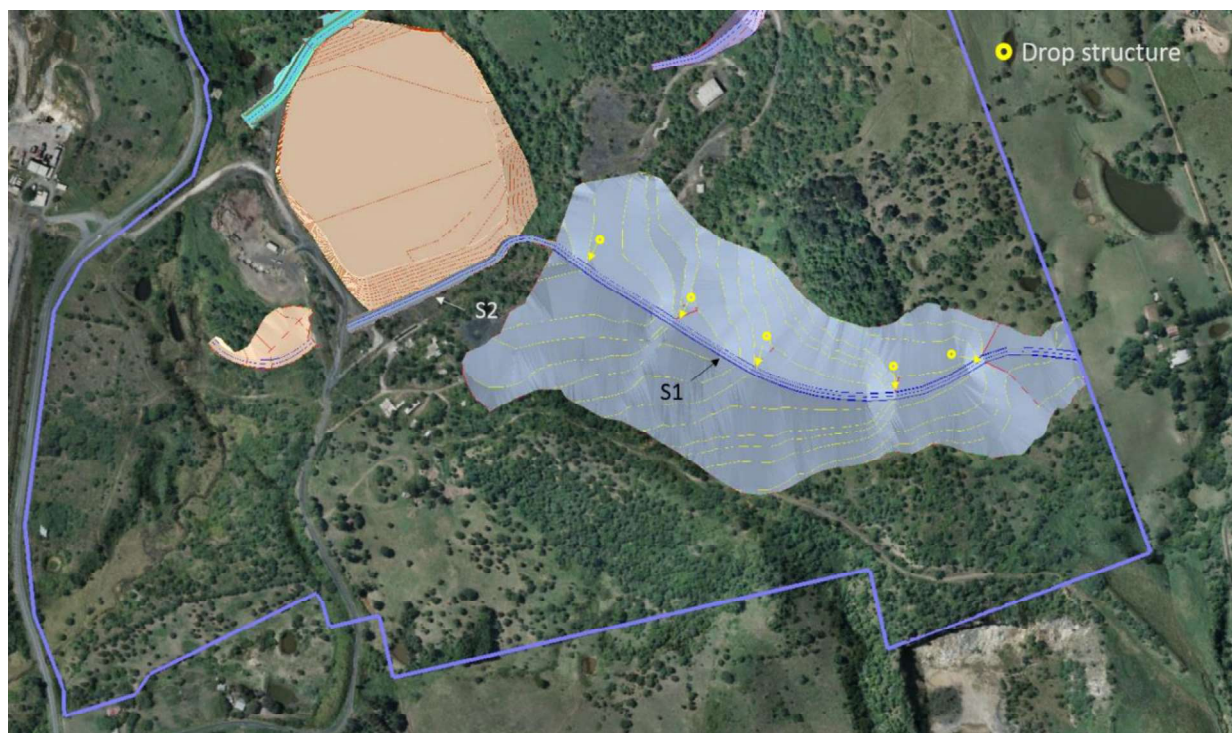
**Figure 5.2 Detailed layout of southern work area showing key features of surface water management in relation to final proposed landform**

The plan focuses on moving only the optimum amount of material required to achieve a sustainable, functional surface drainage system that will meet regulator requirements for relinquishment rather than targeting something approaching the pre-mining condition. The design features for the southern work area are shown in Figure 5.2.

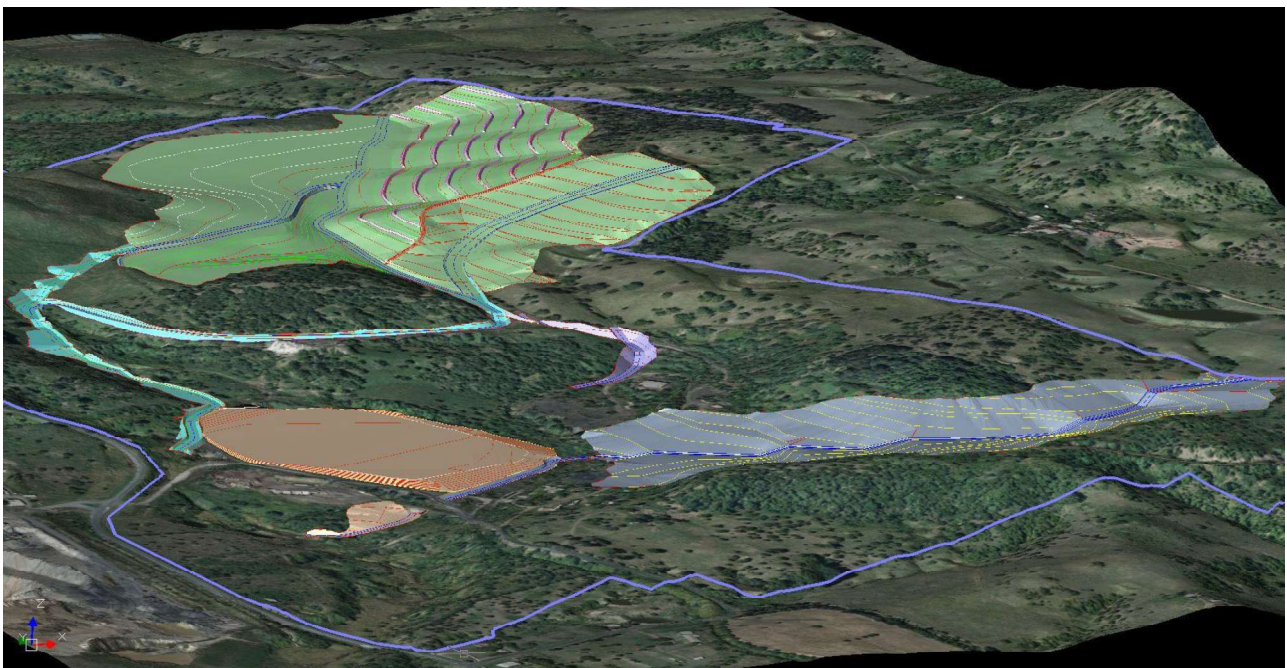
An overall oblique view of the proposed landform showing the works areas for the complete site is provided in Figure 5.3 to give a general perspective of the proposed works. This plan is shown relative to the known area of disturbance associated with the open cut mining. All drainage will leave the site in the south-west corner of the mined area at the lower left of the image.

**Figure 5.3 Oblique representation of final landform proposal looking from south-west**

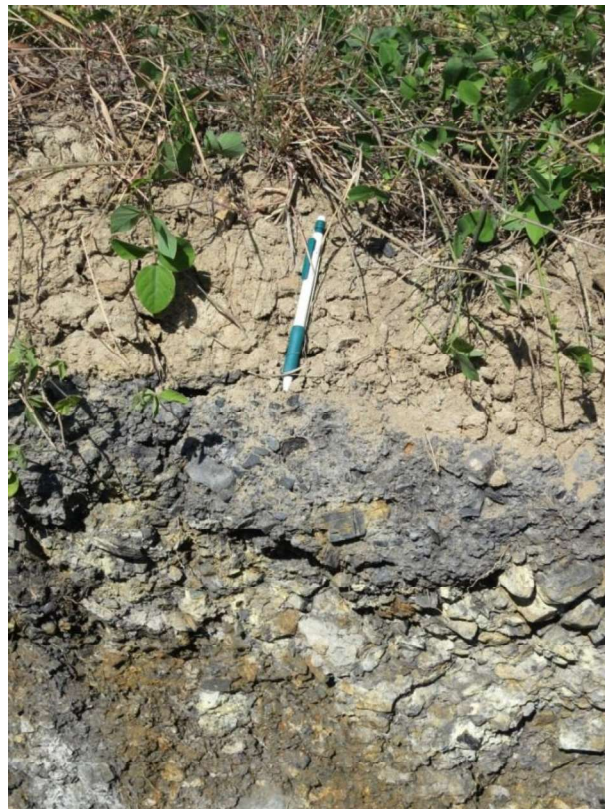
**Figure 6.1 Topdressing on current rehabilitated landform**

Erosion gullies exposing currently rehabilitated spoil suggest that the better quality topdressing may be thicker than 10 cm in places (light brown material in Figure 6.1) though site observations did not indicate that this was a uniform characteristic across the site. Therefore, where there is a visual difference between the upper and lower spoil material suggesting an accumulation of organic matter, the complete upper layer should be stockpiled separately or at least a maximum thickness of 30 cm if deeper to the poorer quality spoil material. This will improve the potential to retain the partially leached top layer that contains a level of biological activity, seed sources and may be somewhat leached of salts for better outcomes. From the limited observations made, it does not appear that rehabilitation and ground cover responses have been as marked as at the Normanton Pit and this may reflect different species selection (e.g. an apparent lack of a legume species in the mix), fertiliser rates and different grazing pressures.

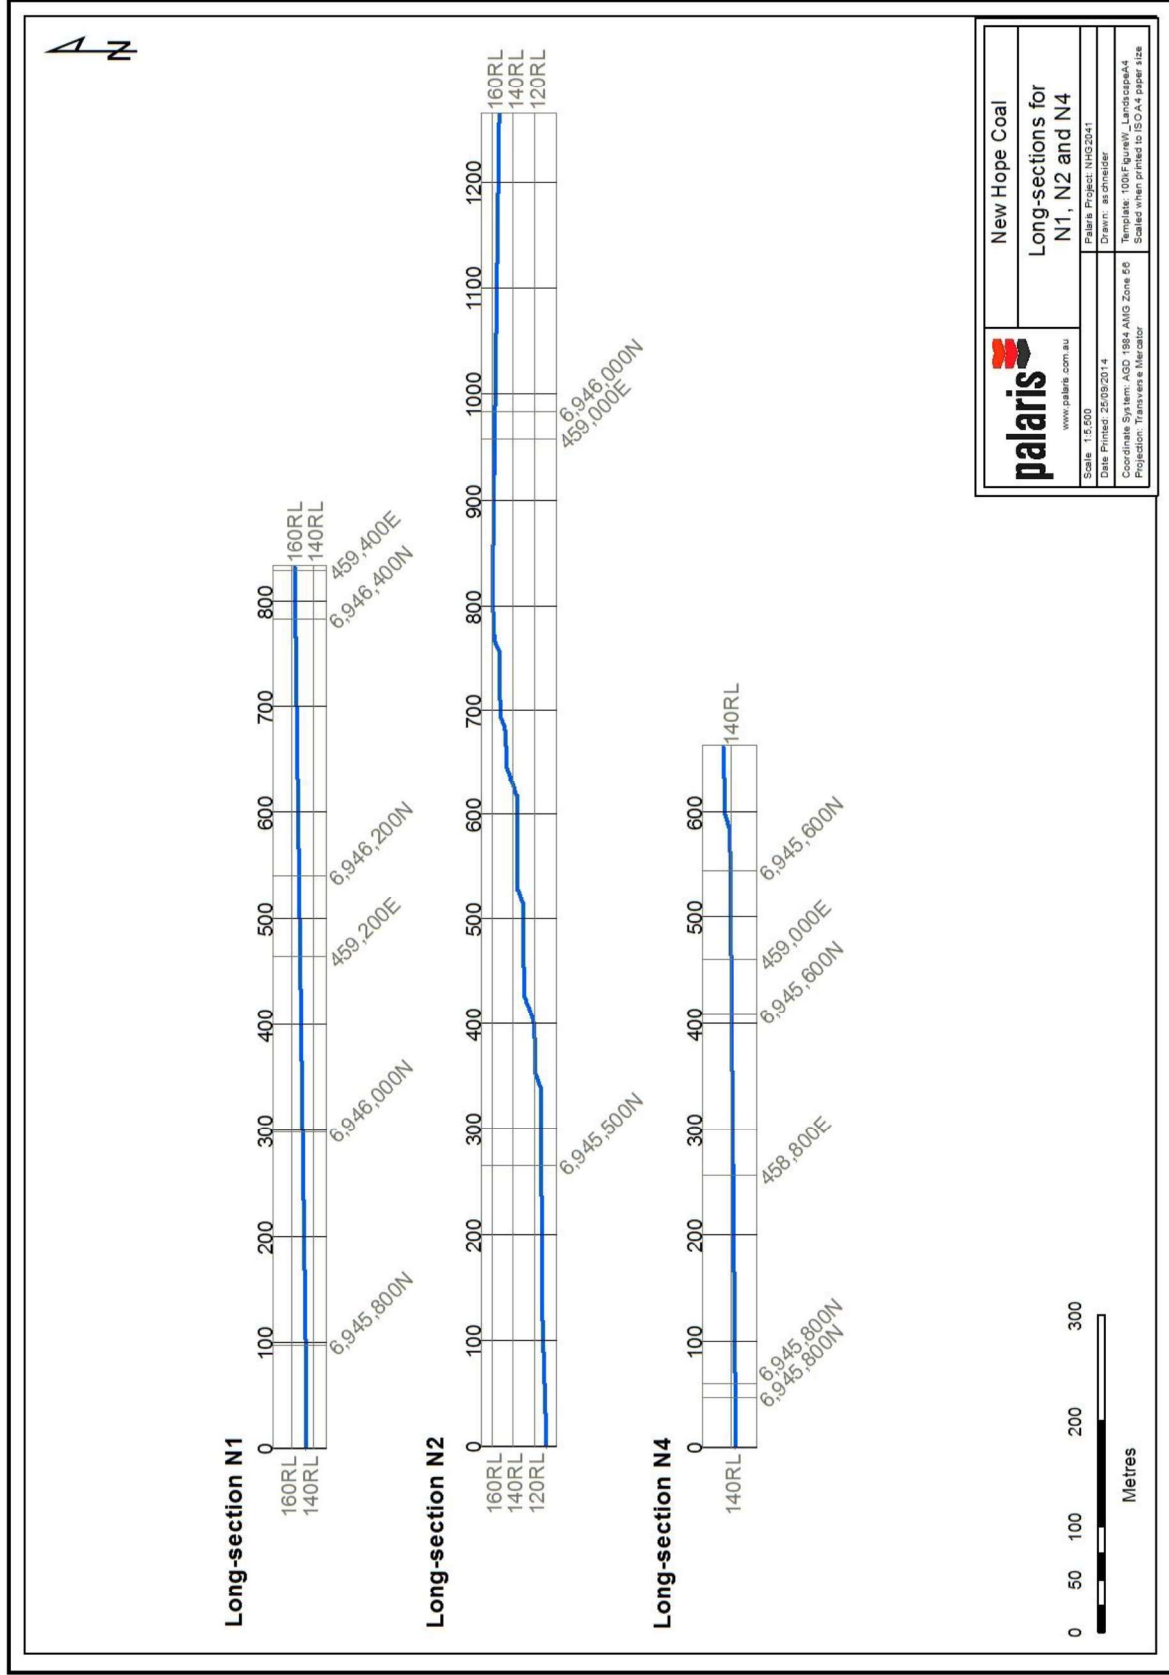
Figure A1 Long-sections for streams in the northern work area (N1, N2, N4)

No drop structures are required in N1 and N3 and a long-section profile is not provided for N3.

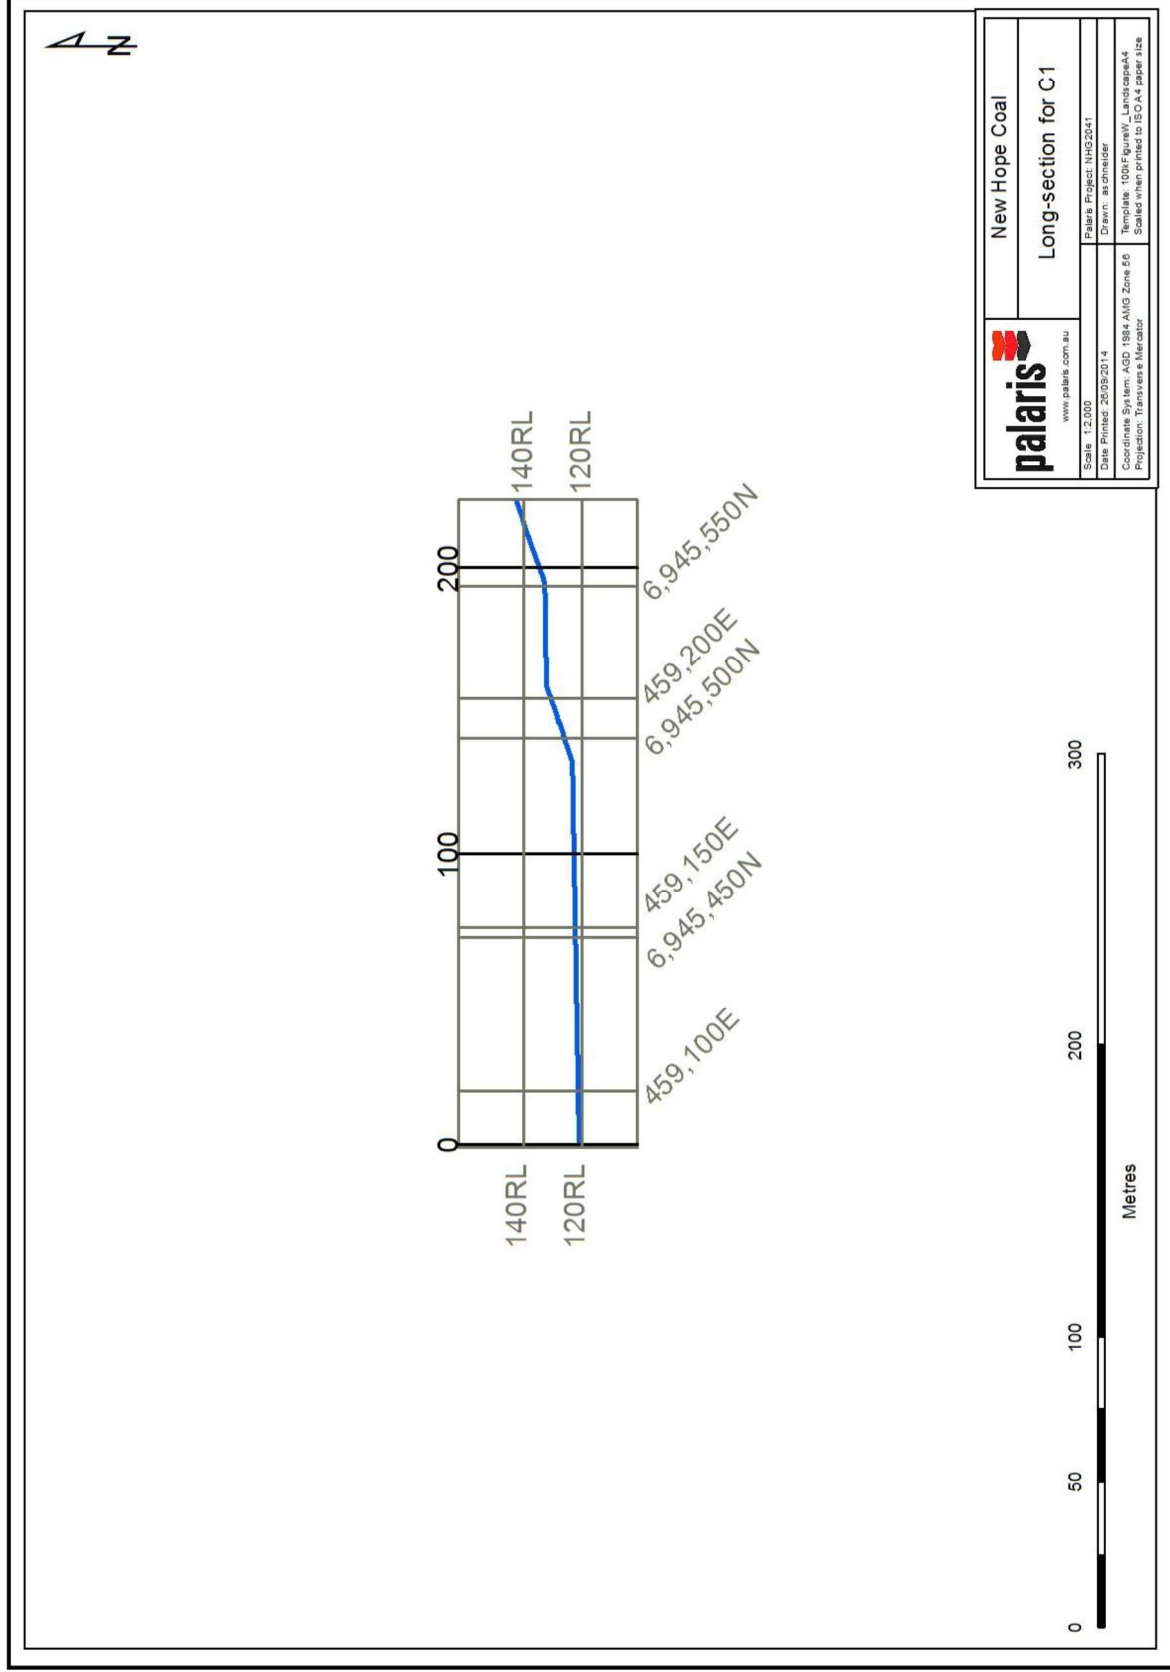
Figure A2 Long-section for stream with drop structures in the central work area (C1)

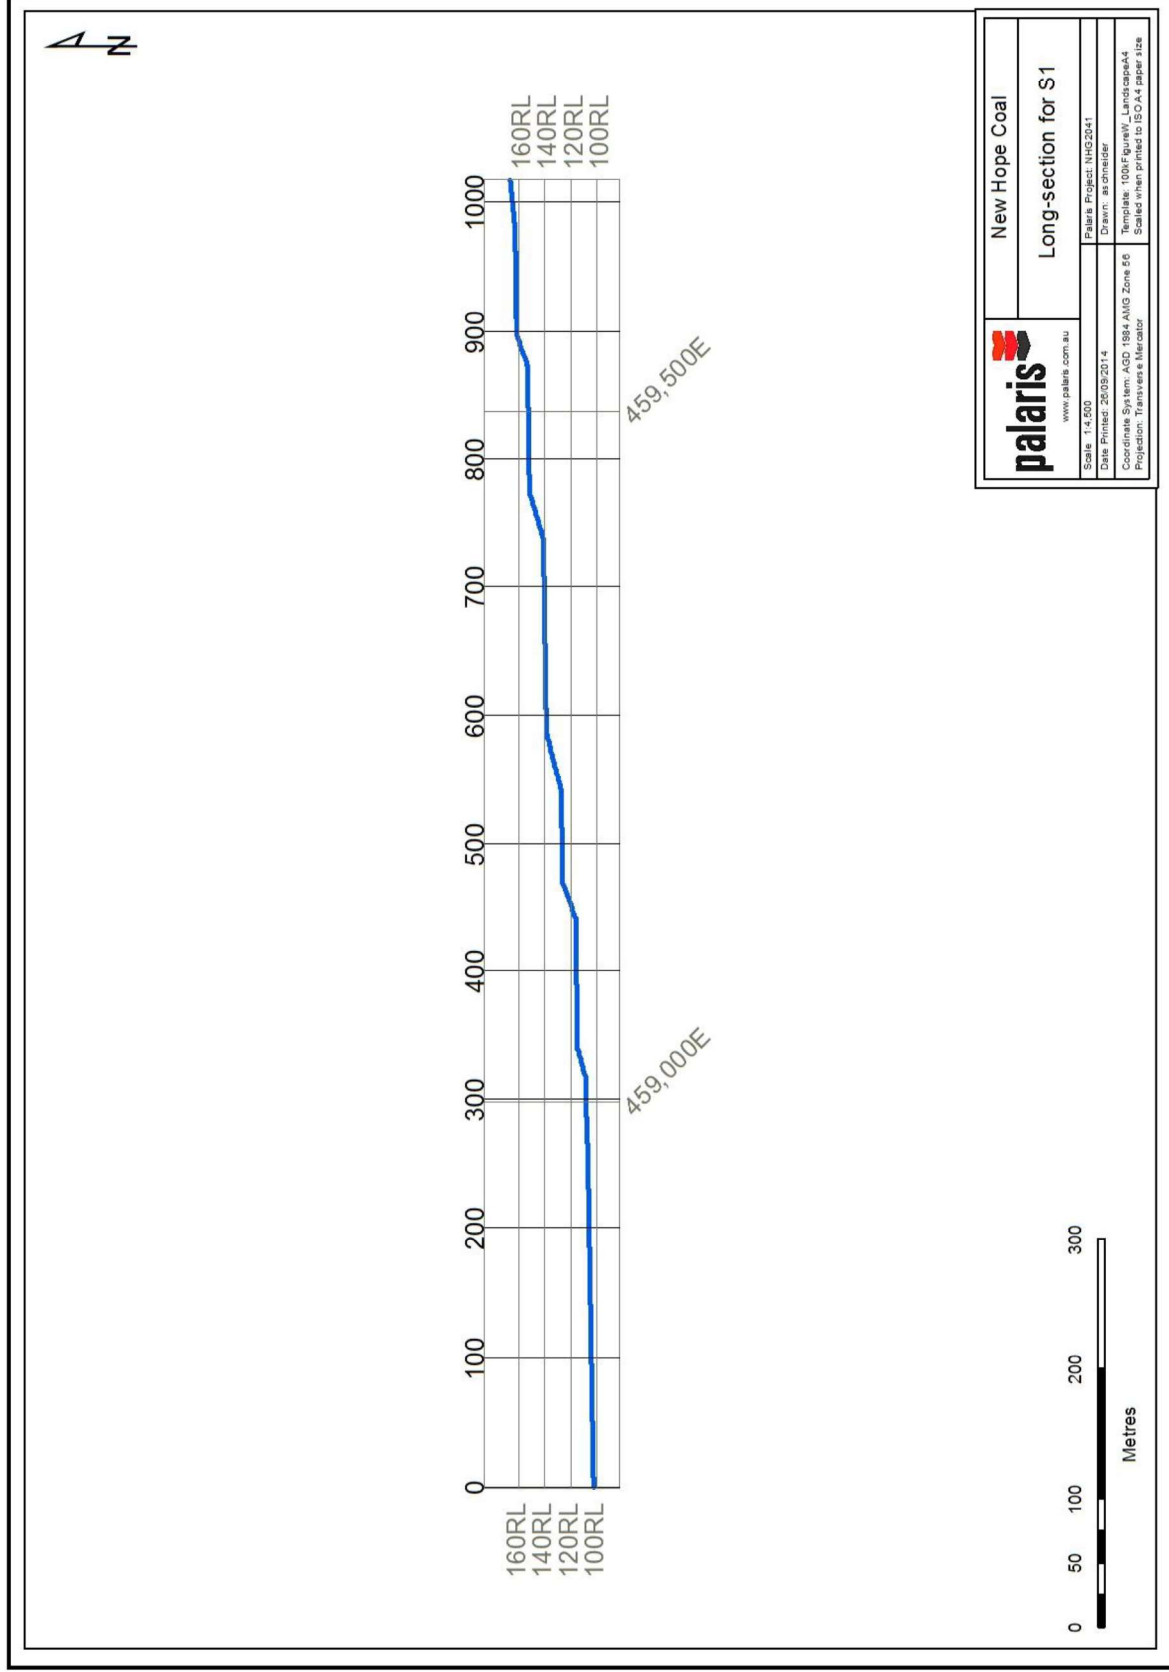
Figure A3 Long-section for stream with drop structures in the southern work area (S1)

For S1 in particular, there is potential to instate shock dams as an additional or alternative means of controlling runoff. The long-sections would assist in determining best locations but at this stage no attempt has been made to indicate positions in the absence of client agreement as to their interest in this approach.

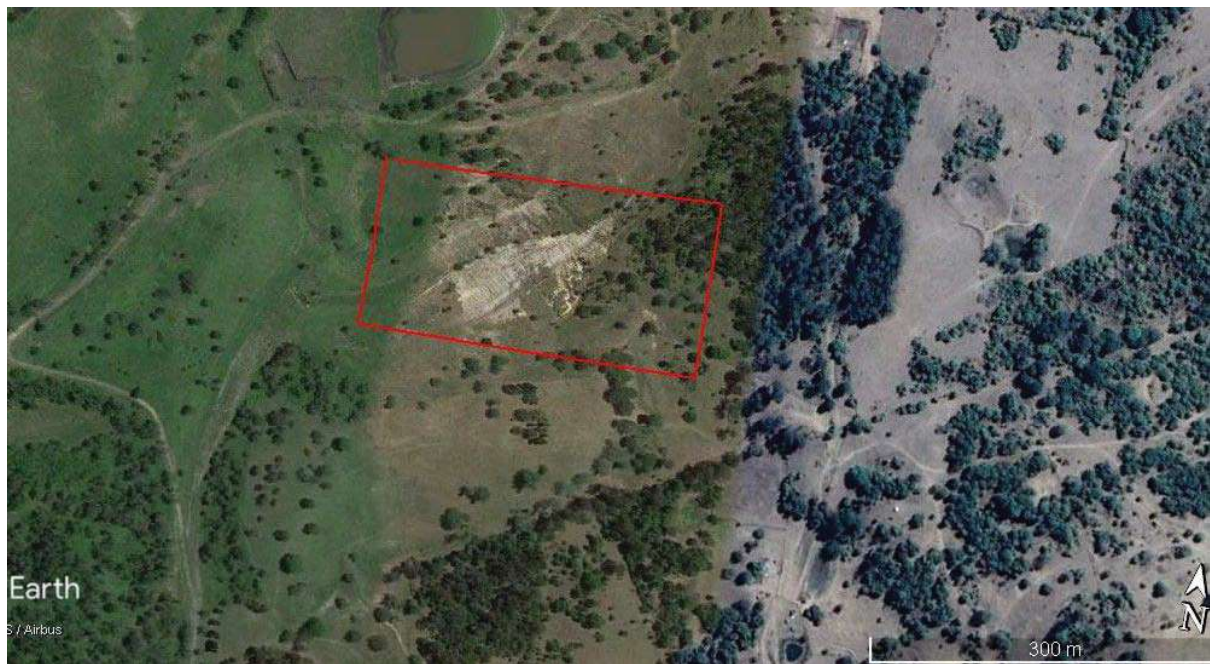
Figure 3.1 Site Aerial (@2020)

**Figure 3.1** presents an aerial view of the site and surrounding former mine area as at 2020.

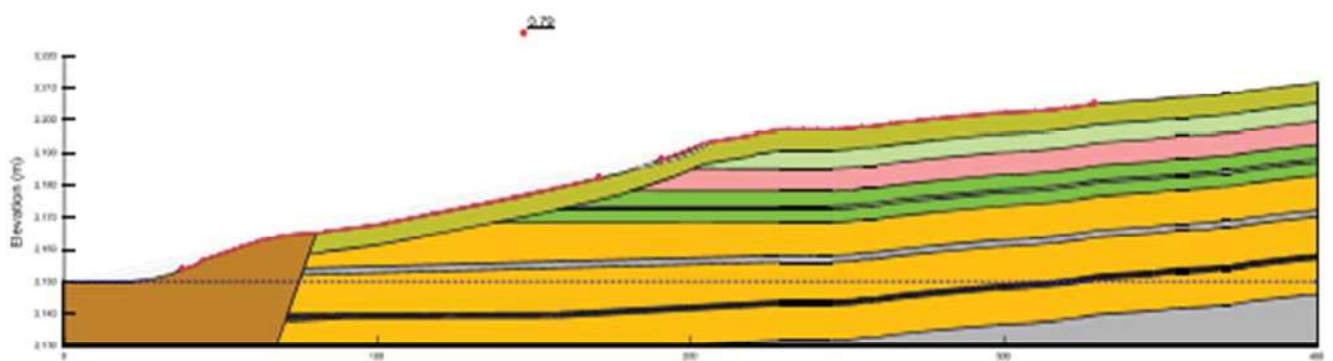
Figure 3.2 Geological X-section (from Knight Piesold)

**Figure 3.2** (from Knight Piesold 2020) presents a diagrammatic cross-sectional representation of the geology of the batter in question.

The Knight Piesold (KP-2020) preliminary stability assessment summarised that the current slope profile did not meet the acceptance criteria for geotechnical stability. Under drained conditions, the failure was indicated as being mobilised through the coal layer, which is largely due to low shear strength parameters indicated by previous testing. In the undrained and post seismic conditions, the instability is characterised by shallow surface slipping, which was considered to be reflective of the current eroded slope condition.

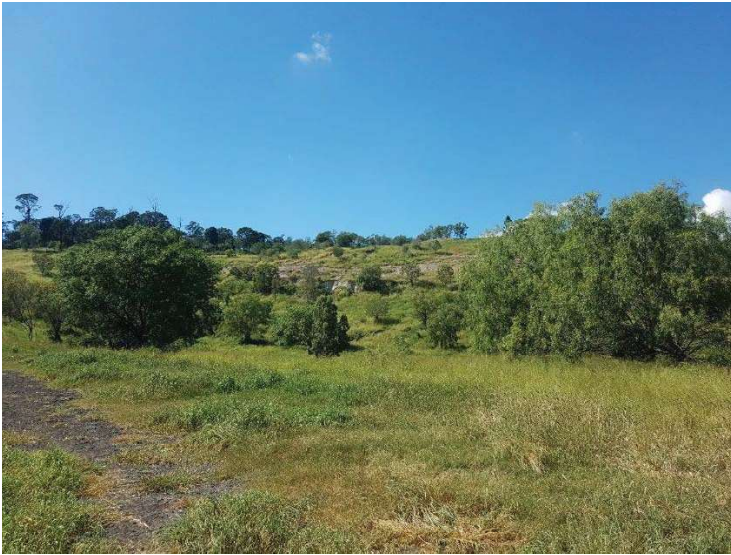
**Plate 1 View to site**

At the time of the site inspection (1 April 2020), a heavy grass and legume cover was evident over most of the rehabilitated landscape. The predominantly bare area of the Northern Highwall (herein Area A - an approximate area of 1ha) is in stark contrast to the surrounding vegetated area (see **Plate 1**). Indeed, the standard of vegetative cover in surrounding lands at the time of inspection was considered to be very good. This includes the steeply sloping spoil placement area to the immediate west of the Northern Highwall (see **Plate 2**).

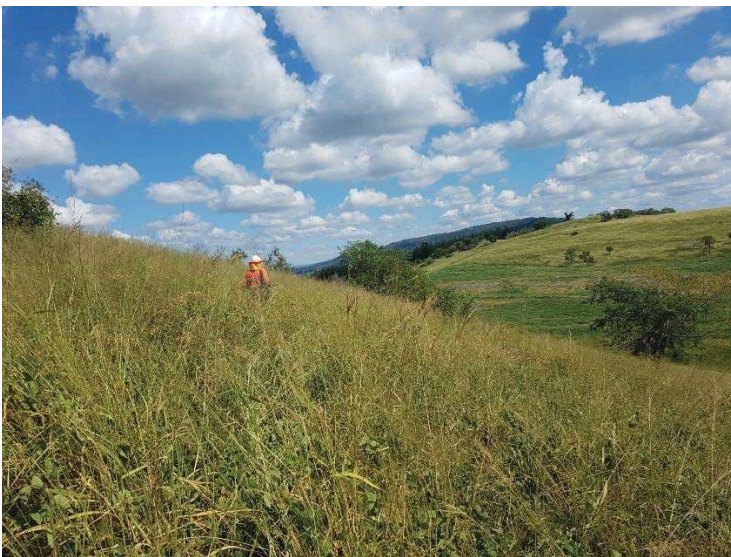
**Plate 2 Rehabilitated slope within Area A**

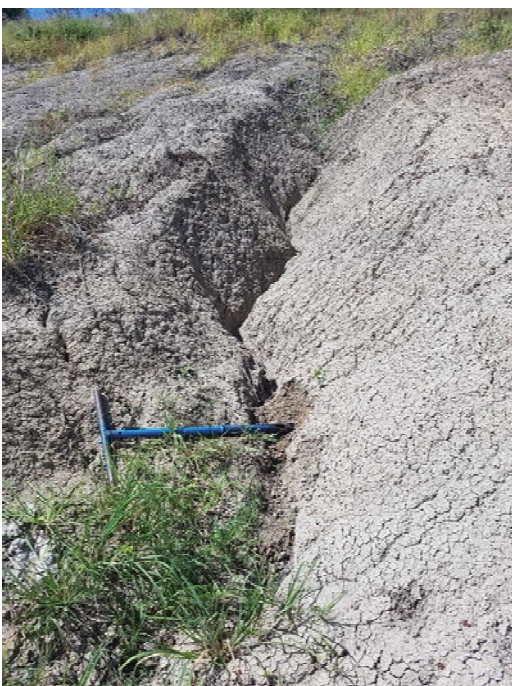
**Plate 3 Gully erosion within Area A**

- Approximately 1.04ha of the Northern Highwall is essentially bare and exposed to erosive forces (Area A – see **Figure 3.3**). Only isolated tussocks of Rhodes grass are present in places. This erosion comprises extensive sheet and rill erosion with intermittent gullying up to 1.5m deep (see **Plate 3**)

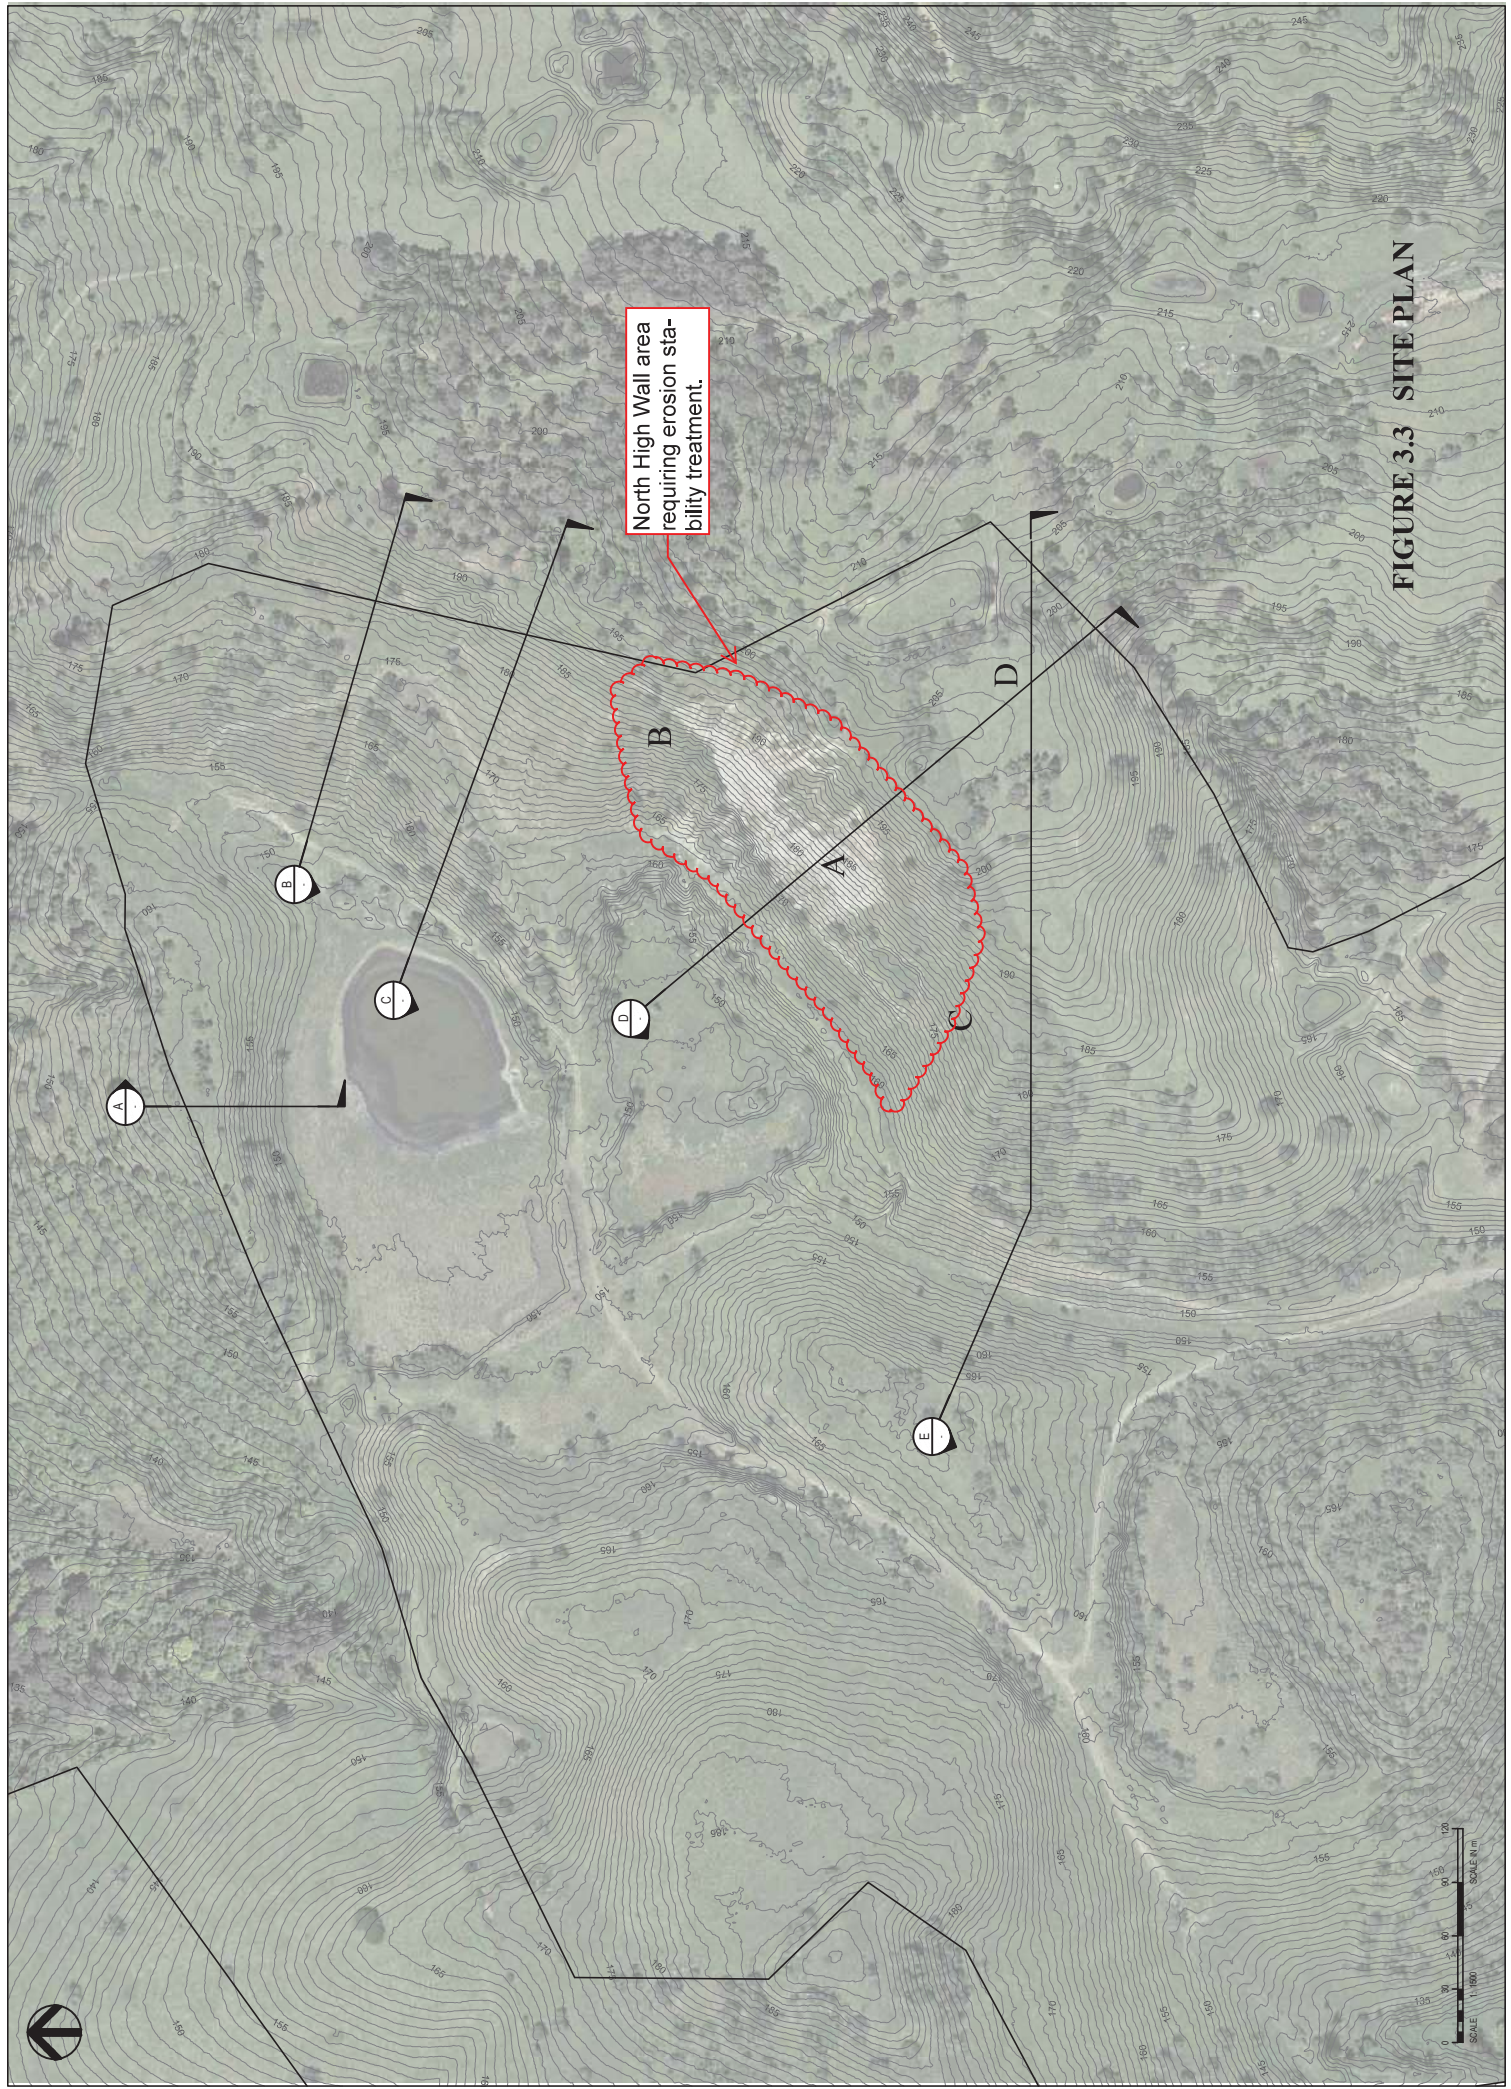
FIGURE 3.3 SITE PLAN

**Figure 3.3** presents the general boundary of the Northern Highwall area that has been previously assessed as in need of erosion stability treatment. This figure also indicates the existing 1m contour interval for the site and surrounds.

- Land to the immediate west of Area A (Area C – refer **Figure 3.3**) is stable with good cover and limited evidence of extensive erosion
- There is minimal lateral extension of the rills and gullies. Erosion caused by runoff from areas upslope of the bare Area A has thus been predominantly due to sheet flow erosive effects. The catchment area above the slope contributing runoff is relatively small with good vegetative cover and the length of overland flow relatively short (generally 50 to 80m)

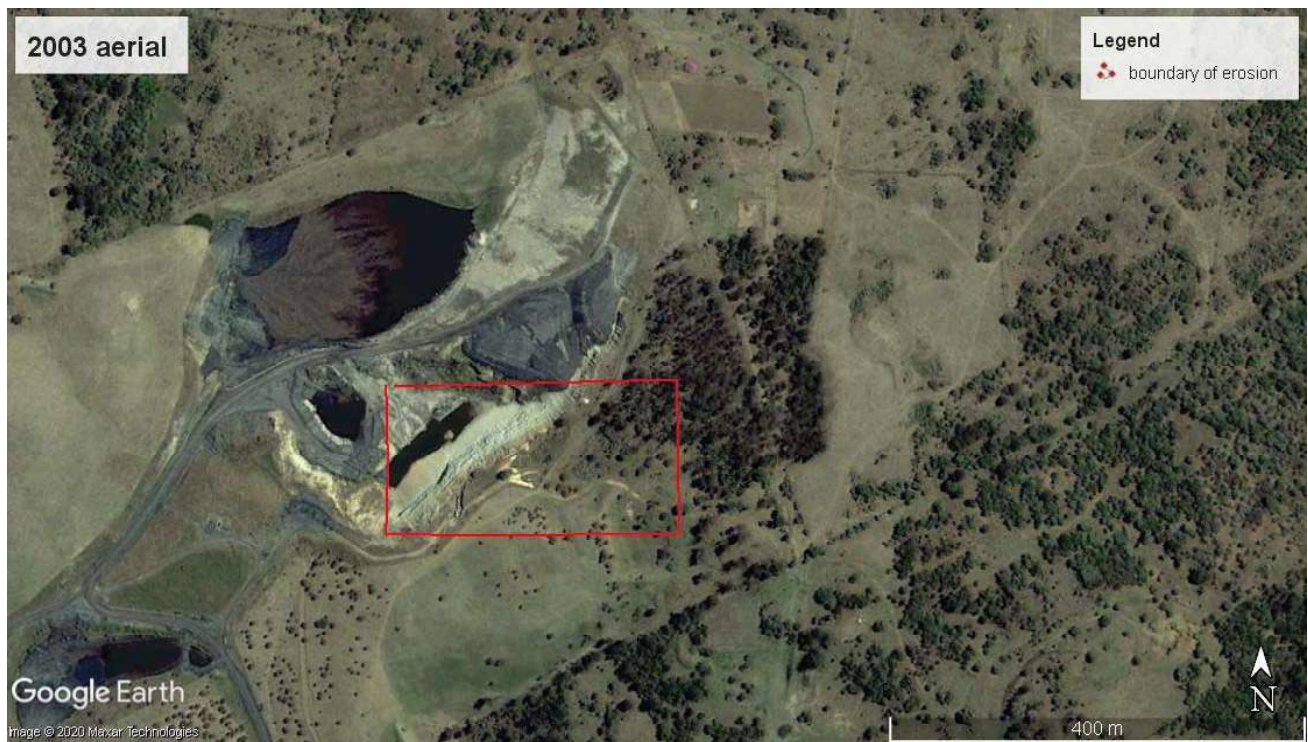
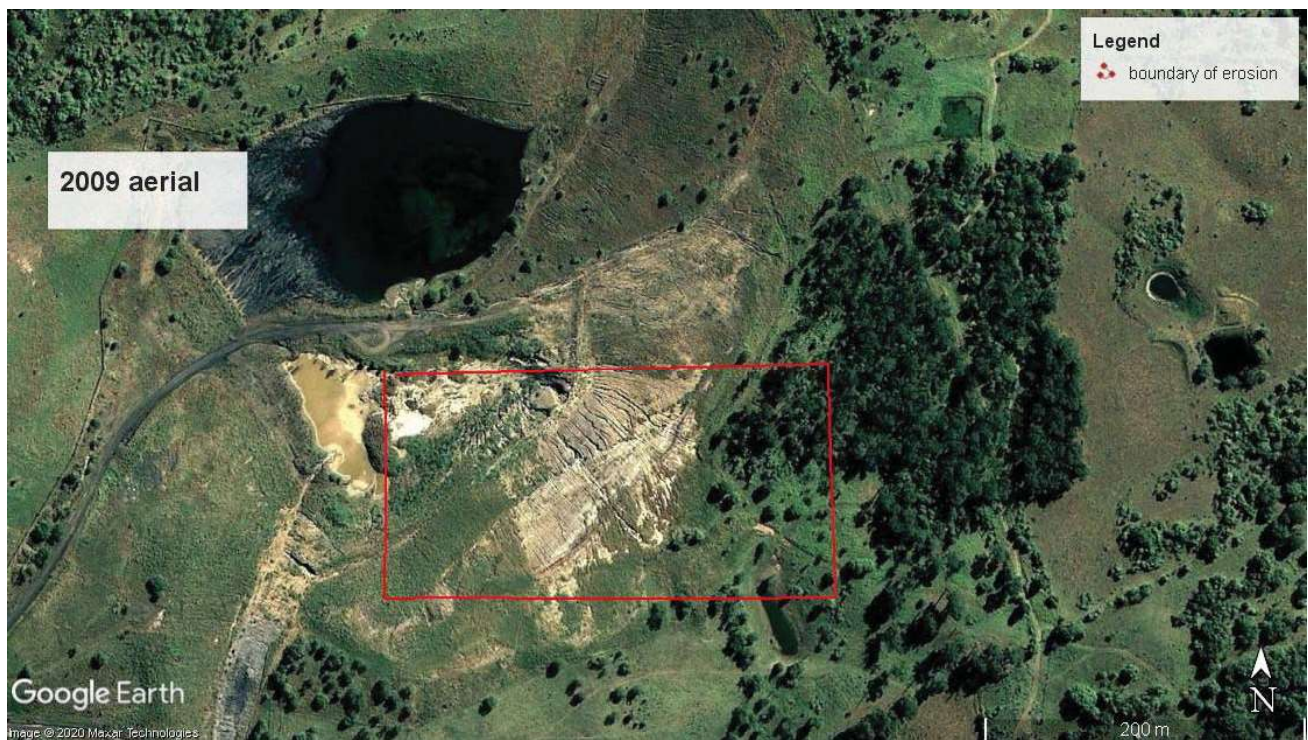
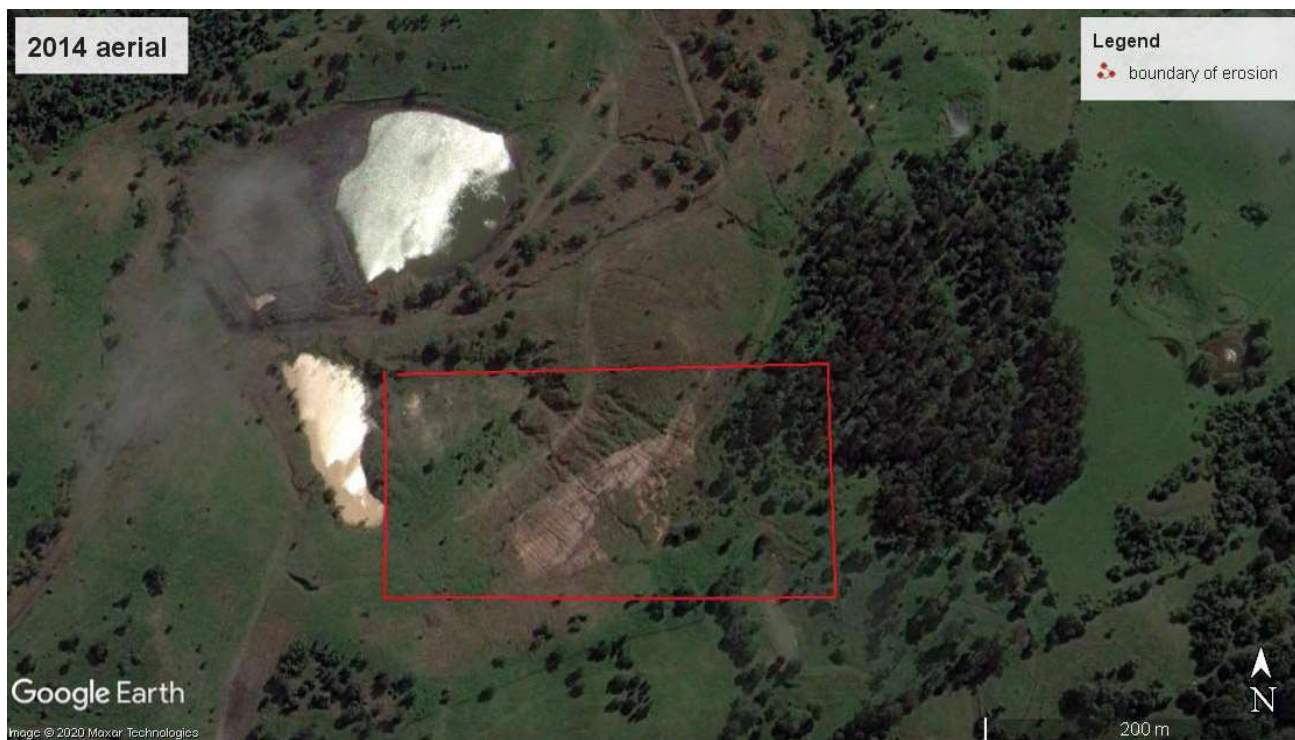
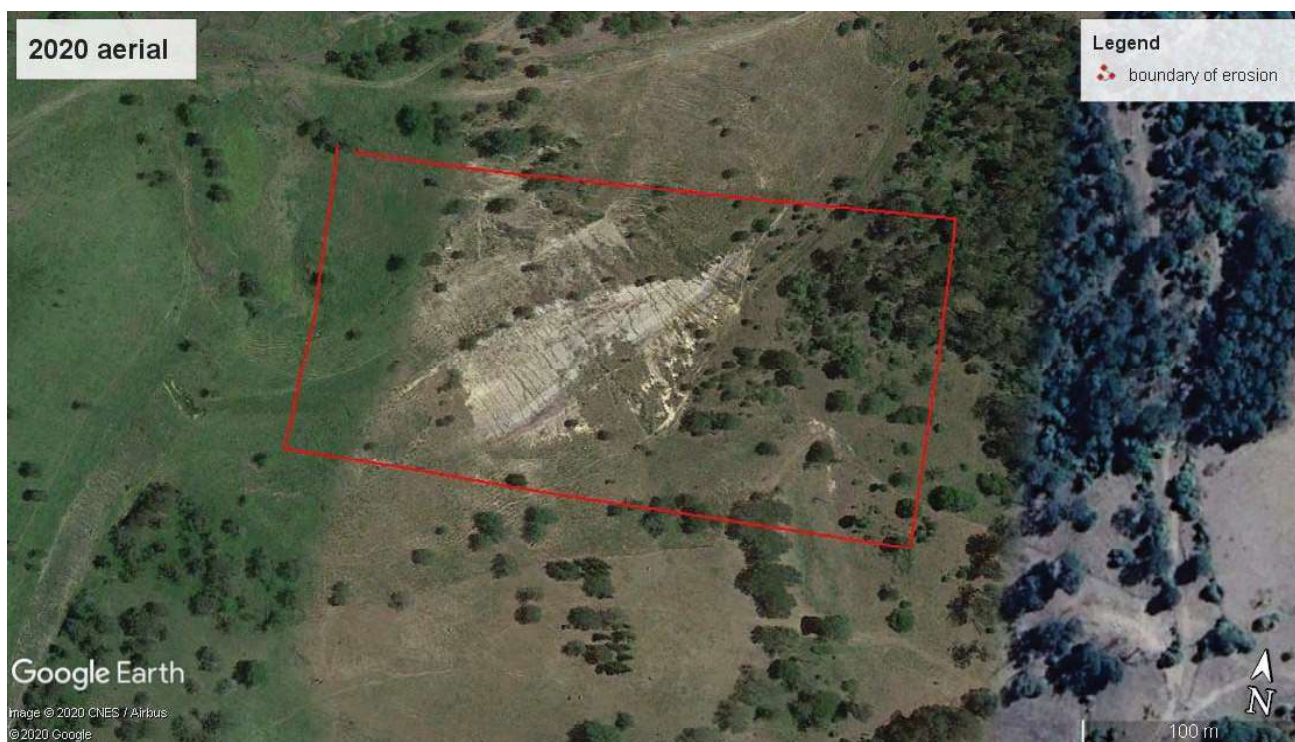
In addition to the assessment of current site conditions, an assessment of changes to the extent of erosion over time has been conducted. This has been based on aerial photography available from 2003 (see **Figure 3.4 (a)**) when mining activities were active and rehabilitation works, including placement and backfilling of spoil over much of the site, had yet to be undertaken.

**Figures 3.4 (b) to (d)** indicate the changes that have occurred since that time for the years 2009, 2014 and 2020.

Figure 3.4 (a to d) Aerial sequence of changes to rehabilitation and erosion (2003-2020)

- There has been substantial colonisation of pasture over much of the site (*eg* Area C)
- the most severely eroded area (Area A) has shown little change in aerial extent
- The severity of erosion with Area A and adjacent land has shown minor change over time.
