# New Oakleigh Normanton Pit and East and North Drains

Summary Design Report

BEN862-TD-EV-REP-0001 Rev. 0

The sole purpose of this document and the associated services performed by Kellogg Brown & Root Pty Ltd (KBR) is to provide a Design and Documentation for the final landforms for the Normanton Pit and East and North Drains components of former New Oakleigh mine.

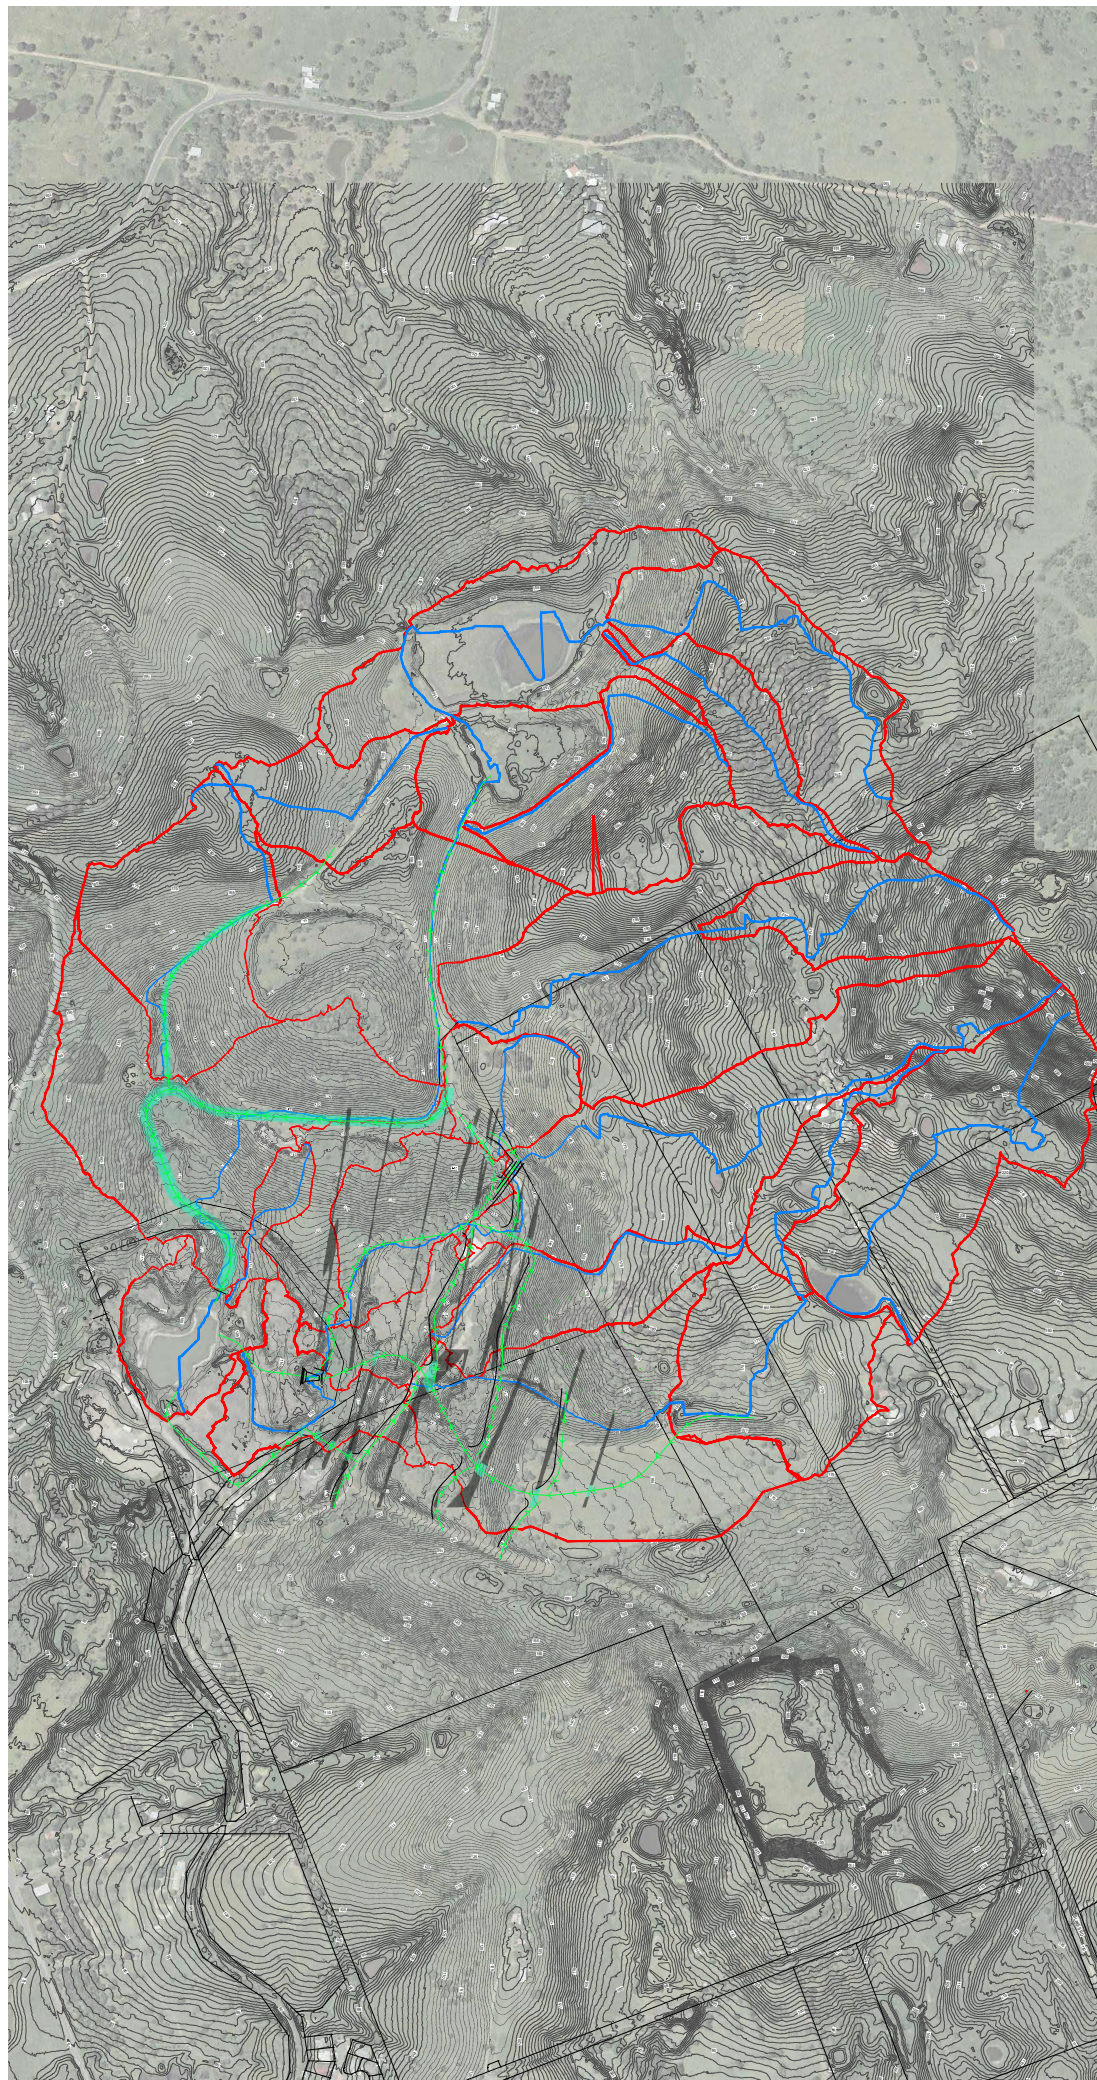
NEW HOPE GROUP  
REHABILITATION PLAN - NEW OAKLEIGH  
EAST DRAIN  
CATCHMENT PLAN

- CATCHMENT BOUNDARY
- STREAM
- EXISTING CONTOURS (1.0m INTERVAL)

PLAN  
SCALE 1:4000 (A1)

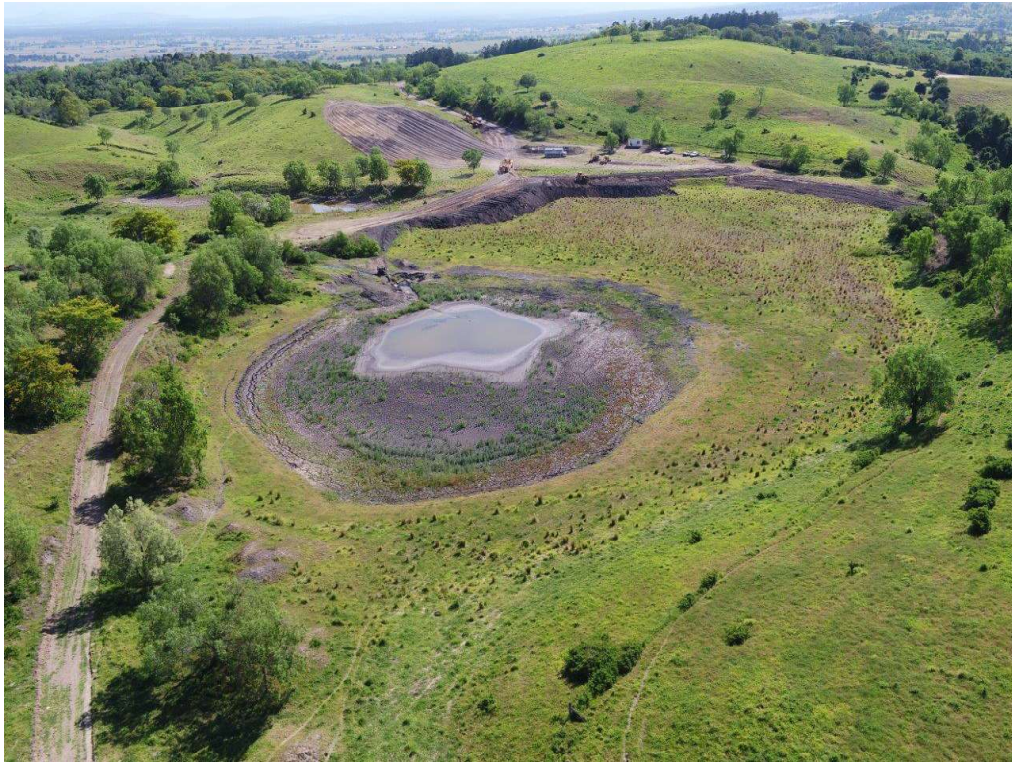
Oakleigh East – Tailings Dam Capping Operations

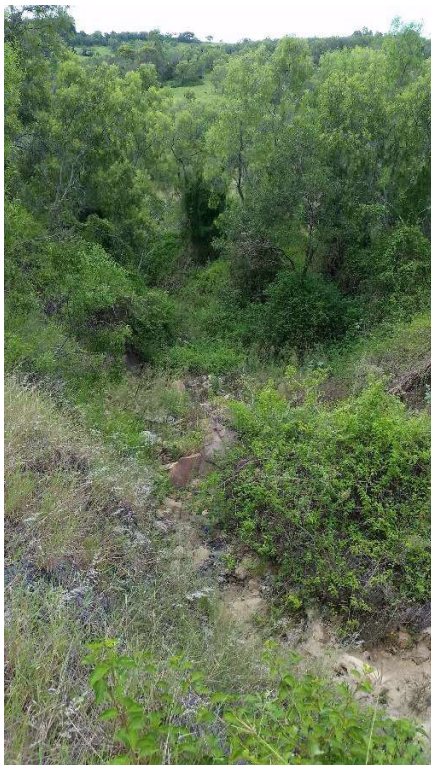
Oakleigh East - Washdown Dam Outlet

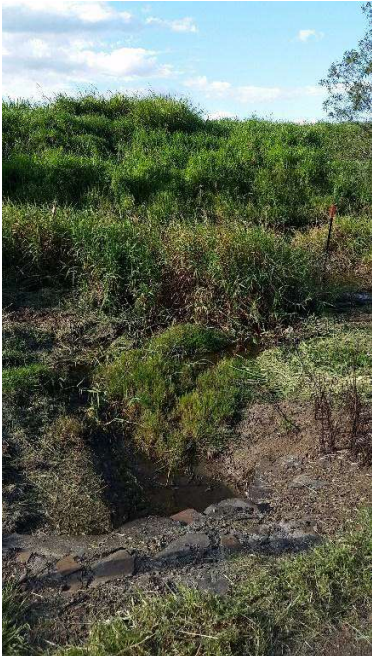
Normanton – Blakes Road Outlet

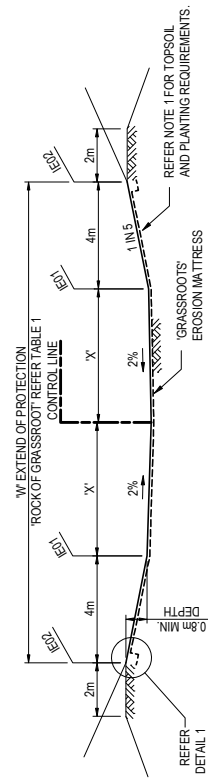
DRAIN TYPICAL SECTION (DR01 - DR04)  
SCALE 1:100

## TOPSOIL & PLANTING NOTE:

1. EROSION MATRESS TO BE INSTALLED OVER 150mm TO 300mm OF FERTILIZED TOPSOIL
2. TOPSOIL TREATMENT AND PLANTING SEED TYPE AND DENSITY TO BE IN ACCORDANCE WITH PLANTING SPECIFICATIONS.

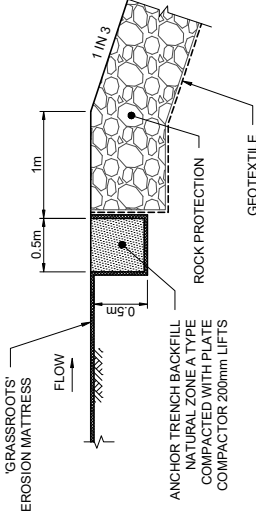
GRASS-ROOT / ROCK ARMOUR TIE IN DETAIL

DISSIPATION POOL DETAIL

Grassroots is an Australian-made permanent Rolled Erosion Control Product (RECP) made from heavy synthetic UV-stabilised fibres which are needle-punched together into an open weave synthetic scrim creating a three-dimensional structure. Grassroots has been designed to protect underlying soil in steep slopes and channels from moderate velocity water flows, rainsplash and other erosive conditions, while allowing seeds to germinate successfully and grow through the matting providing permanent vegetative reinforcement.

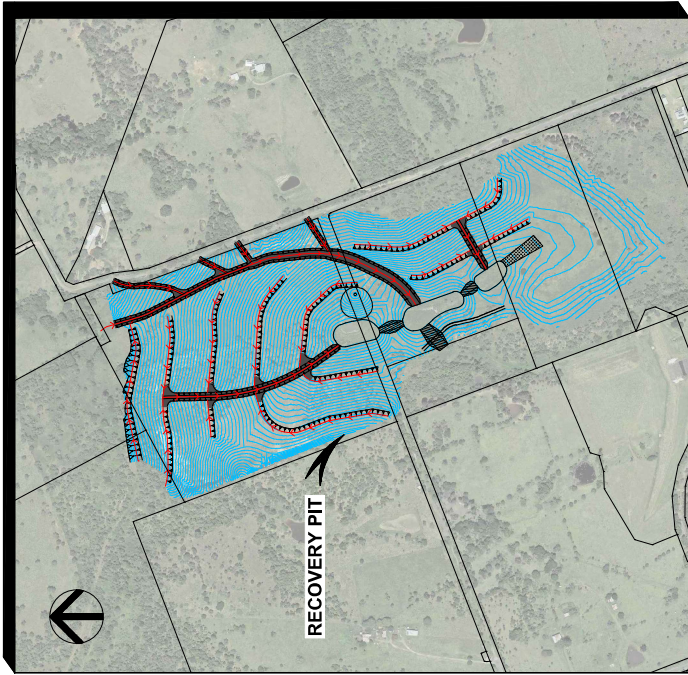
LAYOUT PLAN  
N.T.S.

## RECOVERY PIT

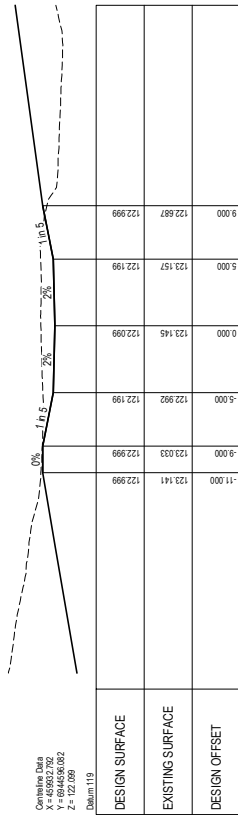
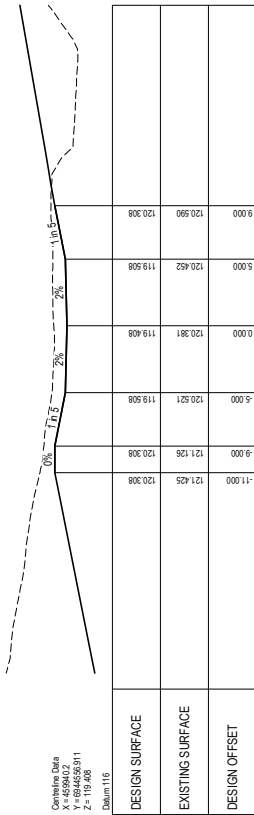
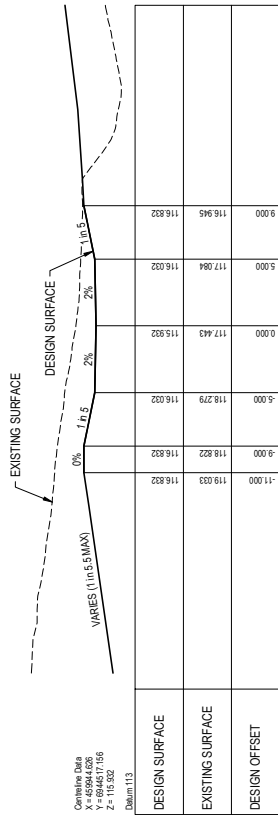
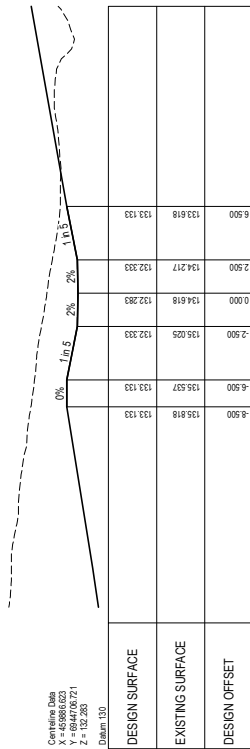
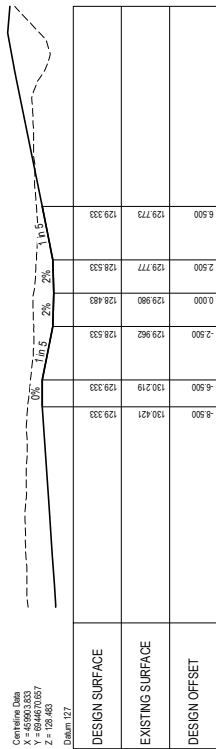
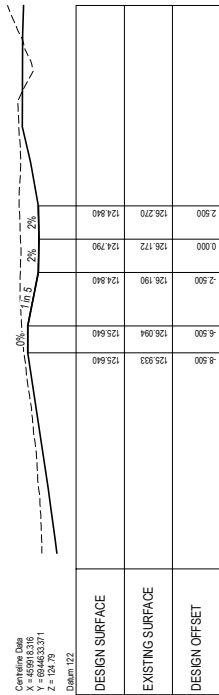
| TITLE<br>NEW HOPE GROUP<br>REHABILITATION PLAN - NEW OAKLEIGH<br>RECOVERY PIT<br>CROSS SECTIONS DR01 - SHEET 2 | DRAWING No.<br>BEN862-DW-CV-CSX-1002 |

## 1. PART SECTIONS SHOWN FOR CLARITY

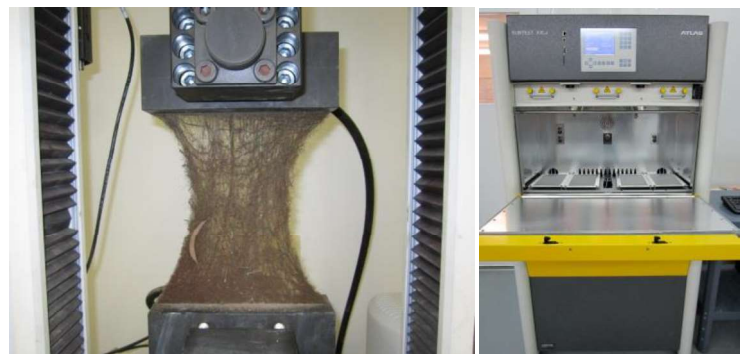
#### PERMISSIBLE SHEAR AND CHANNEL EROSION – ASTM D7207

Grassroots has been used successfully in many channel lining and road edge rehabilitation applications requiring increased resistance to soil loss as a result of hydraulically-induced shear stresses. Grassroots has been tested according to ASTM D7207 *Determination of Unvegetated Rolled Erosion Control Product (RECP) Ability to Protect Sand from Hydraulically-Induced Shear Stresses under Bench-Scale Conditions* which subjects containers with bare soil and containers with Grassroots-protected soil to shear stresses caused by the rotation of an impeller while fully immersed in water. Unvegetated tests show Grassroots is able to provide a reduction in soil loss to <13mm under shear stresses up to 180N/m<sup>2</sup>.

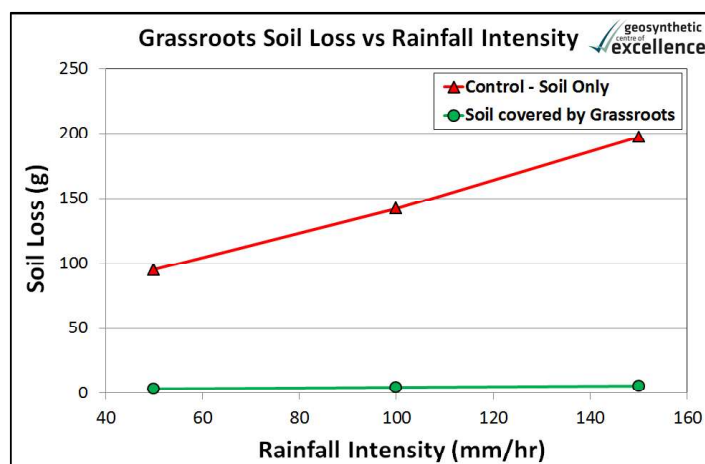
#### RAIN SPLASH PROTECTION – ASTM D7101

One of the primary design characteristics of an RECP is to reduce the loss of soil during rainfall events. ASTM D7101 *Determination of Unvegetated Rolled Erosion Control Product (RECP) Ability to Protect Soil from Rain Splash and Associated Runoff under Bench-Scale Conditions* determines the soil loss ratio by comparing the loss of soil with and without an RECP using different rainfall intensities. As seen below, Grassroots provides an excellent barrier against soil loss even during heavy rainfall events.

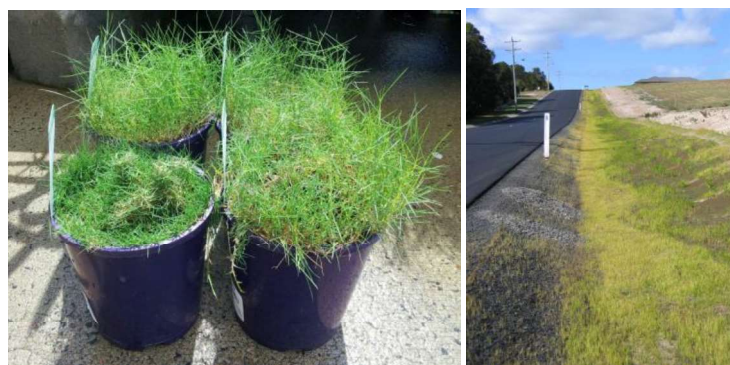
#### GERMINATION ENHANCEMENT – ASTM D7322

Another important feature of RECP's is their ability to provide an enhanced long-term structure to assist with seed germination and reinforcement to the vegetation throughout maturation. Grassroots has been tested according to ASTM D7322 *Determination of Rolled Erosion Control Product (RECP) Ability to Encourage Seed Germination and Plant Growth under Bench-Scale Conditions* in which "containers containing soil are sown with seeds and then covered with an RECP. Additional containers of soil are sown with seed and left uncovered as controls. The light, temperature and humidity are maintained and documented. The amount of germination and growth is measured periodically throughout the test, and the mass of vegetation is calculated at the conclusion of the test" (ASTM D7322, Section 4.1). Using this method, Grassroots showed a 555% increase in biomass after 21 days when compared with the control pots.

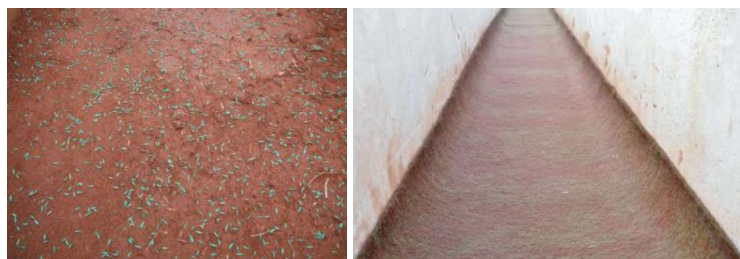
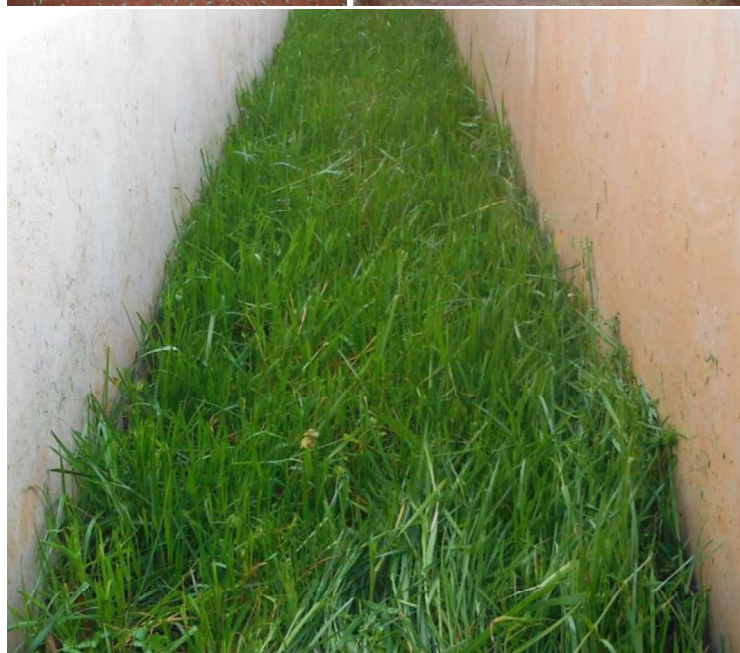
#### LARGE SCALE VEGETATED CHANNEL TESTING – ASTM D6460

A 300mm deep compacted soil bed was constructed in a 0.6m wide x 12.2m long flume on a 20% slope. Grass seed was sprinkled at a prescribed rate directly on top of the soil, followed by a sample of Grassroots, which was anchored at 0.3m intervals. The channel was then left for 6 months to allow the grass to establish through the sample.

The analysis determines the maximum hydraulic forces that may be exerted on an RECP as a flexible channel liner in a vegetated condition. An RECP is considered to have failed once the average soil loss under the product has exceeded 12.7mm. During the execution of each test, flow velocity, flow depth and discharge are measured. At the conclusion of each test, the topography of the bed surface is quantified to determine the net erosion over the system. At the conclusion of the series of flows, shear stress (tractive force) is computed and compared to the soil loss measured. Evaluation of the data allows for a determination of the maximum shear stress and velocity achieved prior to 12.7mm of soil loss. Further, the resistance to flow (roughness, quantified as Manning's 'n') is computed from test data.

Four levels of flow were used in the analysis, each running for 60 minutes, up to flow velocities of 7.5 m/s. Even after subjecting the channel to increasing levels of flow, there was an insignificant loss of soil and vegetation.

ASTM D6460 Standard Test Method for Determination of Rolled Erosion Control Product (RECP) Performance in Protecting Earthen Channels from Stormwater-Induced Erosion models and examines conditions typically found on construction sites involving earthwork activities, including: highways and roads; airports; residential, commercial and industrial developments; pipelines, mines, and landfills; golf courses; etc.

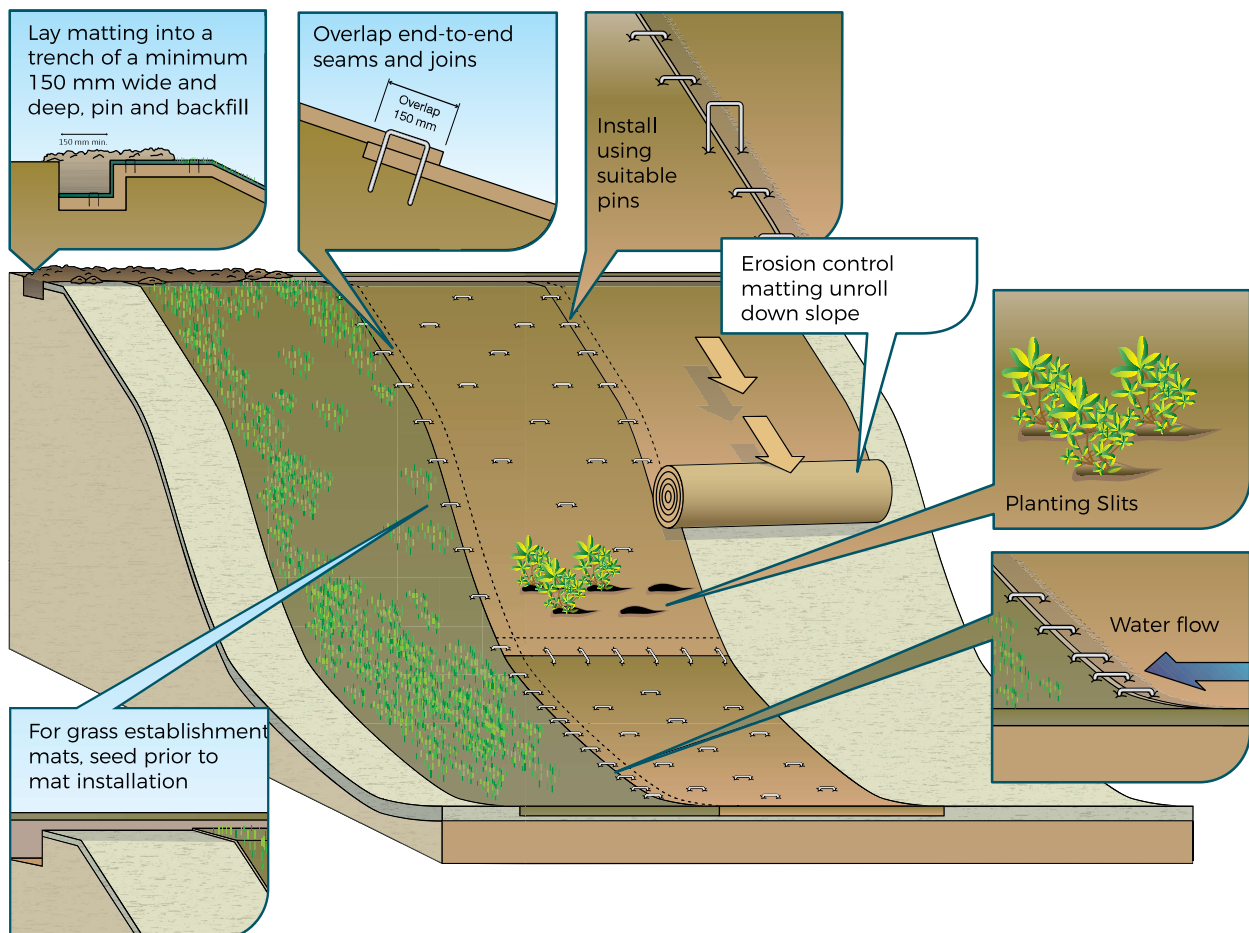
- The material should be rolled from top to bottom of steep batters, as opposed to across the batter. The material may sag between fastening pins if laid across steep slopes.
- Minimum overlap of 150 mm is recommended. Overlaps should be pinned at 300 mm intervals.
- The matting should be laid down the flow line in swale drains. The leading edges should be trenched and overlaps must follow the flow line downstream.
- Sites subject to flooding require the laying pattern to mimic a fish-scale pattern. The material should be laid so that the leading edges are not exposed to water flow.
- Do not pull the material tightly across the soil surface. Allow it to contour to the soil profile and into undulations. This allows the material to settle and bond with the topsoil.
- If the site requires the matting to be laid across slopes, then the top edge should be trenched and pinned at a higher rate.

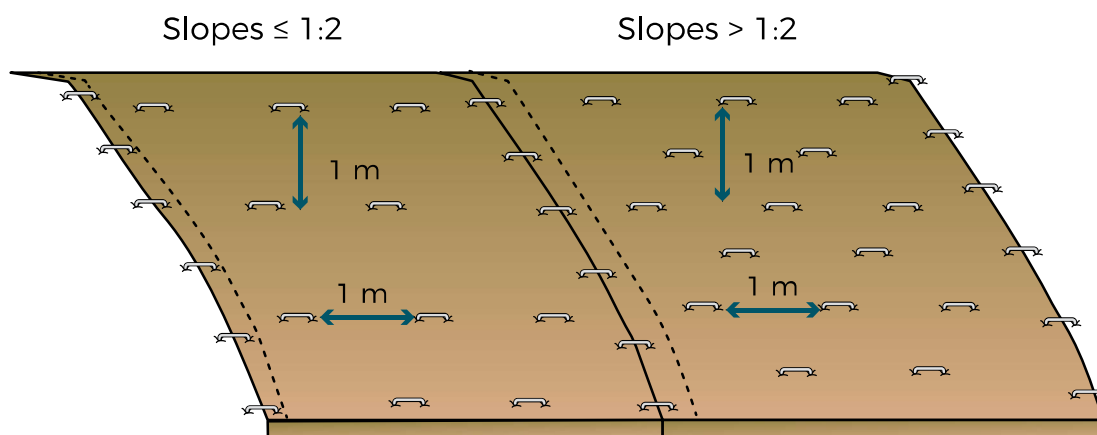
## PINNING

- Minimum pinning frequency is shown in the figures below.
- Additional pinning may be required in undulating soil with low spots to ensure intimate contact between mat and soil.
- On steeper batters, flooding areas or areas prone to high wind and unstable subsoils, a higher pinning rate should be used.
- Pinning is extremely important to the long-term stability of the matting. Insufficient pinning may result in the material lifting in the wind or under water flow.
- Pin type and size will depend on site conditions, soil depth, compaction, wind and water flow. For suggested pins sizes, please refer to the designer. Contact Geofabrics for options available in your area.
