# New Oakleigh Normanton Pit and East and North Drains

Summary Design Report

BEN862-TD-EV-REP-0001 Rev. 0

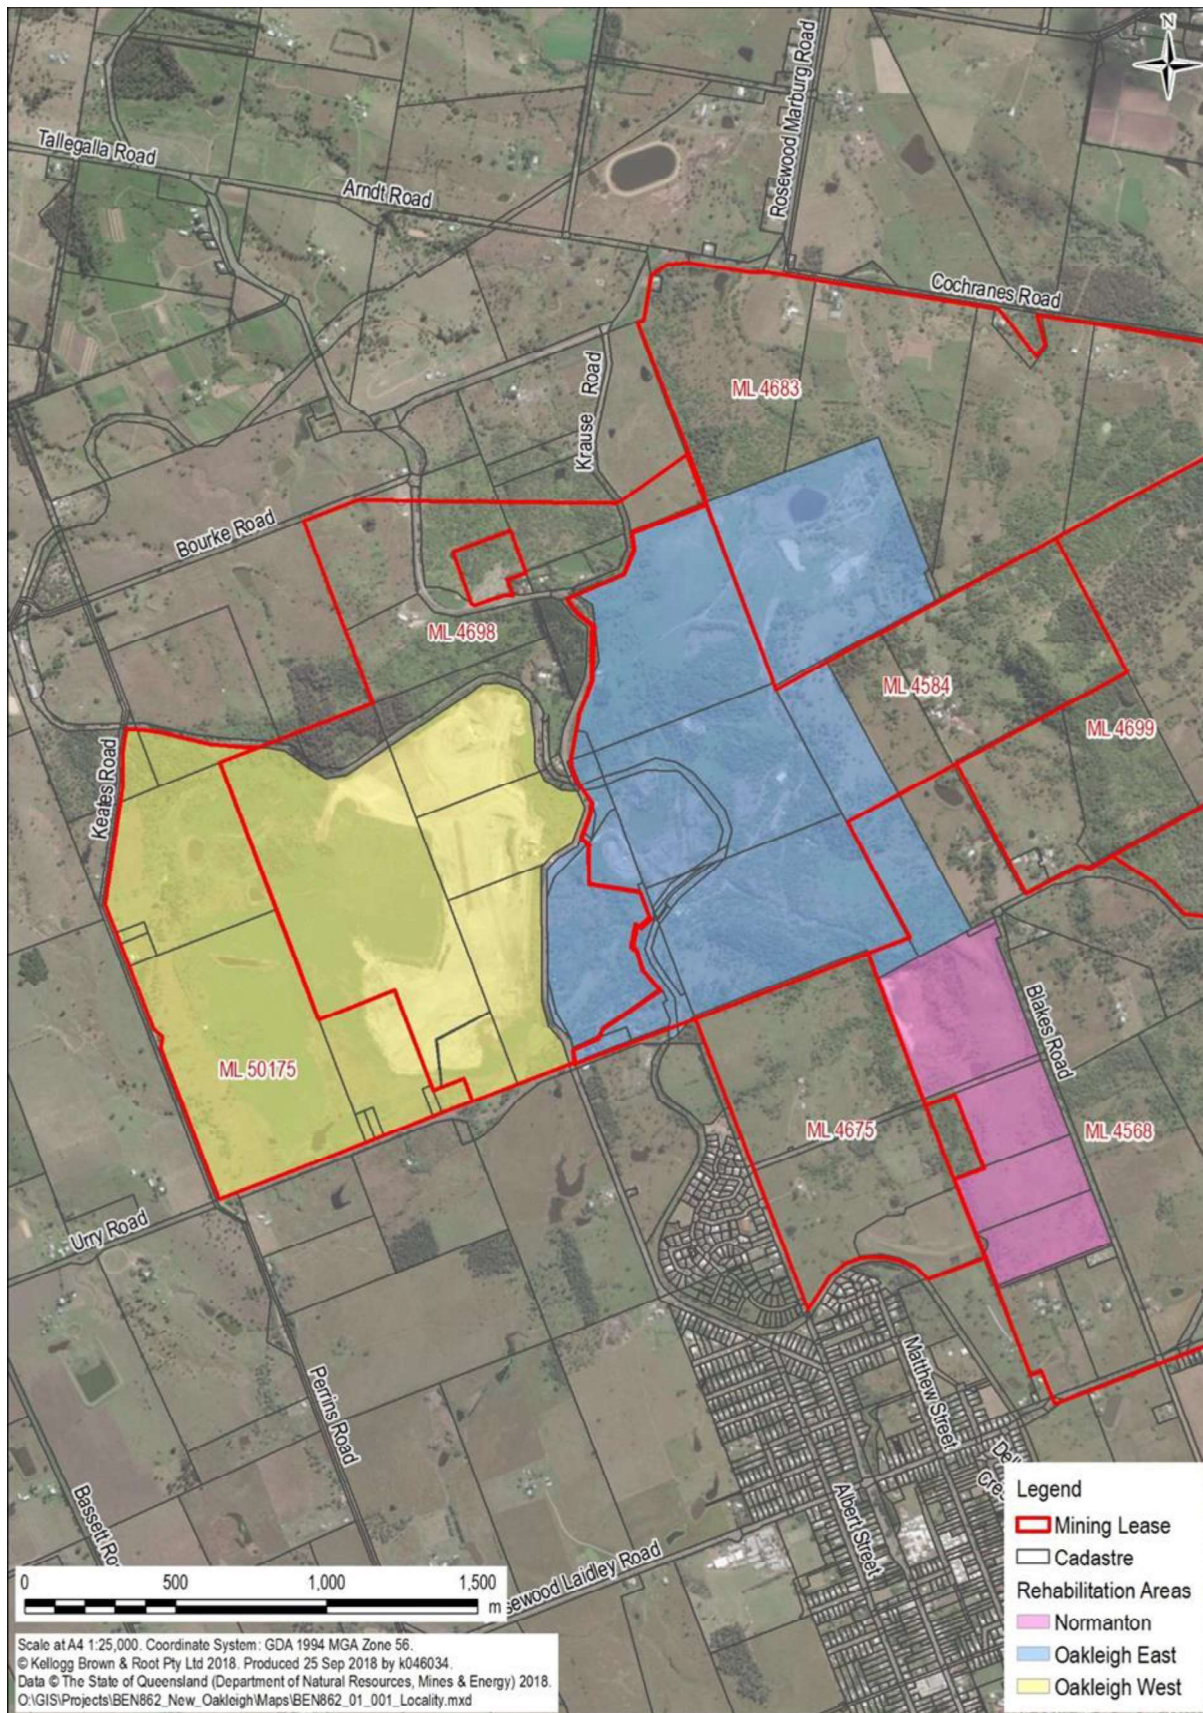
Figure 1.1 Oakleigh East and Normanton Battery Limits

Design is limited to Oakleigh East and Normanton areas within surface rights and existing mining lease (ML) areas (known as the project area). Although the New Oakleigh site incorporates Oakleigh East and Normanton Pit areas as well as the Oakleigh West areas, design was not required outside the surface rights areas of Oakleigh East and Normanton Pit areas (as shown in shaded pink and blue areas in Figure 1.1).

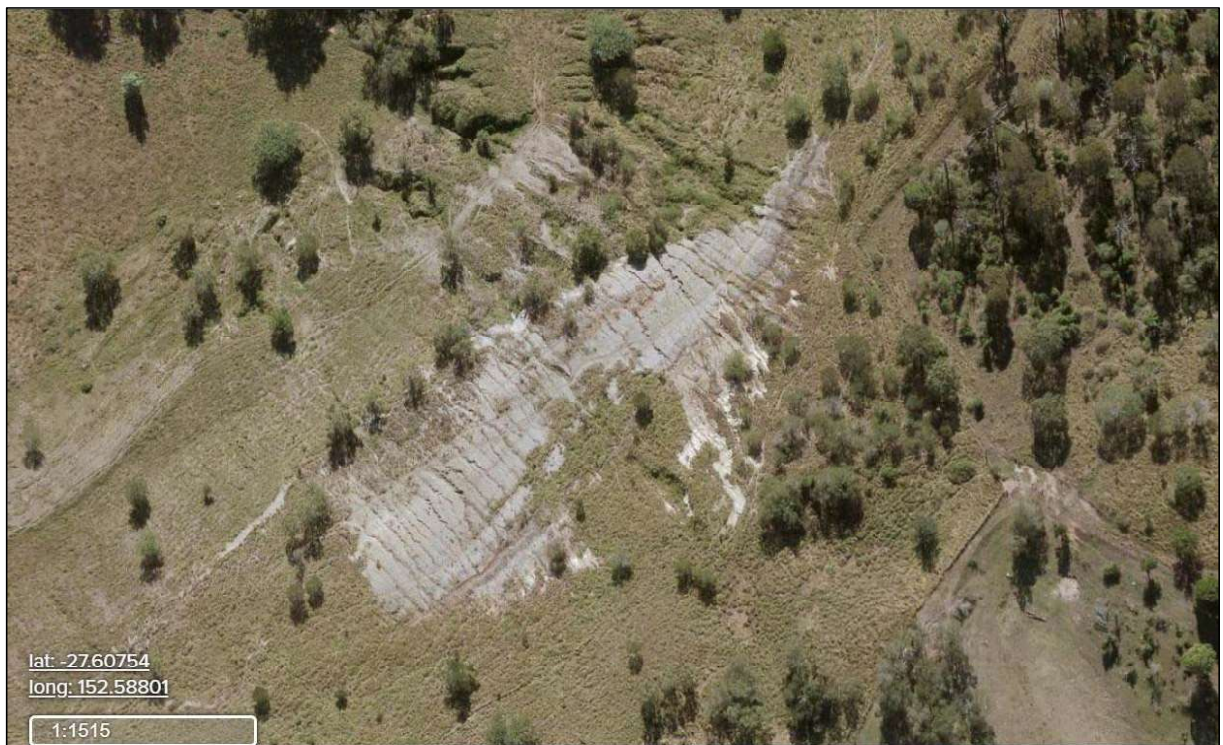
**Figure 2** New Oakleigh North Cut exposed highwall strata aerial view [QldGlobe imagery, accessed 3/02/2020]

The shear strength parameters tabulated in **Figure 4** are much lower than WMO parameters recognised by SGRS, and are considered to be unrealistically low given the observed condition of the rock materials exposed in **Figure 2** and **Figure 3**. For many of the materials described as rocks, the listed shear strengths are lower than the listed shear strengths for soil materials. Other analysis results, for undrained (short-term) conditions, utilised SHANSEP or  $\Phi=0$  strength models which SGRS considers to be inappropriate for the conditions.

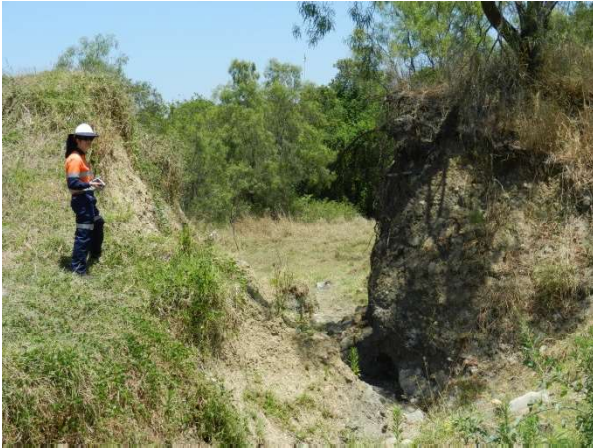
**Figure 2.2** Failed detention dam discharging offsite

- a small, opportunistic, detention basin along the central western boundary where almost all site drainage ultimately leaves the ML – this storage was not designed or constructed properly and has failed (Figure 2.2 Failed detention dam discharging offsite), generating a significant source of sediment from an expanded catchment due to capturing runoff from the out-of-pit dump as well

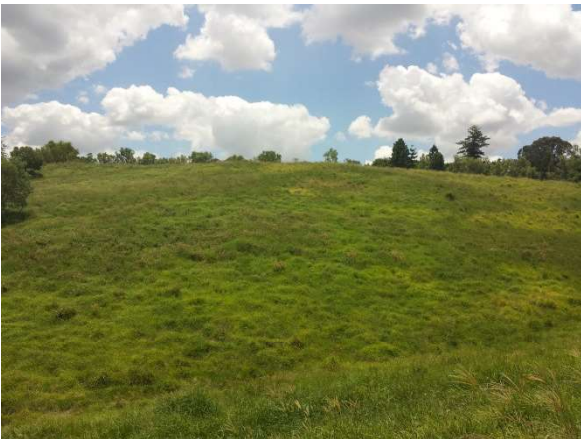
**Figure 2.8** Good groundcover on backfilled area

The majority of the site is well-vegetated and good groundcover prevents erosion except in the gullied areas (Figure 2.8). Some minor rilling occurs on the longer and steeper slopes in the north-east.

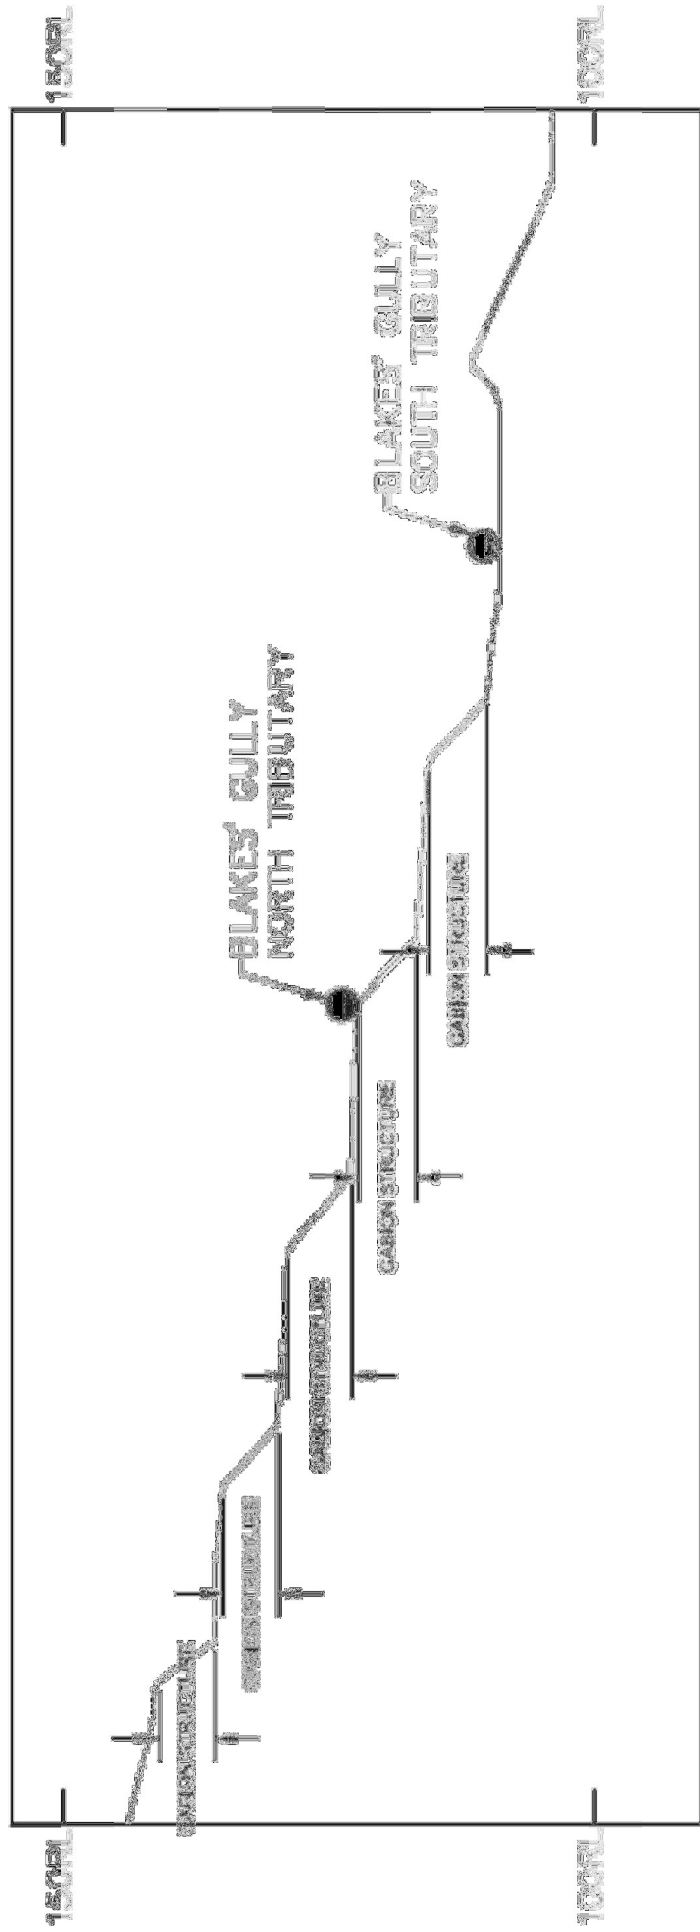
Figure 4.3 Long-section of re-formed Blakes Gully to shock dam

It is recommended that drop structures, required to maintain grassed channel sections at grades likely to minimise erosion potential, be constructed of gabions or similar (Figure 4.3) with additional gabion mattresses upstream and downstream of those forming the near-vertical structures. In this context, gabions are rectangular woven wire mesh boxes, generally constructed of heavily zinc galvanised wire with or without additional coatings, and filled with competent rock. Galmac or galfan wire units are recommended as the coating is zinc and aluminium which has a much longer design life than zinc galvanising alone.

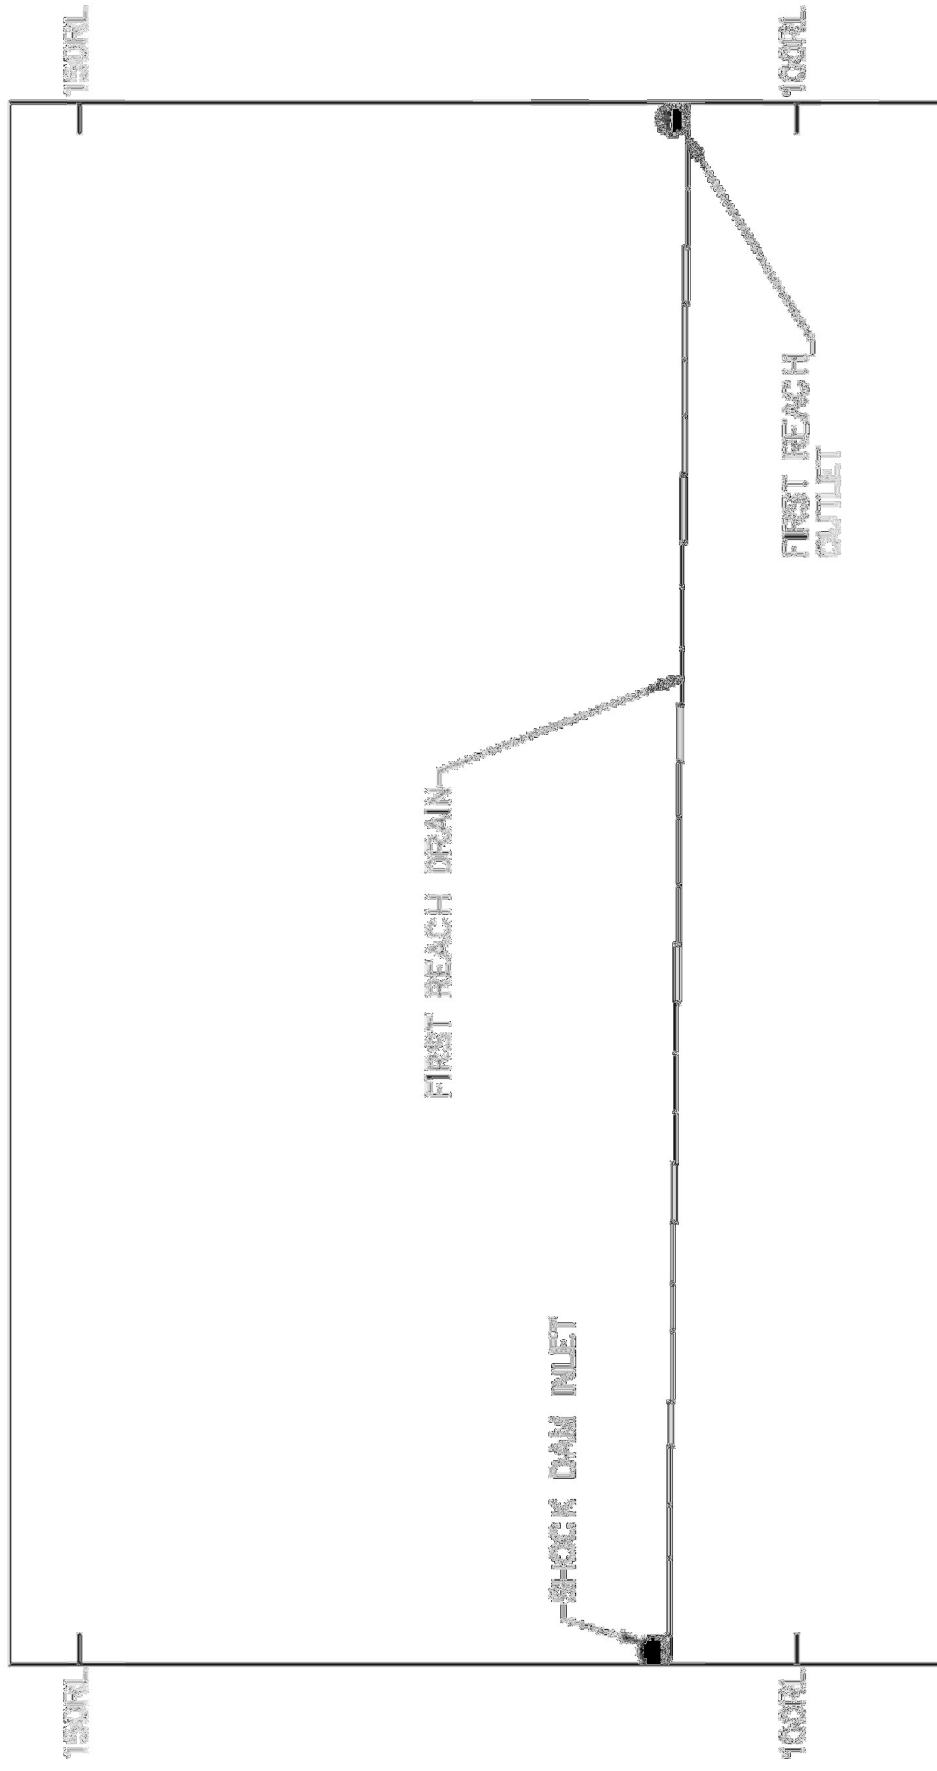
Figure 4.4 Long-section of drainage profile from shock dam to furthest north-west point

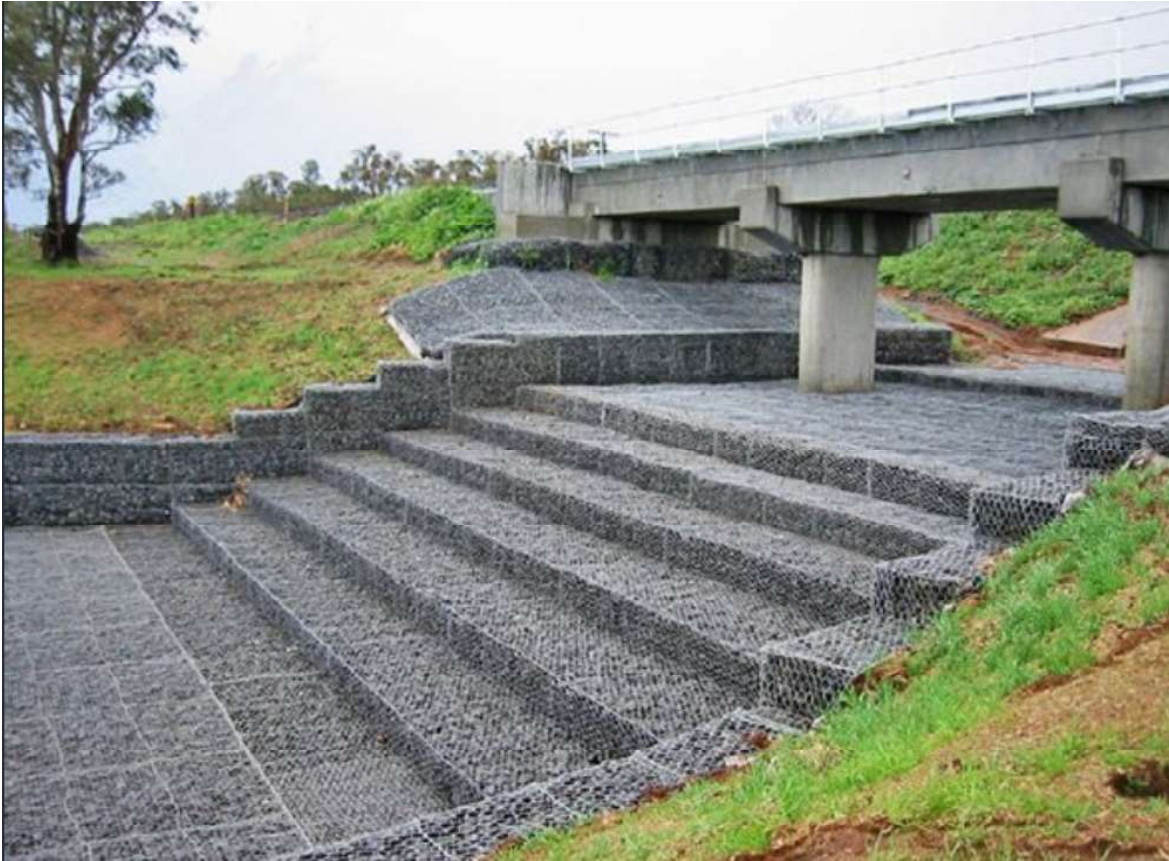
Example of drop structure using gabion baskets and mattresses at top and base of structure. In the Blakes Road instance, the structure would be near-vertical and not be associated with a bridge, but in other aspects is similar.

Gabion boxes are supplied as flat packs so that they are assembled, placed and fastened according to the final design, filled with rock, and closed with space behind backfilled and compacted progressively on site. Filling can be by machine or by hand but the rock needs to be tightly packed with the minimum of voids. Optimum rock size is 125 to 250 mm with a small percentage of smaller material allowable. Rock fill can be rounded or angular but angular rock that tends to fracture with flat sides, such as basalt or similar material has advantages because it can be packed with minimum voids and more readily be amenable to constructing flat faces within the baskets for optimum stacking of baskets. Alternative products such as permeable concrete modular units can also be used. Examples of the use of gabion baskets/mattresses are provided in Appendix B Gabion drop structure information.

Geofabric is required behind and below gabion structures to prevent erosion of backfill and underlying material flowing through and into the baskets silting up the voids and leading to eventual failure of the structure through loss of material behind/underneath the baskets.

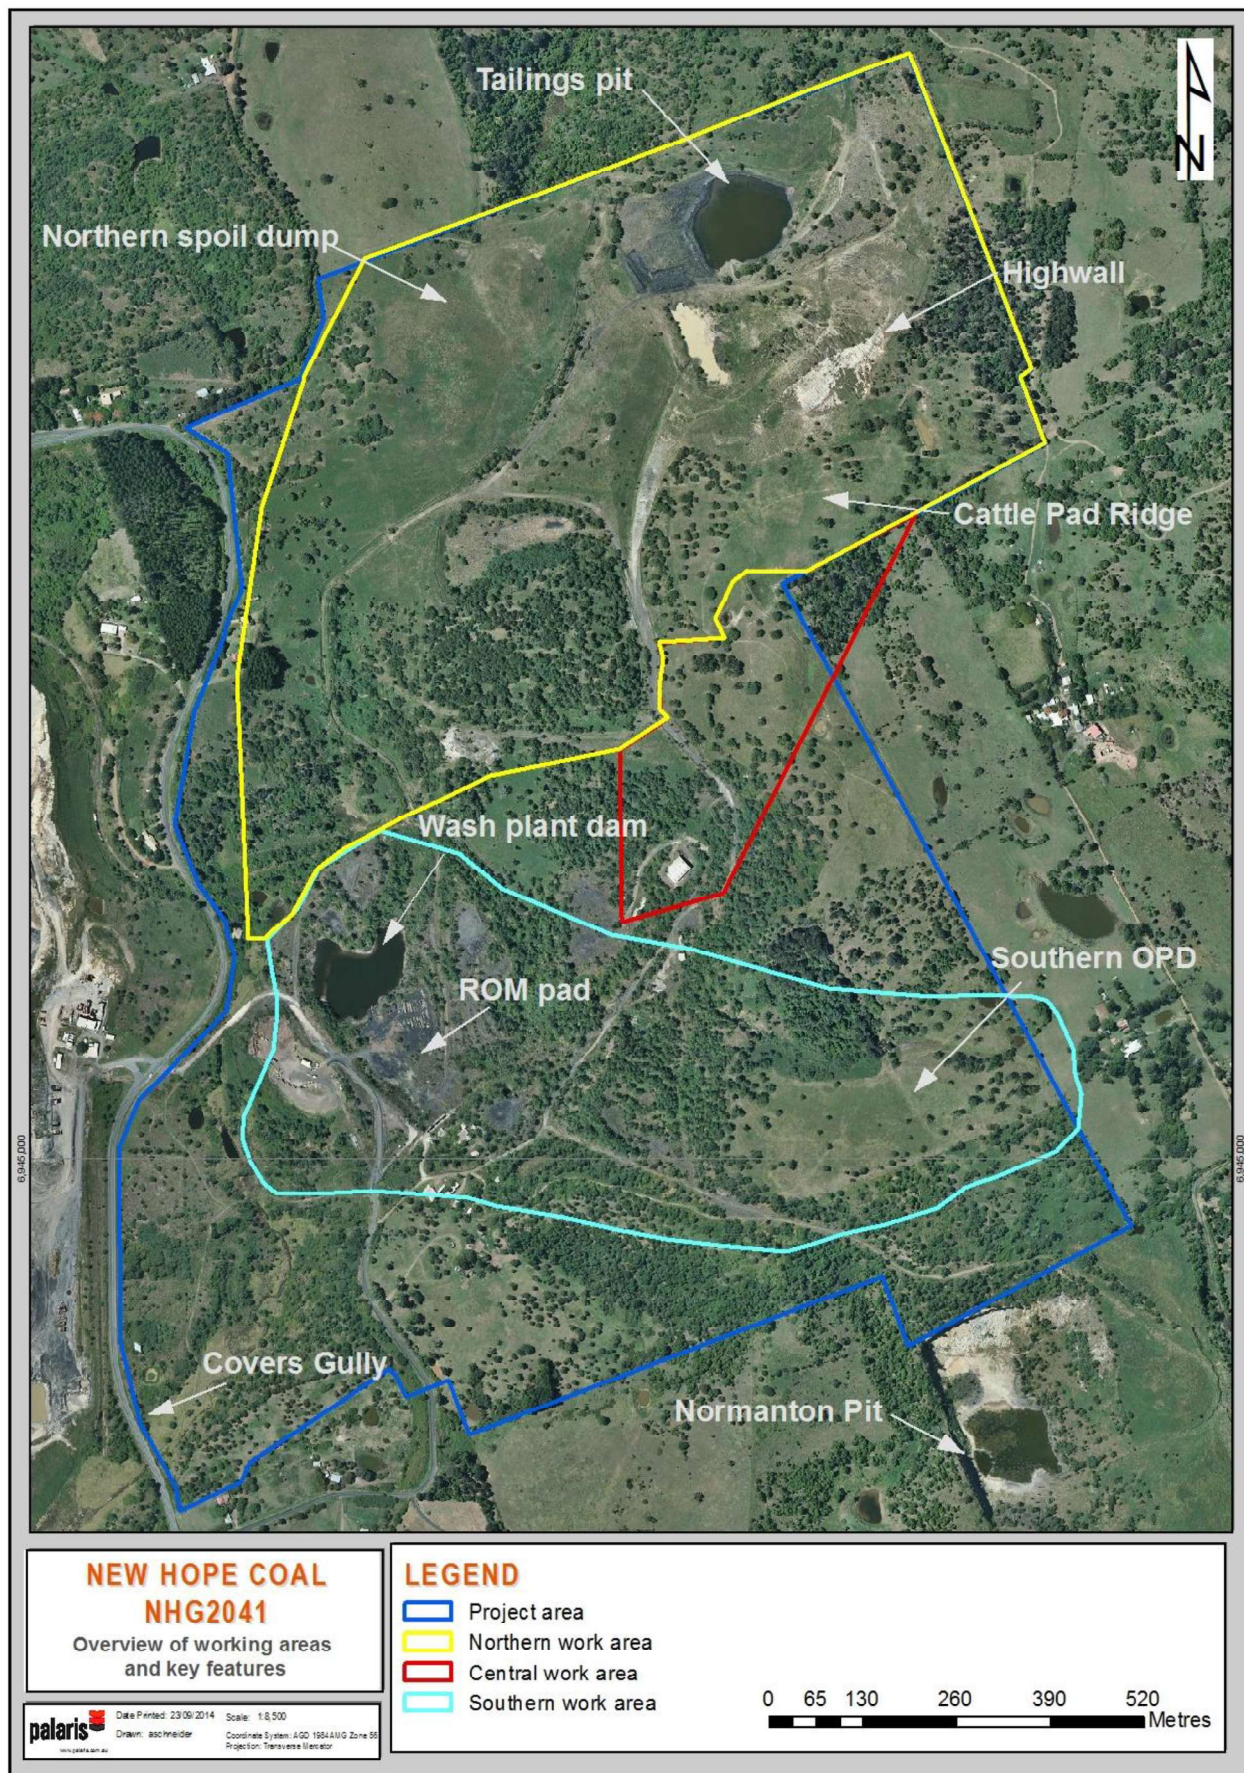
The layout of the proposed work areas and naming conventions are given in the following figure:

Overview of work areas and naming conventions for on-site features

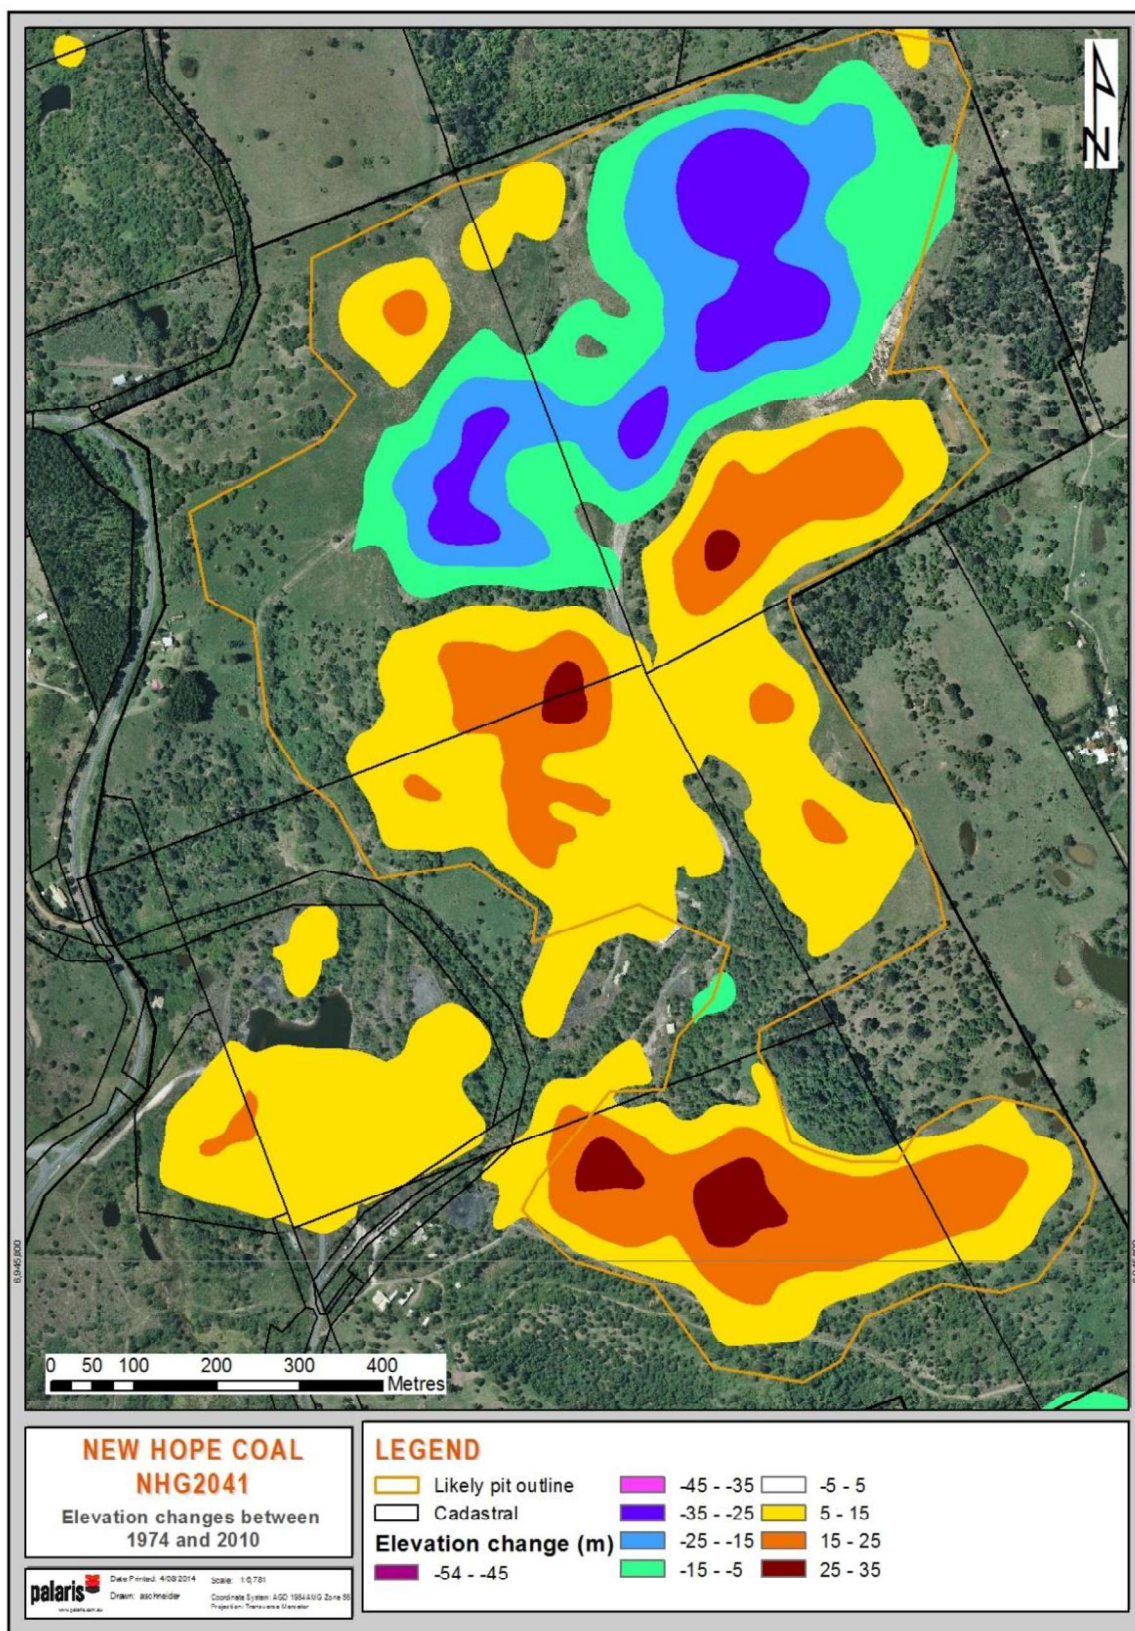
The landscape has been strongly altered through mining activities and the subsequent rehabilitation to date. The change in elevation of the pre-mining landscape in 1974 relative to the mined and reshaped landscape of 2010 is shown in Figure 2.2. It is evident that the area around the tailings pit in the north has been lowered substantially compared to the pre-mined surface as is also shown in Figure 2.2. The areas south and south-west of the northern tailings pit have gained in elevation and the surfaces today are up to 30 m above the 1974 landscape. Both of the raised areas now have steeper slopes associated with them than were present in the initial landscape. In the south-east, a former valley has been backfilled with spoil as part of the out-of-pit dump, elevating the surface up to 30 m above the pre-mining landscape (Figure 2.2) and significantly altering the drainage in this area. This dump has diverted runoff (a portion of which is sourced from outside the project area from an unmined part of the catchment) to the north where it has resulted in a deep gully forming partly in fill and partly in a natural surface hard up against a remnant area of protected vegetation.

Figure 2.2 Elevation changes between the pre- and post-mining landscape

Extensive use has been made of the data provided by NHG showing the pre-mining DEM of the site to identify where spoil has been placed throughout the life of the mine and for which no mine plan was available (see Figure 2.2). This imagery was also useful in determining some locations of probable tailings dams and former drainage lines. It is clear from the DEM that at least two of the major prior drainage lines have been buried under more than 30 m of spoil and that this has caused the remaining residual catchments that are located above the dumps and outside the project site to find new pathways for discharge. This has resulted in severe erosion that now requires attention as part of the present concept planning.

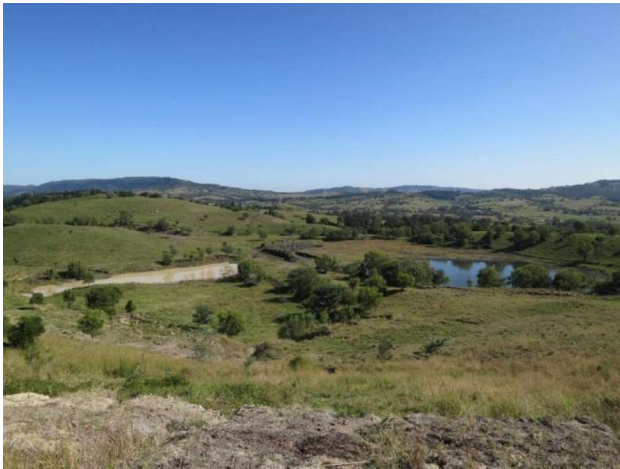
**Figure 2.3** Reshaped landform looking north-east with tailings dam to the right and reshaped spoil to the left

The current reshaped landscape for the area disturbed by the open cut mining, though it is sympathetic to the surrounding landscape (Figure 2.3), is unstable and showing extensive gullying on fill slopes (Figure 2.4). The final highwall in the north-east of the project area has been partially stabilised by grading the overlying slope to a gentler grade and pushing spoil against it to reduce erosion to a degree. This has been partly successful but the highwall remains unstable due to the exposure of sodic subsoil material during the reshaping of the land above the highwall. This exposure has affected vegetation establishment resulting in the formation of severe gullying (Figure 2.5 and Figure 2.6).

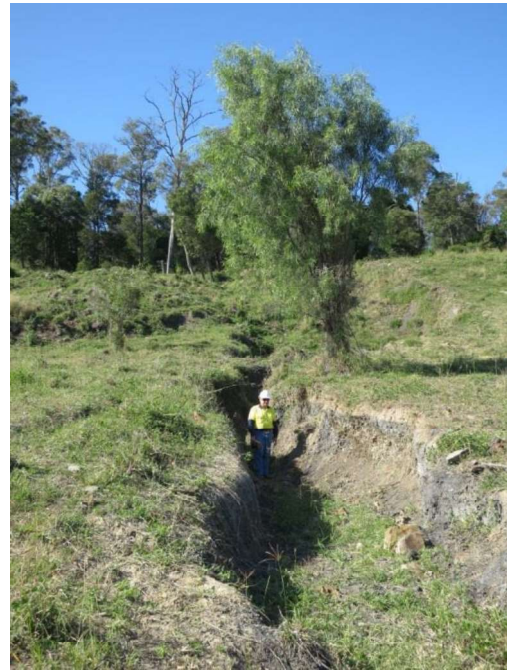
**Figure 2.4** Severe gullying close to the tailings dam in the north east

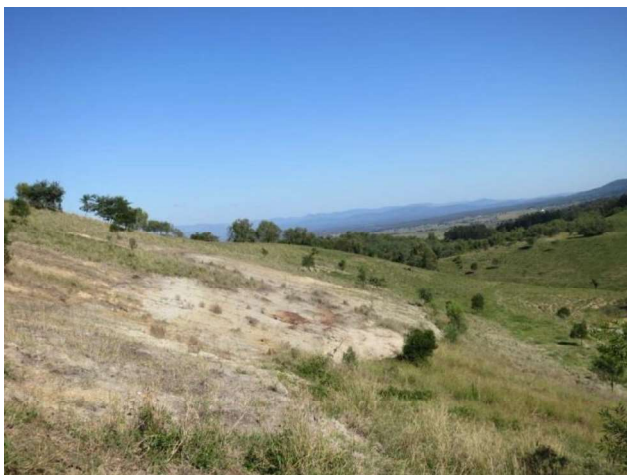
**Figure 2.5** Sodic material exposed and resulting in severe gullying – looking south-west across highwall

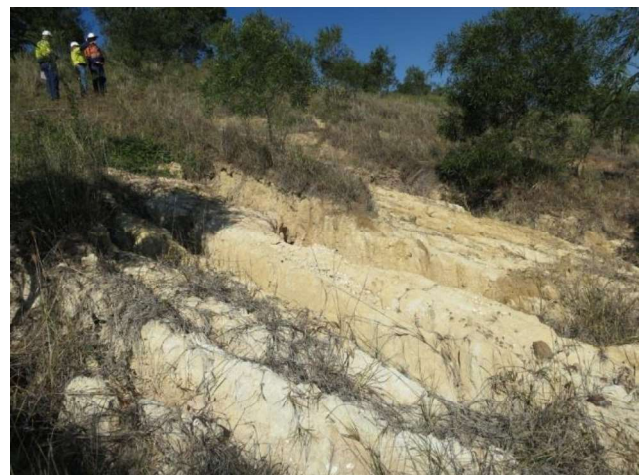
**Figure 2.6** Gullying in sodic subsoil material exposed above highwall during reshaping

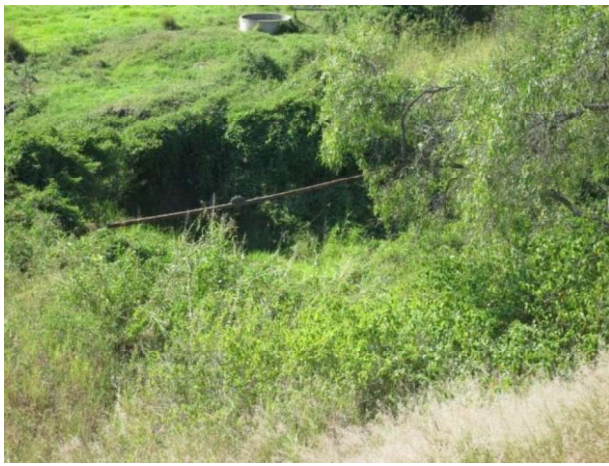
**Figure 2.11 Washed out rail bridge**

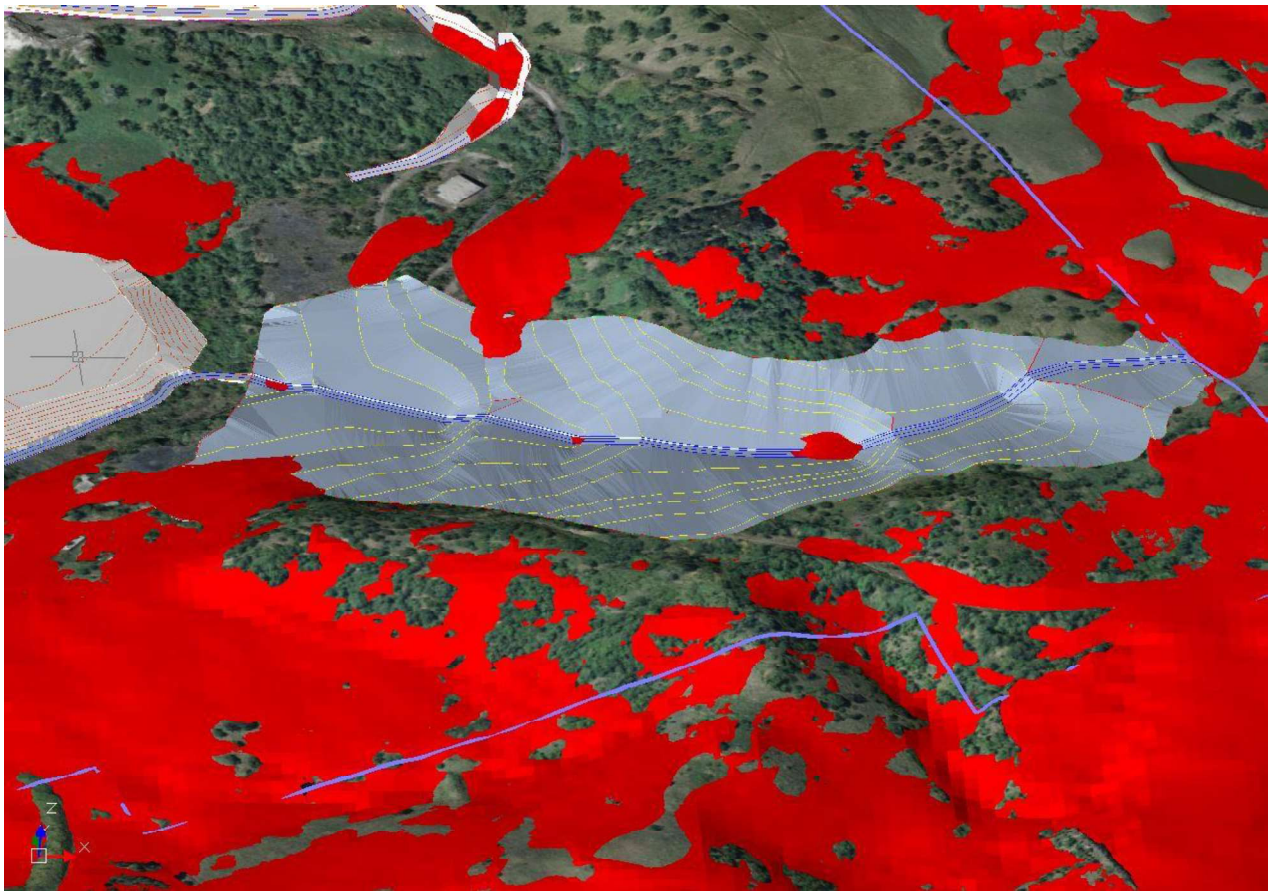
**Figure 4.2** Red areas showing the pre-mining surface in relation to the out-of-pit dump (grey). Note: three small red areas intersected by drainage line to be re-established coincide with locations of gabion drop structures meaning that they can be located on *in situ* surface

Next, various design iterations were completed to restore the OPD area to a stable drainage system. Five drop structures were required down the centre of this rehabilitated OPD area, which help limit the required movement of material as well as providing a stable flow of water to discharge at the washplant area. The new stable design requires the removal of ~1,470,000 bcm of material. NHG requested that 1,000,000 bcm of this area be kept for use in the nearby Normanton Pit rehabilitation program. This, along with the need to transport ~311,000 bcm of material to the final highwall area to meet the deficit, and to keep ~260,000 bcm of material to complete all other drains, meant ~184,000 bcm of excess material were then available to cap the washplant dam and pad area. This leaves approximately 690,000 bcm of spoil above the original surface in the southern OPD as shown in Figure 4.2, meaning that the new channel at the OPD is constructed almost entirely in fill.

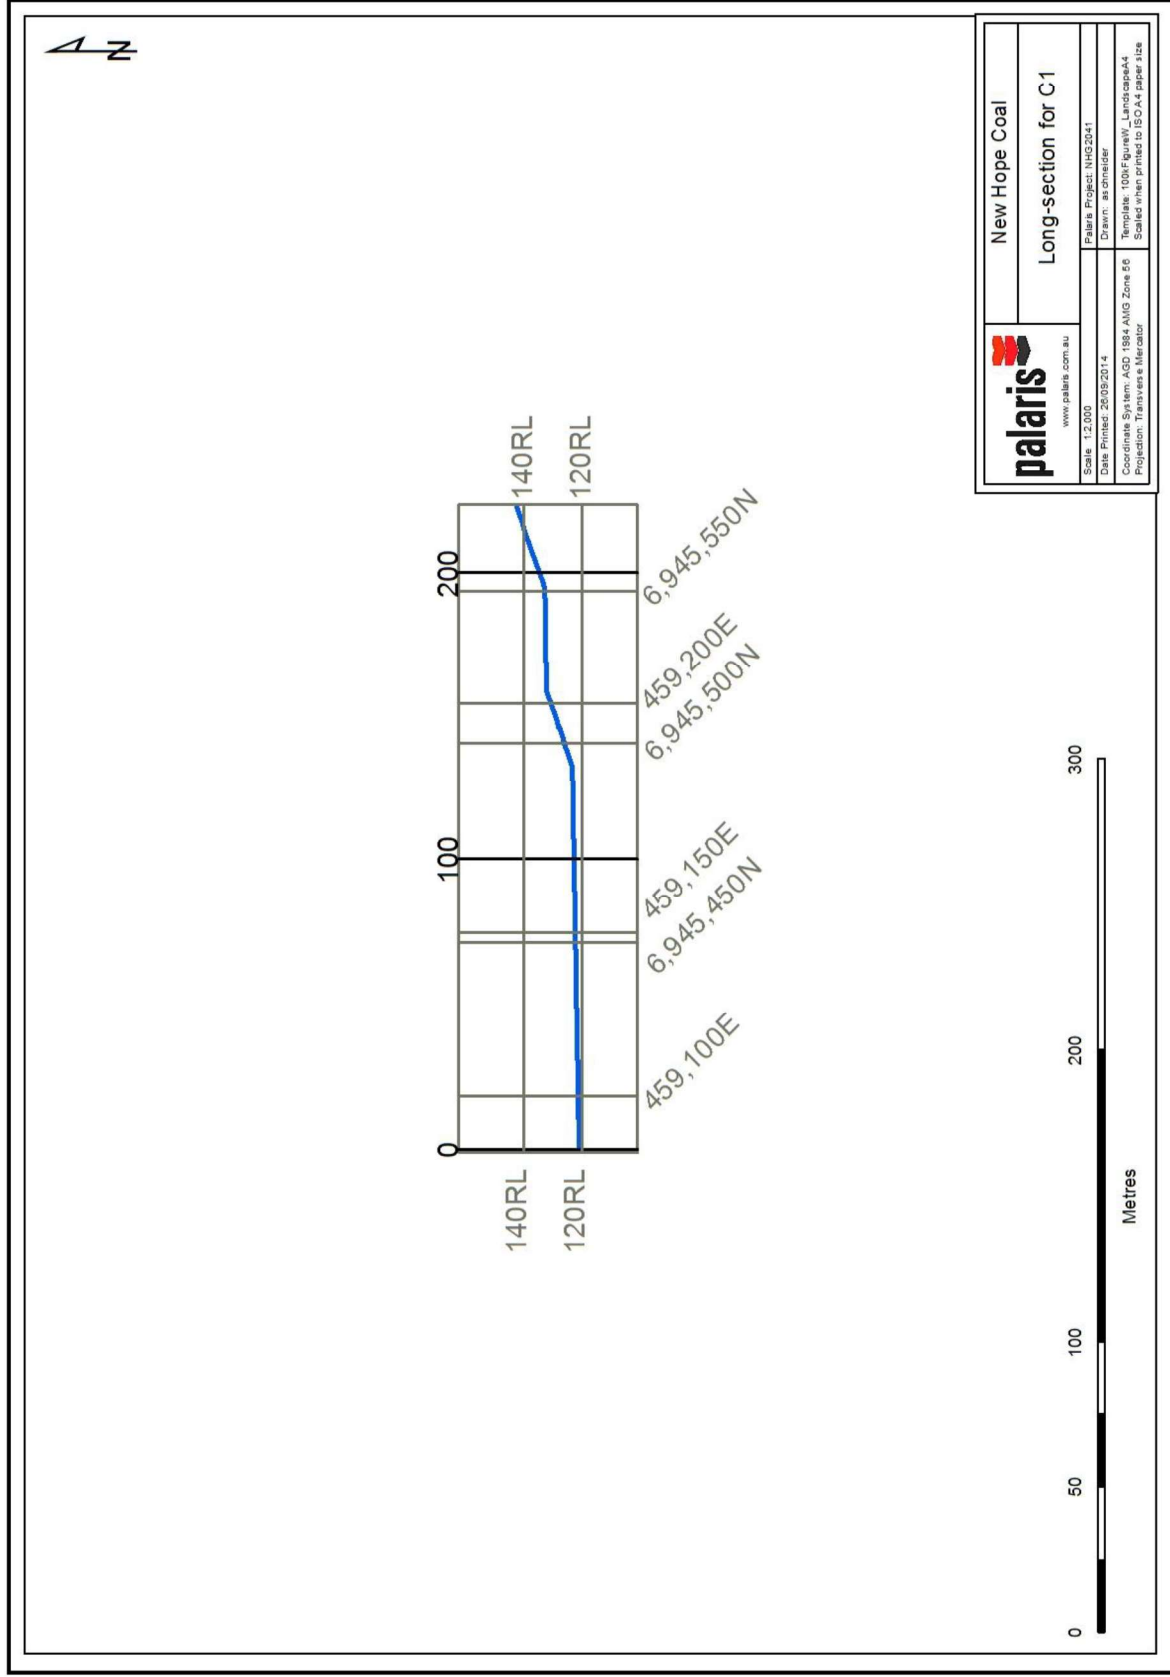
Figure A2 Long-section for stream with drop structures in the central work area (C1)

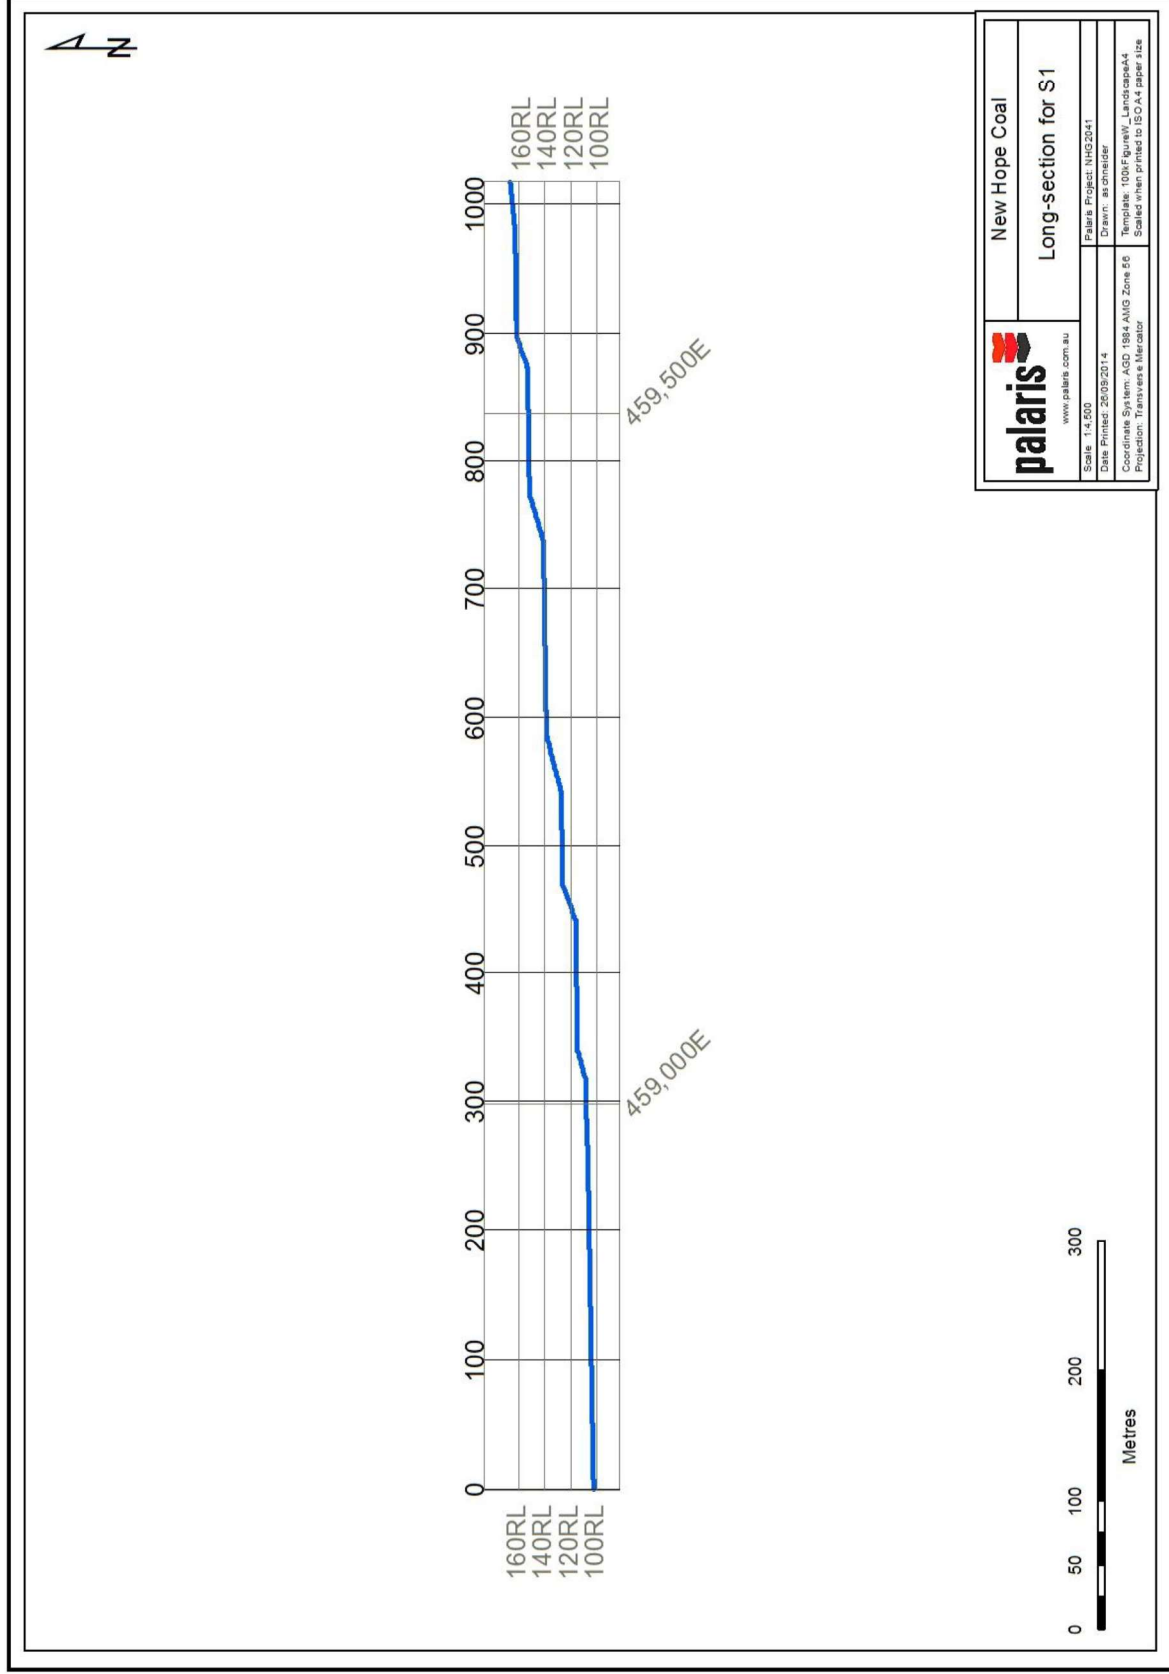
Figure A3 Long-section for stream with drop structures in the southern work area (S1)

For S1 in particular, there is potential to instate shock dams as an additional or alternative means of controlling runoff. The long-sections would assist in determining best locations but at this stage no attempt has been made to indicate positions in the absence of client agreement as to their interest in this approach.

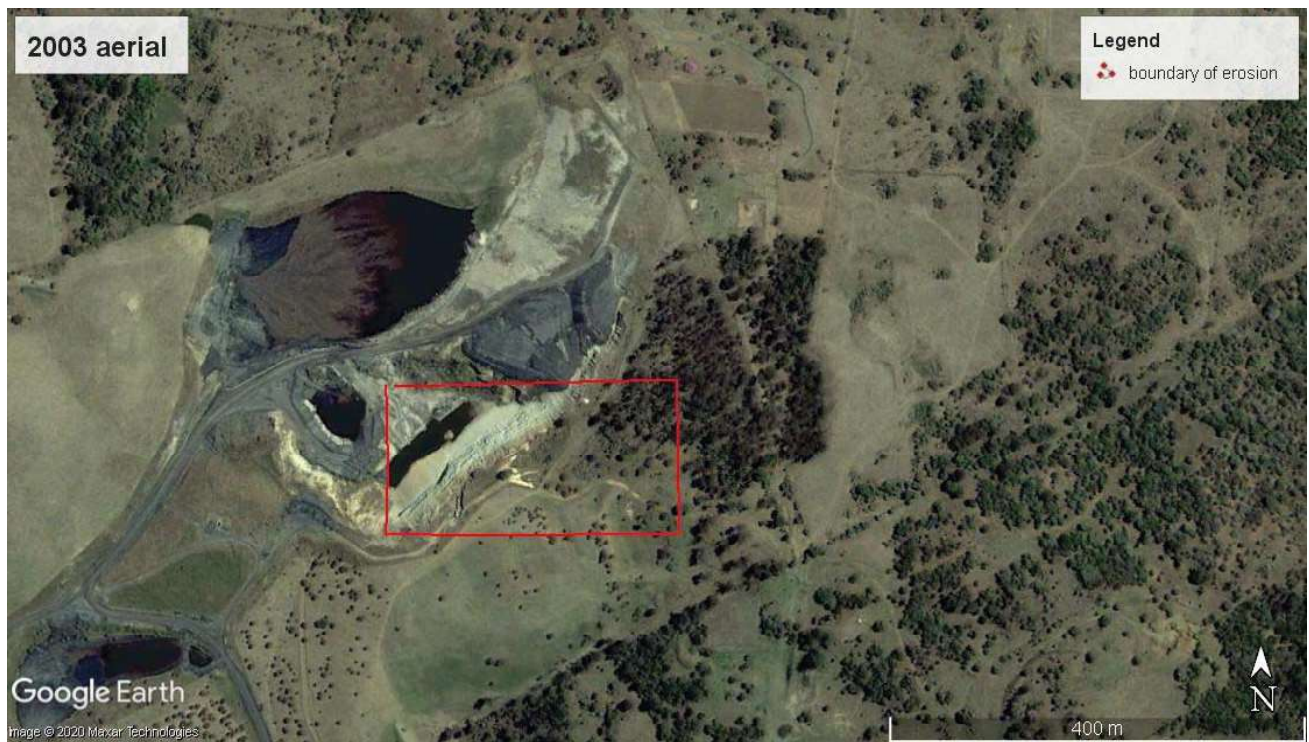
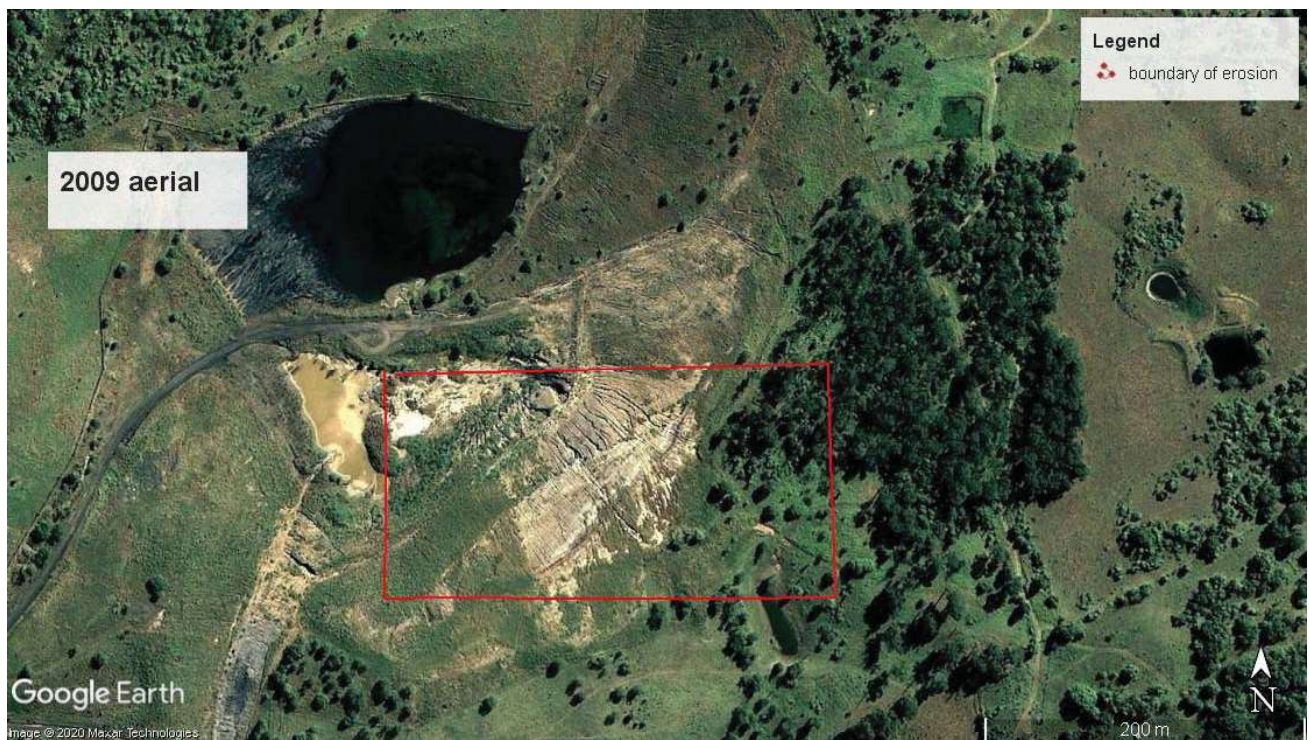
Figure 3.4 (a to d) Aerial sequence of changes to rehabilitation and erosion (2003-2020)

In addition to the assessment of current site conditions, an assessment of changes to the extent of erosion over time has been conducted. This has been based on aerial photography available from 2003 (see **Figure 3.4 (a)**) when mining activities were active and rehabilitation works, including placement and backfilling of spoil over much of the site, had yet to be undertaken.

**Figures 3.4 (b) to (d)** indicate the changes that have occurred since that time for the years 2009, 2014 and 2020.

- There has been substantial colonisation of pasture over much of the site (*eg* Area C)
- the most severely eroded area (Area A) has shown little change in aerial extent
- The severity of erosion with Area A and adjacent land has shown minor change over time.
