# New Oakleigh Normanton Pit and East and North Drains

Summary Design Report

BEN862-TD-EV-REP-0001 Rev. 0

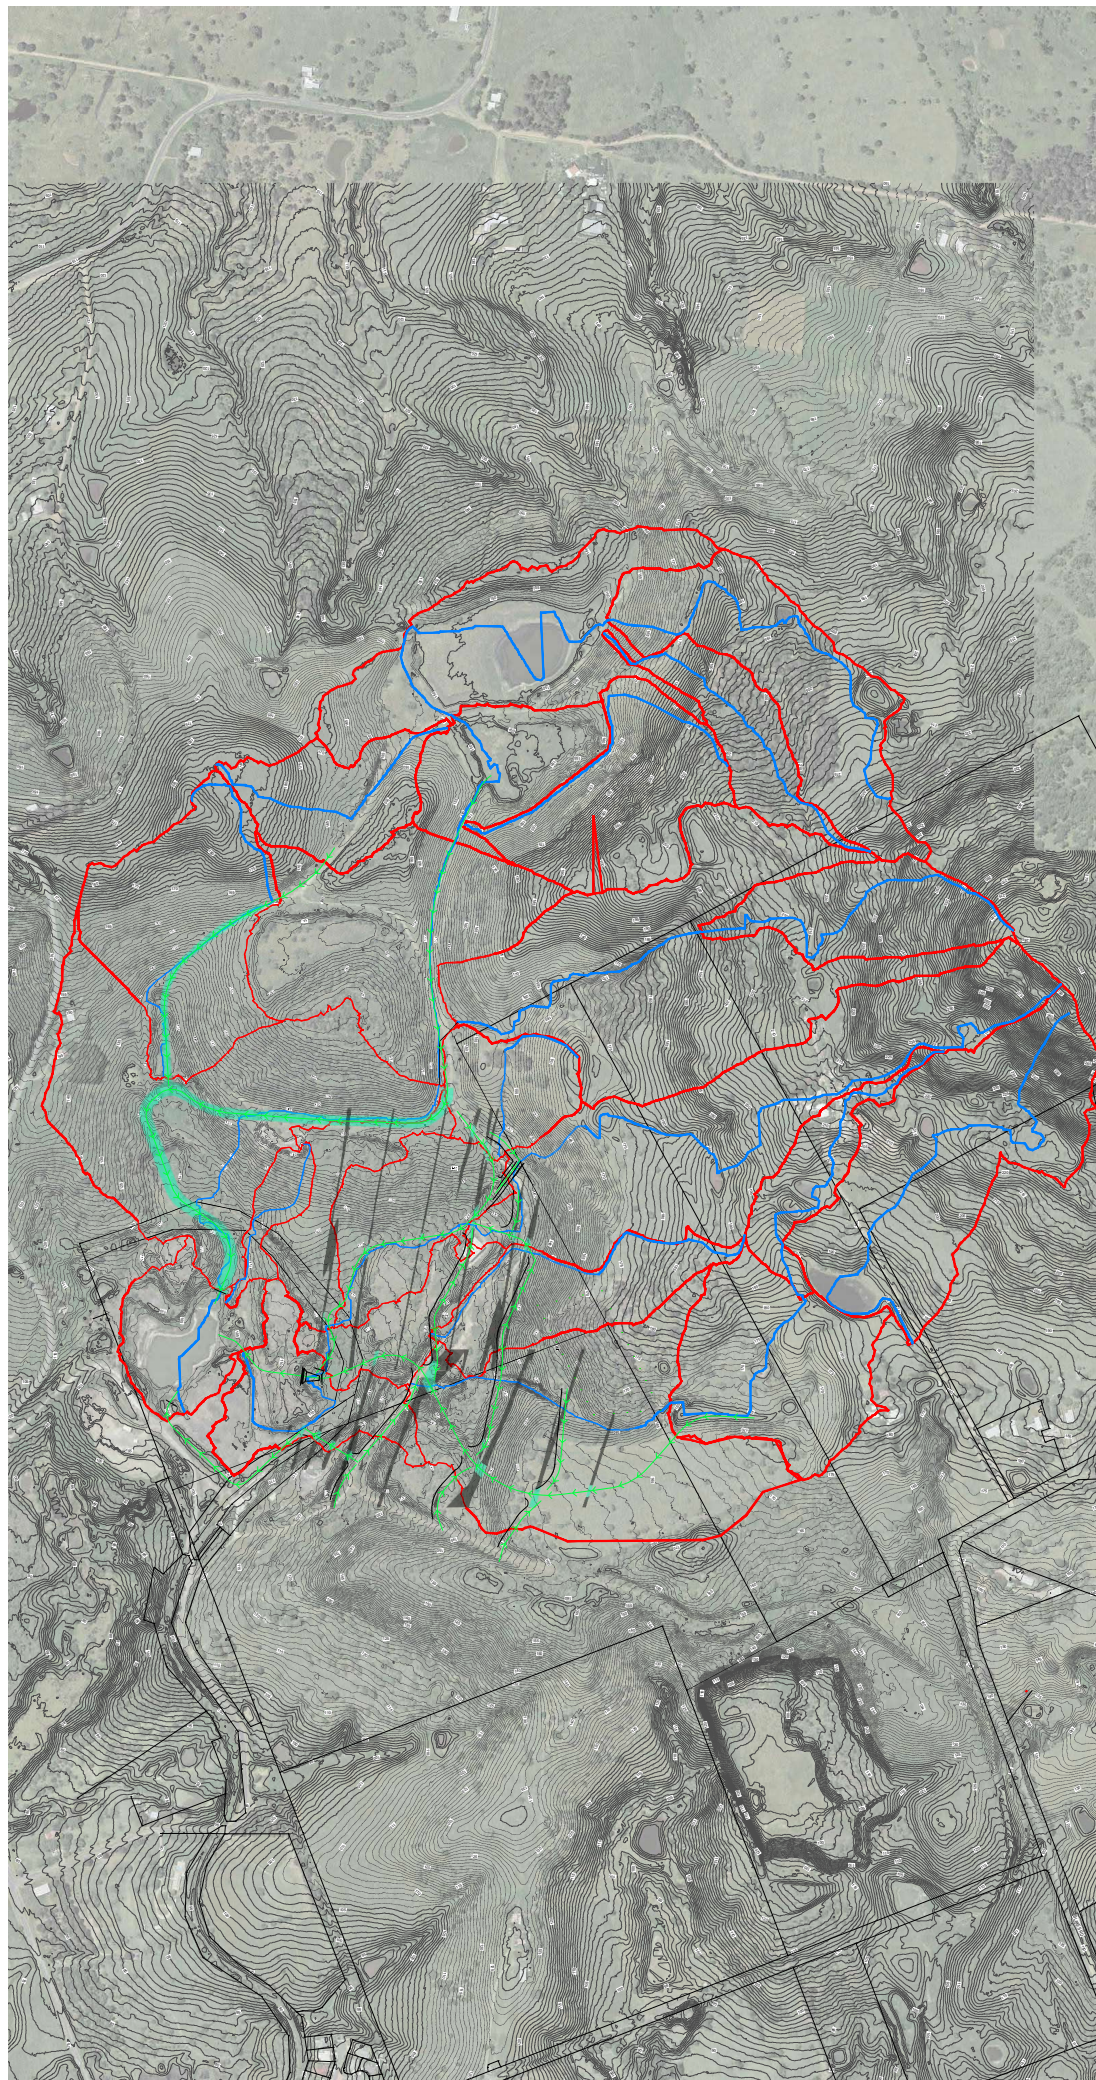
PLAN  
SCALE 1:4000 (A1)

NEW HOPE GROUP  
REHABILITATION PLAN - NEW OAKLEIGH  
EAST DRAIN  
CATCHMENT PLAN

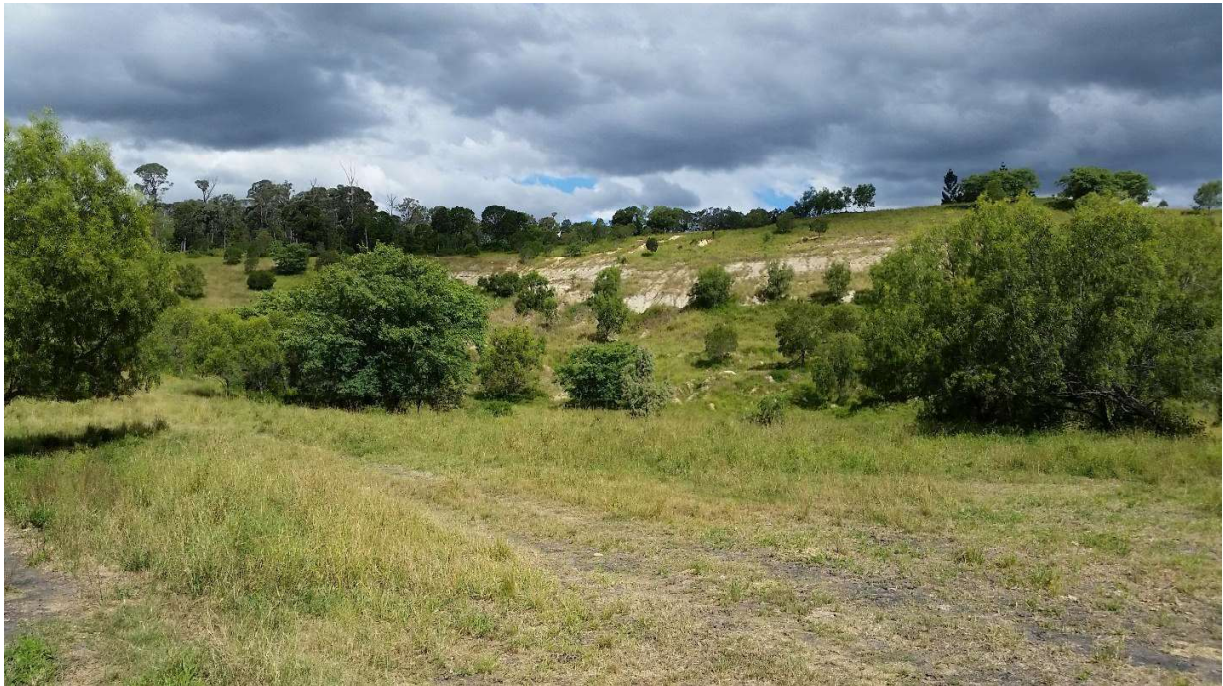
Oakleigh East - North High Wall

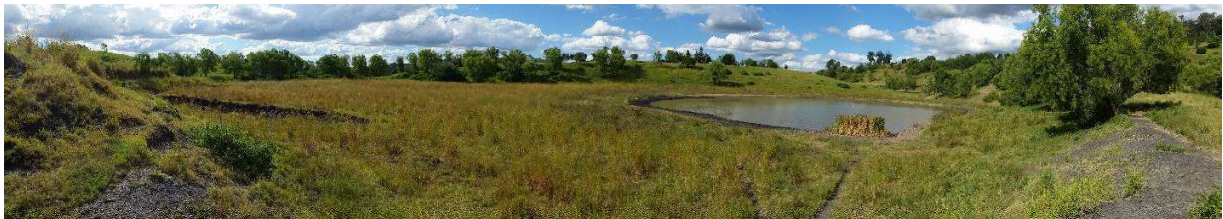
Oakleigh East – Old Tailings Dam before infill

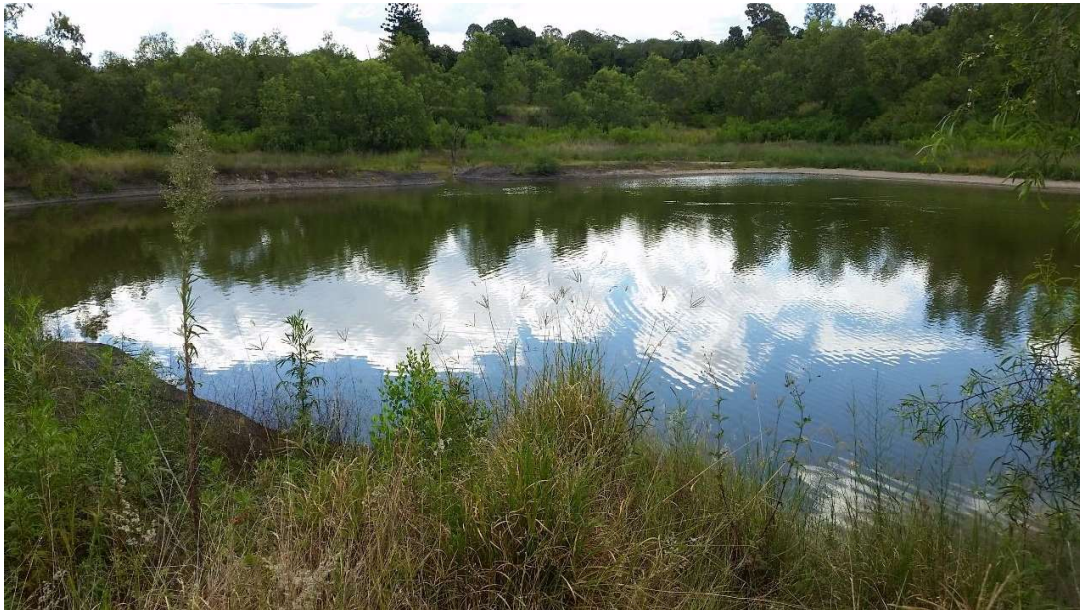
Oakleigh East - Washdown Dam

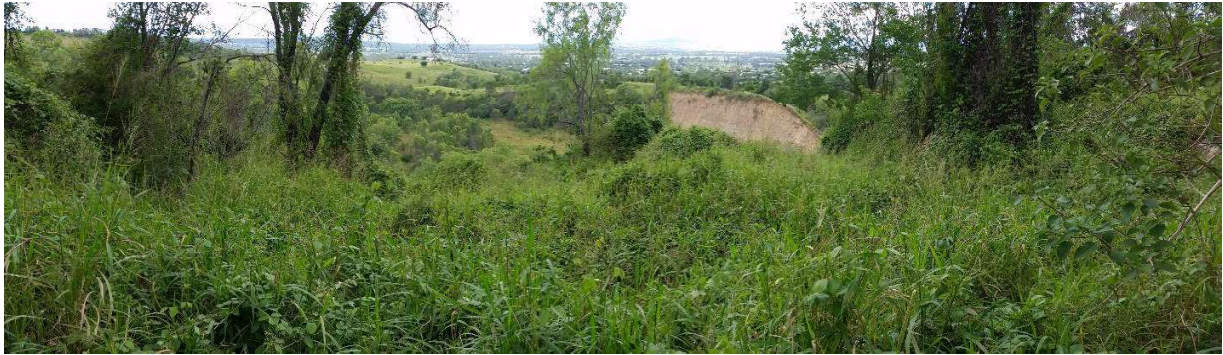
Normanton – Pit Cliff Face

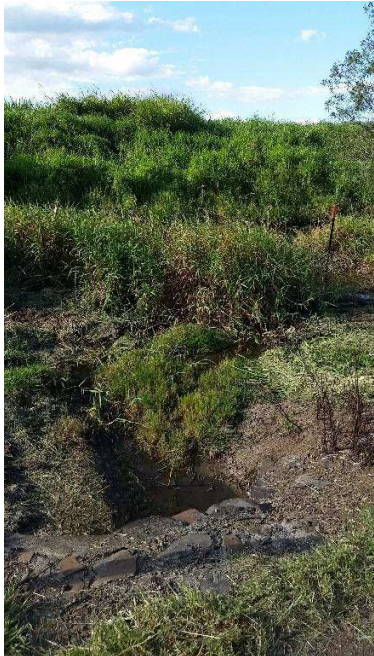
Normanton – Blakes Road Outlet

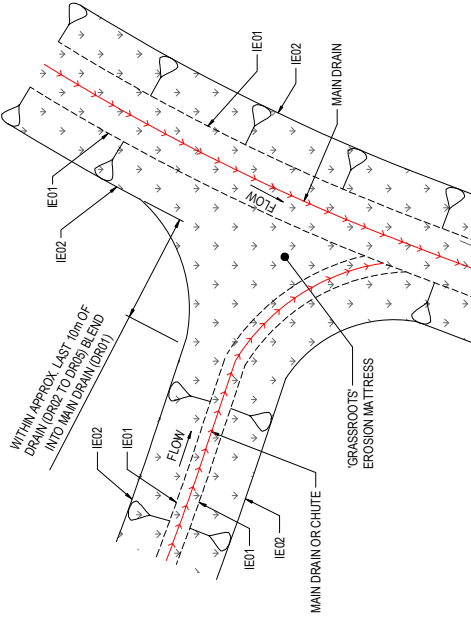
TYPICAL TIE DETAIL - MAIN DRAIN WITH MAIN DRAIN OR CHUTE  
SCALE 1:250

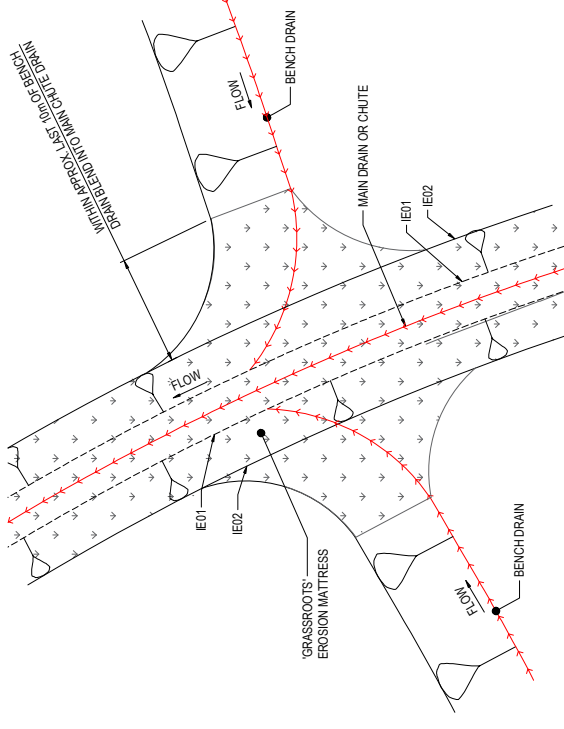
TYPICAL TIE DETAIL - BENCH DRAIN WITH MAIN DRAIN OR CHUTE  
SCALE 1:250

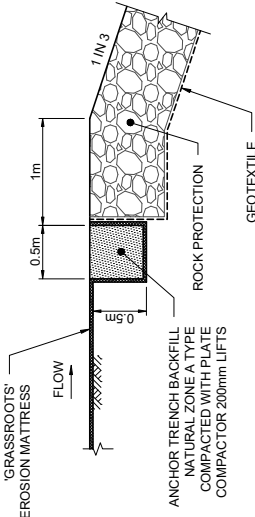
GRASS-ROOT / ROCK ARMOUR TIE IN DETAIL  
SCALE 1:25

Grassroots is an Australian-made permanent Rolled Erosion Control Product (RECP) made from heavy synthetic UV-stabilised fibres which are needle-punched together into an open weave synthetic scrim creating a three-dimensional structure. Grassroots has been designed to protect underlying soil in steep slopes and channels from moderate velocity water flows, rainsplash and other erosive conditions, while allowing seeds to germinate successfully and grow through the matting providing permanent vegetative reinforcement.

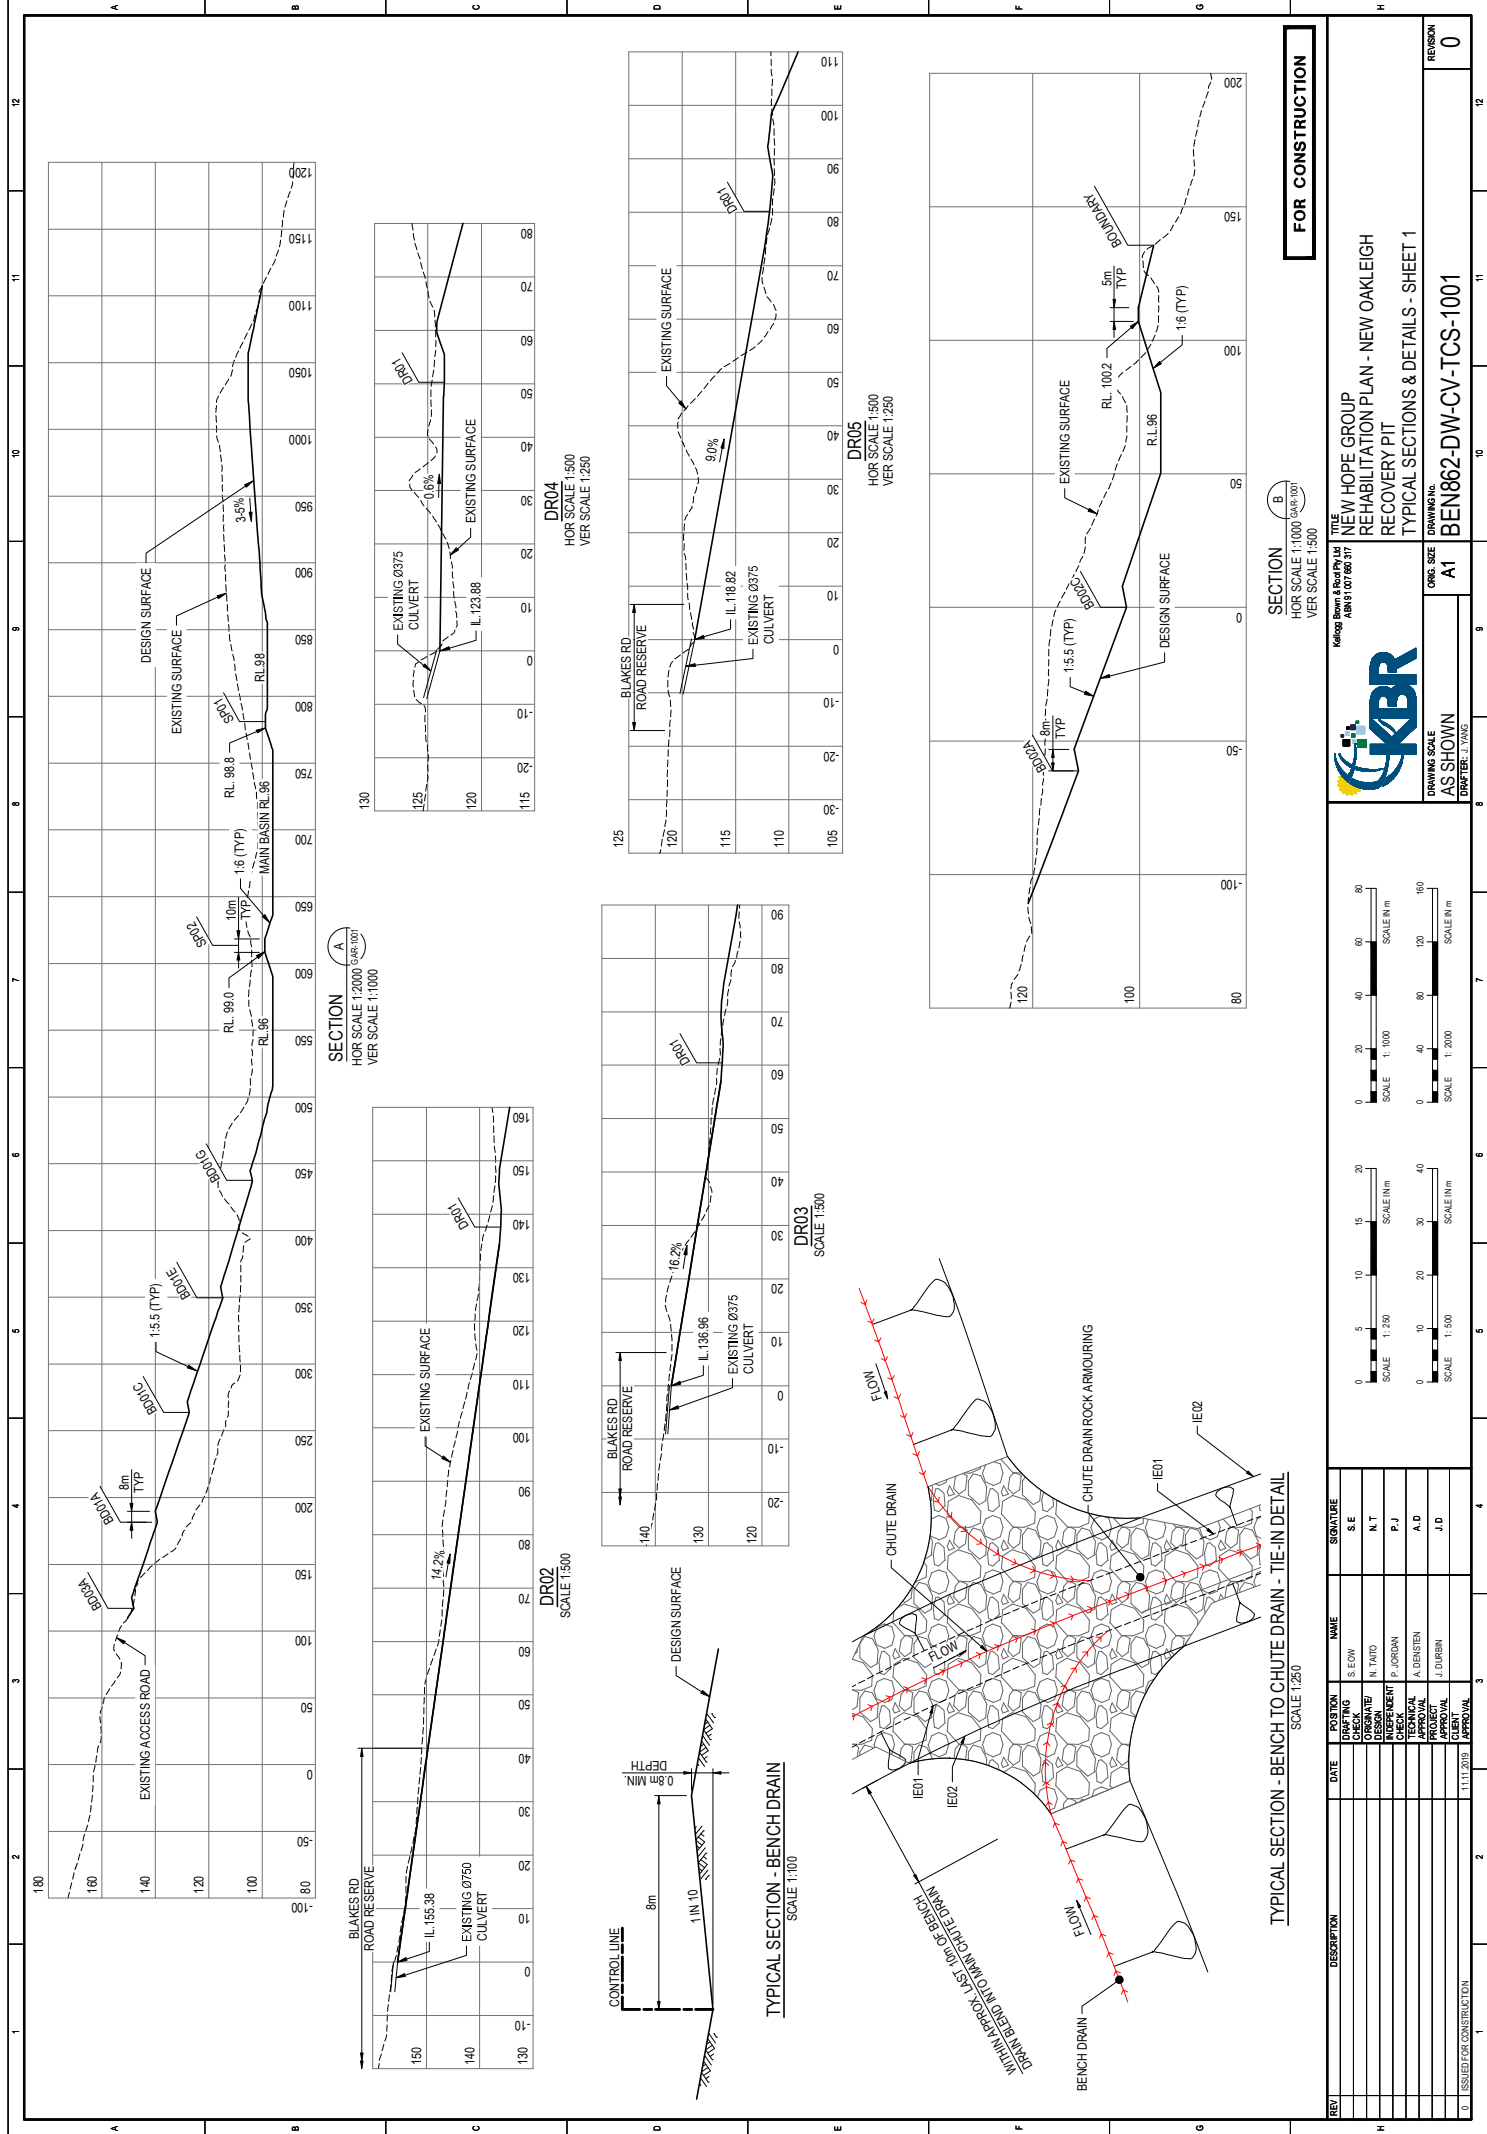
NEW HOPE GROUP  
REHABILITATION PLAN - NEW OAKLEIGH  
RECOVERY PIT  
TYPICAL SECTIONS & DETAILS - SHEET 1

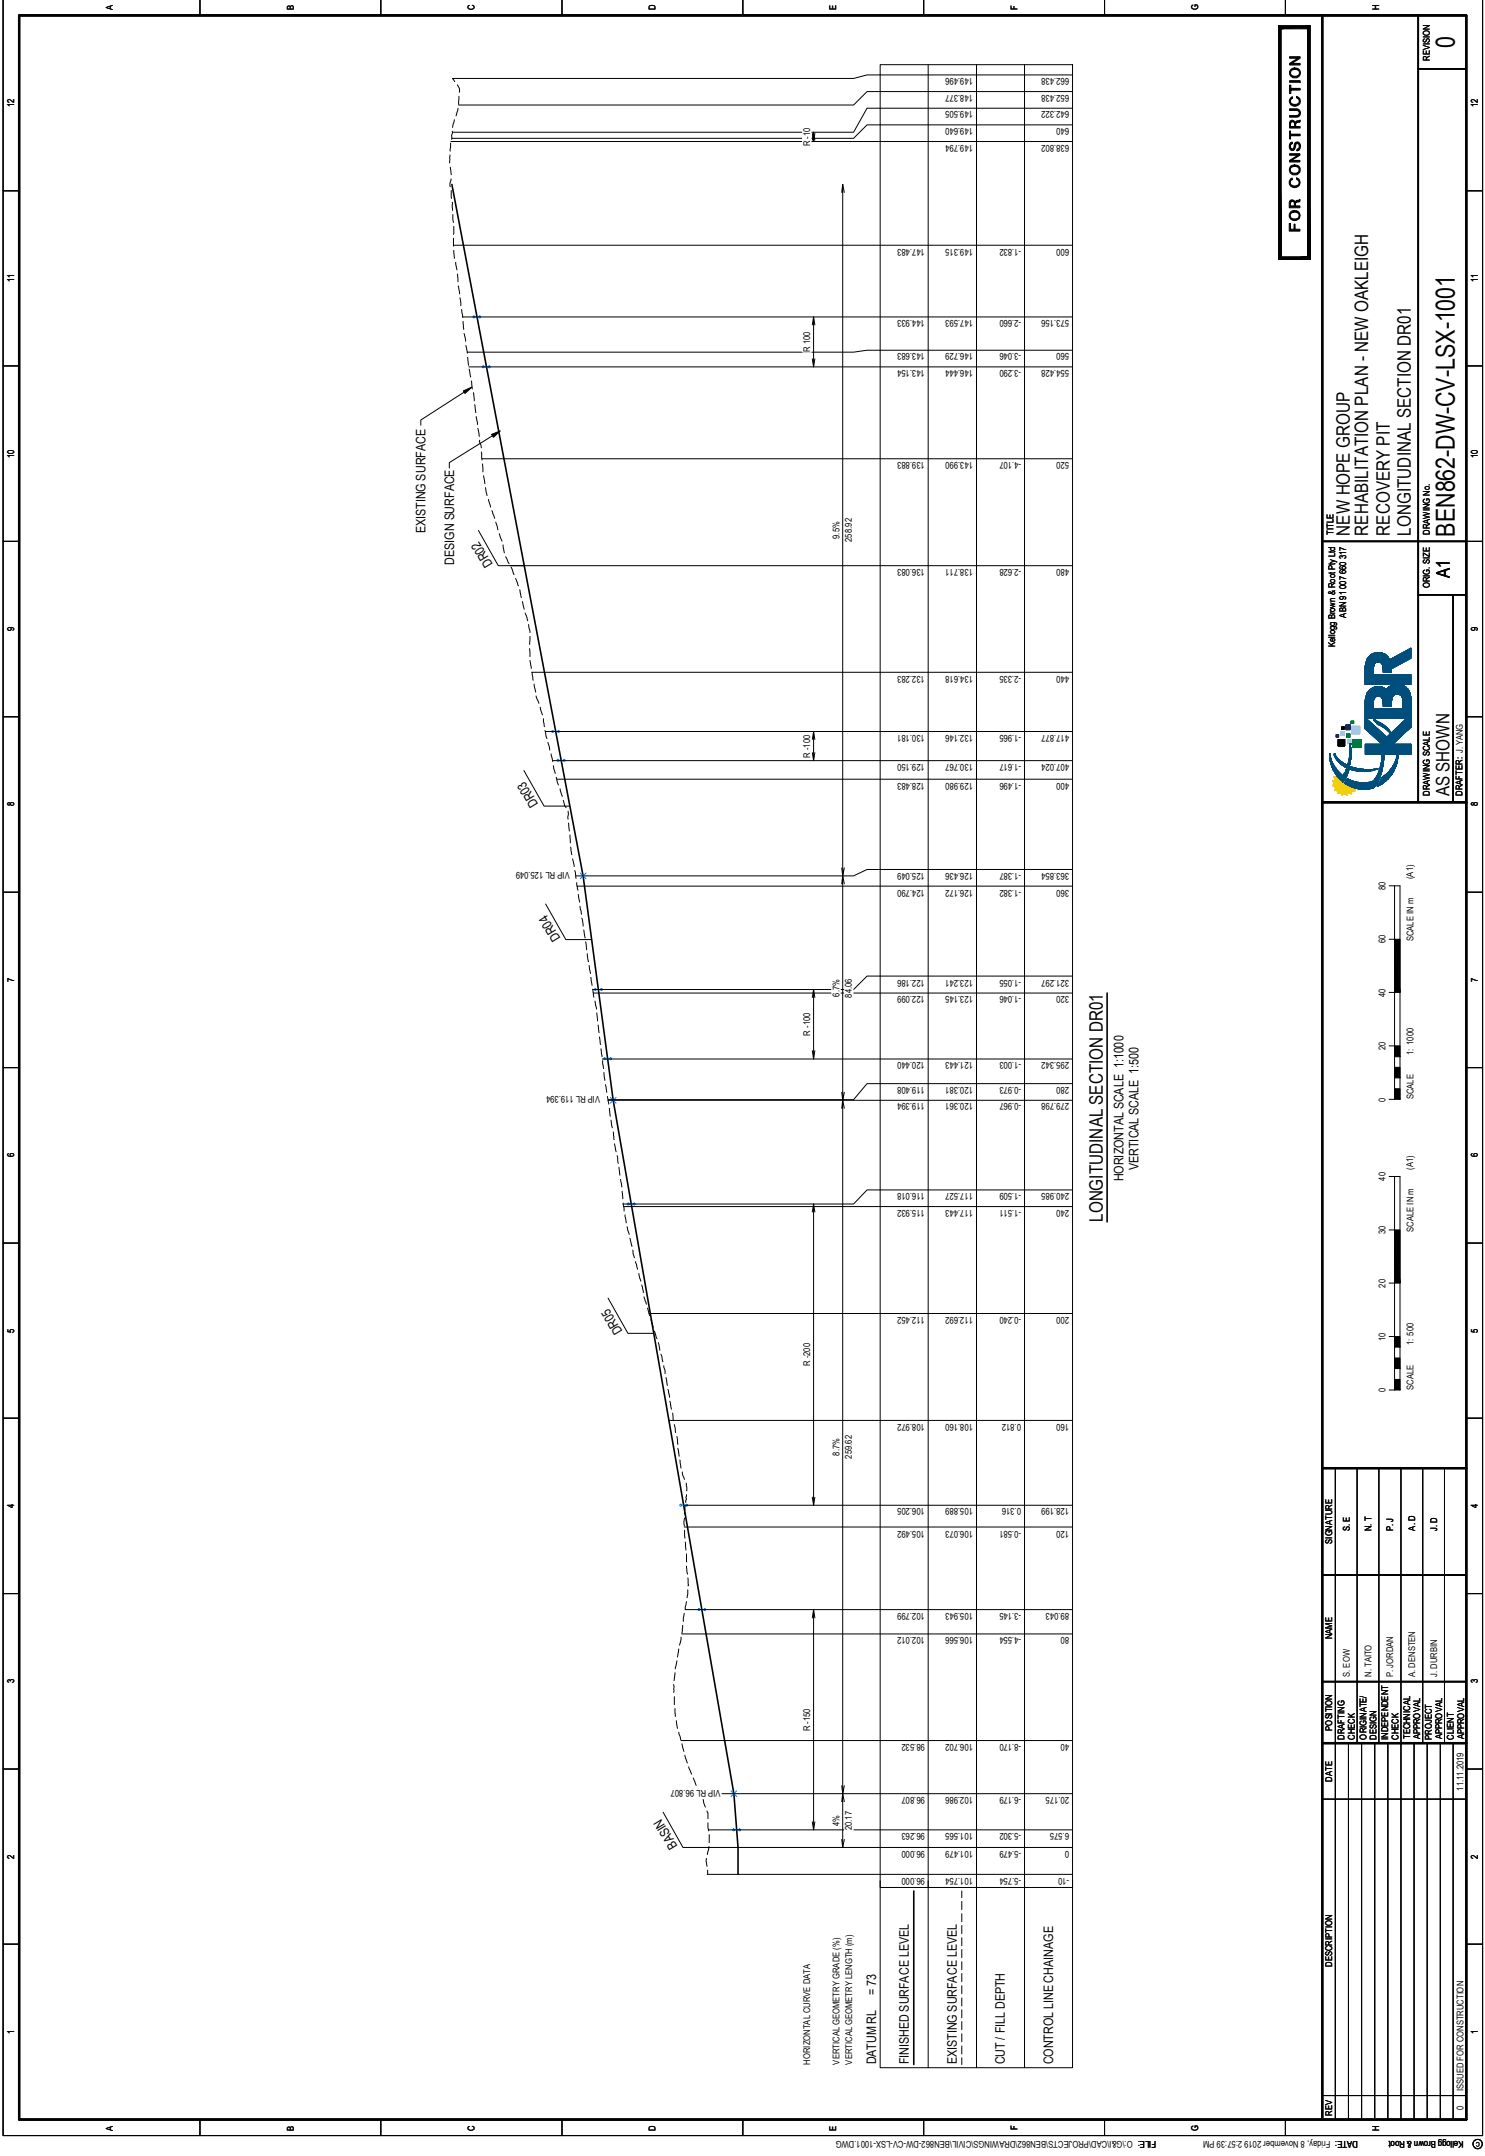
| KBR | | KBR Group & Soil Pty Ltd<br>KBR 81 007 800 377 | | NEW HOPE GROUP<br>REHABILITATION PLAN - NEW OAKLEIGH<br>RECOVERY PIT<br>LONGITUDINAL SECTION DR01 | | REVISION<br>0 | |

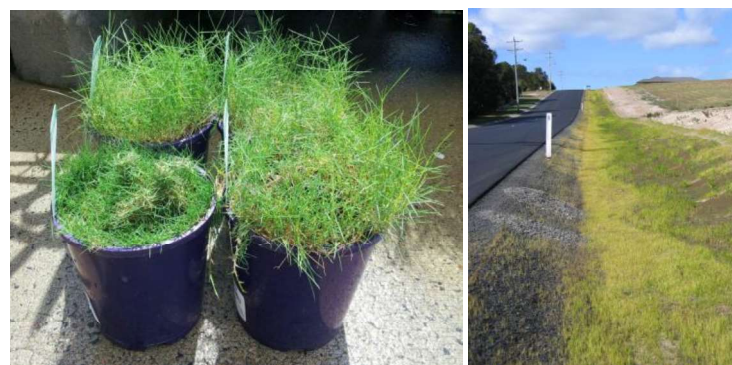
#### GERMINATION ENHANCEMENT – ASTM D7322

Another important feature of RECP's is their ability to provide an enhanced long-term structure to assist with seed germination and reinforcement to the vegetation throughout maturation. Grassroots has been tested according to ASTM D7322 *Determination of Rolled Erosion Control Product (RECP) Ability to Encourage Seed Germination and Plant Growth under Bench-Scale Conditions* in which "containers containing soil are sown with seeds and then covered with an RECP. Additional containers of soil are sown with seed and left uncovered as controls. The light, temperature and humidity are maintained and documented. The amount of germination and growth is measured periodically throughout the test, and the mass of vegetation is calculated at the conclusion of the test" (ASTM D7322, Section 4.1). Using this method, Grassroots showed a 555% increase in biomass after 21 days when compared with the control pots.

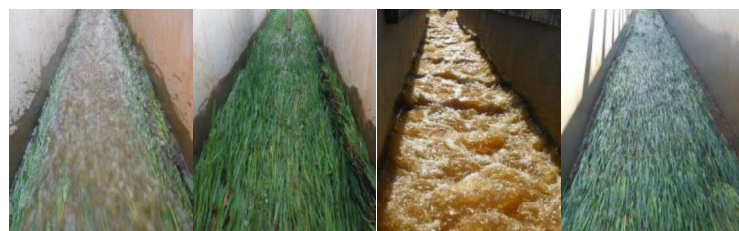
During LOW FLOW After During VERY HIGH FLOW After

Four levels of flow were used in the analysis, each running for 60 minutes, up to flow velocities of 7.5 m/s. Even after subjecting the channel to increasing levels of flow, there was an insignificant loss of soil and vegetation.

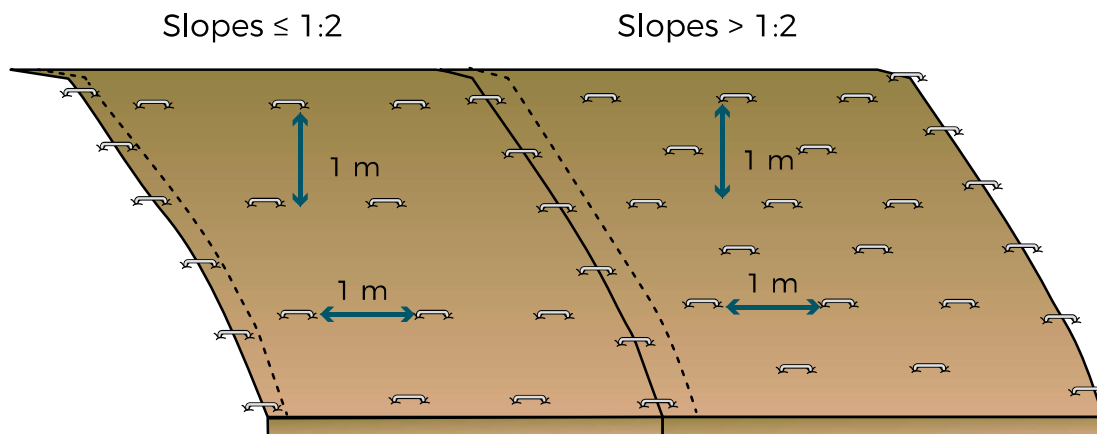
- Minimum pinning frequency is shown in the figures below.
- Additional pinning may be required in undulating soil with low spots to ensure intimate contact between mat and soil.
- On steeper batters, flooding areas or areas prone to high wind and unstable subsoils, a higher pinning rate should be used.
- Pinning is extremely important to the long-term stability of the matting. Insufficient pinning may result in the material lifting in the wind or under water flow.
- Pin type and size will depend on site conditions, soil depth, compaction, wind and water flow. For suggested pins sizes, please refer to the designer. Contact Geofabrics for options available in your area.
