# SUBERA'S PROGRESSIVE REHABILITATION AND CLOSURE PLAN

Version 02

Document ID – Subera's PRCP

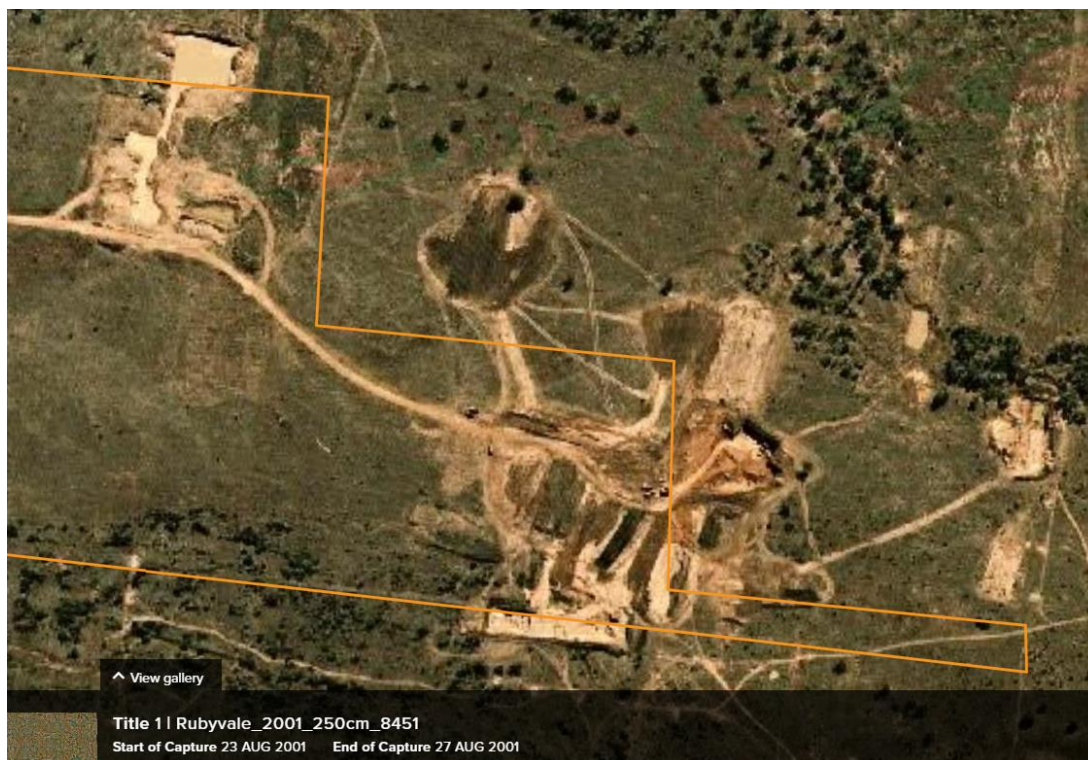
Figure 9: Historical Disturbance 2001 – Others

Historical disturbance on “Subera” is shown in Figure 9 to Figure 11. The disturbance of this mining extends into the current leases. Access to these mining areas can be observed to the west demonstrating that it was mined by others with a separate access. Figure 10 indicates that by 2012 the disturbance has been rehabilitated prior to relinquishment. Figure 11 is of a breached dam south of the industrial area. No records exist as to the timing of construction or the responsible party for the dam. Spatial data of the historical disturbance has been recorded from the 2001 mosaic in Qld Globe and from the current Google Earth image (see Figure 12).

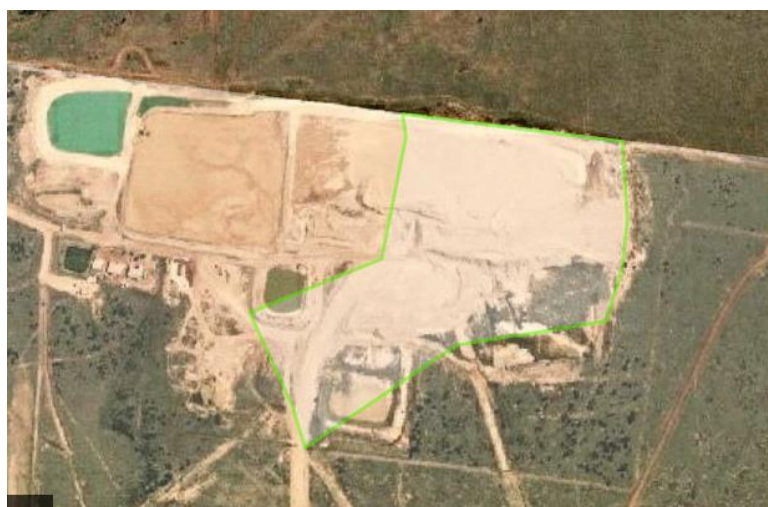
**Figure 13: Rejects Hill 2001**

Fura Gems has 2 certified rehabilitated domain that contained a Plant Area i.e. Rejects Hill and Lois Lane with its associated TSFs. Rejects Hill/Main Dam Site is an elevated Plant Area. Figure 13 shows the area in plan view in 2001. Green Polygon is the now certified rehabilitation of Rejects Hill. Figure 14 shows the area looking north-east in 2017.

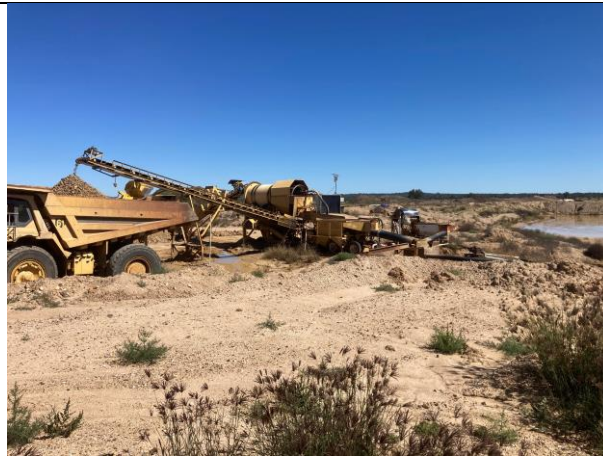
Figure 15: Wash Plant

Area that will serve as future Plant Areas are identified prior to mining. With Plant Areas, the topsoil is stripped and pushed or carted to the perimeter of the planned Plant footprint in the first instance to prevent re-handling. Placement of overburden is planned to create the landform required to set up a mining pit as a Plant Area once all wash is removed for processing. Plant Areas require one pond for recycled water used for processing, one pond for wet tails and a larger dry tails pond. A built-up area next to the dry tails pond is required for the processing plant. Overburden is stockpiled on the pond perimeters. This overburden combined with oversize and dry tails is used to obtain the final landform and to cap the wet tails. Plant Areas (see Figure 15) typically have the capacity for two years of tails.

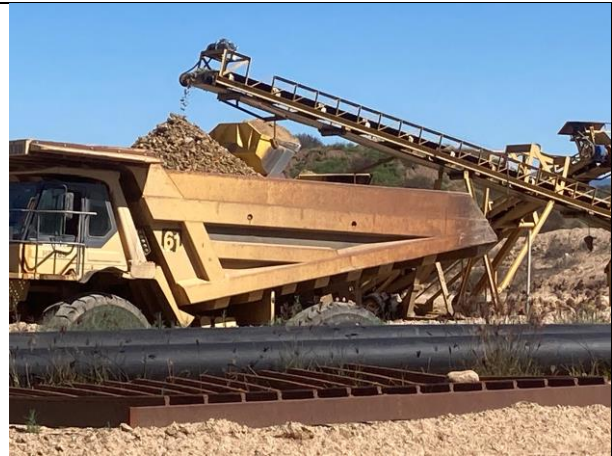
Figure 16: Oversize from Screen conveyed into Truck

The wash is hauled to a stockpile area and fed by a loader to a dry screening plant where up to 35% of the feed (oversize @ plus 18mm) is rejected being conveyed onto a truck (see Figure 16). This material is either returned to the mining pits by the trucks on their return journey or used for earthworks. The remaining 65% of sapphire bearing gravels is washed using a trommel and pulsator to a concentrate. No chemicals are used in the process. The waste stream flows by gravity onto the dry tails beach. The pipe is continuously moved to manage the beach and wet tails/return water flow. Dense rocks from the trommel and pulsator are collected in the base of the Plant. This material containing the sapphires is removed daily and further separated in the Industrial Area. Dense rocks are less than 0.01% of the wash tonnage with the sapphires are a similar percentage of the dense rocks.

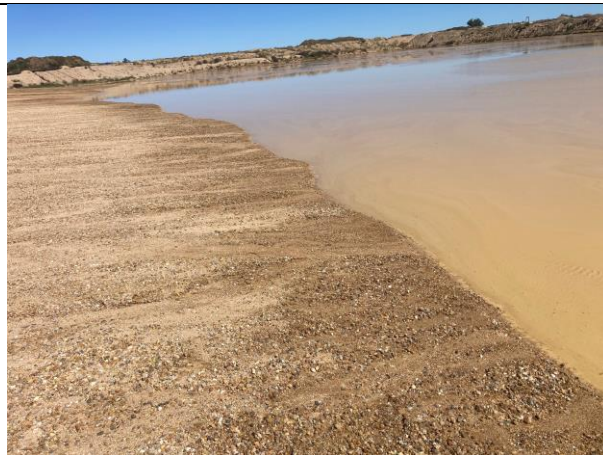
Figure 17: Dry tails beach

Dry tails deposit on an elevated beach with water and wet tails flowing off. The dry tails are sands and gravels and are trafficable immediately (see Figure 17). As the dry tails beach expands, the bund and the dry tails (Figure 18) can be removed maintaining a bund of dry tails to contain the return water and wet tails.

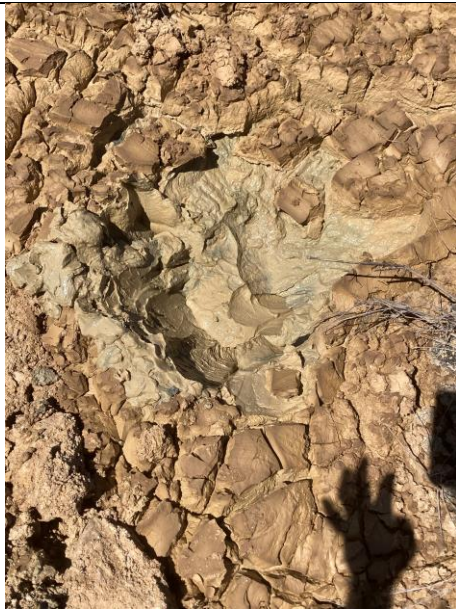
Figure 20: PL2 Wet Tails showing crusting

The wet tail's pH and salinity equate to TSF water quality (see Table 12). Water content of wet tails is high. Moisture content for Promised Land 2 wet tails which has been available for rehabilitation for 2 years is 70%. The wet tails surface rapidly crusts on drying (see Figure 20). Vegetation has established and grown on this pond (see Figure 21). Recent crowding of the wet tails has drowned the vegetation. Crowding and drying out of the wet tails take time and is the reason for the maximum of 5 years scheduled from a Plant Area being available to achieving RM2 i.e., final landform achieved. Fura Gems crews understand the nature of the wet tails and have successfully rehabilitated all wet tails to date with two Plant Areas achieving certified rehabilitation status in addition to two areas achieving RM4.

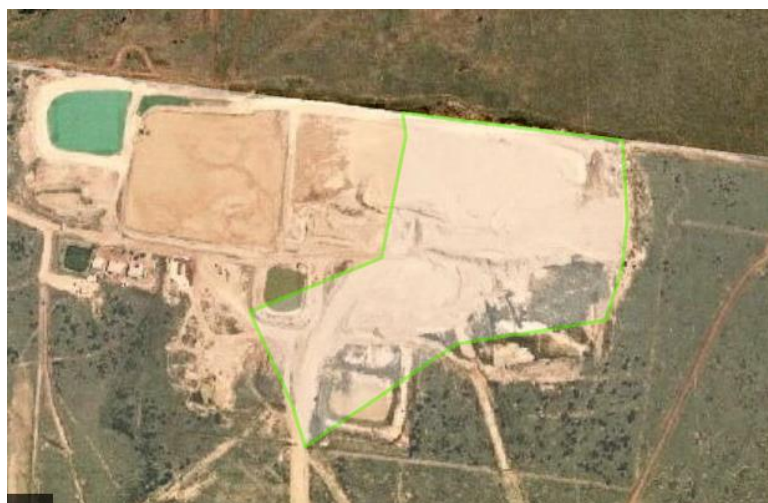
**Figure 22: Rejects Hill 2001**

Fura Gems has 2 certified rehabilitated domains that contained a Plant Area i.e. Rejects Hill and Lois Lane with its associated dry and wet tails. Rejects Hill/Main Dam Site is an elevated Plant Area. Figure 22 shows the area in plan view of Rejects Hill in 2001. Green Polygon is the now certified rehabilitation of Rejects Hill. Figure 23 shows Rejects Hill looking north-east in 2017.
