# GREAT NORTHERN MINE'S PROGRESSIVE REHABILITATION AND CLOSURE PLAN

Version 01

Document ID – Great Northern Mine's PRCP

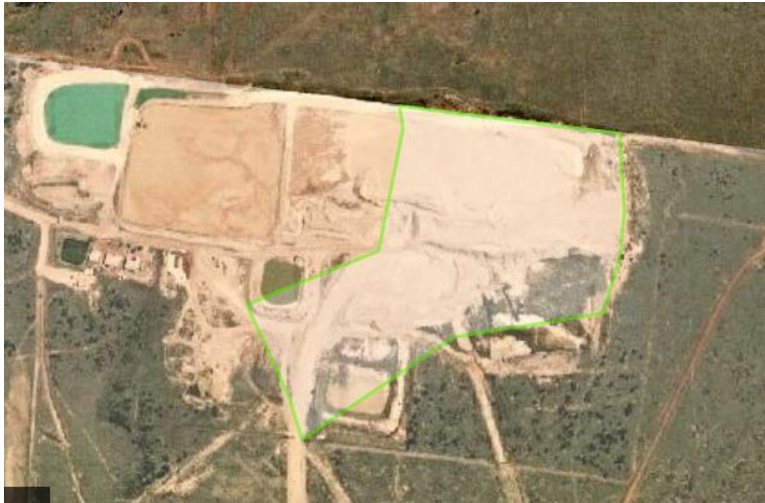
**Figure 3: Rejects Hill 2001**

GNM has 2 certified rehabilitated domain that contained a Plant Area i.e. Rejects Hill and Lois Lane with its associated TSFs. Rejects Hill/Main Dam Site is an elevated Plant Area. Figure 3 shows the area in plan view in 2001. Green Polygon is the now certified rehabilitation of Rejects Hill. Figure 4 shows the area looking north-east in 2017.

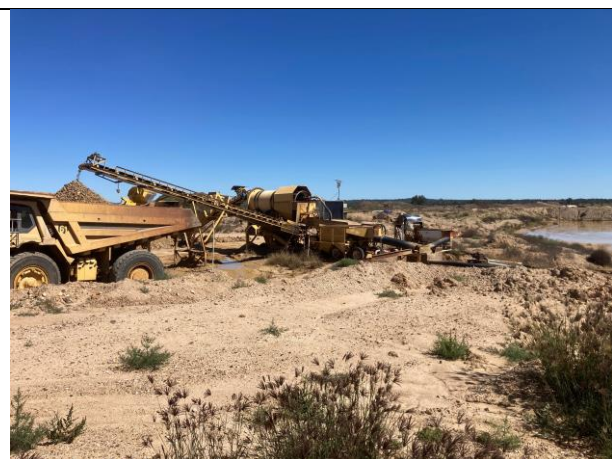
Figure 5: Wash Plant

Area that will serve as future Plant Areas are identified prior to mining. With Plant Areas, the topsoil is stripped and pushed or carted to the perimeter of the planned Plant footprint in the first instance to prevent re-handling. Placement of overburden is planned to create the landform required to set up a mining pit as a Plant Area once all wash is removed for processing. Plant Areas require one ponds for recycled water used for processing, one pond for wet tails and a larger dry tails pond. A built-up area next to the dry tails pond is required for the processing plant. Overburden is stockpiled on the pond perimeters. This overburden combined with oversize and dry tails is used to obtain the final landform and to cap the wet tails. Plant Areas (see Figure 5) typically have the capacity for two years of tails.

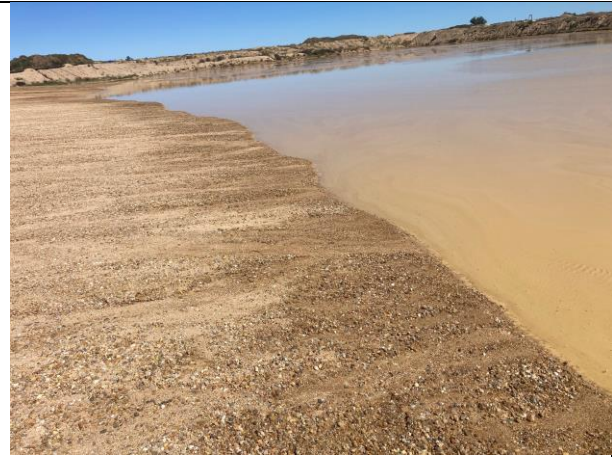
Figure 7: Dry tails beach

Dry tails deposit on an elevated beach with water and wet tails flowing off. The dry tails are sands and gravels and are trafficable immediately (see Figure 7). As the dry tails beach

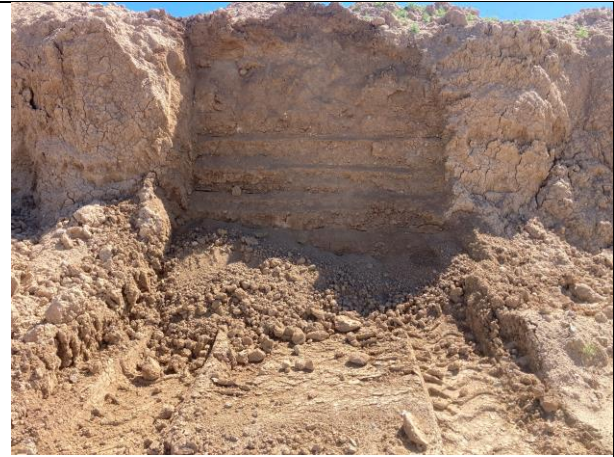
Figure 8: Dry Tails Vertical Face

expands, the bund and the dry tails (Figure 8) can be removed maintaining a bund of dry tails to contain the return water and wet tails.

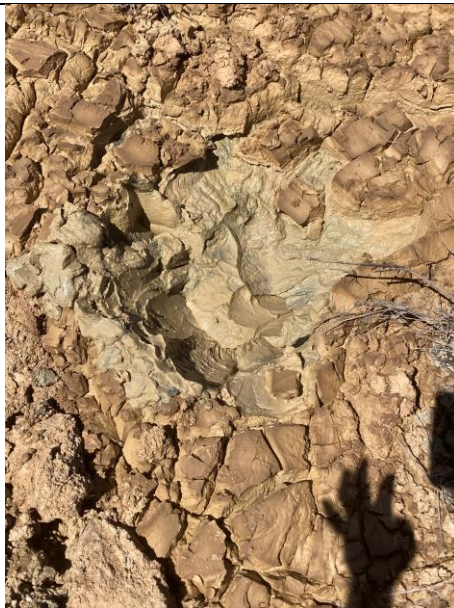
Figure 10: PL2 Wet Tails showing crusting

The wet tail's pH and salinity equate to TSF water quality (see Table 11). Water content of wet tails is high. Moisture content for Promised Land 2 wet tails which has been available for rehabilitation for 2 years is 70%. The wet tails surface rapidly crusts on drying (see Figure 10). Vegetation has established and grown on this pond (see Figure 11). Recent crowding of the wet tails has drowned the vegetation. Crowding and drying out of the wet tails take time and is the reason for the maximum of 5 years scheduled from a Plant Area being available to achieving RM2 i.e., final landform achieved. GMN crews understand the nature of the wet tails and have successfully rehabilitated all wet tails to date with two Plant Areas achieving certified rehabilitation status in addition to two areas achieving RM5.

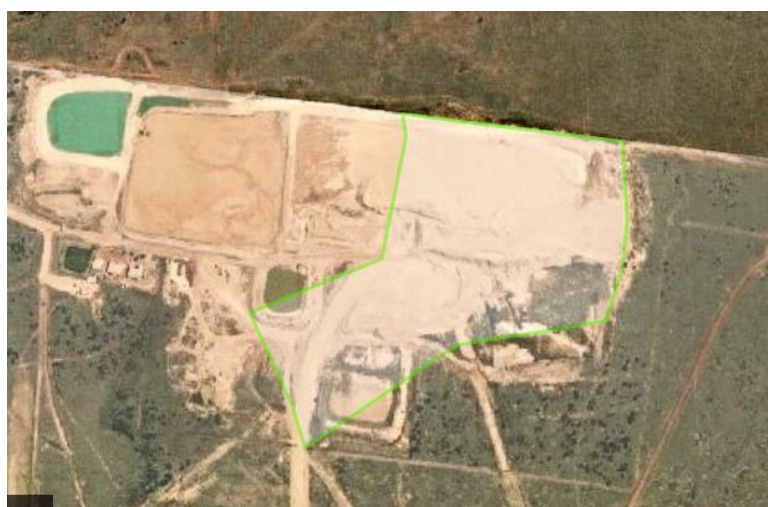
**Figure 12: Rejects Hill 2001**

GNM has 2 certified rehabilitated domains that contained a Plant Area i.e. Rejects Hill and Lois Lane with its associated dry and wet tails. Rejects Hill/Main Dam Site is an elevated Plant Area. Figure 12 shows the area in plan view of Rejects Hill in 2001. Green Polygon is the now certified rehabilitation of Rejects Hill. Figure 13 shows Rejects Hill looking north-east in 2017.
