# TRANSITIONAL PROGRESSIVE REHABILITATION AND CLOSURE PLAN

## ELIMATTA COAL MINE

PREPARED FOR  
NEW HOPE GROUP  
on behalf of TAROOM COAL PROPRIETARY LIMITED

31 MARCH 2023

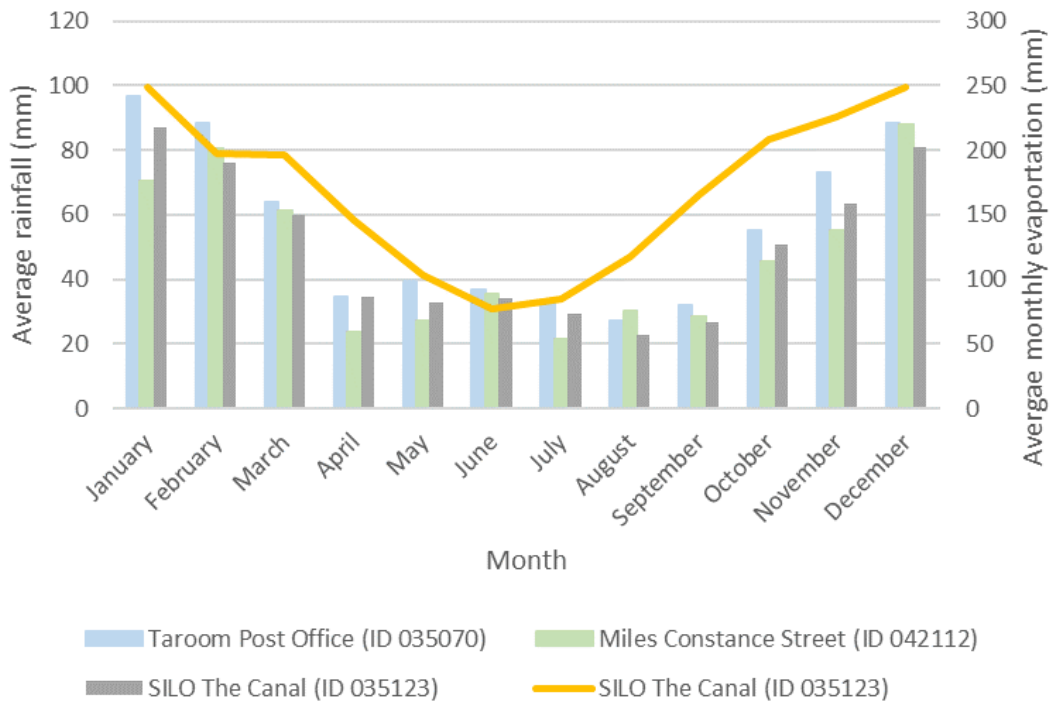
Figure 5: Regional average monthly rainfall and evaporation

The climate of the Project region is subtropical with a distinctly dry winter. The wet season generally aligns with the November to March period which accounts for over 65% of the region’s average rainfall (Figure 5). Annual rainfall records for between the period of 1889-2022 are as follows.

Evaporation records are available from SILO (The Canal ID 035123) which recorded a potential annual average evaporation (Class A pan) of approximately 2,021 mm, approximately three times the average rainfall (Figure 5). Based on the available datasets, measured, monthly average potential evaporation is approximately three times higher than the average rainfall.

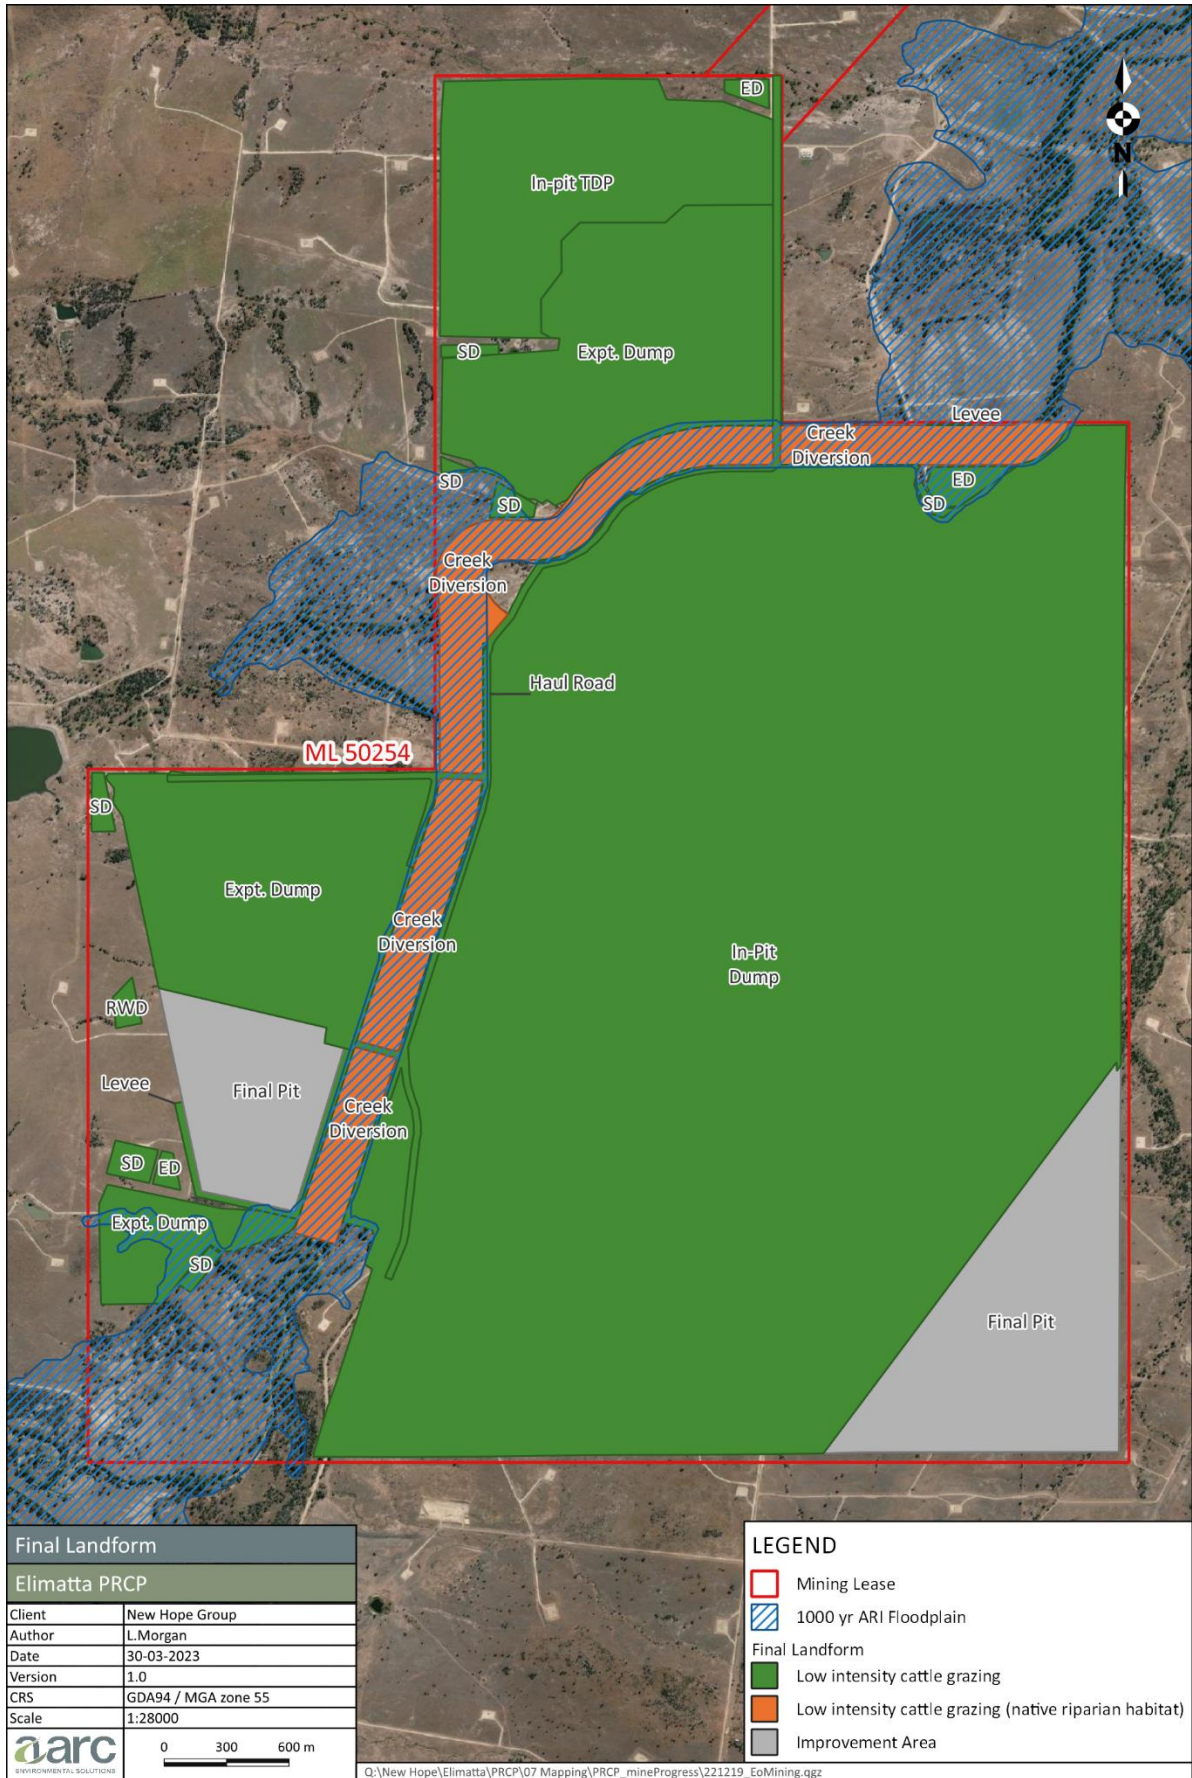
Figure 18: Final landform design (ML 50254)

As per the EIS Assessment Report (EHP 2014), the residual voids have been nominated as NUMAs (Table 10 and Figure 18).

Both the location and size of the residual voids as described in the land outcome documents are consistent with the NUMAs proposed for this PRCP (refer Figure 17 and Figure 18). Design parameters for the NUMAs are presented in Table 12.

Figure 17 and Figure 18 present the final landform for the Project. The predicted ARI 1:100 flood levels are included on this map to provide an indication of the location of residual voids and other infrastructure in relation to this flood level. Details of rehabilitation strategies for each mine domain are discussed in the following sections.

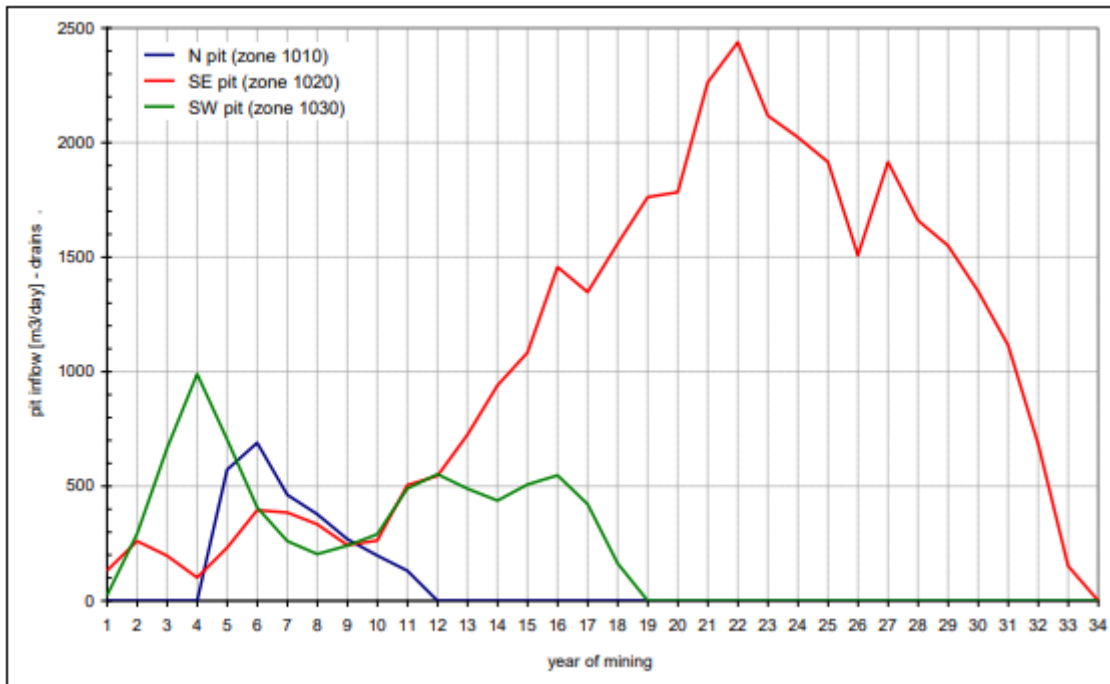
Figure 22: Predicted inflow from coal seams

As recommended by a review of the groundwater model by JBT (2017), the model was also rerun to determine the proportion of groundwater flow from the Walloon Coal Measures in the mine highwall, and the spoils that form the open cut pit low wall.

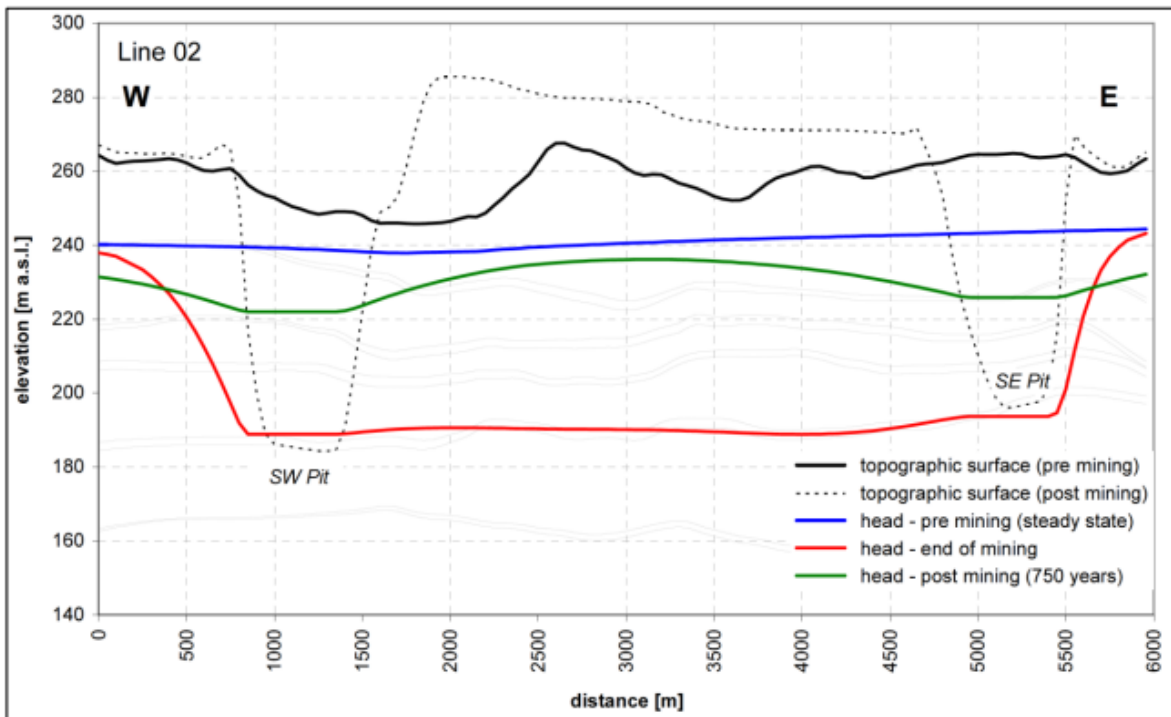
Figure 28: Groundwater cross section – Line 2
