## **Minerva Mine**

# **Progressive Rehabilitation and Closure Plan**

**ML70145 and ML70376**

**EA Holder - Minerva Coal Pty Ltd**

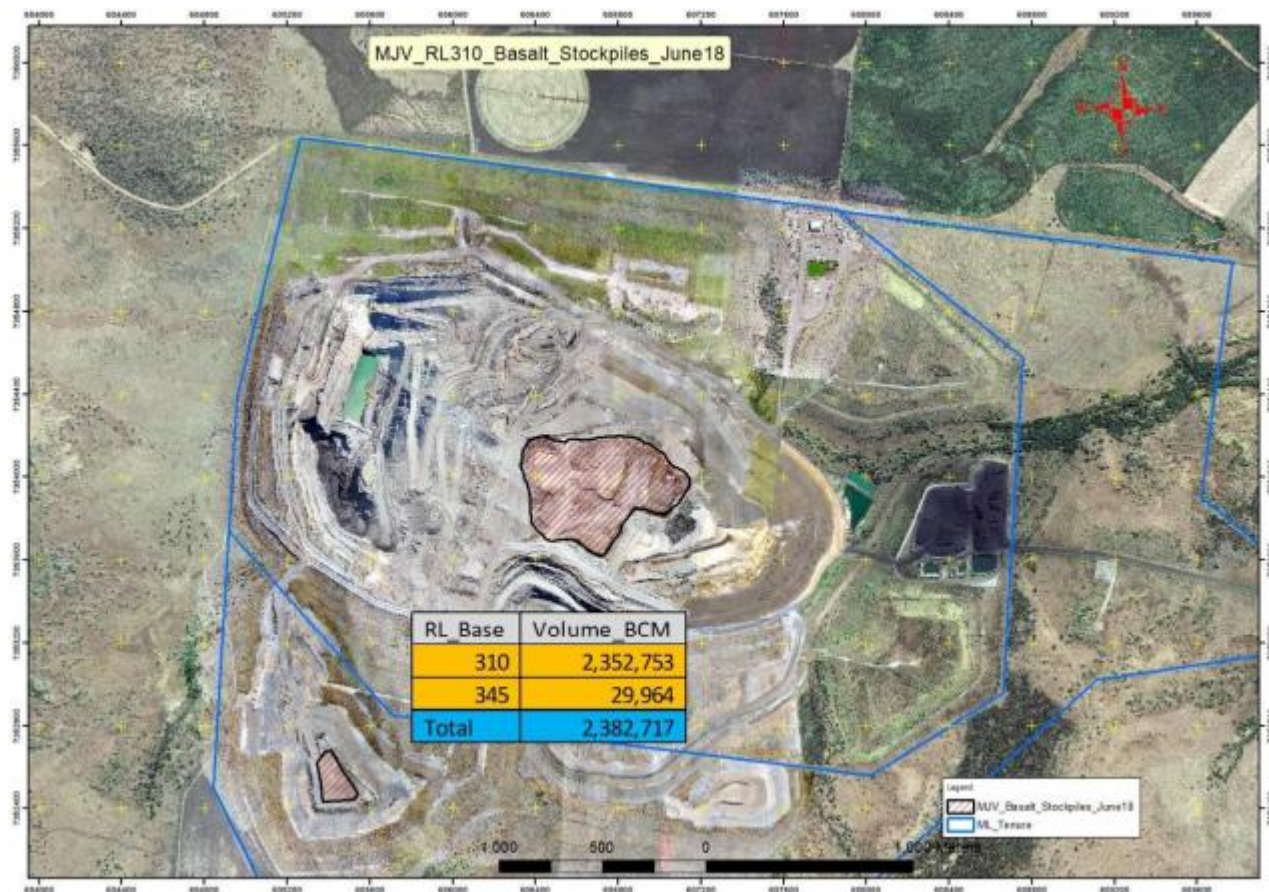
**Figure 16 – Basalt Stockpiles and Volumes**

Minerva Mine has stockpiled approximately 2,382,000 m<sup>3</sup> of competent basalt on the in Main pit dump and the Southern dump, based on the site's most recent survey reconciliation. The locations and volumes of the basalt stockpiles are provided in **Figure 16**.

The total disturbed area requiring rehabilitation with rock mulch at the end of mine life is 202.5 ha. The rock mulch rehabilitation treatments allow for 0.5 m thick of basalt over the surface of reprofiled areas. The total volume of 2,382,000 m<sup>3</sup> of basalt rock provides more than sufficient material to cover the entire 202.5 ha with a minimum rock mulch thickness of 0.5m.

The Western pit high wall contained large volumes of competent basalt, with the thickness of the basalt strata reaching ~130 m in the western portion of ML 70145. Basalt from pre-strip activities has been stockpiled for use in rock mulch rehabilitation on dumps that have a re-profiled surface greater than 5% slope. Placement of 0.5 m thick basalt rock mulch over shaped spoil dumps mimics stable rock scree landforms in the area and promotes the development of a bushland habitat for the rehabilitated areas.

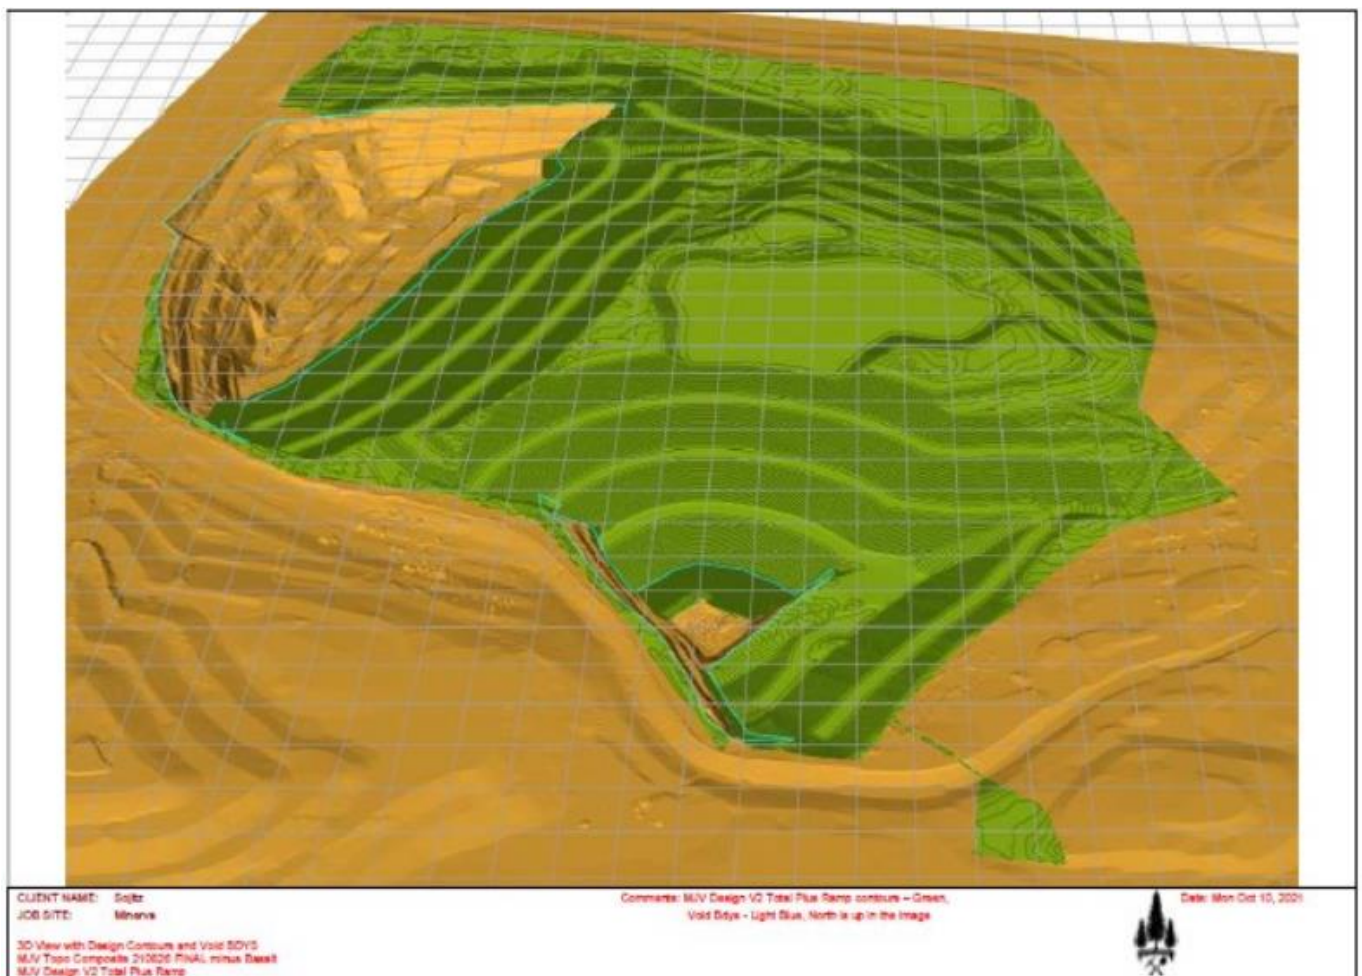
**Figure 17 – 3D Model of Final Landform**

A three-dimensional model of the final landform has been prepared and is shown in **Figure 17**, with the green shading indicating the area requiring reshaping. The final heights of the rehabilitated landforms are provided in **Figure 18**, with the South-West dump forming the highest elevation at RL 345 m.

- Batter surfaces with a grade of 25% slope or less with 0.5m basalt rock mulch plus topsoil;
- Benches installed at 15 m or less vertical lifts, wide enough to enable topsoil haulage along the benches;
- With slopes less than 5%, topsoil only application to shaped surfaces; and
- Rehabilitated surfaces designed to shed water to the receiving environment.
