ENSHAM  
RESOURCES  
PTY LIMITED

# PROGRESSIVE REHABILITATION AND CLOSURE PLAN

Version 4

Mining Leases

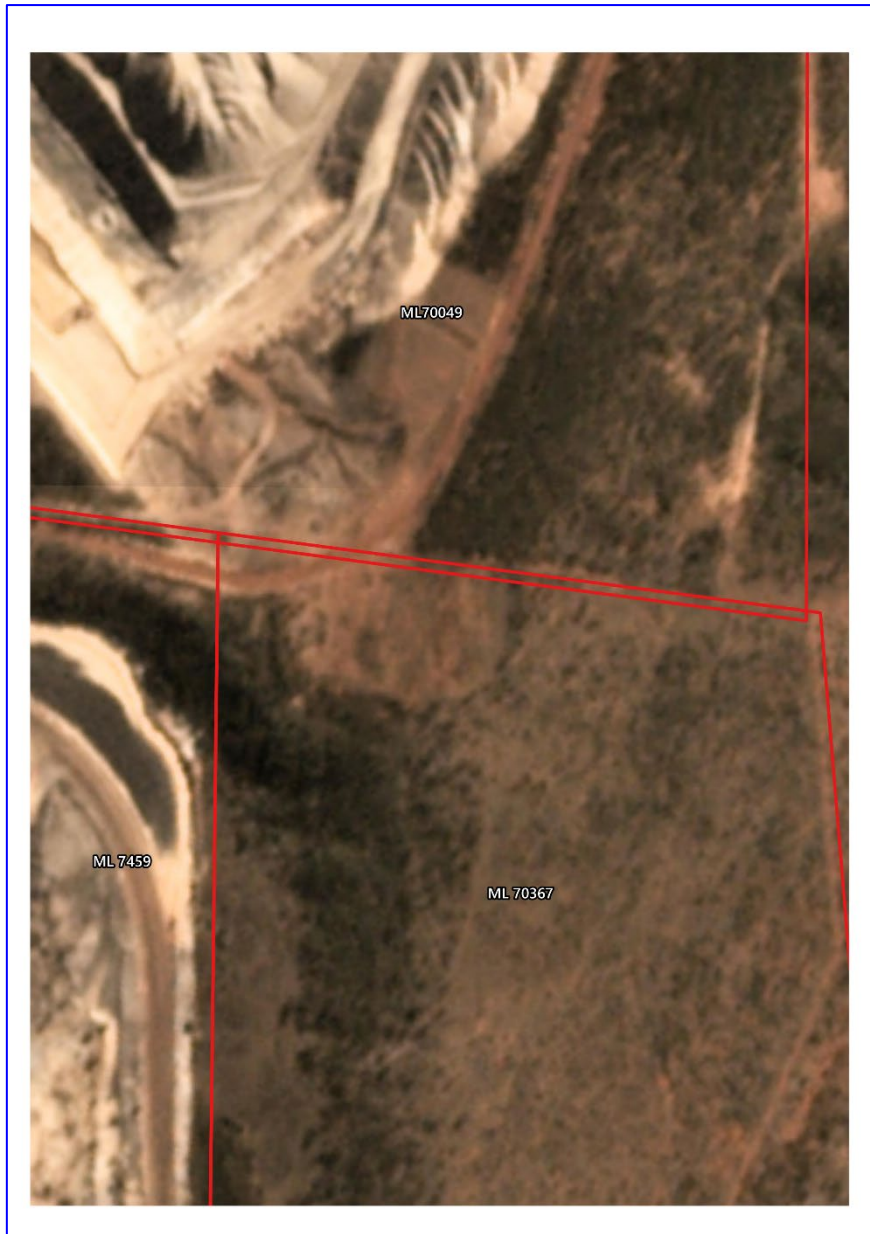
Figure P0-1 Example of spatial data inaccuracies in QSpatial

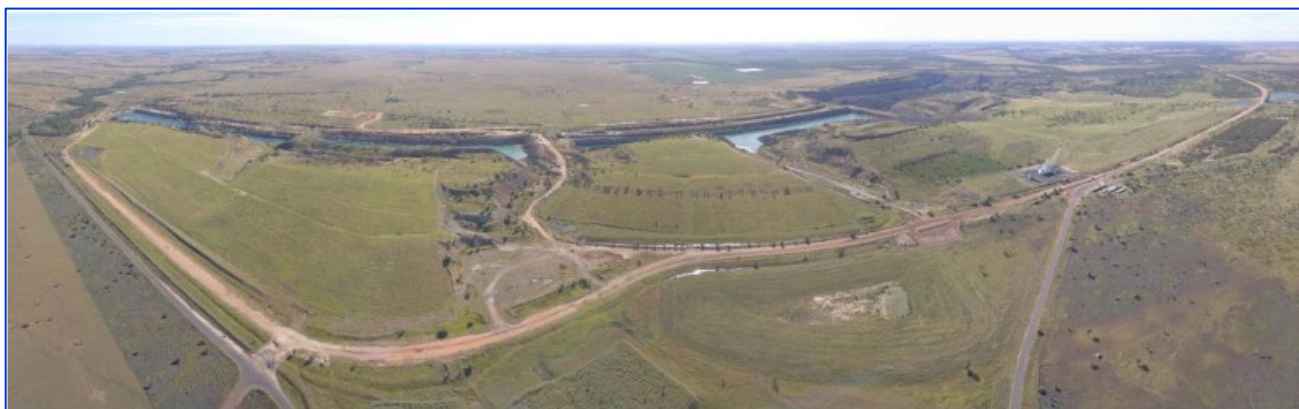
**Figure 1-5 Existing rehabilitation at AB Pit (ML7459)**

These areas are currently used for beef cattle grazing.

Ensham has completed more than 1,600 ha of opencut mine rehabilitation since 2001 (Figure 1-5, Figure 1-6, Figure 1-7 and Figure 1-8). This equates to approximately one third of total mining disturbances. Most existing rehabilitation has a target PMLU of beef cattle grazing. Portions of existing rehabilitation have been approved as certified under the EP Act (Table 1-4) or not yet applied for. Following approval of the application for certification of progressive rehabilitation in 2021, Ensham has more certified opencut rehabilitation than any other opencut coal mine in Queensland.

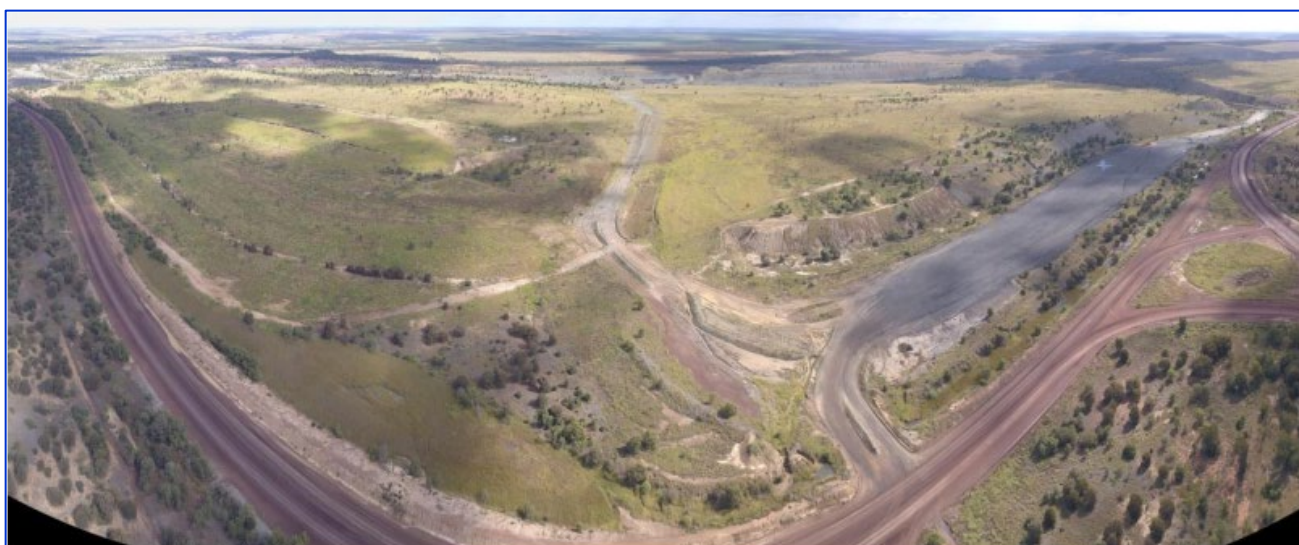
**Figure 1-6 Existing rehabilitation at CDE Pit (ML7459)**

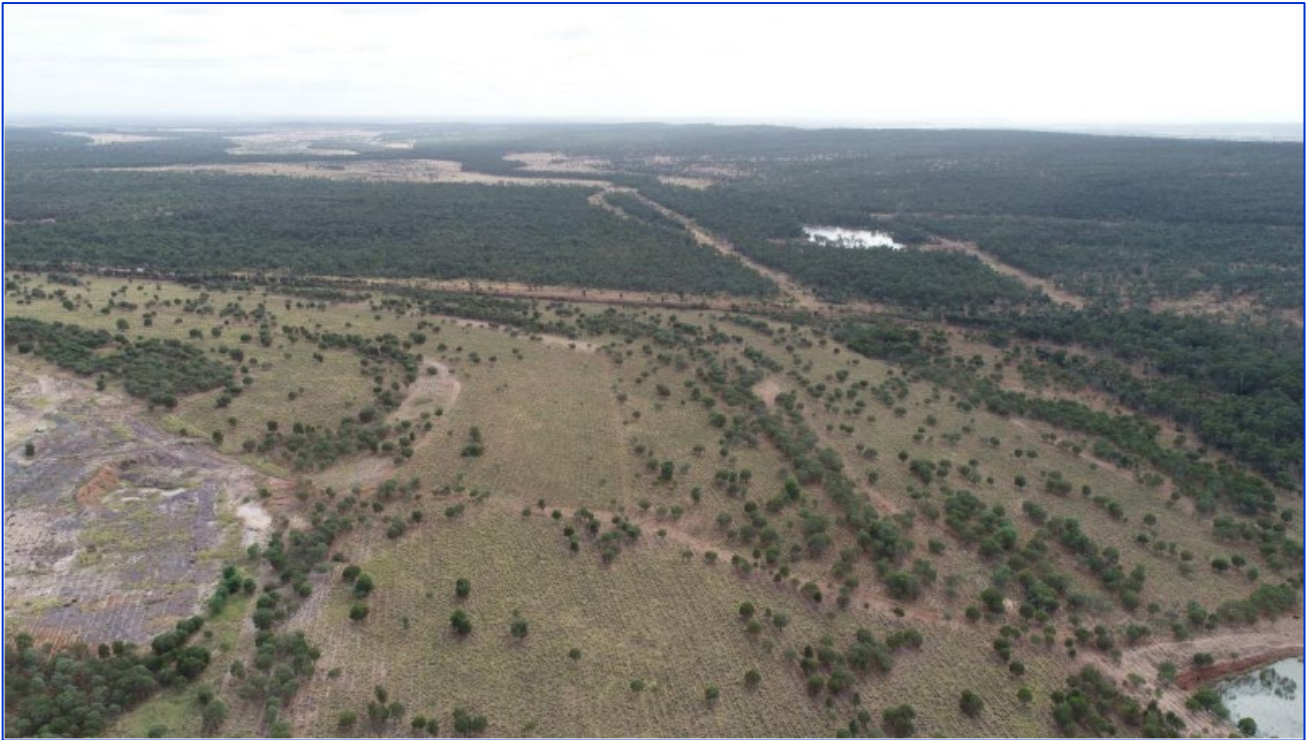
**Figure 1-7 Existing rehabilitation at Y Pit (ML70049)**

This area was certified in 2019 and is currently used for beef cattle grazing.

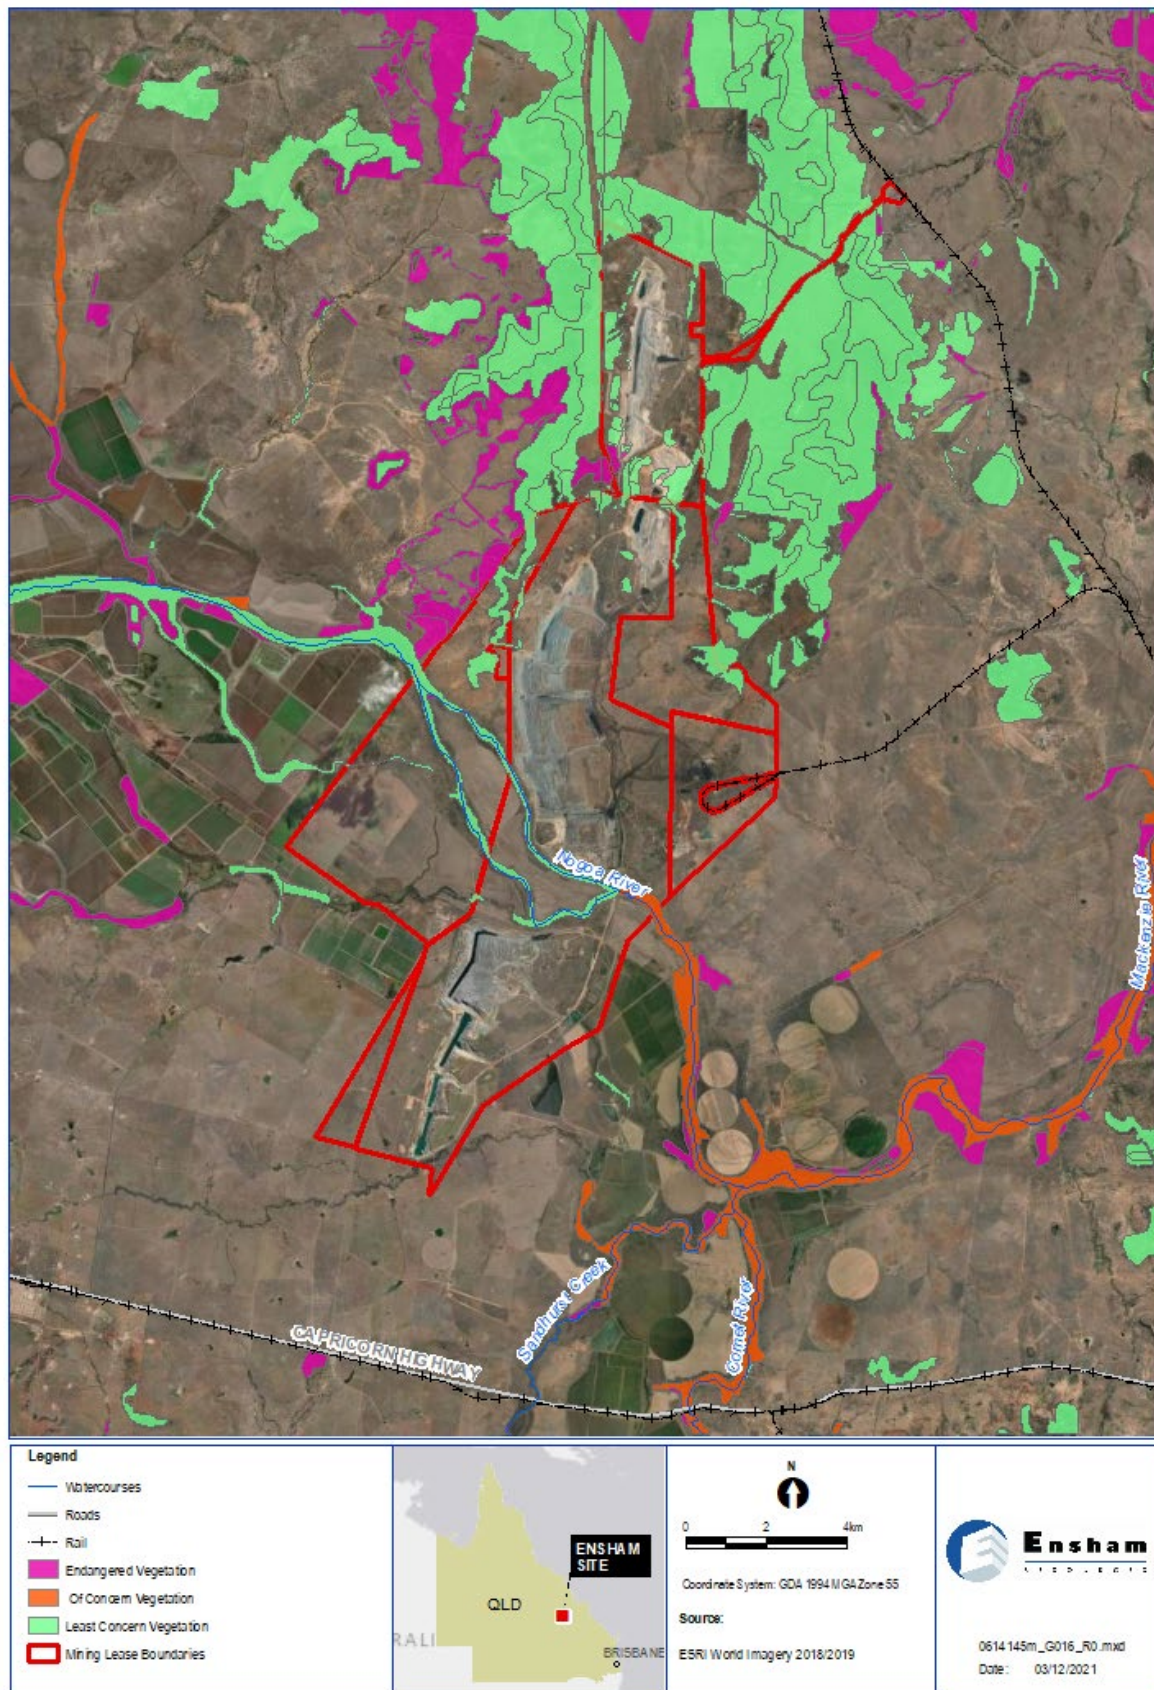
Figure 1-16 Regional ecosystems mapped at Ensham

Much of the land at Ensham had been cleared of vegetation for agricultural development prior to mining. Vegetation mapping shows there are 13 regional ecosystems within the mining leases (Table 1-10 and Figure 1-16). There are four Threatened Ecological Communities identified as potentially occurring (Table 1-11).

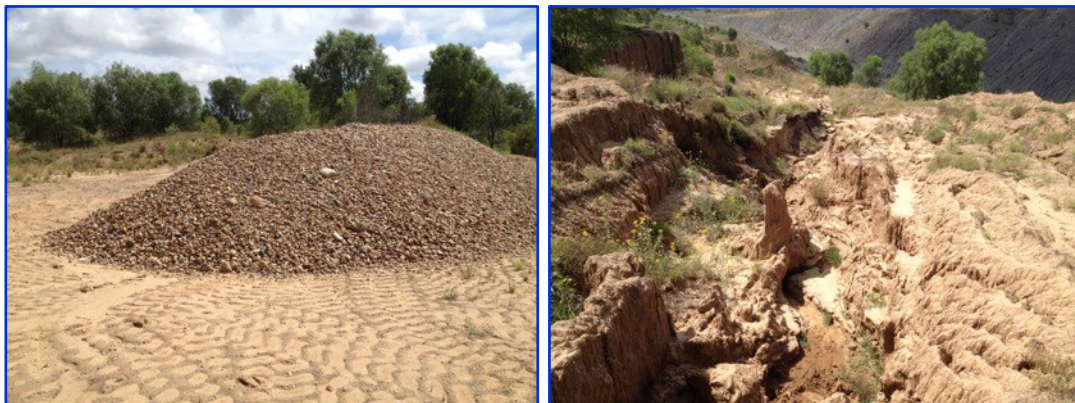
Figure 5-3 Quaternary spoil in B Pit is screened for gravel and sand for use around site (left) and erosion in situ Quaternary spoil in B Pit endwall (right)

Pale brown to yellow alluvial sands and gravels (Figure 5-3). Low clay content means material has little water or nutrient holding capacity. Non-saline but sodic with low surface cohesion, this overburden is highly dispersive and prone to excessive erosive when exposed to rainfall.

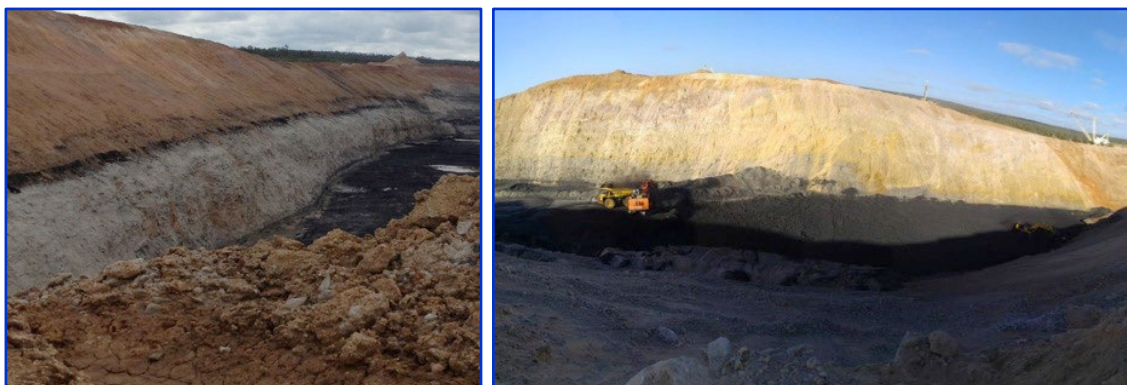
Figure 5-4 Tertiary spoil overlying Permian spoil in Y Pit (left) and F Pit (right)

Overlying the Permian overburden, this material is derived from Tertiary age alluvium or colluvium (Figure 5-4). It is consistently saline to extremely saline, with chloride levels toxic to plants at Y Pit, and consistently sodic to extremely sodic. This material is extremely dispersive.

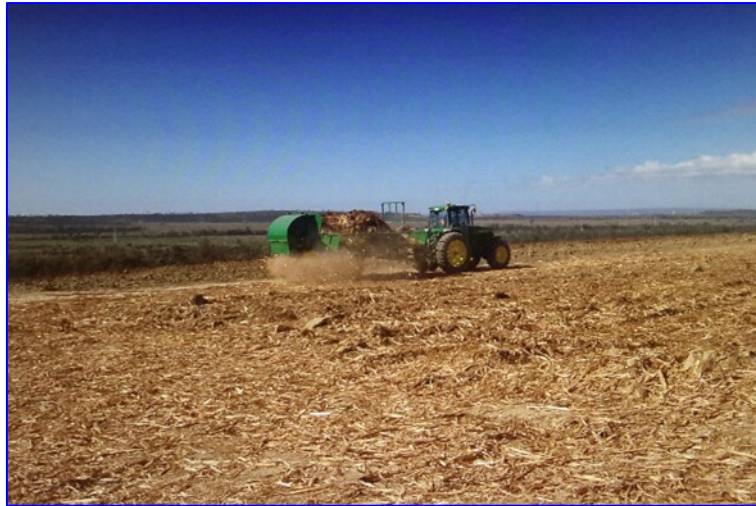
**Figure 5-10 Spreading hay mulch for erosion control in rehabilitation at Ensham**

Ensham applies hay mulch immediately after sowing to provide instant groundcover and close the window of erosion risk (Figure 5-10). This is particularly important for any slopes greater than 20%. Hay mulch applied at a minimum rate of 5 t/ha is a quick, cheap, and effective erosion hazard control. It also promotes germination and establishment of sown species by assisting to retain soil moisture through reducing evapotranspiration and lowering soil temperatures in the hotter months.

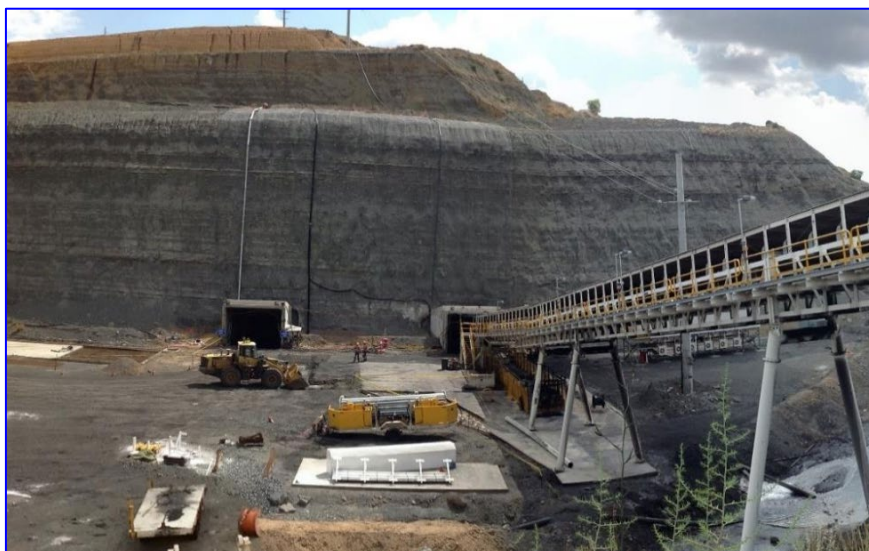
**Figure 5-11 Entrances to the existing Ensham underground mine.**

Underground mining at Ensham has negligible surface impacts because, unlike longwall mining, bord and pillar mining does not cause discernible surface subsidence. The underground workings are accessed from a section of C Pit highwall (Figure 5-11).

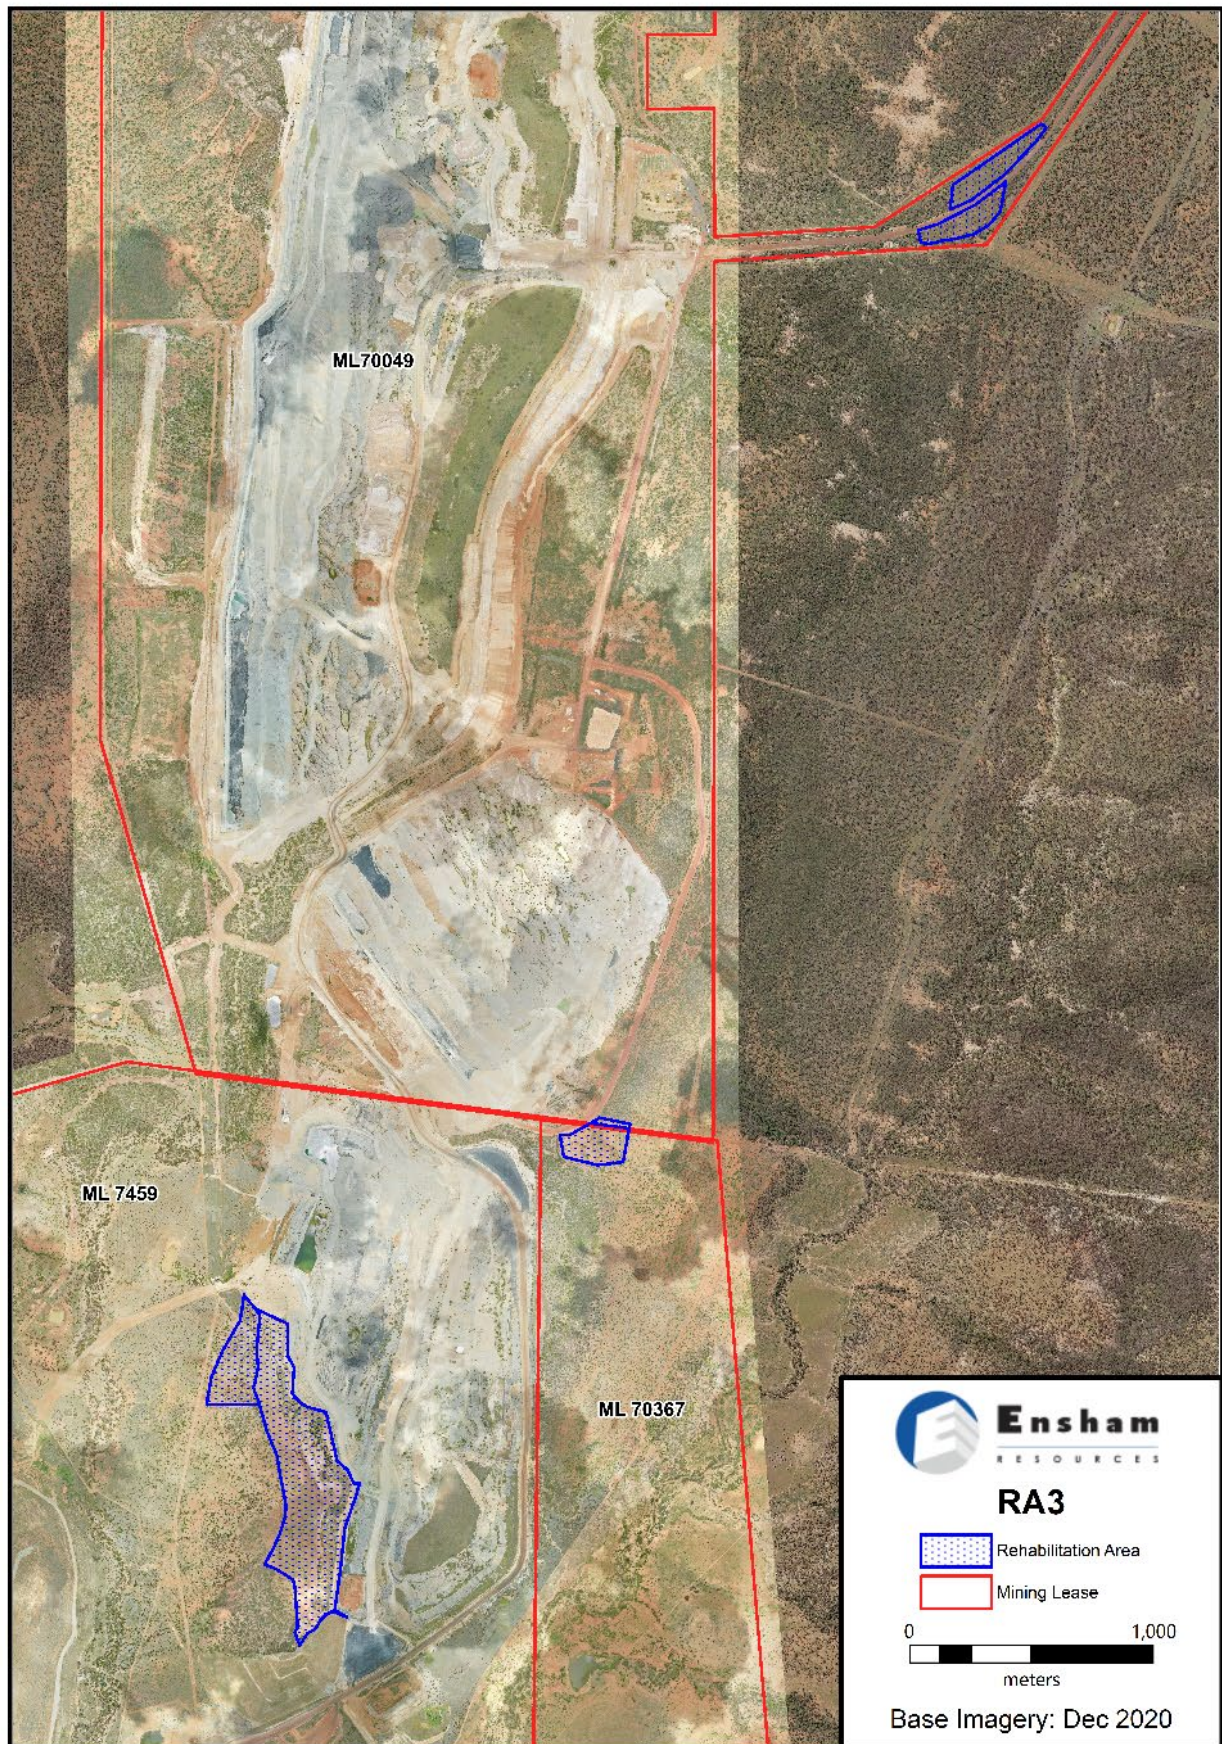
Figure 9-11 Rehabilitation Area 3 (RA 03)

| Post-mining land uses (PMLU) | | |
|---|---|--|
| Relevant activities | Mine domain 4 – cleared areas (Figure 9-11 Rehabilitation Area 3 (RA 03)) | |

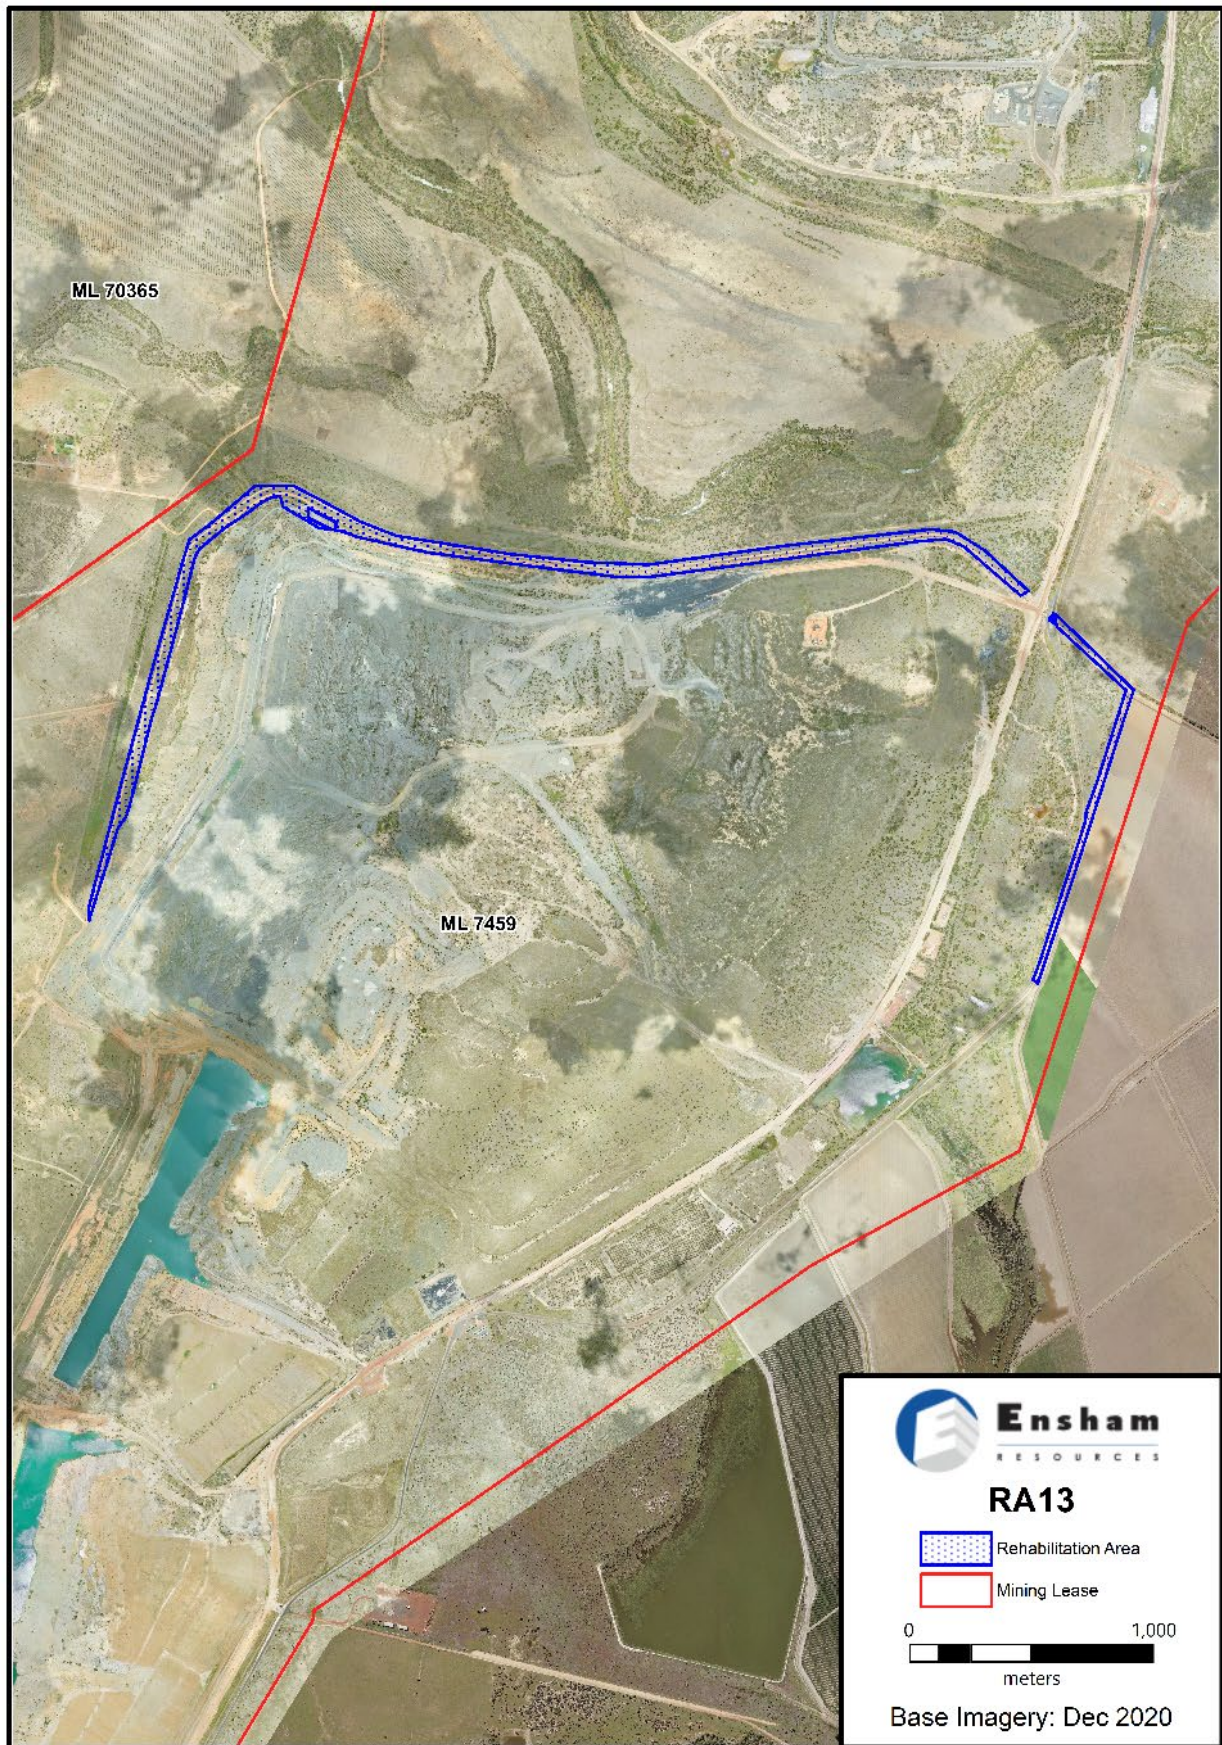
Figure 9-21 Rehabilitation Area 13 (RA 13)

| Post-mining land uses (PMLU) | | | | | | | | | | | | | | | | | |
|---|---|---|---|---|---|---|---|---|---|---|---|---|---|---|---|---|---|
| Relevant activities | Mine domain 7 - Flood protection landform constructed over existing levee (Figure 9-21 Rehabilitation Area 13 (RA13)) | | | | | | | | | | | | | | | | |

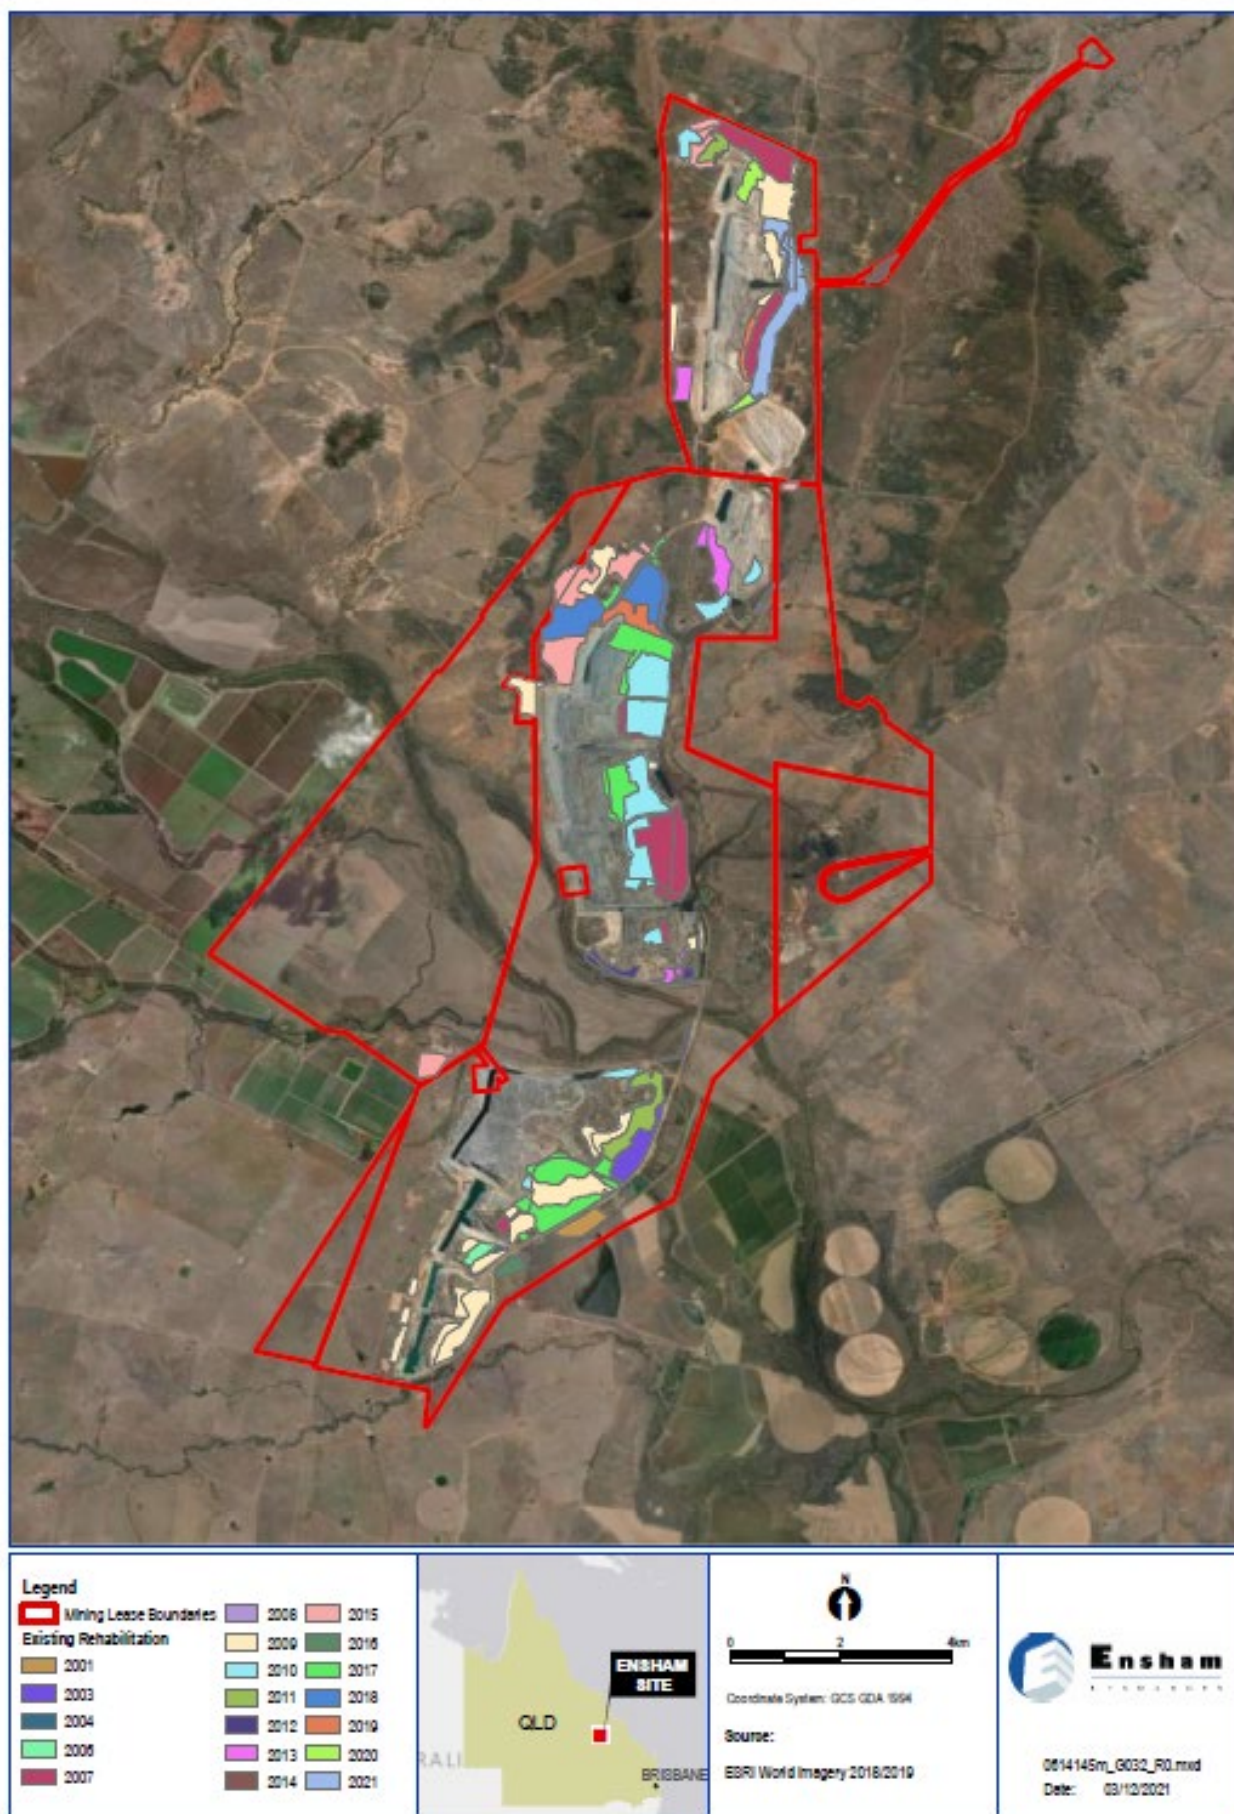
Figure 2-1 Progressive rehabilitation areas at Ensham

This demonstrates that progressive rehabilitation has been occurring across the disturbance footprint and for the full range of PMLUs proposed for the Ensham site. Figure 2-1 shows the location of these areas.

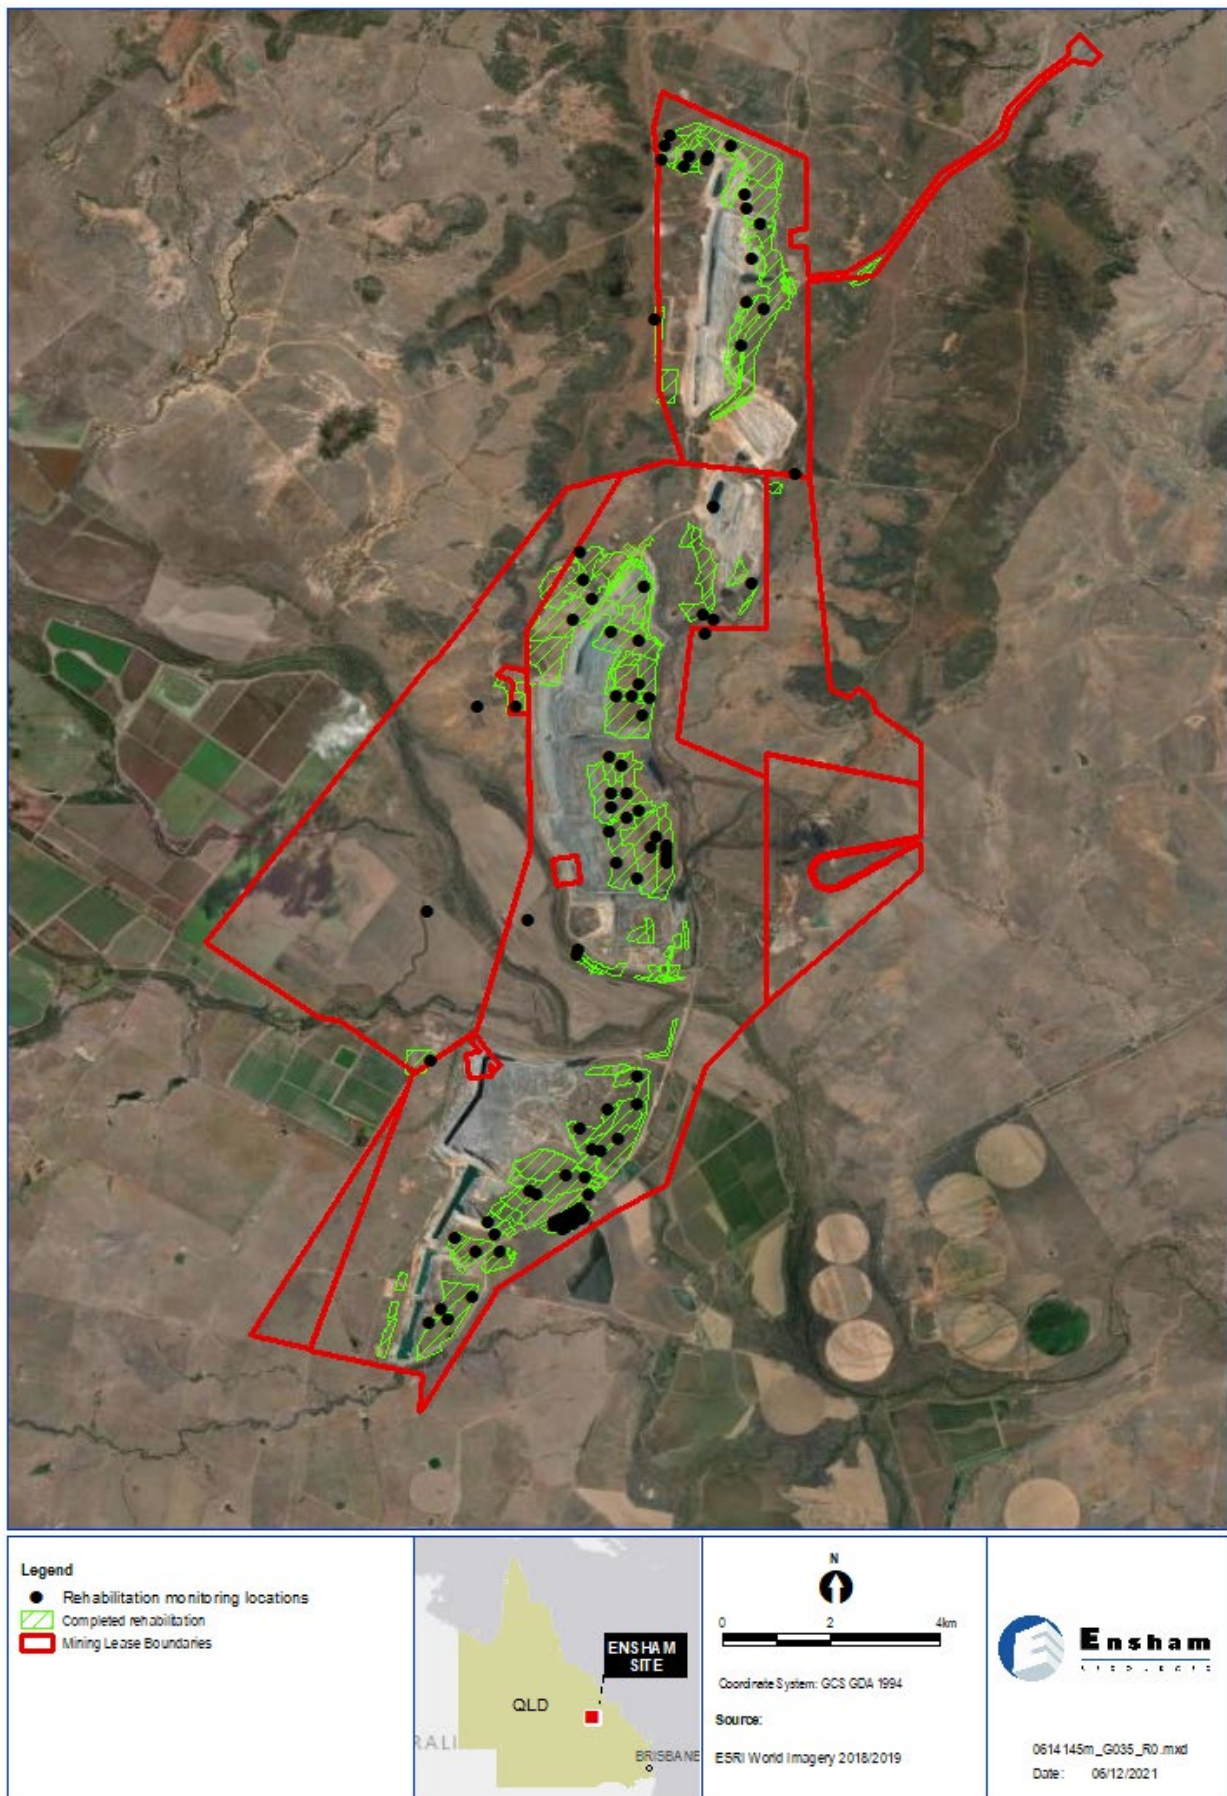
Figure 3-1 Rehabilitation monitoring locations at Ensham

Figure 3-1 shows areas of monitoring locations within areas of progressive rehabilitation from the most recent monitoring campaign completed in 2020. This campaign aimed to complete a comprehensive baseline of rehabilitation monitoring data for all areas of historical progressive rehabilitation. In this way, a recent and consistent data set has been established for Ensham.

Monitoring sites and areas were subsequently divided by method of assessment in accordance with the type of site as detailed in Section 3.2.1 above. Satellite assessments were conducted for observation sites (using VegMachine) and on-ground survey was completed for detail/check sites, using field flora survey, photo assessment and satellite review.

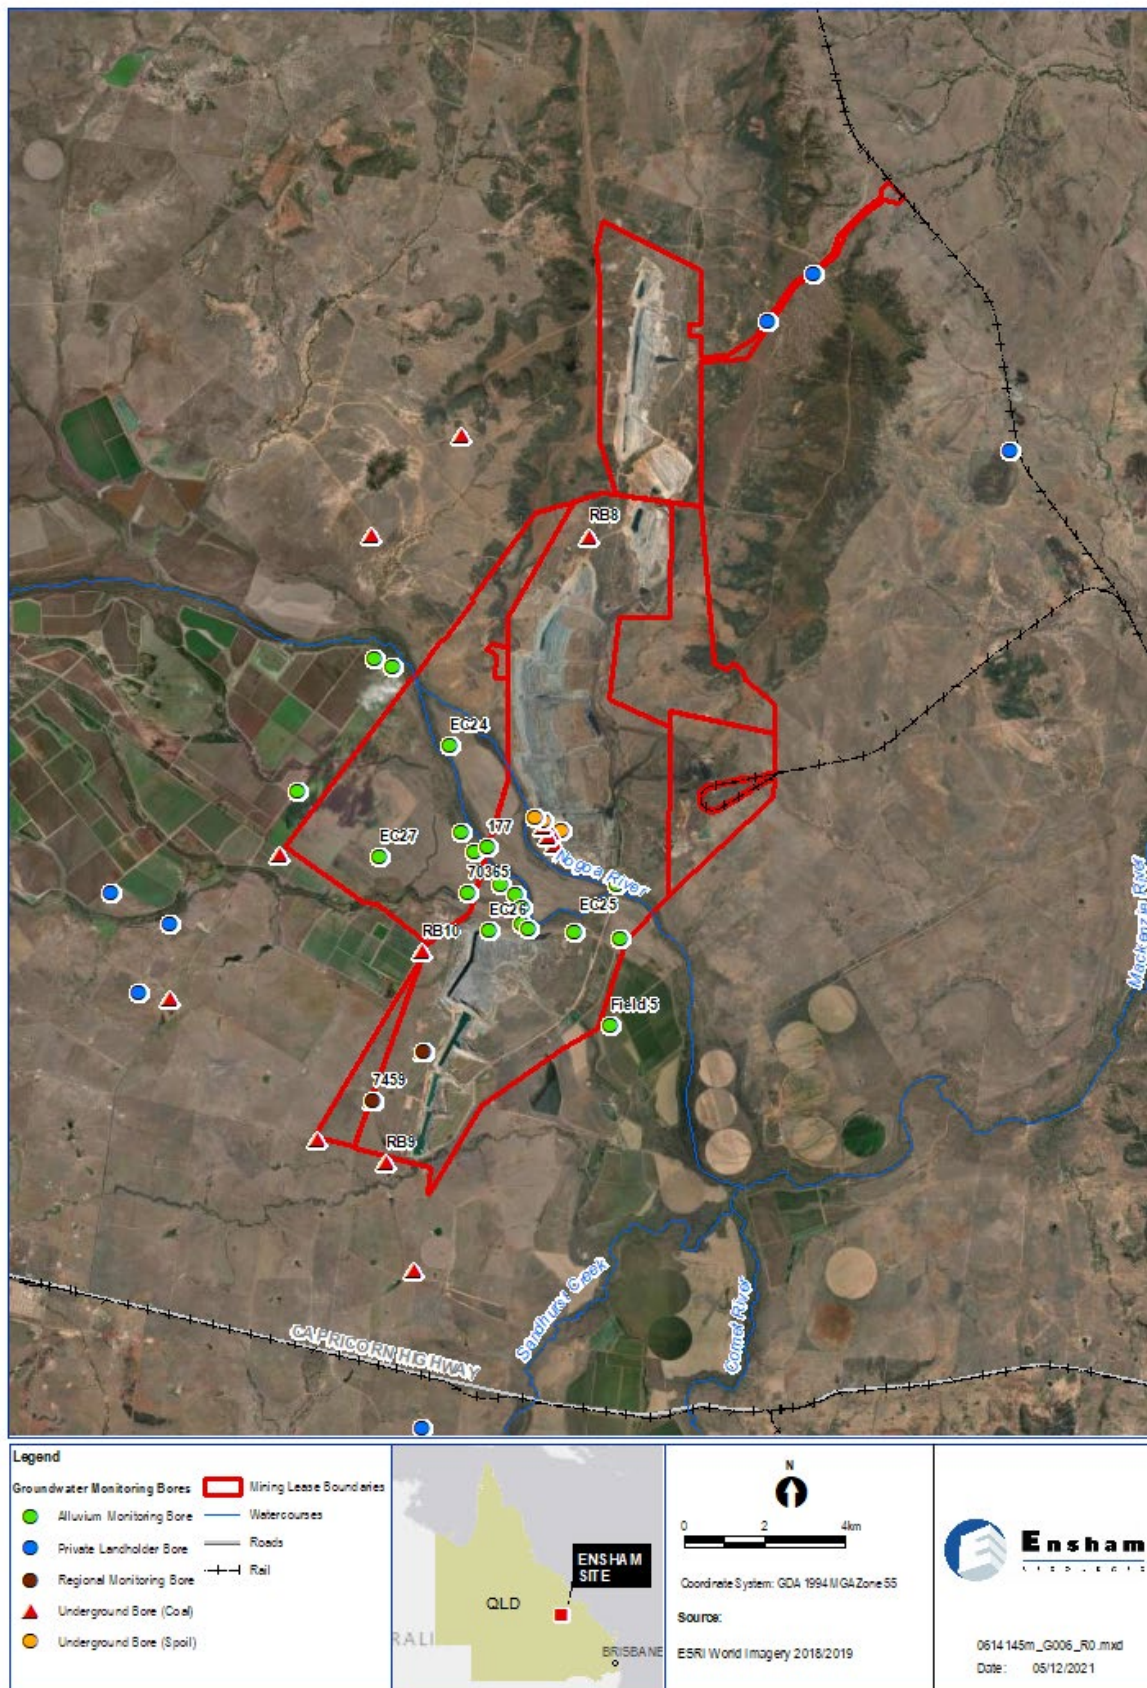
Figure 3-1 Groundwater monitoring network for Ensham

The layout and extent of the existing groundwater bore monitoring network is presented in Figure 3-1.

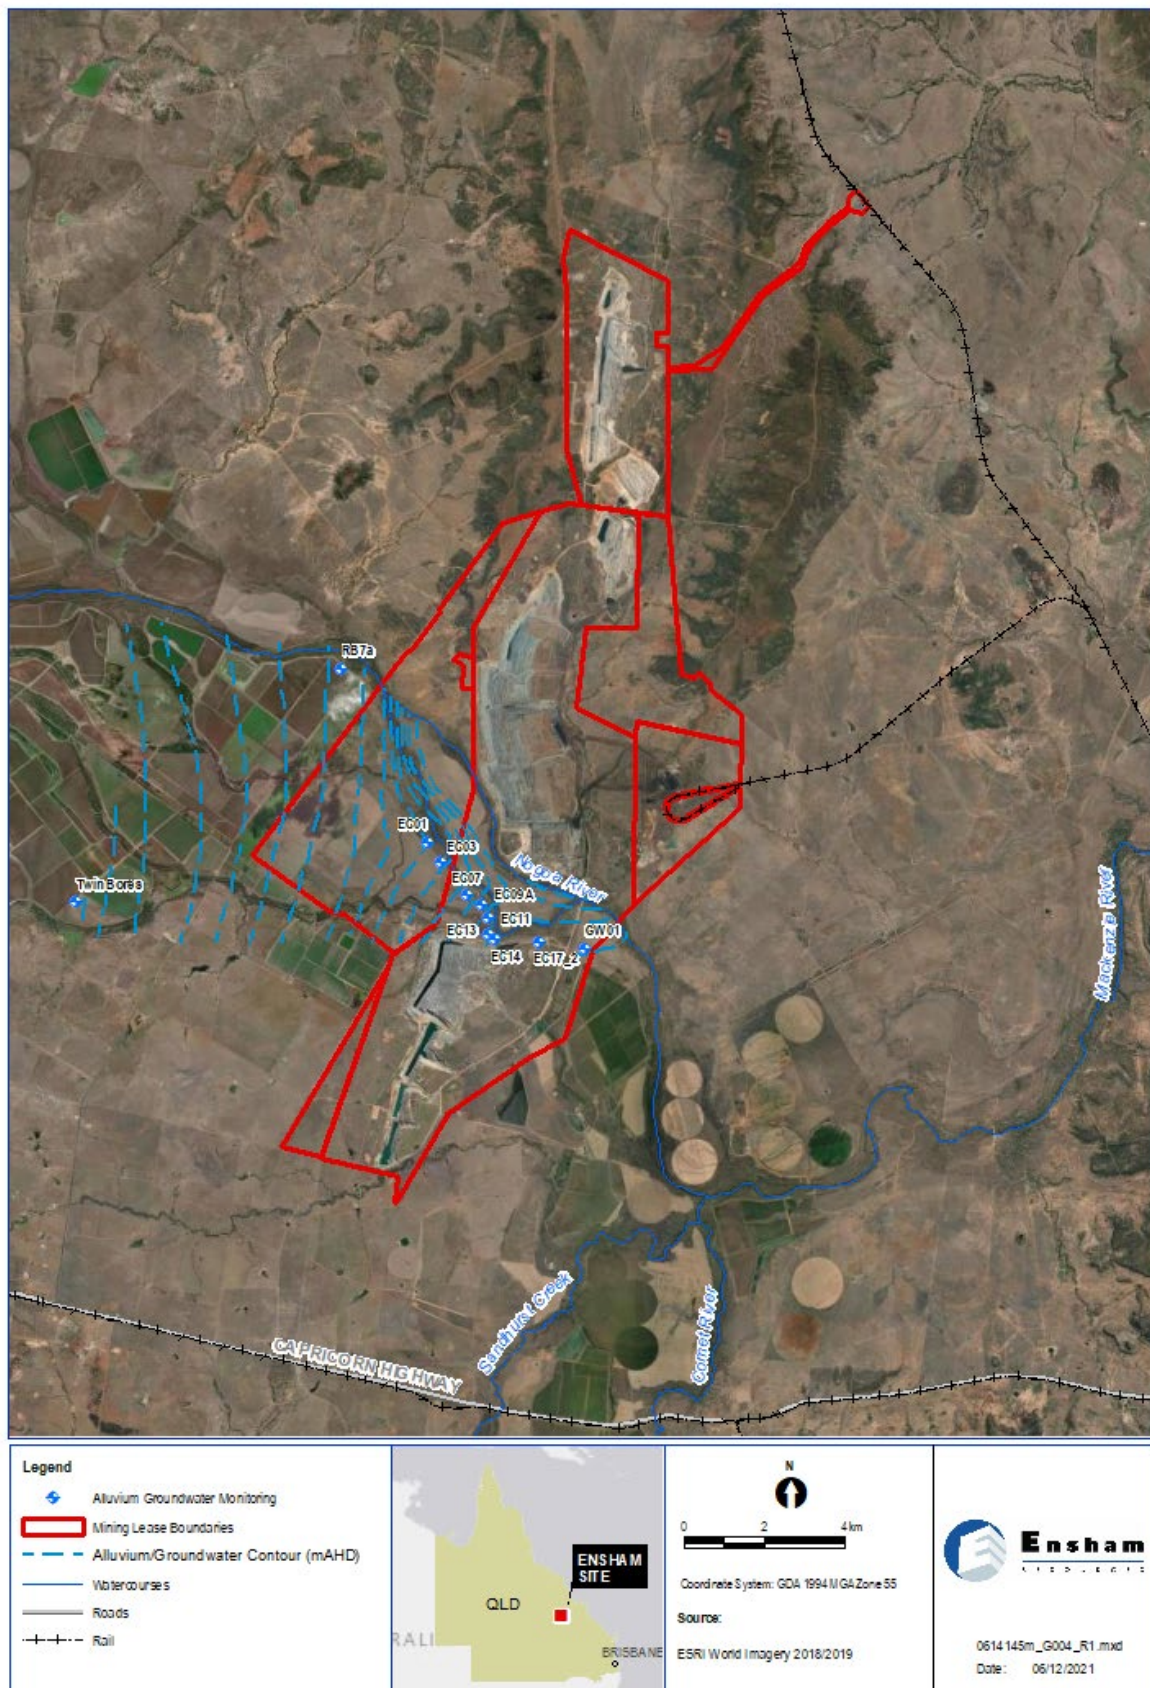
Figure 4-4 Potentiometric mapping for the Quaternary Alluvium

Groundwater level observations are recorded quarterly for the bores within the Ensham monitoring network and contours were developed for each aquifer to illustrate flow directions (as shown in Figure 4-4 and Figure 4-5). Some professional judgement is applied to development of groundwater contour plots by reconciling observed groundwater levels with hydrogeologically significant features such as mining features (mine dewatering and waste storages) and surface water bodies.

The primary driver of groundwater flow in this aquifer is topographic gradients, following the direction of the Nogoa River from north-west to south-east in the study area, as can be seen in Figure 4-4.

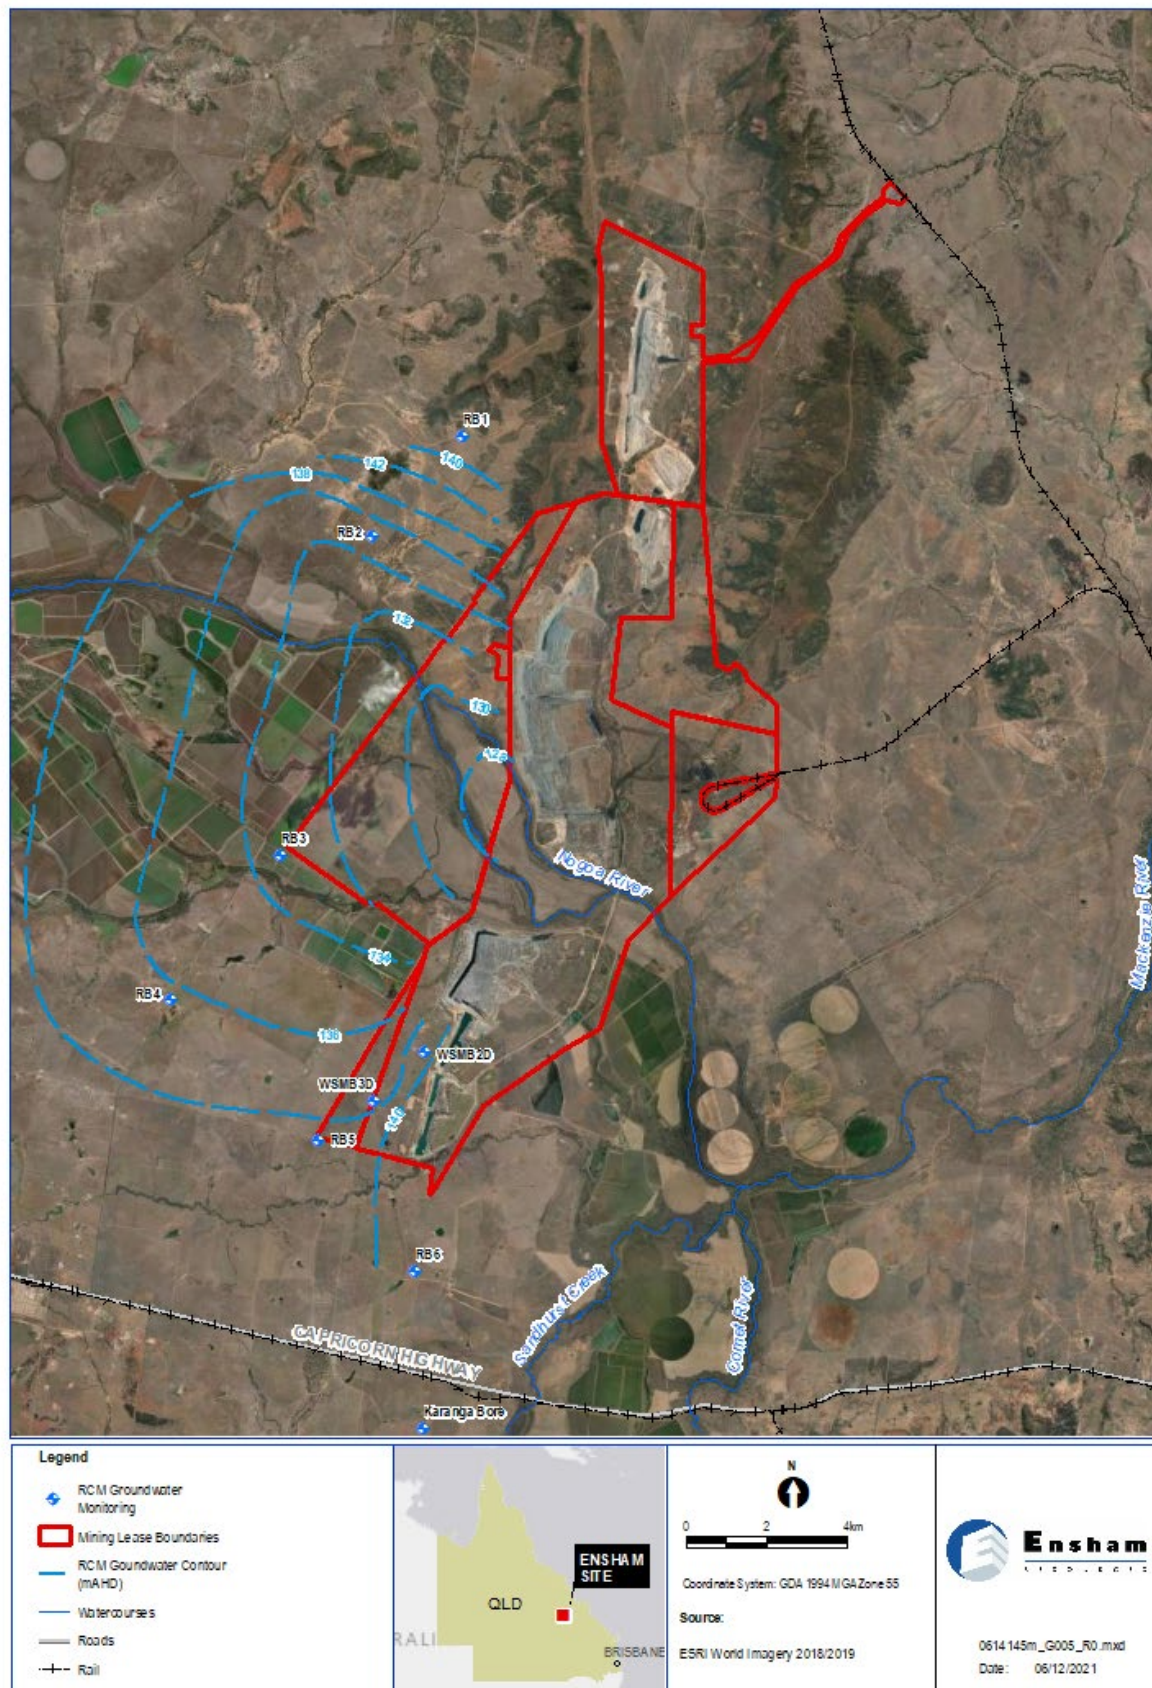
Figure 4-5 Potentiometric mapping for the Rangal Coal Measures

As the mined unit for Ensham, this formation is well monitored regionally. The groundwater level observations from November 2020, show that water level ranges from 133.46 mAHD (RB3) to 145.51 mAHD (RB1). Groundwater in the Rangal Coal Measures flows primarily towards the Ensham underground mine area due to the dewatering and depressurisation associated with underground mine development. Potentiometric level contours of November 2020 monitoring shown in Figure 4-5 illustrate the influence of this depressurisation.
