ENSHAM  
RESOURCES  
PTY LIMITED

# PROGRESSIVE REHABILITATION AND CLOSURE PLAN

Version 4

Mining Leases

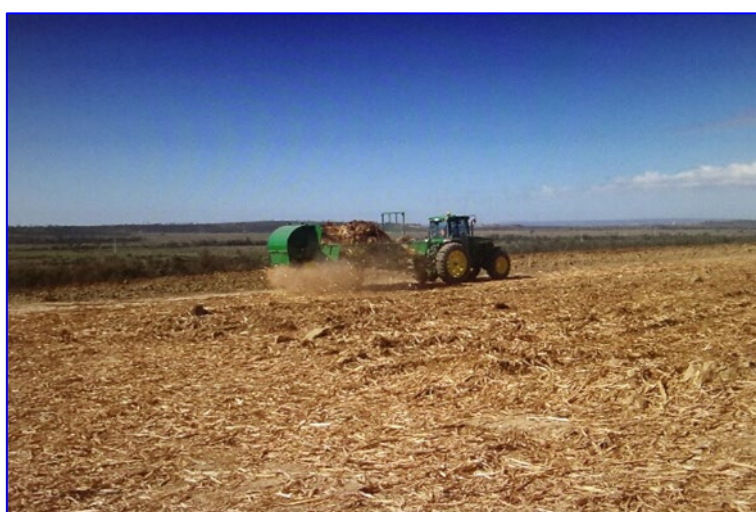
Figure 6-1 Spreading hay mulch for erosion control in rehabilitation at Ensham

Ensham typically applies hay mulch immediately after seed sowing to provide instant groundcover and close the window of erosion risk (as shown in Figure 6-1). Hay mulch applied at a minimum rate of 5 t/ha (20 round bales/ha) is a quick, cheap, and effective erosion hazard control. It also promotes germination and establishment of sown species by assisting to retain soil moisture through reducing evapotranspiration and lowering soil temperatures in the hotter months. The mulch cover is particularly effective in minimising erosion arising from raindrop impact and also serves to retain moisture within the upper soil profile to assist with seed germination and vegetation establishment.
