# **Ensham Mine Landform Supplementary Report**

| <b>Project number</b> | 17 Final Voids Options Project |
| <b>Document title</b> | Ensham Mine Landform Supplementary Report |
| <b>Site address</b> | Ensham Mine, Duckponds Road, Emerald Queensland |

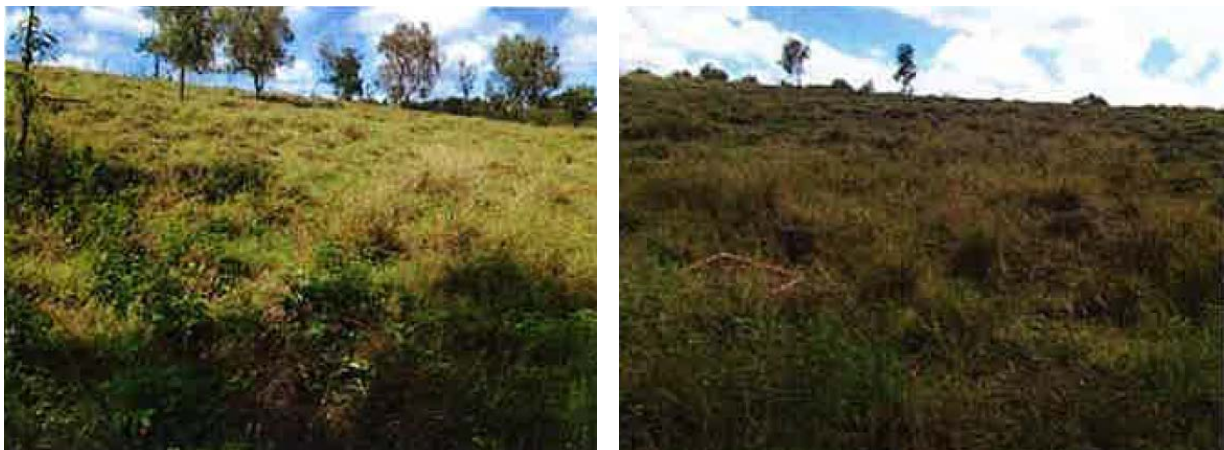
**Figure 6      Certified 20% slope at Norwich Park Mine**

- spoil slopes have been certified at Norwich Park Mine at 20% (Figure 6) and Newlands Mine at 22% (Figure 7) as safe, stable and suitable for grazing without the use of rock mulching.
- There are current contemporary Environmental Authorities that allow residual void low wall slopes up to 45°, and
- 25% slopes and hydro mulching have been previously approved on outward facing rehabilitation slopes.
- A recent approval was granted where the low walls are required to be stable. No angle is specified.

There is therefore contemporary evidence supporting that slopes up to 22% can be successfully rehabilitated, and other Proponents have approval for residual void low wall slopes greater than those proposed by Ensham Mine. Ensham is then left to discuss in this report how residual void low wall slopes between 22% and 25% are able to be rehabilitated.

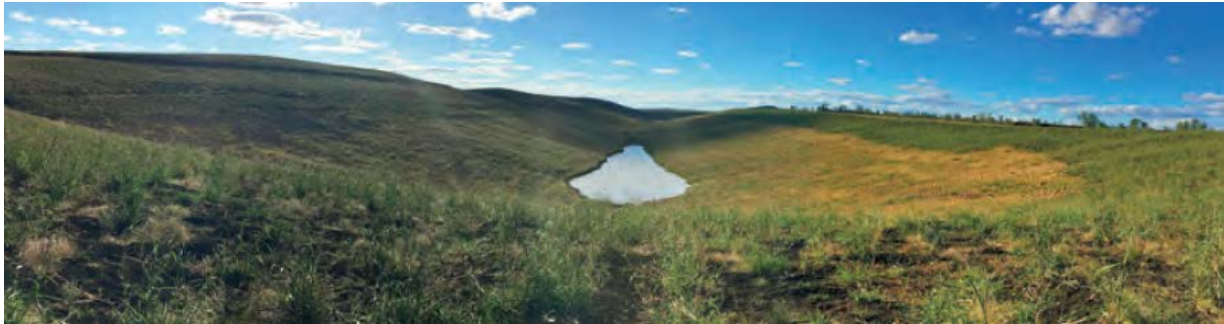
**Figure 7 Certified 22% slopes at Newlands Mine**

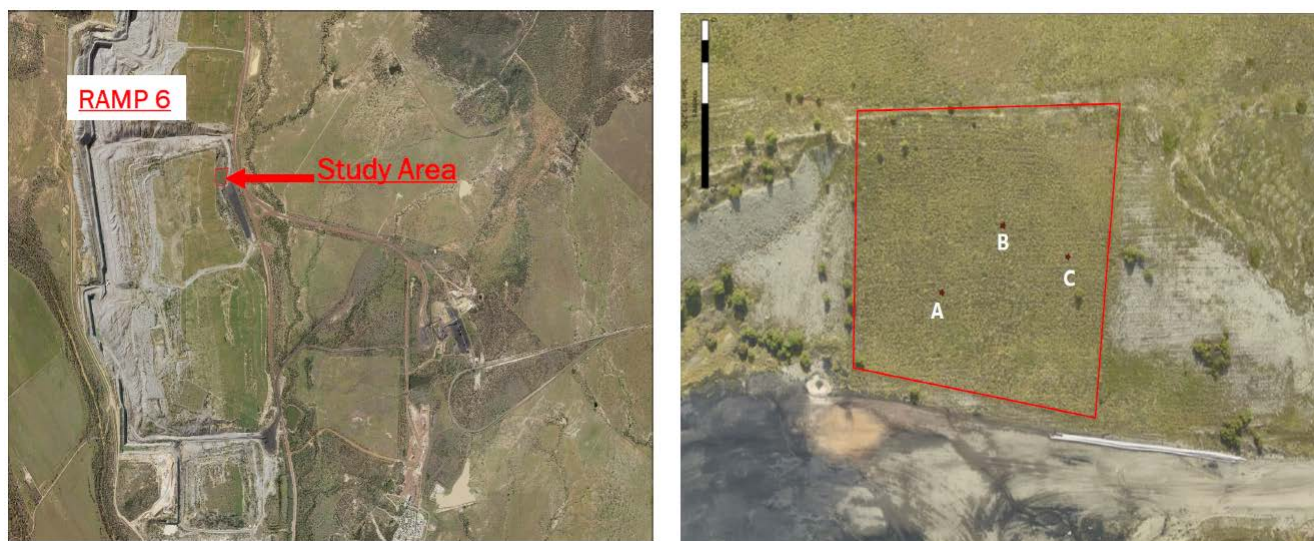
Figure 8 The inspected area relative to the C/D Pit

- Figure 8 which identifies the location of the inspected area and reference locations within the inspection area
- Figure 9 which shows the side profile of the inspected area based on Lidar and confirms the slope of approximately 25%
- Figure 10 which shows the inspected area from the base of the slope, and
- Figures 11 and 12 which shows additional pictures of the rehabilitated slope from different viewpoints.

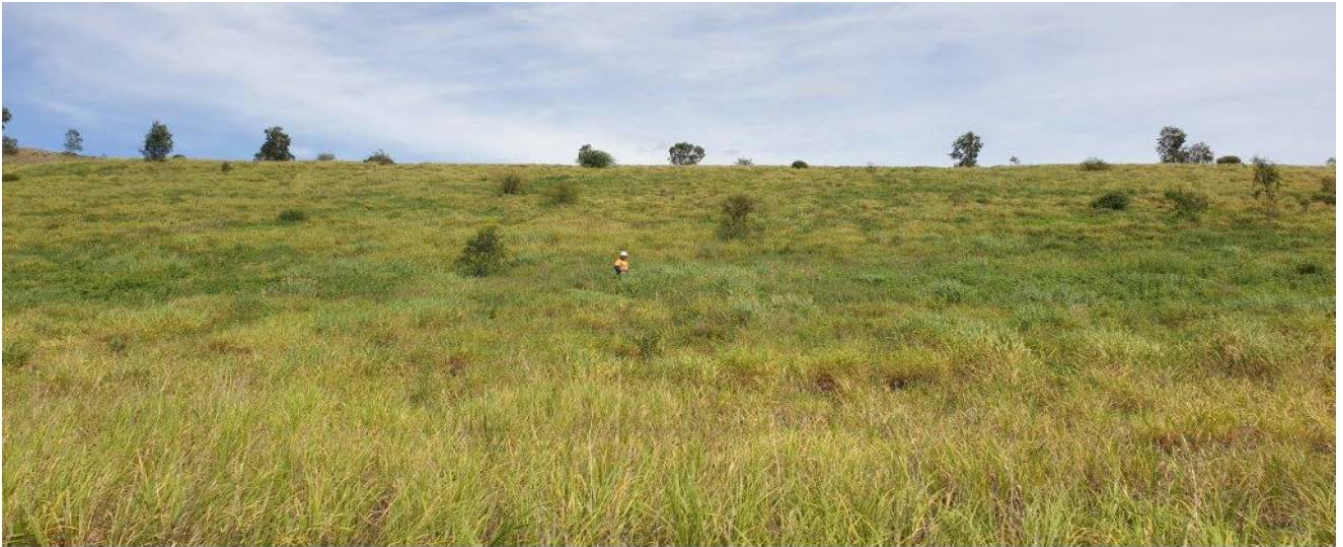
**Figure 10**      **The inspected area looking towards location B**

The RPEQ reported that the 25% slope is generally performing well with no visible signs of significant erosion. The vegetation was observed to be in good condition and demonstrates that slopes up to 25% can be successfully rehabilitated, including being erosionally stable, at Ensham Mine.

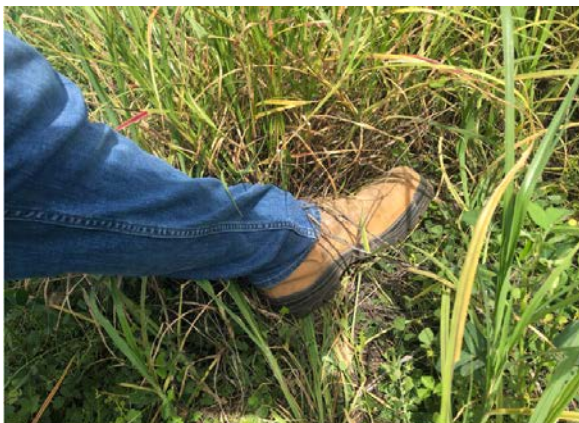
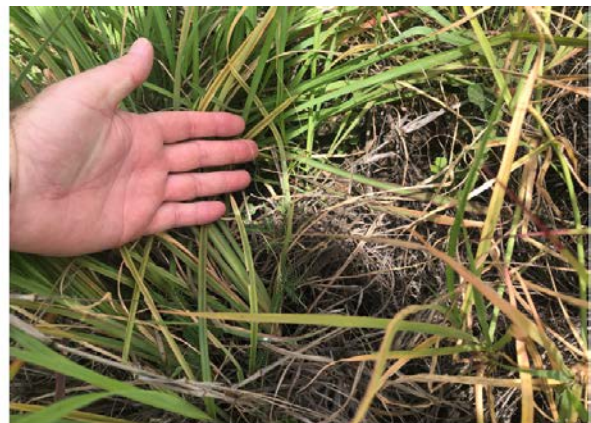
**Figure 11**      **Vegetation taken from location B**

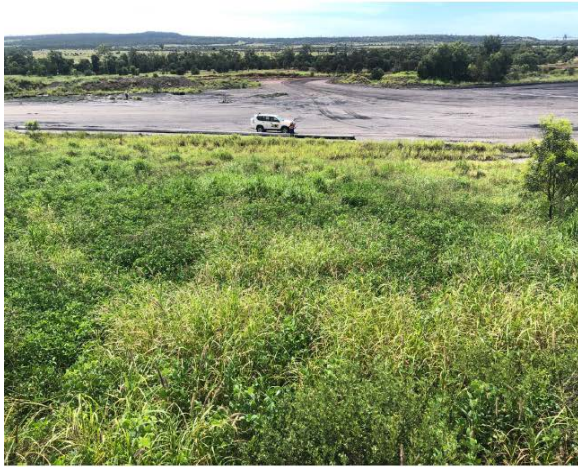
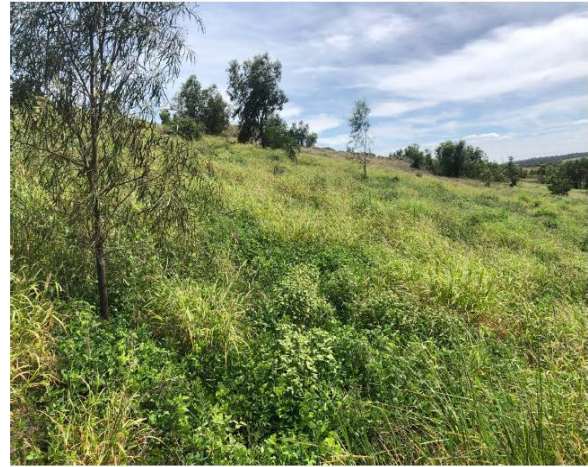
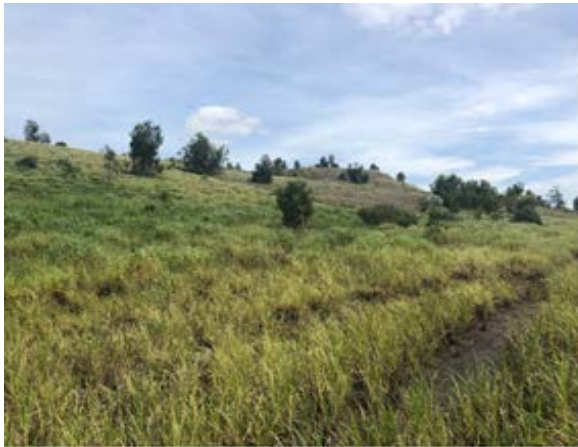
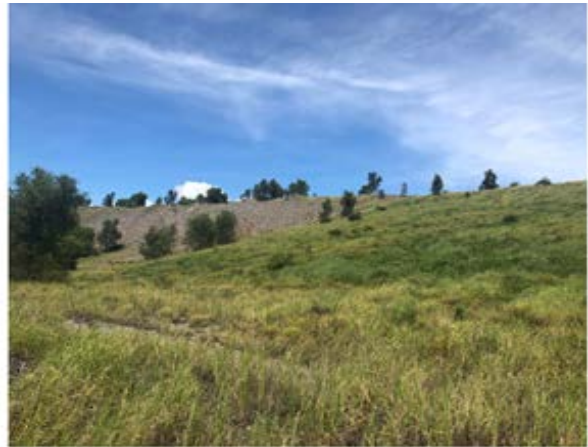
Looking downslope from location B

Looking upslope from the base across the inspected area

**Figure 12 Landscape photos (4) from different viewpoints**

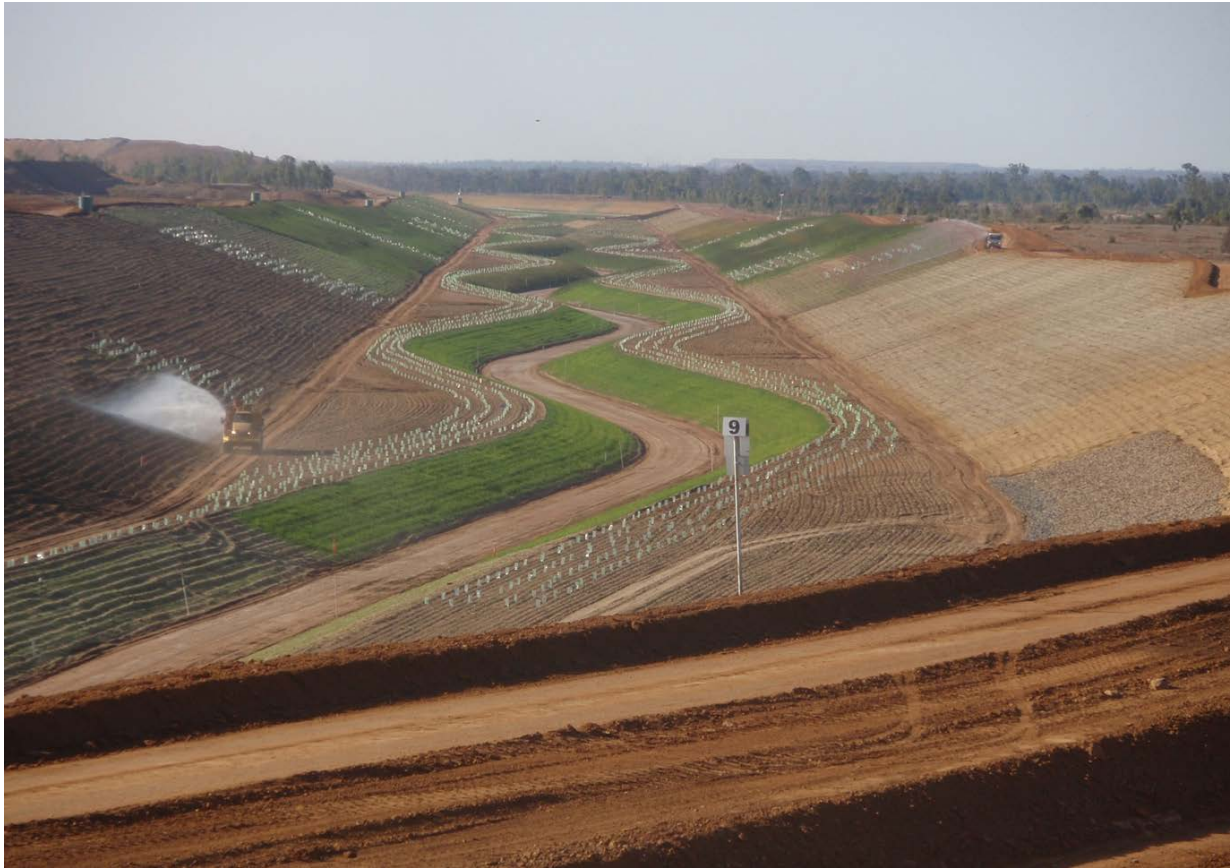
**Figure 14      Slope preparation and application of hydro mulching at Blackwater Creek**

Examples of hydro mulching applied to spoil slopes at 25% in coal mining in Queensland include the Blackwater Creek Diversion which used hydro mulching and hydro seeding to treat 179 ha of land as shown in Figure 14.

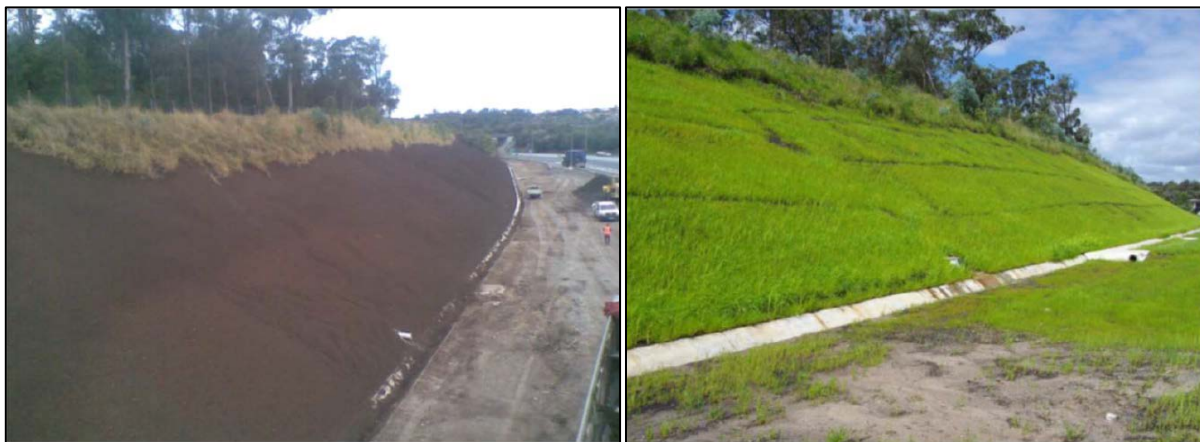
**Figure 15** Centennial Motorway - Amelioration of fresh rock slope and two months post application

Figures 15 and 16 demonstrate that fresh rock slopes profiled to angles higher than 100%, which is the maximum for the self-sustaining vegetation domain, can be successfully rehabilitated without the use of rock mulch. These figures are representative of the height of the 11ha of self-sustaining vegetation slope in D rehabilitated open cut mining area.

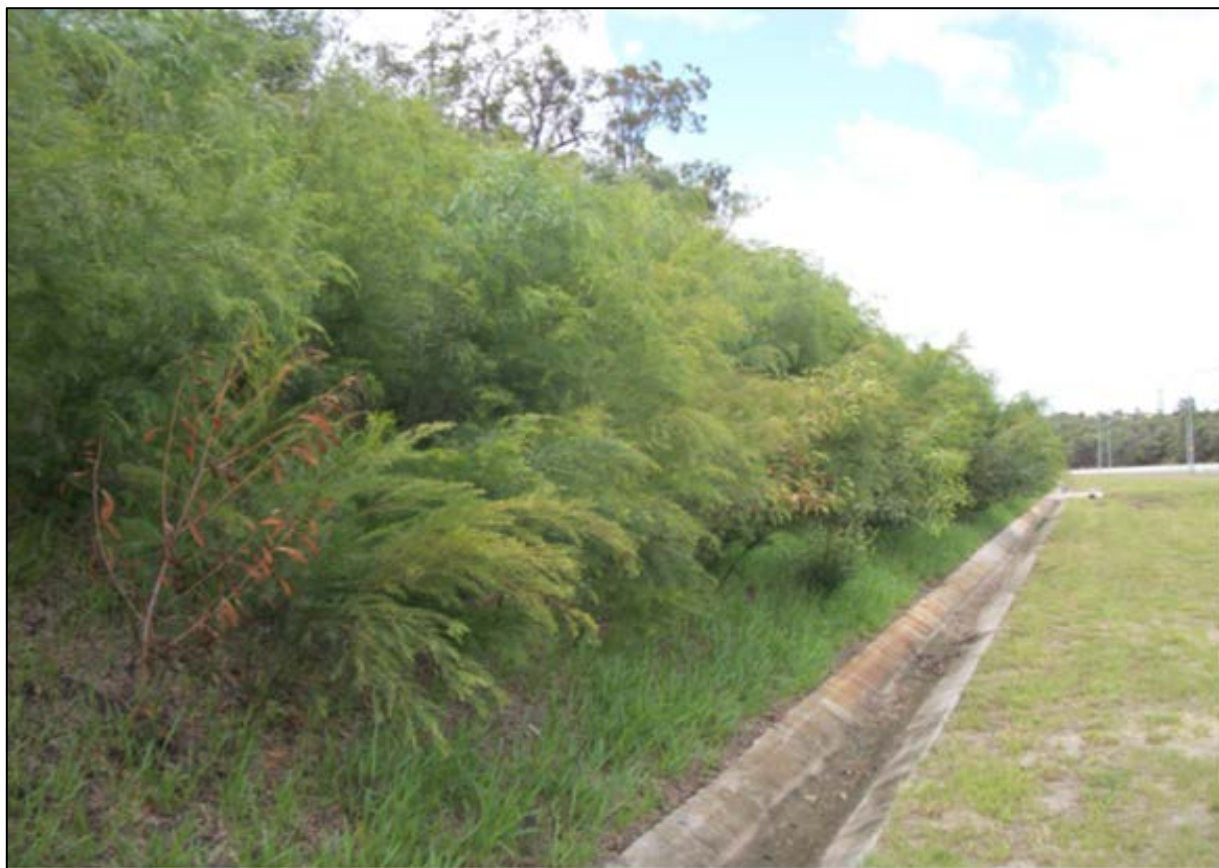
**Figure 16** The same Centennial Motorway fresh rock slope after 3yrs

As such, slopes from 33% to 100% can be successfully rehabilitated and the self-sustaining vegetation will provide habitat for local fauna and compliment the adjacent Native Bushland Habitat domain. Plant species selection will be determined closer to time of rehabilitation and would logically require the inclusion of small trees similar to Figure 16 to assist with water infiltration and velocities.

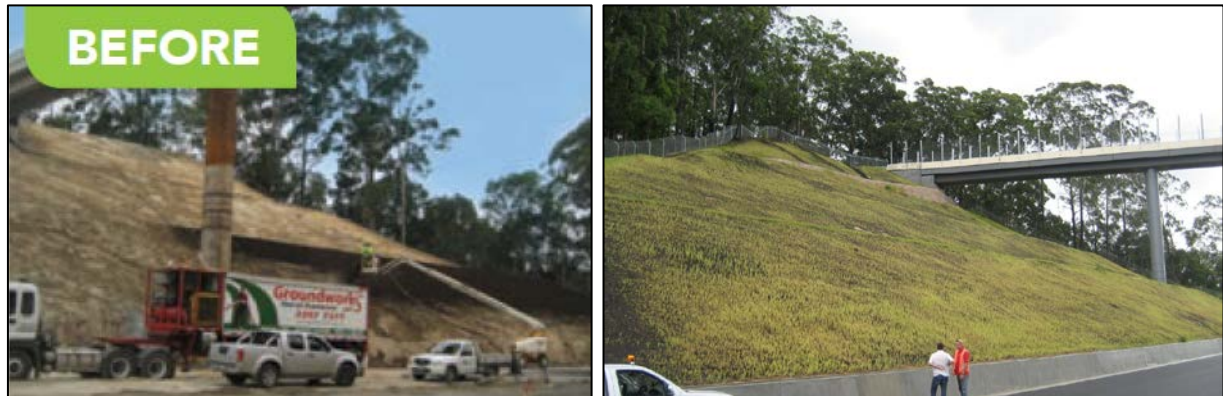
**Figure 17** Tugun Bypass - Amelioration of fresh rock slope and post application (April 2008)

Similar applications have been successful on the Tugan Bypass which has required stabilisation of much higher slopes runs than expected for the self-sustaining vegetation domain at Ensham Mine. Refer to Figures 17 and 18 over page.

Safe access to these higher slopes on the Tugun Bypass during the construction phase was an operational issue safely managed with the use of elevated work platforms. The slopes at Ensham mine would be constructed in multiple steps to achieve the final batter slopes safely using tracked equipment which are regularly operated on down-gradients in excess of 100%. Once profiled and treated, there would not be any need for further vehicle traffic on these slopes.

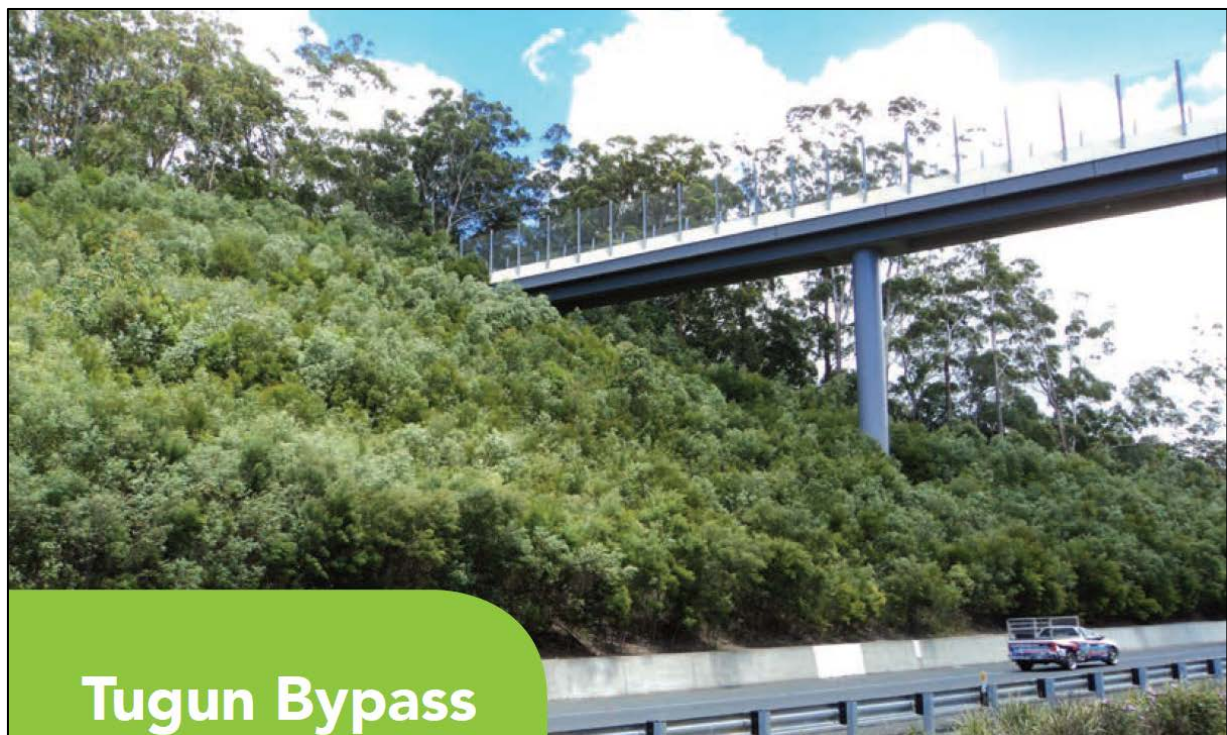
**Figure 18** Tugun Bypass slope stabilisation with hydro mulching (February 2012)
