**Ensham**  
R E S O U R C E S

As Operator of the  
Ensham Coal Project

# PROGRESSIVE REHABILITATION AND CLOSURE PLAN

Version 3

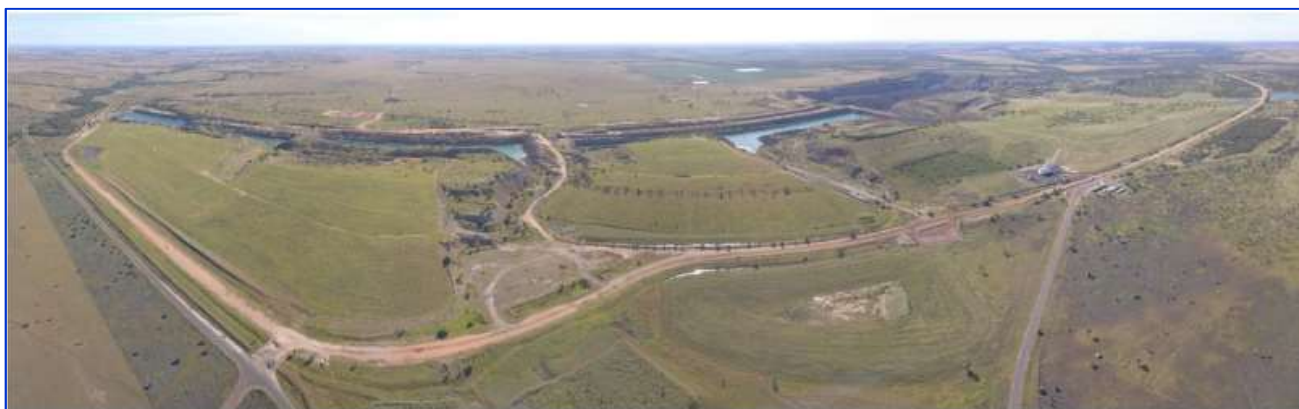
**Figure 1-5 Existing rehabilitation at AB Pit (ML7459)**

These areas are currently used for beef cattle grazing.

Ensham has completed more than 1,600 ha of opencut mine rehabilitation since 2001 (Figure 1-5, Figure 1-6, Figure 1-7 and Figure 1-8). This equates to approximately one third of total mining disturbances. Most existing rehabilitation has a target PMLU of beef cattle grazing. Portions of existing rehabilitation have been approved as certified under the EP Act (Table 1-4) or not yet applied for. Following approval of the application for certification of progressive rehabilitation in 2021, Ensham has more certified opencut rehabilitation than any other opencut coal mine in Queensland.

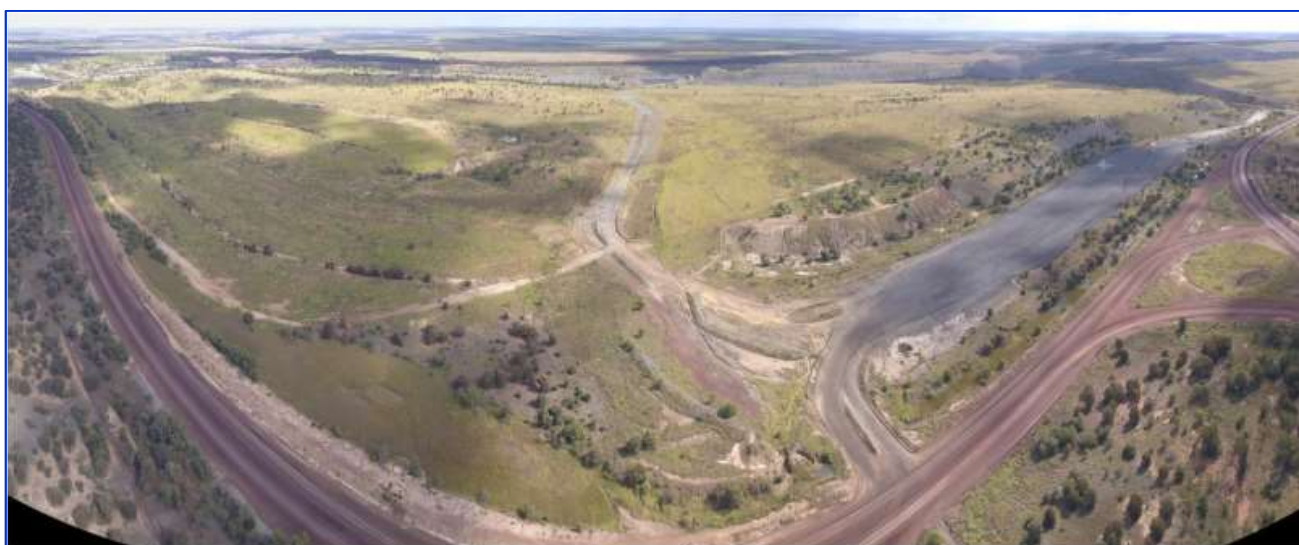
**Figure 1-6 Existing rehabilitation at CDE Pit (ML7459)**

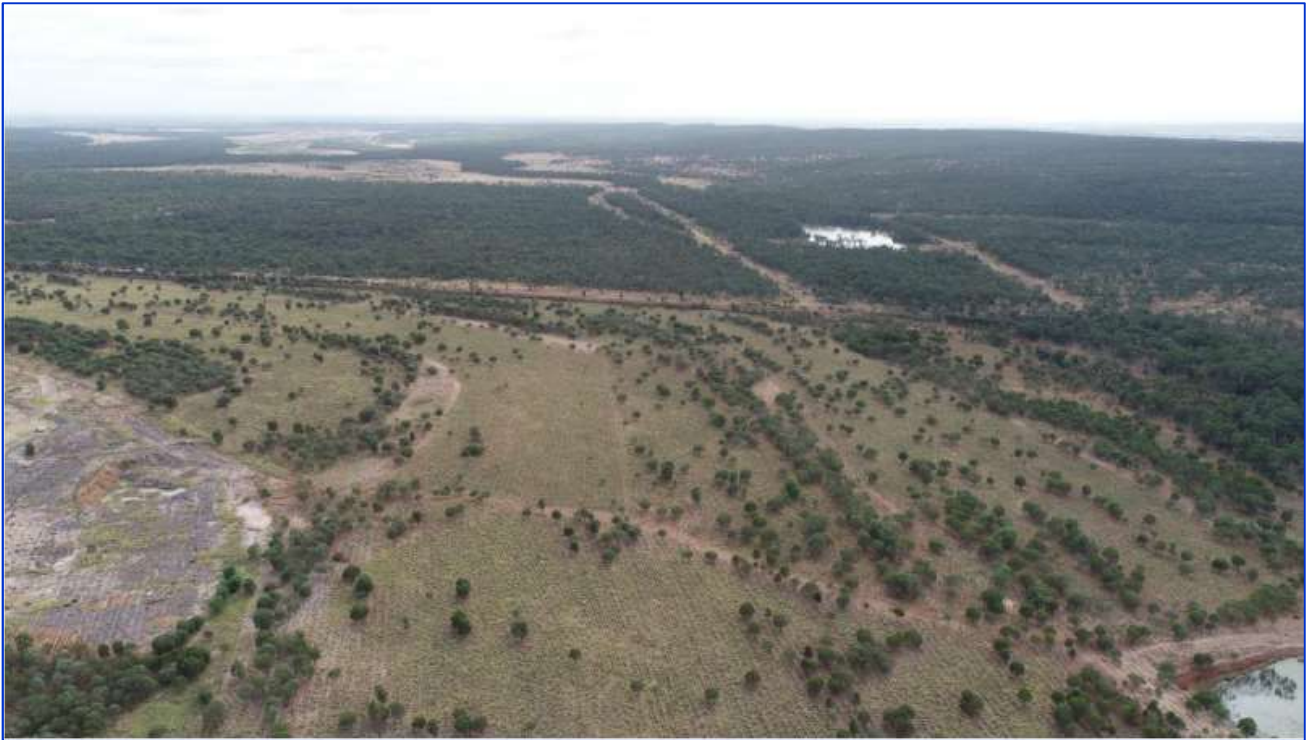
**Figure 1-7 Existing rehabilitation at Y Pit (ML70049)**

This area was certified in 2019 and is currently used for beef cattle grazing.

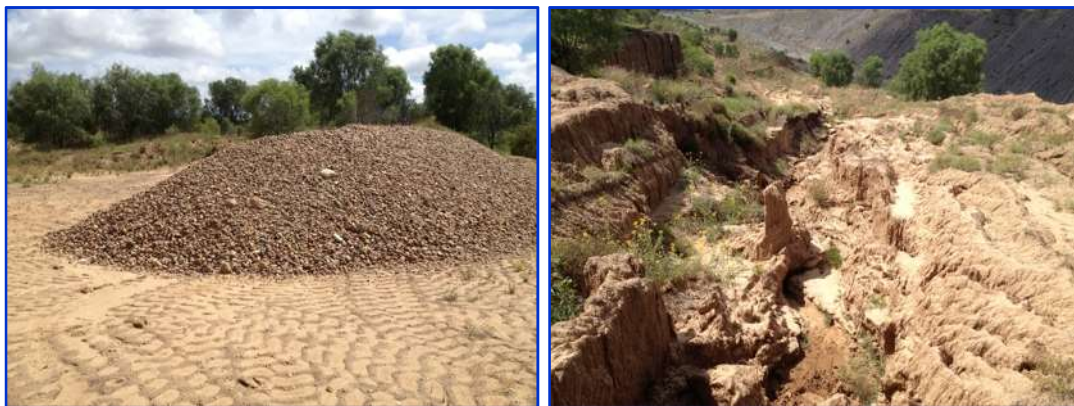
Figure 5-3 Quaternary spoil in B Pit is screened for gravel and sand for use around site (left) and erosion in situ Quaternary spoil in B Pit endwall (right)

Pale brown to yellow alluvial sands and gravels (Figure 5-3). Low clay content means material has little water or nutrient holding capacity. Non-saline but sodic with low surface cohesion, this overburden is highly dispersive and prone to excessive erosion when exposed to rainfall.

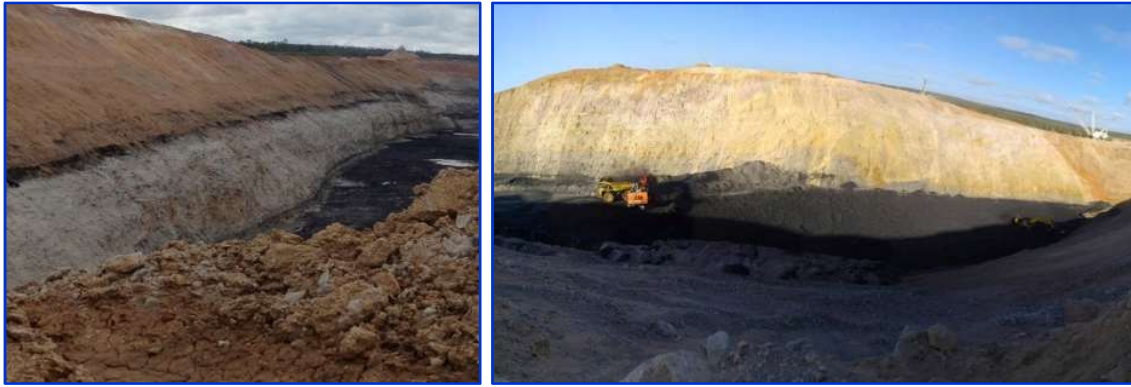
**Figure 5-4 Tertiary spoil overlying Permian spoil in Y Pit (left) and F Pit (right)**

Overlying the Permian overburden, this material is derived from Tertiary age alluvium or colluvium (Figure 5-4). It is consistently saline to extremely saline, with chloride levels toxic to plants at Y Pit, and consistently sodic to extremely sodic. This material is extremely dispersive.

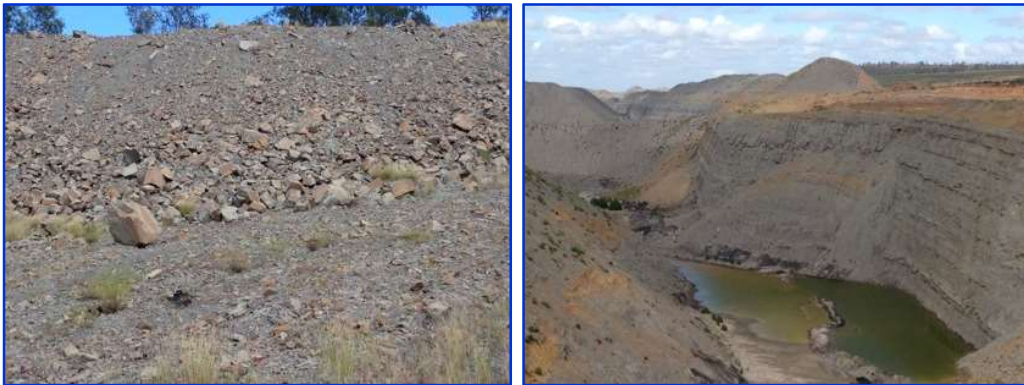
**Figure 5-5 Permian spoil in D Pit emplacement (left) and E Pit highwall (right)**

Easily distinguished by its bluish grey colour, consisting of rapidly weathering mudstones and siltstones, with orange/yellow resistant sandstone fragments (Figure 5-5). Derived from Permian sedimentary rocks of the Blackwater Group, it is generally non-saline to saline and sodic.

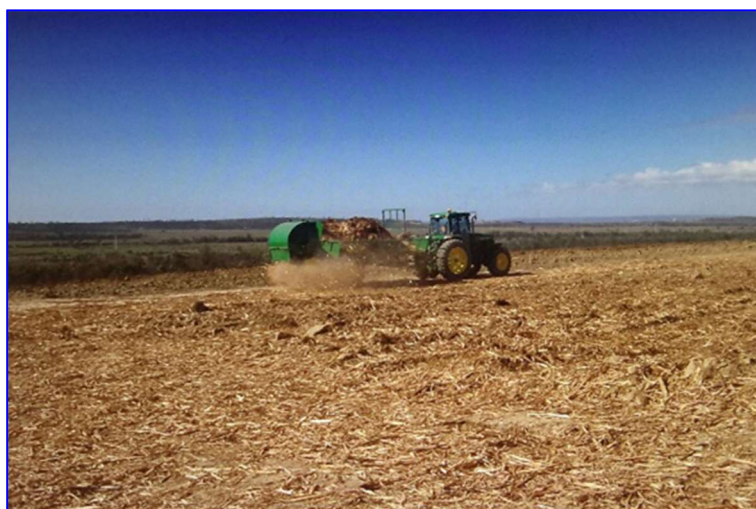
Ensham applies hay mulch immediately after sowing to provide instant groundcover and close the window of erosion risk (Figure 5-10). This is particularly important for any slopes greater than 20%. Hay mulch applied at a minimum rate of 5 t/ha is a quick, cheap, and effective erosion hazard control. It also promotes germination and establishment of sown species by assisting to retain soil moisture through reducing evapotranspiration and lowering soil temperatures in the hotter months.

Figure 5-10 Spreading hay mulch for erosion control in rehabilitation at Ensham

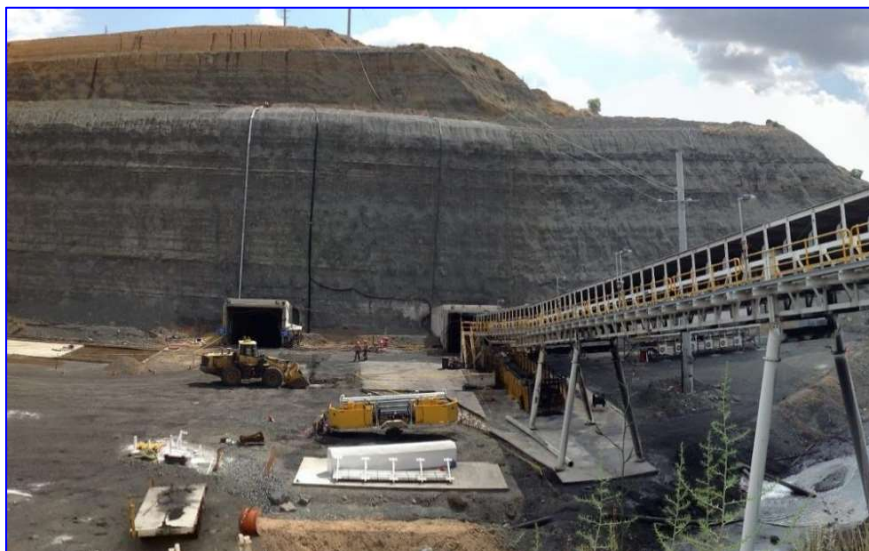
Underground mining at Ensham has negligible surface impacts because, unlike longwall mining, bord and pillar mining does not cause discernible surface subsidence. The underground workings are accessed from a section of C Pit highwall (Figure 5-11).

**Figure 5-11 Entrances to the existing Ensham underground mine.**

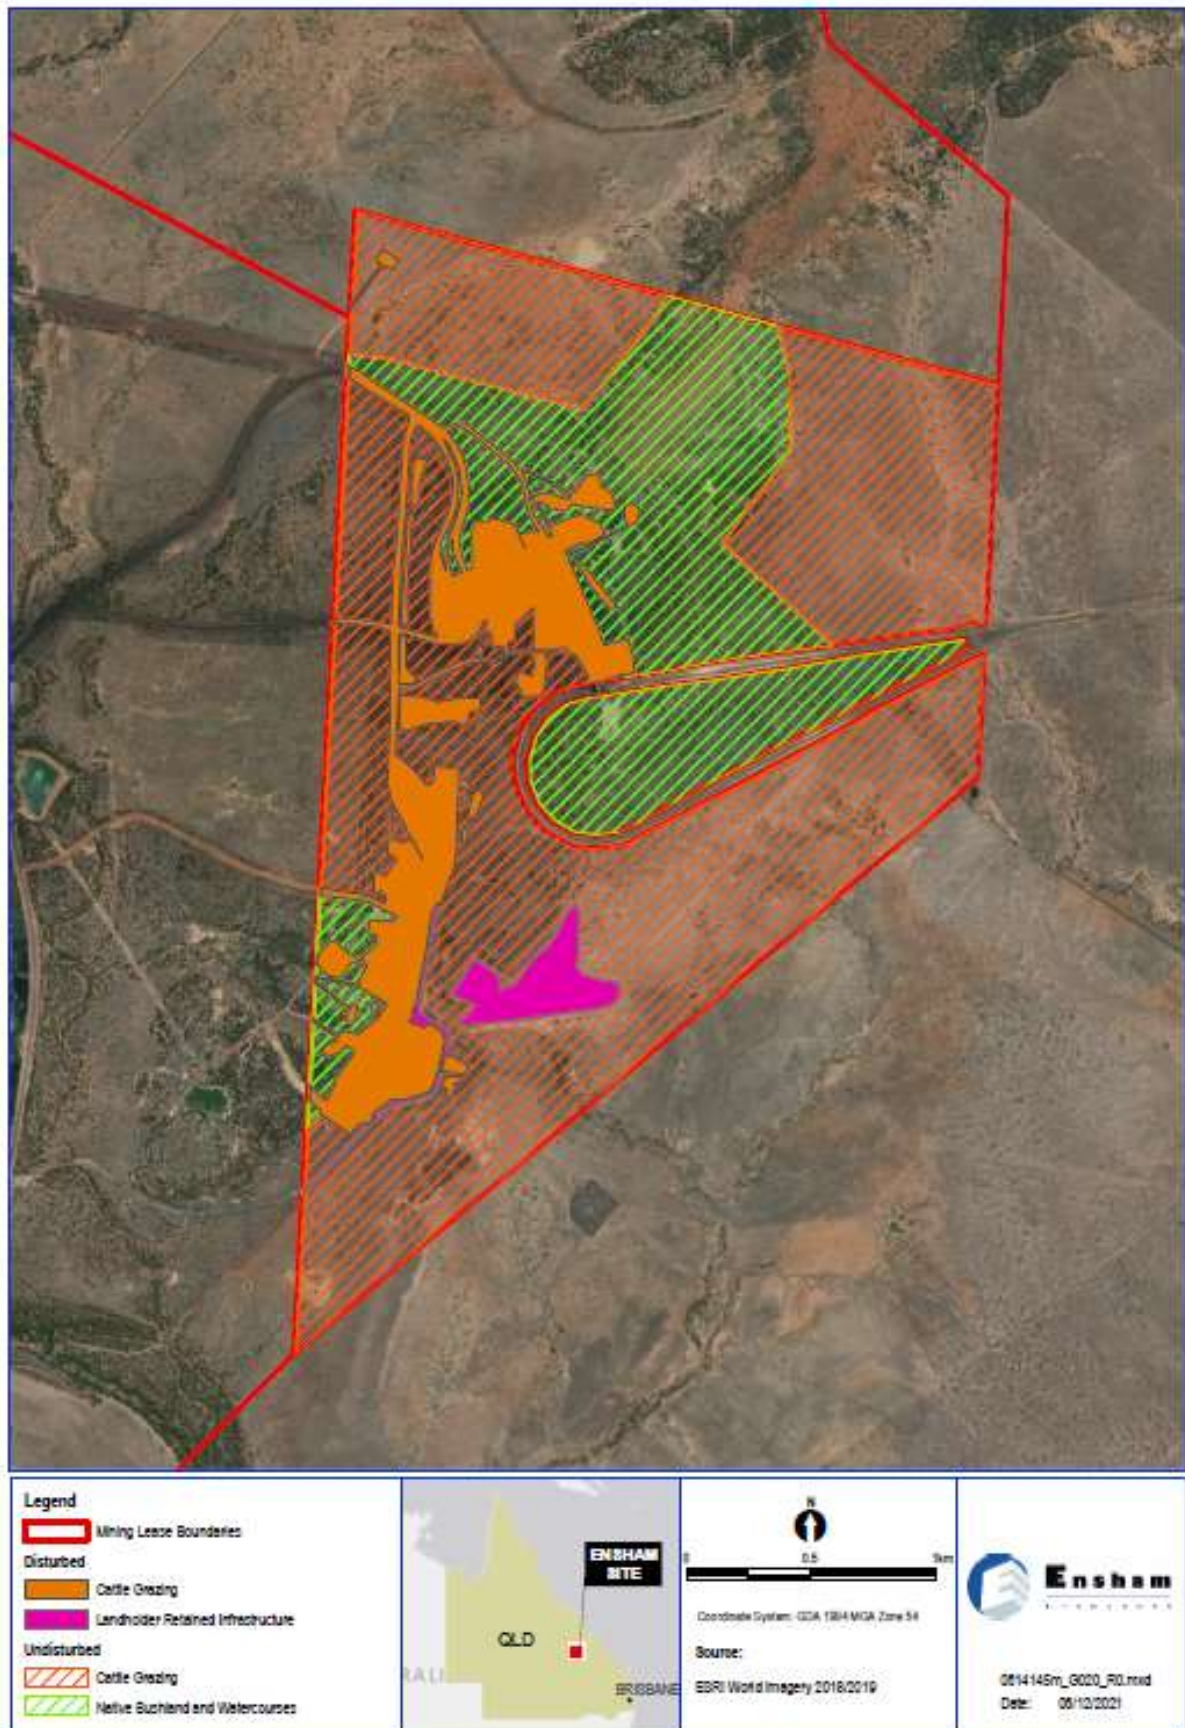
Figure 9-3 ML7460 land use categories

Figure 9-2 to Figure 9-8 (inclusive) shows the key PMLUs and NUMAs for each of the mining leases, and includes both disturbed and undisturbed lands. Subsequently, Figure 9-10 to Figure 9-21 are further focused on the disturbance footprint at Ensham, which related to both rehabilitation and/or improvement areas.

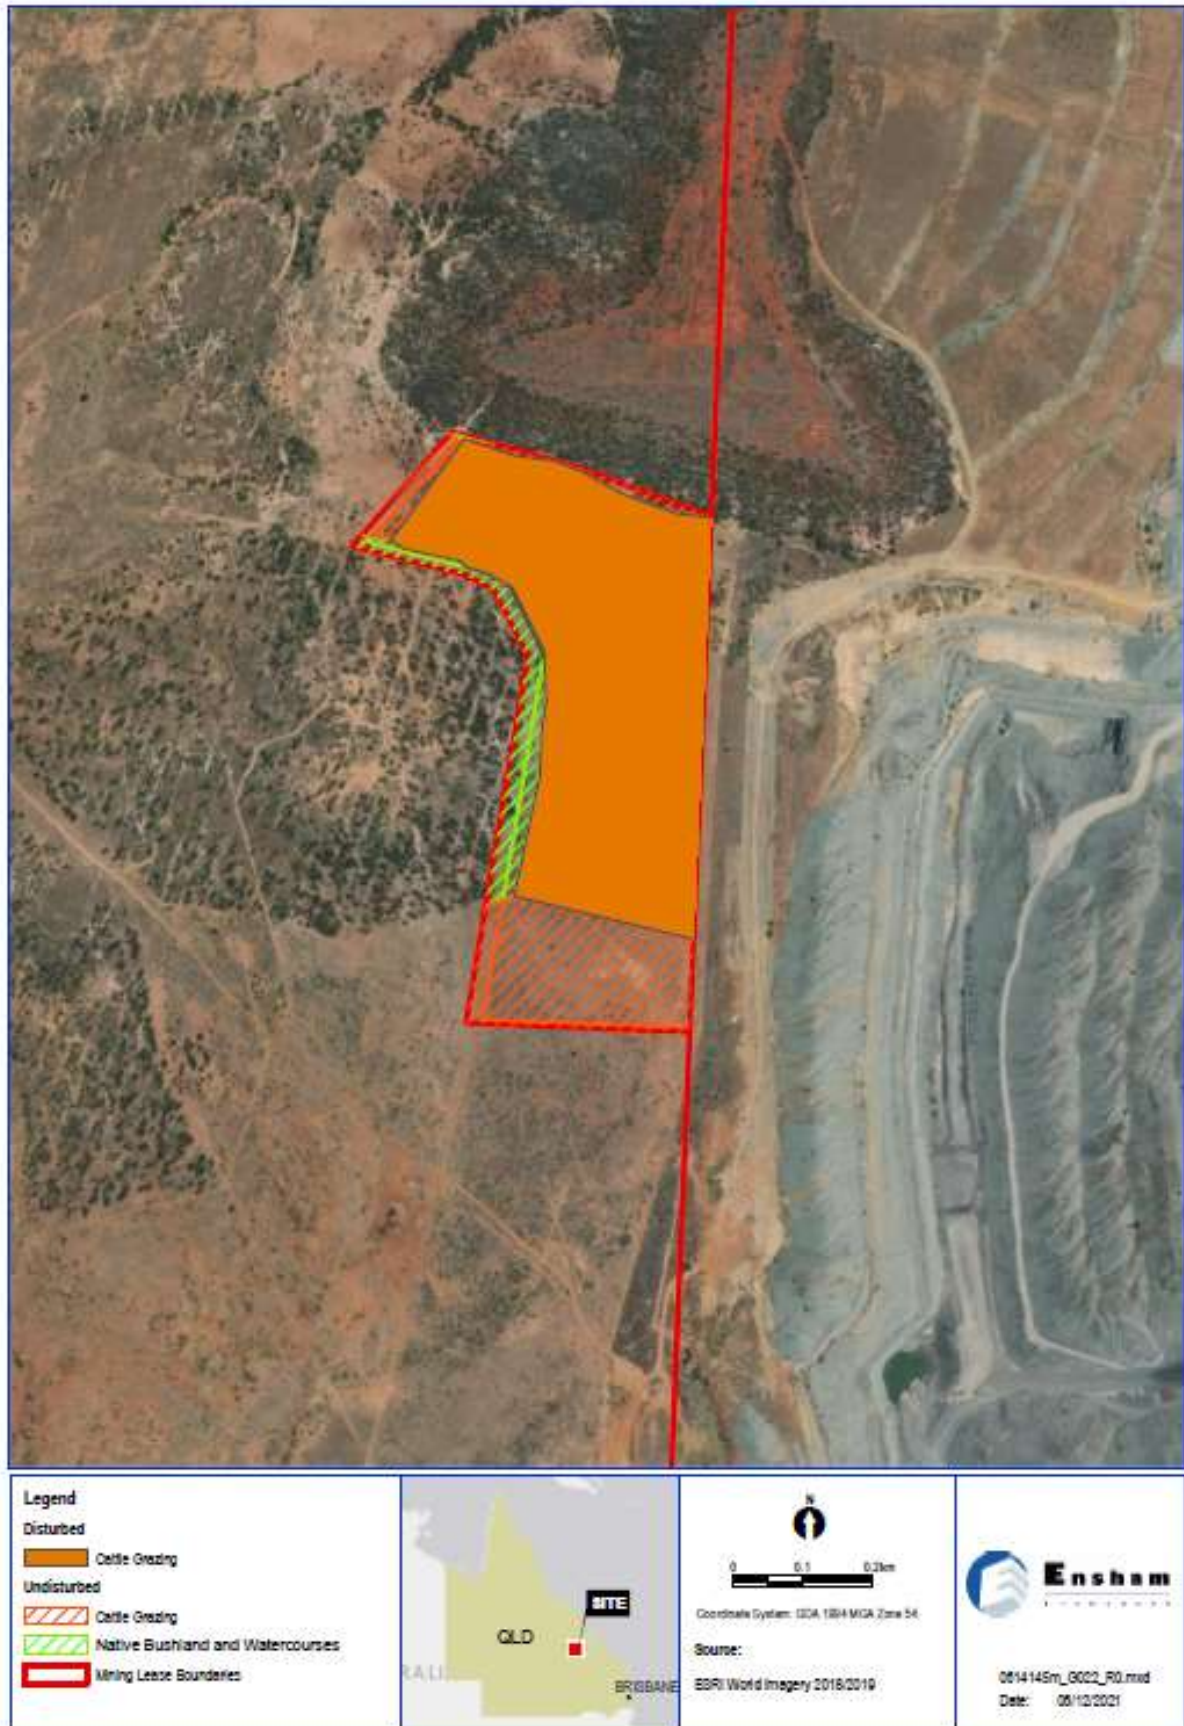
Figure 9-5 ML70326 land use categories

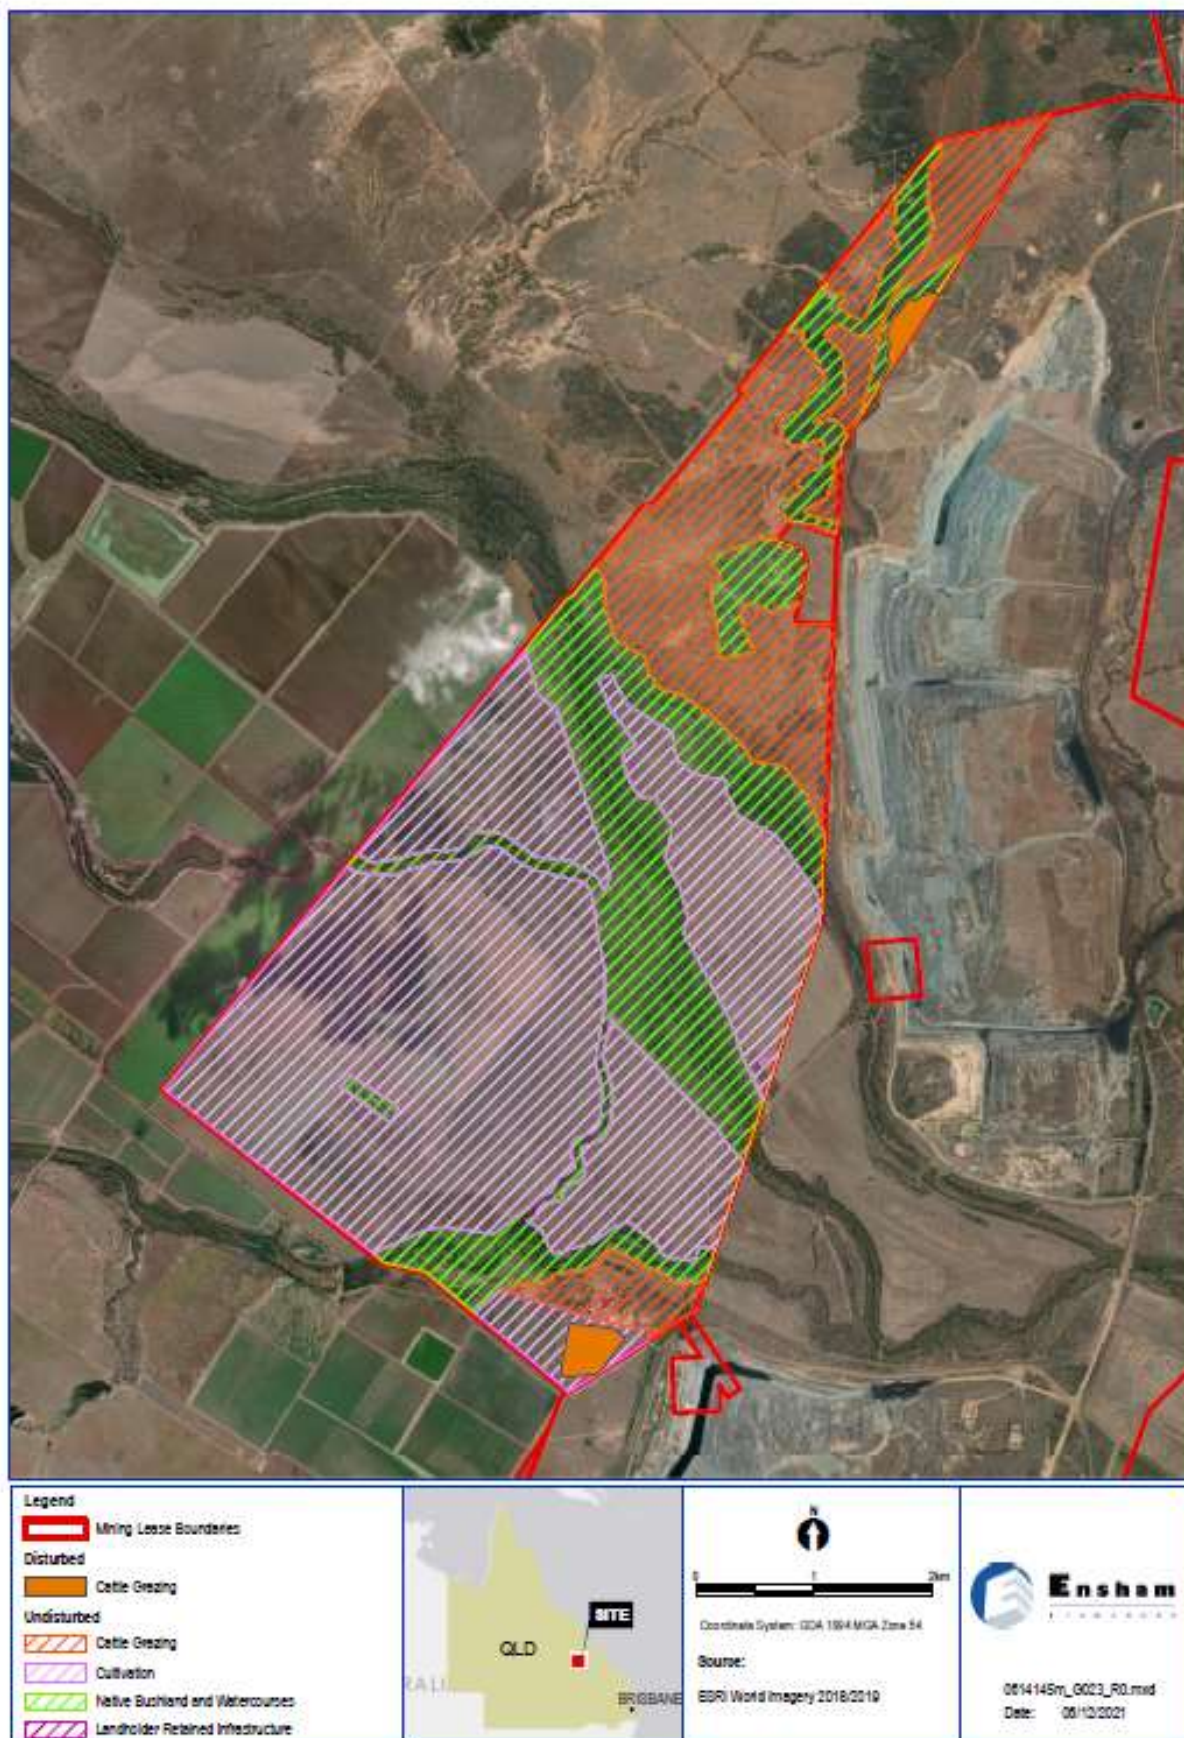
Figure 9-6 ML70365 land use categories

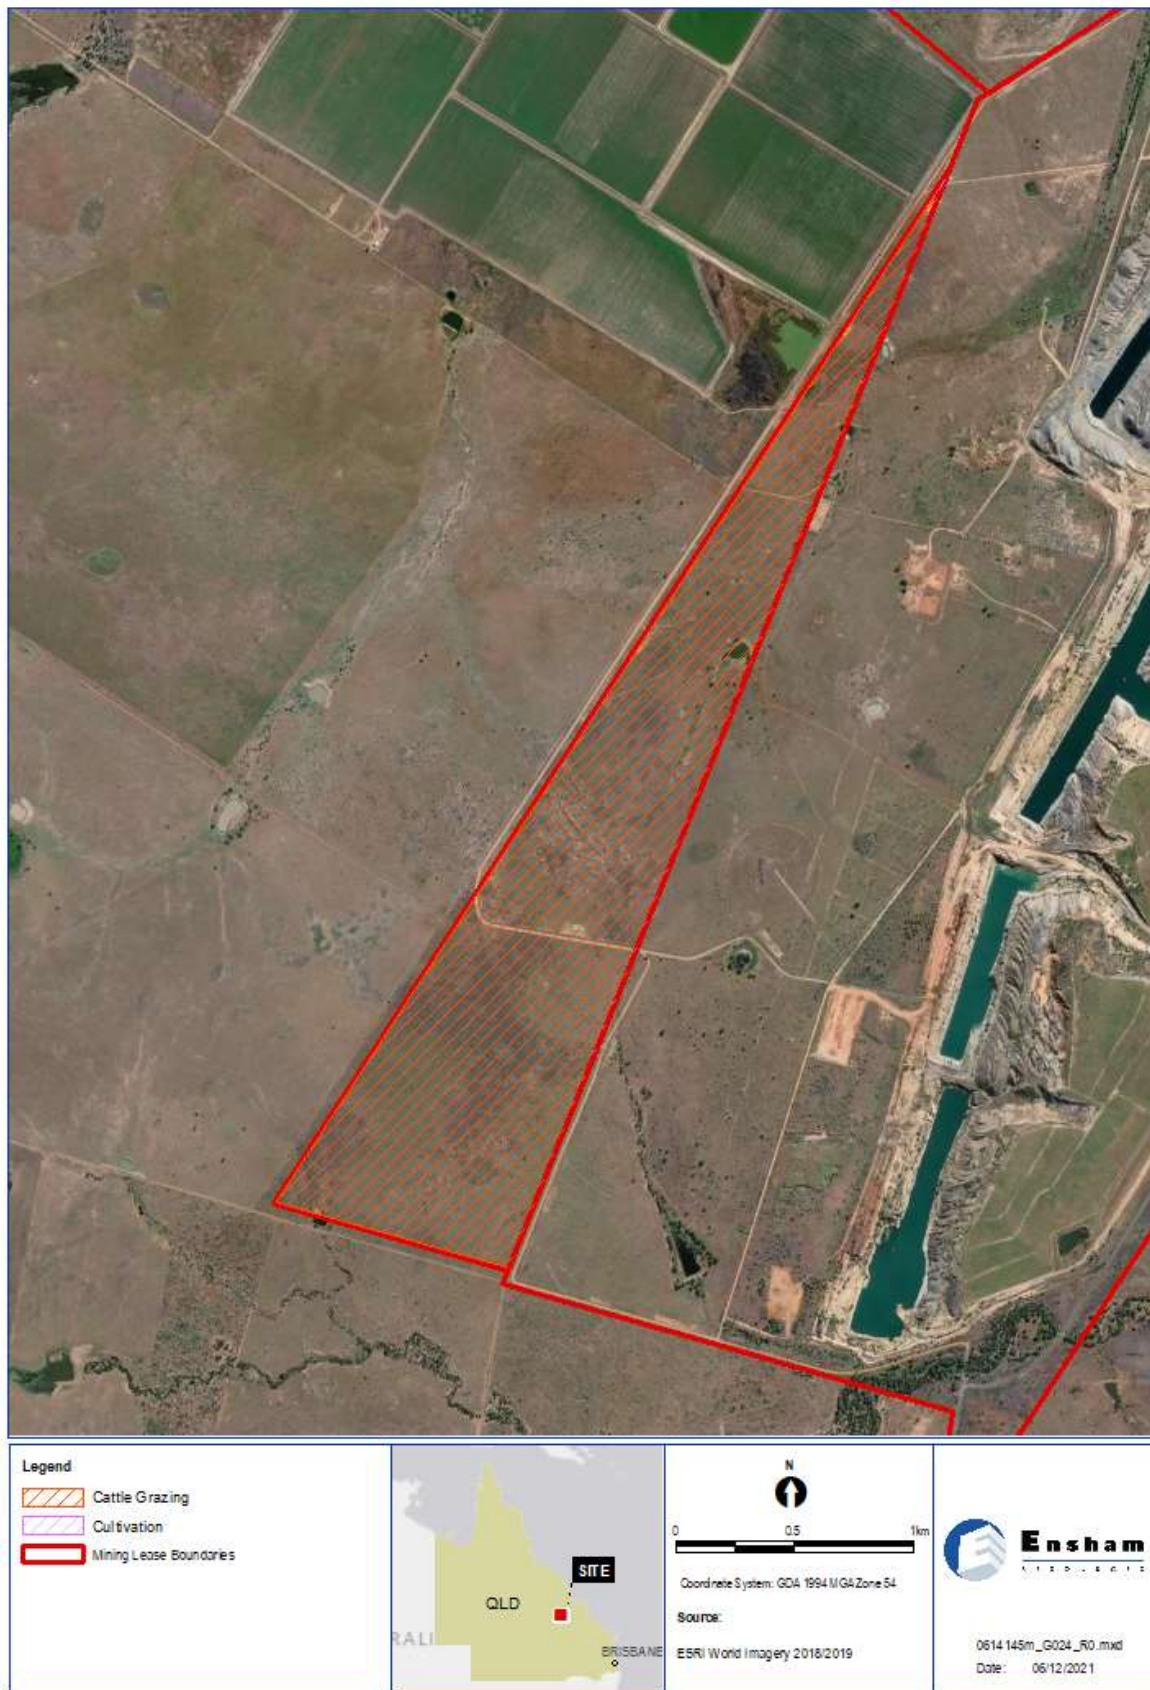
Figure 9-7 ML70366 land use categories

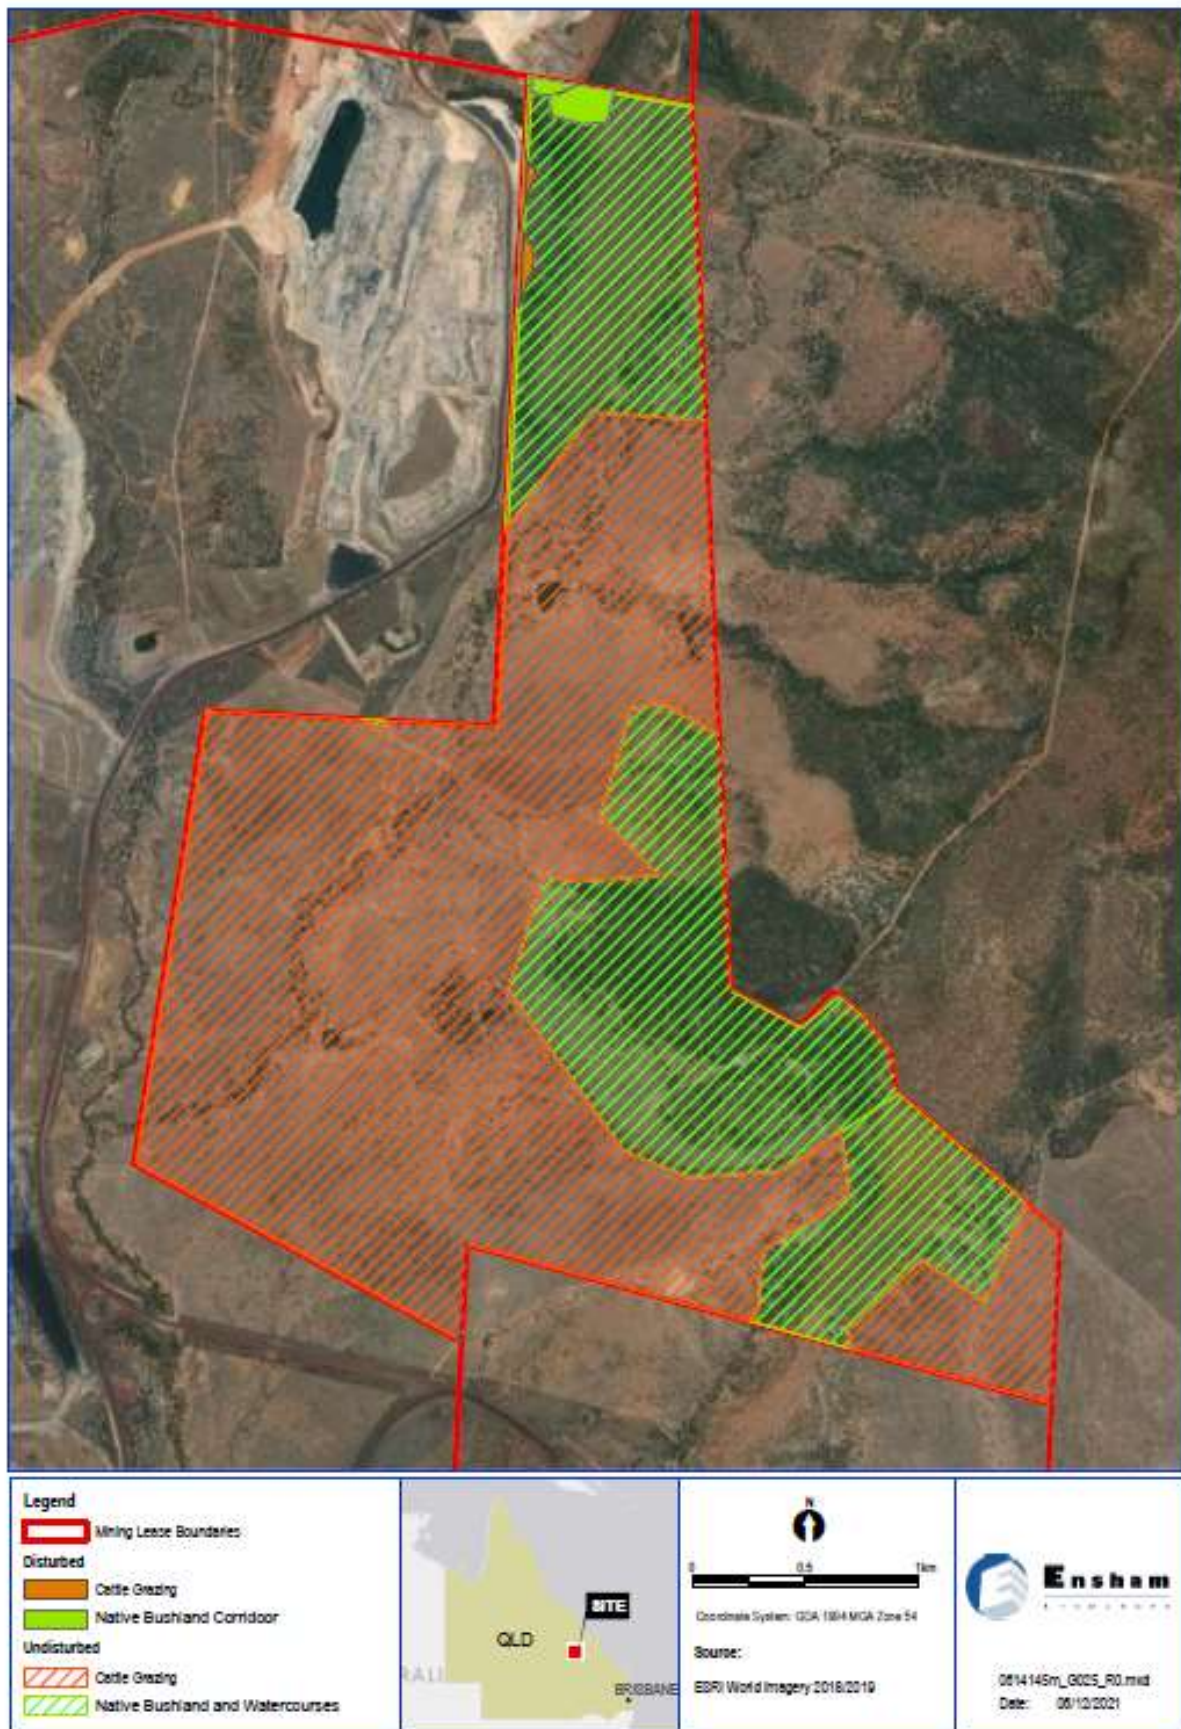
Figure 9-8 ML70367 land use categories

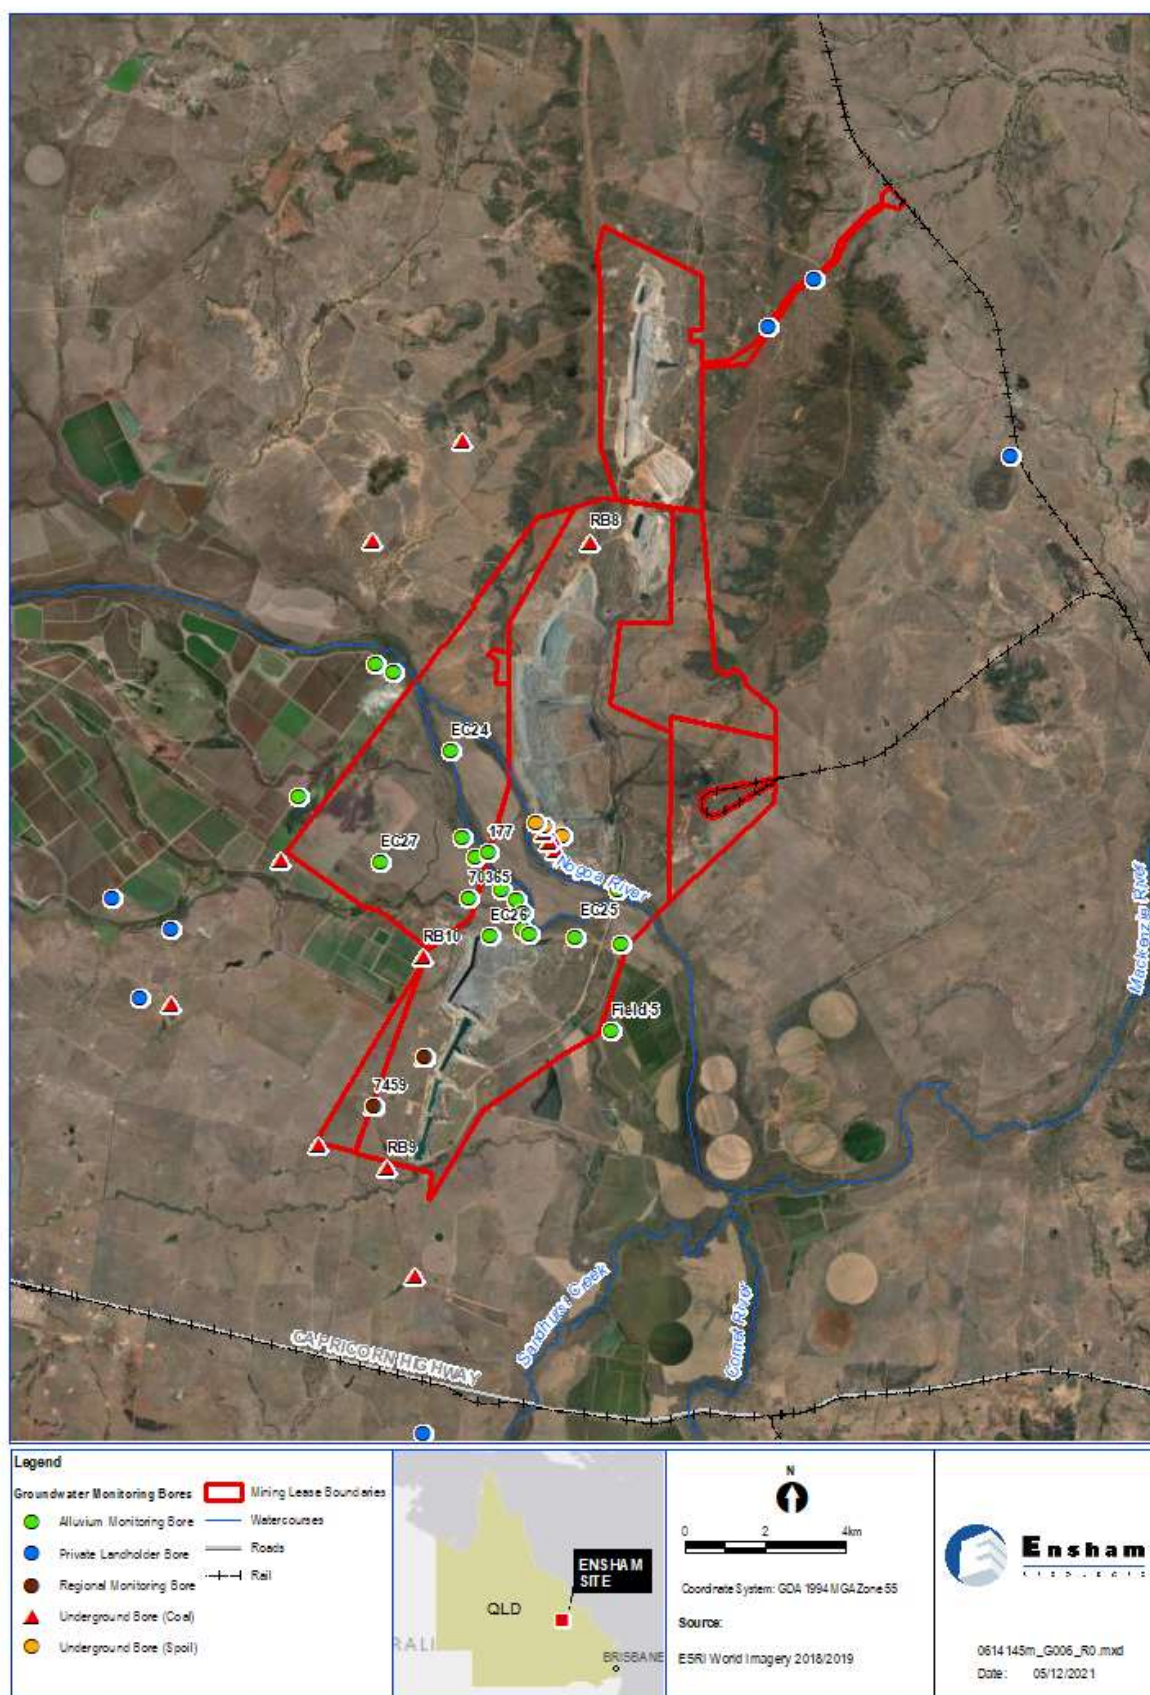
The layout and extent of the existing groundwater bore monitoring network is presented in Figure 3-1.

Figure 3-1 Groundwater monitoring network for Ensham

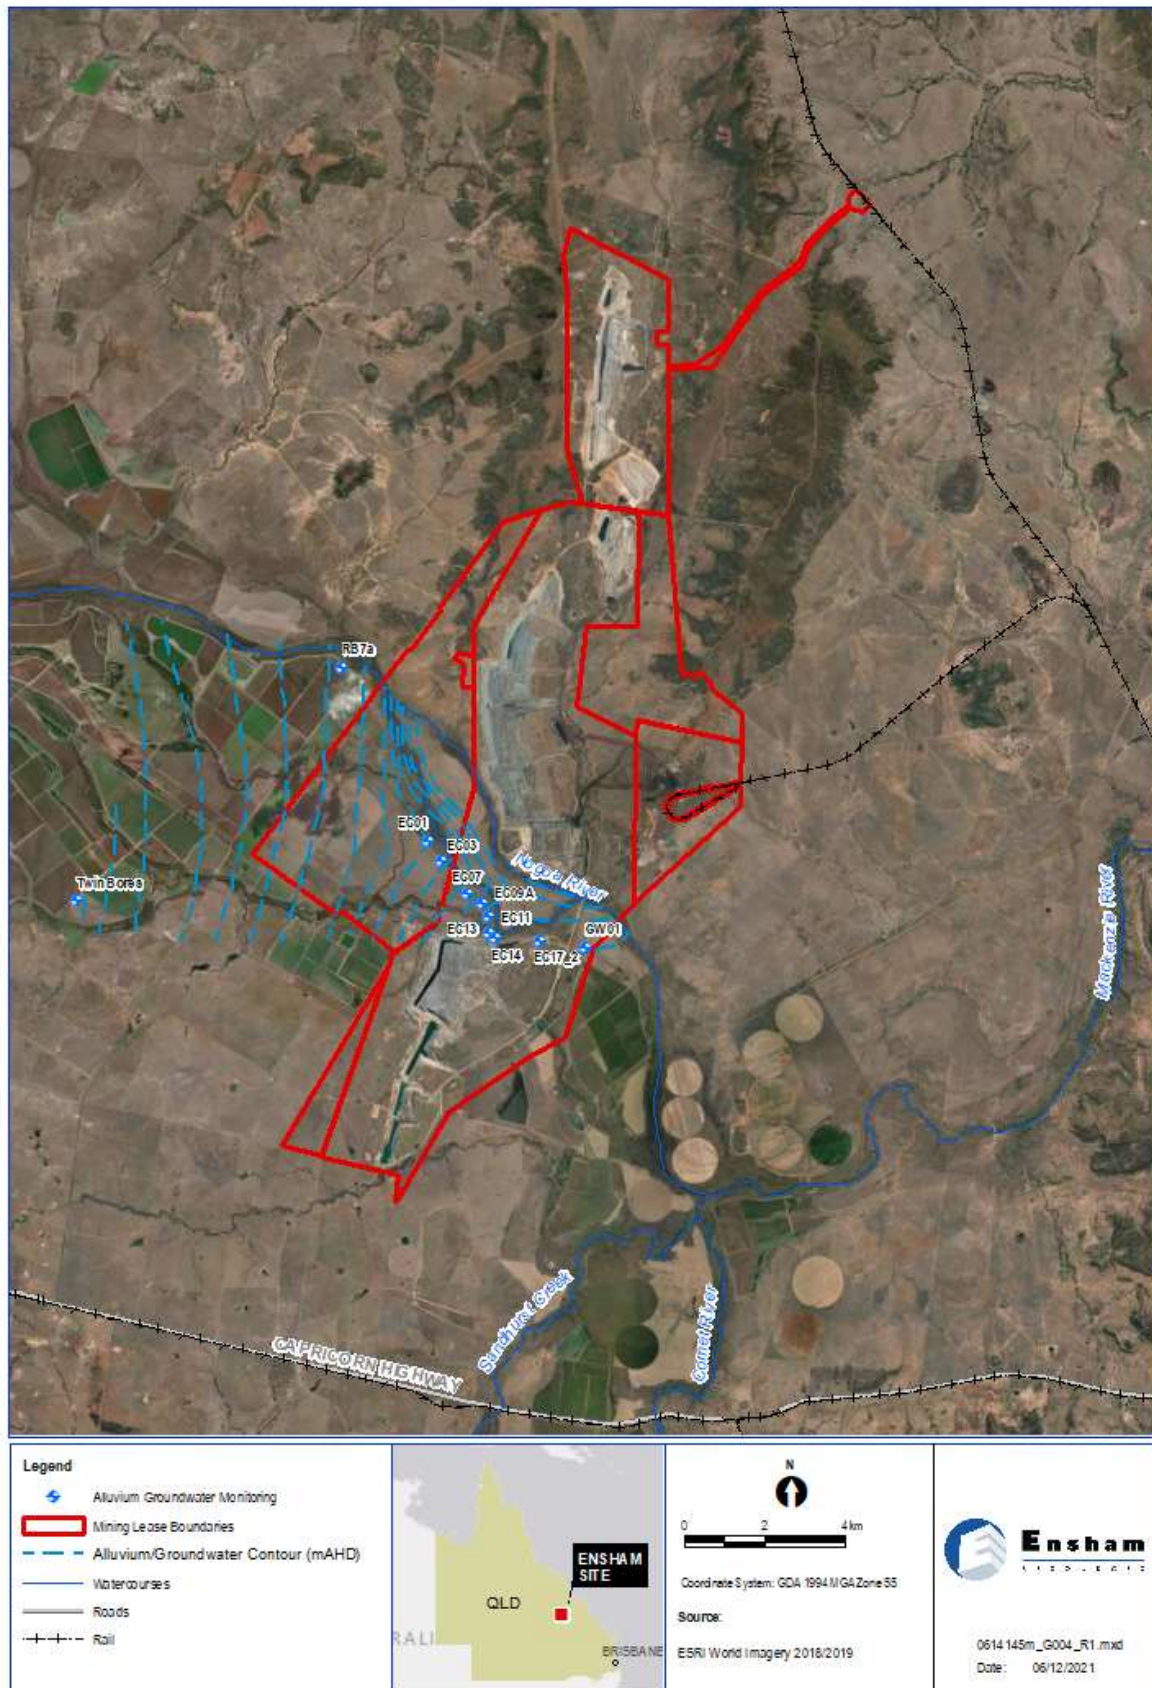
The primary driver of groundwater flow in this aquifer is topographic gradients, following the direction of the Nogoa River from north-west to south-east in the study area, as can be seen in Figure 4-4.

Figure 4-4 Potentiometric mapping for the Quaternary Alluvium

Groundwater level observations are recorded quarterly for the bores within the Ensham monitoring network and contours were developed for each aquifer to illustrate flow directions (as shown in Figure 4-4 and Figure 4-5). Some professional judgement is applied to development of groundwater contour plots by reconciling observed groundwater levels with hydrogeologically significant features such as mining features (mine dewatering and waste storages) and surface water bodies.

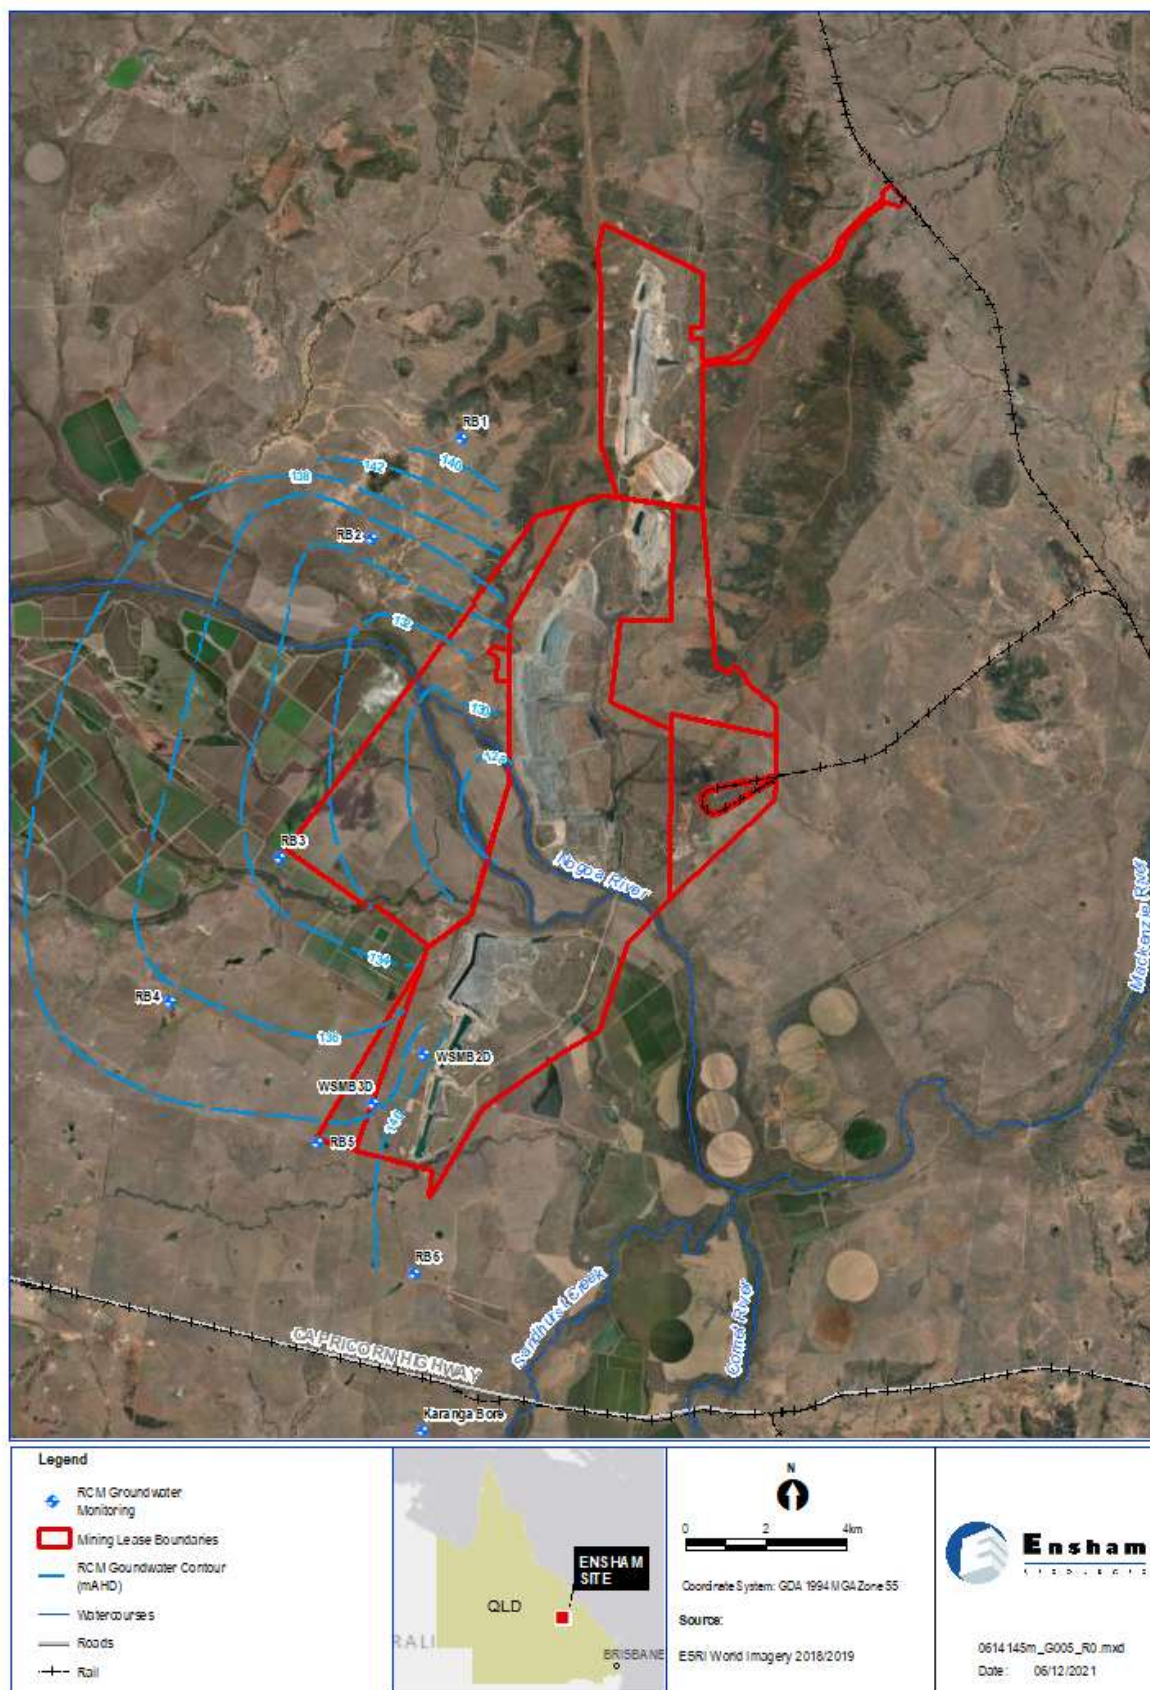
As the mined unit for Ensham, this formation is well monitored regionally. The groundwater level observations from November 2020, show that water level ranges from 133.46 mAHD (RB3) to 145.51 mAHD (RB1). Groundwater in the Rangal Coal Measures flows primarily towards the Ensham underground mine area due to the dewatering and depressurisation associated with underground mine development. Potentiometric level contours of November 2020 monitoring shown in Figure 4-5 illustrate the influence of this depressurisation.

Figure 4-5 Potentiometric mapping for the Rangal Coal Measures
