**Ensham**  
R E S O U R C E S

As Operator of the  
Ensham Coal Project

# PROGRESSIVE REHABILITATION AND CLOSURE PLAN

Version 3

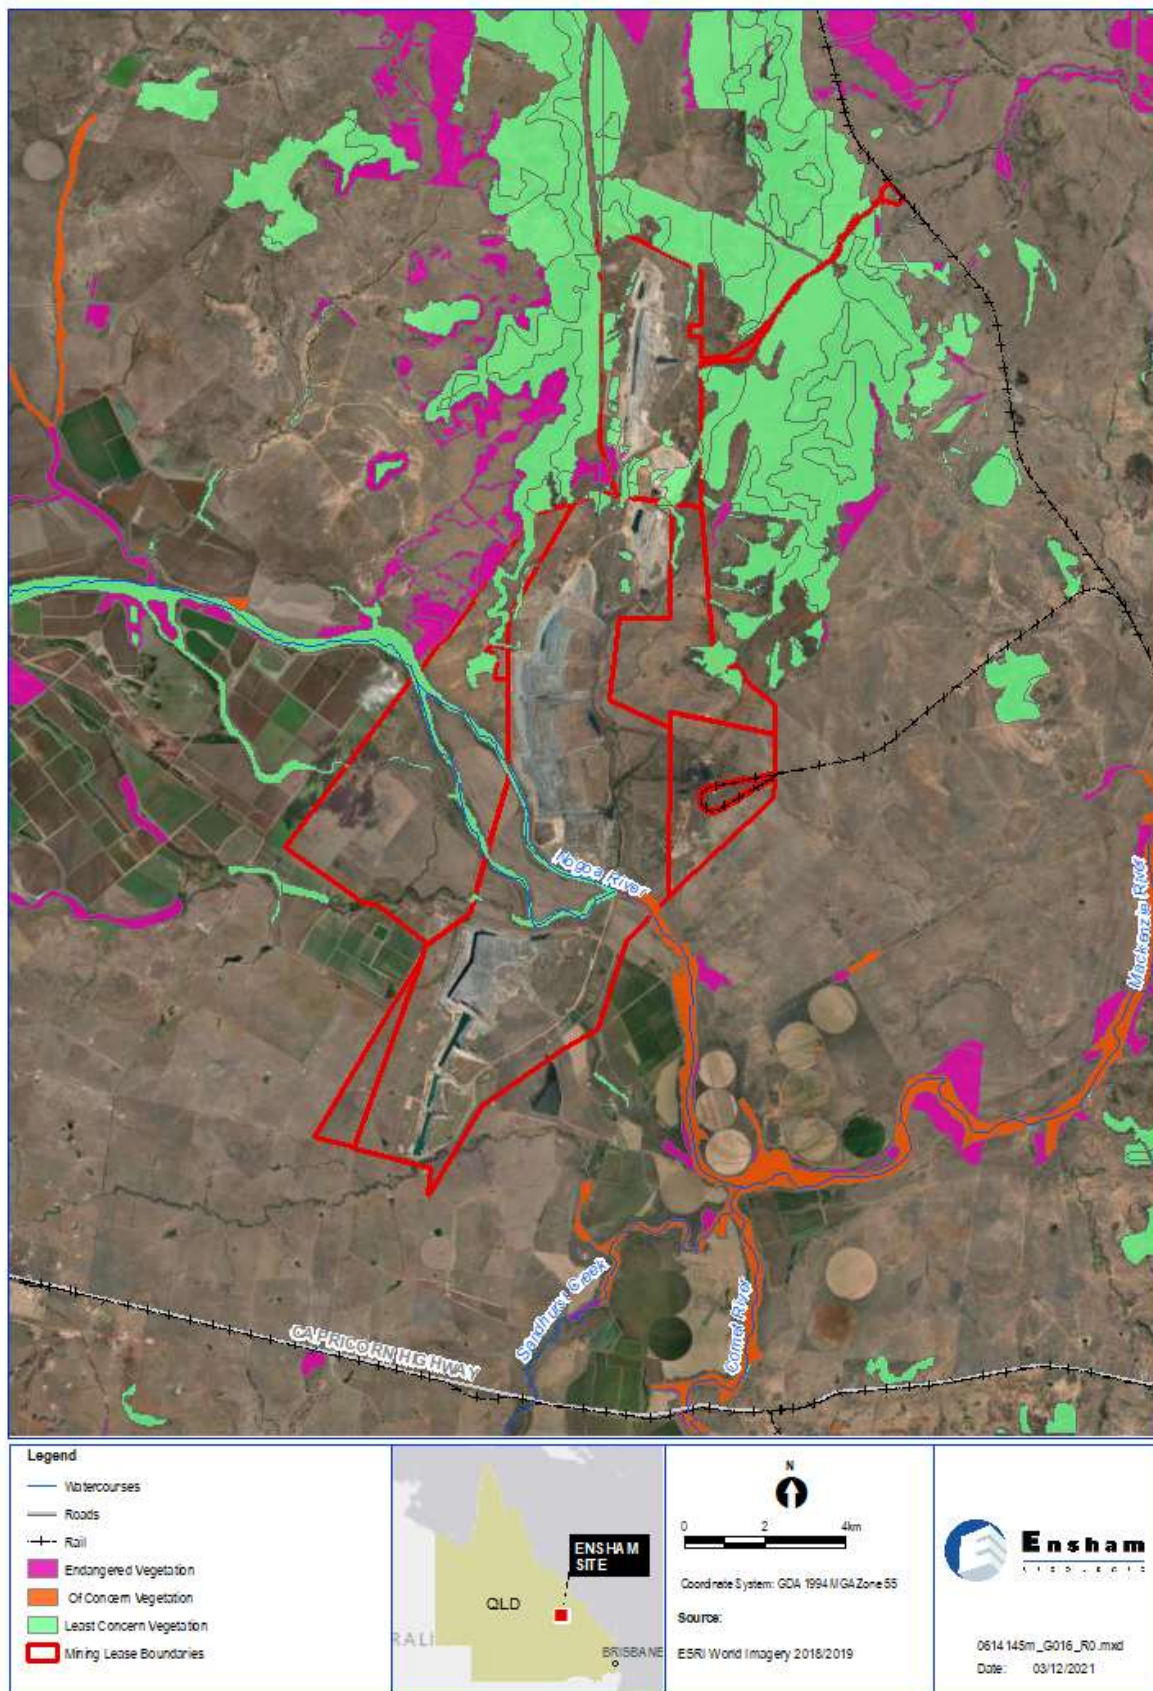
Figure 3-2 Regional Ecosystems mapped at Ensham

Much of the land at Ensham has historically been cleared of vegetation for agricultural development well prior to mining. Vegetation mapping shows there are 13 regional ecosystems within and surrounding the mining leases as outlined in Table 3-3 and presented in Figure 3-2.

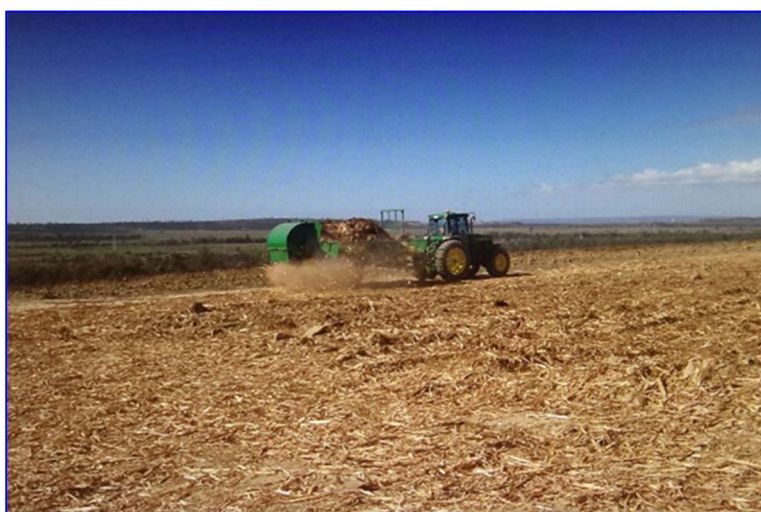
Figure 6-1 Spreading hay mulch for erosion control in rehabilitation at Ensham

Ensham typically applies hay mulch immediately after seed sowing to provide instant groundcover and close the window of erosion risk (as shown in Figure 6-1). Hay mulch applied at a minimum rate of 5 t/ha (20 round bales/ha) is a quick, cheap, and effective erosion hazard control. It also promotes germination and establishment of sown species by assisting to retain soil moisture through reducing evapotranspiration and lowering soil temperatures in the hotter months. The mulch cover is particularly effective in minimising erosion arising from raindrop impact and also serves to retain moisture within the upper soil profile to assist with seed germination and vegetation establishment.
