**Ensham**  
R E S O U R C E S

# PROGRESSIVE REHABILITATION AND CLOSURE PLAN

Version 5

Mining Leases

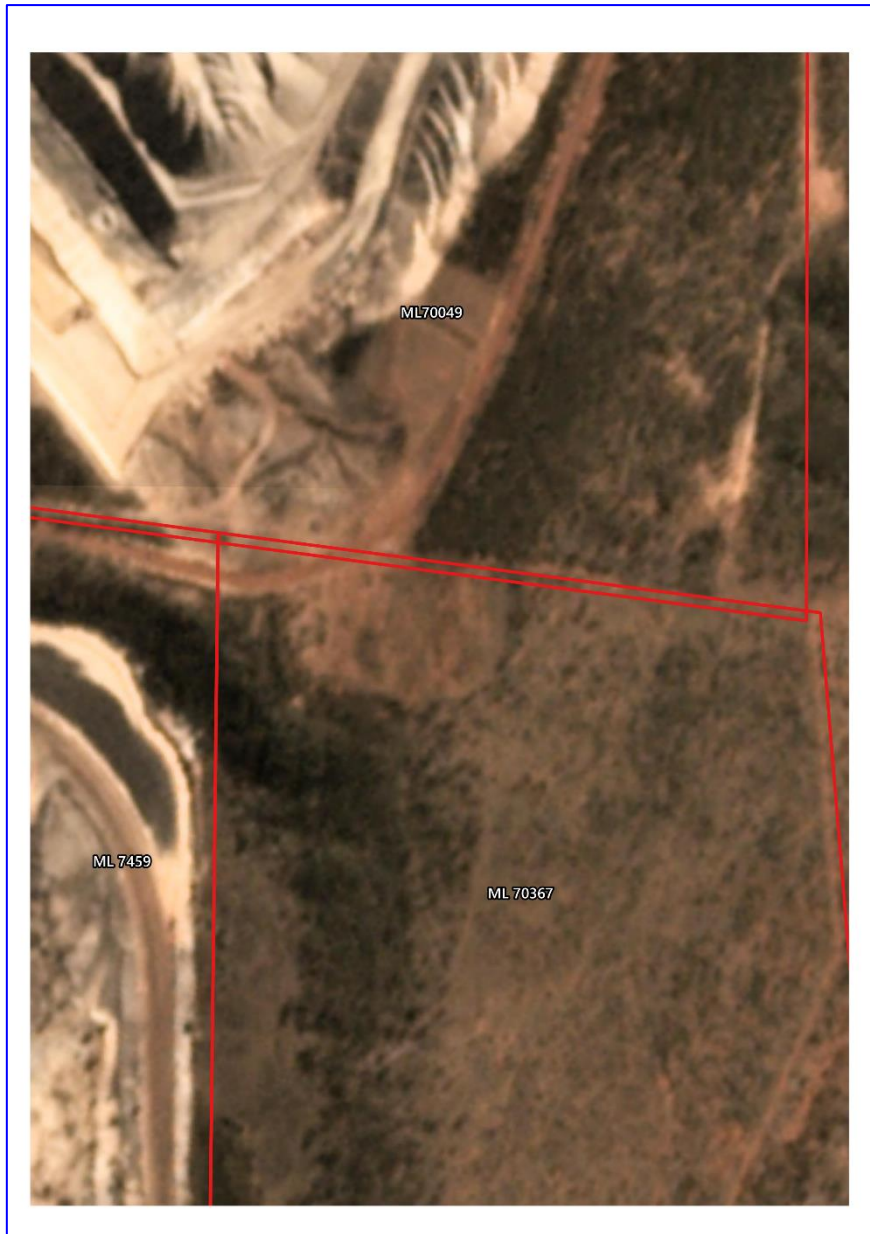
Figure P0-1 Example of spatial data inaccuracies in QSpatial

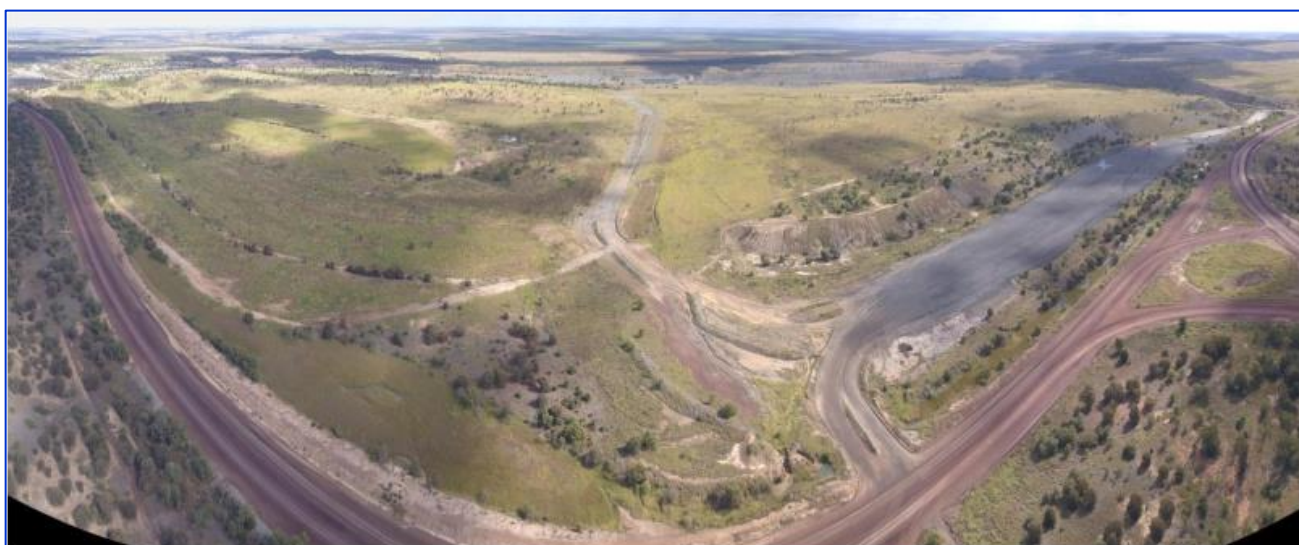
**Figure 1-6 Existing rehabilitation at CDE Pit (ML7459)**

Ensham has completed more than 1,600 ha of opencut mine rehabilitation since 2001 (Figure 1-5, Figure 1-6, Figure 1-7 and Figure 1-8). This equates to approximately one third of total mining disturbances. Most existing rehabilitation has a target PMLU of beef cattle grazing. Portions of existing rehabilitation have been approved as certified under the EP Act (Table 1-4) or not yet applied for. Following approval of the application for certification of progressive rehabilitation in 2021, Ensham has more certified opencut rehabilitation than any other opencut coal mine in Queensland.

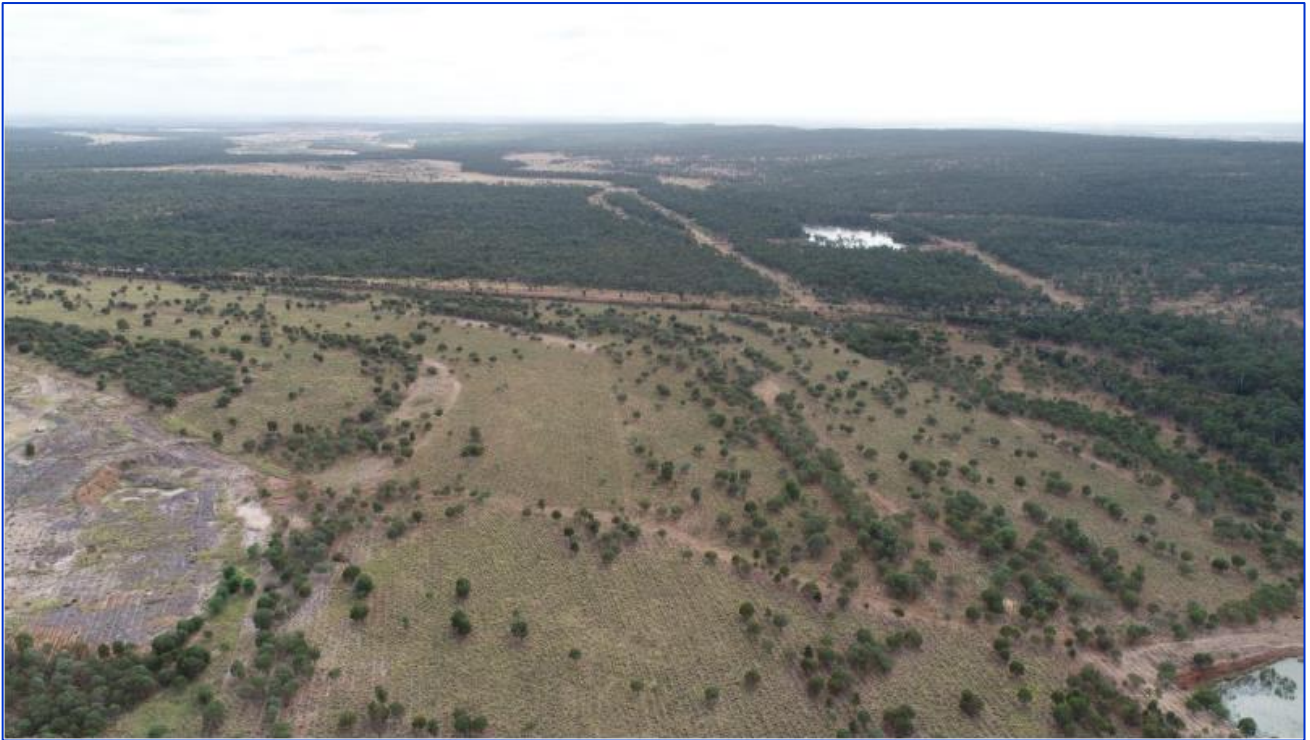
**Figure 1-7 Existing rehabilitation at Y Pit (ML70049)**

This area was certified in 2019 and is currently used for beef cattle grazing.

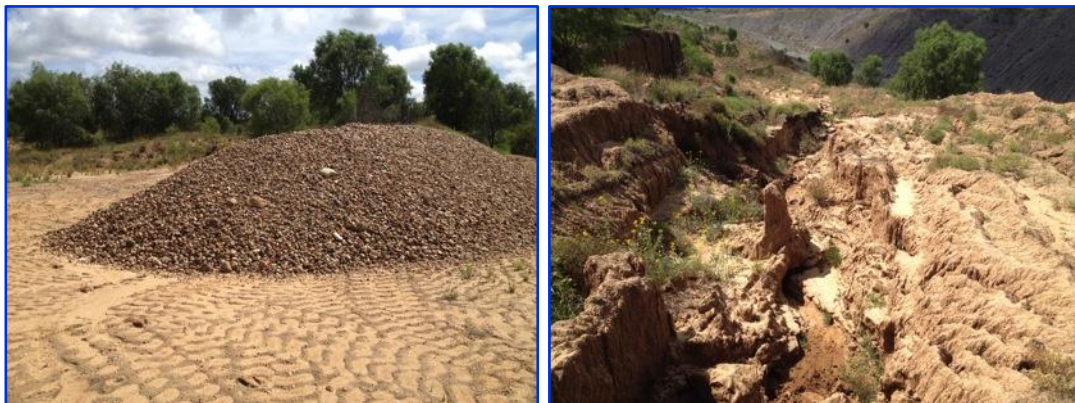
Figure 5-3 Quaternary spoil in B Pit is screened for gravel and sand for use around site (left) and erosion in situ Quaternary spoil in B Pit endwall (right)

Pale brown to yellow alluvial sands and gravels (Figure 5-3). Low clay content means material has little water or nutrient holding capacity. Non-saline but sodic with low surface cohesion, this overburden is highly dispersive and prone to excessive erosive when exposed to rainfall.

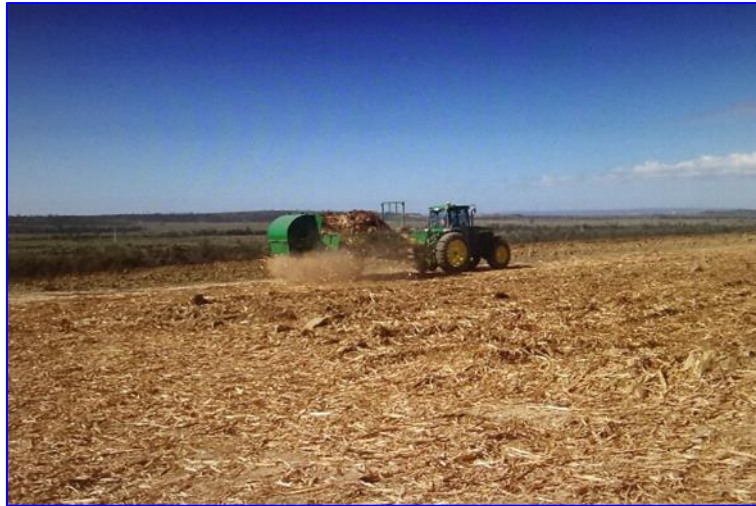
Ensham applies hay mulch immediately after sowing to provide instant groundcover and close the window of erosion risk (Figure 5-10). This is particularly important for any slopes greater than 20%. Hay mulch applied at a minimum rate of 5 t/ha is a quick, cheap, and effective erosion hazard control. It also promotes germination and establishment of sown species by assisting to retain soil moisture through reducing evapotranspiration and lowering soil temperatures in the hotter months.

**Figure 5-10 Spreading hay mulch for erosion control in rehabilitation at Ensham**

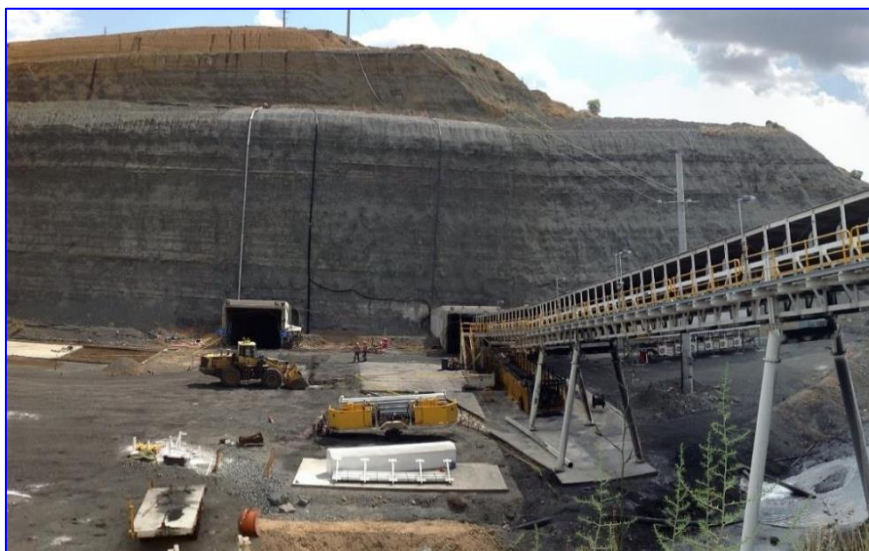
Underground mining at Ensham has negligible surface impacts because, unlike longwall mining, bord and pillar mining does not cause discernible surface subsidence. The underground workings are accessed from a section of C Pit highwall (Figure 5-11).

**Figure 5-11 Entrances to the existing Ensham underground mine.**

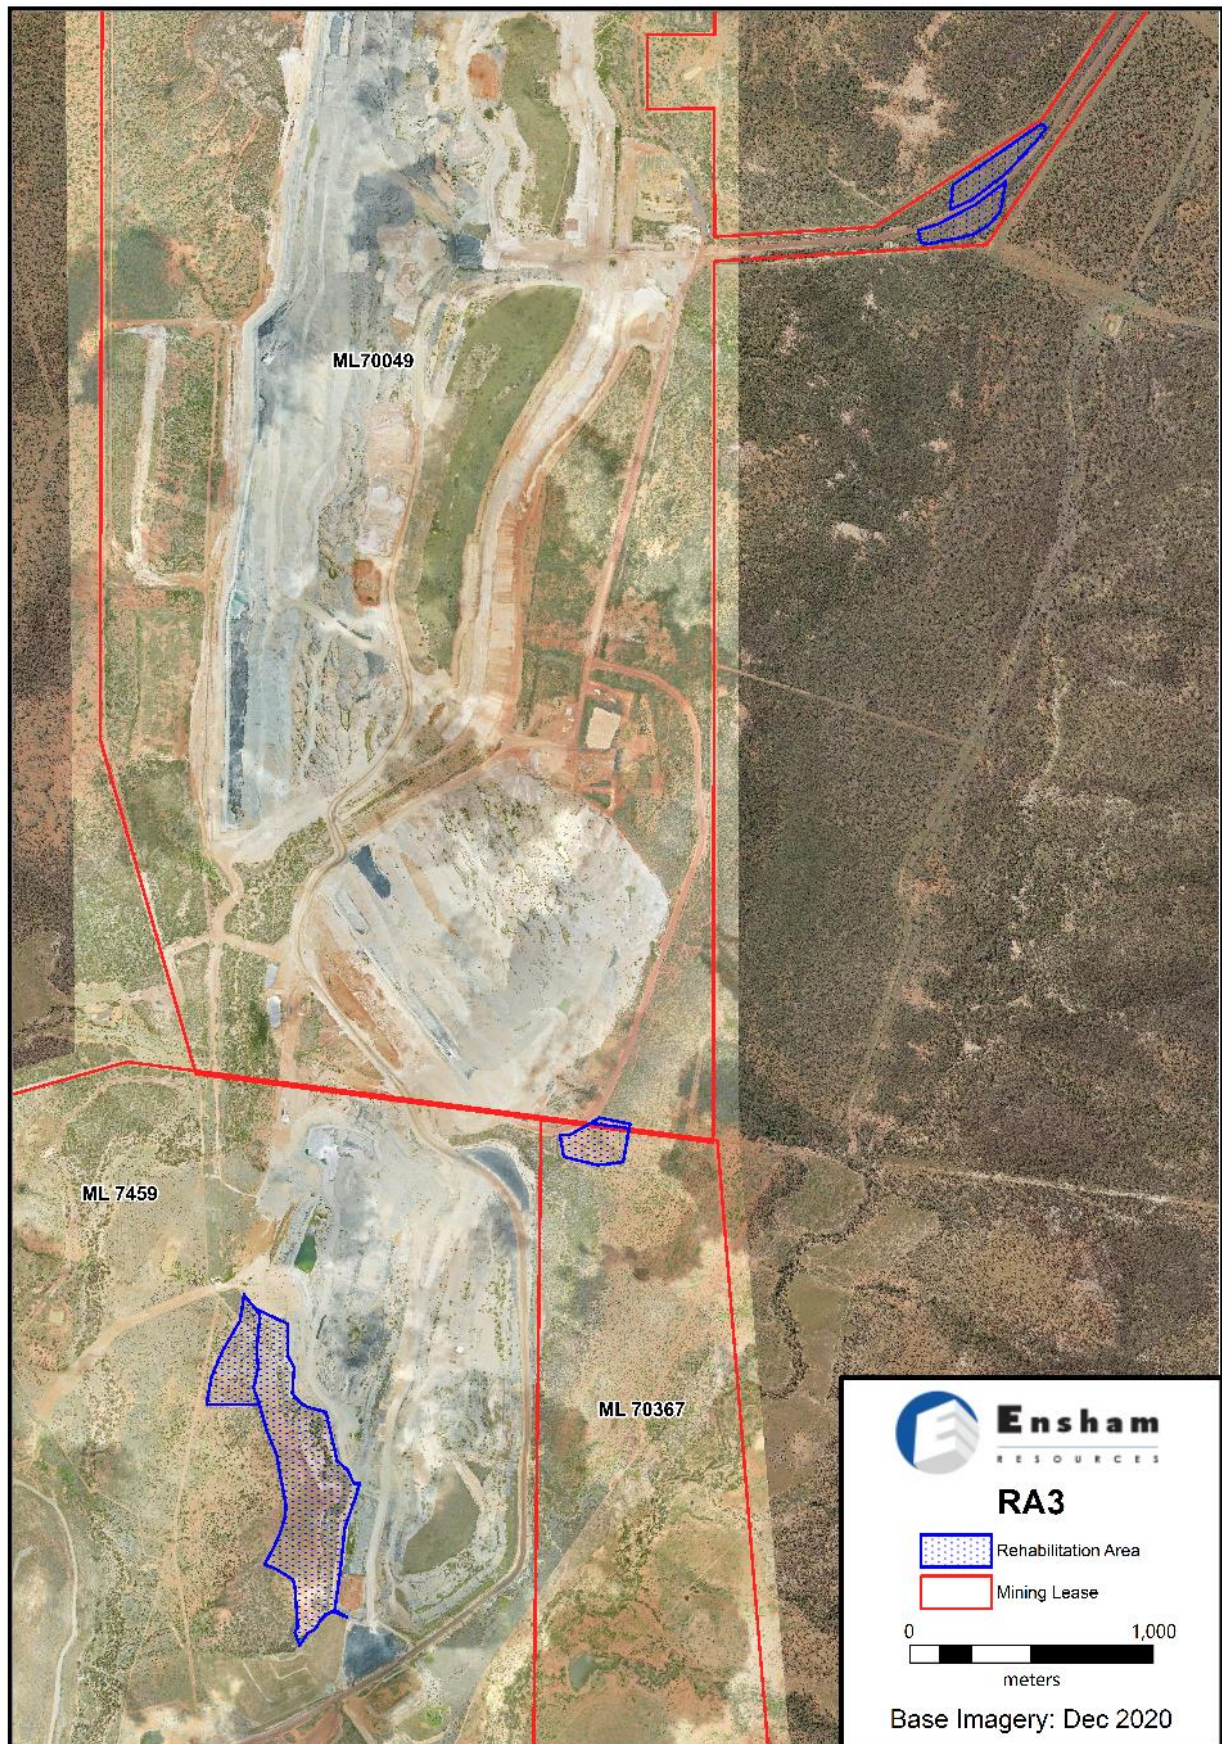
Figure 9-11 Rehabilitation Area 3 (RA 03)

| Post-mining land uses (PMLU) | | |
|---|---|--|
| Relevant activities | Mine domain 4 – cleared areas (Figure 9-11 Rehabilitation Area 3 (RA 03)) | |

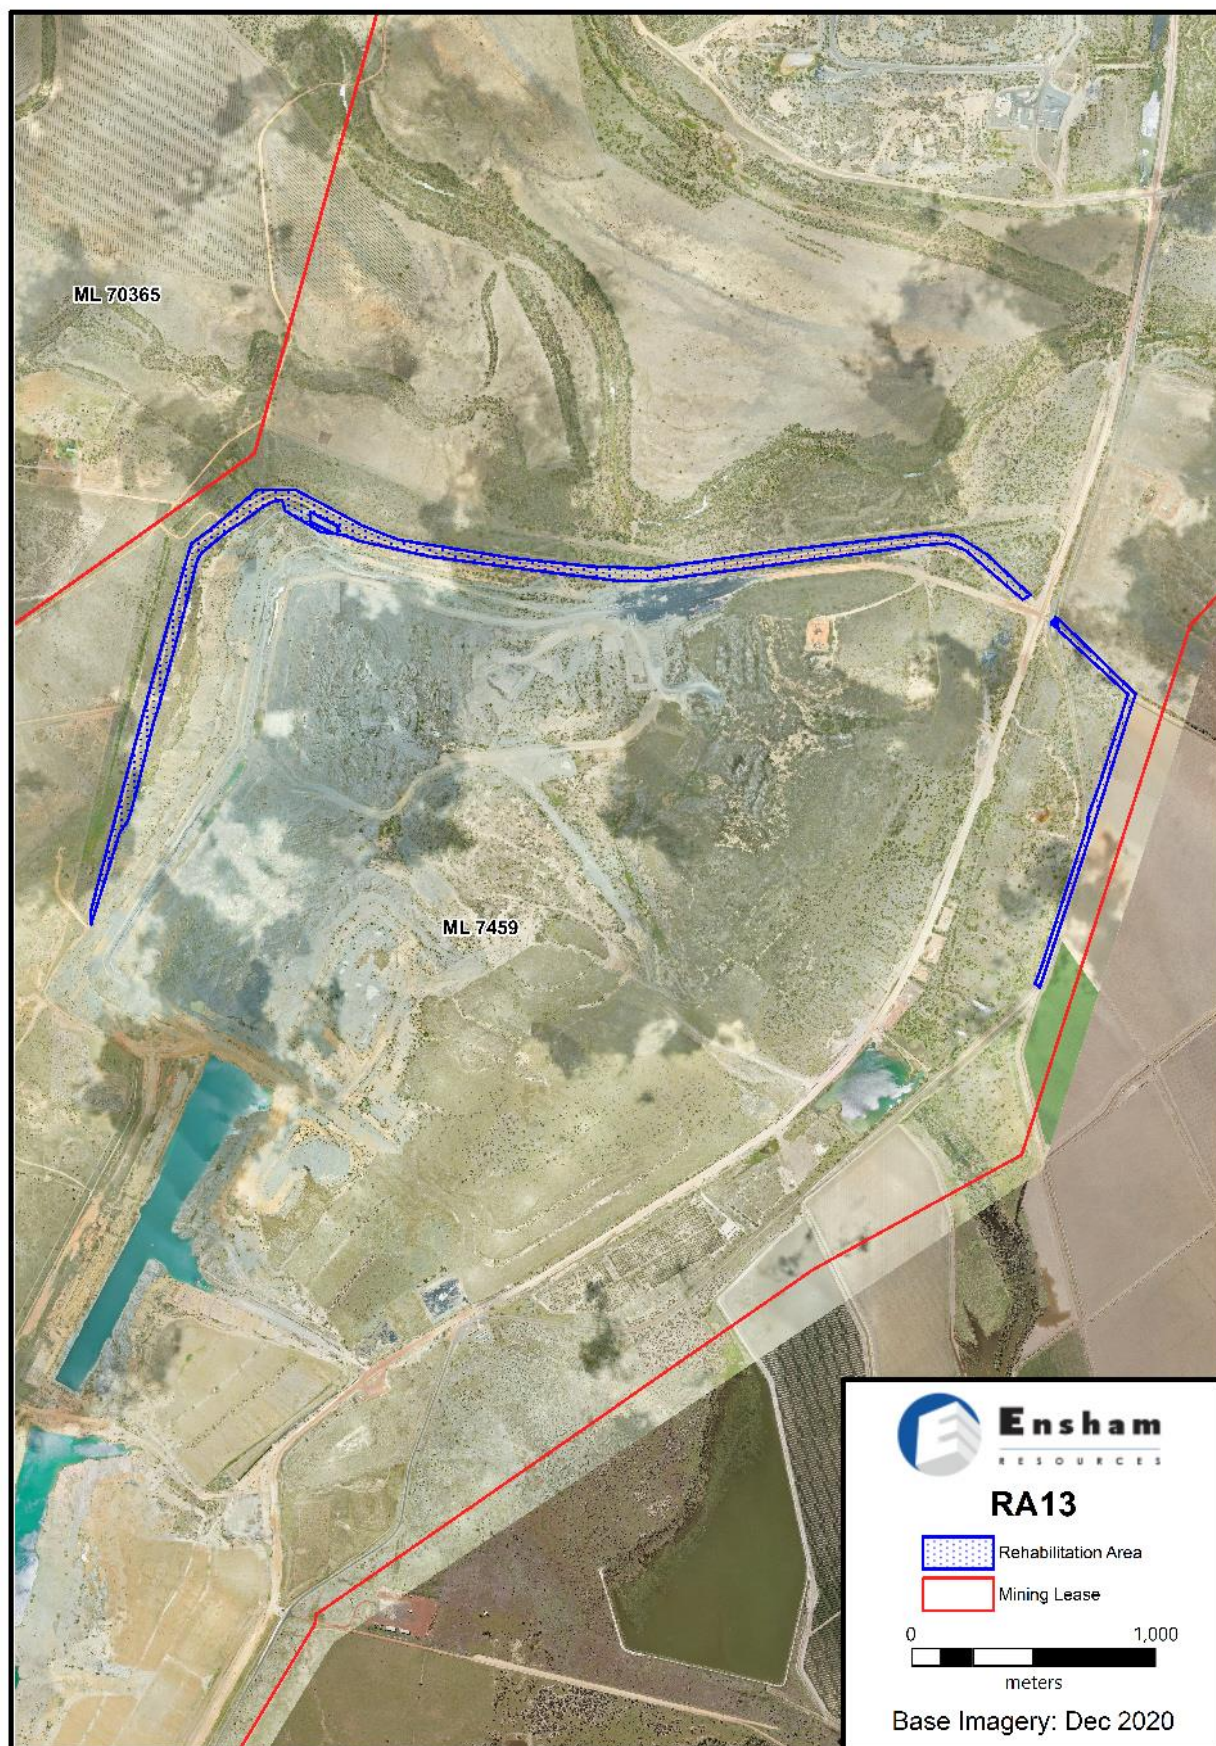
Figure 9-21 Rehabilitation Area 13 (RA 13)

| Post-mining land uses (PMLU) | | | | | | | | | | | | | | | | | |
|---|---|---|---|---|---|---|---|---|---|---|---|---|---|---|---|---|---|
| Relevant activities | Mine domain 7 - Flood protection landform constructed over existing levee (Figure 9-21 Rehabilitation Area 13 (RA13)) | | | | | | | | | | | | | | | | |
