**Ensham**  
R E S O U R C E S

# PROGRESSIVE REHABILITATION AND CLOSURE PLAN

Version 7

Mining Leases

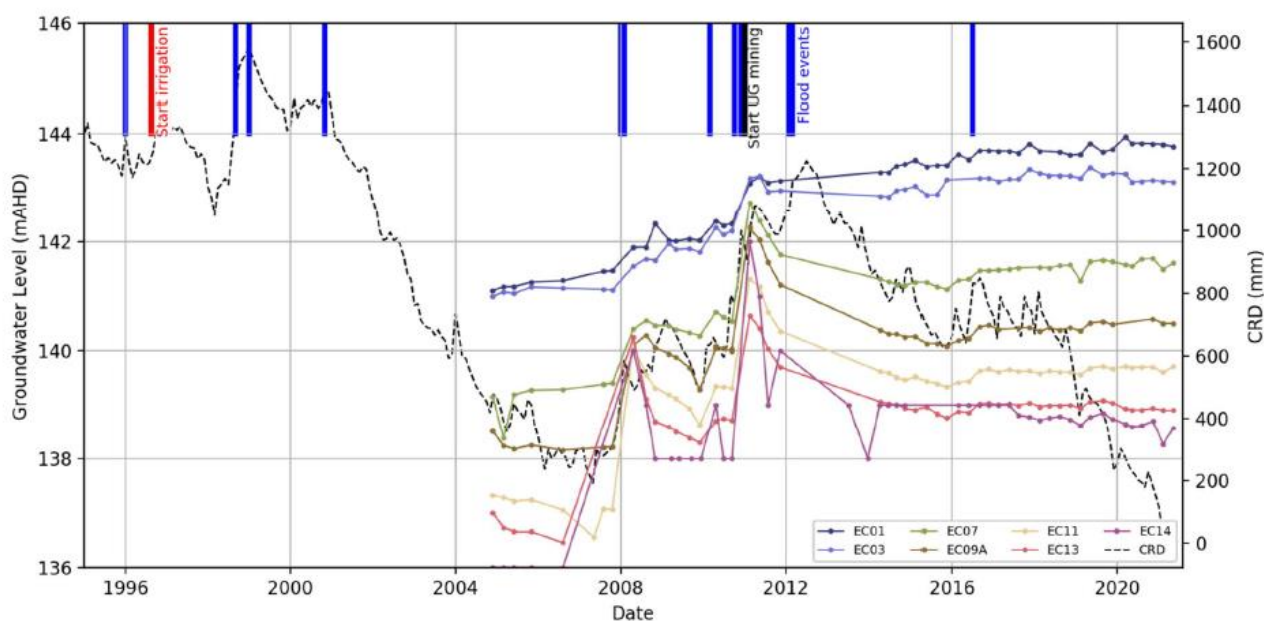
Figure 1-14 Standing water levels in Quaternary alluvium monitoring bores and cumulative rainfall departure (CRD)

The alluvium is an unconfined system recharged by rainfall and irrigation practices. Its water is generally very saline and unsuitable for uses such as stock watering or irrigation. The alluvium is not well connected with the Nogoa River (Figure 1-13). Notwithstanding, groundwater monitoring by Ensham indicates standing water levels are influenced by rainfall and large flooding events (Figure 1-14). This creates large fluctuations in water level and quality.
