ENSHAM  
RESOURCES  
PTY LIMITED

As an operator of the  
Ensham Coal Project

# PROGRESSIVE REHABILITATION AND CLOSURE PLAN

Version 7

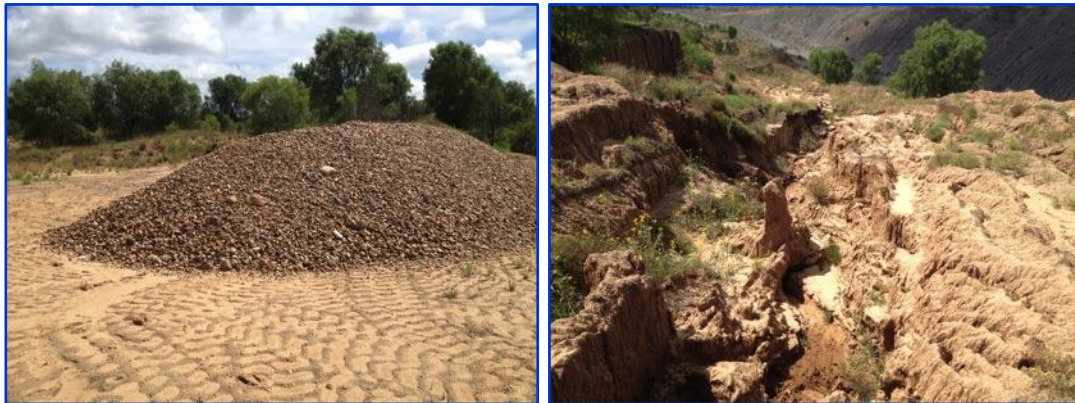
Pale brown to yellow alluvial sands and gravels (Figure 5-3). Low clay content means material has little water or nutrient holding capacity. Non-saline but sodic with low surface cohesion, this overburden is highly dispersive and prone to excessive erosive when exposed to rainfall.

Figure 5-3 Quaternary spoil in B Pit is screened for gravel and sand for use around site (left) and erosion in situ Quaternary spoil in B Pit endwall (right)

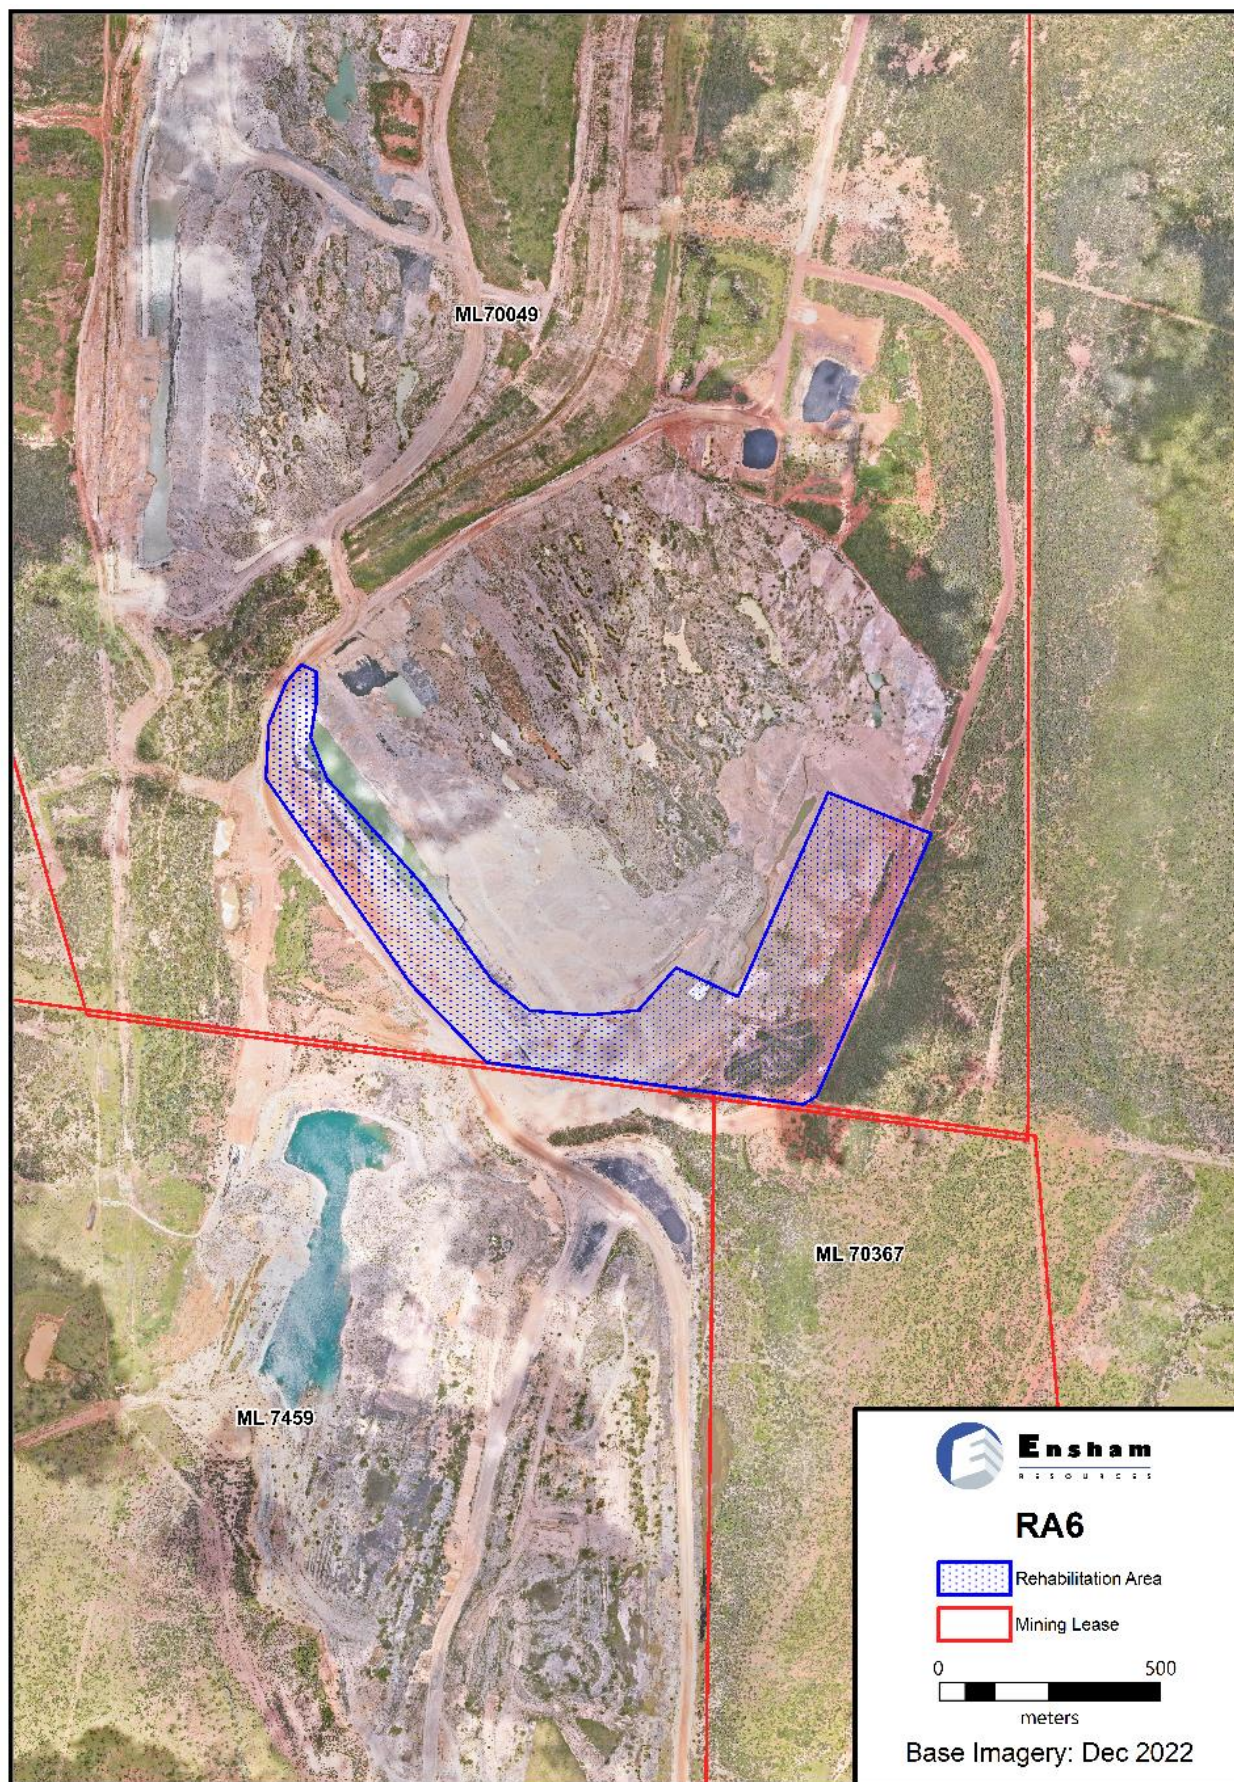
Figure 9-14 Rehabilitation Area 6 (RA 06)

| Post-mining land uses (PMLU) | | | | | | | | | | | |
|---|---|---|---|---|--|--|--|--|--|--|--|
| Relevant activities | | | | Mine domain 3 – Overburden / mine disturbed areas including overburden emplacement areas, low walls, highwalls and cleared areas (Figure 9-14 Rehabilitation Area 6 (RA 06)) | | | | | | | |

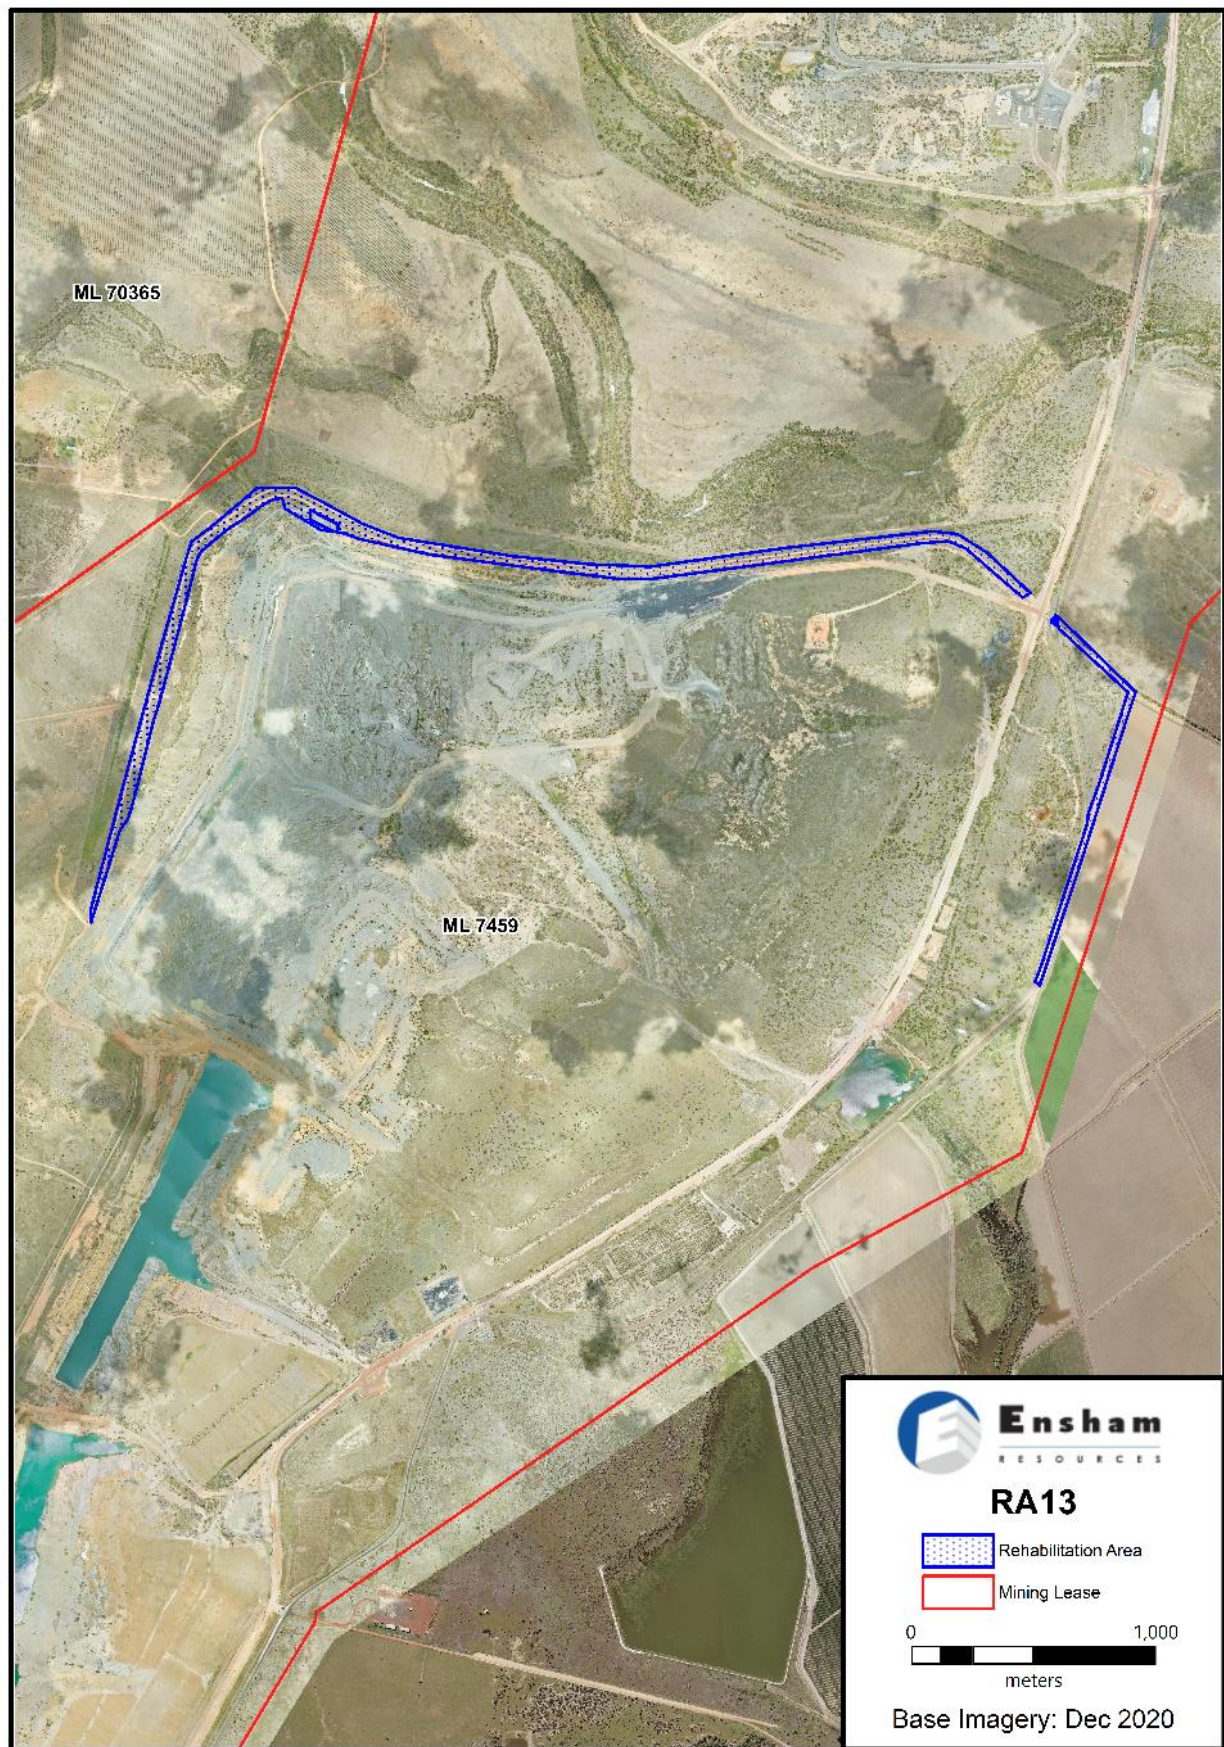
Figure 9-21 Rehabilitation Area 13 (RA 13)

| Post-mining land uses (PMLU) | | | | | | | | | | | | | | | | | |
|---|---|---|---|---|---|---|---|---|---|---|---|---|---|---|---|---|---|
| Relevant activities | Mine domain 7 - Flood protection landform constructed over existing levee (Figure 9-21 Rehabilitation Area 13 (RA13)) | | | | | | | | | | | | | | | | |
