ENSHAM  
RESOURCES  
PTY LIMITED

# PROGRESSIVE REHABILITATION AND CLOSURE PLAN

Version 6

Mining Leases

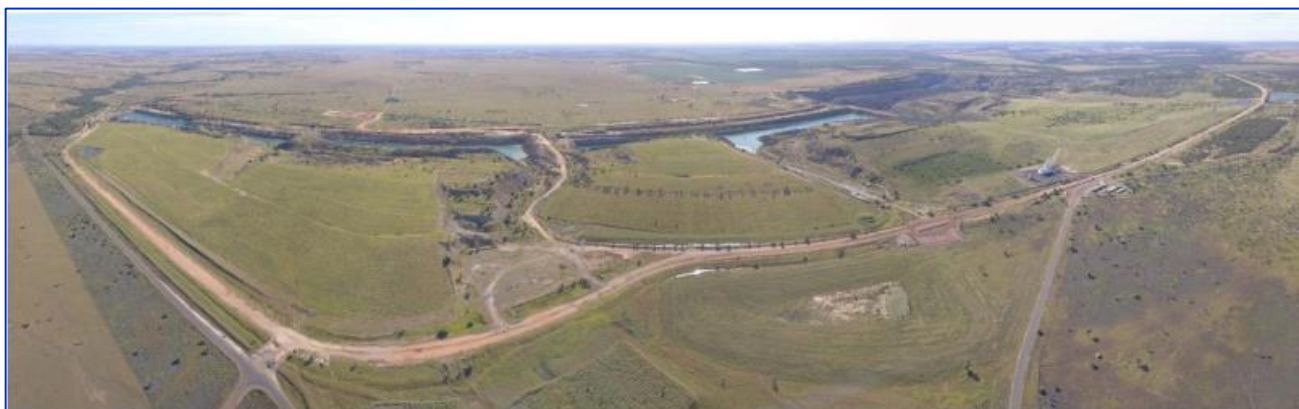
**Figure 1-5 Existing rehabilitation at AB Pit (ML7459)**

These areas are currently used for beef cattle grazing.

Ensham has completed more than 1,600 ha of opencut mine rehabilitation since 2001 (Figure 1-5, Figure 1-6, Figure 1-7 and Figure 1-8). This equates to approximately one third of total mining disturbances. Most existing rehabilitation has a target PMLU of beef cattle grazing. Portions of existing rehabilitation have been approved as certified under the EP Act (Table 1-4) or not yet applied for. Following approval of the application for certification of progressive rehabilitation in 2021, Ensham has more certified opencut rehabilitation than any other opencut coal mine in Queensland.

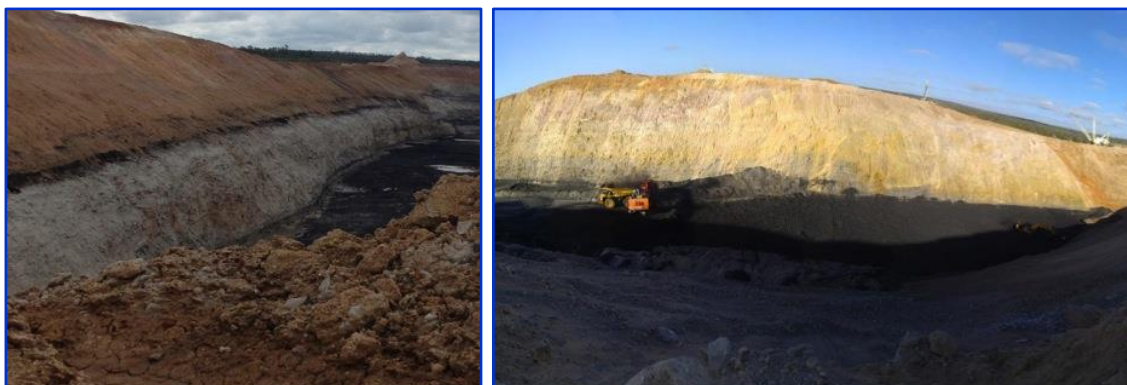
Figure 5-4 Tertiary spoil overlying Permian spoil in Y Pit (left) and F Pit (right)

Overlying the Permian overburden, this material is derived from Tertiary age alluvium or colluvium (Figure 5-4). It is consistently saline to extremely saline, with chloride levels toxic to plants at Y Pit, and consistently sodic to extremely sodic. This material is extremely dispersive.

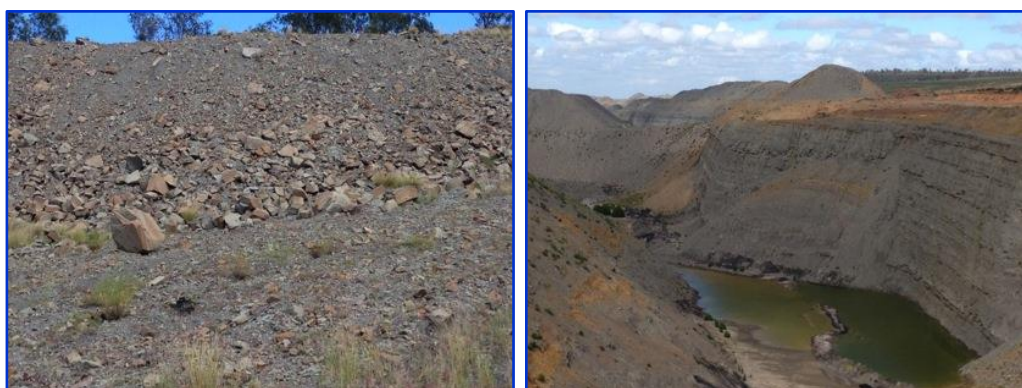
Figure 5-5 Permian spoil in D Pit emplacement (left) and E Pit highwall (right)

Easily distinguished by its bluish grey colour, consisting of rapidly weathering mudstones and siltstones, with orange/yellow resistant sandstone fragments (Figure 5-5). Derived from Permian sedimentary rocks of the Blackwater Group, it is generally non-saline to saline and sodic.
