## Progressive Rehabilitation and Closure Plan

**Mt Leyshon Mine**

M13000\_024-REP-001-2

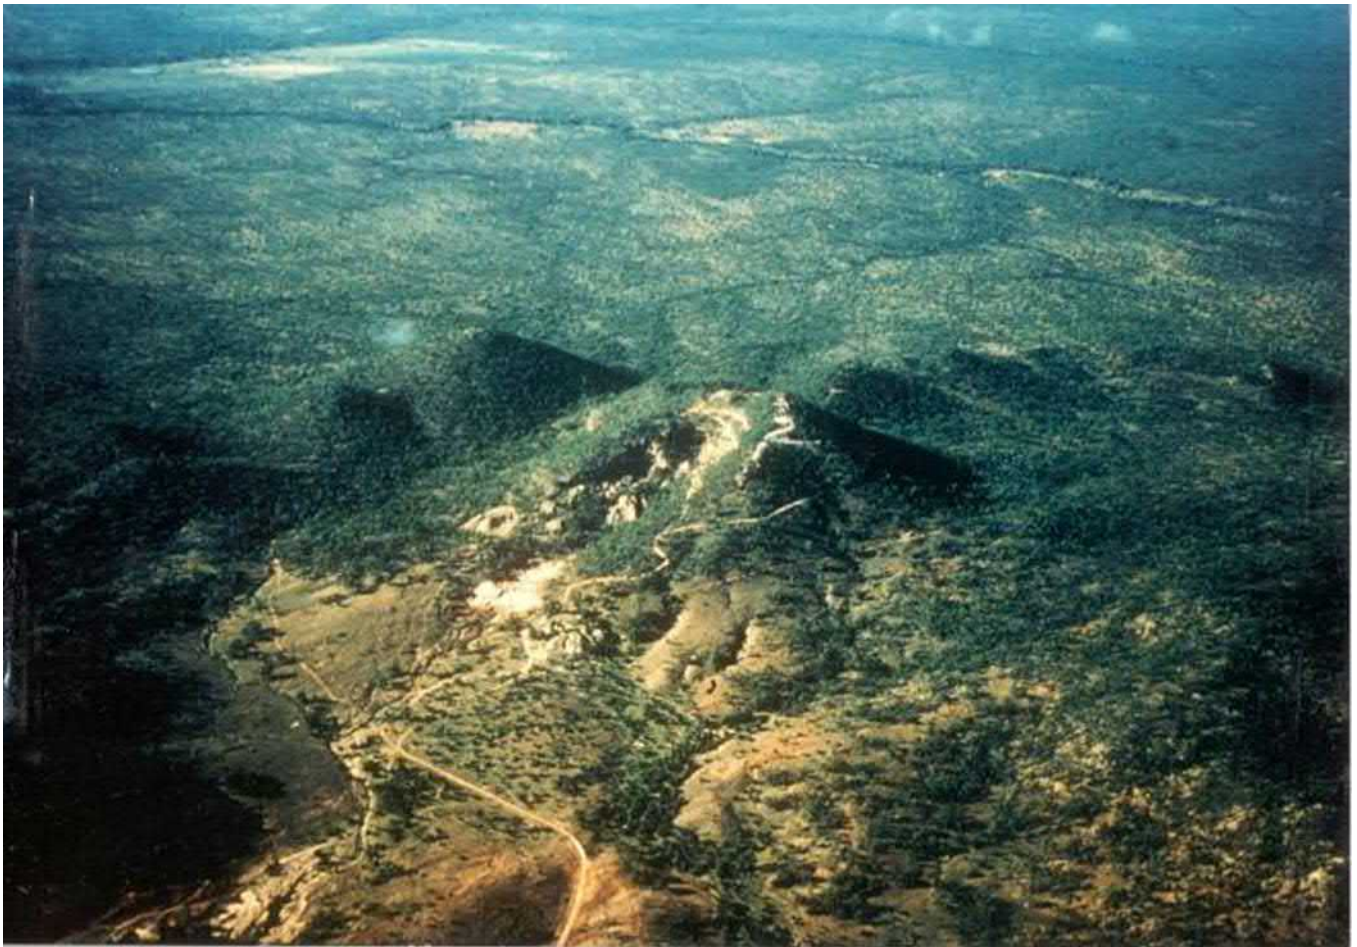
**Figure 1.5: Topography and Landforms at Mt Leyshon Mine Prior to Modern Mining Operations (view to the south-east)**

The original topography at Mt Leyshon Mine prior to mining was dominated by steep hills with rocky outcrops (including Mt Leyshon and Mt Mawe). These hills formed a regional topographic high and coincided with several catchment boundaries, with natural surface water drainage being directed to the north (towards Clarke Creek), south (towards Puddler Creek) and east (towards Two Mile Creek). The topography and landforms that existed at the Mt Leyshon Mine prior to the modern mining operations are shown in Figure 1.5. The original Mt Leyshon (shown in the centre of Figure 1.5) was the highest landform in the area, while there were a number of smaller hills surrounding Mt Leyshon, including Mt Mawe which is located immediately to the east of the original Mt Leyshon (landform to the left of Mt Leyshon in Figure 1.5).

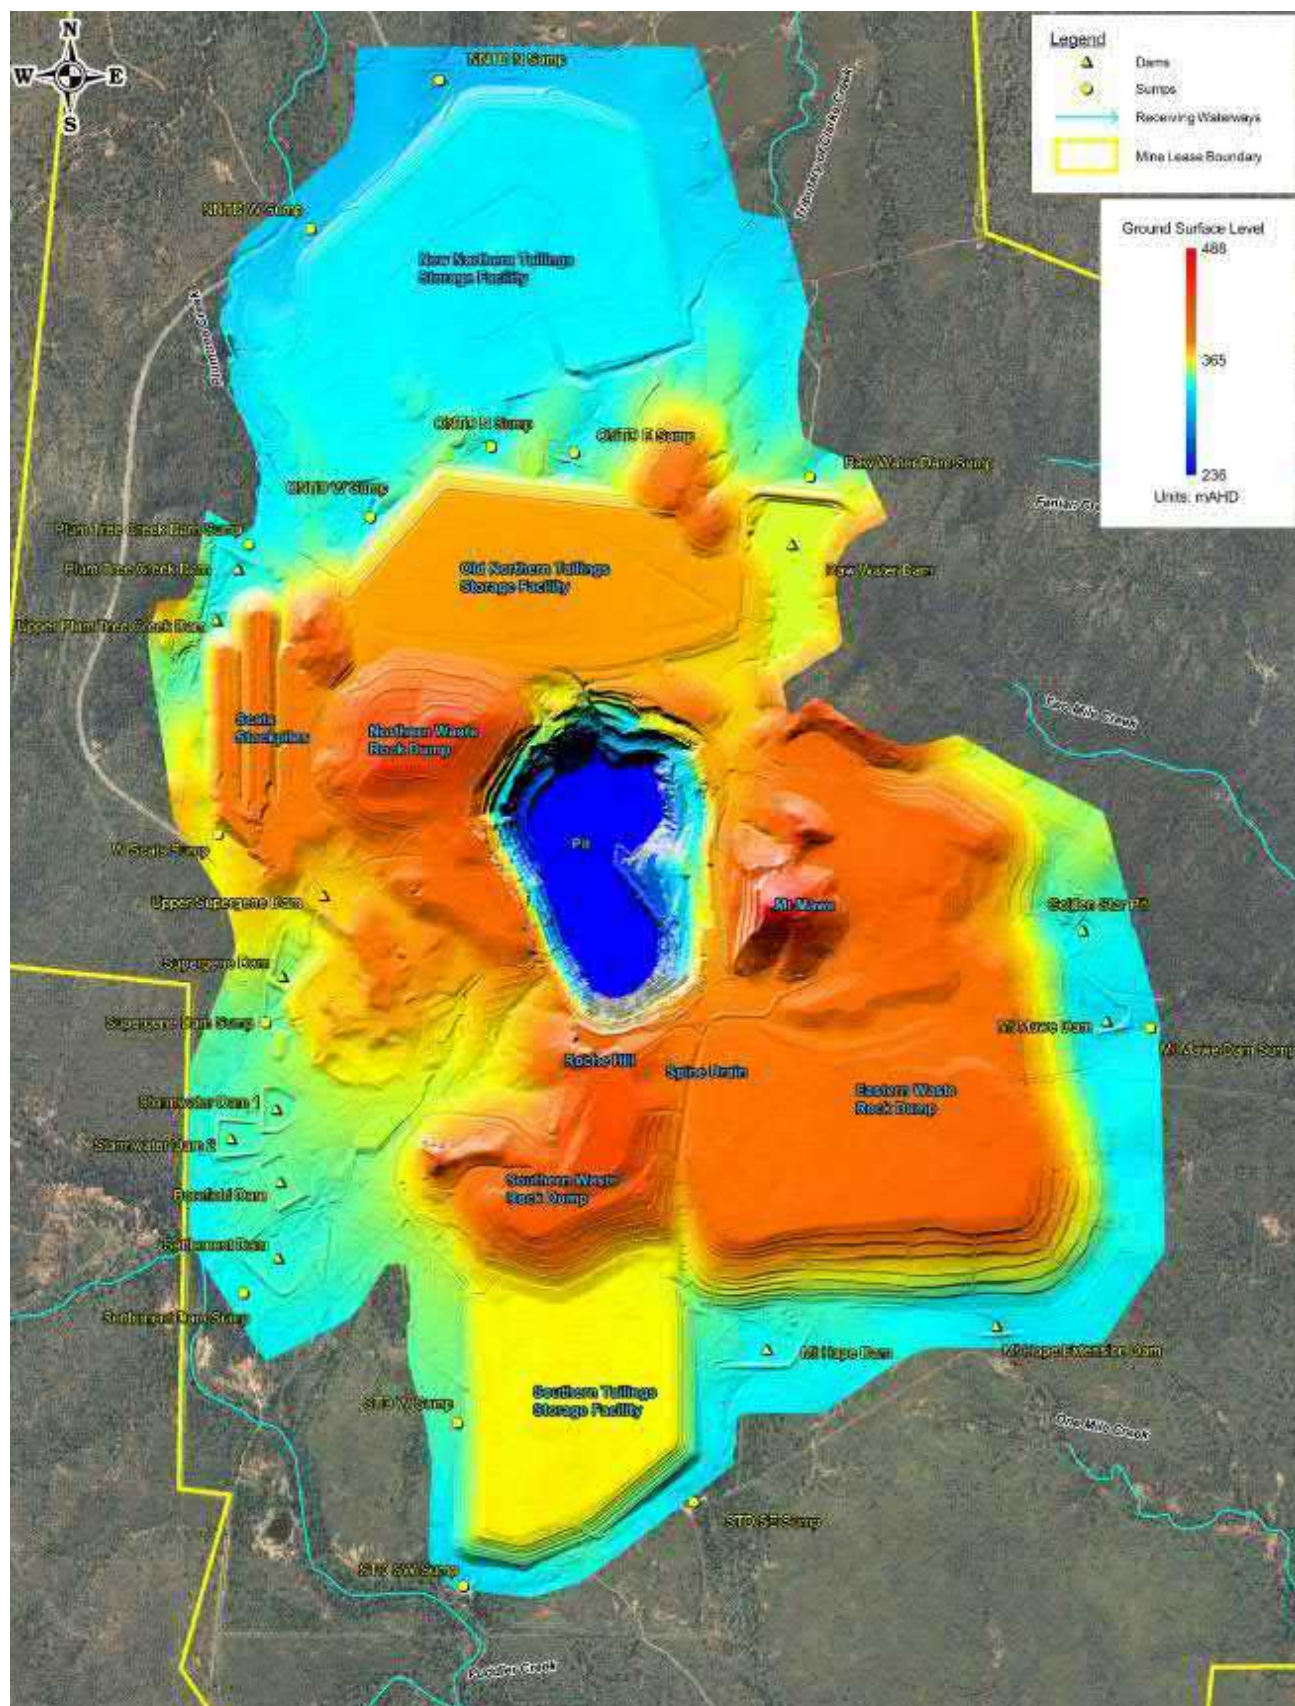
Figure 1.8: Current (post-closure) Topography at Mt Leyshon Mine

Current ground elevations at the mine are shown in Figure 1.8 and summarized in Table 1.3. The highest elevation is 488m AHD on the top of Mt Mawe while the lowest elevation is in the open cut pit, below the pit lake level.

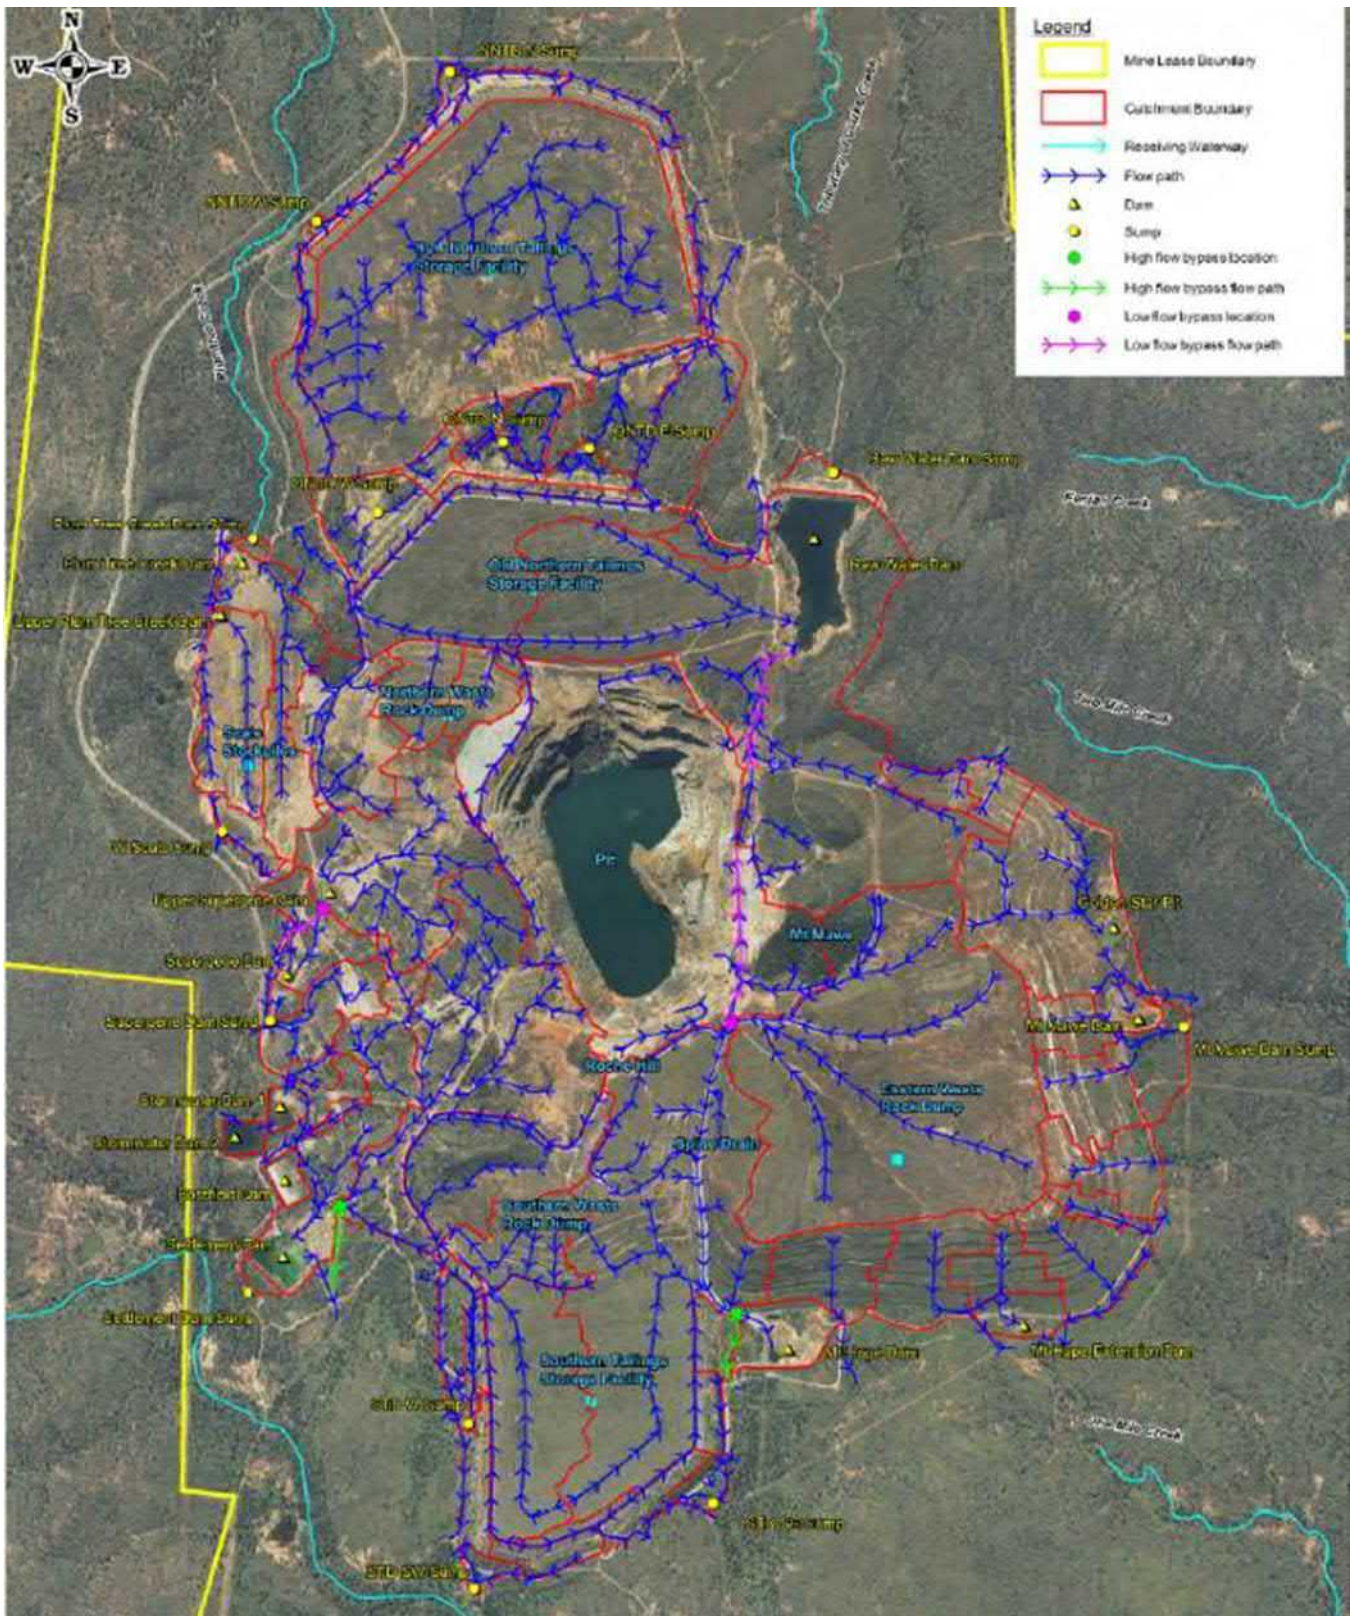
Figure 1.9: Current Catchments and Flow Paths

Figure 1.9 and Figure 1.10 shows the primary surface drainage paths within the mine disturbance area, catchment boundaries for the water containment dams, and flow paths that drain to the edge of the mine disturbance area.

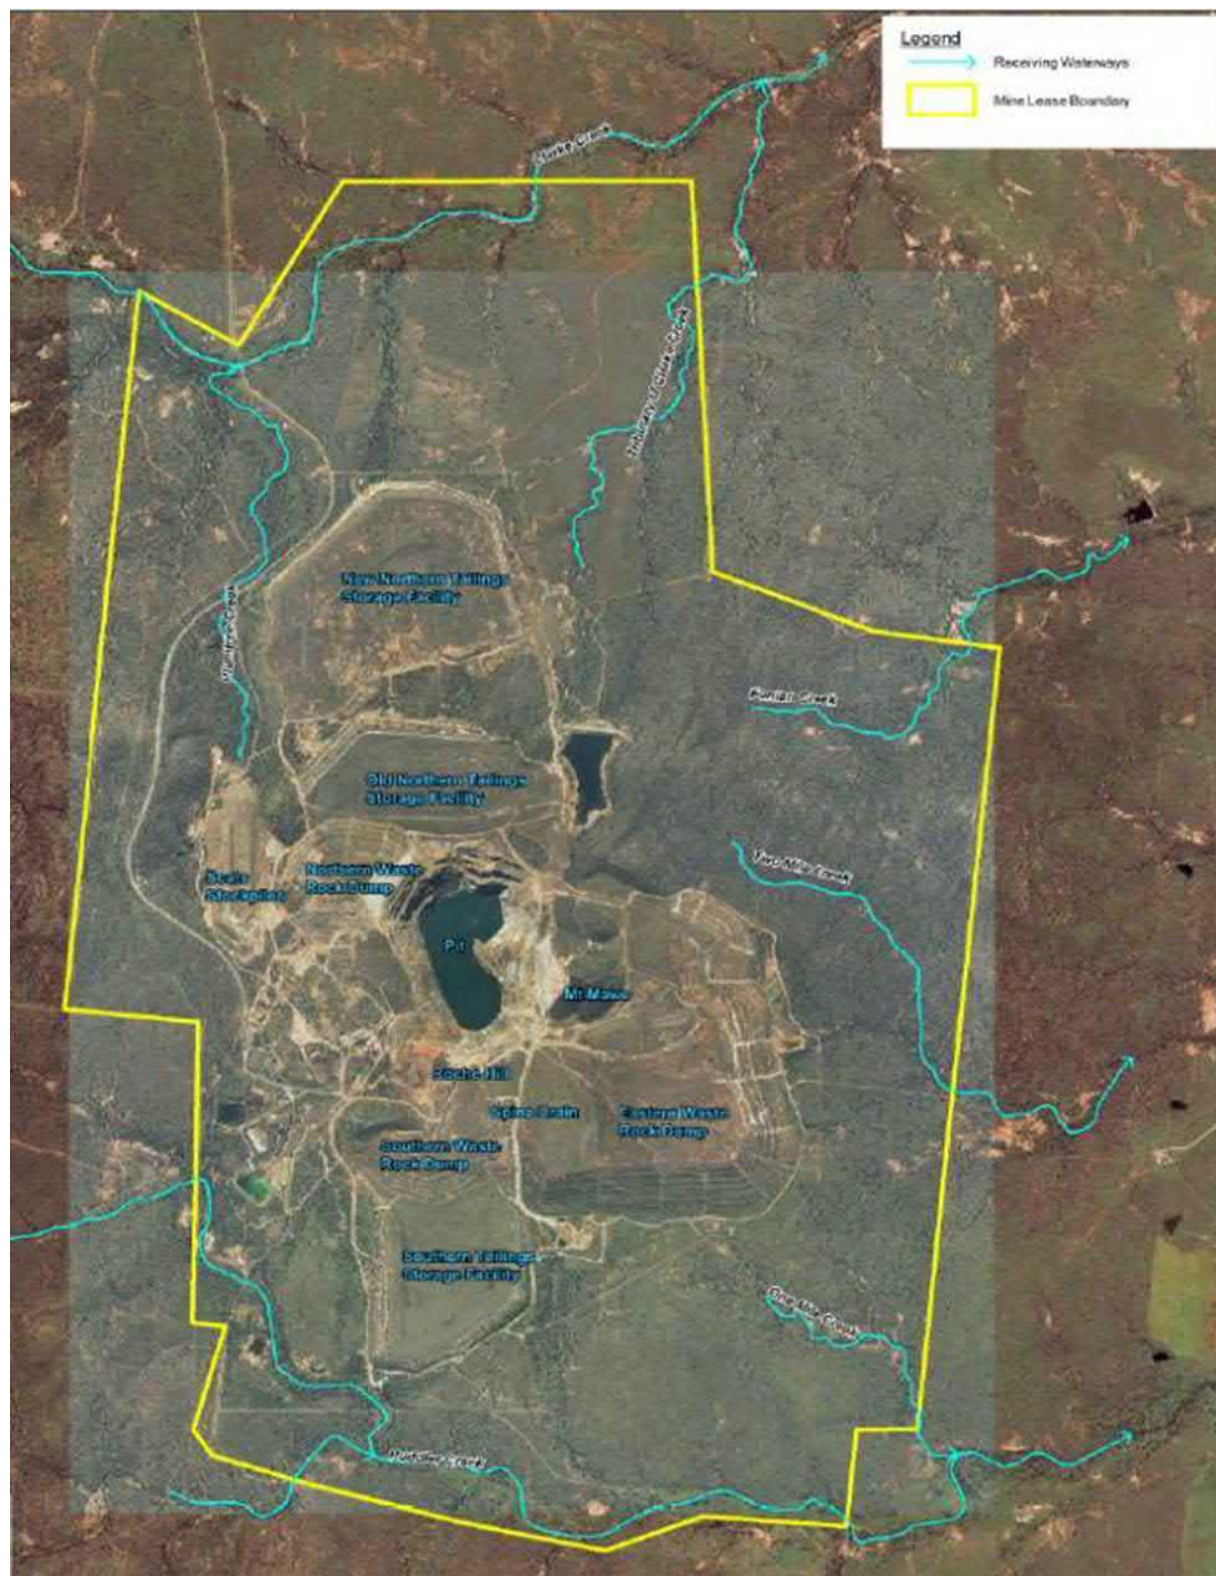
Ephemeral waterways between the edge of the mine disturbance area and the mine lease boundary are identified in Figure 1.11.

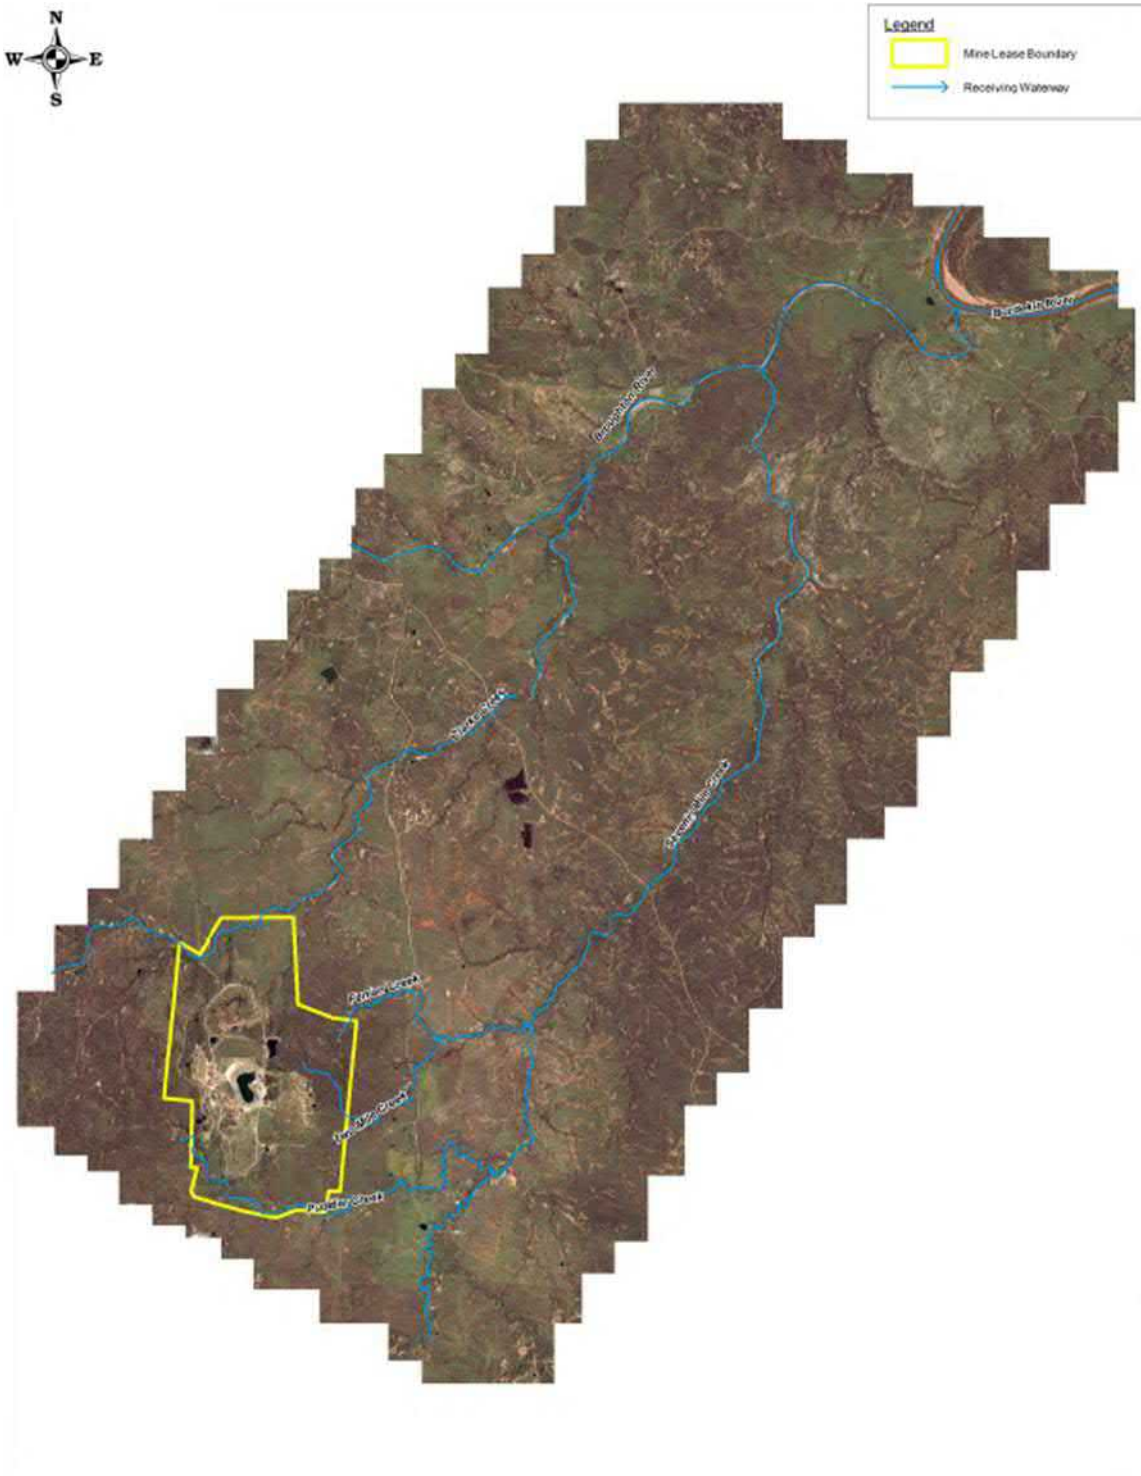
**Figure 1.12: Regional Receiving Waterways**

The receiving waterways downstream of the mine lease area are shown in Figure 1.12. All of the local receiving waterways eventually discharge into the Broughton River, which flows into the Burdekin River 25 km to the north-east of the mine site (straight line distance).

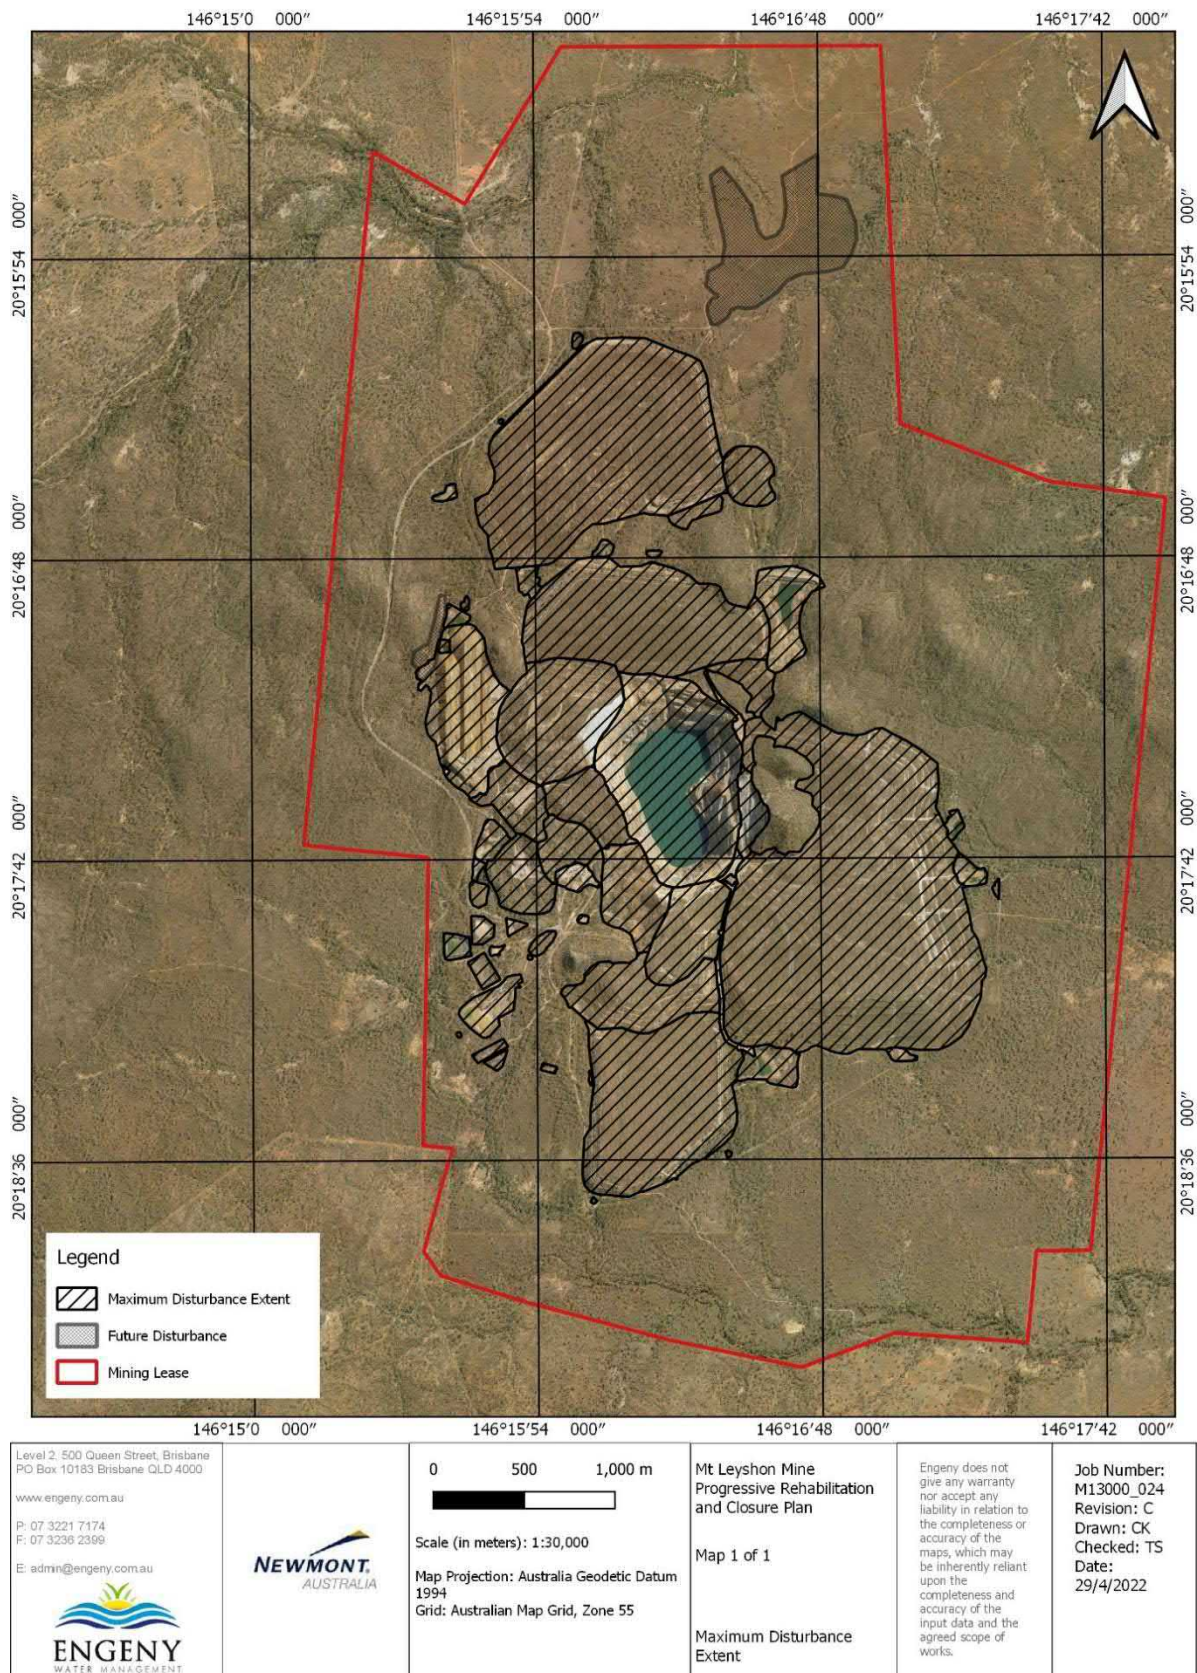
Figure 1.21: Maximum Disturbance Extent

The maximum disturbance extent from mining activities including the creation of future borrow pits for sourcing of rehabilitation materials is shown in Figure 1.21 below.

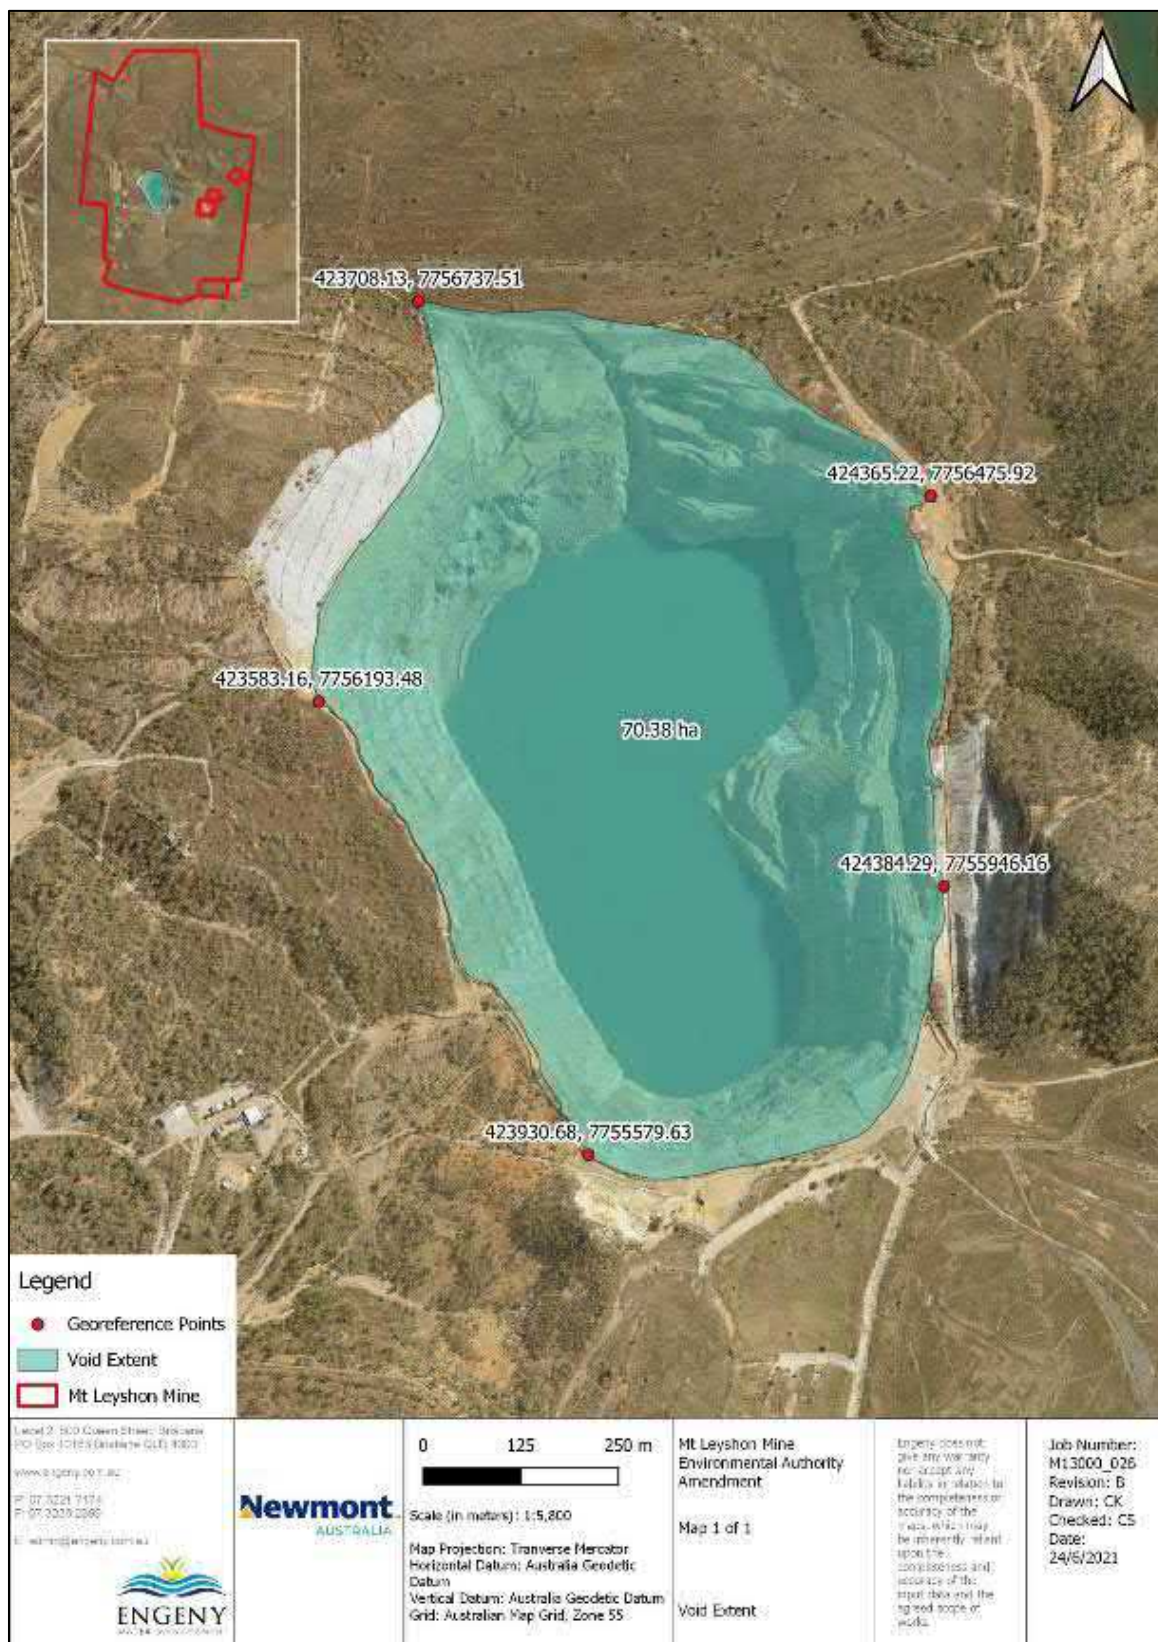
Figure 1.23: Extent of Pre Approved Non-Use Management Area

As displayed in Figure 1.23, the final void left by the open cut mine pit is situated in the center of the Mt Leyshon Mine within ML10144. It is approximately 210 m deep, has pit wall slope angles between 35 and 50 degrees, and has a storage capacity of approximately 63 GL' (Newmont, 2018; Engeny Water Management, 2020). The total surface area of the final void is 70.4 ha as per Schedule A – Table A1 in the EA.

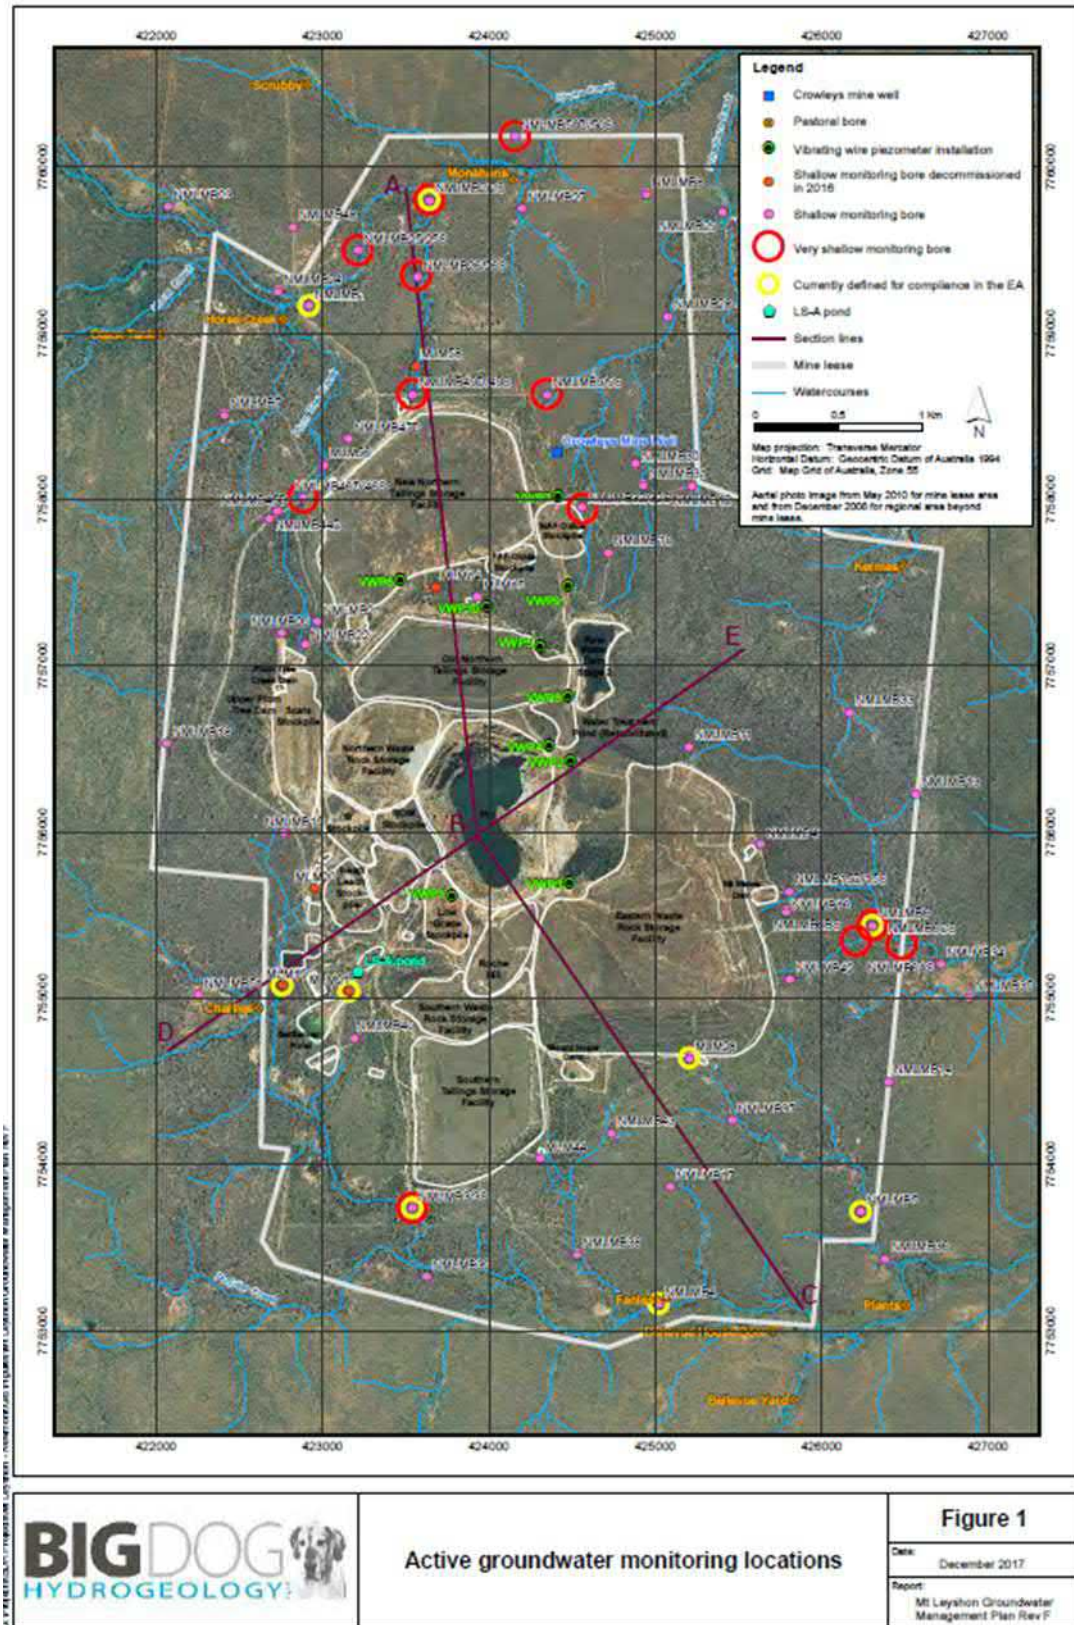
Figure 1.24: Groundwater Investigation Bores (Source: BDH, 2017a)

The locations of investigation bores are illustrated in Figure 1.24 and a groundwater elevations and flow direction shown in Figure 1.25.

A schematic hydrogeological section is provided in Figure 1.33 which has been constructed along line AC as marked in Figure 1.24. This identifies that:

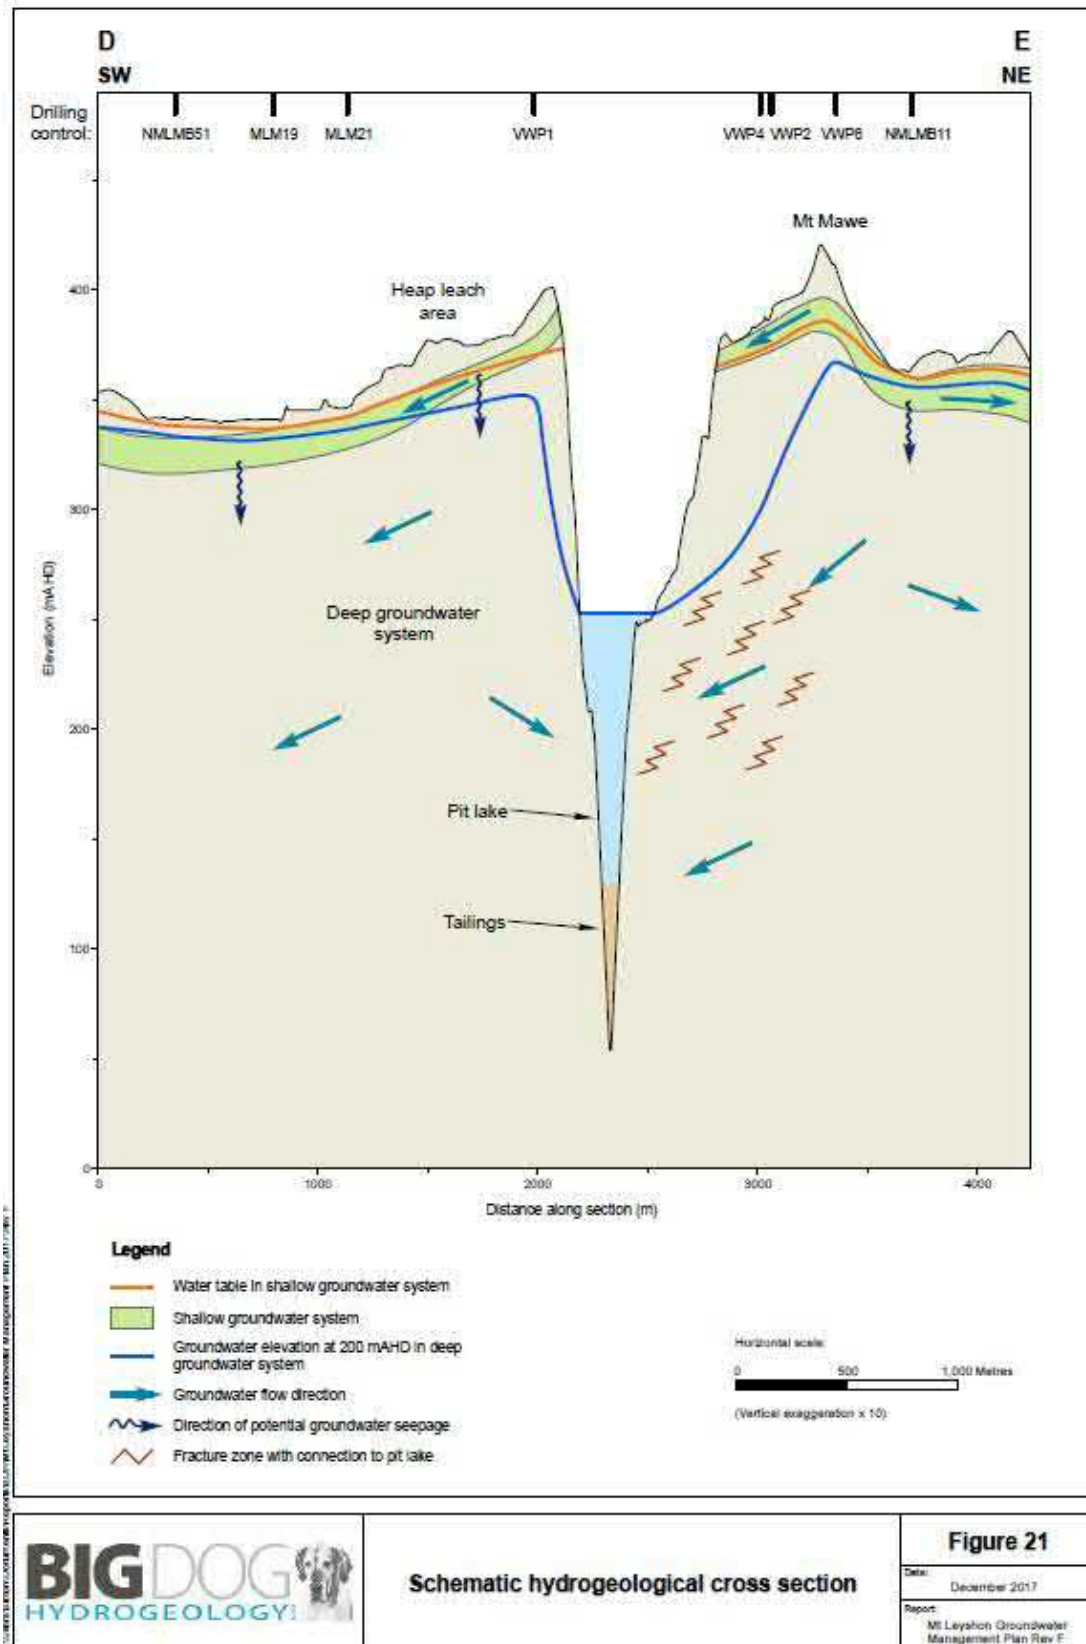
Figure 1.26: Schematic Hydrogeological Cross Section (Source: BDH, 2017a)

The deep groundwater system comprises fracture zones within the deep unweathered basement rocks, which include the breccias close to the open pit, and the surrounding dolerite and granite country rocks. The deep groundwater system typically occurs from 50 mBGL to 200 mBGL and is separated from the overlying shallow groundwater system by unfractured basement. Most of the basement rocks across the Mt Leyshon Mine have a low degree of fracturing (porosity) and limited presence of pore waters. Fracturing may be present in the basement rocks at depths of up to 200 m, but is limited to the area close to, and to the northeast of the final void. The available data indicate that there is little development of fracturing beyond about 1 km to 2 km from the final void, and the granite/dolerite country rocks in the surrounding area have limited fracturing. The deep groundwater system therefore is a localised discrete groundwater zone, which does not extend into the receiving environment beyond the lease boundary. Cross sections shown in Figure 1.24 conceptualising Mt Leyshon's groundwater system is shown in Figure 1.26 and Figure 1.27.

A schematic hydrogeological cross section through the pit void is shown in Figure 1.26.

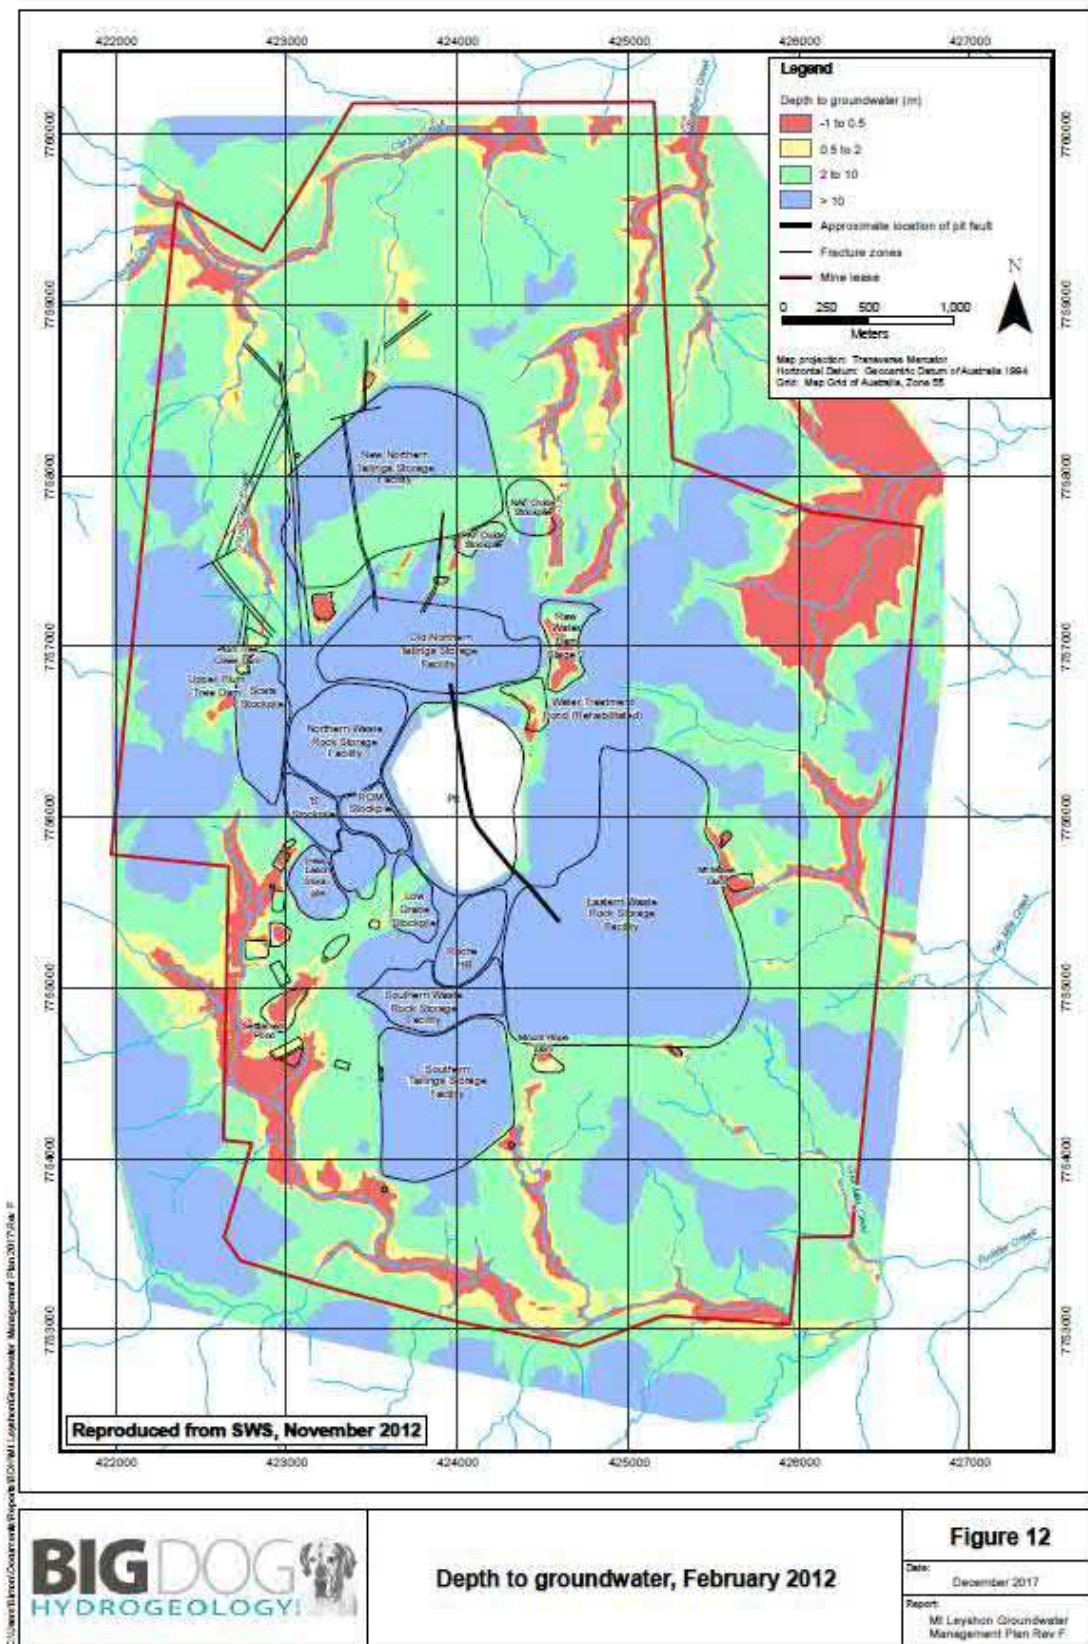
Figure 1.28: Depth to Groundwater (Source: BDH, 2017a)

Locations in the vicinity of the Mt Leyshon Mine where there is potential for groundwater discharge from the shallow groundwater system to occur are illustrated in Figure 1.28 which demonstrates zones where groundwater elevations approach the natural surface at the end of the wet season (areas shaded yellow and red).

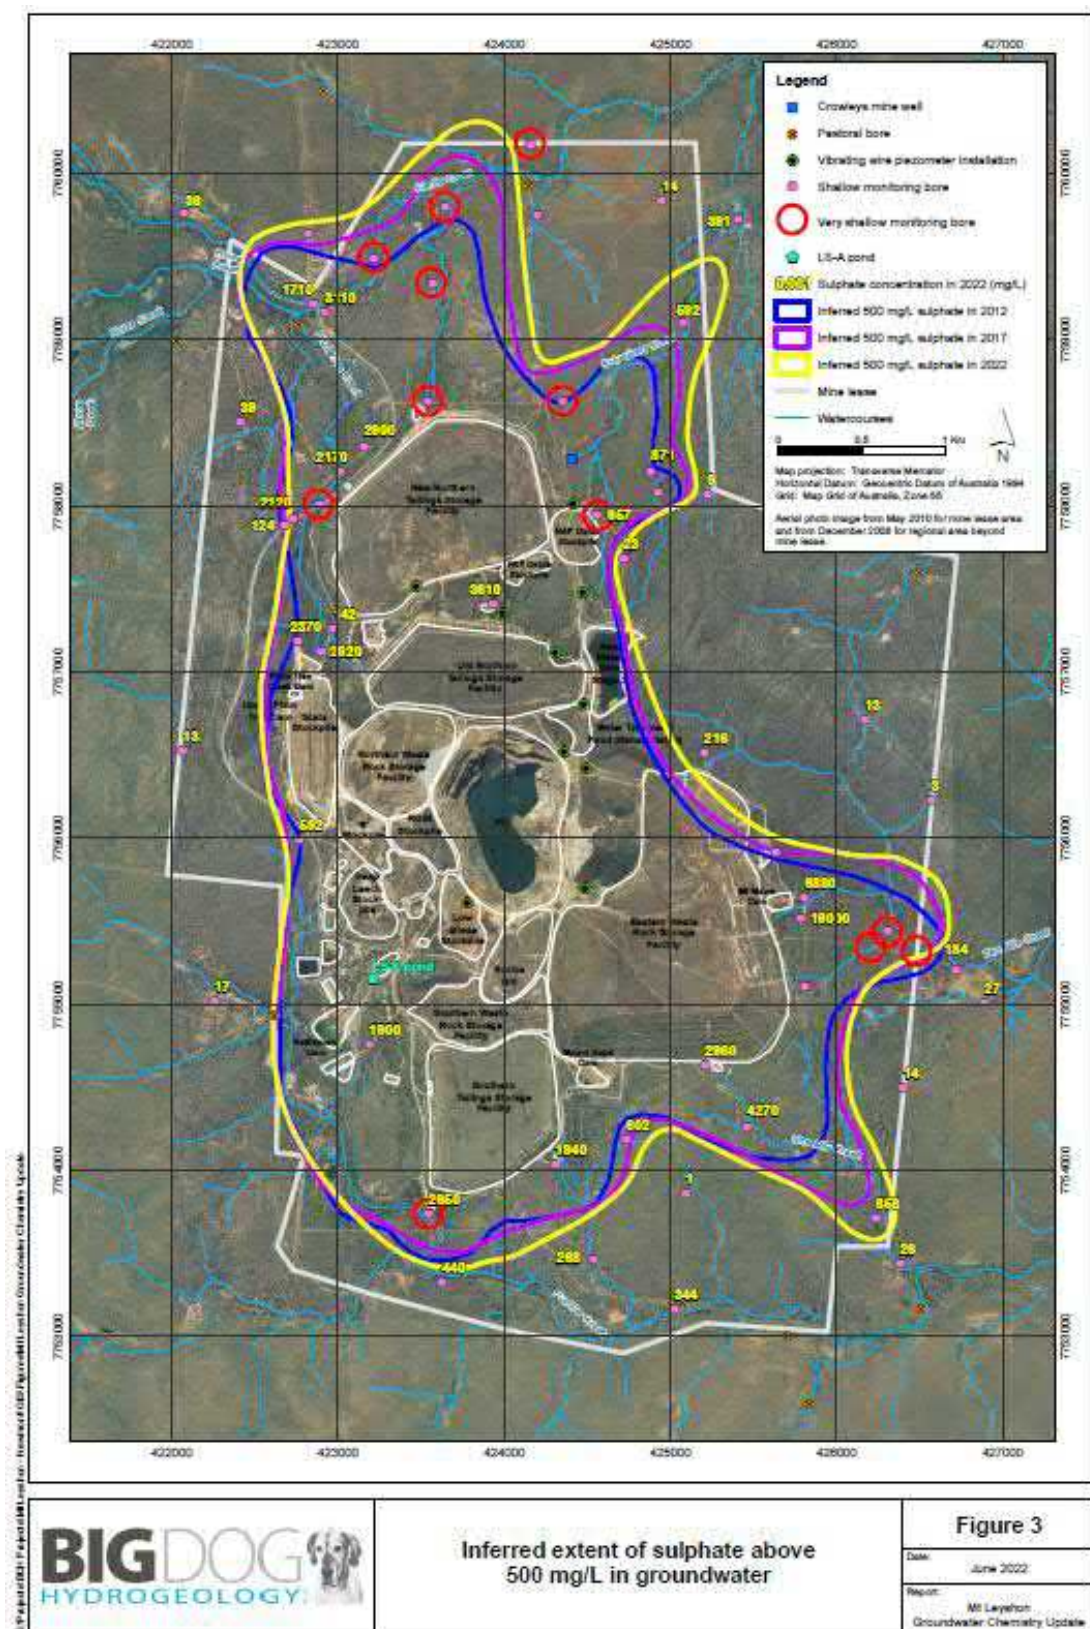
Figure 1.29: Inferred Extent of Sulphate Above 500 mg/L in Groundwater

The Groundwater Management Plan (BDH, 2017a) presented contours defining the extent of groundwater containing more than 500 mg/L and 1,000 mg/L sulphate in the shallow groundwater system (the ANZECC Water Quality Guidelines trigger value for sulphate for adverse health effects for livestock drinking water is 1,000 mg/L). These contours were interpreted from a site wide groundwater sampling snapshot conducted in 2012. Similar site wide groundwater sampling undertaken in June 2017 and in April 2022 have been interpreted in the same manner to generate updated contours. Figure 1.29 and Figure 1.30 illustrate that between 2012 and 2022, there have been only minor changes in the extent of sulphate in groundwater, consistent with previous groundwater model predictions that sulphate concentrations in most locations are approaching equilibrium (BDH, 2017a). At NMLMB26 to the north of the NNTSF, sulphate concentrations decreased in 2017 and increased in 2022 compared to 2012, which results from the influences of recharge pulses and seepage pulses originating in the operating period. Locations where the extent of sulphate has increased by a small amount from 2012 to 2022 are:
