## Progressive Rehabilitation and Closure Plan

**Mt Leyshon Mine**

M13000\_024-REP-001-2

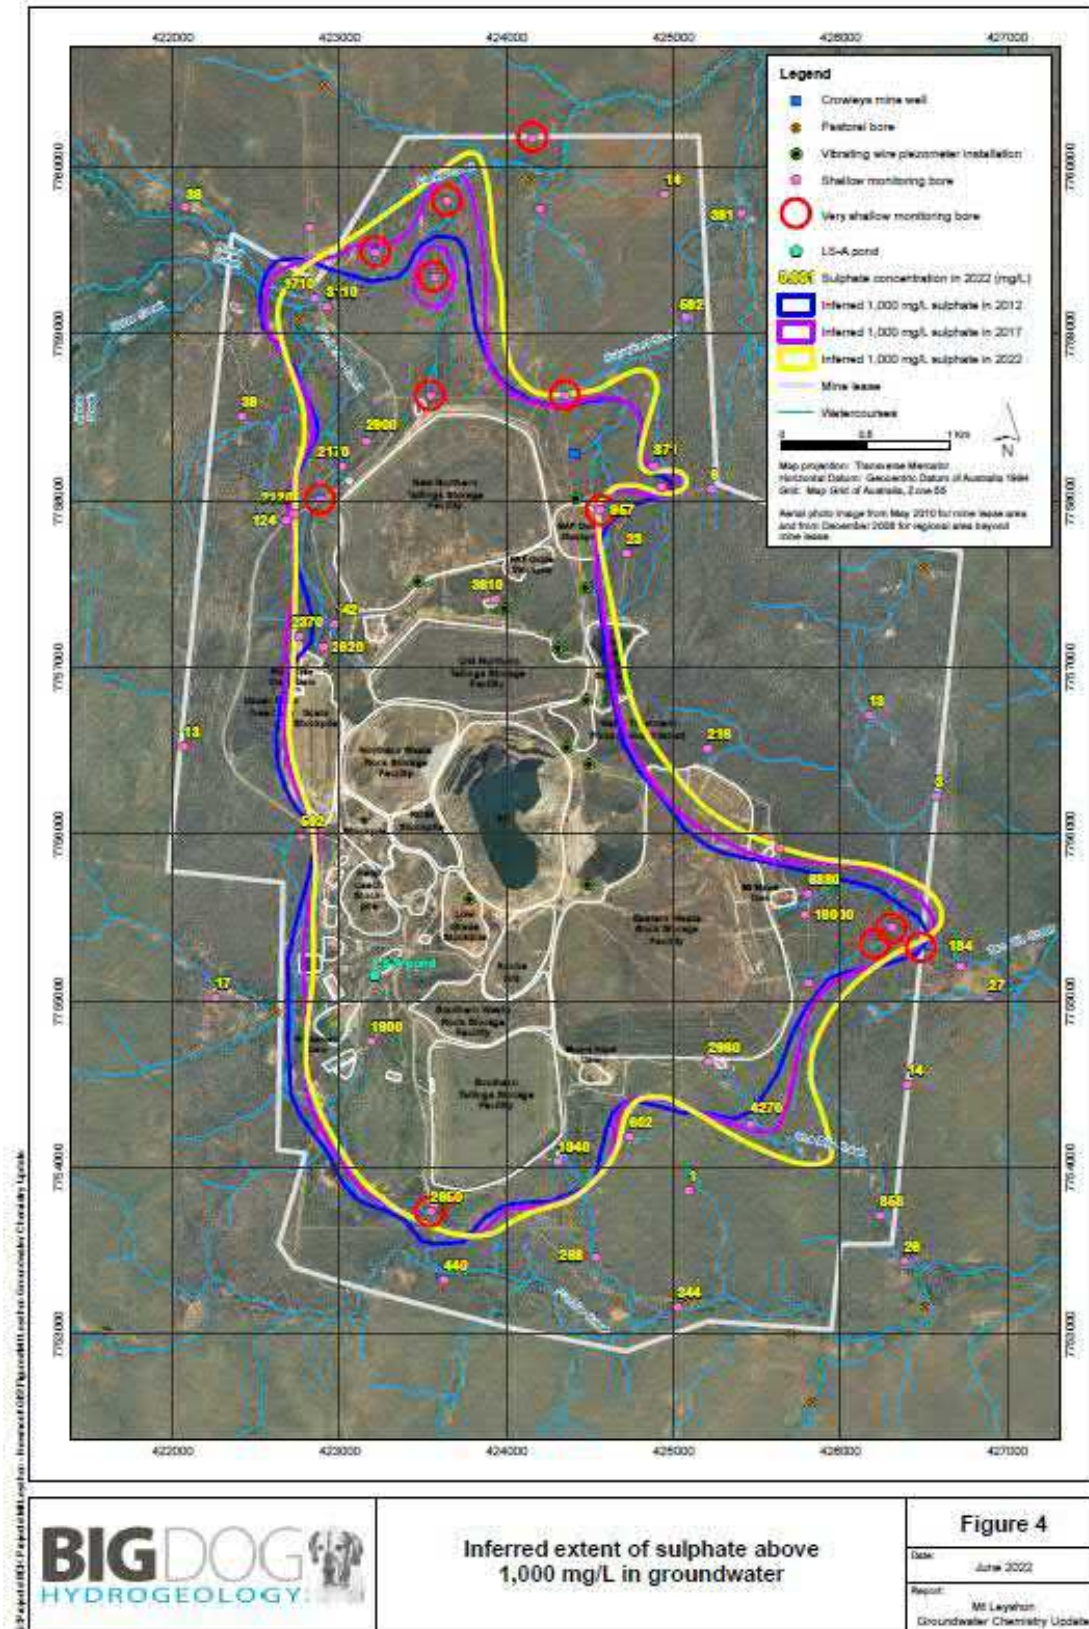
Figure 1.30: Inferred Extent of Sulphate Above 1,000 mg/L in Groundwater

The Groundwater Management Plan (BDH, 2017a) presented contours defining the extent of groundwater containing more than 500 mg/L and 1,000 mg/L sulphate in the shallow groundwater system (the ANZECC Water Quality Guidelines trigger value for sulphate for adverse health effects for livestock drinking water is 1,000 mg/L). These contours were interpreted from a site wide groundwater sampling snapshot conducted in 2012. Similar site wide groundwater sampling undertaken in June 2017 and in April 2022 have been interpreted in the same manner to generate updated contours. Figure 1.29 and Figure 1.30 illustrate that between 2012 and 2022, there have been only minor changes in the extent of sulphate in groundwater, consistent with previous groundwater model predictions that sulphate concentrations in most locations are approaching equilibrium (BDH, 2017a). At NMLMB26 to the north of the NNTSF, sulphate concentrations decreased in 2017 and increased in 2022 compared to 2012, which results from the influences of recharge pulses and seepage pulses originating in the operating period. Locations where the extent of sulphate has increased by a small amount from 2012 to 2022 are:

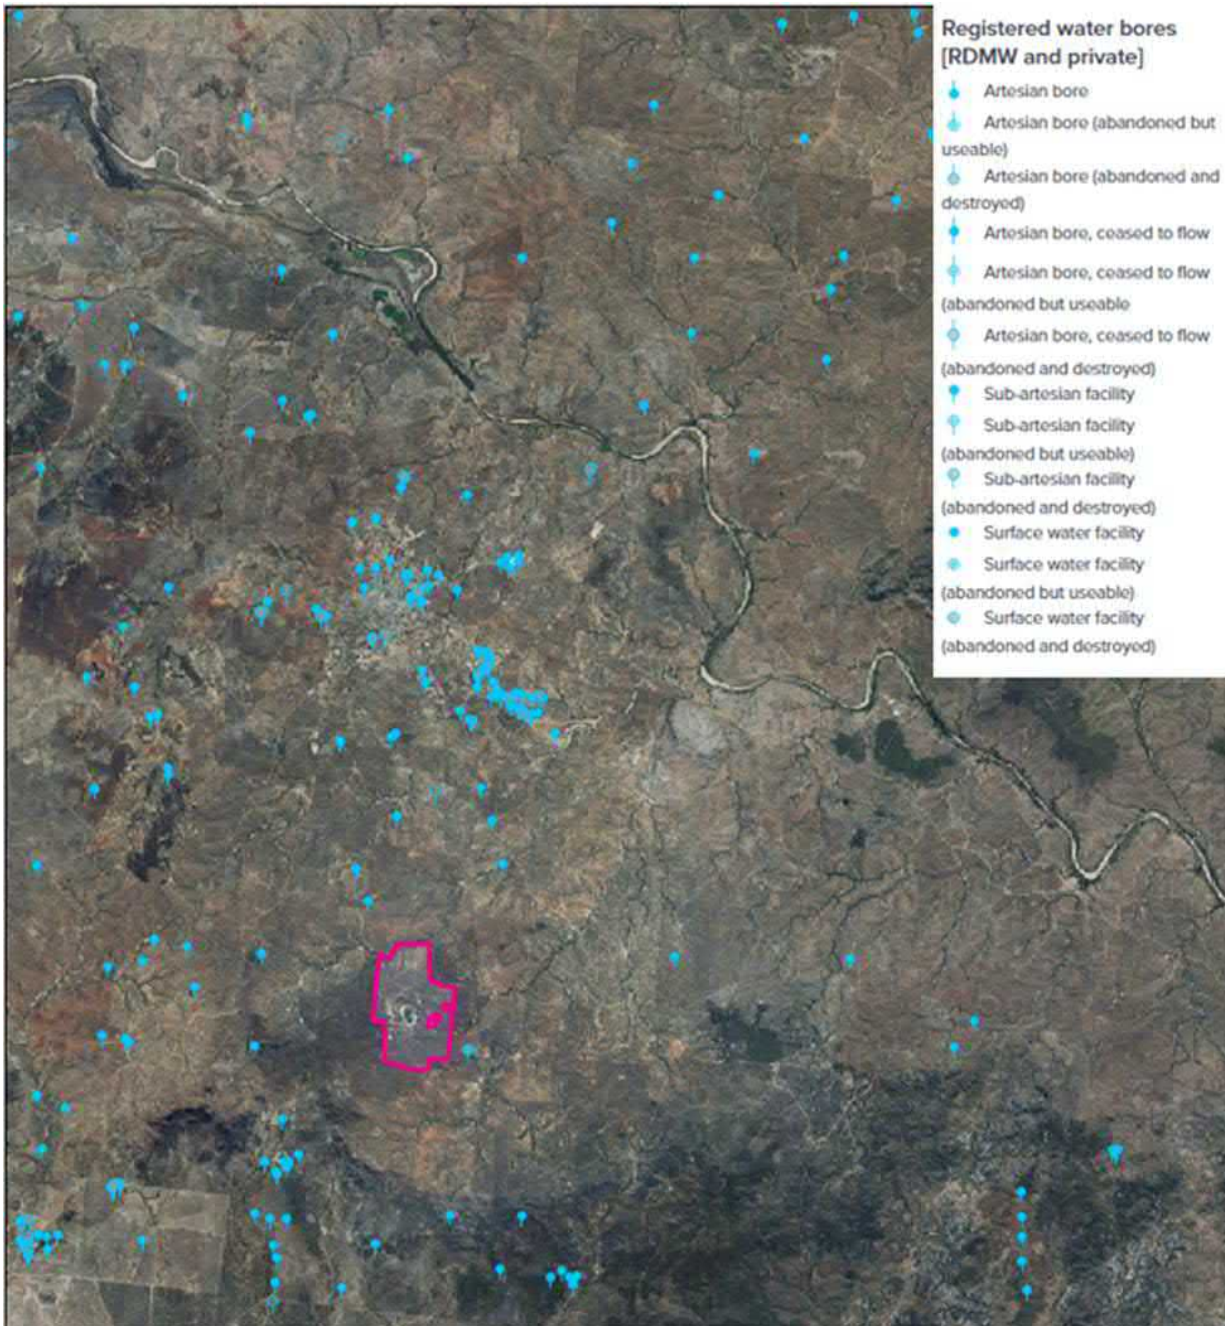
**Figure 1.31: Registered Water Bores (Source: Queensland Globe)**

On a regional basis groundwater flow within the shallow groundwater systems is from the mine leases to the northeast, eventually reaching the Burdekin River 30 km distant. There are three registered bores (Qld Government, 2021) intersecting the shallow groundwater system along potential flowpaths between the mine and the Burdekin River, located between 5 km and 25 km from the mine (refer Figure 1.31). These bores have not been investigated, but the likely use of groundwater in the region is for stock watering.

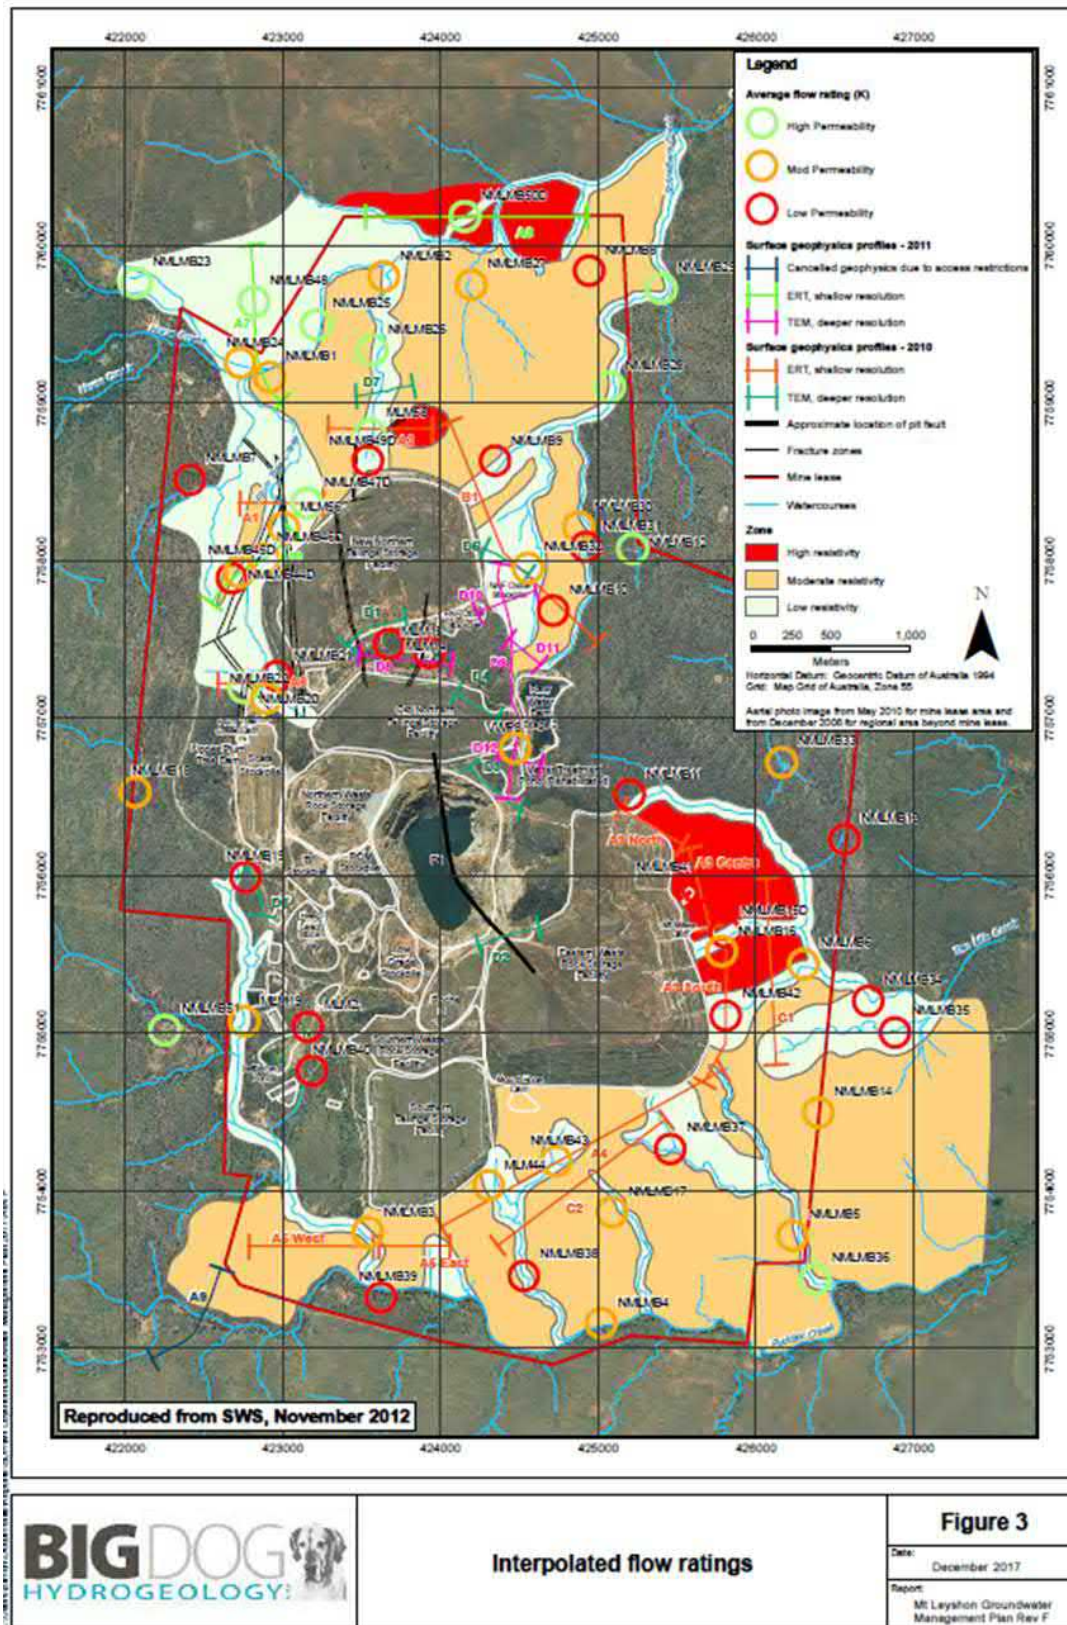
Figure 1.32: Interpolated Flow Rating (BDH, 2017a)

In order to develop a regional interpretation for the variation in groundwater flow characteristics for the shallow groundwater system across the Mt Leyshon mine, the individual bore classifications were subsequently interpolated using the results of the ERT profiles running past each of the bores. The resulting generalised interpretation of potential groundwater flow zones is presented in Figure 1.32. The interpretation suggests that higher groundwater transmission zones are mostly restricted to the current surface water drainages in the south and east of the site but become more extensive close to Clarke Creek in the north of the site.

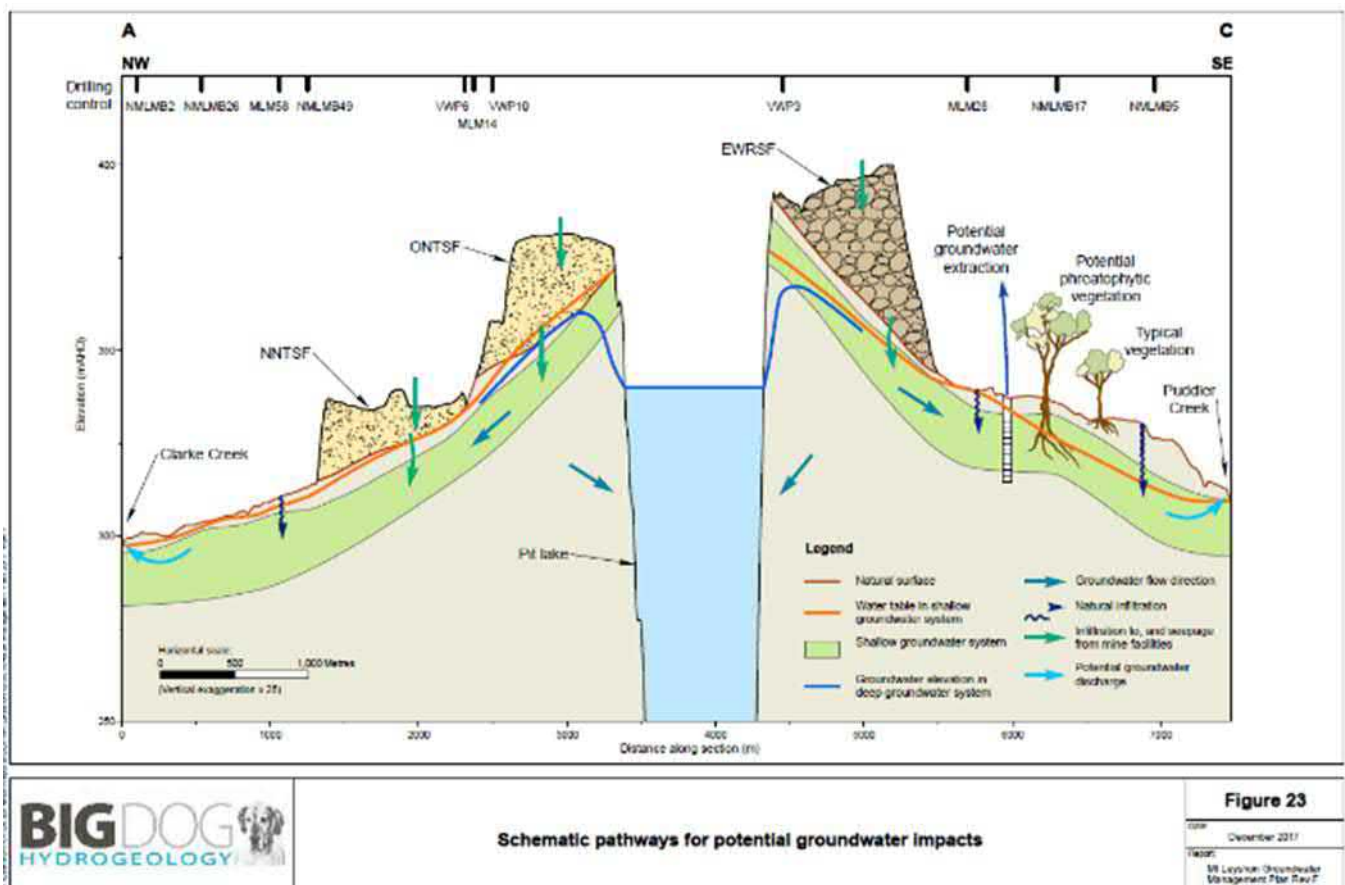
Figure 1.33: Schematic Pathways for Potential Groundwater Impacts (BDH, 2017a)

A schematic hydrogeological section is provided in Figure 1.33 which has been constructed along line AC as marked in Figure 1.24. This identifies that:

2. Groundwater flow in the shallow groundwater system is radially away from the open pit, driven by natural infiltration and facility seepage in the elevated portions of the site.

3. Groundwater elevations approach surface at Clarke Creek and at Puddler Creek, and groundwater discharge into the surface water system may occur in some conditions.

4. The primary influence of the rehabilitated mine facilities on shallow groundwater conditions is identified to be changes in hydrochemistry associated with remnant seepage which occurred in the operating period, and ongoing seepage driven by reduced rates of infiltration through the facility covers, and potential influences on the receiving groundwater and surface water environments.

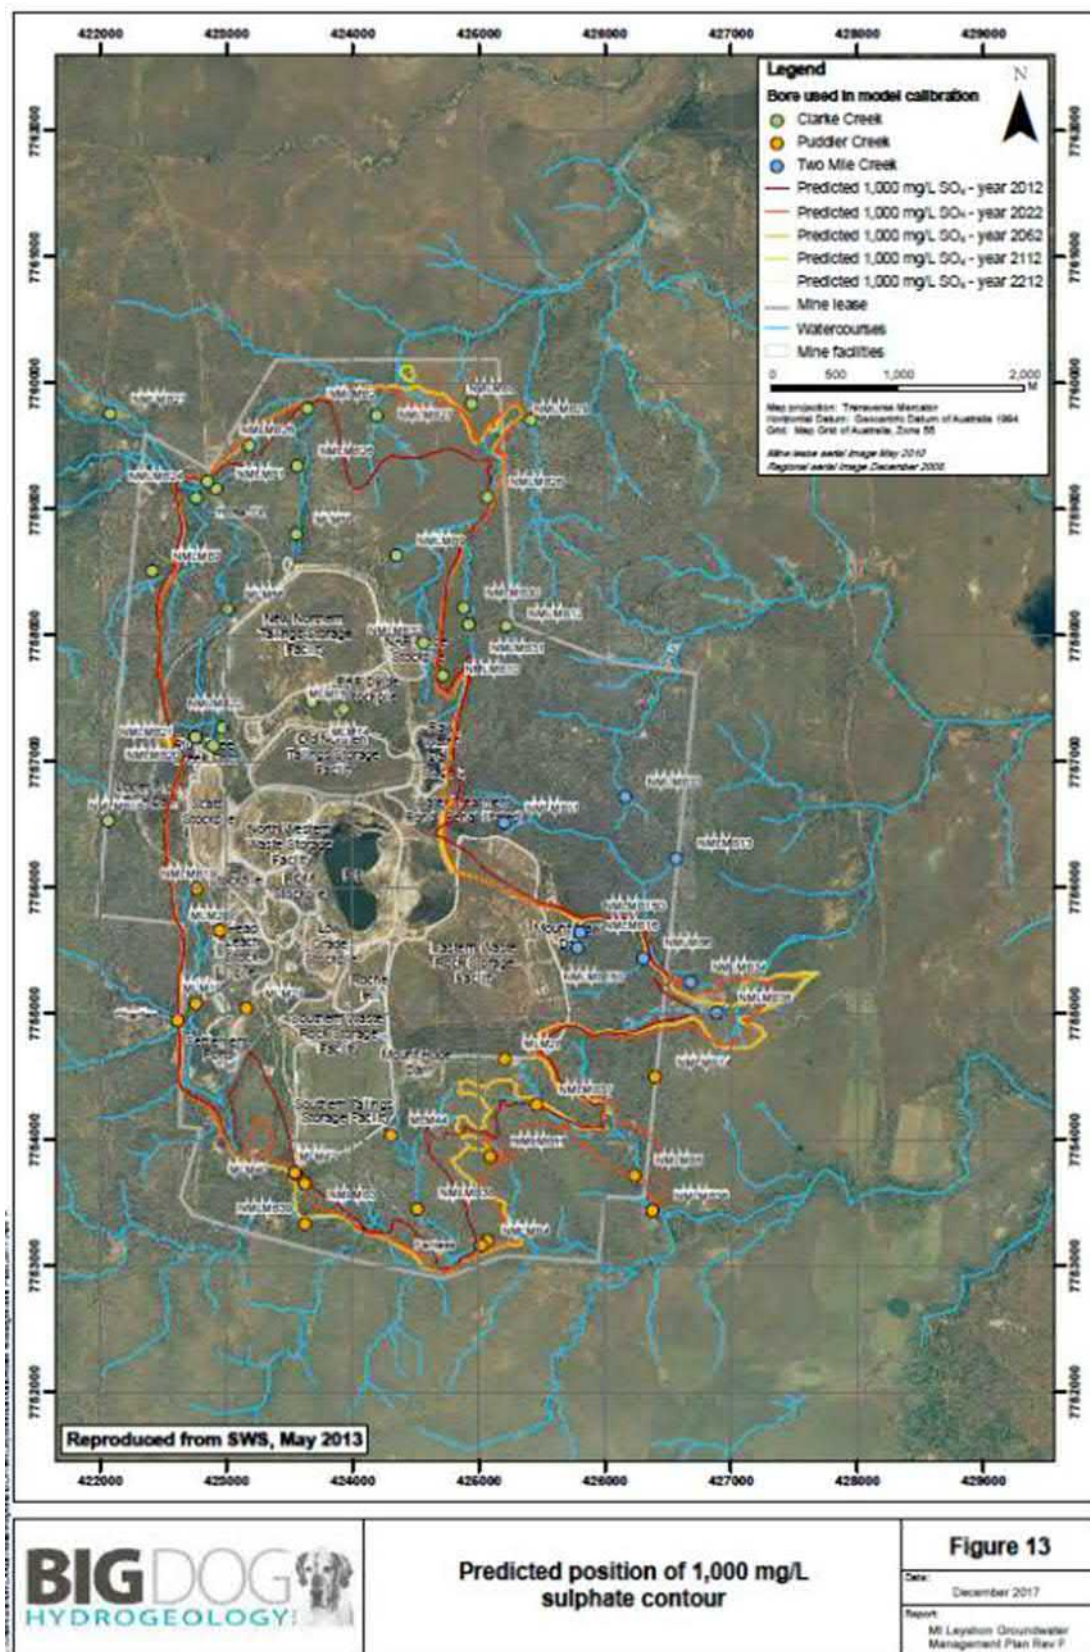
Figure 1.34: Predicted Future Position of 1,000mg/L Sulphate Contour (BDH, 2017a)

- These calibration parameters resulted in a good fit to the average groundwater elevations and sulphate concentrations in the receiving groundwater system from 1989 to 2012. A key outcome from the model predictions was that if the facility covers continued to perform at the same average level assumed in the model, under average rainfall conditions the maximum future extent of sulphate concentration was unlikely to change a great deal from the extent observed in 2012 (refer Figure 1.34). In two areas (to the north-east and south-east) continued migration away from the facilities was predicted, resulting in an additional extent of around 1 km to 2 km in the very long term (200 year timeframe) in these locations (refer Figure 1.34). The maximum extent of sulphate in groundwater was concluded to be within Newmont controlled land.

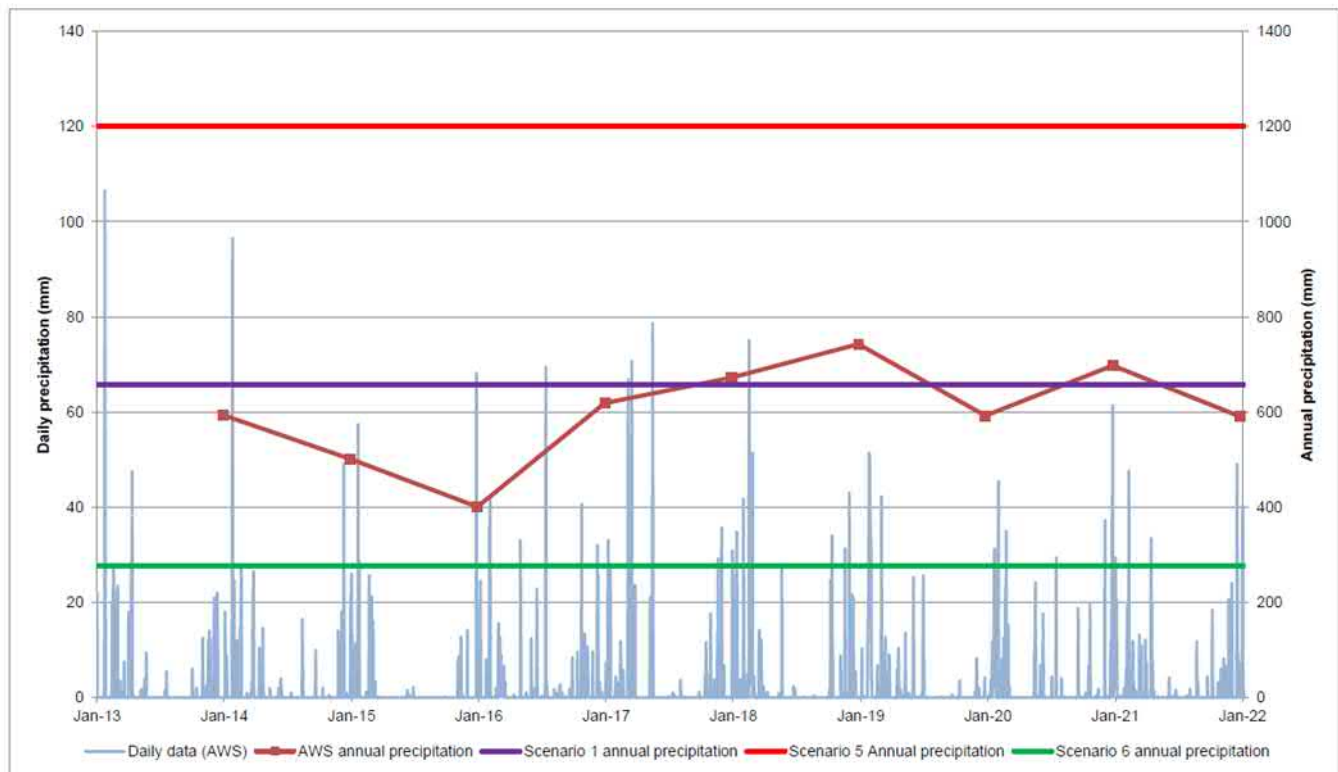
**Figure 1.35: Precipitation Conditions at Mt Leyshon Mine since 2012 (BDH, 2022)**

The numerical groundwater model provided predictions of future groundwater chemistry under a range of scenarios, including different precipitation conditions. Scenario 1 corresponded to the facility covers continuing to perform at the same level, the sulphate concentration of seepage from the facilities remaining constant at 5,000 mg/L, and average precipitation conditions (658 mm/year). Scenario 5 adopted the same facility assumptions under wet conditions (1,200 mm/year), while Scenario 6 adopted the same facility assumptions under dry conditions (277 mm/year). Figure 1.35 illustrates precipitation conditions at Mt Leyshon Mine since 2012 as measured at the Automated Weather Station (AWS) located in the middle of the mine. In the period 2013 to 2022, actual precipitation has been between the values assumed in Scenarios 1 and 6 and has clearly been closest to the average conditions in Scenario 1.

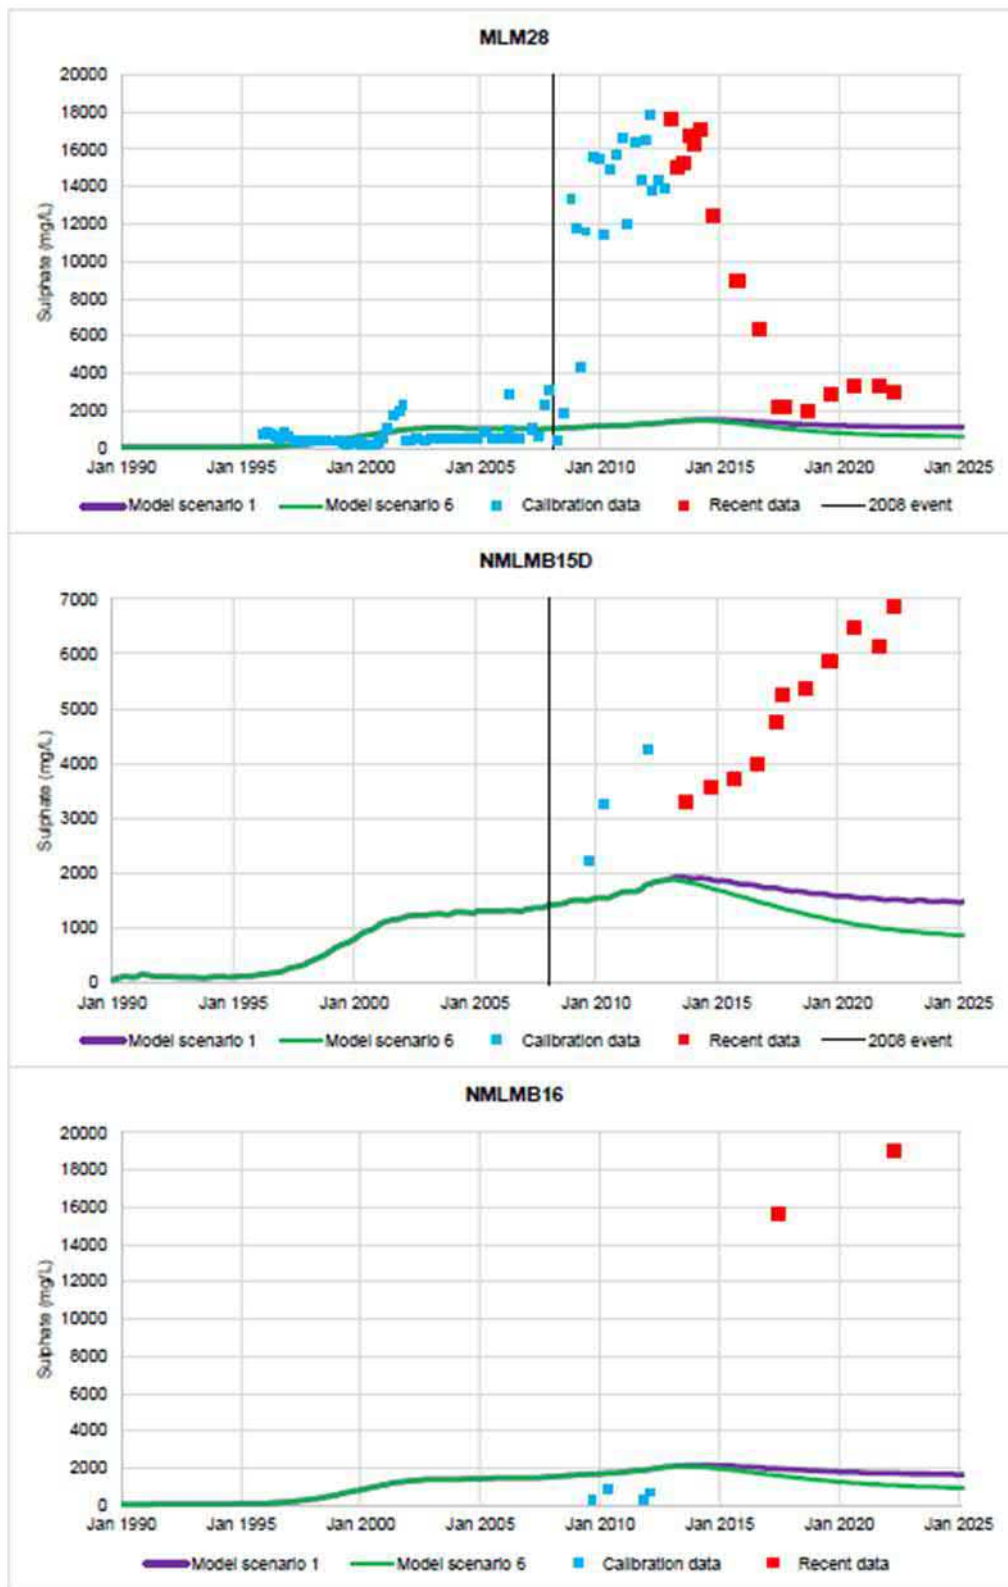
Figure 1.37: Locations of Seepage Pulse Responses after 2012 (BDH, 2022)

As with the calibration model results, the model predictions are based on regional average conditions, and there will be locations or periods where localised effects cause the actual sulphate trends to depart from those modelled. Figure 1.37 provides examples of locations where sulphate concentrations have been significantly higher than predicted by the model. MLM28 is located at the toe of the EWRSF. Following a very large precipitation event on 15 January 2008, groundwater sulphate concentrations in this location rose from 1,500 mg/L to 15,000 mg/L over a seven month period. The groundwater chemistry changes are interpreted to reflect a localised pulse of seepage emanating from the EWRSF. The updated monitoring data illustrate that this pulse decayed from 2012 to 2017 with groundwater sulphate concentrations returning to close to the modelled value. These responses at MLM28 illustrate that the model correctly reflects the long term average conditions but may not replicate localised or short term trends resulting from local effects.

The other locations where observed sulphate concentrations depart most significantly from the model predictions are at NMLMB15D and NMLMB16 plotted in Figure 1.37. These bores are located downgradient of the EWRSF and are in locations similar to MLM28. The increasing sulphate concentrations at these locations likely reflect the same seepage pulse from the EWRSF which occurred in 2008. As a result of the bores being 100 m to 200 m from the EWRSF, and due to the low sulphate migration velocity within the shallow groundwater system, it has taken several years for the sulphate concentrations to rise, but as demonstrated at MLM28, in the long term the concentrations are expected to reduce, and the observed values will return to the modelled average trends.

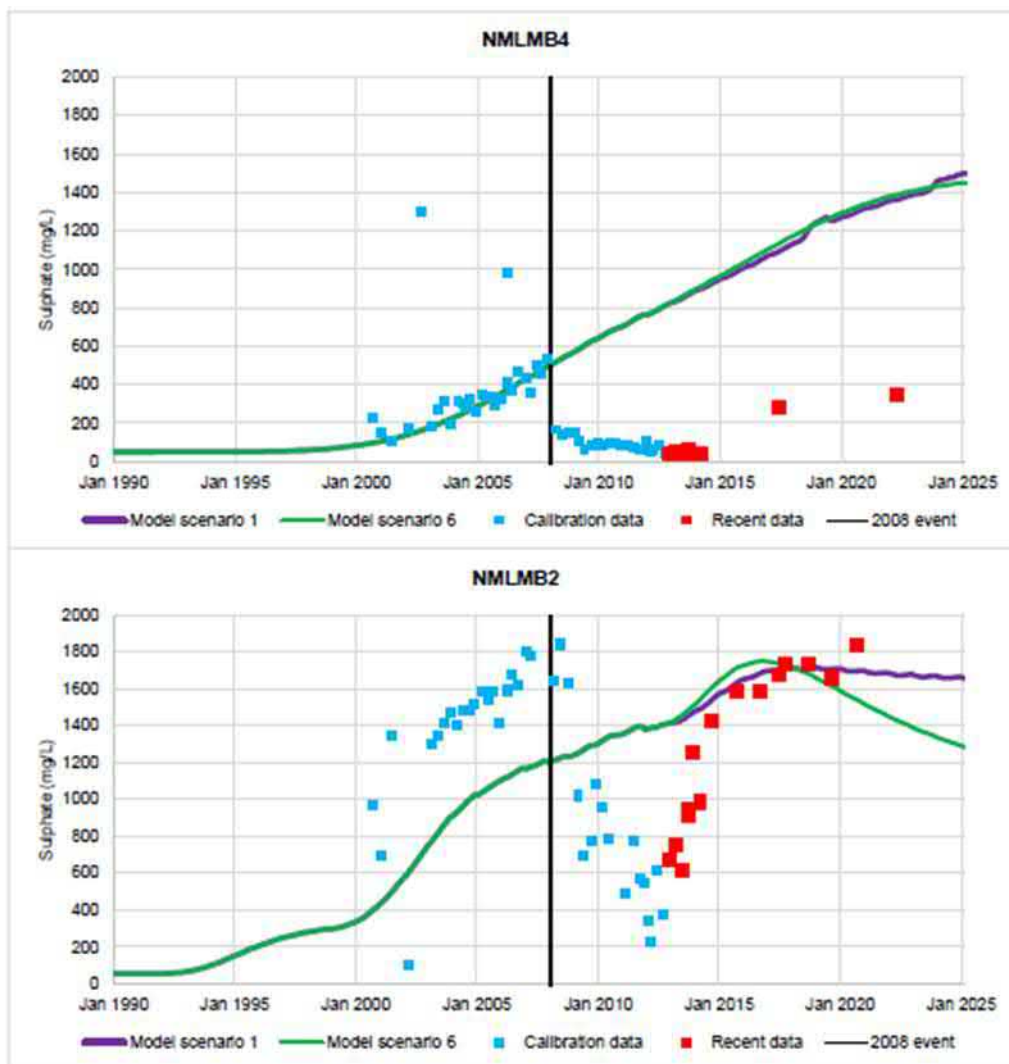
**Figure 1.38: Locations of Recharge Responses after 2012 (BDH, 2022)**

Figure 1.38 illustrates two bores where sulphate concentrations have been significantly lower than predicted by the model. NMLMB2 is located close to Clarke Creek while NMLMB4 is located close to Puddler Creek. Following the large precipitation event in 2008, both these bores showed a significant decrease in sulphate concentrations, which lasted for several years before concentrations started to recover towards the model predicted values. In each case this response is attributed to localised high rates of natural recharge associated with flooding in the precipitation event. While the model does not replicate the specific effects of this individual event at these bores, the long term average trends in the observed data provide a good match to the model indicating the average recharge rate applied in the model is appropriate.

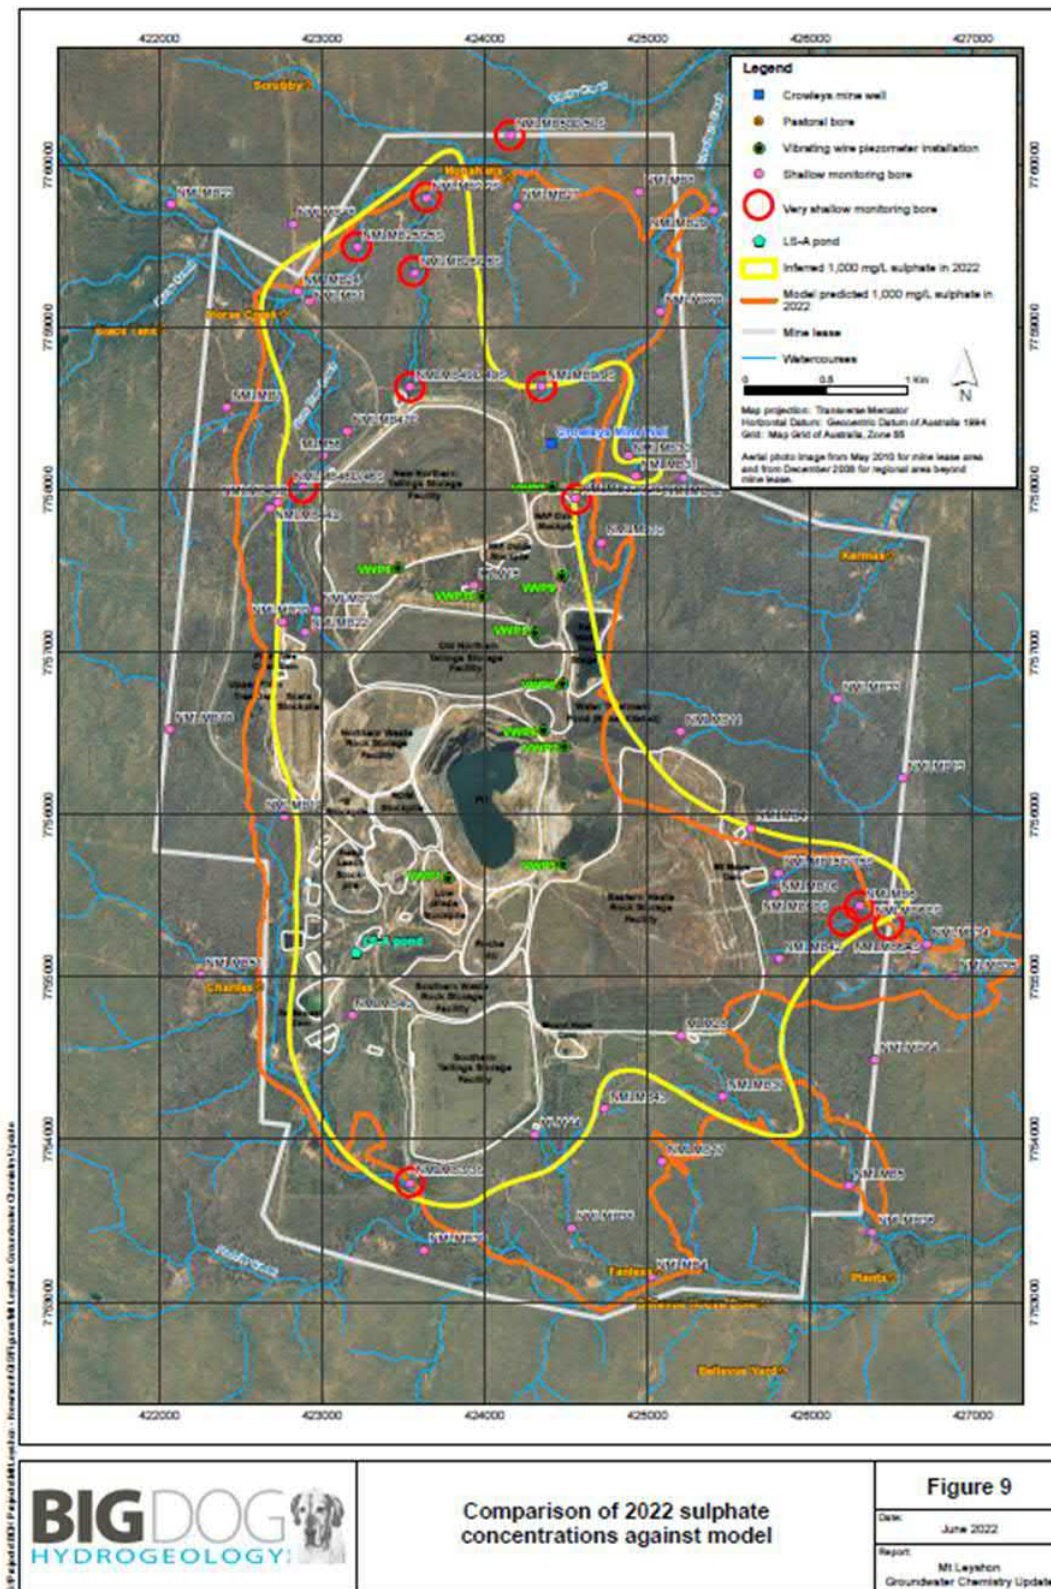
Figure 1.39: Comparison of Actual 2022 1,000 mg/L Sulphate Extent Against Groundwater Model Prediction (BDH, 2022)

The Groundwater Management Plan (BDH, 2017a) presented contours for the model predicted position of the 1,000 mg/L sulphate contour for prediction year 2022. Figure 1.39 compares the actual sulphate extent in 2022 with the model predicted extent in 2022 under the base case model assumptions. The observed data confirm that the general shapes and locations of the model contours are consistent with the actual distributions, and also that the model is highly conservative, in that to the north-east and south-east, the model predicts significantly more sulphate migration in 2022 than has been observed. The over prediction of the current sulphate extent may result from the model assumed seepage infiltration rates reflecting both operating and covered conditions, while the observed responses are now more driven by the closed conditions.

The results of the most recent groundwater model validation indicate that the predicted future extent of sulphate migration away from the closed mine facilities is likely to be less than originally predicted in the two areas where the greatest future migration was predicted (i.e., to the north-east and south-east). This further confirms the previous conclusions from the groundwater modelling that the maximum future extent of sulphate concentration is unlikely to change a great deal from the extent currently observed.

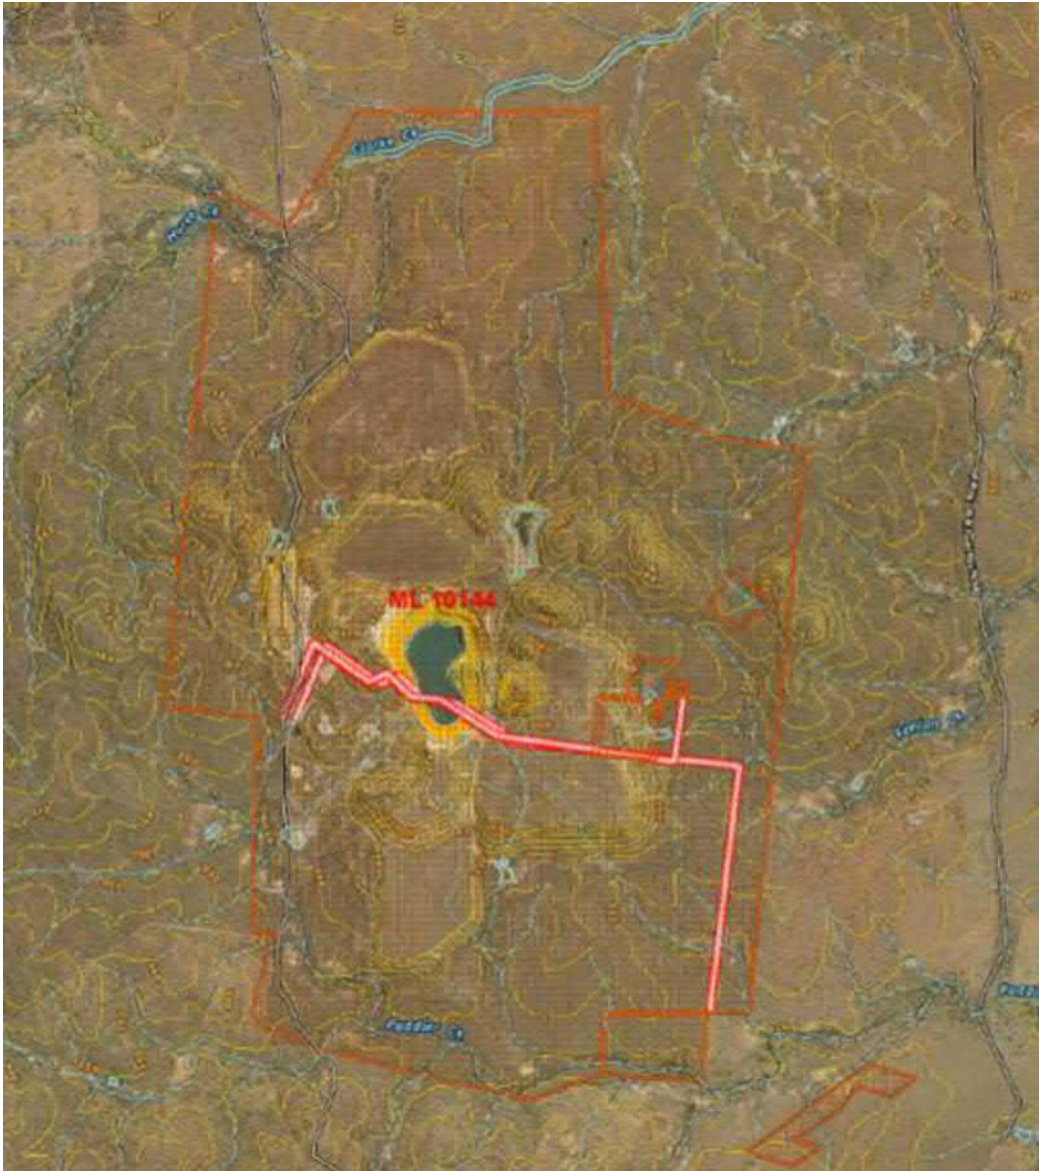
**Figure 1.40: Topography and Surface Drainage Features in Vicinity of Mt Leyshon Mine (Source: Queensland Globe)**

The Mt Leyshon Mine is located on the topographic divide between the Clarke Creek (north) and Puddler Creek (south) drainage systems (refer Figure 1.40). Clarke Creek is a 4<sup>th</sup> order drainage system that flows in an easterly direction along the northern boundary of the mining lease, with the headwaters of the catchment originating approximately 9 km to the west of the mining lease. Puddler Creek is a 3<sup>rd</sup> order drainage system that flows in an easterly direction along the southern boundary of the mining lease, with the headwaters of the catchment originating approximately 4 km to the west of the mining lease.

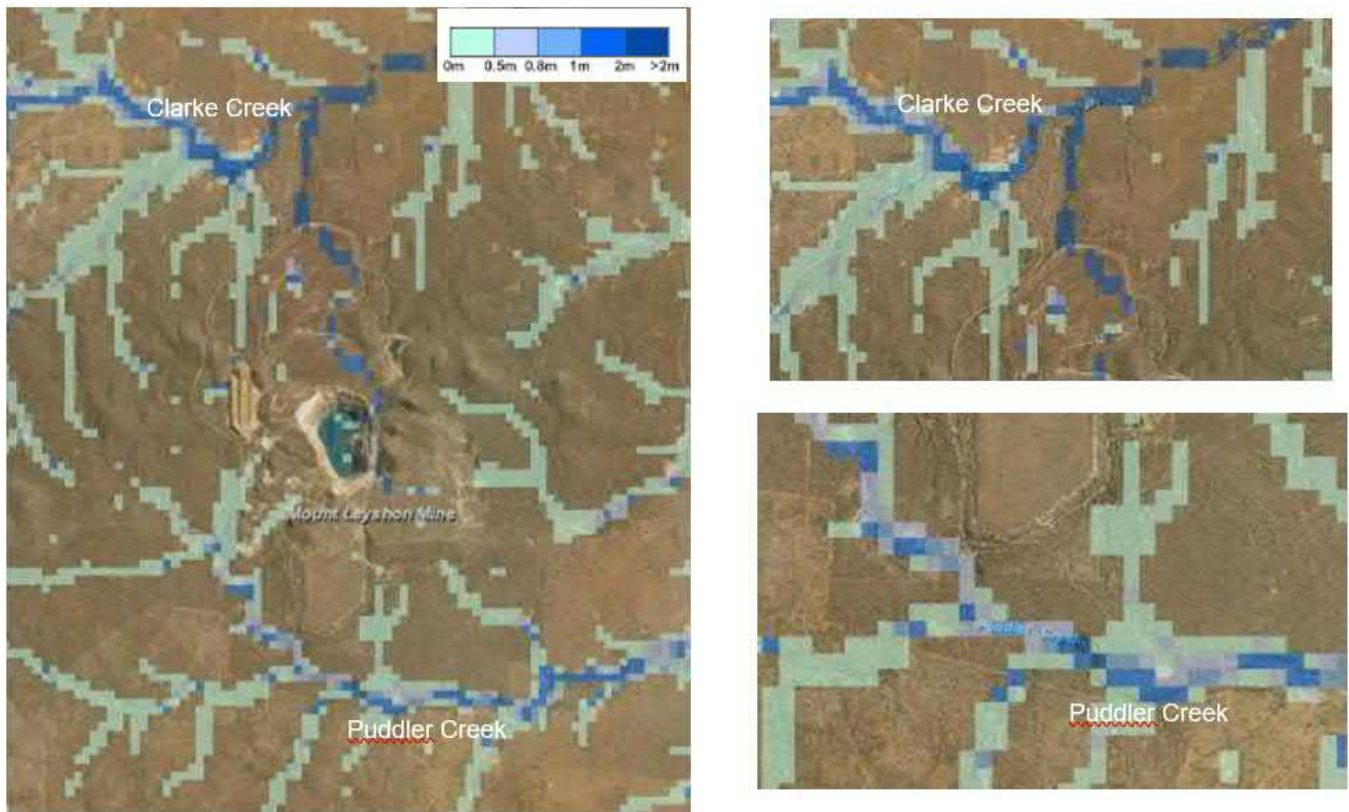
**Figure 1.41: 1% AEP Basin Level Flood Modelling in Vicinity of Mt Leyshon Mine (Source: FloodCheck Queensland)**

Broad-scale (low accuracy) flood mapping of the Burdekin River basin (Basin Level Flood Modelling) was performed during Phase 3 of the Queensland Flood Mapping Program (QFMP). The modelled 1% AEP flood extents (<https://floodcheck.information.qld.gov.au>) in the vicinity of the Mt Leyshon Mine are shown in Figure 1.41 and demonstrate that the Mt Leyshon Mine landforms are not susceptible to creek flooding. In particular, the edges of the pit void (which is in the footprint of the former Mt Leyshon prior to mining) are more than 2 km from either Clarke Creek or Puddler Creek and well outside of the floodplain areas of these two creeks.

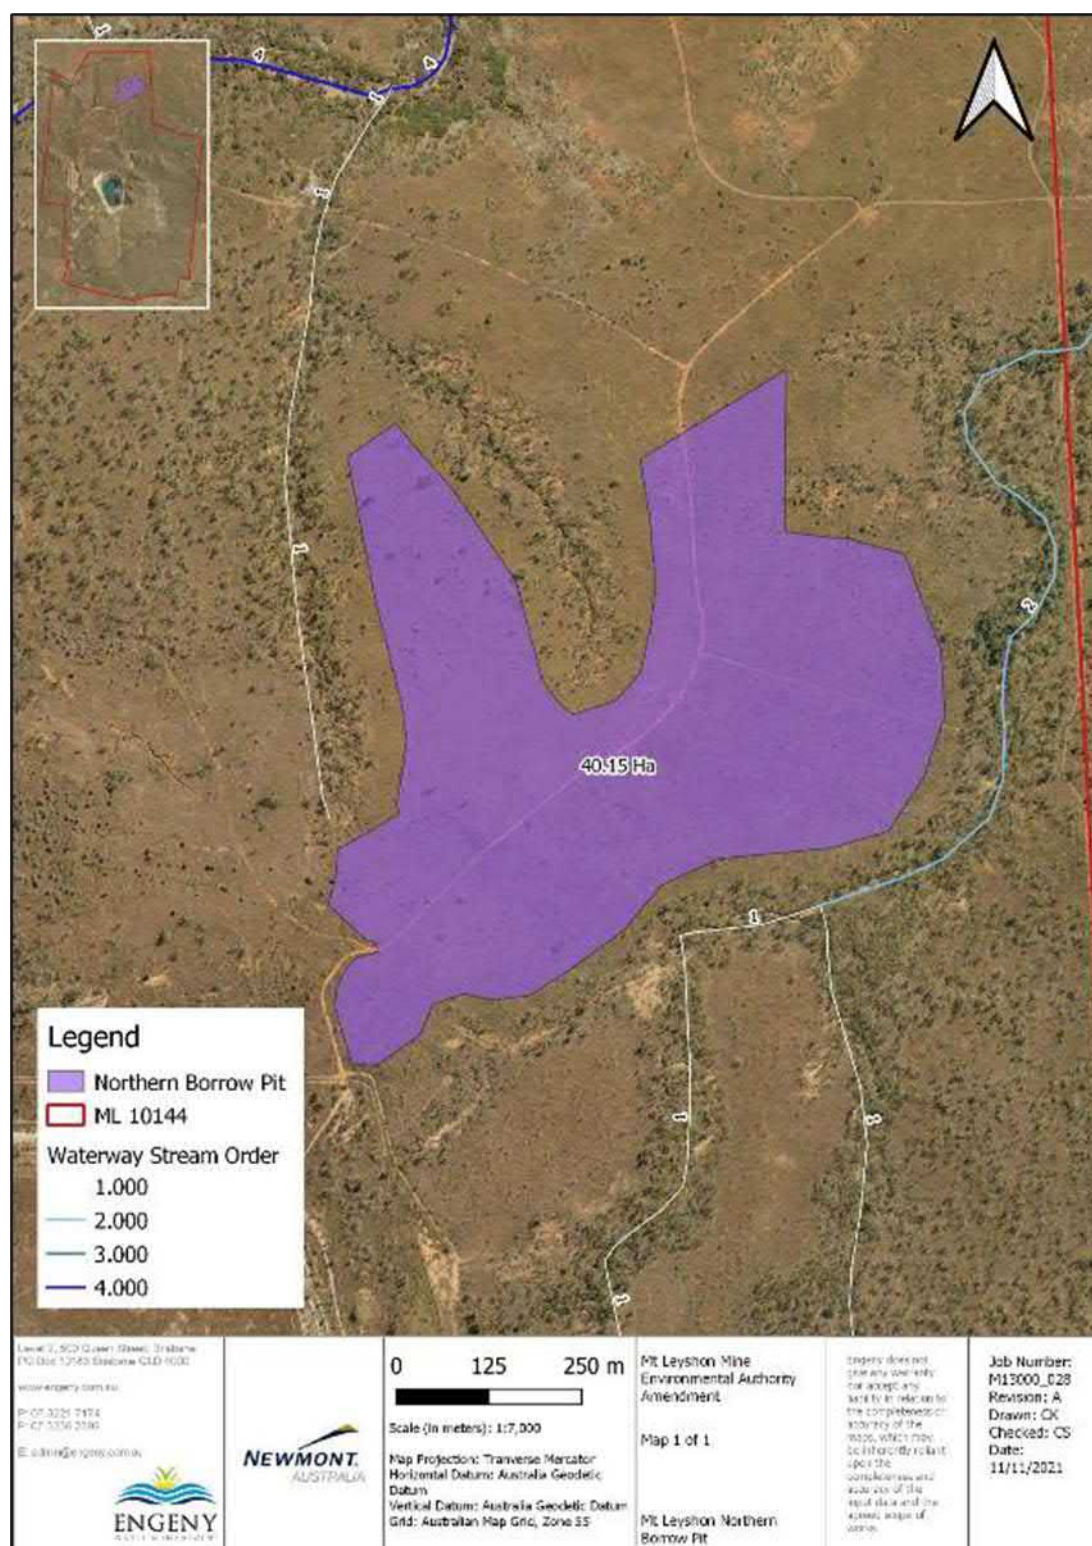
Figure 1.42: Location of the Northern Borrow Pit

Topsoil and rock required for all future rehabilitation works at the site will be sourced from the future Northern Borrow Pit and Quarry (refer to Figure 1.42 and Figure 1.43), or from external suppliers (i.e. BGM liner for the Scats Stockpile rehabilitation). It is noted that Rehabilitation Milestone 5 provides a mechanism for an assessment of soil health and suitability to be completed for target vegetation establishment and for ameliorants to be applied following this assessment. Table 1.16 presents the volumes of topsoil, general fill and rock estimated to be available from the Northern Borrow Pit and Quarry. The volumes presented are based on experience with sourcing material from borrow pits as part of the 2017 works to rehabilitate Roche Hill.

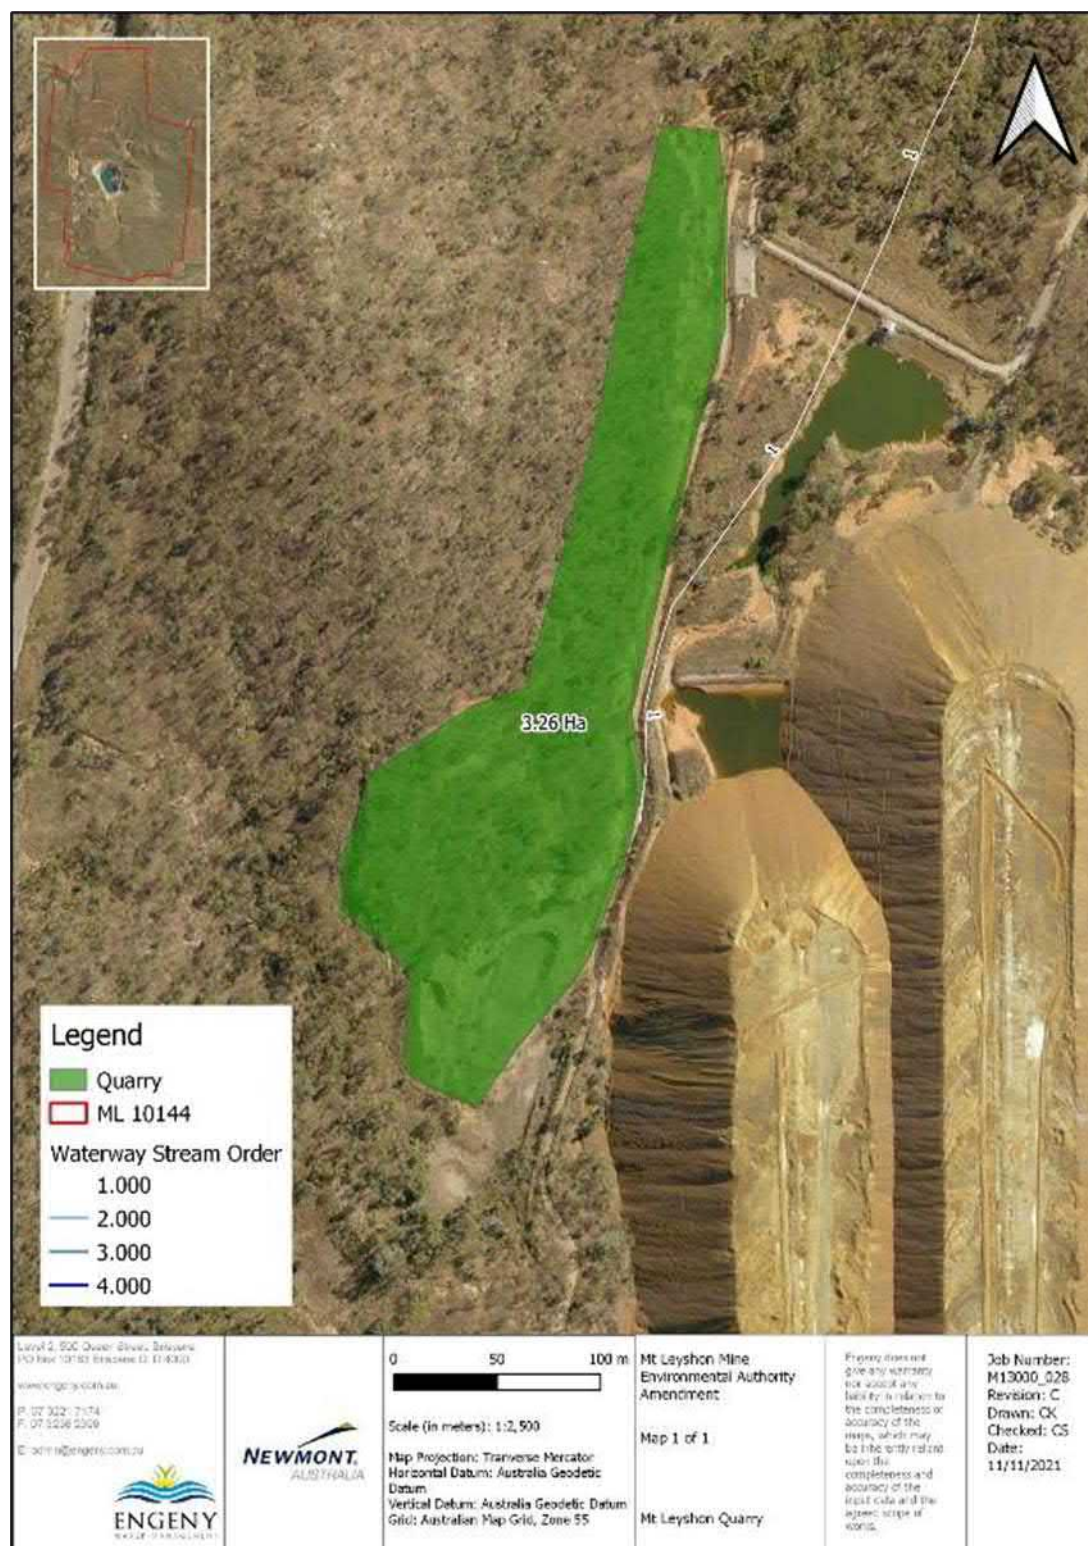
Figure 1.43: Location of the Quarry
