## Progressive Rehabilitation and Closure Plan

**Mt Leyshon Mine**

M13000\_024-REP-001-2

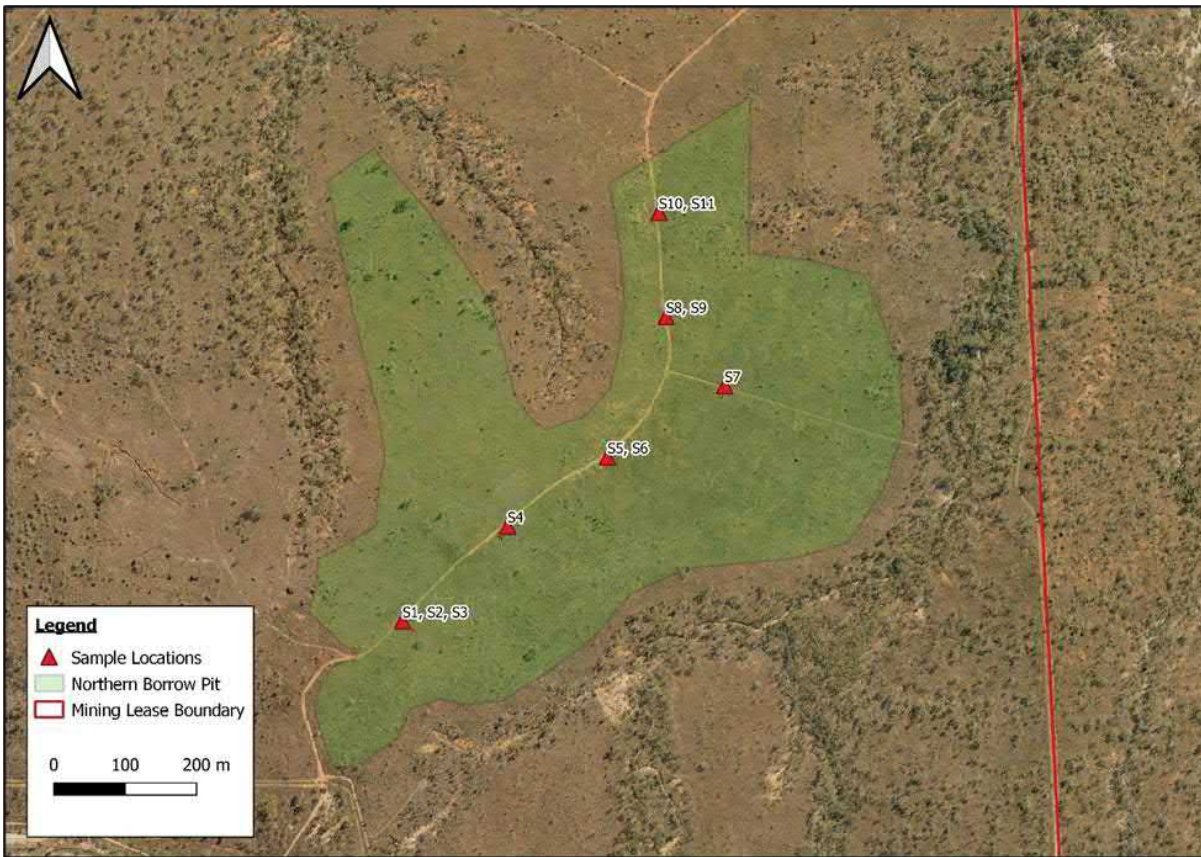
**Figure 1.44: Material Testing Locations – Northern Borrow Pit**

TropWATER was engaged by Newmont in 2022 to collect and coordinate testing of soil samples from the Northern Borrow Pit area. Eleven samples were collected from the seven test pits in Figure 1.44 and Table 1.18.

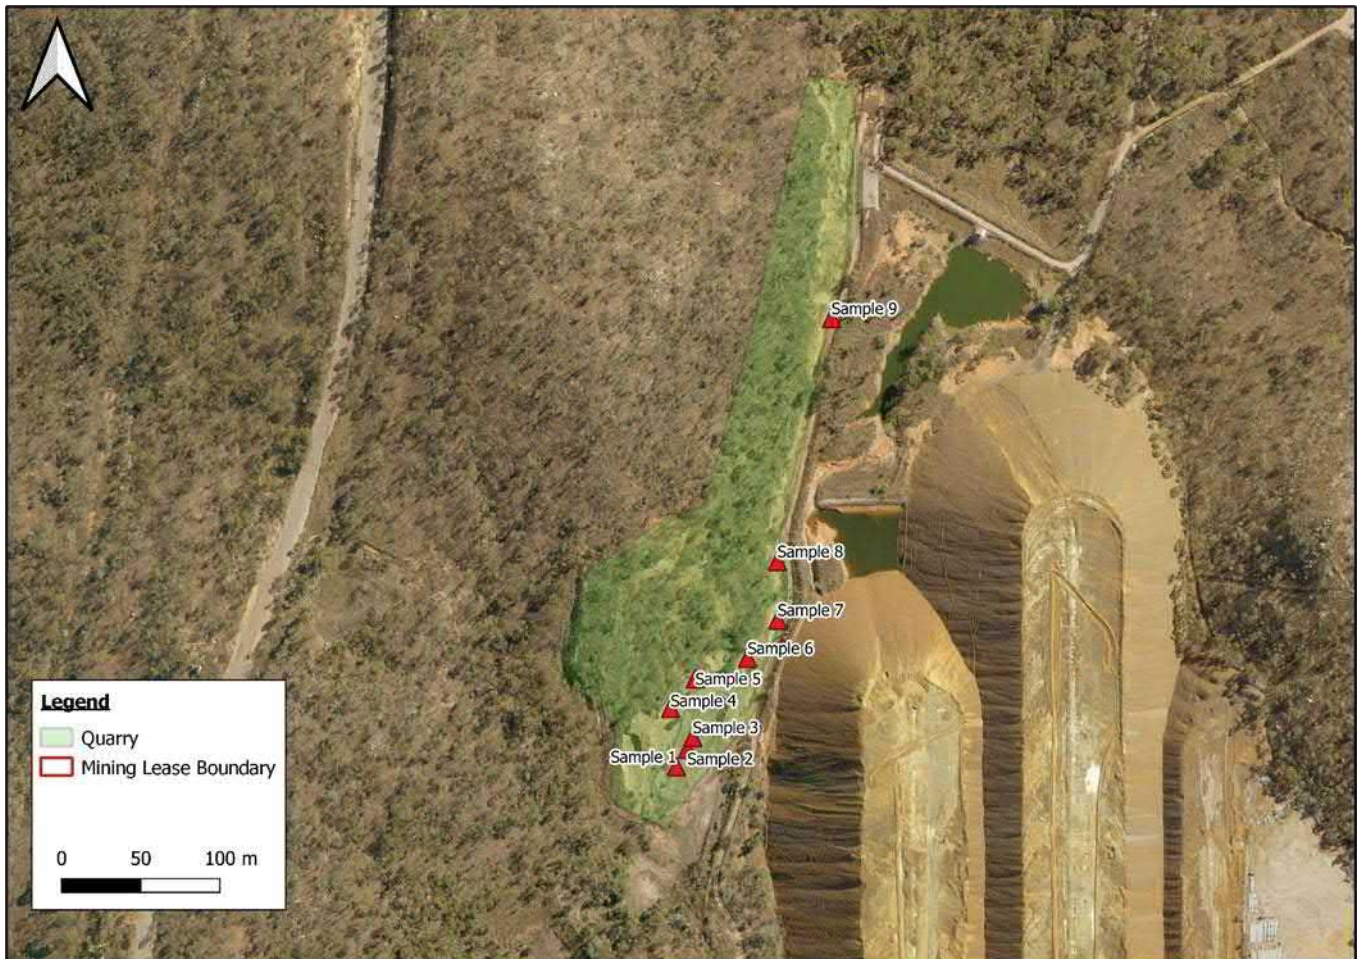
**Figure 1.46: Material Testing Locations – Quarry**

Nine separate sets of rock chip samples were collected from the Quarry on 28th October 2020, from the locations indicated in Figure 1.46. The rock samples were subsequently tested for:

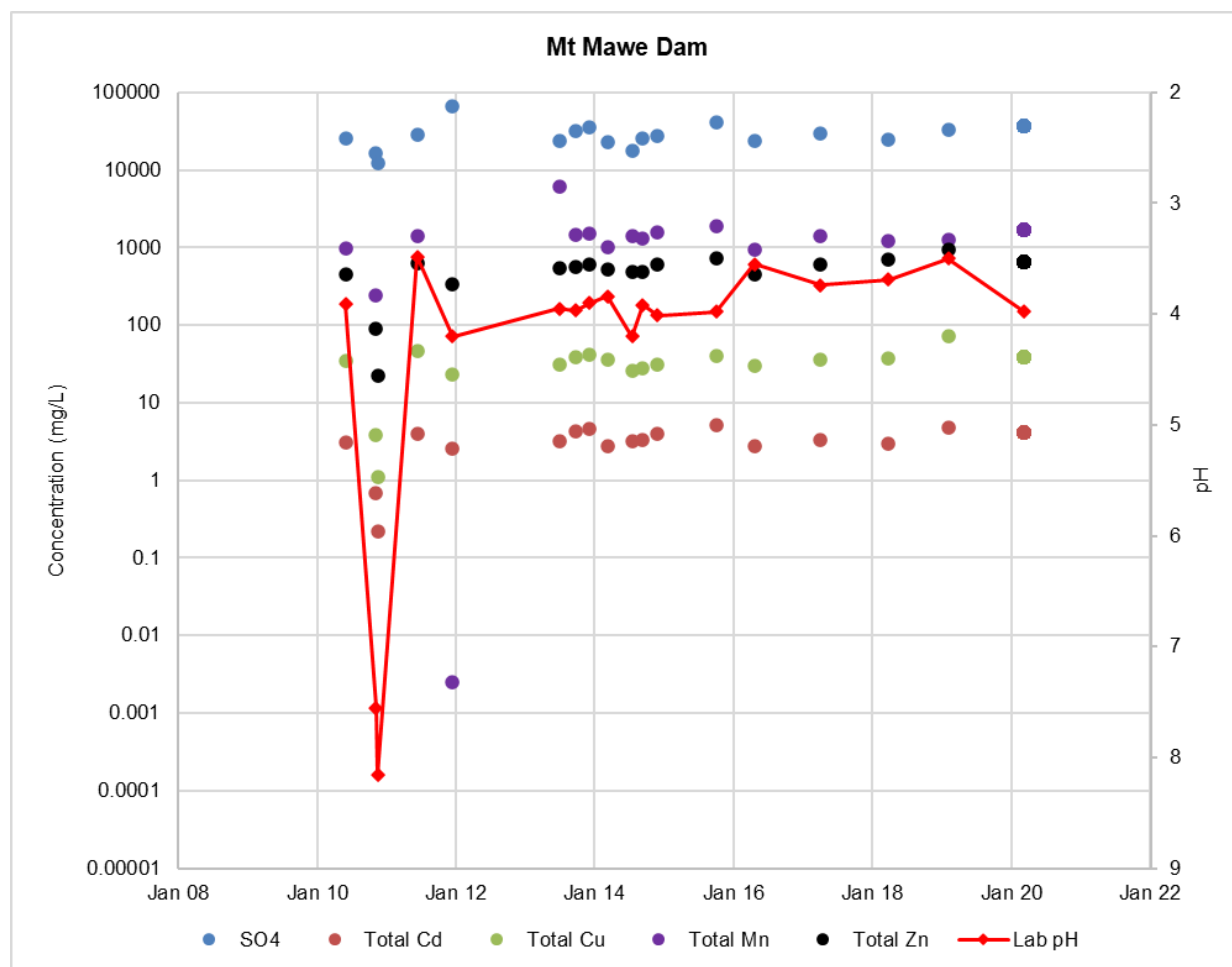
**Figure 1.47: Mt Mawe Dam Hydrochemistry**

Figure 1.47 to Figure 1.52 below present the hydrochemistry of the selected dams and sumps since 2008.

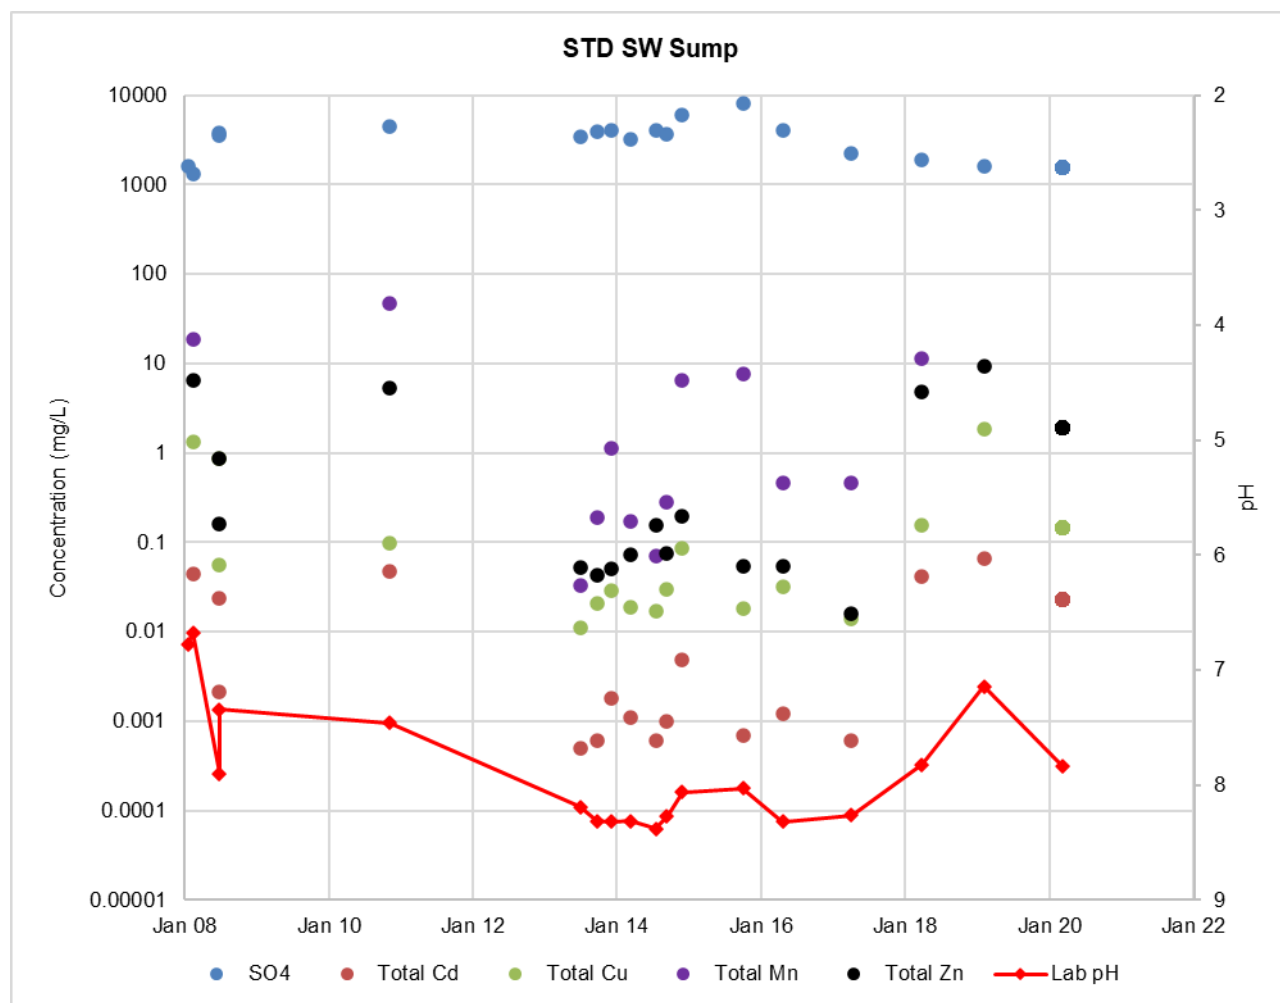
Figure 1.48: STDSW Sump Hydrochemistry

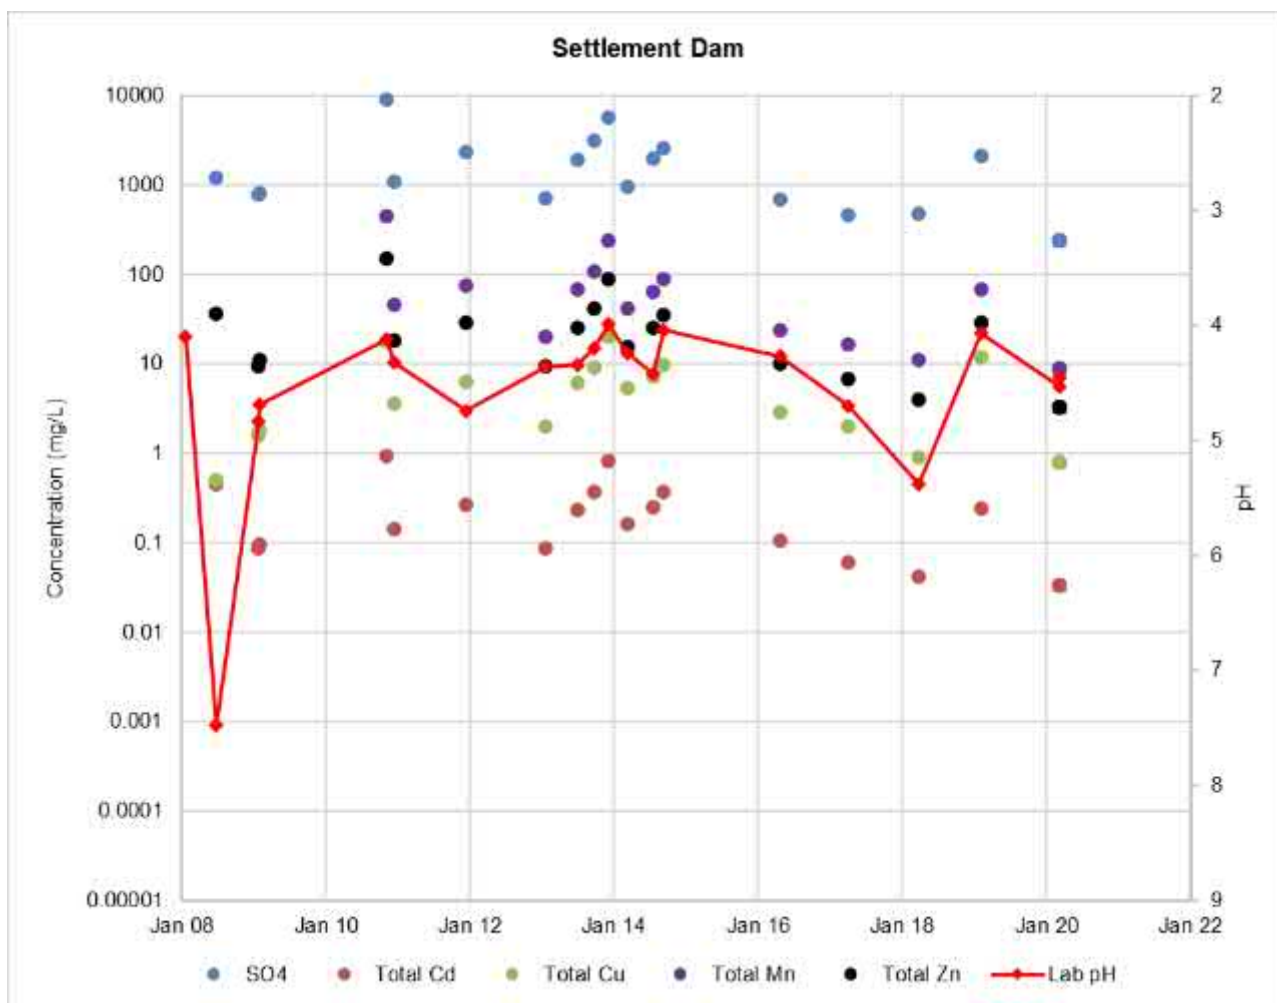
Figure 1.49: Settlement Dam Hydrochemistry

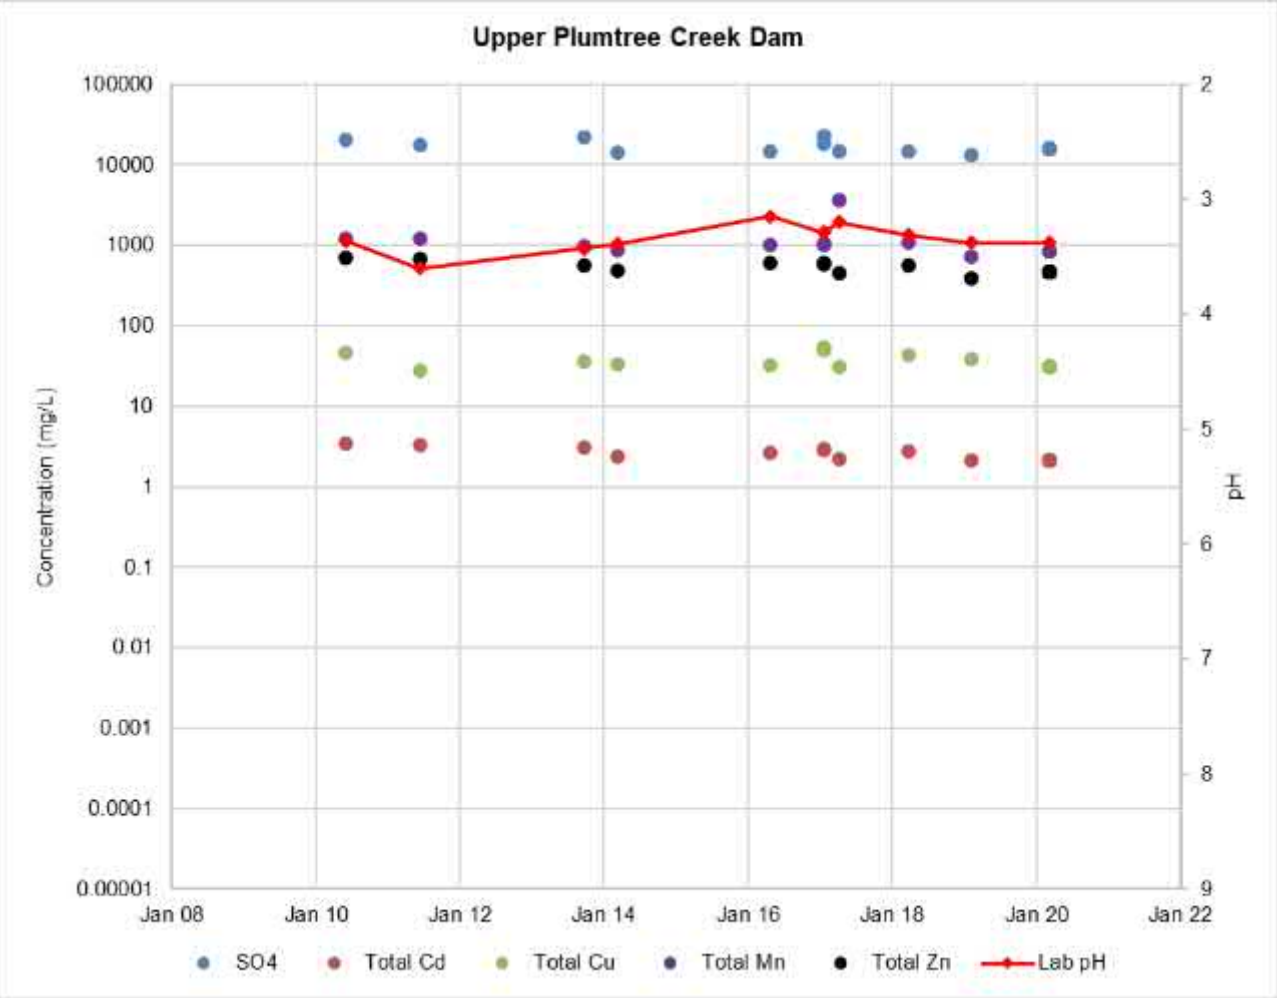
Figure 1.50: Upper Plum Tree Creek Dam Hydrochemistry

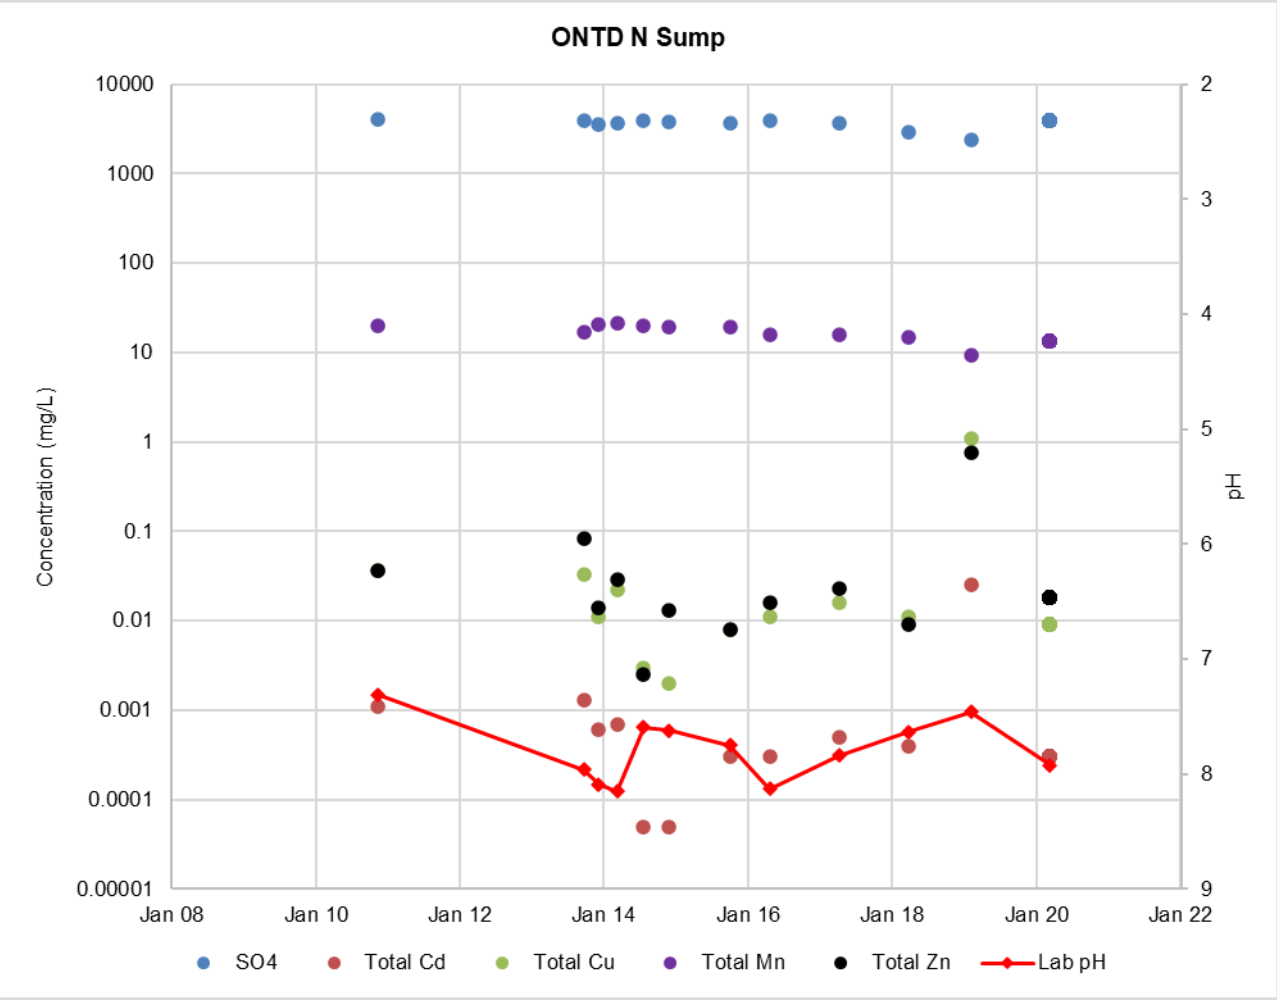
Figure 1.51: ONTD N Sump Hydrochemistry

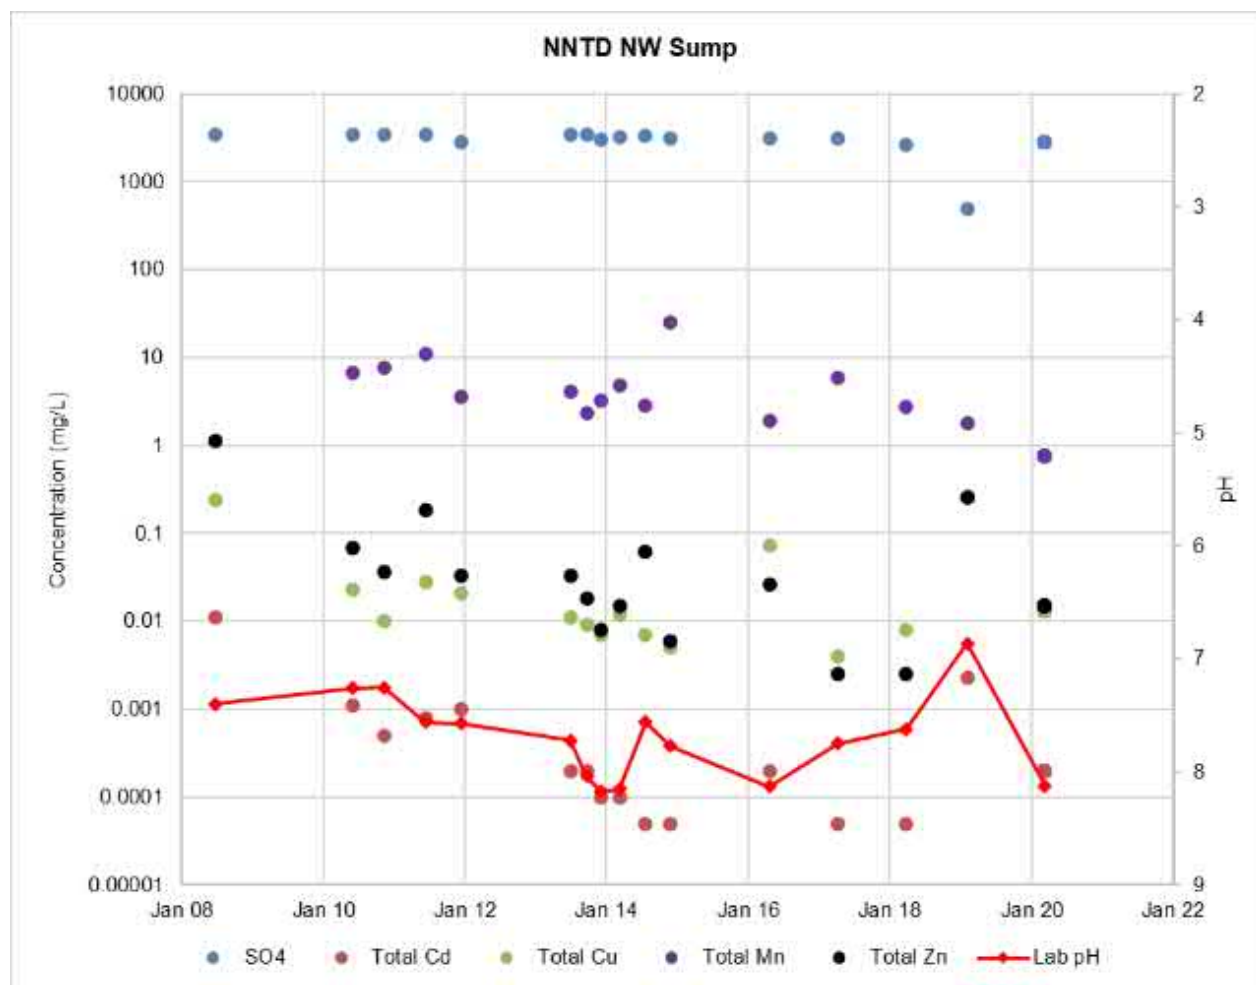
Figure 1.52: NNTD NW Sump Hydrochemistry

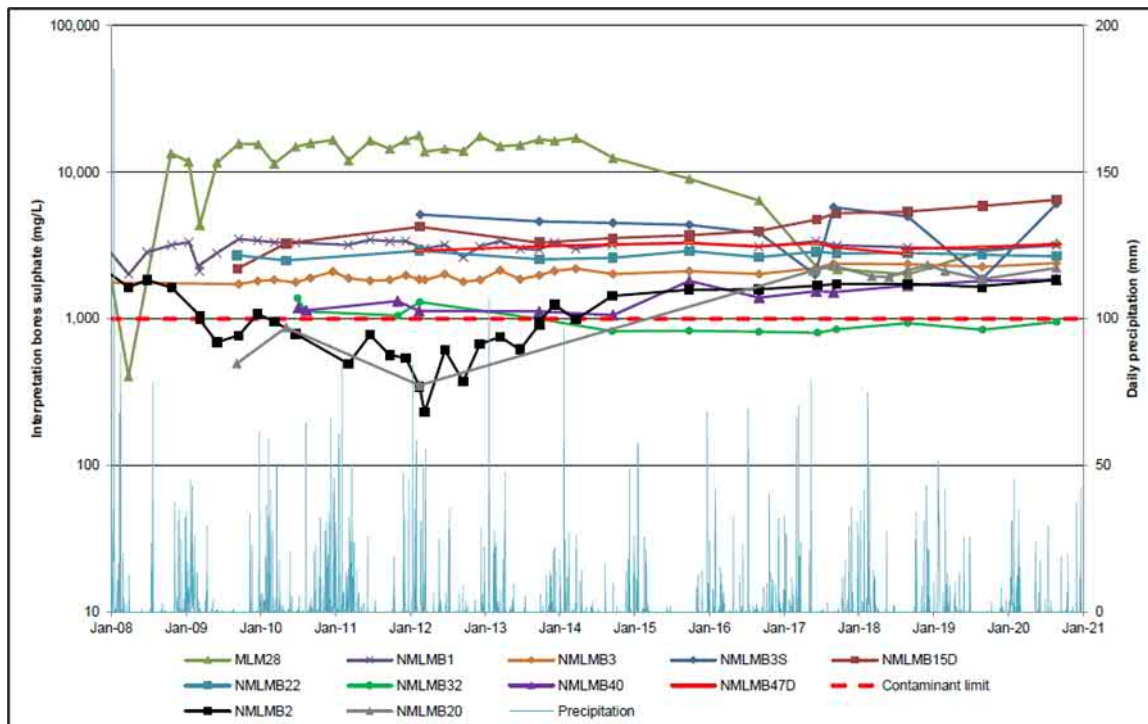
**Figure 1.55: Groundwater Sulphate Concentrations at Groundwater Interpretation Bores (Big Dog Hydrogeology, 2021)**

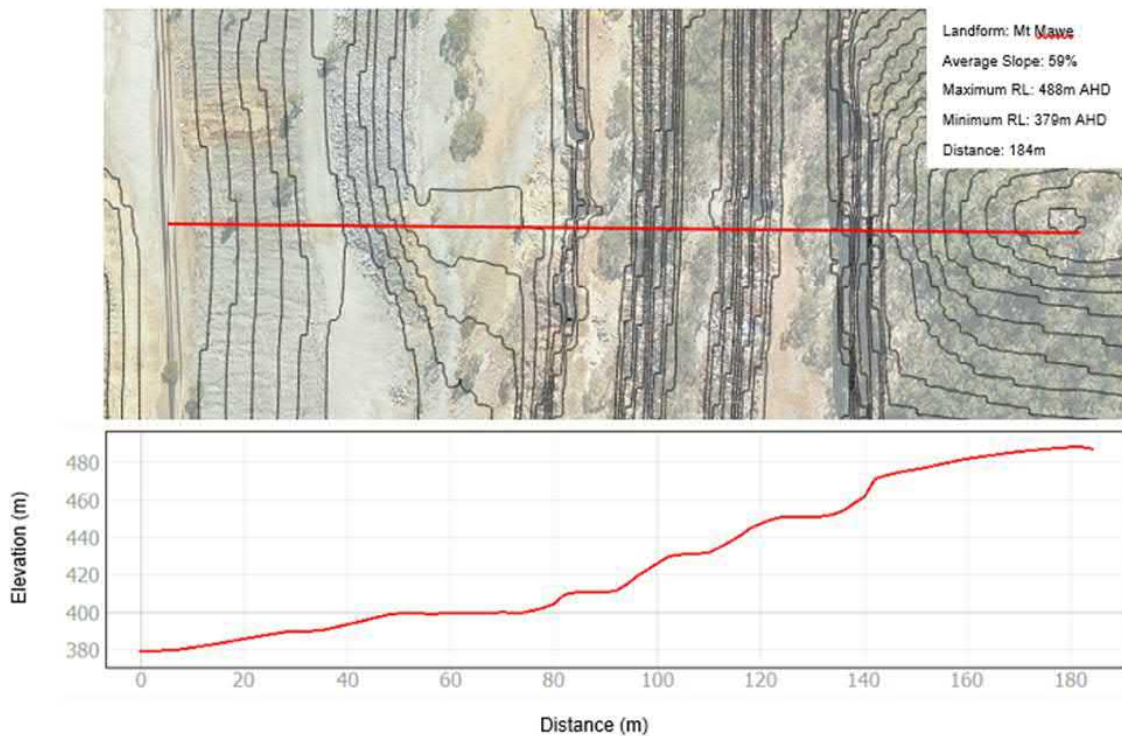
**Figure 1.56: Western Face of Mt Mawe Elevation Profile**

- Additional vegetation disturbance impacts would occur with the reprofiling earthworks.
- The current geometry is stable (as has been observed during the last 30 years) and a reprofiled geometry could result in a less stable final landform.
- The existing geometry is generally consistent with the steeper natural landforms within the mining lease (e.g., original Mt Leyshon and Wallaby Tail Hill) as shown in Figure 1.56 and Figure 1.57.

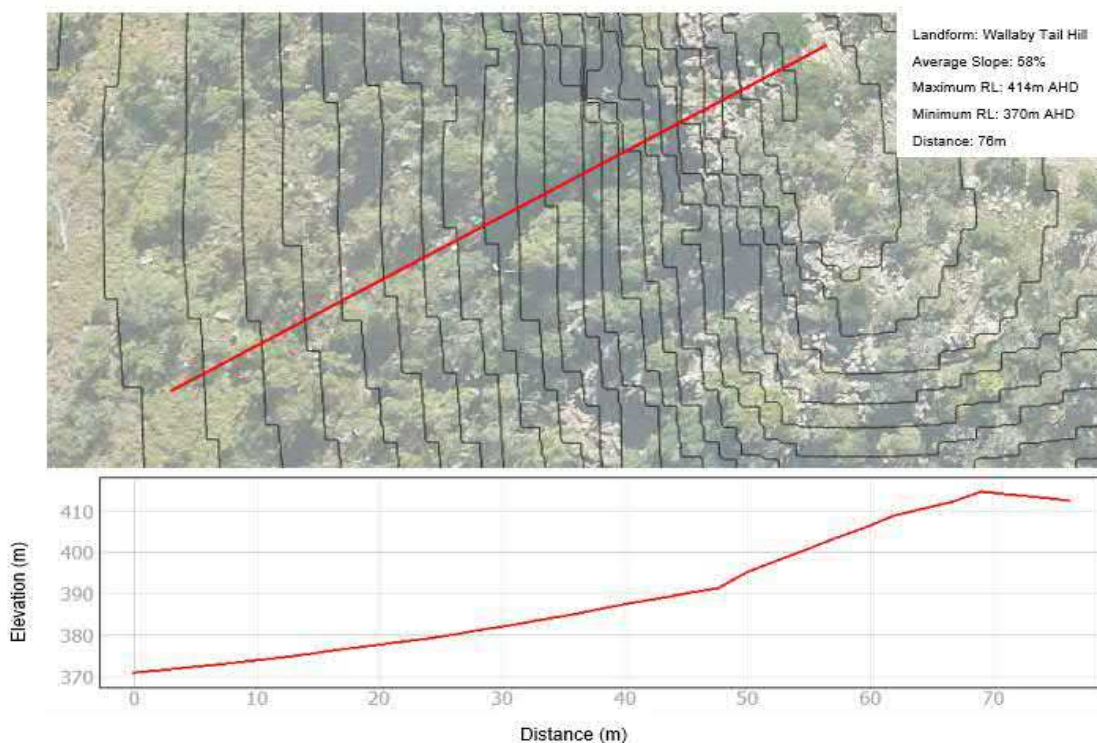
**Figure 1.57: Wallaby Tail Hill Elevation Profile**

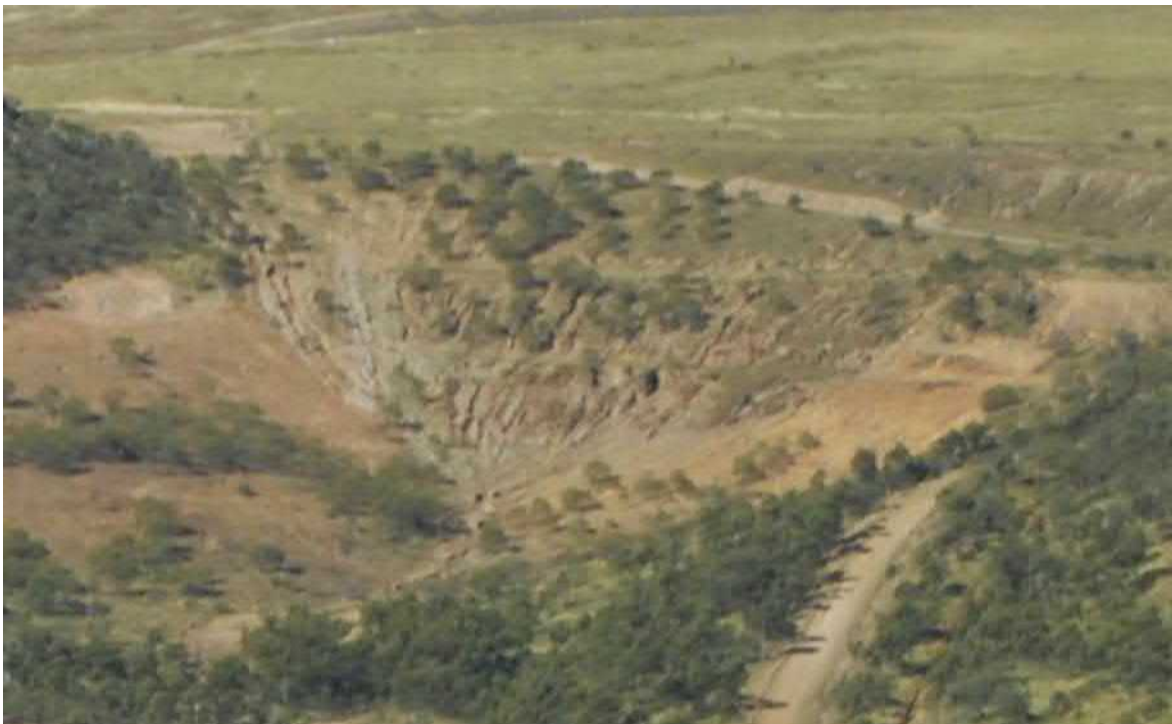
**Figure 1.58: Western Section of Roche Hill prior to Rehabilitation Repair Works in 2017**

Roche Hill was part of an area previously used as a low grade ore stockpile, subject to material movements throughout operations and also hosted waste materials that were PAF. The original rehabilitation of Roche Hill at closure involved capping with oxidised heap leach material and constructing berms to manage surface water. Following several high intensity rainfall events and possibly poor construction methods, erosion became evident on the western section (see Figure 1.58). Poor water quality resulted from rainfall runoff and seepage that contacted parts of Roche Hill and revegetation success was limited.

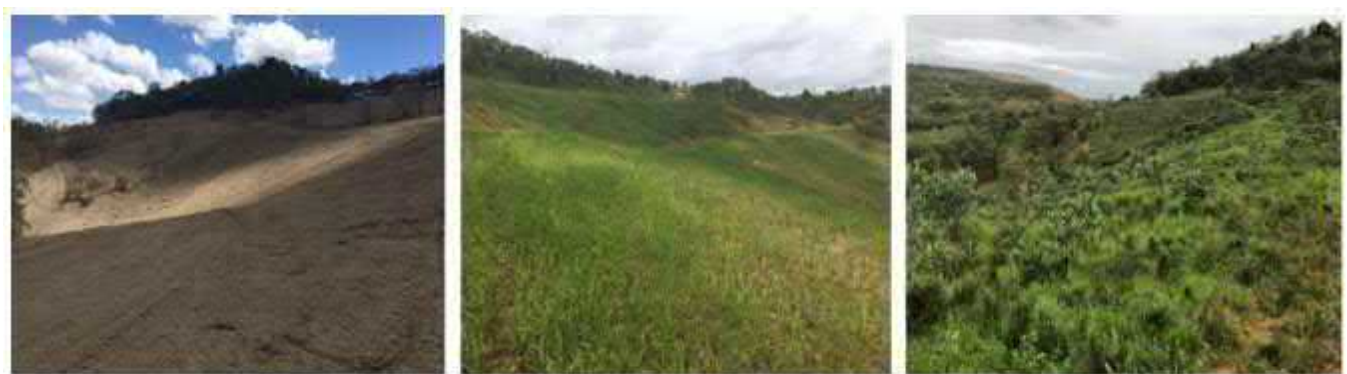
**Figure 1.59: Roche Hill after 2017 Rehabilitation Works**

surfaces, covering bare areas with fill/rock mulch, growth media and hydromulch, rock armouring of concentrated flow channels, managing catchment areas, and providing vehicle access. Rock was sourced from the existing quarry in the western parts of the mining lease while growth media was sourced from borrow pits in the northern part of ML 101144. The rehabilitation works were performed by a local civil contractor (revegetation/hydro mulching works were undertaken by a specialist vegetation subcontractor) and supervised by Newmont. The rehabilitation works were completed in 2017 and photos of the completed works are shown in Figure 1.59.

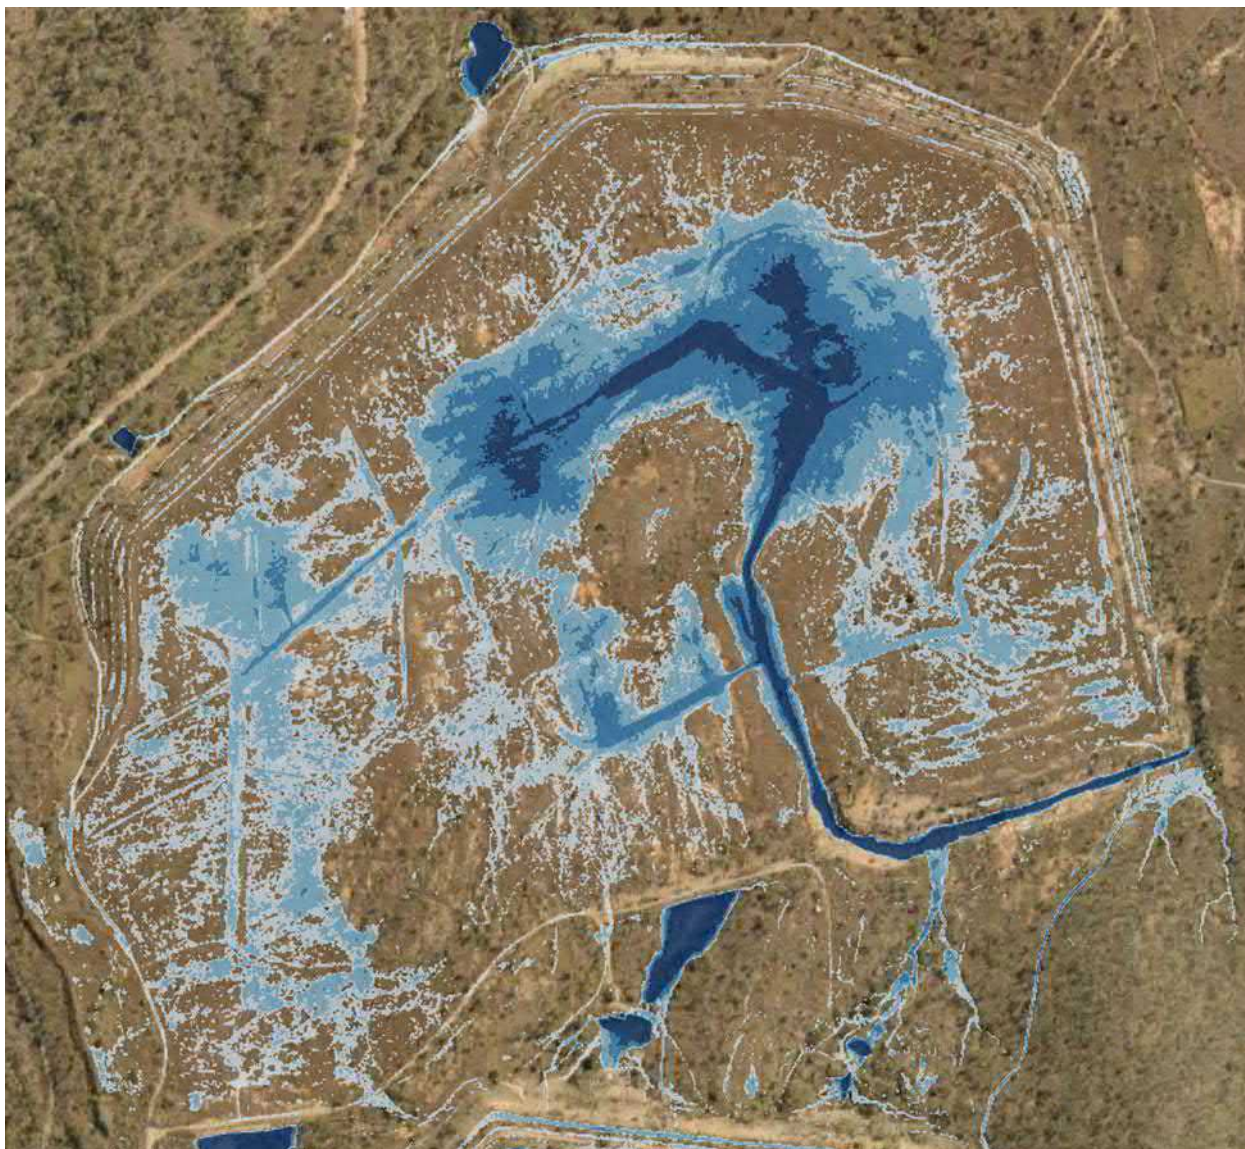
Figure 1.60: 1:1,000 AEP Peak Flood Extent for ONTSF

- Figure 1.60 and Figure 1.61: ONTSF and ONTSF spillway.
- Figure 1.62 to Figure 1.64: NNTSF and NNTSF spillways.
- Figure 1.65 to Figure 1.67: STSF and STSF spillways.

The flood modelling results indicate that all TSF closure spillways are adequately sized to convey the 1:1,000 AEP peak flood discharges from the top surfaces of the TSFs.

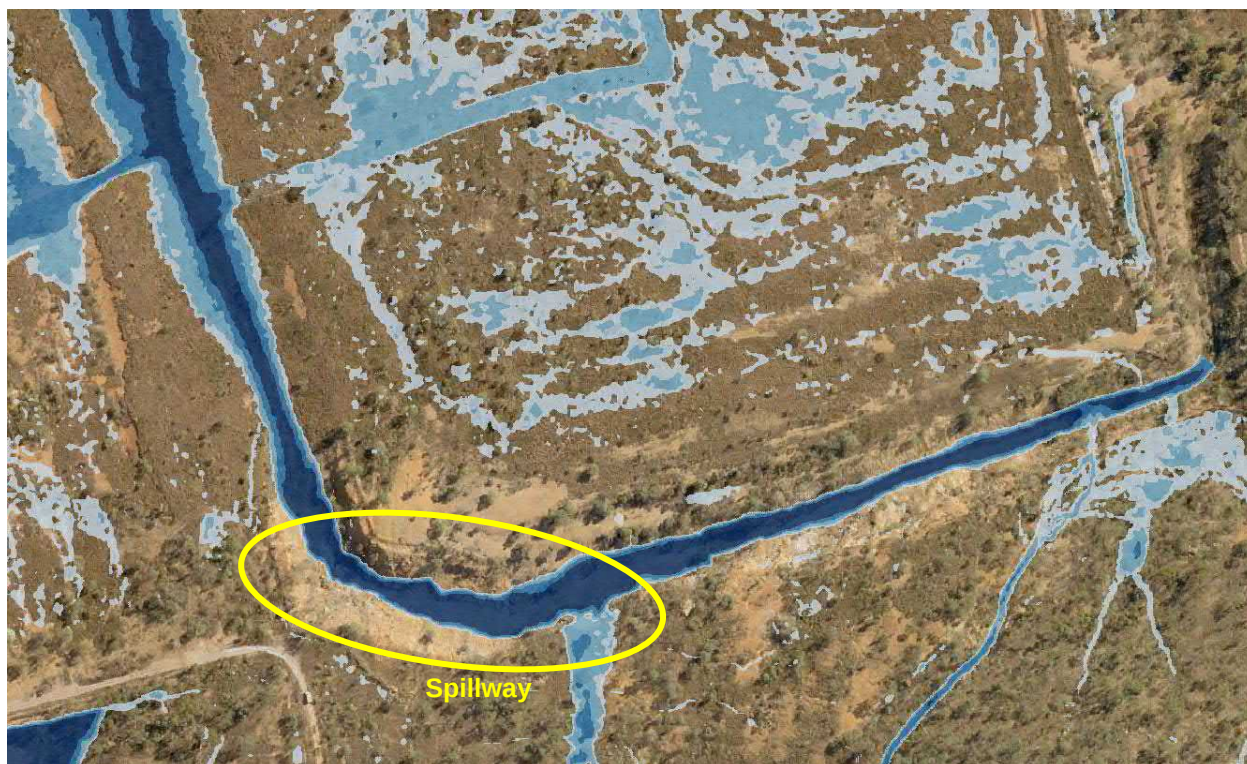
Figure 1.61: 1:1,000 AEP Peak Flood Extent for ONTSF Spillway Channel

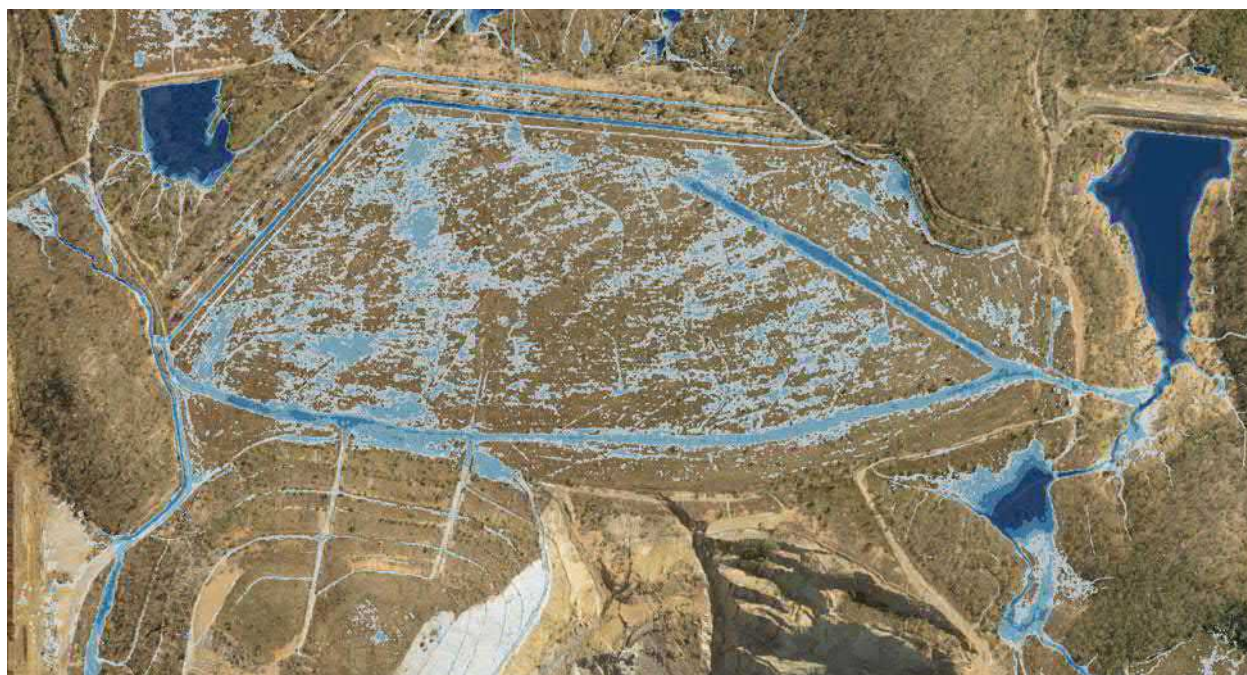
Figure 1.62: 1:1,000 AEP Peak Flood Extent for NNTSF

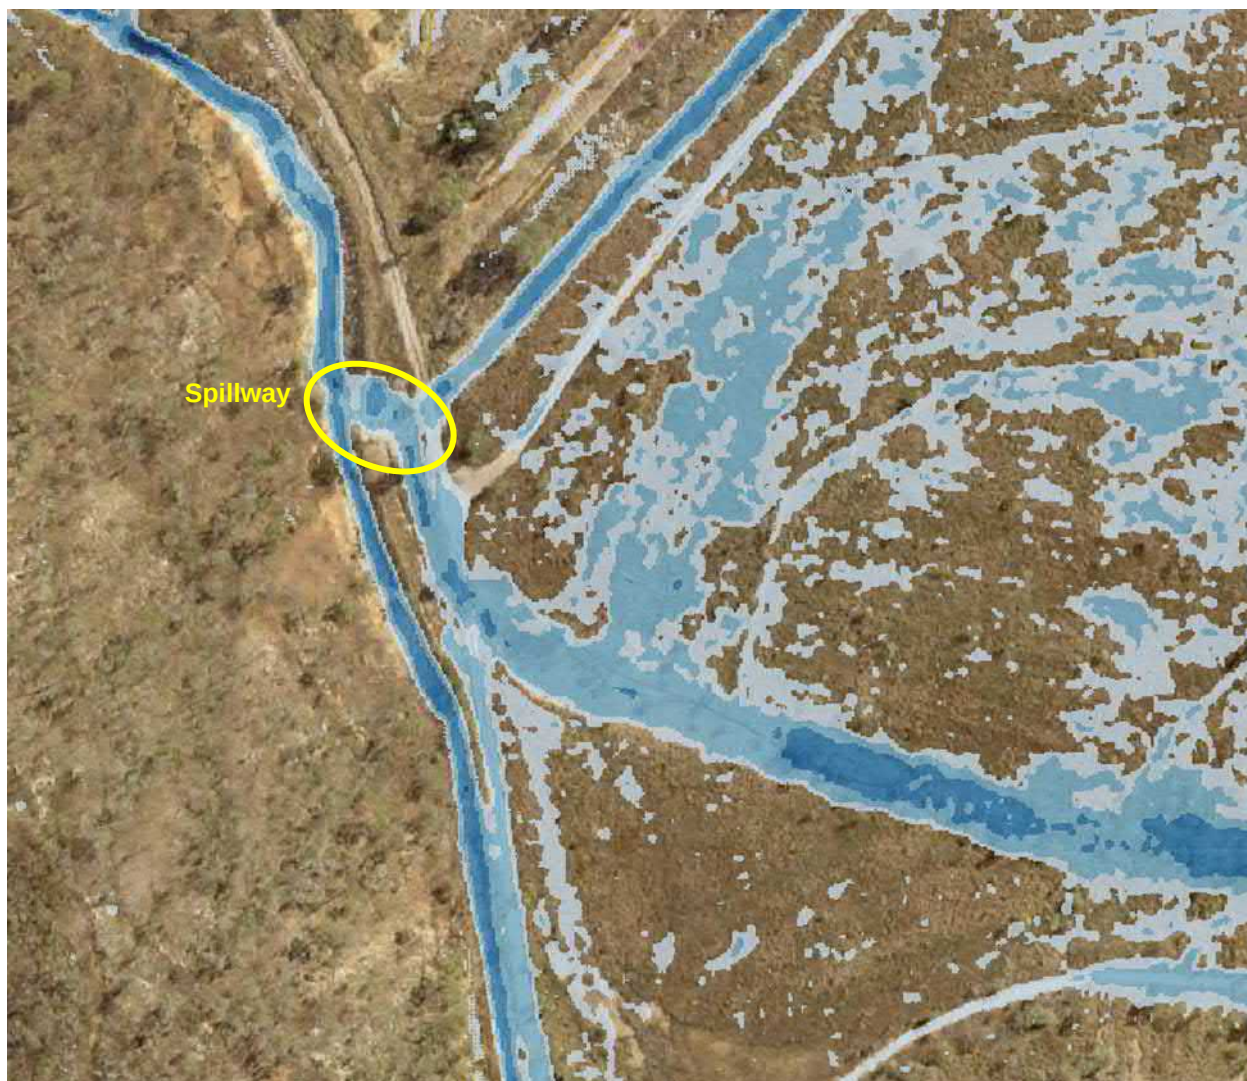
Figure 1.63: 1:1,000 AEP Peak Flood Extent for Spillway at Western Side of NNTSF

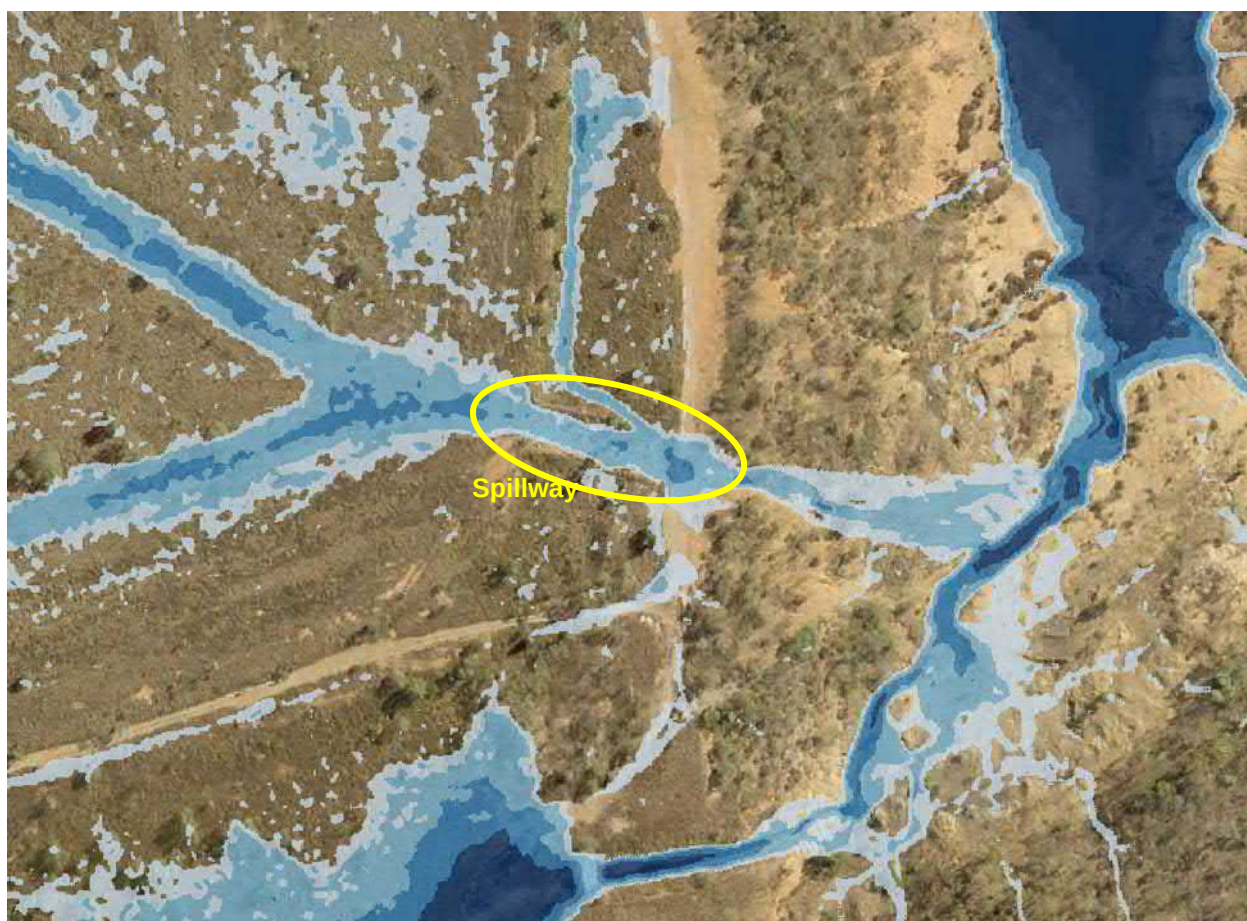
Figure 1.64: 1:1,000 AEP Peak Flood Extent for Spillway at Eastern Side of NNTSF

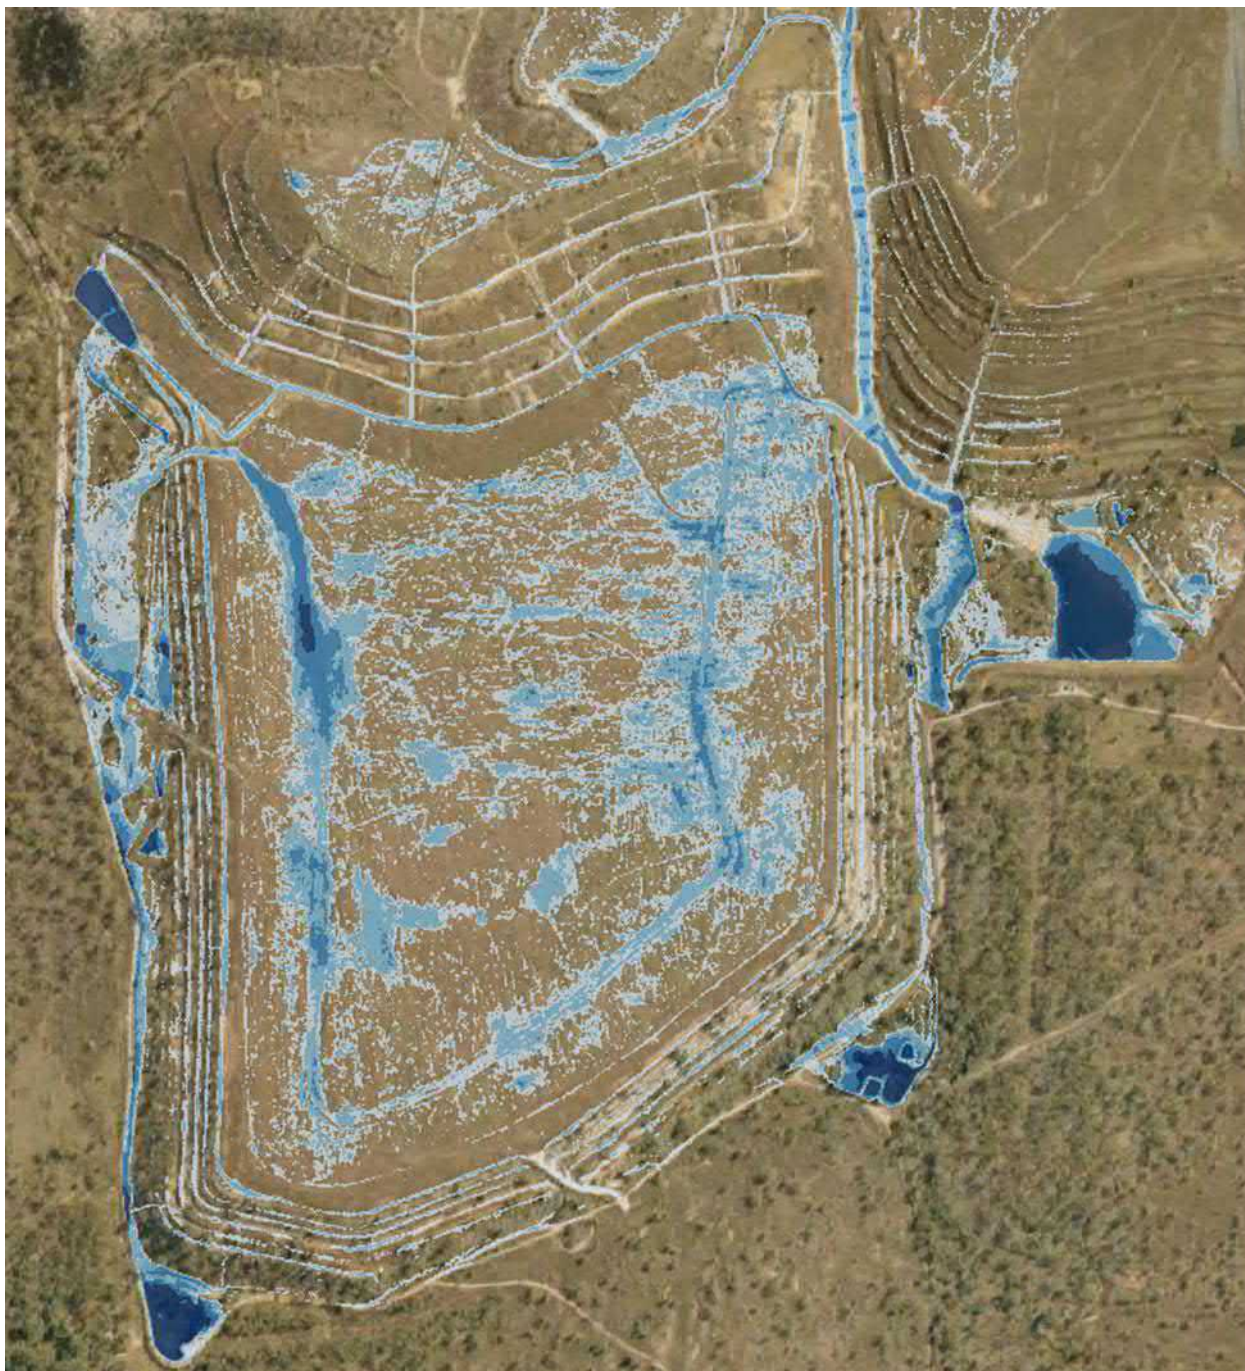
Figure 1.65: 1:1,000 AEP Peak Flood Extent for STSF
