## Progressive Rehabilitation and Closure Plan

**Mt Leyshon Mine**

M13000\_024-REP-001-2

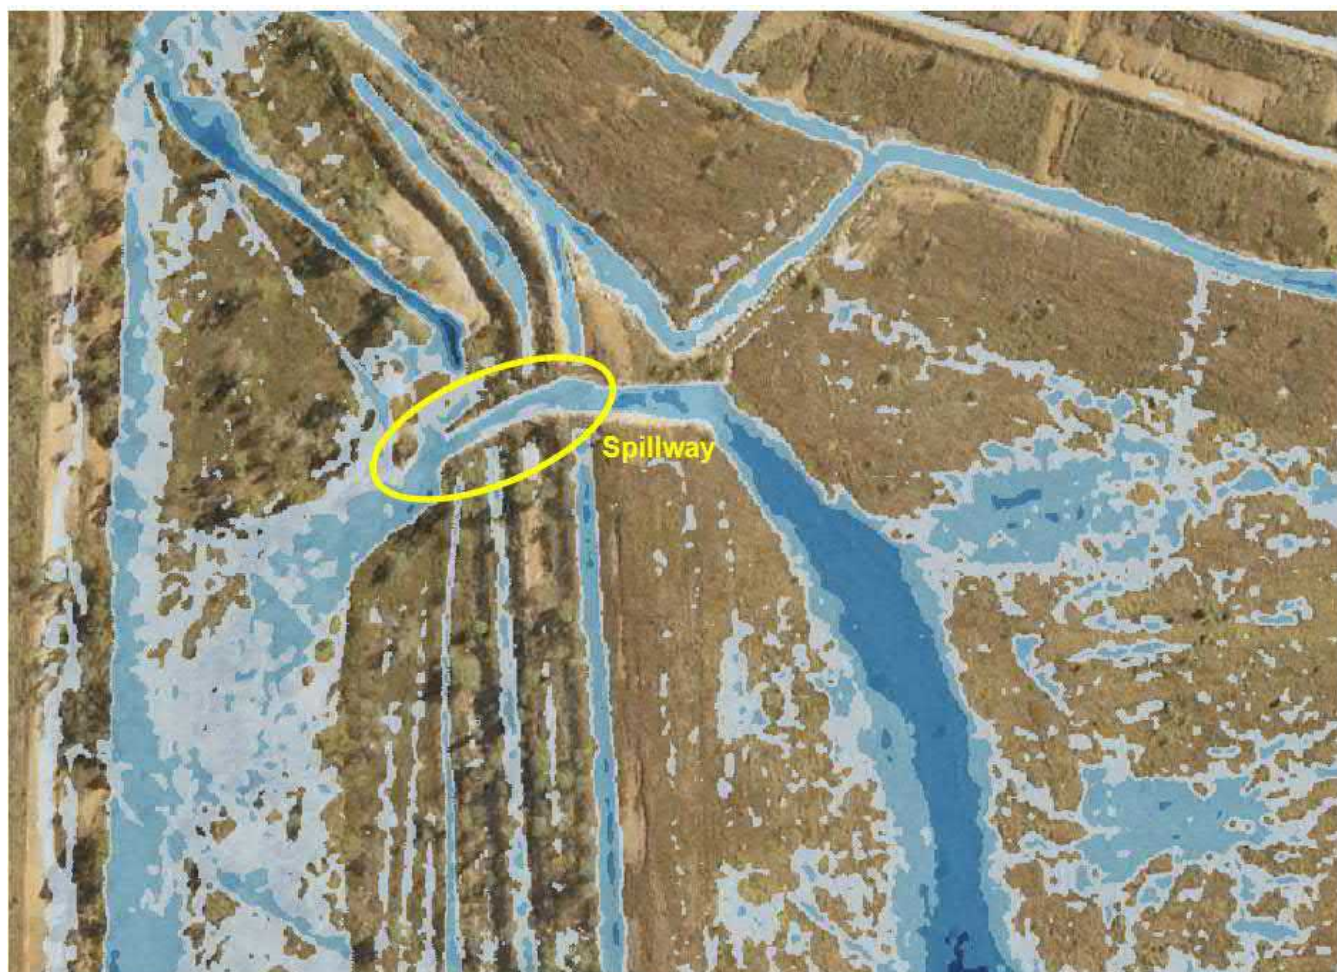
Figure 1.66: 1:1,000 AEP Peak Flood Extent for Spillway at North-Western Corner of STSF

- Figure 1.60 and Figure 1.61: ONTSF and ONTSF spillway.
- Figure 1.62 to Figure 1.64: NNTSF and NNTSF spillways.
- Figure 1.65 to Figure 1.67: STSF and STSF spillways.

The flood modelling results indicate that all TSF closure spillways are adequately sized to convey the 1:1,000 AEP peak flood discharges from the top surfaces of the TSFs.

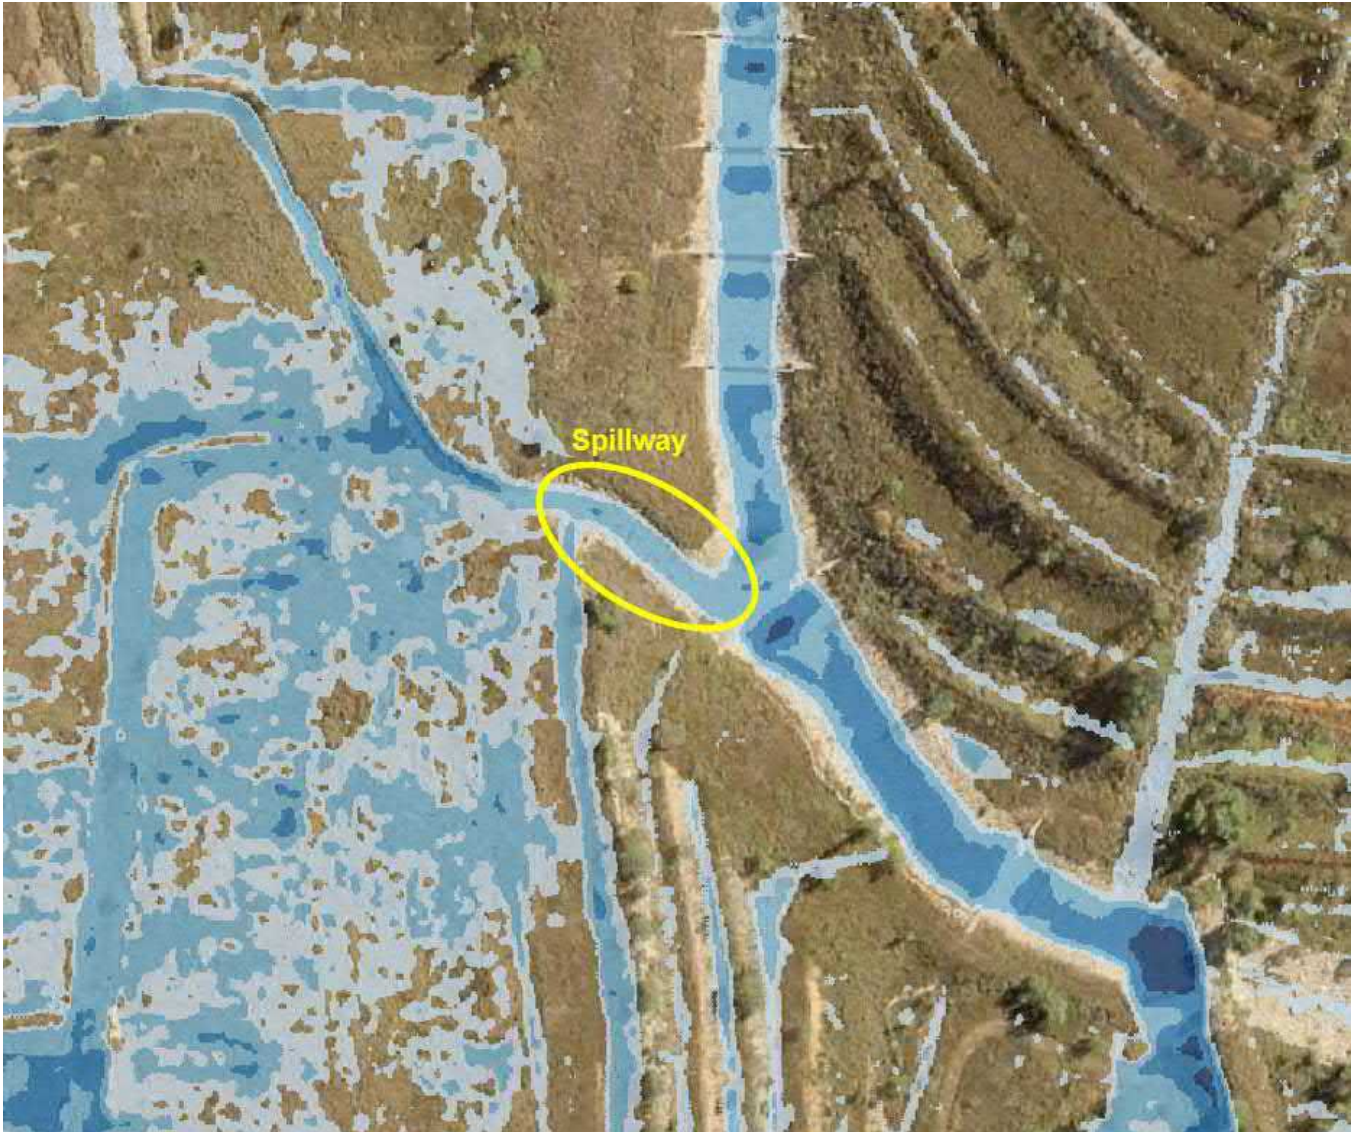
**Figure 1.67: 1:1,000 AEP Peak Flood Extent for Spillway at North-Eastern Corner of STSF**

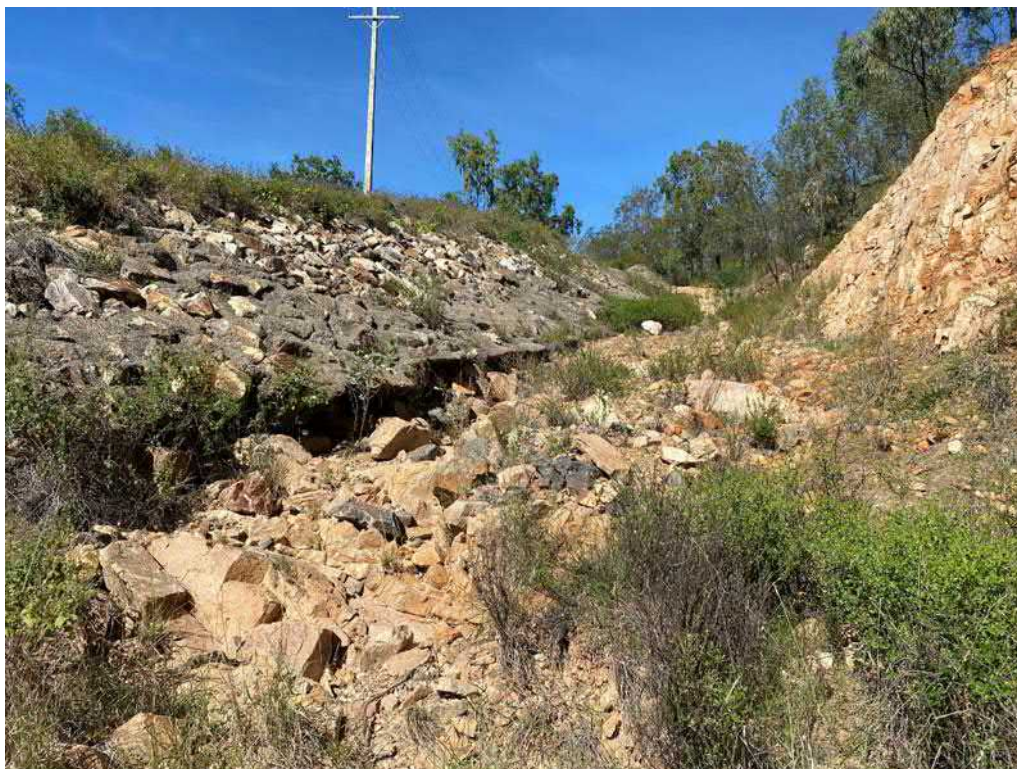
**Figure 1.68: ONTSF Closure Spillway – Western Side of Landform**

The closure spillways have been in place since 2002 and have been stable during the 20 year period since closure. This period included a large rainfall event in January 2008 resulting from an extensive low pressure system associated with ex-Tropical Cyclone Helen. Approximately 160 mm of rainfall occurred in a 6 hour period during the January 2008 rainfall event which exceeded the 1:100 AEP design rainfall total for this rainfall duration. The adequacy of the TSF closure spillways was demonstrated by their ability to convey the flood flows from the large January 2008 rainfall event (greater than 1:100 AEP rainfall event) without any significant erosional damage to the spillways. Photos of the current configuration and condition of the TSF closure spillways are provided in Figure 1.68 (ONTSF Western Spillway), Figure 1.69 (ONTSF Eastern Spillway), Figure 1.70 (NNTSF Southern Spillway), Figure 1.71 (STSF North-Western Spillway) and Figure 1.72 (STSF North-Eastern Spillway).

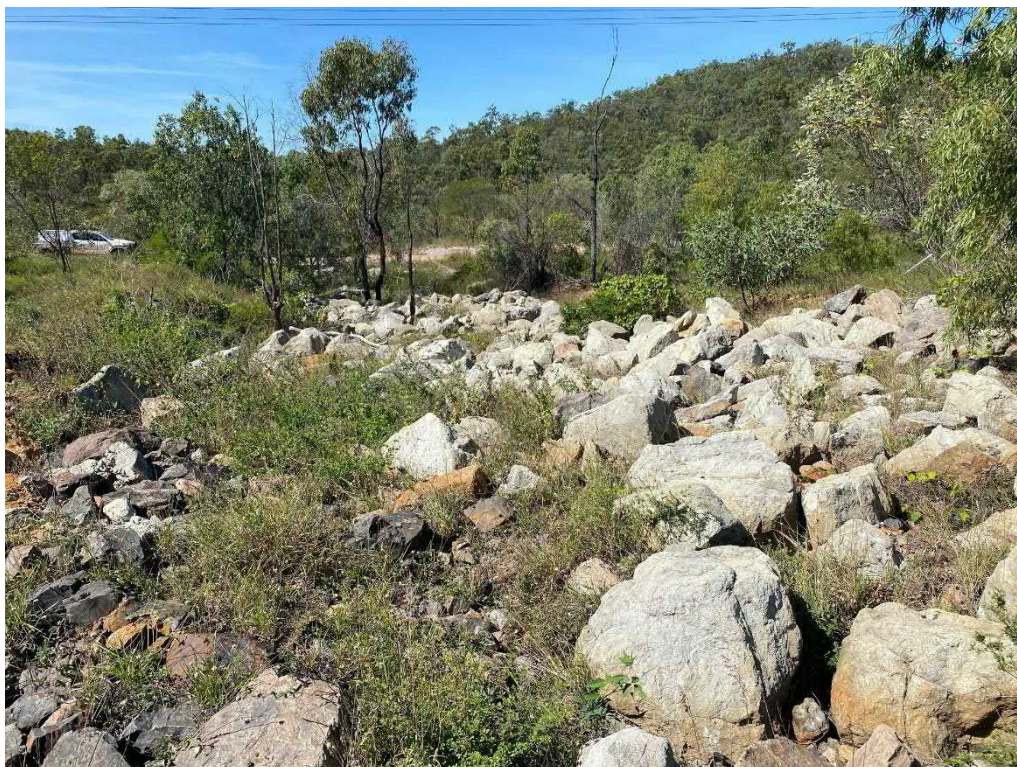
**Figure 1.69: ONTSF Closure Spillway – Eastern Side of Landform**

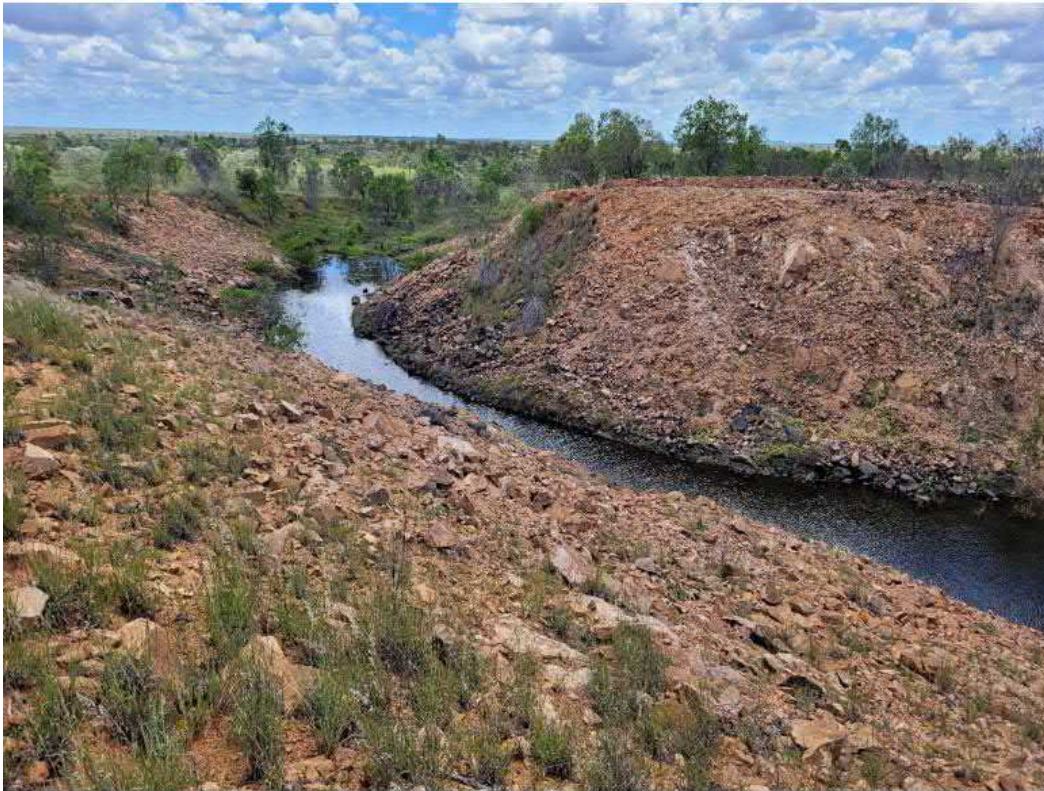
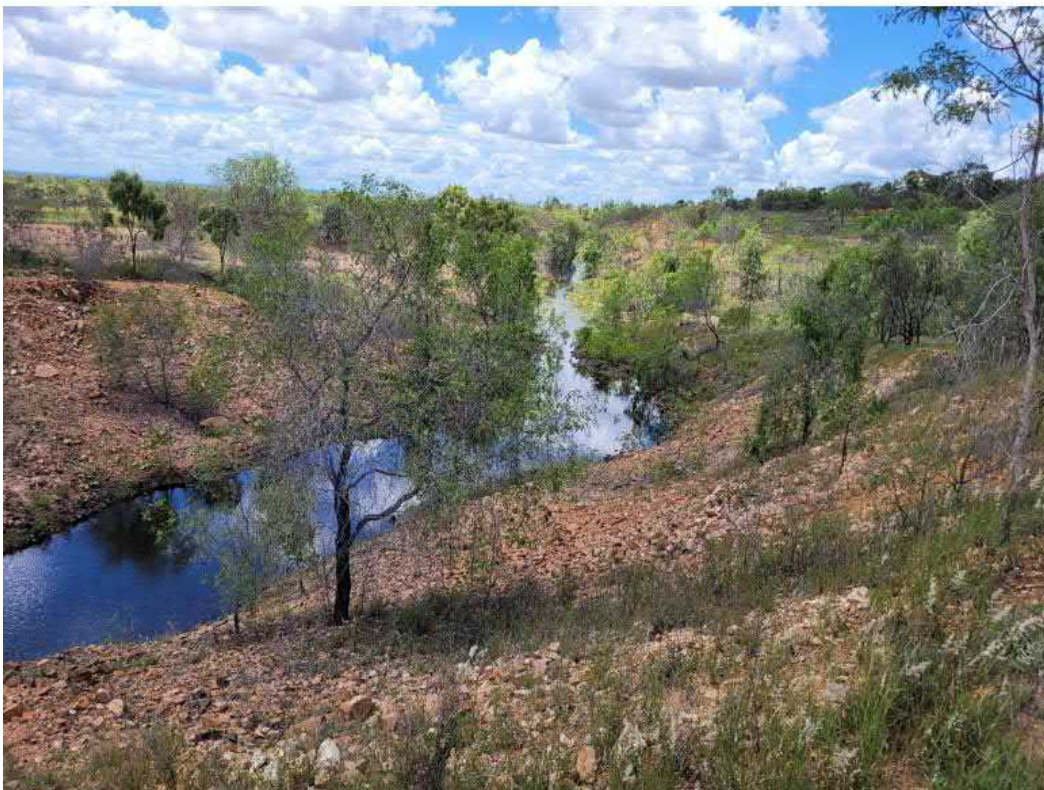
**Figure 1.70: NNTSF Closure Spillway – Southern Side of Landform**

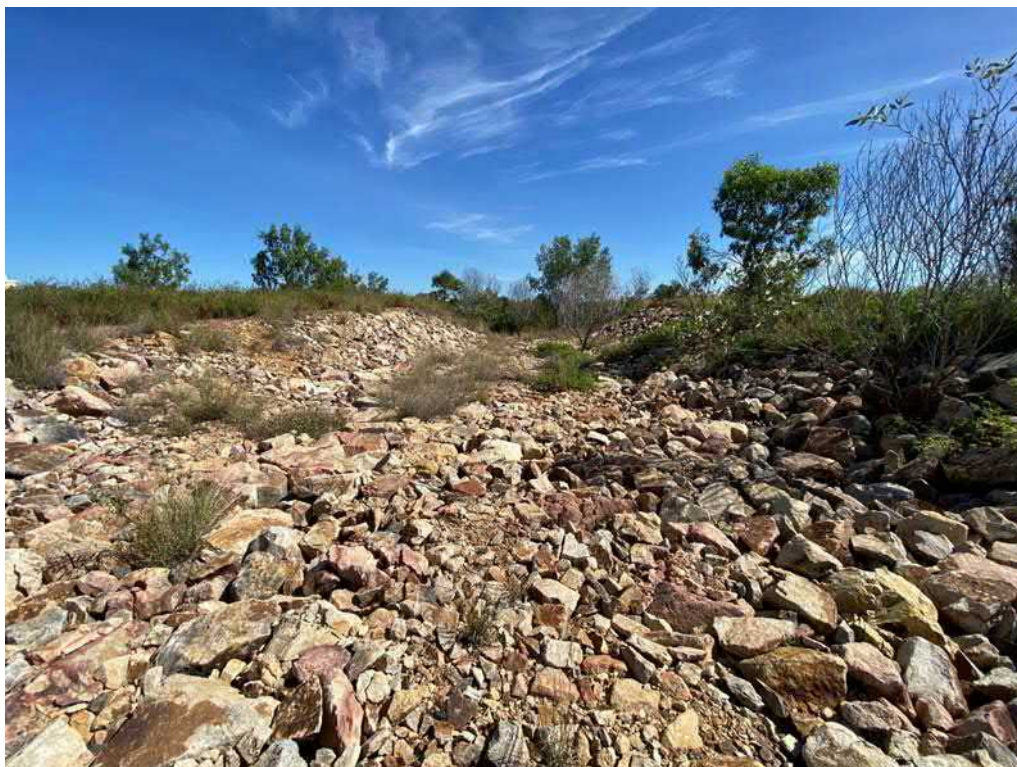
**Figure 1.71: STSF Closure Spillway – North-Western Corner of Landform**

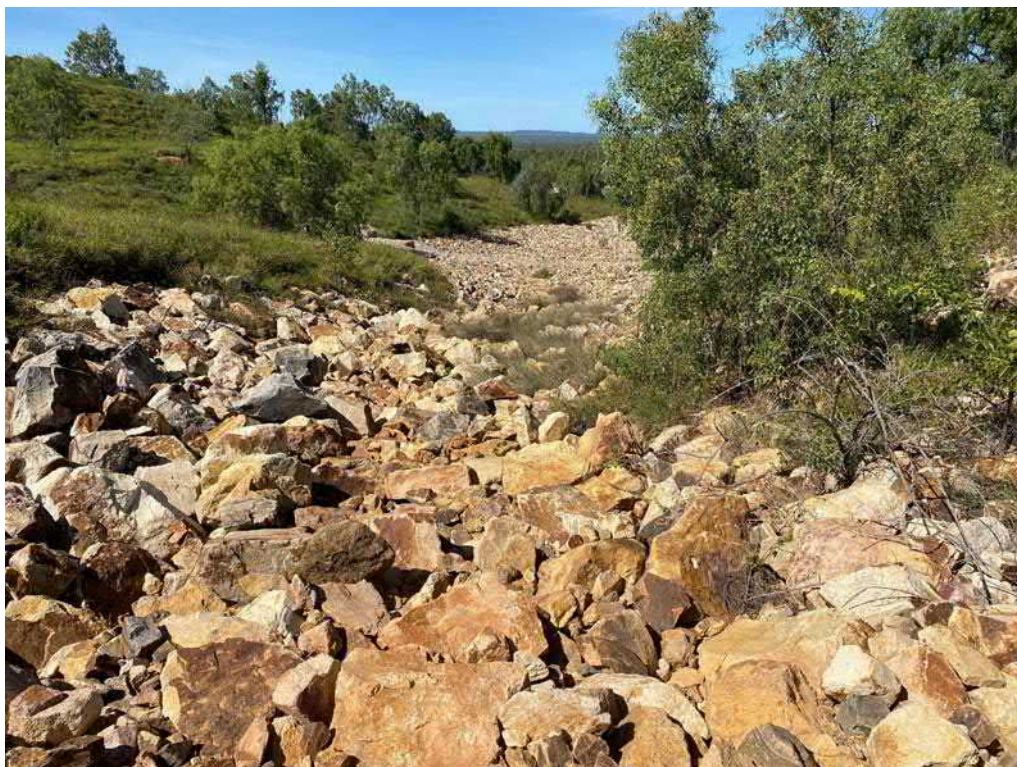
**Figure 1.72: STSF Closure Spillway – North-Eastern Corner of Landform**

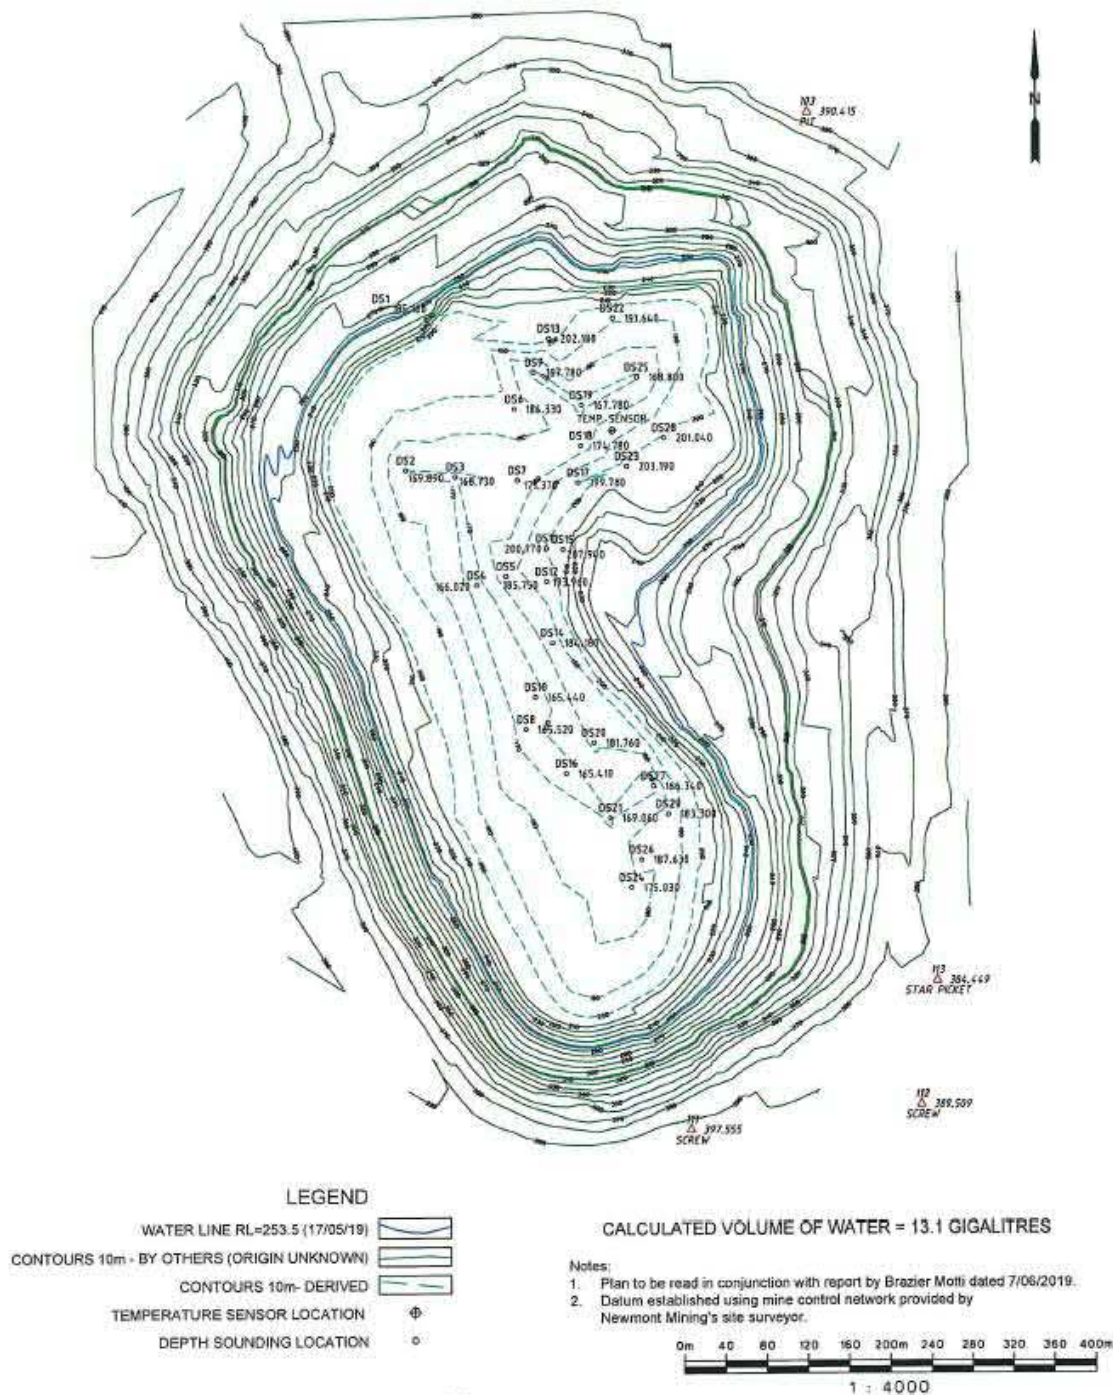
Figure 1.73: Pit Void Landform Geometry

A contour plan showing the current geometry of the pit walls and tailings deposition surface in the pit floor is provided in Figure 1.73 and is based on a bathymetry survey of the pit lake that was undertaken in May 2019 and LiDAR survey of the exposed pit walls that was captured in 2010. The final dimensions of the pit void are as follows:

- Length of void: 1,175 m.
- Width of void: 810 m.
- Depth of void (to tailings surface in floor of pit): 213 m.
- Tailings surface level in pit floor: 165.5 m AHD.
- Original pit floor level (prior to in-pit tailings deposition): 30 m AHD (approximate).
- Pit rim level: 378.5 m AHD.
- Storage capacity to pit rim level: 63 GL.

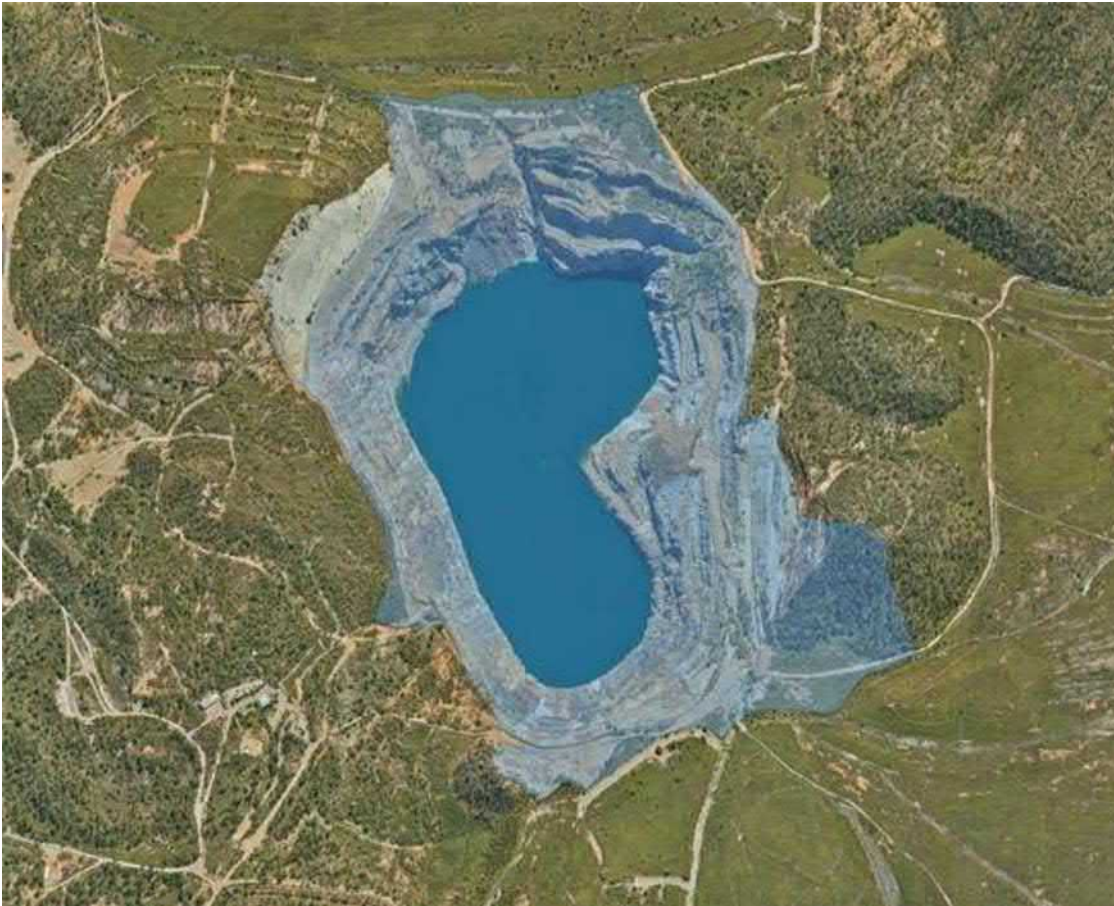
**Figure 1.74: Pit Void Catchment Area**

The direct catchment area reporting to the pit is 88 ha (Figure 1.74) and comprises primarily the area within the pit rim (68 ha inclusive of the pit lake area which is currently 25 ha) in addition to a small external area (20 ha) that drains off the western and southern sides of Mt Mawe.

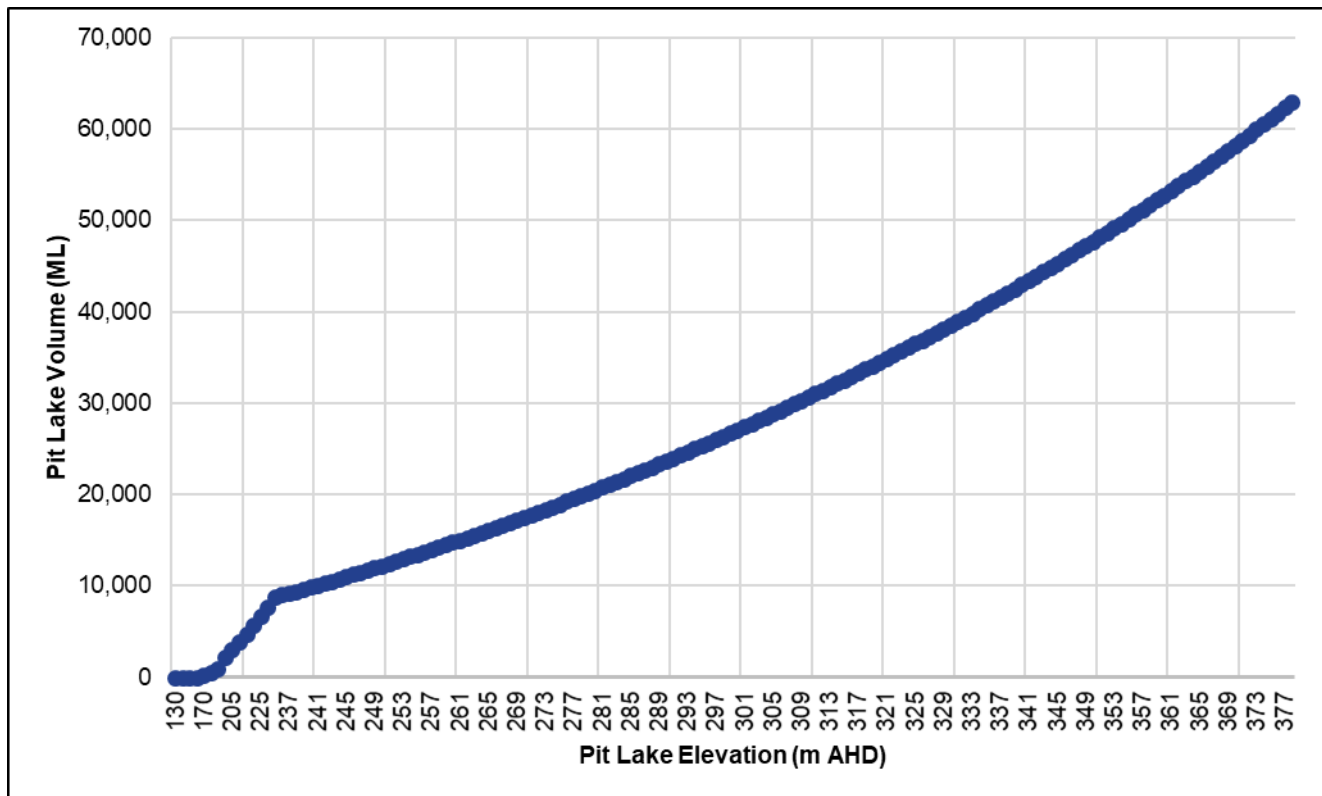
**Figure 1.75: Pit Void Storage Characteristics**

The storage characteristics of the final void are illustrated in Figure 1.75. The storage capacity of the pit void to the pit rim level is approximately 63 GL. The current pit lake level is 253 m AHD and there is approximately 13 GL of water in the pit lake.

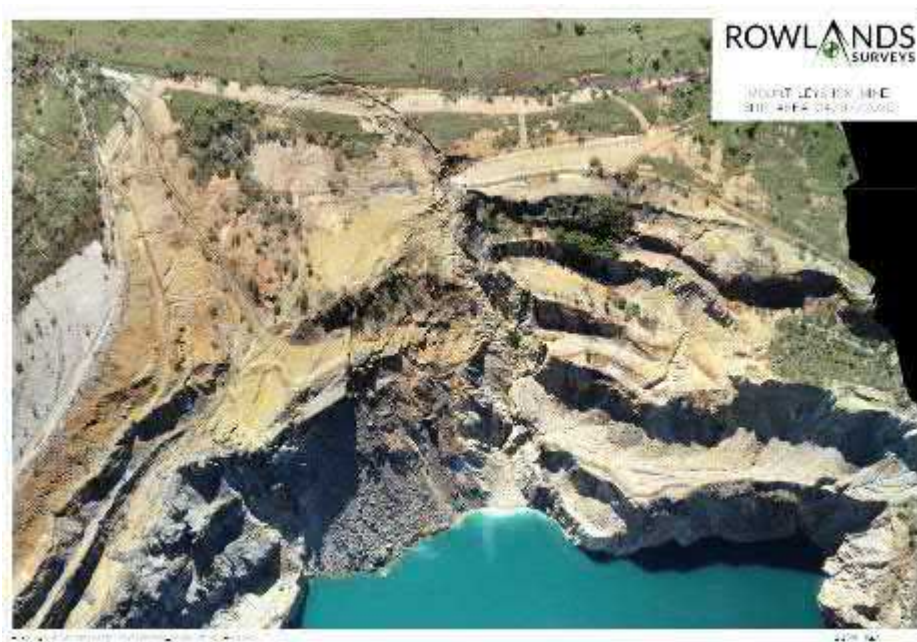
Figure 1.76: Slip Failure of Pit Void North Wall

The predicted slip failure of the north pit wall along the Mine Fault occurred in January 2009 and extended into the southern side of the ONTSF impoundment (refer Figure 1.76). No tailings were exposed as a result of the slope failure and associated surface subsidence. The extent of the north wall slip failure surface is very similar to what was originally predicted.

Survey monuments have been installed on the southern edge of the ONTSF approximately 50 m away from the northern-most edge of the existing slip surface. These monuments are surveyed annually to detect any ongoing movement of the slip surface. Fencing has also been installed as a temporary measure to exclude access to the pit north wall slip failure area.

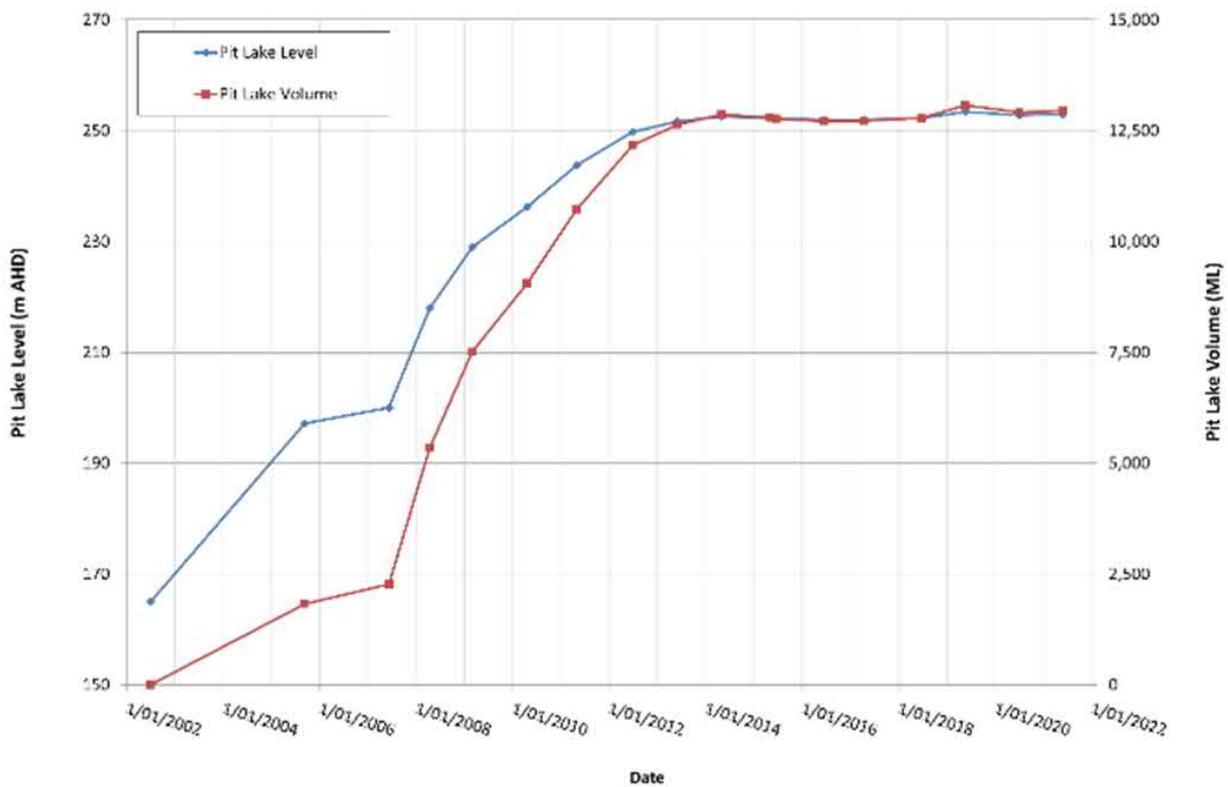
Figure 1.77: Pit Lake Rise Since Mine Closure

The pit lake has been filling since the mine closed in 2002 and the pit dewatering ceased. The pit lake filling history since mine closure is shown in Figure 1.77 and Table 1.27. The pit lake filling history can be characterised by:

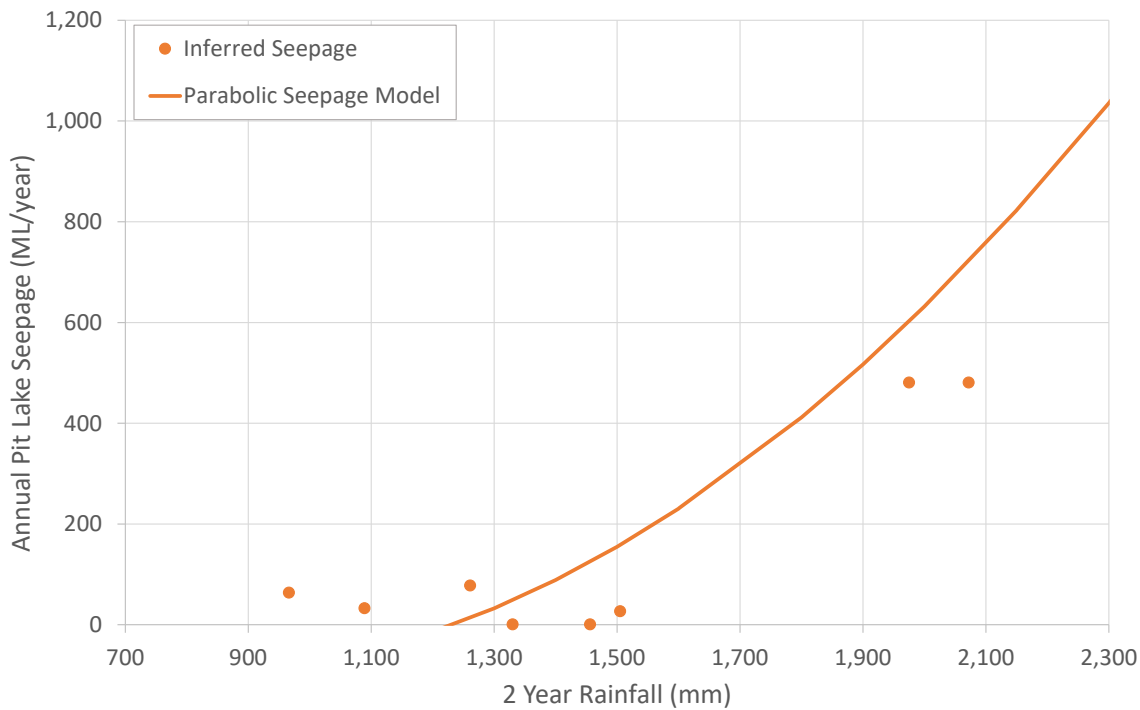
Figure 1.78: Inferred Groundwater Inflows to the Pit Lake

- Pumped inflows from water containment dams and seepage sumps: Obtained directly from flow metering data for pumps that transfer water to the pit.
- Groundwater inflows to the pit lake: Calculated using empirical groundwater inflow relationships inferred from previous pit lake water balance reconciliations (Figure 1.78). It is noted that the groundwater inflow rates have been correlated against running 2 year duration rainfall totals, with the inferred inflows being primarily rainfall driven, suggesting an inflow pathway of seepage from the shallow groundwater system.

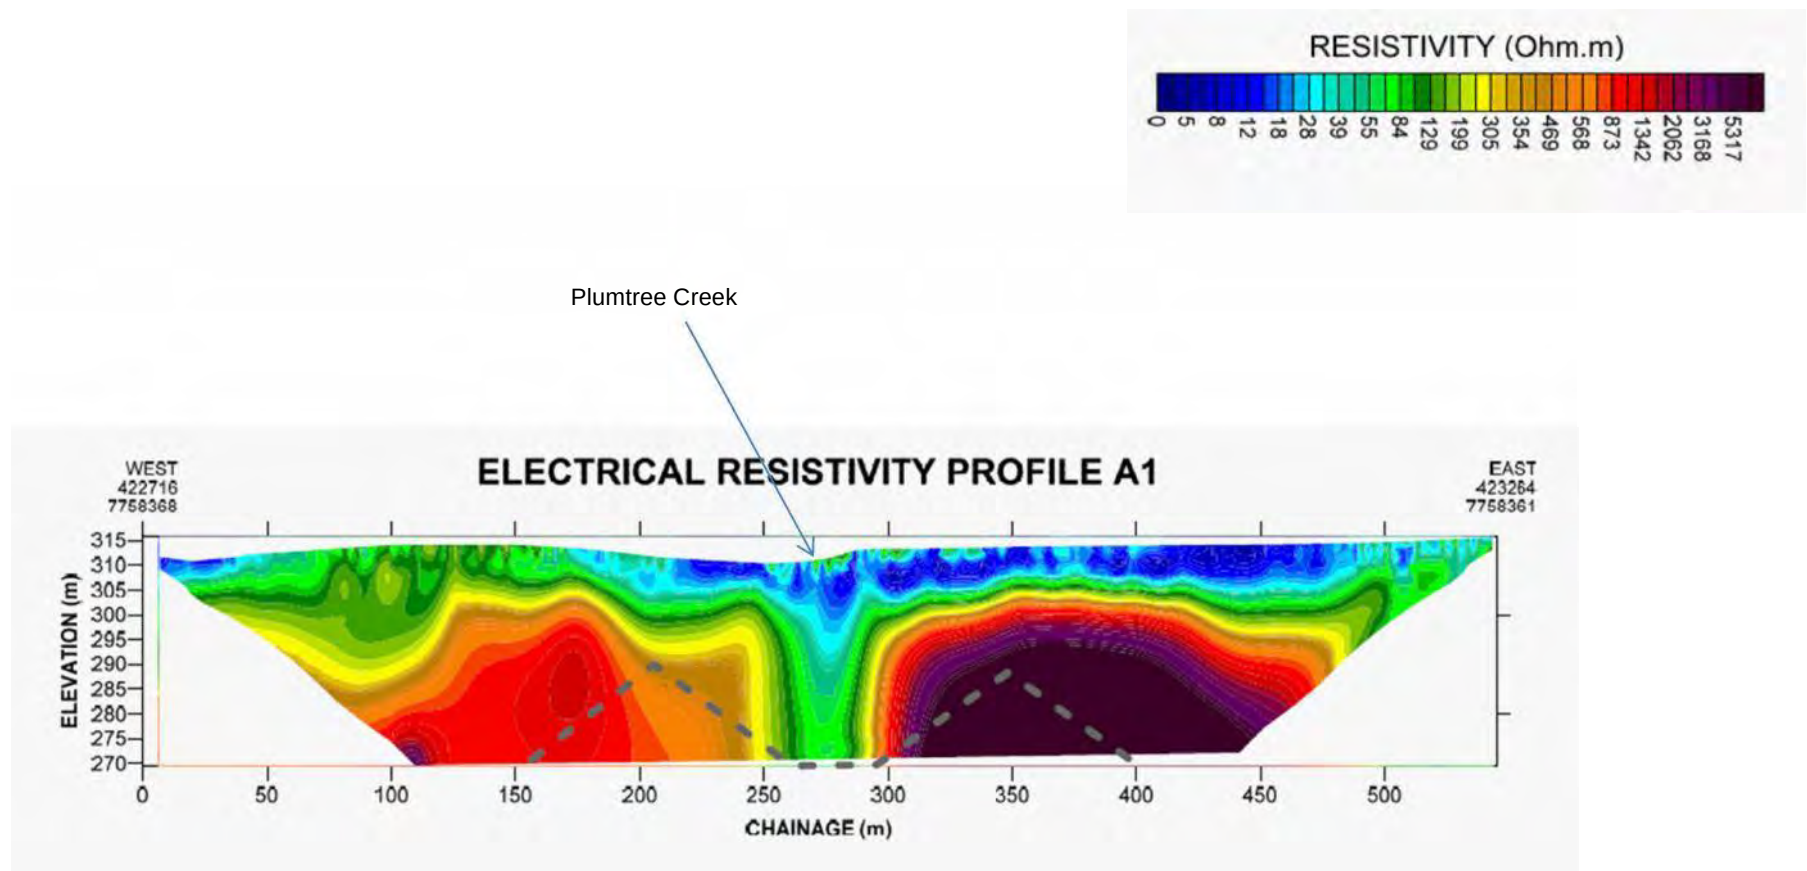
Shallow ERT profiling across Plumtree Creek, illustrating a conductive zone developed to around 30 m depth at the current location of the surface water drainage.
