## Progressive Rehabilitation and Closure Plan

**Mt Leyshon Mine**

M13000\_024-REP-001-2

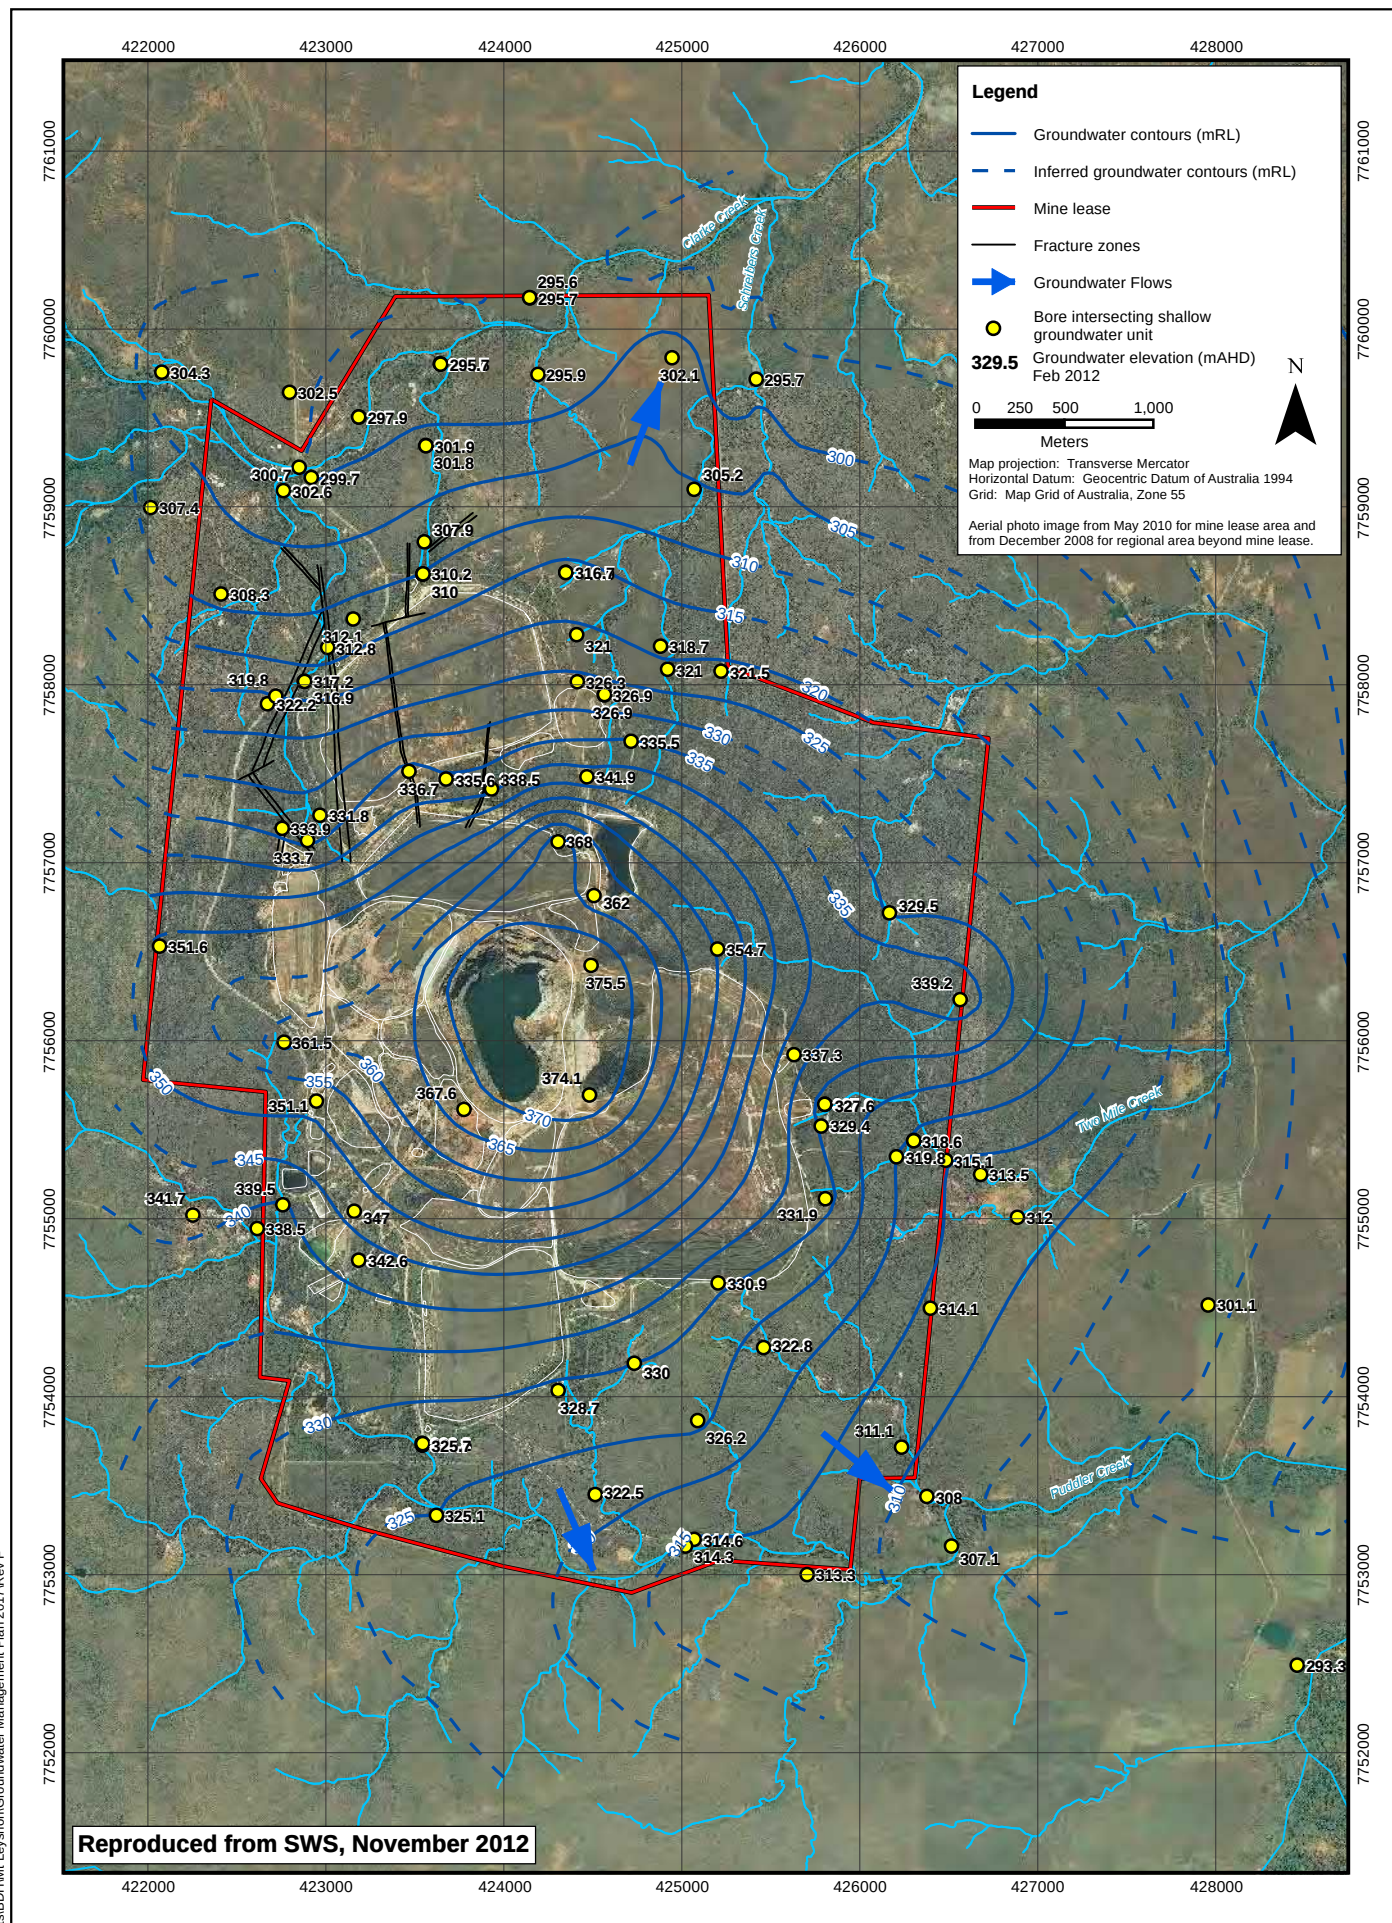
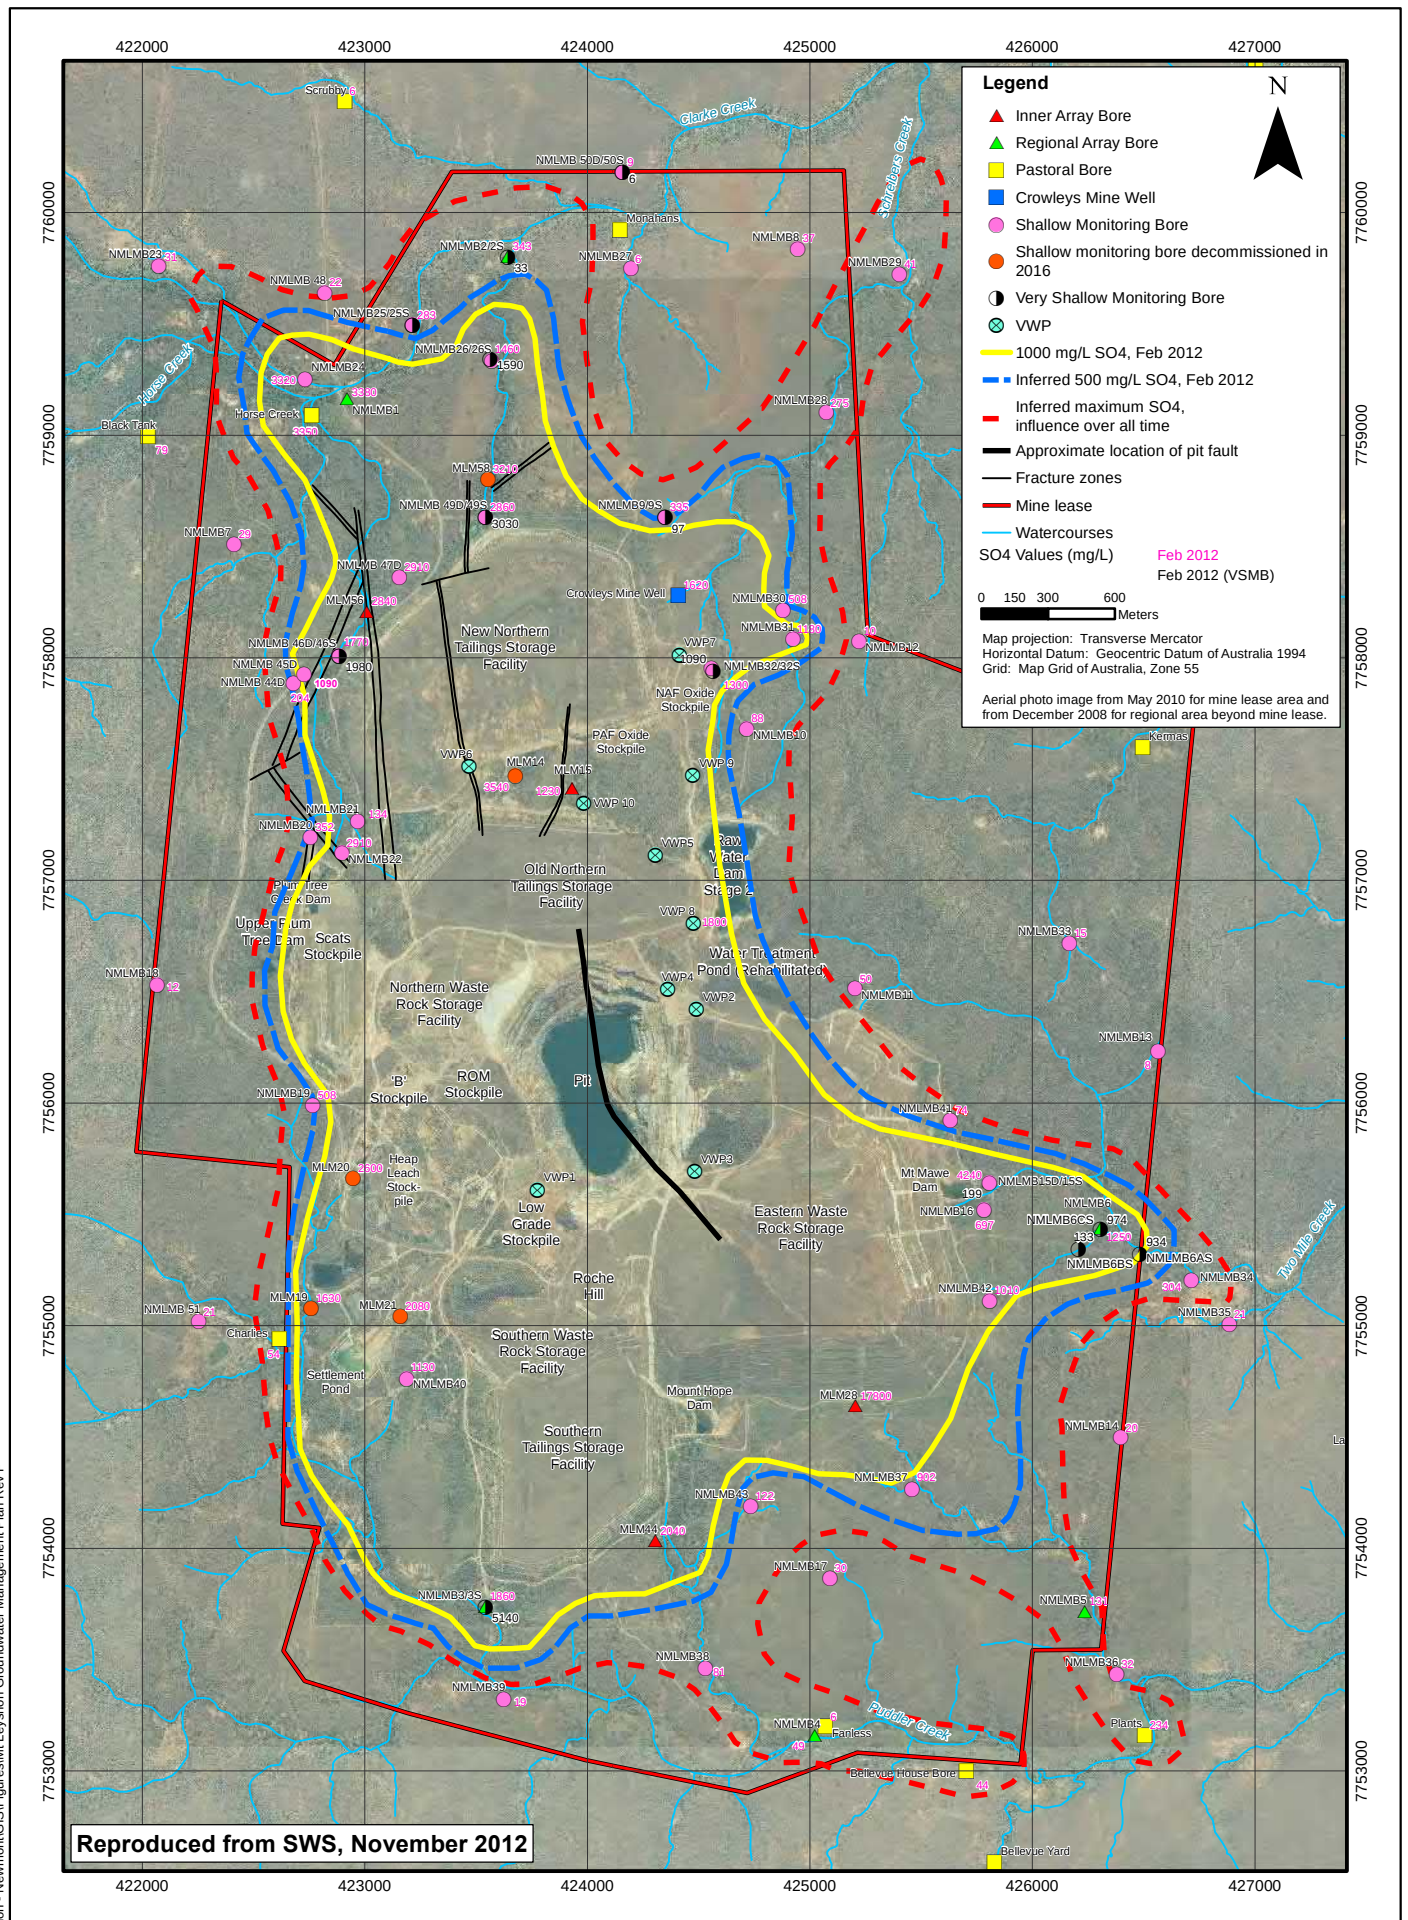
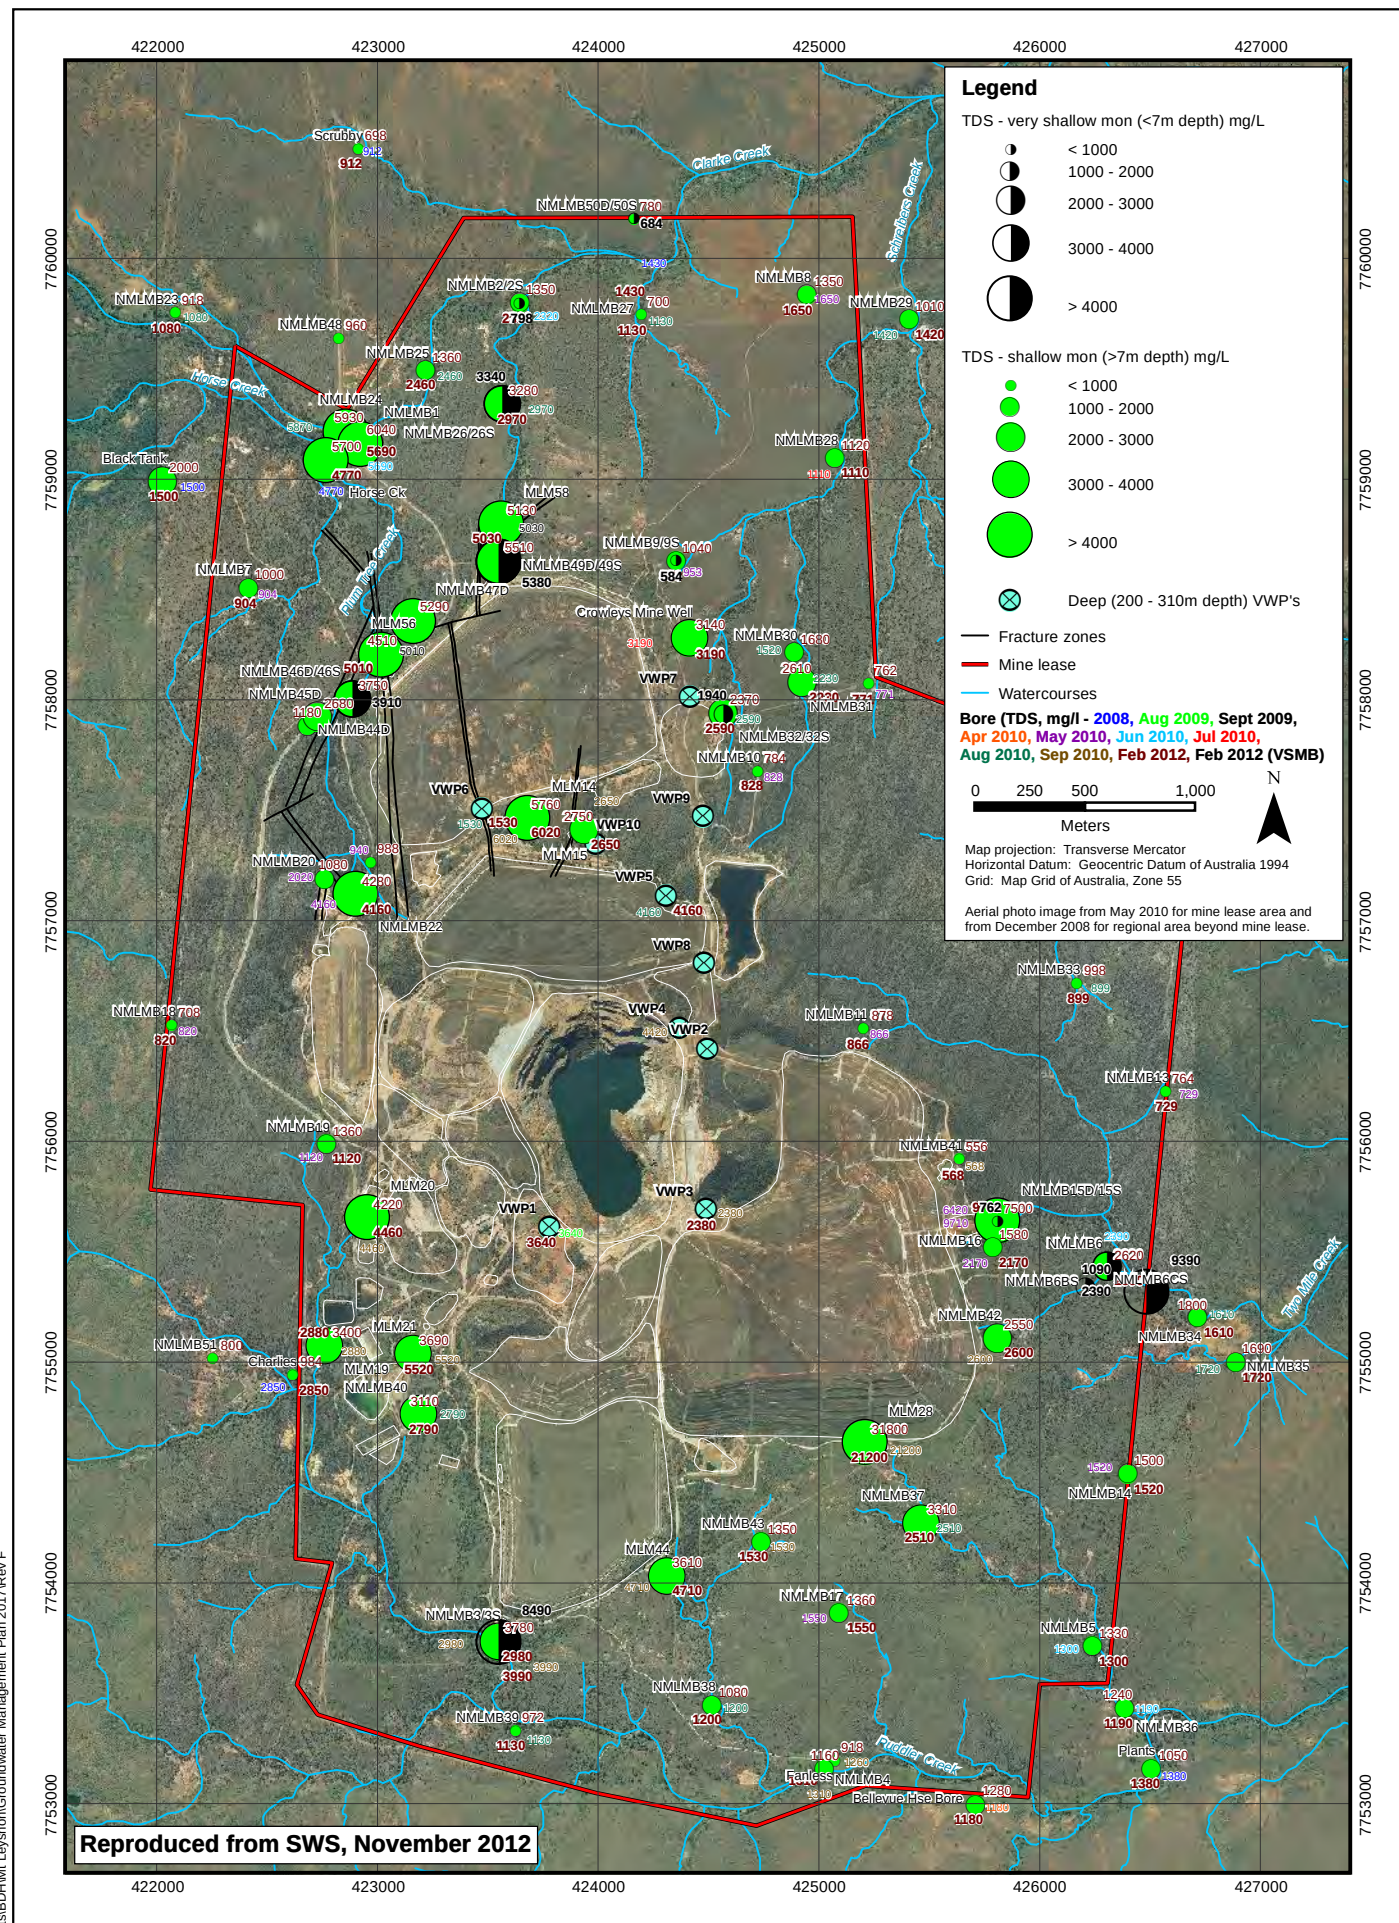
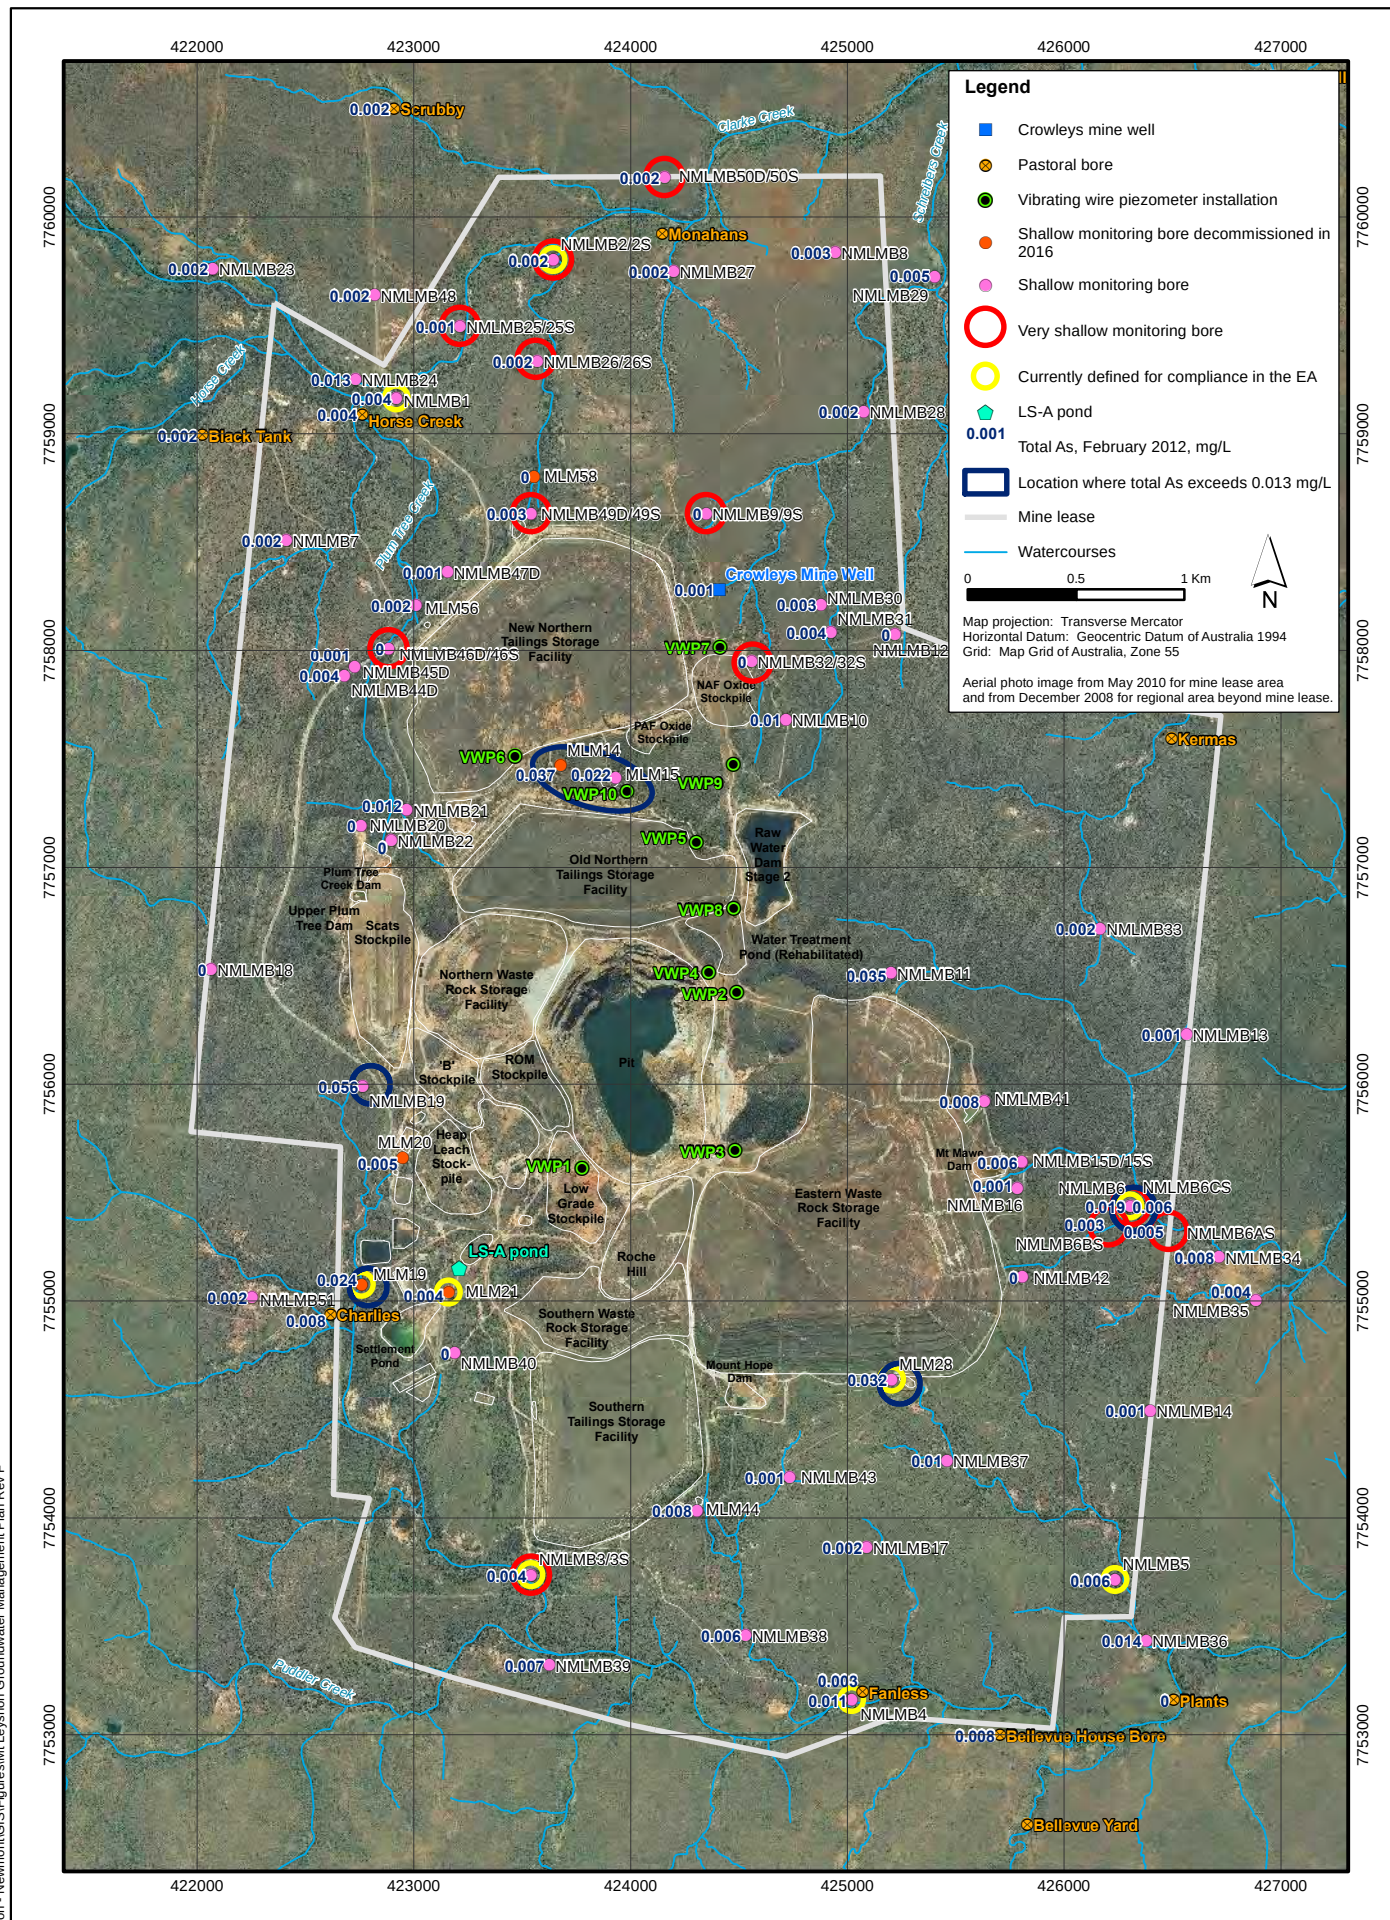
**Figure 10**

**Total As concentrations in groundwater**

- Figure 10 summarises total As concentrations measured in February 2012. Migration of As within the groundwater system is not widespread, and the small number of locations at which the trigger value of 0.013 mg/L (defined for filterable concentrations) is exceeded comprise individual bores generally located very close to the mine facilities.

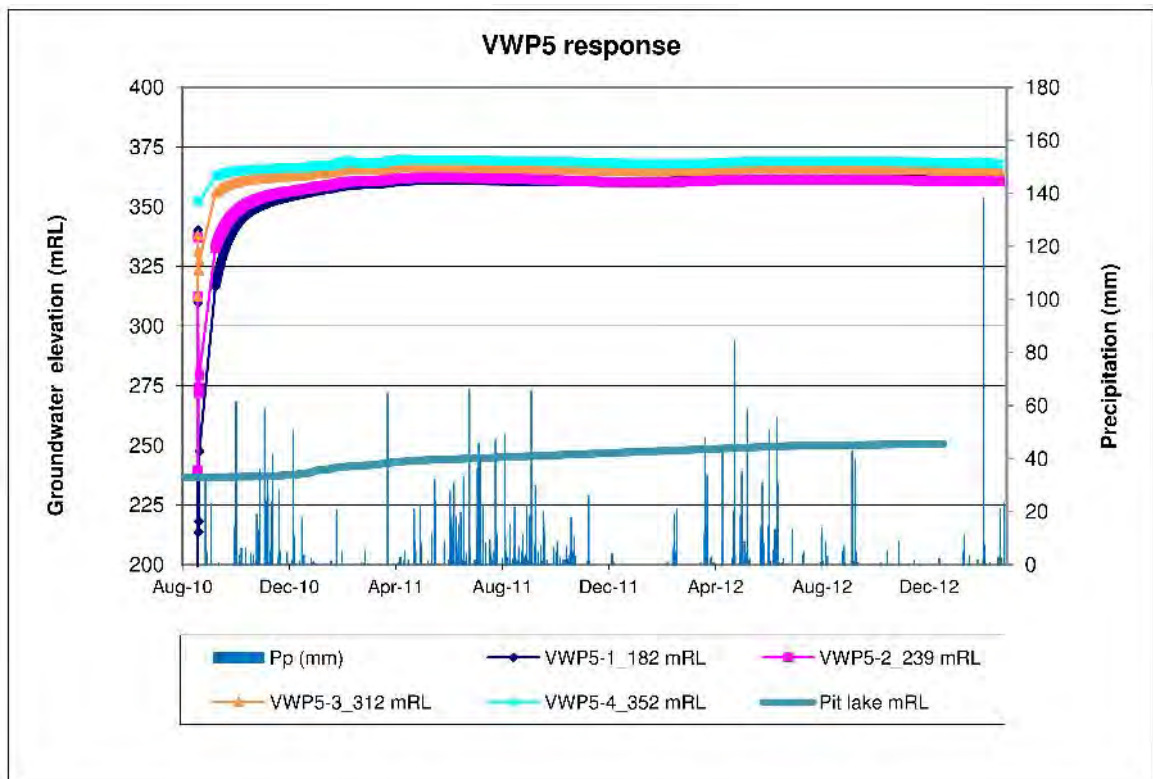
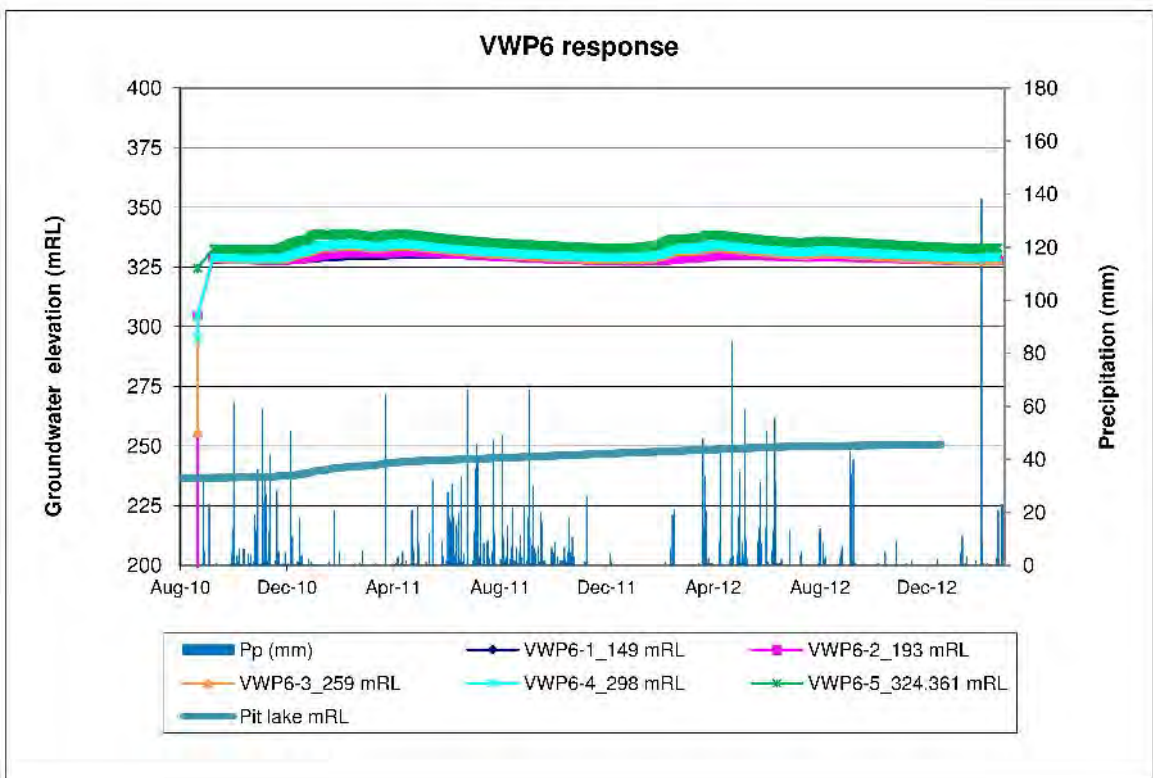
**Figure 17**

**Groundwater elevations, VWP5 and VWP6**

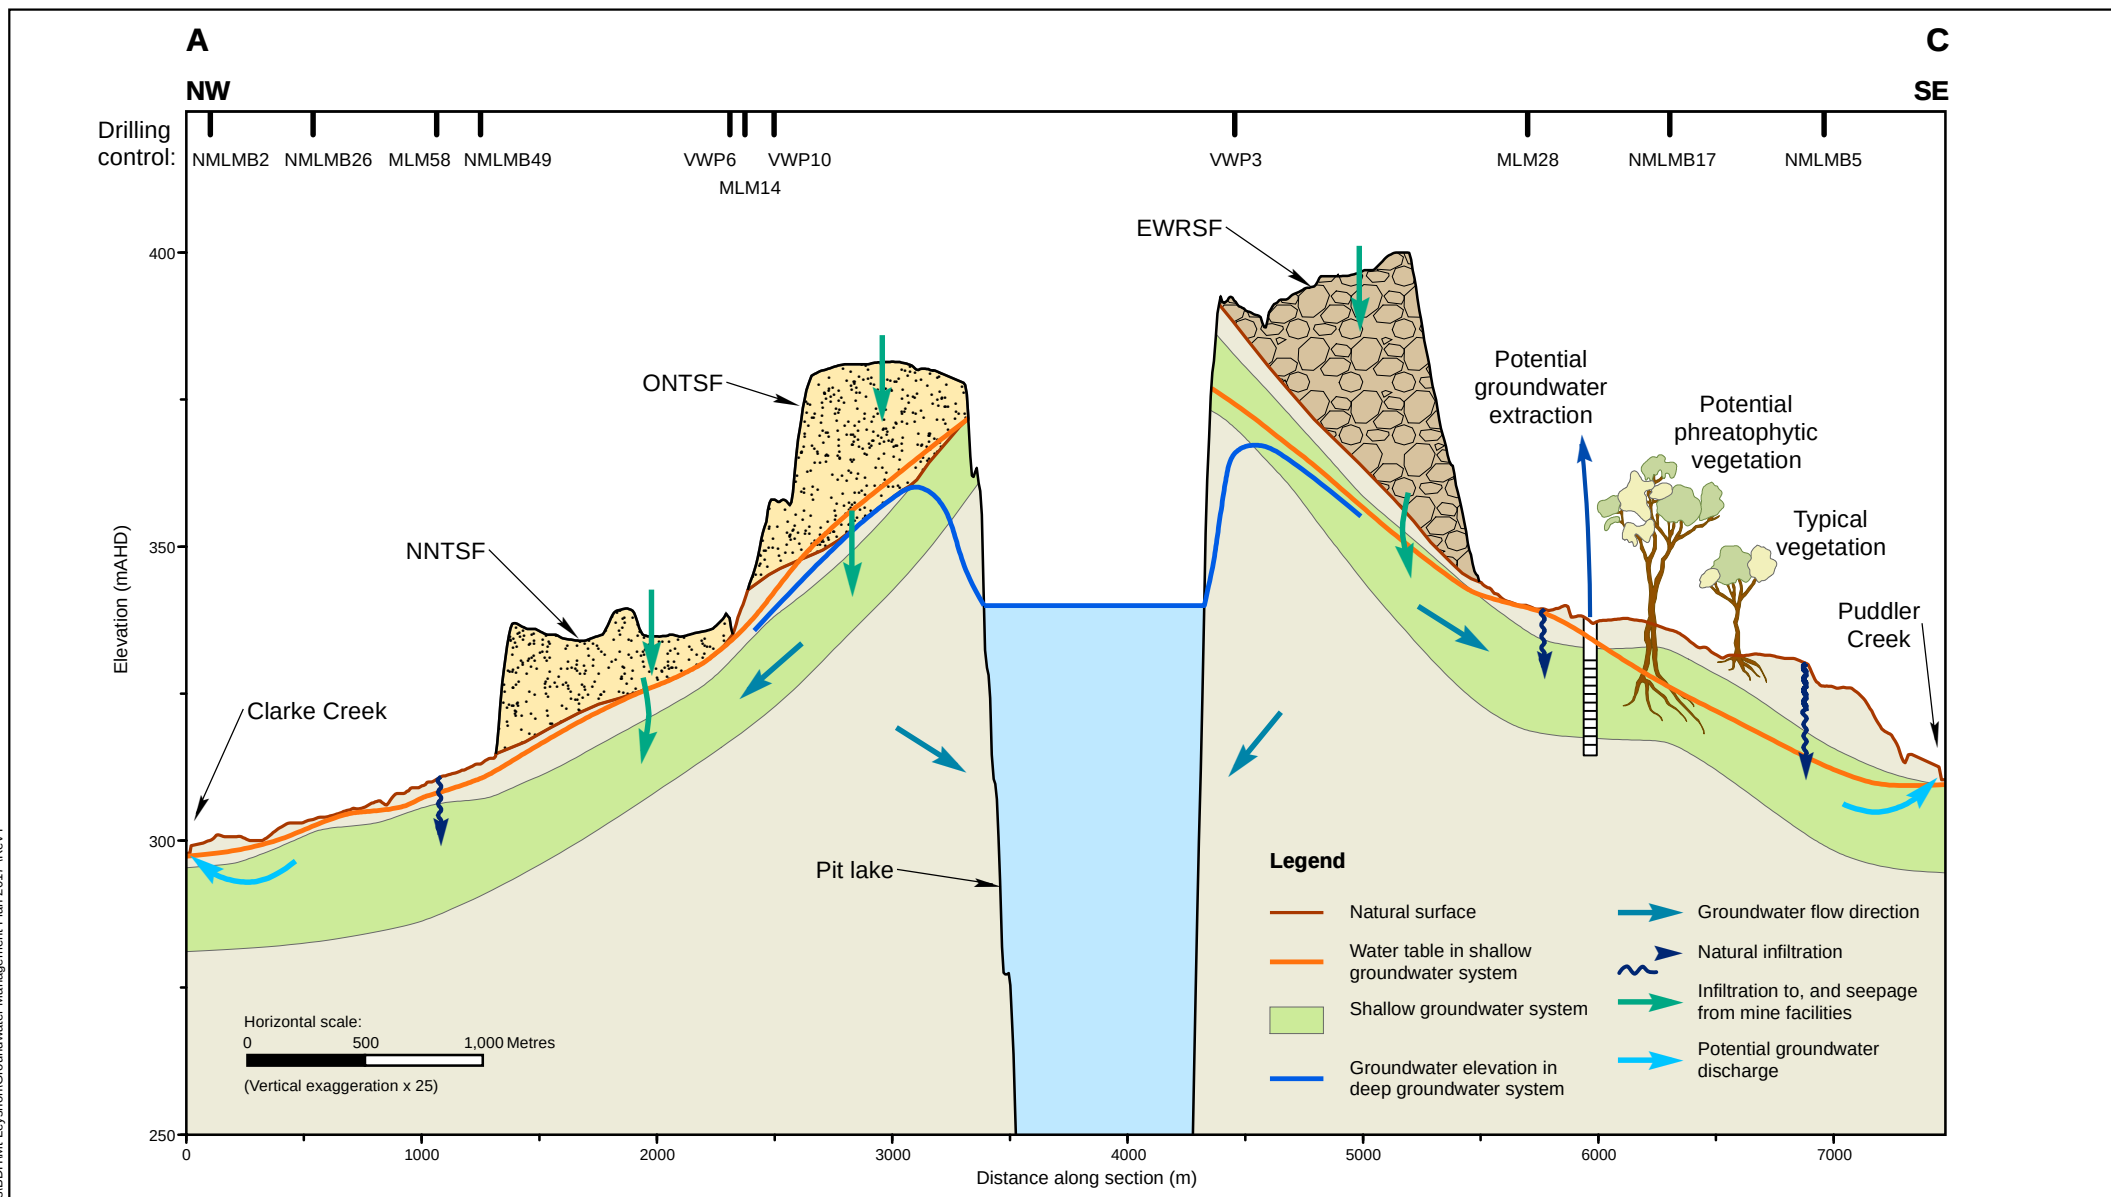
Schematic pathways for potential groundwater impacts

Figure 23 provides a schematic illustration of potential pathways for the migration of groundwater impacts, using a hydrogeological cross section constructed along line ABC as drawn in Figure 1. The section in Figure 23 illustrates that groundwater flows away from the pit area to the north, and away from the pit area to the south, driven by a combination of natural recharge and infiltration of seepage from the closed mine facilities. The section also illustrates examples of potential impacts on environmental values, including discharge into Puddler Creek, groundwater use by phreatophytic vegetation, and groundwater abstraction via bores.

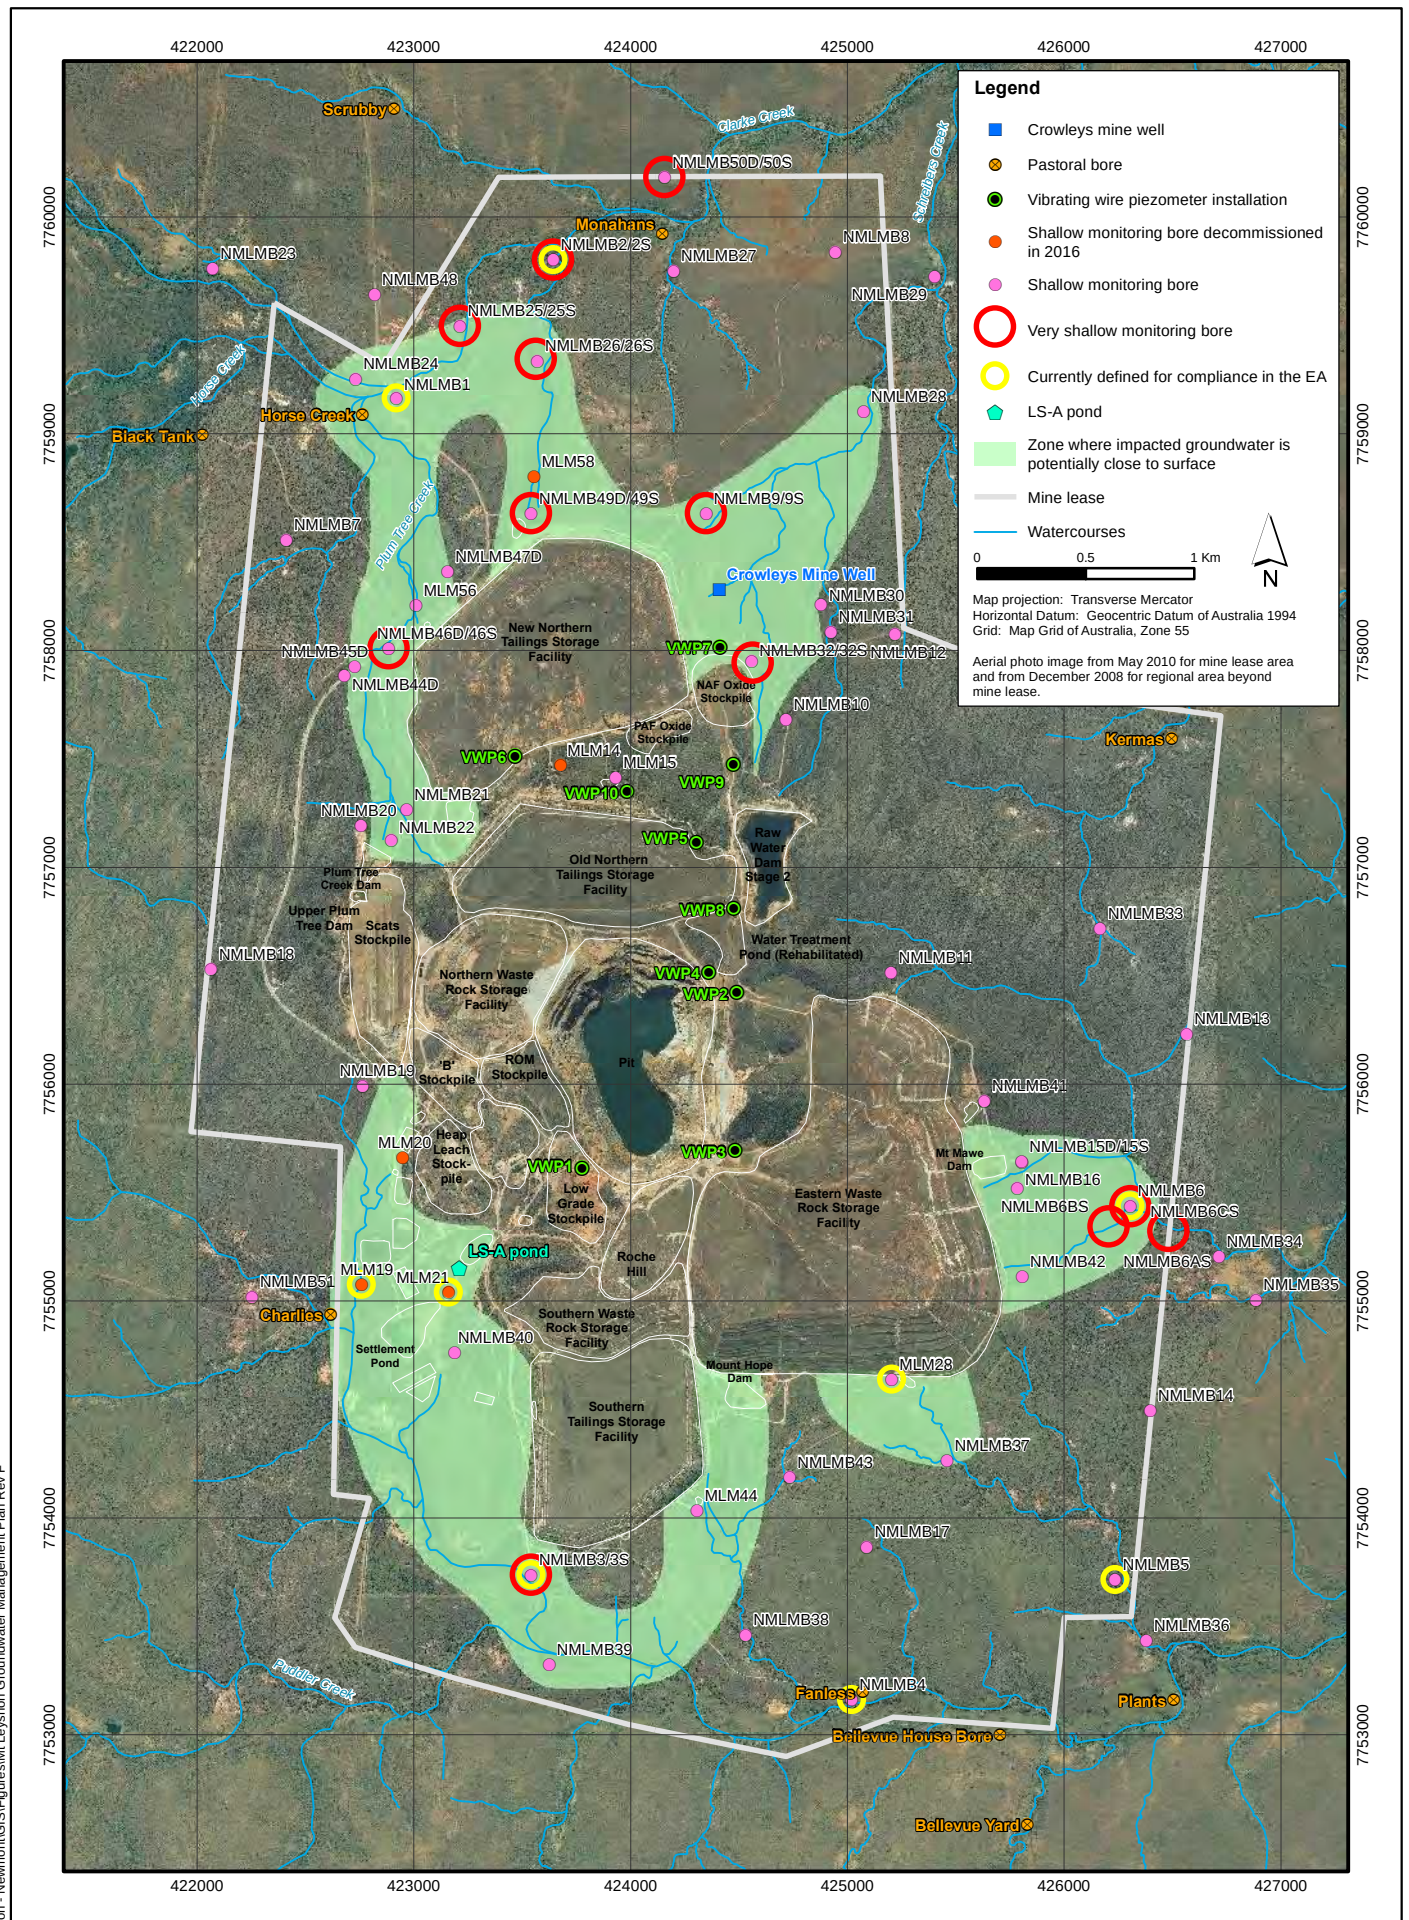
Priority monitoring zones at surface

- Interpolation of groundwater and surface elevations in Figure 12 identifies a significant extent of streams where discharge may occur.
- Some of the identified discharge zones coincide with areas where sulphate and total Co concentrations are elevated in groundwater. Figure 25 provides an indication of the areas which are potentially at highest risk from discharge of groundwater at surface, by highlighting areas where 1) sulphate concentrations exceed 1,000 mg/L and/or total Co concentrations exceed 0.01 mg/L; and 2) groundwater was interpolated to be within 4 m of surface in February 2012.

- Figure 25 does not represent an assessment of actual impacts at surface. Potential impacts will be determined during the ongoing studies into the fate and implications of TDS, sulphate and Co in the surface environment. Rather Figure 25 defines the zones where the potential risk is relatively higher, and is intended to be used to prioritise the monitoring and investigation studies.

The areas at greatest risk for this potential impact are as defined in Figure 25, where groundwater is identified to be potentially shallow, and groundwater quality has been impacted during the mining and closure period. Monitoring which is proposed to investigate the level of risk associated with this potential impact is:

- Regular sampling of groundwater chemistry outside the current area of mining influence to identify future migration of the zone of impacted groundwater.
- Investigation of vegetation health in the higher priority zones defined in Figure 25 during the ongoing environmental monitoring and maintenance operations at the site.

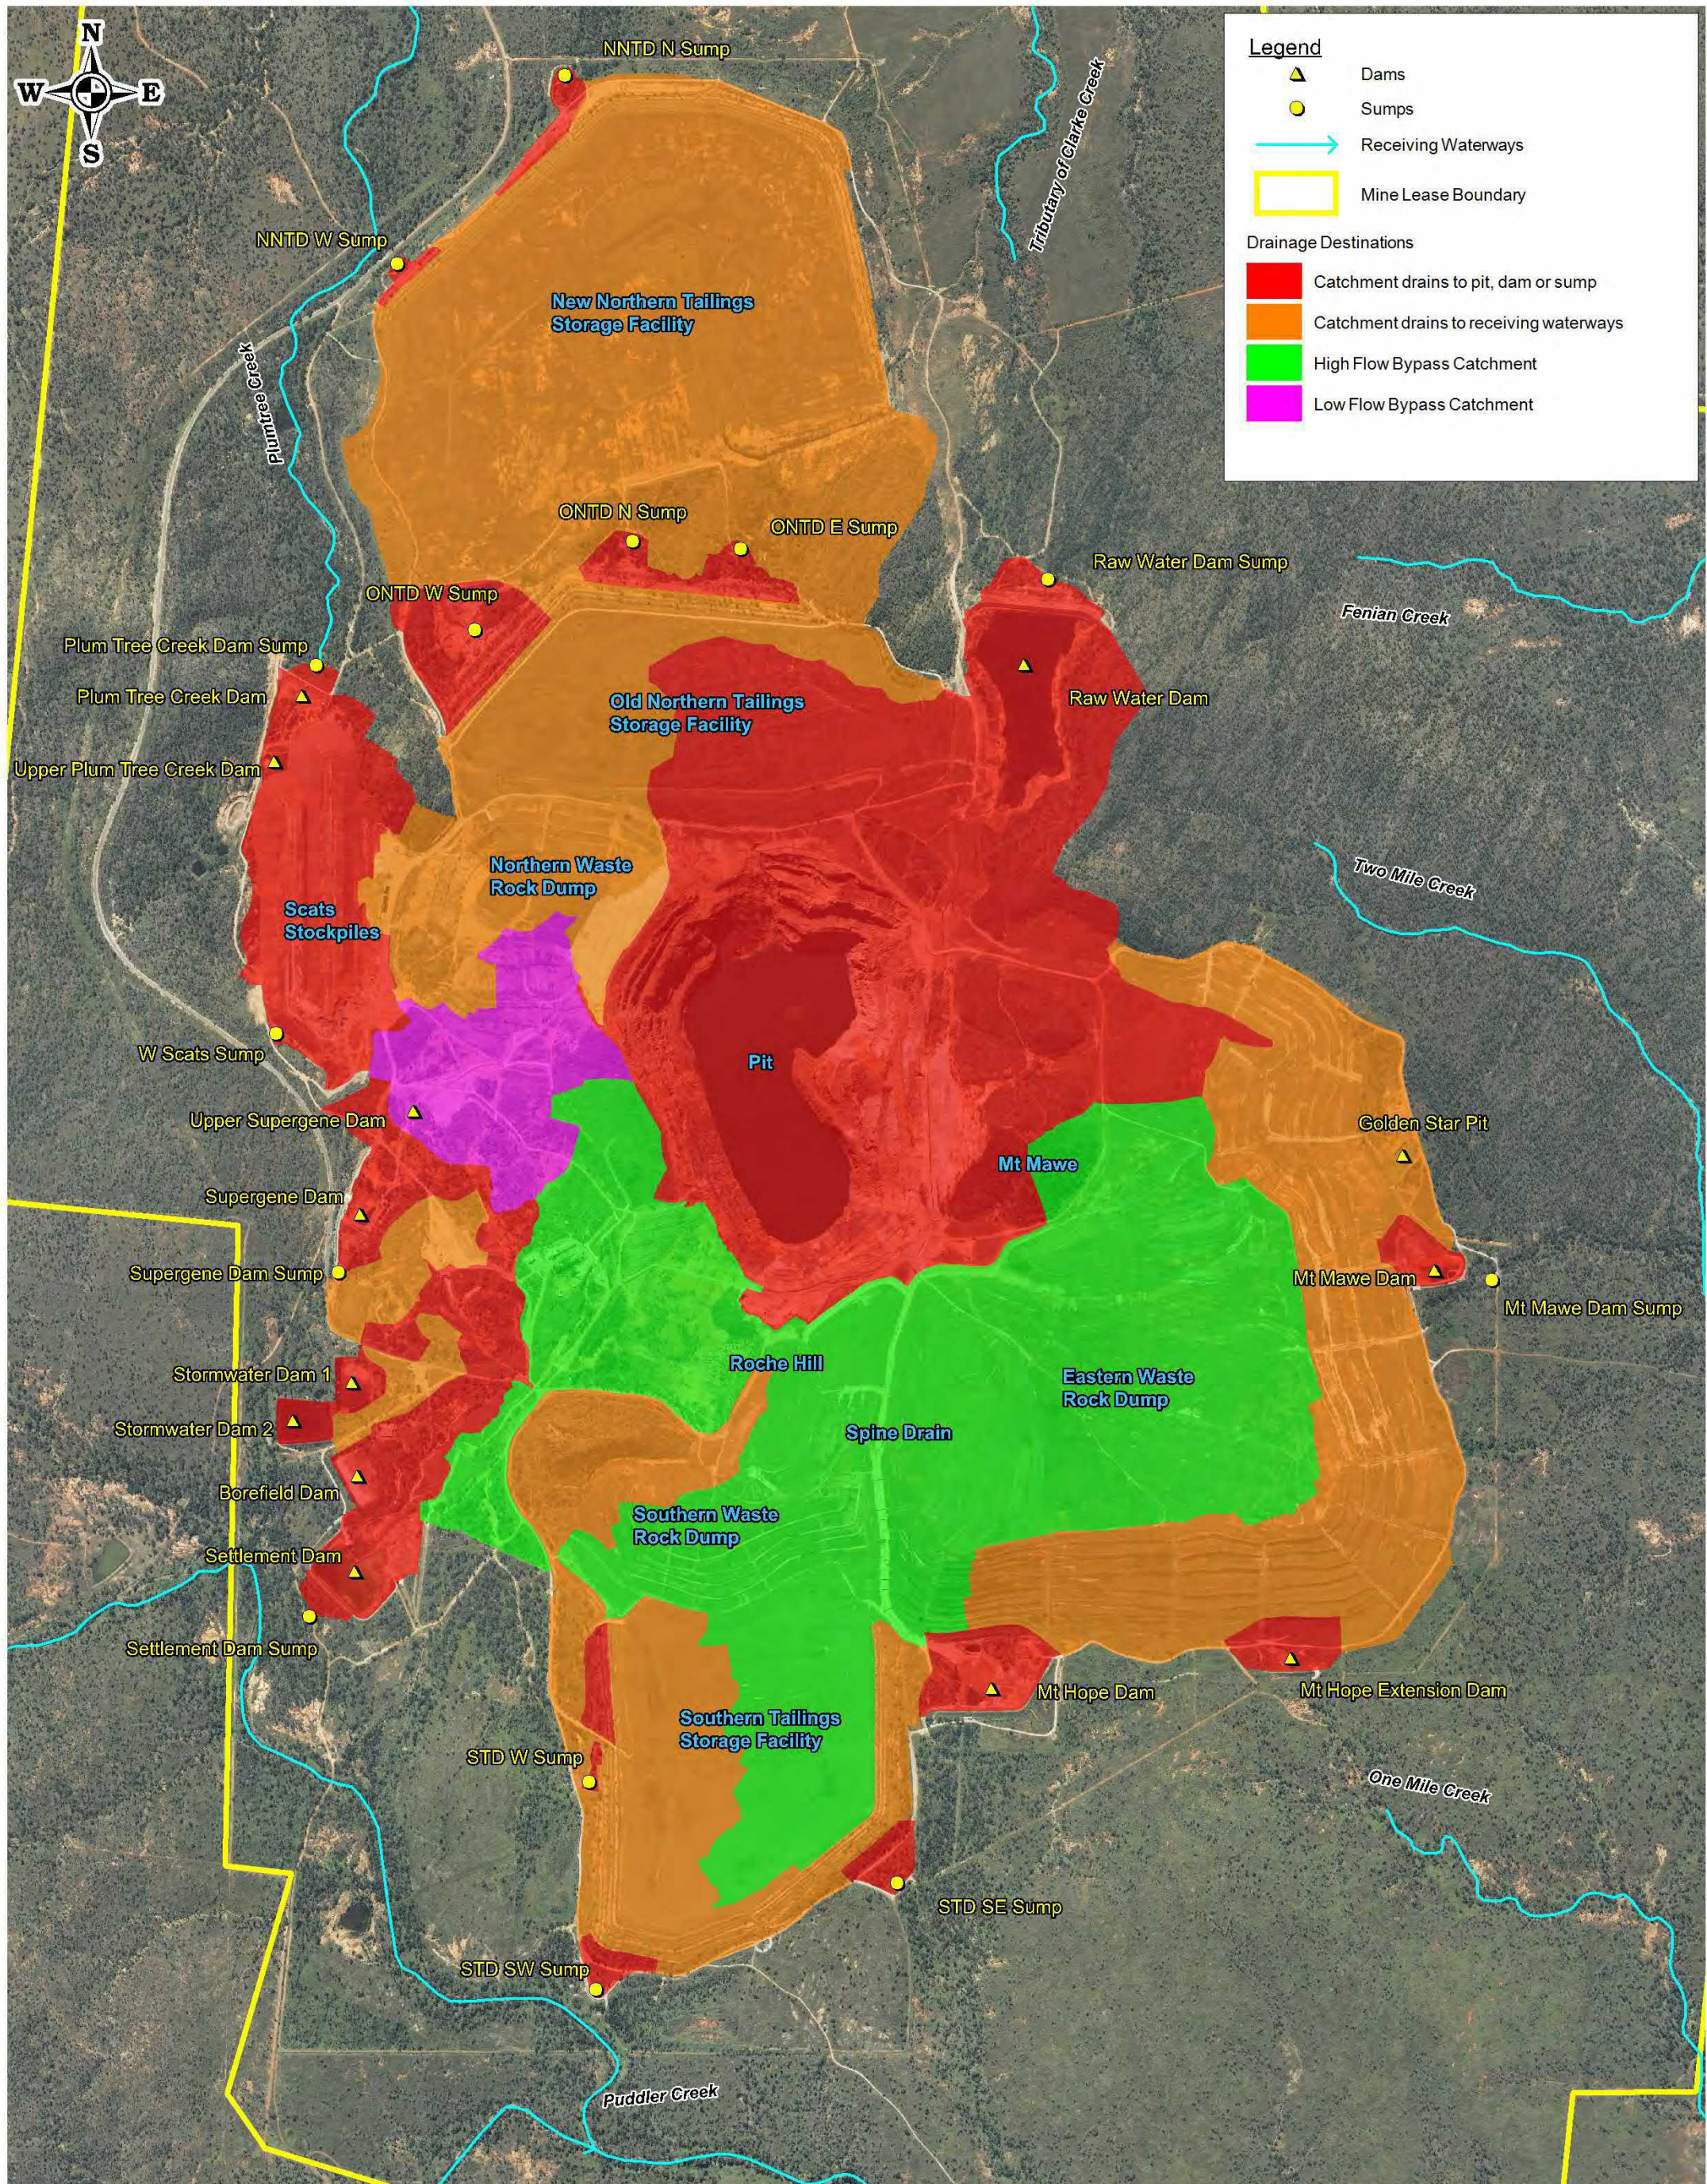
### **2.5.2 Local Receiving Waterways**

Ephemeral waterways between the edge of the mine disturbance area and the mine lease boundary are identified in Figure 2.4. In the limited periods when runoff occurs, the topography within the mine lease area drains to:

The main drainage divisions between these receiving waterways are shown in Figure 2.4. The fraction of the mine lease area draining to the three main receiving waterways is detailed in Table 2.5.
