## Progressive Rehabilitation and Closure Plan

**Mt Leyshon Mine**

M13000\_024-REP-001-2

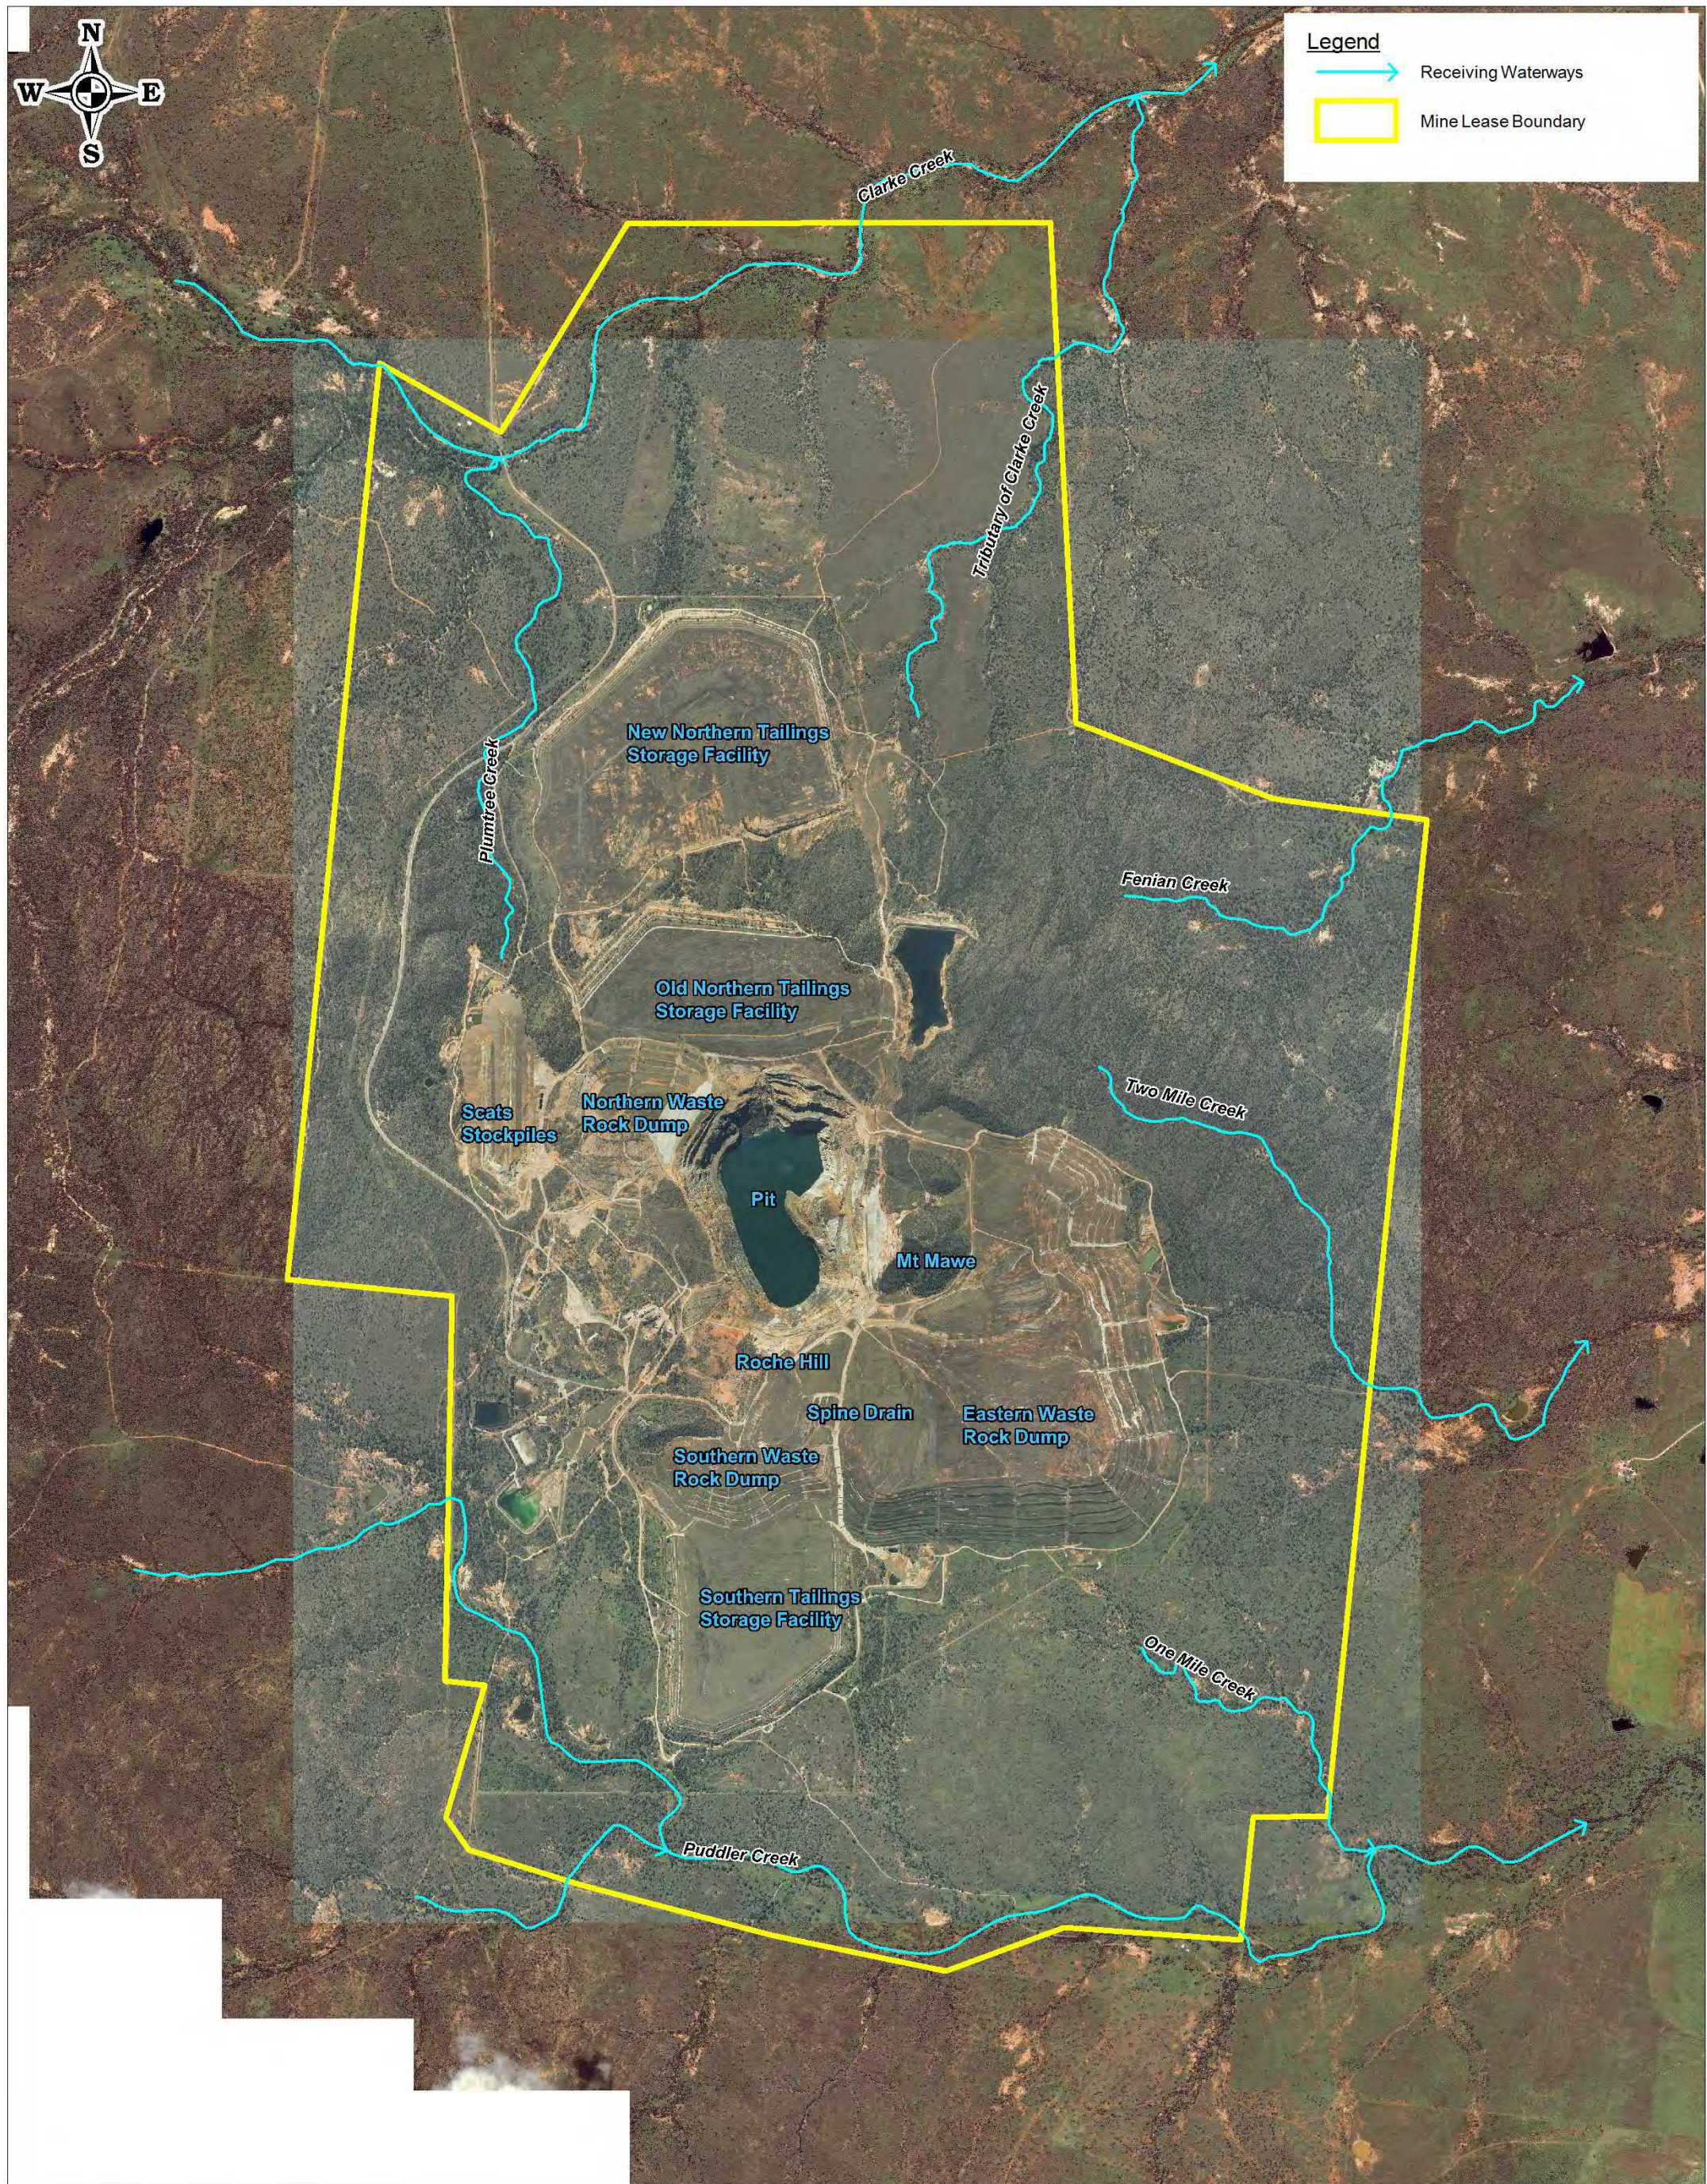
### 2.5.3 Regional Receiving Waterways

The receiving waterways downstream of the mine lease area are shown in Figure 2.5. All of the local receiving waterways eventually discharge into the Broughton River, which flows into the Burdekin River 25 km to the north-east of the mine site (straight line distance).

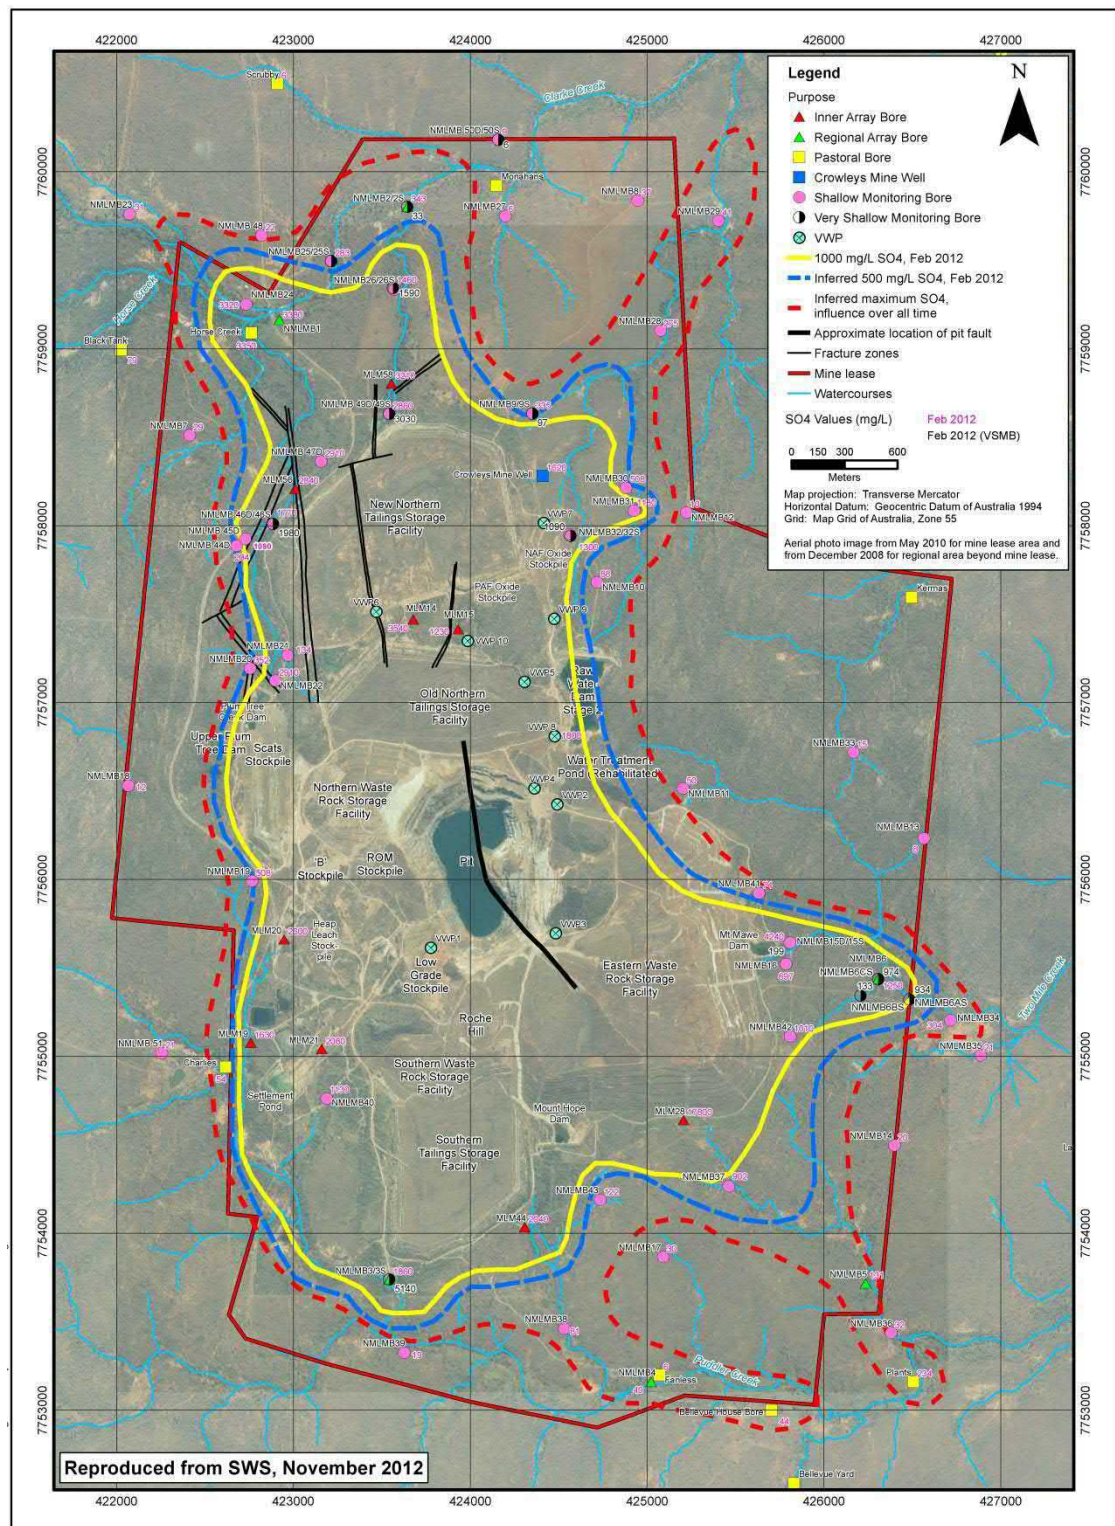
**Figure 5.1 2012 Extent of Sulphate in Groundwater (Schlumberger Water Services, 2012)**

The extent of elevated sulphate concentrations in groundwater has been inferred by Schlumberger Water Services (2012) based on groundwater quality monitoring data (refer Figure 5.1) and indicates that:

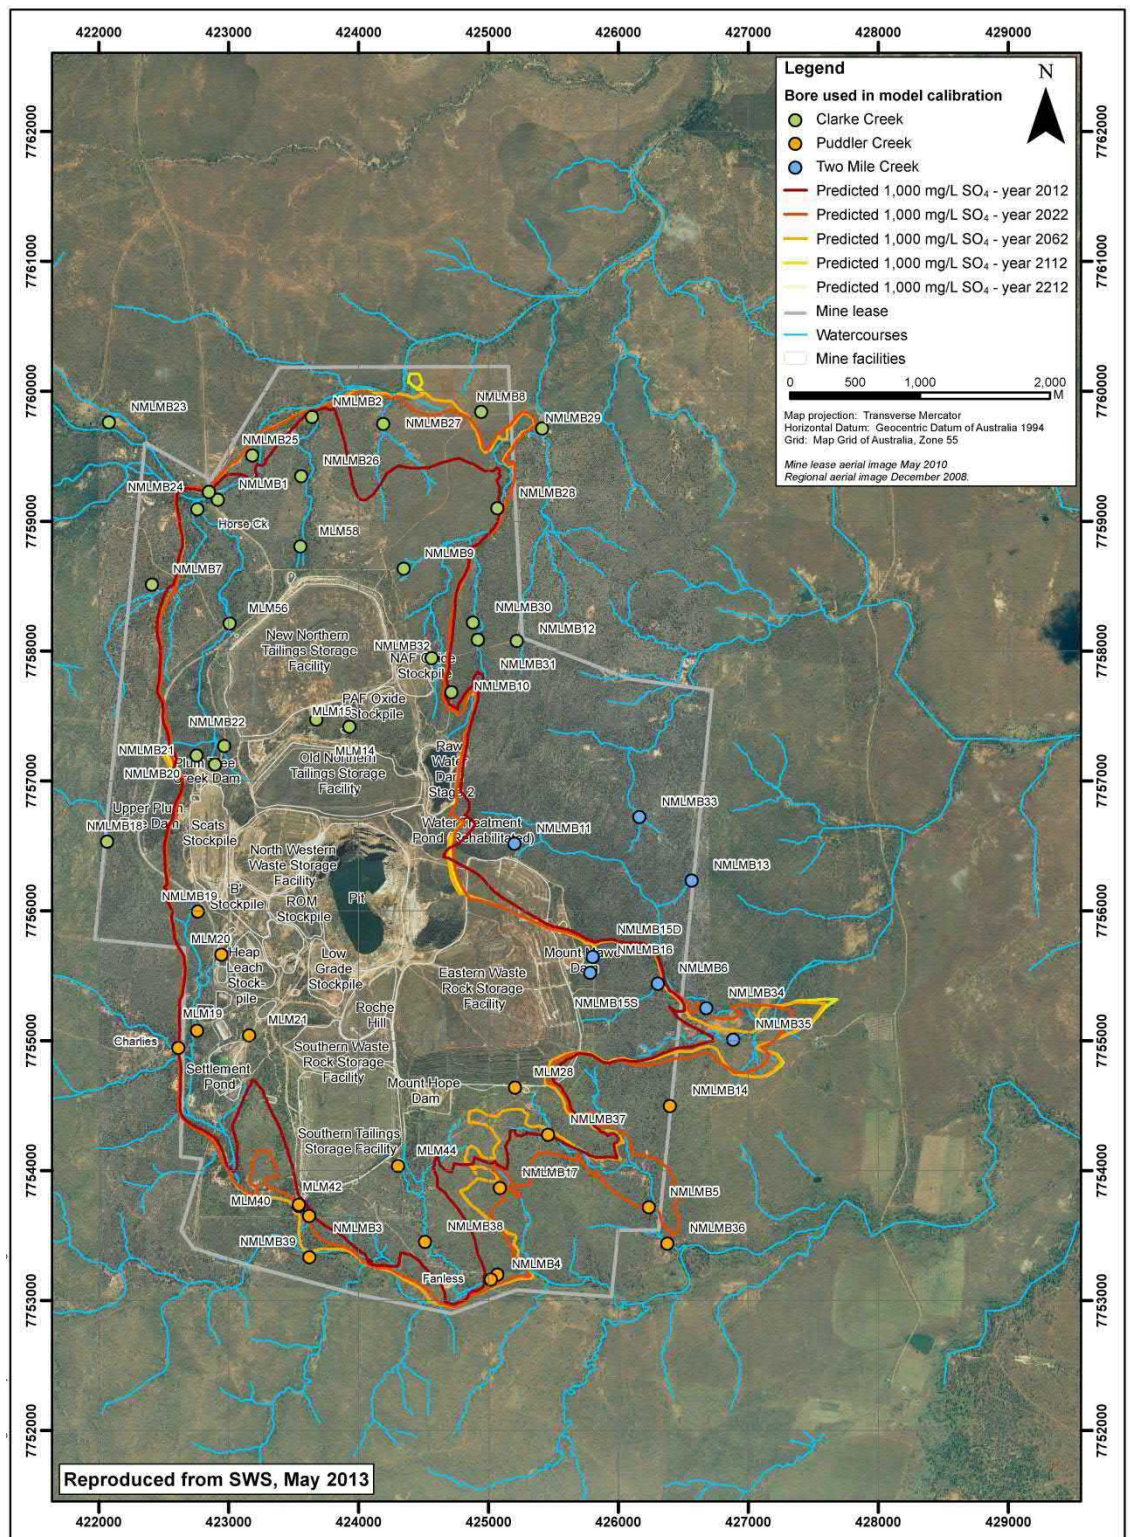
Figure 5.2 Predicted Future Extent of 1,000 mg/L Sulphate Contour (Schlumberger Water Services, 2013)

The results showed that with the calibrated parameters and average rainfall conditions the maximum future extent of sulphate concentration is unlikely to change a great deal from the extent observed in 2012. In two areas (to the northeast and southeast) continued migration away from the facilities is predicted, but this is limited to about an additional 1 to 2 km to the east in the year 2212 as shown in Figure 5.2 and Figure 5.3.

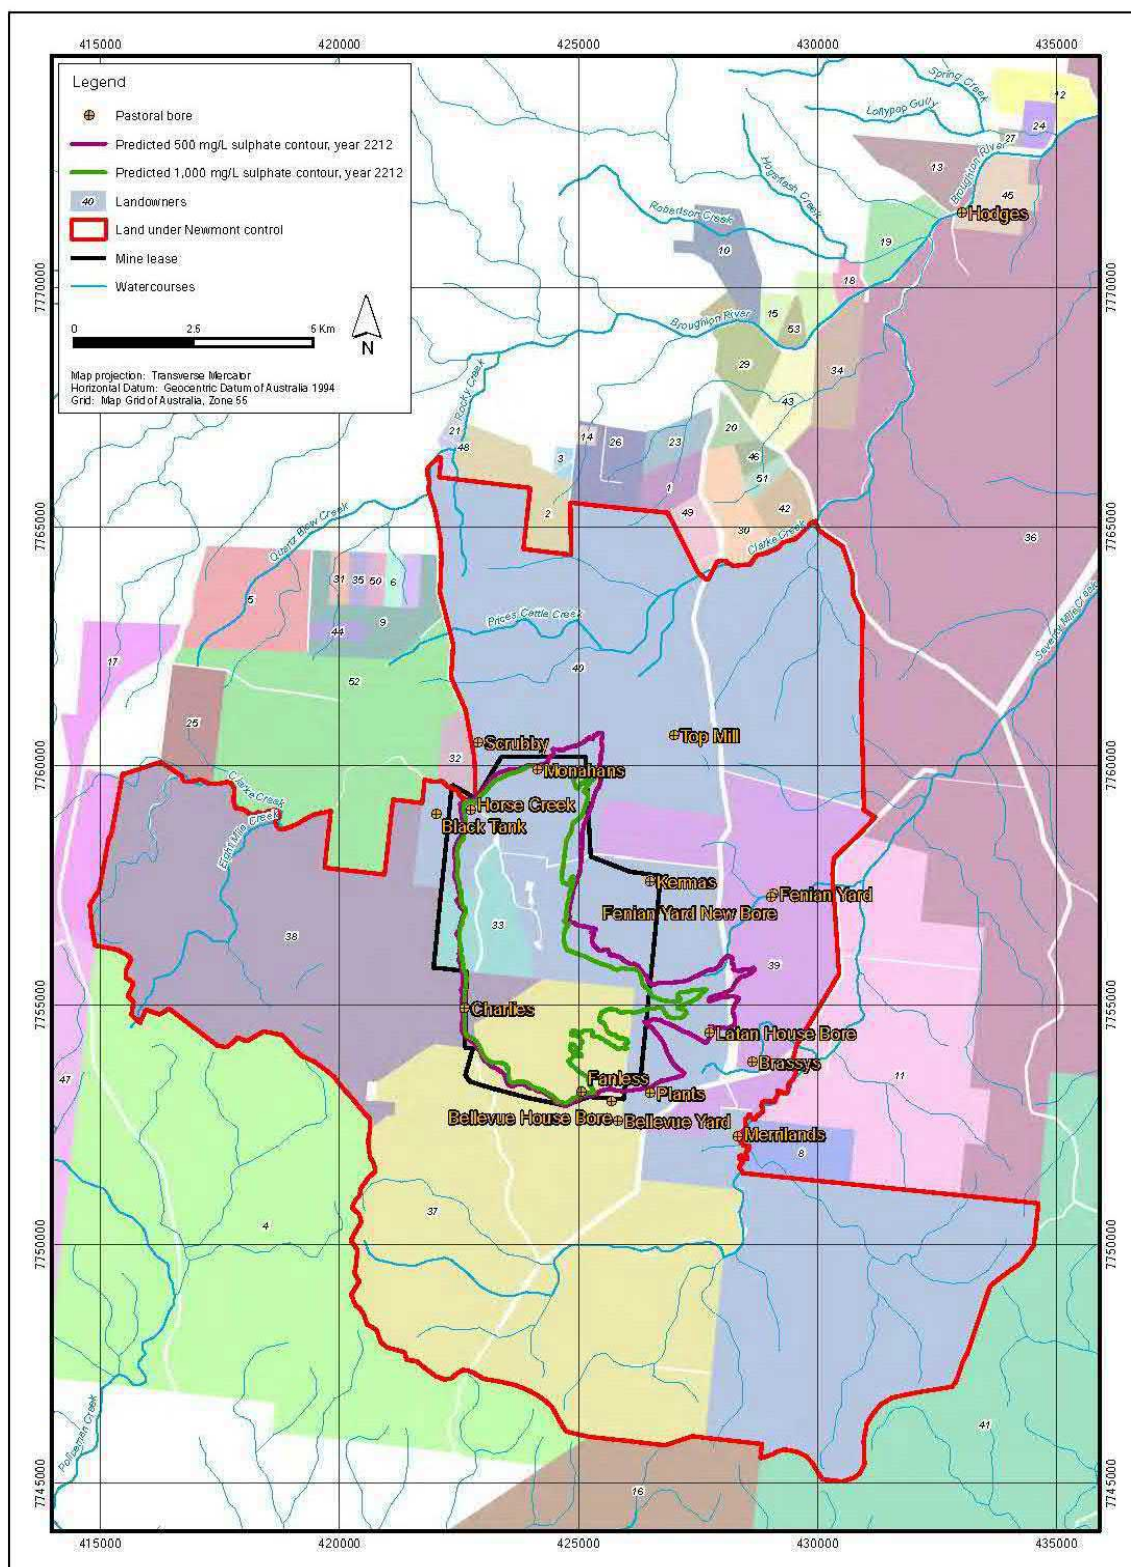
**Figure 5.3 Predicted Future Extent of 1,000 mg/L Sulphate Contour including Property Ownership (Schlumberger Water Services, 2013)**

- Continuation of works to improve the cover and drainage systems on the closed mine facilities to minimise infiltration.
- Control of access to groundwater in the mine lease and in the down-gradient properties and ensuring that any future changes in land use maintain these restrictions. Newmont has purchased all pastoral holdings adjacent to the Mt Leyshon Mine (Figure 5.3).

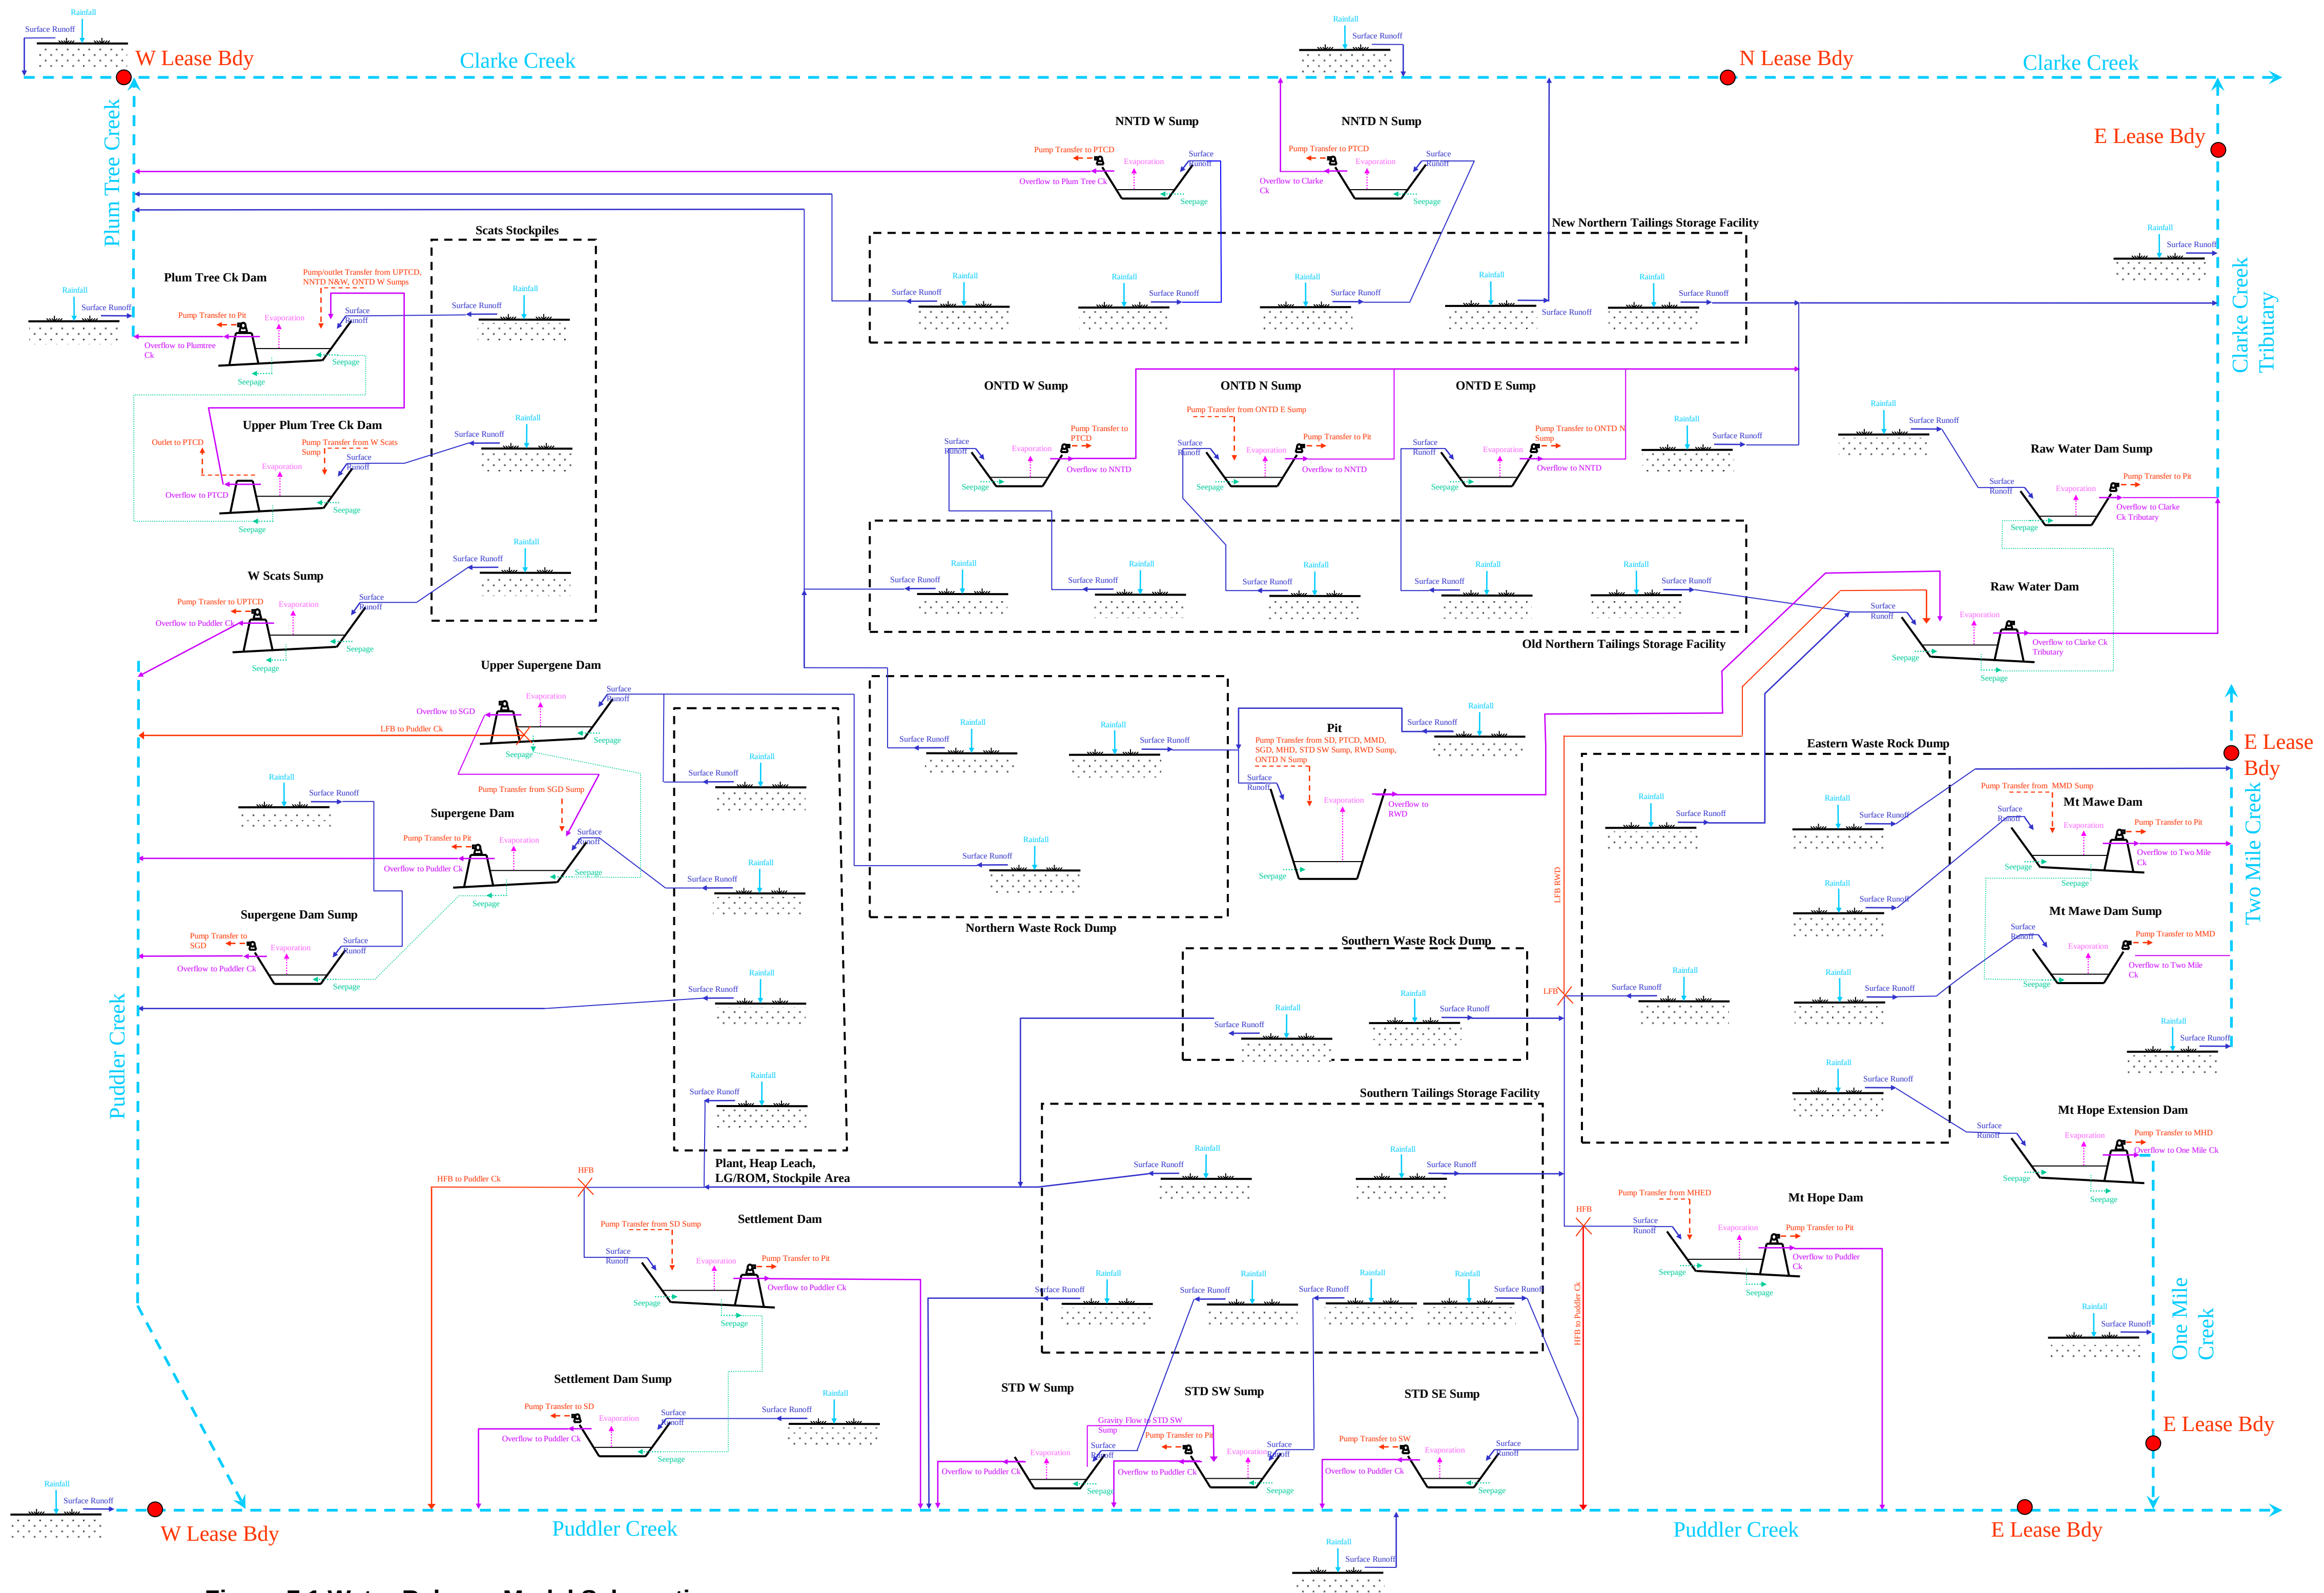
Figure 7.1 Water Balance Model Schematic

A detailed description of the water balance model setup and functionality is provided in the 2010/11 Wet Season Review – Mt Leyshon Mine (Engeny, 2011). However, the following Sections provide an overview of the model inputs, assumptions and validation. A schematic of the water balance model is provided in Figure 7.1.

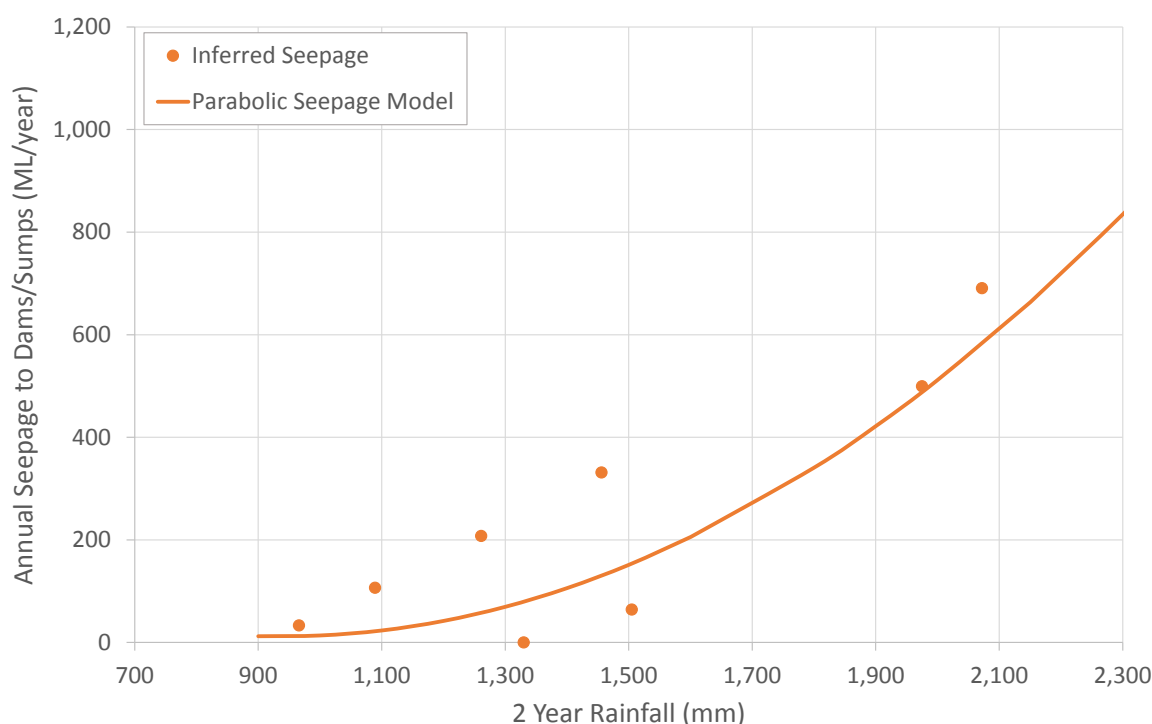
**Figure 7.2 Inferred Seepage Flow Model for Seepage Flows Reporting to Dams and Sumps**

The conceptual site seepage model results in an over-prediction of the pit lake level rise in lower rainfall years. The conceptual site seepage model has been replaced with parabolic seepage flow relationships that have been inferred from available pit lake level and seepage pumping flow metering data as shown in Figure 7.2 (seepage flows into dams and sumps) and Figure 7.3 (direct seepage inflows to the pit lake). The seepage flow relationships are based on a rolling 2 year rainfall total which reflects the observed compounding effect of consecutive dryer or wetter years on the site seepage flows.

validation was also used to derive the site seepage relationships shown in Figure 7.2 and Figure 7.3.

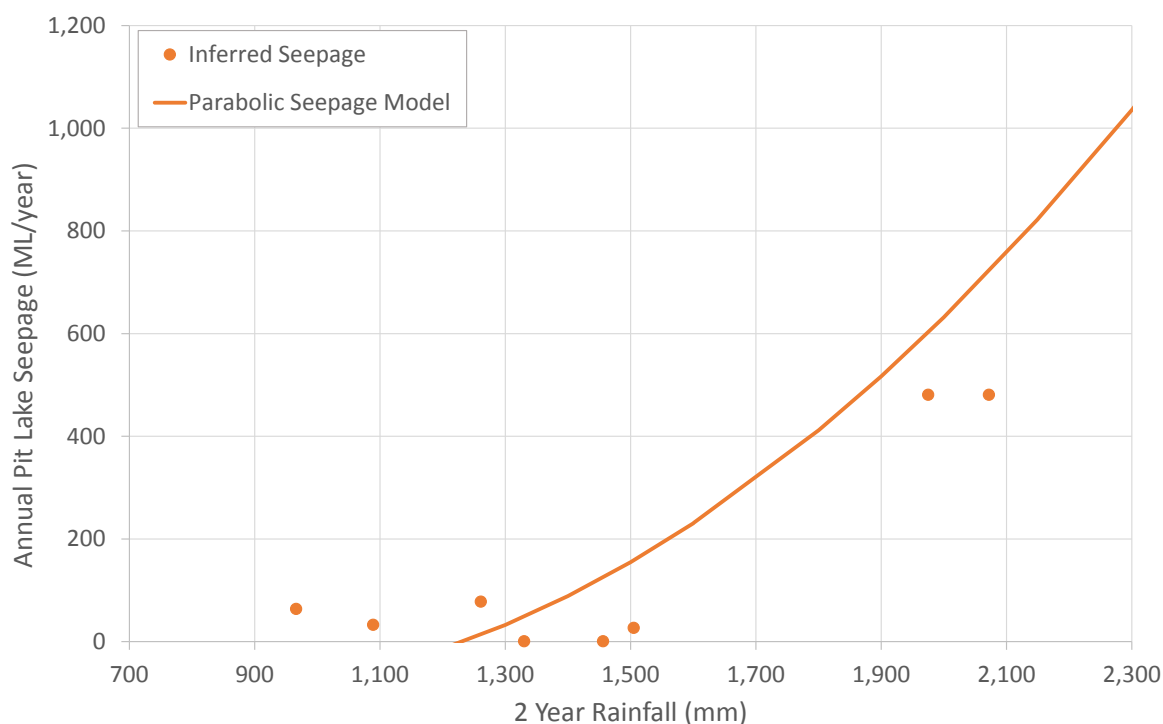
**Figure 7.3 Inferred Seepage Flow Model for Direct Seepage Flows to the Pit Lake**

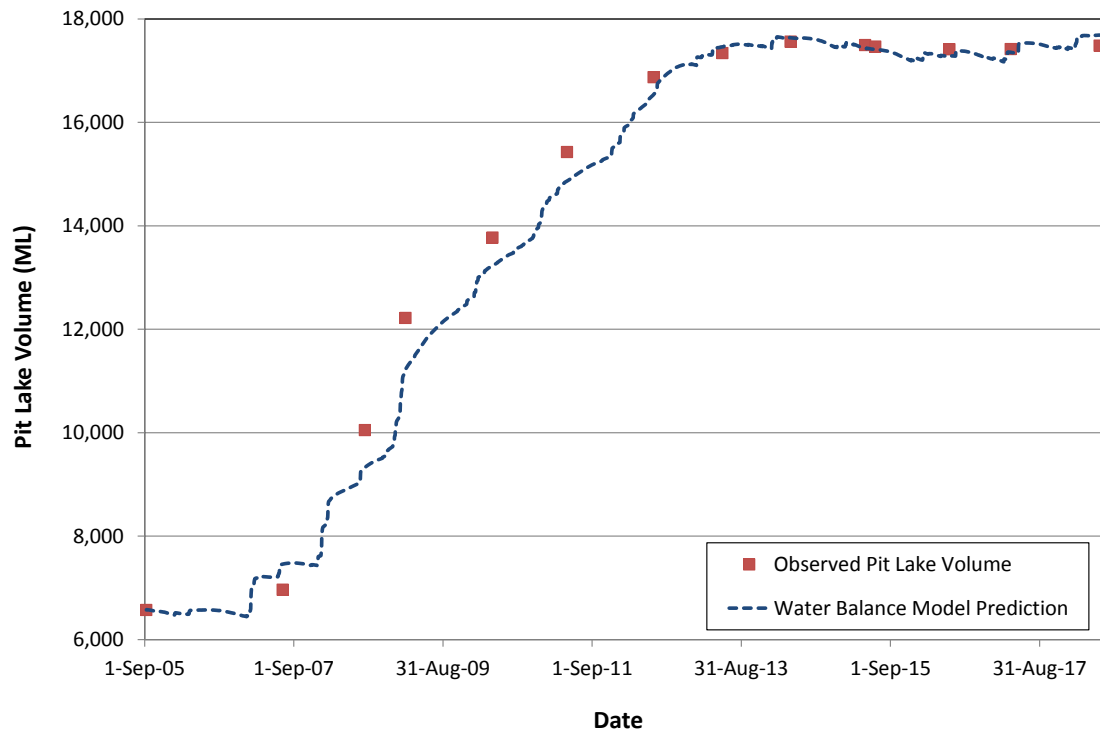
Figure 7.4 Water Balance Model Validation Results – 2005 to 2019

Validation of the water balance model was undertaken for the historical period 2002 to 2020 (18 years). The predicted rise in the pit lake level is compared to the pit lake level monitoring data in Figure 7.4.

The pit lake level rise predicted by the updated water balance model compares well with the observed pit lake levels during the period 2002 to 2020. The water balance model

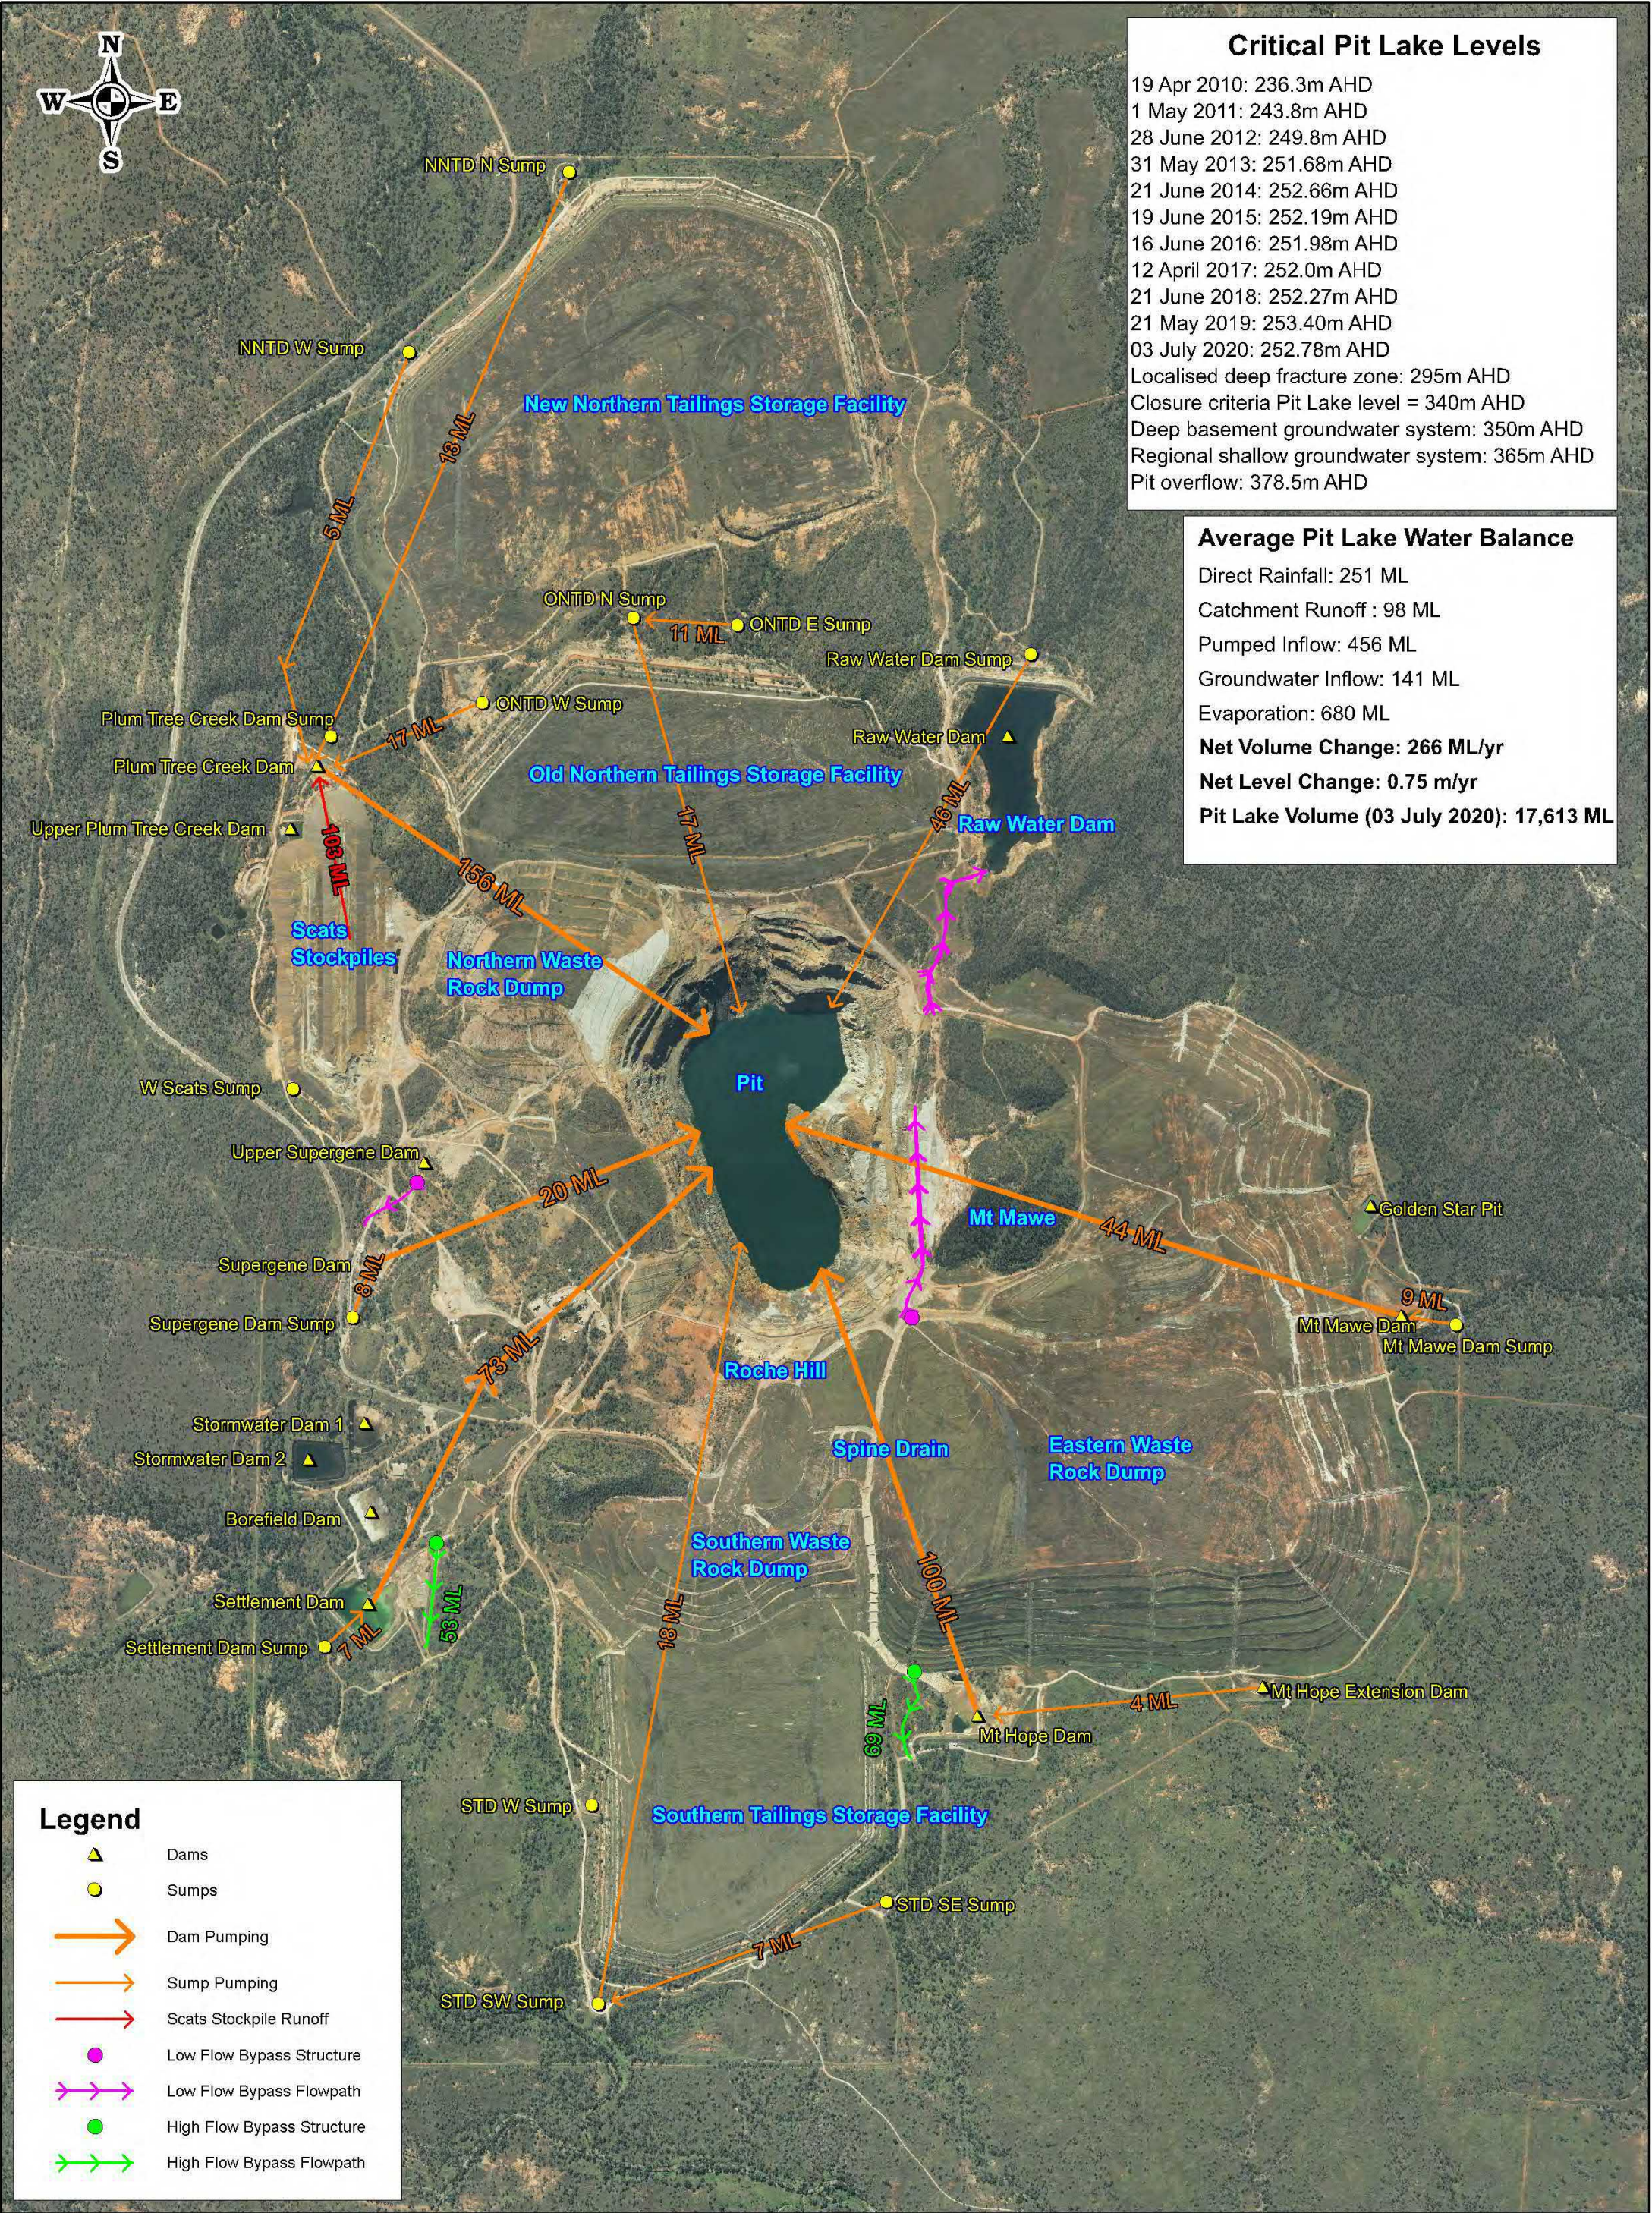
Average Pit Lake Water Balance

Direct Rainfall: 251 ML  
Catchment Runoff : 98 ML  
Pumped Inflow: 456 ML  
Groundwater Inflow: 141 ML  
Evaporation: 680 ML  
**Net Volume Change: 266 ML/yr**  
**Net Level Change: 0.75 m/yr**  
**Pit Lake Volume (03 July 2020): 17,613 ML**

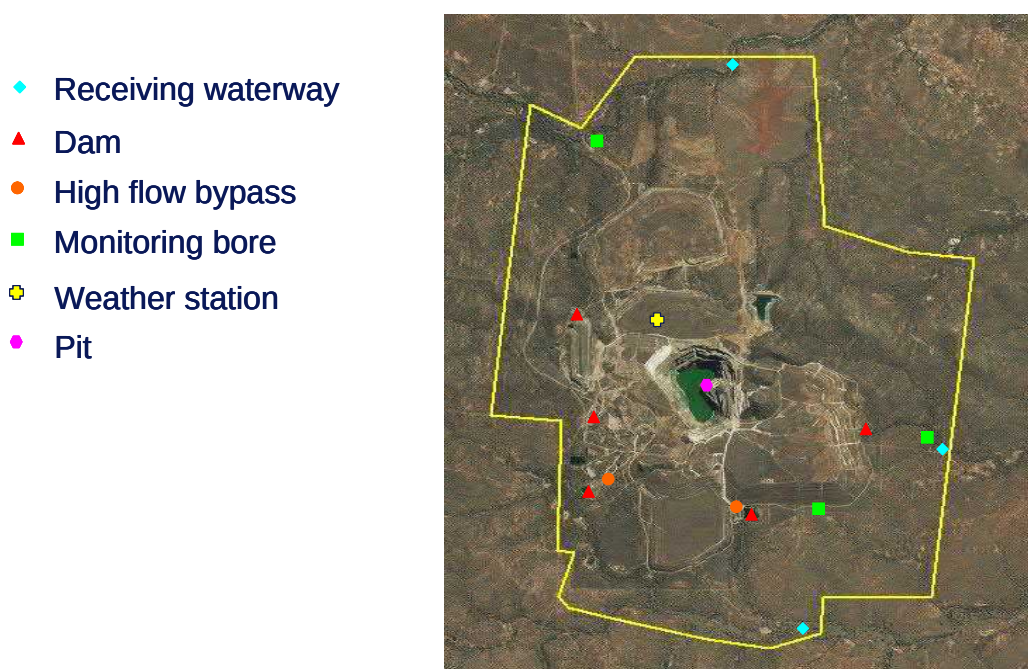
**Figure 9.6 Location of On-lease Automated Surface Water Monitoring Stations (from GHD, 2011)**

The locations of the on-lease and off-lease monitoring stations are shown in Figure 9.6 and Figure 9.7 respectively. Photographs of the monitoring systems are provided in Appendix H.

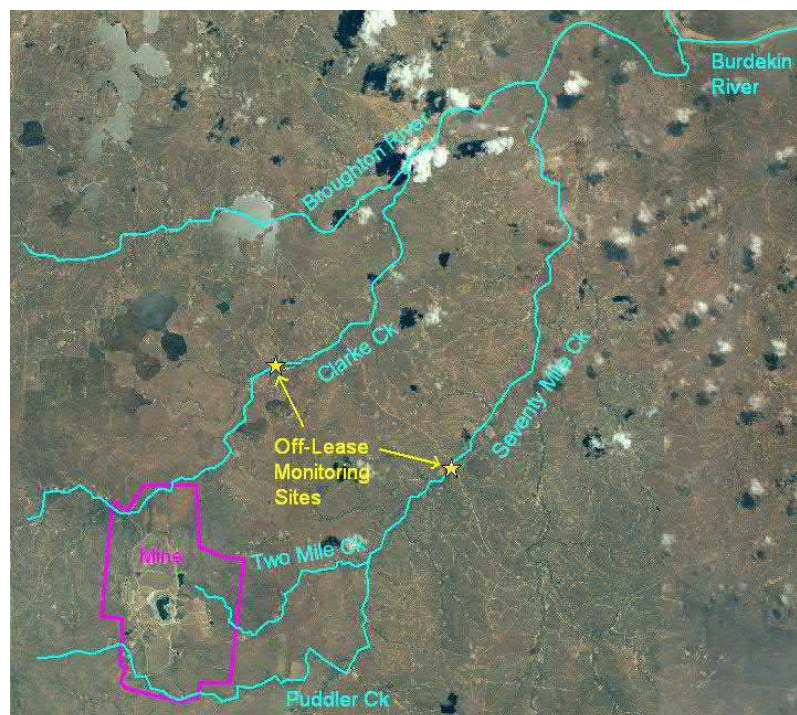
Figure 9.7 Location of Off-lease Automated Surface Water Monitoring Stations (from GHD, 2011)

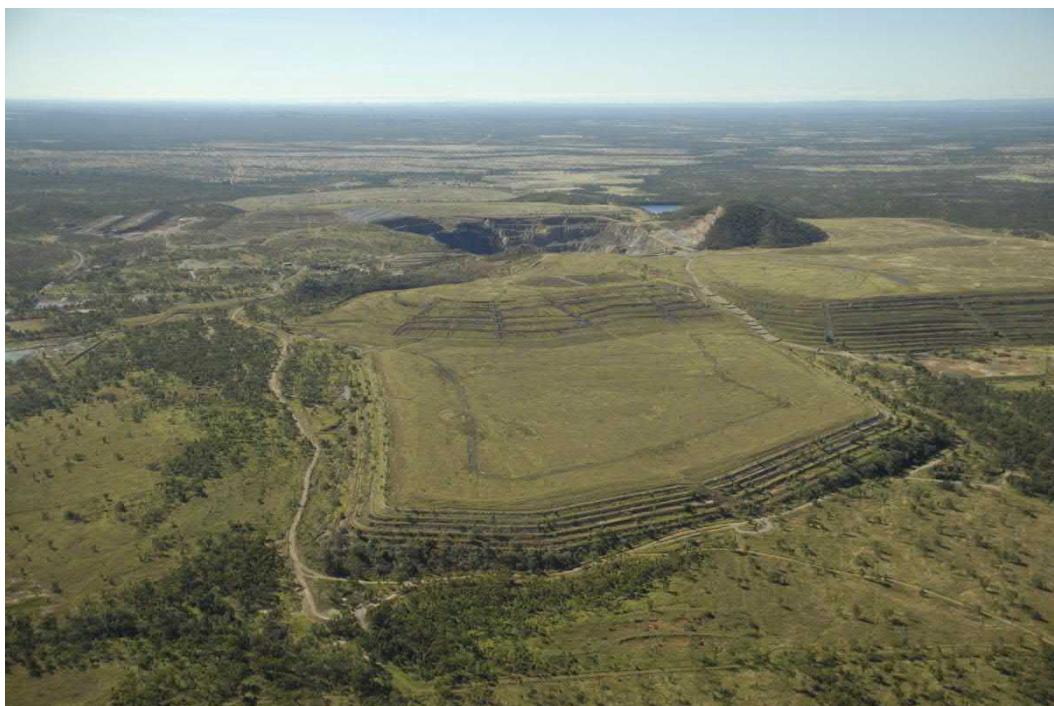
**Landforms Looking North (Southern Tailings Dam in Foreground)**

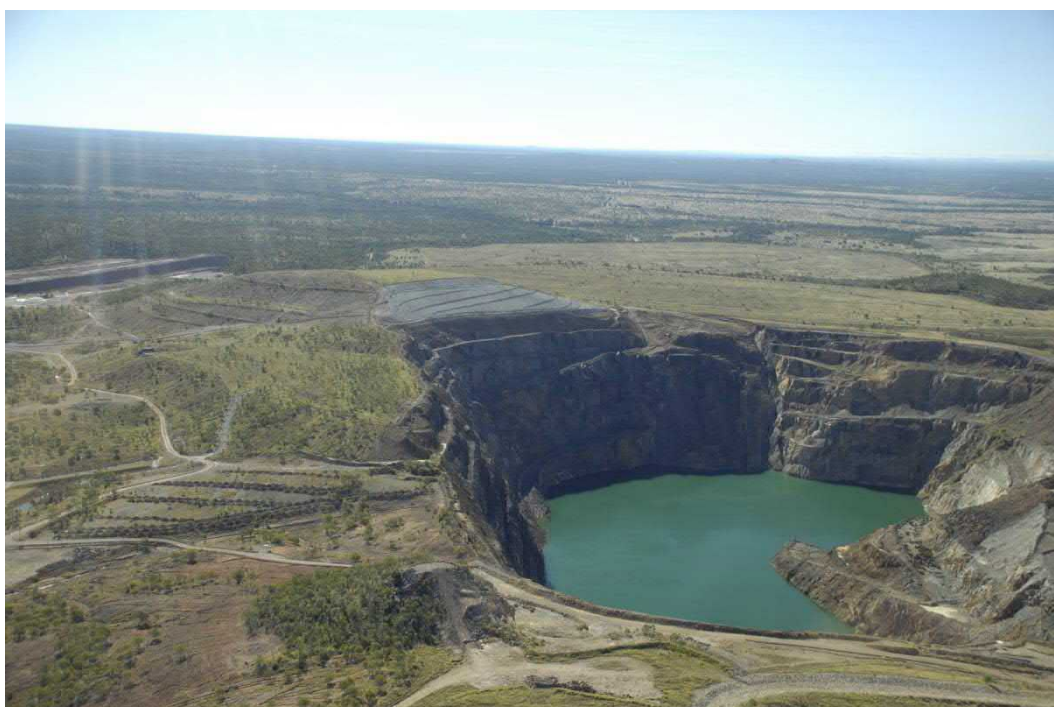
**Final Void Looking North**
