## Progressive Rehabilitation and Closure Plan

**Mt Leyshon Mine**

M13000\_024-REP-001-2

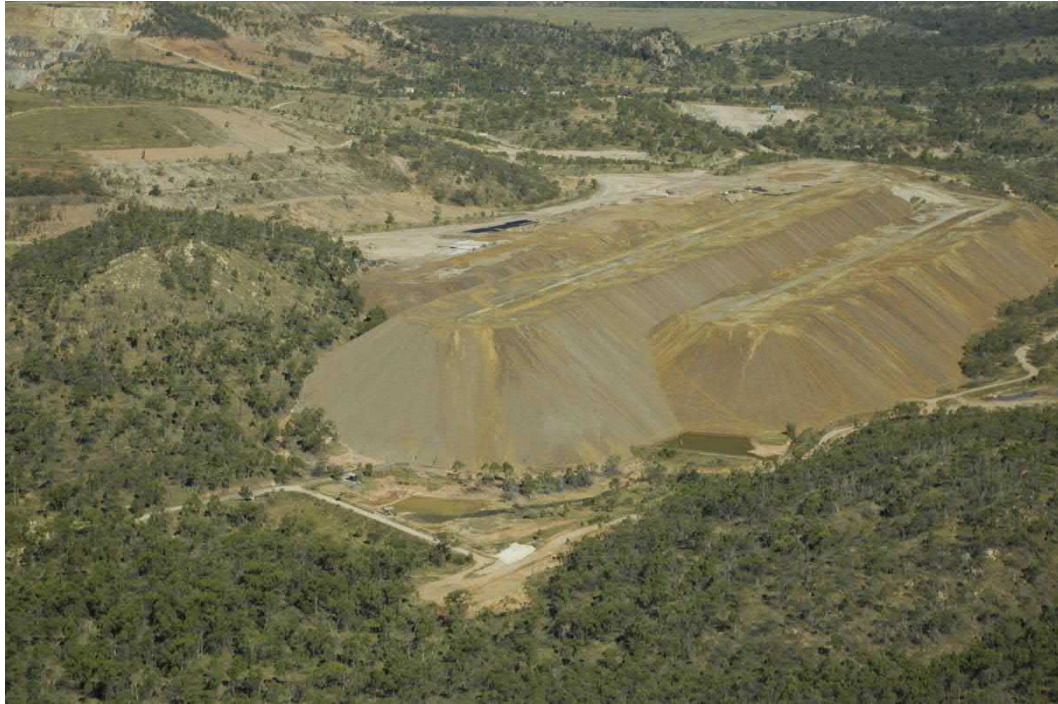
**Scats Stockpiles**

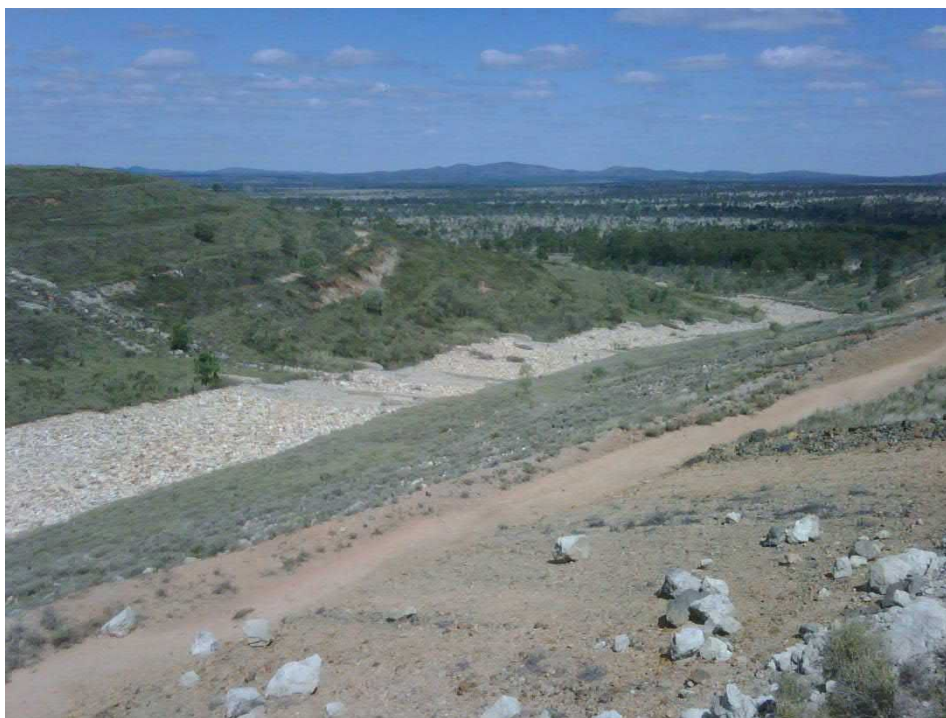
**Spine Drain**

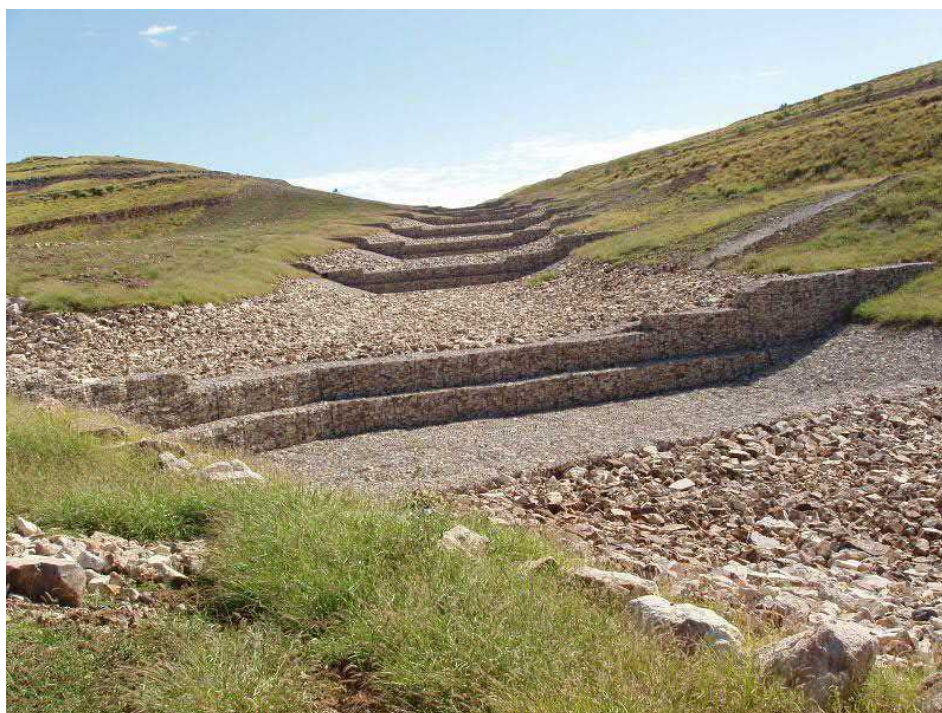
**Spine Drain**

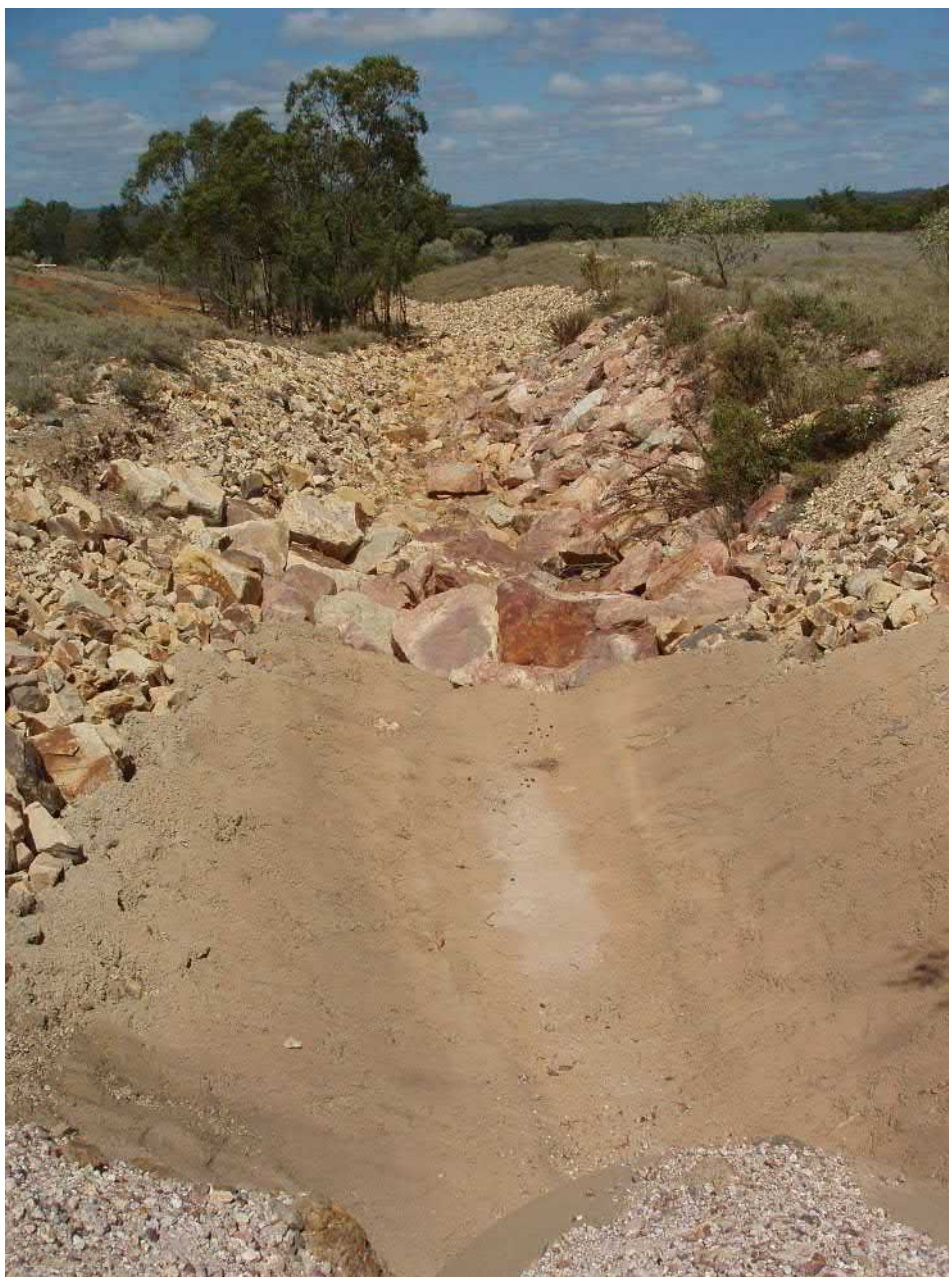
**Inflow drain to Settlement Drain**

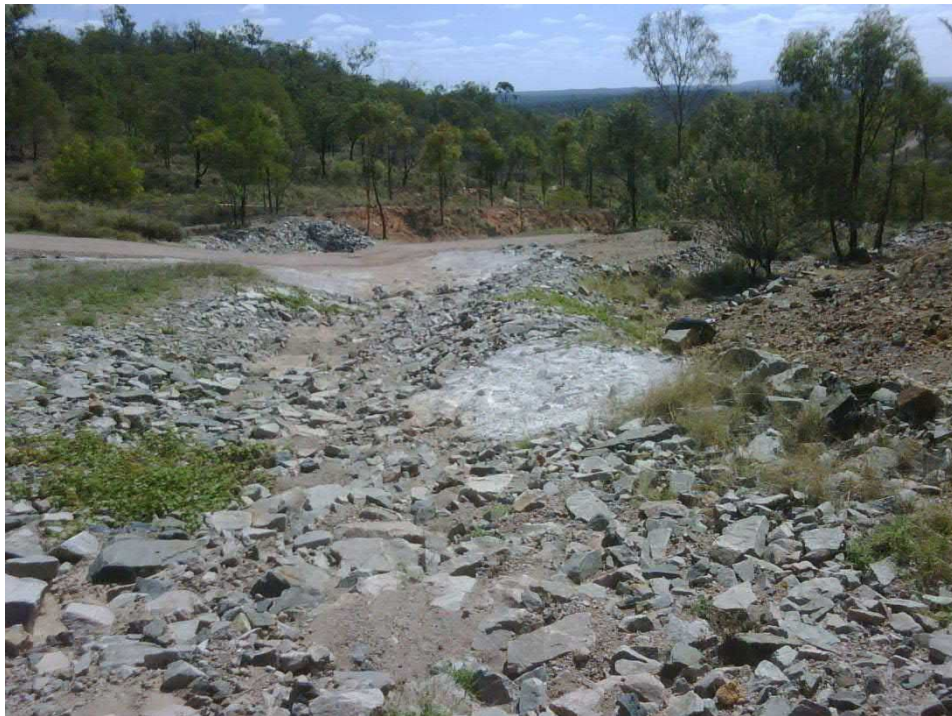
**Drain on Roche Hill**

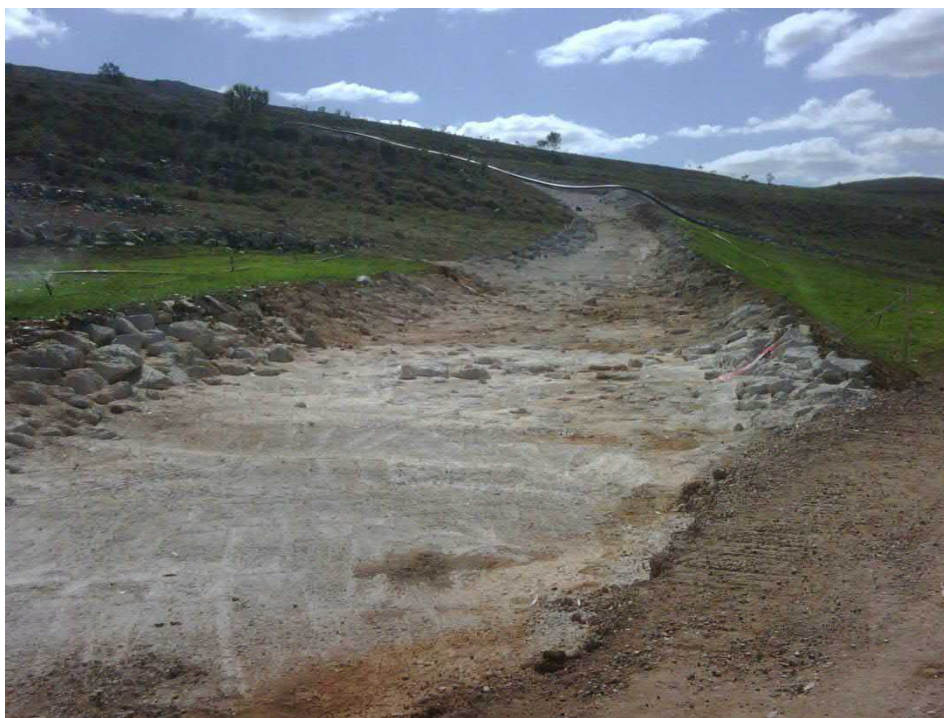
**Diversion of drop structure above Mt Mawe Dam**

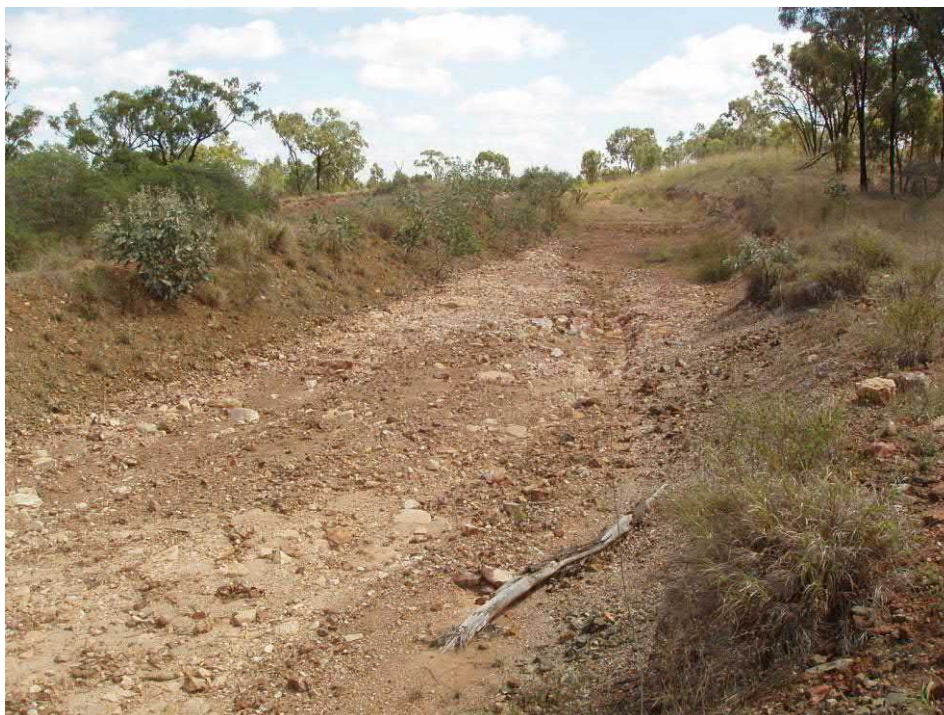
**Wallaby Tail Hill diversion channel**

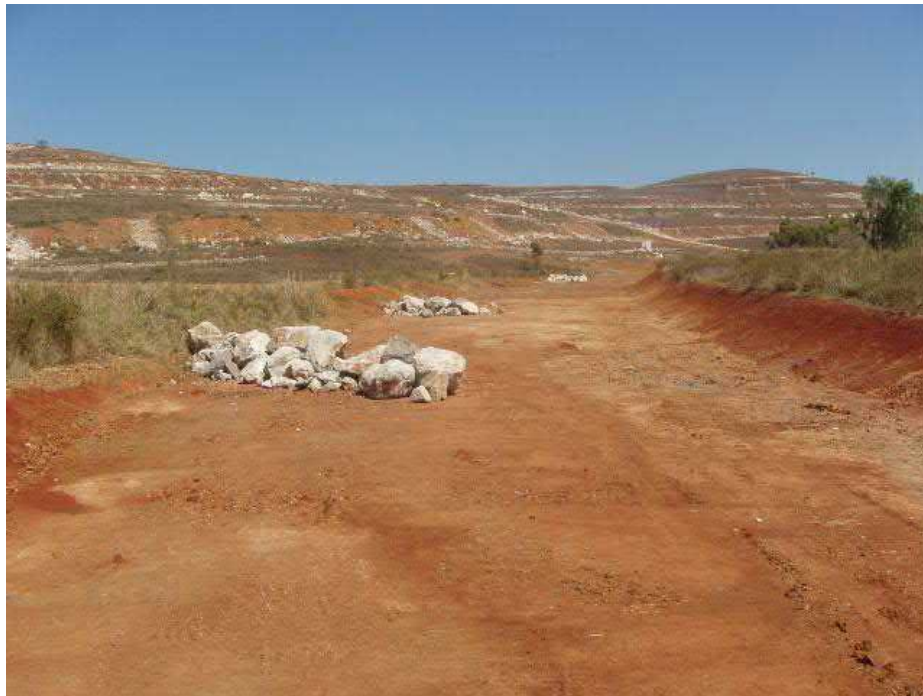
**Golden Star Pit diversion channel around Mt Mawe Dam**

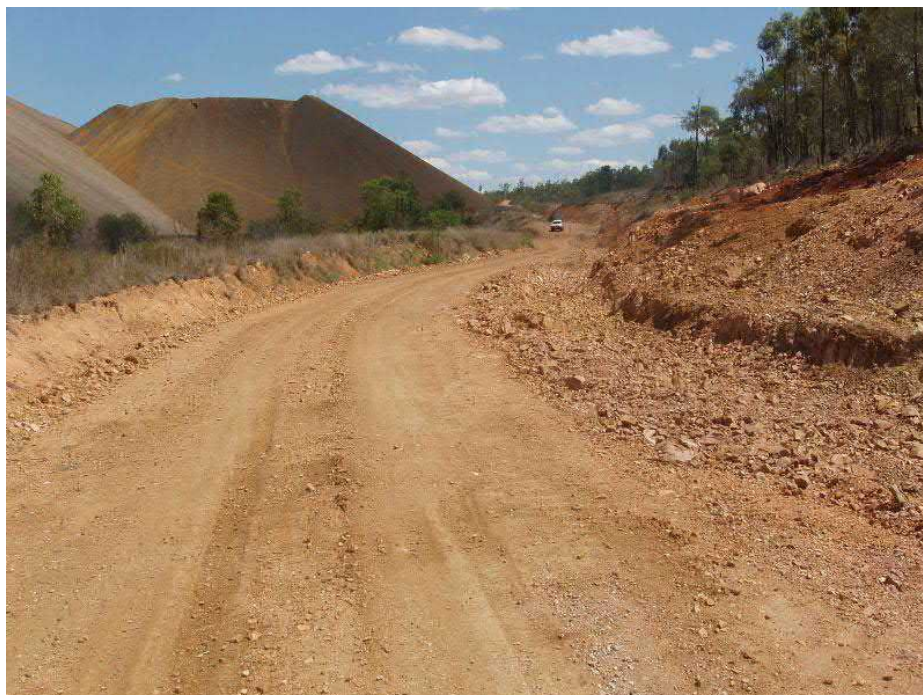
**Plum Tree Creek Dam external catchment diversion channel**

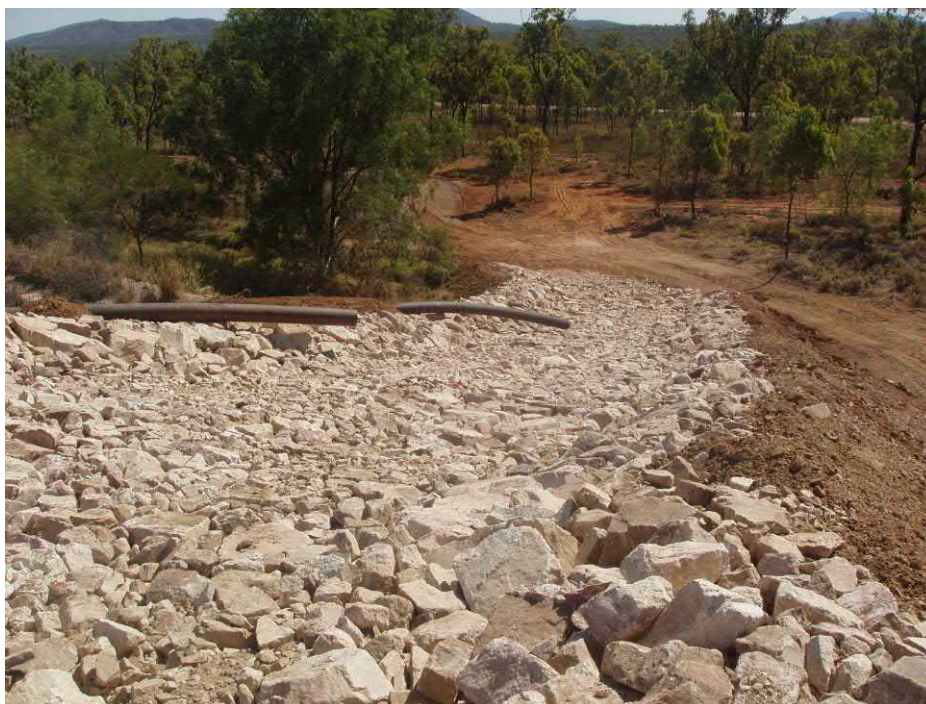
**Southern Tailings Storage Facility Diversion**

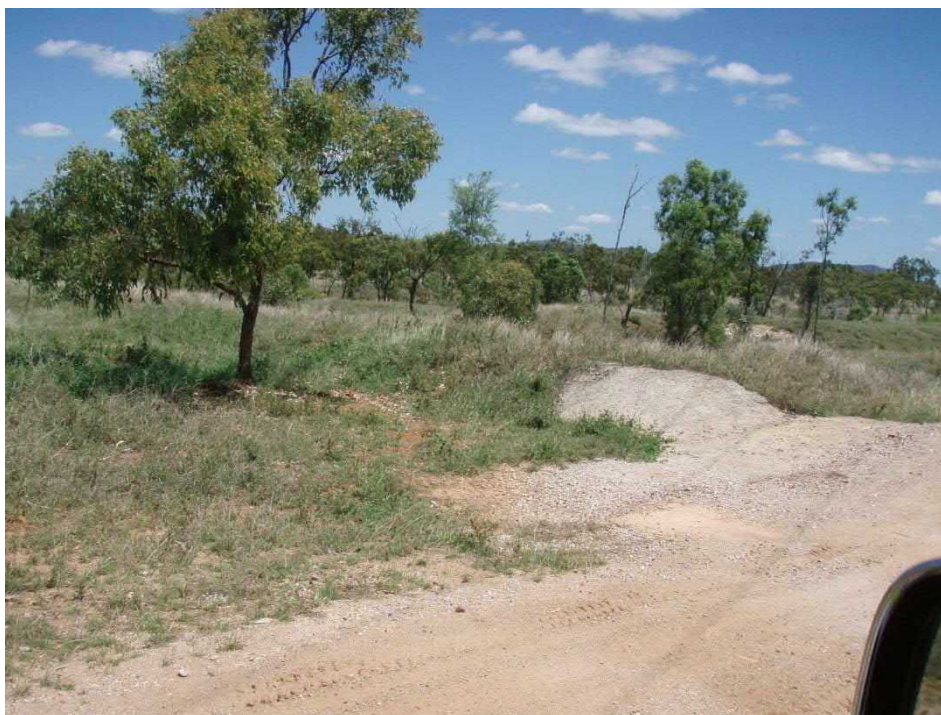
**Diversion bund around eastern side of Mt Hope Extension Dam**

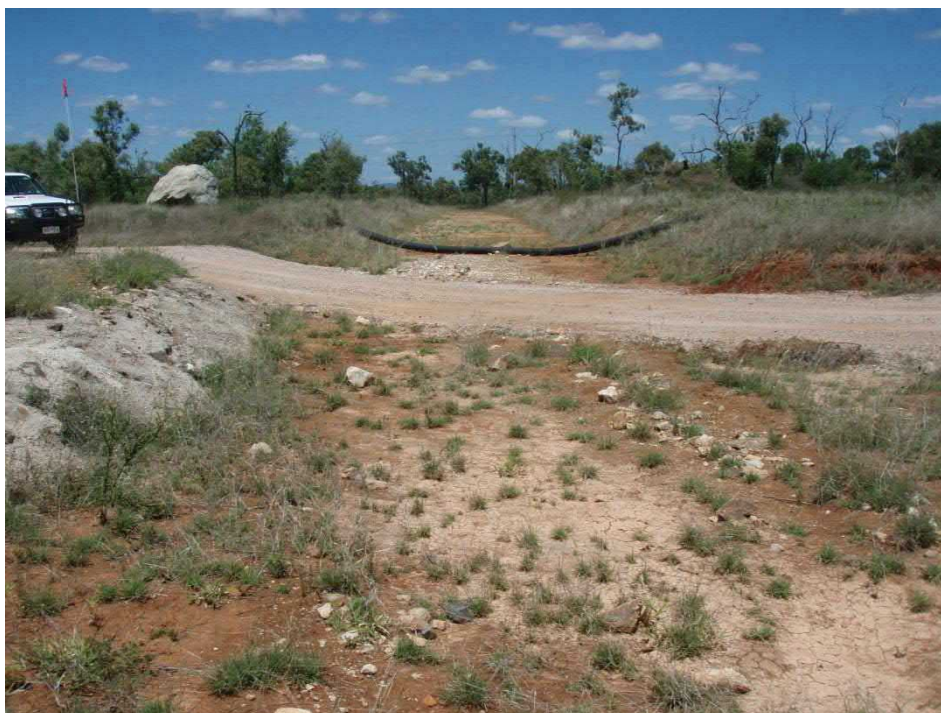
**Diversion drain around western side of Mt Hope Extension Dam**

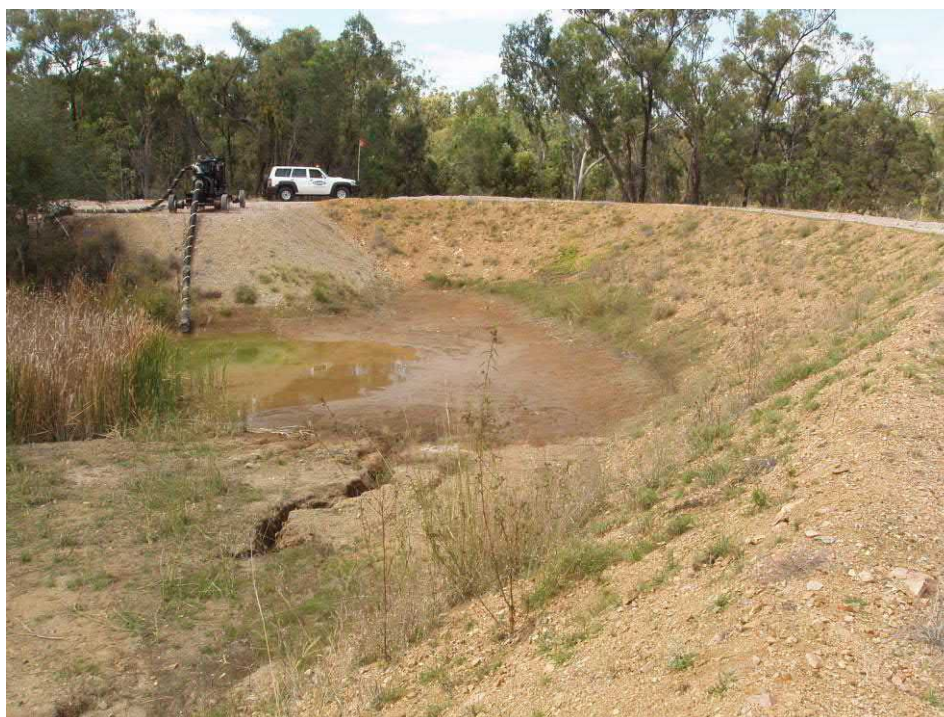
**Flood protection levee around STD SW Sump**

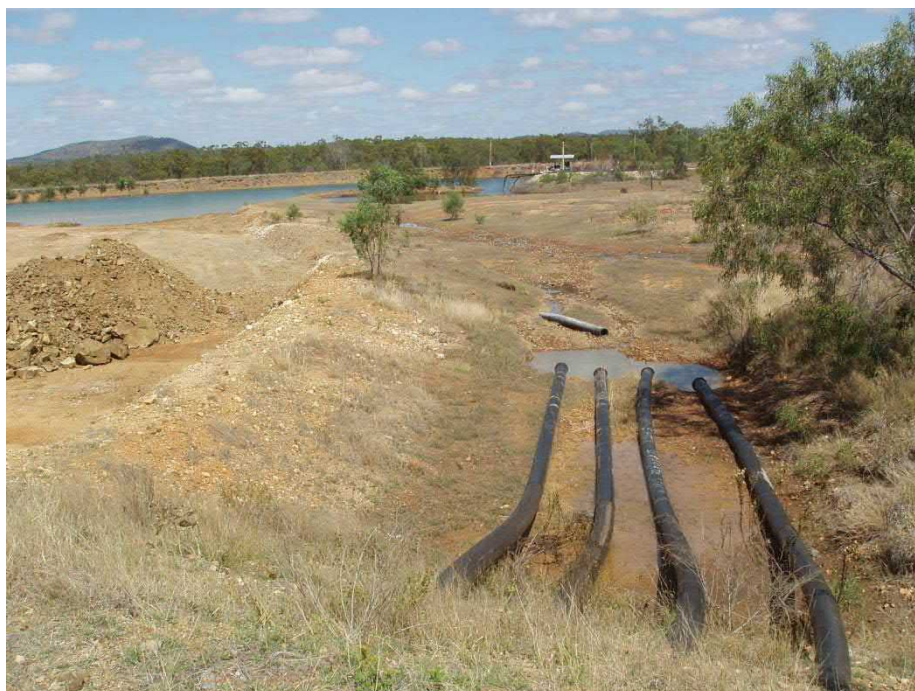
**Settlement Dam high flow bypass facility**

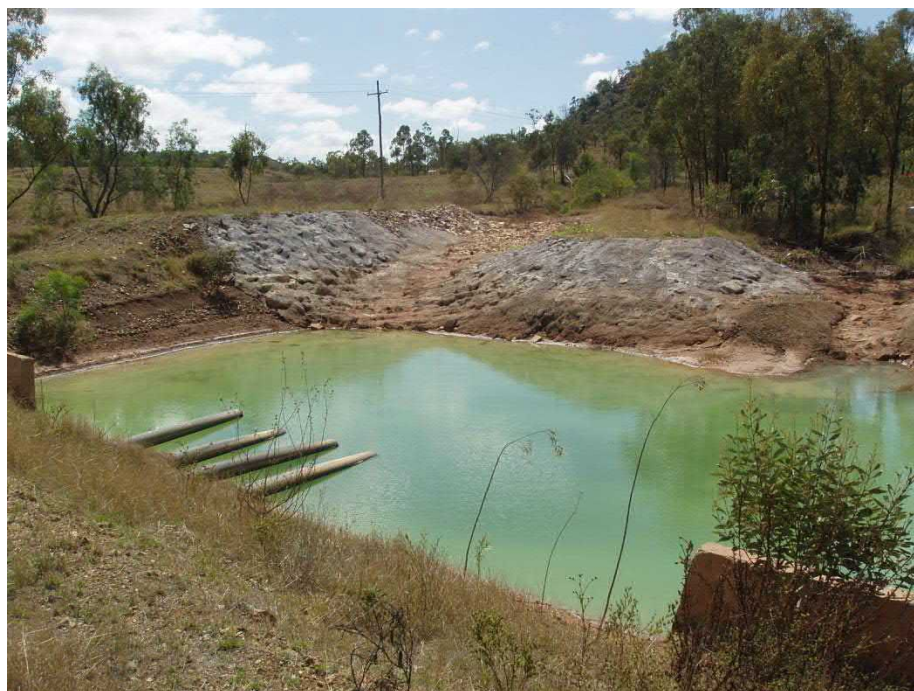
**Settlement Dam high flow bypass facility**

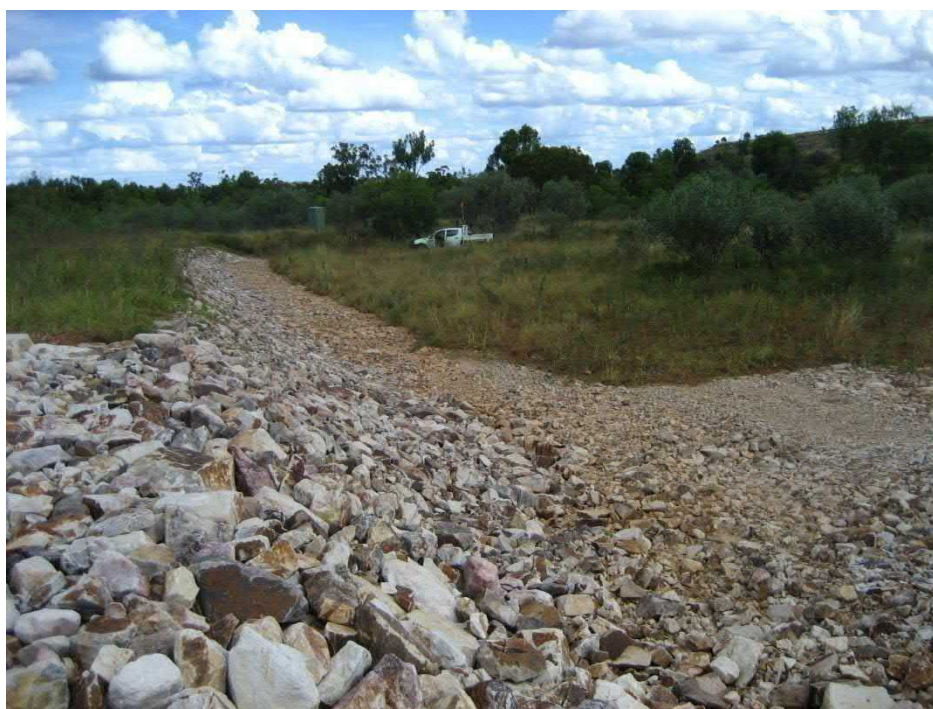
**Mt Hope Dam high flow bypass facility**

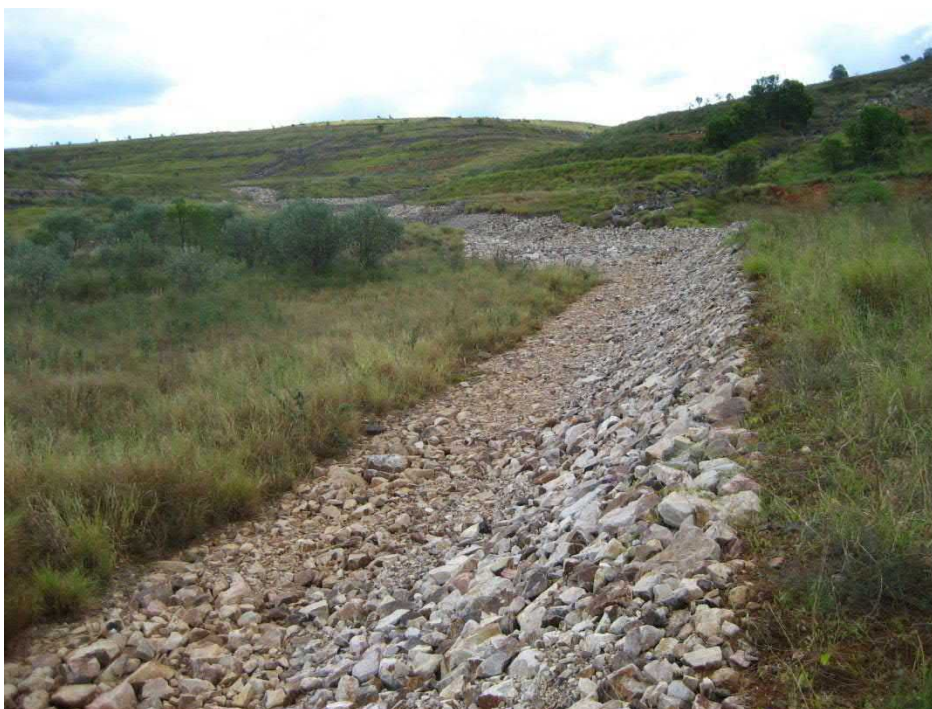
**Mt Hope Dam high flow bypass facility**

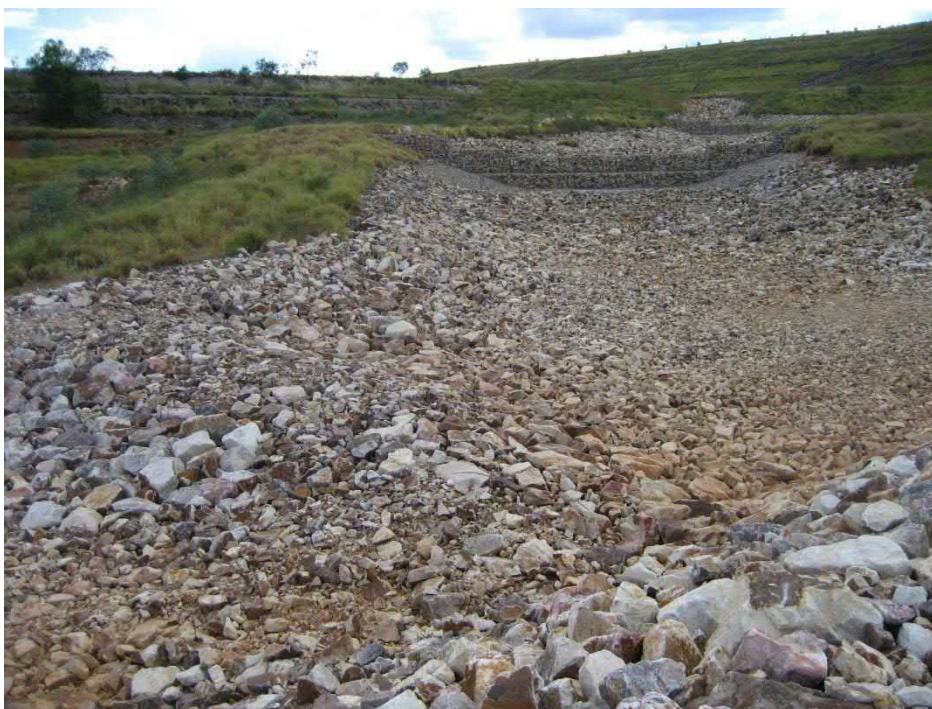
**Mt Hope Dam high flow bypass facility**

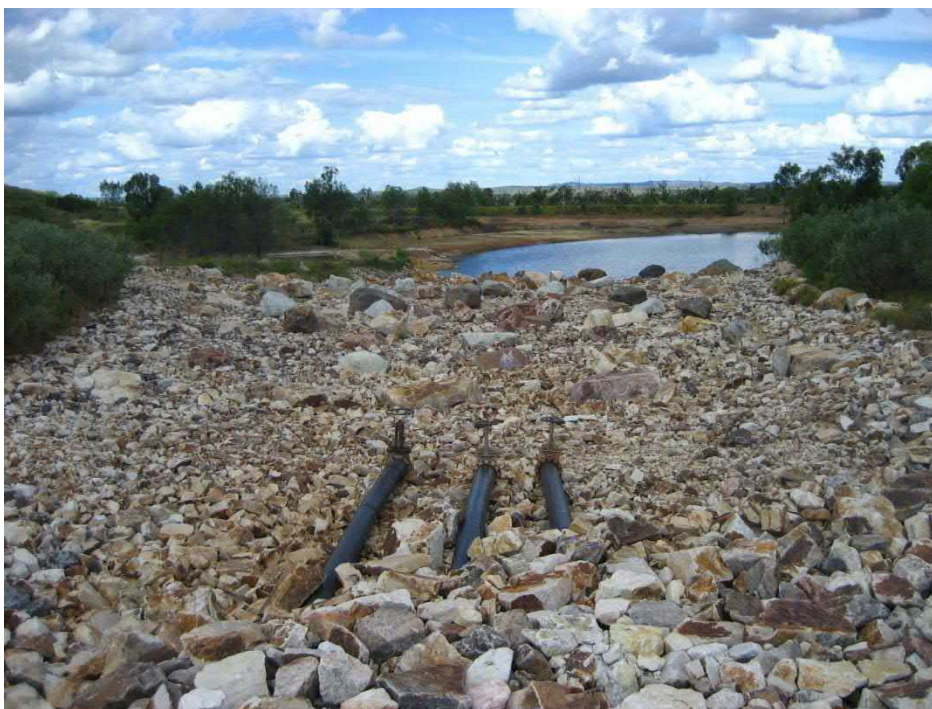
**Mt Hope Dam high flow bypass facility**

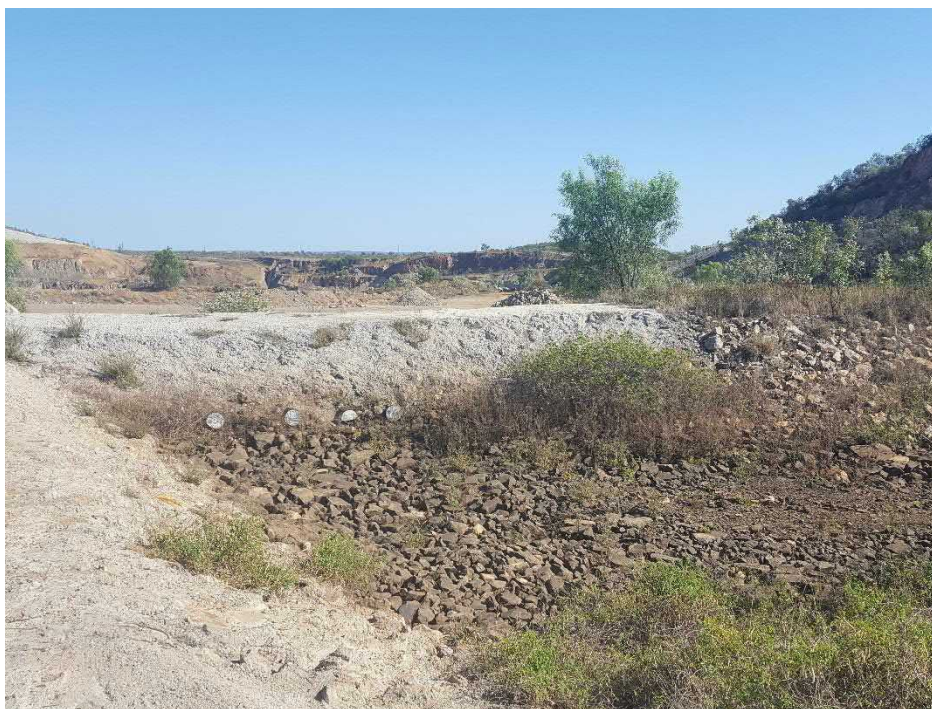
**Eastern Waste Rock Dump low flow bypass facility**

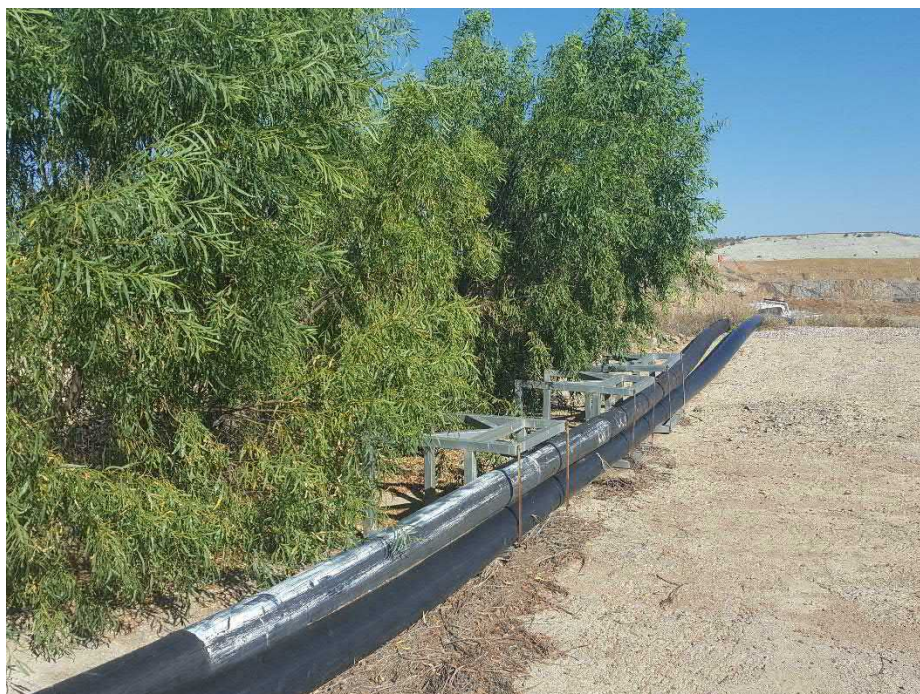
**Eastern Waste Rock Dump low flow bypass facility**

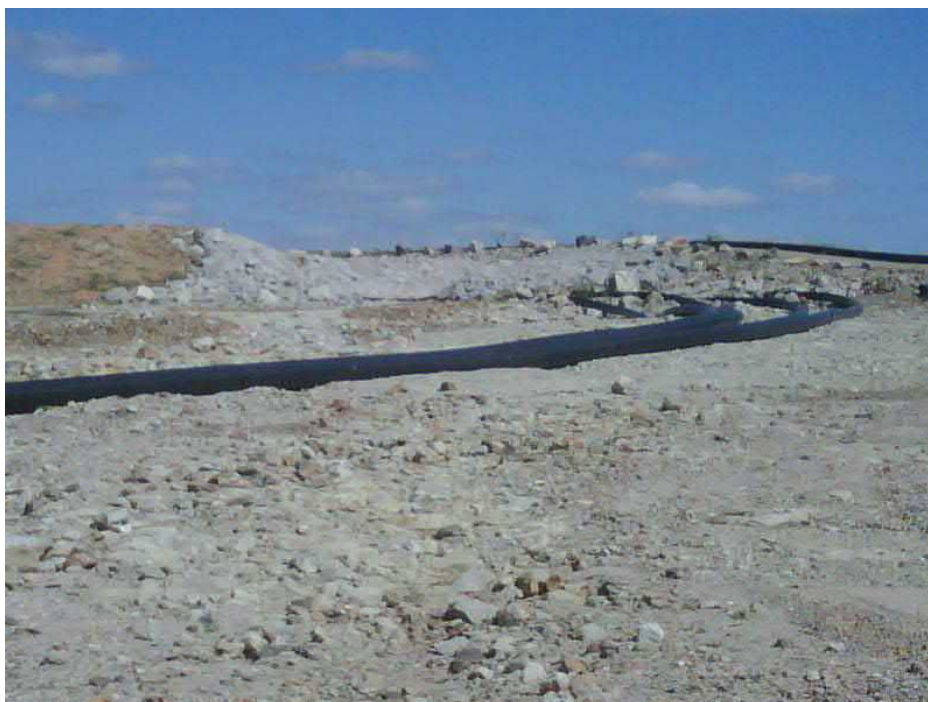
**Eastern Waste Rock Dump low flow bypass facility**

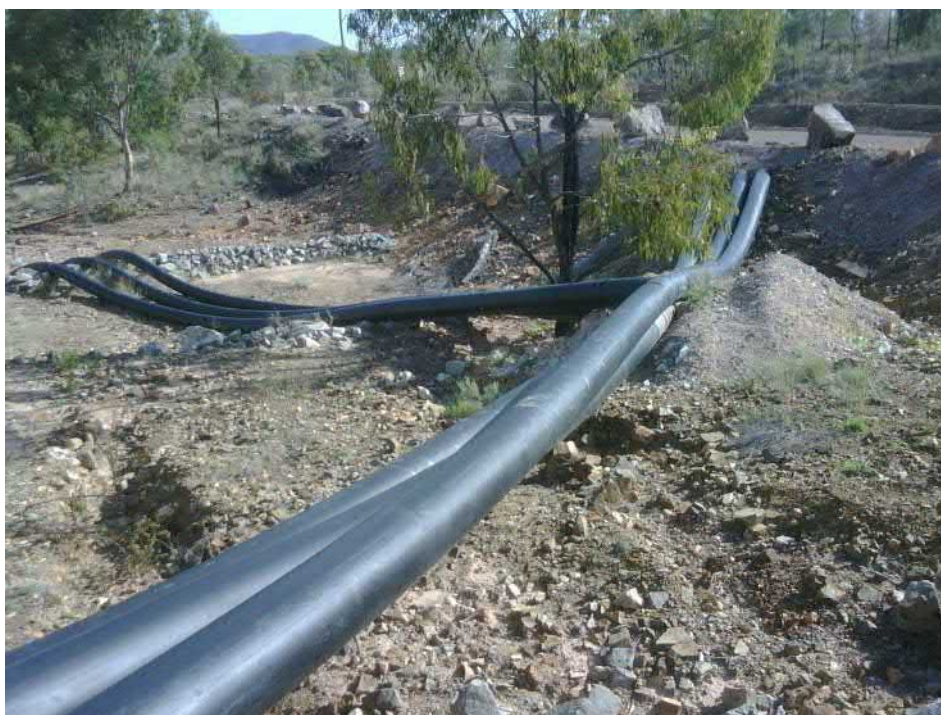
**Supergene Stormwater Dam low flow bypass facility**

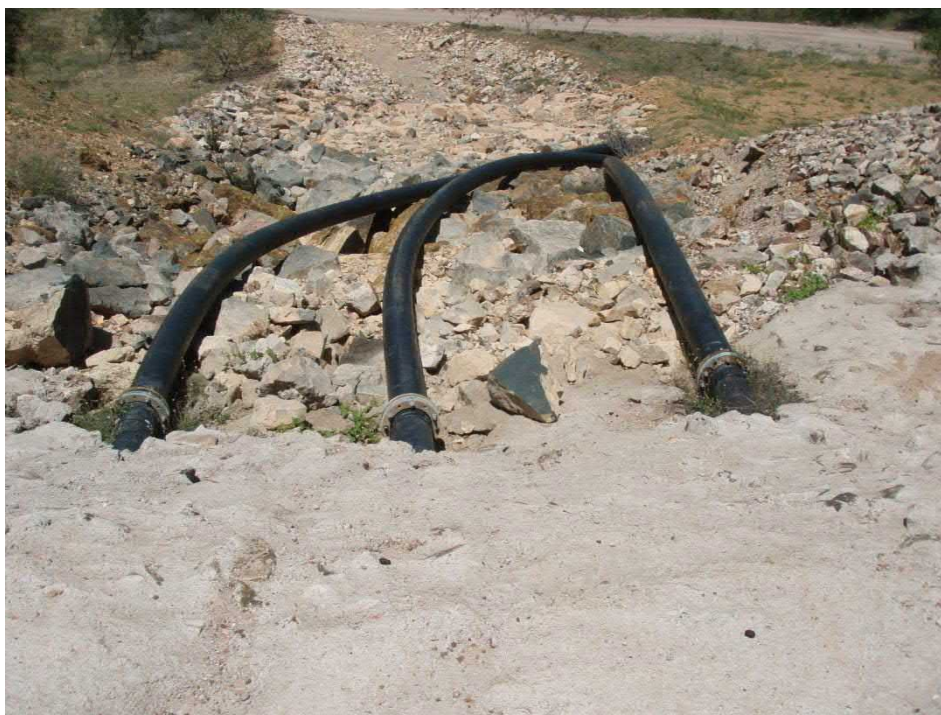
**Supergene Stormwater Dam low flow bypass facility**

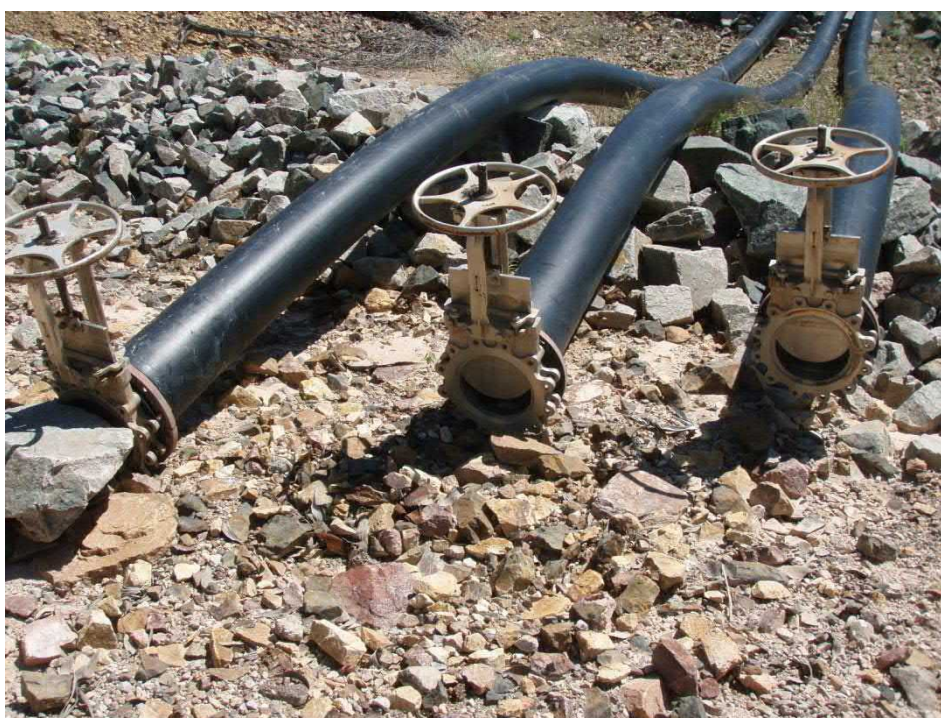
**Supergene Stormwater Dam low flow bypass facility**

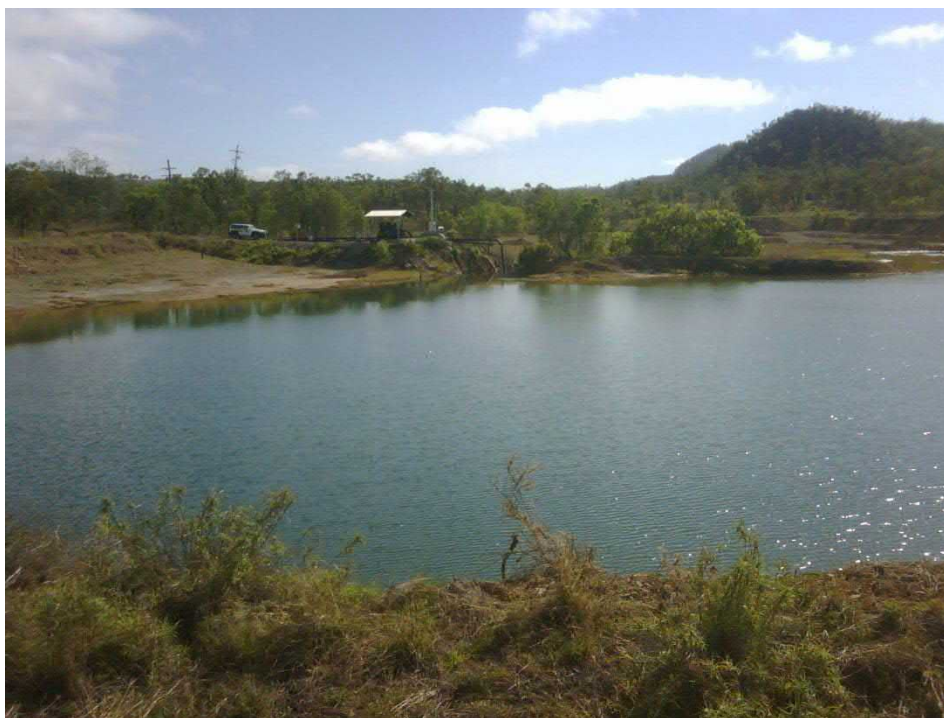
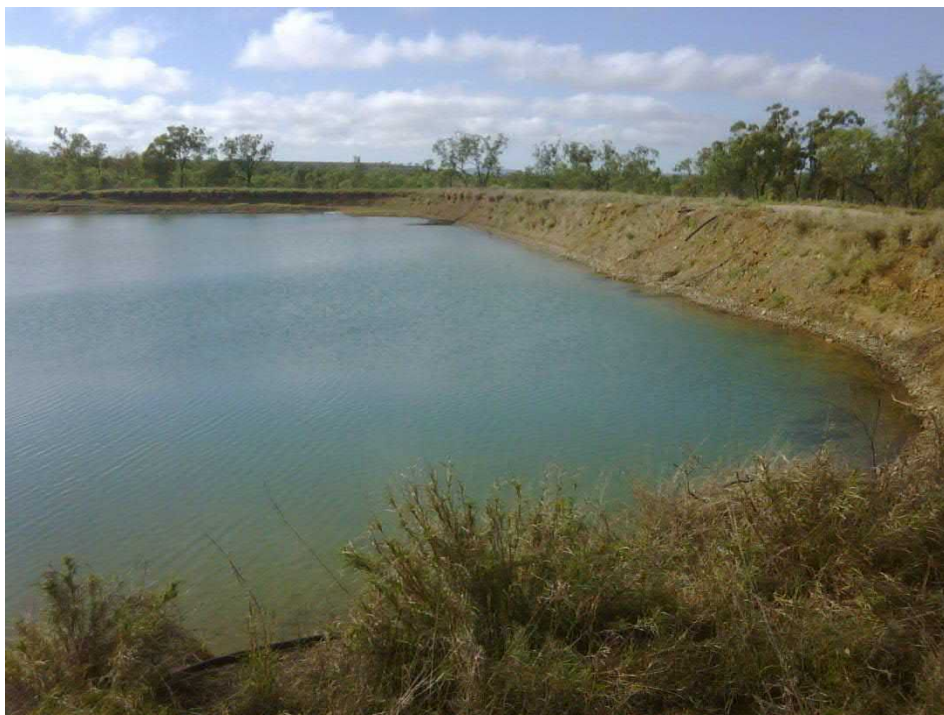
**Settlement Dam**

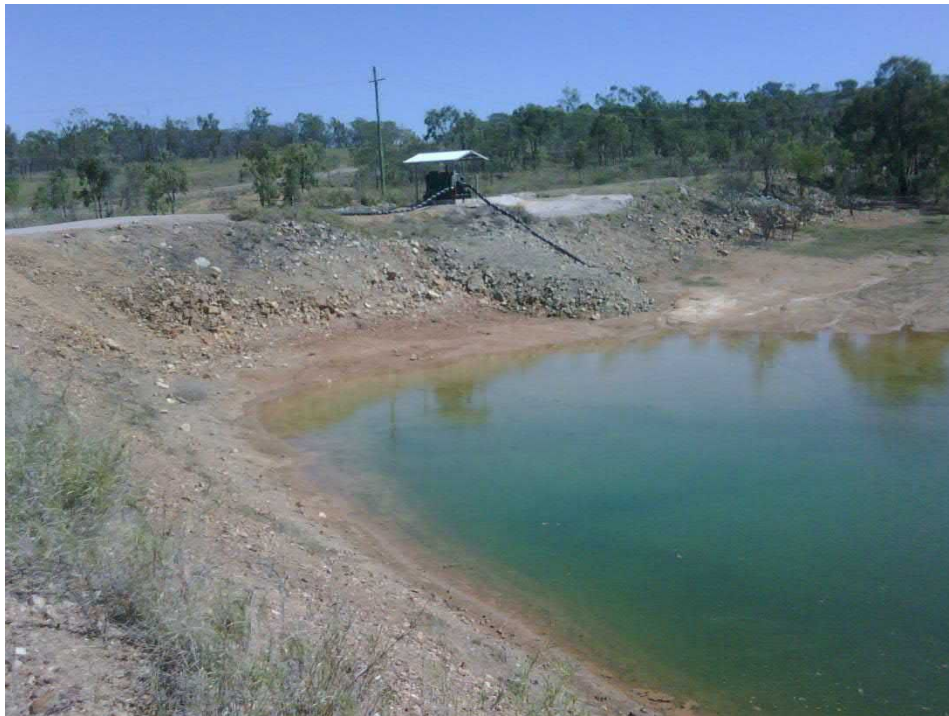
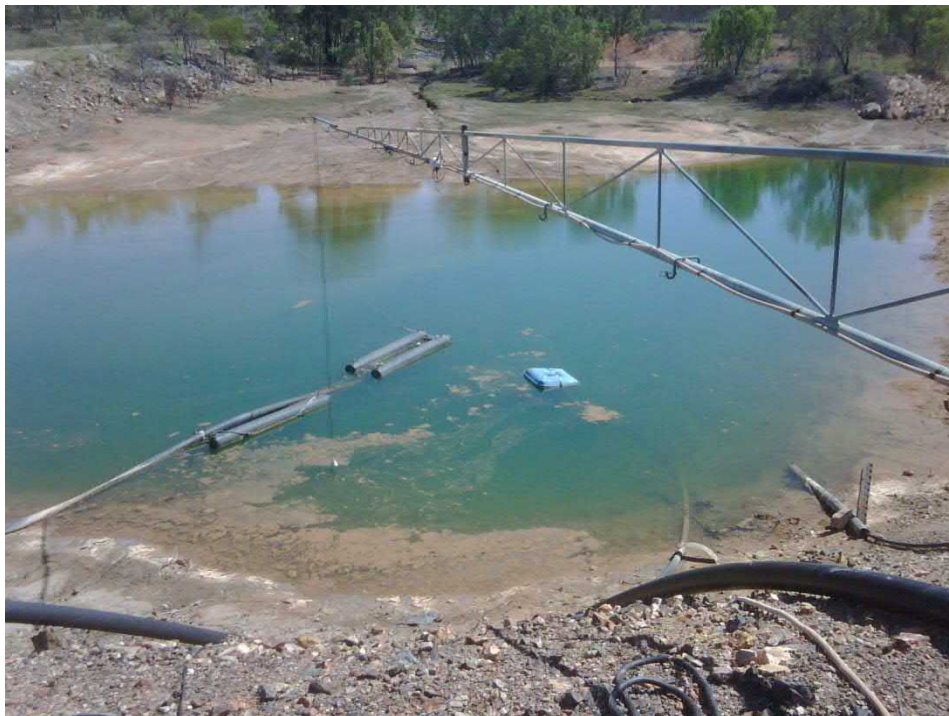
**Supergene Dam**

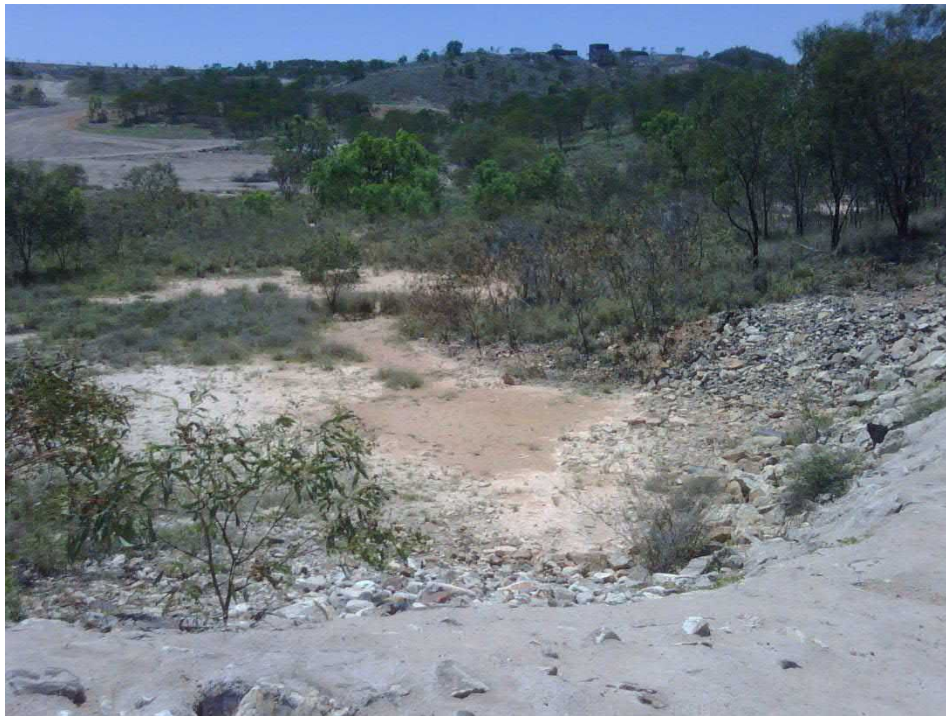
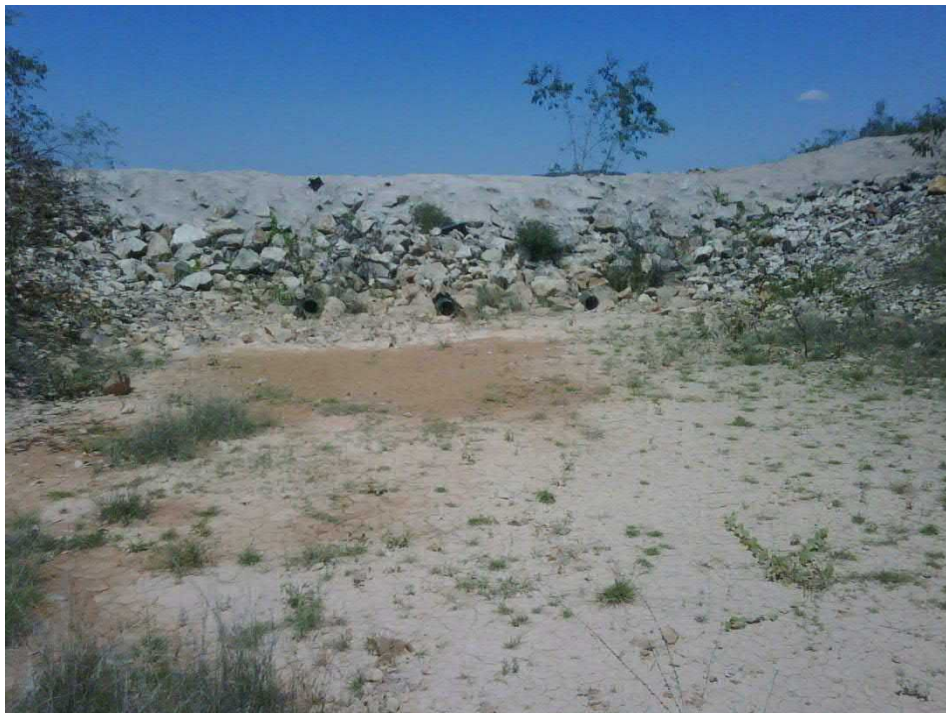
**Upper Supergene Dam**

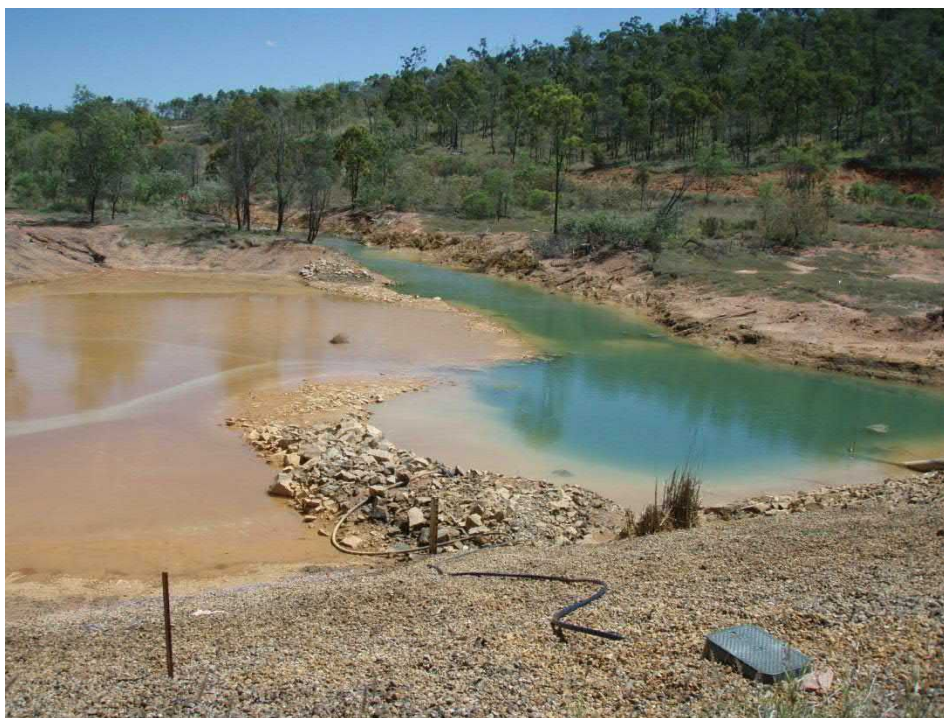
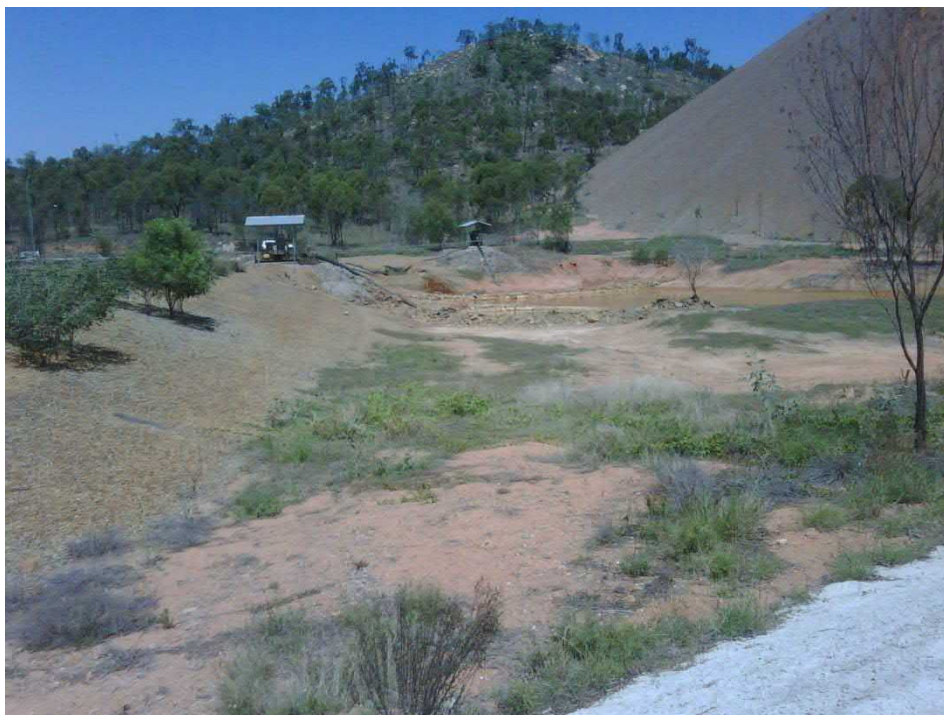
**Plum Tree Creek Dam**
