## Progressive Rehabilitation and Closure Plan

**Mt Leyshon Mine**

M13000\_024-REP-001-2

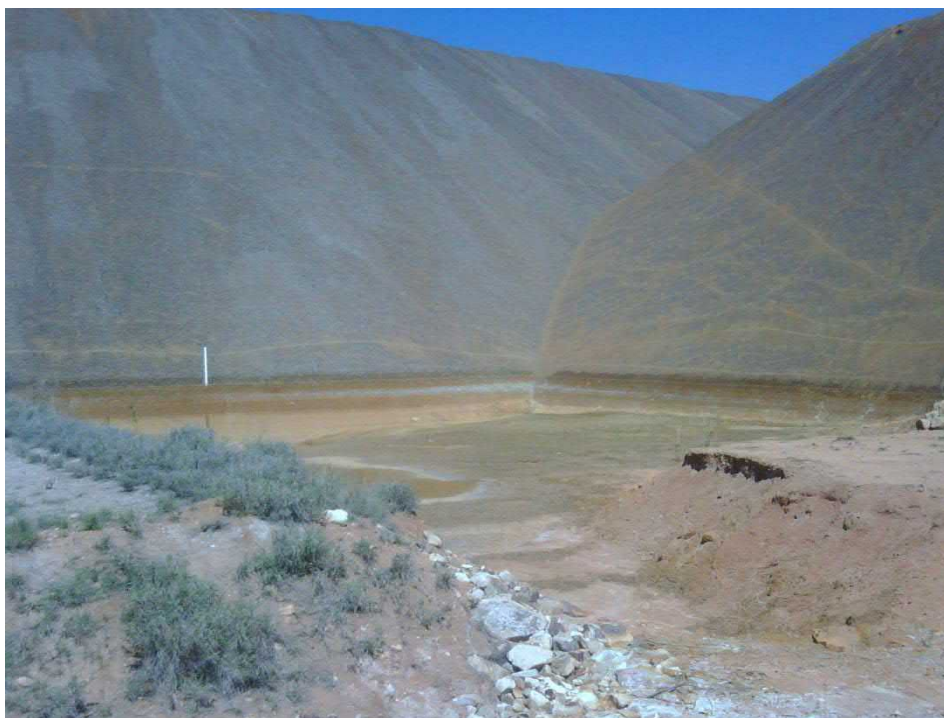
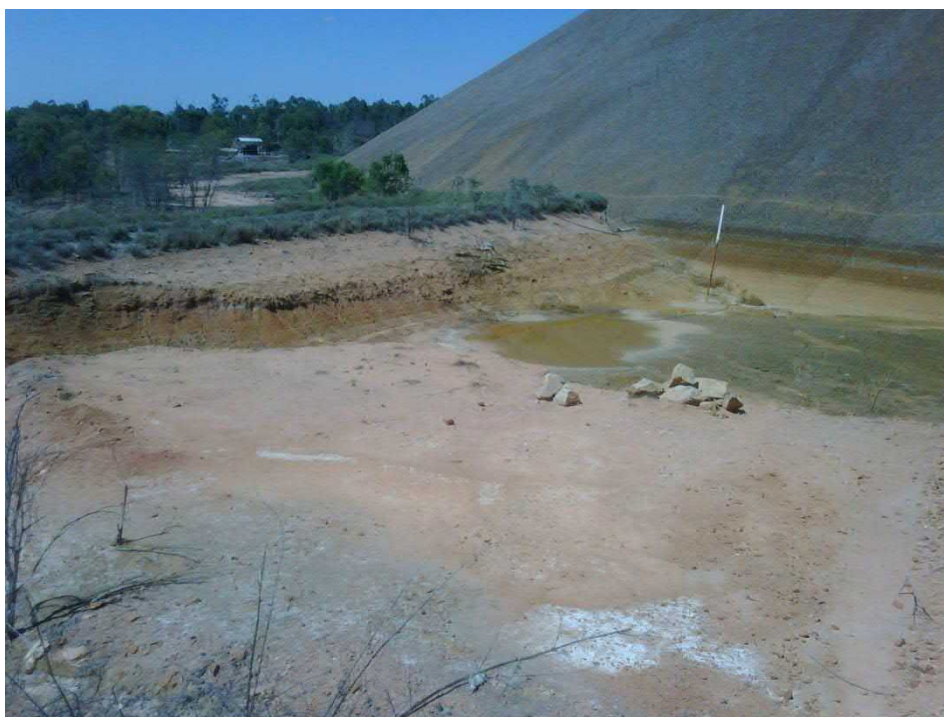
**Upper Plum Tree Creek Dam**

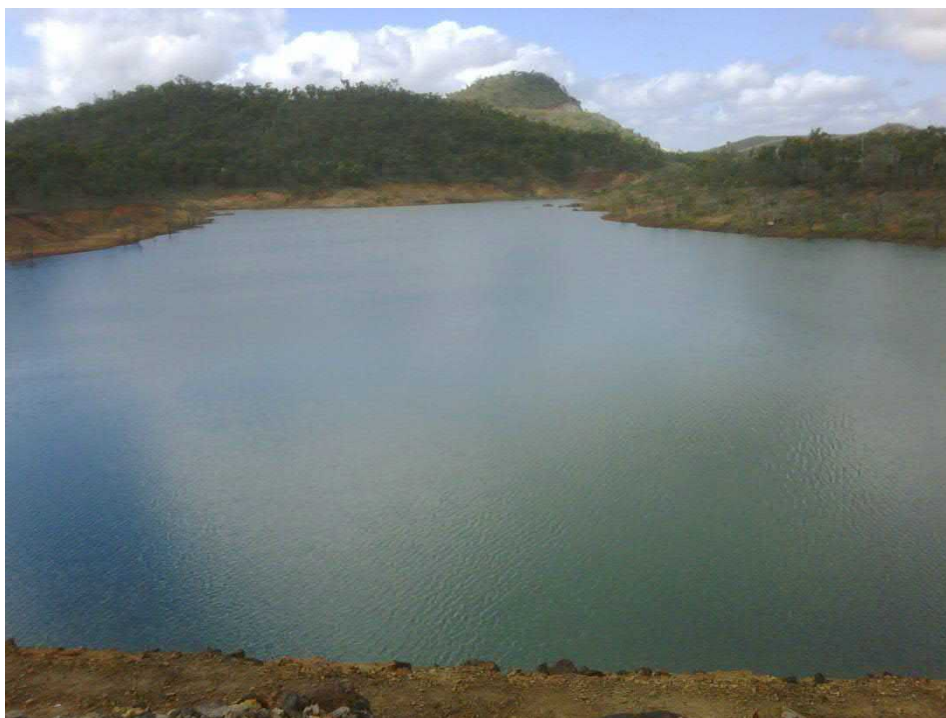
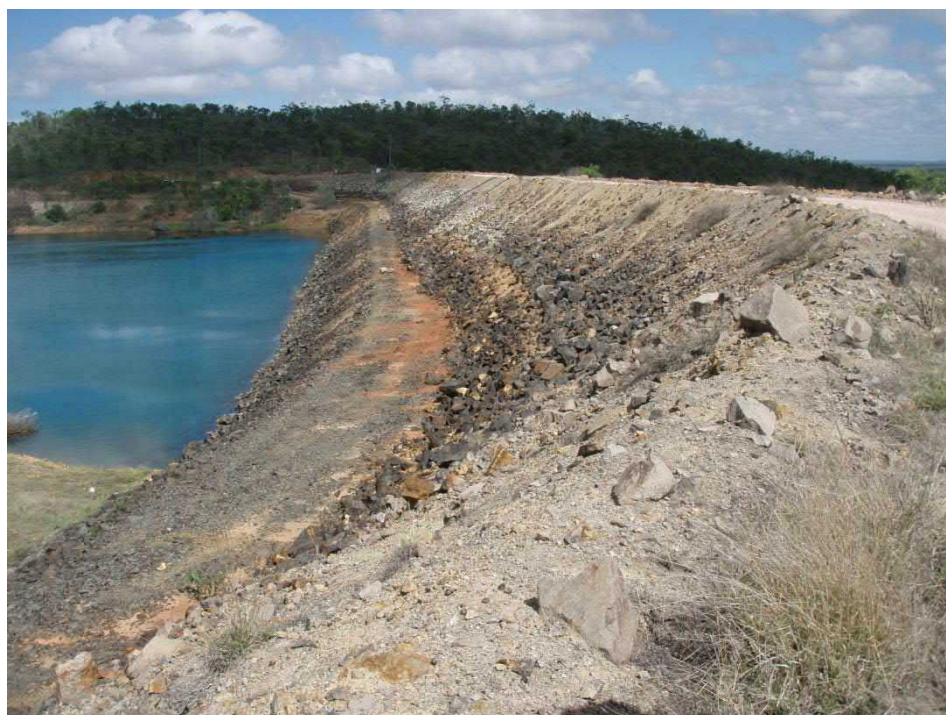
**Raw Water Dam**

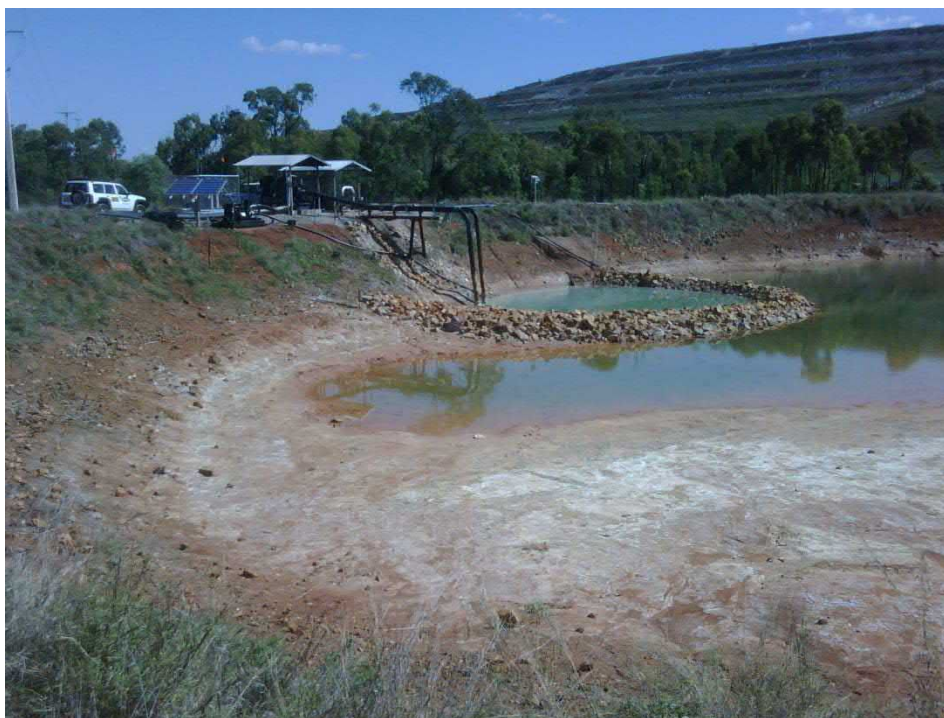
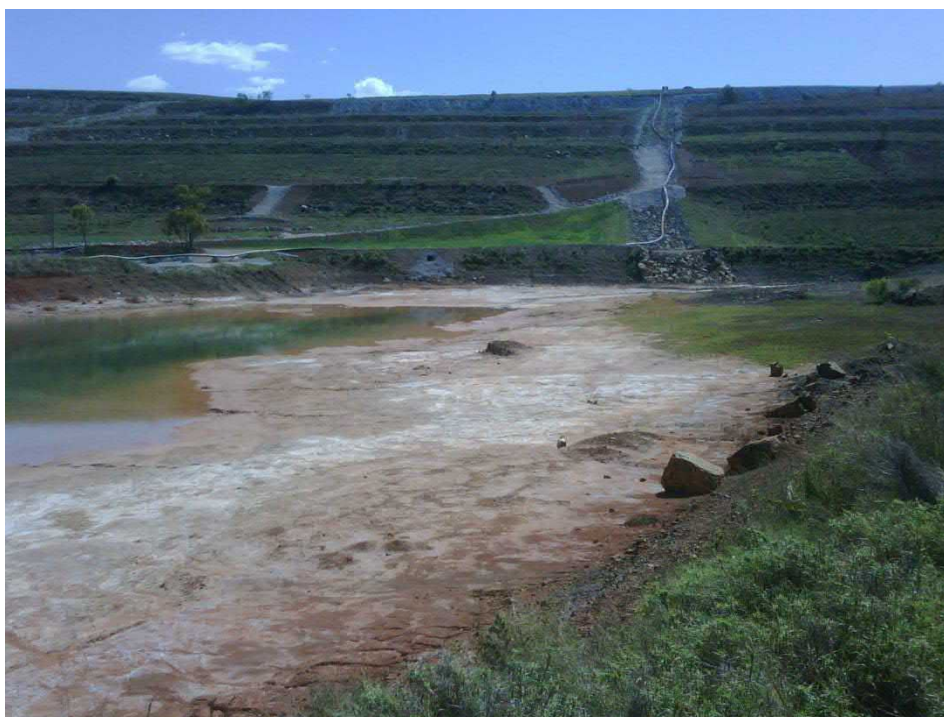
**Mt Mawe Dam**

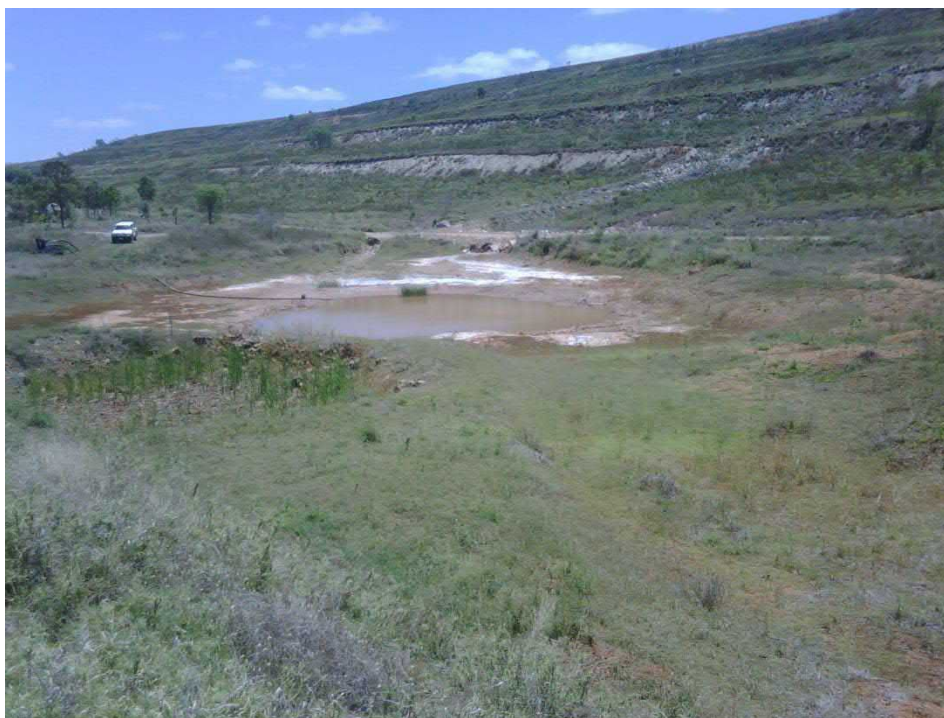
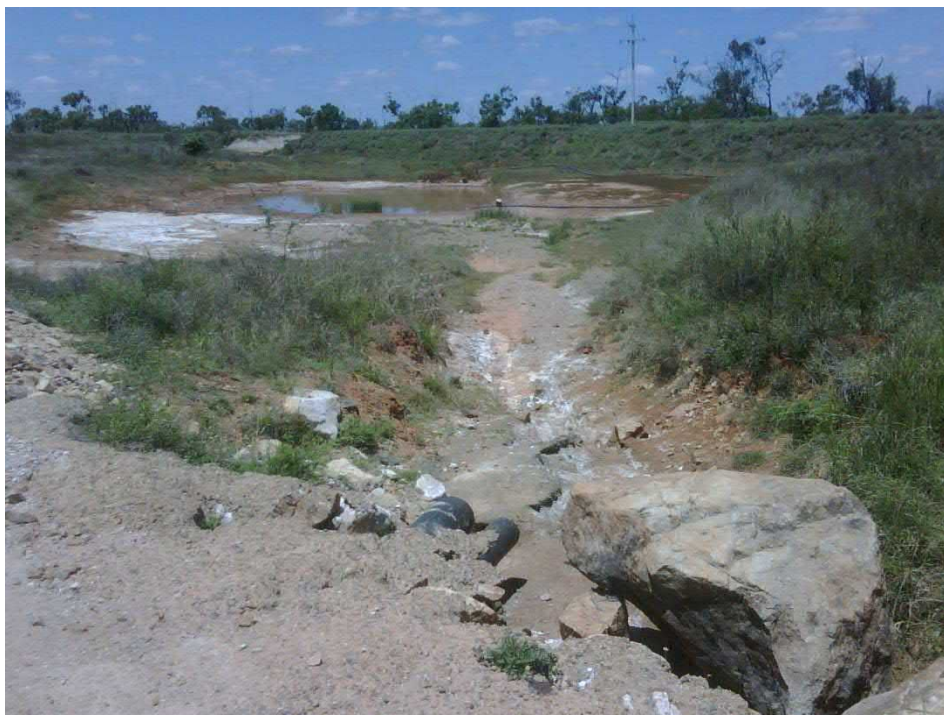
**Mt Hope Extension Dam**

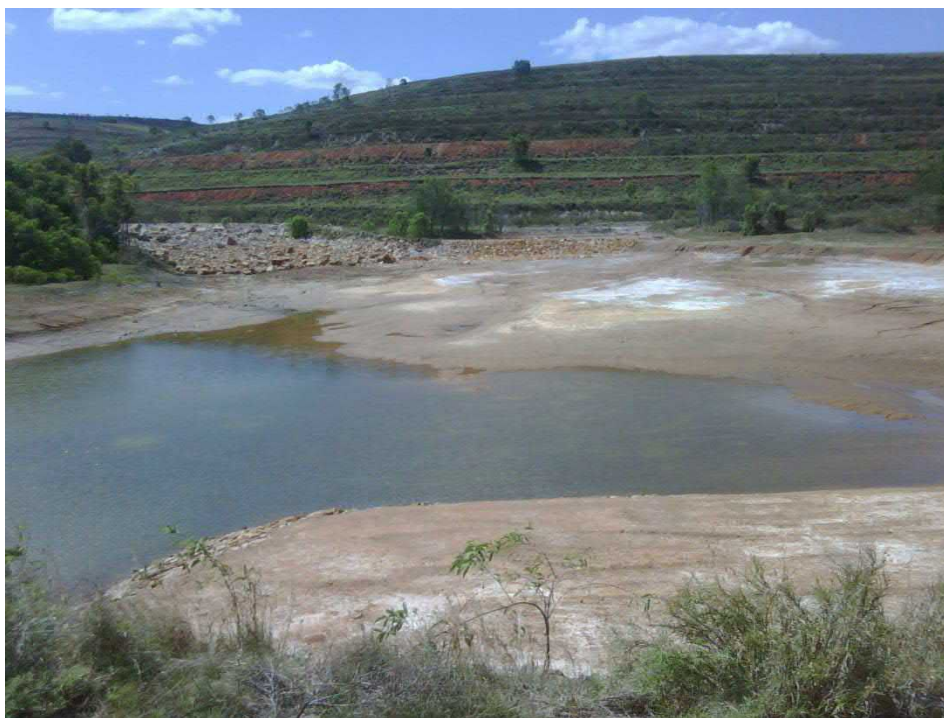
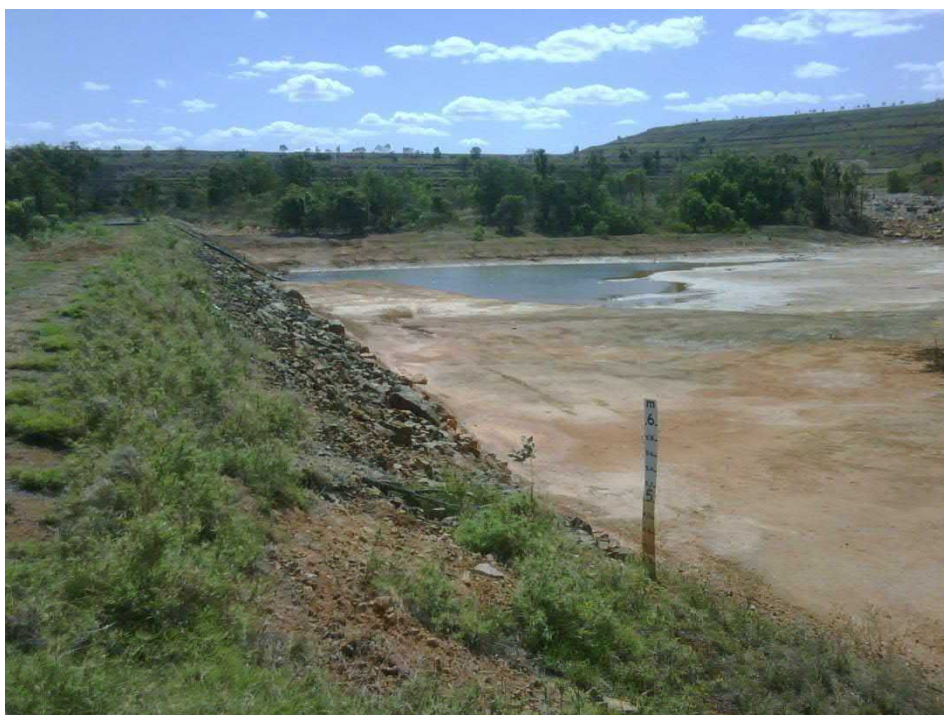
**Mt Hope Dam**

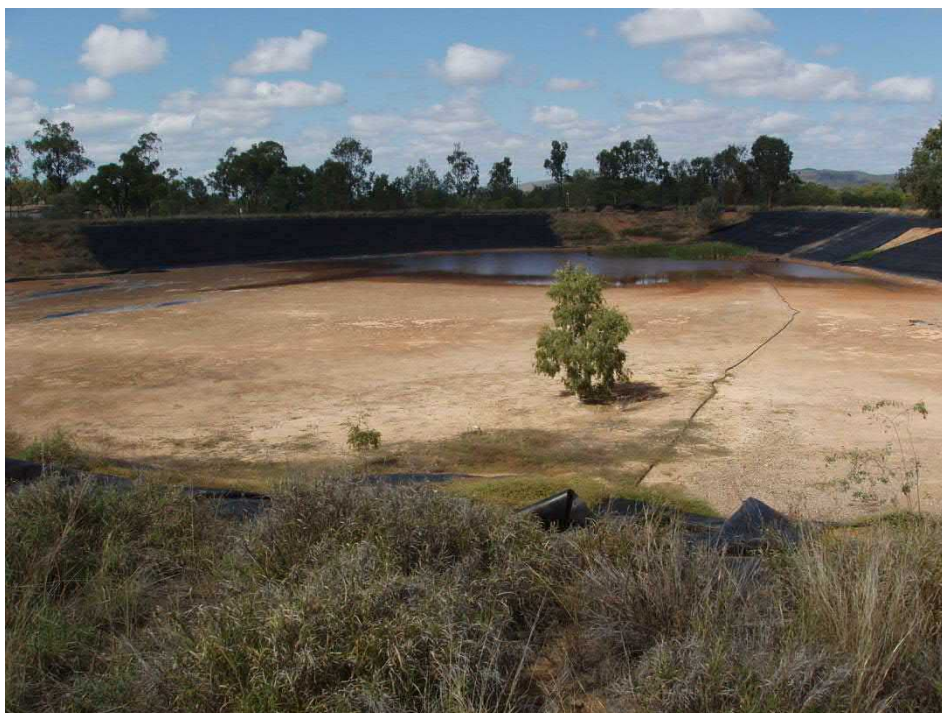
**Stormwater Dam No. 1**

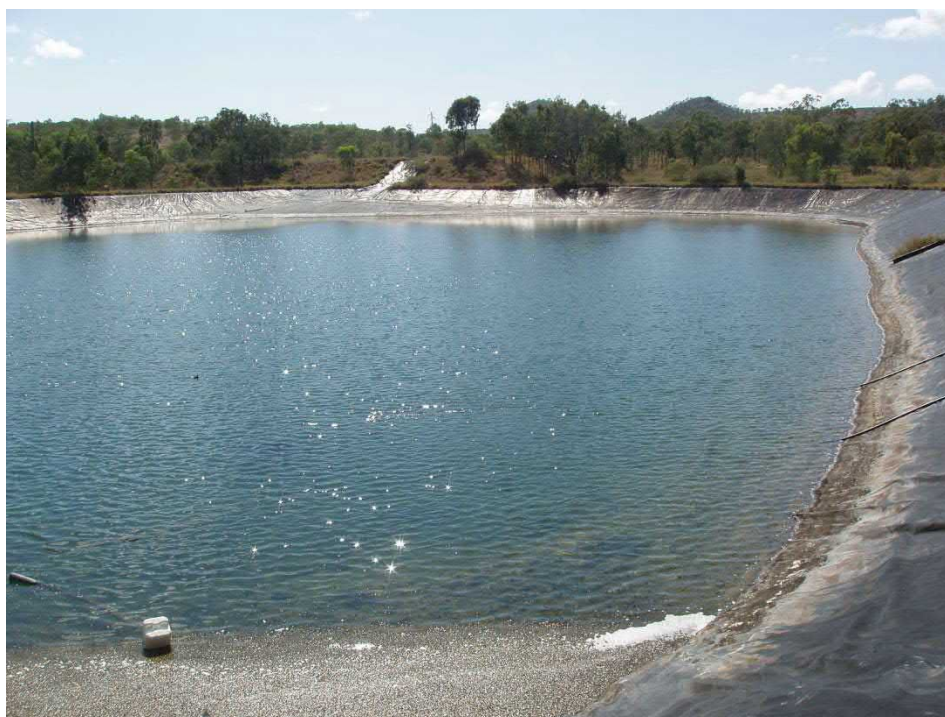
**Stormwater Dam No. 2**

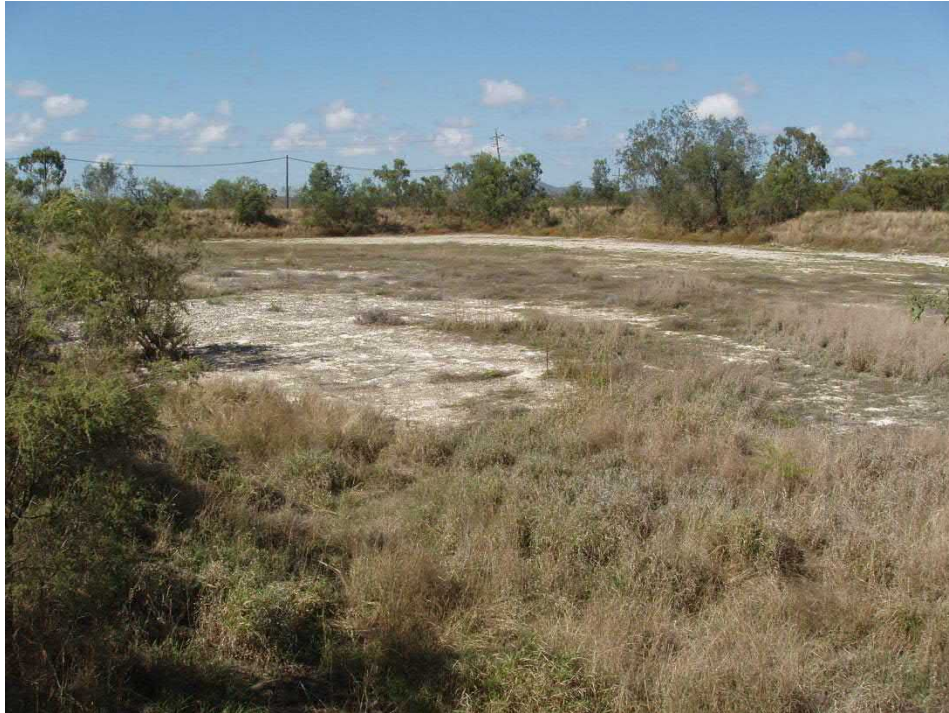
**Borefield Dam**

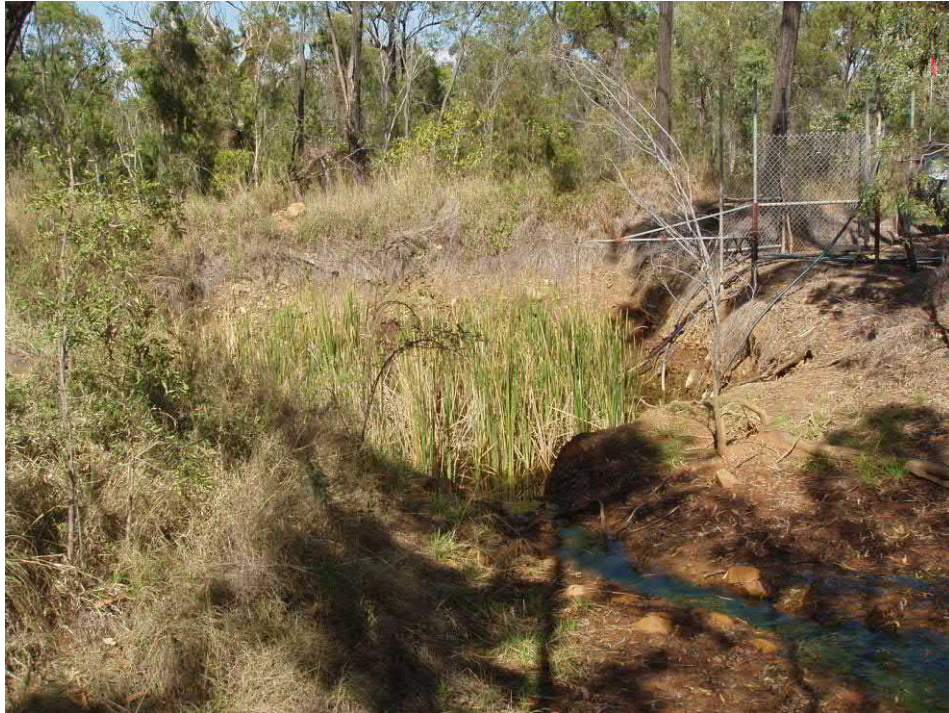
**Settlement Dam Sump**

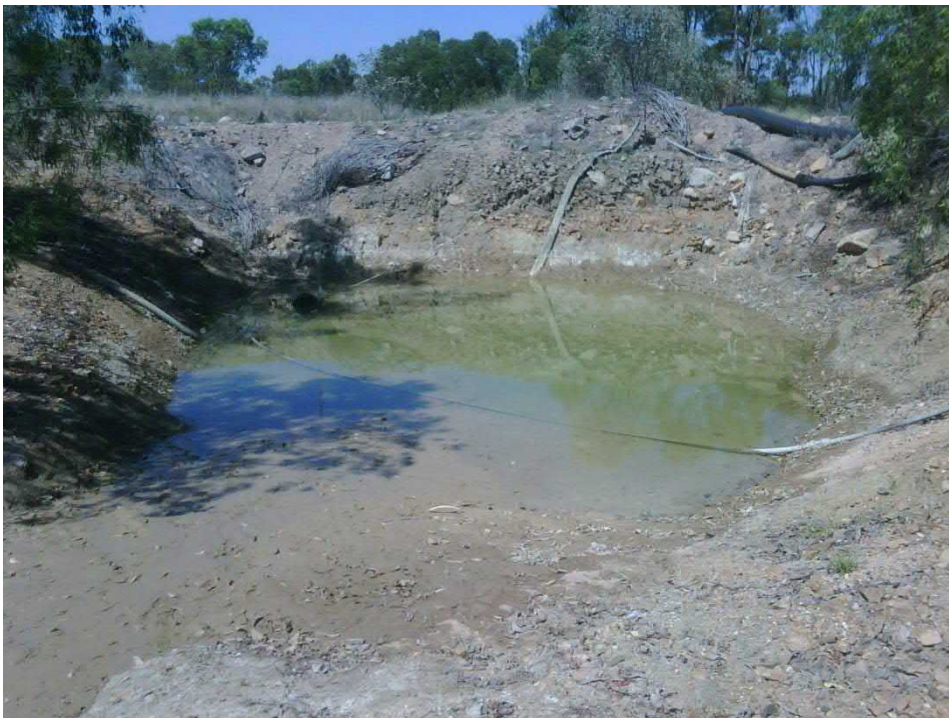
**Supergene Dam Sump**

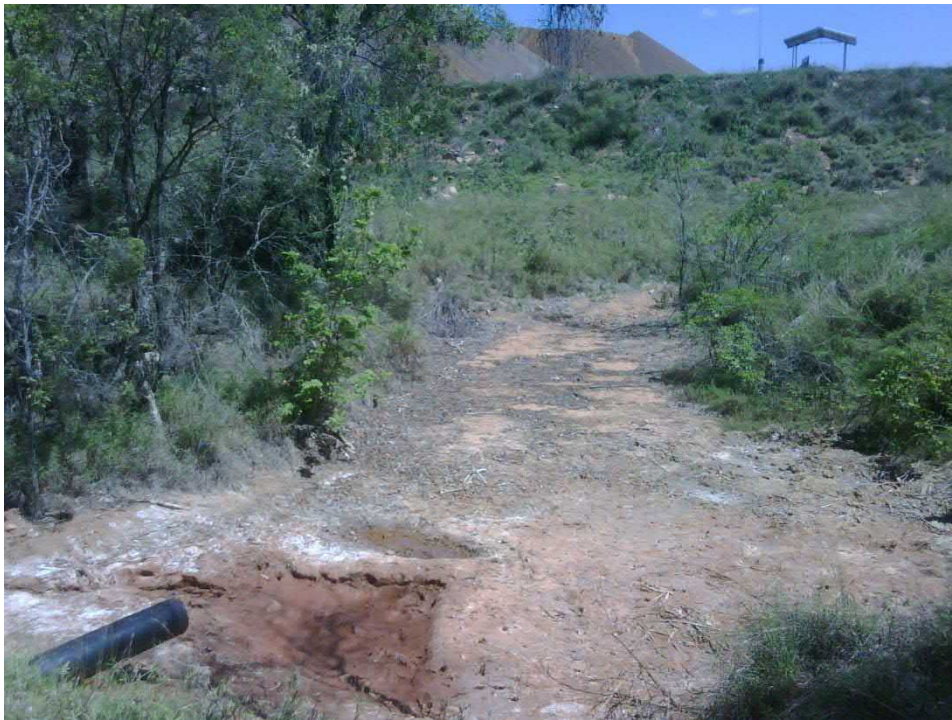
**Plum Tree Creek Dam Sump**

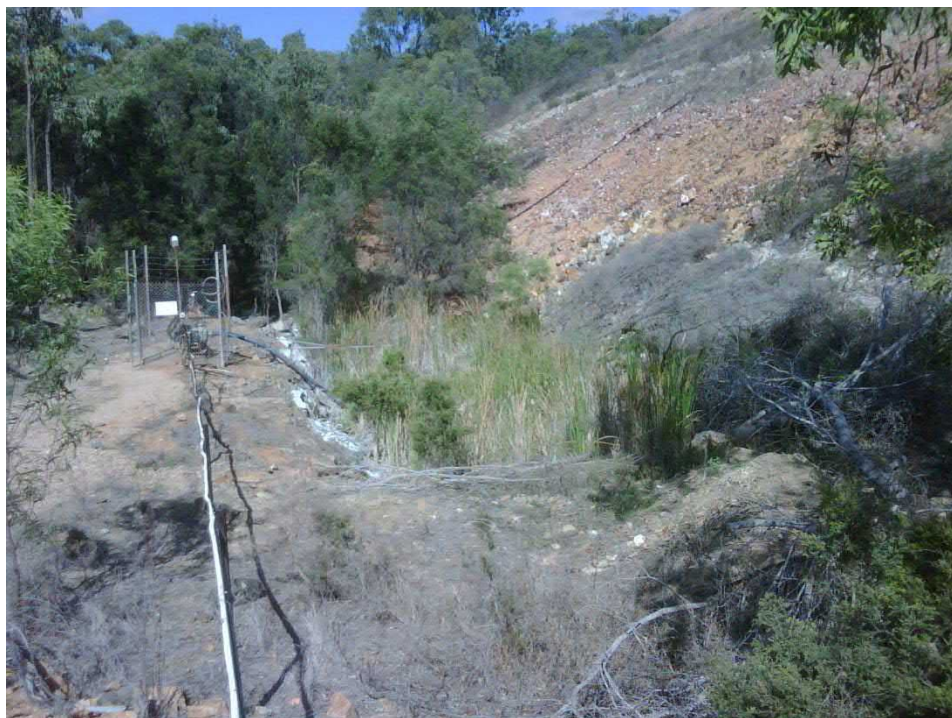
**Raw Water Dam Sump**

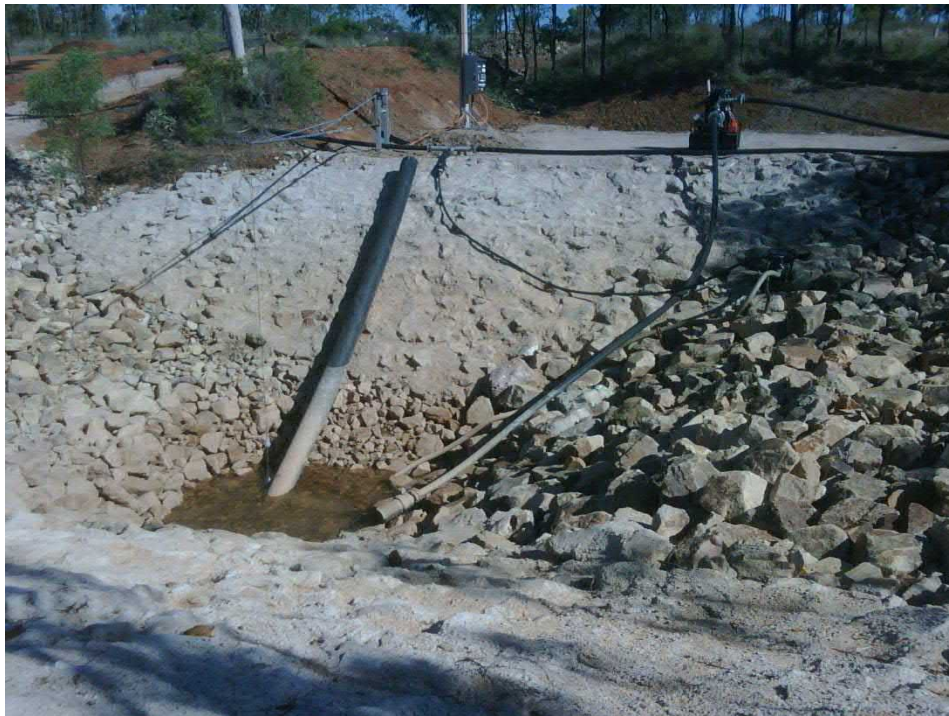
**Mt Mawe Dam Sump**

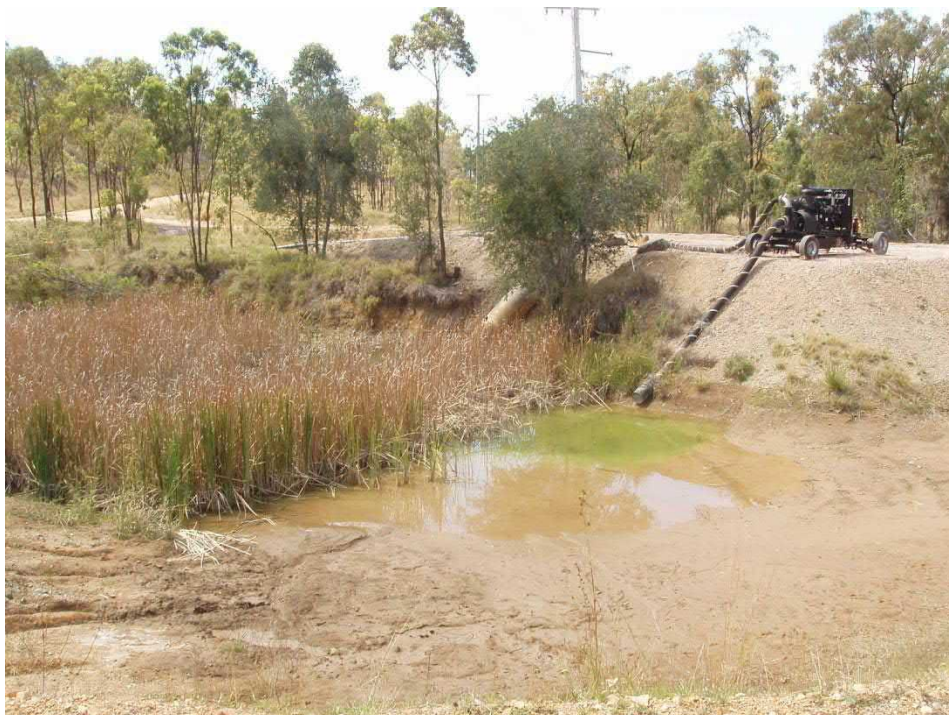
**STD SW Sump**

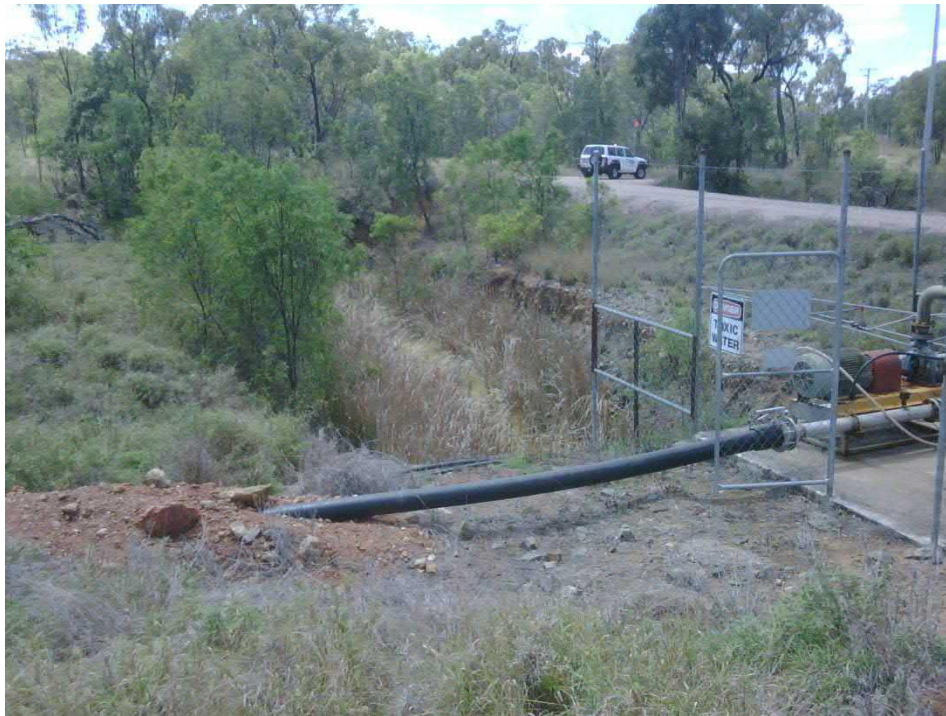
**STD SE Sump**

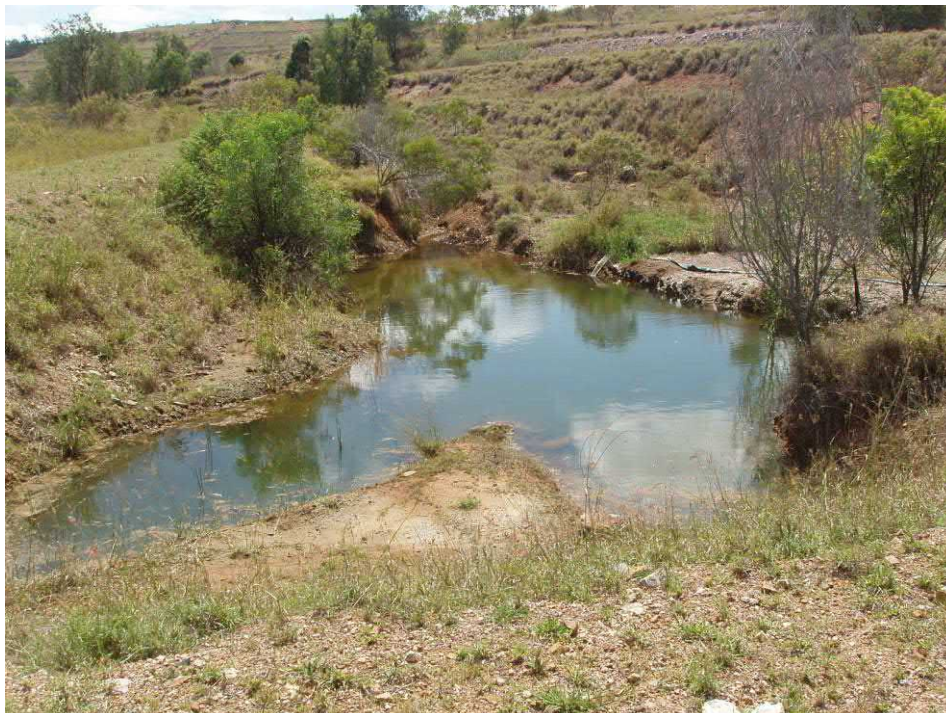
**STD W Sump**

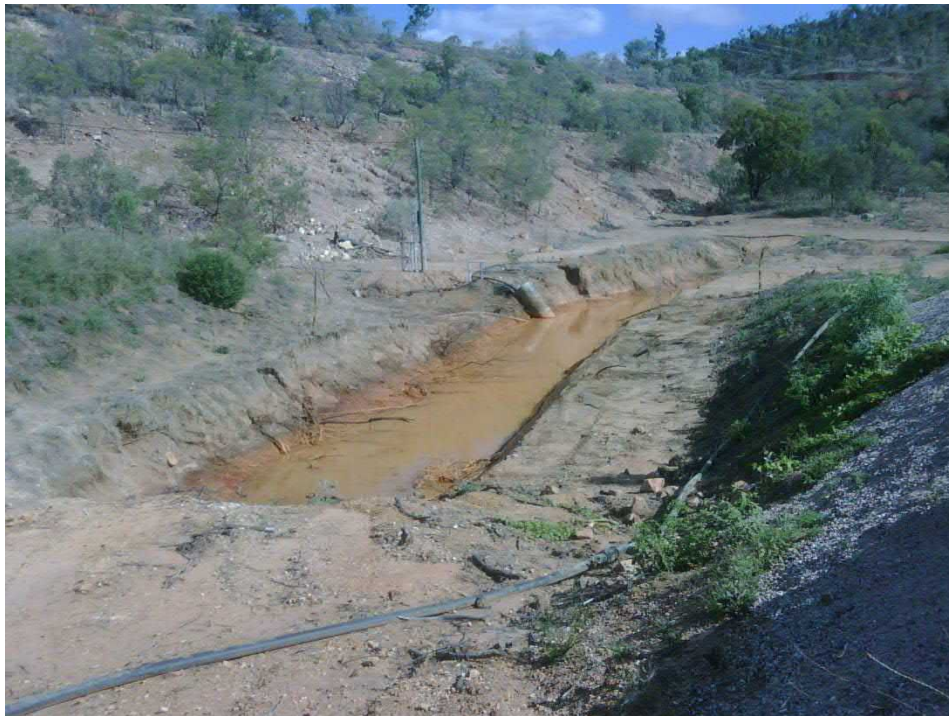
**ONTD W Sump**

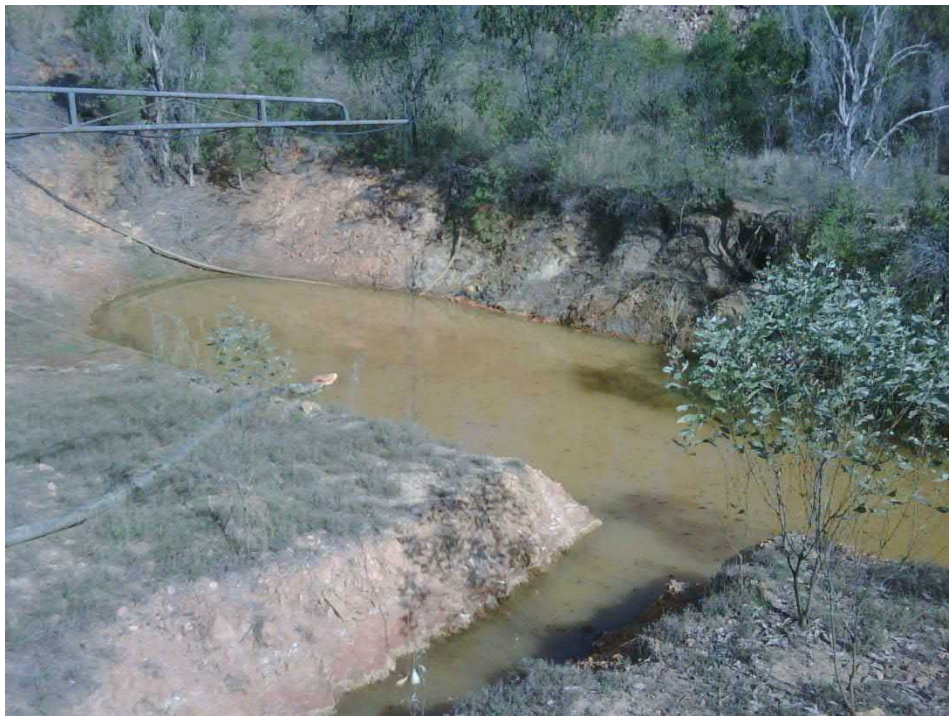
**ONTD N Sump**

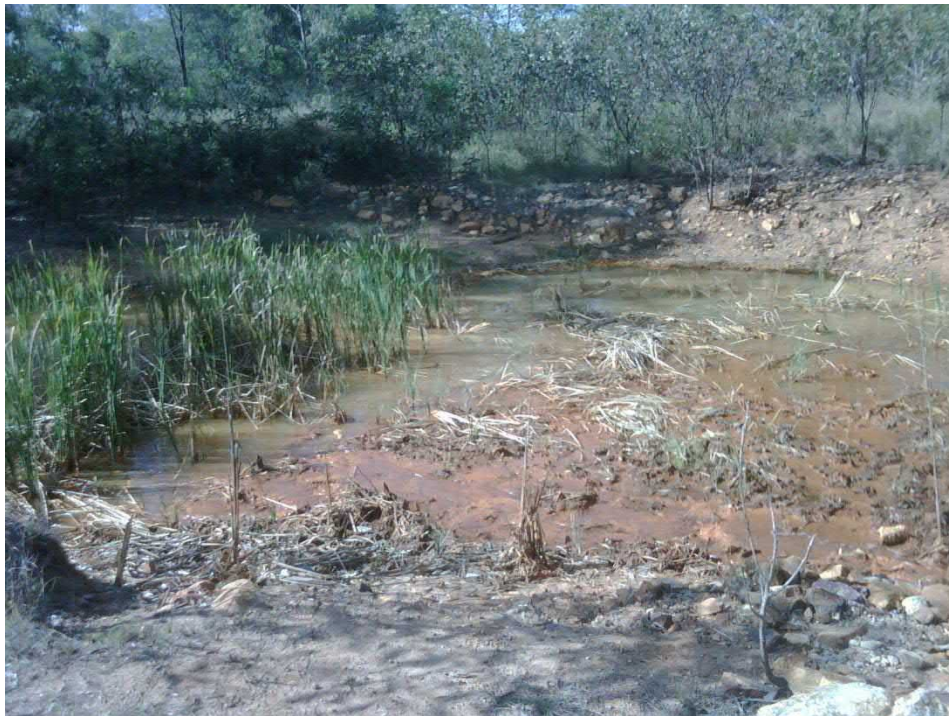
**ONTD E Sump**

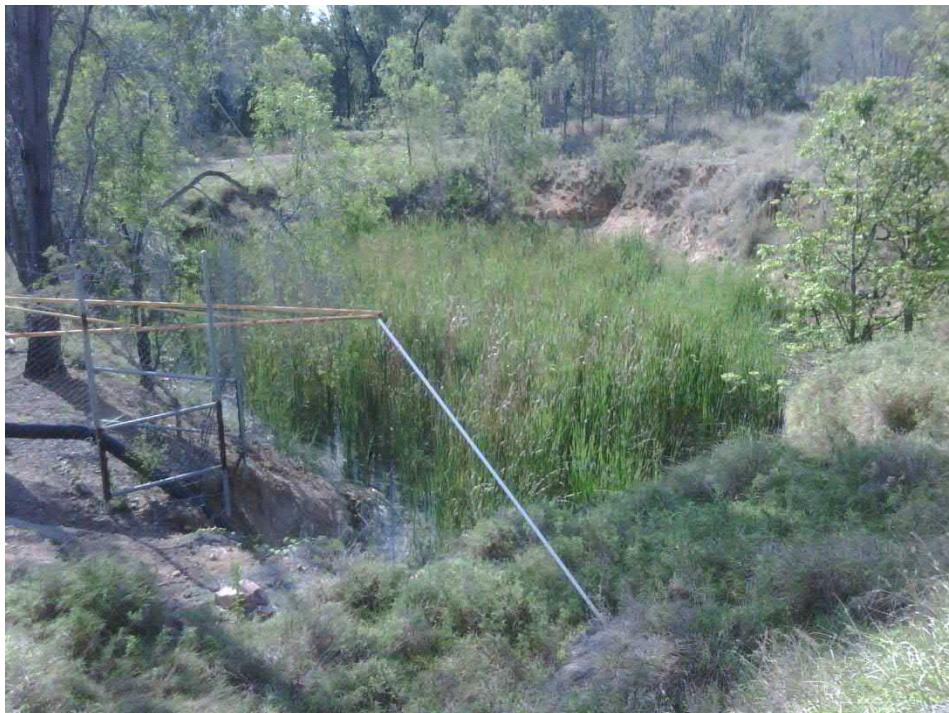
**NNTD W Sump**

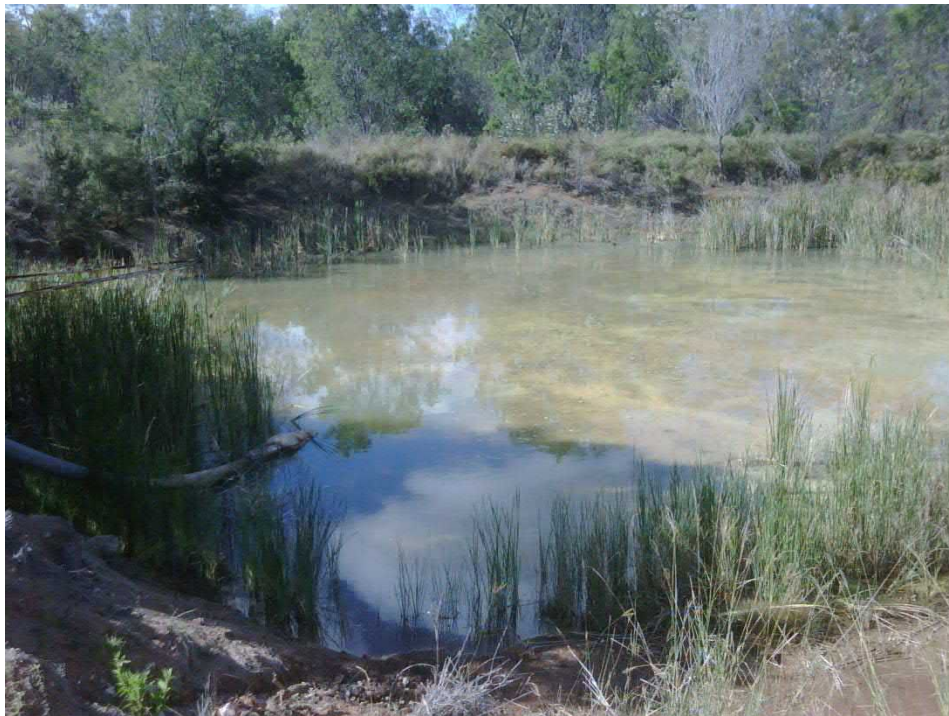
**NNTD N Sump**

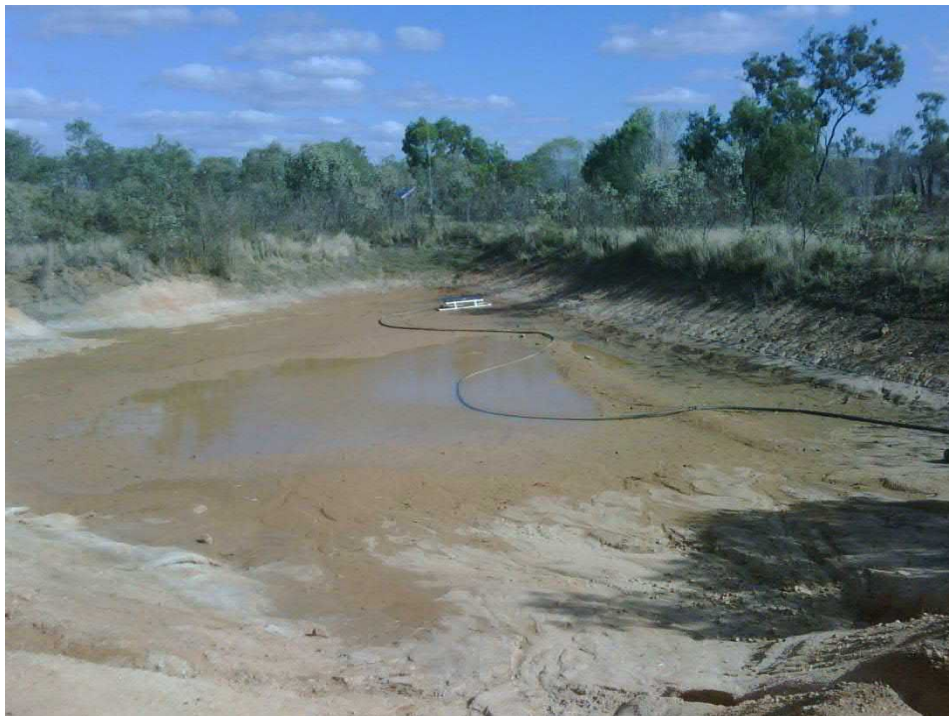
**Western Scats Sump**

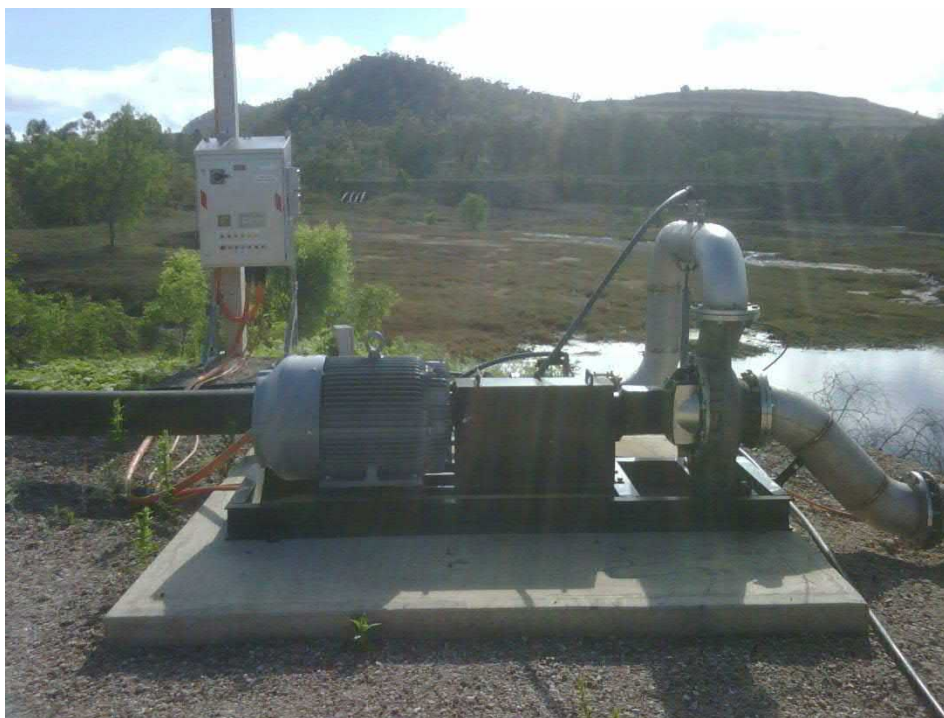
**Settlement Dam electric pump**

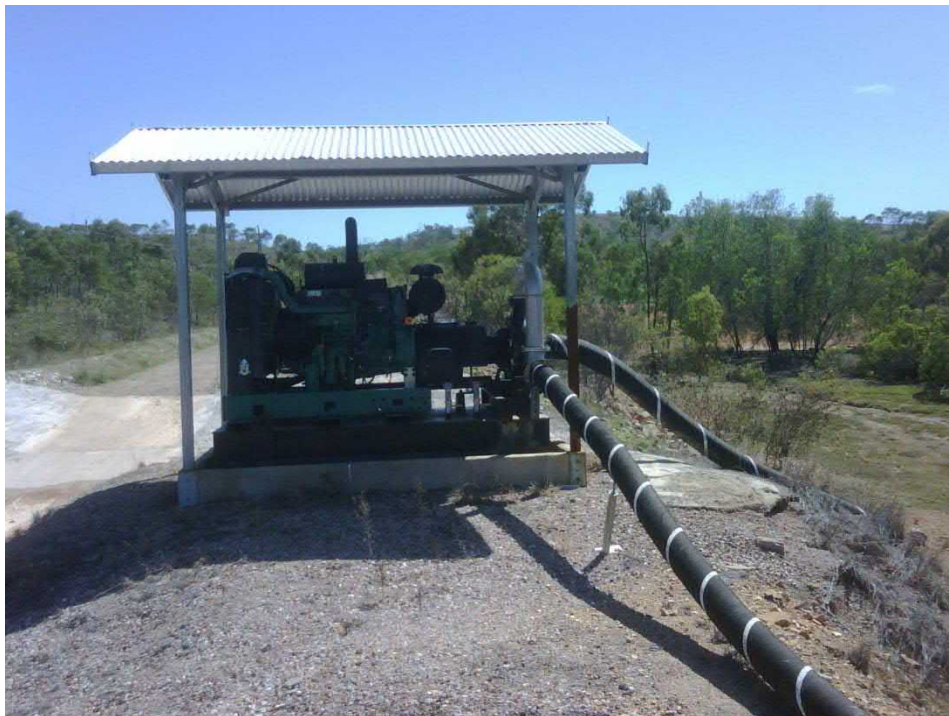
**Supergene Dam diesel pump**

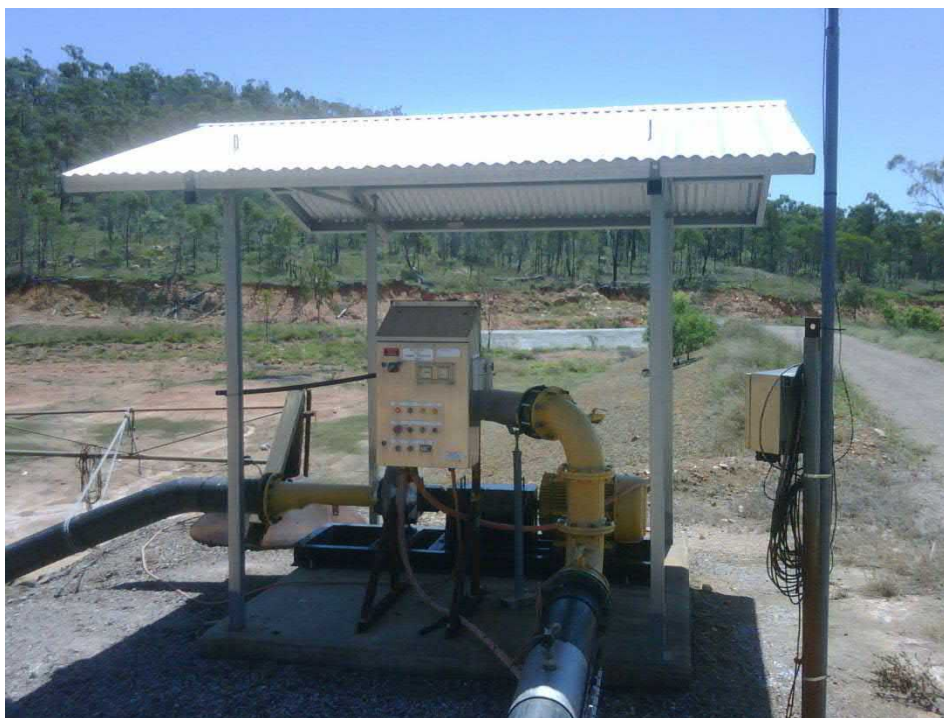
**Plum Tree Creek Dam electric pump**

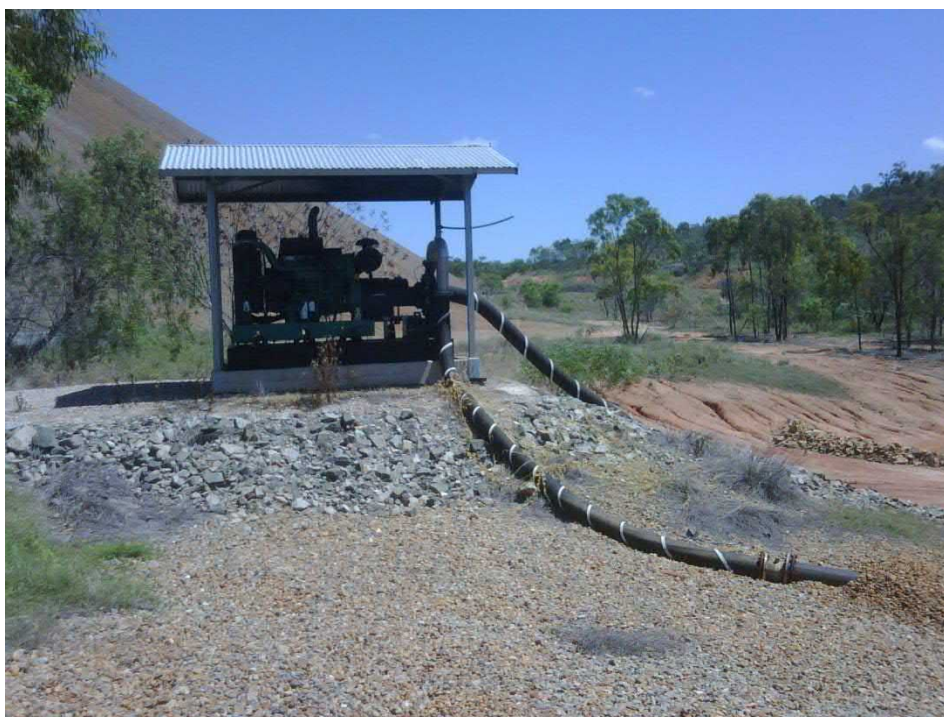
**Plum Tree Creek Dam diesel pump**

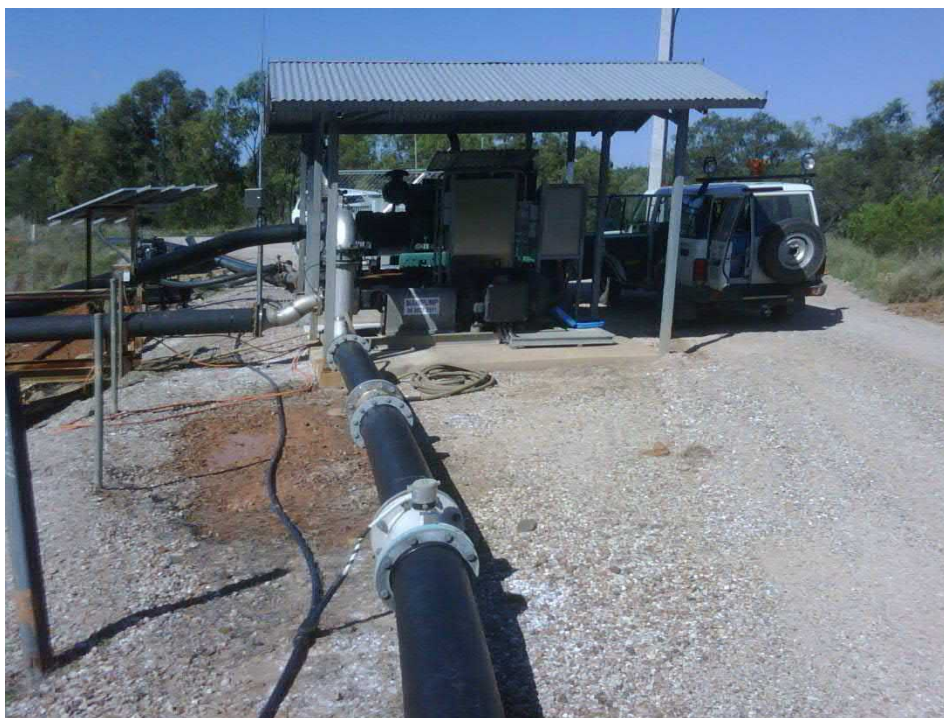
**Mt Mawe Dam electric pump**

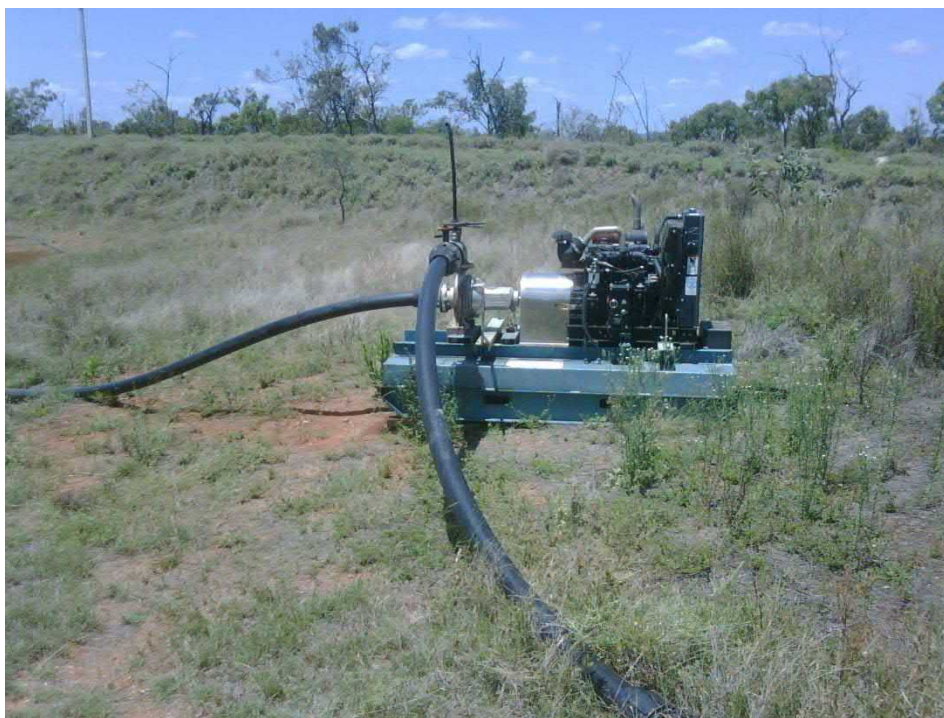
**Mt Hope Extension Dam diesel pump**

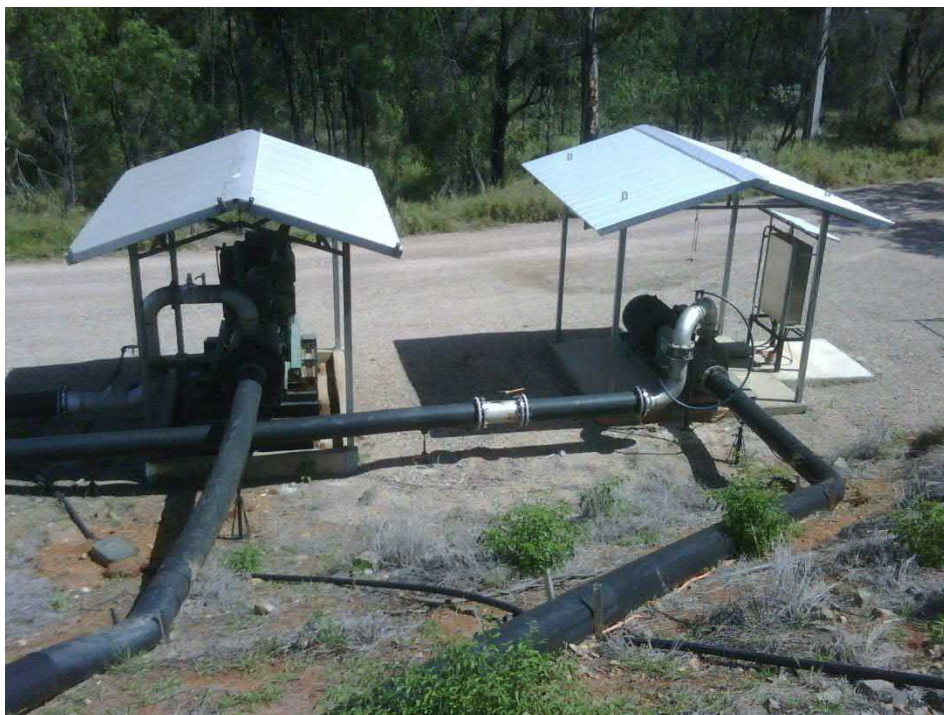
**Mt Hope Dam electric and diesel pumps**
