## Progressive Rehabilitation and Closure Plan

**Mt Leyshon Mine**

M13000\_024-REP-001-2

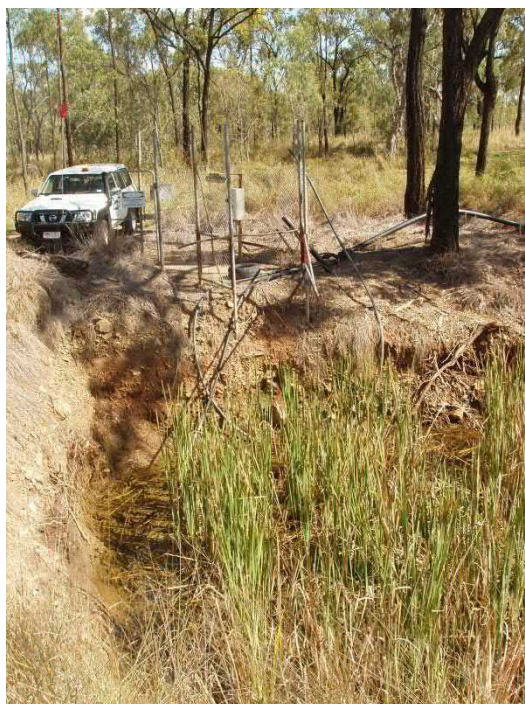
**Settlement Dam Sump electric pump (submersible pump)**

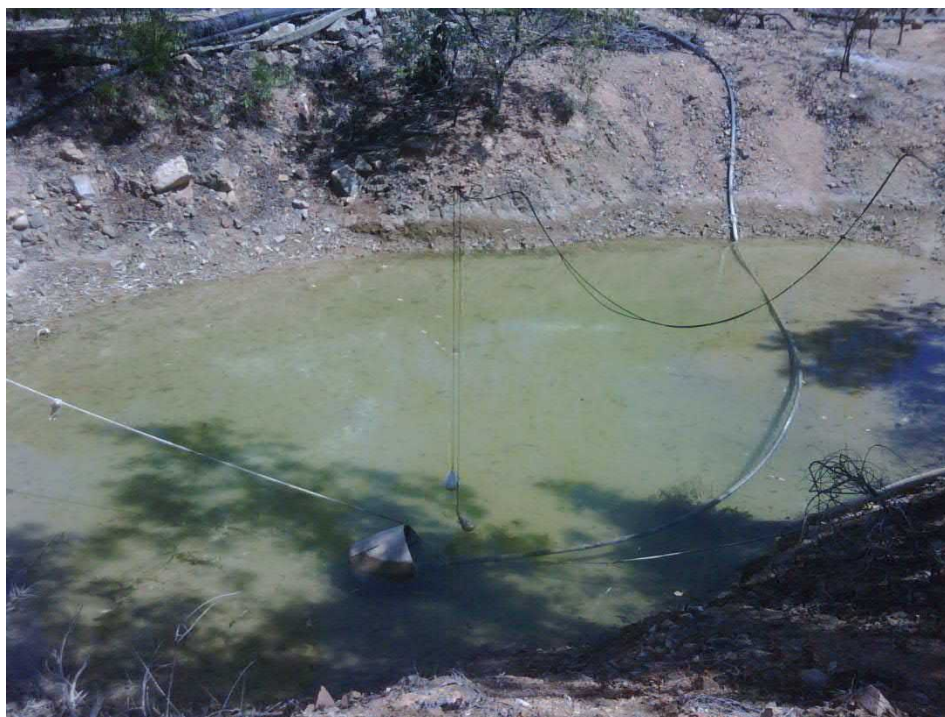
**Supergene Stormwater Dam Sump electric pump (submersible pump)**

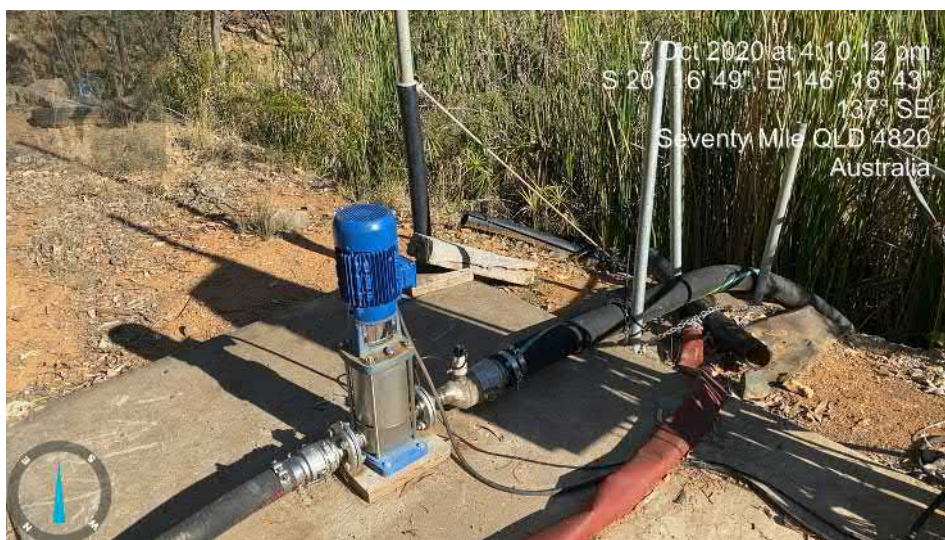
**Raw Water Dam Solar Pump**

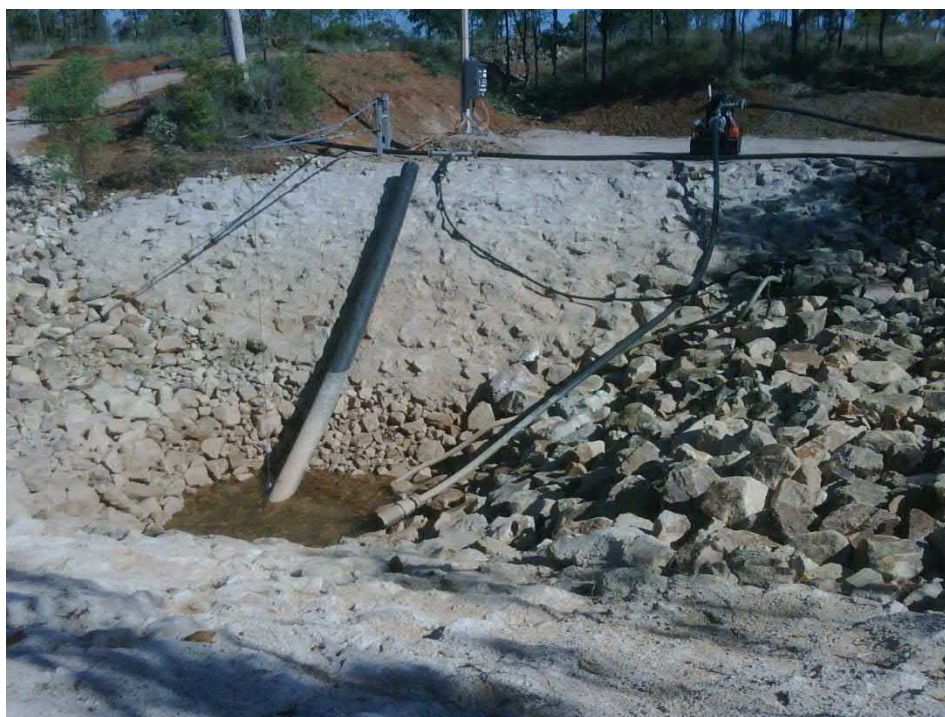
**Mt Mawe Dam Sump diesel pump**

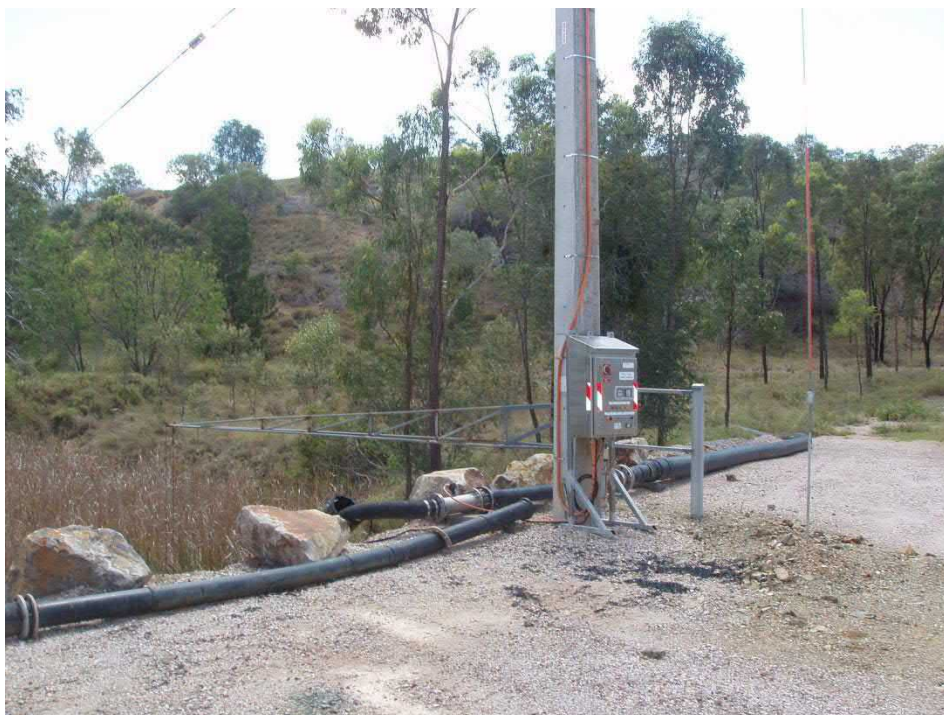
**STD SW Sump electric pump (submersible pump)**

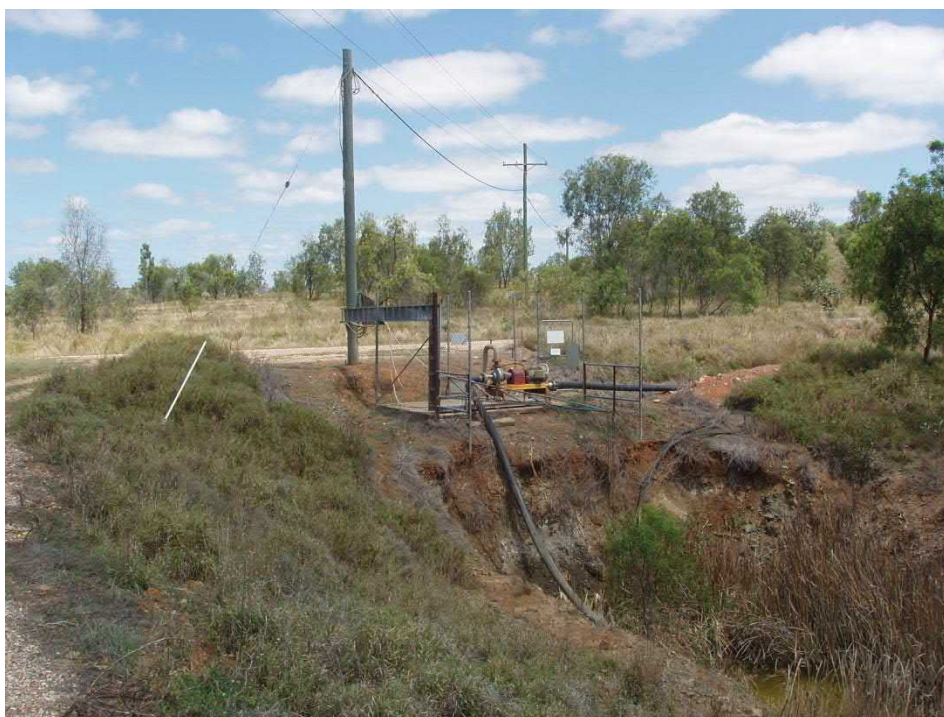
**STD SE Sump electric pump**

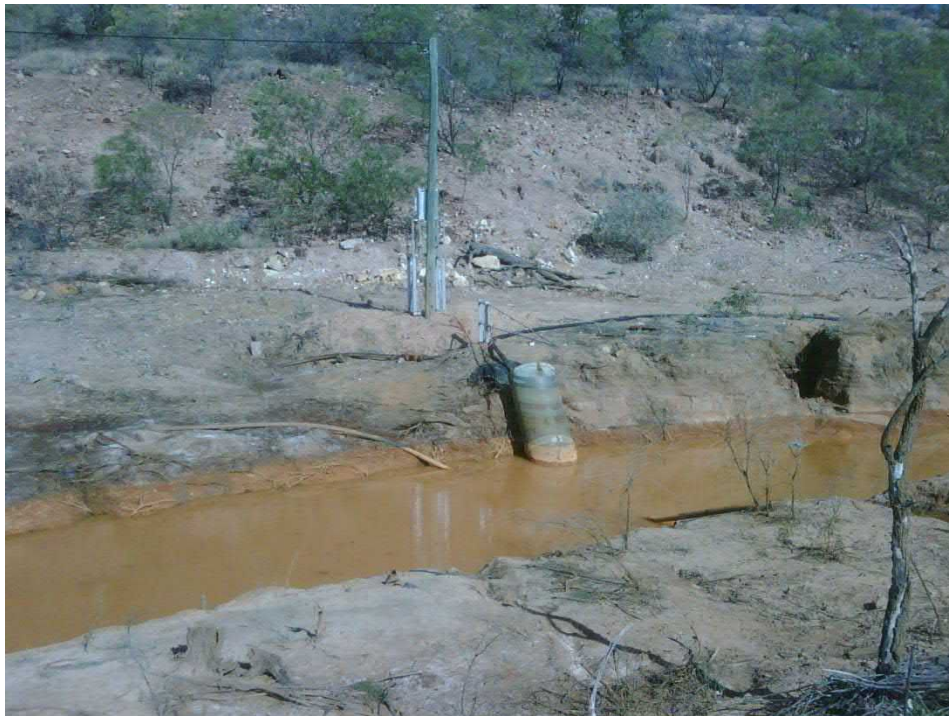
**ONTD W Sump electric pump (submersible pump)**

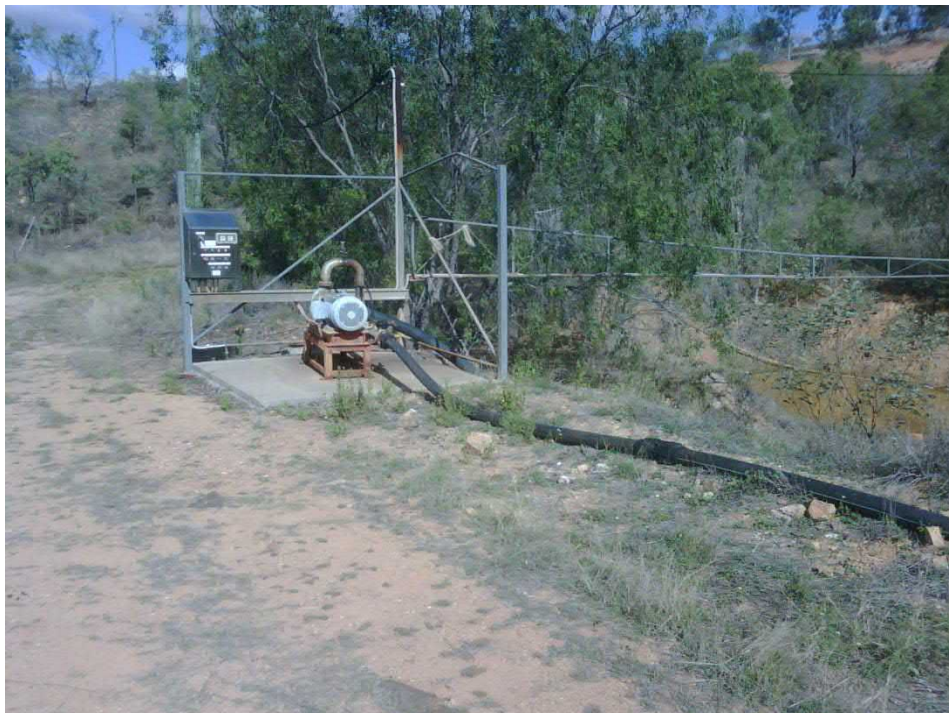
**ONTD N Sump electric pump**

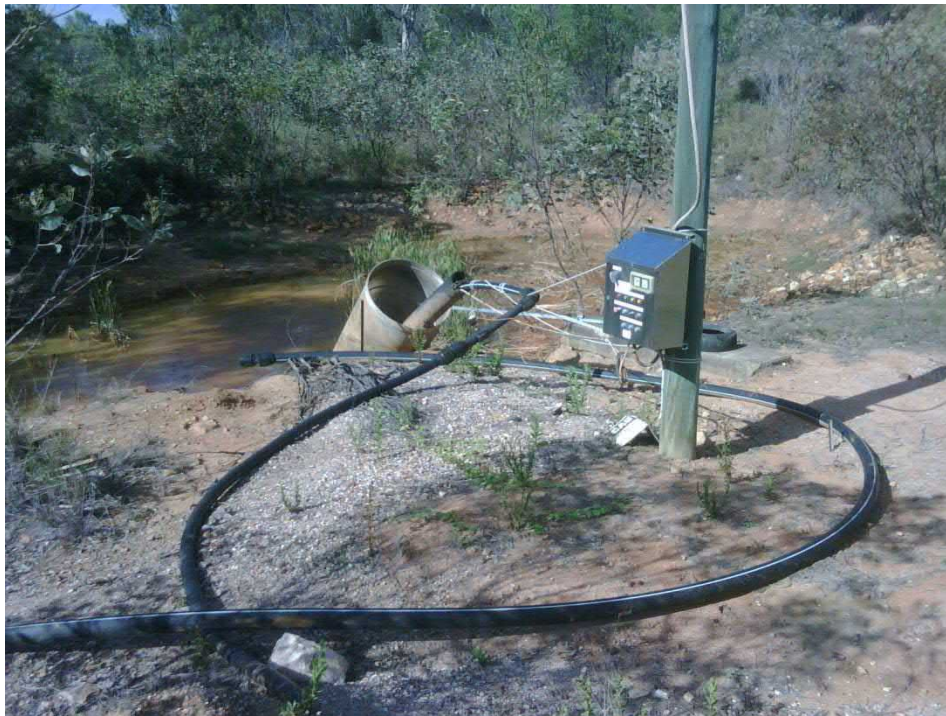
**ONTD E Sump electric pump (submersible pump)**

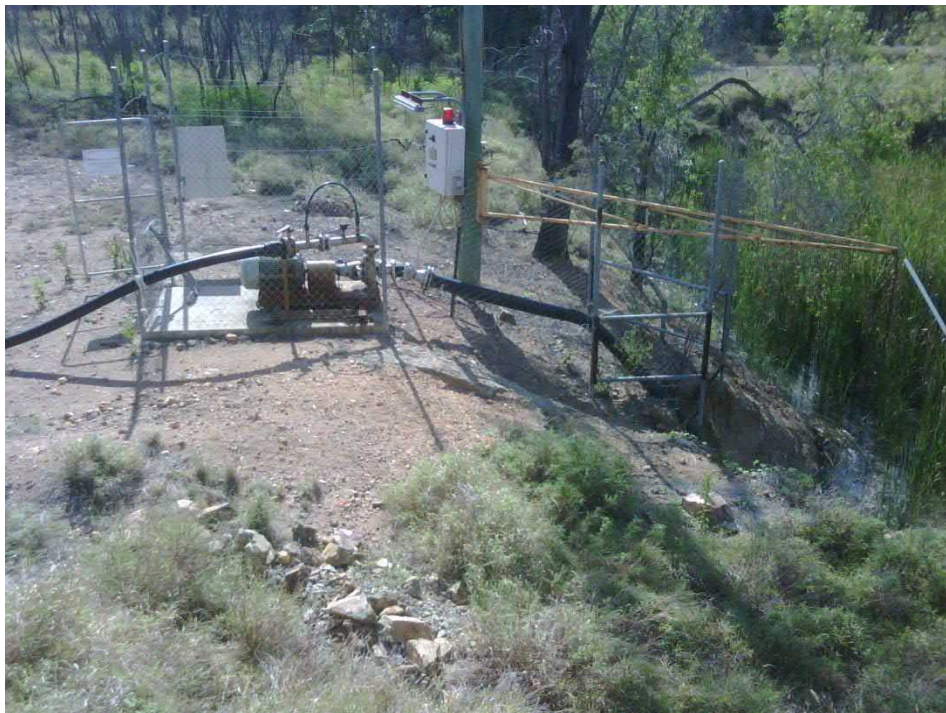
**NNTD W Sump electric pump**

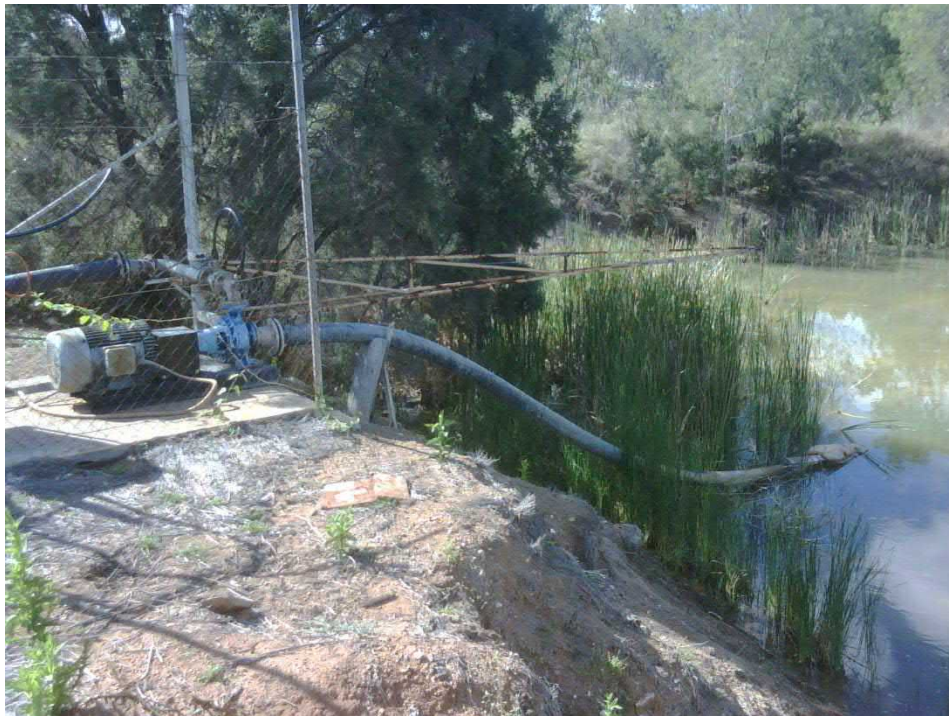
**NNTD N Sump electric pump**

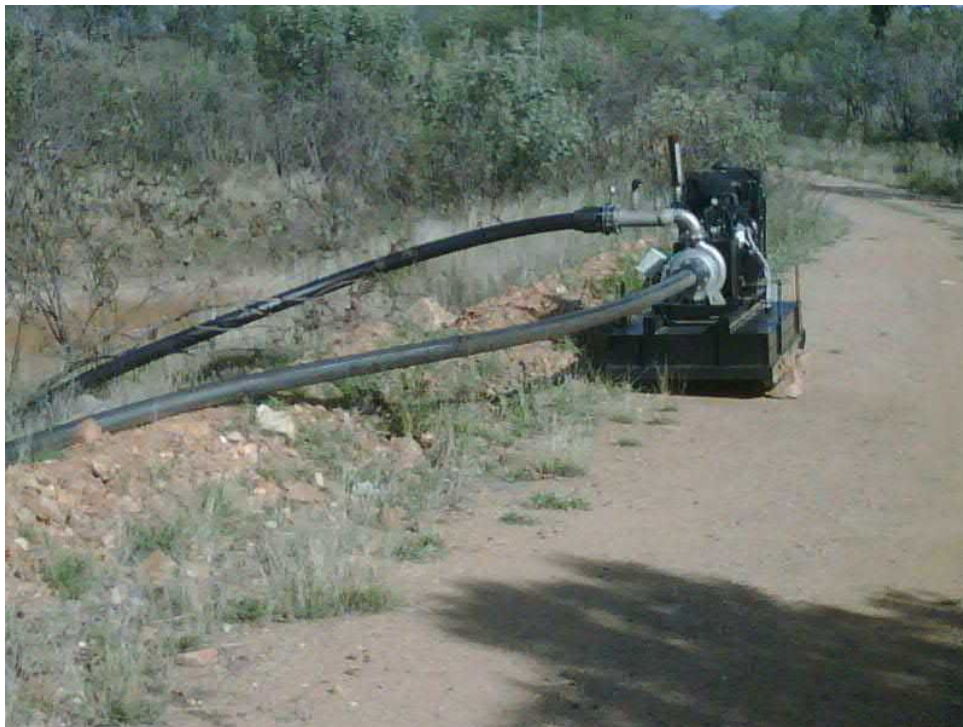
**Western Scats Sump diesel pump**

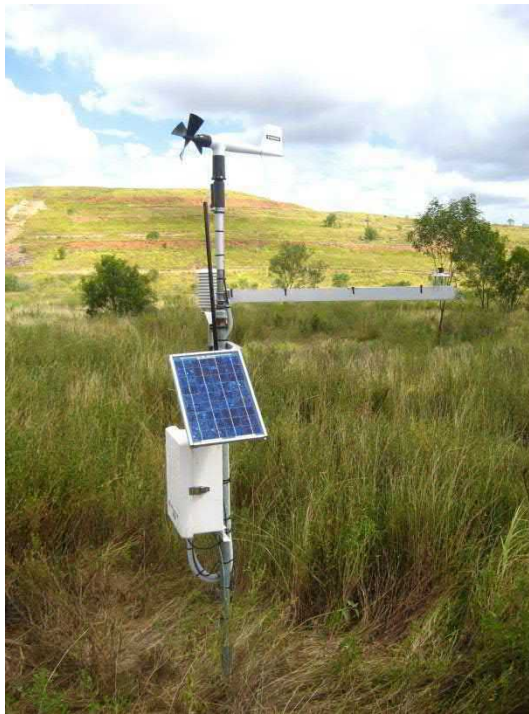
**Automatic weather station**

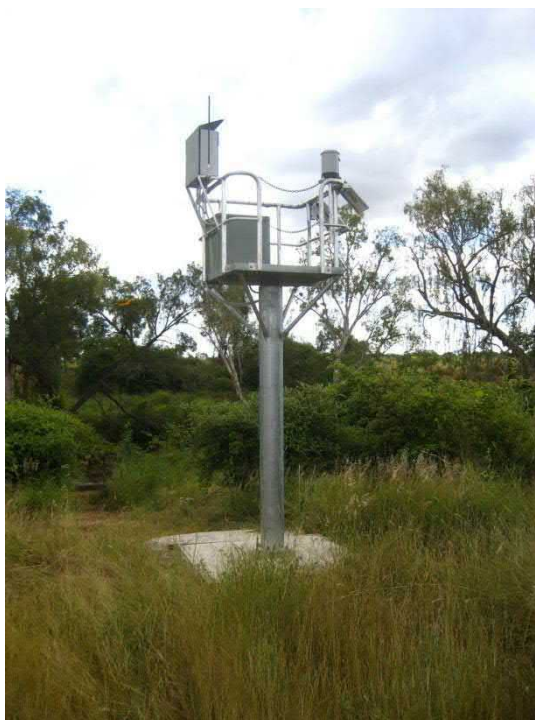
**On-lease receiving waterway automatic monitoring station – Clarke Creek**

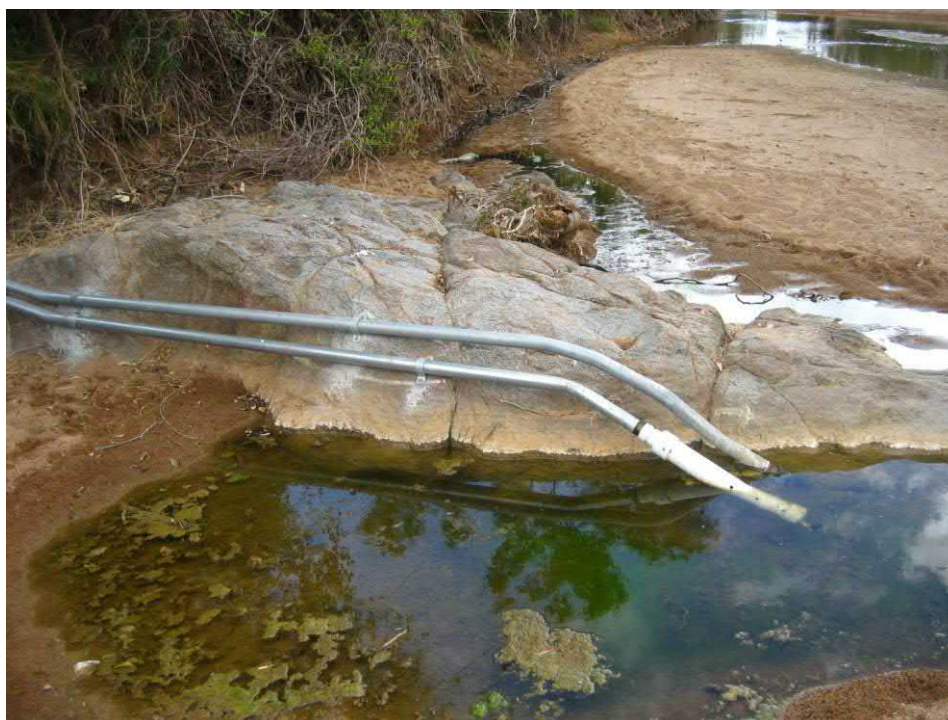
**On-lease receiving waterway automatic monitoring station – Clarke Creek**

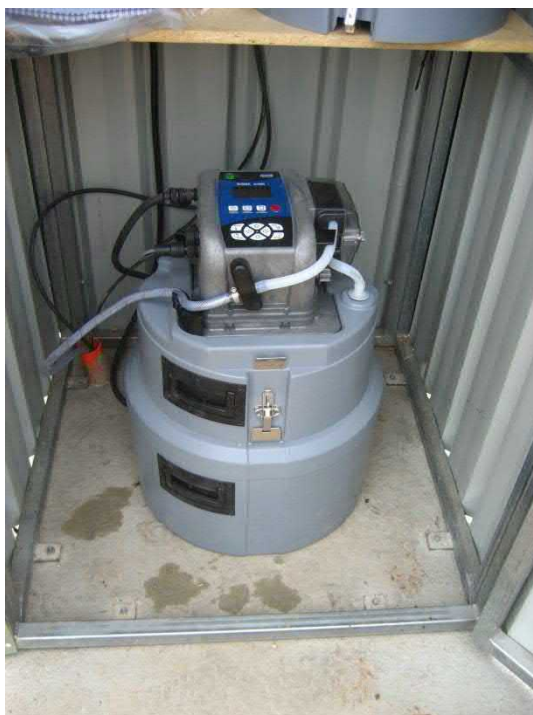
**Automatic sampler unit**

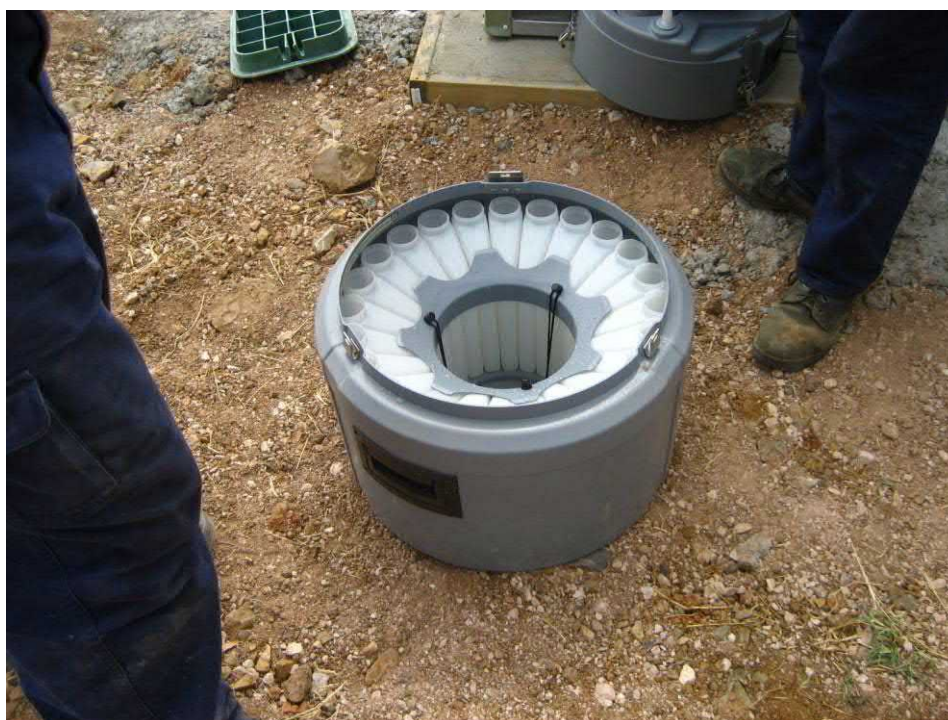
**Automatic sampler unit**

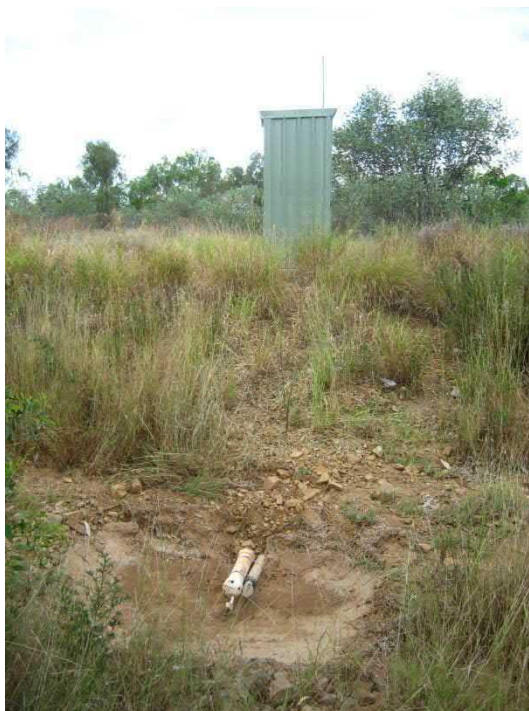
**Mt Hope Dam high flow bypass automatic monitoring station**

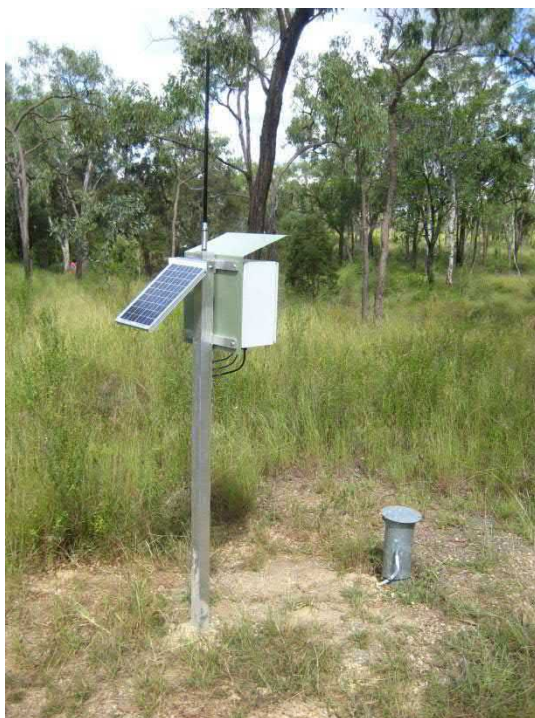
**Typical monitoring bore automatic monitoring station**

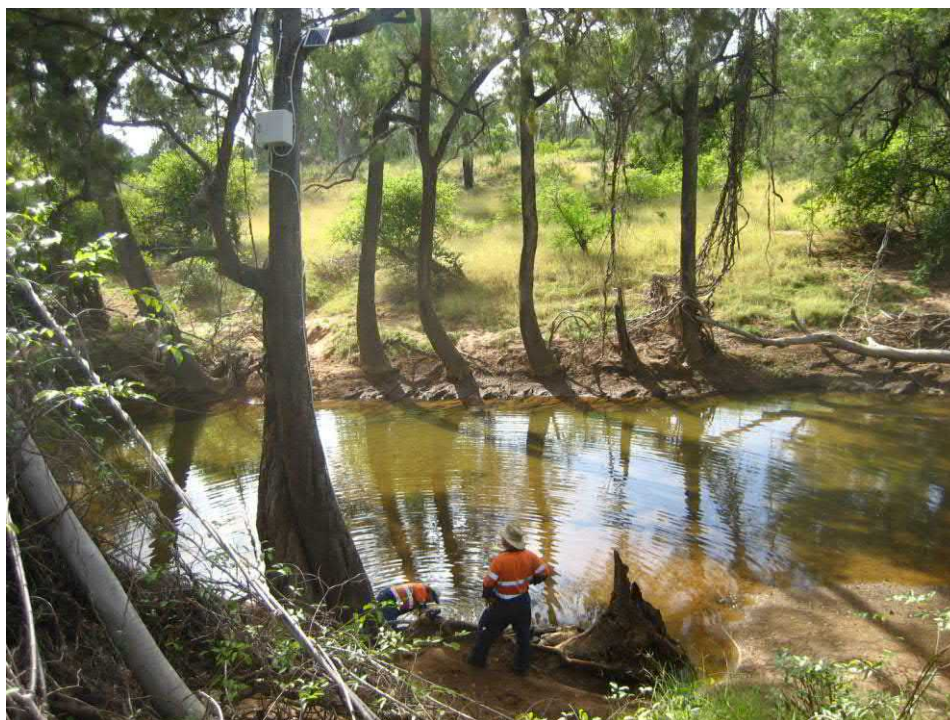
**Off-lease receiving waterway automatic monitoring station – Seventy Mile Creek**

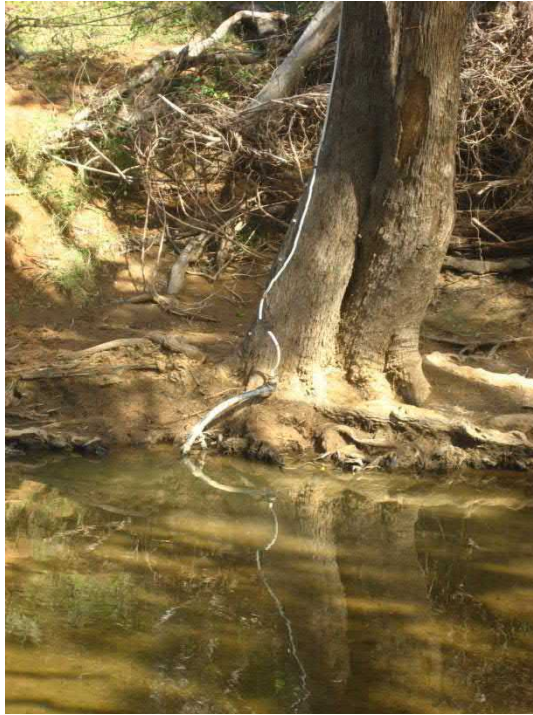
**Off-lease receiving waterway automatic monitoring station – Seventy Mile Creek**

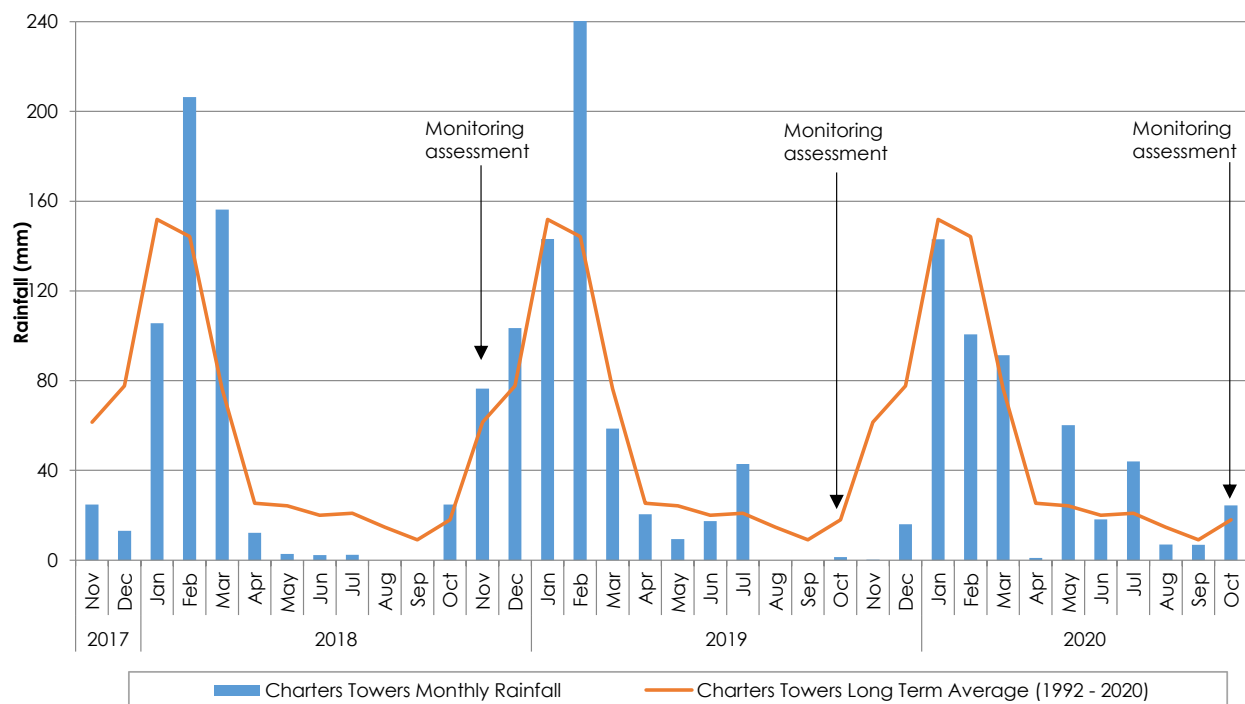
Figure 1-1: Monthly rainfall at Charters Towers Airport (station number 034084) from November 2017 to October 2020, in comparison with the long-term average (1992-2020)

Mt Leyshon is located in the dry tropical region of Northern Queensland. The closest weather station is Charters Towers Airport (station number 034084), approximately 27 km north of Mt Leyshon. It receives an annual average rainfall of 644 millimetres (mm), and mean maximum temperatures ranging from 25°C in June (winter) to 35°C in December (summer) (BOM 2020). In the 12 months prior to the 2020 monitoring, 490 mm of rain was recorded at Charters Towers, 154 mm below the long-term annual average. In contrast, above-average rainfall was received prior to the 2019 assessment, however, this was a result of above-average rainfall mostly received in February 2019. Drier than average conditions were experienced in the two months prior to the 2020 assessment (**Figure 1-1**).

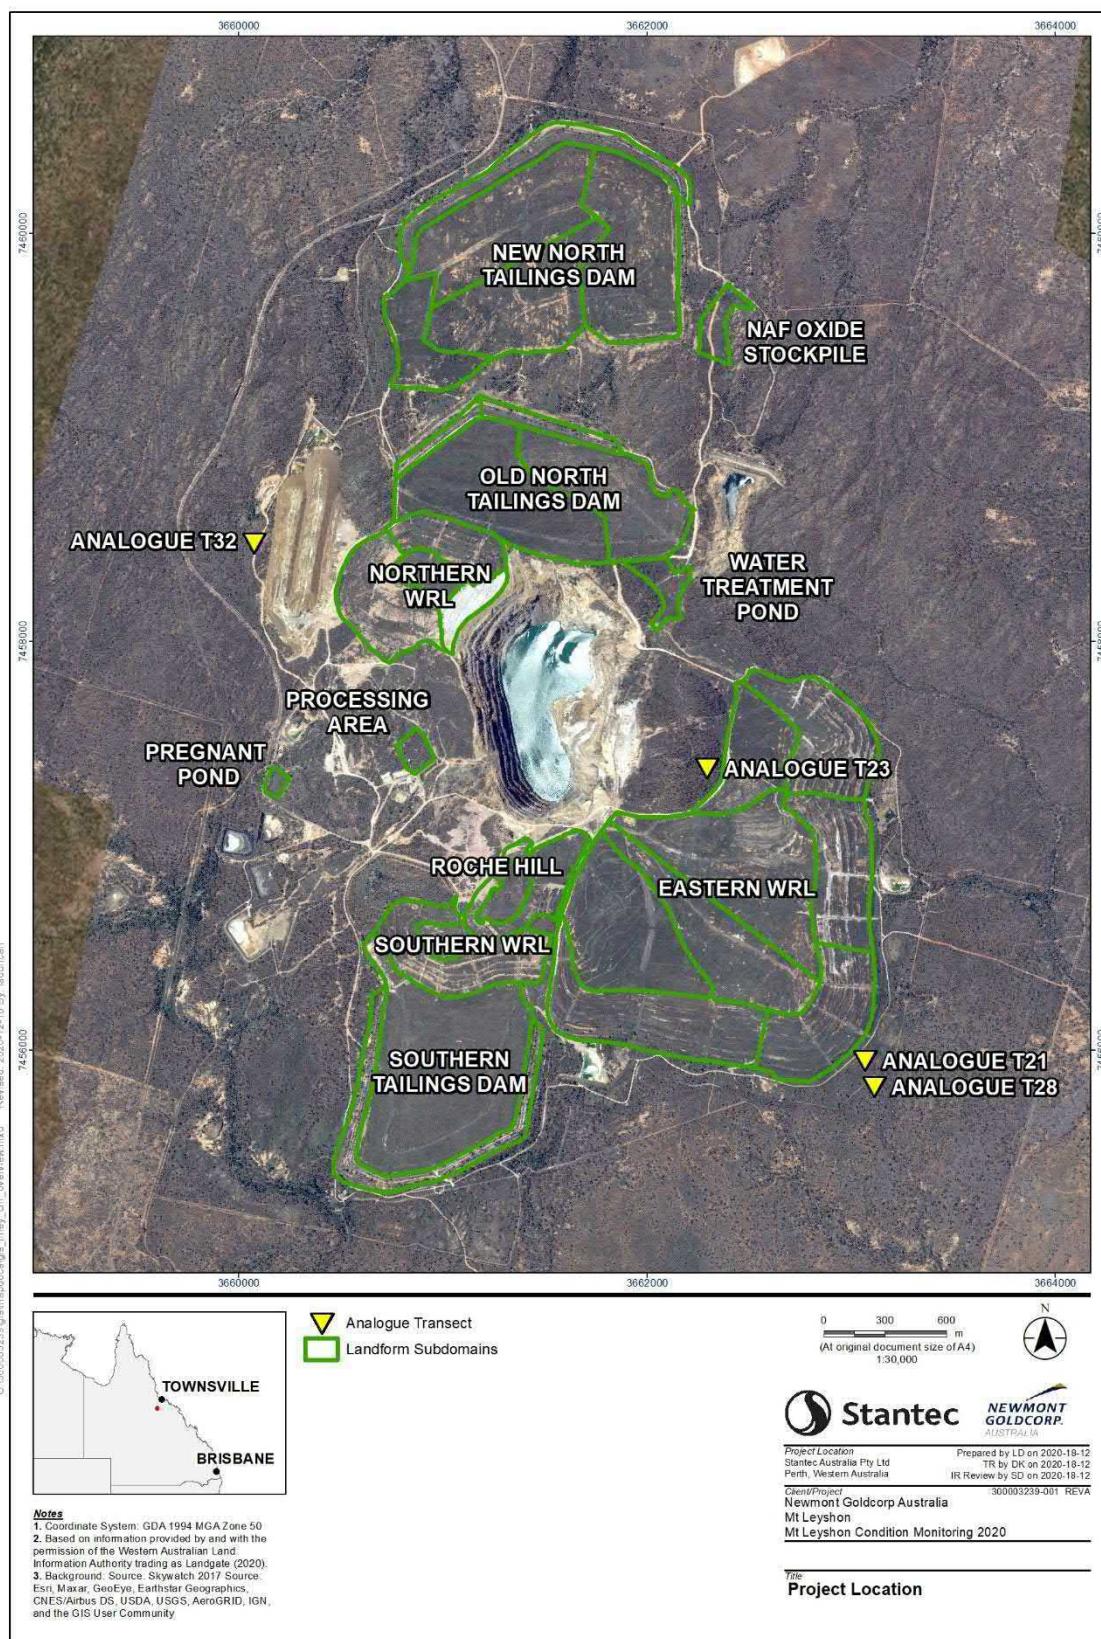
Figure 2-1: Landforms (domains) and analogues monitored in 2020 at Mt Leyshon

Rehabilitation across eleven landforms (domains) and 31 sub-domains, were monitored using the Rapid Assessment by two Stantec rehabilitation specialists between 12-16 October 2020 (**Table 2-1, Figure 2-1**). In addition, three analogue areas (with four analogue transects) were monitored for comparison with rehabilitation. Analogue sites were representative of areas undisturbed by mining activities. Analogue transects T21 and T23, were installed in 2007, while analogue transects T28 and T32, were installed in 2008.

The rehabilitation domain demarcations displayed in **Figure 2-1** were utilised for the remote sensing analysis. The target size of the analogue areas (polygons) analysed was determined by using the average size of a rehabilitation domain, which was 6 ha. The shape of the polygons was drawn to avoid disturbance. All analogue polygons were 6 ha in size, except T2, whose size was limited to 3.4 ha by visibly altered or cleared land, and the Eastern WRL.

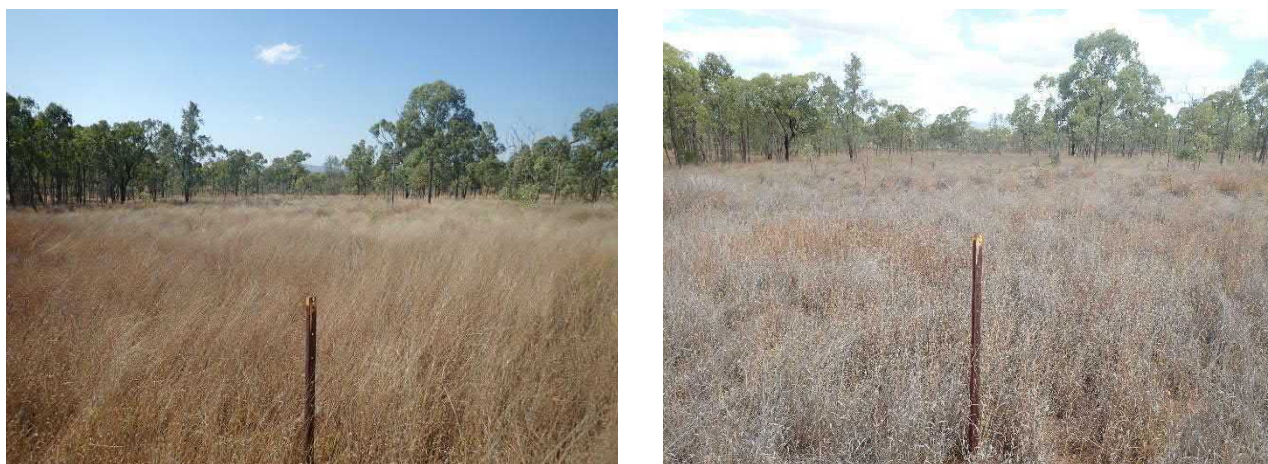
Figure 3-1: Grassland analogue transect T21 start in 2019 (left) and 2020 (right)

Transect T21 (grassland analogue) was located on a gently-sloping, grassy area near the south-eastern tip of the Eastern WRL. As detailed in previous monitoring reports (Outback Ecology 2012), this site was dominated by introduced Buffel Grass, and legume species *Stylosanthes* spp., with sparse mid and upper storey vegetation strata present (**Figure 3-1**). The gentle slope of the grassland analogue area and surrounding area was most comparable to flat rehabilitation areas.

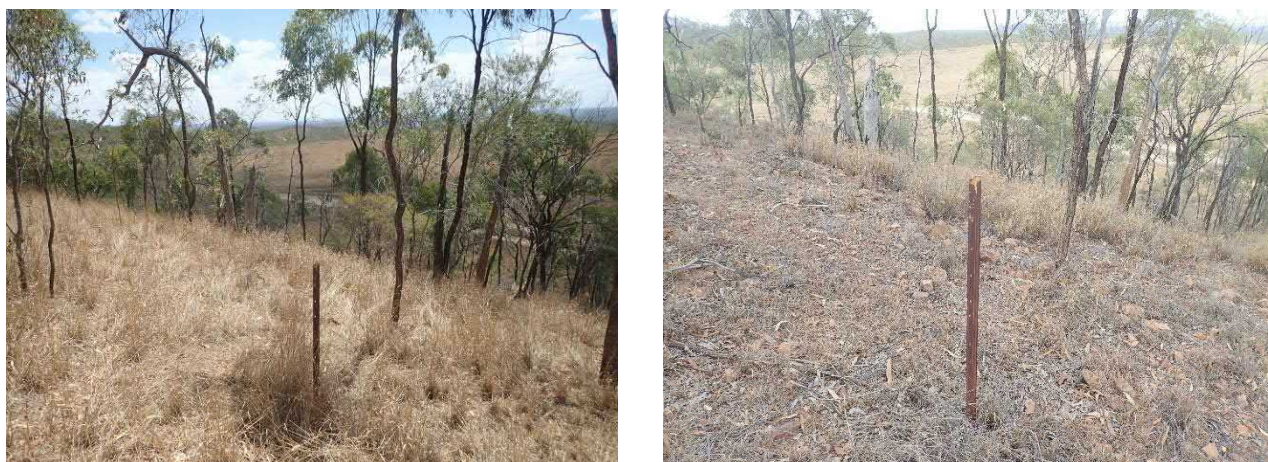
Figure 3-2: *Eucalyptus*/*Acacia* grassland analogue transect T23 start in 2019 (left) and 2020 (right)

Transect T23 (*Eucalyptus*/*Acacia* grassland analogue) was located on a sloping wooded area between the Mt Leyshon pit and the Eastern WRL. Vegetation was described as dense grassy understorey dominated by Buffel Grass covered by a moderately dense upper storey of *Eucalyptus crebra* (Narrow-leaf Ironbark), tall *Acacia* species and other *Eucalyptus* species (**Figure 3-2**). T23 was the steepest of the analogue areas monitored and was an appropriate reference for most sloping rehabilitation areas.

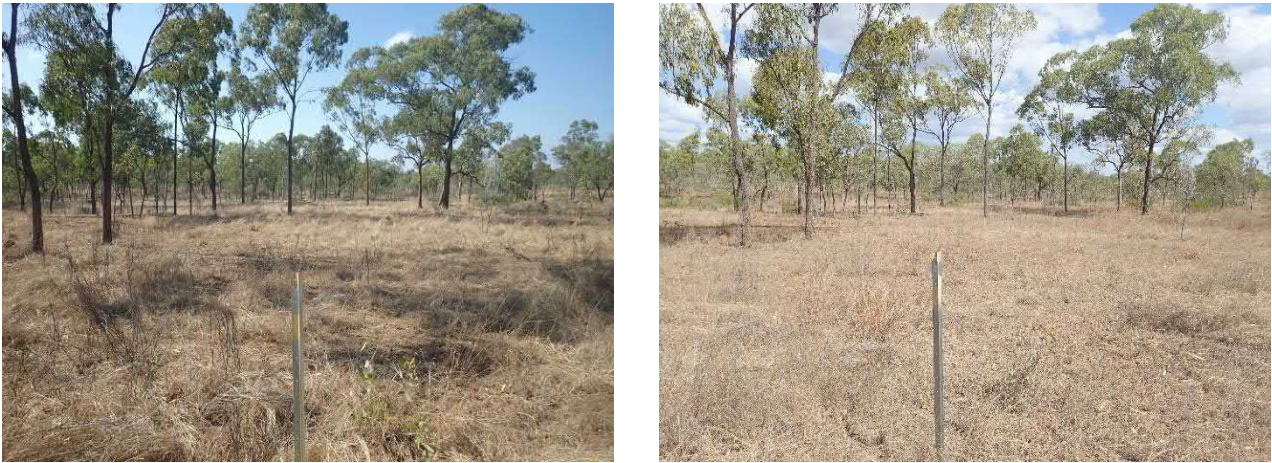
Figure 3-3: *Eucalyptus/Corymbia* grassland analogue transect T28 in 2019 (left) and 2020 (right)

compliment analogue transect T21, with the transects being adjacent to one another, although on opposing sides of the mine lease boundary. Transect T28 and the surrounding area were gently sloping and considered an appropriate reference site for flat rehabilitation areas (**Figure 3-3**).

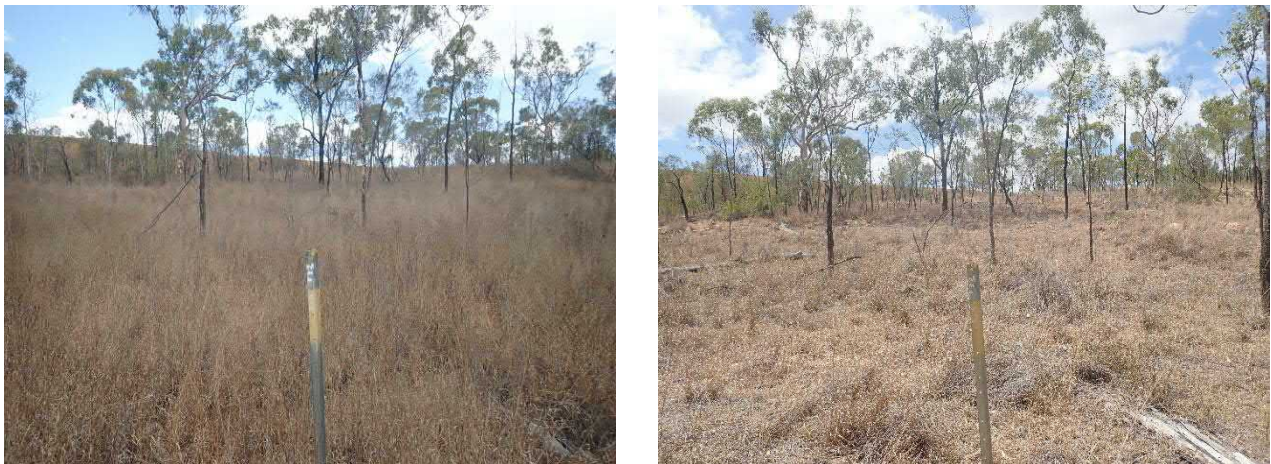
Figure 3-4: Mixed *Acacia/Eucalyptus* analogue transect T32 start in 2019 (left) and 2020 (right)

Transect T32 (mixed *Acacia/Eucalyptus* analogue) was composed of an upper storey dominated by *Acacia* and *Eucalyptus* species, and a lower storey dominated by the introduced *Melinis repens* (Red Natal Grass) (Outback Ecology 2012). The transect and surrounding area was moderately sloped, and was comparable to sloping rehabilitation areas, in particular those that support grasses other than Buffel Grass (**Figure 3-4**).

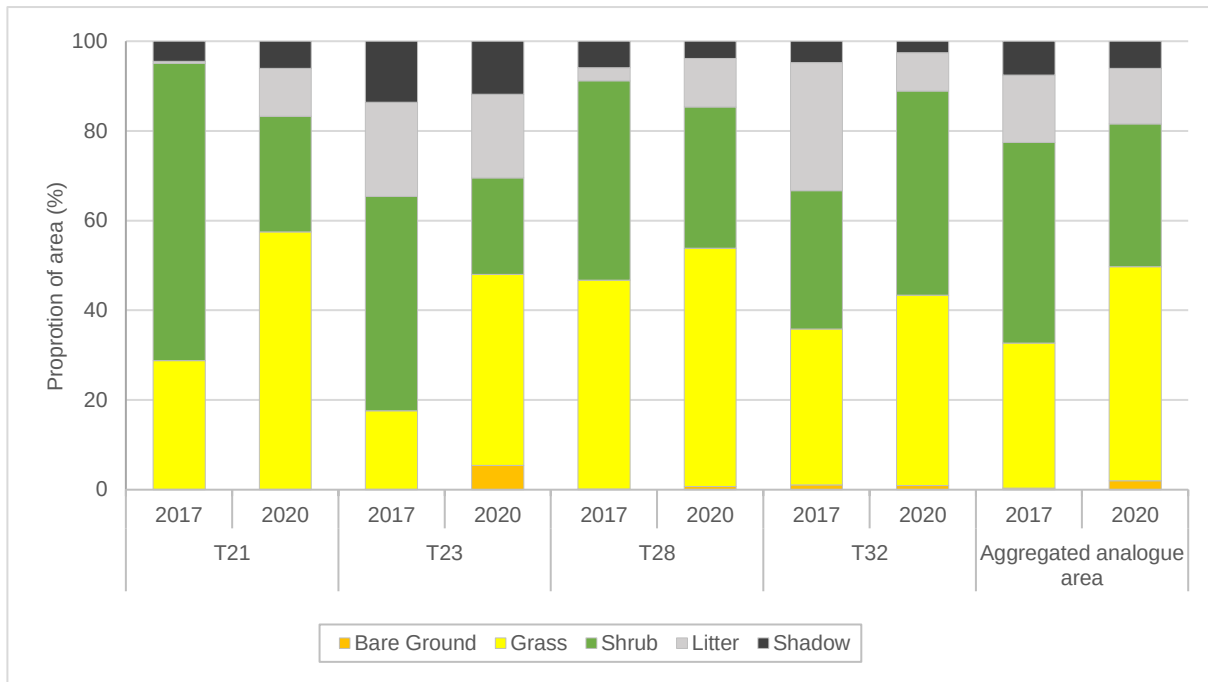
Figure 3-5: Proportion of ground cover types on analogue areas in 2017 and 2020 based on analysis of satellite imagery

All analogue areas assessed in 2017 and 2020 had few bare areas and were dominated by grass and shrub cover (**Figure 3-5; Appendix F**). All analogue sites comprised of high grass and high shrub cover, however, the proportions of each varied between analogues sites and between years. The proportion of the analogues that were assessed as litter also varied substantially between areas and years. The variation between 2017 and 2020 values was most likely due to the different time of year the imagery was captured: December ("wet-season") for 2017 and June ("dry-season") for 2020.

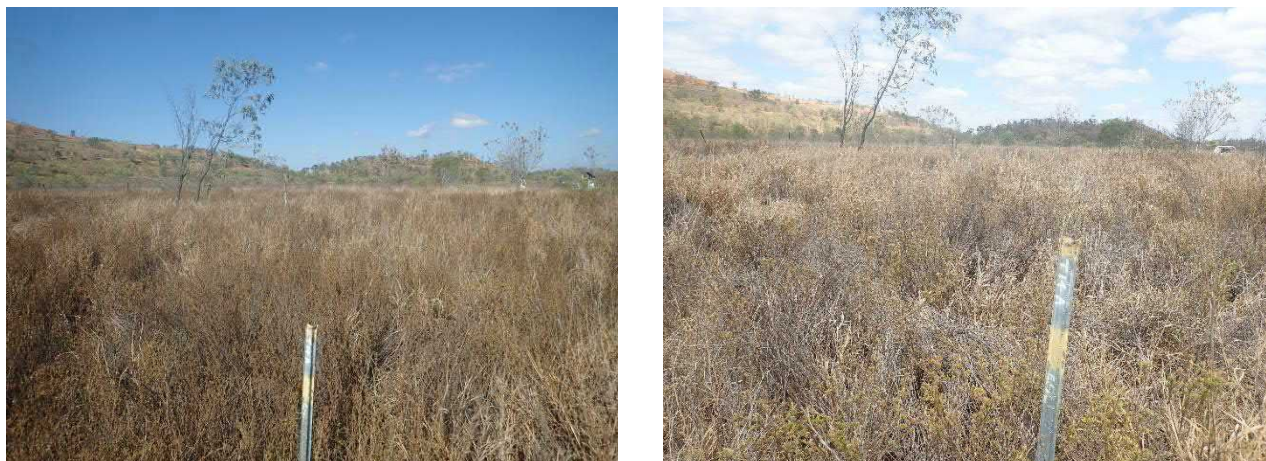
Figure 3-6: Old North Tailings Dam West Flat sub-domain transect T14A end in 2019 (left) and 2020 (right)

Old North Tailings Dam rehabilitation works were completed in 2001 and the area was divided into four sub-domains; East Flat, West Flat, North Face (East) Batters, and North Face (West) Batters (**Figure 3-7**). One transect, T14 consisting of four sub-transects (A-D) (**Figure 3-6**), was established on the West Flat sub-domain in 2007 and five photo-points were established on the remaining sub-domains in 2013.

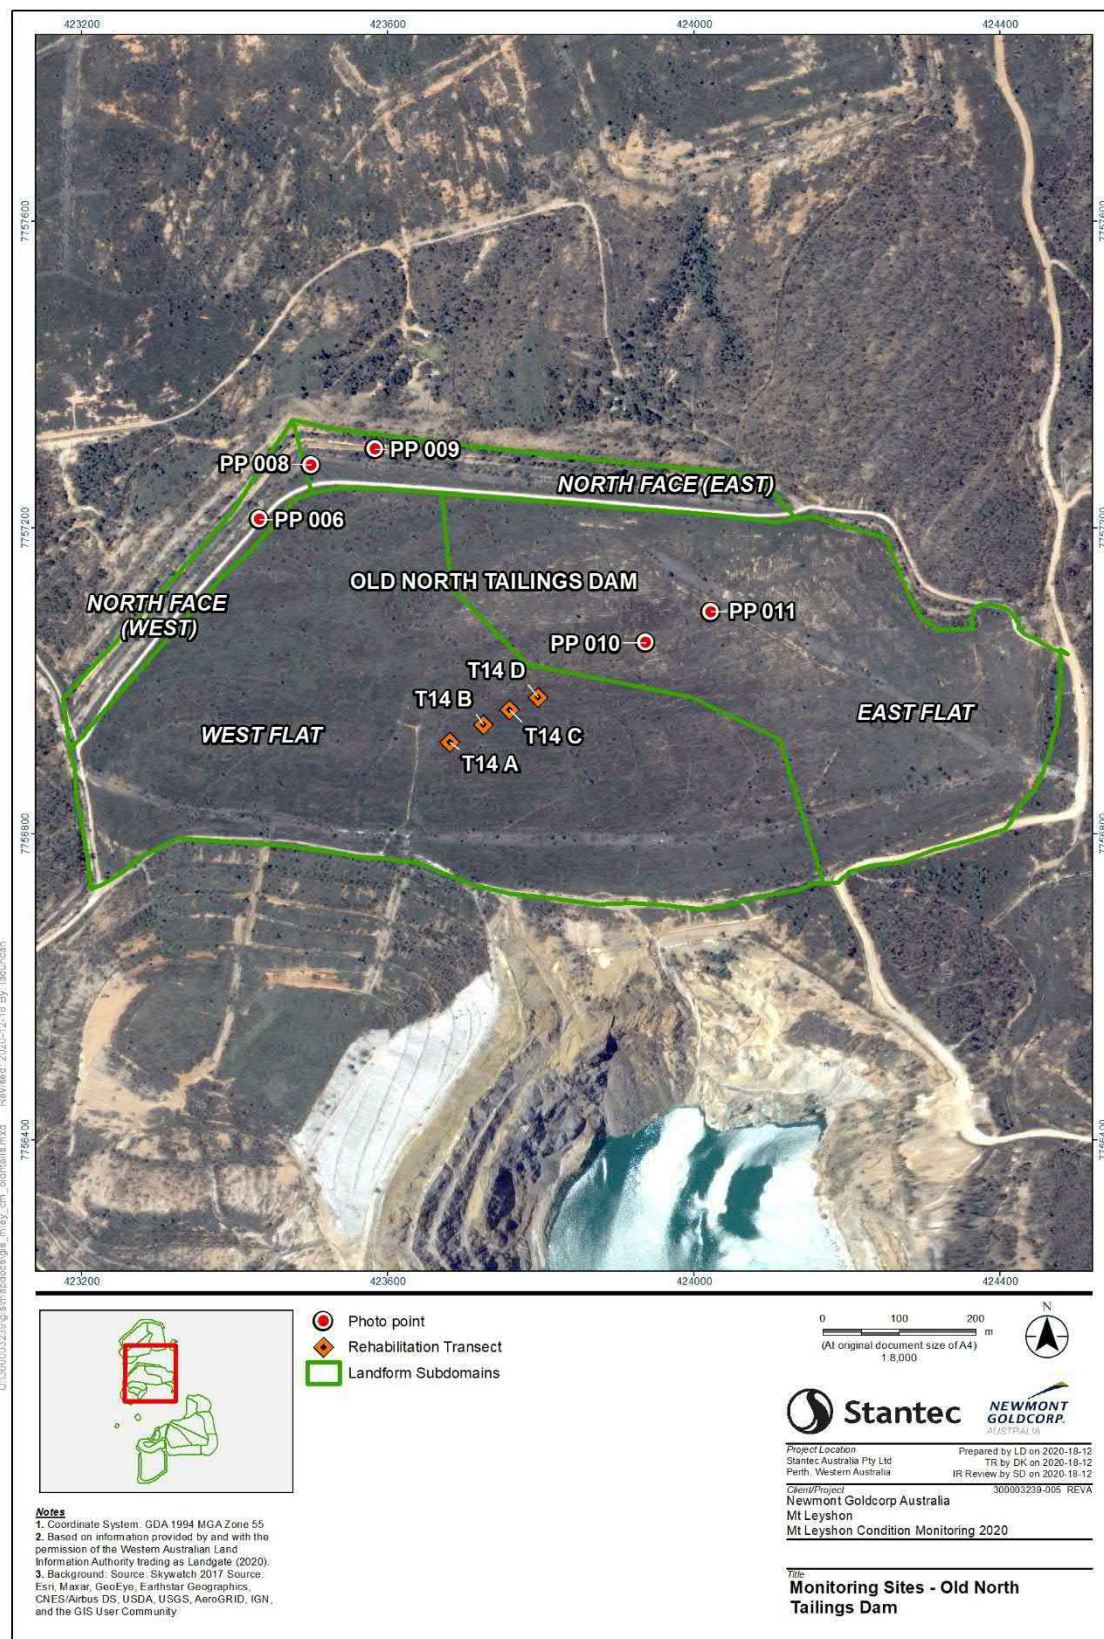
Figure 3-7: Old North Tailings Dam with sub-domains and 2020 monitoring locations

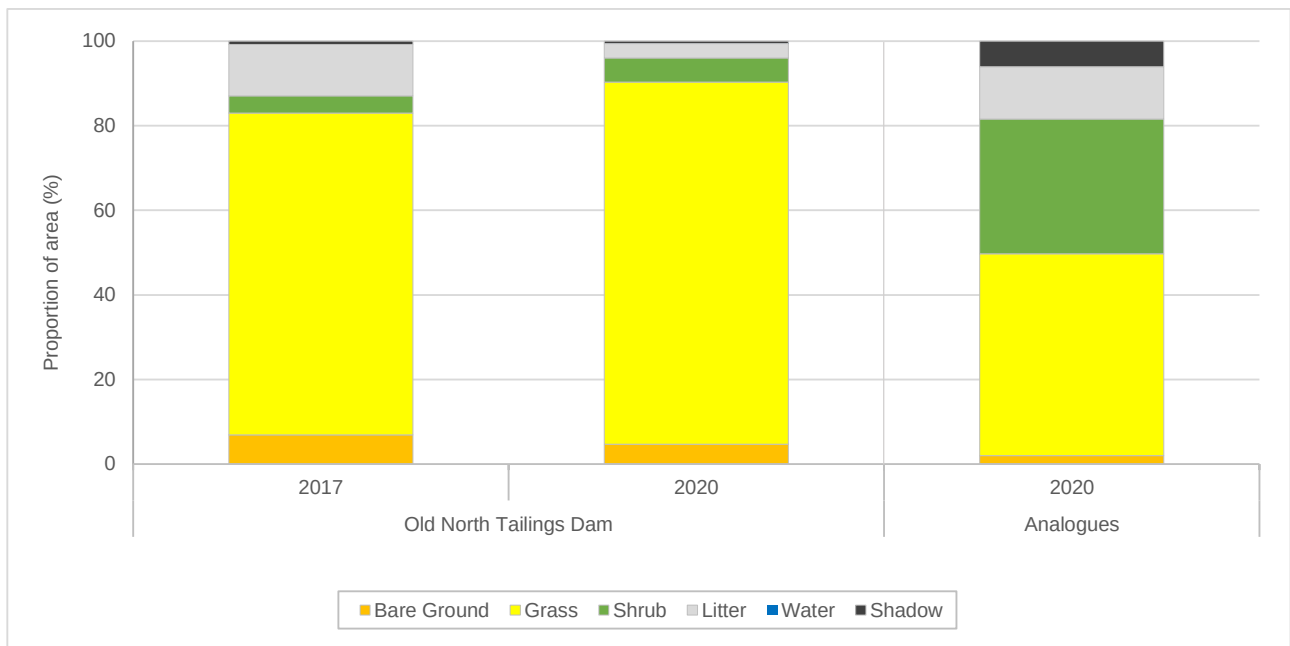
Figure 3-8: Proportion of ground cover types of the Old North Tailings Dam rehabilitation in 2017 and 2020, based on image analysis, compared to the analogue areas in 2020.

The remote sensing OBIA analysis showed the Old North Tailings Dam was dominated by grass, with sparse shrubs (**Figure 3-8; Appendix F**), supporting on-ground observations in 2020. Compared to the aggregated analogue ground cover values, the rehabilitation had more grass cover and notably less shrub cover, however, there was a similar amount of bare ground between the two. Grass cover on the rehabilitation did not change substantially between 2017 and 2020, despite the 2017 imagery capture occurring in the “wet-season”, and 2020 in the “dry-season”.
