## Progressive Rehabilitation and Closure Plan

**Mt Leyshon Mine**

M13000\_024-REP-001-2

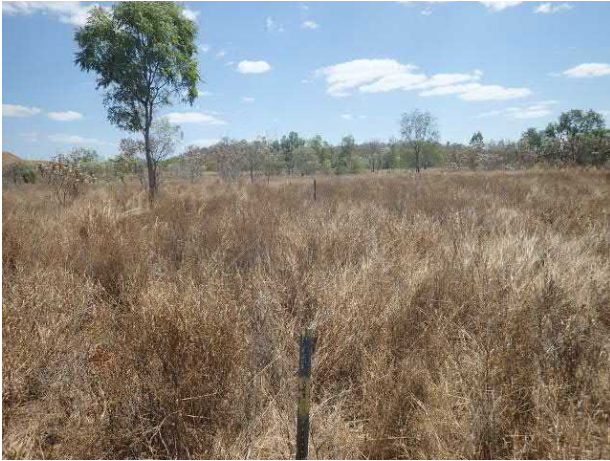
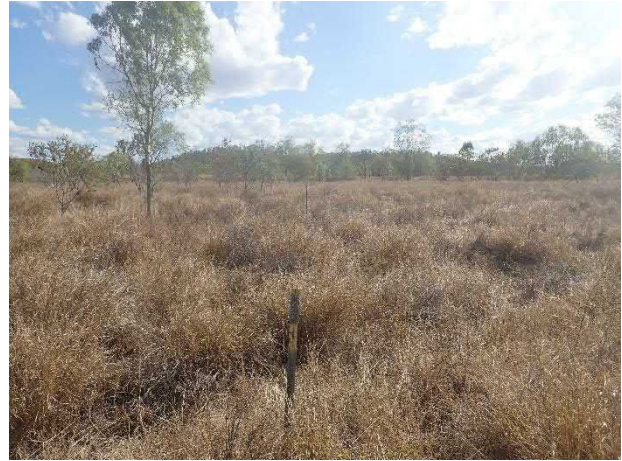
Figure 3-9: New North Tailings Dam West Flat sub-domain transect T15a end in 2019 (left) and 2020 (right)

Rehabilitation works on the New North Tailings Dam landform occurred in 2005. The New North Tailings Dam was divided into five sub-domains, four on the flat areas and one on the north batters (**Figure 3-10**). In 2007, two transects, T15 and T16, were established on the West Flat and North Flat sub-domains (**Figure 3-9**). Photo-points established in 2013 were present on all sub-domains. Some areas on the batters do not appear to be rehabilitated as they consisted of only loose rock, especially on the lower lift.

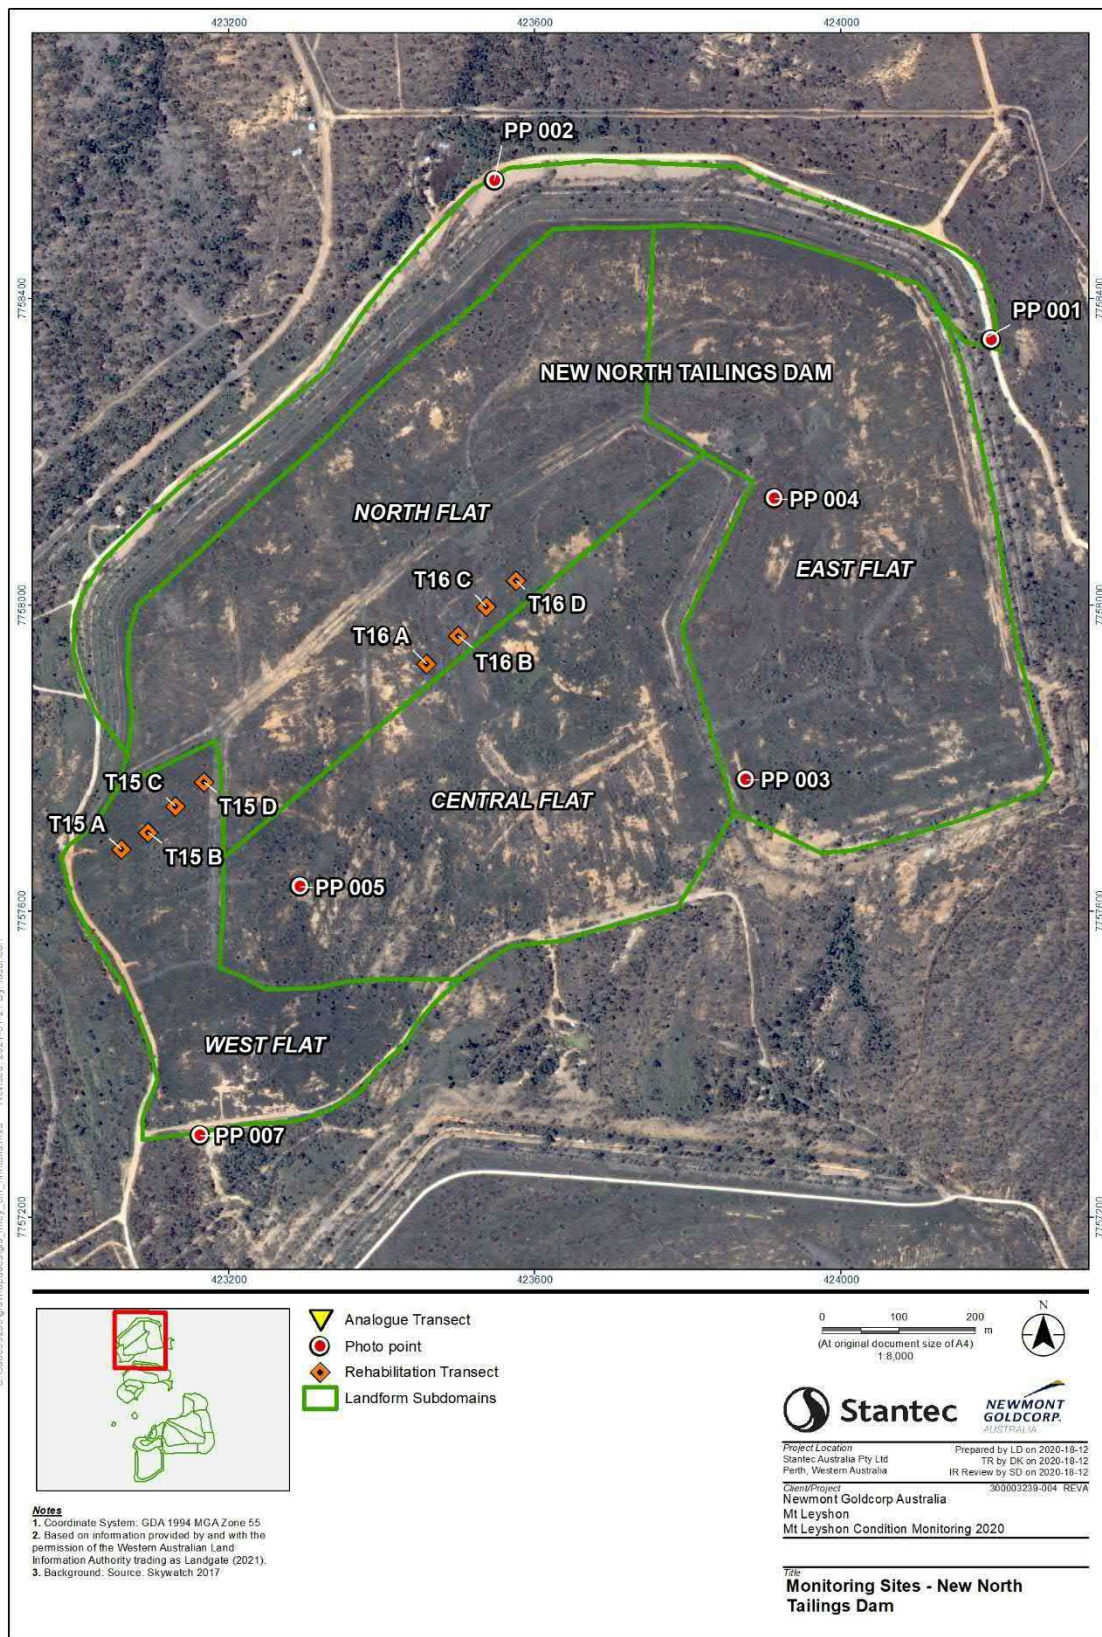
Figure 3-10: New North Tailings Dam with sub-domains and 2020 monitoring locations

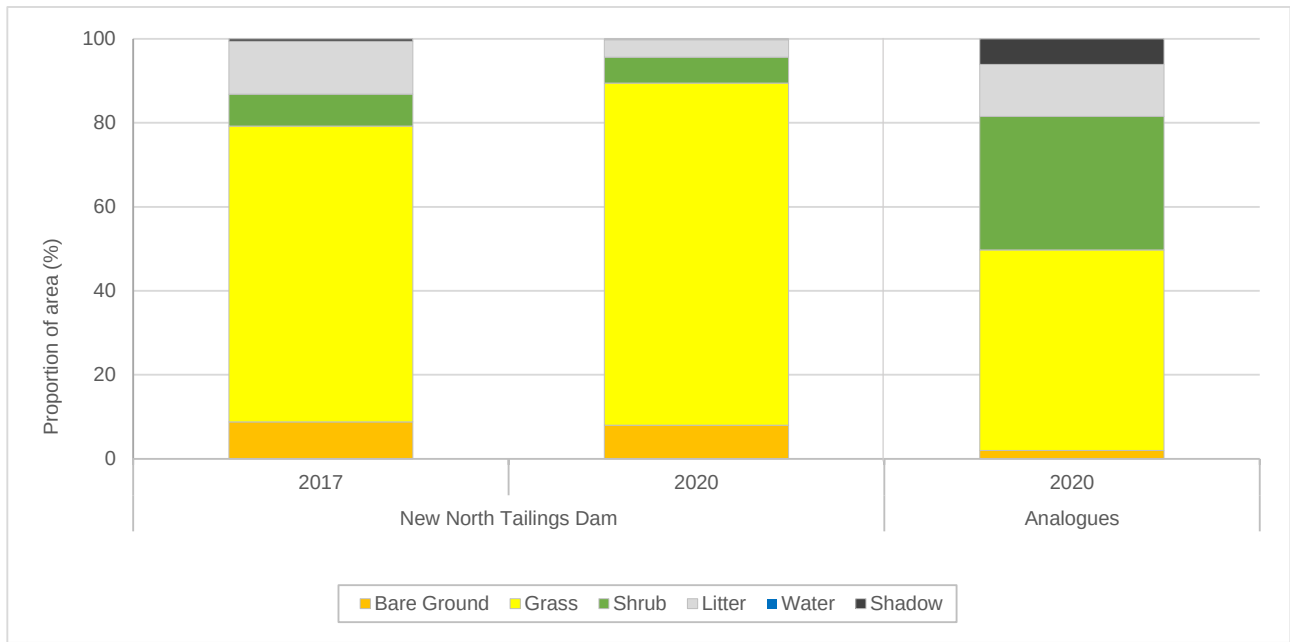
Figure 3-11: Proportion of ground cover types of the New North Tailings Dam rehabilitation in 2017 and 2020, based on image analysis, compared to the analogue areas in 2020.

Similar to the analogues, the New North Tailings Dam rehabilitation area was mostly composed of living vegetation cover, with notably smaller areas covered by litter or bare (**Figure 3-11; Appendix F**). However, the rehabilitation was notably different to the analogues in 2020 because it comprised of substantially more grass and substantially less shrub cover.

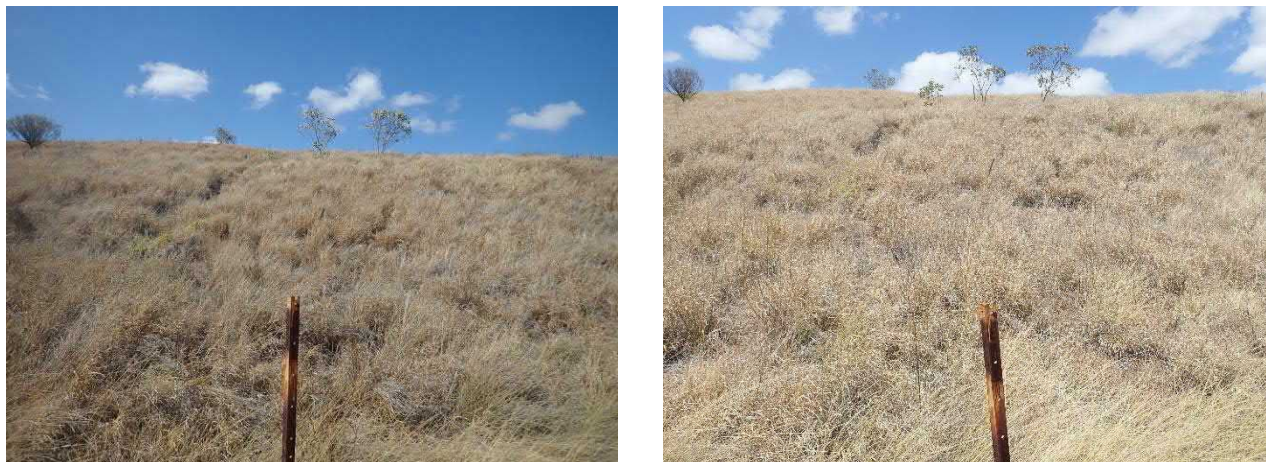
Figure 3-12: Northern WRL North Face sub-domain transect T12A end in 2019 (left) and 2020 (right)

Rehabilitation of the Northern WRL was completed in 1997, with a surface profile described as topsoil spread over heap leach material. In 2007, transect T12 was established on the North Face sub-domain, with sub-transect A located on the steep upper batter (**Figure 3-12**) and sub-transect B on the lower batter. Photo-points were established on the Southwest Face, East Face, and Top (Flat) sub-domains in 2013. The landform was divided into four sub-domains; North Face, South and West Face, East Face, and Top (Flat) (**Figure 3-13**) for the purposes of this assessment.

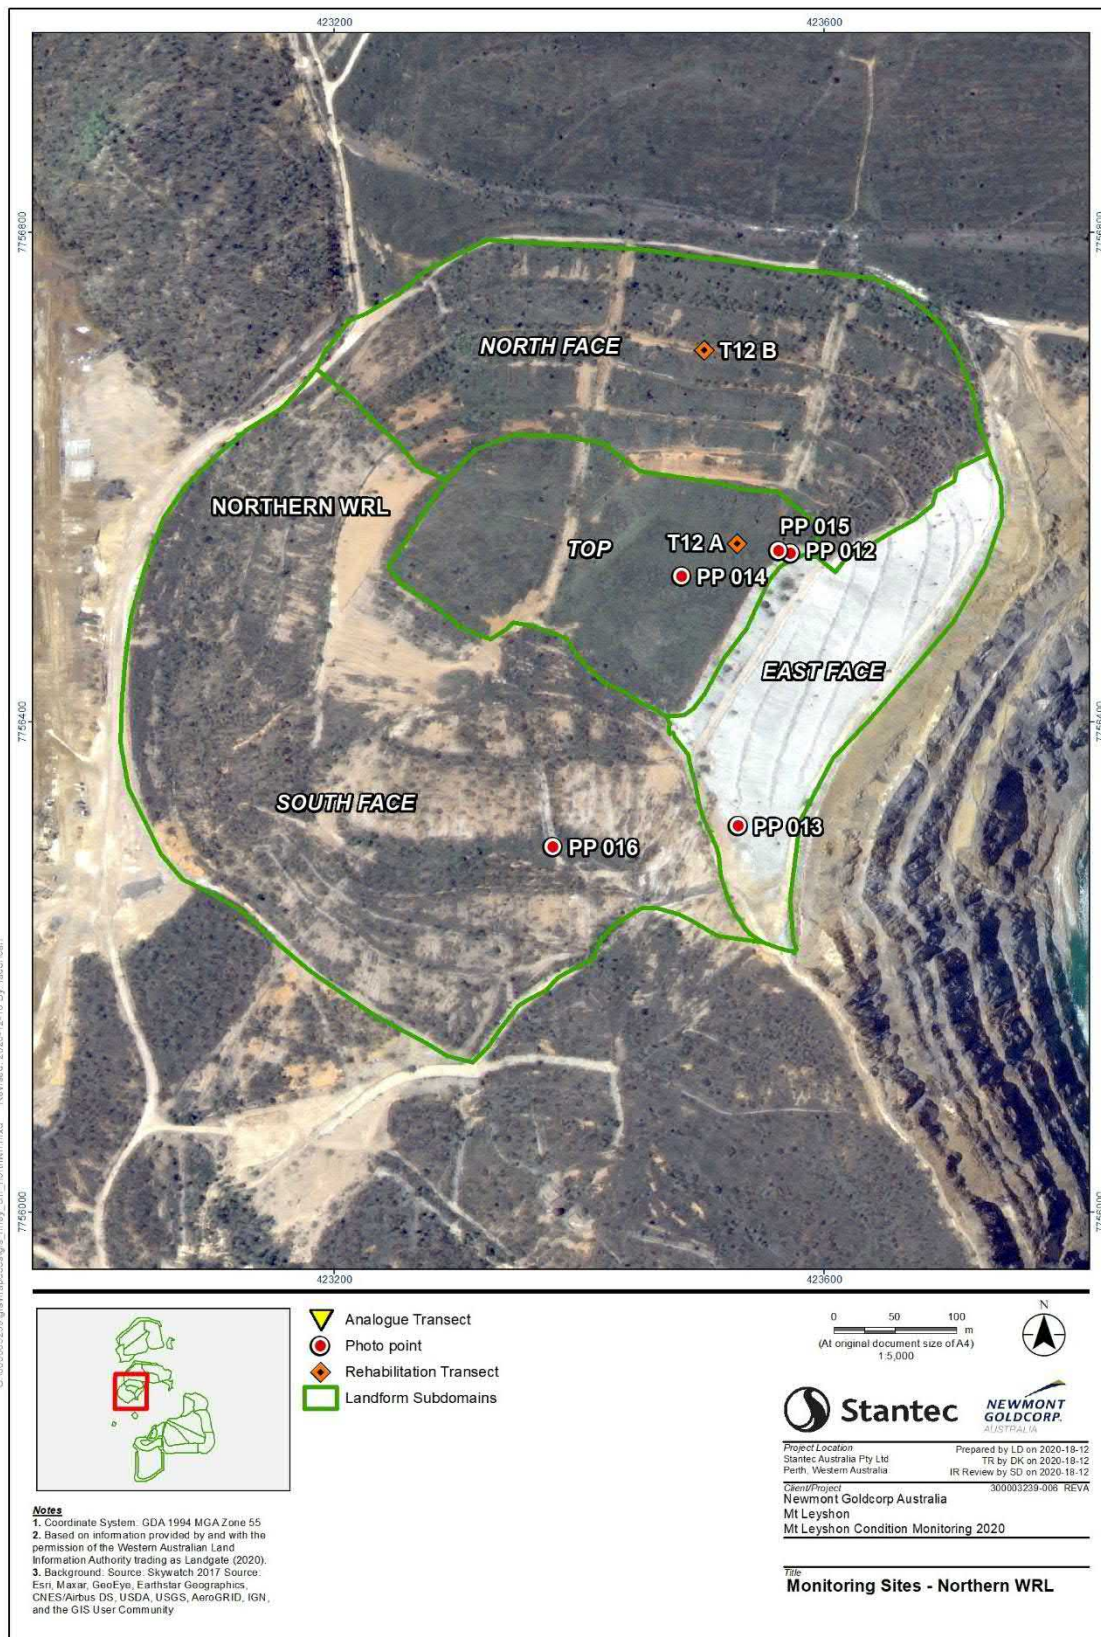
Figure 3-13: Northern WRL with sub-domains and 2020 monitoring locations

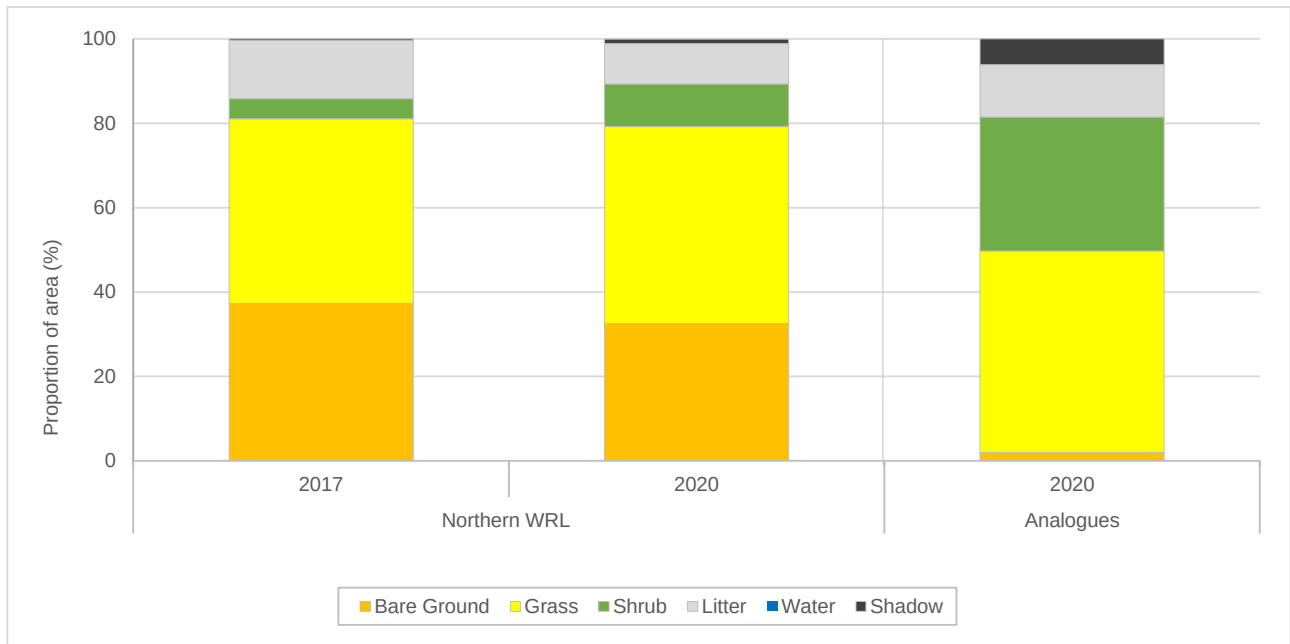
Figure 3-14: Proportion of ground cover types of the Northern WRL rehabilitation in 2017 and 2020, based on image analysis, compared to the analogue areas in 2020.

The remote sensing OBIA analysis showed the Northern WRL was dominated by grass cover, with substantially less shrub cover (**Figure 3-14; Appendix F**), supporting on-ground observations in 2020. Compared to the analogues, the rehabilitation had similar grass cover but notably less shrub cover. However, compared to the analogues there was substantially more bare area, which was mainly contributed by the east face of the landform. In 2020, there was slightly more grass and shrub cover, and slightly less litter cover and bare ground than in 2017, which likely represented typical seasonal fluctuations in ground cover.

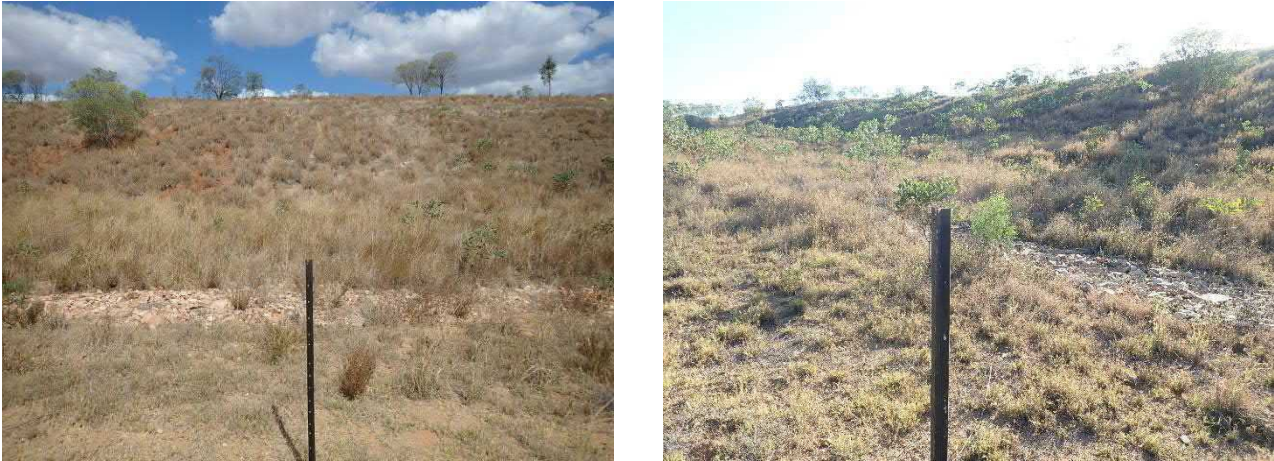
Figure 3-15: Re-worked Roche Hill Batters sub-domain in 2019 (left) and in 2020 (right) from PP18

The surface profile of the Roche Hill landform consisted of topsoil spread over porphyry rock. Rehabilitation works were completed around 2004, with rework of the Batters sub-domain (western side) completed in 2017. It was split into two sub-domains, the Flat and surrounding Batters (**Figure 3-15, Figure 3-16**). Photo-points were established in 2013 on both sub-domains, however, re-work of the Batters sub-domain in 2017 resulted in the removal of the photo-point monitoring post PP18. This photo-point was re-established in 2019. Additional photo-points, PP18b, PP18c, PP18d and PP18e were established in 2020 (**Figure 3-16**).

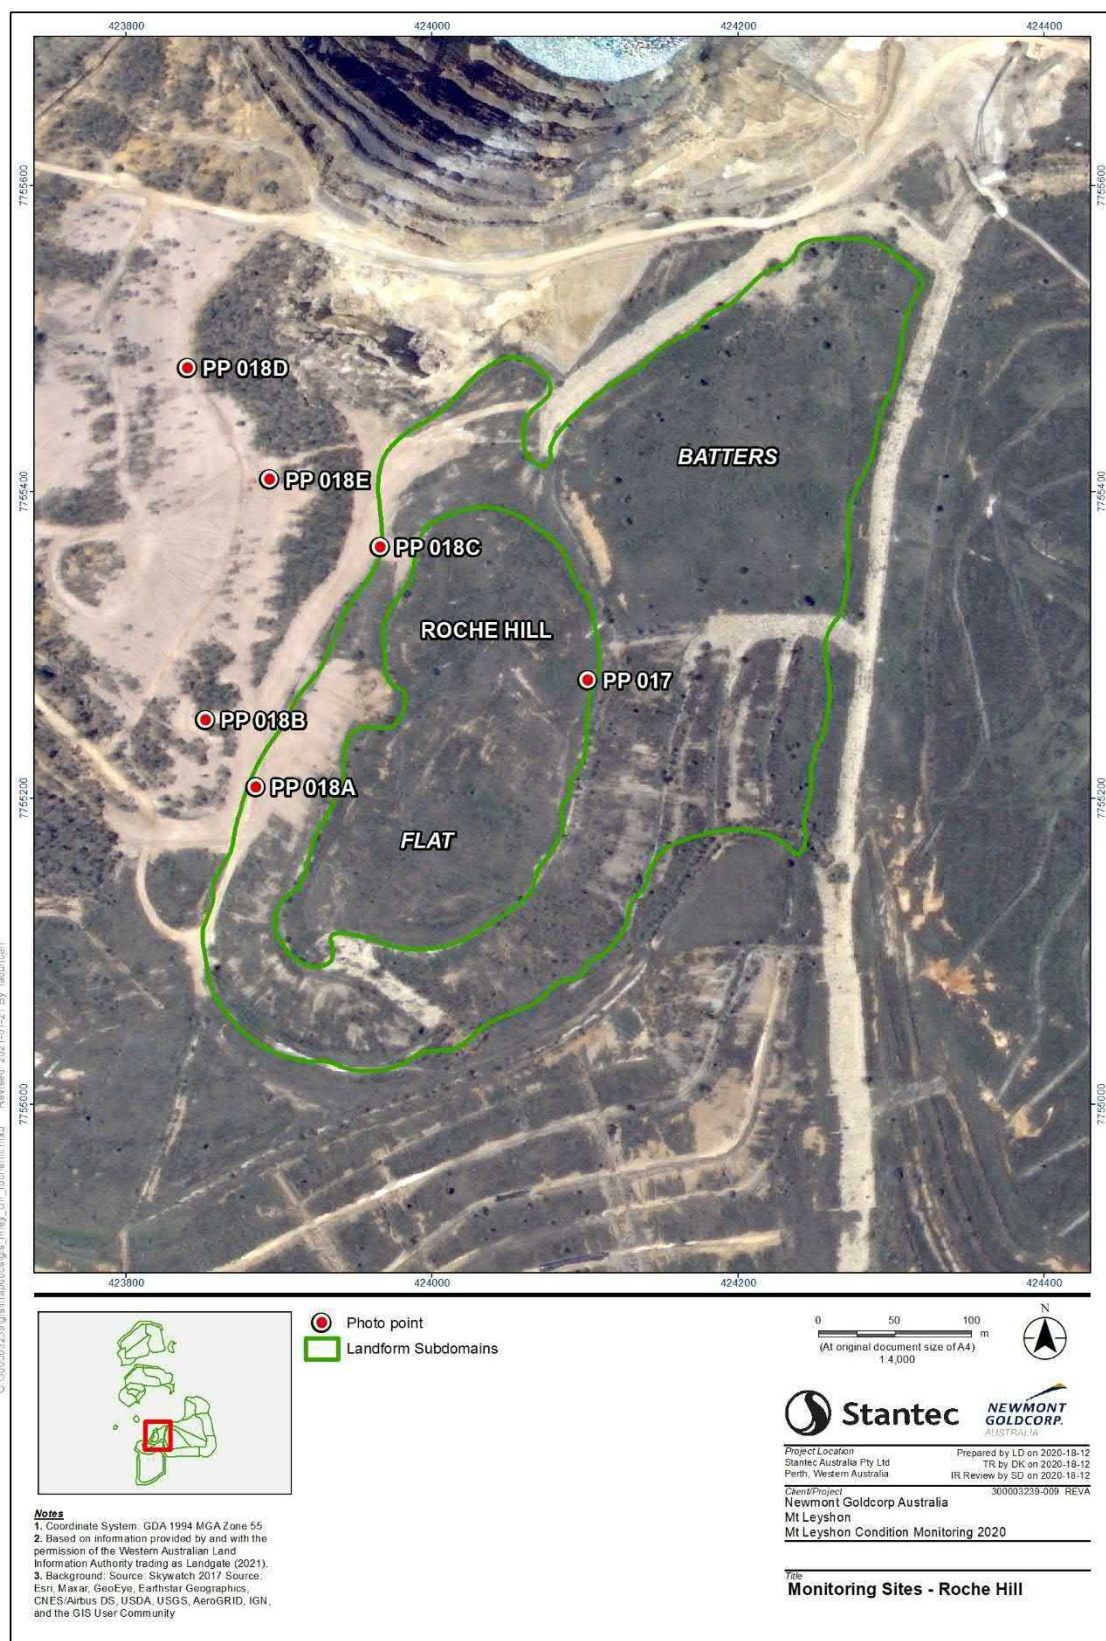
Figure 3-16: Roche Hill with sub-domains and 2020 monitoring locations

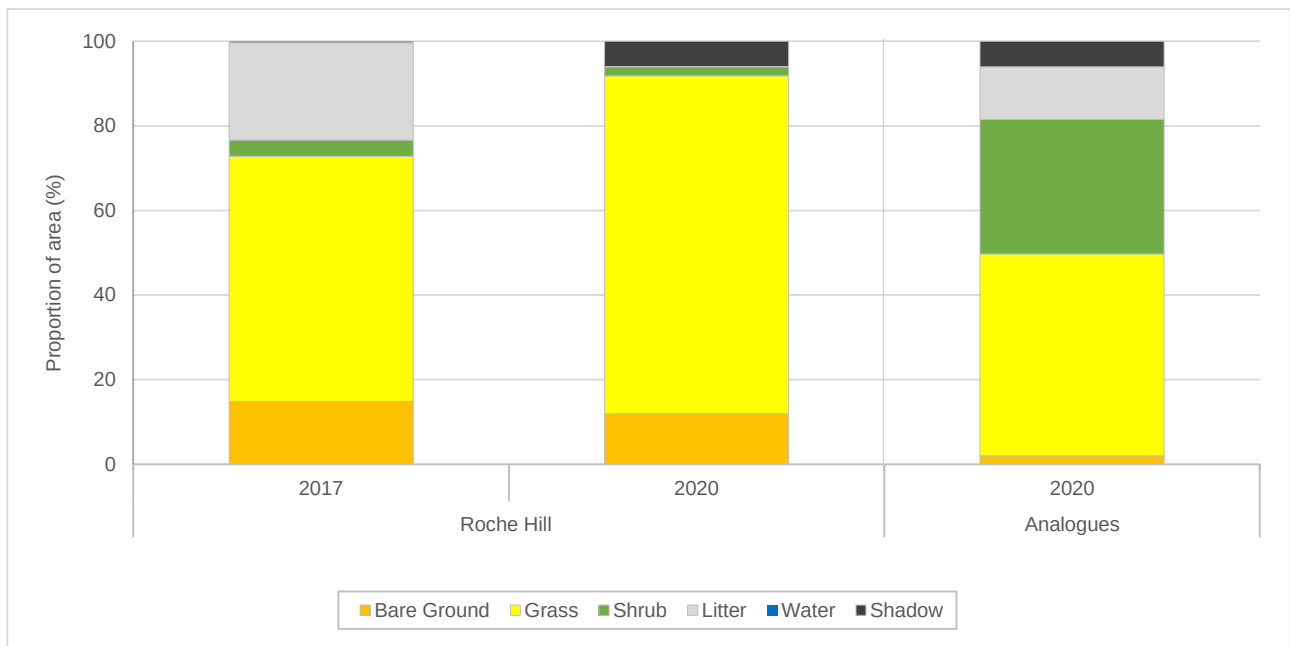
Figure 3-17: Proportion of ground cover types of the Roche Hill rehabilitation in 2017 and 2020, based on image analysis, compared to the analogue areas in 2020.

Based on image analysis, Roche Hill rehabilitation was dominated by grass cover (**Figure 3-17; Appendix F**) with less than 1% shrub cover. Compared to the analogues, the rehabilitation had more grass cover and notably less shrub cover. In 2019, there was substantially more litter cover and substantially less grass cover than in 2020, likely due to seasonal fluctuations between grass and litter.

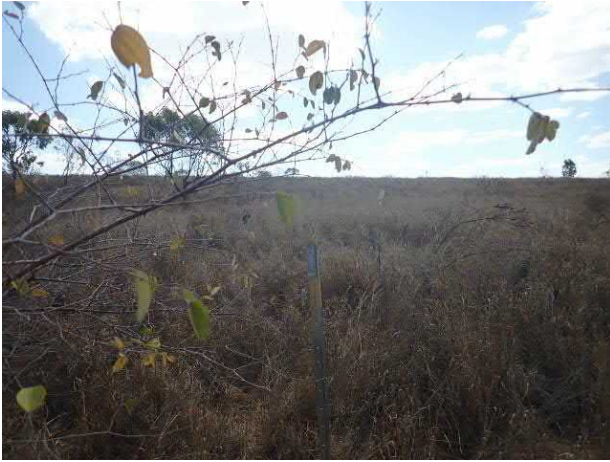
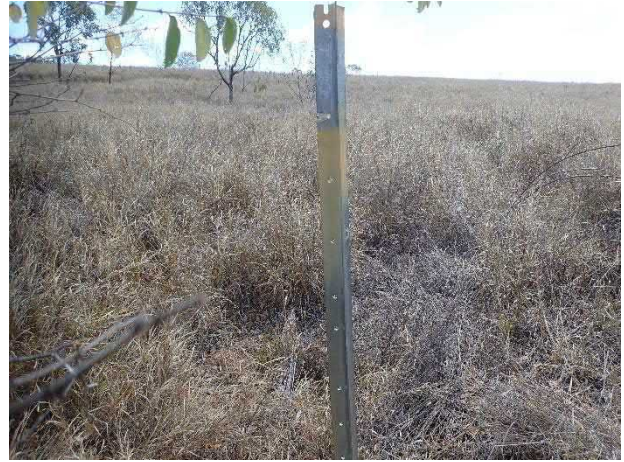
Figure 3-18: NAF Oxide Stockpile transect T30 end in 2019 (left) and 2020 (right)

Rehabilitation works on the Non-Acid Forming (NAF) Oxide Stockpile landform were completed in 2006, with two transects, T30 and T31, installed in 2008 (**Figure 3-18** and **Figure 3-19**). Due to the homogenous nature of the landform and its small size, it was not divided into sub-domains (**Figure 3-20**).

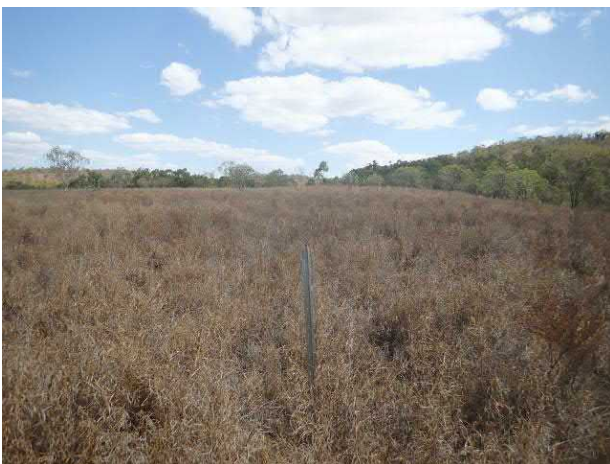
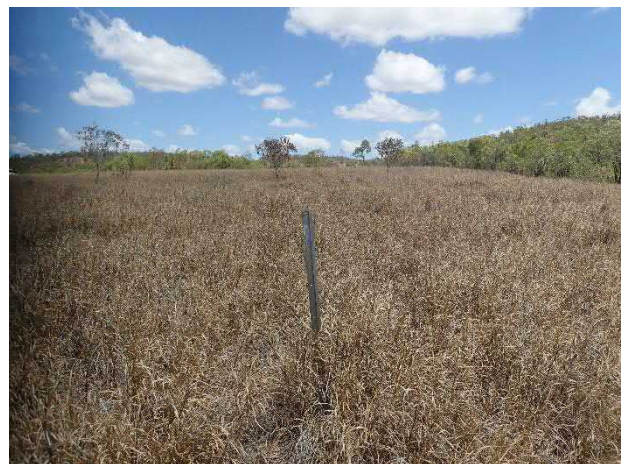
Figure 3-19: NAF Oxide Stockpile transect T31 end in 2019 (left) and 2020 (right)

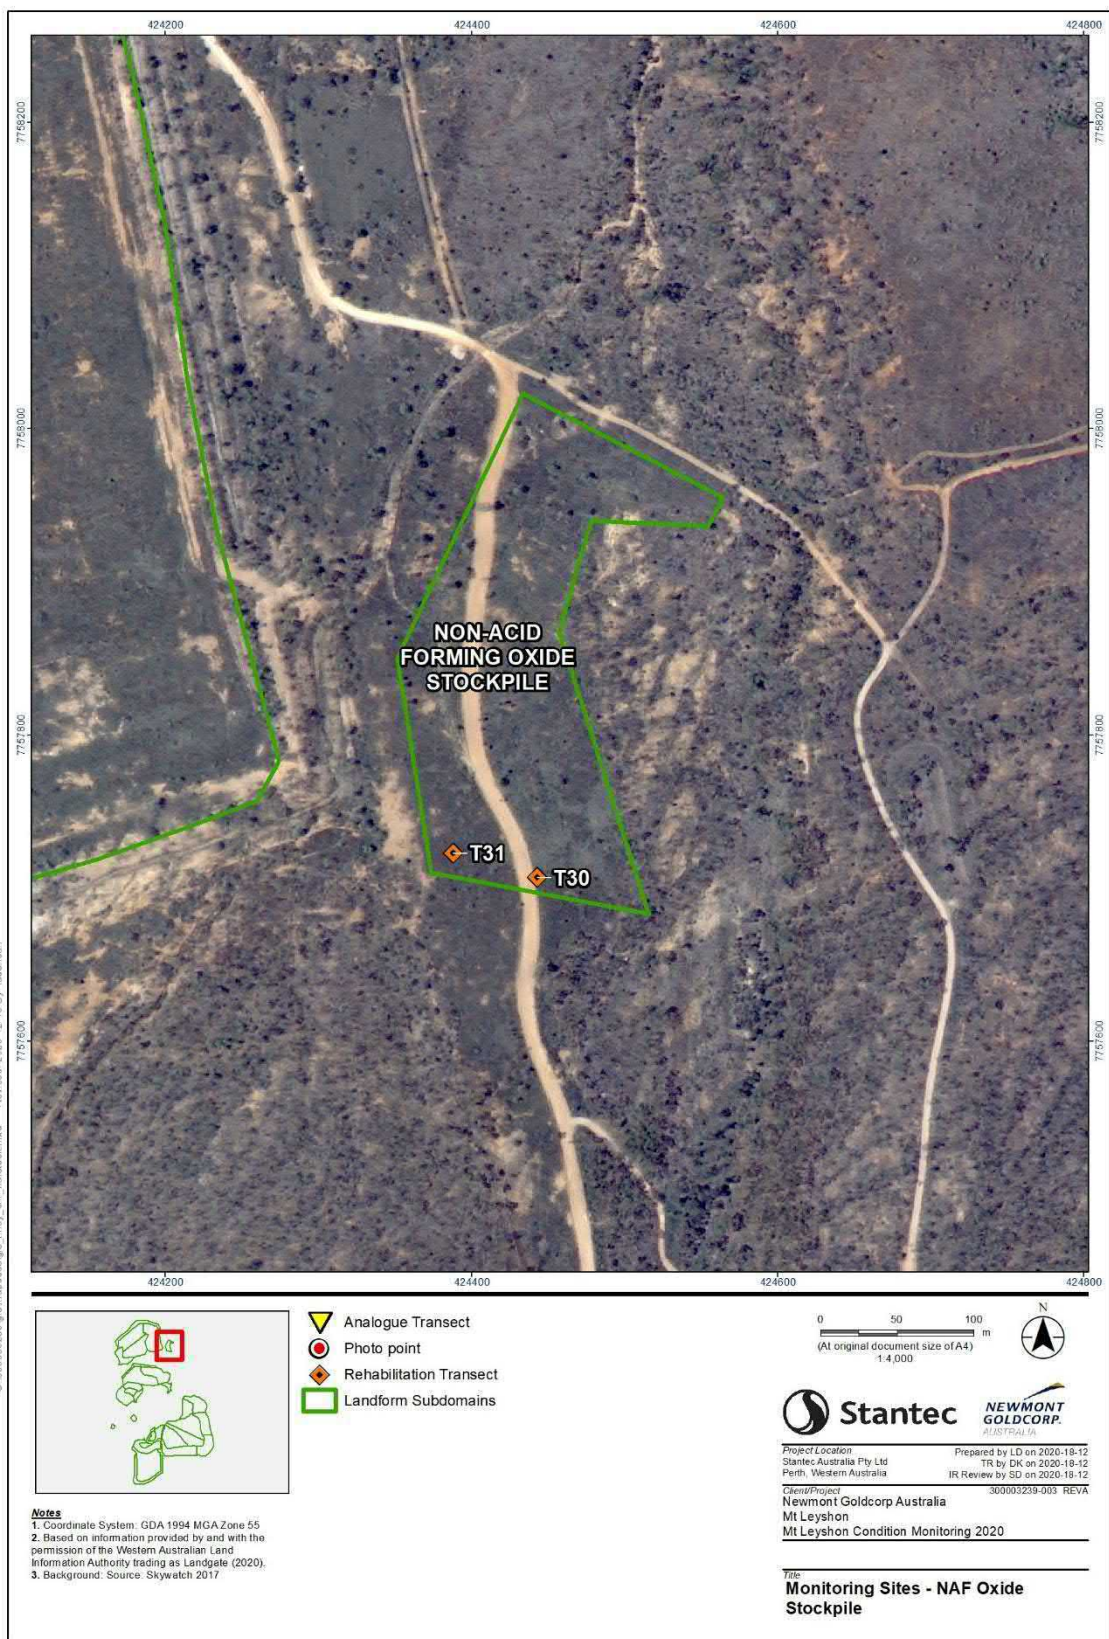
Figure 3-20: NAF Oxide Stockpile rehabilitation area and 2020 monitoring locations

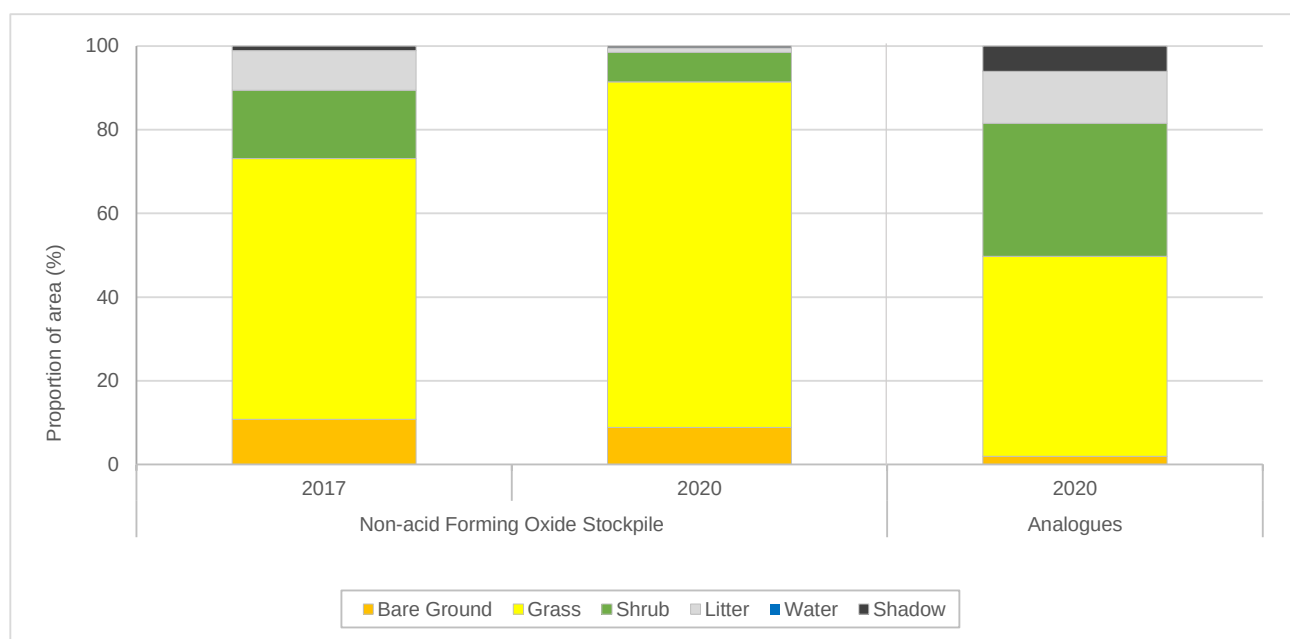
Figure 3-21: Proportion of ground cover types of the Non-acid Forming Oxide Stockpile rehabilitation in 2017 and 2020, based on image analysis, compared to the analogue areas in 2020.

Based on image analysis, the dominant cover of the NAF stockpile rehabilitation was overwhelmingly grass cover (**Figure 3-21; Appendix F**). There was substantially less cover contributed by the other ground cover types, with bare ground followed by shrub cover the next highest covers in 2020. Compared to the analogues, the rehabilitation had more grass cover but notably less shrub cover in 2020. In 2020, there was more grass cover, and slightly less shrub and litter cover than in 2017, which likely represented typical seasonal fluctuations in ground cover types.

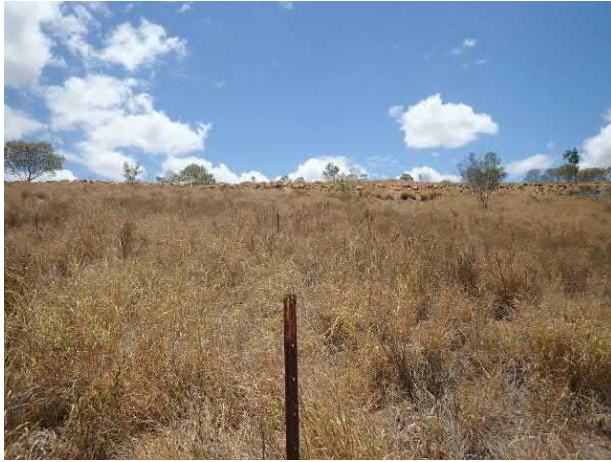
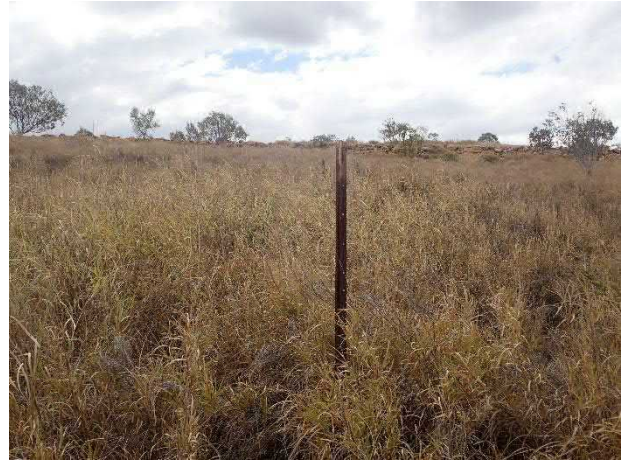
Figure 3-22: Southern WRL Batters sub-domain transect T11a end in 2019 (left) and 2020 (right)

The Southern WRL was rehabilitated in 1995 and divided into two sub-domains (Flat and Batters). In 2007, two transects were installed on the Batters sub-domain (**Figure 3-22, Figure 3-23**) and a photo-point was installed on the Flat sub-domain in 2008 (**Figure 3-24**).

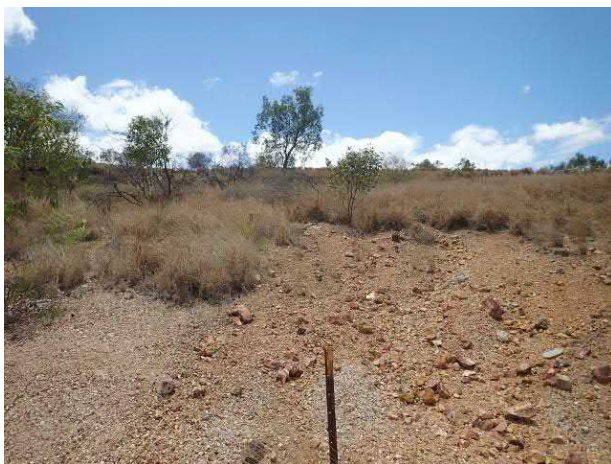
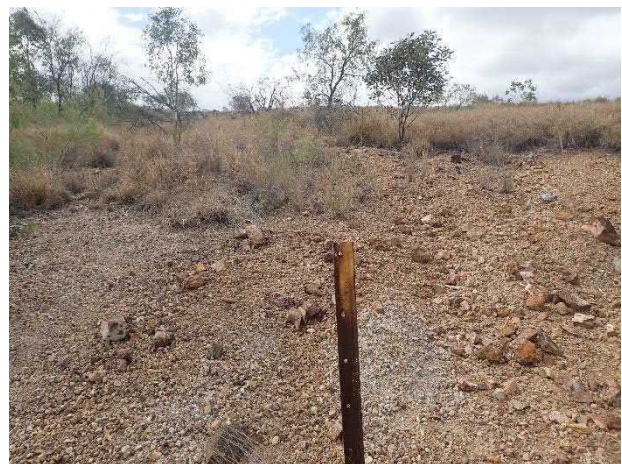
Figure 3-23: Southern WRL Batters sub-domain transect T11b start in 2019 (left) and 2020 (right)

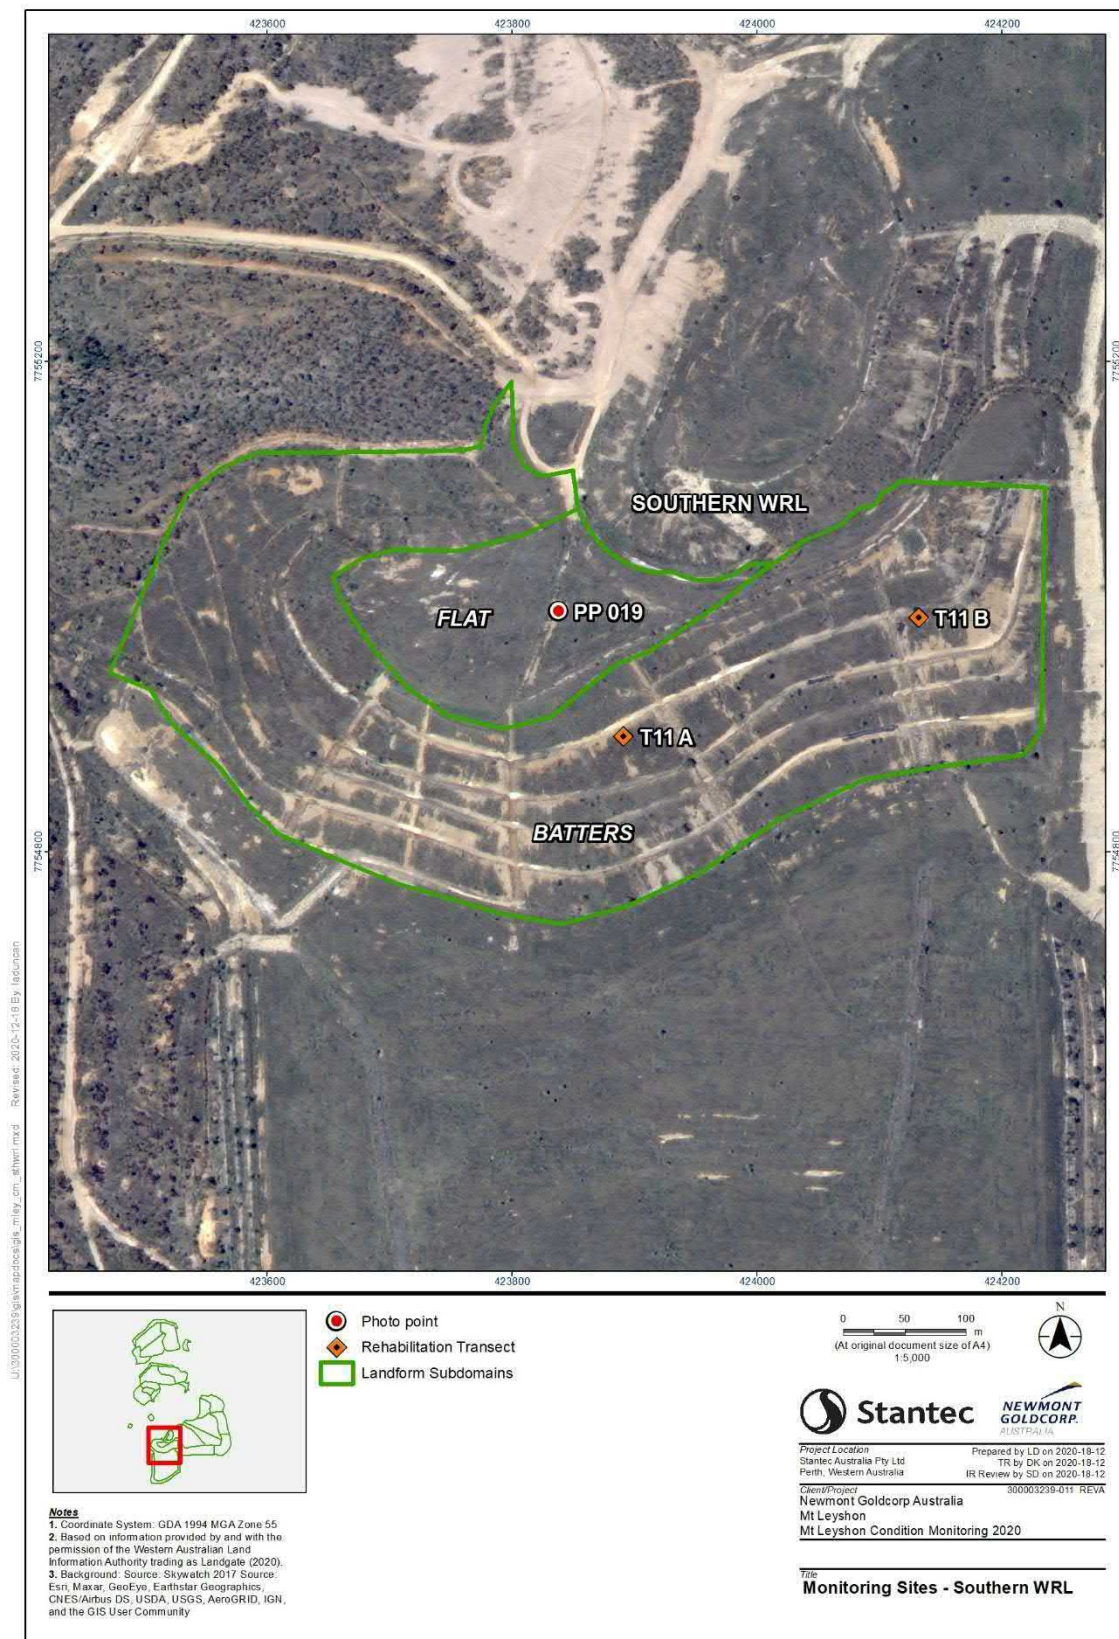
Figure 3-24: Southern WRL with sub-domains and 2020 monitoring locations

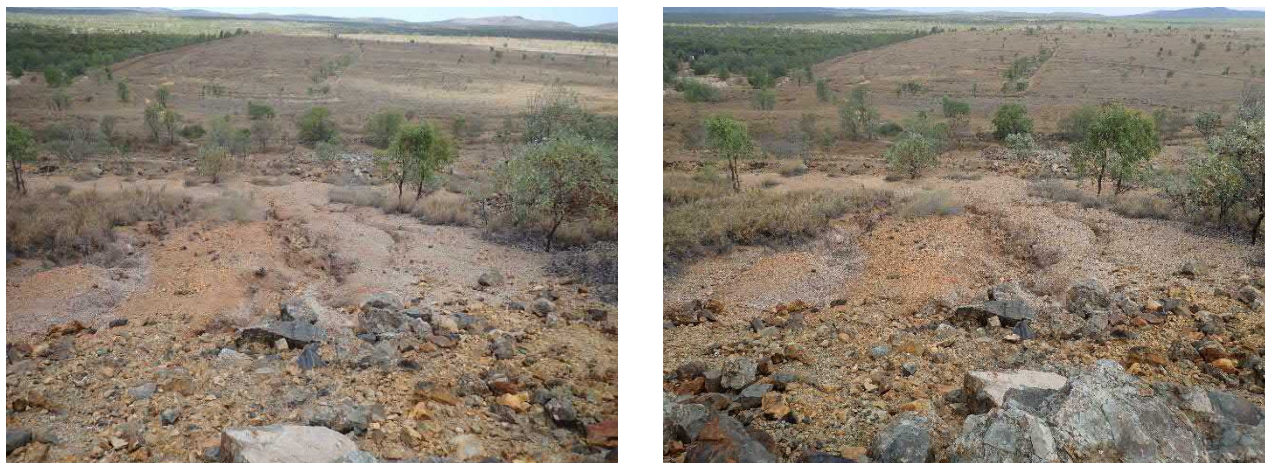
Figure 3-25: An erosion gully on the Southern WRL Batters in 2019 (left) and 2020 (right)

Significant erosion features were present on the Batters sub-domain, many of which have worsened since 2018 (**Figure 3-25**). Localised erosion may have increased since 2019, although erosion features were considered mostly active in 2020 as they had been in 2019, hence, no change to condition score. Some major erosion features were active with vegetation growth in the gullies, although not considered enough to stabilize the features.

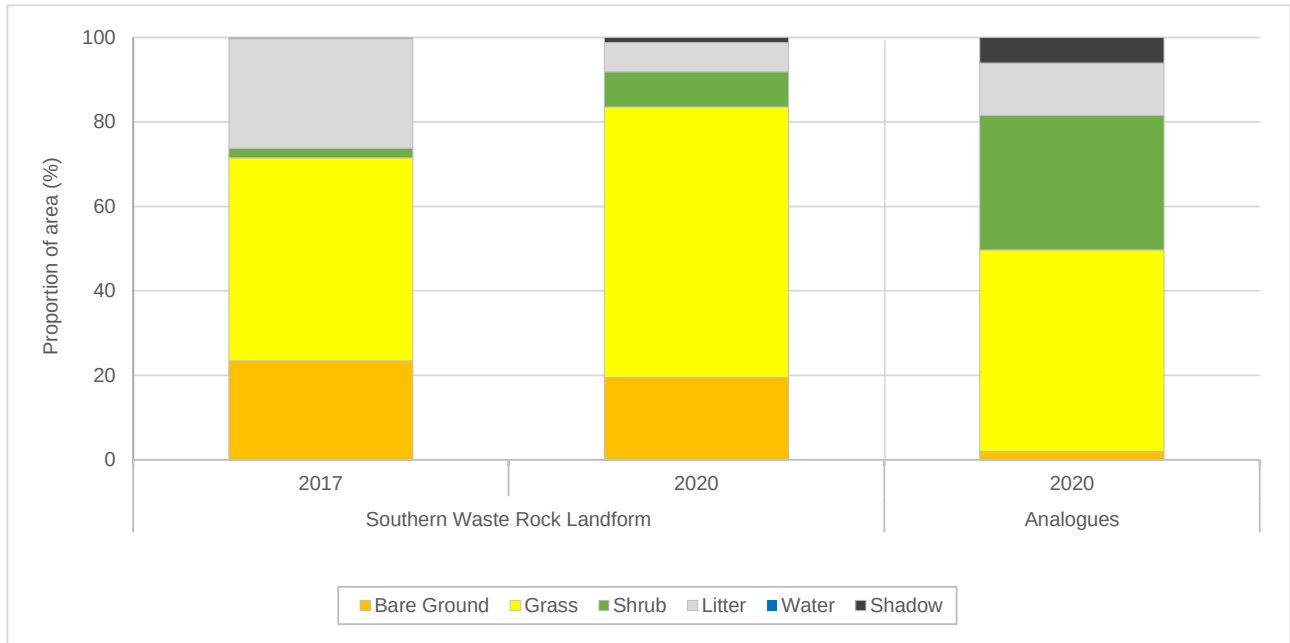
Figure 3-26: Proportion of ground cover types of the Southern WRL rehabilitation in 2017 and 2020, based on image analysis, compared to the analogue areas in 2020.

The remote sensing OBIA analysis showed the Southern WRL was dominated by grass cover (**Figure 3-26; Appendix F**). The rehabilitation had more grass cover and bare ground than the analogues, and substantially less shrub cover. In 2020, there was slightly more grass and shrub cover, slightly less bare ground, and notably less litter cover than in 2017, however, this still likely represented typical seasonal fluctuations in ground cover.

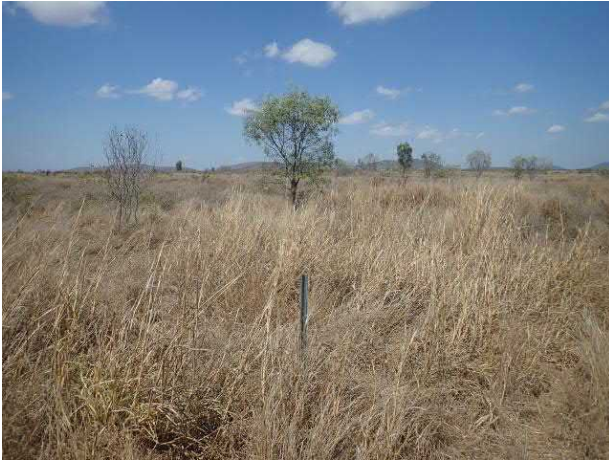
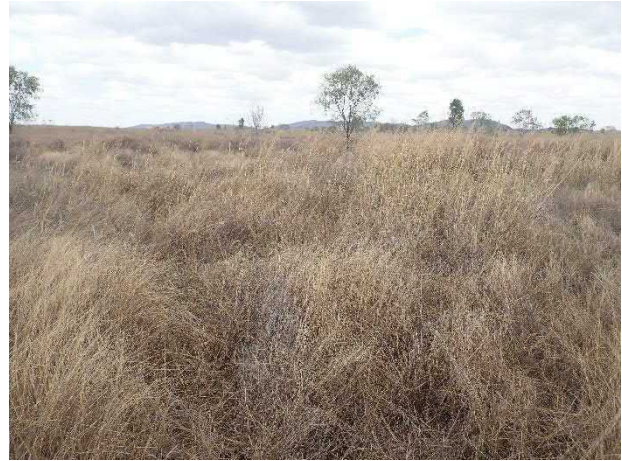
Figure 3-27: Southern Tailings Dam Flat sub-domain transect T10a end in 2019 (left) and 2020 (right)

The cover profile of the Southern Tailings Dam consisted of topsoil over heap-leach material and was rehabilitated in 1995. The area was divided into Flat and Batters sub-domains (**Figure 3-29**). On the Flat sub-domain, one transect (T10) was installed in 2007, consisting of four sub-transects (A-D) (**Figure 3-27**). On the Batters sub-domain, two transects (T26 and T27) were installed in 2008 (**Figure 3-28**). Photo-points were installed in 2013; PP20 on the Flat sub-domain and PP23 on the Batters sub-domains (**Figure 3-29**).

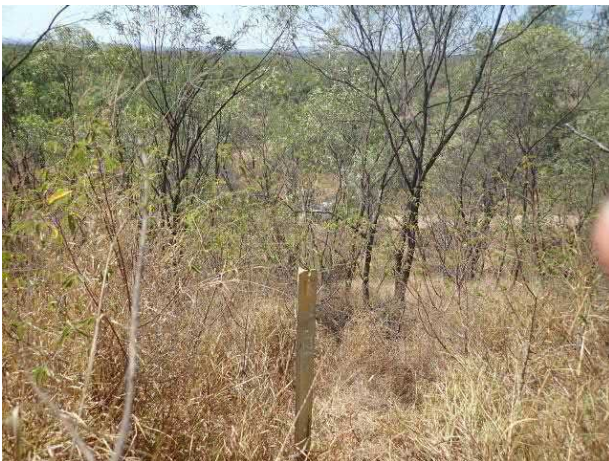
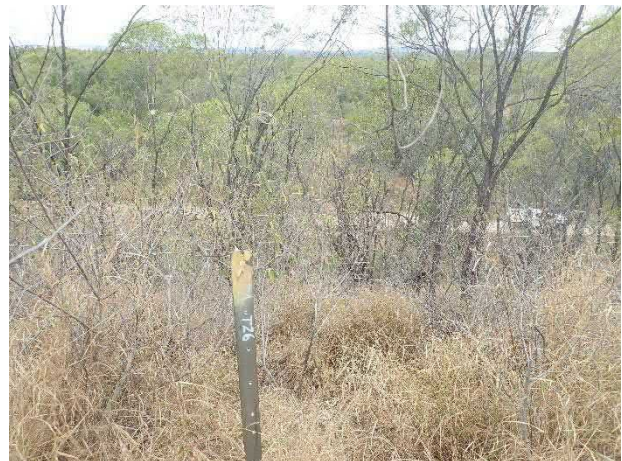
Figure 3-28: Southern Tailings Dam Batters sub-domain transect T26 start in 2019 (left) and 2020 (right)

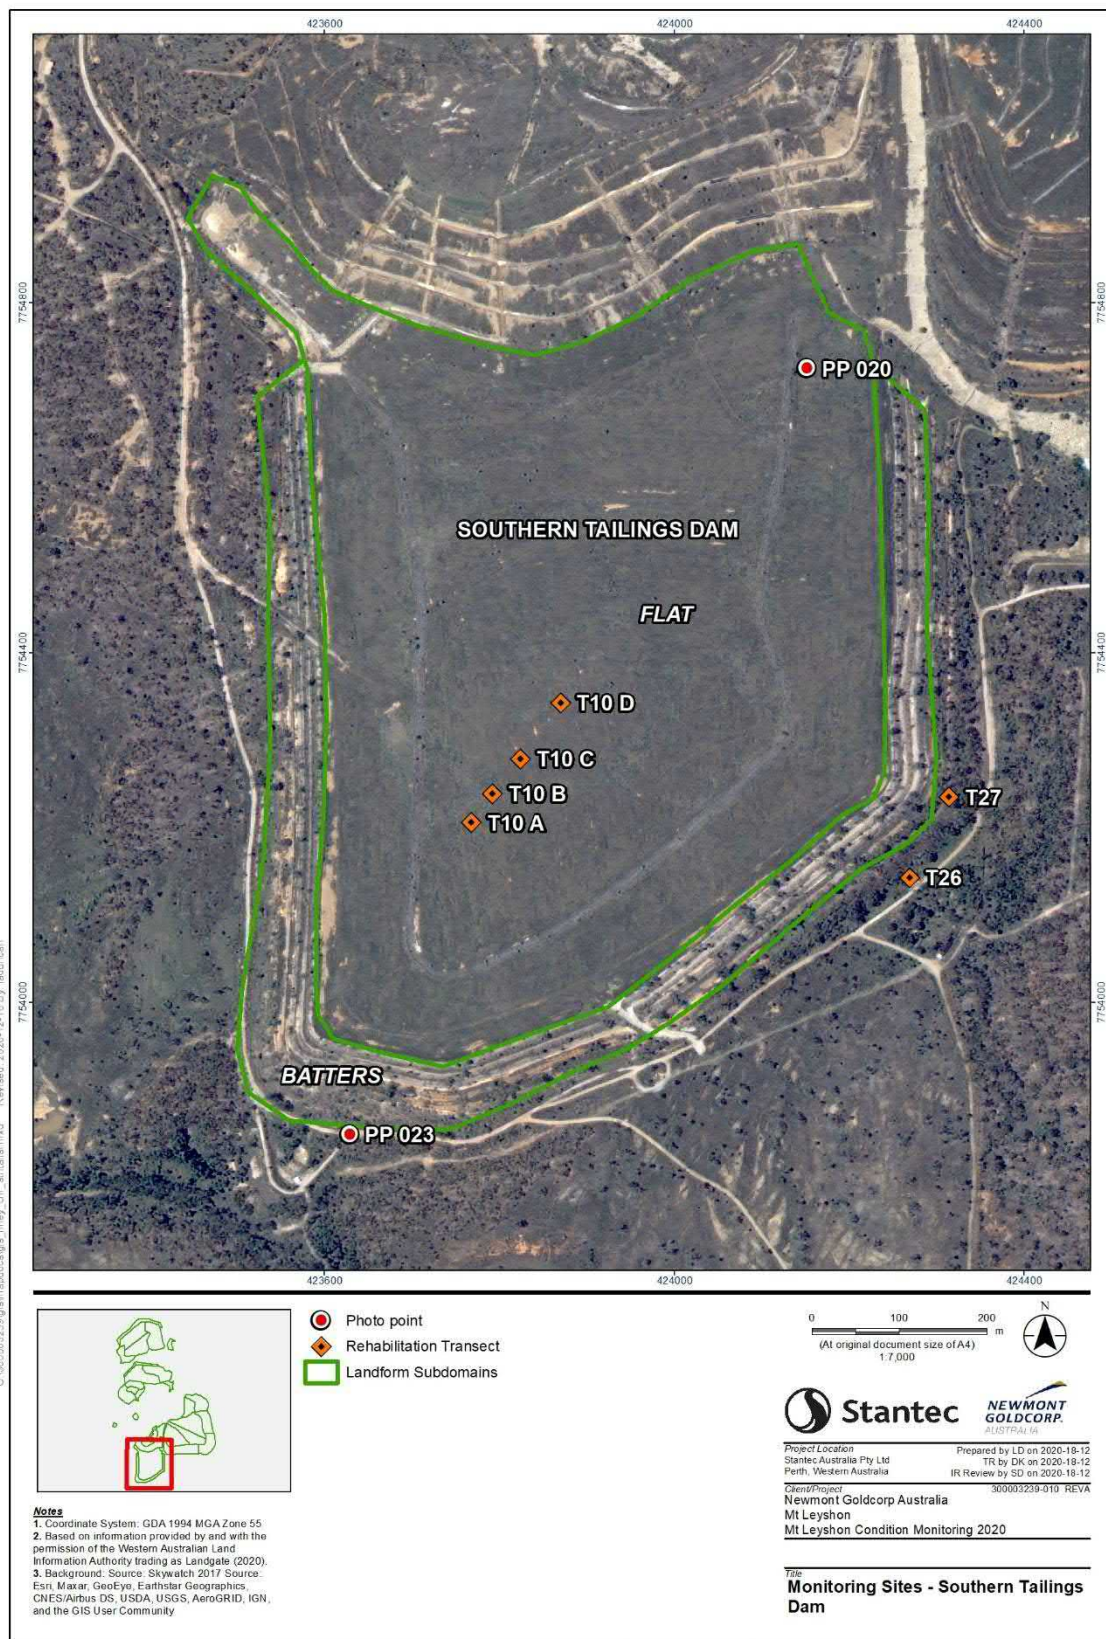
Figure 3-29: Southern Tailings Dam with sub-domains and 2020 monitoring locations
