## Progressive Rehabilitation and Closure Plan

**Mt Leyshon Mine**

M13000\_024-REP-001-2

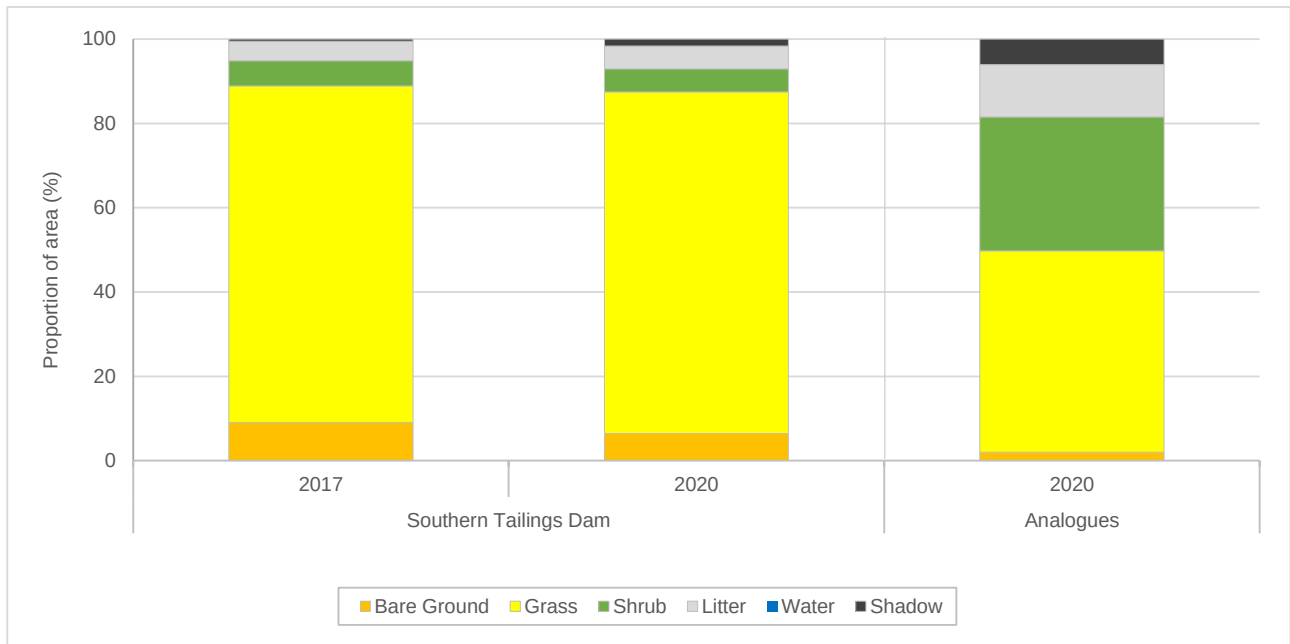
Figure 3-30: Proportion of ground cover types of the Southern Tailings Dam rehabilitation in 2017 and 2020, based on image analysis, compared to the analogue areas in 2020.

The remote sensing OBIA analysis showed the Southern Tailings Dam, like most other rehabilitation areas assessed, was dominated by grass cover (**Figure 3-30; Appendix F**). The rehabilitation had notably more grass cover than the analogues, and substantially less shrub cover. In 2017 and 2020 there was similar coverage of the different ground cover types.

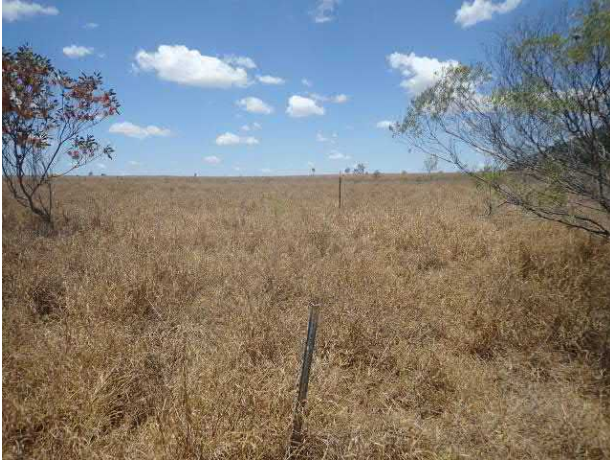
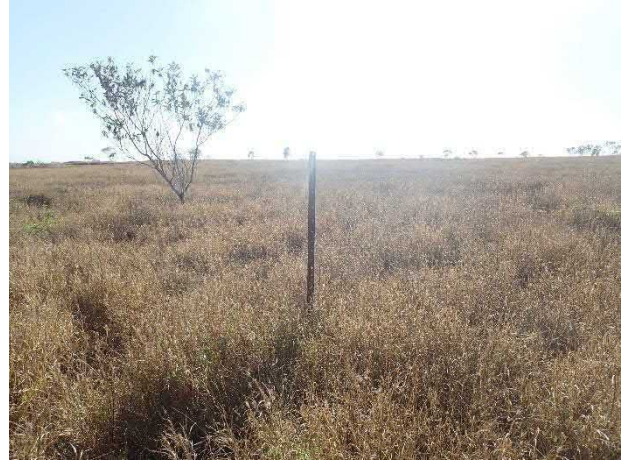
Figure 3-31: Eastern WRL North Flat sub-domain transect T02A end in 2019 (left) and 2020 (right)

The Eastern WRL is the largest landform rehabilitated at Mt Leyshon and was divided into eight sub-domains; four flat areas and four sloping areas (**Figure 3-31** to **Figure 3-33**). It had a cover profile of topsoil spread over a porphyry rock layer. Five different ages of rehabilitation were estimated from the assessment of historic aerial imagery: 1995, 1996, 1998, 2000, and 2001.

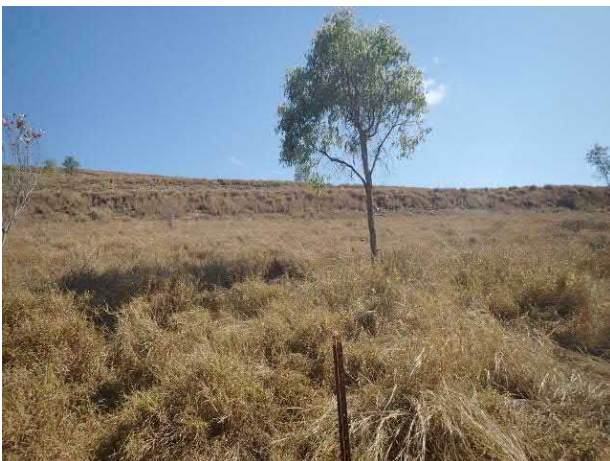
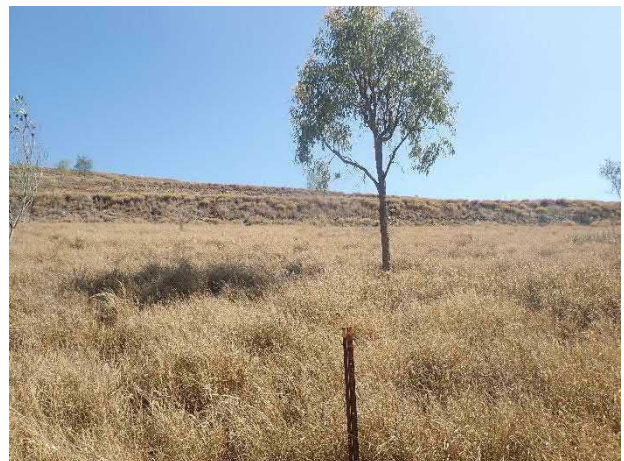
Figure 3-32: Eastern WRL South East Batters sub-domain transect T20 end in 2019 (left) and 2020 (right)

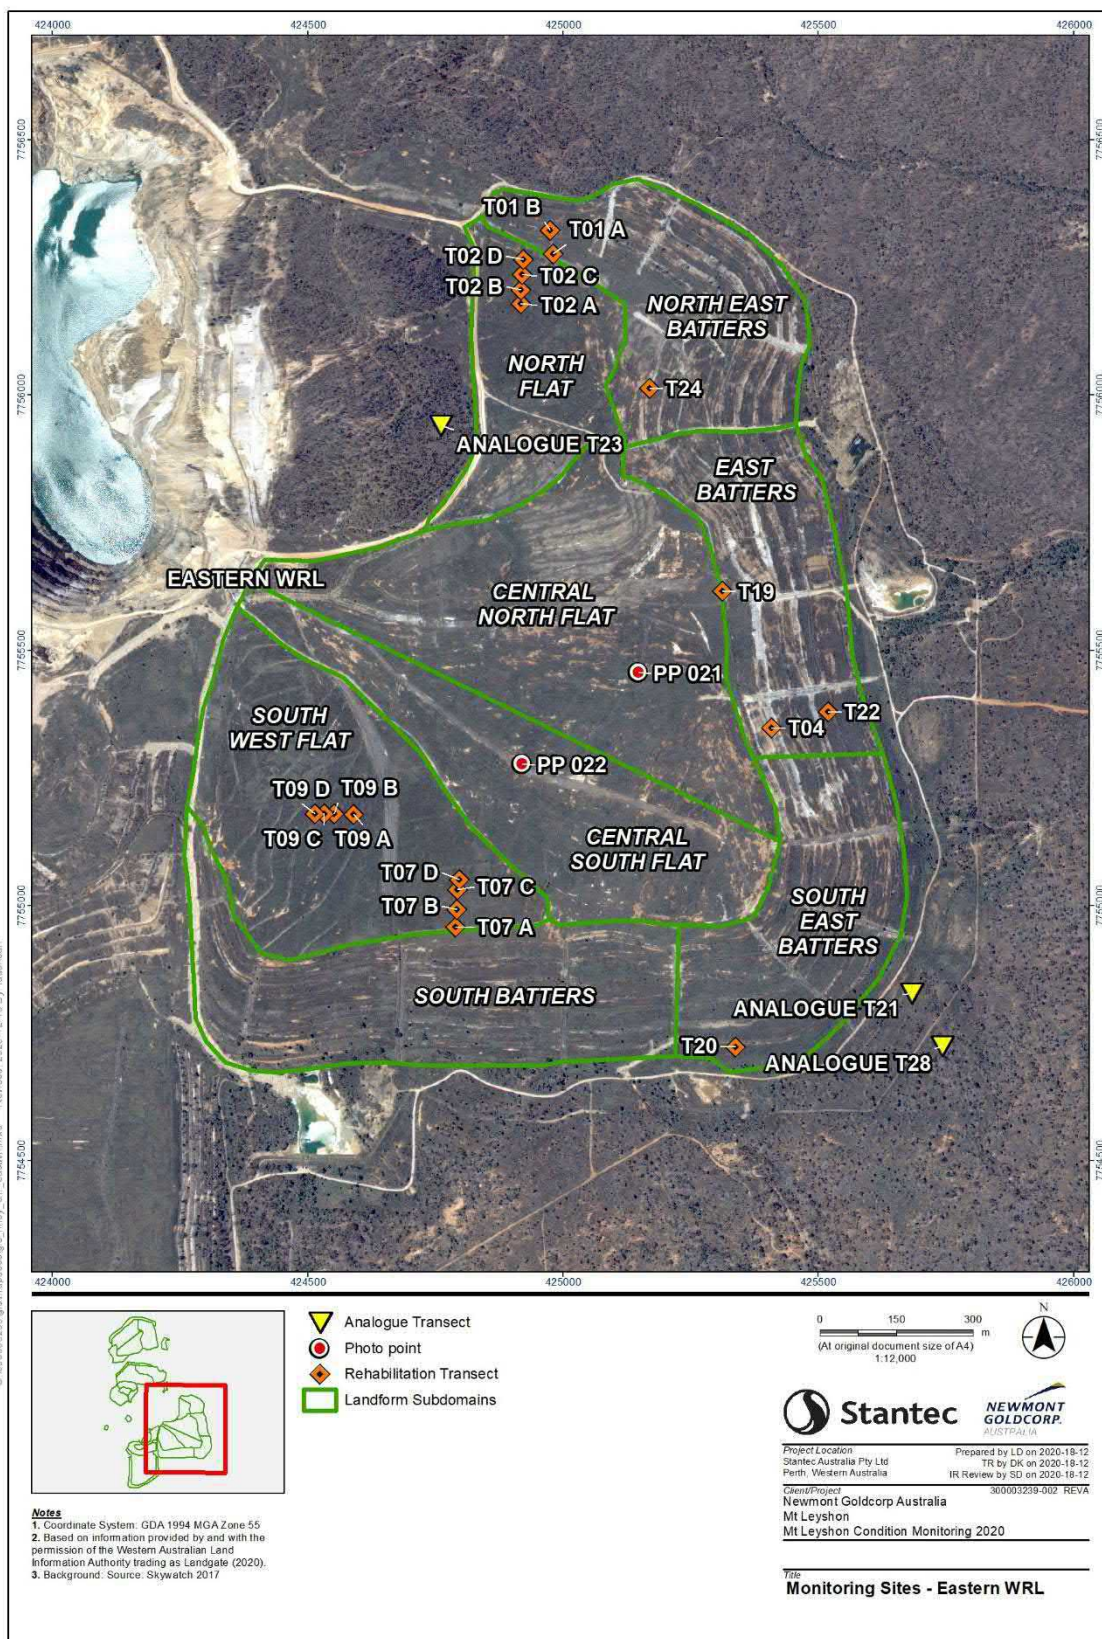
Figure 3-33: Eastern WRL with sub-domains and 2020 monitoring locations

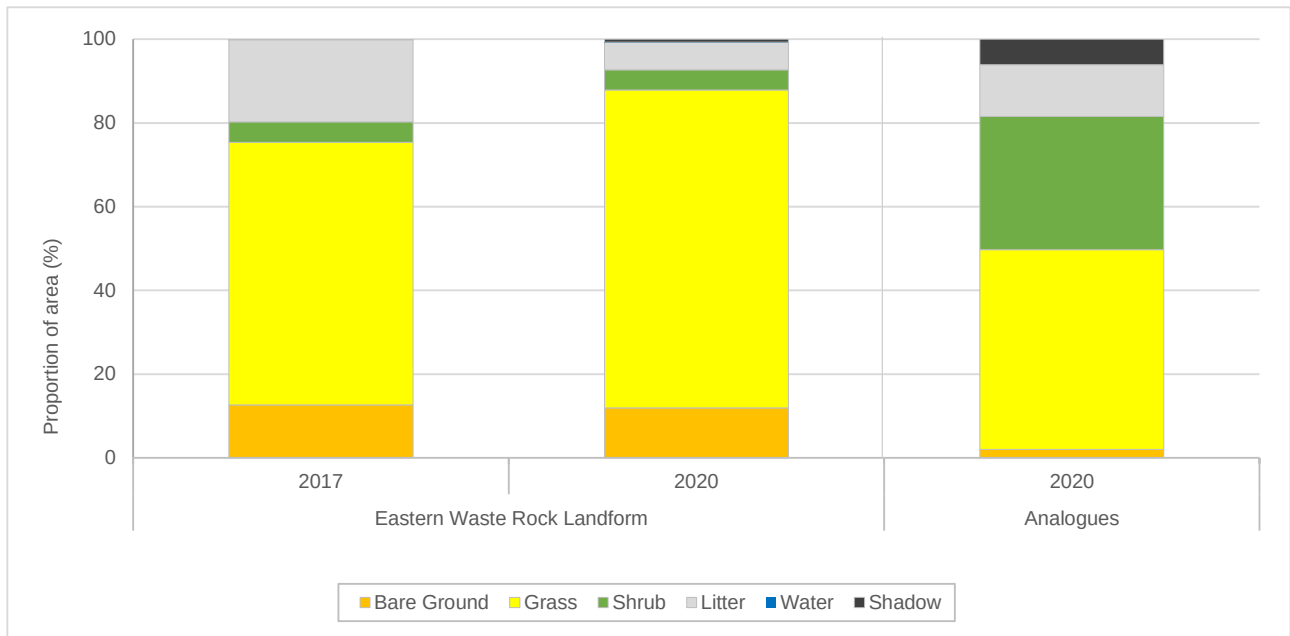
Figure 3-34: Proportion of ground cover types of the Eastern WRL rehabilitation in 2017 and 2020, based on image analysis, compared to the analogue areas in 2020.

The Eastern WRL rehabilitation, was dominated by grass cover (**Figure 3-34; Appendix F**), with substantially less contribution from the other ground cover types. Compared to the analogues, the rehabilitation had notably more grass cover, but substantially less shrub cover. Between 2017 and 2020 there was a slight increase in grass cover and decrease in litter cover, which was likely part of normal seasonal variations in cover types.

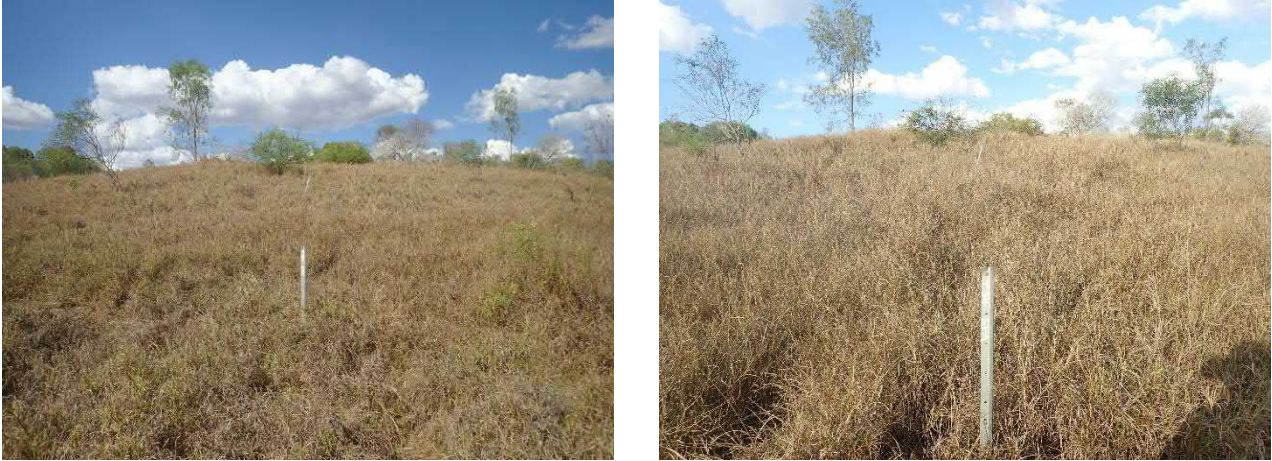
Figure 3-35: Pregnant Pond transect T34 end in 2019 (left) and 2020 (right)

The Pregnant Pond landform rehabilitation works, which involved topsoil application, ripping, and seeding with a Buffel Grass and *Stylosanthes* spp. mix, were completed in 2004. Due to the small footprint and homogenous nature of the vegetation at the site, this site was not sub-divided and one monitoring transect was sufficient. Transect T34 was installed in 2010 to monitor rehabilitation (**Figure 3-35, Figure 3-36**).

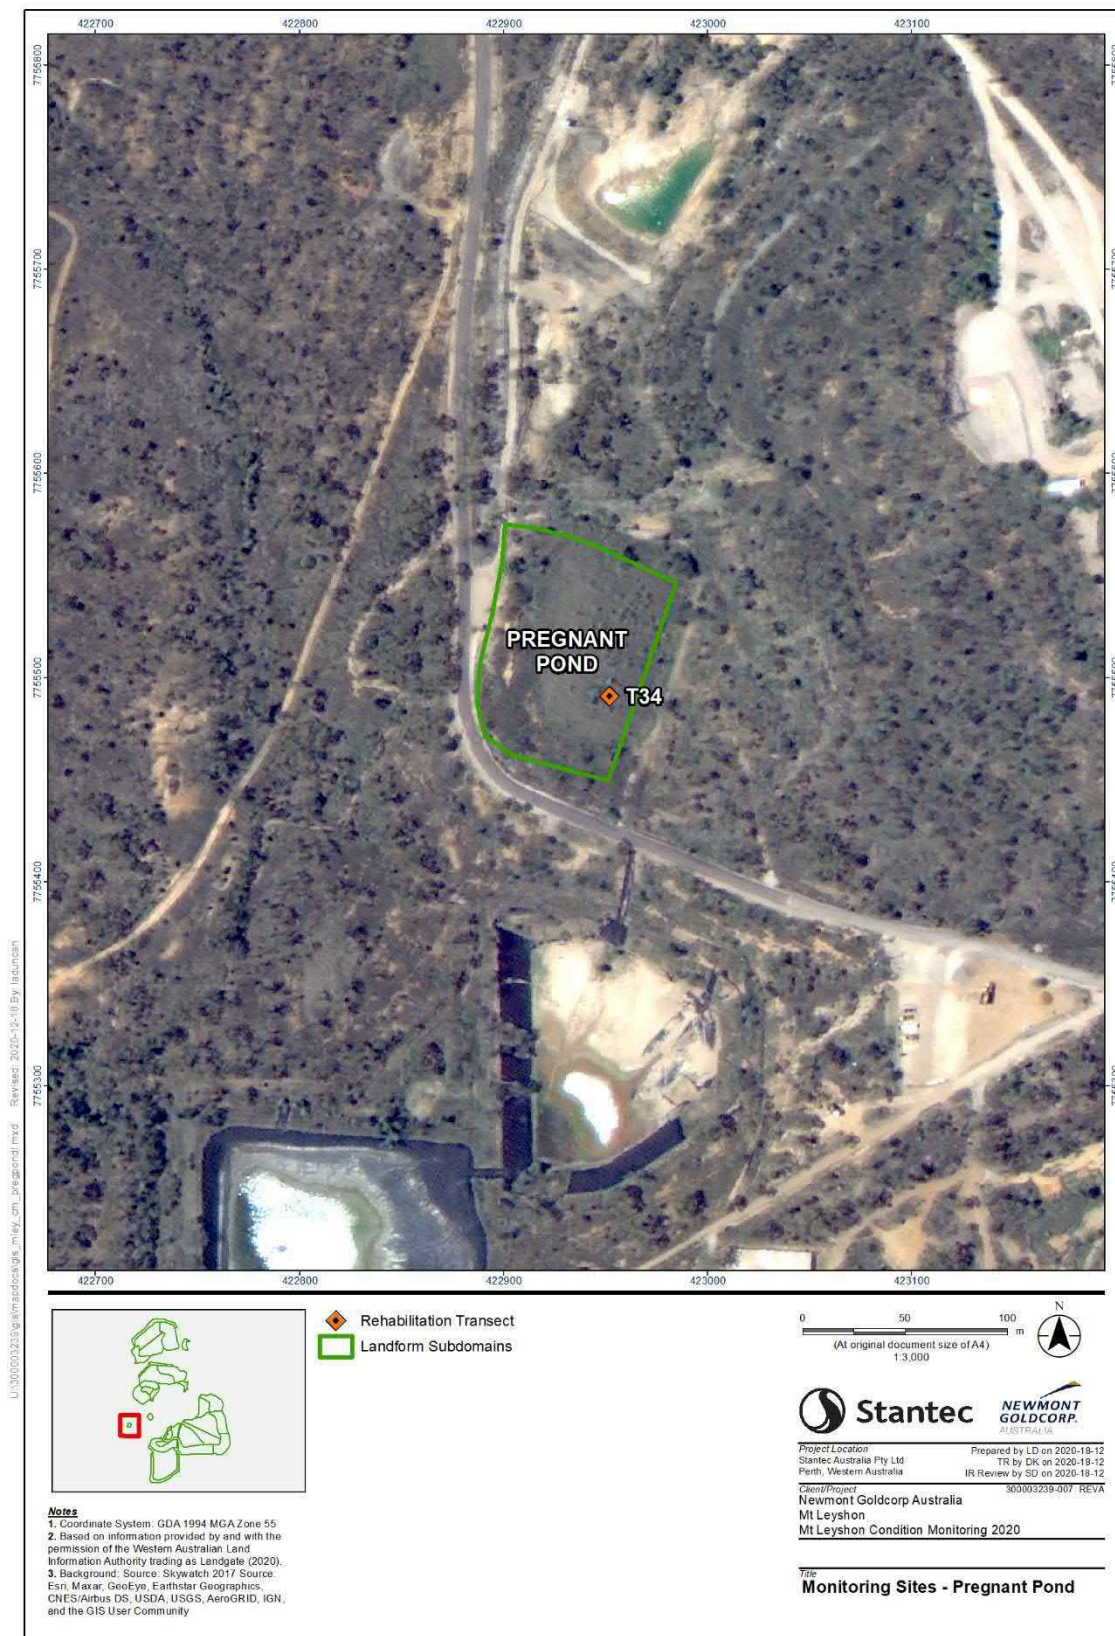
Figure 3-36: Pregnant Pond rehabilitation area and 2020 monitoring location

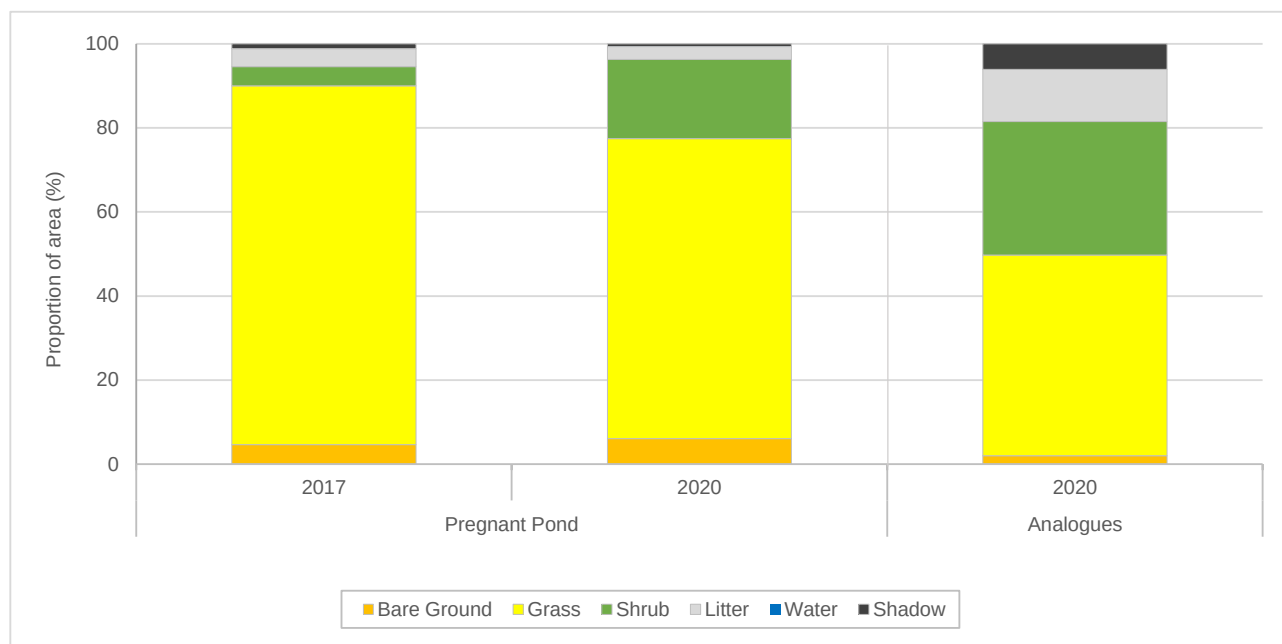
Figure 3-37: Proportion of ground cover types of the Pregnant Pond rehabilitation in 2017 and 2020, based on image analysis, compared to the analogue areas in 2020.

The Pregnant Pond rehabilitation was dominated by grass cover (**Figure 3-37; Appendix F**), with notably less cover contributed by the other ground cover types. The rehabilitation had notably more grass cover, but substantially less shrub cover, than the analogues. Between 2017 and 2020 there was a slight decrease in grass cover and an increase in shrub cover, which was likely part of normal seasonal variations in cover types.

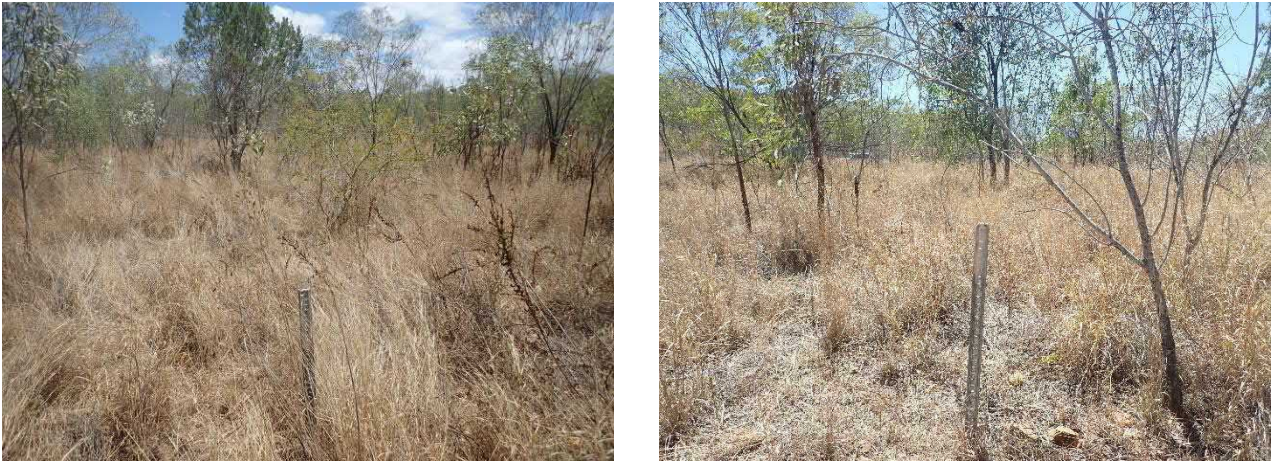
Figure 3-38: Processing Area transect T35A end in 2019 (left) and 2020 (right)

The Processing Area rehabilitation works were completed in 2009. Although two transects, T35 and T36, were installed in 2009, T36 has not been located since 2011. Transect T35 consisted of four sub-transects (A-D) spread across the rehabilitation (**Figure 3-38** and **Figure 3-39**). Due to the small size of the rehabilitation area, it was not divided into sub-domains.

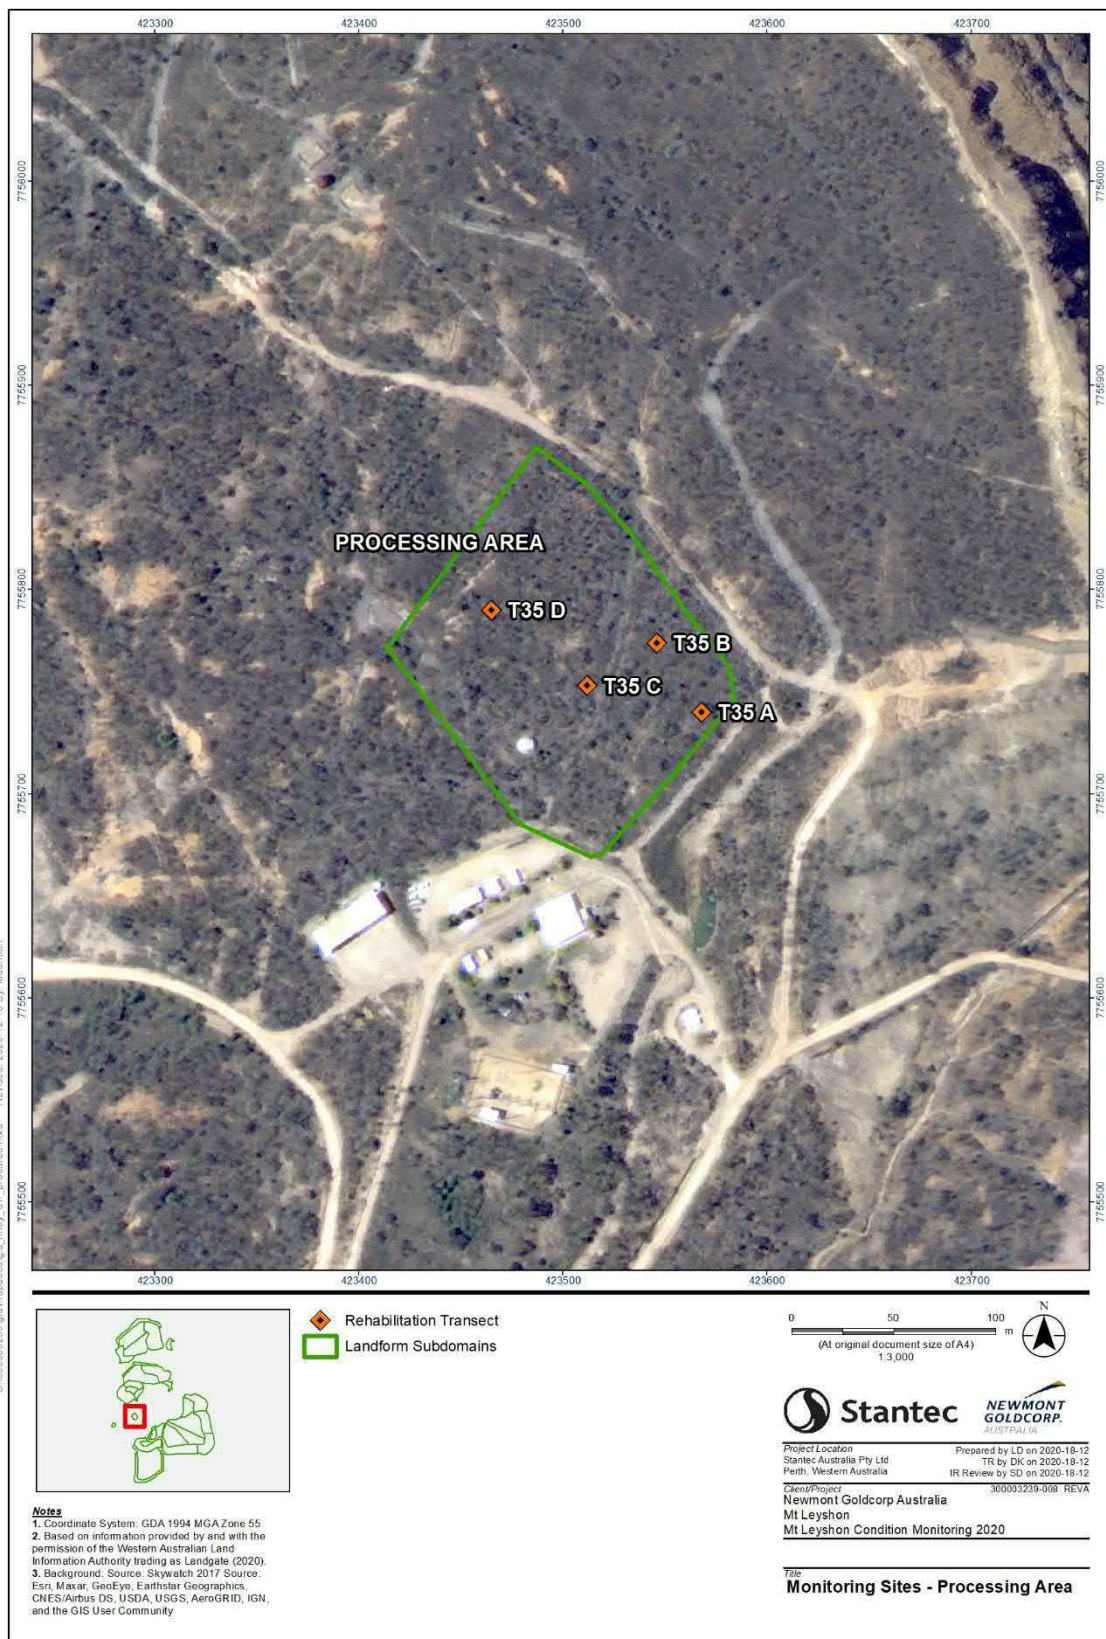
Figure 3-39: Processing Area and 2020 monitoring locations

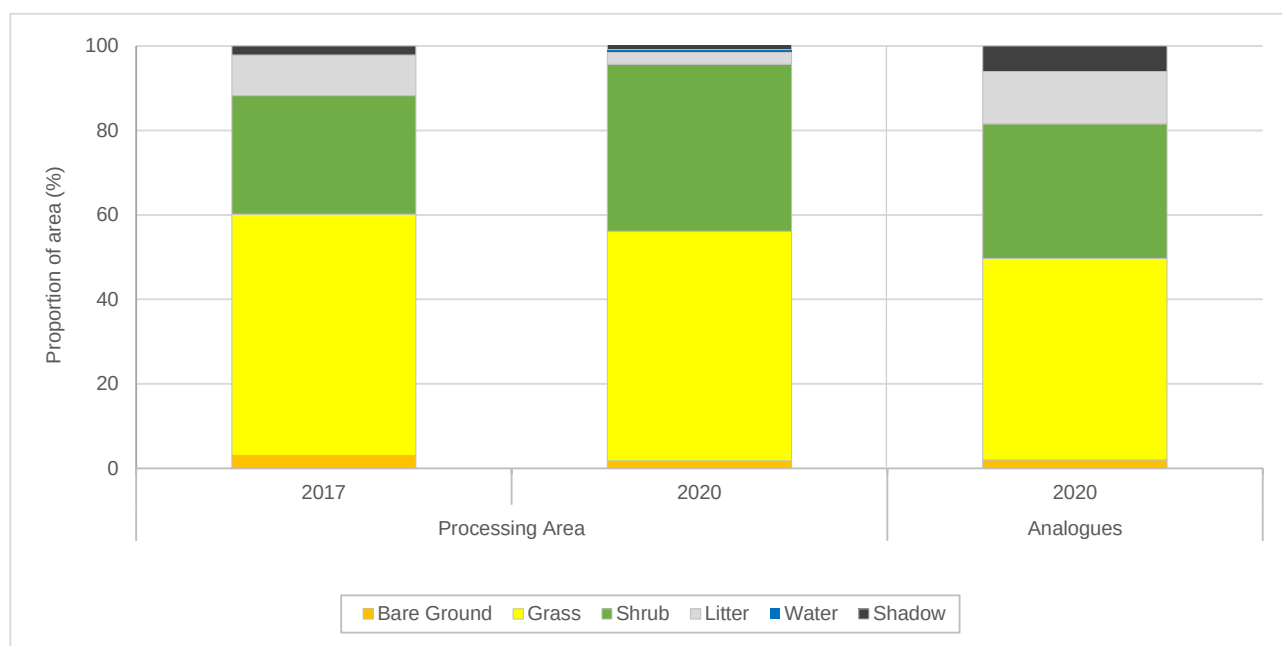
Figure 3-40: Proportion of ground cover types of the Processing Area rehabilitation in 2017 and 2020, based on image analysis, compared to the analogue areas in 2020.

The Processing Area rehabilitation was dominated by grass cover, closely followed by shrubs in 2020 (**Figure 3-40; Appendix F**). The rehabilitation had roughly similar grass and shrub coverage to the analogues. Between 2017 and 2020 there was a slight decrease in grass and litter cover and an increase in shrub cover, which was likely part of normal seasonal variations in cover types.

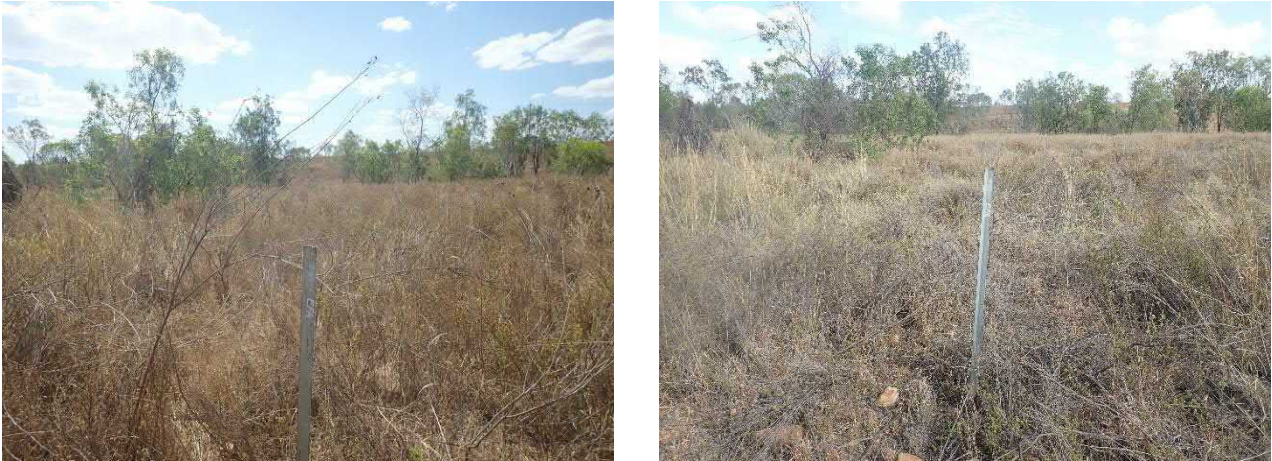
Figure 3-41: Water Treatment Pond transect T33 end in 2019 (left) and 2020 (right)

The Water Treatment Pond was located northeast of the Mt Leyshon Pit and covered approximately one hectare. Rehabilitation of the Water Treatment Pond occurred in 2007, involving the application of topsoil which had been collected from around the mine, and seeding the area, predominantly with Buffel Grass and *Stylosanthes* spp. In 2010, transect T33, was installed on a low sloping section of the site (**Figure 3-41**). A drain was located at the base of the transect, and a raw water dam was located to the northeast. Due to the small size of the rehabilitation area, it was not divided into sub-domains (**Figure 3-42**).

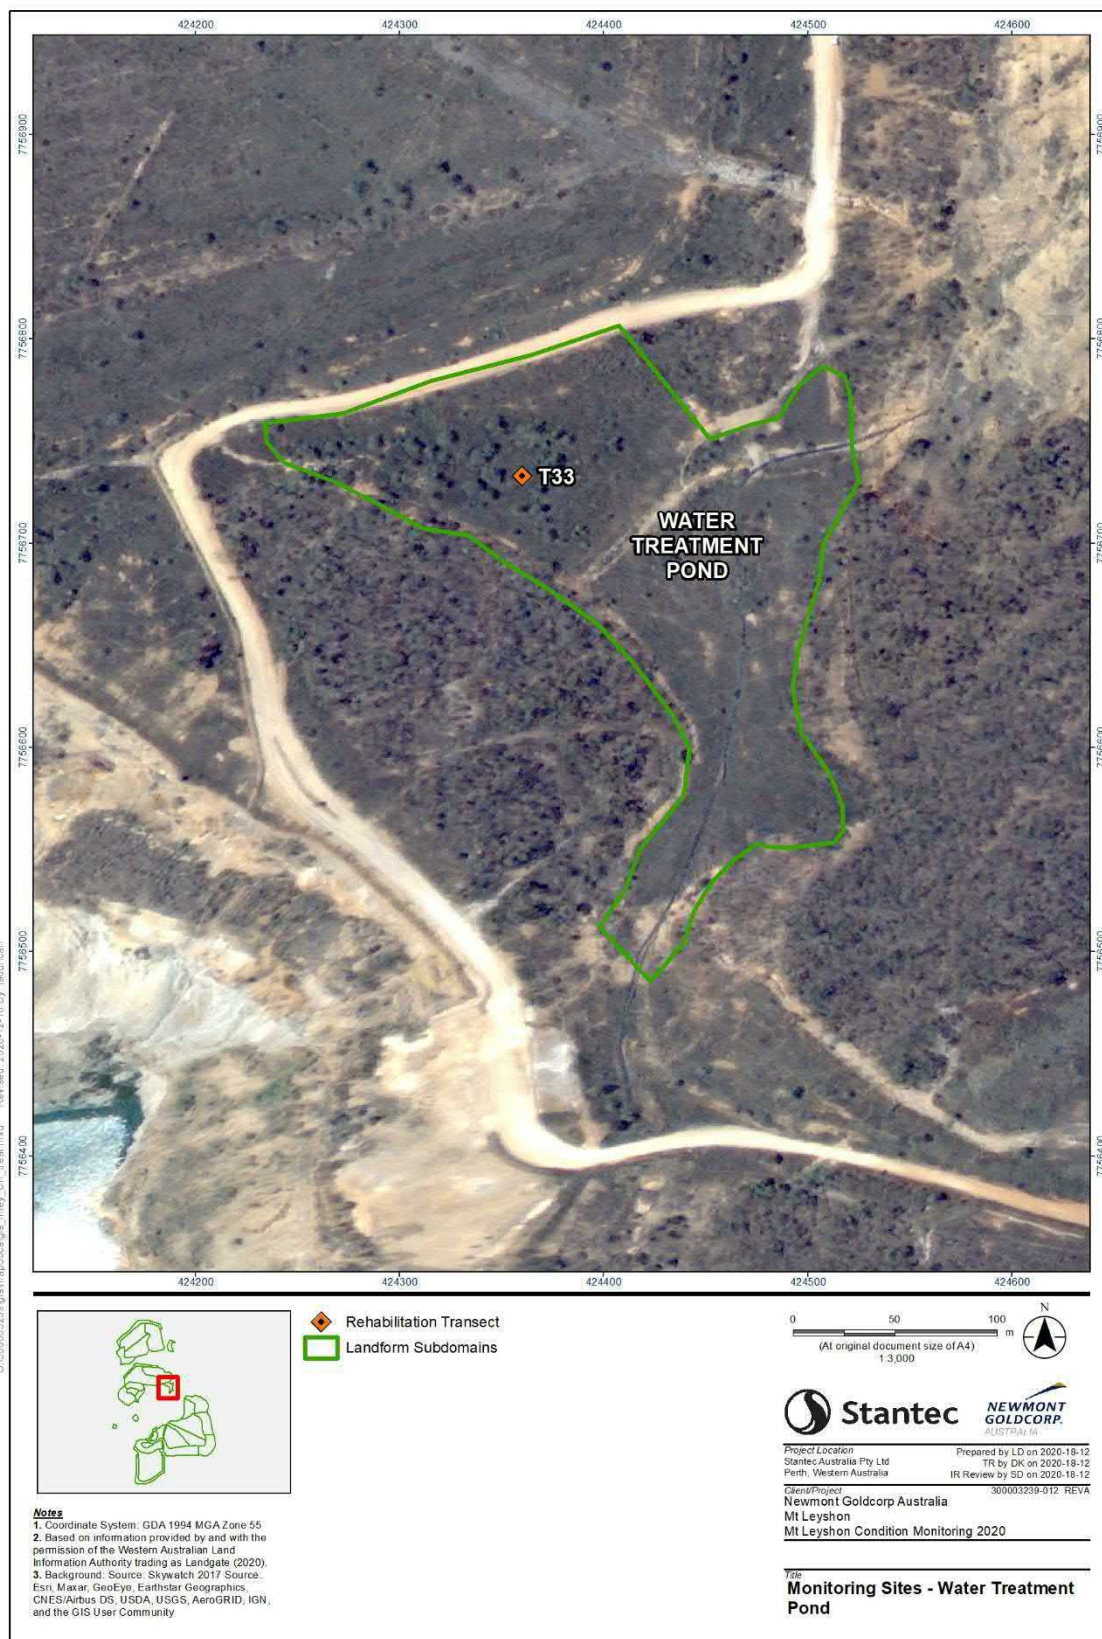
Figure 3-42: Water Treatment Pond rehabilitation area and 2020 monitoring location

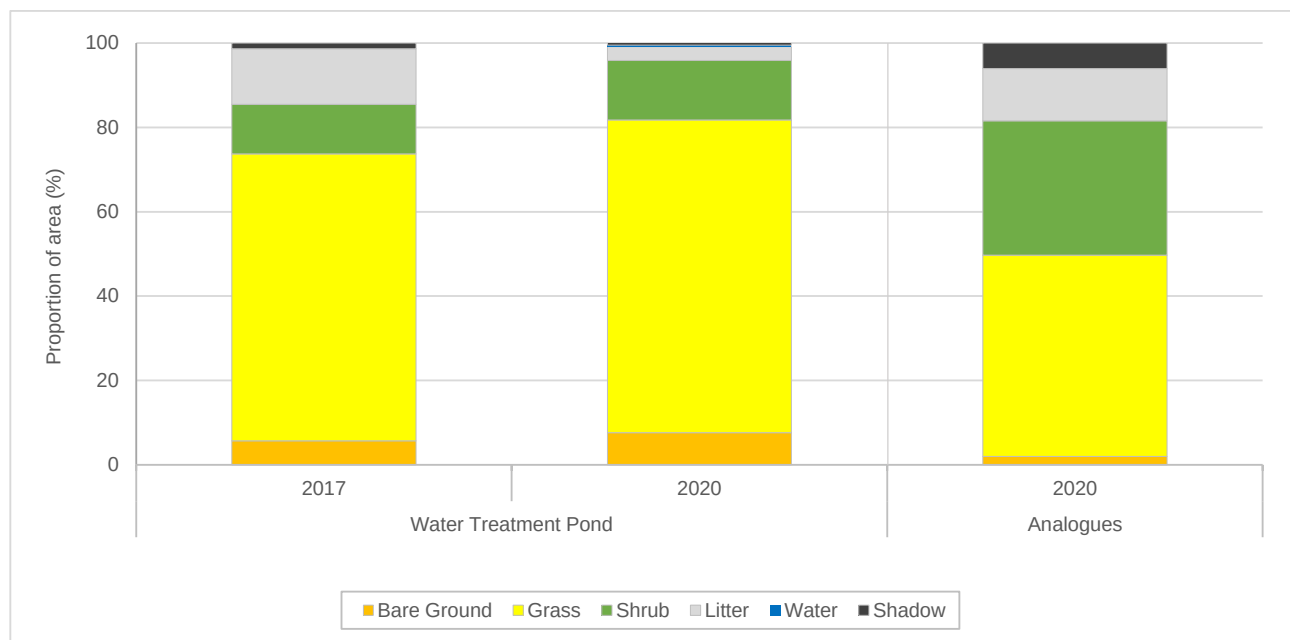
Figure 3-43: Proportion of ground cover types of Water Treatment Pond rehabilitation in 2017 and 2020, based on image analysis, compared to the analogue areas in 2020.

The Water Treatment Pond rehabilitation was dominated by grass cover, with far less cover contributed by the other ground cover types (**Figure 3-43; Appendix F**). The rehabilitation had notably more grass and substantially less shrub cover than the analogues. Between 2017 and 2020 there was a slight increase in grass cover and shrub cover, with a decrease in litter cover, which was likely part of normal seasonal variations in cover types.

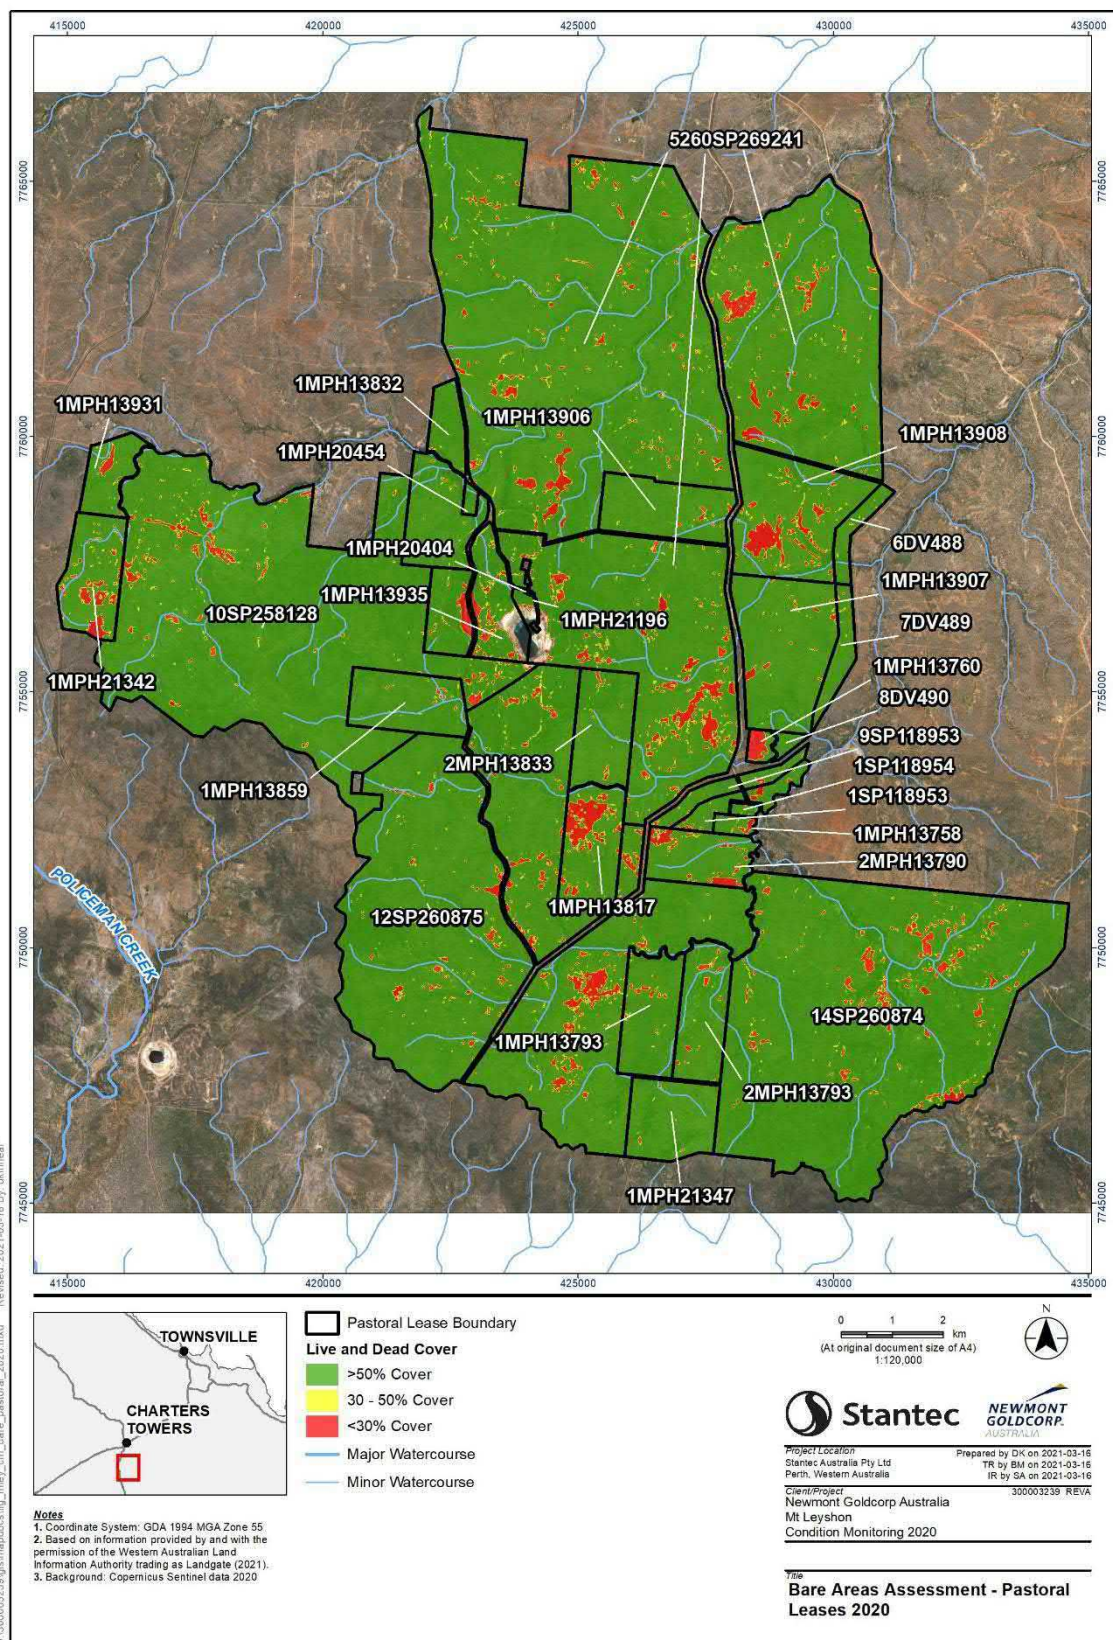
Figure 3-44: Organic ground cover classes over the Mt Leyshon pastoral leases in 2020

Remotely-sensed ground cover data of the study area at Mt Leyshon revealed that 8% of the 20,960 ha had <30% organic ground cover, which included living and dead plants, and plant litter (**Figure 3-44**). This was similar in 2019 where 7% of the pastoral lease had <30% organic cover. Areas with organic ground cover of <30% are considered at a higher risk of eroding soil than areas with higher organic ground cover (Queensland Government 2020). This is because plants help stabilise the soil surface, help it resist disturbance, and ultimately reduce erosion of the soil surface.

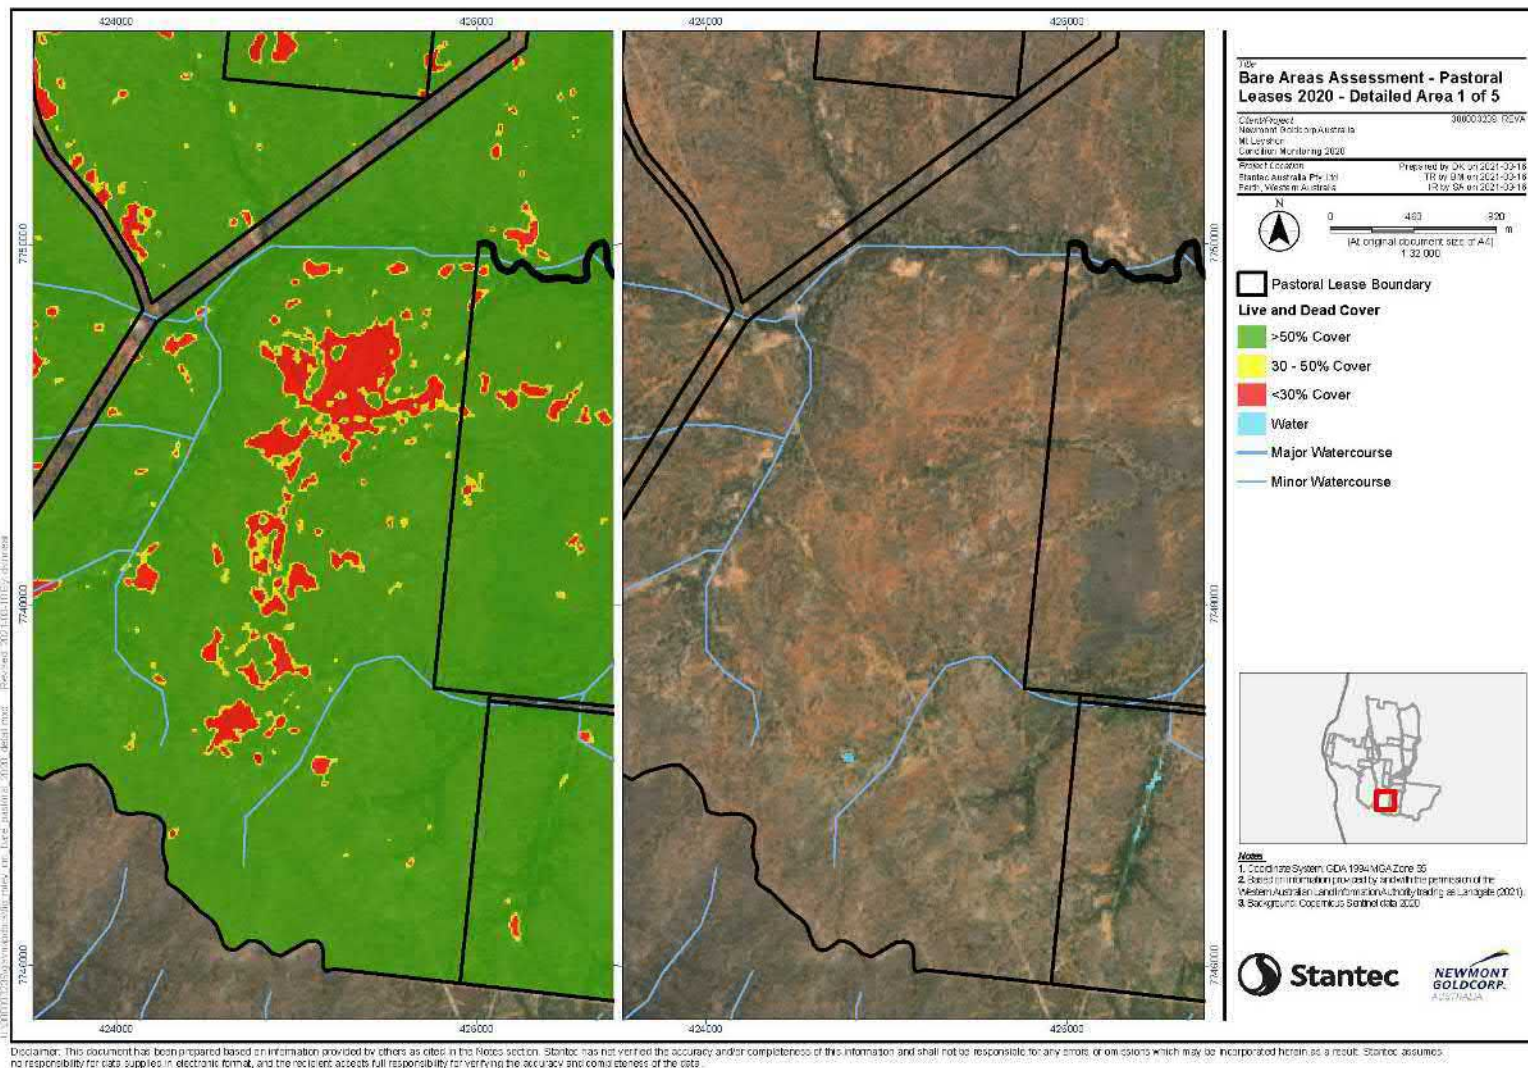
Figure 3-45: Organic ground cover classes in Area 1 at Mt Leyshon in 2020

Five areas were visually assessed as being of particular interest because they had larger patches of <30% cover in proximity to water courses (**Figure 3-45** to **Figure 3-49**). Vegetation generally improves the stability of the soil surface because plants, especially those in the lower to mid storey, shelters the soil surface from disturbance, plant roots exude chemicals which bind soil particles together and encourage soil microbial activity, and plant litter incorporation into the soil improves its water moisture content and also binds soil particles together. At Mt Leyshon, large bare areas near water courses were at potential risk of soil eroding into tributaries of the Burdekin River.

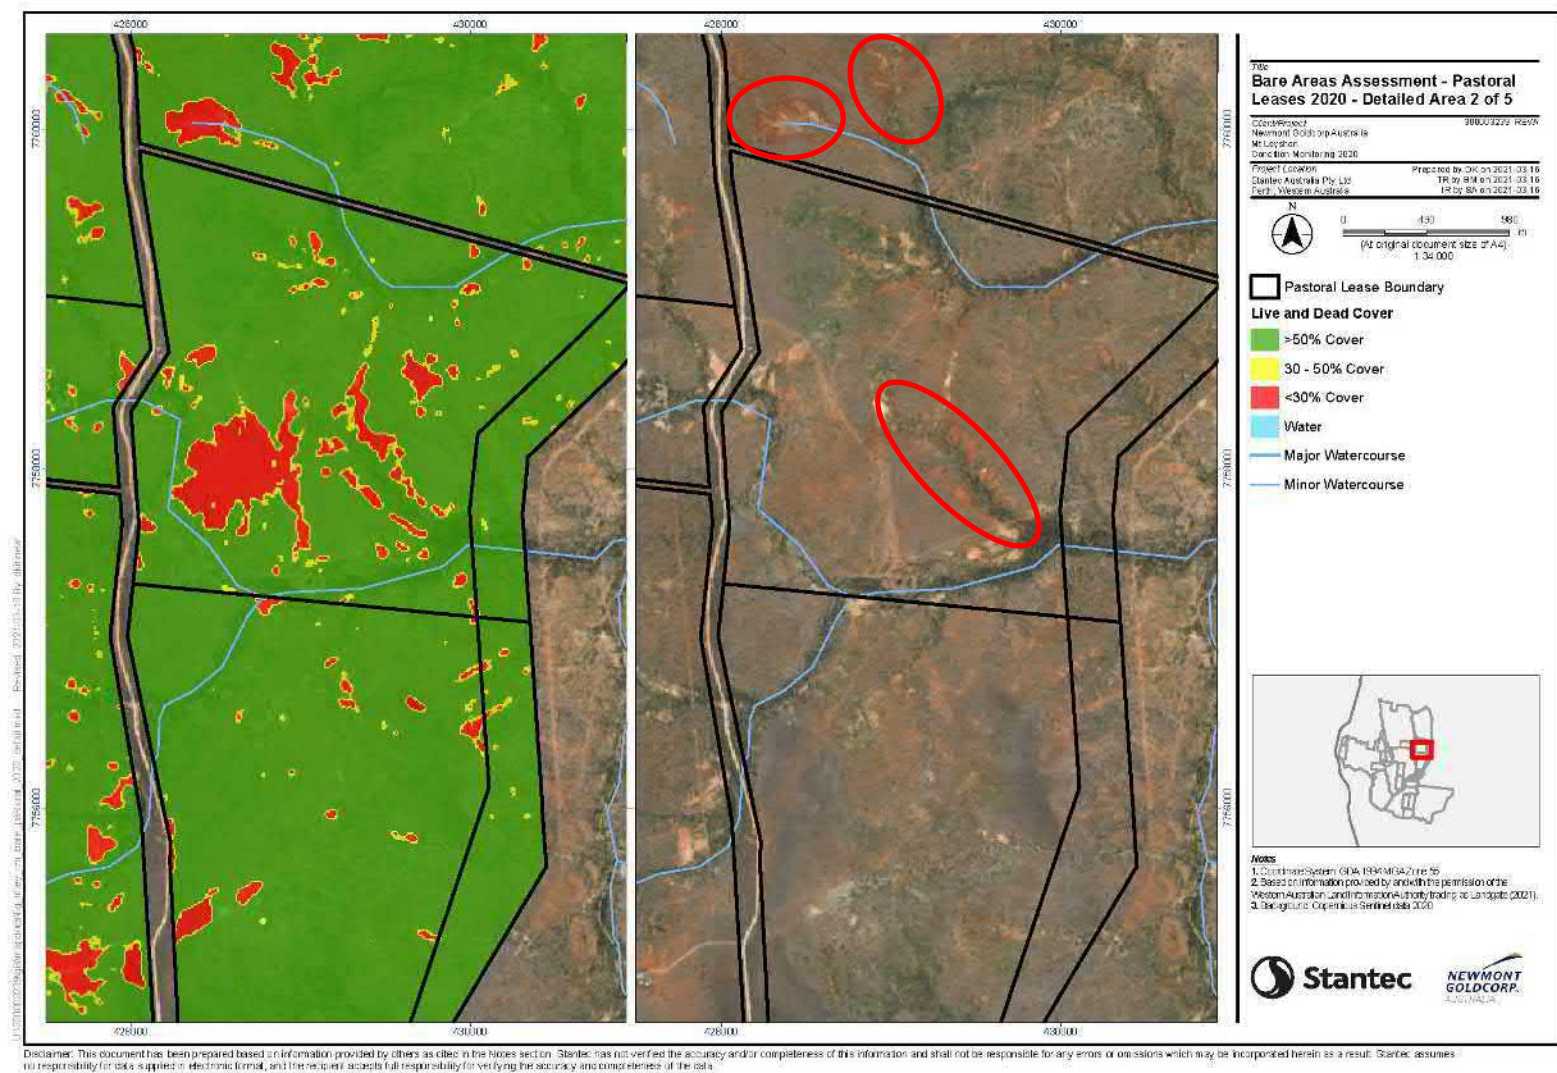
Figure 3-46: Organic ground cover classes in Area 2 at Mt Leyshon in 2020, with the encircled red areas of the right image showing what appeared to be stream bank erosion

Each of the five areas identified had large sections of <30% vegetation cover along one or more water courses. Area two (**Figure 3-46**) was of particular interest because it showed at least three locations where it appeared stream banks were unstable and eroding (Queensland Government 2020). An on-ground assessment would be required to ground truth the remote sensing and confirm sediment was, or was at risk of, eroding into watercourses. Many of the areas with low vegetation cover were apparent in both the 2019 (**Appendix F**) and 2020 imagery and appeared to be related to cattle watering points, pastoral infrastructure, and vehicle and cattle tracks.
