## Progressive Rehabilitation and Closure Plan

**Mt Leyshon Mine**

M13000\_024-REP-001-2

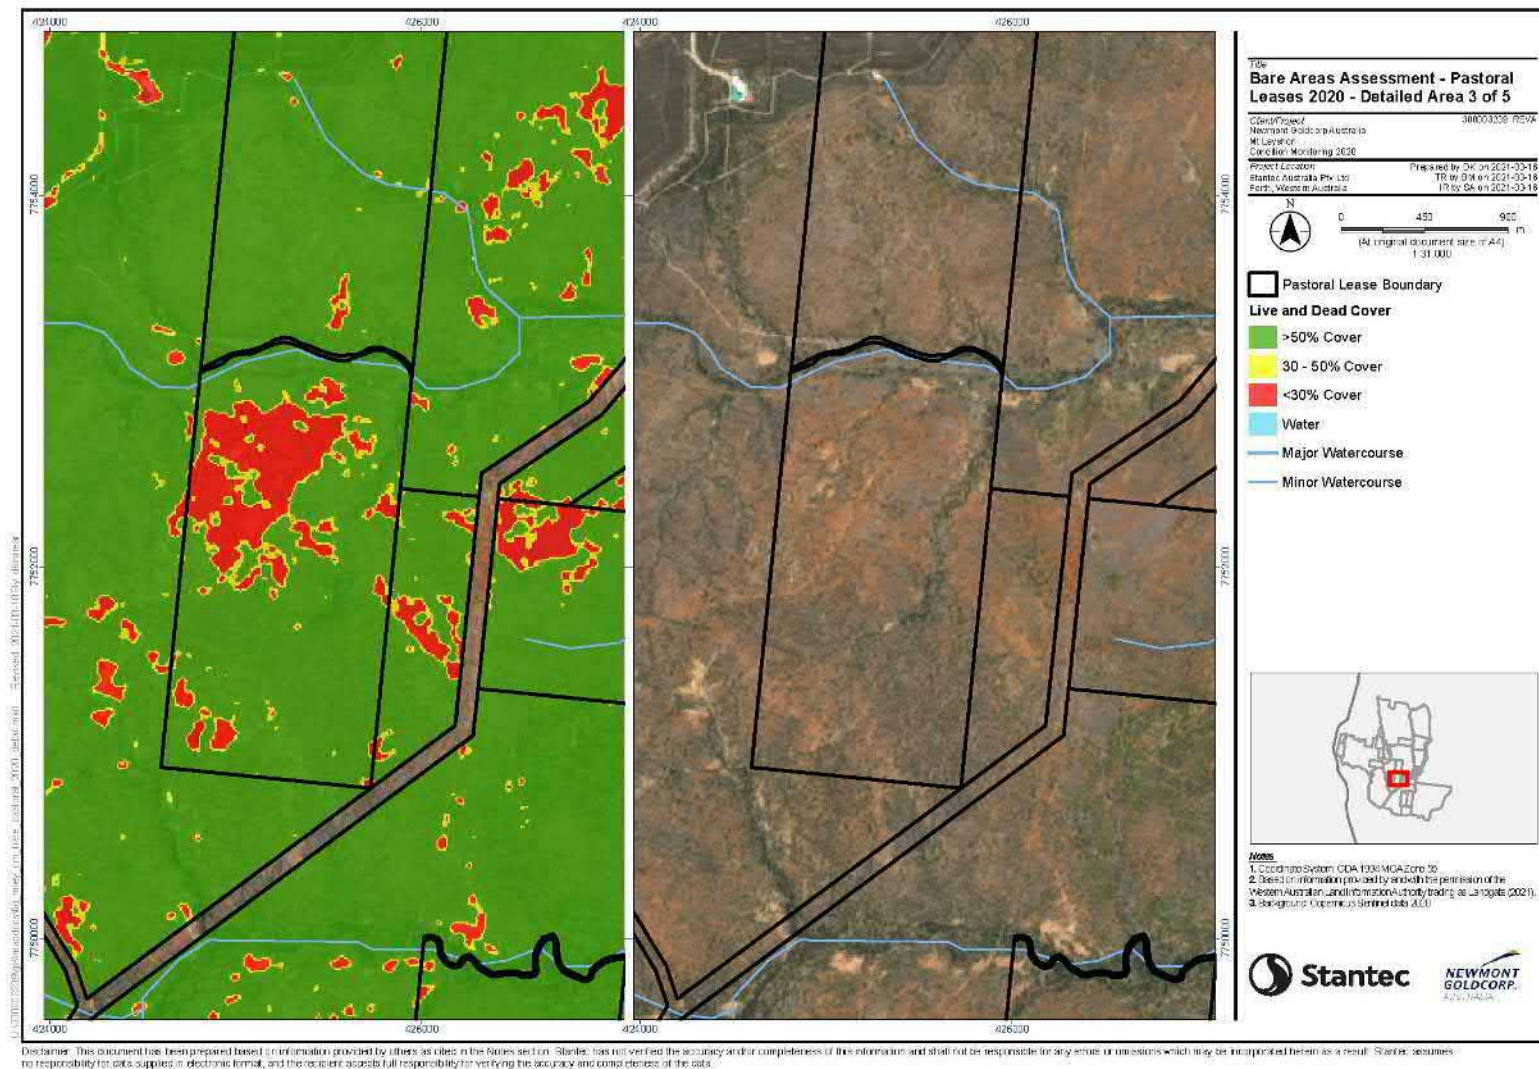
Figure 3-47: Organic ground cover classes in Area 3 at Mt Leyshon in 2020

Five areas were visually assessed as being of particular interest because they had larger patches of <30% cover in proximity to water courses (**Figure 3-45** to **Figure 3-49**). Vegetation generally improves the stability of the soil surface because plants, especially those in the lower to mid storey, shelters the soil surface from disturbance, plant roots exude chemicals which bind soil particles together and encourage soil microbial activity, and plant litter incorporation into the soil improves its water moisture content and also binds soil particles together. At Mt Leyshon, large bare areas near water courses were at potential risk of soil eroding into tributaries of the Burdekin River.

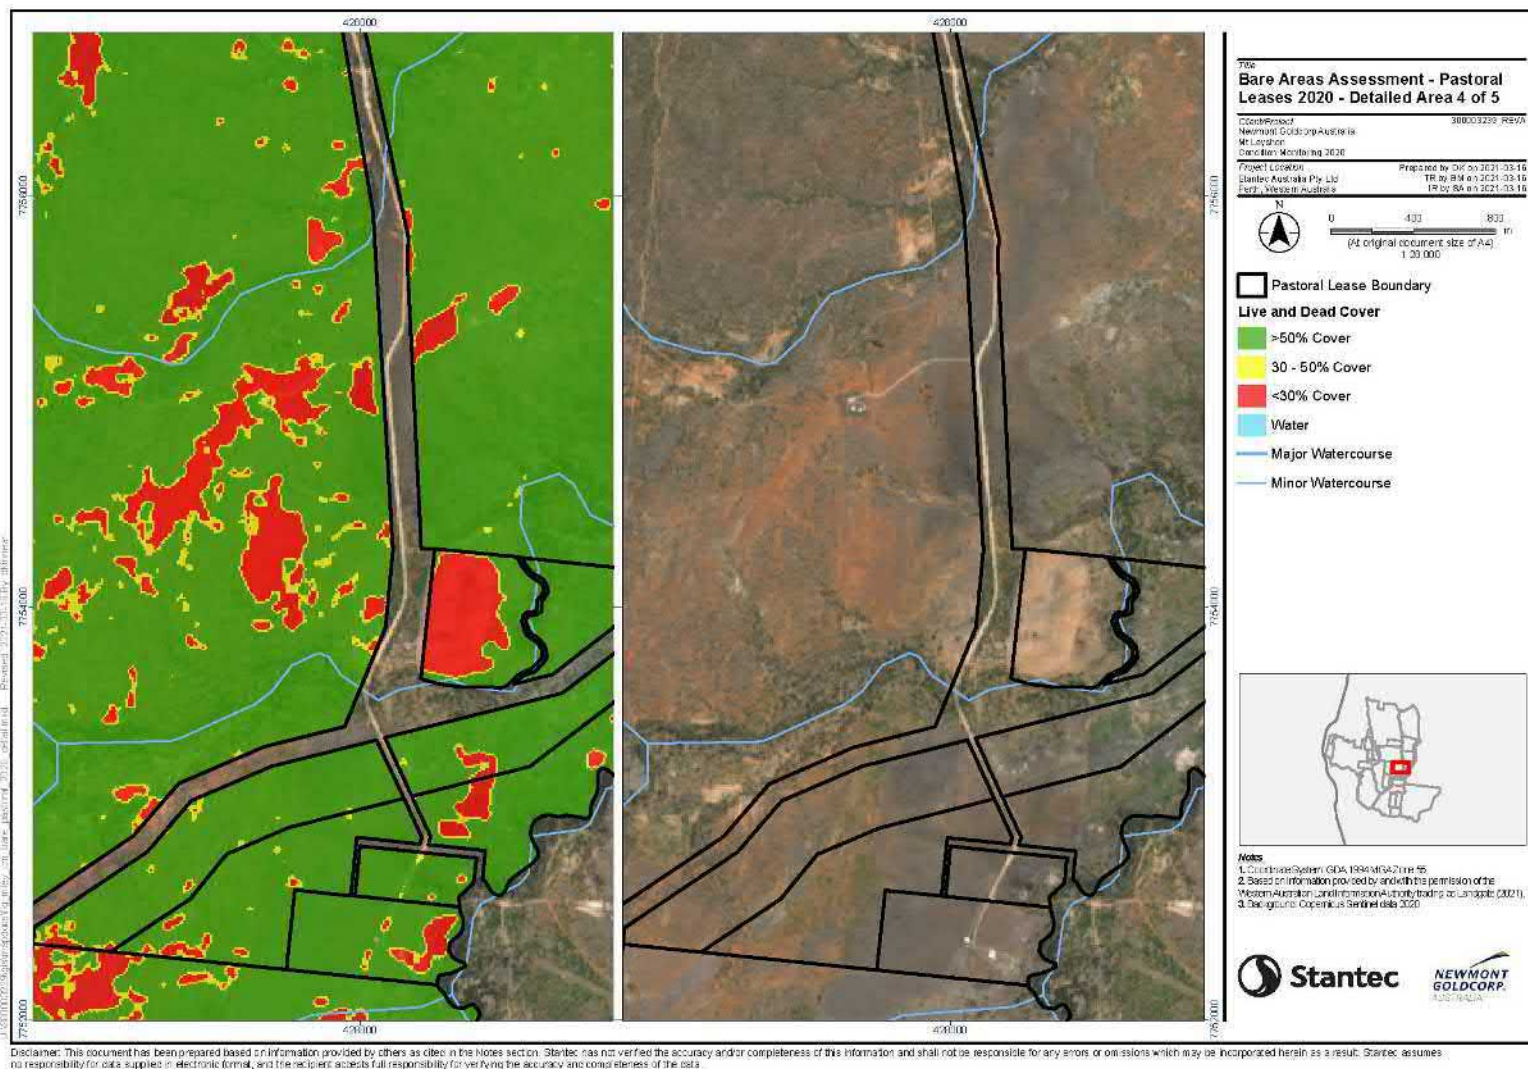
Figure 3-48: Organic ground cover classes in Area 4 of interest at Mt Leyshon in 2020

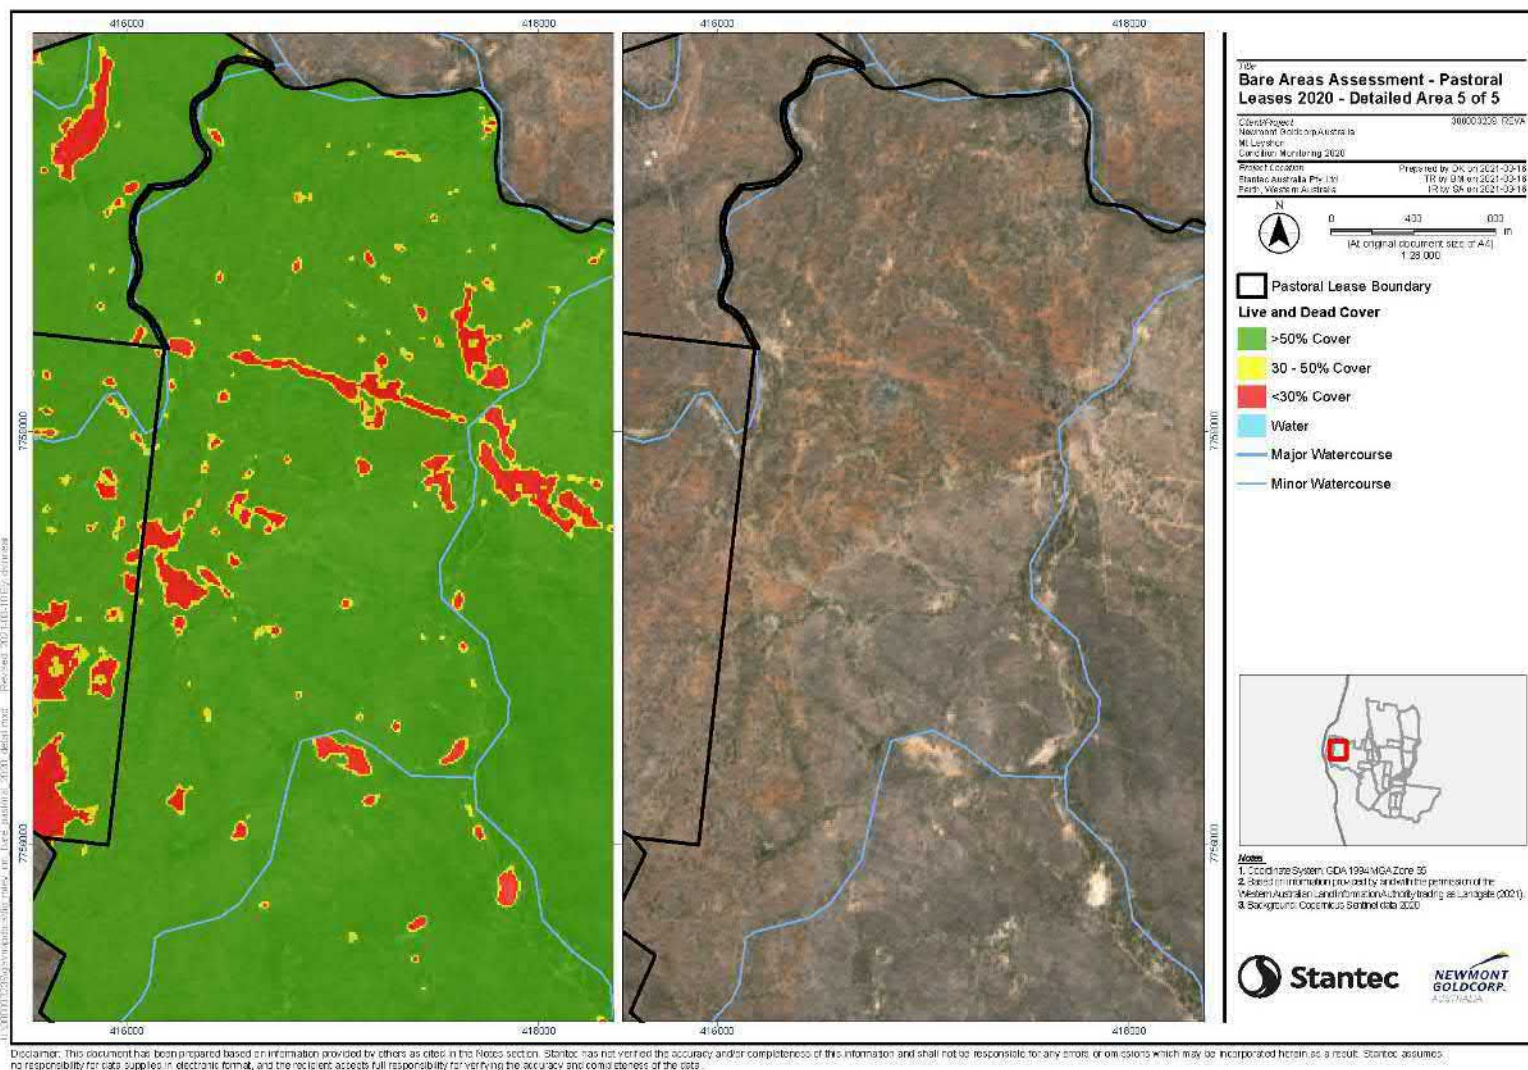
Figure 3-49: Organic ground cover classes in Area 5 at Mt Leyshon in 2020

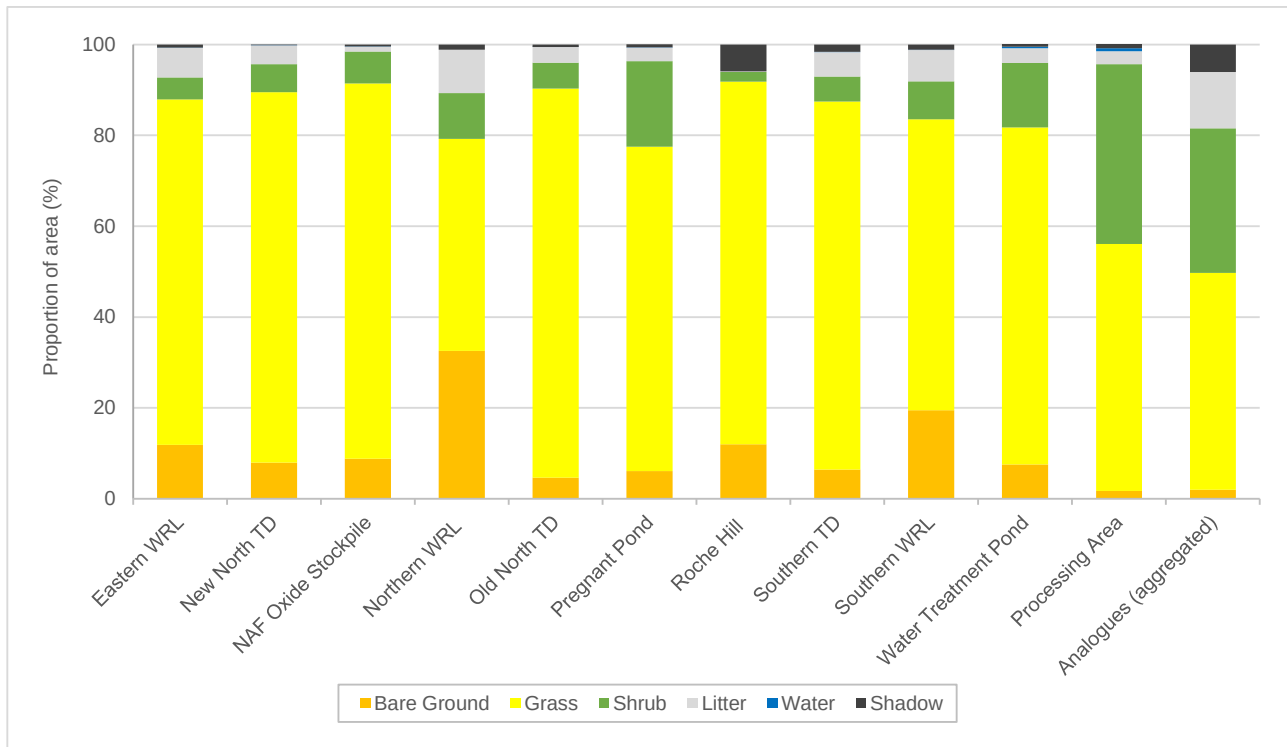
Figure 4-1: Proportions of ground cover types on the Mt Leyshon rehabilitation areas in 2020

Based on image analysis, grass cover was the dominant cover at all rehabilitation areas assessed at Mt Leyshon in 2020 and grass contributed substantially more cover than shrubs at most domains (**Figure 4-1**). All rehabilitation areas had substantially more grass and substantially less shrub cover than the analogues, except for the Processing Area which had a similar vegetation structure to the analogues. In general, the rehabilitation areas had more ground considered bare than the analogues, however, except for the Northern WRL, all had bare cover of less than 20%. The Northern WRL was noted for a higher proportion of bare areas than the analogues and other domains, however, this was largely due to the bare east batter which consisted of exposed waste rock with little to no soil on the surface.

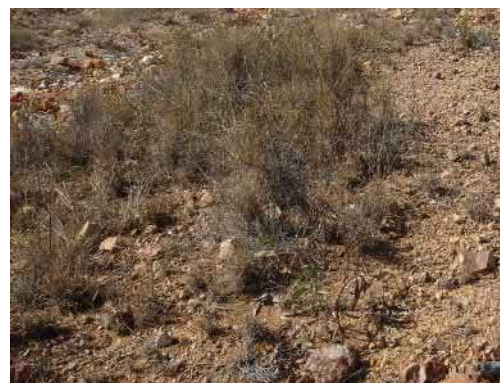
| Topsoil | Score | Description |
|---|---|---|
| High | 5 | High amount of topsoil integration and cover. |

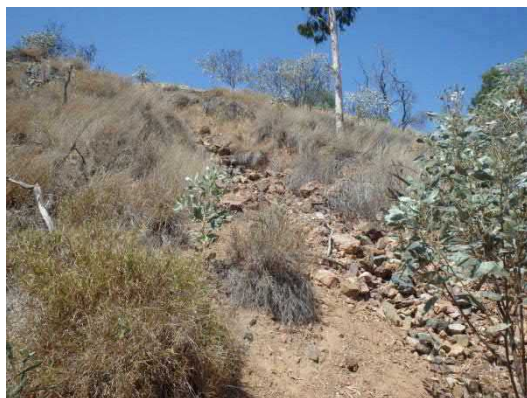
| Feature Stability | Score | Description |
|---|---|---|
| Stable | 5 | Features not recently active and low potential for reactivating and/or with high grass cover |

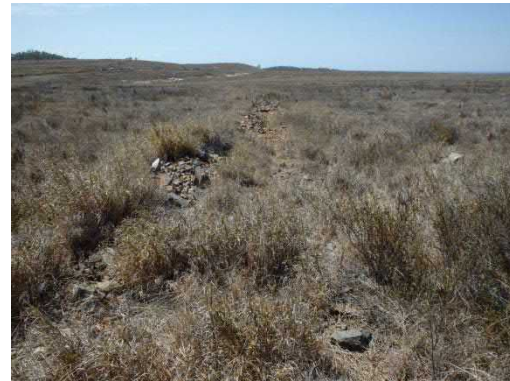
| Habitat Value (Terrestrial) | Score | Description |
|---|---|---|
| Very High | 5 | Numerous rocks, high lower storey plant cover (e.g. grass, herbs) and abundant litter |

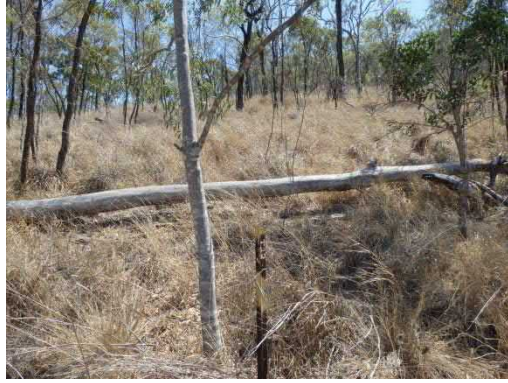
| Habitat Value (Arboreal) | Score | Description |
|---|---|---|
| Very High | 5 | High upper-storey cover. Mixed aged, well stratified and with numerous nesting hollows. |

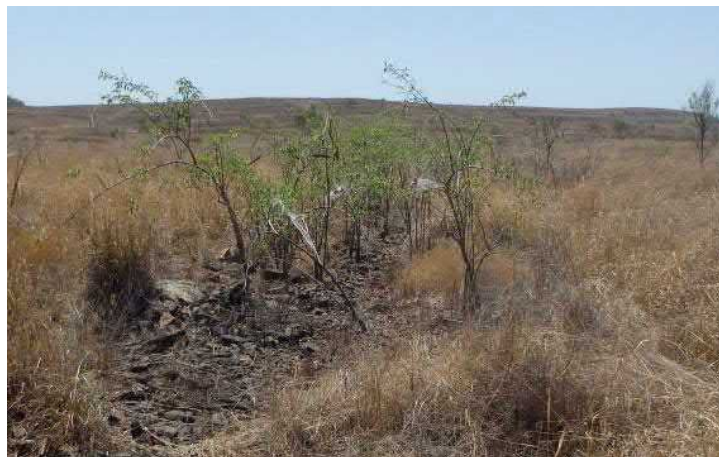
*Cryptostegia grandiflora* in drain on rehabilitated landform

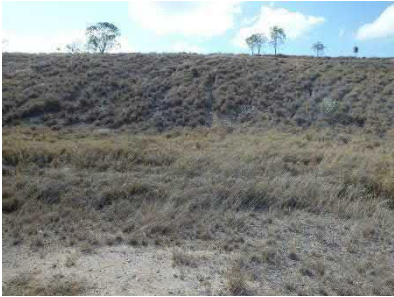
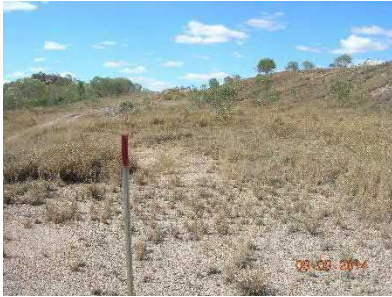
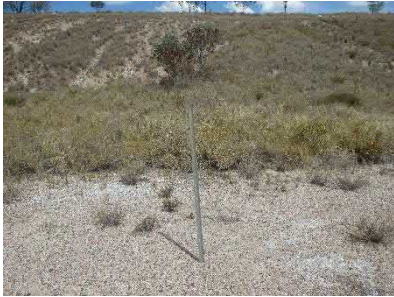
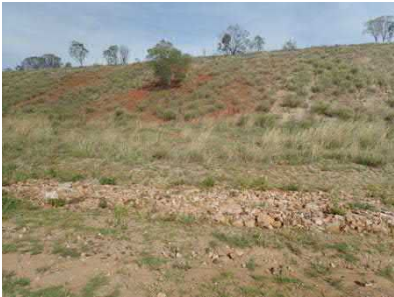
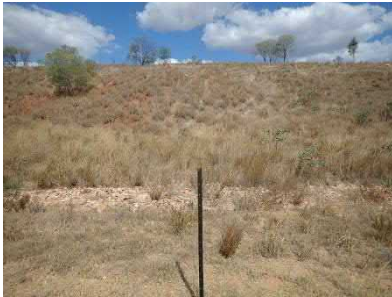
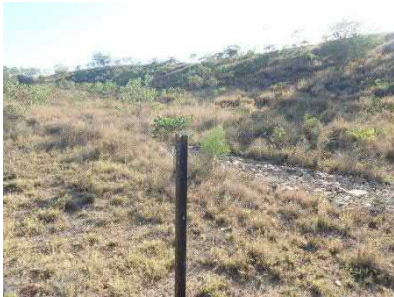
# Roche Hill Batters sub-domain PP18

| 2013 | 2014 | 2016 | 2017 |
|---|---|---|---|
| | | | not monitored – rework in progress |

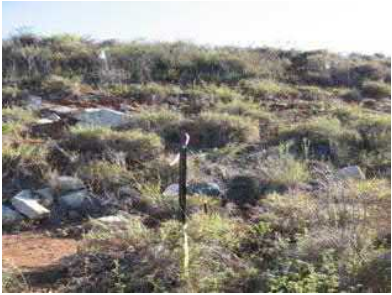
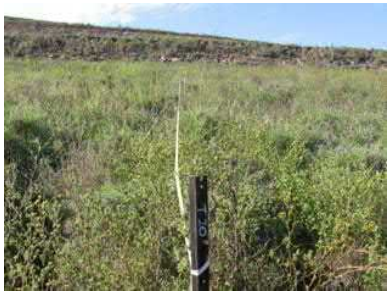
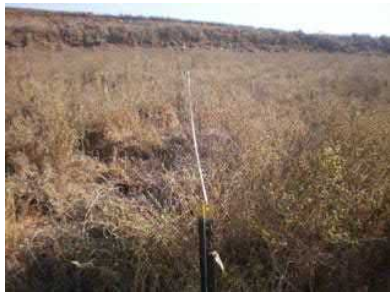
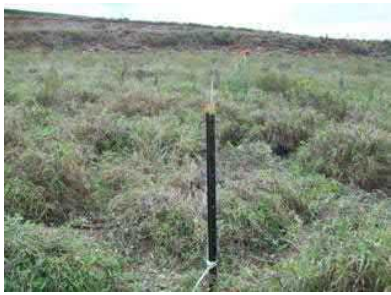
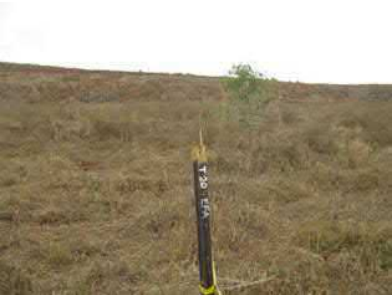
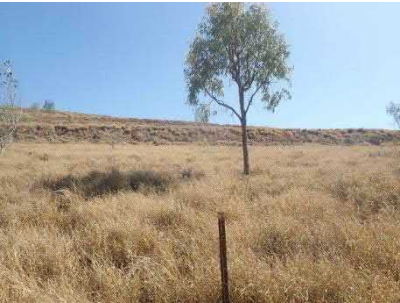
Eastern WRL South East Batters sub-domain T20

| 2020 (End NNW) | | | |

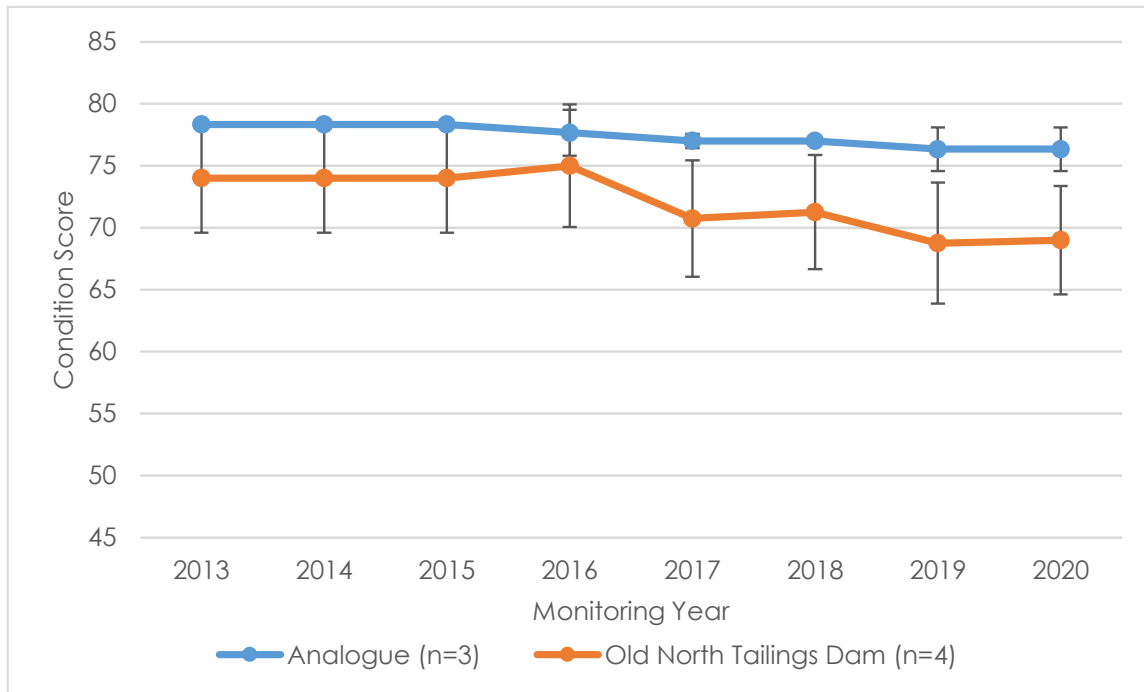
Figures (D-1 – D-11) below present the mean condition scores of the analogue sites (n = 3 sites) compared to each rehabilitation area (n = the number of sub-domains monitored as indicated in each figure legend), between 2013 and 2020. Error bars show standard errors. Where only one rehabilitation domain was monitored (n = 1) there is no associated error.

Figure D-1: Old North Tailings Dam

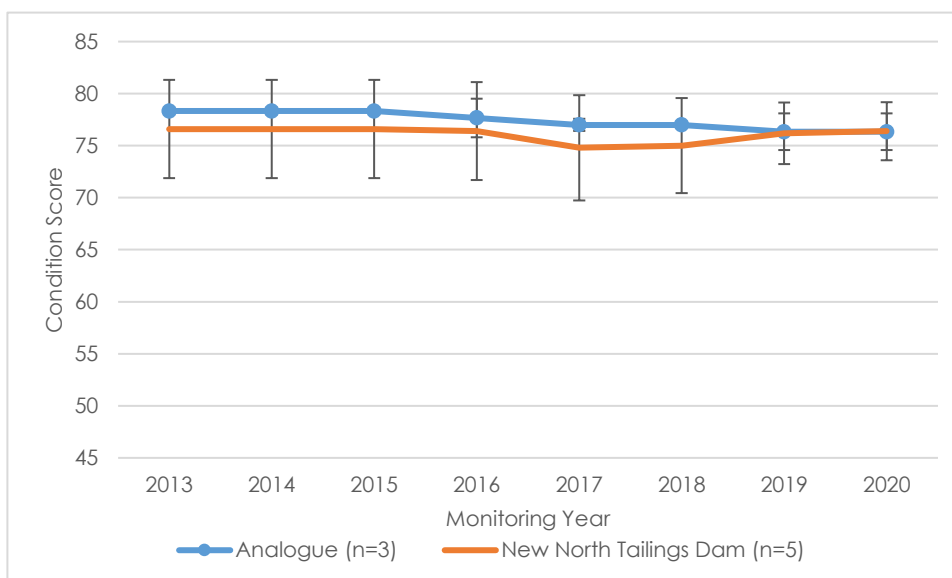
Figure D-2: New North Tailings Dam

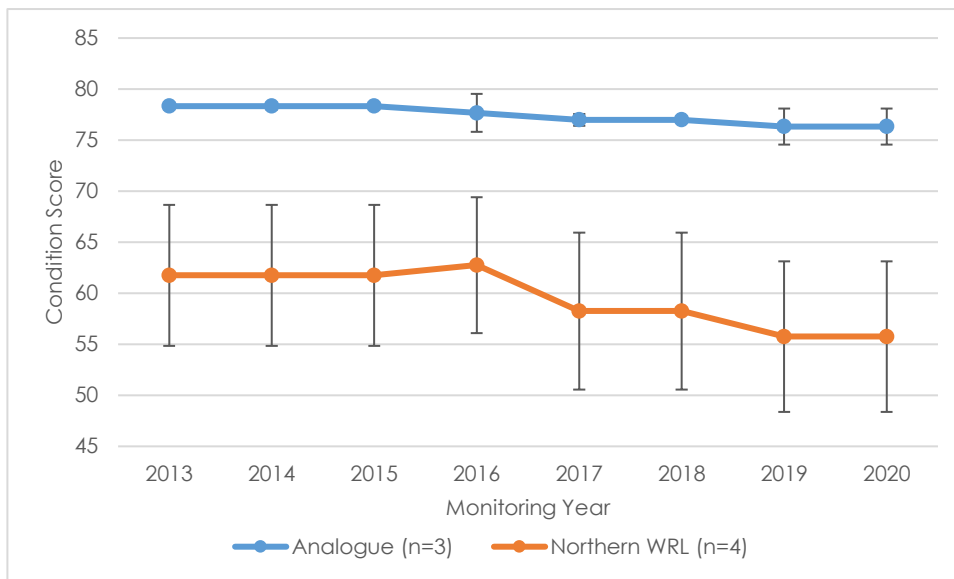
Figure D-3: Northern WRL

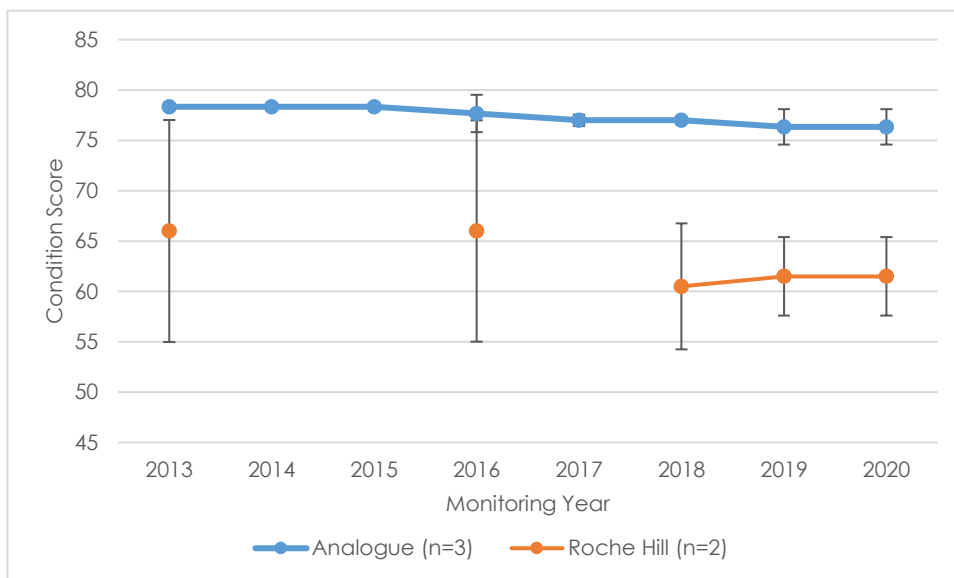
Figure D-4: Roche Hill

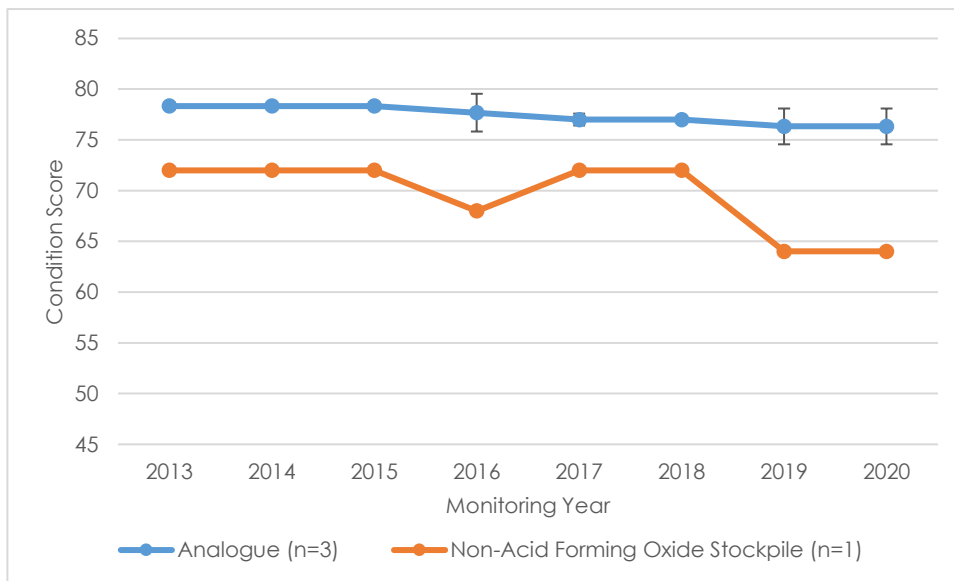
Figure D-5: Non-Acid Forming Oxide Stockpile

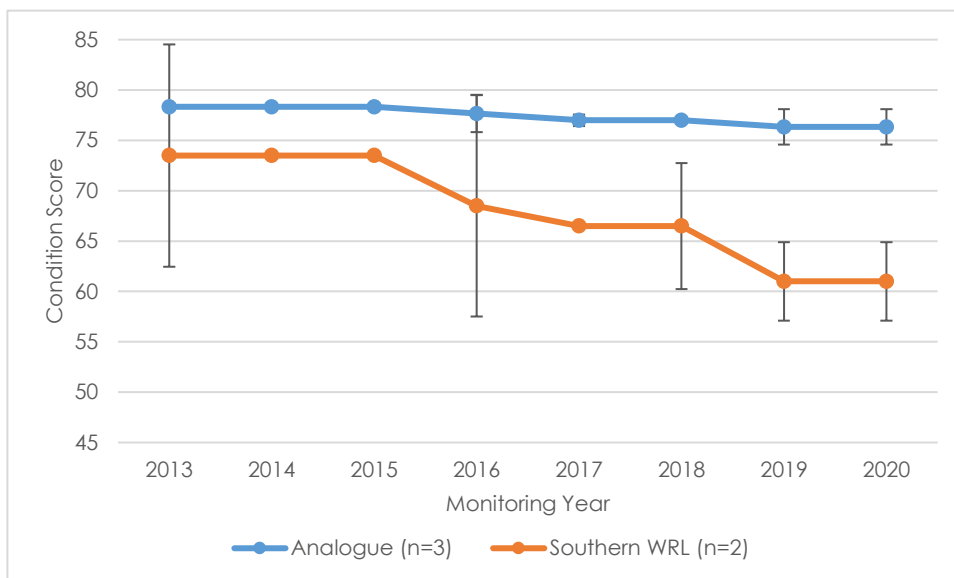
Figure D-6: Southern WRL

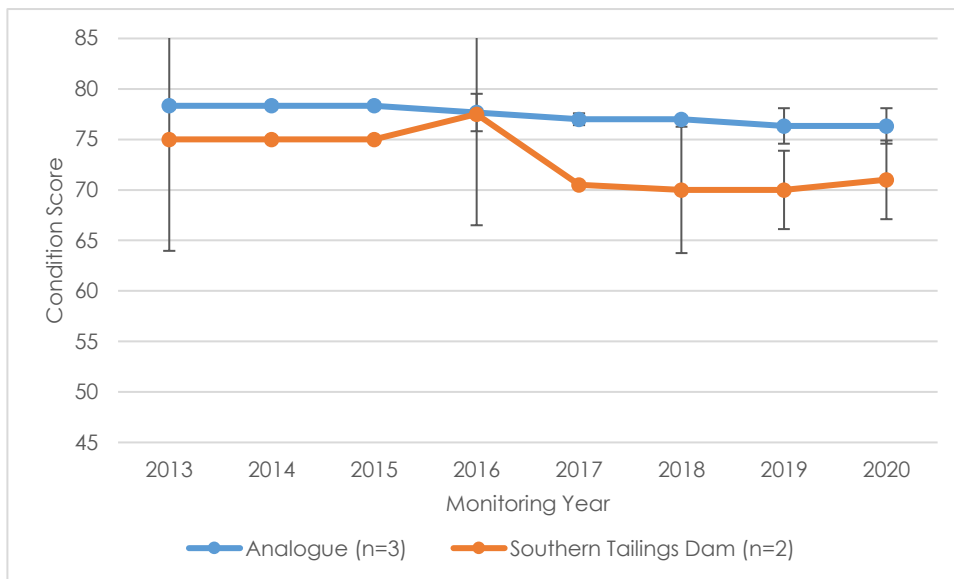
Figure D-7: Southern Tailings Dam

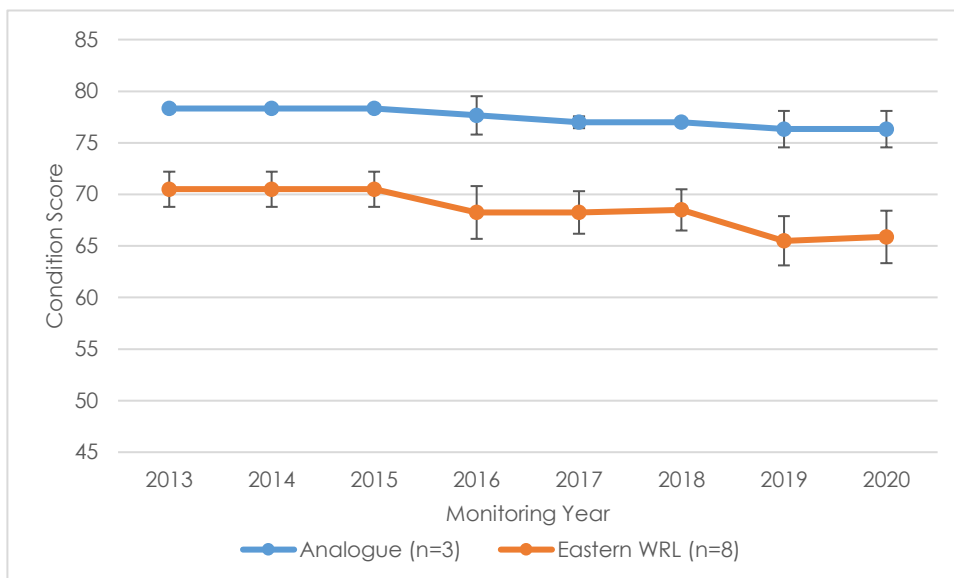
Figure D-8: Eastern WRL

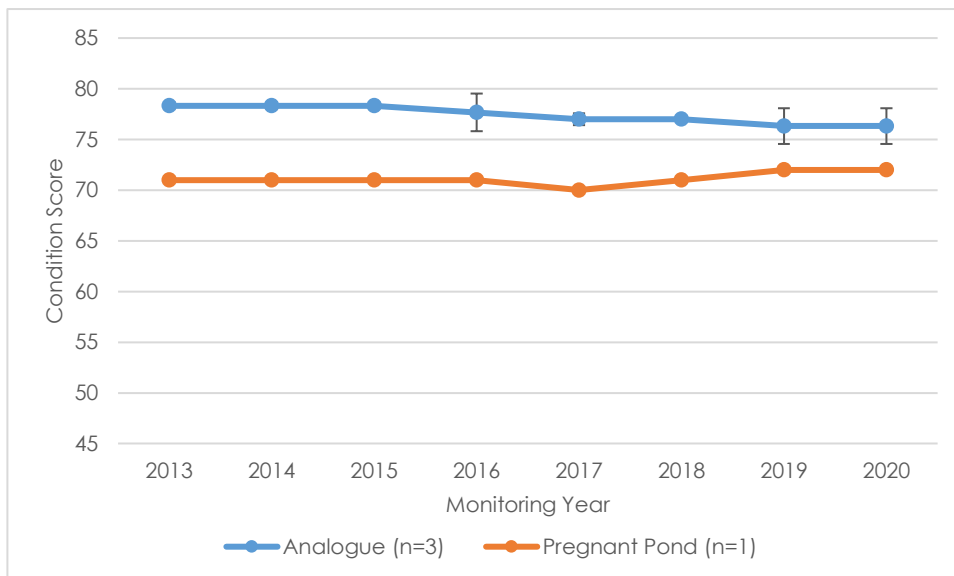
Figure D-9: Pregnant Pond

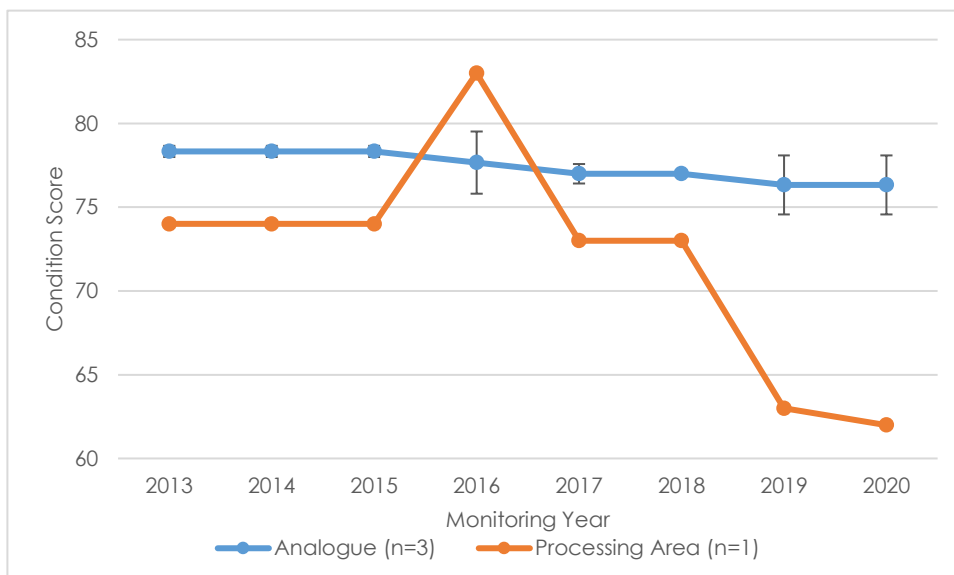
Figure D-10: Processing Area

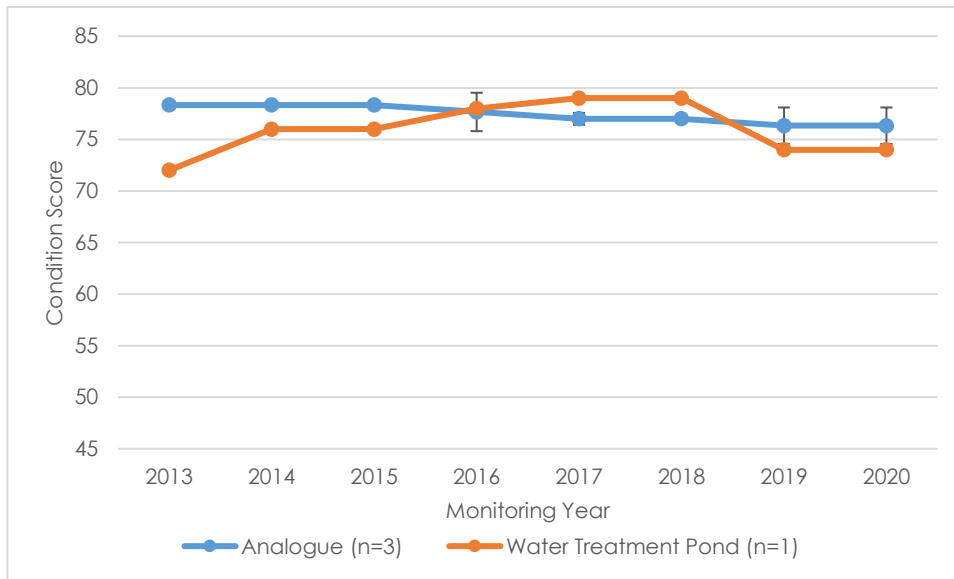
Figure D-11: Water Treatment Pond

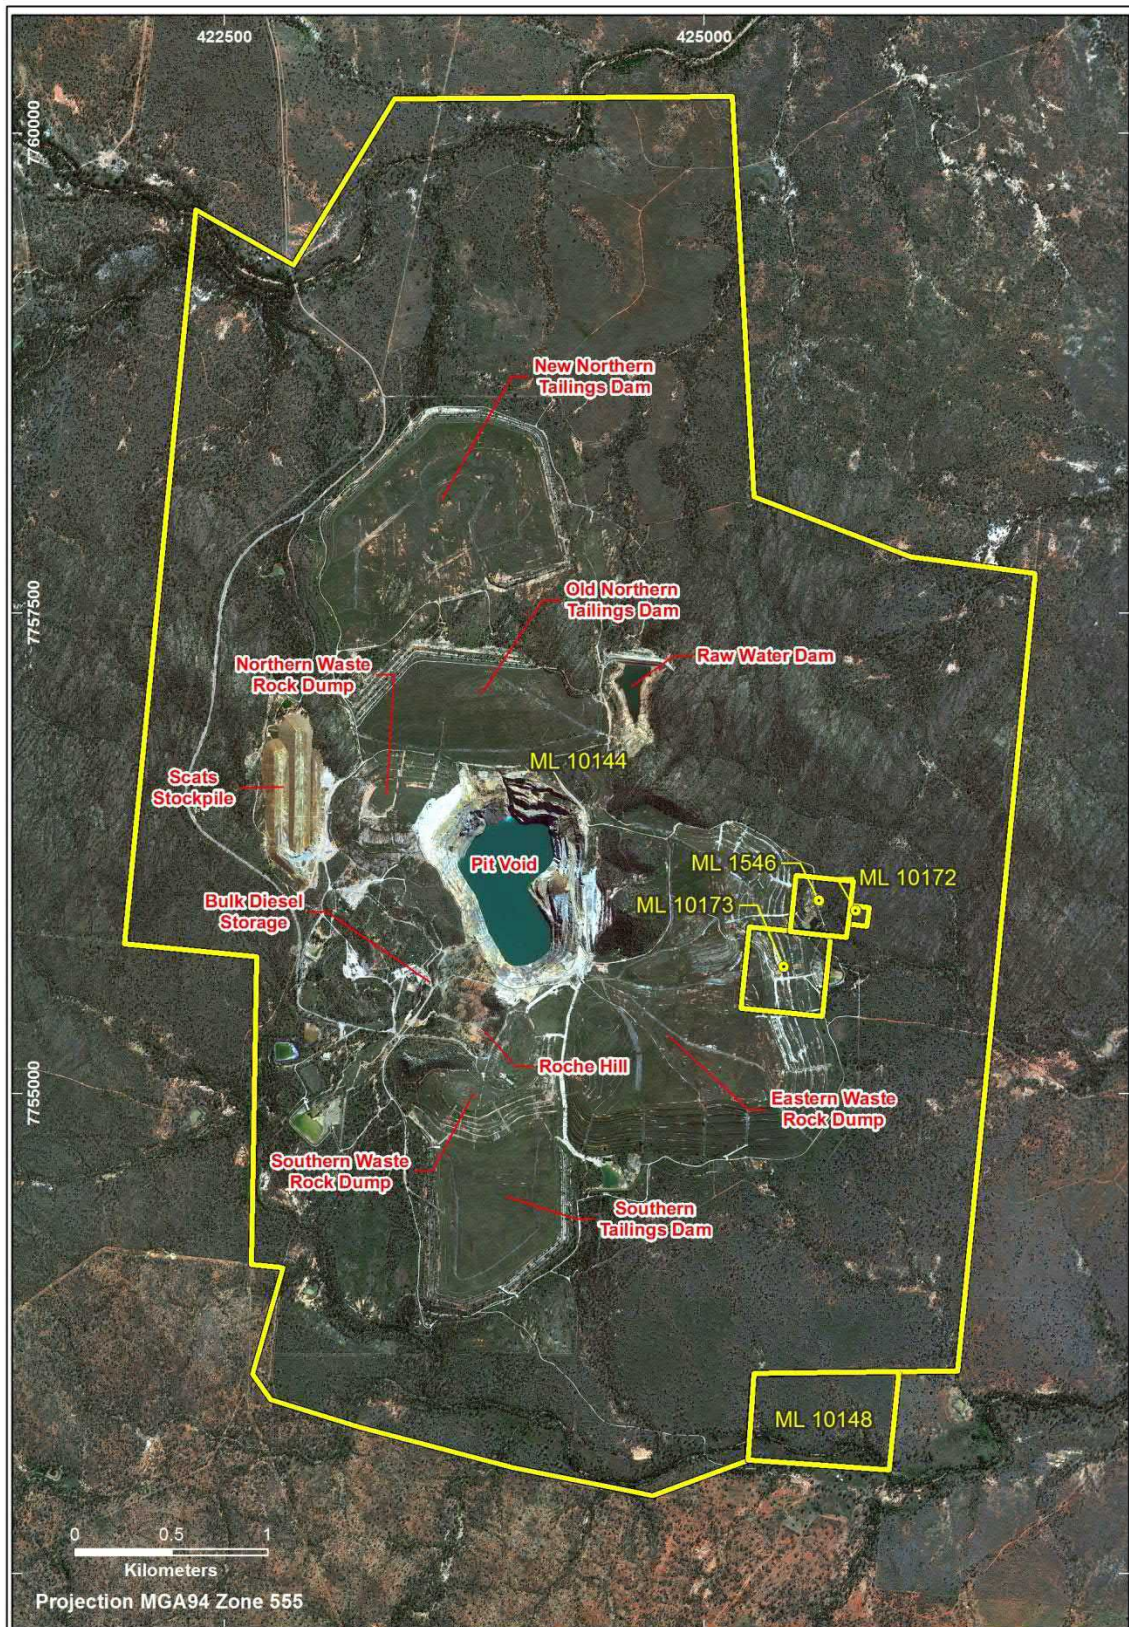
Figure 2: Mt Leyshon site features

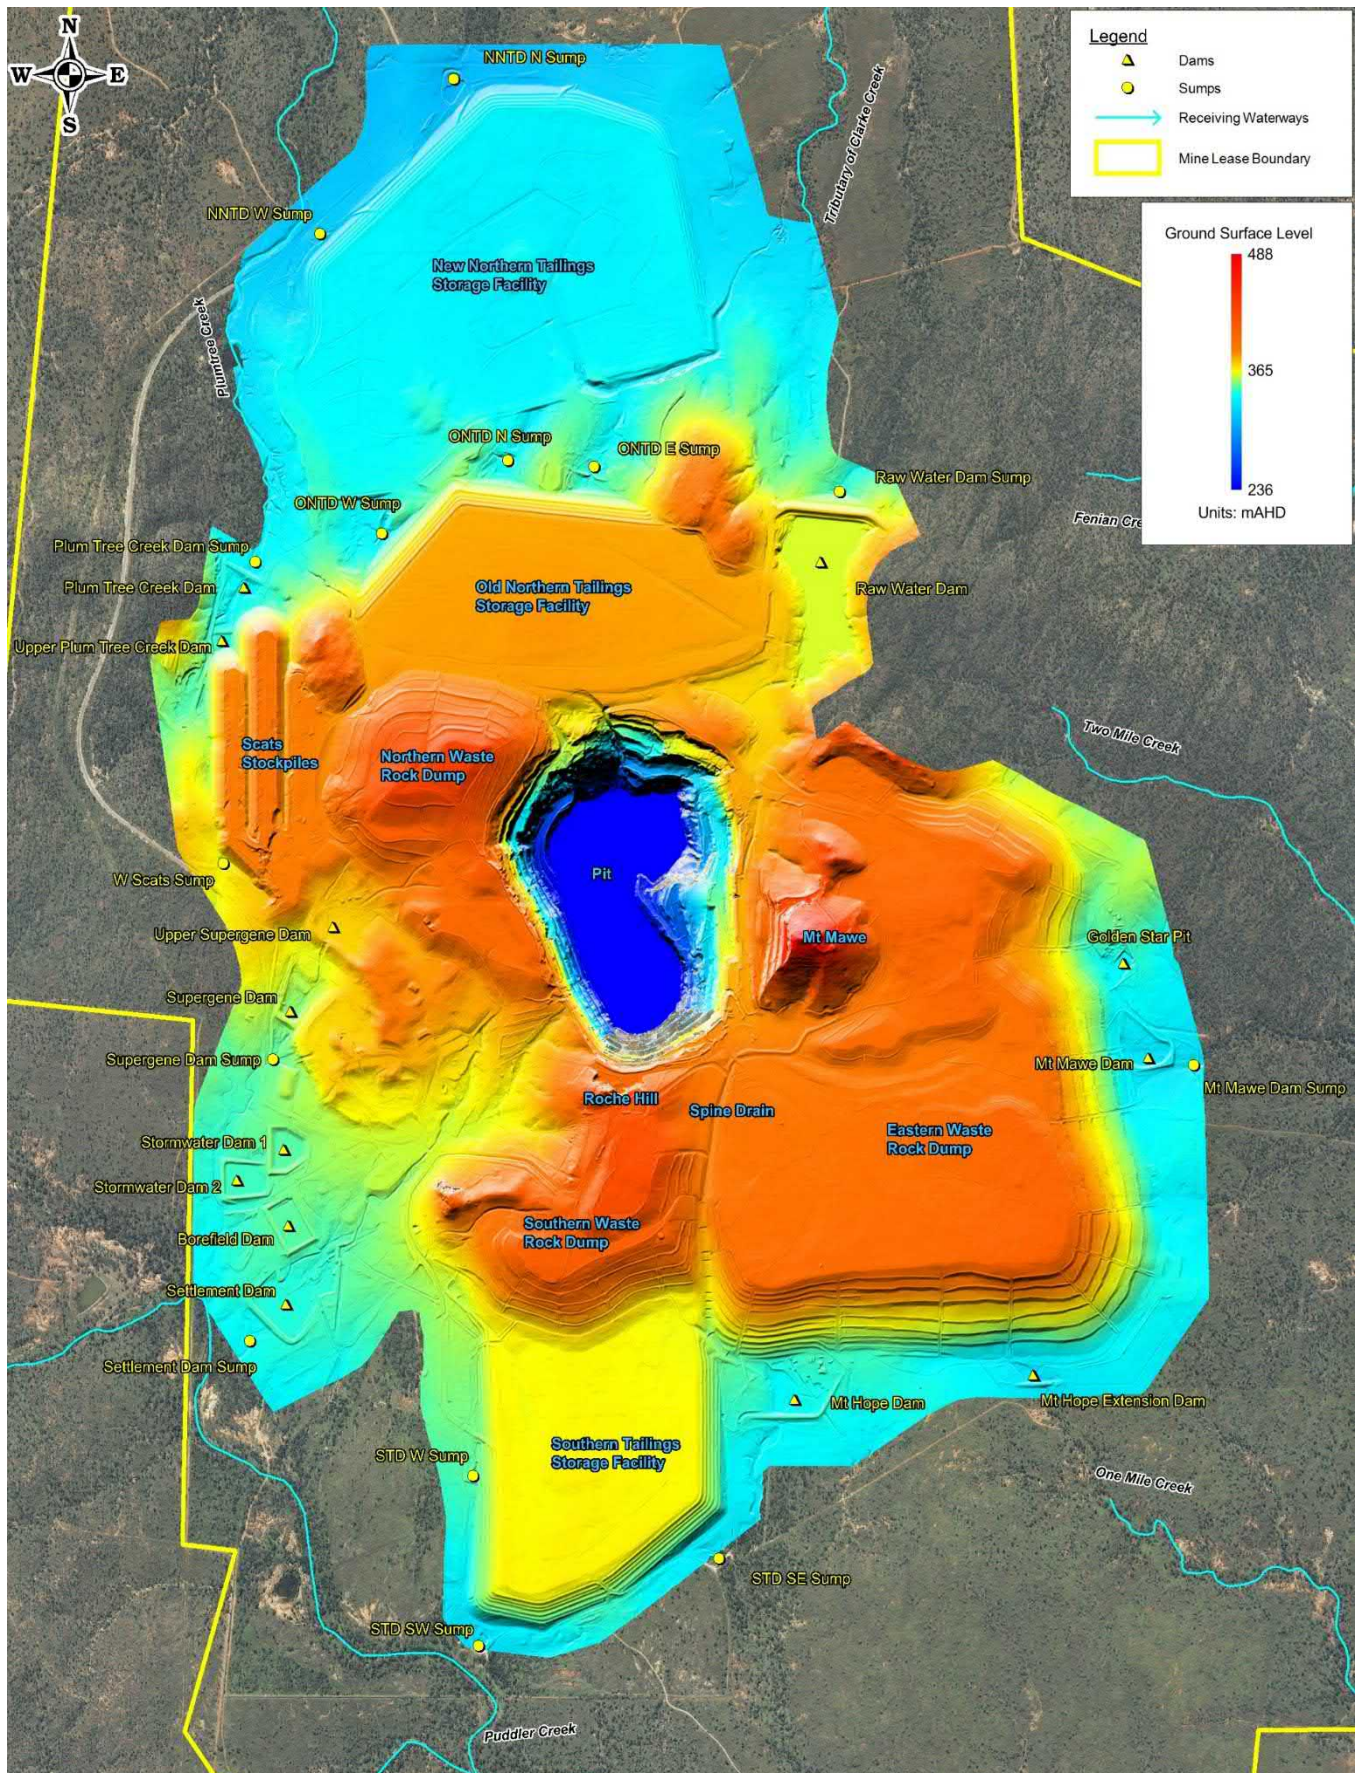
Figure 3.1: Mt Leyshon Mine Layout Plan with Topography (Source: Engeny, 2020a)

Figure 3.1 shows the surface topography at the Mt Leyshon Mine, while surface drainage catchments and flow paths are shown in Figure 3.2. Recent imagery of the TSFs is provided in Figure 3.3 to Figure 3.6.

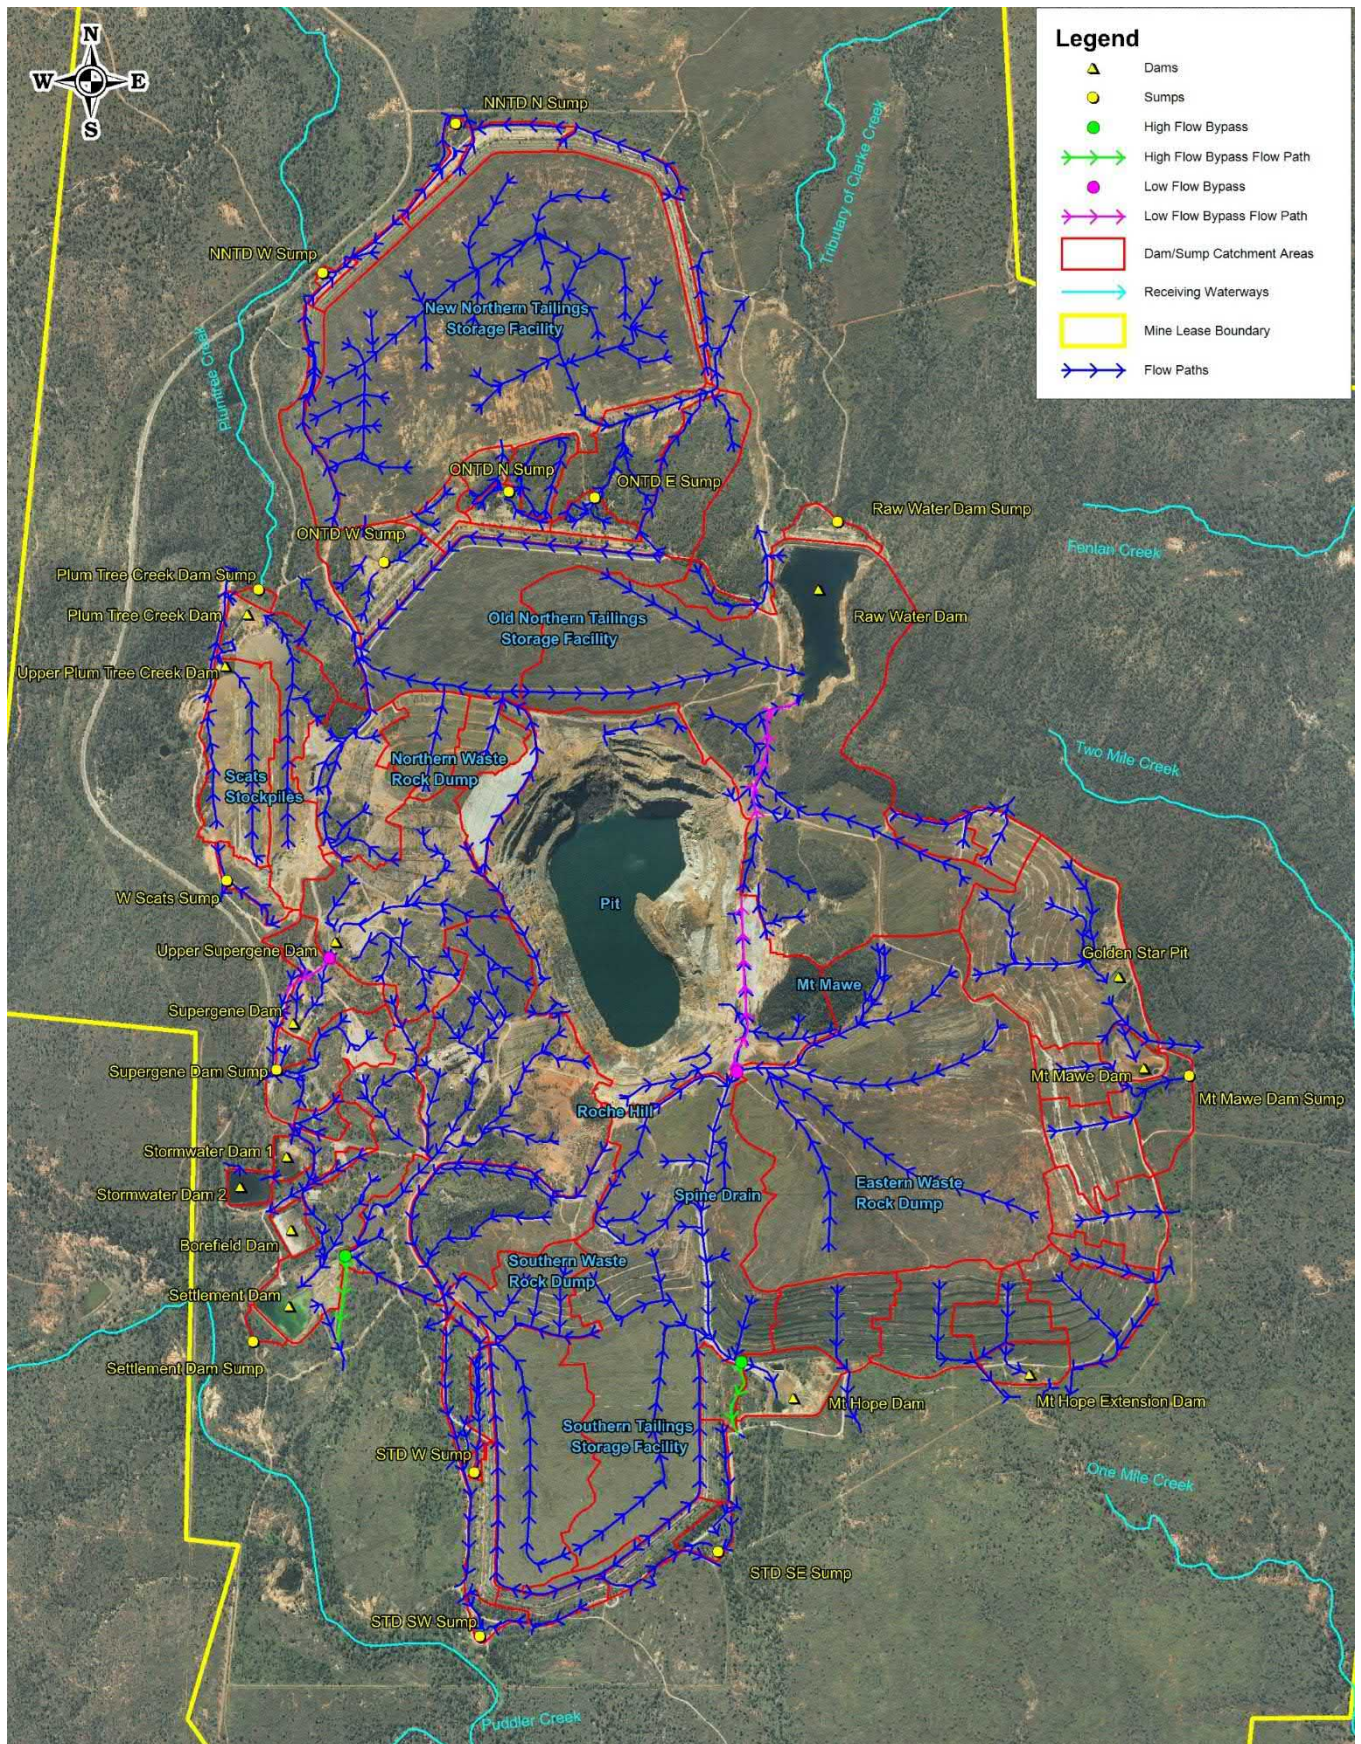
Figure 3.2: Mt Leyshon Mine Layout Plan with Catchments and Flow Paths (Source: Engeny, 2020a)

As indicated in Section 3.3.1, seepage interception trenches/sumps were installed along the down-gradient perimeters of the above-ground TSFs while the TSFs were in operation. These seepage collection sumps have been continued to be used in the post-closure phase of the mine to intercept seepage flows from the TSF landforms, with the seepage flows intercepted in the sumps pumped to the Open Pit via pumping systems installed in the sumps. The seepage sumps currently in use at the above-ground TSFs are shown in Figure 3.2 and comprise:
