## Progressive Rehabilitation and Closure Plan

**Mt Leyshon Mine**

M13000\_024-REP-001-2

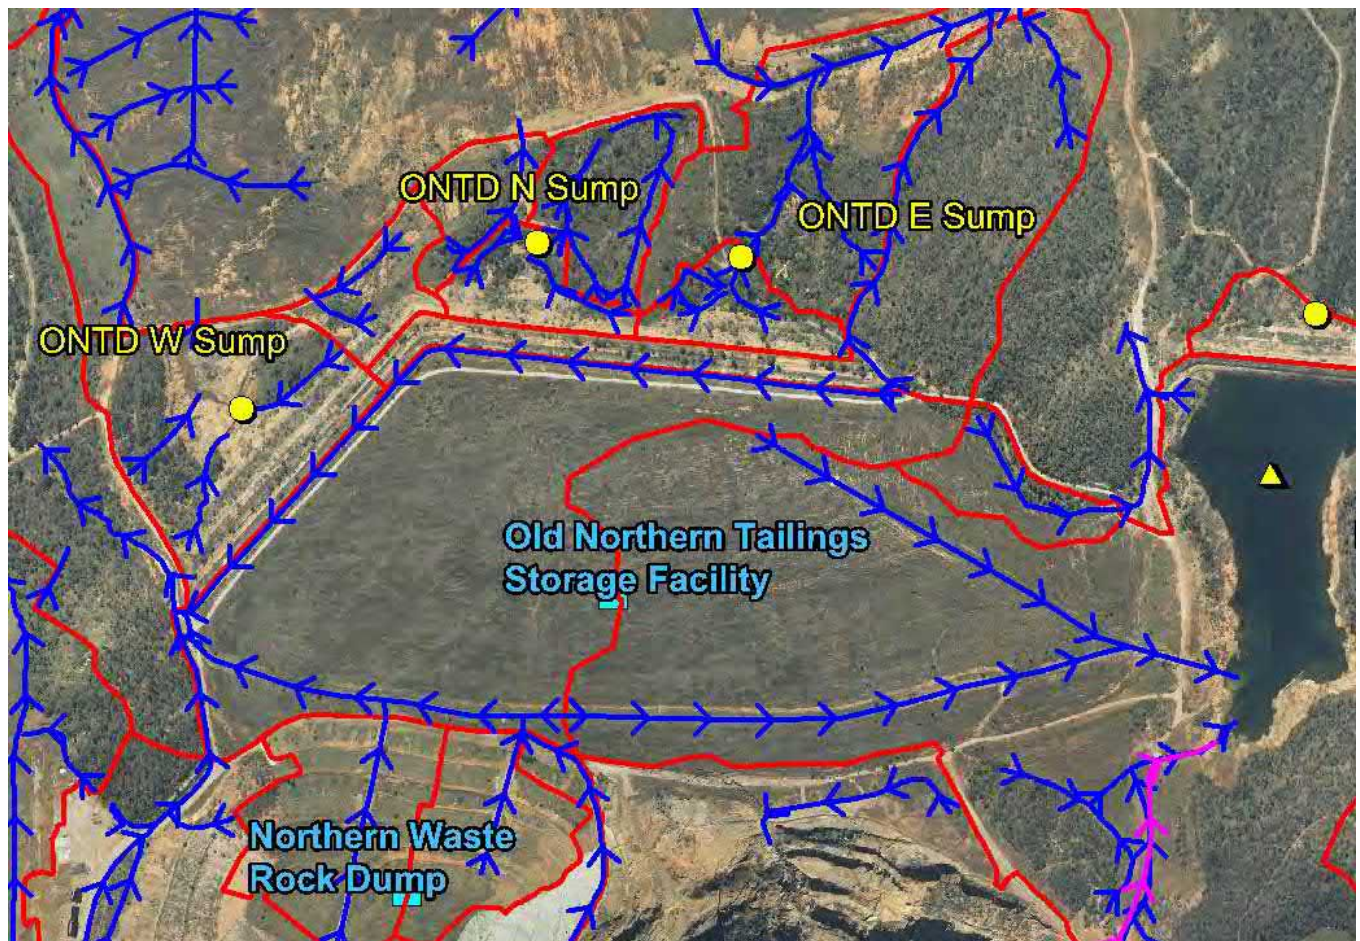
The surface drainage on the rehabilitated ONTSF landform is shown in Figure 4.1. The top surface of the ONTSF drains via a number of contour banks and rock-lined open drains to the following destinations:

- Western parts of the ONTSF drain to Plum Tree Creek (the northern batters of the Northern Waste Rock Dump drain into this drainage system).
- Eastern parts of the ONTSF drain to the Raw Water Dam.
- Small area at the north-east corner of the ONTSF drains to Schreibers Creek.

The northern embankment batters drain via bench drains to the ends of the embankments. There are no ramps or drop structures that convey runoff from the embankment batters.

Figure 4.1: ONTSF Landform Surface Drainage

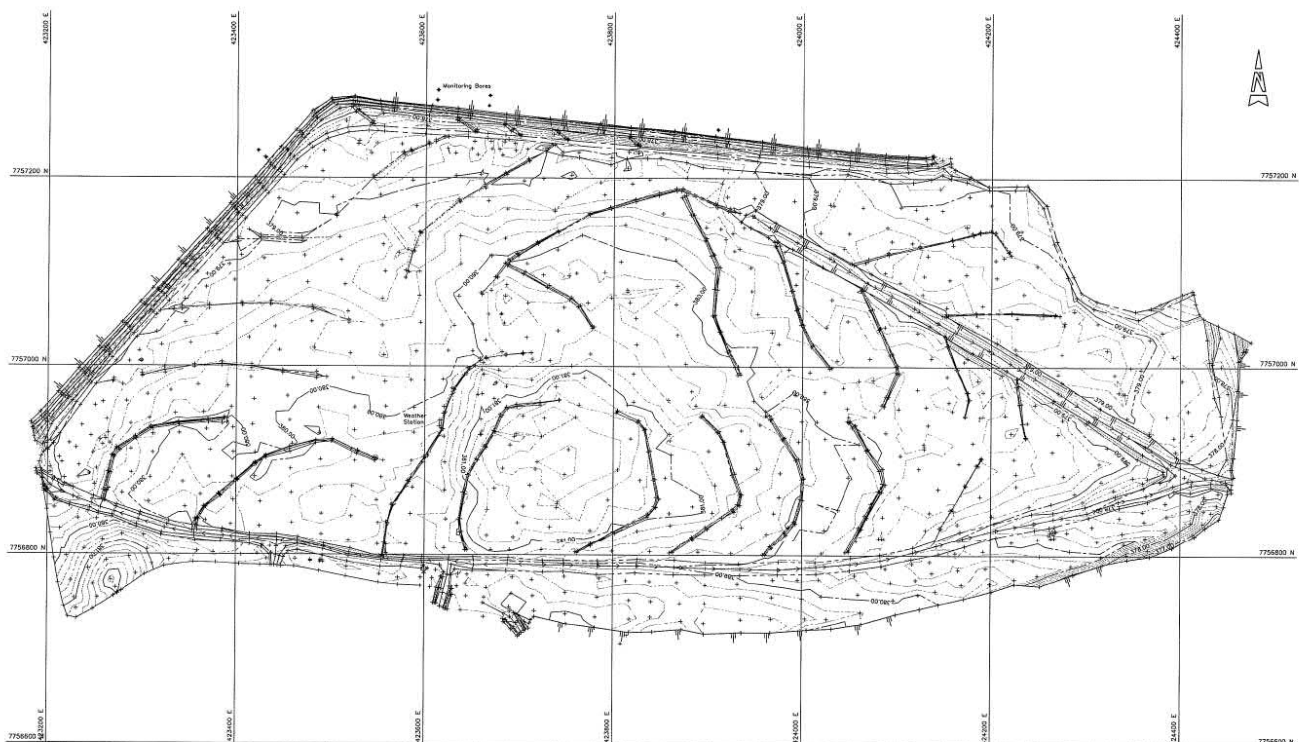
An assessment of the adequacy of the surface drainage on the ONTSF was undertaken by GHD Pty Ltd in 2010 (GHD, 2010b) based on a ground survey of the ONTSF by Rowlands Surveys in April/May 2010 (Figure 4.2).

**Figure 4.2: 2010 ONTSF Landform Topographic Survey by Rowlands Surveys**

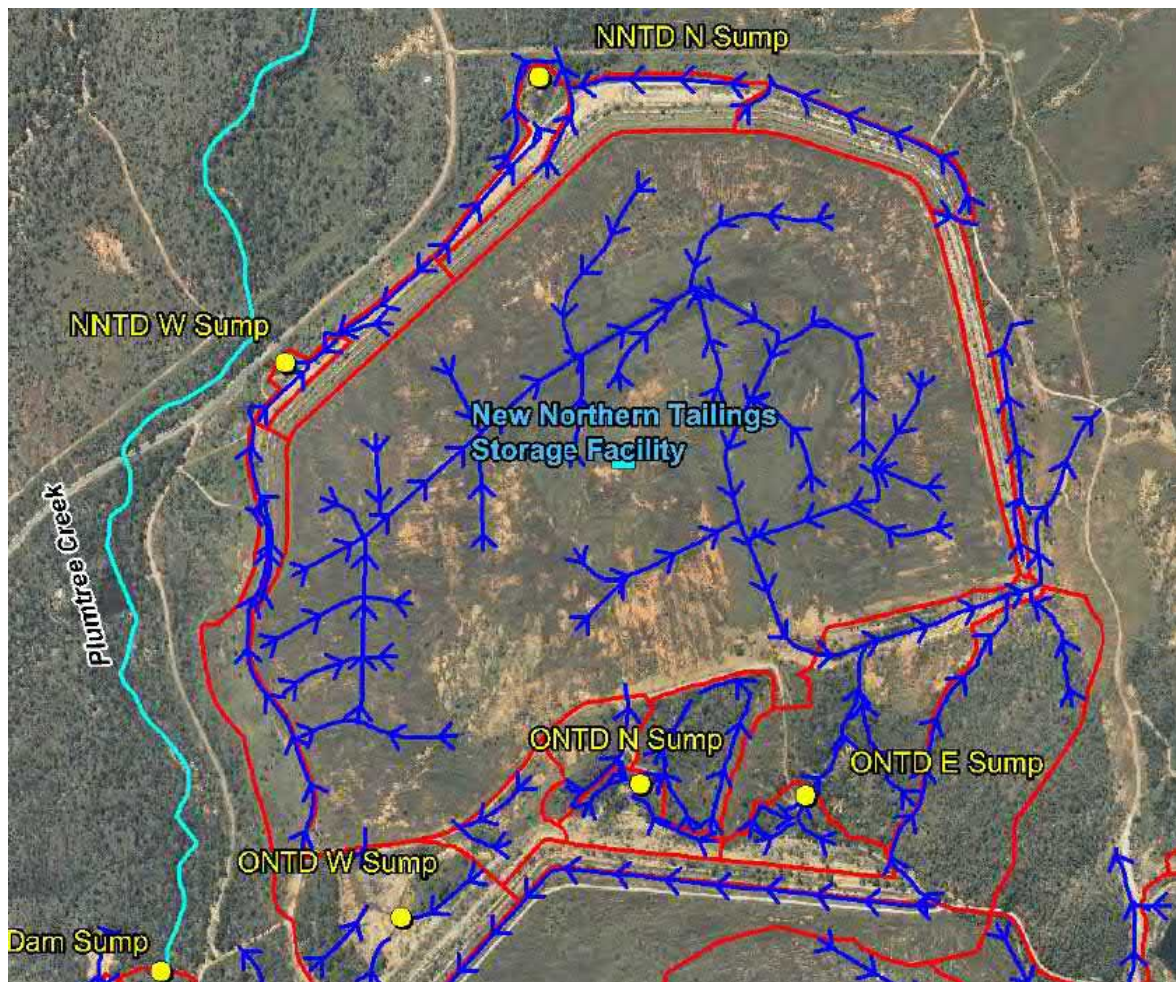
The surface drainage on the rehabilitated NNTSF landform is shown in Figure 4.3. The top surface of the NNTSF drains via a number of rock-lined open drains to the south-eastern corner of the landform and then to Schreibers Creek.

The embankment batters drain via bench drains to a number of access ramps which convey the drainage to the base of the batters.

**Figure 4.3: NNTSF Landform Surface Drainage**

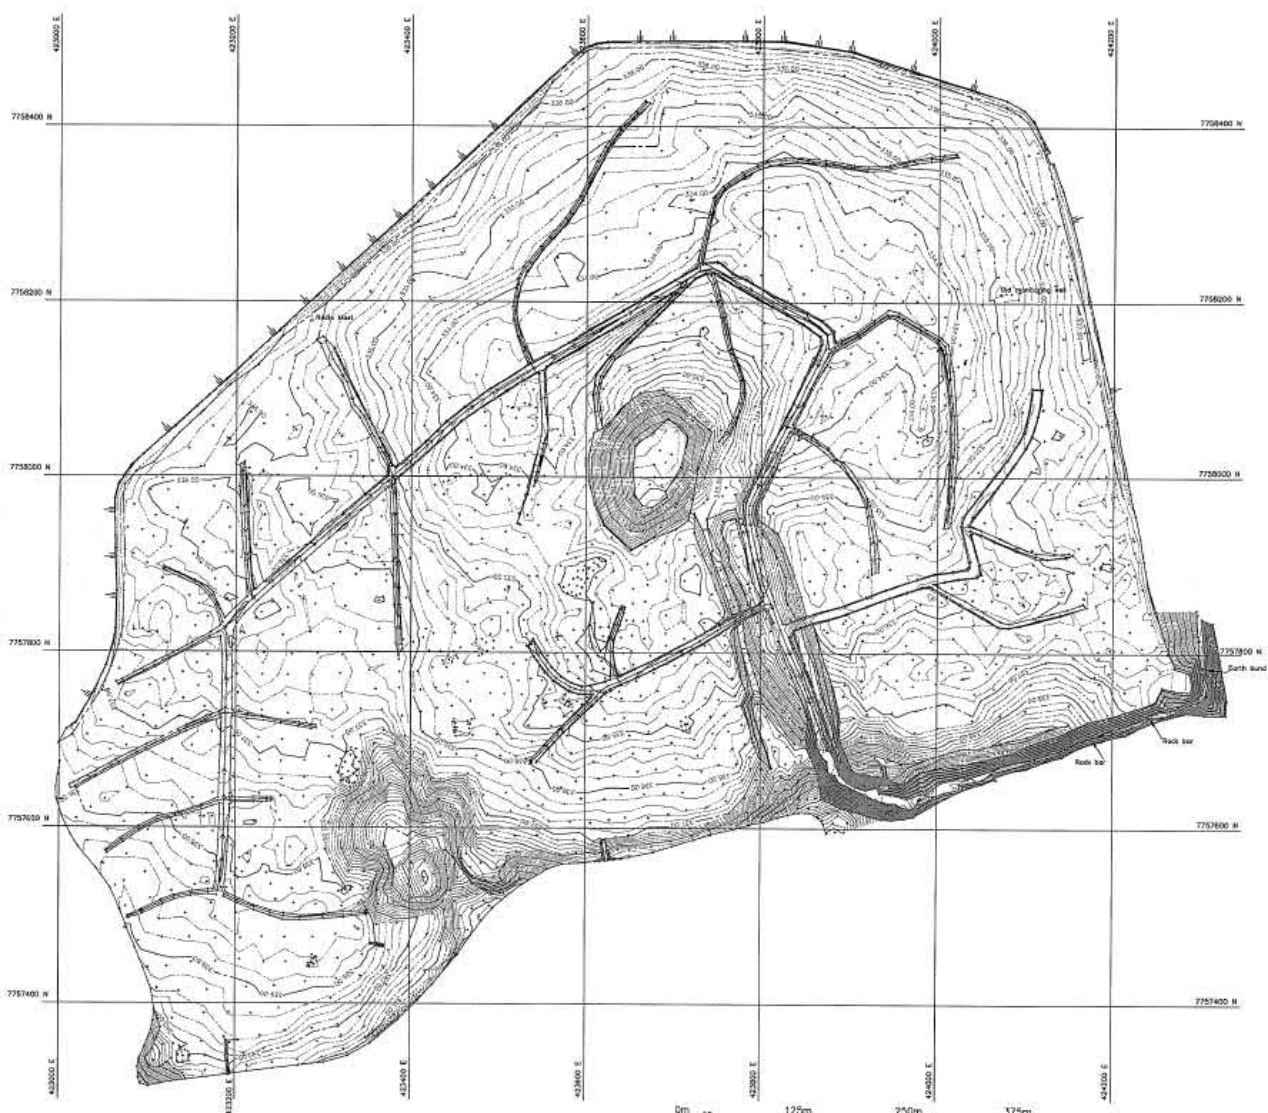
An assessment of the adequacy of the surface drainage on the NNTSF was undertaken by GHD Pty Ltd in 2010 (GHD, 2010a) based on a ground survey of the NNTSF by Rowlands Surveys in April/May 2010 (Figure 4.4).

- The upstream section of the main drain is very shallow (typically shallower than 0.3 to 0.5 m deep). Many of the feeder drains are also very shallow (typically shallower than 0.3 m deep). These drains do not have capacity to convey large flood flows.
- Some of the feeder drains have a very flat longitudinal gradient (possibly a result of differential settlement in the tailings dam surface).

Concept designs were prepared for proposed drainage upgrade works (GHD, 2010a) including filling and regrading of depressions in the surface of the tailings dam, increasing the depth, width and gradient of the main drainage channel, and increasing the depth and width of the feeder drains. These proposed drainage upgrade works have not been constructed. The drainage problems on the rehabilitated TSF landform are likely to be contributing to rainfall infiltration through the TSF cover system and corresponding seepage flows expressing down-gradient of the landform. Seepage sump pump flow metering data indicates that the TSF landform has only produced very small seepage flows into the seepage sumps in recent years; however, high rainfall conditions have not been experienced during this period.

**Figure 4.4: 2010 NNTSF Landform Topographic Survey by Rowlands Surveys**

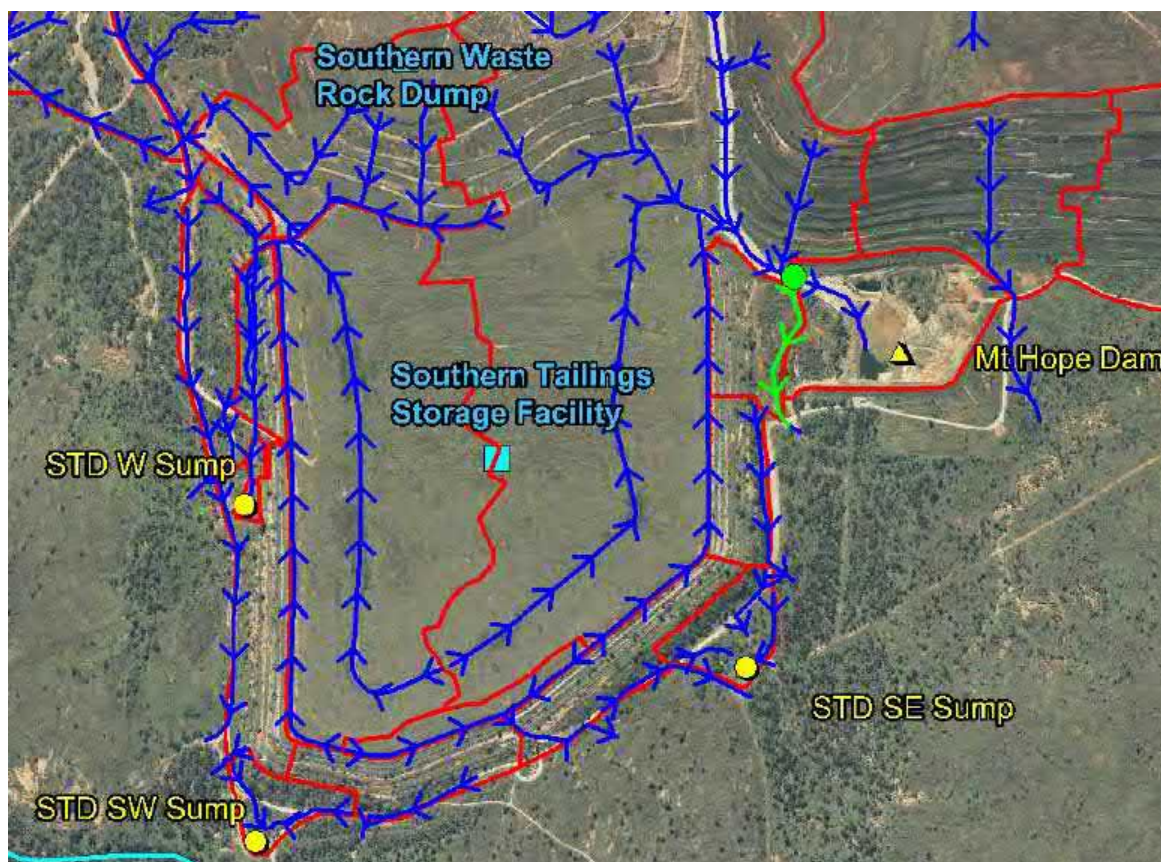
The surface drainage on the rehabilitated STSF landform is shown in Figure 4.5. The top surface of the SNTSF drains via a number of contour banks and rock-lined open drains to the following destinations:

- Western parts of the STSF drain to a drop structure at the north-western corner of the TSF and then ultimately to Puddler Creek.
- Eastern parts of the STSF drain to the Spine Drain upstream of the Mt Hope Dam High Flow Bypass Structure (low flows in the Spine Drain enter the Mt Hope Dam and high flows bypass the dam). Parts of the southern batters of the Southern Waste Rock Dump drain into this drainage system

The embankment batters drain via bench drains to a number of access ramps which convey the drainage to the base of the batters. A new drop structure was installed below the lowest bench at the south-western corner of the landform in 2018 to repair an erosion gully that had formed at this location.

**Figure 4.5: STSF Landform Surface Drainage**

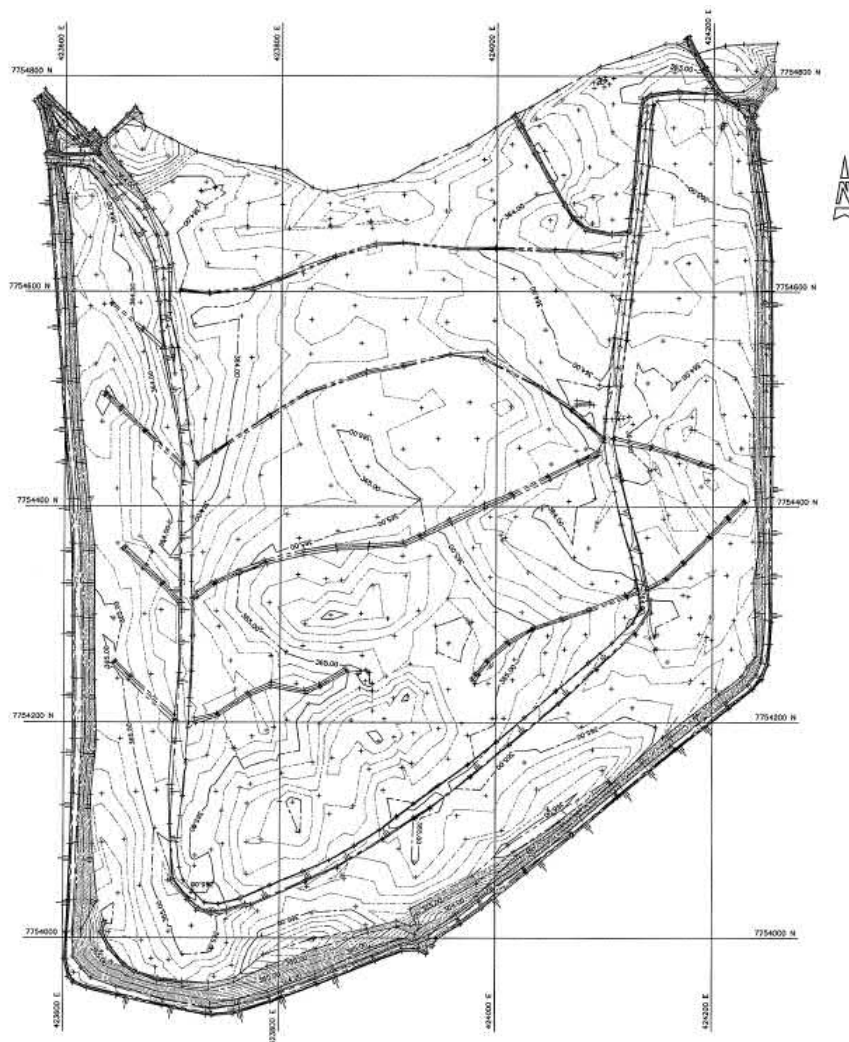
An assessment of the adequacy of the surface drainage on the STSF was undertaken by GHD Pty Ltd in 2010 (GHD, 2010c) based on a ground survey of the STSF by Rowlands Surveys in April/May 2010 (Figure 4.6).

- The entire length of the main drainage channel on the eastern side of the dam is shallow and has insufficient capacity to convey flood flows. There are bunds running parallel to the downstream section of this drain which would seem to restrict the flow of surface water into the drain itself.
- The perimeter drains on the edge of the top surface of the landform have an undulating bed profile and sections of the drains have a very flat longitudinal gradient.
- A small number of the feeder drains have flat or adverse gradients, presenting isolated drainage problems adjacent to these points.

Concept designs were prepared for proposed drainage upgrade works (GHD, 2010c) including filling and regrading of depressions in the surface of the tailings dam, regrading and increasing the depth of the main drainage channels, and regrading and increasing the depth of two feeder drains. These proposed drainage upgrade works have not been constructed. The drainage problems on the rehabilitated TSF landform are likely to be contributing to rainfall infiltration through the TSF cover system and corresponding seepage flows expressing down-gradient of the landform. Seepage sump pump flow metering data indicates that the TSF landform has only produced very small seepage flows into the seepage sumps in recent years; however, high rainfall conditions have not been experienced during this period.

**Figure 4.6: 2010 STSF Landform Topographic Survey by Rowlands Surveys**

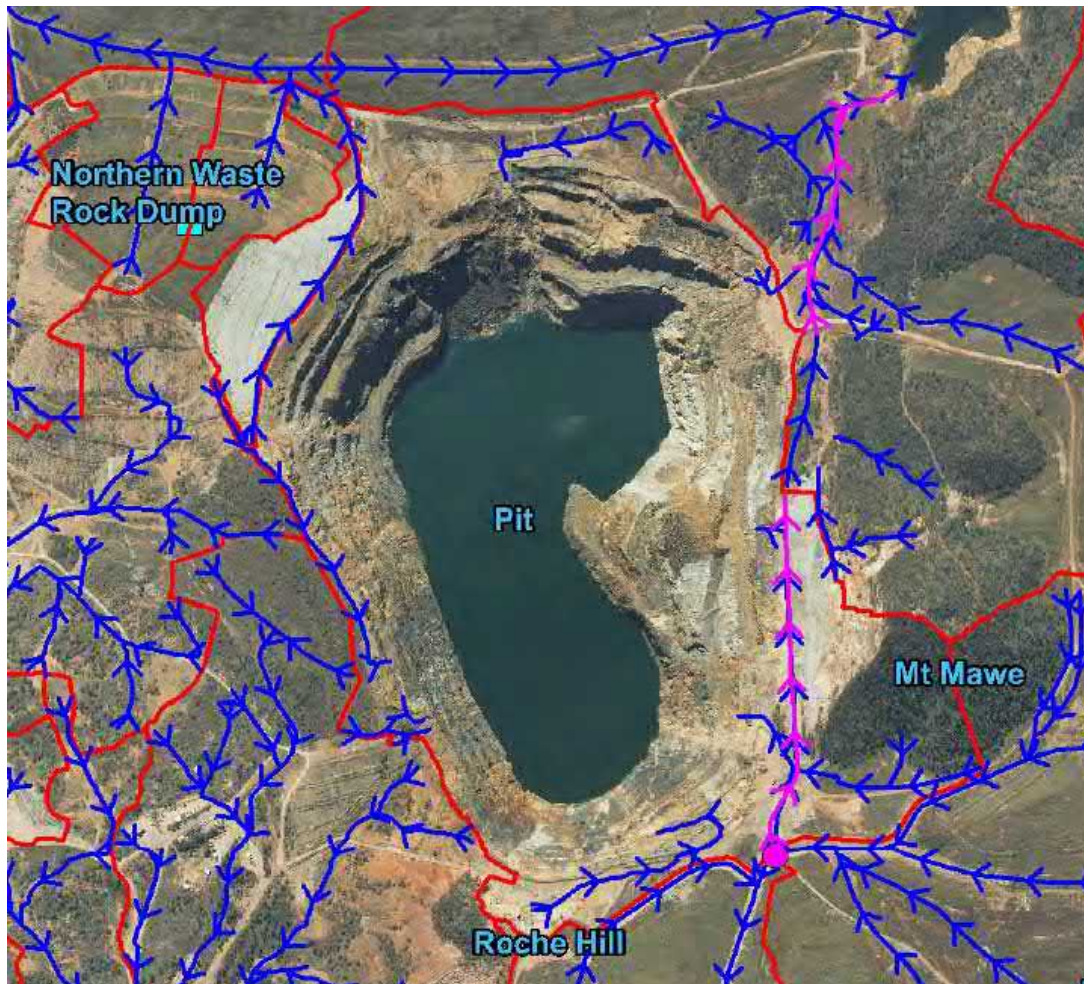
The surface drainage in the vicinity of the Open Pit is shown in Figure 4.7. Drainage on the landforms surrounding the Open Pit is typically diverted away from the pit, resulting in the pit having minimal external catchment beyond the pit rim. The small external catchment areas outside of the pit rim that drain into the pit include:

- Area to the north of the pit adjoining the ONTSF (this area has previously subsided as a result of a slip of the northern wall of the pit along a fault line).
- Mt Hope quarry area on the southern edge of the pit.
- Parts of Mt Mawe which is a natural hill adjacent to the south-eastern corner of the pit.

The pit receives pumped inflows from the water containment dams and seepage sumps that collect impacted surface runoff and seepage flows from the rehabilitated mine landforms. These pumped inflows are typically larger than the rainfall inflows to the pit from its' direct catchment area.

**Figure 4.7: Open Pit Surface Drainage**

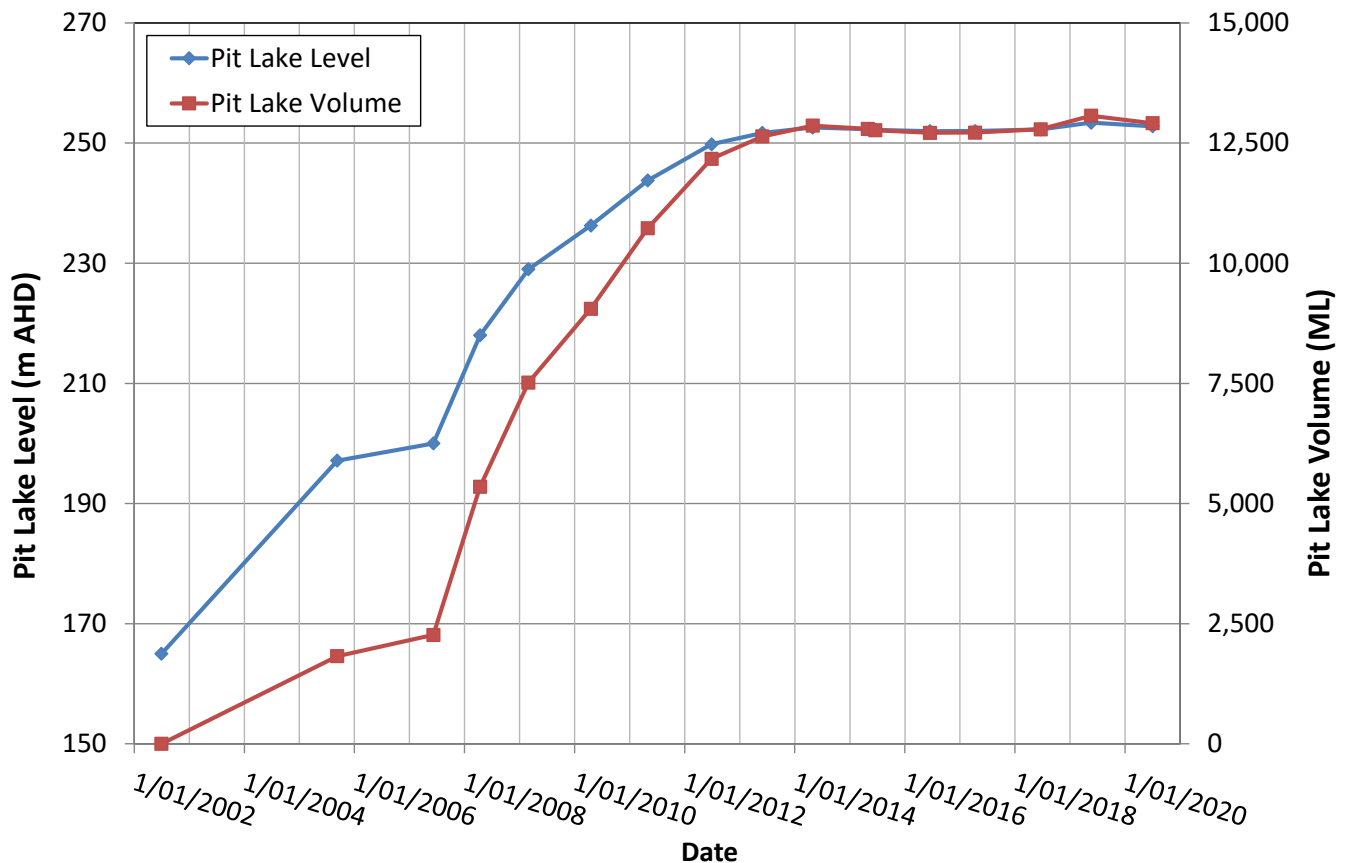
**Figure 4.8: Pit Lake Filling History Since Mine Closure**

A lake has progressively formed in the Open Pit since pit dewatering ceased in 2001 at the end of mining (Figure 4.8). The pit lake is currently approximately 90 m deep above the lowest point in the tailings deposition surface in the floor of the pit. Water balance modelling of the Open Pit residual void (Engeny, 2020a) indicates that there will always be a deep pit lake in the residual void, ensuring that the tailings in the floor of the pit will remain saturated and preventing ongoing oxidation of the PAF tailings material.

The significant slow-down in the pit lake filling rate observed over the last 7 years (2013 to 2020) (Figure 4.8) cannot be fully explained by the current knowledge of the pit lake water balance and groundwater conditions and further monitoring of the pit lake response to different wet season rainfall totals is required to predict the future pit lake conditions with greater confidence.

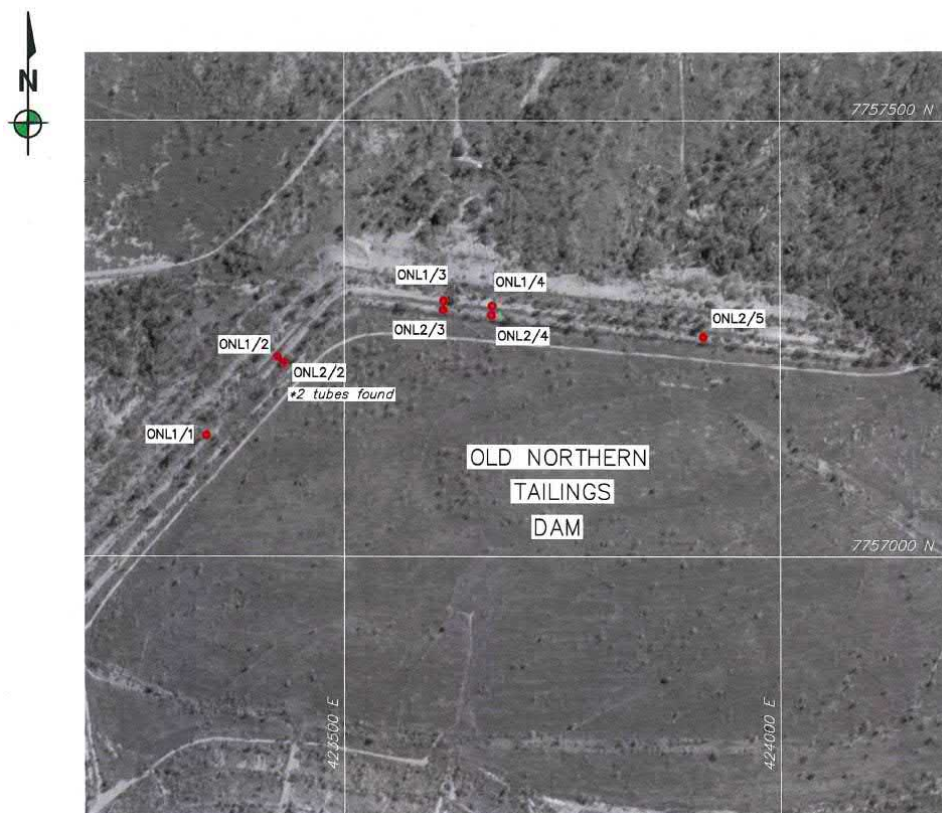
Figure 5.1: ONTSF Piezometer Locations

Standpipe piezometers were installed in the embankments of the above-ground TSFs during the decommissioning of the facilities. The locations of the piezometers are shown in Figure 5.1 (ONTSF), Figure 5.2 (NNTSF) and Figure 5.3 (STSF).

The piezometer monitoring data indicates that the piezometer water levels declined between April 2009 and February 2019 and then have either remained relatively constant or continued to decline during 2019 and 2020. In September 2020, all piezometers were dry with the exception of one piezometer at the NNTSF (NNL1/4) and four piezometers at the STSF (SL1/1, SL1/3, SL1/4 and SL1/5).

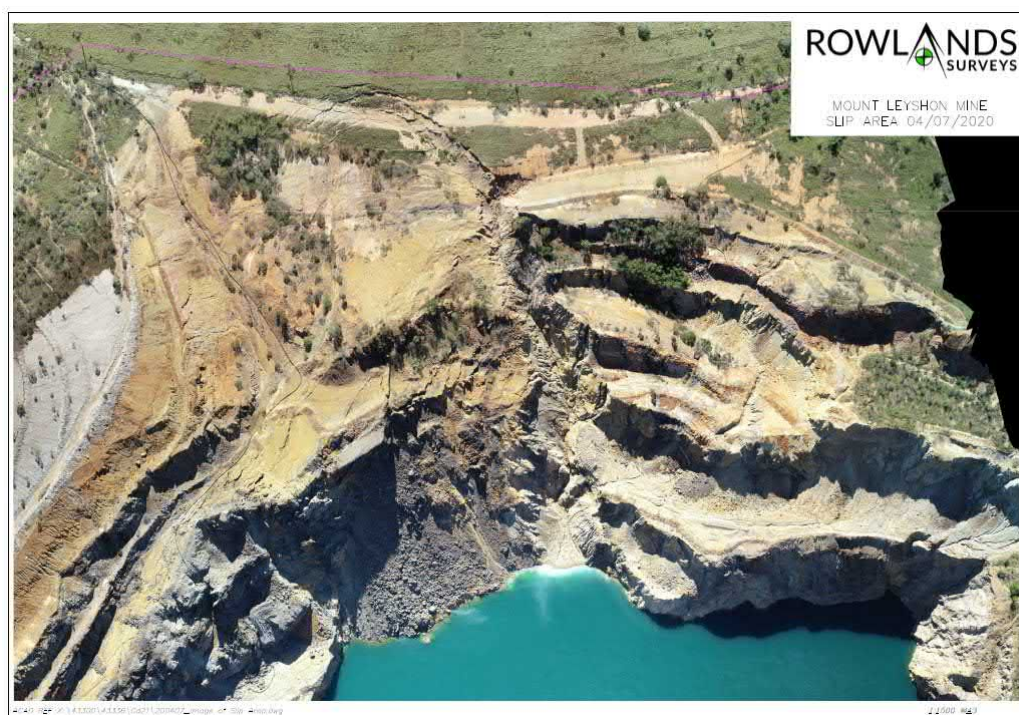
**Figure 5.4: July 2020 Aerial Imagery of Open Pit North Wall Slope Failure Area**

Aerial imagery and a ground surface topographic scan of the north wall slope failure area of the Open Pit was acquired by Rowlands Surveys using a drone in July 2020. The aerial imagery is shown in Figure 5.4.

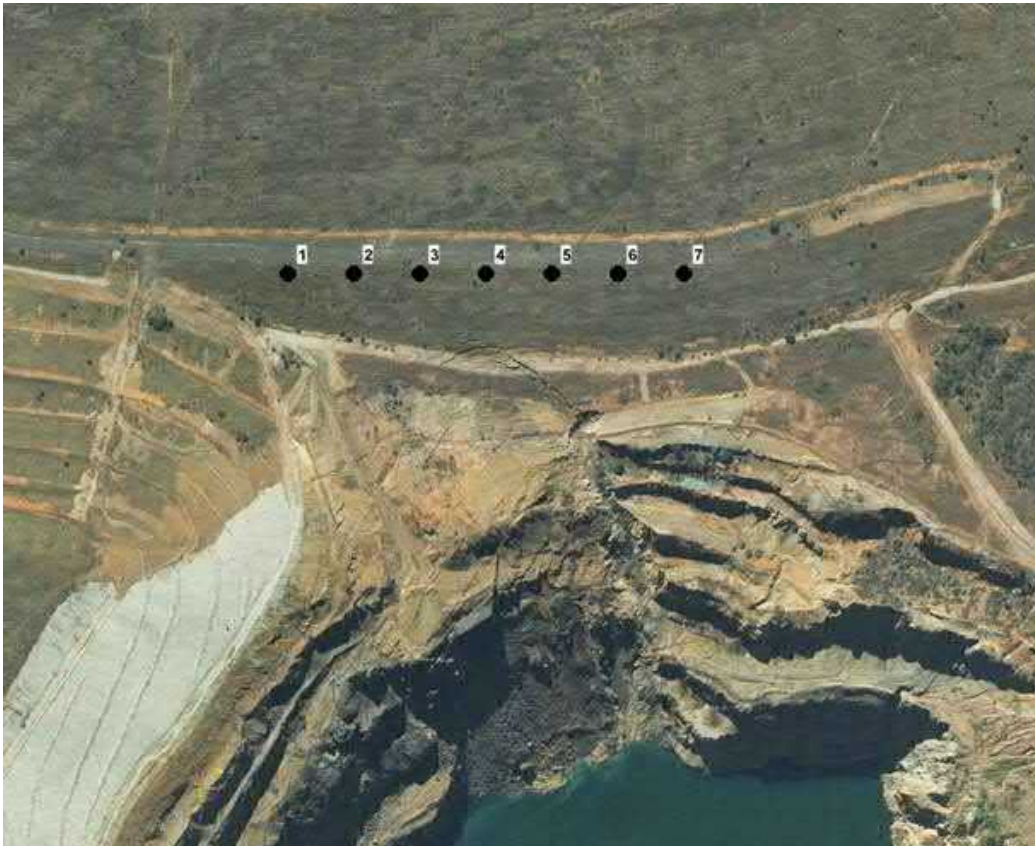
**Figure 5.5: Movement Detection Survey Monuments for Open Pit North Wall Slope Failure Area**

Seven survey monuments have been installed on the southern edge of the ONTSF approximately 50m away from the northern-most edge of the existing slip surface / surface cracking (Figure 5.5). These monuments will be surveyed annually to detect any ongoing movement of the slip surface.

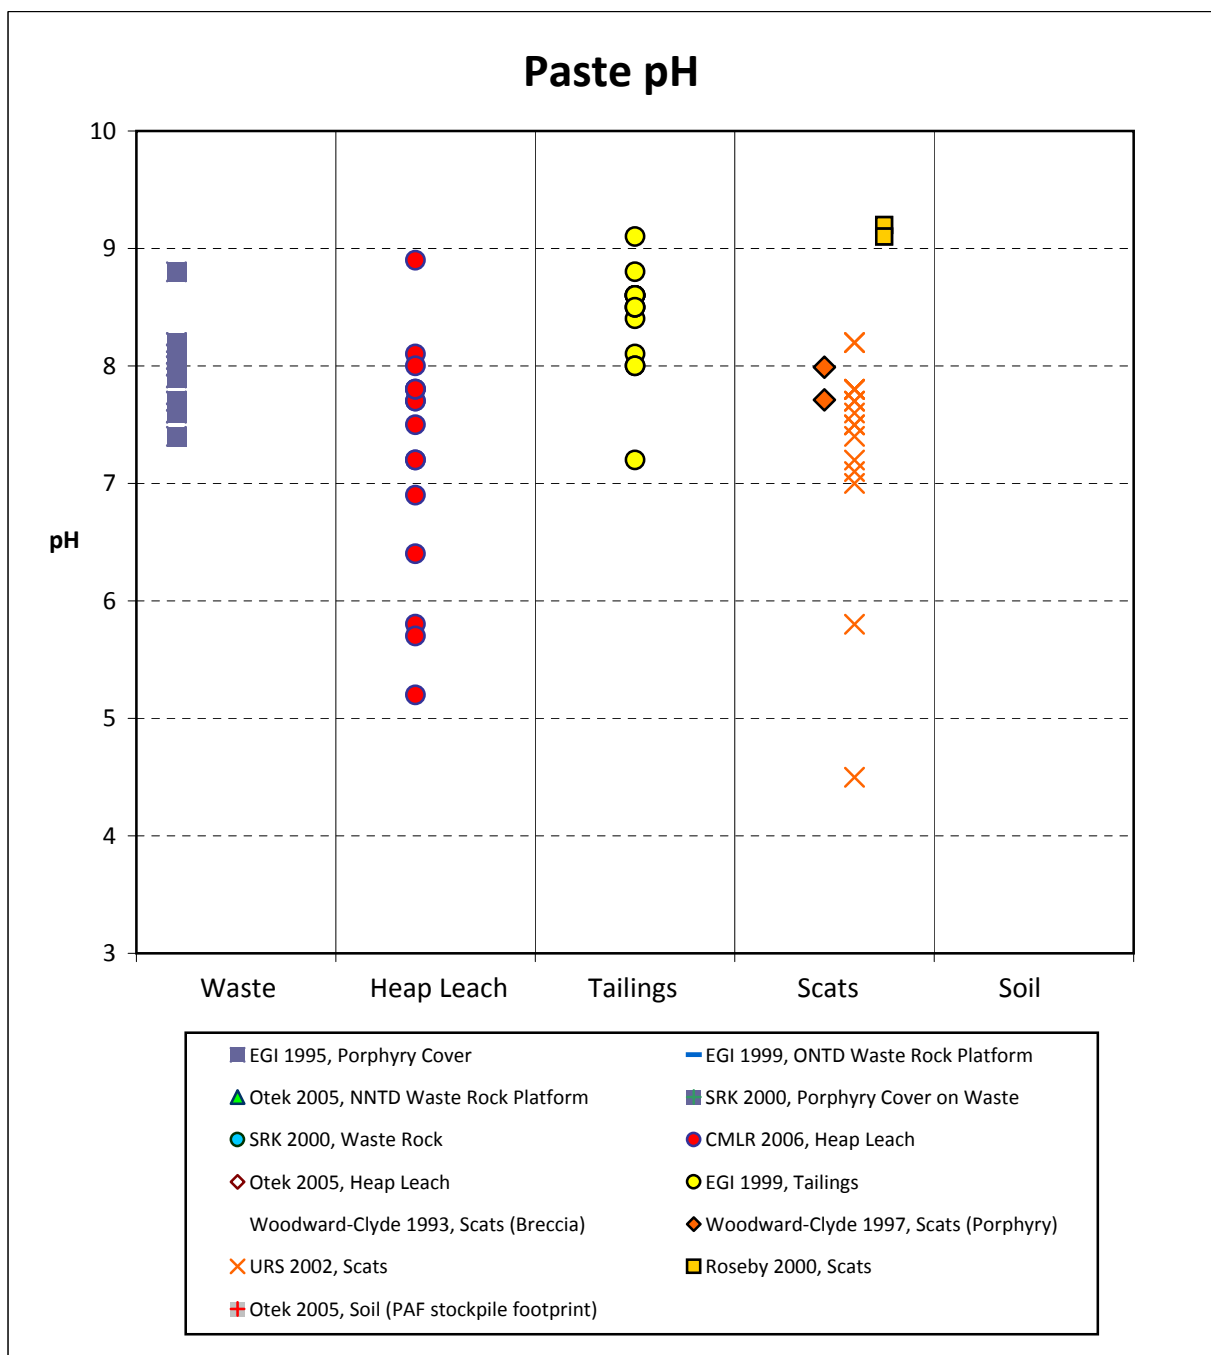
**Figure B1 Paste pH values in Mt Leyshon materials**

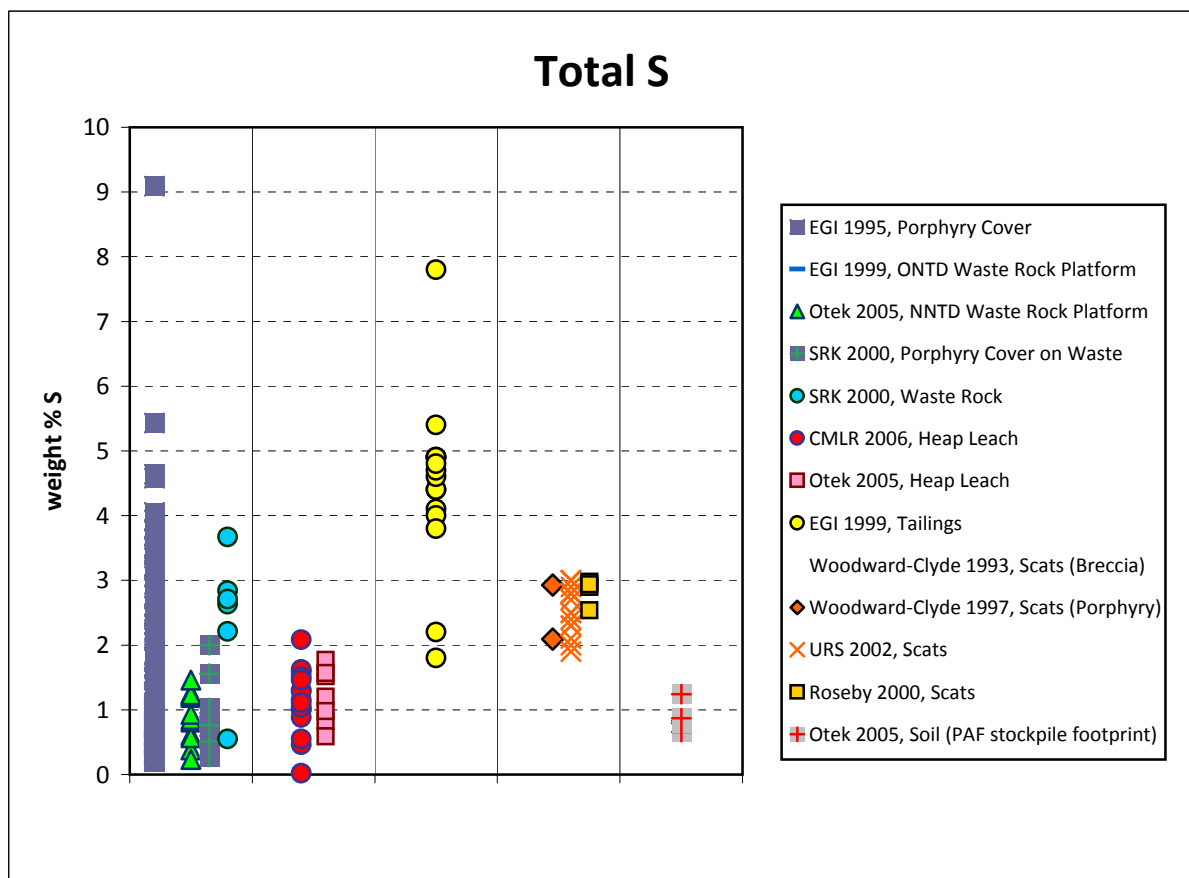
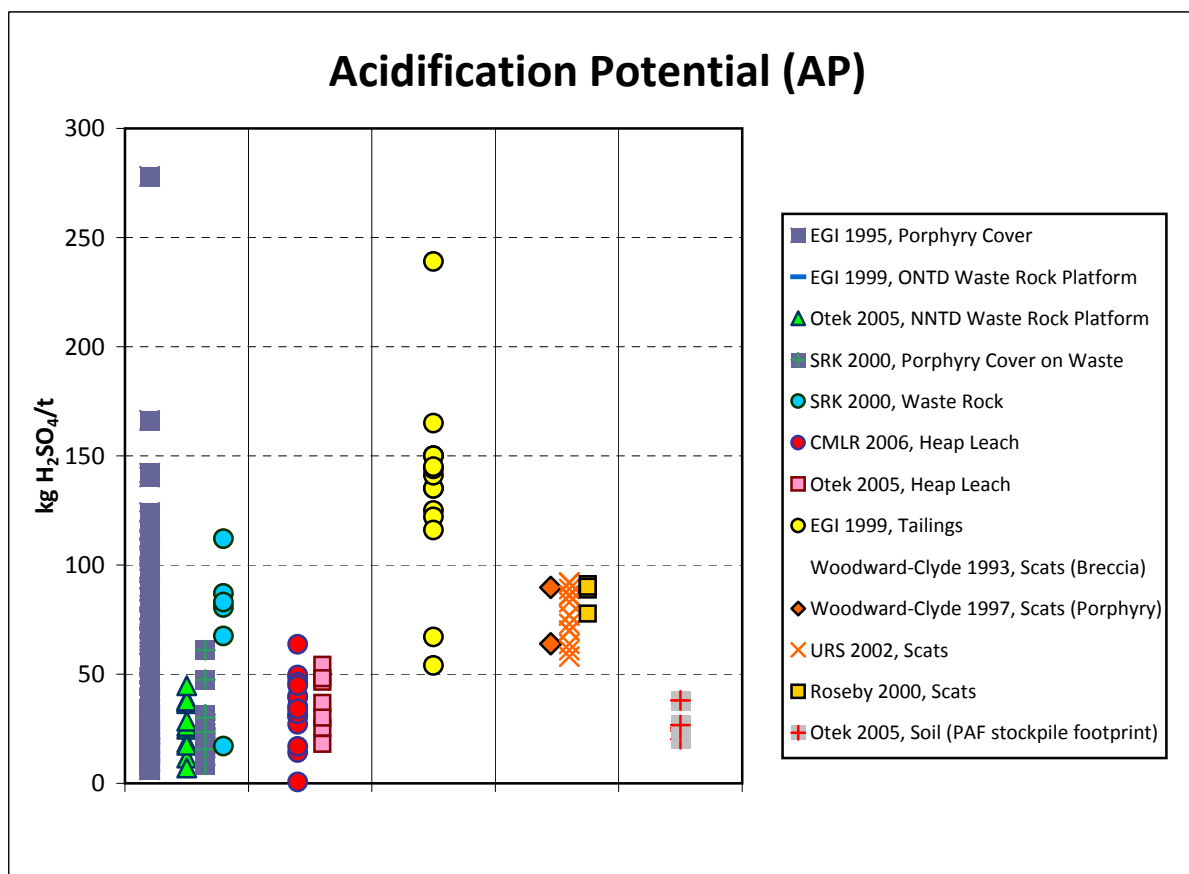
**Figure B2 Total S concentrations and Acidification Potential (AP)**

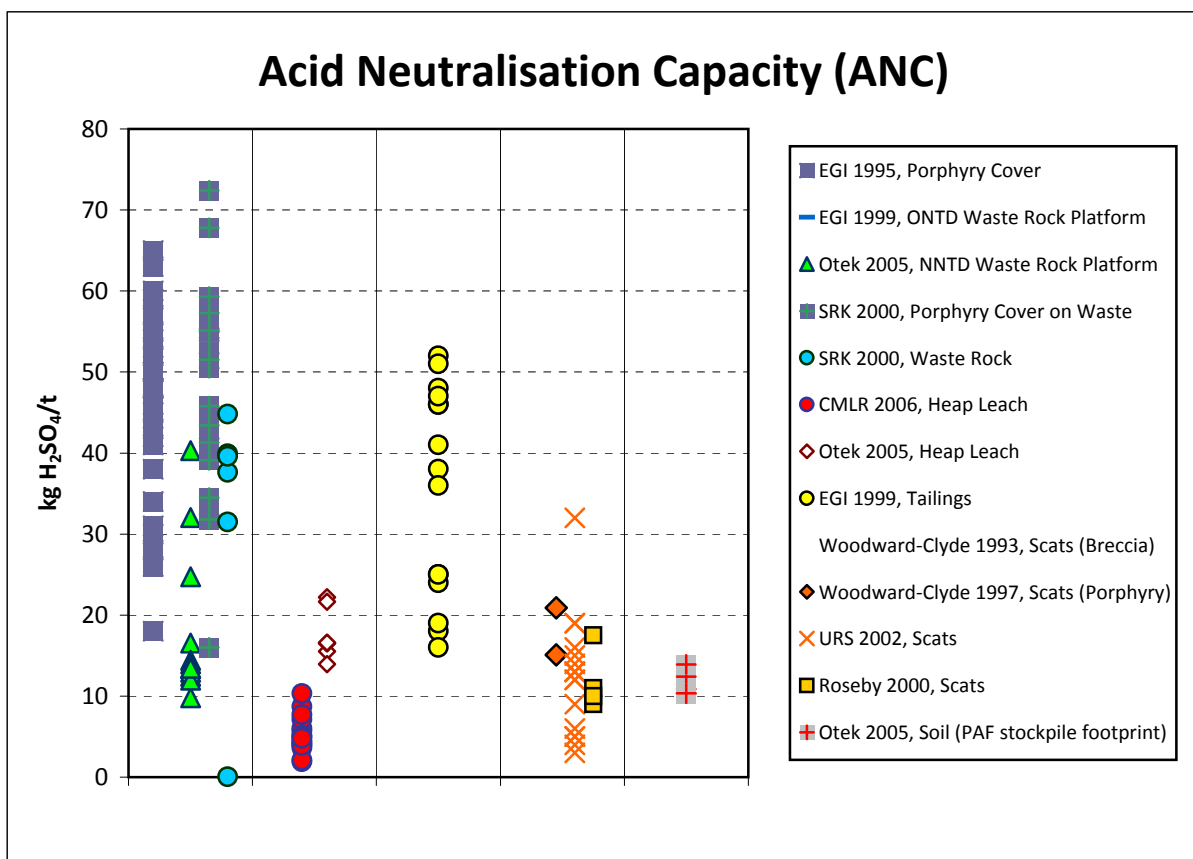
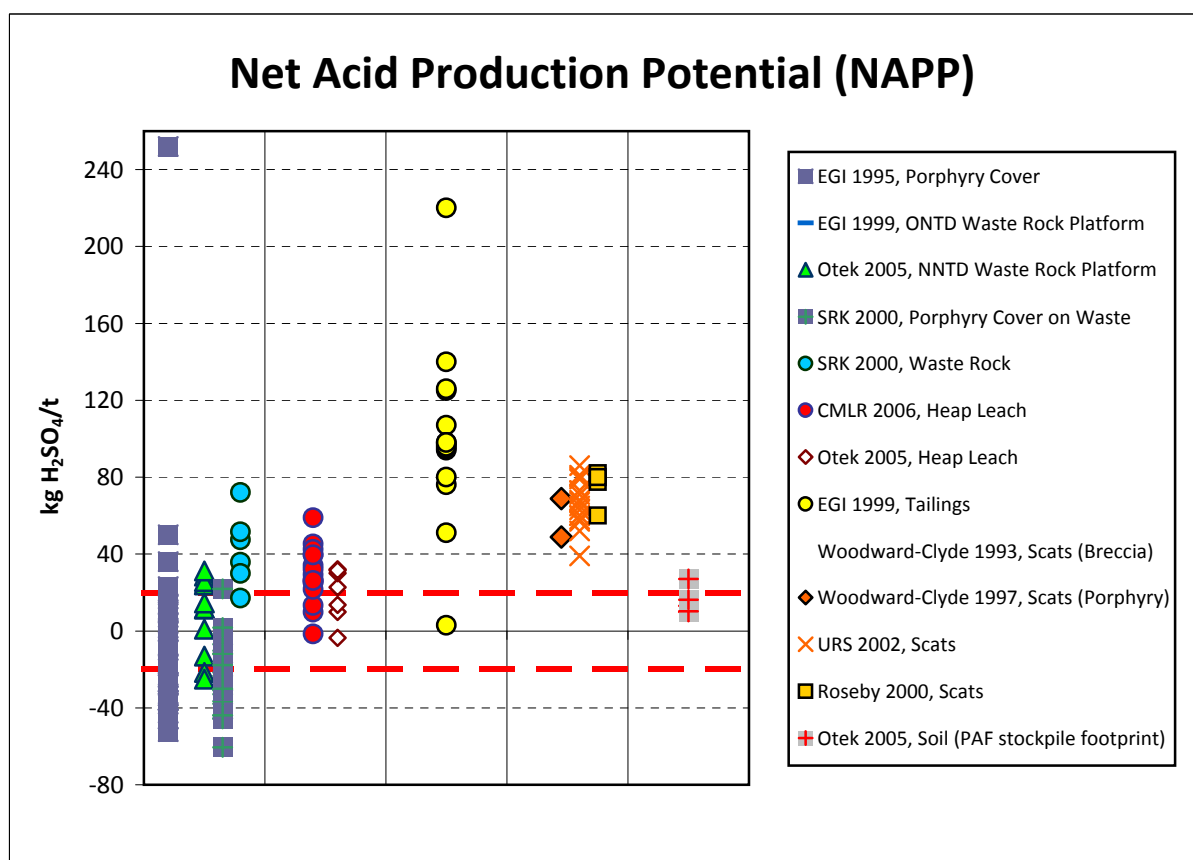
**Figure B3 Acid Neutralisation Capacity (ANC) and  
Net Acid Production Potential (NAPP)**

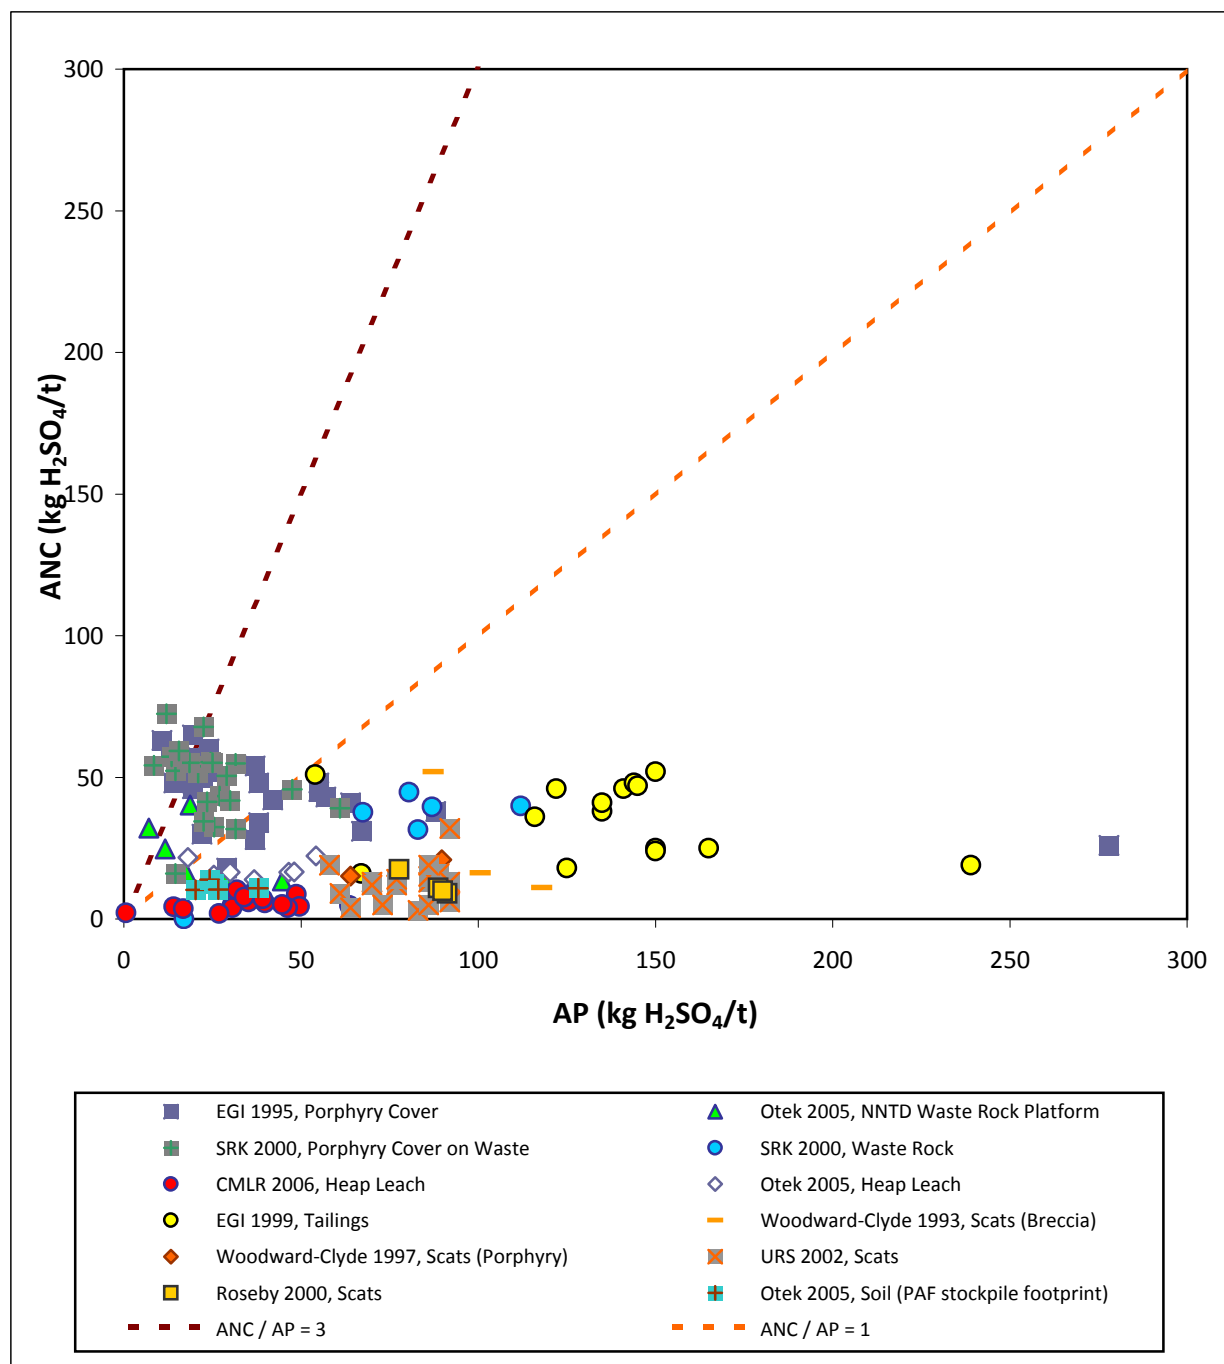
**Figure B4 Acid Neutralisation Capacity (ANC) and Acidification Potential (AP)**
