## Progressive Rehabilitation and Closure Plan

**Mt Leyshon Mine**

M13000\_024-REP-001-2

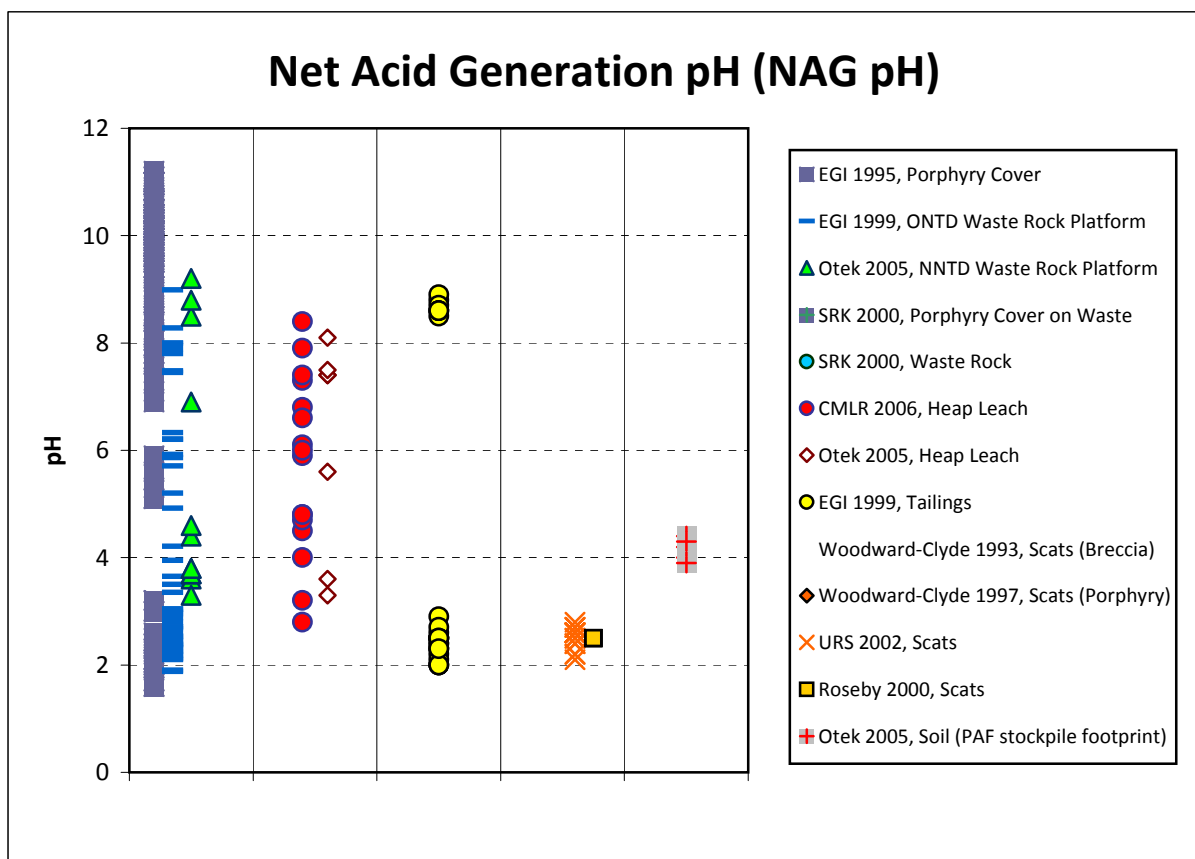
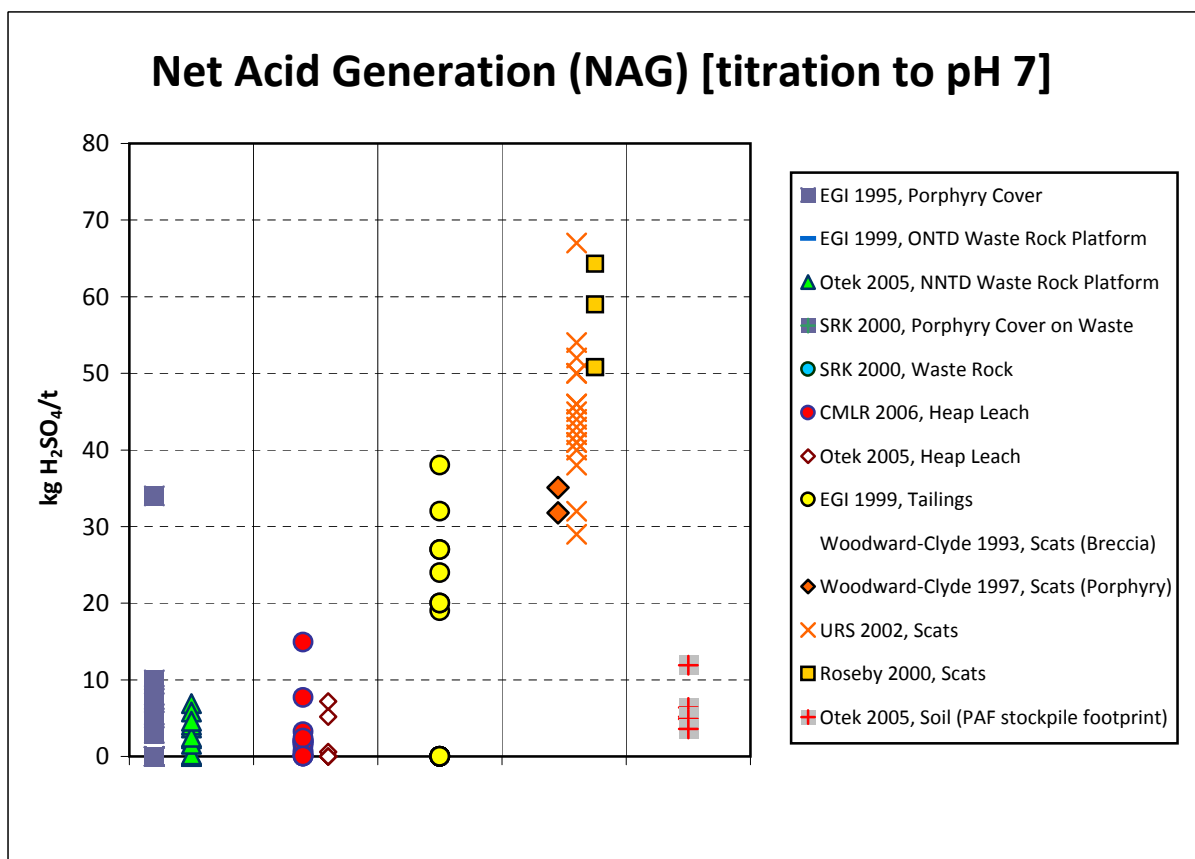
**Figure B5 Net Acid Generation (NAG) Testwork Results**

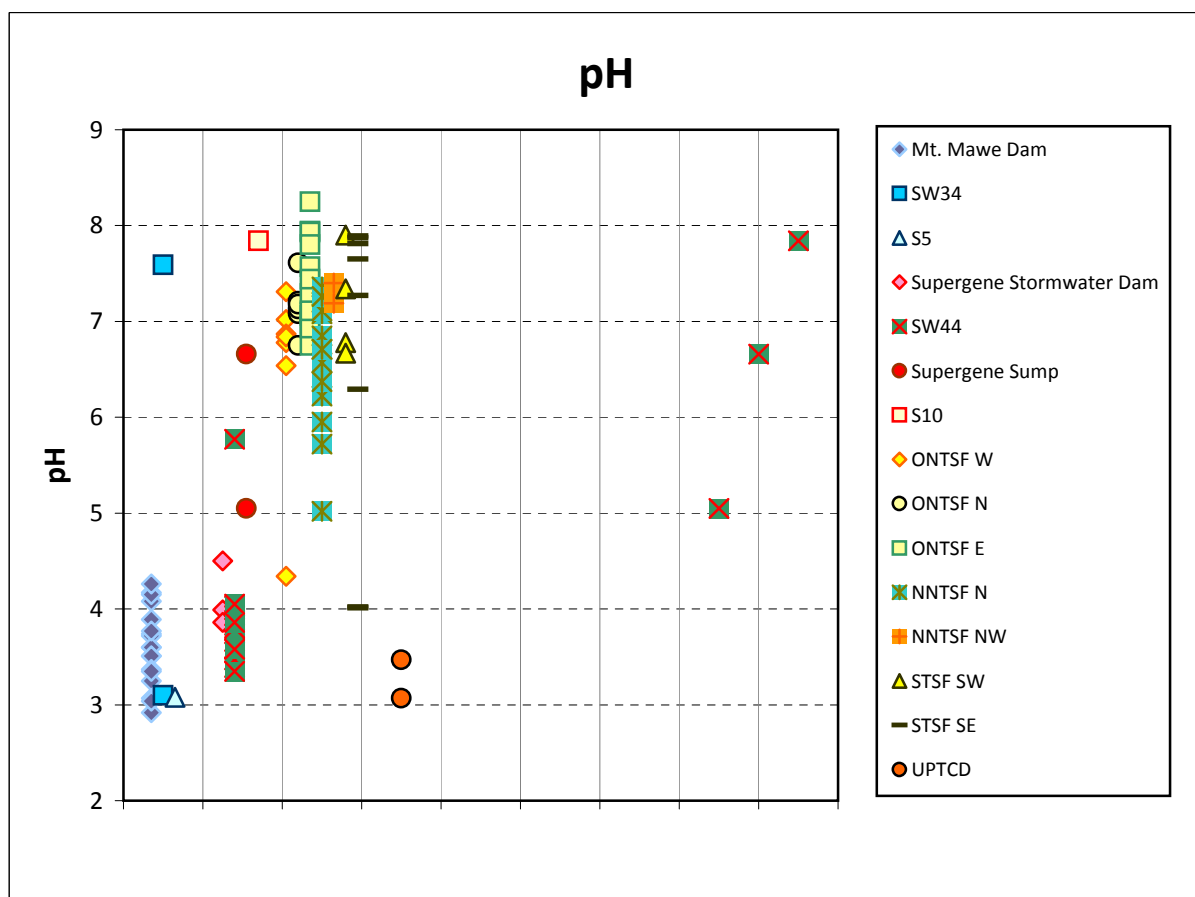
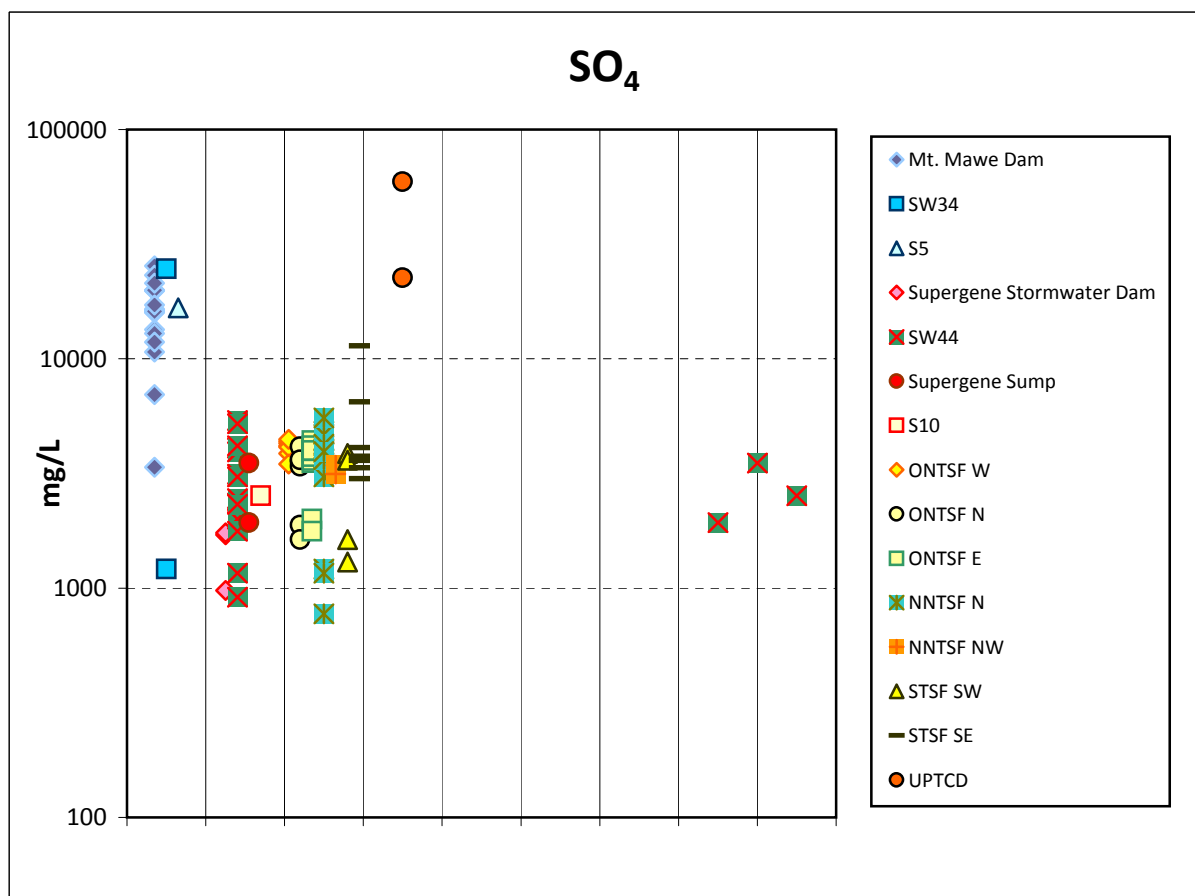
**Figure C1 pH values and SO<sub>4</sub> concentrations in seepages and surface water associated with main Mt Leyshon material types**

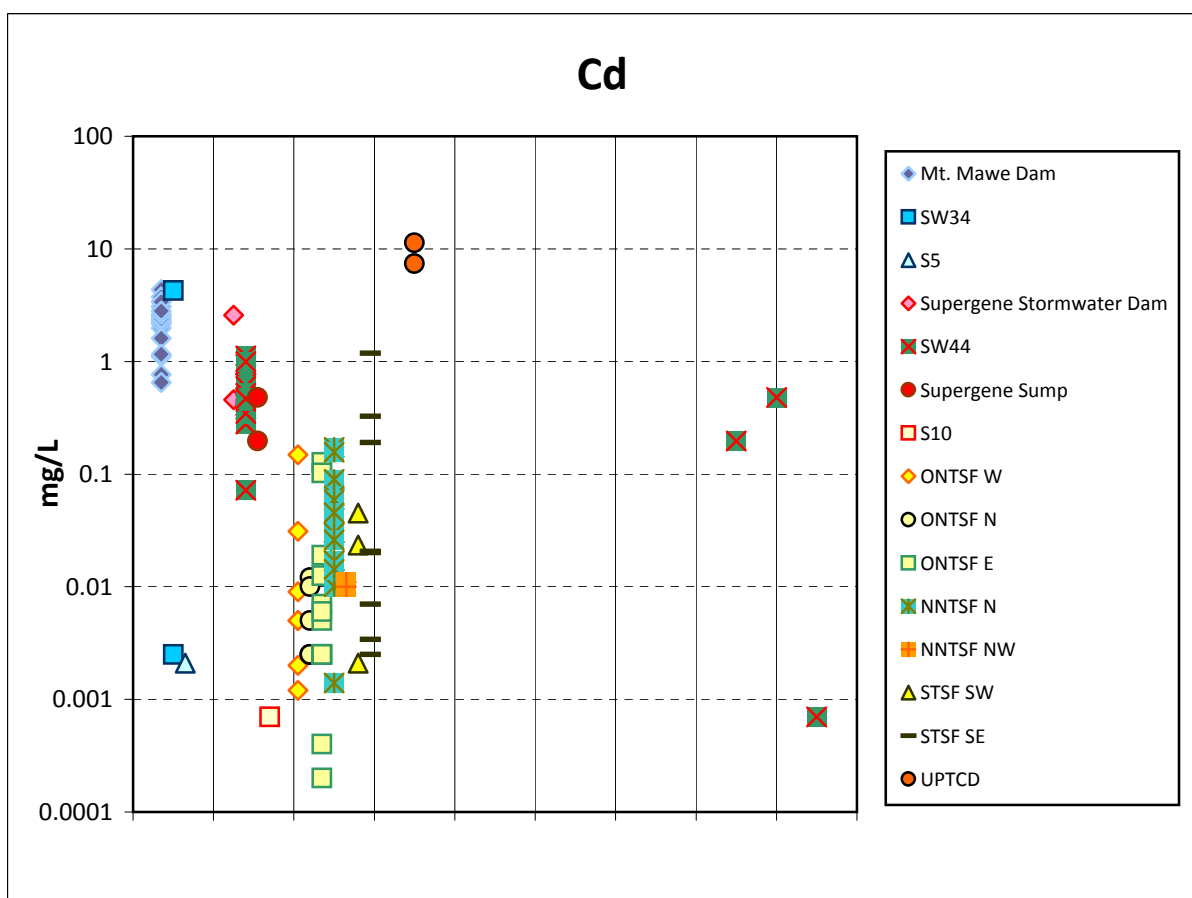
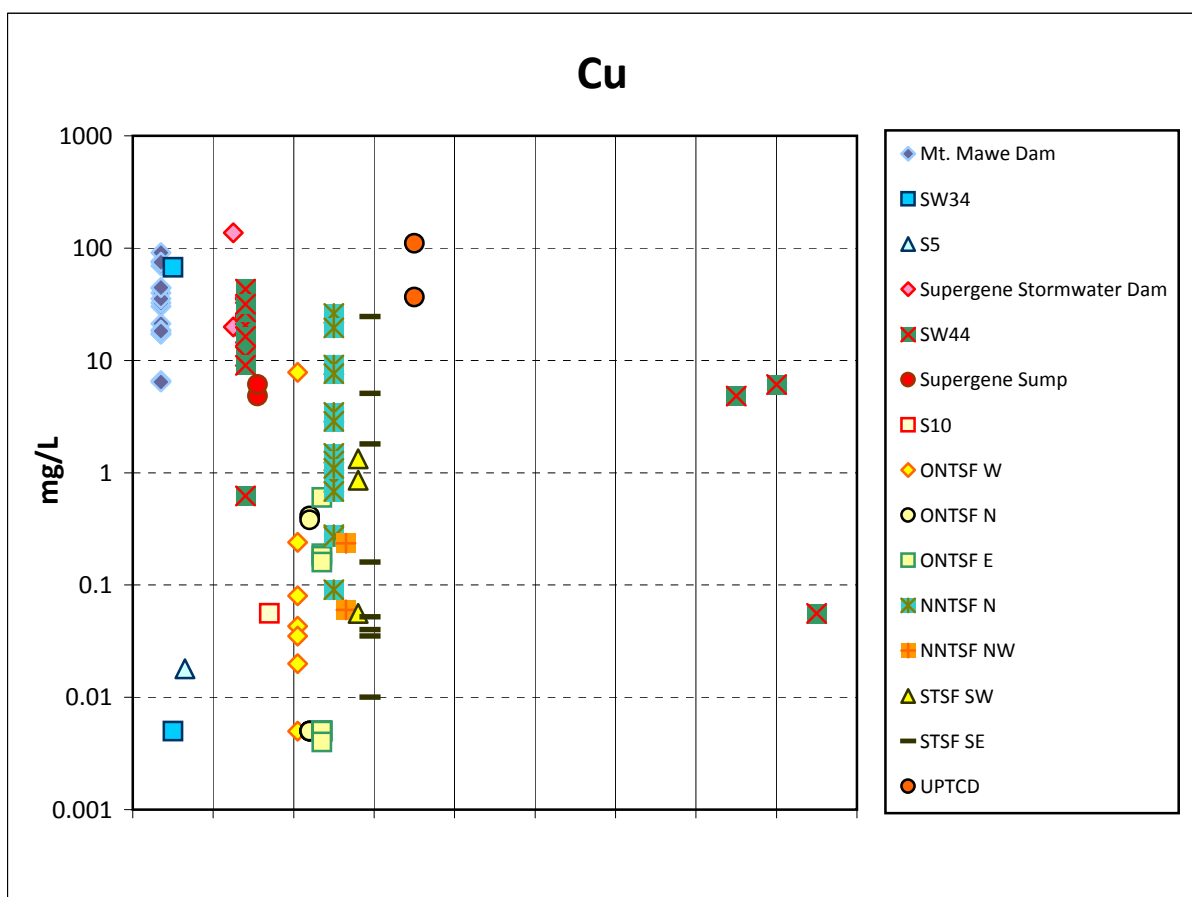
**Figure C2 Cd and Cu concentrations in seepages and surface water associated with main Mt Leyshon material types**

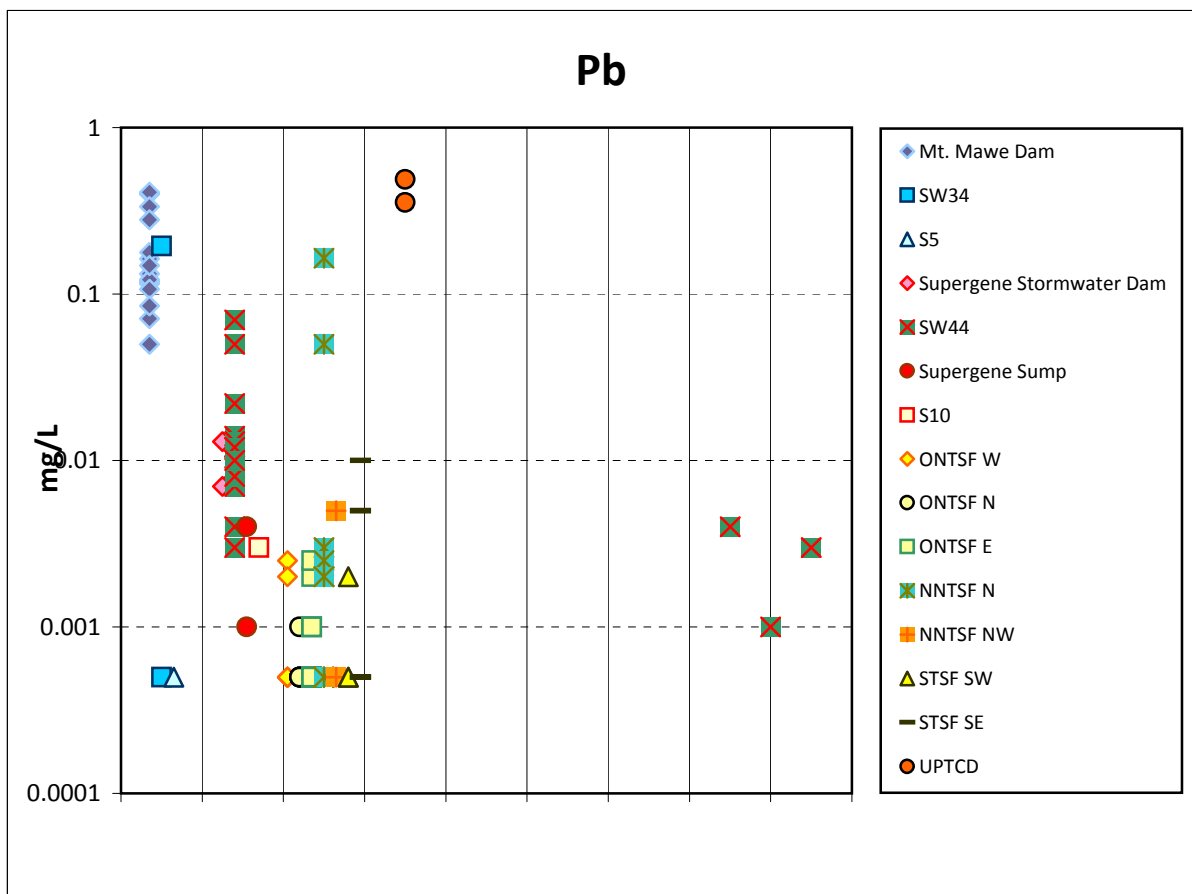
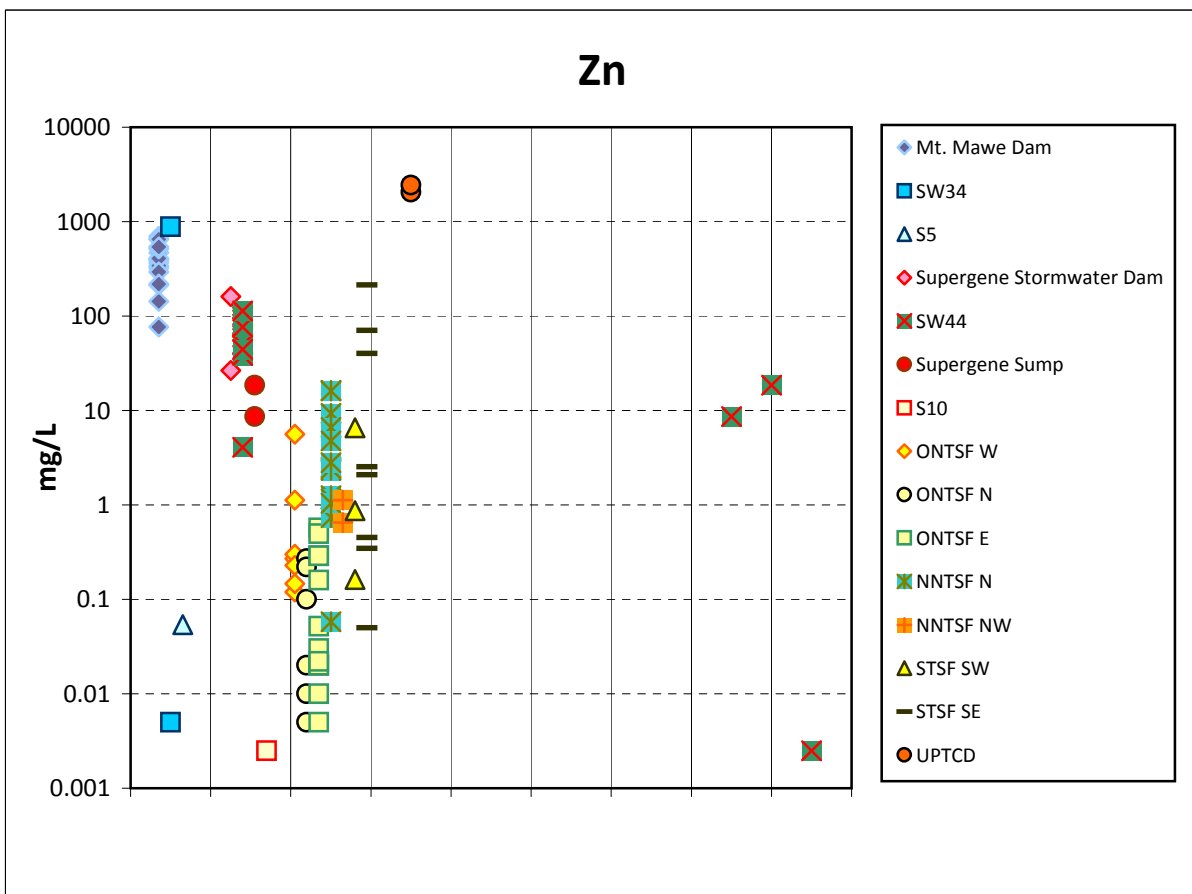
**Figure C3 Pb and Zn concentrations in seepages and surface water associated with main Mt Leyshon material types**

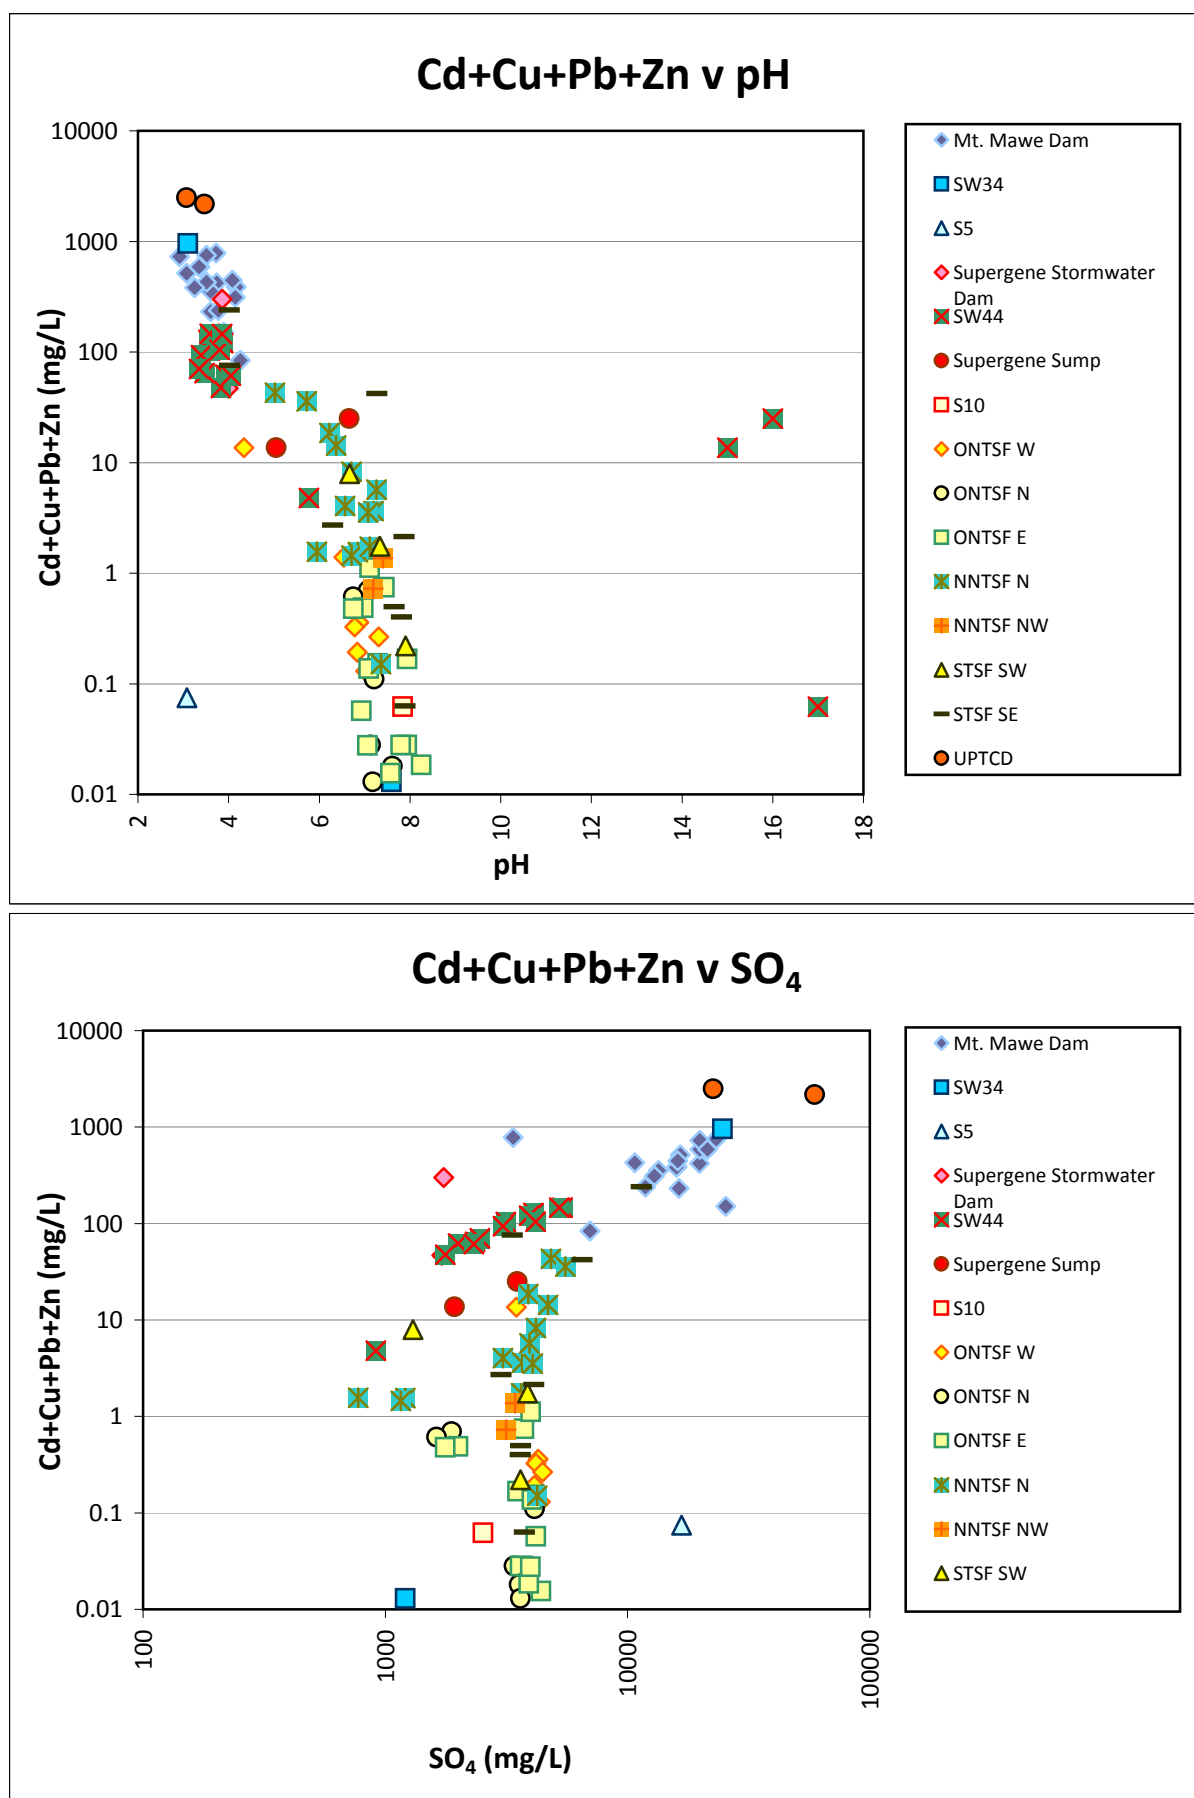
**Figure C4 Variations in pH, SO<sub>4</sub> and selected metals concentrations in seepages and surface water**

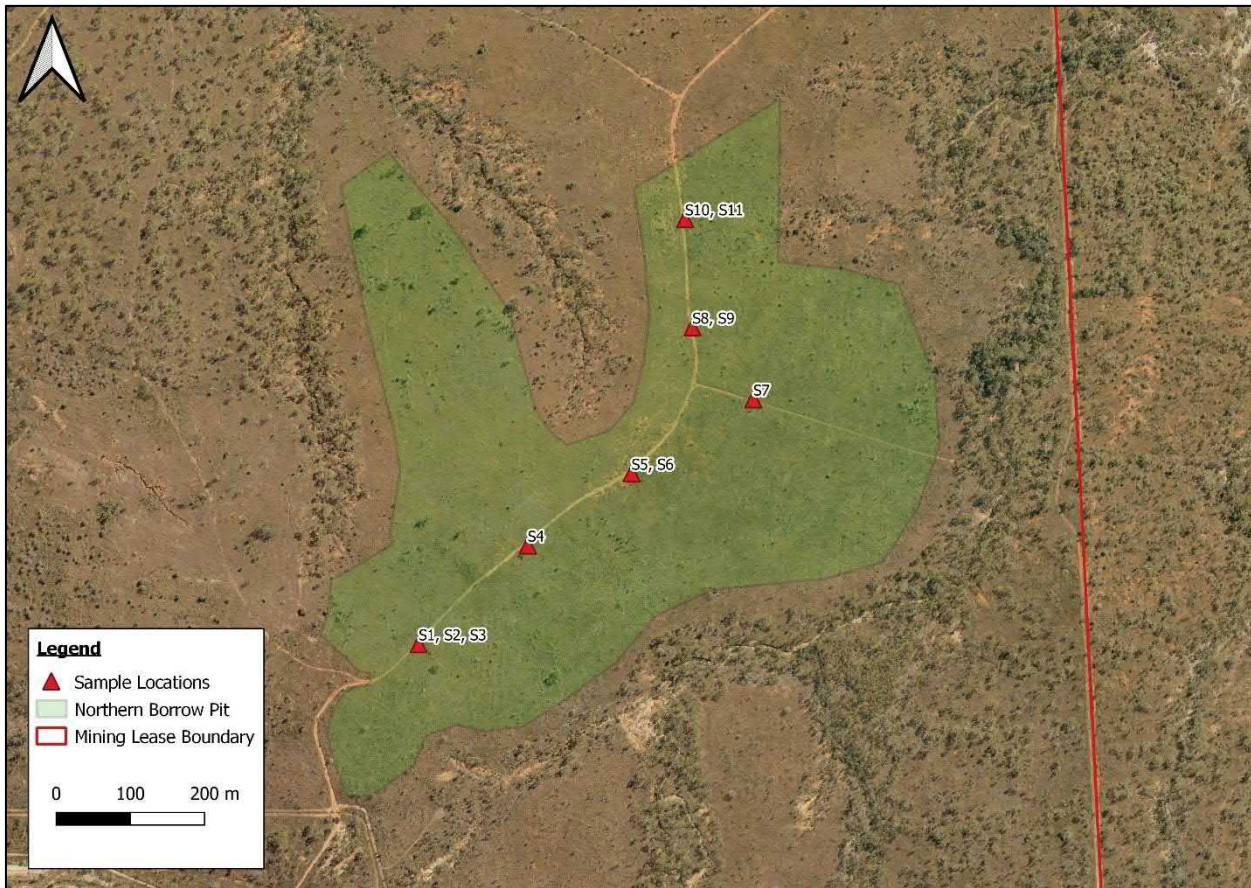
**Figure 1: Soil Sampling Locations**

TropWATER was engaged by Newmont in 2022 to collect and coordinate testing of soil samples from the Northern Borrow Pit area. Eleven soil samples were collected on 22<sup>nd</sup> March 2022 from the seven test pits shown in Figure 1 and described in Table 1. Due to cultural heritage restrictions, the test pits had to be located next to the existing access track through the Northern Borrow Pit.

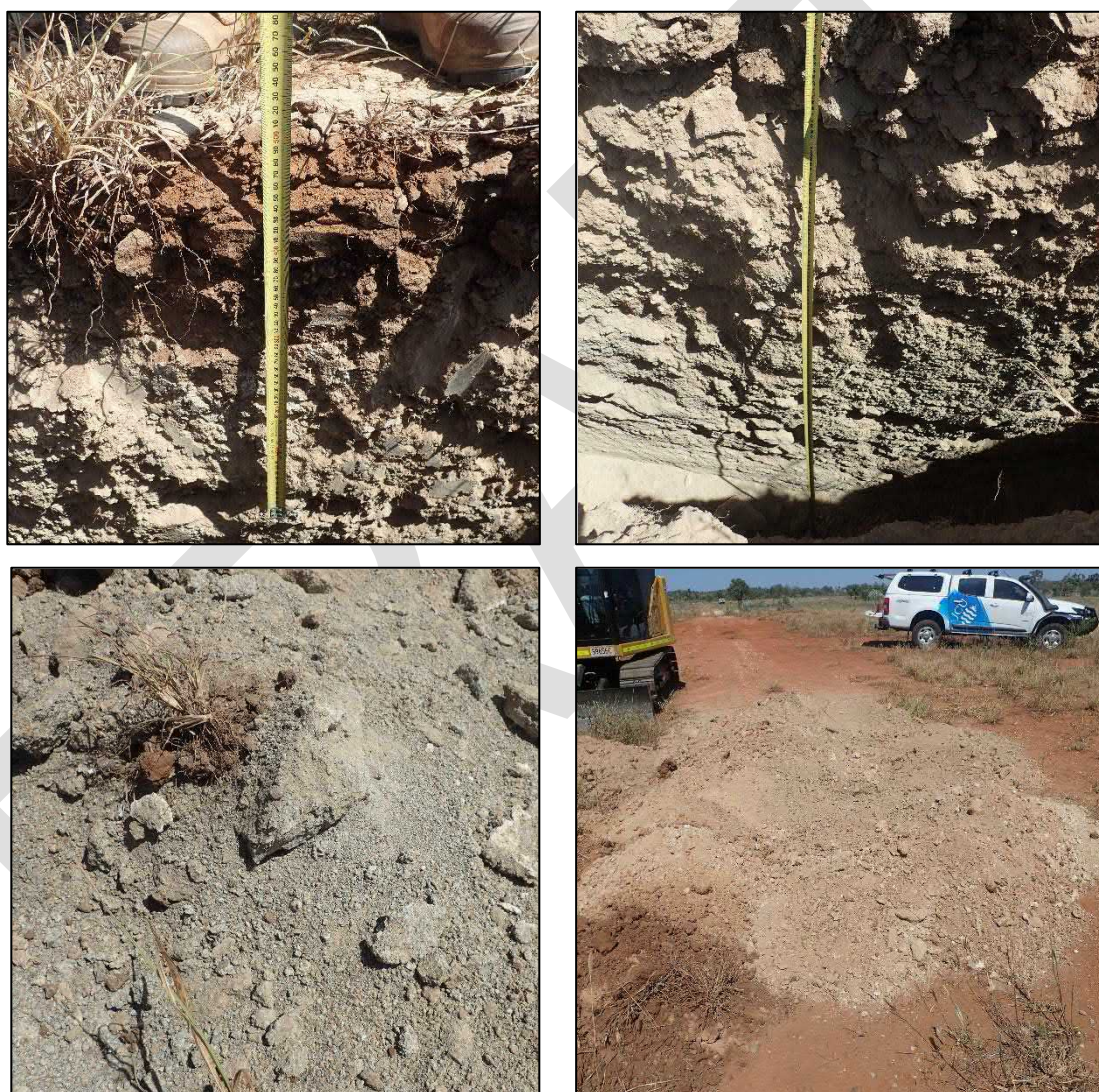
Pit 4 did not exhibit any strong variation through the white-grey material which was generally similar to the lower horizon in Pit 5.

Both pits were terminated at shallower depth than target (2.1 m depth in Pit 4 and 2.3 m depth in Pit 5) as digging became increasingly hard.

**Figure 2: Photos Showing the Typical Condition of Test Pits 4 and 5**

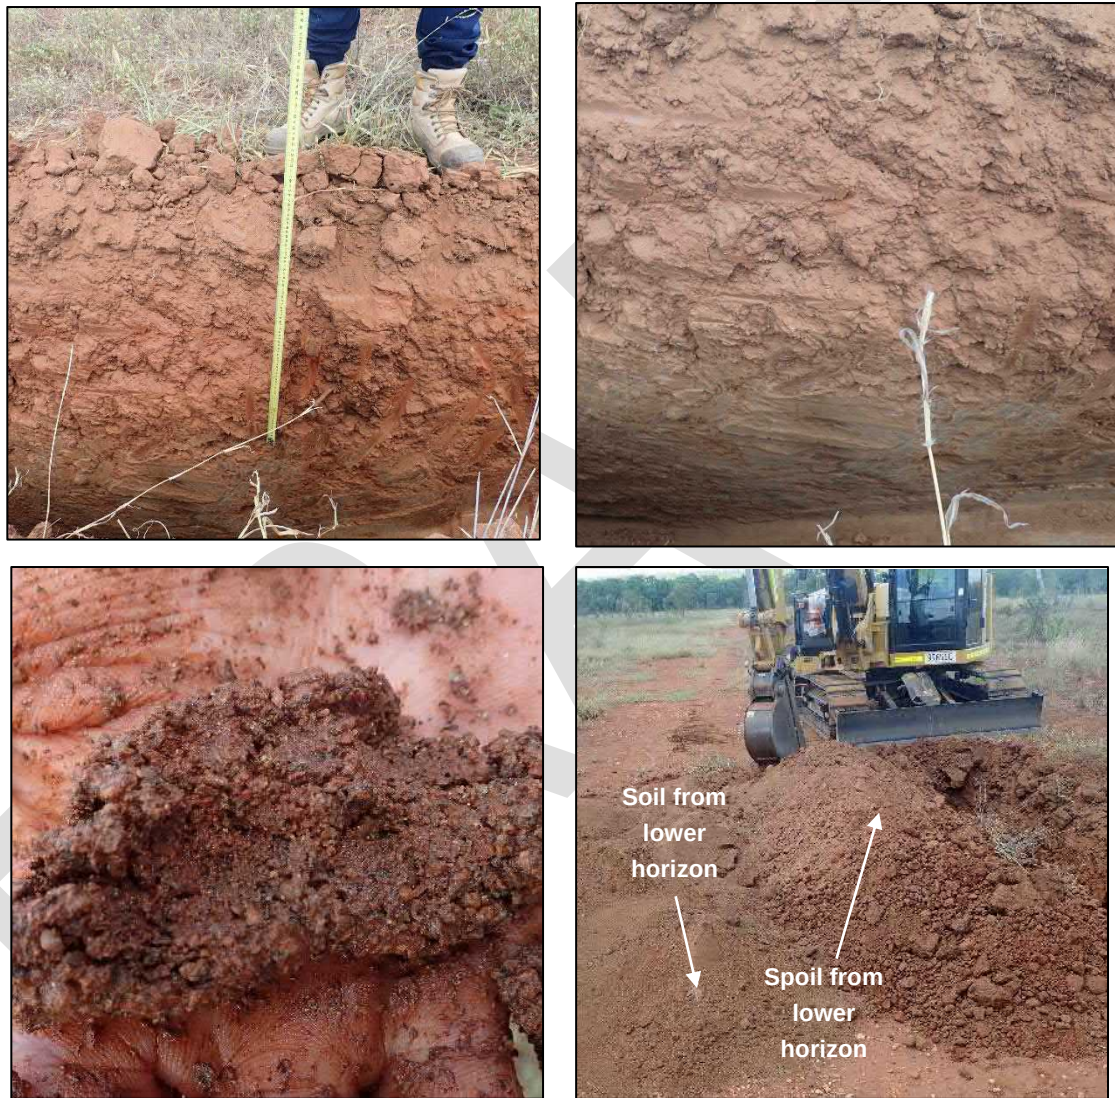
Clay 'smears' were visible in the excavated face and a relatively high clay content was inferred.

Excavated soil from the lower horizon typically presented as a clayey sand that has some structure when wetted, but crumbles easily. The material was generally easier to dig than the white-grey material in Pits 4 and 5, although refusal was reached at <2.5 m in most of the pits.

**Figure 3: Photos Showing the Typical Condition of the Remainder of the Test Pits**

Photos showing the typical condition of the remainder of the test pits are shown in Figure 3.

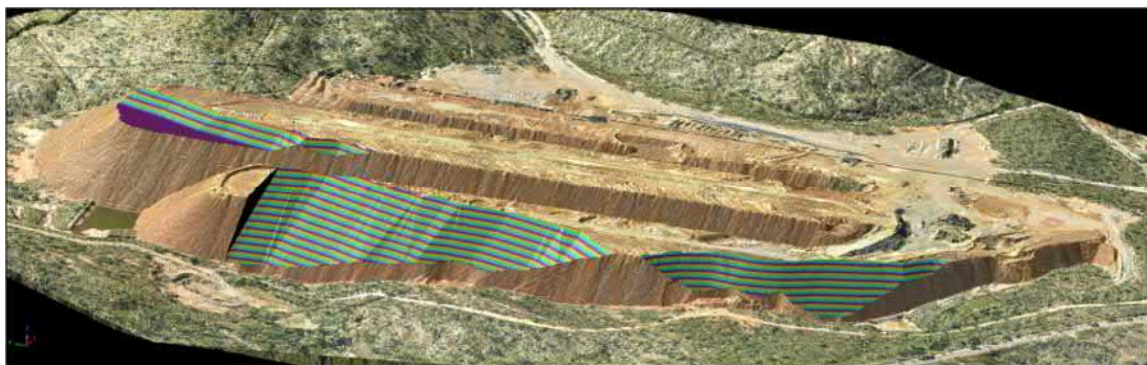
**Figure 2 - Slope Cut Requirement**

There are three areas of the western slope where the toe constraint requires the relocation of significant scats volume. Figure 2 shows these areas, with two relating to cutting back the western finger and the third being on the central finger. The limited excavation on the central finger can be deferred to Stage 3 if

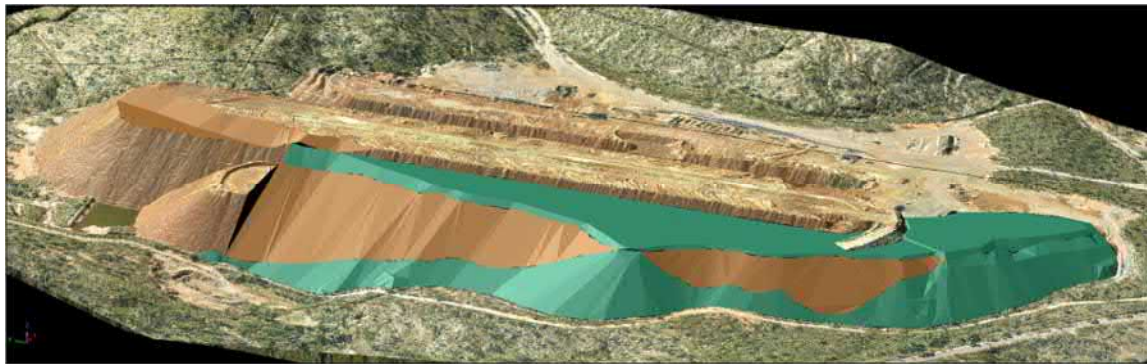
**Figure 3 - Landform Post Stage 1**

Figure 3 shows the final surface from Stage 1. There are two main areas of deposition for the 205 km<sup>3</sup> of excavated scats being:

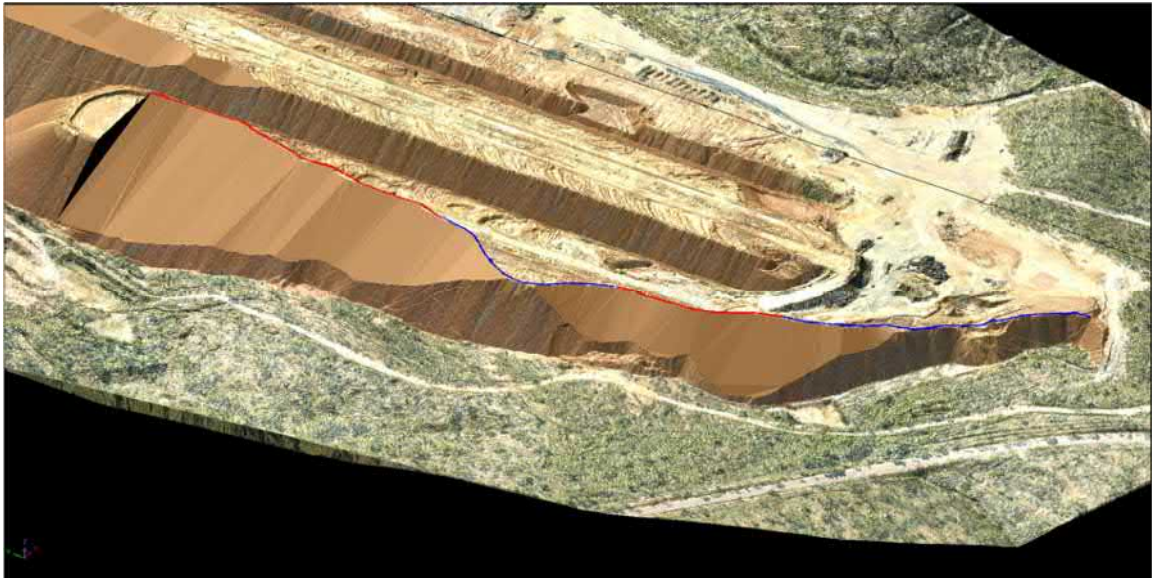
**Figure 4 - Crestline Identification of Areas of Excess and Insufficient Fill**

- **The Western Face** The northern and southern cut areas generate a significant volume of scats reporting at the toe of the dump (205 km<sup>3</sup>). Figure 4 shows the two western face crest areas in red that generate excess material at the toe. The remaining crest areas, shown in blue, have insufficient material present and require additional material to be dumped at the crest or on the floor below if access is available. Approximately 175 km<sup>3</sup> of material needs is hauled out from the western toe, with 123 km<sup>3</sup> required for the fill of the face.

Detailed section by section analysis highlights where surplus scats are present at the toe and where additional material is required to form the final 15° slope.

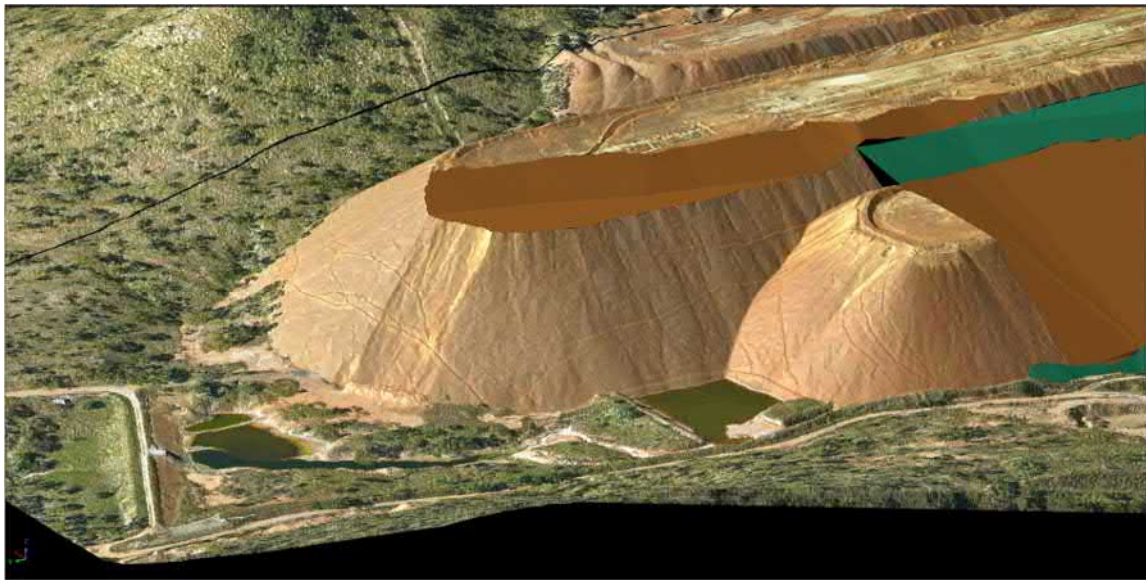
**Figure 5 - Northern End of the Landform at the Nominal End of Stage 1**

Stage 2 consists of removing scats from the western finger to the post-rehabilitation 15° slope and relocating these northward to form the base of the stockpile. The before and after view of this work is shown in Figure 5 and Figure 6 below.

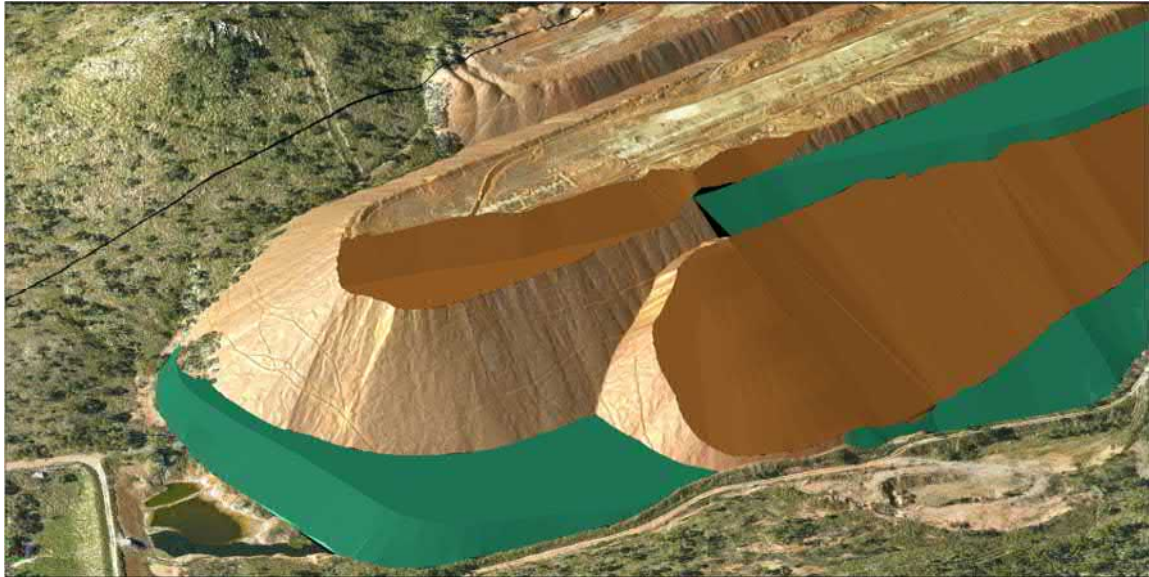
**Figure 7 - Northern End of Landform at the End of Stage 2**

After Stage 3, the main earthworks on the northern end of the scats stockpile is complete.  
Figure 7 and Figure 8 show the landform at the end of Stages 2 and 3, respectively.

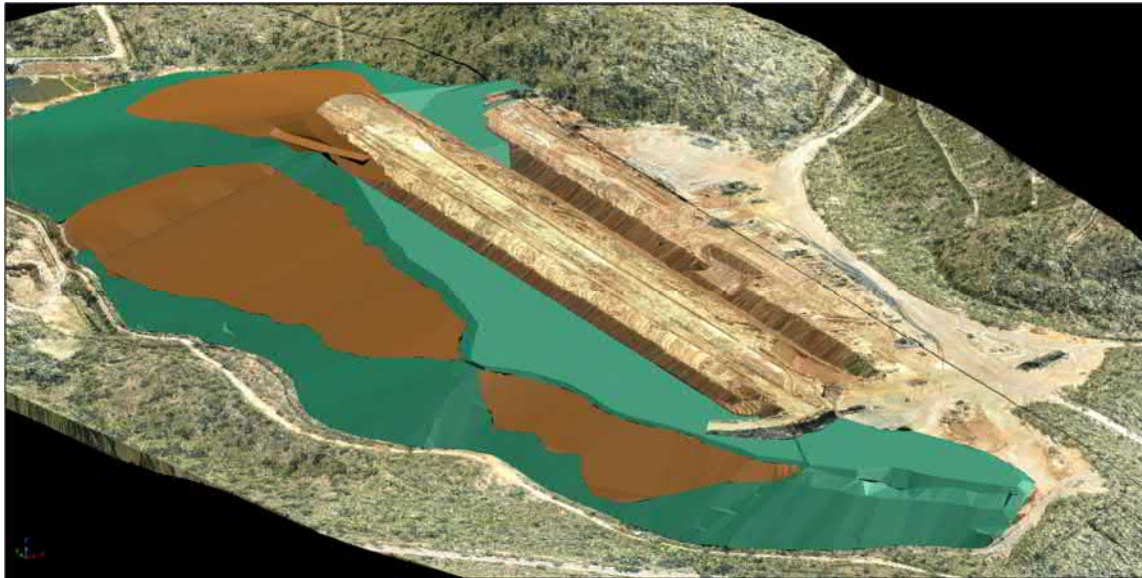
Figure 9 - Landform Post Stage 4

Images of the landform before and after the Stage 4 work are shown in Figure 9 and Figure 10 below.

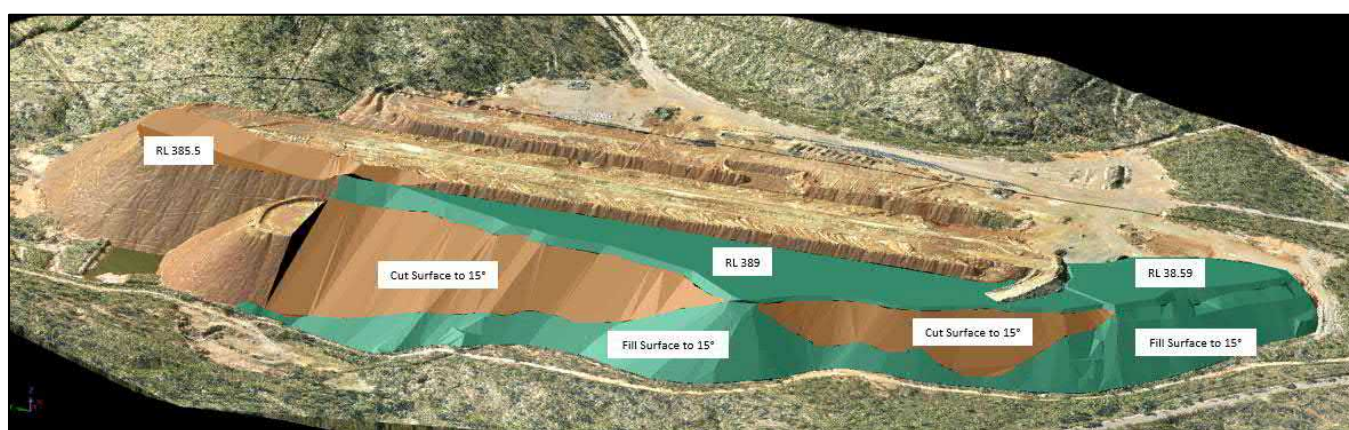
Figure 2: Scats Stockpile Re-Profiling Stage 1

### RE-PROFILING STAGE 1 (FIGURE 2)

The aim of Stage 1 is to create an outer slope of 15° on the western face of the Scats Stockpile. This involves shifting a significant volume of scats from the western and central fingers. The scats will be placed on the western face, on top of the western finger, and in the gully between the western and central fingers. This will increase the elevation of the western finger, which is acceptable because it will assist in creating a top surface that falls towards the east (i.e. no valleys or depressions).

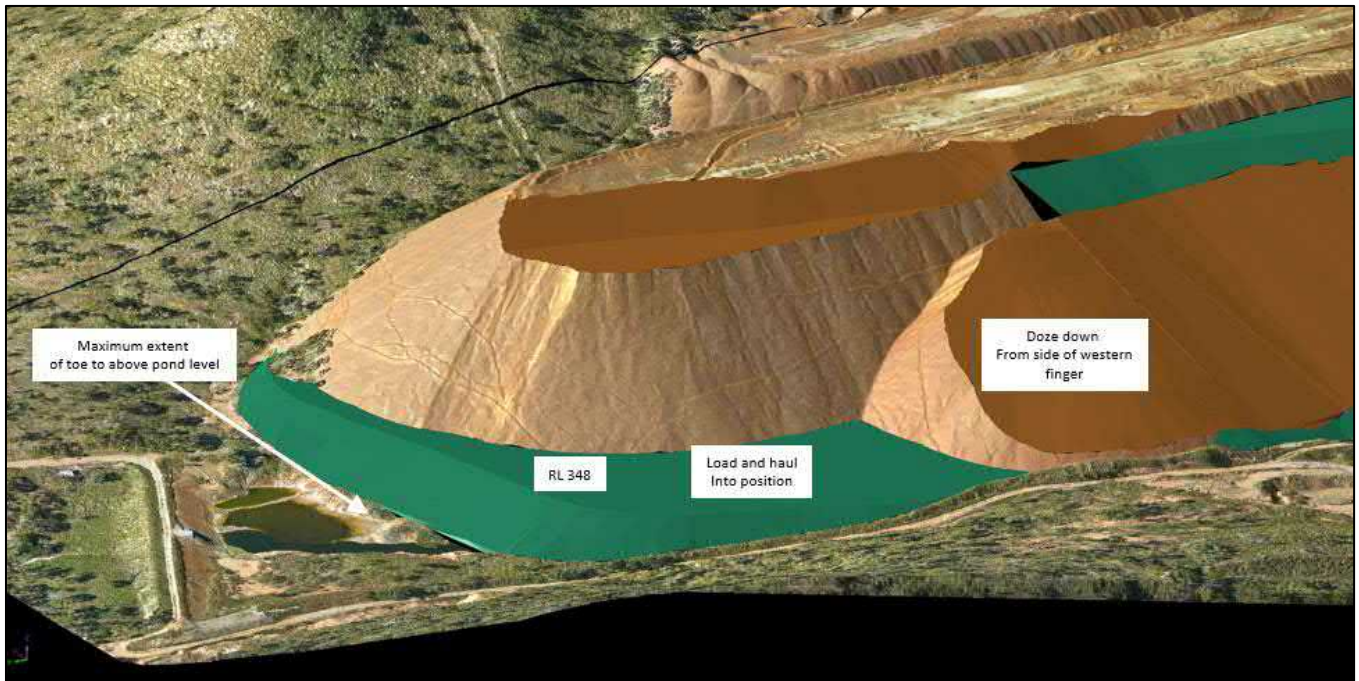
**Figure 3: Scats Stockpile Re-Profiling Stage 2**

### RE-PROFILING STAGE 2 (FIGURE 3)

The aim of Stage 2 is to create an outer slope of 15° on the northern ends of the western and central fingers. This involves shifting scats from the western finger and placing it to the north of the western and central fingers. The Upper Plum Tree Creek Dam will be fully subsumed by the re-profiled landform (current dam is already partly infilled by the stockpiles); however, the Plum Tree Creek Dam will remain in place during rehabilitation and for some time afterwards to capture any seepage and to act as a sediment basin for the steeper western and northern batters of the Scats Stockpile final landform during vegetation establishment. Water quality in the Plum Tree Creek Dam will be monitored to ensure that the rehabilitated Scats Stockpile is trending towards achieving a stable condition.

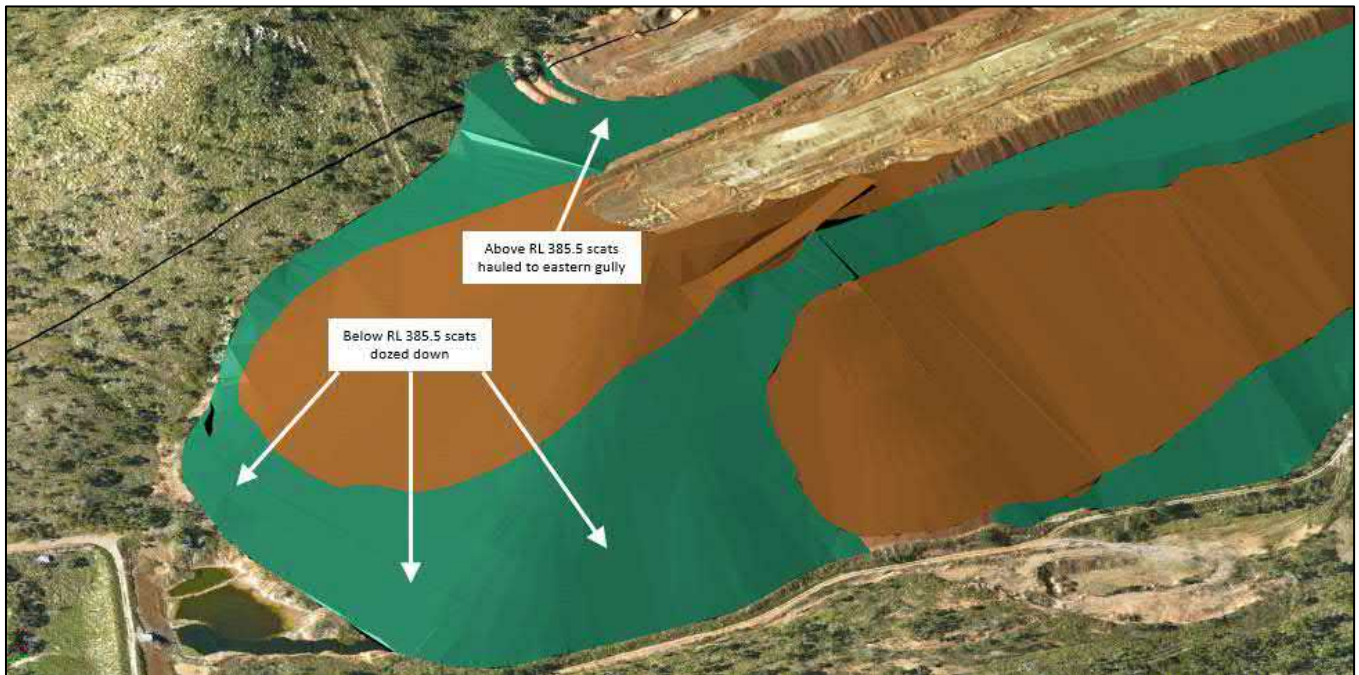
**Figure 4: Scats Stockpile Re-Profiling Stage 3**

#### RE-PROFILING STAGE 3 (FIGURE 4)

The aim of Stage 3 is to create an outer slope of 15° around the entire northern end of the central finger. This involves shifting scats from the top of the central finger and placing it around the northern end of the central finger. As stated above, Stages 2 and 3 may be undertaken concurrently to maximise the use of down-dip dozing and eliminate/reduce the need for more costly truck and shovel haulage.

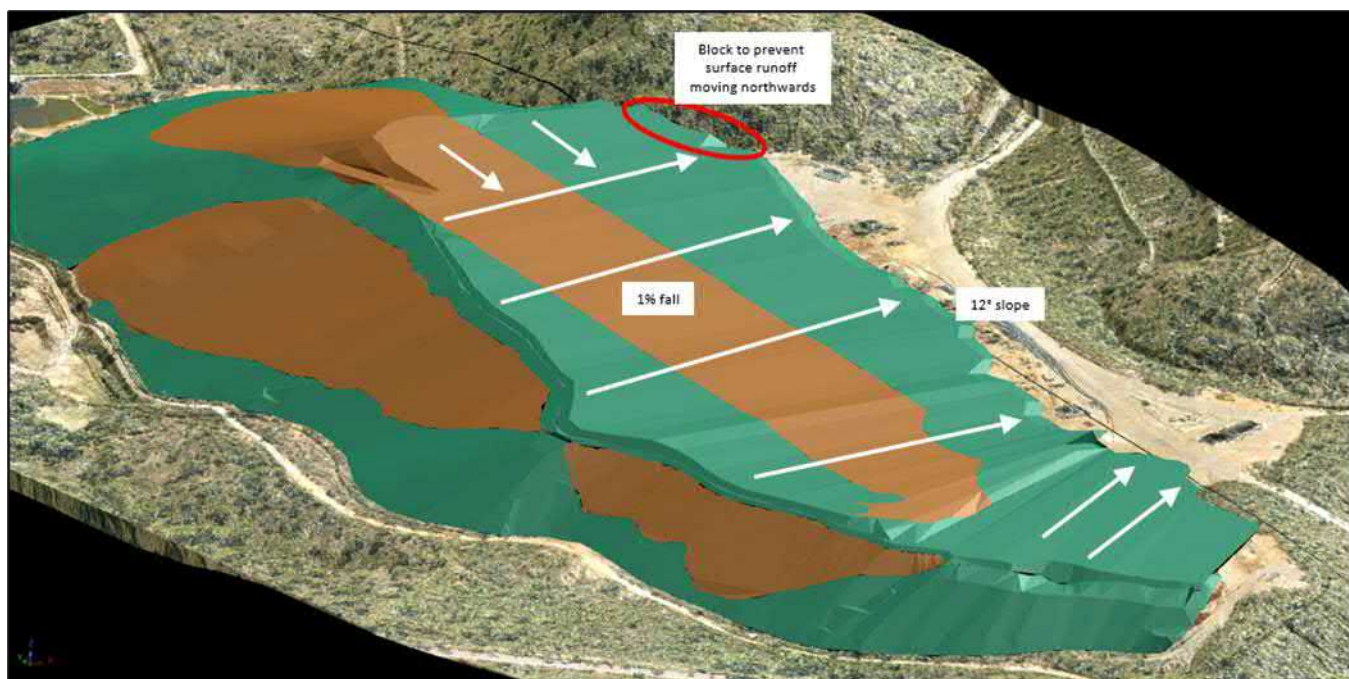
**Figure 5: Stats Stockpile Re-Profiling Stage 4**

## RE-PROFILING STAGE 4 (FIGURE 5)

The aim of Stage 4 is to flatten the top surface of the Scats Stockpile and create a gradual fall to the east of 1% (0.6°). At the very southern end of the Scats Stockpile, the final landform will tie-in to the natural topography in the east. This wasn't possible for the remainder of the Scats Stockpile, so a 12° slope of the eastern face of the Scats Stockpile will be constructed, although to a much lower height/shorter slope than the western and northern batters of the landform.

Stage 4 will remove the 'fingers and valleys' profile from the Scats Stockpile landform.
