## Progressive Rehabilitation and Closure Plan

**Mt Leyshon Mine**

M13000\_024-REP-001-2

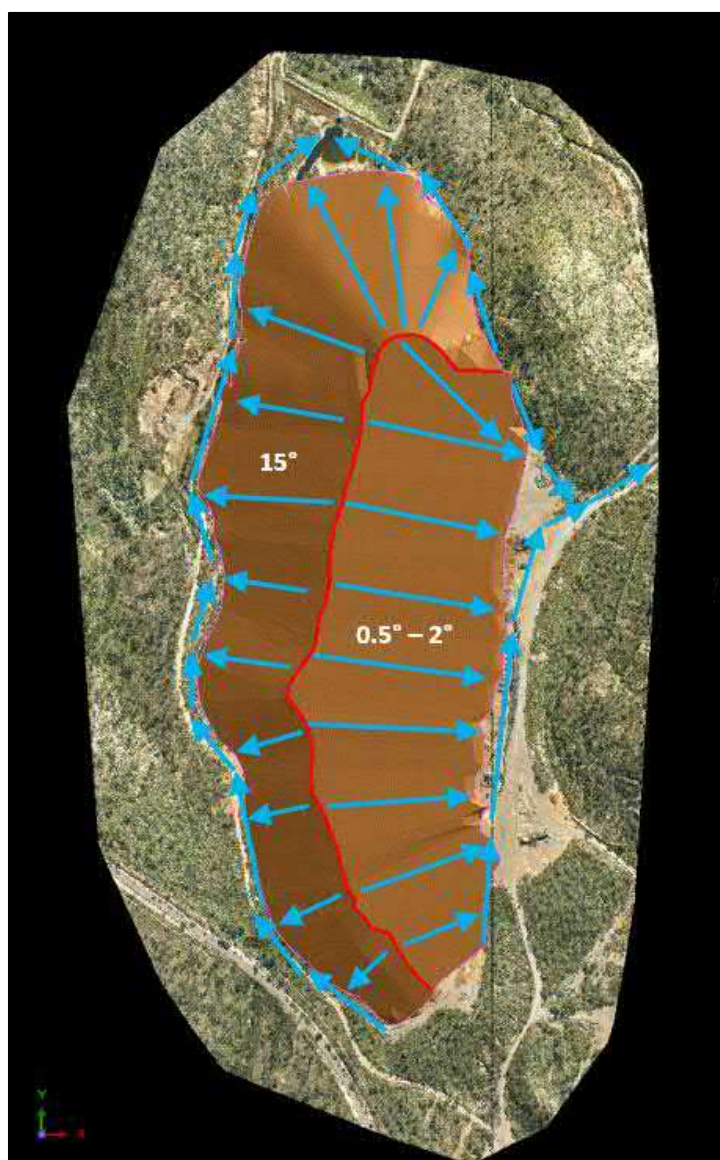
Figure 6: Scats Stockpile Drainage

Figure 6 shows the direction of surface water drainage flows off the Scats Stockpile surface at the completion of Stage 4. Surface water drainage on the rehabilitated landform will occur by way of sheet flow down the vegetated surfaces of the landform, with constructed drainage channels around the perimeter of the landform. The Plum Tree Creek Dam will be retained at the northern end of the landform to collect any seepage water and to act as a sediment dam for the steeper western and northern batters of the landform. The rehabilitated Scats Stockpile landform will be a free-draining surface.

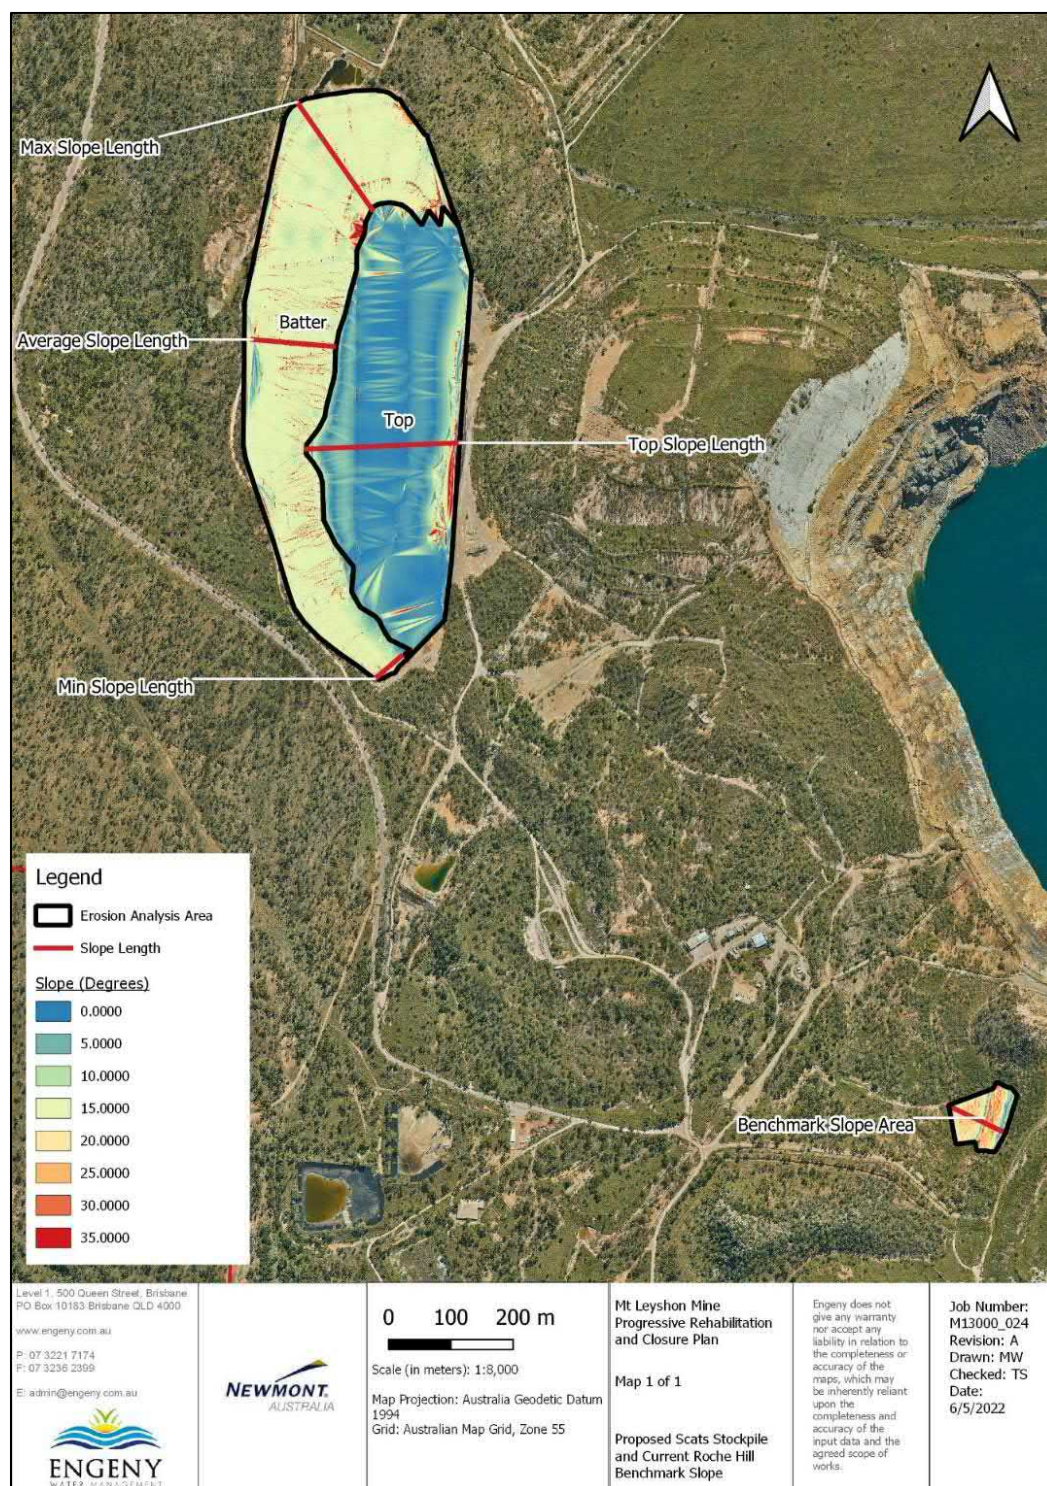
**Figure 7: Areas on the Scats Stockpile Final Landform for which LS Factors Were Derived**

LS factors for the Scats Stockpile and Roche Hill landform were derived using spatial data (refer to Figure 7 and Table 1). LS factors were derived for four different locations on the Scats Stockpile final landform, representing the range of slope gradients and lengths, and therefore soil erosion rates, that may be encountered on the rehabilitated Scats Stockpile landform (and Roche Hill).

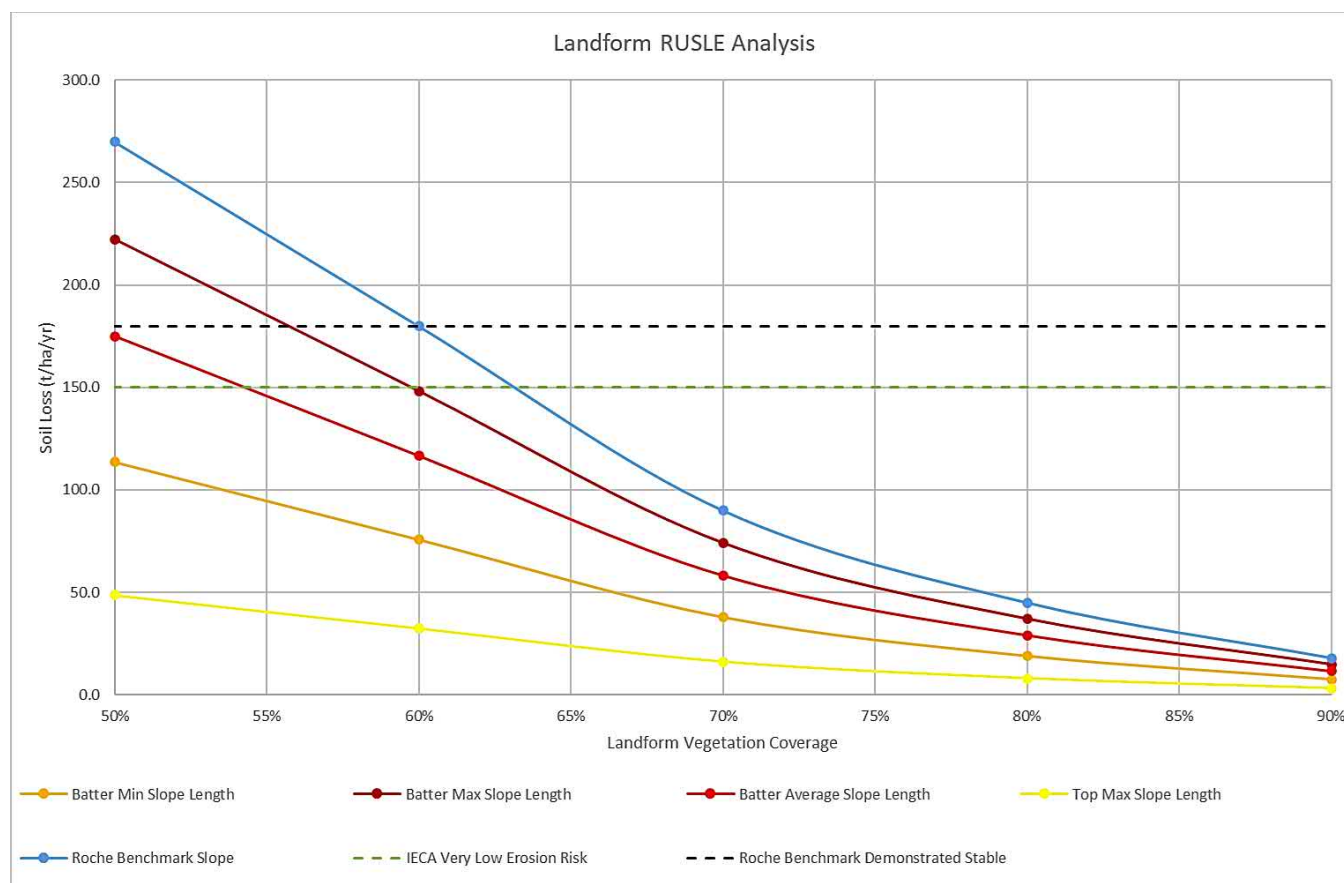
**Figure 8: Results of the Erosional Stability Assessment for the Scats Stockpile Final Landform**

The results of the erosional stability assessment for the Scats Stockpile final landform are presented in Figure 8.

- The top of the Scats Stockpile final landform represents the lowest risk of erosion – lower than the Roche Hill landform and lower than the IECA threshold for ‘very low’ erosion hazard landforms. The predicted rate of soil loss from the top of the Scats Stockpile once 90% vegetation coverage is achieved is approximately 3.2 t/ha/yr.
- The batters of the Scats Stockpile also present a relatively low risk of erosion – lower than the Roche Hill landform, and lower than the IECA threshold for ‘very low’ erosion hazard landforms once 60% vegetation coverage on the steepest areas of the batters has been achieved. The predicted rate of soil loss from the batters once 90% vegetation coverage is achieved ranges from 7.6 t/ha/yr on the shallow slopes and 14.8 t/ha/yr on the steep slopes.

The rate of soil erosion from all areas on the rehabilitated Scats Stockpile final landform is predicted to be less than the IECA threshold for ‘very low’ erosion hazard landforms once 60% vegetation coverage has been achieved. Considering that growth media for the Scats Stockpile rehabilitation will be sourced from a similar area to where growth media was sourced for Roche Hill, it is expected that 60% vegetation coverage on the Scats Stockpile will be achieved in a similar timeframe to Roche Hill (approximately two years). This timeframe has been factored in the PRCP schedule.

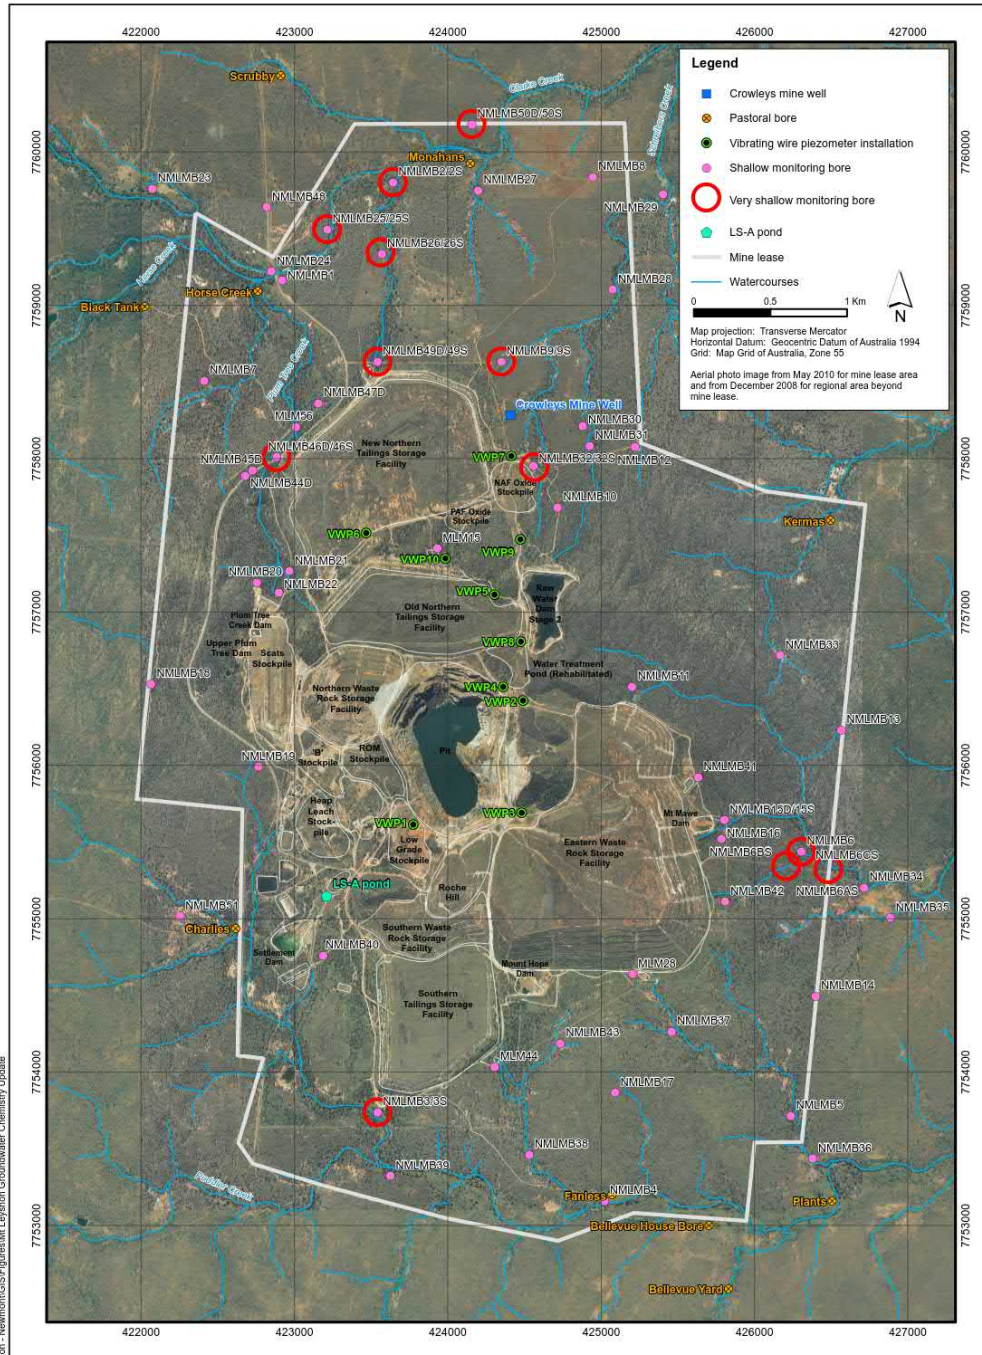
Figure 1

Groundwater monitoring locations

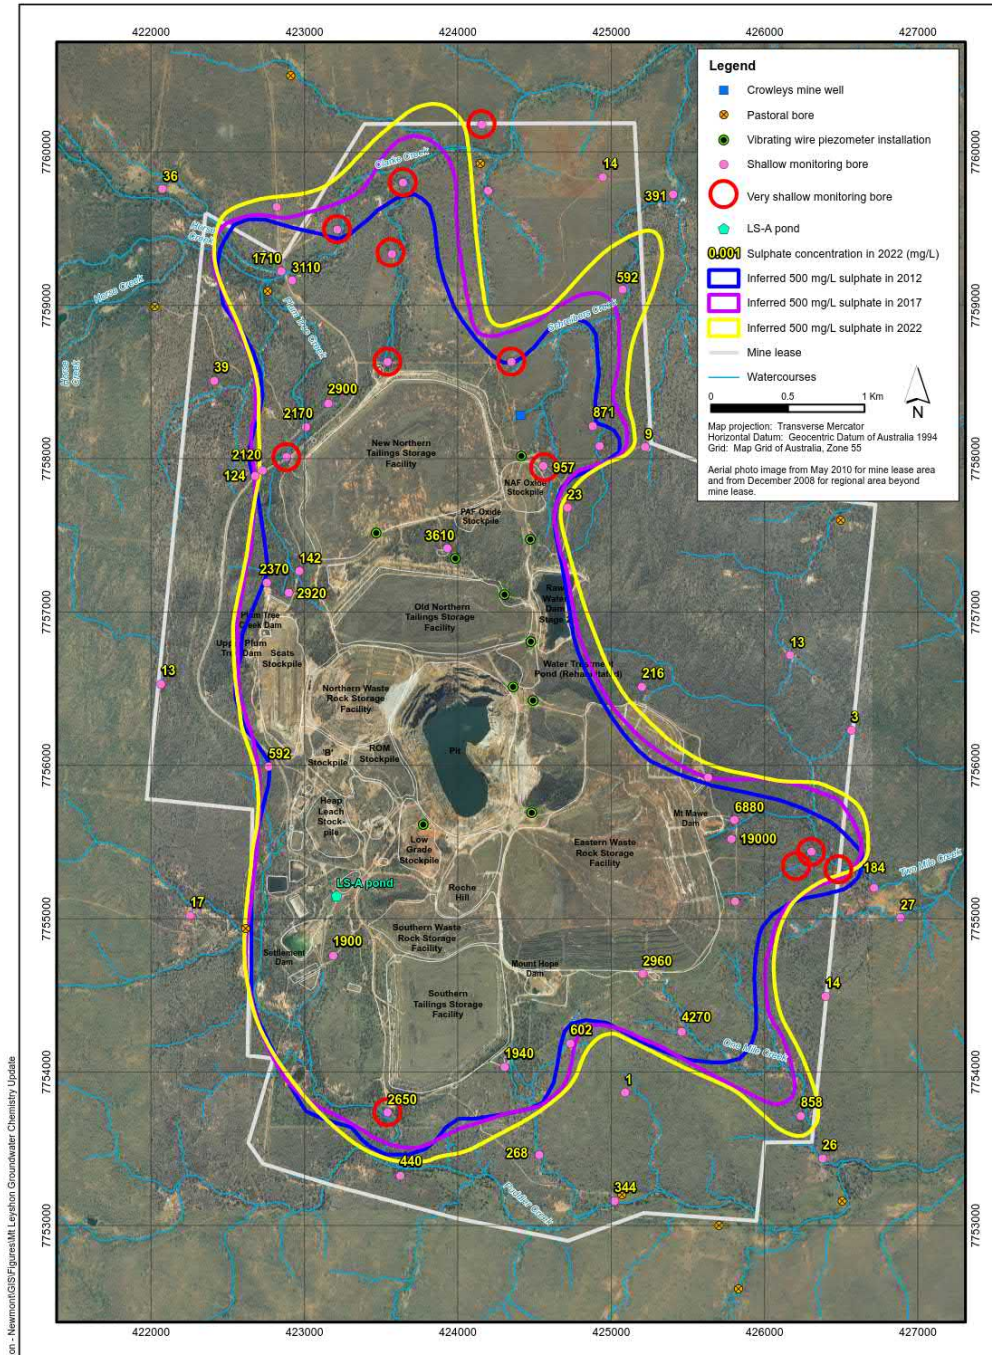
**Figure 3**

**Inferred extent of sulphate above  
500 mg/L in groundwater**

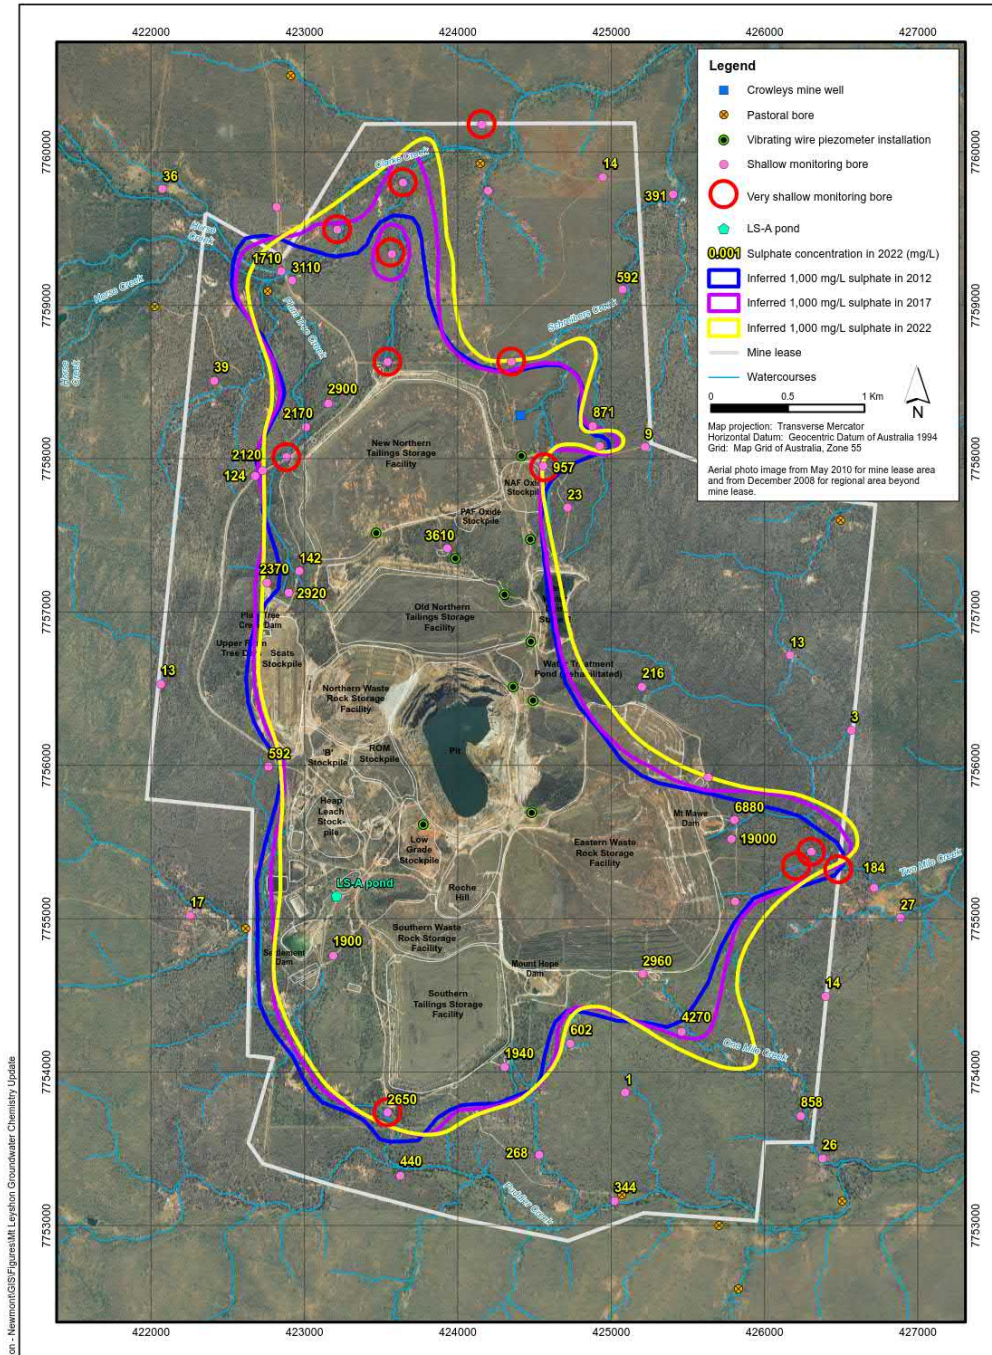
**Figure 4**

**Inferred extent of sulphate above  
1,000 mg/L in groundwater**

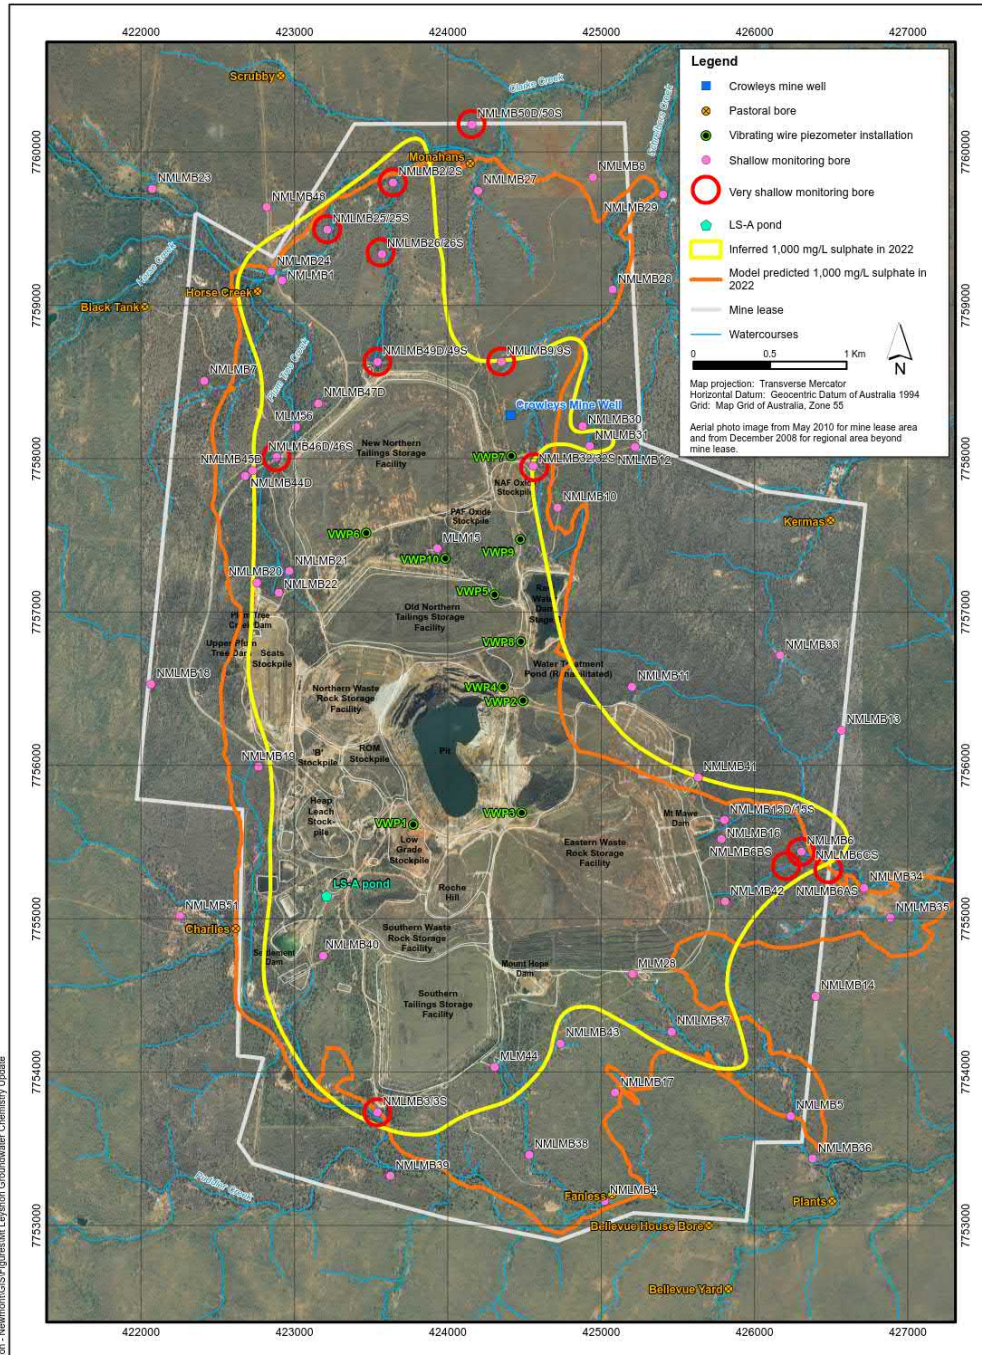
**Figure 9**

**Comparison of 2022 sulphate concentrations against model**

The GMP presented contours for the model predicted position of the 1,000 mg/L sulphate contour for prediction year 2022. Figure 9 compares the actual sulphate extent in 2022 with the model predicted extent in 2022 under the basecase model assumptions. The observed data confirm that the general shapes and locations of the model contours are consistent with the actual distributions, and also that the model is highly conservative, in that to the northeast and southeast, the model predicts significantly more sulphate migration in 2022 than has been observed. The over prediction of the current sulphate extent may result from the model assumed seepage infiltration rates reflecting both operating and covered conditions, while the observed responses are now more driven by the closed conditions.

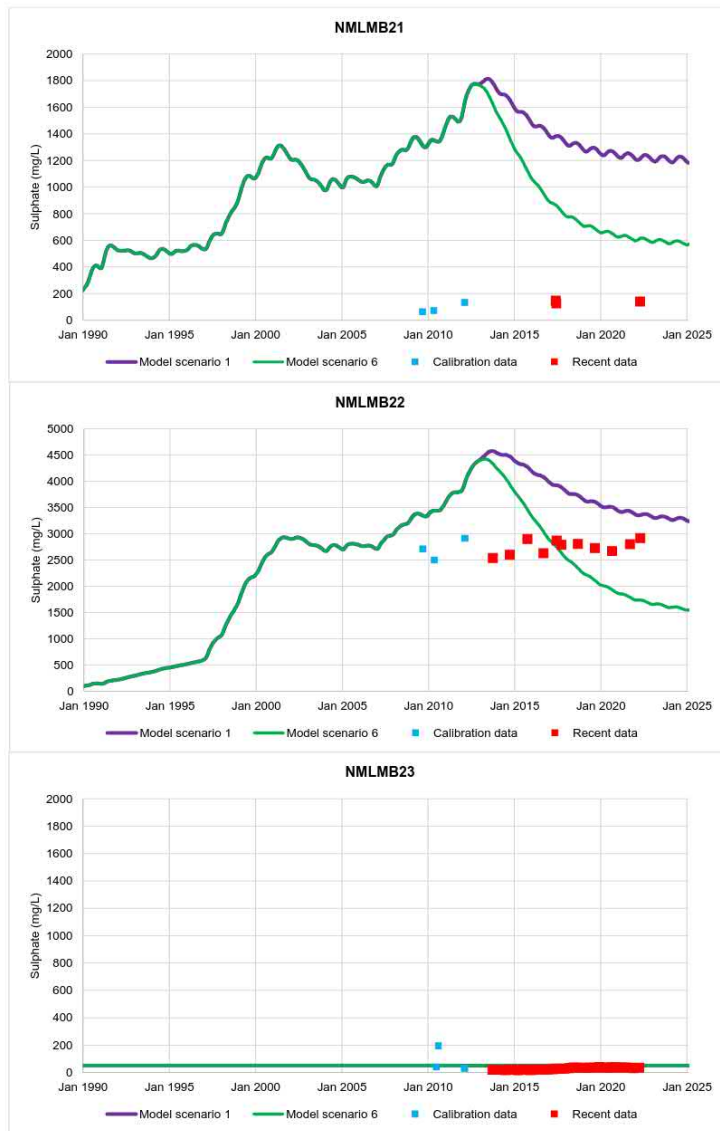
Figure C7

Modelled and observed sulphate trends part 7

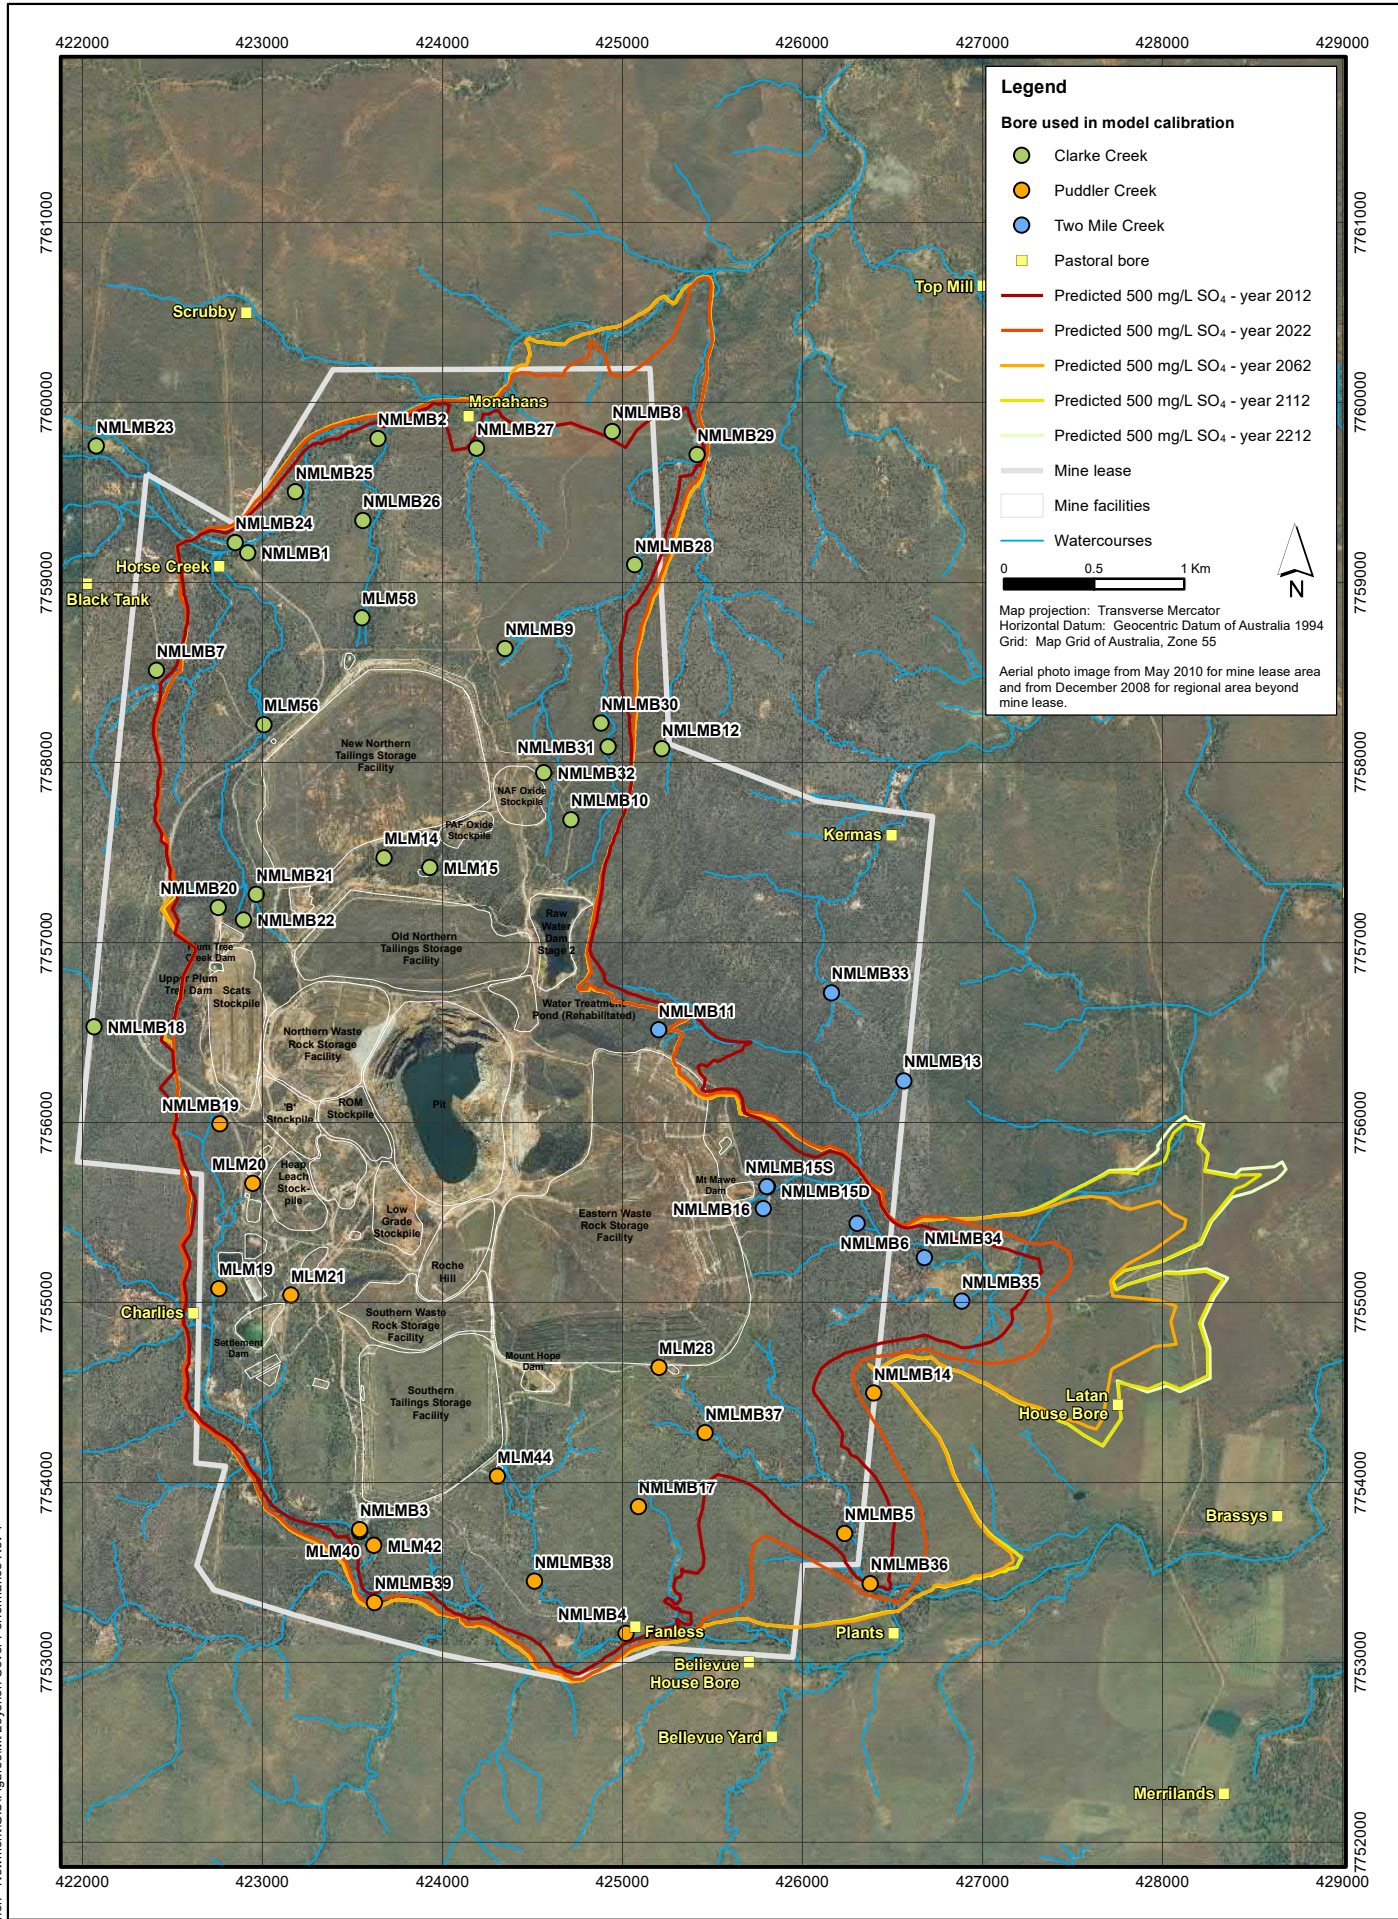
**Figure 1**

**Basecase model predictions for 500 mg/L sulphate contour**

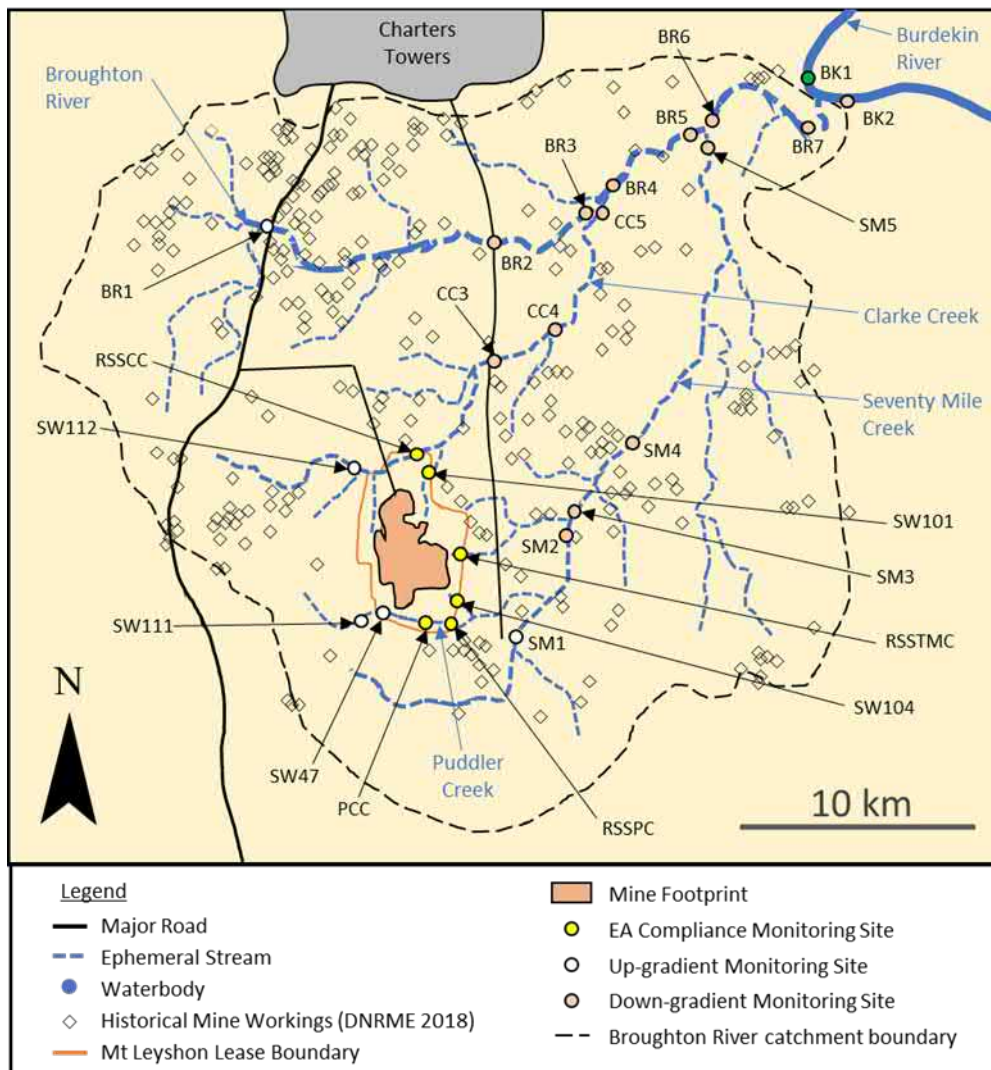
**Figure 1:** Surface water drainages and REMP surface water monitoring locations.

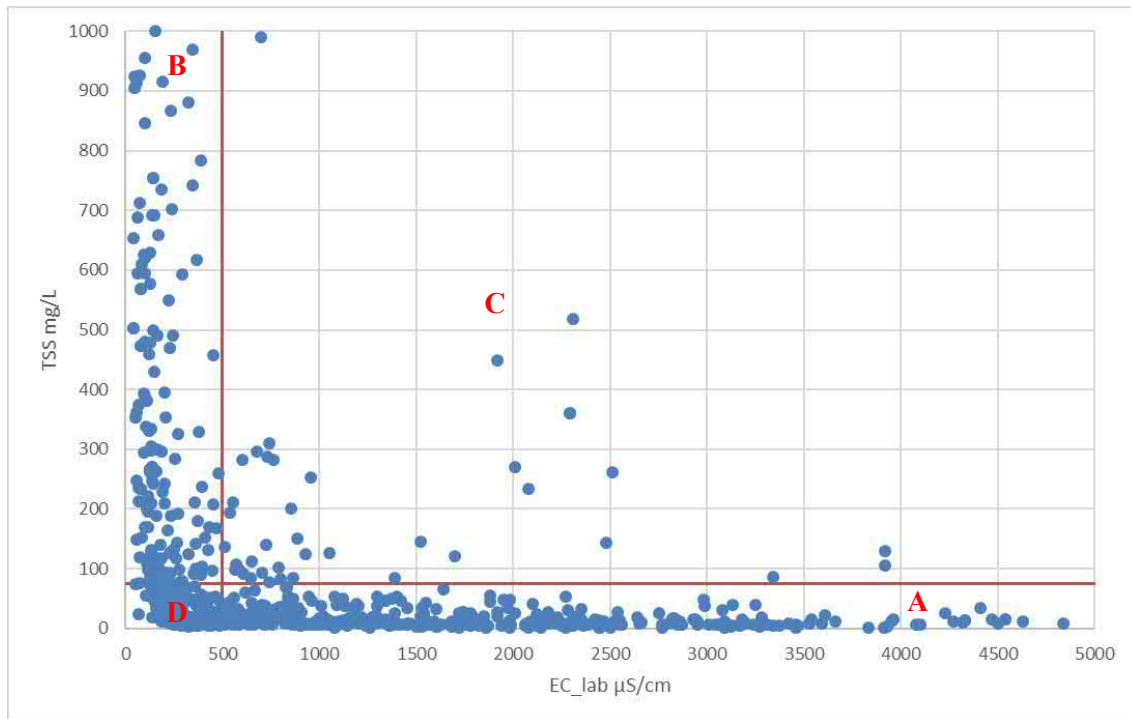
**Figure 2:** Boundary partitioning for discrimination of ambient water quality conditions for the historical sampling record at Mt Leyshon. The red lines represent an ambient boundary of  $500 \mu\text{S/cm}$  (vertical) and  $75 \text{ mg/L}$  TSS (horizontal). Letter in red represent the different water quality conditions described in Section 4 above.

The Mt Leyshon surface water database contains data collected under pulse/event flow, ambient, first flush and intermediate conditions. To separate ambient water quality from other conditions, boundaries for EC and TSS were used to partition the data (Figure 2). If either the TSS or EC values for a given data point were missing, data was excluded from further assessment. Duplicate and blank samples collected for QA/QC purposes were also excluded (Tables 1 & 2).

The criteria for partitioning ambient conditions were  $\text{TSS} < 75 \text{ mg/L}$  and  $\text{EC} > 500 \mu\text{S/cm}$  ('A' in Figure 2). Pulse flow conditions are typically represented by high TSS ( $>75 \text{ mg/L}$ ) and lower EC ( $< 500 \mu\text{S/cm}$ ) values and identified as 'B' in Figure 2. Possible first flush conditions were characterised as being high TSS and corresponding high EC ('C' in Figure 2), while indeterminate conditions had low TSS and low EC ('D' in Figure 2). The  $500 \mu\text{S/cm}$  EC threshold was used as a proxy for potential natural groundwater influence which typically lies in the range of  $800 - 2500 \mu\text{S/cm}$  (see Section 3 above). The TSS threshold was set to reflect lower TSS conditions typical of ambient conditions. The threshold value for TSS is higher than ambient thresholds for ecological settings (e.g. Newham et al, 2017), but provides a slightly more conservative threshold for incorporating data that reflects first potential for groundwater expression into the surface water environment.

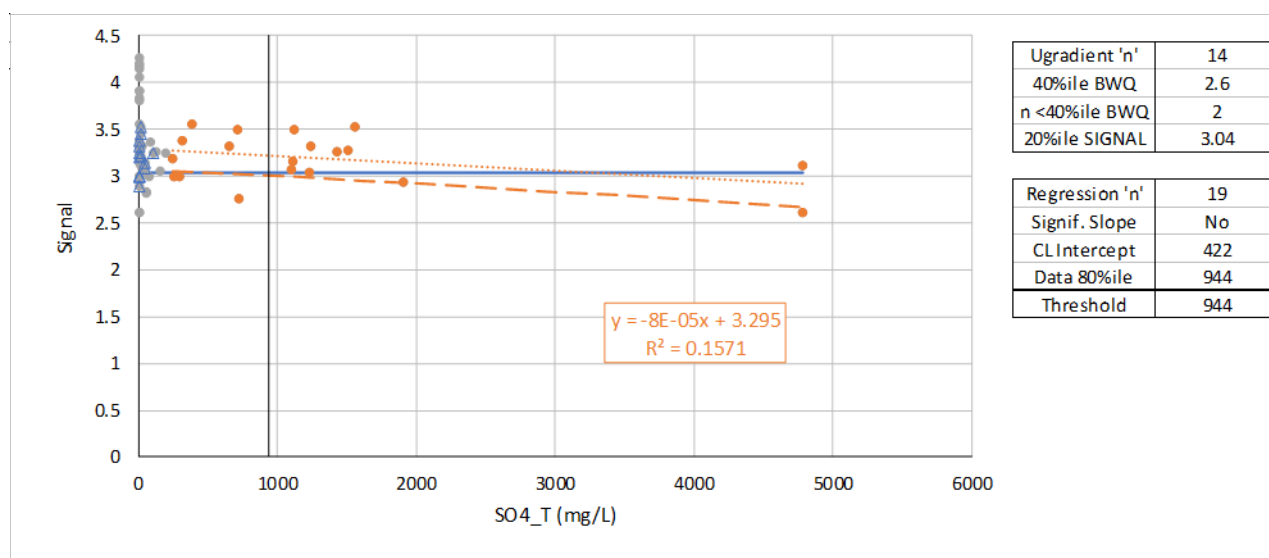
**Figure 3:** Historical relationship between aquatic macroinvertebrate SIGNAL score and sulphate for the historical sampling record at Mt Leyshon.

'n <40%ile BWQ' = the number of upgradient records in the historical macroinvertebrate dataset where the corresponding water quality result was less than the '40%ile BWQ' (i.e. upgradient macroinvertebrate records associated with relatively 'natural' background water quality. '20%ile SIGNAL' = the 20th percentile SIGNAL score for the sub-set of upgradient records with relatively 'natural' background water quality. The horizontal blue line on the plot also shows this '20% SIGNAL' value (Figure 3).

'CL Intercept' = the water quality parameter value at the intercept between the lower 80th percentile, one-tailed confidence limit for the regression and the horizontal line defined by '20%ile SIGNAL'. 'Data 80%ile' = the 80th percentile water quality parameter value for all macroinvertebrate records with SIGNAL score greater than the '20% SIGNAL' value. 'Threshold' = the identified threshold for potential change in the macroinvertebrate community compared with relatively 'natural' background conditions. Where the slope of the regression is significantly different from zero ( $p < 0.05$ ) this was taken as the intercept of the regression confidence limit and the background 20th percentile condition (i.e. 'CL Intercept'). Where the slope of the regression is not significantly different from zero this was taken as the 80th percentile water quality value for the set of records with community outcomes better than the background 20th percentile condition (i.e. 'Data 80%ile'). The vertical black line on the plot also identifies the 'Threshold' value – in this case 944 mg/L  $\text{SO}_4$ .

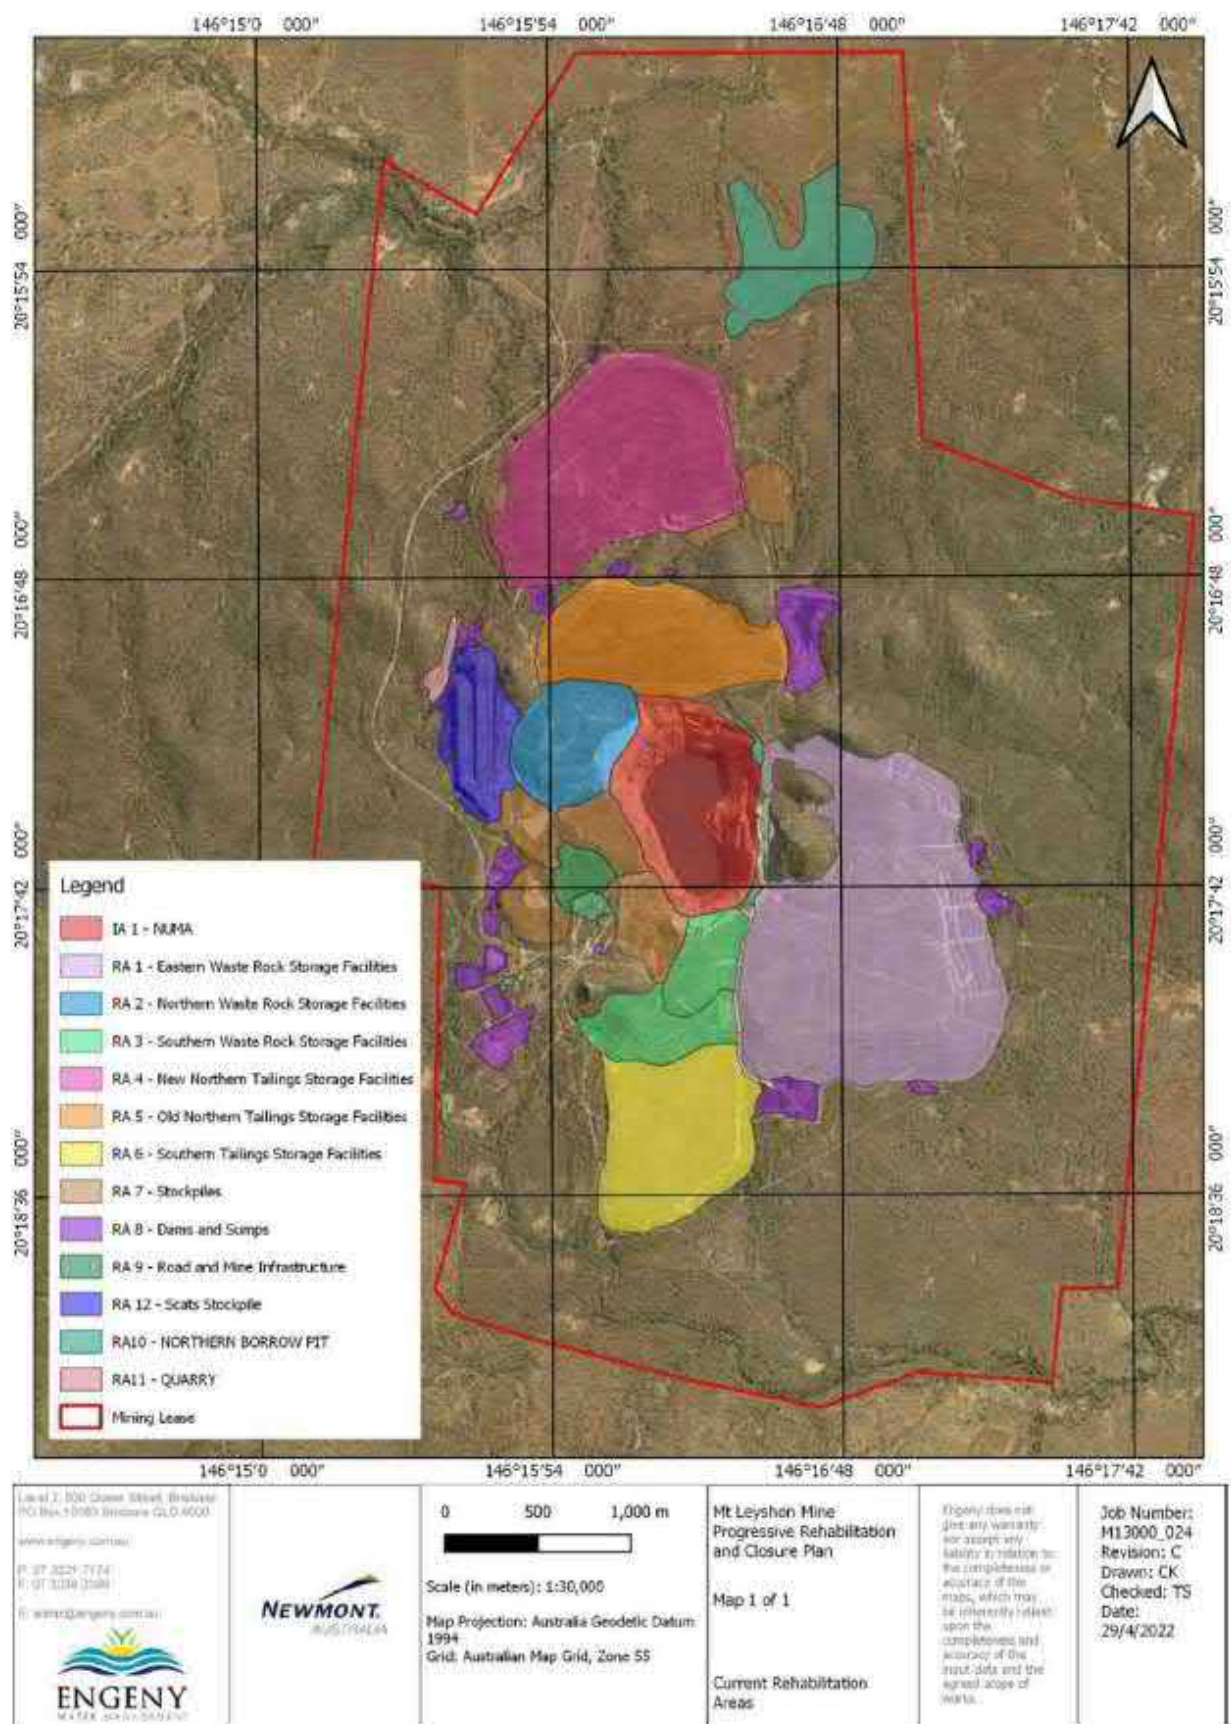
Figure 2. Rehabilitation Areas and Improvement Areas

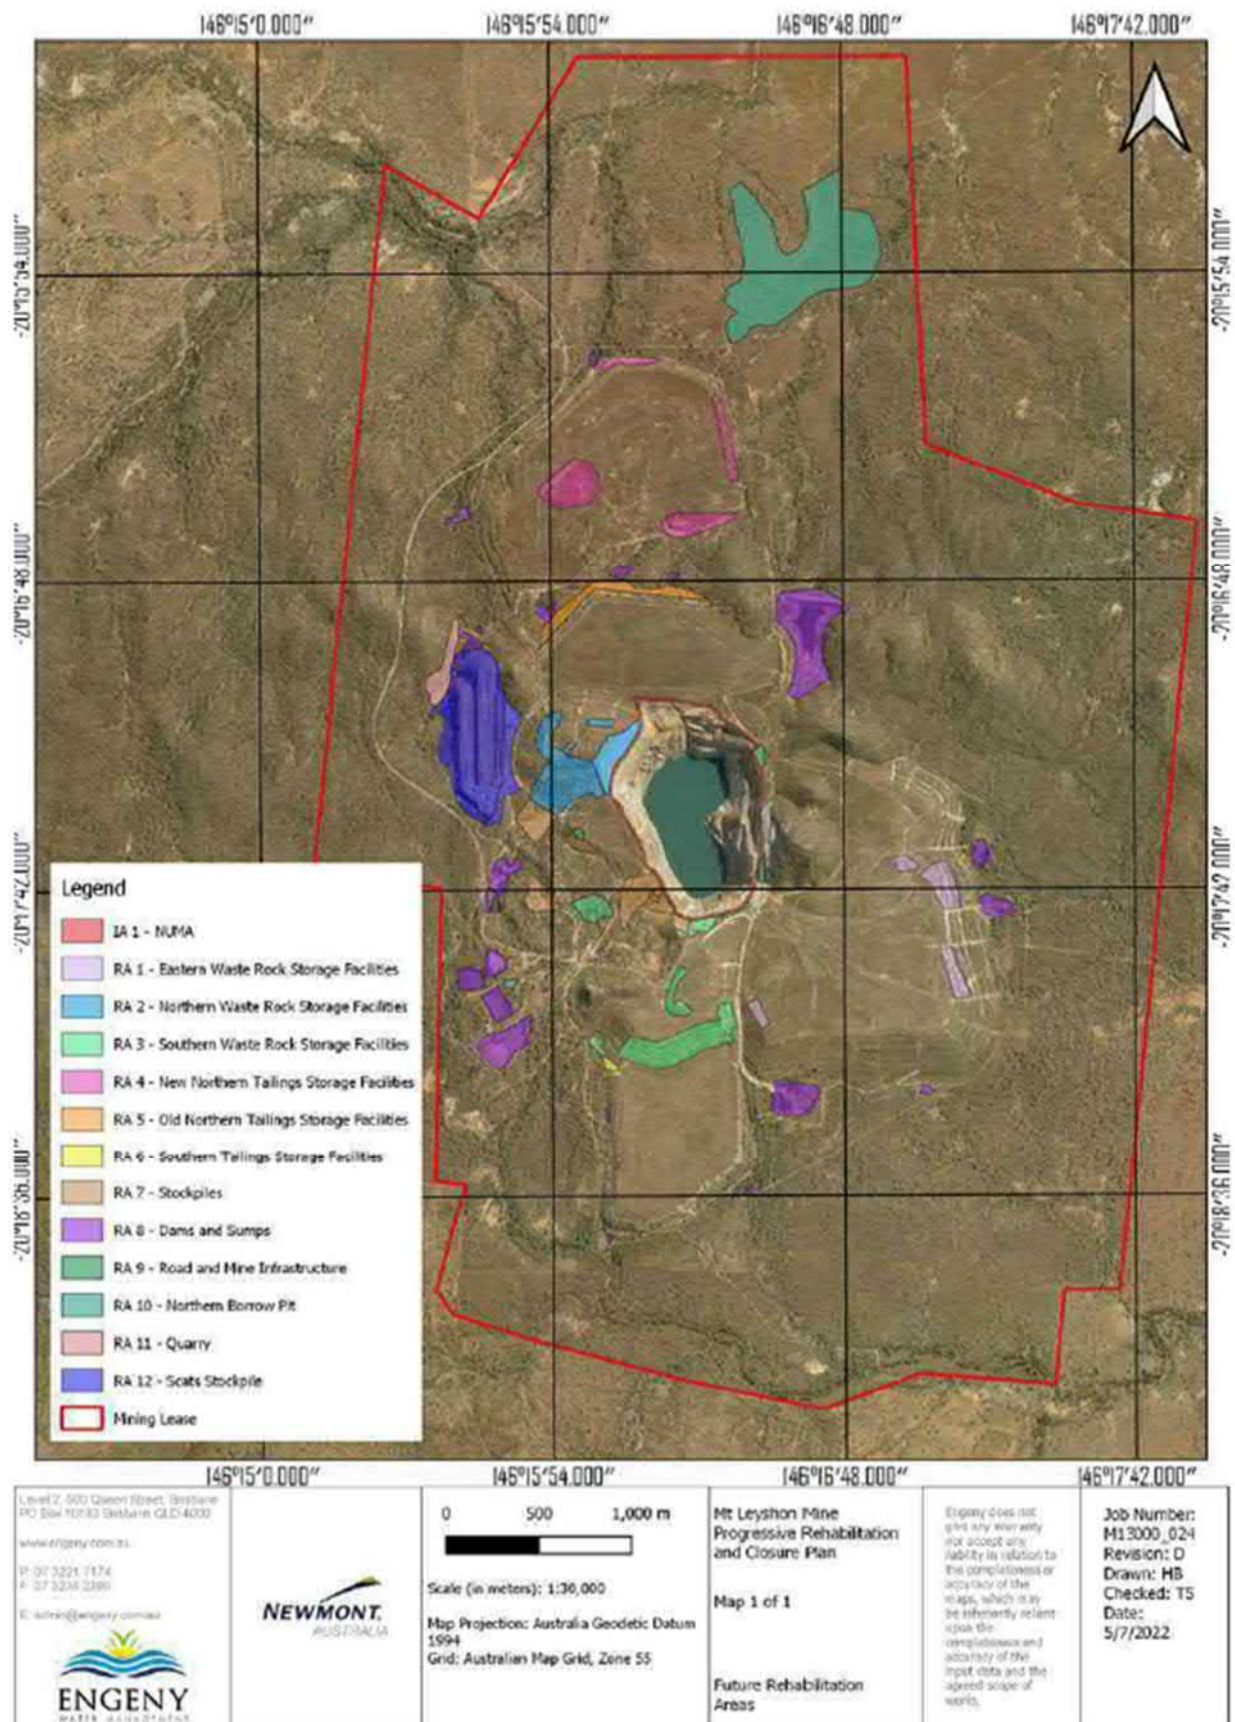
**Figure 3.** Areas where further rehabilitation works will be undertaken
