# Detailed Mine Closure Plan

## Burton Mine

Prepared for Peabody (Burton) Pty Ltd | December 2018

Project number:	I8019
Document title:	Detailed Mine Closure Plan   Burton Mine
Revision:	V2-2
Date:	19 December 2018
Client:	Peabody (Burton) Pty Limited
Project manager:	T Rohde
Author:	T Rohde / K Drapala

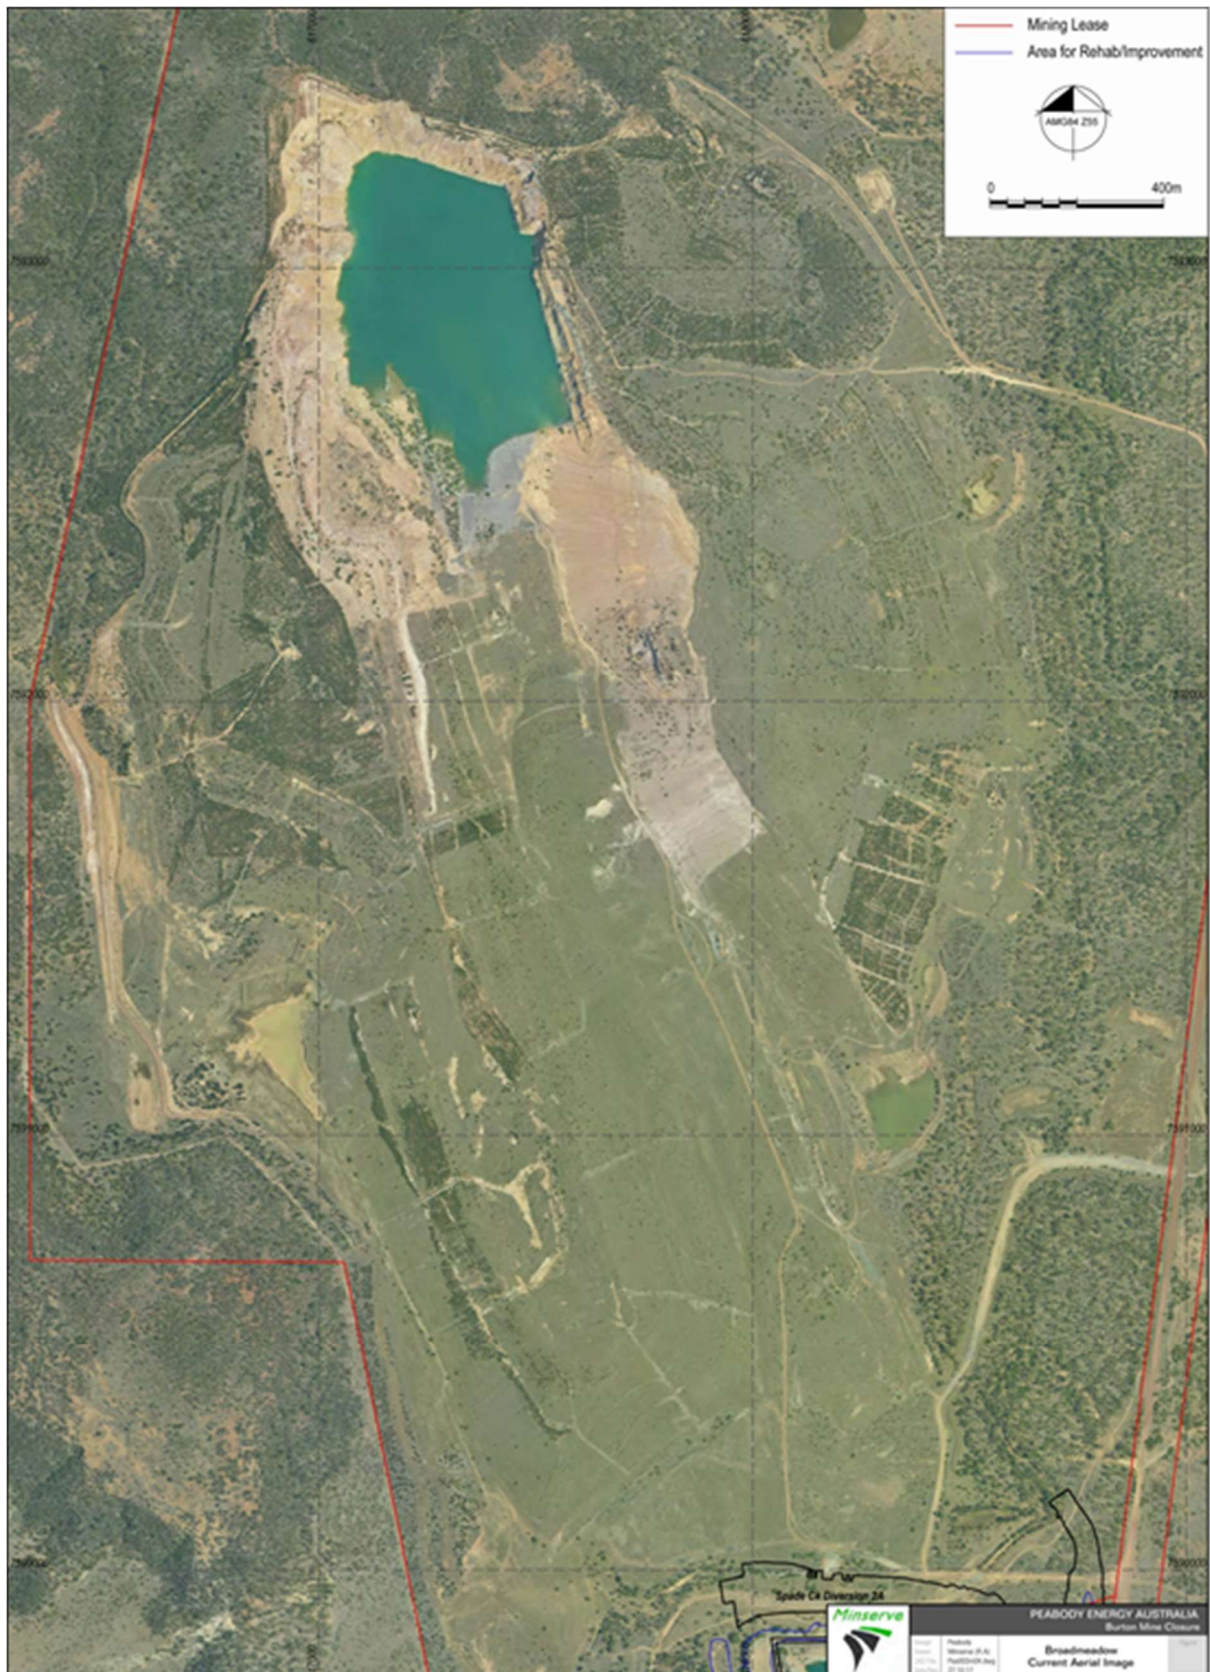
**Figure 8 Existing Wallanbah Pit landform**

Figure 8 shows the existing landform of the Wallanbah Pit.

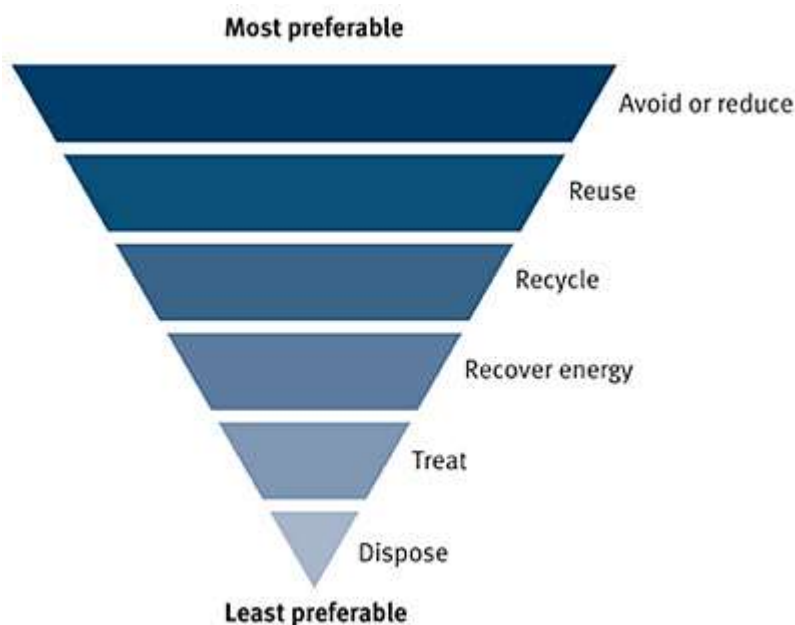
**Figure 17** Waste and resource management hierarchy

Where practicable, consideration will be given to Waste — *Everyone's responsibility: Queensland Waste Avoidance and Resource Productivity Strategy (2014–2024)* (EHP 2014) waste and resource management hierarchy, in decreasing order of preference as shown in Figure 17.
