Codrilla Coal Mine Project Progressive Rehabilitation & Closure Plan

ML 70450 & ML 70455

Prepared for:	Department of Environment and Science
Prepared by:	Peabody on behalf of the CMJV
EA holders:	Peabody Coppabella Pty Ltd – CITIC Australia Coppabella Pty Ltd – Winchester Coal Operations Pty Ltd – KC Resources Pty. Ltd. – NS Coal Pty Ltd
EA holder contact details:	Level 5, 100 Melbourne Street, South Brisbane, QLD 4101
Document ID No.:	PRCP2021:1 Codrilla Mine
Version:	v.3
Date resubmitted:	14 February 2022

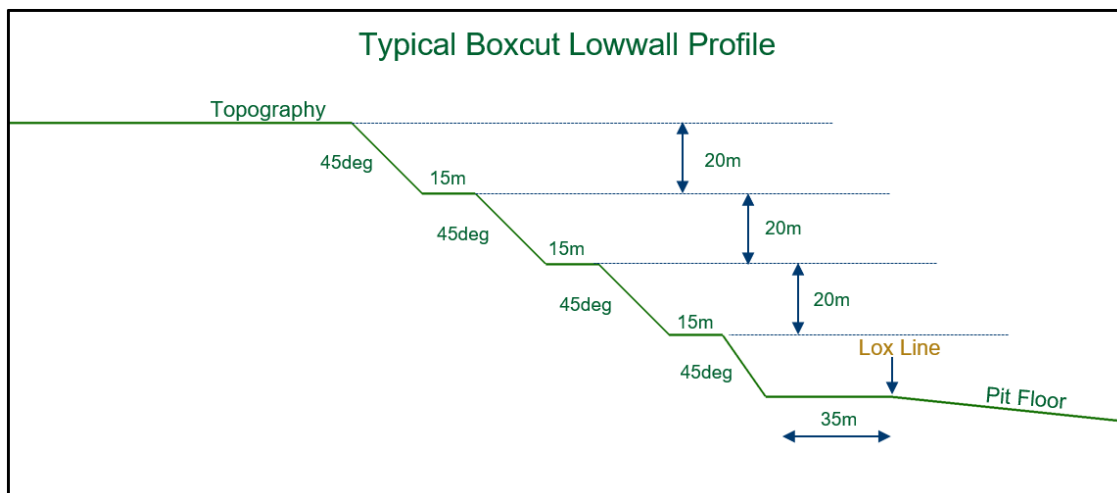
Figure 42 Generic Cut Slope Design for Low Walls

The initial low wall will be cut into natural Tertiary material and will be constructed to a similar profile as the highwall above the base of weathering. The profile will be constructed in 20m stages with a 10m bench between each stage and batter slopes of 45°. The overall batter angle will be in the order of 35° as a result of the 10m step back between each 20m section. The generic low wall slope profile is presented in Figure 42 below.
