Capricorn Stone Products PL Rehabilitation Management Plan

Capricorn Stone Products Pty Ltd – Rehabilitation
Management Plan - Capricorn Sandstone Quarries, 227
Power Station Road, Stanwell 4702

Report Type: Rehabilitation Management Plan

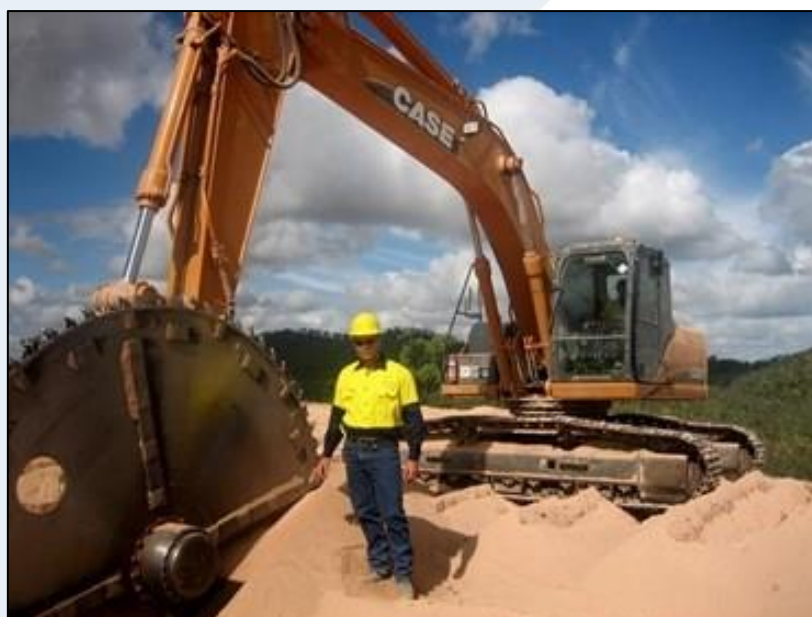
Figure 2. Excavator mounted stone saw.

When Roy Gough and his son Reece reopened the quarry in 1994 the blocks were cut with Fantini chainsaws, then drilled underneath to extract the blocks. CSP has come a long way since then with substantial investments in excavator mounted cutting wheels (see Figure 2). These have enabled CSP to significantly improve efficiency whilst dramatically reducing physical workloads on employees concurrently.

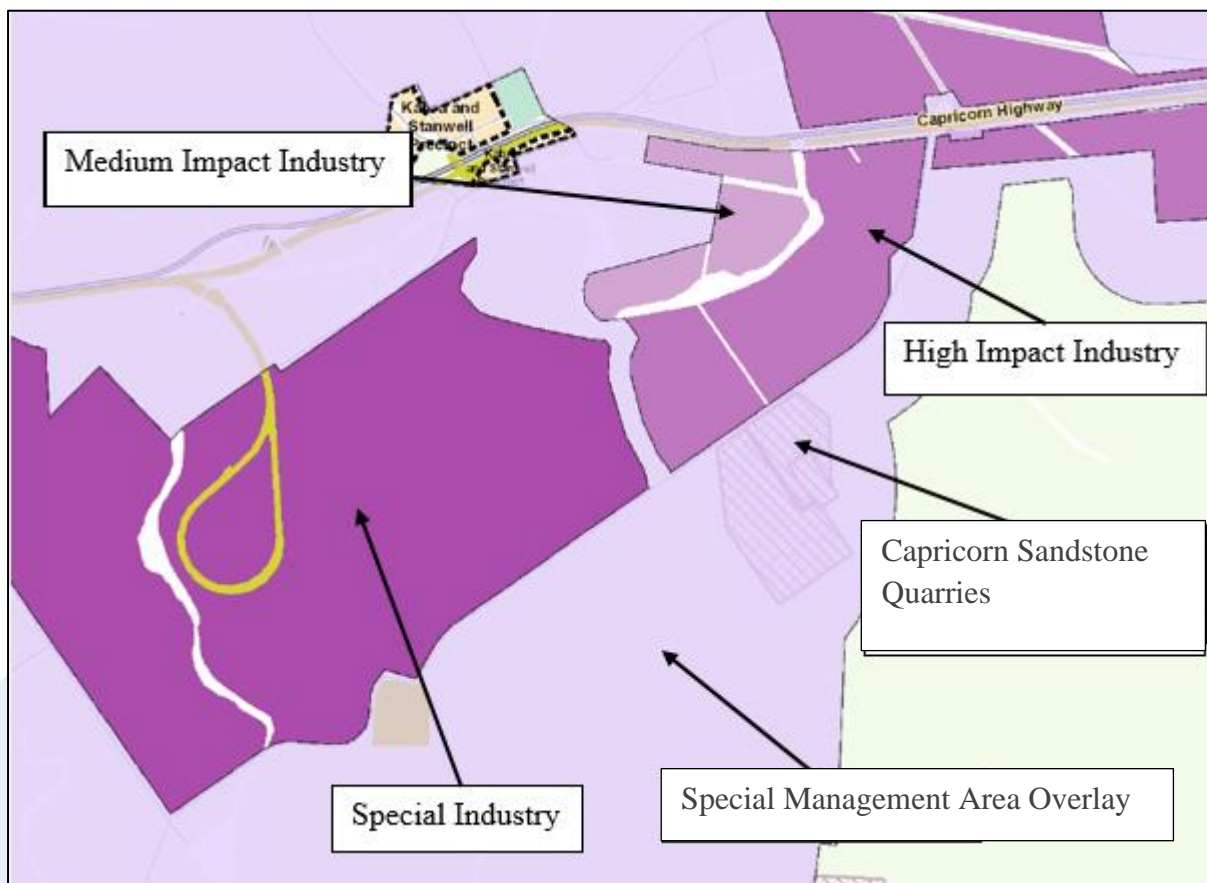
Figure 4. Industrial zoning in relation to Capricorn Sandstone Quarries.

Land use in the area consists of low value pasture, with some areas of sown pasture use. The surrounding area is also zoned for rural residential, medium impact industry, high impact industry and special industry under the Rockhampton Regional Council planning scheme (see Figure 4 and Appendix B). Much of the Stanwell corridor is also subject to special management area overlay.

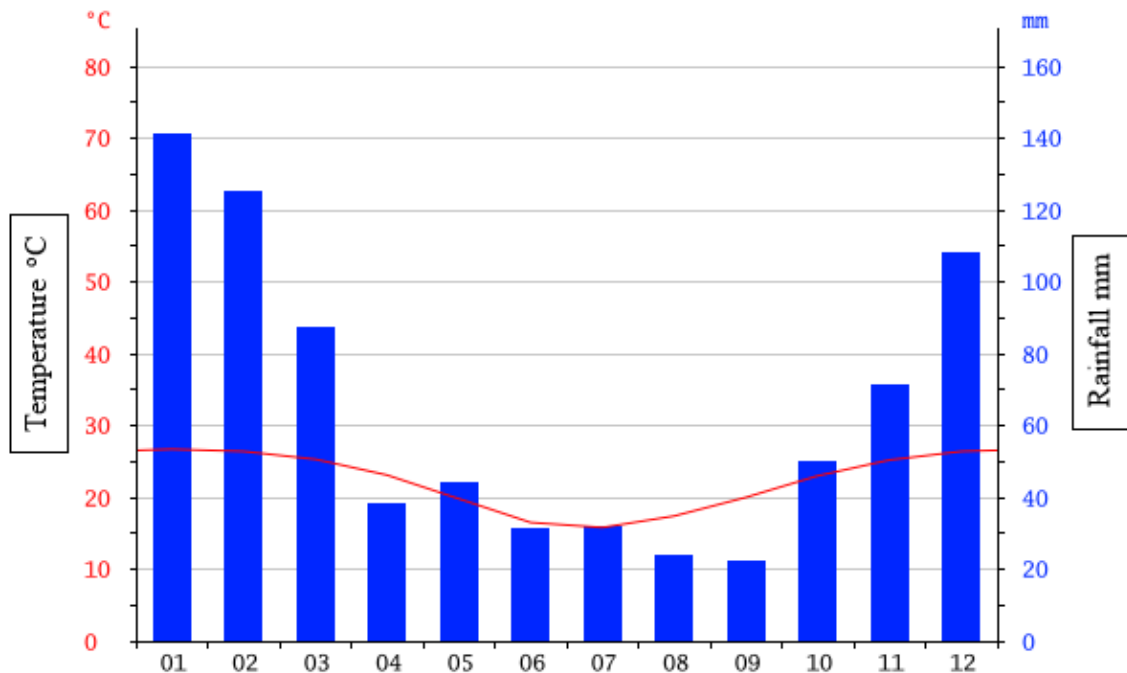
Figure 5. Average temperature and rainfall data for the Stanwell area.

The climate is classified as warm and temperate. The average rainfall is 773mm with the majority falling between October and March (see Figure 5). Average temperature ranges from 26.7 °C in January to 15.8 °C in July (see Figure 5).

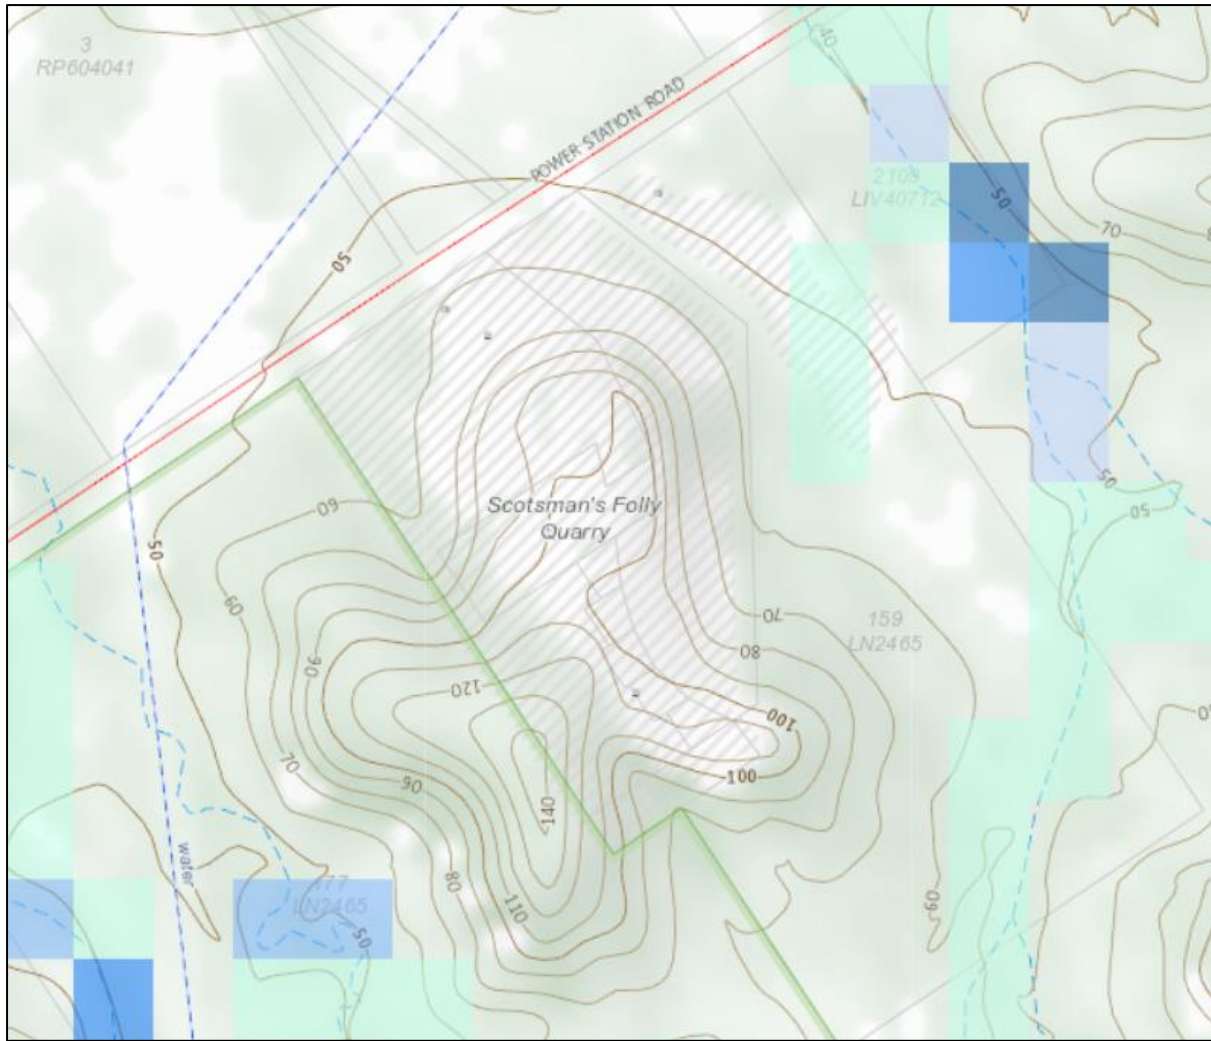
Figure 6. NRM Flood check mapping for Capricorn Sandstone Quarries from basin 1% AEP showing no impact.

The entire site of the mine is located in an elevated position on a sandstone outcrop and is therefore unlikely to be impacted in any significant manner by flooding. Consideration of the mine in relation to NRM Flood check mapping (<https://floodcheck.information.qld.gov.au/>) indicates no impacts from basin 1% AEP and only a very small potential impact on a single isolated area from basin extreme events (Fig. 6 & 7).

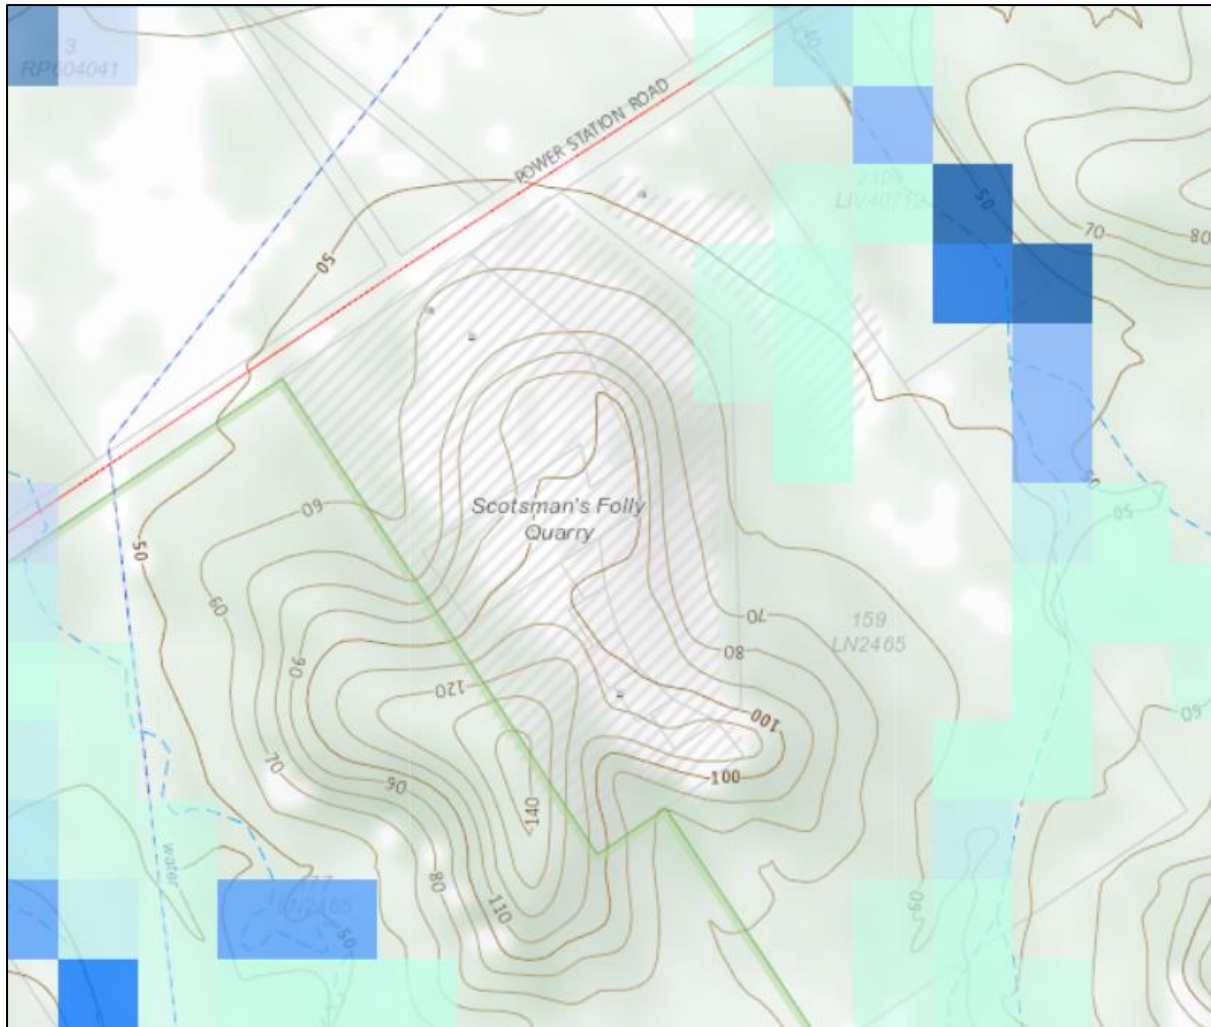
Figure 7. NRM Flood check mapping for Capricorn Sandstone Quarries from basin extreme events, showing very minor potential impact in one isolated area.

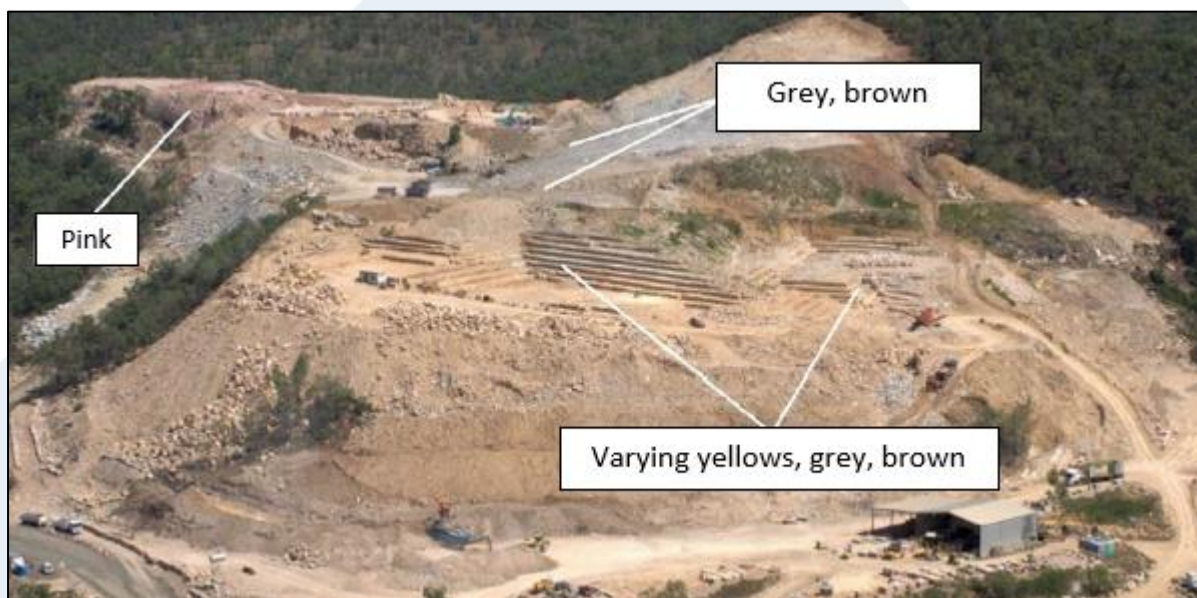
Figure 9. Variability of product across Capricorn Sandstone Quarries.

Mining operations at Capricorn Sandstone Quarries are somewhat unusual, in that they provide a high value but low volume commodity. The sandstone that is extracted on site is not a homogenous resource. The characteristics of the stone is highly variable across the site (see Figure 7) and demand for stone with certain features can vary significantly from a temporal point of view. This characteristic means that mining is not performed on a progressive basis, as consumer demand dictates when and where extraction is occurring on site. Essentially, this results in the entire site being active for the entire life of the mine. The non-progressive nature of mining activities on the site precludes progressive rehabilitation of the site. Rehabilitation of a dormant area only to reopen extractive activities at a later date would be both economically and environmentally irresponsible.

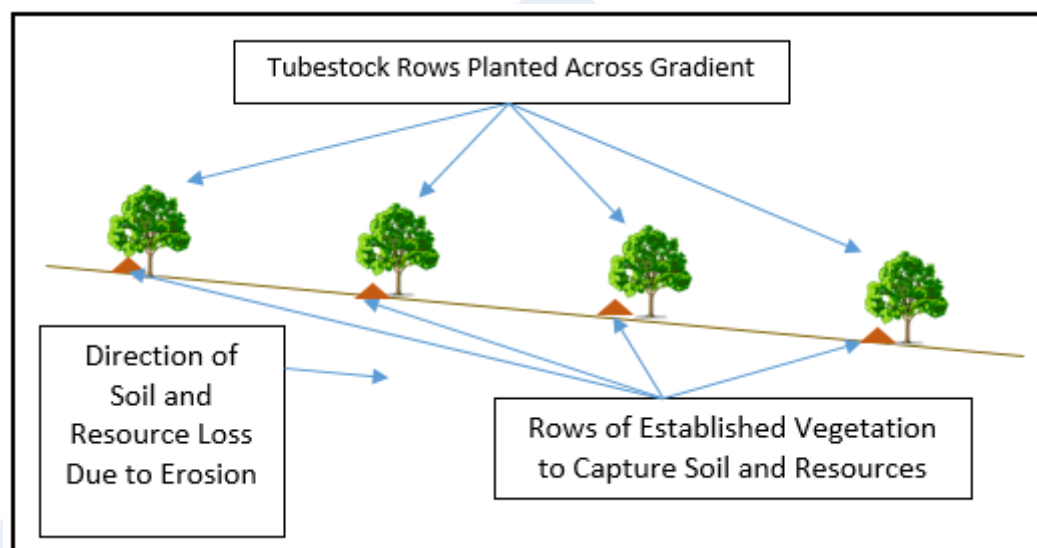
Figure 10. Across gradient rows of tube stock aimed at enhancing soil stability, reducing erosion and accelerating rehabilitation timeframes.

Tube stock planting will be supported by watering where required, which will be enabled by the recycling of water held in the onsite water management dams. This will allow for the establishment of tree and shrub species before the onset of the wet season, will enhance the establishment of native species, thereby accelerating trends towards rehabilitation goals. This will also facilitate root penetration of the soil with the view to enhance soil stability and thus reduce erosion. Tube stock plantings will be in rows across gradient and with the contour of the site, to effectively reduce slope length and assist in the retention of soil and resources on the rehabilitation site (see Figure 8).

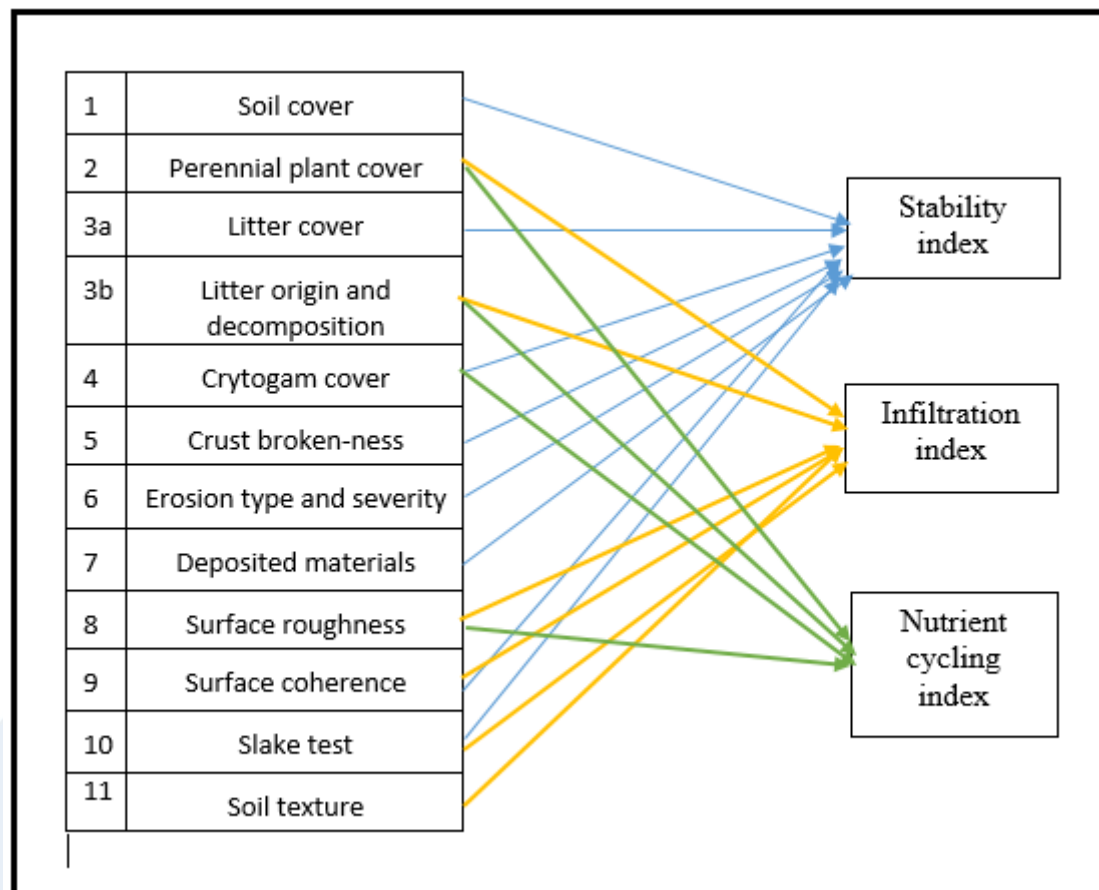
Figure 11. The 11 soil surface indicators and their relationship with the synthetic soil indices².

Revegetation criteria should be assessed against local reference sites that are to be used as benchmarks for final species diversity, abundance and dominance. Soil surface indicators will also require analysis in order to gain data for soil property comparison across reference and rehabilitation sites. Reference sites will be assessed using the principles of Landscape Function Analysis (LFA). This system uses a series of indicators including landscape organisation, which looks at the structures present in the landscape and how they interact to either retain or lose resources. LFA also considers a series of 11 soil surface indicators, the results of which are used to calculate three synthetic soil surface indices which show the sites ability to resist erosion, retain and store water and cycle nutrients in order to enhance and support plant growth (see Figure 9).

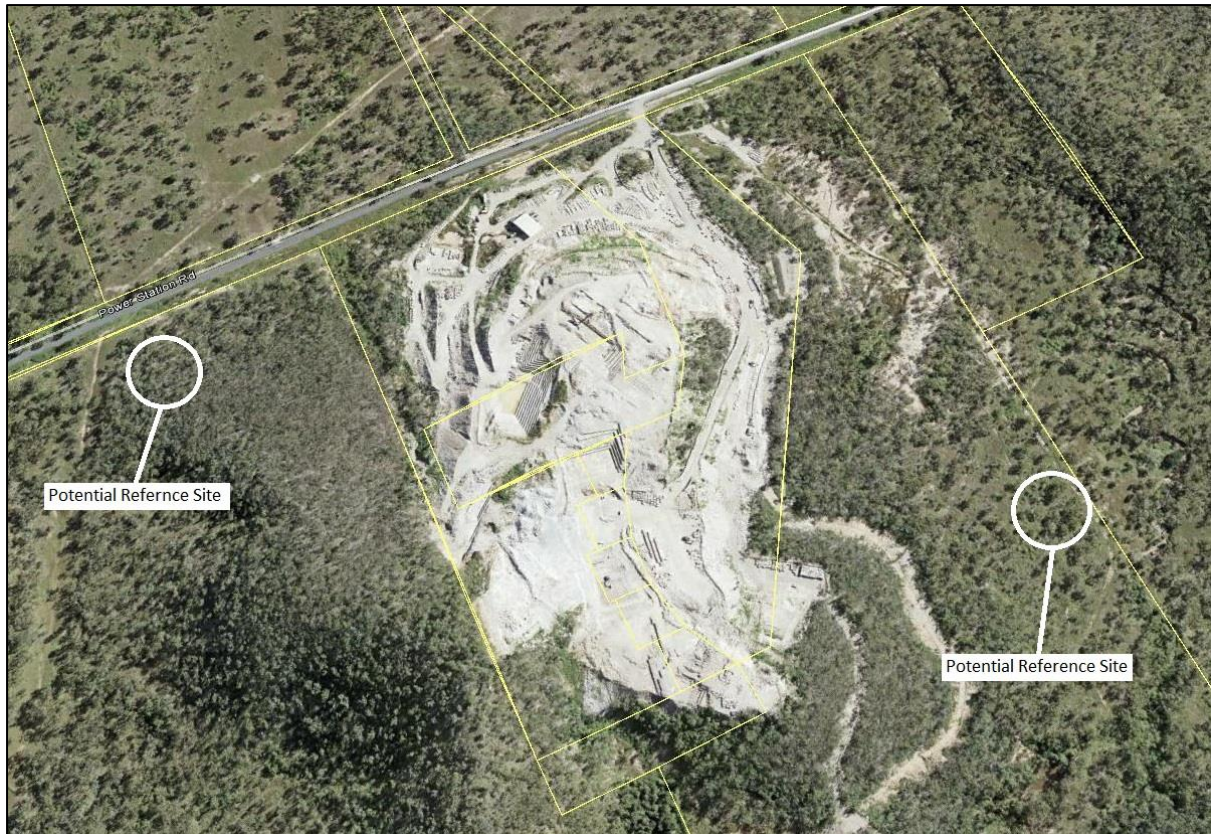
Figure 12. Potential rehabilitation reference sites.

Potential reference sites have been identified in Figure 10. These potential reference sites will be evaluated for suitability at an appropriate time in the future, closer to activation of rehabilitation actions.
