# **Progressive Rehabilitation and Closure Plan**

**Jubilee Metals Limited  
Croydon Gold Mine  
ML5248  
BAA220037.01  
13 November 2023**

| Required Cover Page Information | Description |
|---|---|
| Document title | Croydon Gold Mine Project – Progressive Rehabilitation and Closure Plan |

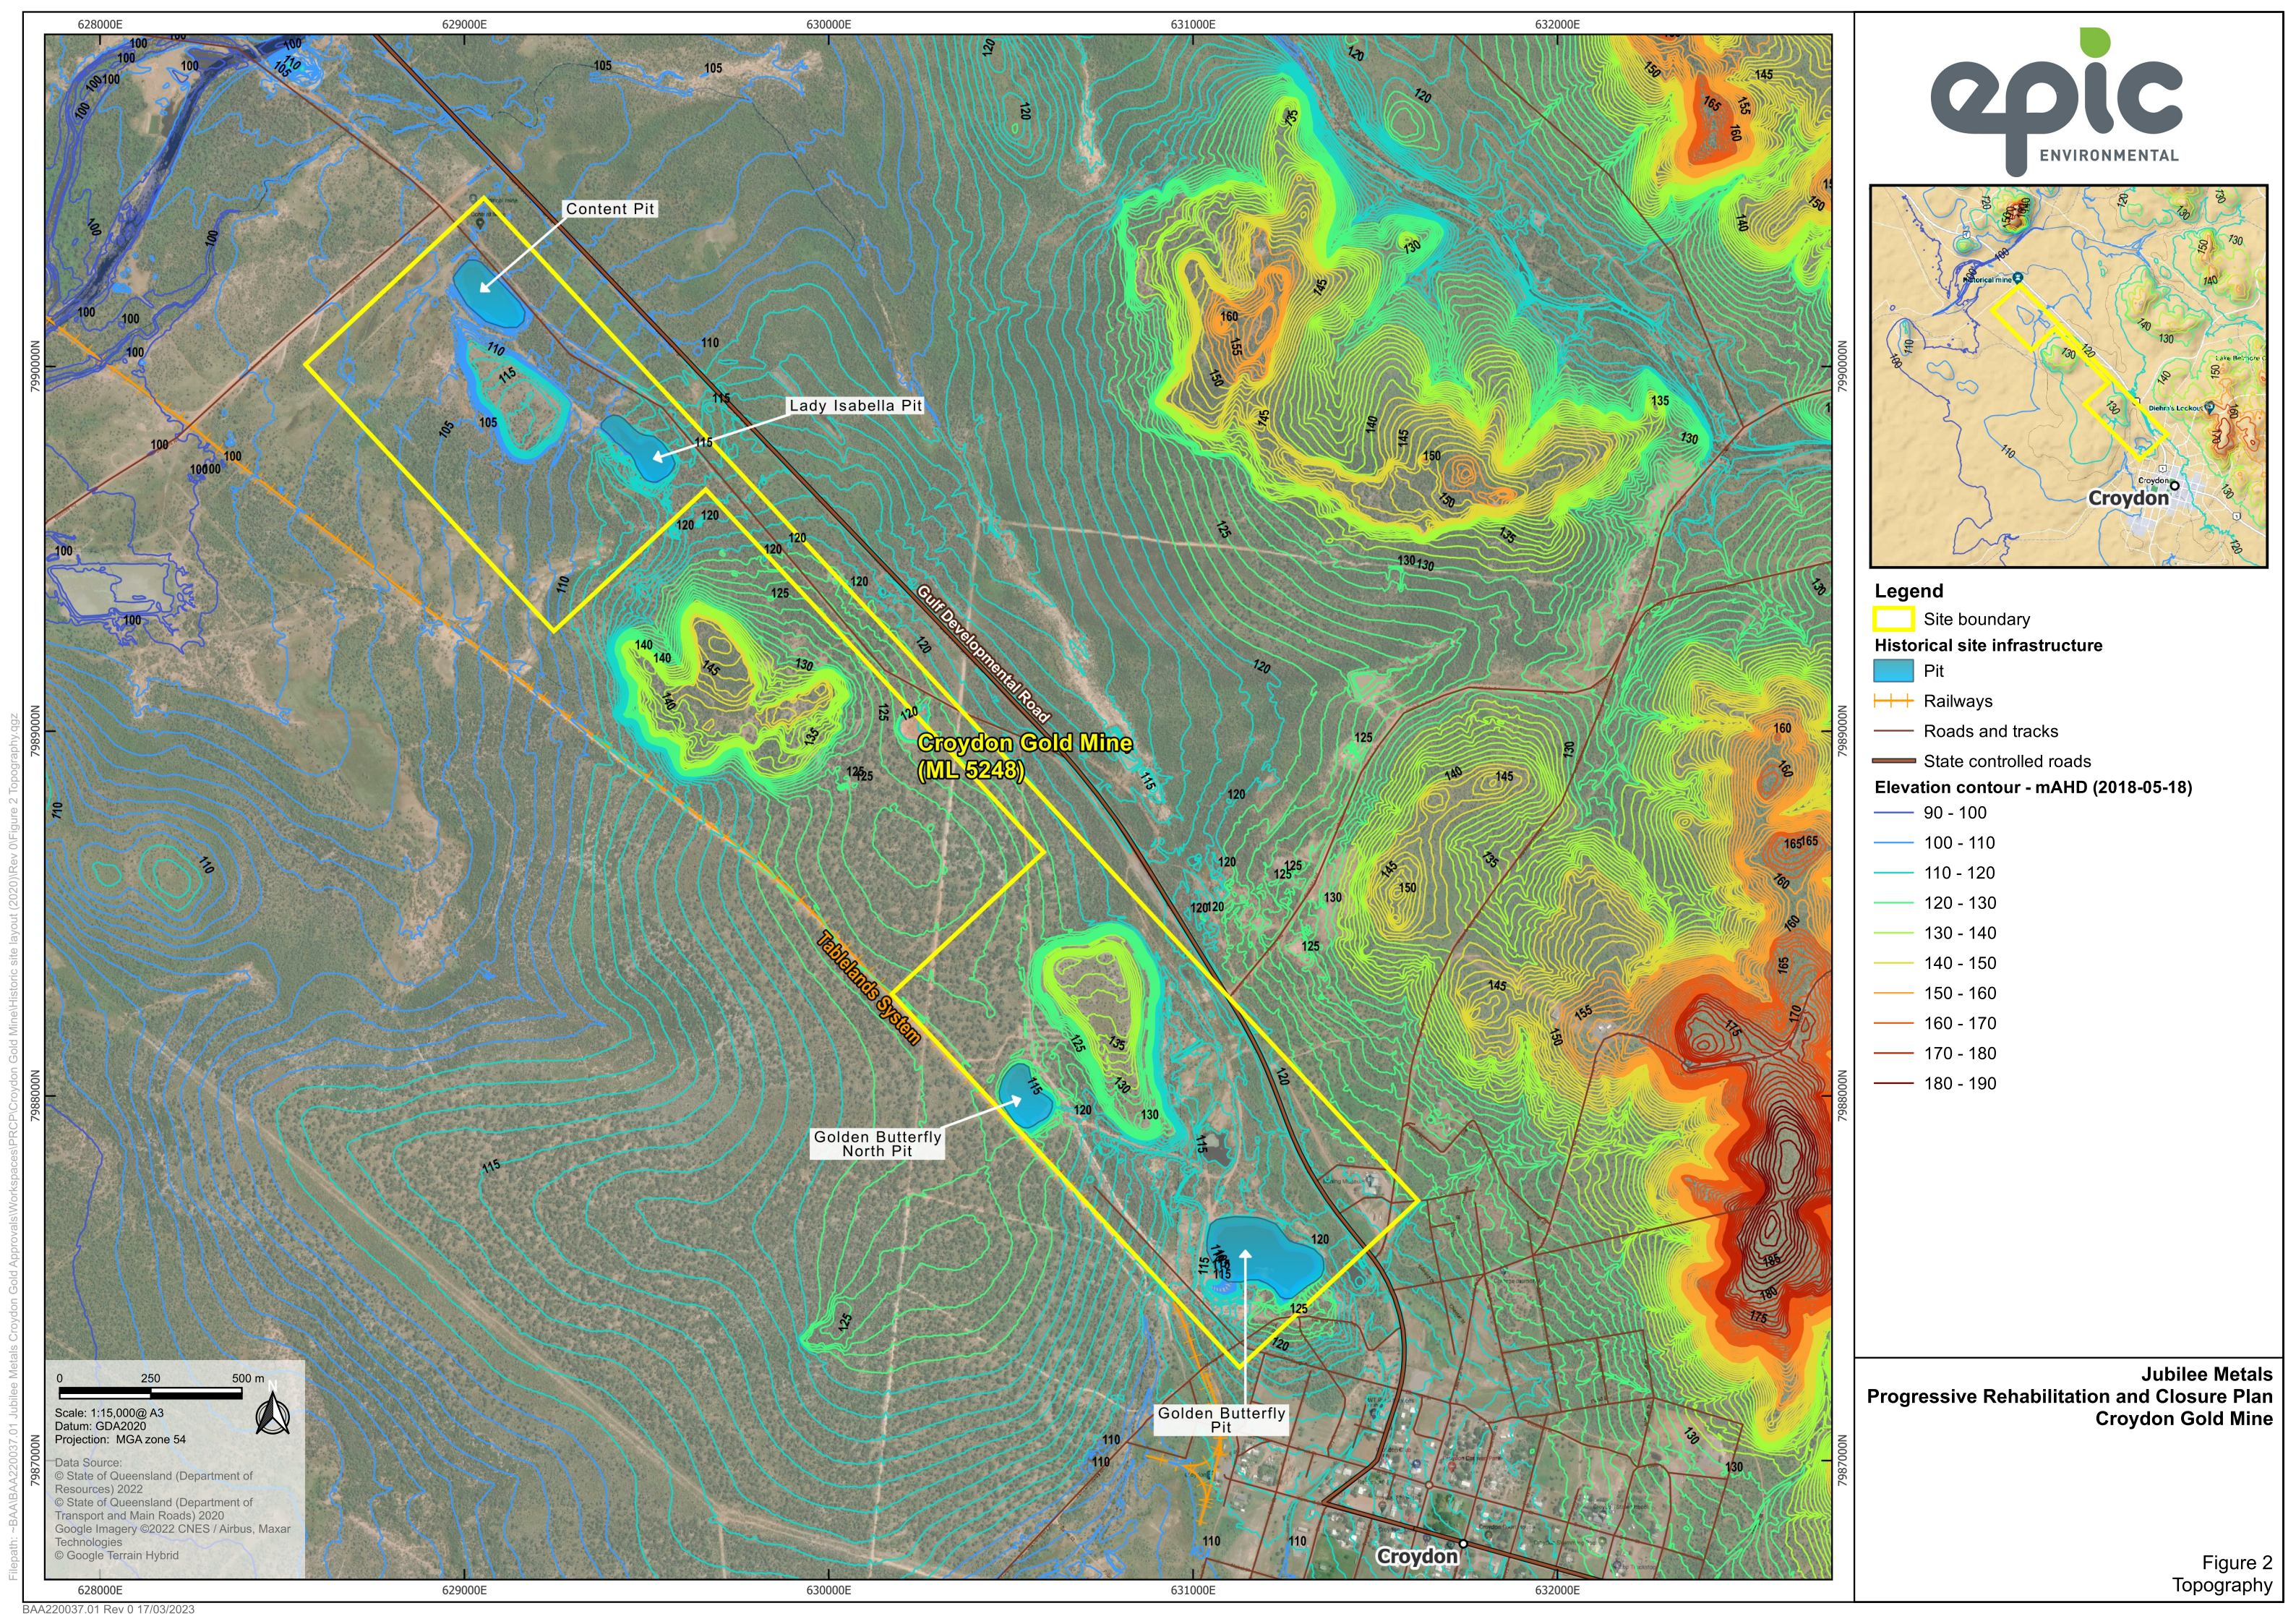
Topography within the Project area ranges from 105 m AHD elevation in the north to 130 m AHD in the south of the ML. There is a slight topographical rise located immediately west of ML5248, however the shape of the ML skirts this area of elevation and does not intersect it (**Figure 2**).

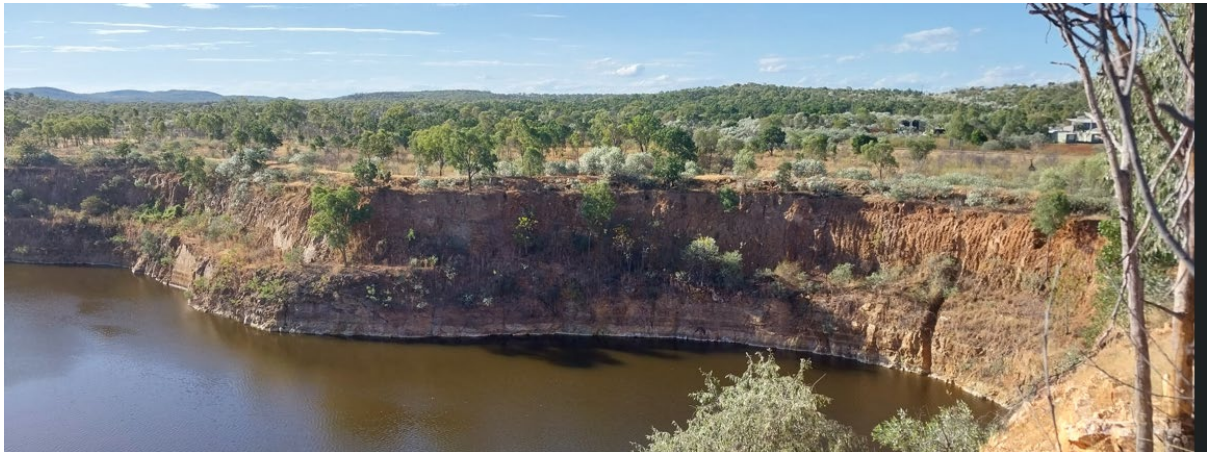
**Plate 2. Stability of Golden Butterfly North Pit**

A geotechnical report for the Croydon Gold Project was written by Cartledge Mining and Geotechnics which focused on the creation of future open pit voids and their stability using a FoS of 1.5 for long term slopes. The designs that were provided for 3D analysis had vertical walls 20 m high for all but the upper 15 m to 20 m where the slopes were 70 degrees. These pits for Golden Butterfly North Pit and Golden Butterfly Pit were found to have FoS of 3.0 and 3.1 so it can be inferred that the pits that were mined 30+ years ago have a similar FoS, which is evidenced by how stable the voids are currently.

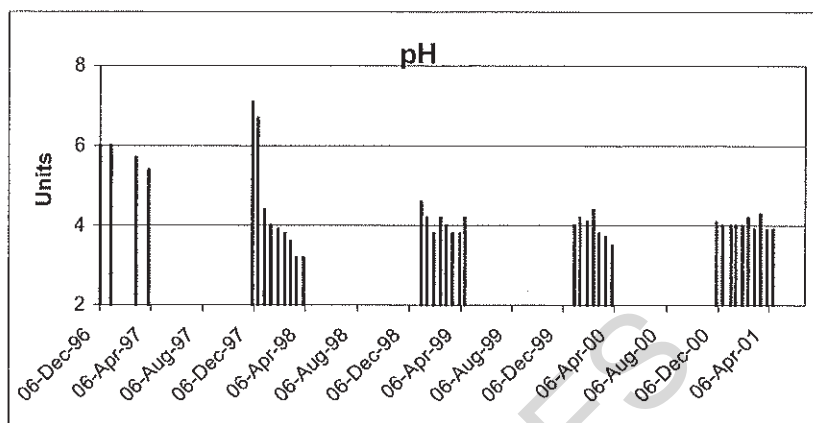
Figure 3: pH at SW5 over Time

SW5 is located at a small dam in the drainage line from the Content waste rock dump. The water quality at this site was good between December 1996 and December 1997, but started deteriorating in January 1998 (Table A4-6). The drop in pH (Figure 3) and increase in TDS (Figure 4), sulphate (Figure 5) and some of the metals suggested the presence of acid drainage. While the concentration of sulphate did not remain elevated above the livestock watering guideline after April 1998, that of cadmium has been consistently above the relevant guideline concentration since December 1997 and appears to have stabilised at around twenty times the guideline concentration (Figure 6). This is most likely because the pH of the drainage is at the optimum level for mobilisation of cadmium while other metals have become relatively insoluble. Mobilisation of cadmium will likely continue until the supply of the metal is exhausted or the characteristics of the drainage change.

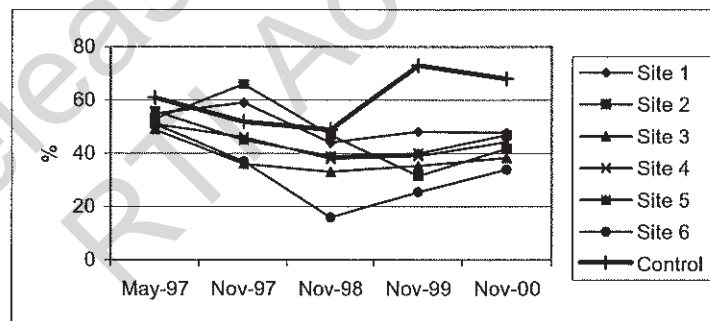
Figure 14: Stability Index at Monitoring Sites

The Landscape Function Analysis survey showed that there were no substantial changes to landscape surface condition. Soil surfaces were stable, and minor rilling that was recorded at some sites in previous surveys had not deteriorated. Rip lines remained essentially intact but were shallower due to infilling. The soil surface stability index either remained unchanged or increased slightly at all sites (Figure 14). Similarly, there was little movement in the indicators of infiltration (Figure 15) and nutrient cycling capacity (Figure 16). These indicators are slow to increase due to the absence of topsoil and decomposing litter. Litter accumulation is the major component of these two indices and their values will inevitably increase as the volume and rate of decomposition of litter increases.

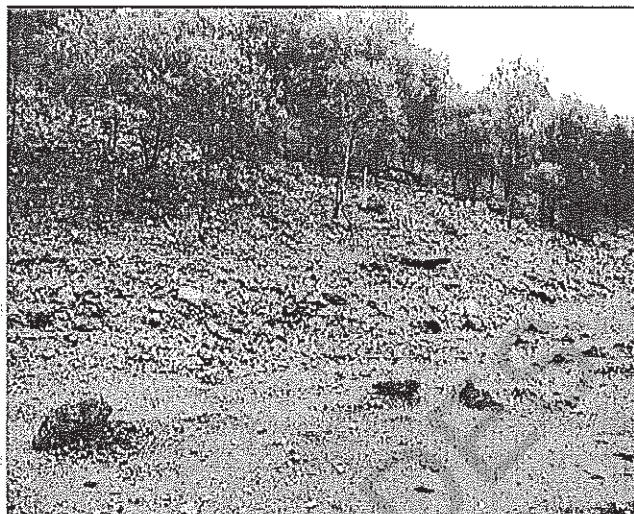
**Plate 4: Lower Batter of Content Waste Rock Dump showing Effect of Acid Drainage**

It would appear that this small area of acid producing rock was identified during the 1996 site assessment but not considered for remediation because of the apparently successful rehabilitation of the western batter of the dump. Remediation of this site now would require extensive disturbance of the dump cover by stripping it back to the dump surface and installing an engineered cover at considerable cost and effort. Appropriate cover materials would have to be located and transported to the site, requiring further rehabilitation of the borrow area. Excavation of the dump surface could also result in further acid drainage being triggered in areas currently not affected. Given the relatively small area affected by the acid drainage, and the apparent chemical stability of the drainage, Goldfields considers that further remediation work on the Content waste rock dump is not warranted.

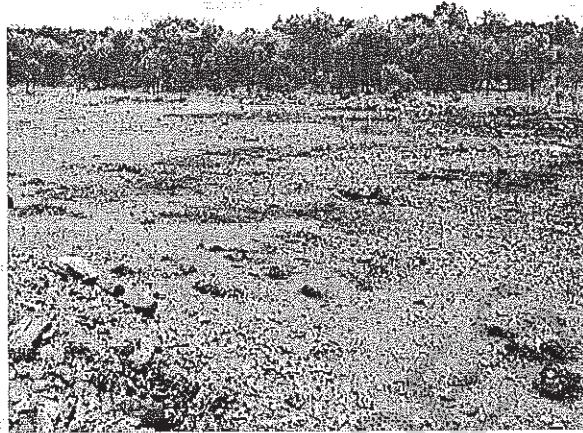
Plate 5: Former Hardstand Area adjacent to Content Waste Rock Dump

At this time, the rehabilitation and revegetation status of the western batter was considered to meet criteria and no further capping was constructed on this side. It was later discovered that some seepage occurred from the western side, however these impacts were not identified at the mining lease boundary. It should be noted the Water Management Strategy (Barrick 2018) (**Appendix H** – Section 3.1) outlines a proposed measure to excavate a subsurface trench at the western foot of the Content waste rock dump and installing a collector pipe to drain any contaminated seepage to the Content Pit. However, it should be noted, these activities were undertaken in July 2002. In support of this, Section 3.1 of **Appendix H** also stated that no further drainage management measures are considered necessary for the Content waste rock dump area.

However, it was realised that groundwater was actually the cause of white efflorescence on the surface of the Content hardstand area. As such, the following key activities were undertaken (**Appendix I**), including:

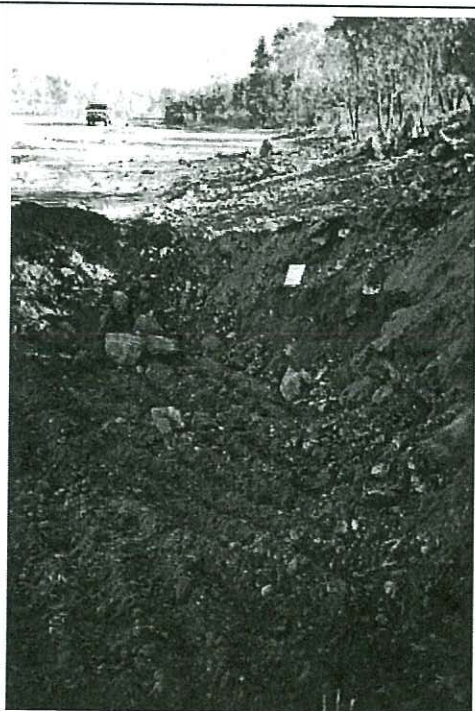
First cut into waste dump next to Content hardstand area showing red clay capping and loose cover layer with no indication of any ARD – 5 July 2002

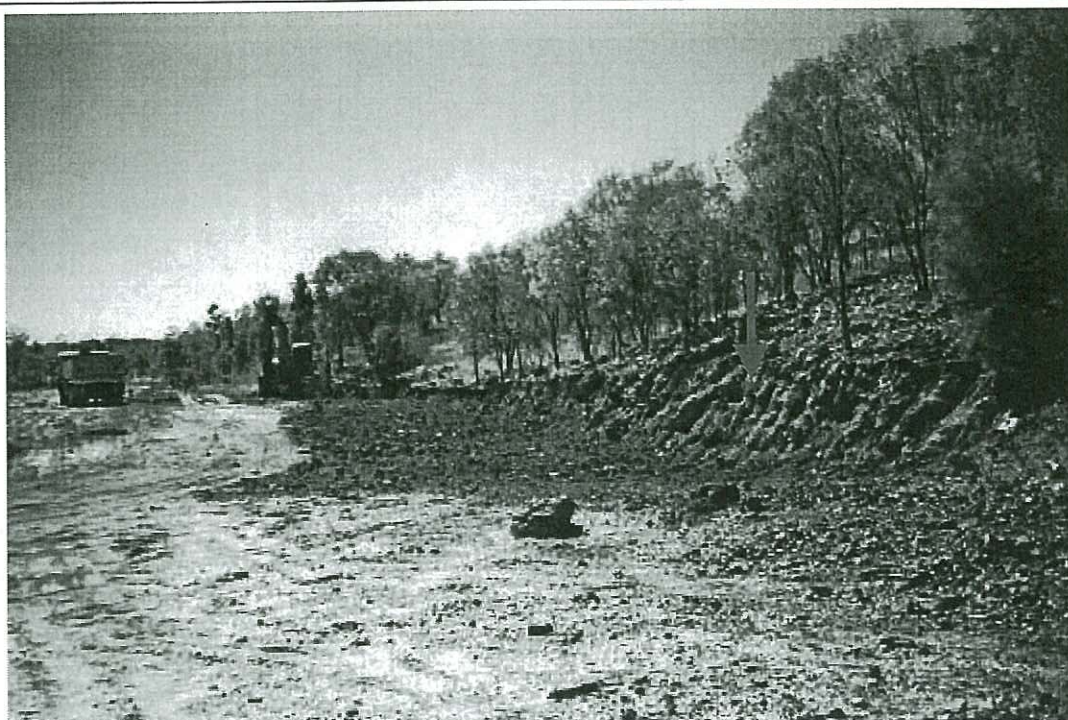
Preliminary cut along toe of waste dump to check for ARD seepage – note red clay layer under loose cover

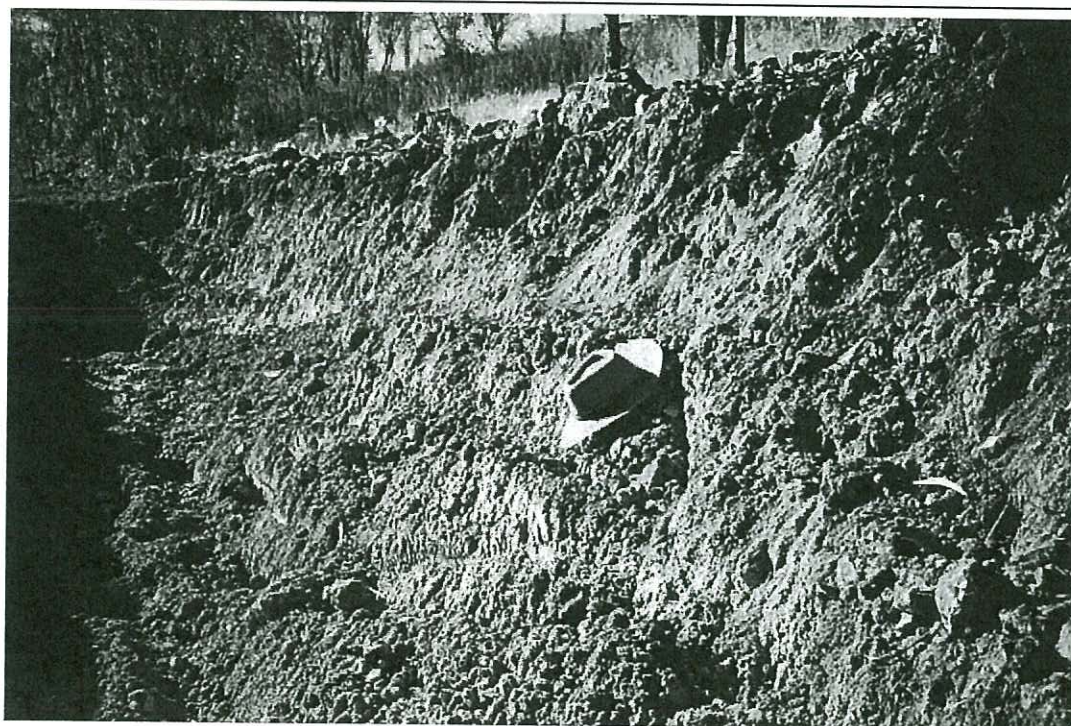
Side of trench showing no trace of ARD, but white salts from evaporation of interstitial or capillary moisture after exposure for 2 days – 7 July 2002

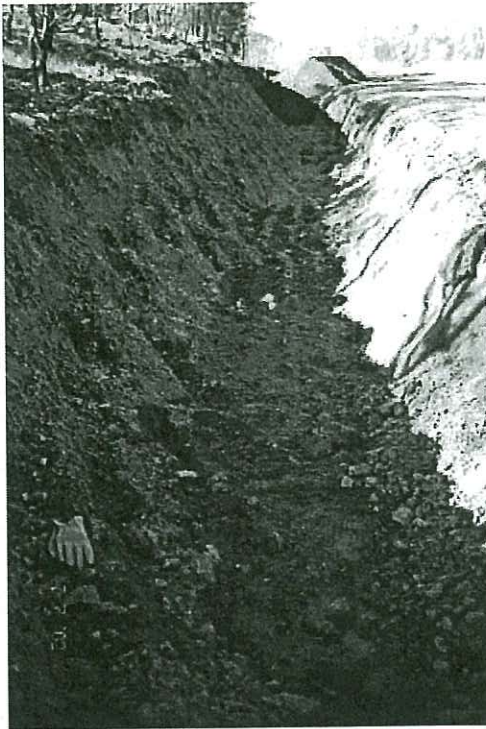
Backfilling trench after finding no indication of ARD – note proximity of high TDS water to surface

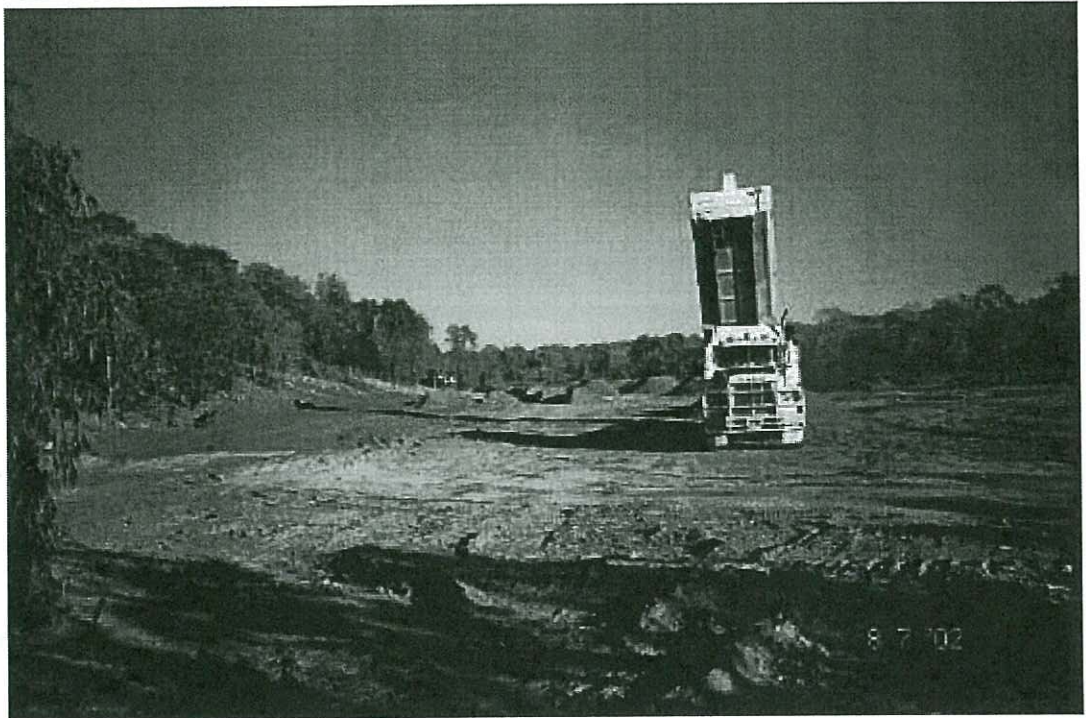
Replacement of reprofiled hardstand area surface with clean sand and soil

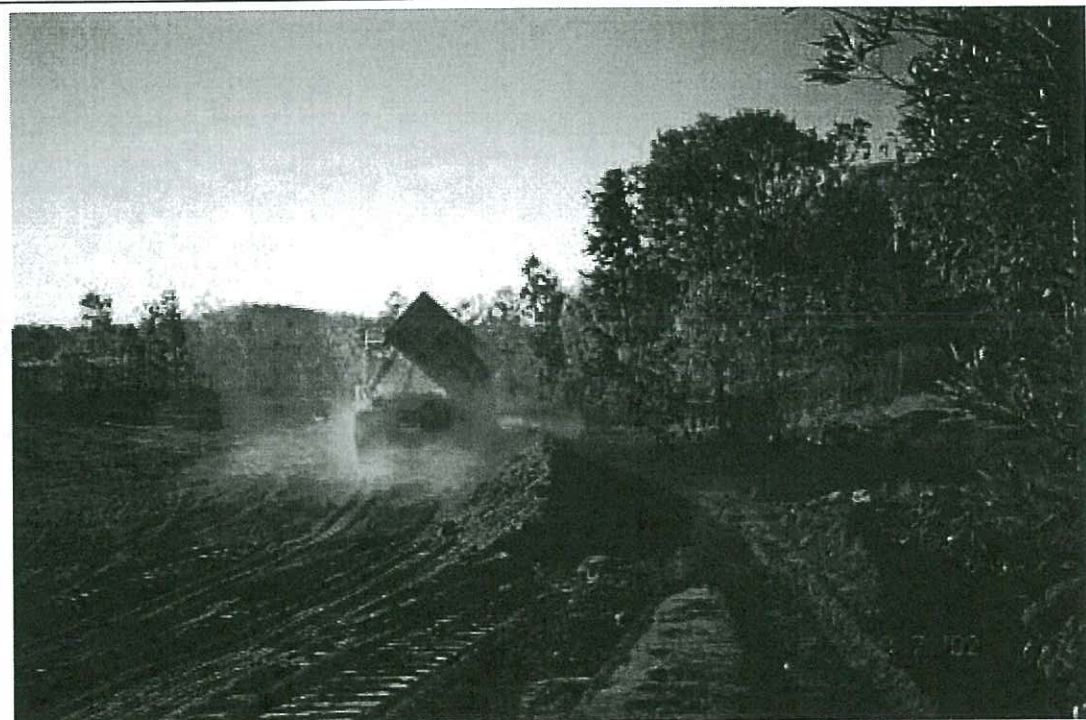
Dumping of sand and soil ready for spreading over hardstand area – 8 July 2002

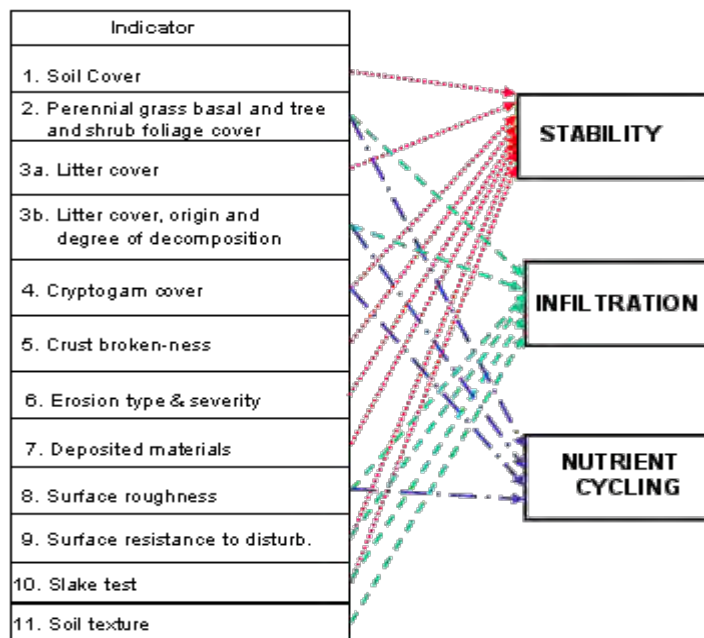
The collected soil surface data are grouped in different combinations to reflect three major soil habitat quality indices: 1) stability or resistance to erosion, 2) infiltration/water holding capacity and 3) nutrient cycling (Figure 1). However, as stated previously, the stability index is the most useful and the only index needed for this application. Collected soil surface data are entered into pre-formatted Excel spreadsheets that generate final values that can then be interpreted (interpretive framework).

Figure 1: The combination of Soil Condition Classes to derive indices of Stability, Infiltration, and Nutrient Cycling.

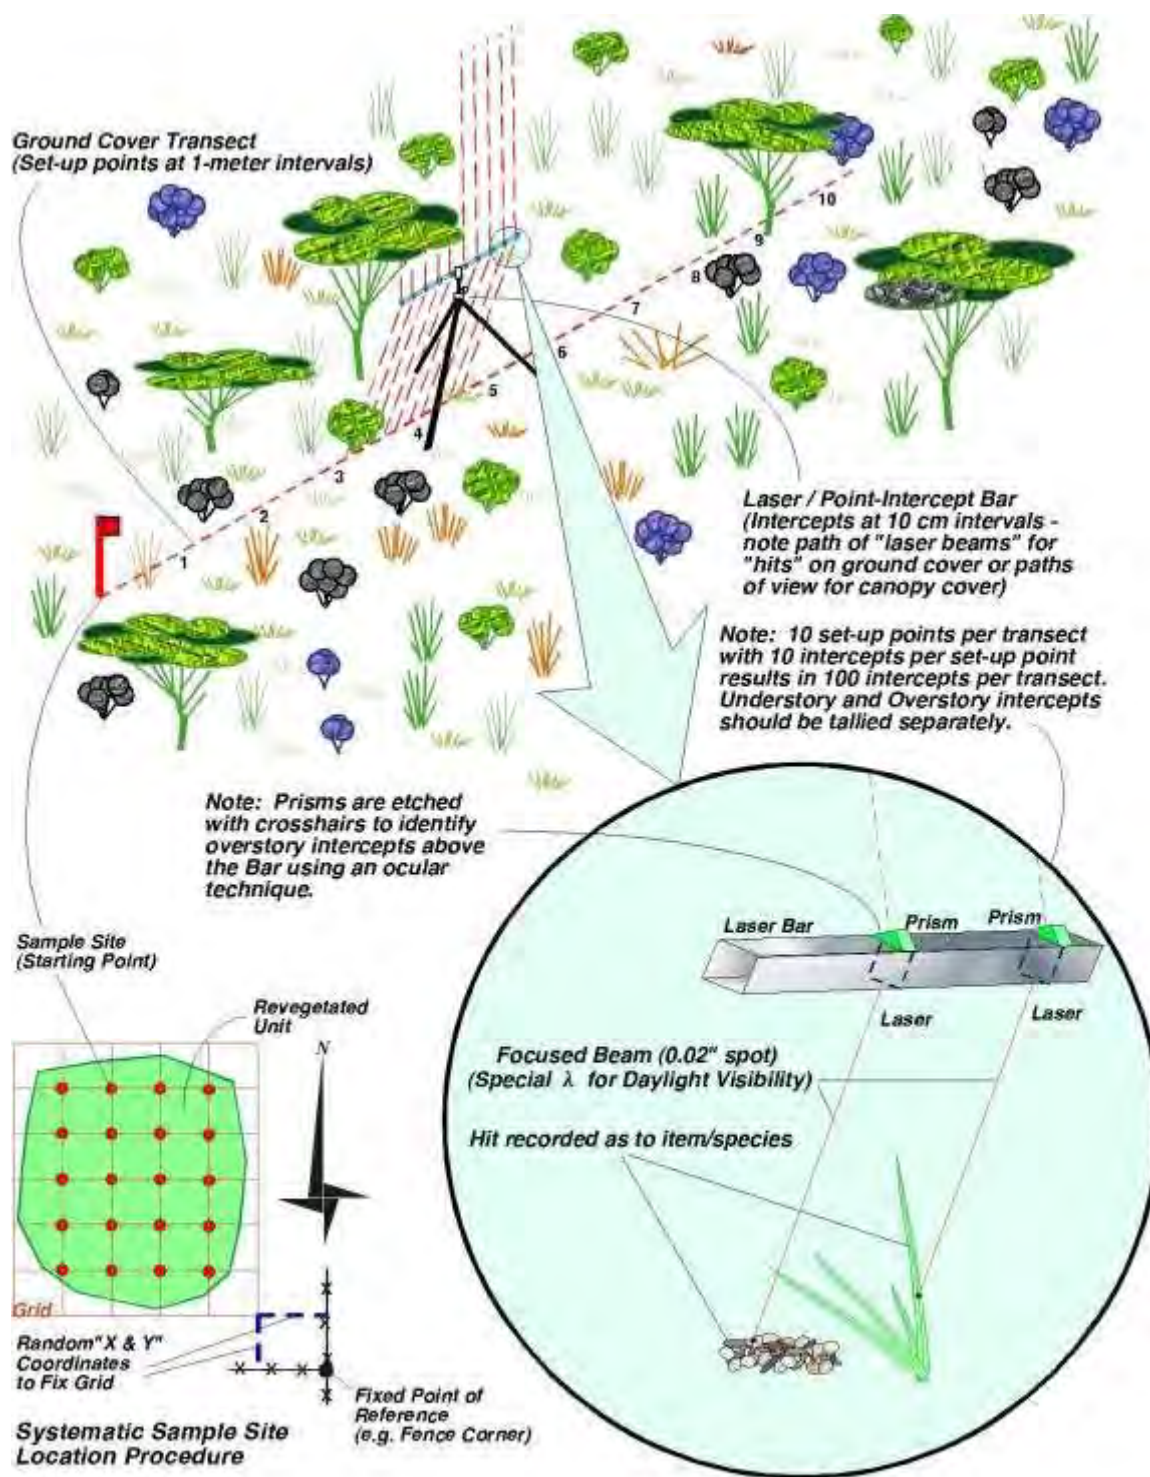
With regard to gaps in the overstory, the point-intercept procedure naturally corrects for overestimations created by 2-dimensional areal (quadrat) or 1-dimensional linear (line-intercept) techniques. In this regard, the 0-dimensional point is extended along a line-of-sight until it “intercepts” something that is then recorded. Frequently points simply pass through overstory gaps until a lower plant part, litter, rock or bare soil is encountered.

**Exhibit 1**  
**Sampling Procedure at a Systematic Sample Site Location**
