CLERMONT

GLENCORE

# Progressive Rehabilitation and Closure Plan (PRC Plan)

January 2023

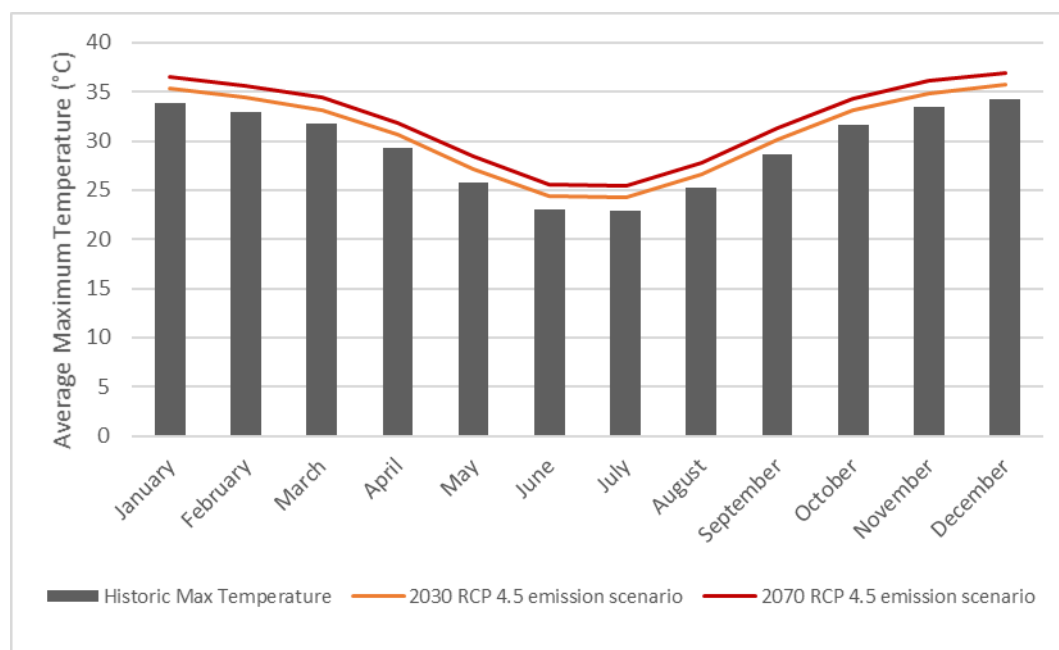
*Figure 5 - Temperature baseline, 2030 and 2070 predictions*

Applying these forecast changes in temperature and rainfall to the baseline climate period used in the study for Clermont climate data (**Table 2**), Figure 5 and 6 provide an indication of future weather. The temperature results indicate the shift from baseline using monthly average maximum temperature for 2030 and 2070. The 2030 and 2070 rainfall scenarios are nearly identical to one another (**Figure 6**).

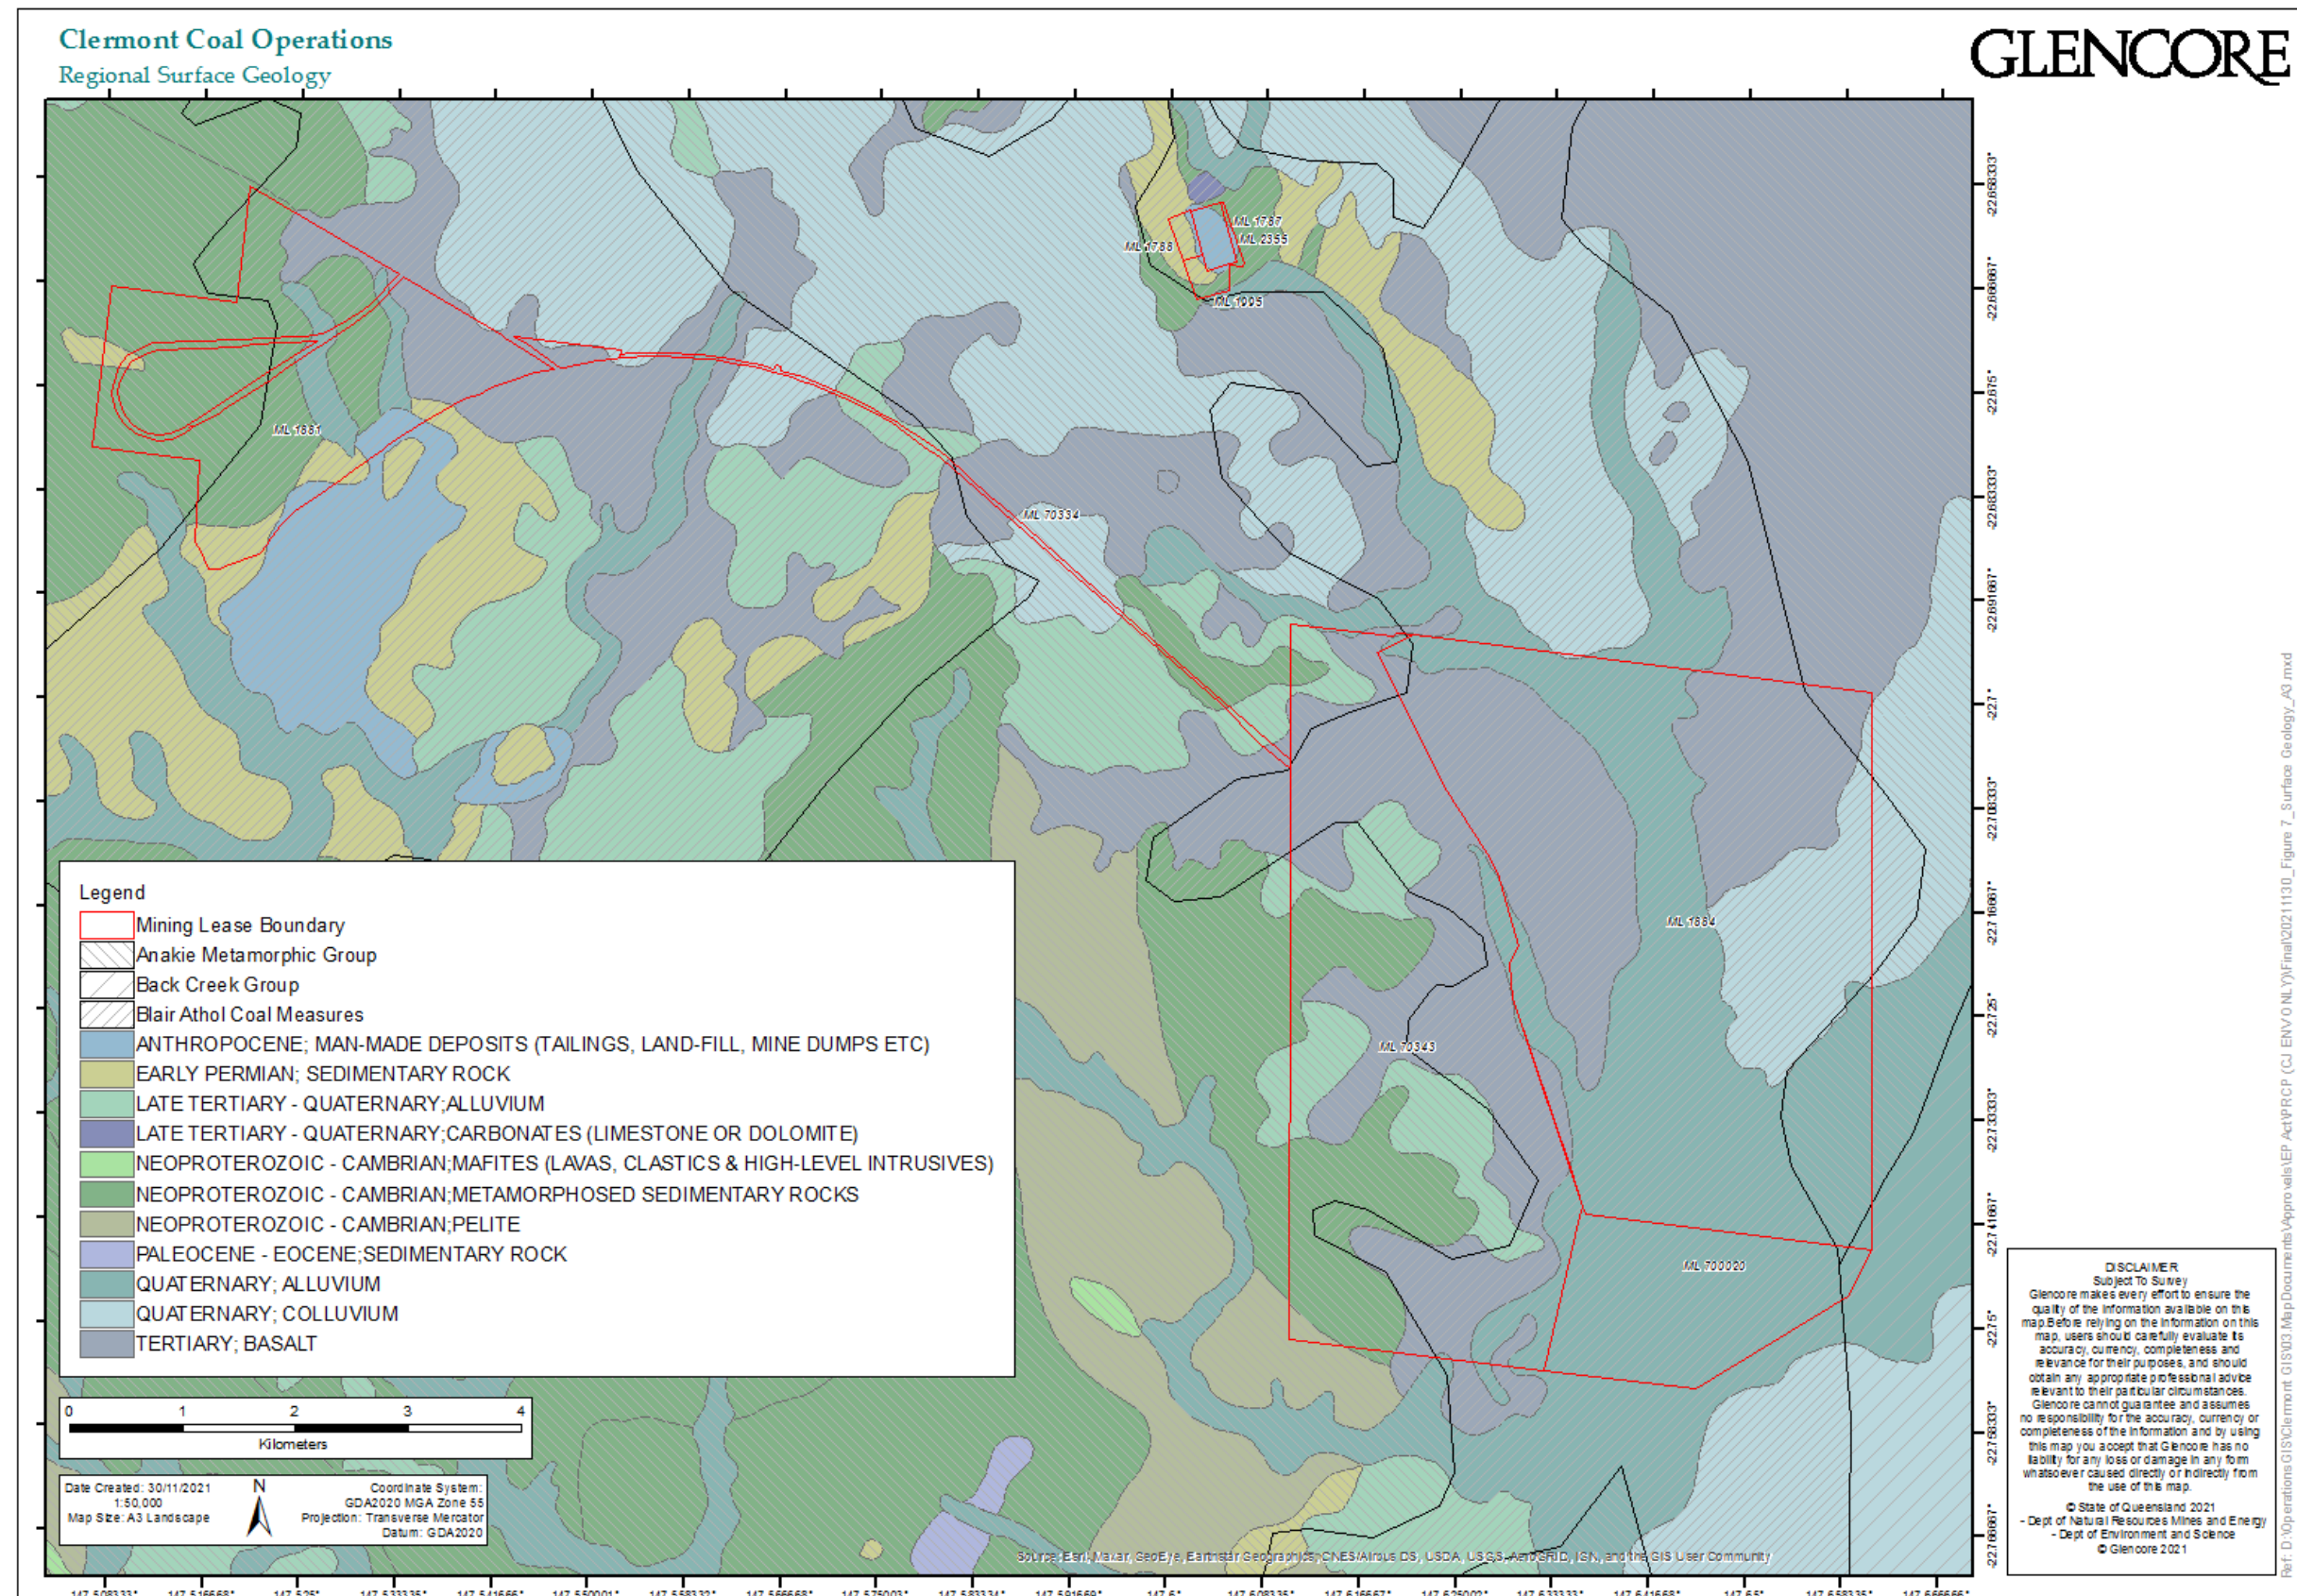
Figure 7 - Geology Units of the Region

The CH area lies within the northern extent of the Permian Blair Athol Coal Measures sedimentary package of rocks, where the basal conglomerate is observed in drill holes and the pit. Basalt overlies the Permian conglomerate sequence of greater than 50 m depth, across most of the site. The limited drilling data available in the area confirms the basement Hurleys Metamorphic unit below the conglomerate. A Tertiary clay unit between the basalt and conglomerate is evident in some areas but continuity is uncertain. The CH gold mining site was previously exploited for alluvial gold located within the gravel deposit, derived from the weathered Permian conglomerate.

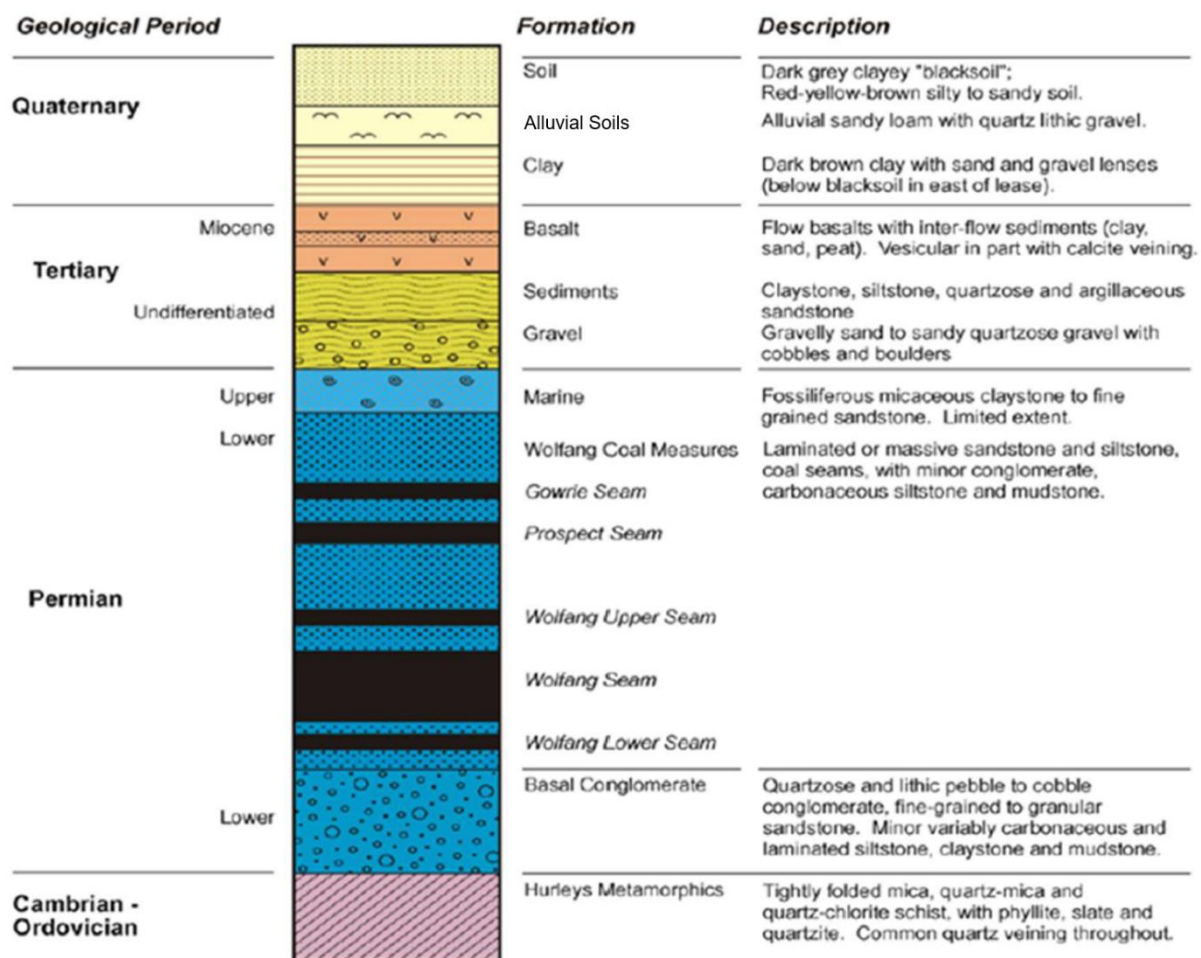
Figure 8 - CCO Stratigraphy

CCO is located within the Wolfgang Basin, a geological map detailing the basin is shown in **Figure 7**. The following geological units are typical of this Basin, listed in descending stratigraphic order (see also **Figure 8**):

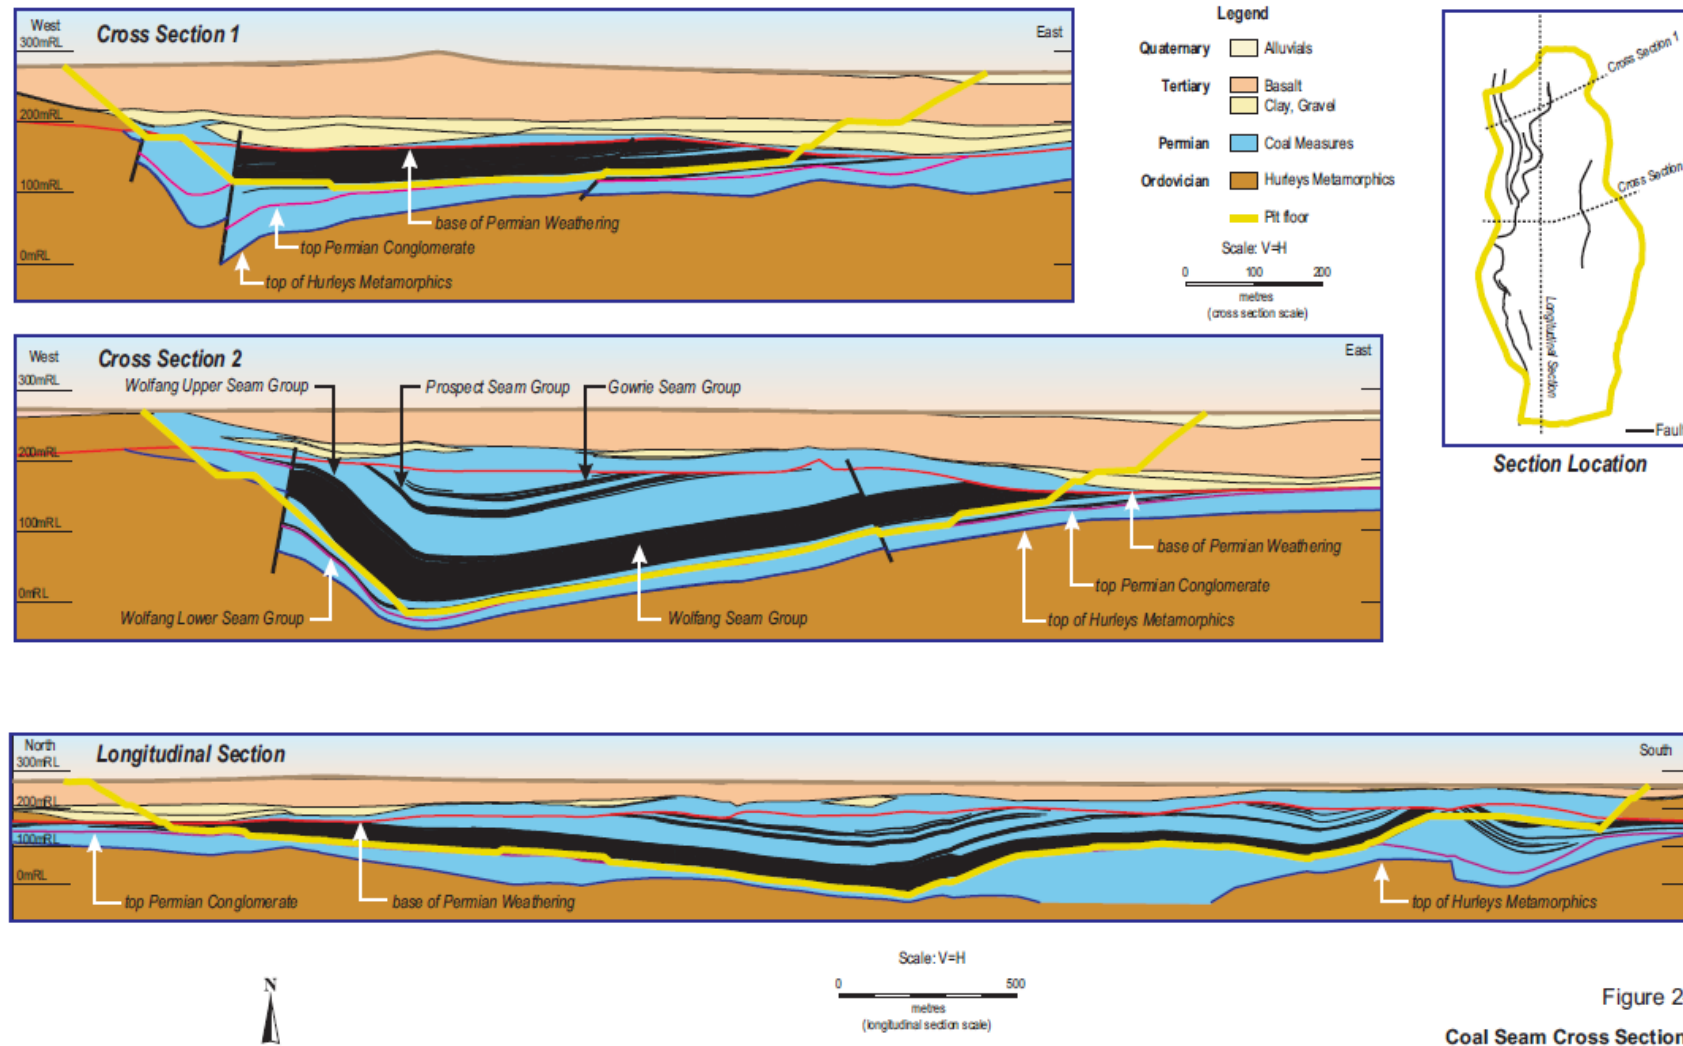
Figure 9 - Coal Seam Cross Sections at CM

The coal seams occur within the Permian sediments unit. Four major coal seams have been identified within the coal sequence at CM, including Gowrie, Prospect, Wolfgang Upper, and Wolfgang, at depths ranging between 80 to 290m beneath the surface. The major coal resource is within the Wolfgang seam, (35m - 40m thick). Another useful material is the Tertiary basalt, used as building material for roads and drain revetments. Cross sections of the key stratigraphic units at CCO are provided in **Figure 9**. Further geological and hydrogeological information is presented in Appendices 4.4 and 4.5.

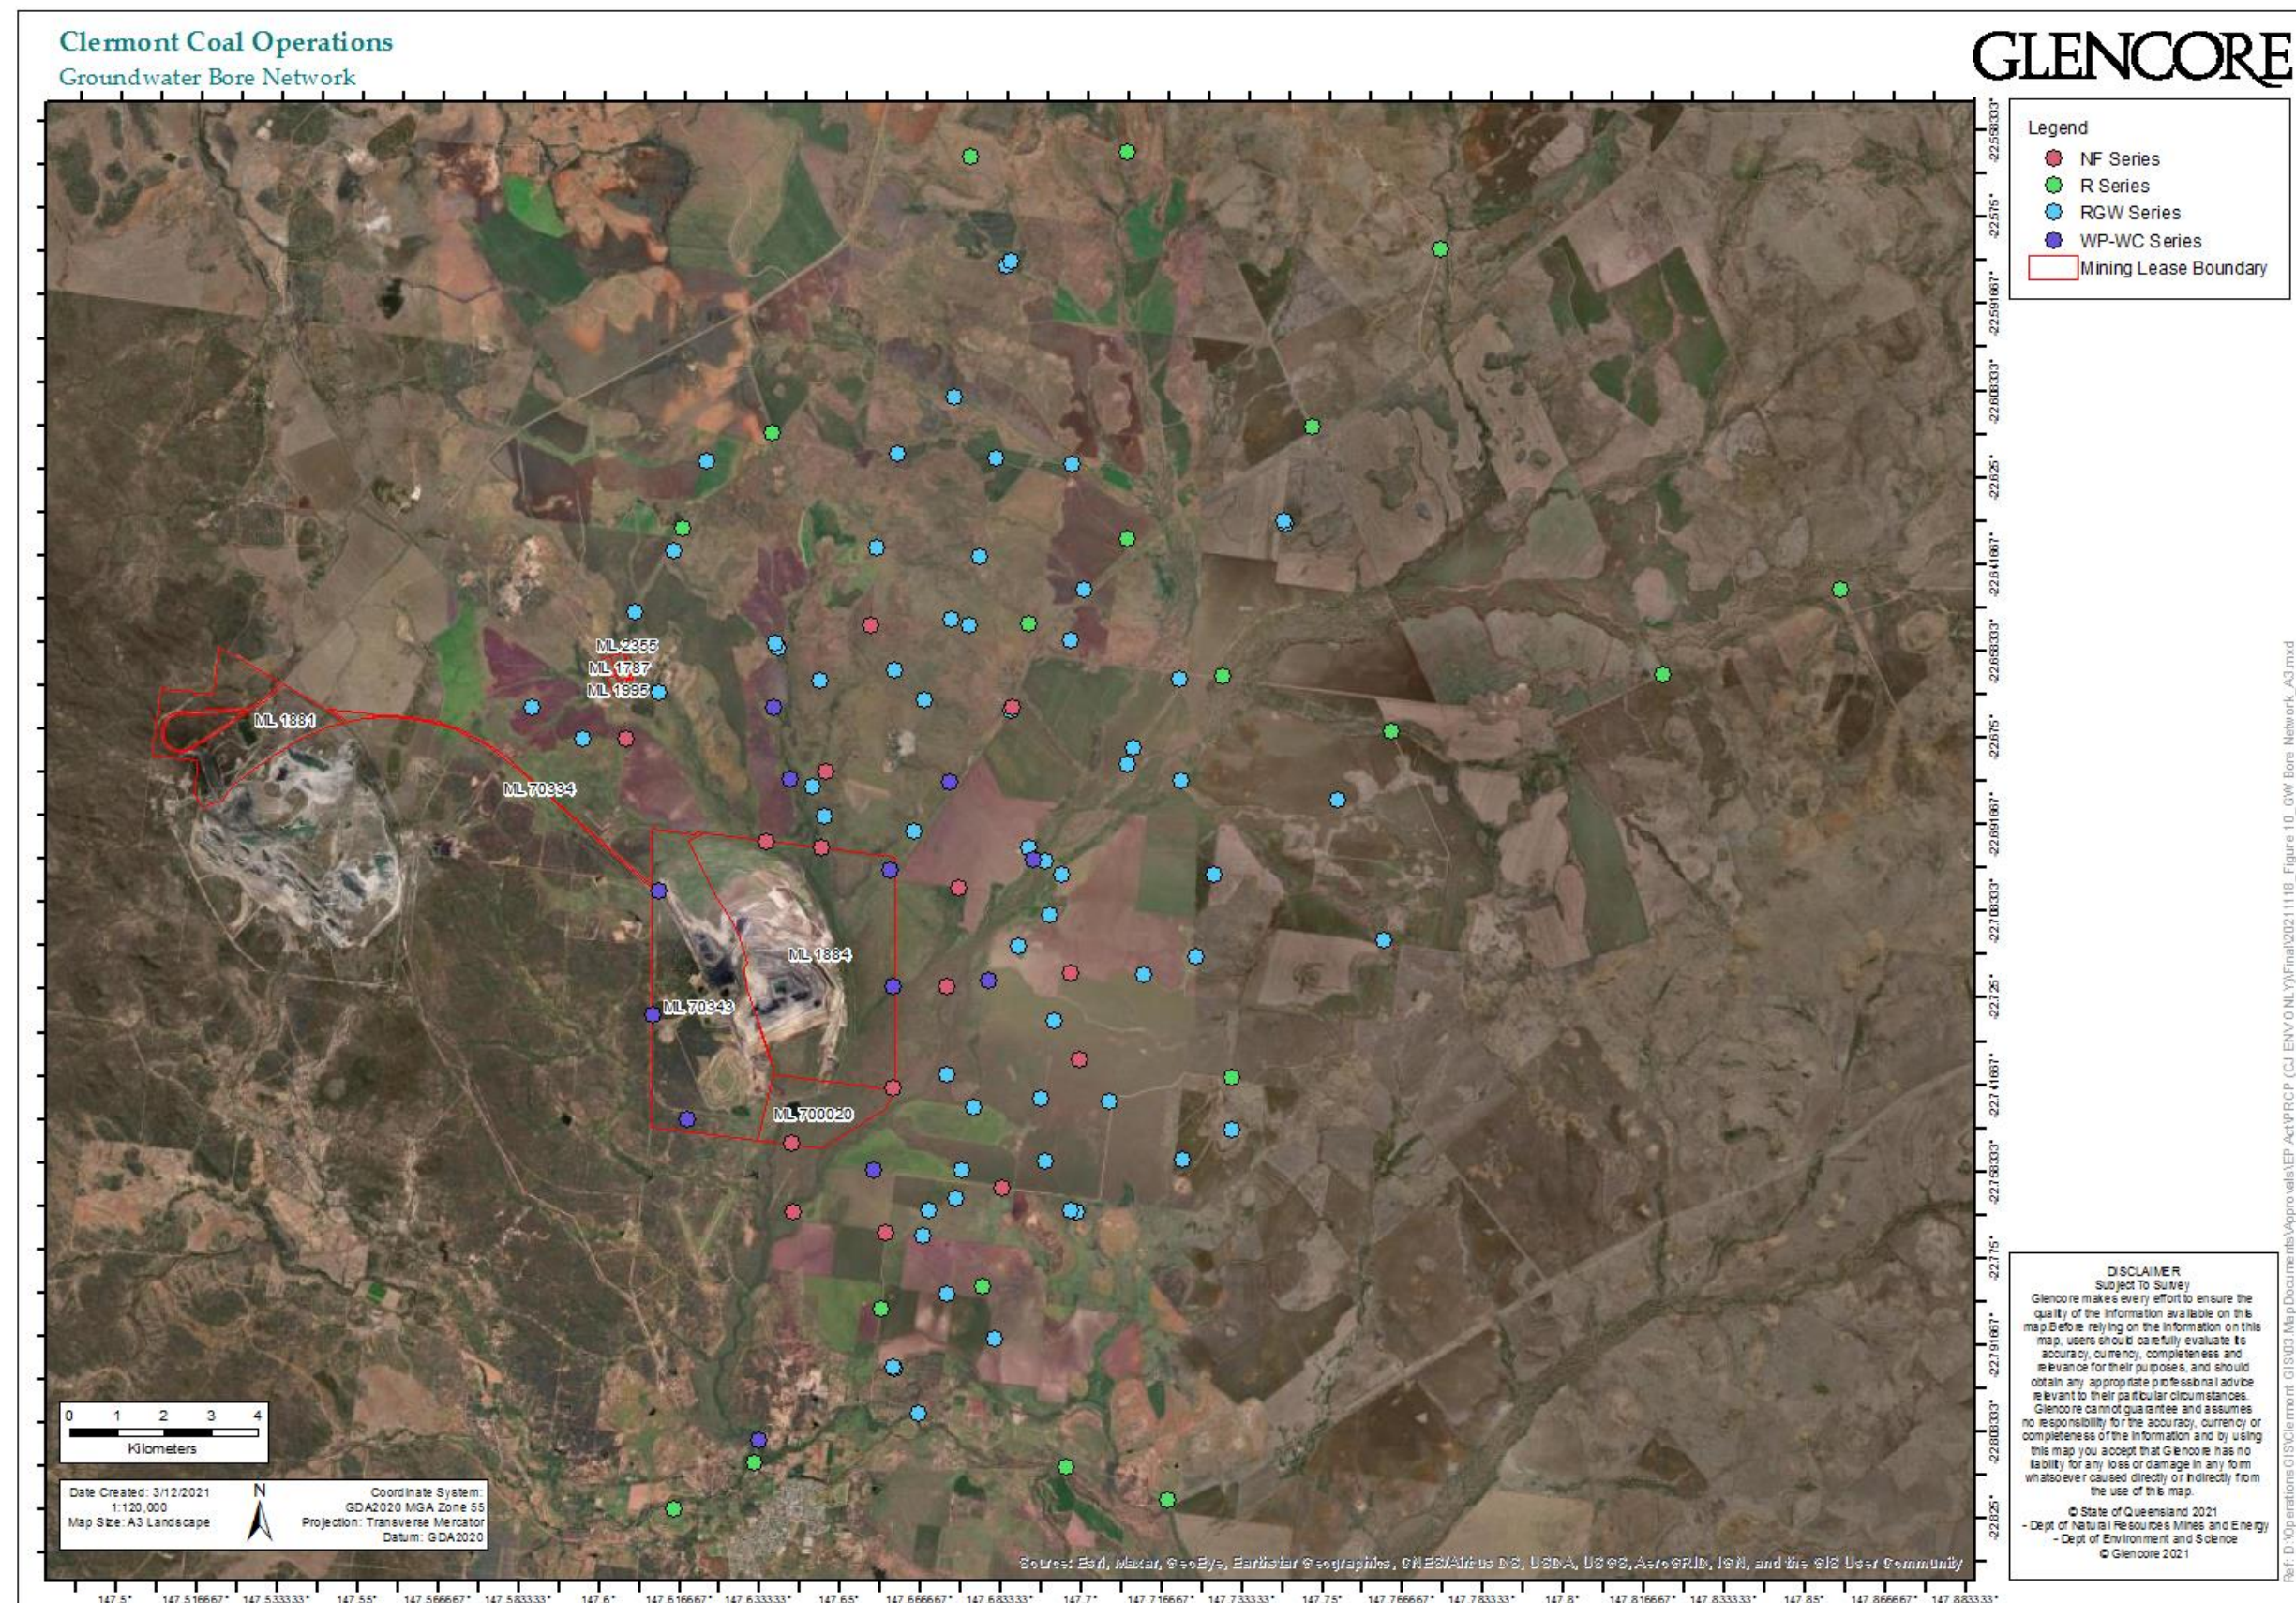
Figure 10 - Groundwater Bore Network

There are a large number (161) of groundwater bores within a 10km radius of the ML boundaries (*Figure 10*). Groundwater levels have been monitored within bores since 1983, and annually (at a minimum) since 2002. Bores include those near the mine site drilled in 1983 (WP-WC series), Near Field Bores (NF series), and regional bores (R series), as shown in *Figure 10*. Further detail on bores is provided in Appendix 4.5.

Of the 161 groundwater bores within a 10km radius of the ML boundary (Figure 10), 99 are neighbouring landholder bores and 62 were CCO bores. A total of 39 bores are not used, with the remainder used for stock water (43), domestic use (5), domestic and stock water (10), domestic and chemical mixing (1), chemical mixing (1), industrial (mining) (8), and CCO groundwater monitoring (54).

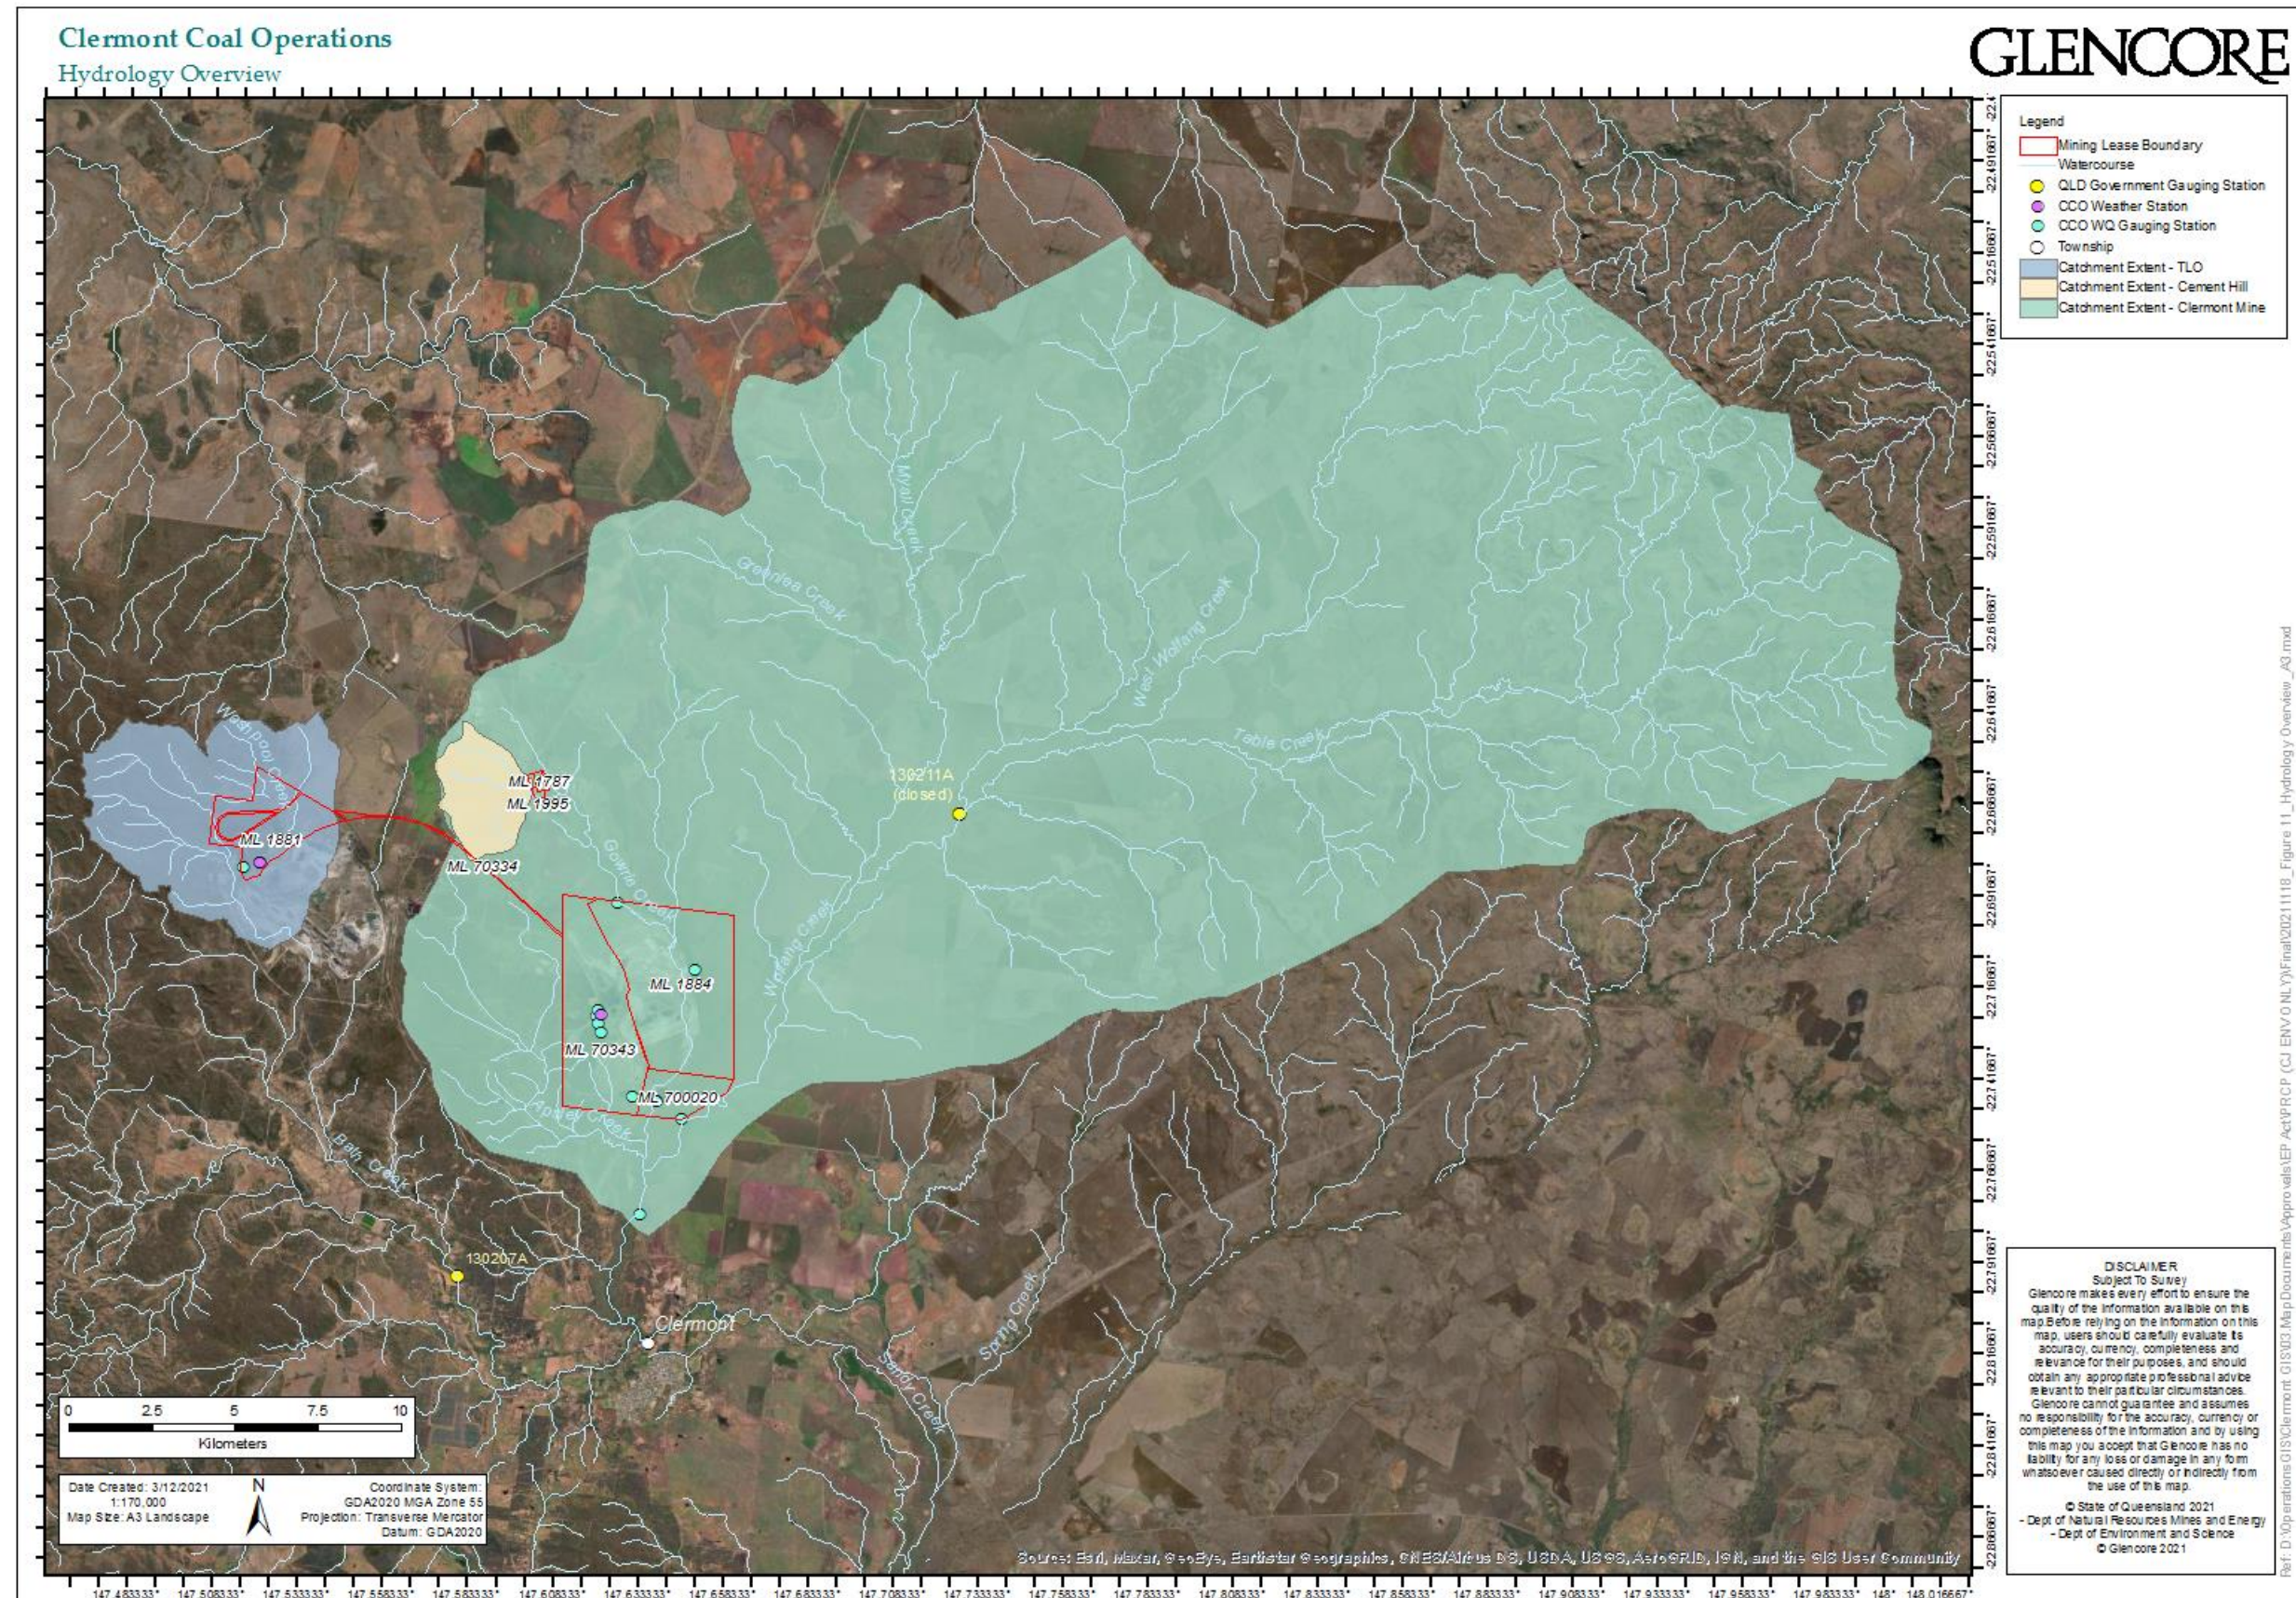
Figure 11 - Hydrological Overview

Figure 11 depicts the catchment extent associated with the major drainage systems associated with CM, CH and TLO, and also identifies gauging stations within those catchments.

Gowrie Creek dominates the local drainage regime of the 32 km<sup>2</sup> CM leases. Teatree Creek drains into Gowrie Creek at the upstream end of the CM and Apsley Creek drains into Gowrie Creek immediately downstream of the CM. The Wolfgang Creek floodplain forms the downstream control to flows in Gowrie Creek (**Figure 11**).

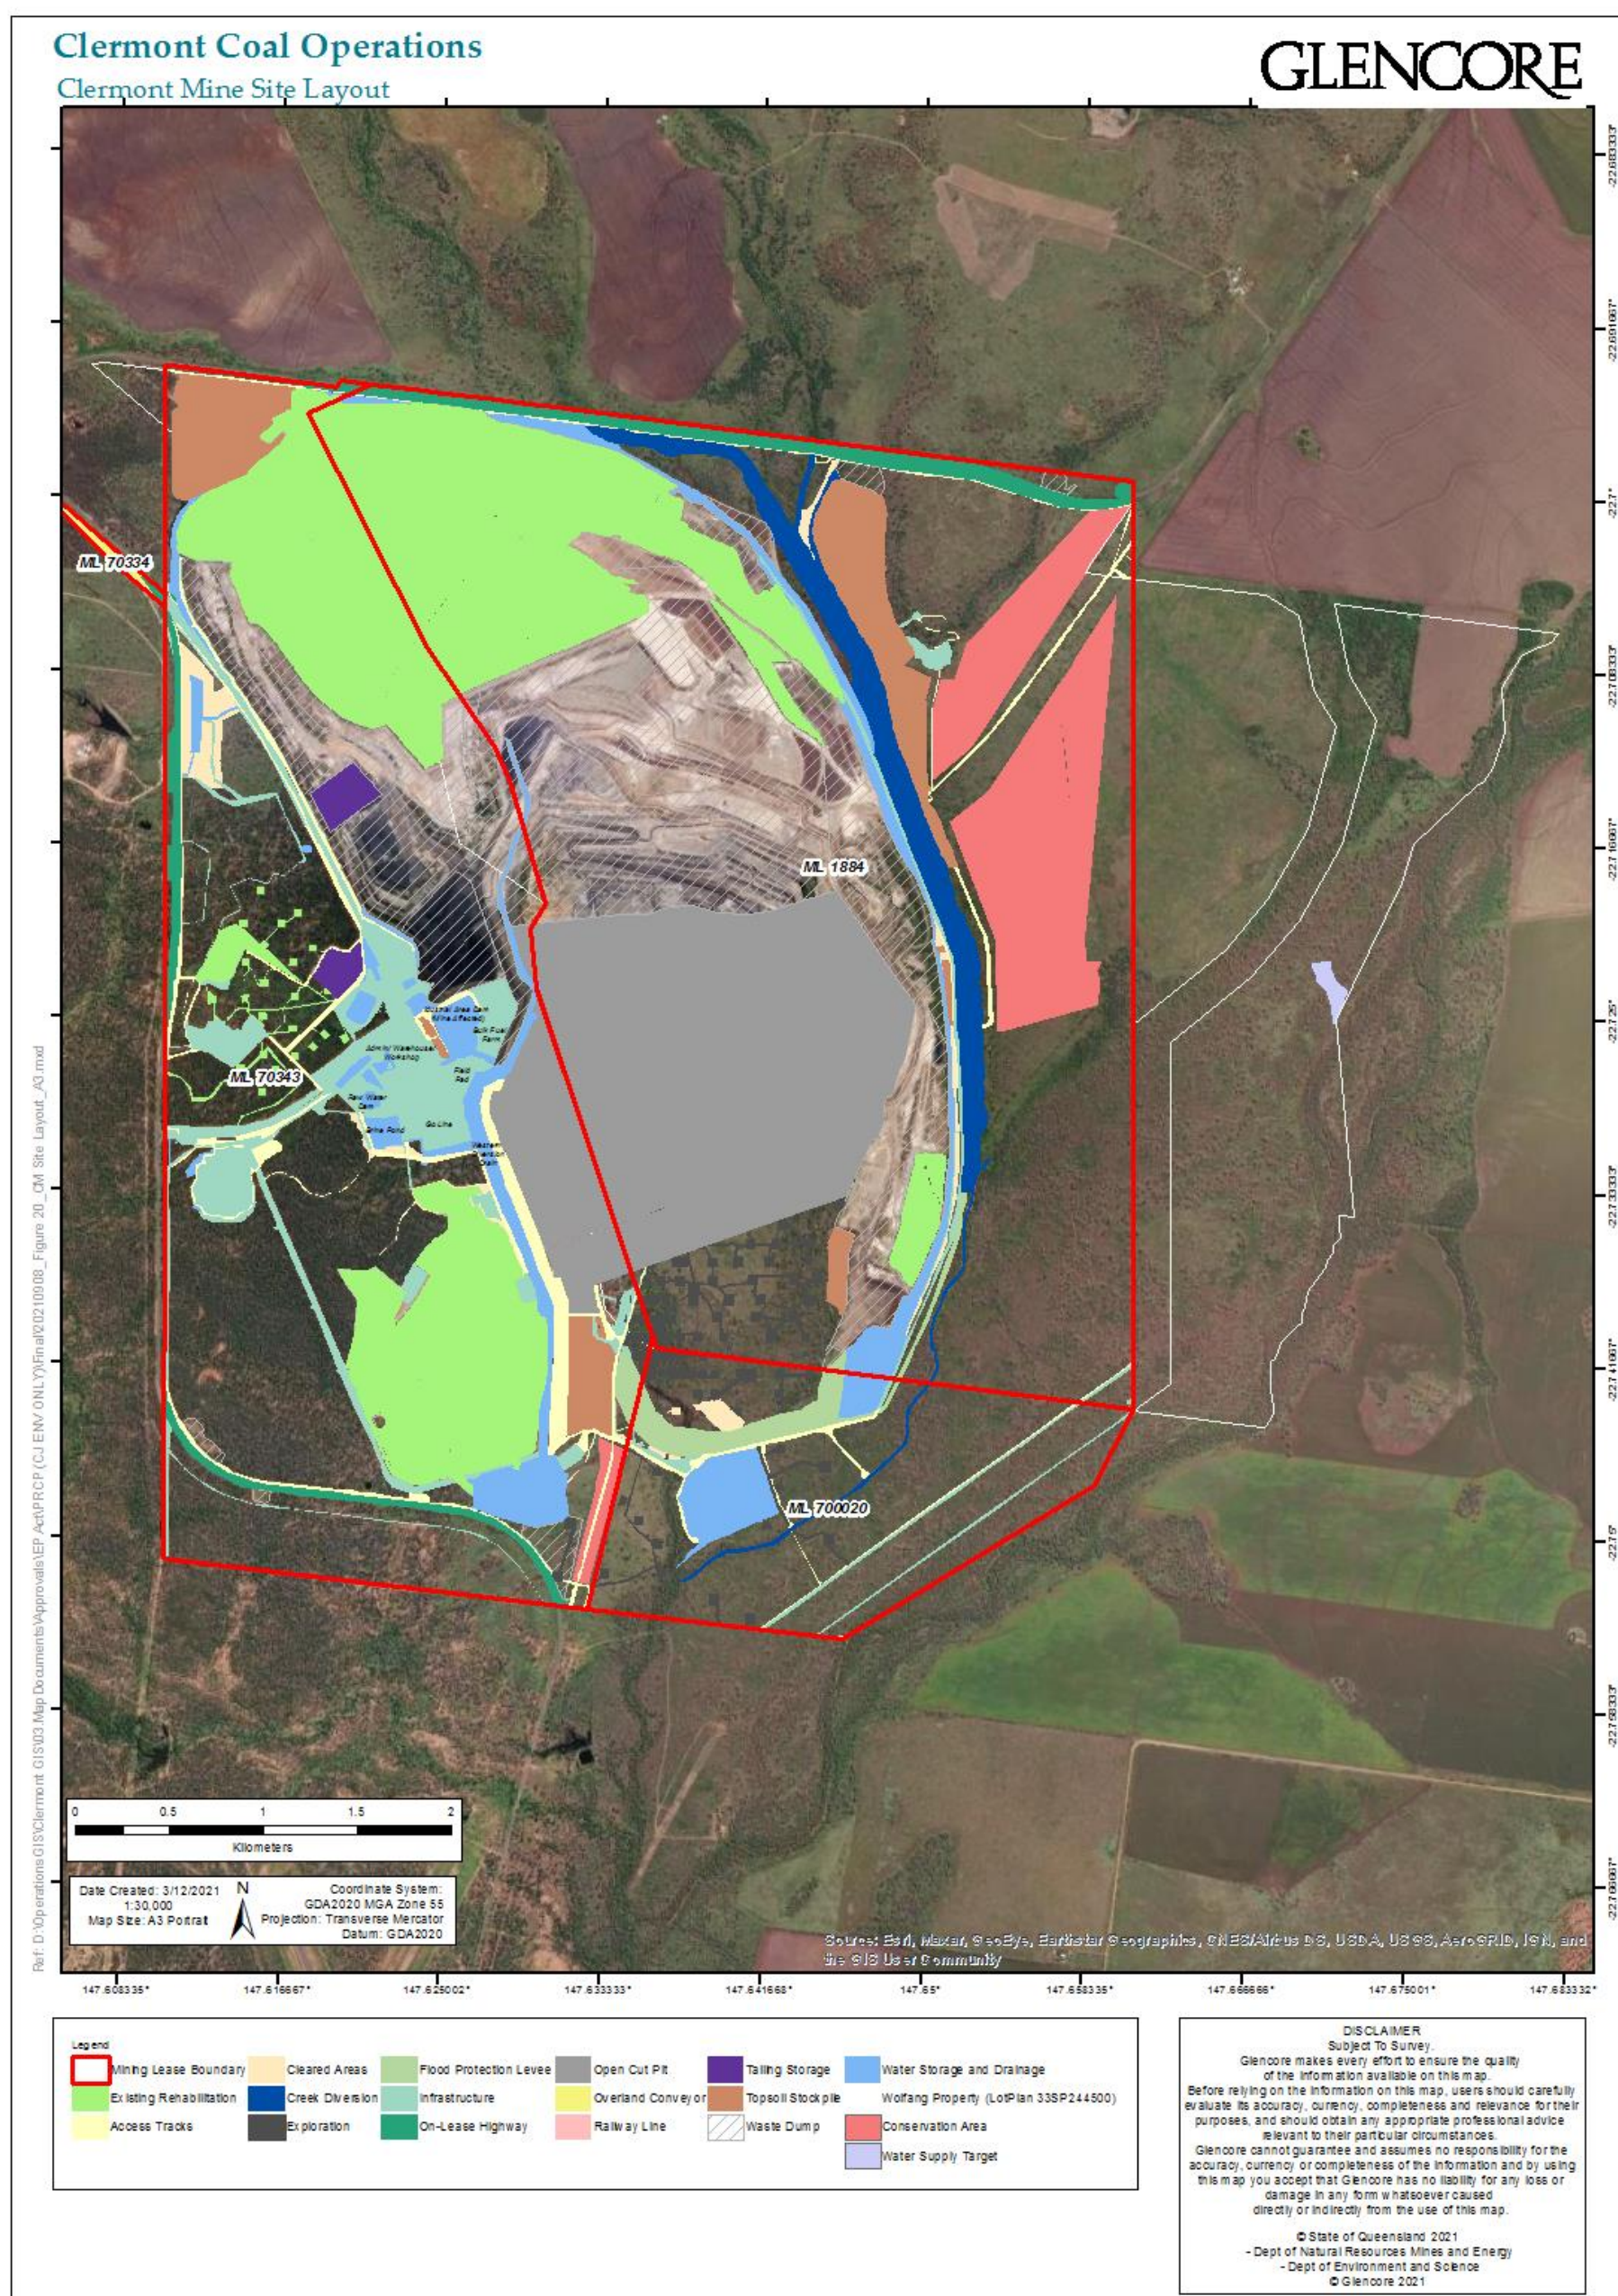
Figure 20 - Site Features - CM

The main features of the CM are as summarised below, and shown in **Figure 20**.
