CLERMONT

GLENCORE

# Progressive Rehabilitation and Closure Plan (PRC Plan)

January 2023

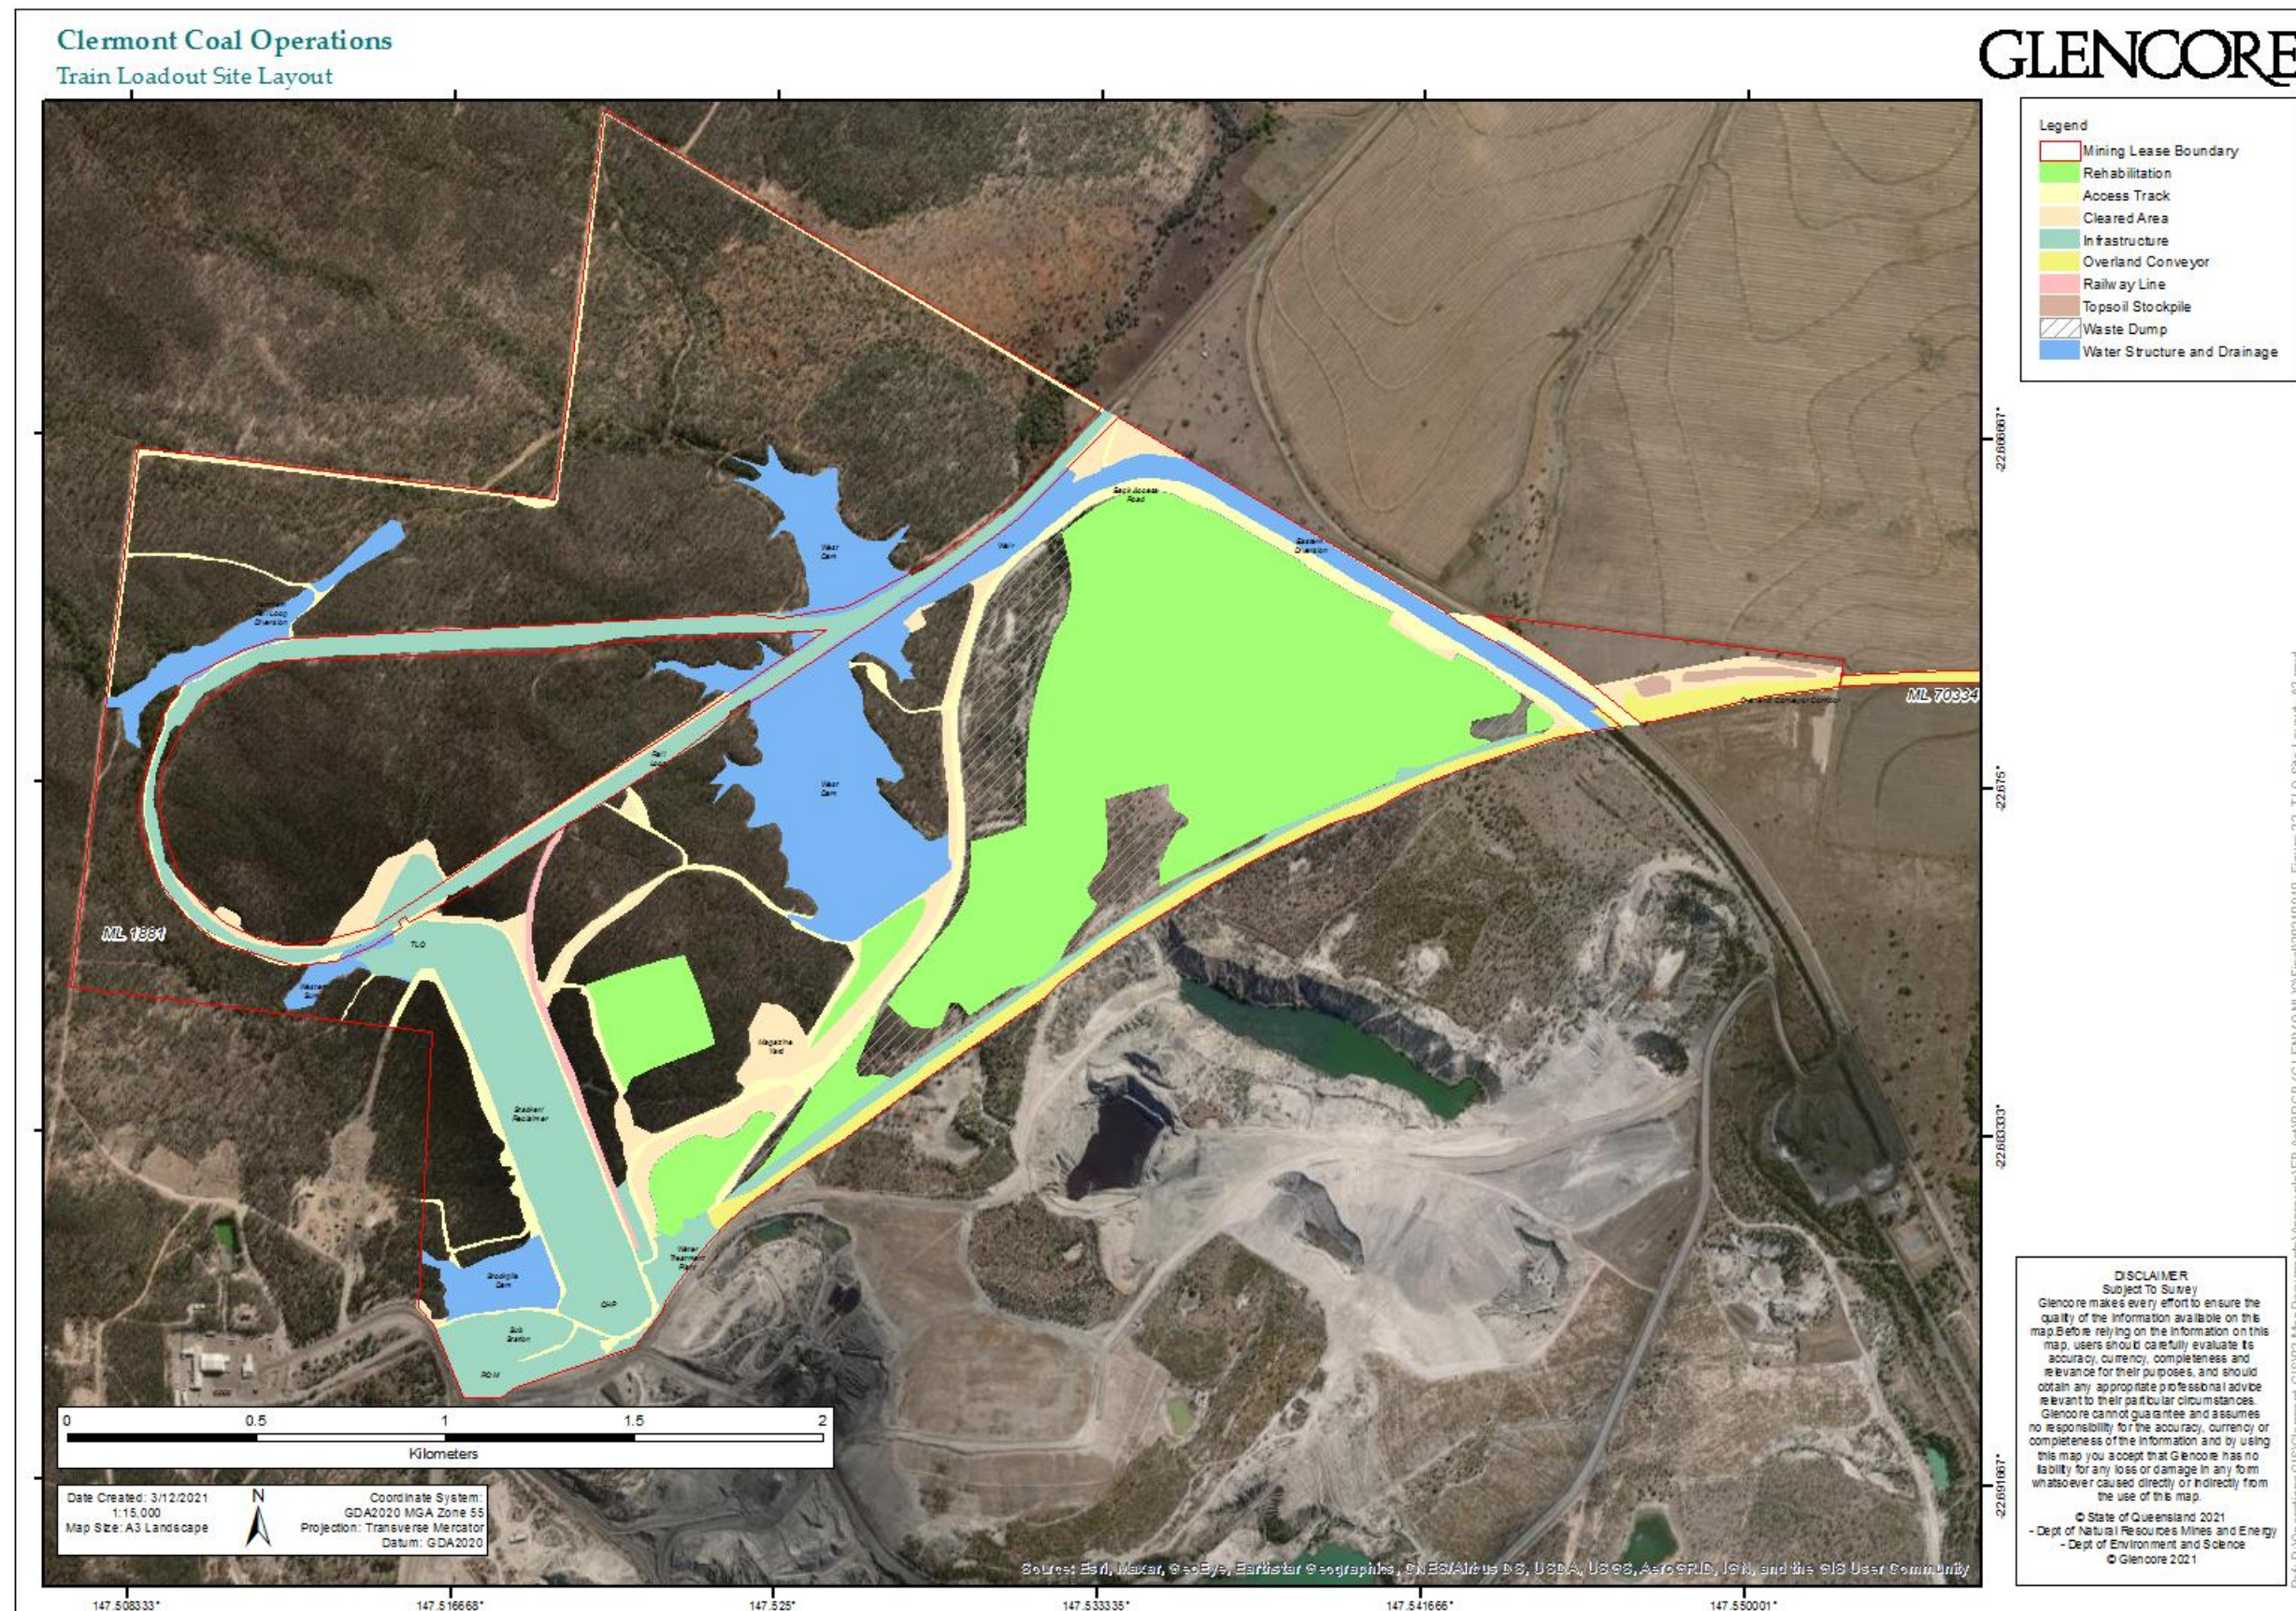
Figure 21 - Site Features – TLO

Coal is transported from the mine to the TLO previously on Blair Athol Mine land, but now part of the CCO, via a 13.3 km long OLC. The TLO contains (**Figure 21**):

- Coal handling facilities;
- Rail loop (outside the CCO ML, and owned by Aurizon);
- West Dam water supply;
- Creek diversions;
- Waste rock dumps in the eastern part of the TLO; and
- Access roads.

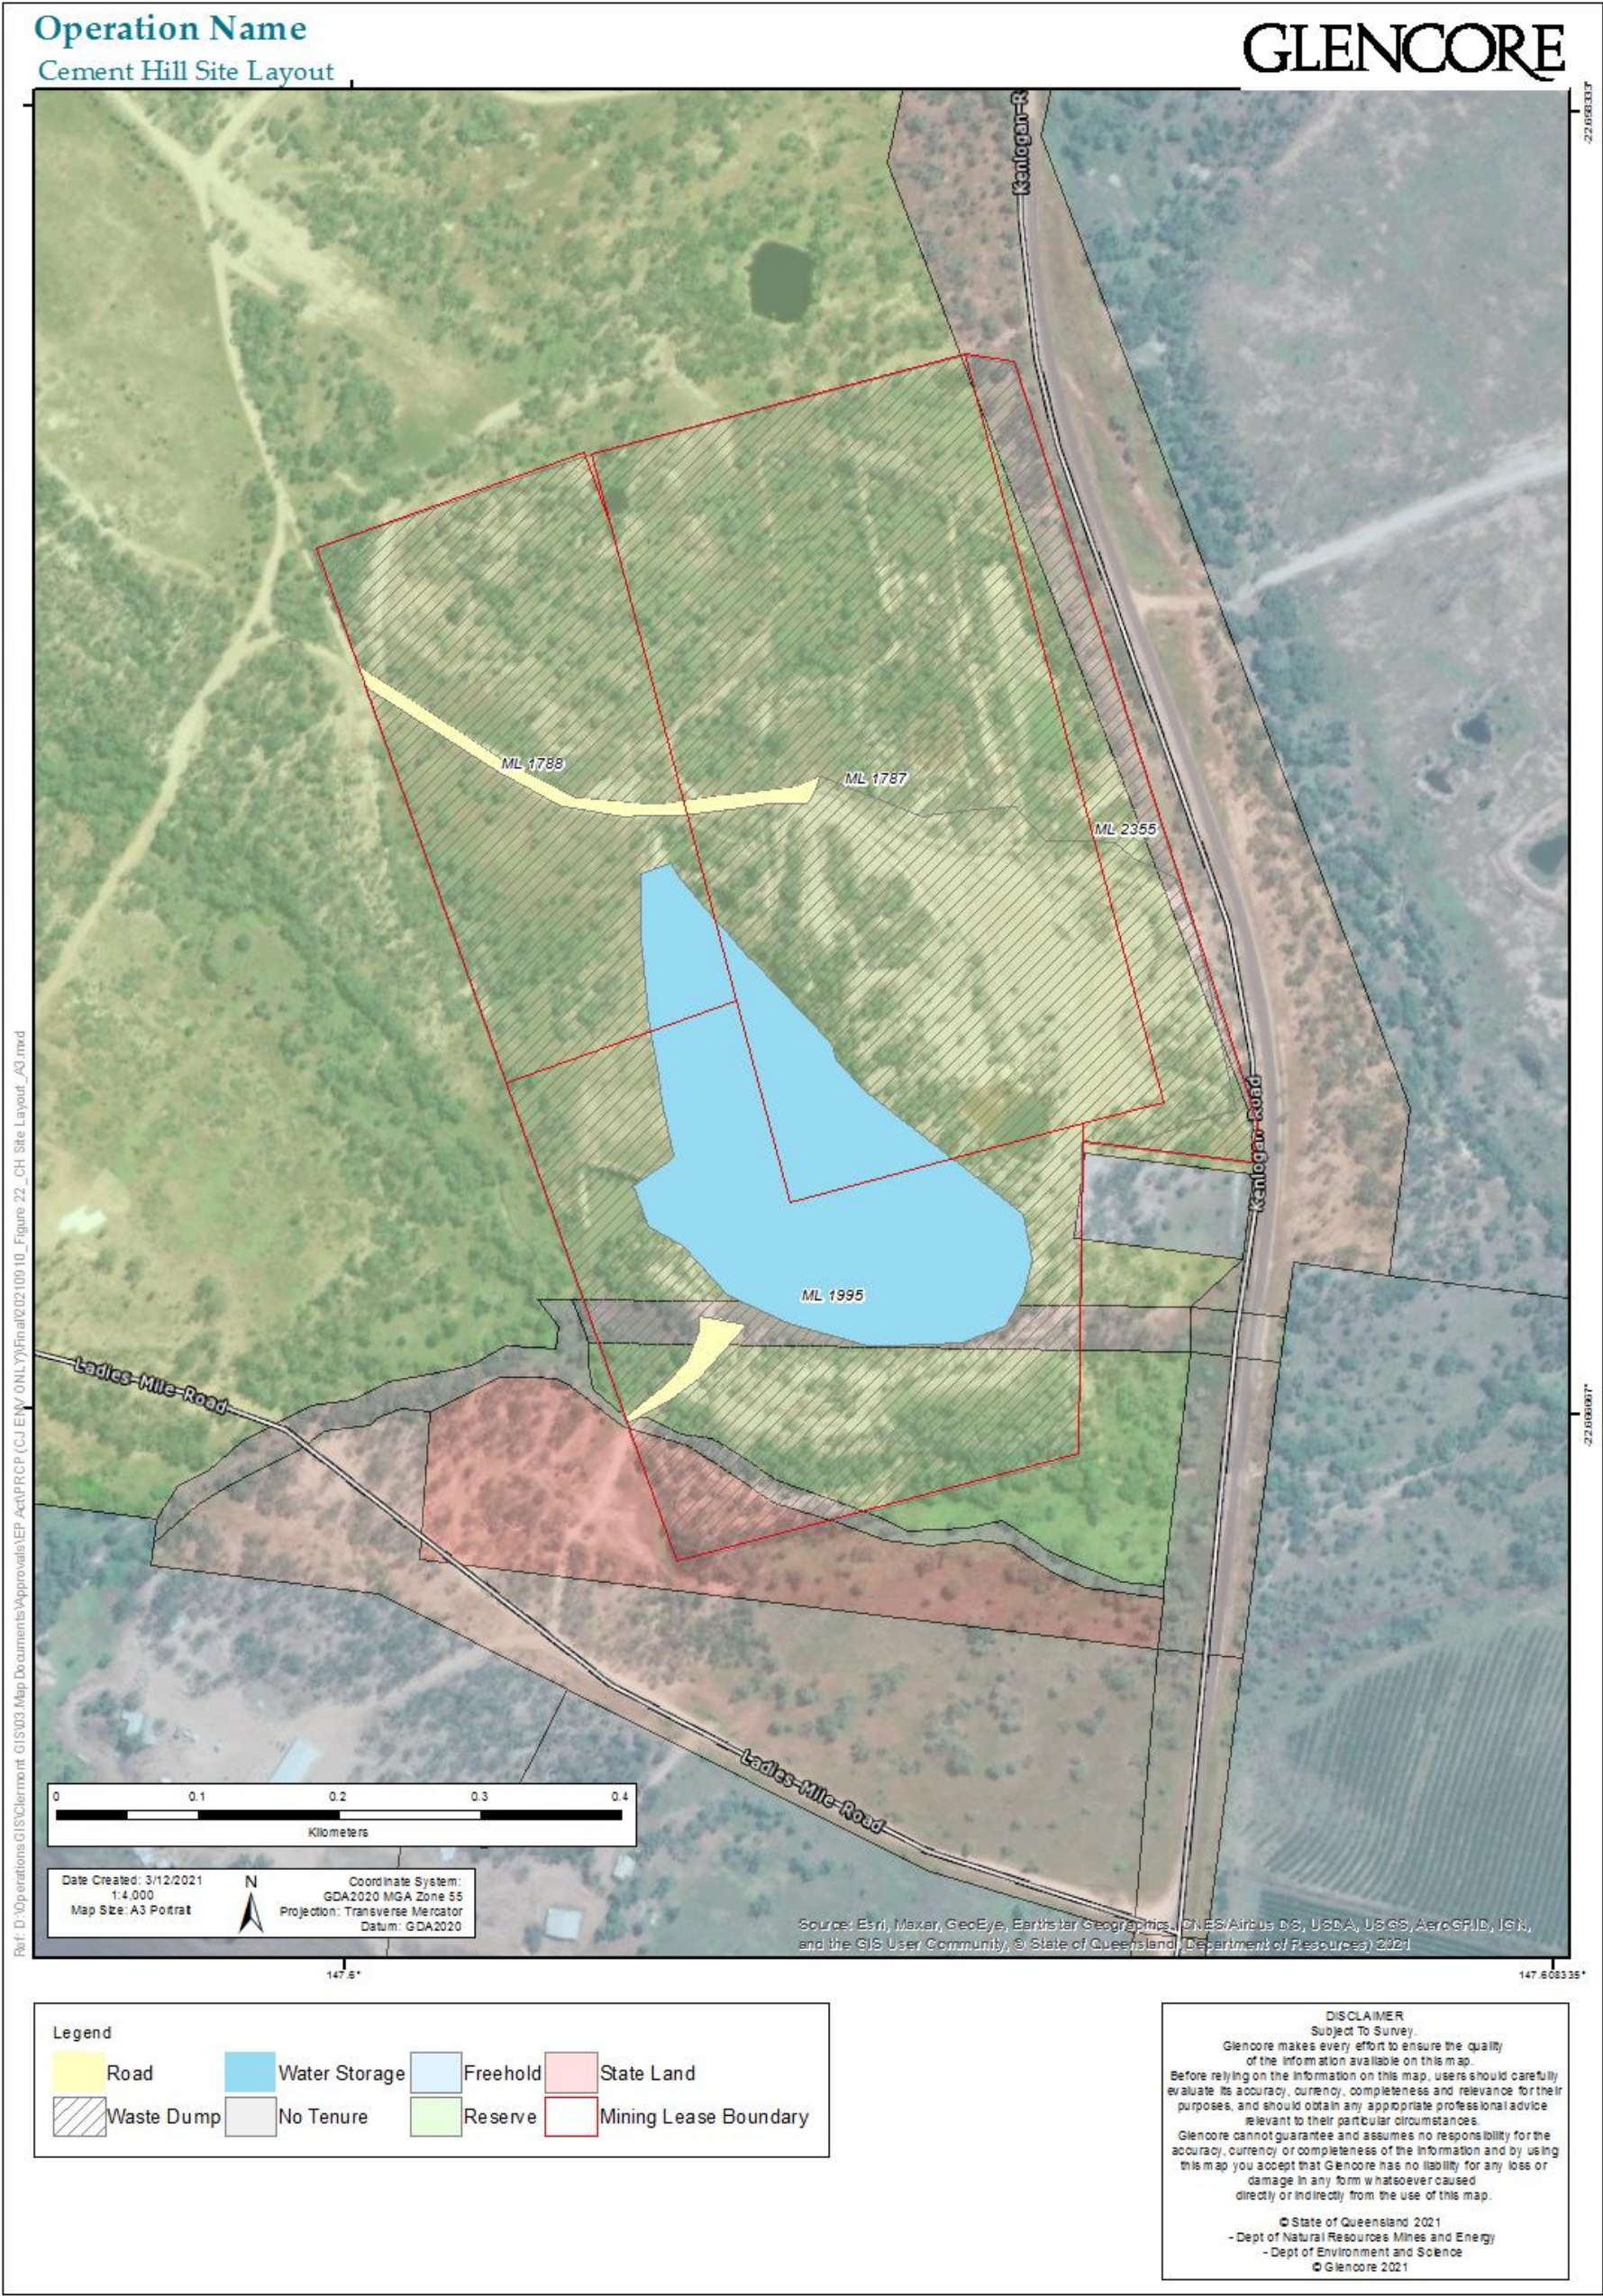
Figure 22 - Site Features – CH

CH is a former alluvial gold mine, primarily containing a final residual void, tailings cells and spoil dumps (**Figure 22**).

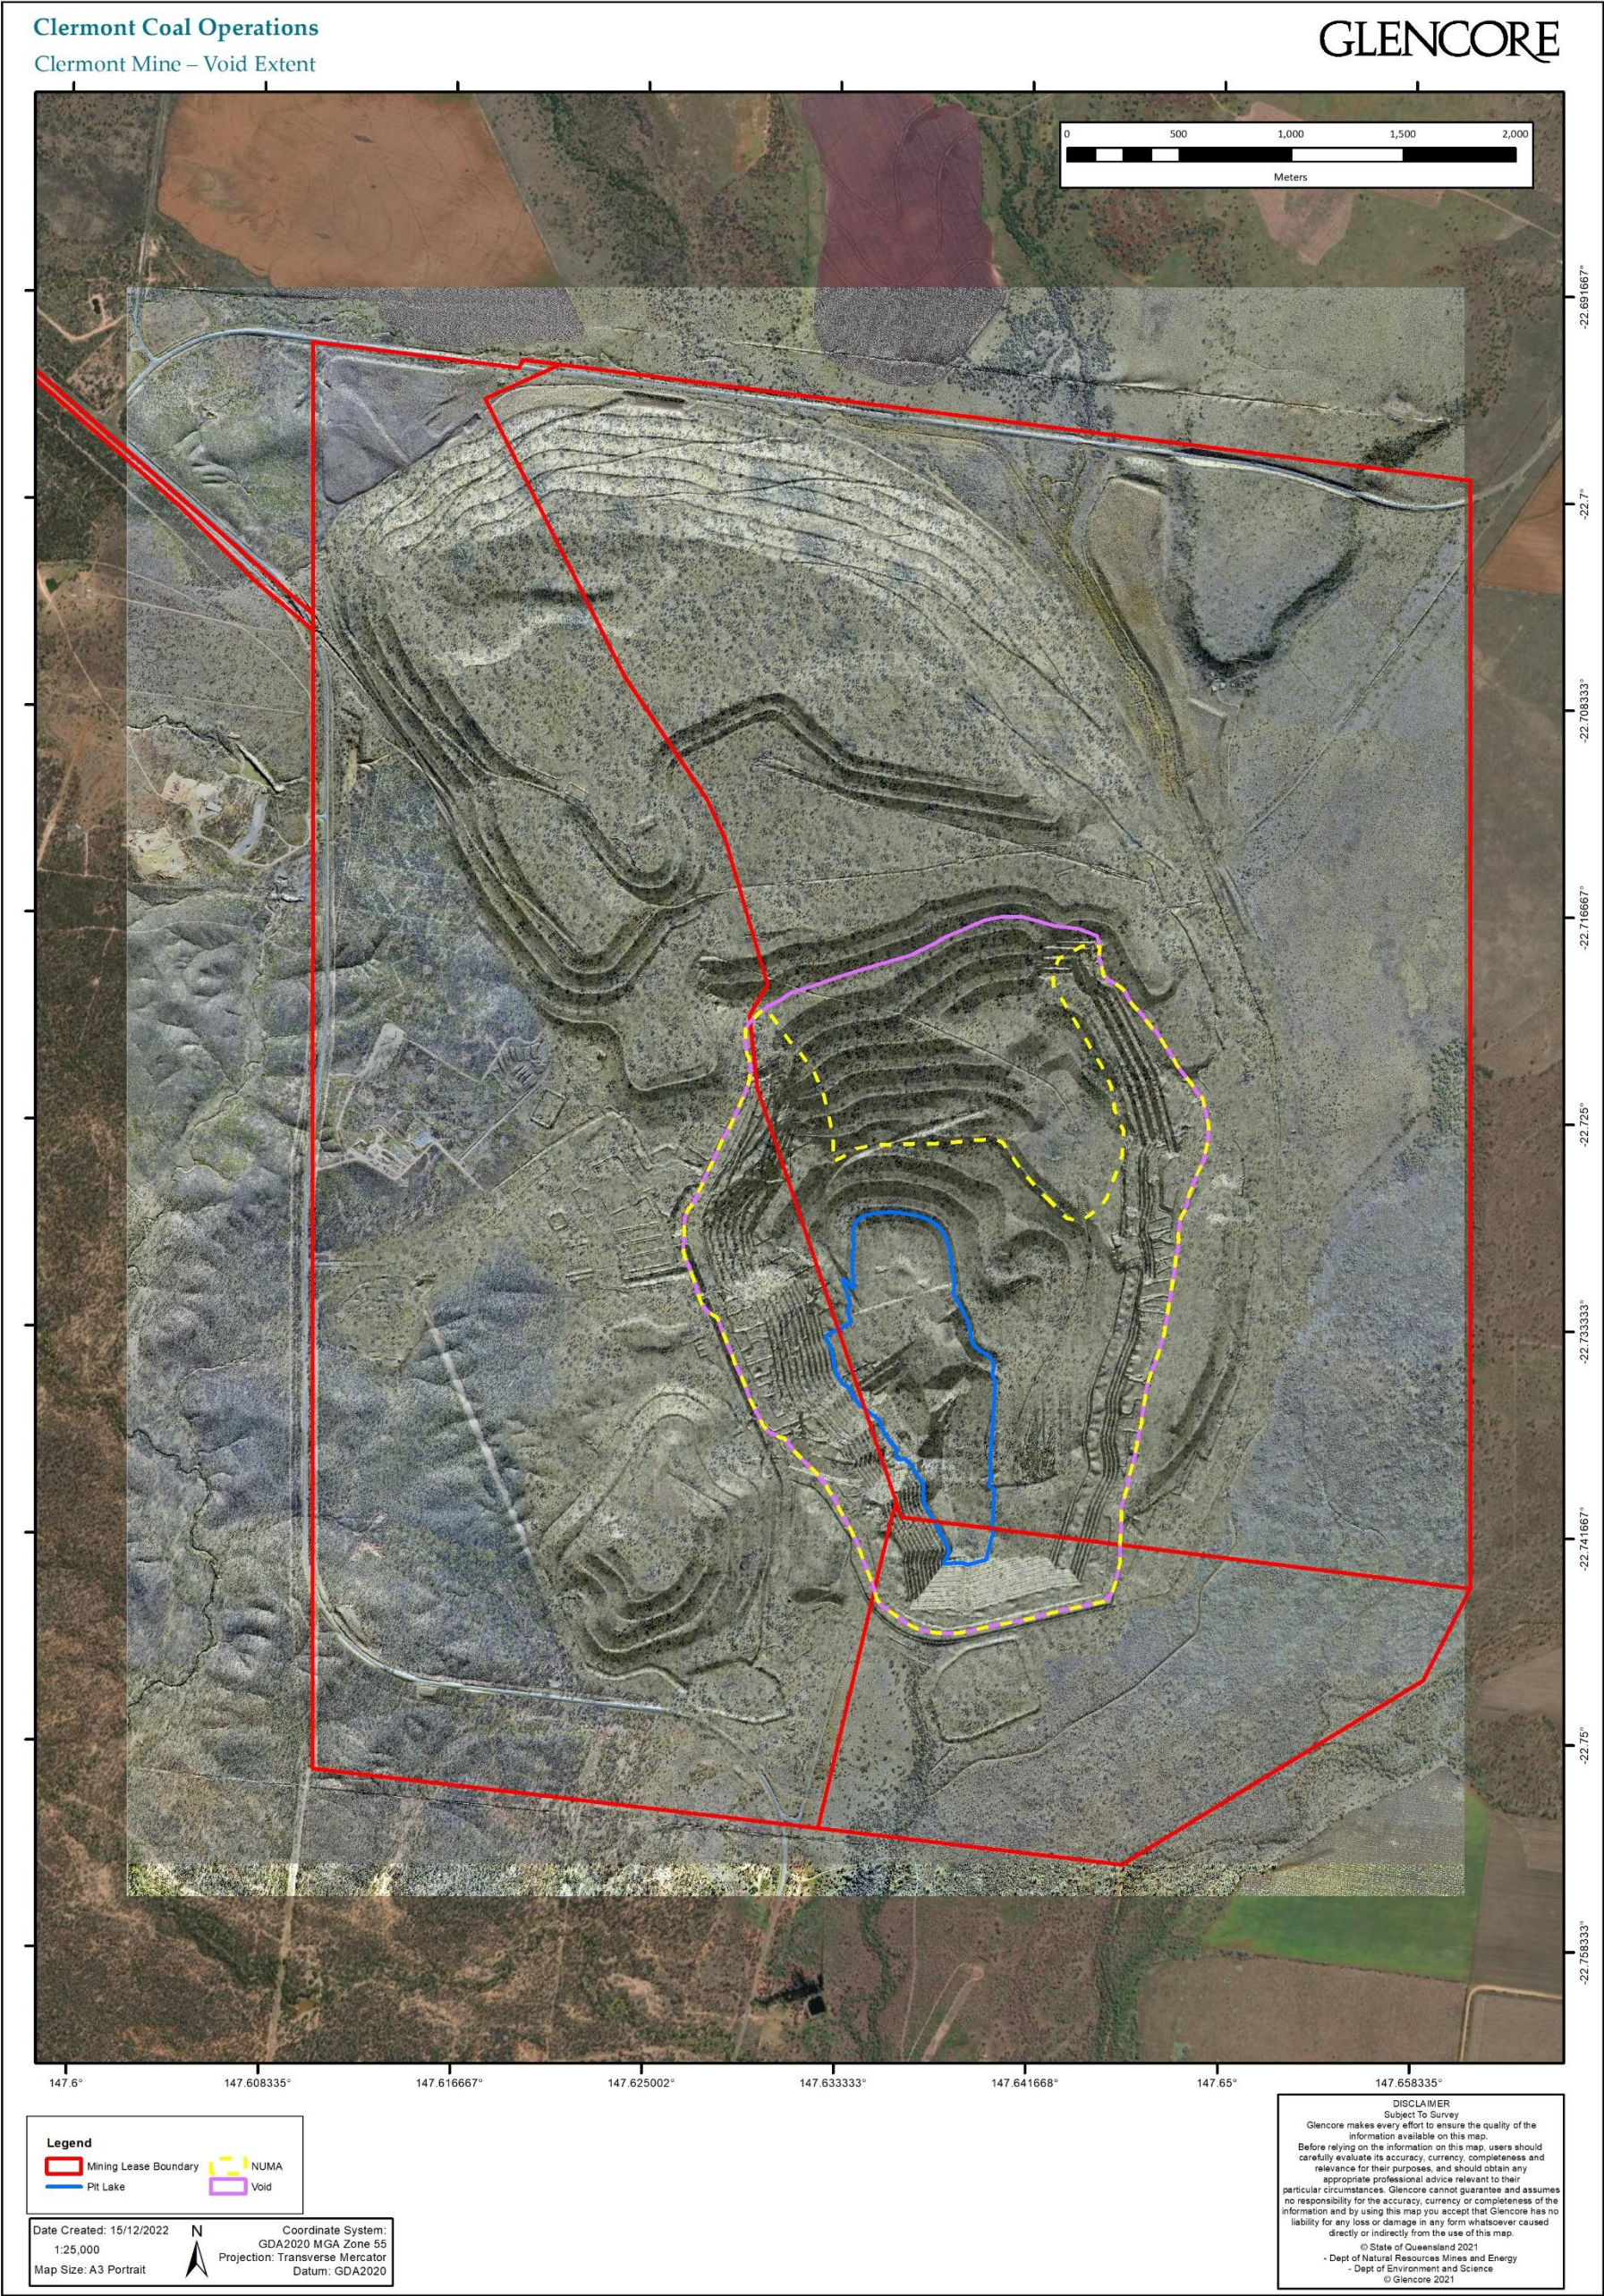
Figure 25 - CM Conceptual Final Void

The CCO final void NUMA has very constrained location options due to the mining activities. The location of the pit lake in the NUMA is outlined in the RMP, and provided in **Figure 25** below. The final void NUMA will be outside the floodplain, separated from it by a permanently rehabilitated landform.

- At CM, ground surface elevation at the top of the highwall is around 260m AHD and the base of the void will have an approximate elevation of around 66m AHD, resulting in a void depth of 194m below natural surface. The surface area (encompassing the full void crest perimeter) is 524.58 ha. The boundaries contain batter slopes with gradients ranging from around 60% in the north and south to round 35% along the eastern batter. *Figure 25* provides the 3D design plan for the CM final void.

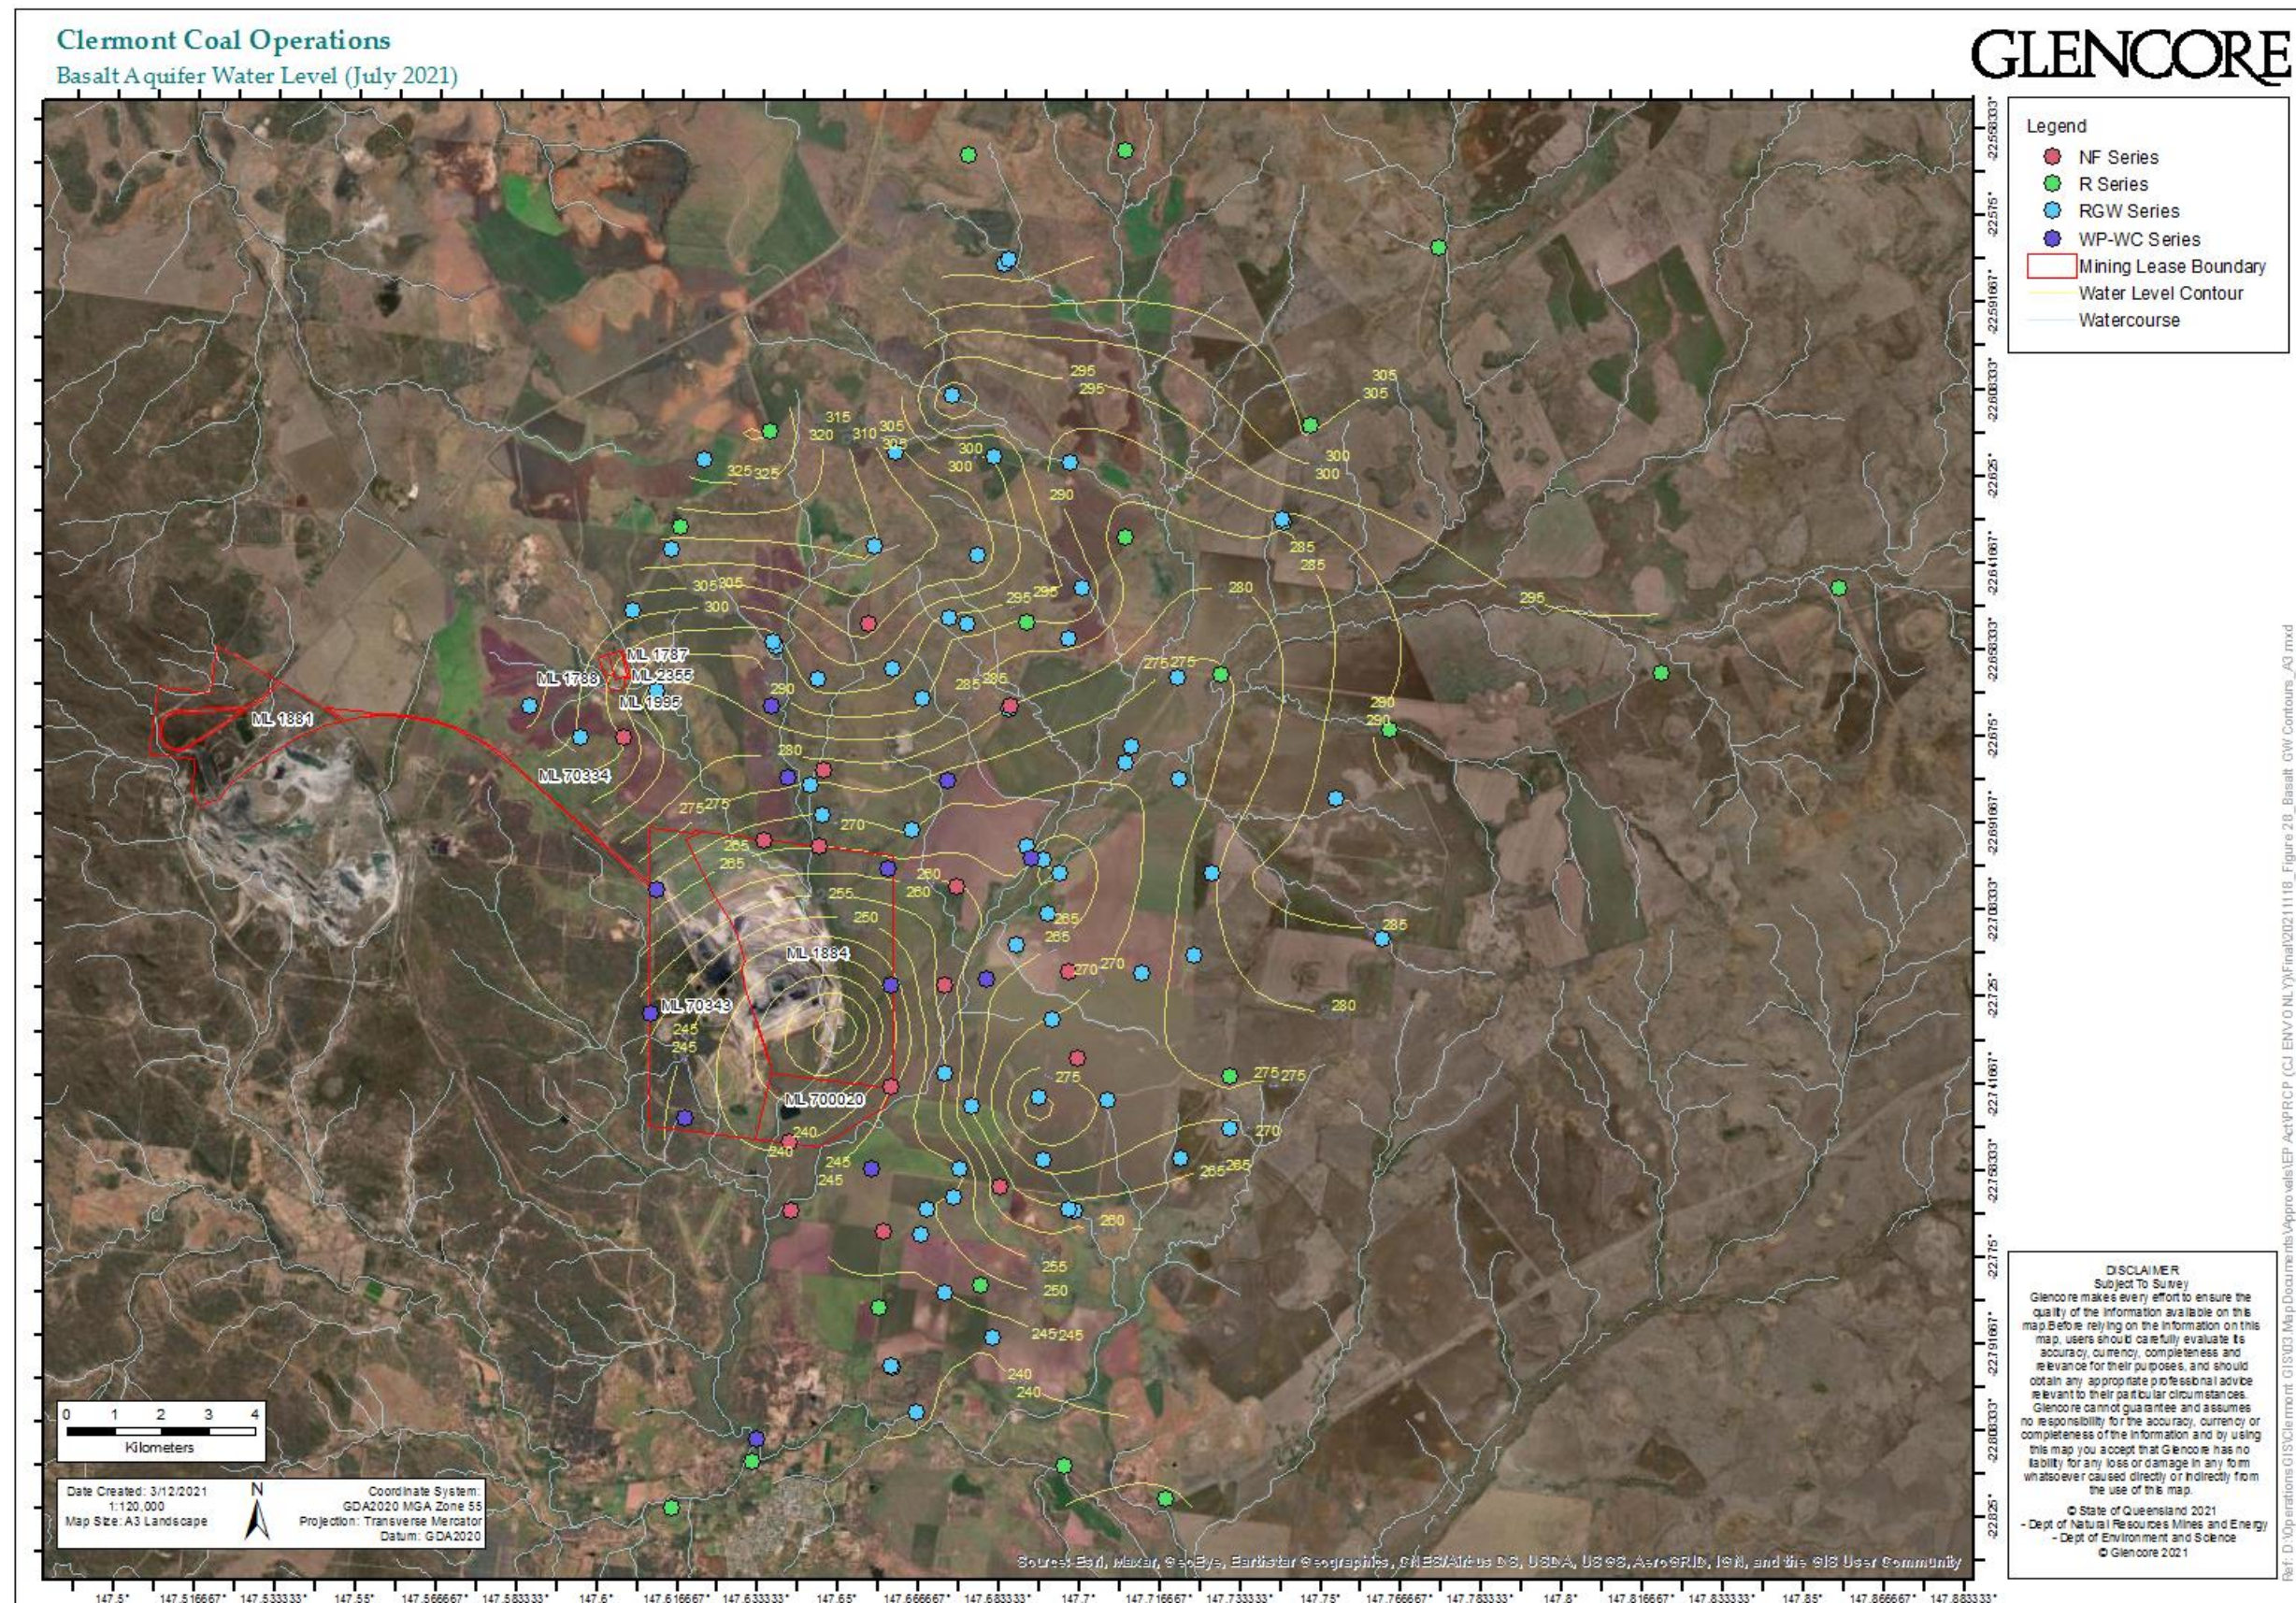
Figure 26 - Basalt Groundwater Contours and Inferred Flow direction

Early groundwater modelling completed as part of the EIS predicted much greater drawdown impacts within the CM Basalt aquifer than what has subsequently been observed and confirmed in a subsequently calibrated model. Modelling the highly fractured and compartmentalised basalt is of limited value as it does not behave as a regional system but as a series of localised storage zones. CCO has estimated a total water extraction of 5847ML through pumping and pit inflows since 2009.

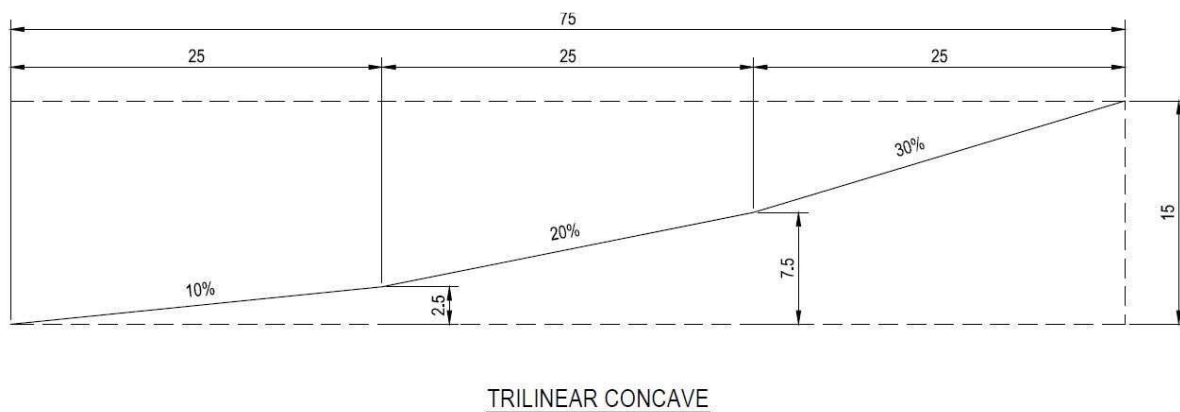
Figure 28 - Trilinear landform arrangement for earthworks at CCO

As explained previously, a trilinear or concave overall landform slope is to be adopted as standard. Figure 28 shows this concept for out of pit areas.

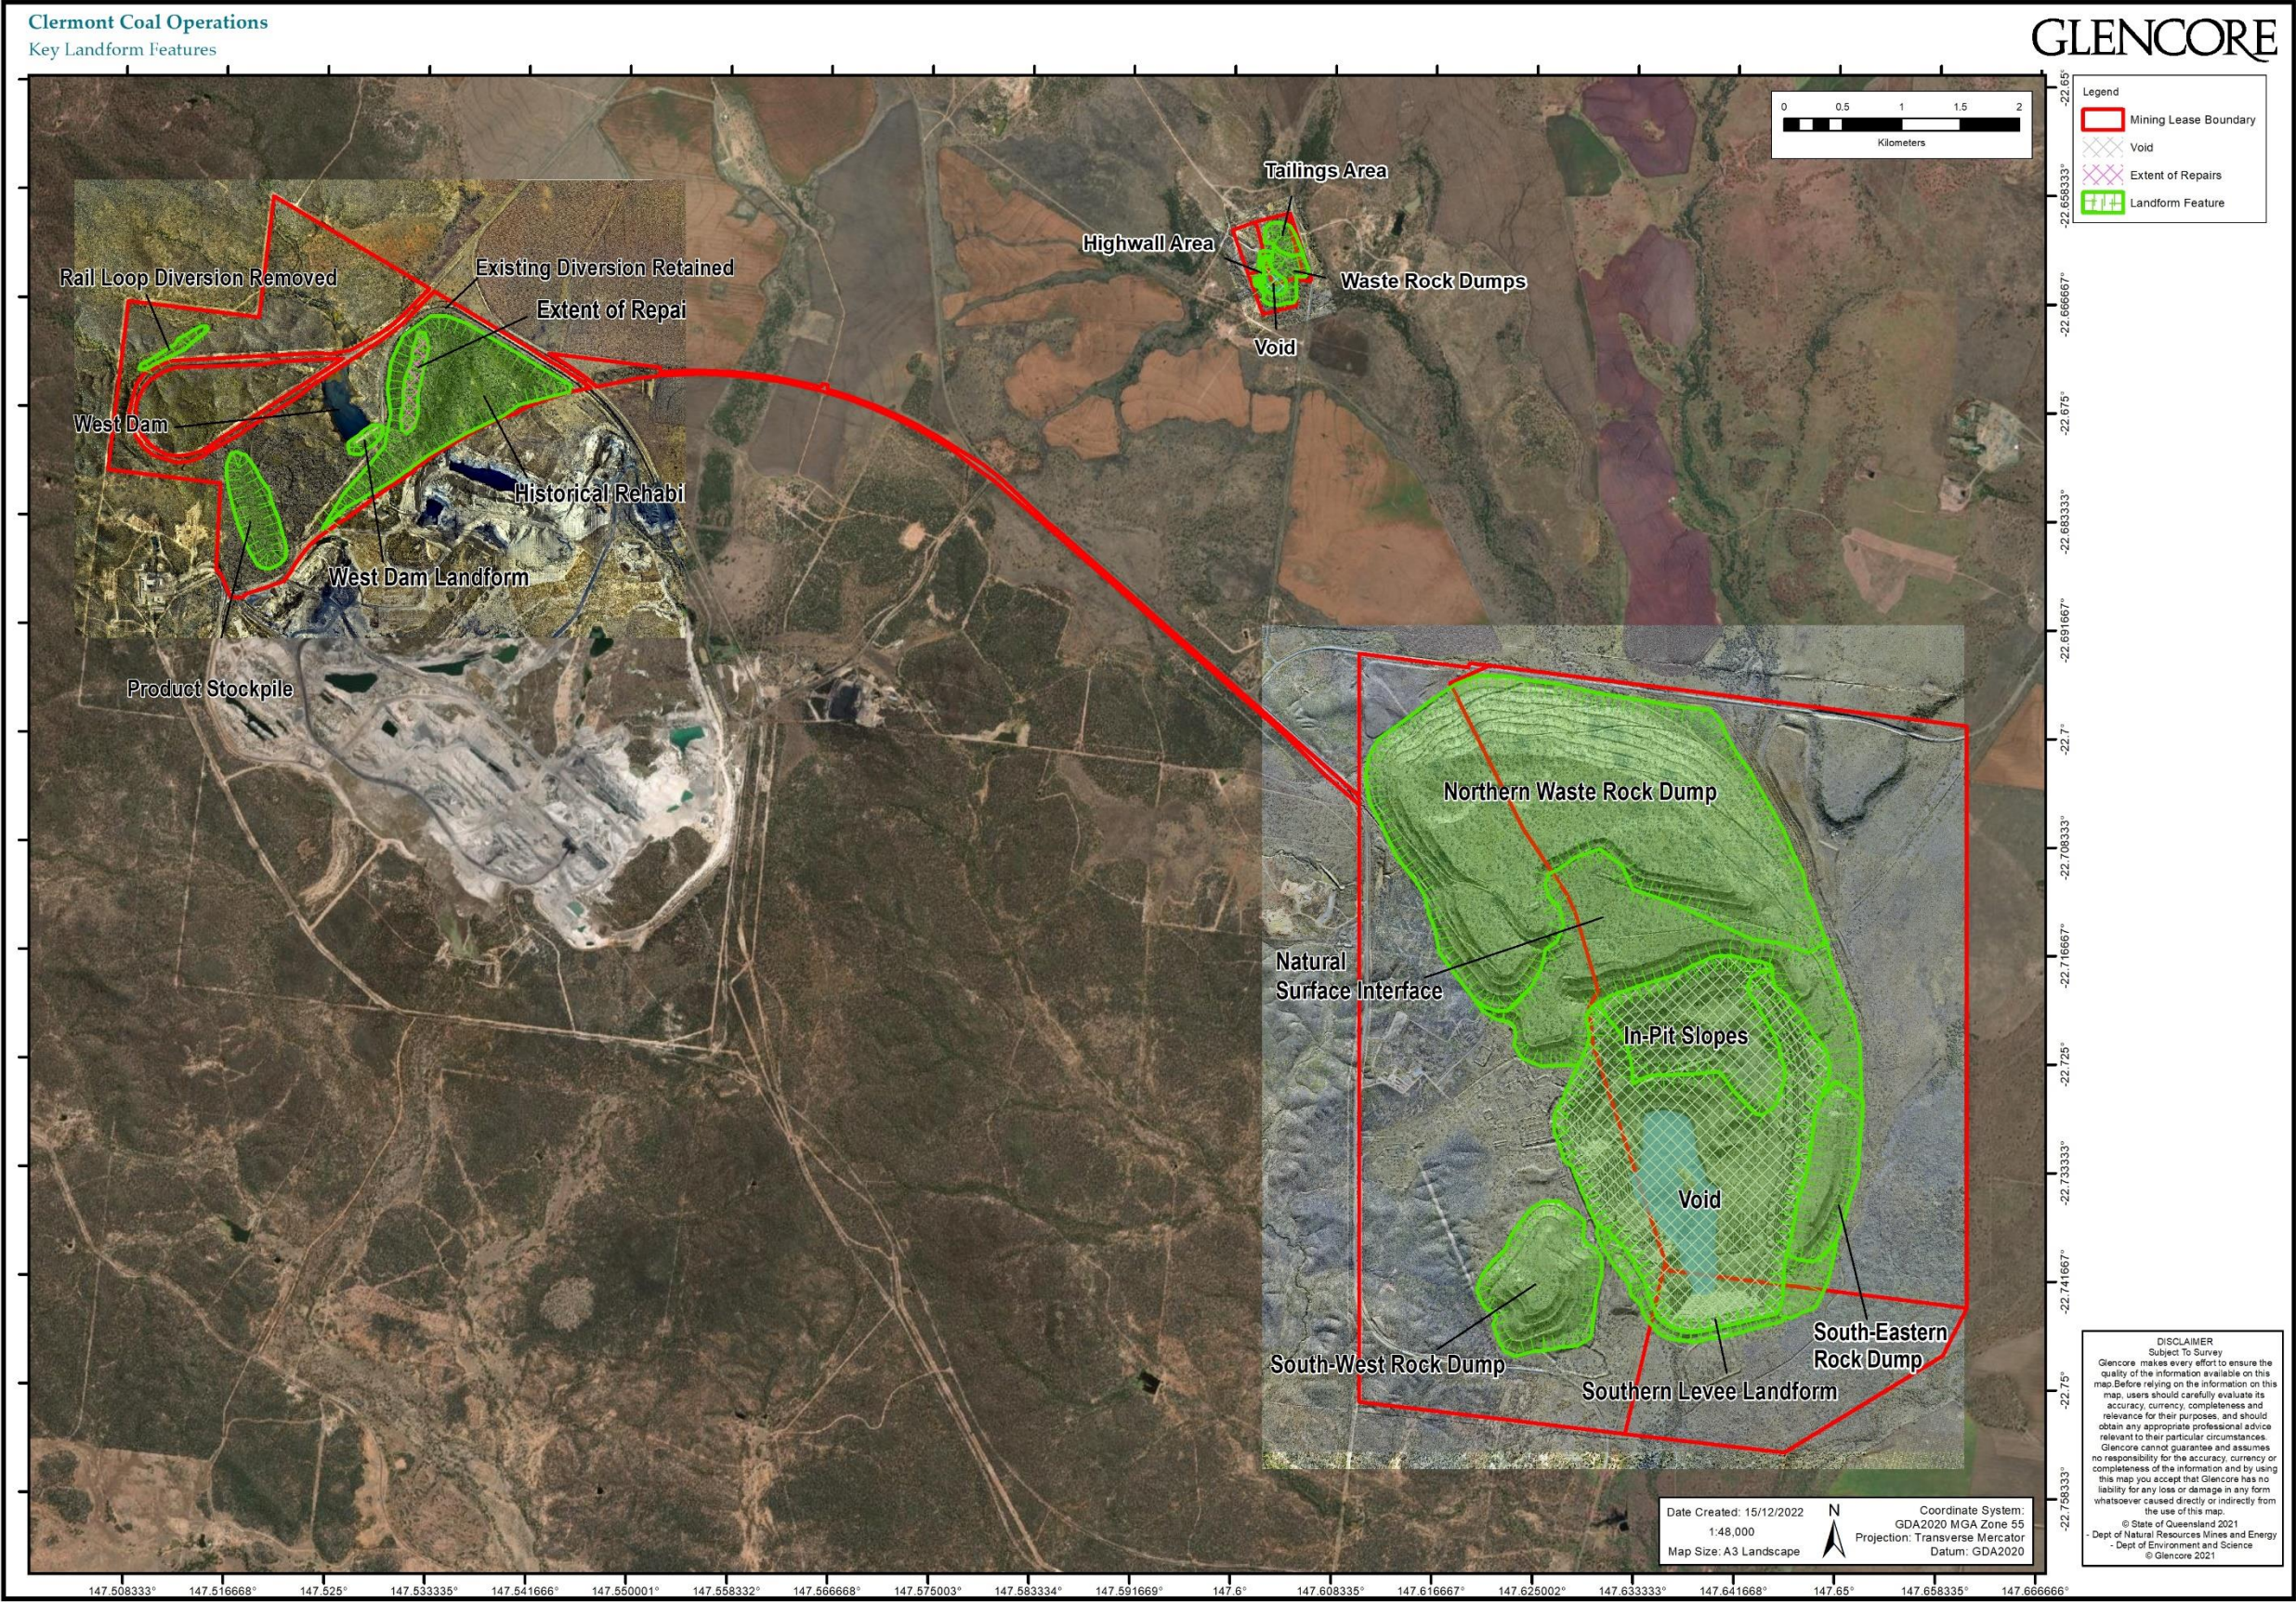
Figure 29 - Key landform areas to be rehabilitated at CCO

Based on local climatic conditions, the landform design concept has adopted a water-shedding arrangement. Large ponding or standing water bodies are avoided on all rehabilitated landforms. It is expected that the primary contaminant from newly rehabilitated landforms will be sediment, and therefore all runoff from rehabilitation areas will have sediment controls in place for the initial period whilst vegetation is establishing. Details of the typical sizing and design criteria to adopt for bench drains and rock chutes is outlined in Appendix 4.11.

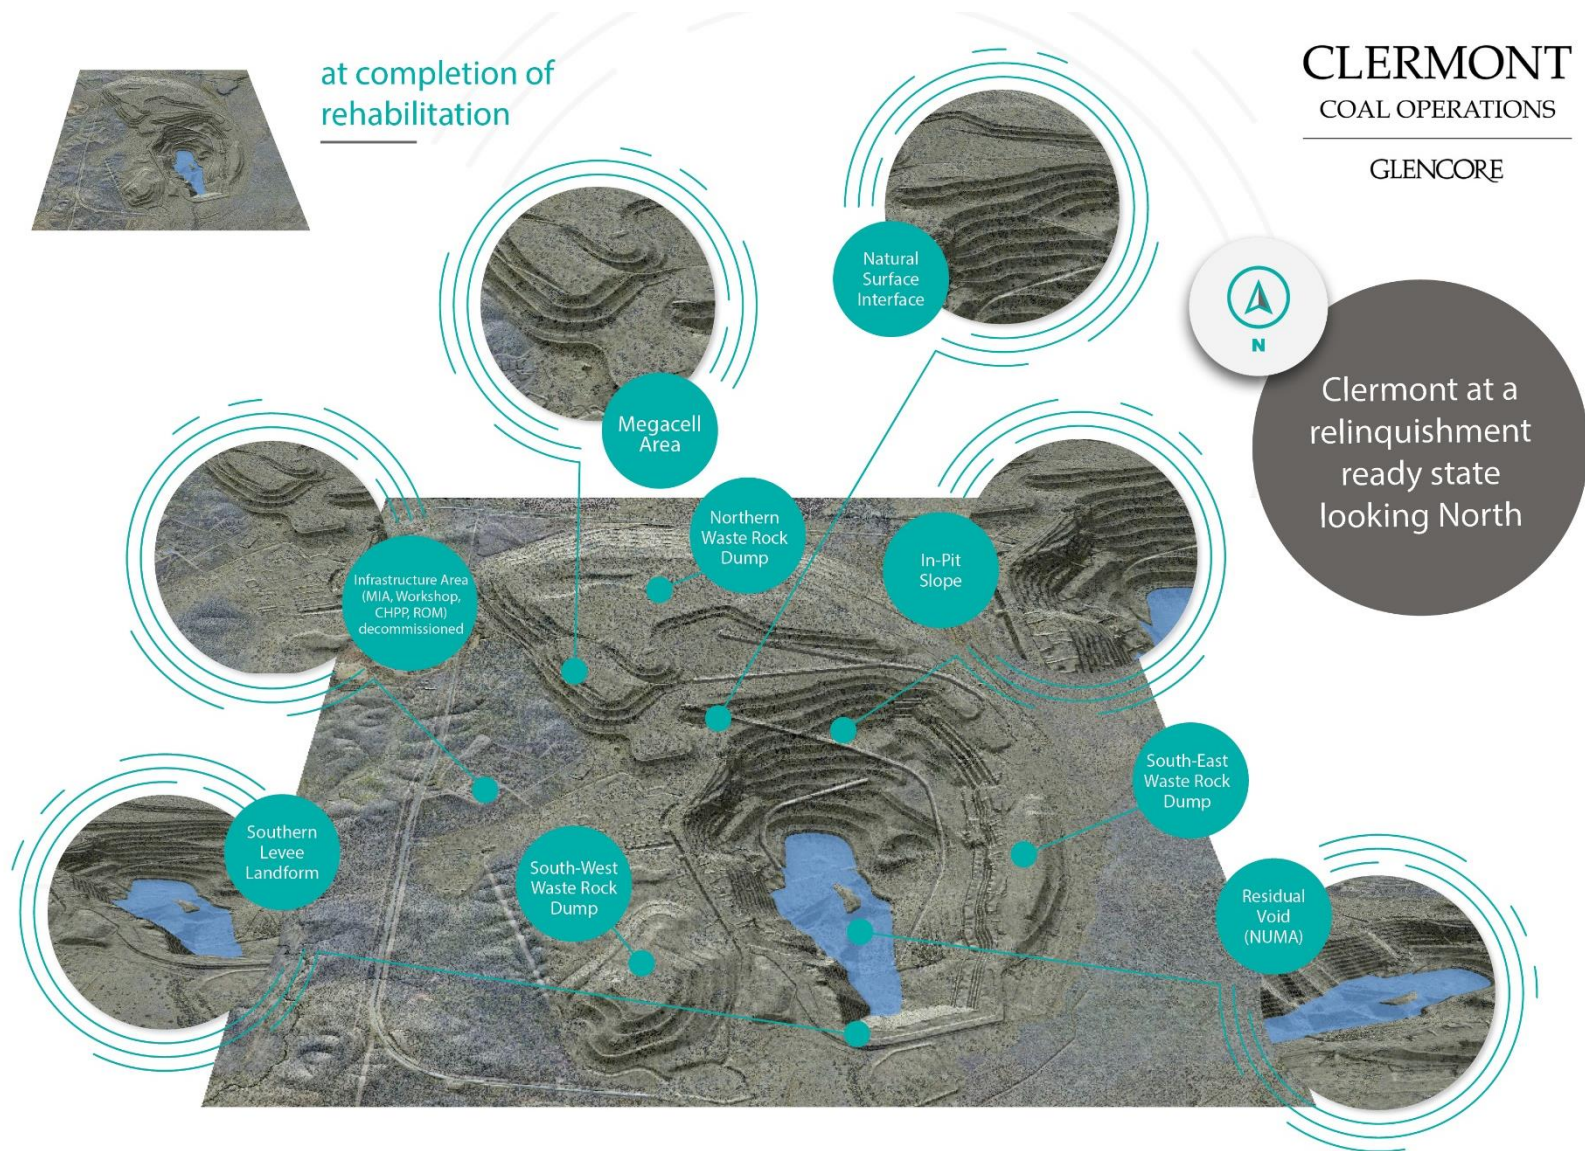
Figure 30 - Landform features at CM after rehabilitation and closure

Rehabilitation and closure visualisations for each of the CCO locations (CM, CH and TLO) are shown in **Figure 30** to **Figure 32**. These have taken the 3D landform design and used advanced spatial visualisations tools to overlay an aerial image over the landform. Additional visual detail is provided to show key features for each location. Further detail of all features for each area is provided as Appendix 4.11.
