CLERMONT

GLENCORE

# Progressive Rehabilitation and Closure Plan (PRC Plan)

January 2023

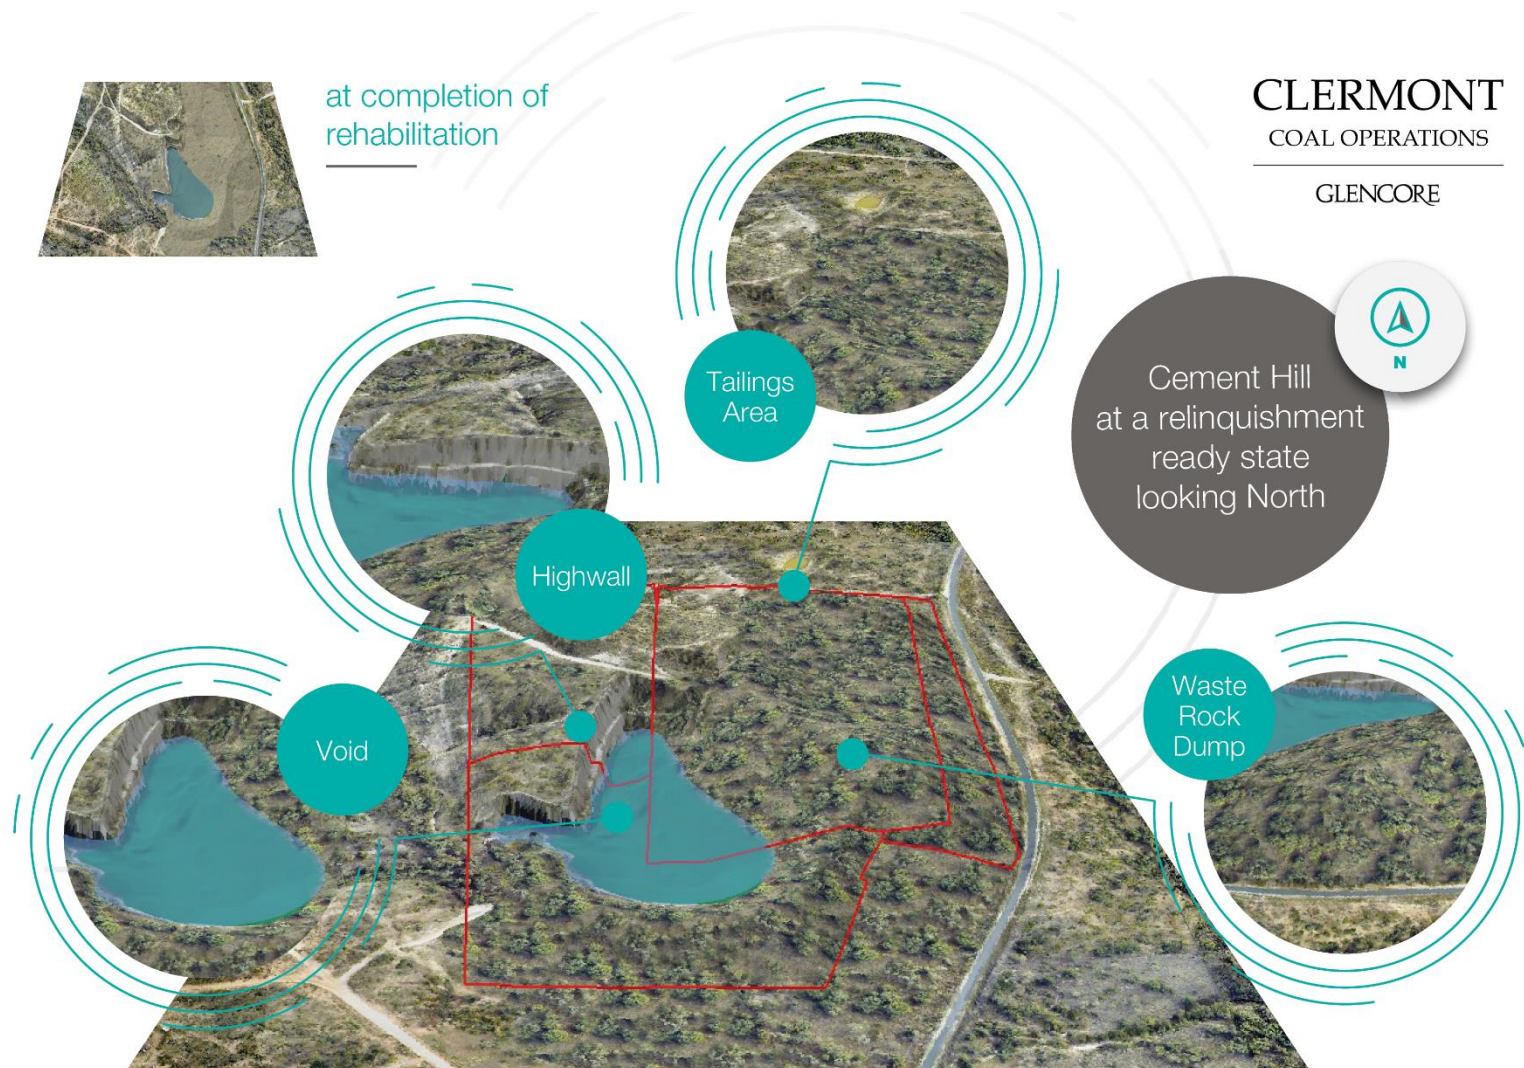
Figure 31 - Landform features at CH after rehabilitation and closure

Rehabilitation and closure visualisations for each of the CCO locations (CM, CH and TLO) are shown in **Figure 30** to **Figure 32**. These have taken the 3D landform design and used advanced spatial visualisations tools to overlay an aerial image over the landform. Additional visual detail is provided to show key features for each location. Further detail of all features for each area is provided as Appendix 4.11.

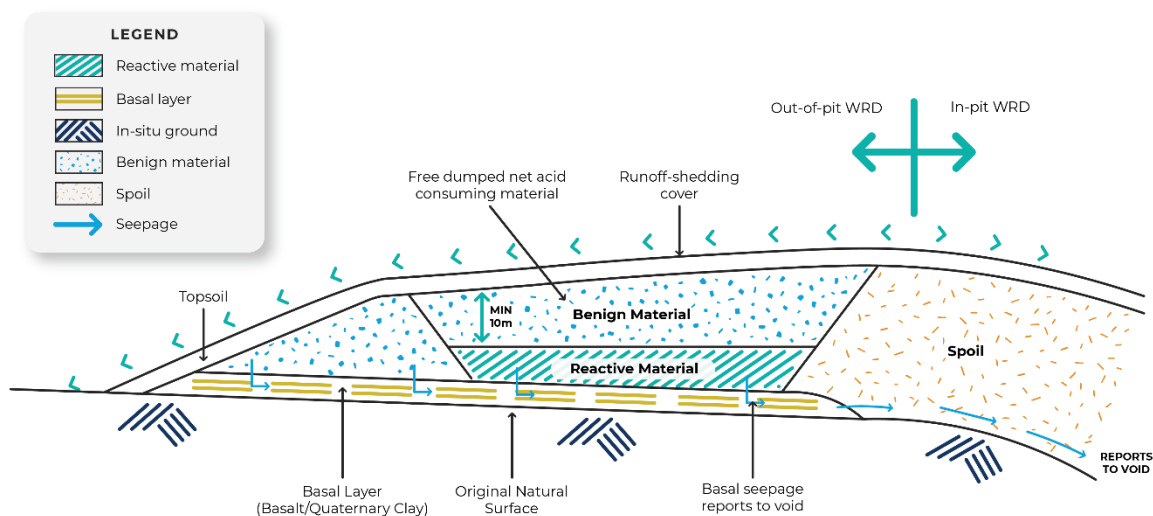
Figure 34 - Encapsulation Diagram for Reactive Tailings

The general design philosophy adopted for CCO is one of integrated landform construction, whereby the tailings waste is disposed of and entirely encircled by a waste rock dump emplacement. Up until 2021 all tailings at the CM were stored in 'Megacells'. These comprise cells formed within spoil that encapsulate the tailings. They consist of a basal layer of basalt (or some other net-acid-consuming material), 'clean' material to form the sides of the Megacells and a minimum 10m layer of net acid consuming material above. The design concept is shown in Figure 34.

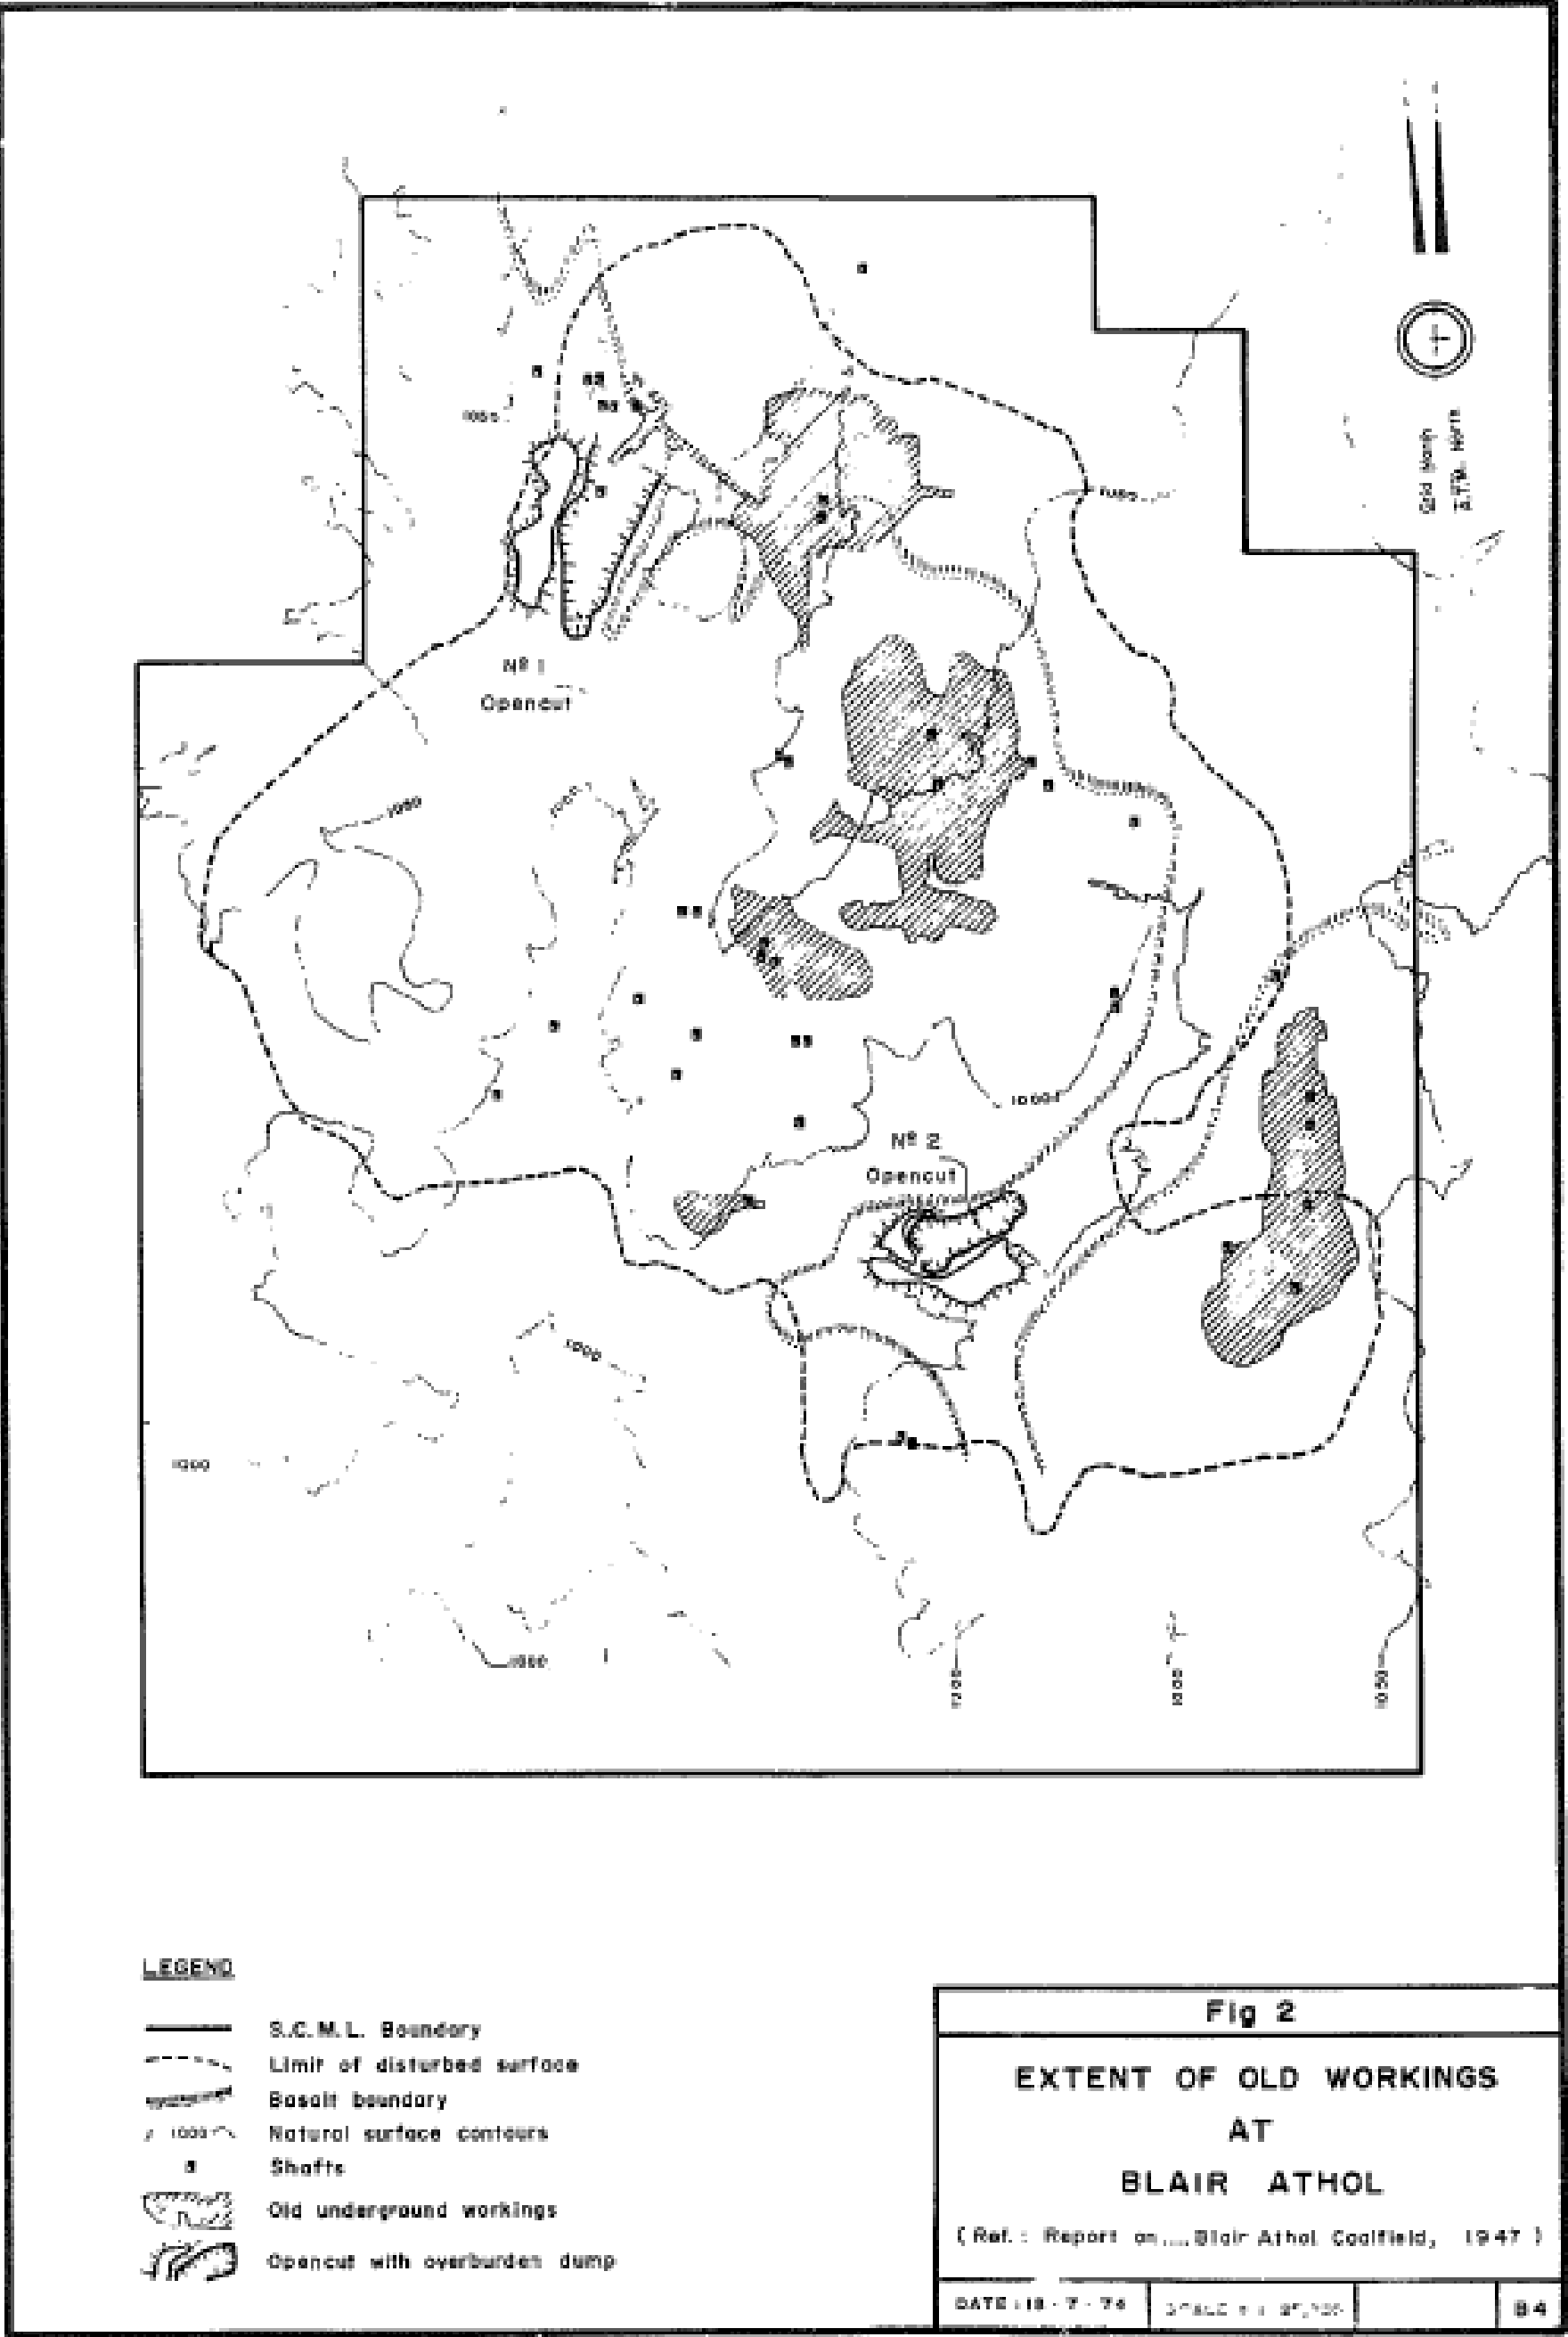
Figure 35 - Historic BAC underground workings

Although there have been historic underground workings underlying the TLO area, they are considered to be minor in scale, and developed utilising historic methods which are not anticipated to result in any geotechnical concerns or significant interactions with groundwater. Underground mining activities ceased 75 years ago, and have subsequently been backfilled to control spontaneous combustion. It is expected that any settlement or subsidence impacts, or indeed tunnelling or collapse related to ongoing spontaneous combustion, would have become apparent during this period. There are no remaining surface entries or shafts to the historic underground workings which require sealing. Rehabilitation monitoring within the historic rehabilitation areas that overlie the underground workings also do not show any signs of surface ponding and cracking that require mitigation.

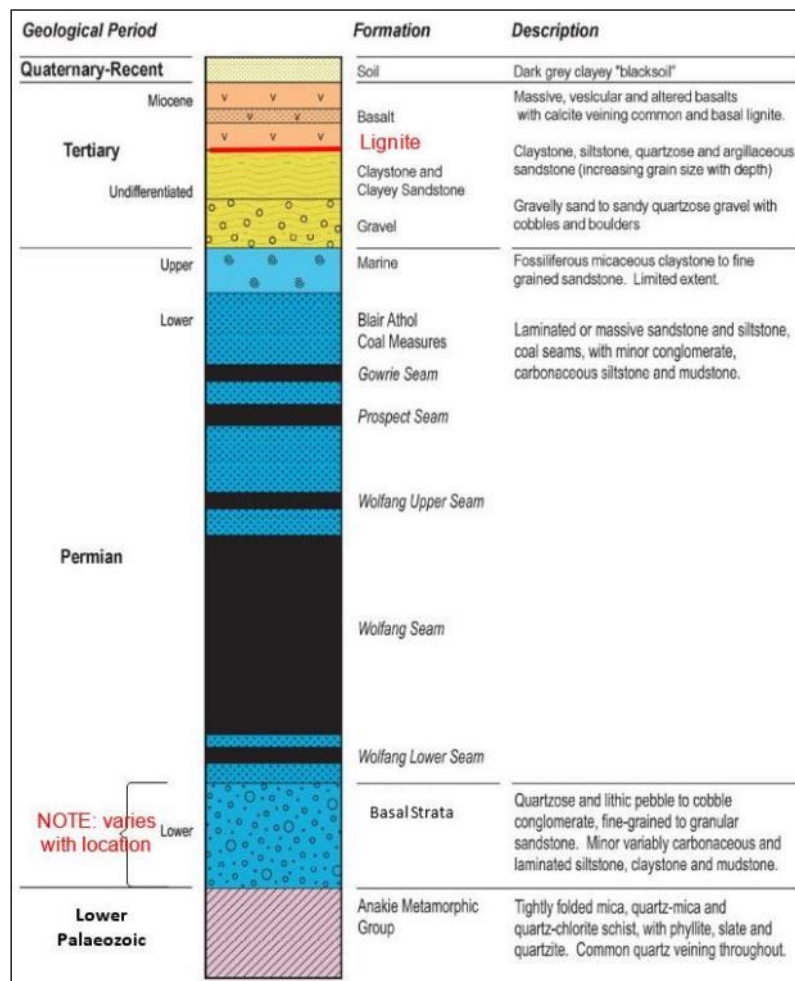
Figure 6-1 - Simplified stratigraphic column for Clermont Open Cut

The CCO coal deposit formed in the localised Wolfgang basin at the western margin of the Permian-Triassic Bowen Basin. The basin was subsequently uplifted and eroded until alluvial sediments accumulated in a localised Palaeogene basin that was subsequently overlain by Miocene basalts. **Figure 6-1** is a summary stratigraphic column from the GRR (Sherwood Geotechnical and Research Services, 2021).

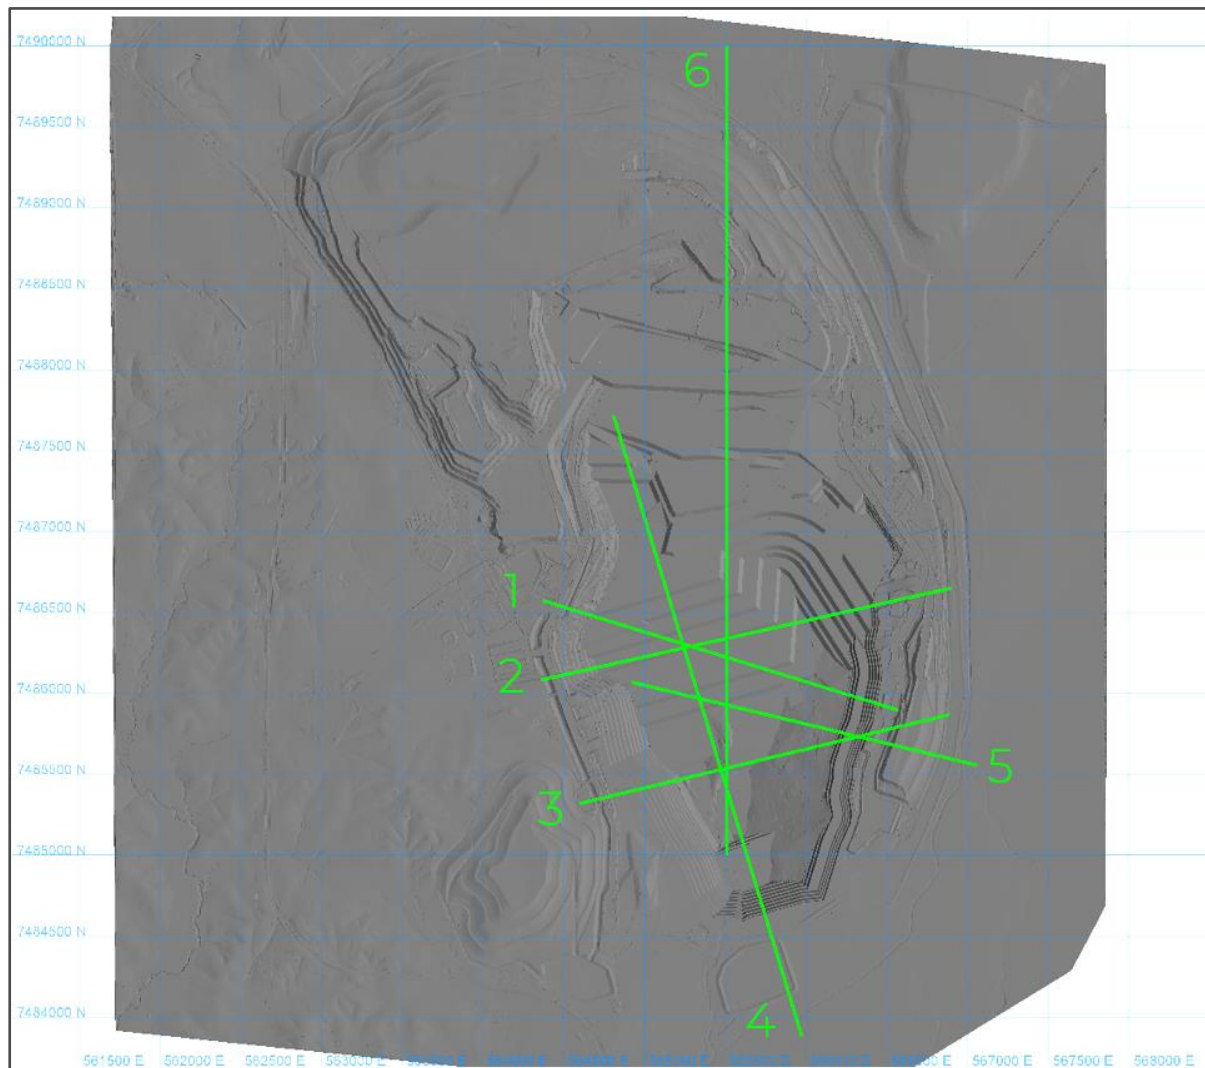
Figure 6-2 - Clermont Open Cut life-of-mine landform plan, January 2021, showing representative Sections 1-6

*Figure 6-2* is a plan showing the mine landform at completion of mining, as determined in January 2021 for budget and high-level equipment utilisation planning purposes. Also shown are locations of Section Lines 1 – 6, selected for stability assessment on the basis of known geological and geotechnical characteristics to be broadly representative of conditions to be considered for post-mining landform assessment purposes. The geometry of each section line is presented as part of the detailed discussion of stability assessment outcomes in Section 6 below.

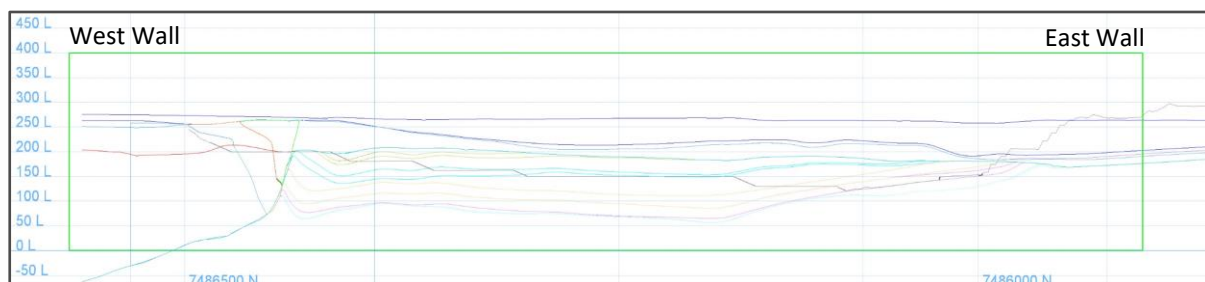
The West Wall is represented by three section lines. Section 1 (**Figure 6-3**) corresponds to conditions where zones of face instability have been experienced during mining, including ongoing fretting of the upper weathered horizons. Risks from the fretting hazard were mitigating by reconfiguring of the Western Drain to minimise seepage inflows to the slope profile. Section 1 also extends to the East Wall.

Figure 6-3 - Section 1 West Wall geological model viewed towards north-northeast

A common feature of Sections 1 – 3 is the thrust fault zone adjacent to the West Wall. The geological model is at best approximate for the fault zone, and particularly for the west side of the fault zone and the deeper strata below the target coal interval. While the model is updated regularly for short-term planning purposes, the approximate nature of the model available for this report means that there is a heightened element of geological uncertainty associated with the outcomes of the stability analyses.

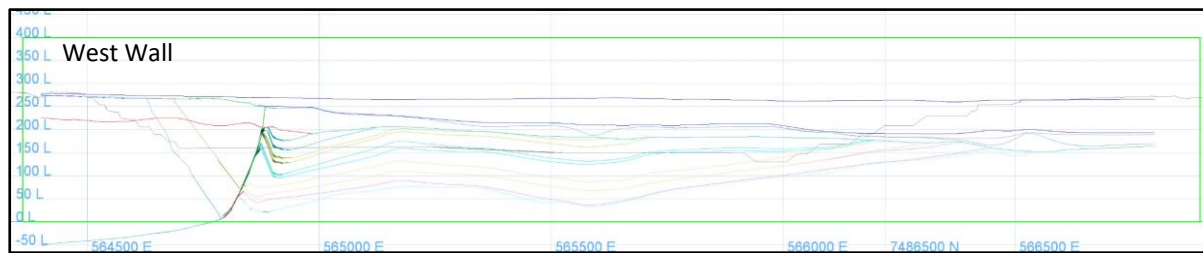
Section 2 (**Figure 6-4**) corresponds approximately to the location of the deepest pit profile, as well as being the focus of active mining activities in early-2021.

Figure 6-4 - Section 2 West Wall geological model viewed towards north-northwest

Section 2 (**Figure 6-4**) corresponds approximately to the P18 West Wall where mining to the W1/W2 horizon was in progress during the preparation of this report. Significant changes to the short-term geological model were required and were based on infill blasthole drilling followed by additional exploration drilling. The short-term geological model changes could not be incorporated in this assessment report and are unlikely to make any significant difference as they affect only the lowest component of the slope where the planned southward progression of the spoil dump can only partially backfill Section 2. The LOM planned backfill level of about 160 mRL was adopted for all stability assessment.

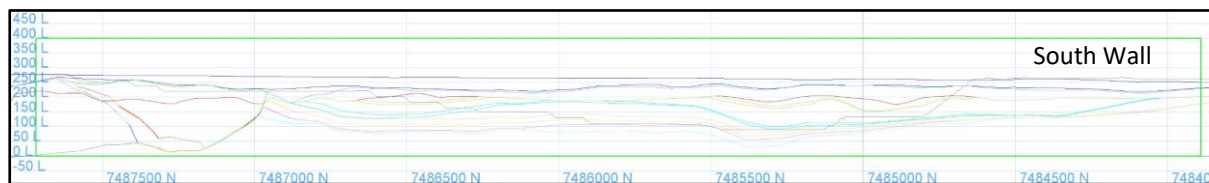
Section 4 (**Figure 6-6**) corresponds to the deepest part of the planned final South Wall, which will potentially be impacted by seepage conditions for the final post-mining landform after decommissioning of the Gowrie Creek levee. The LOM plan does not include backfill buttressing of the South Wall.

Figure 6-6 - Section 4 South Wall geological model viewed towards east

Basal geological model constraints apply equally to the South Wall model. The coal seams are significantly thinner and tend to be more split towards the south because of basin margin effects. A significant geotechnical uncertainty arises because there are known weak bedding-parallel surfaces within the currently mined coal sequence, but it is not clearly known whether the same weak horizons are present nearer the basin margins. For the purposes of the post-mining assessment, the weak surfaces were assumed to be equally present.

The final South Wall (Section 4, **Figure 6-6**) has a limited east-west extent where potential 3D lateral constraining effects might enhance the FOS outcomes from 2D stability analyses. Because of the discrete nature of the Wolfgang coal basin, the final South Wall has a component of seam structure dip towards the north, which has an adverse effect on north-facing slope stability.

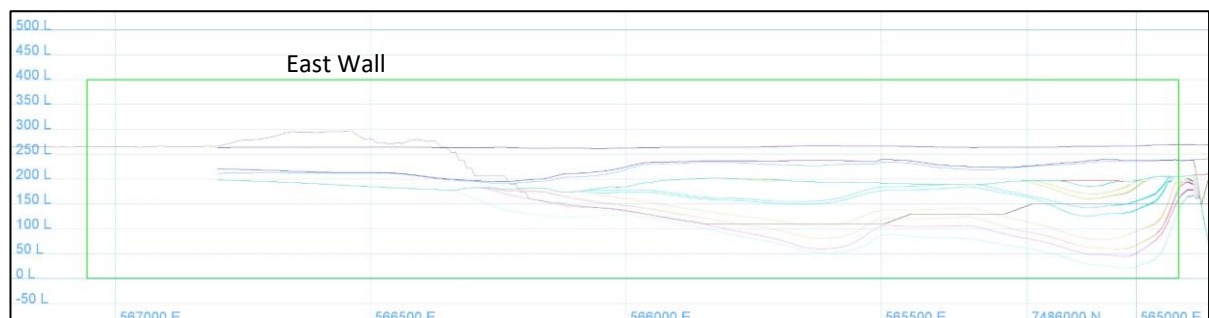
Section 5 (**Figure 6-7**) corresponds to a representative location along the final East Wall where the east out-of-pit dump landform will remain in place, and where the LOM plan until recently did not include backfill buttressing of the East Wall.

Figure 6-7 - Section 5 East Wall geological model viewed towards southwest

Basal geological model constraints apply equally to the East Wall model. The coal seams are thinner and tend to be more split towards the east because of basin margin effects. Significantly, there is a seam structure dip into the basin. There are known weak bedding-parallel surfaces within the currently mined East Wall coal sequence, but it is not clearly known whether these persist further south. For the purposes of the post-mining assessment, the weak surfaces were assumed to be equally present.

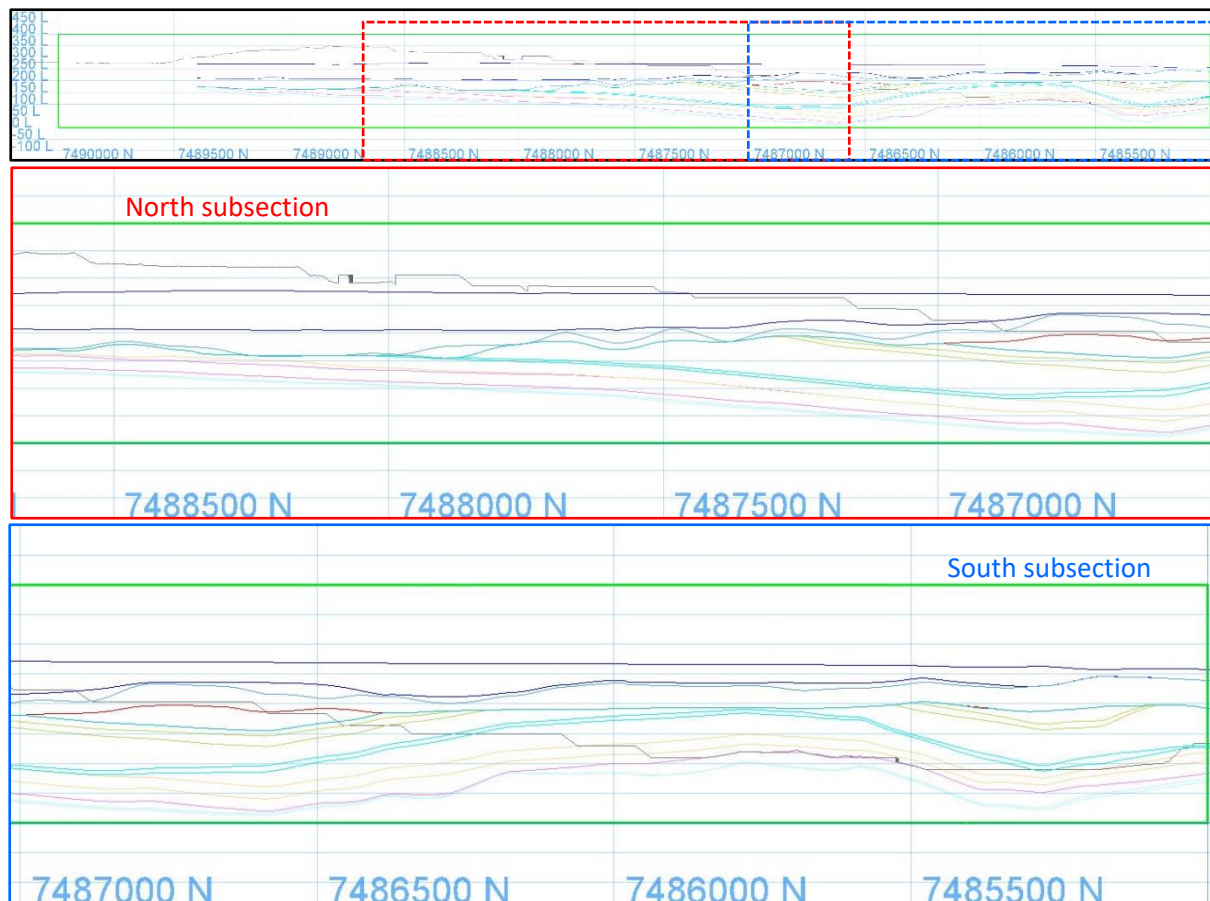
Section 6 (**Figure 6-8**) is representative of the LOM lowwall dump, of which only a component would form part of the significant slopes of the planned LOM final void.

Figure 6-8 - Section 6 North Wall (low wall dump) geological model viewed towards east with subsections enlarged for clarity

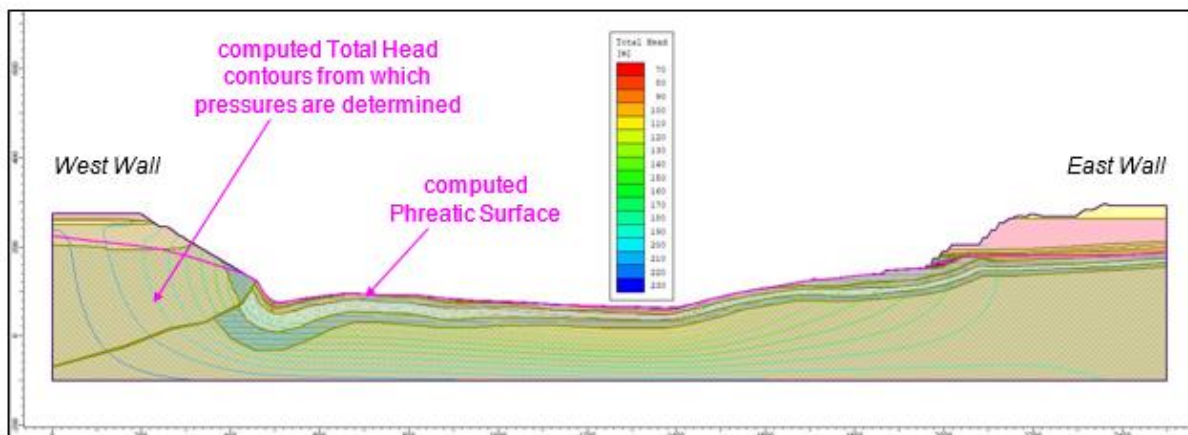
Figure 7-2 - Section 1 West Wall (unbuttressed) overall groundwater flow model outcome showing Total Head contours and location of Phreatic Surface

**Figure 7-2** shows the modelled groundwater pressure conditions for the long-term equilibrium void water level of 100 mRL, represented by the computed phreatic surface (pink line as marked) and contours of Total Head (Pressure Head + Elevation Head). Where the contour of Total Head lies above the phreatic surface level, the groundwater pressure is in a state of suction. The hydraulic conductivity material model is based on treating suction conditions so that they have negligible impacts on computing the groundwater phreatic surface location (RocScience, 2021).

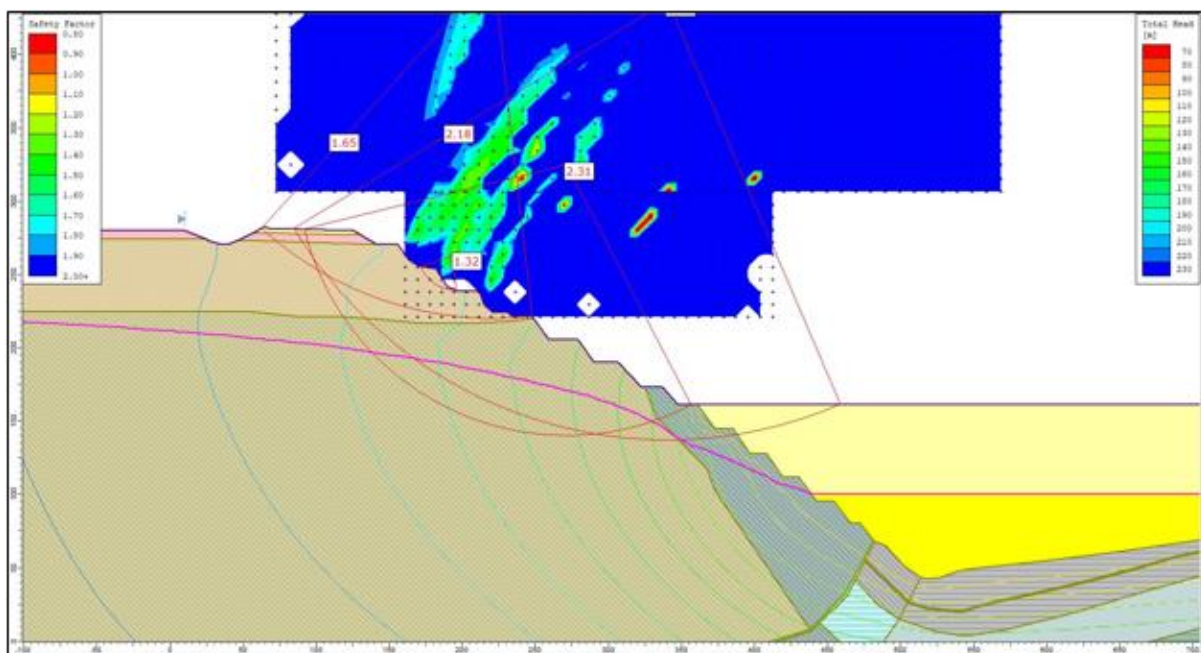
*Figure 7-8 - Section 2 West Wall final buttress condition showing critical stability conditions for potential rock mass strength-controlled circular arc mechanisms*

**Figure 7-8** shows the stability analysis outcome for potential rock mass strength-controlled circular arc mechanisms, with the critical stability condition being FOS=1.32 for a single batter and FOS=1.65 for the entire weathered metamorphics interval of the slope profile. The most critical stability condition is for a multi-wedge mechanism exploiting the foliation within the weathered metamorphics (FOS=1.06, **Figure 7-9**). Marginal stability of this form was experienced during mining, with localised face slumping triggered by rainfall and concentrated runoff.

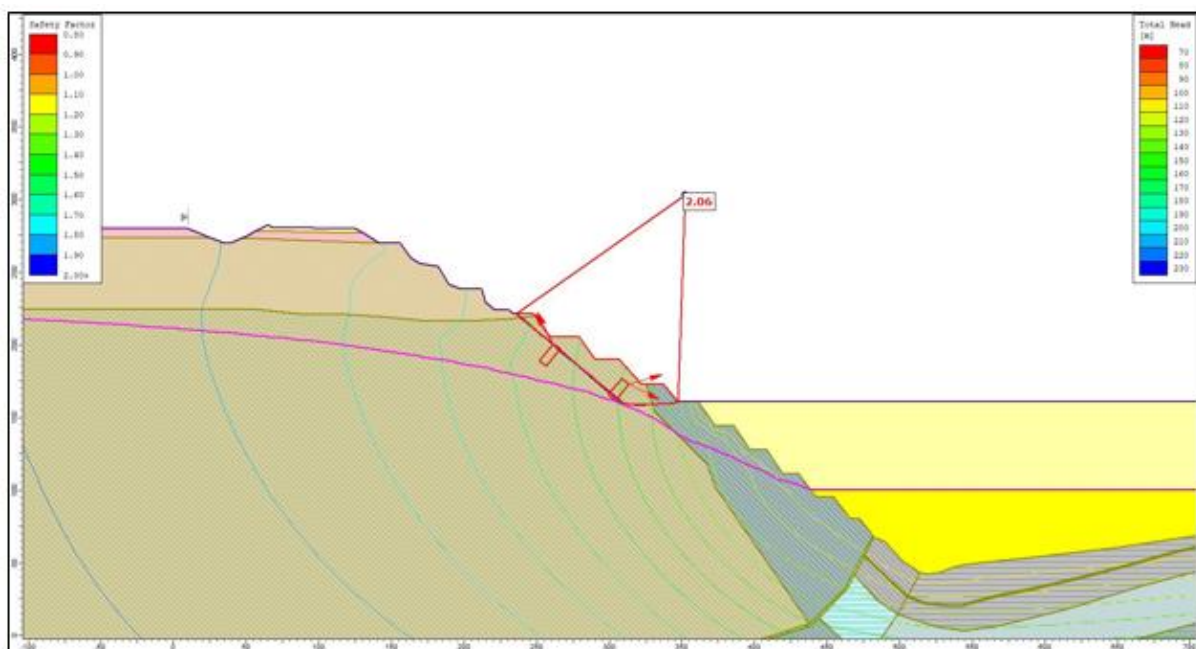
Figure 7-10 - Section 2 West Wall final buttress condition showing adequate stability condition for multi-wedge mechanism exploiting foliation in fresh metamorphics

Foliation-controlled potential instability is less of a concern within the fresh metamorphics because of the increased substance strength of the fresh rock material. This is demonstrated in **Figure 7-10** with a minimum computed FOS=2.06 for the fresh metamorphics alone, and **Figure 7-11** having a minimum computed FOS=1.78 for the full height of the exposed slope above the final buttress level.

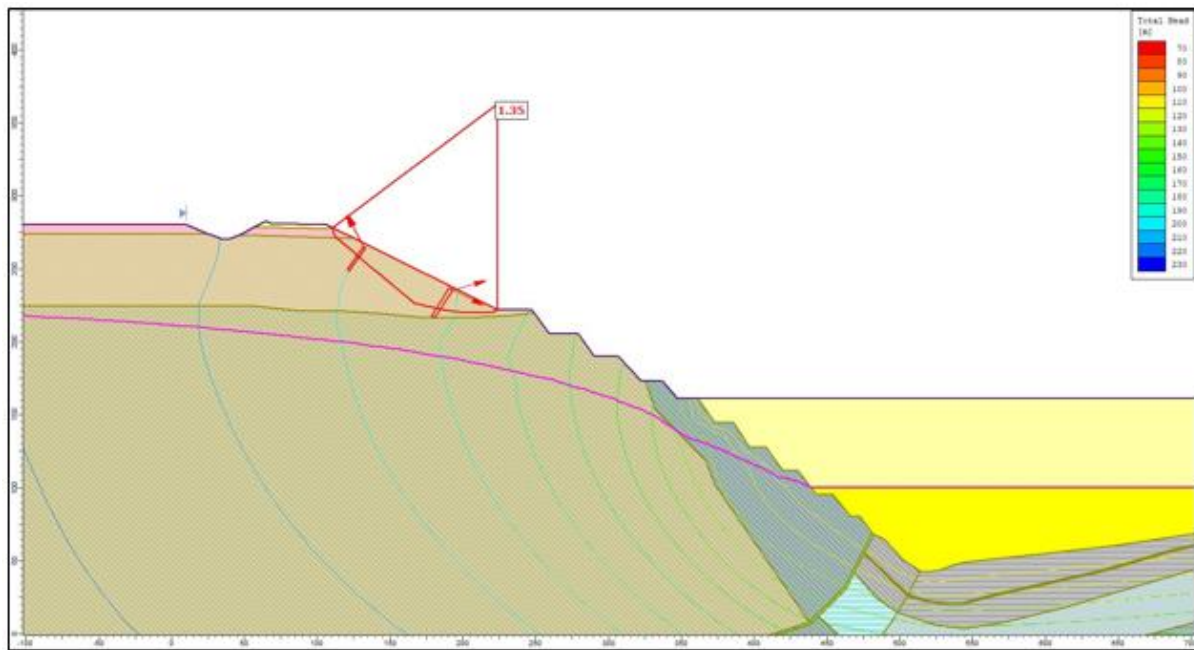
Figure 7-12 - Section 2 West Wall weathered metamorphics treatment with 1v:2h (26.6°) cutback stability condition for multi-wedge mechanism exploiting foliation

Cutback of the weathered metamorphics slope to 1v:2h (26.6°) increased the minimum computed FOS from 1.06 to 1.35 (**Figure 7-12**), which is less than the guidance upper bound of 1.50 but a 30% improvement from the untreated condition. A minimum computed FOS greater than 1.5 (**Figure 7-13**) could be achieved by 1v:2.66h (20.6°) slope reduction but this would be unacceptably close to the drain.

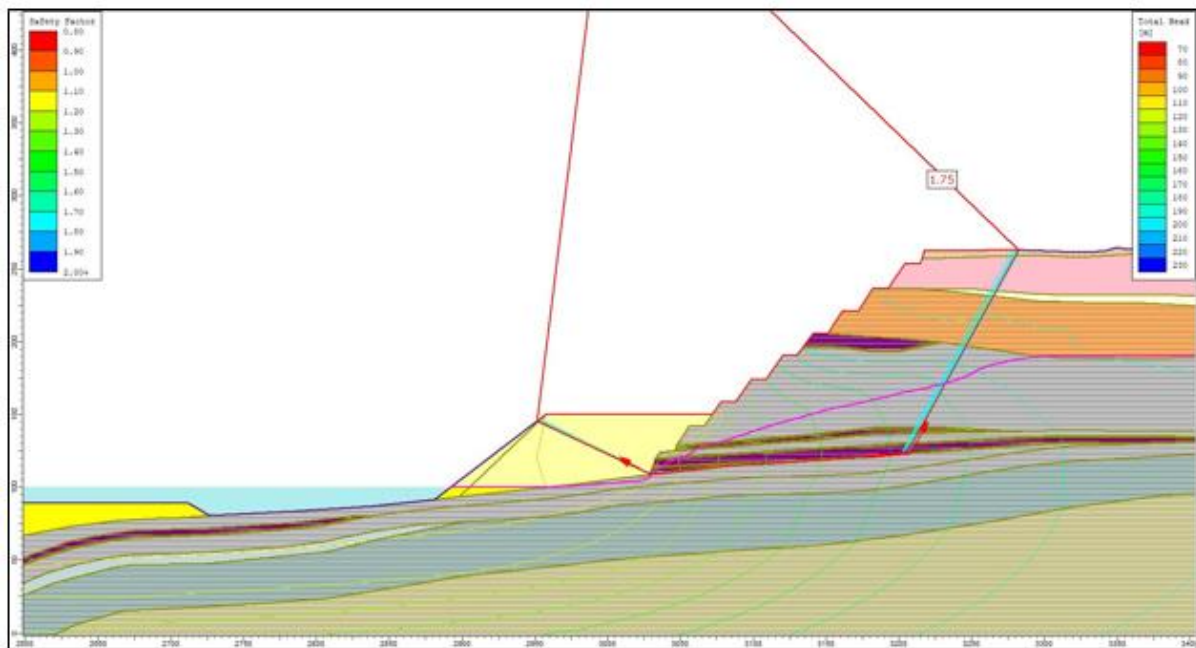
Figure 7-21 - Section 4 South Wall revised final slope profile buttress to 150 mRL with 115 m width and  $FOS=1.75$  for potential sliding on weak W2 floor shear

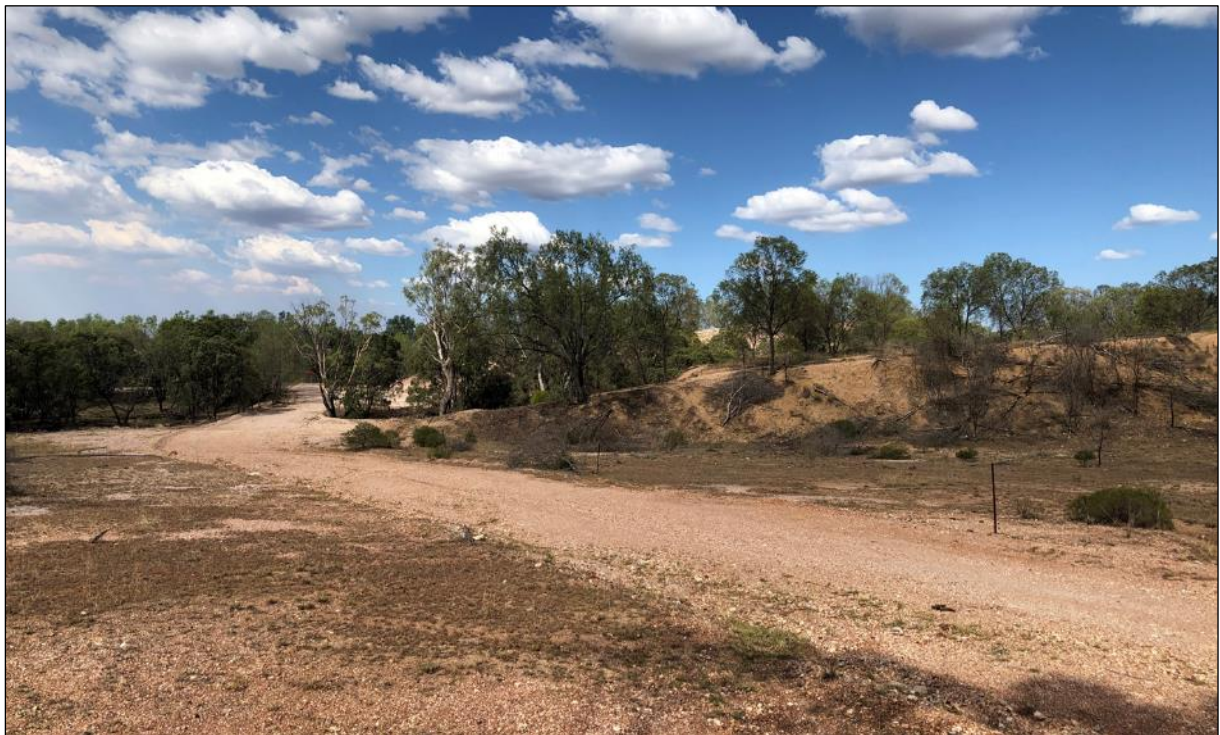
**Figure 10-2** is a general view of the current condition of the waste dumps on the southwest margin of the remnant void. The gravelly nature of the conglomerate waste, and essentially angle-of-repose dump slopes, is clearly evident.

*Figure 10-2 - Cement Hill view to northeast from gated entrance looking towards waste dumps and remnant void*

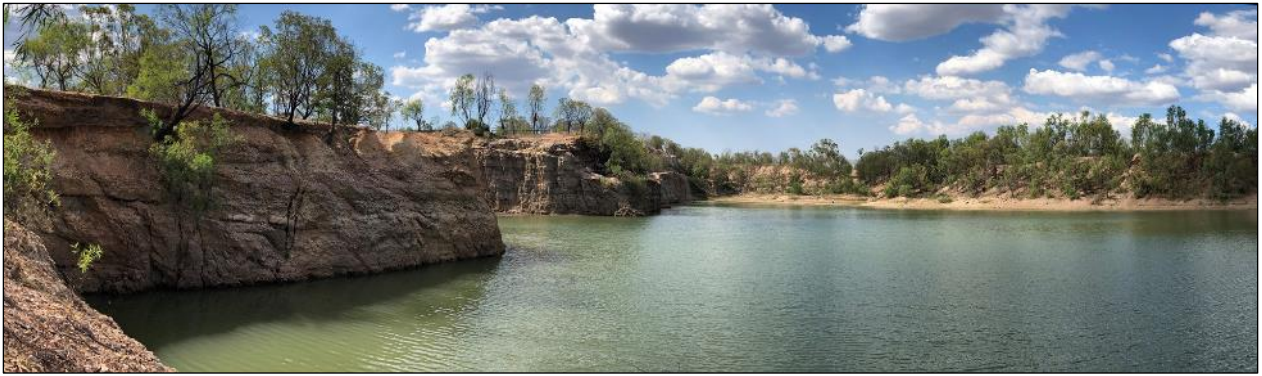
The remnant void has an unknown depth of water contained by excavated faces (batter angle typically 75°) on the west and south margins and dumped spoil backfill elsewhere (**Figure 10-3**).

*Figure 10-3 - Cement Hill remnant void viewed from southwest corner to north*

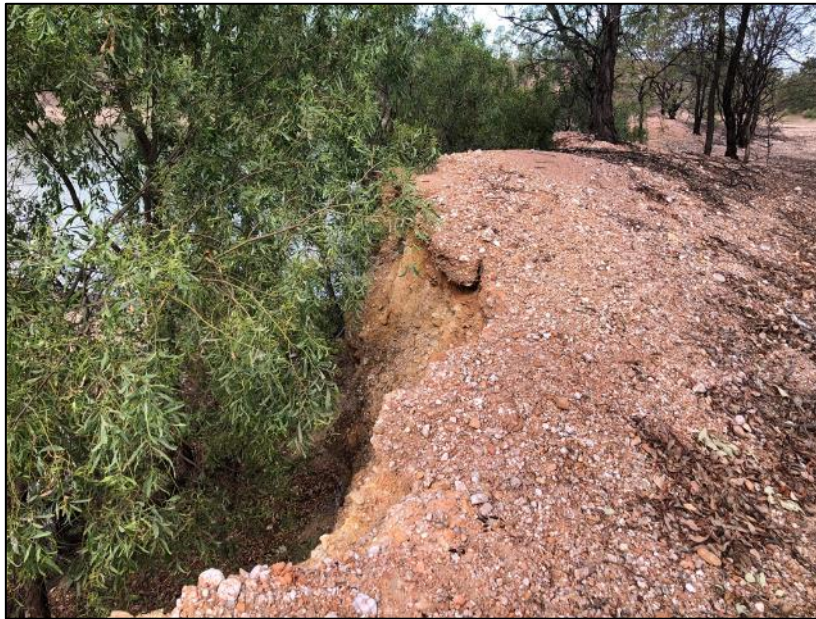
The in-situ materials forming the west and south sides are low strength conglomerate with a capping layer about 1 m thick comprising extremely weathered conglomerate and residual soil (**Figure 10-4**). Along the west side is an excavated “ramp” (**Figure 10-5**) which provides a flow path for flood overflow into the residual void from a tributary ephemeral creek channel. In-situ material is amenable to ripping and dozing, but light blasting may be required for reshaping the deeper conglomerate.

*Figure 10-4 - Cement Hill void crest of south margin viewed to east with weathered gravelly soil capping layer*

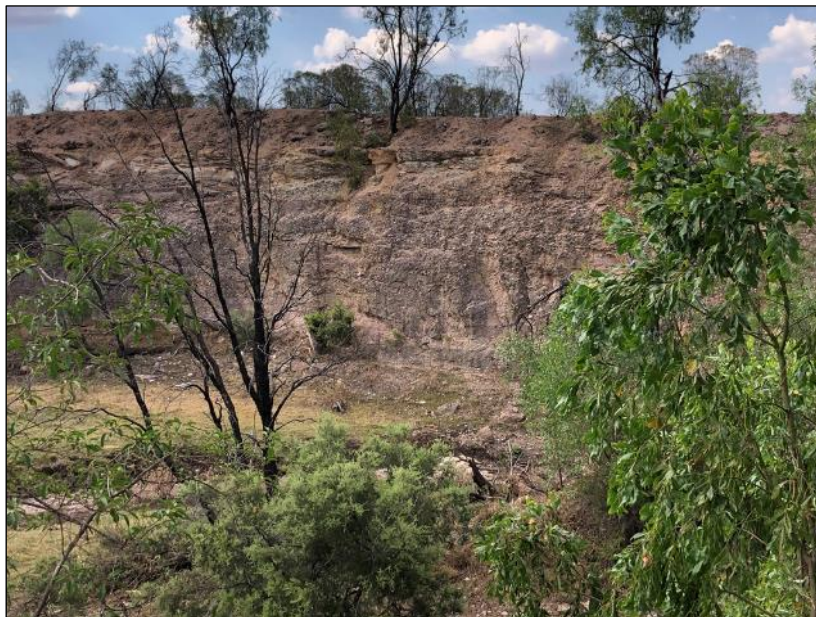
*Figure 10-5 - Cement Hill "ramp" at west void margin provides flow path for flood overflow into void from tributary creek*

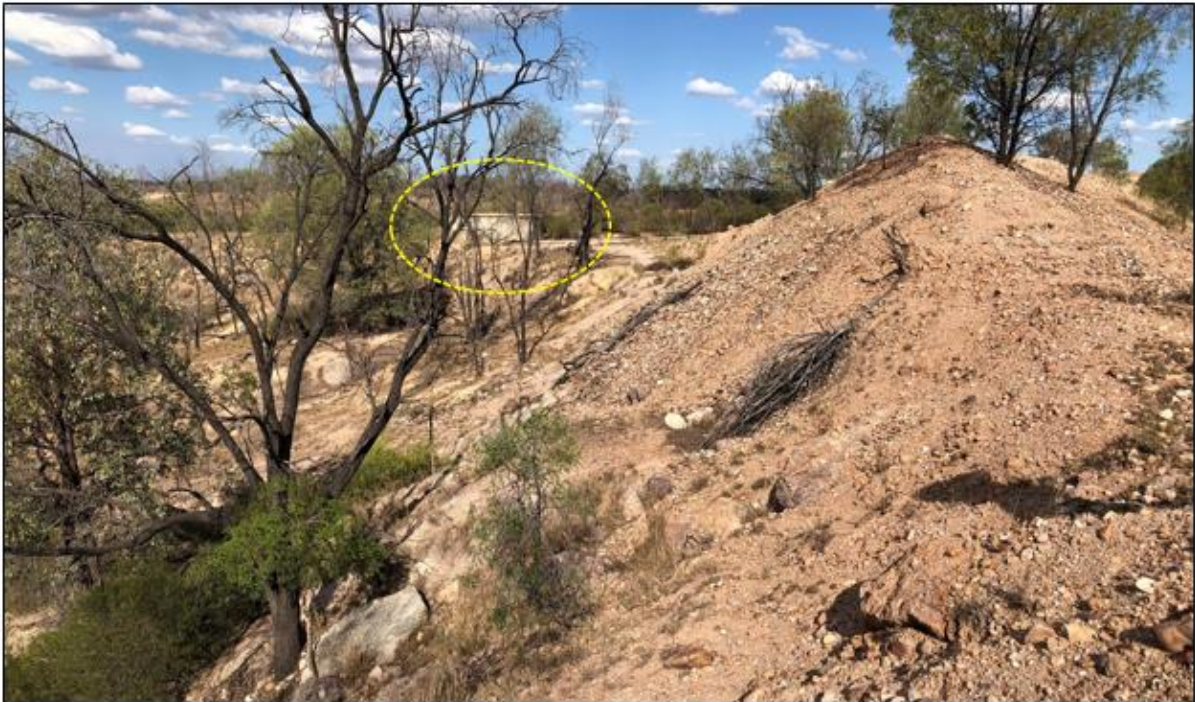
*Figure 10-8 - Cement Hill dumped waste overlying southeast containment wall of tailings cell and remnant concrete tank (circled)*

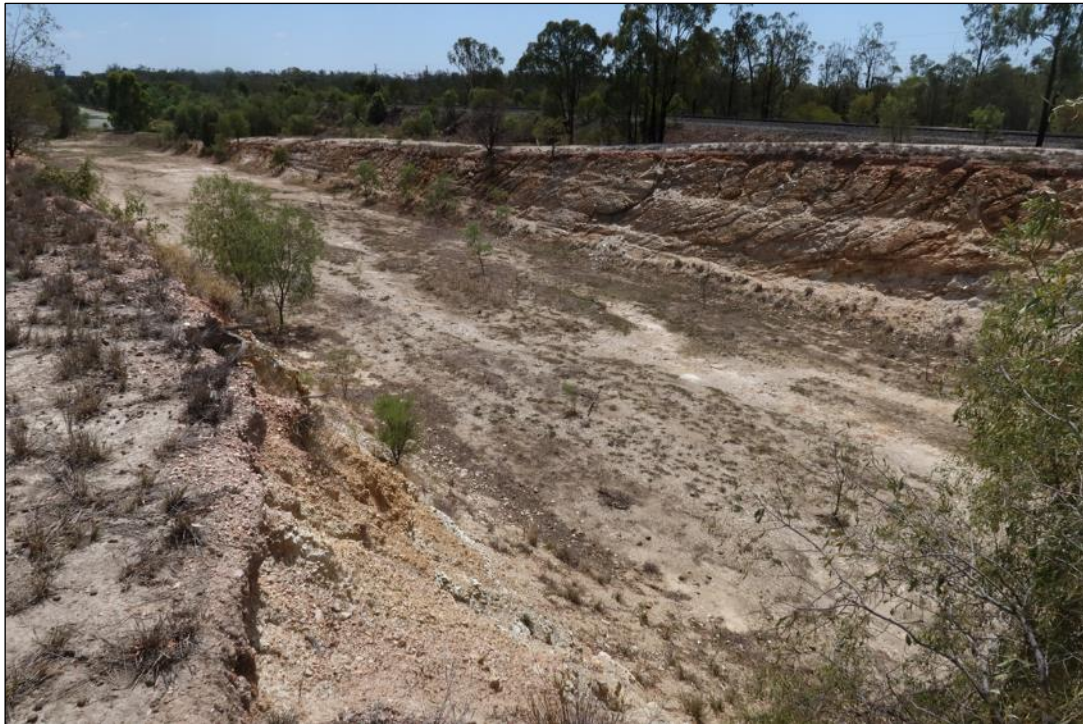
The NDD inlet is at the west part of the northwest channel cut (**Figure 11-2**) which is excavated in weathered Anakie Metamorphics having a thin soil capping layer of silty clayey gravel. Batters at 2v:1h have been weathered and superficially eroded, but with only minor build-up of weathered material at the batter toe-lines. The thrust faulted transition from weathered metamorphics to weathered Blair Athol coal measures conglomerates and sandstones in the central area of the northwest channel cut (**Figure 11-3**) has similarly well-preserved batters and channel floor.

*Figure 11-2 - West part of northwest channel cut viewed towards northwest showing erosion of batters in weathered Anakie Metamorphics and soil capping*

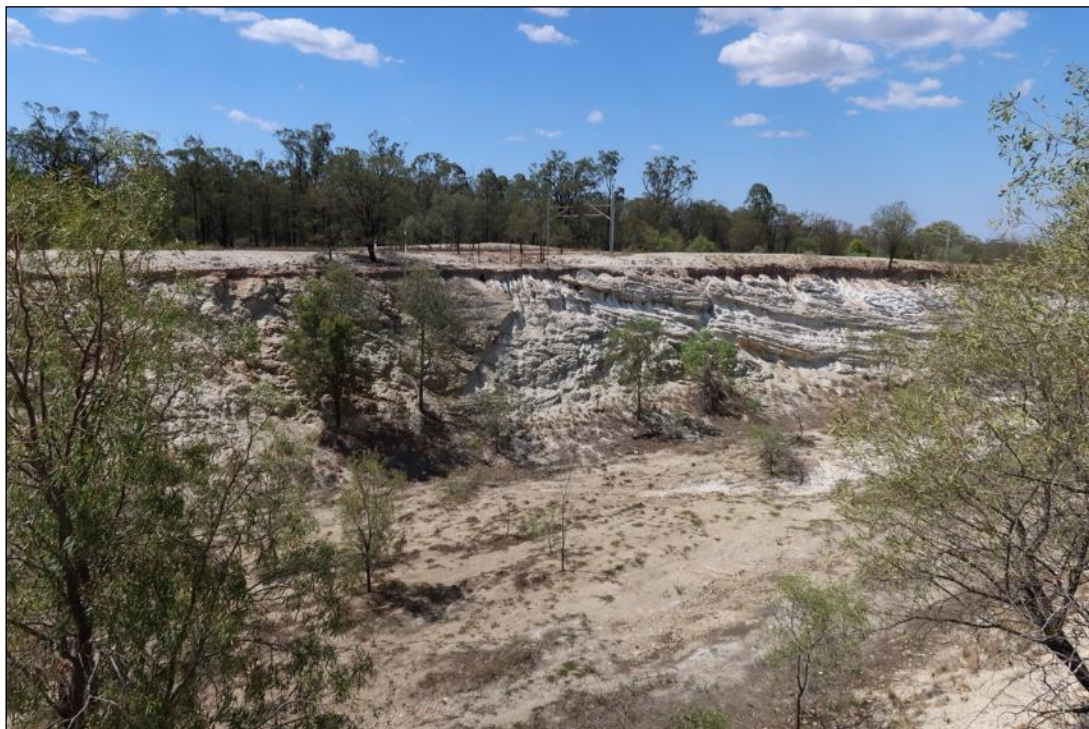
*Figure 11-3 - Central part of northwest channel cut viewed towards northeast showing faulted transition from Anakie Metamorphics to Blair Athol coal measures rocks and erosion of batters*
