CLERMONT

GLENCORE

# Progressive Rehabilitation and Closure Plan (PRC Plan)

January 2023

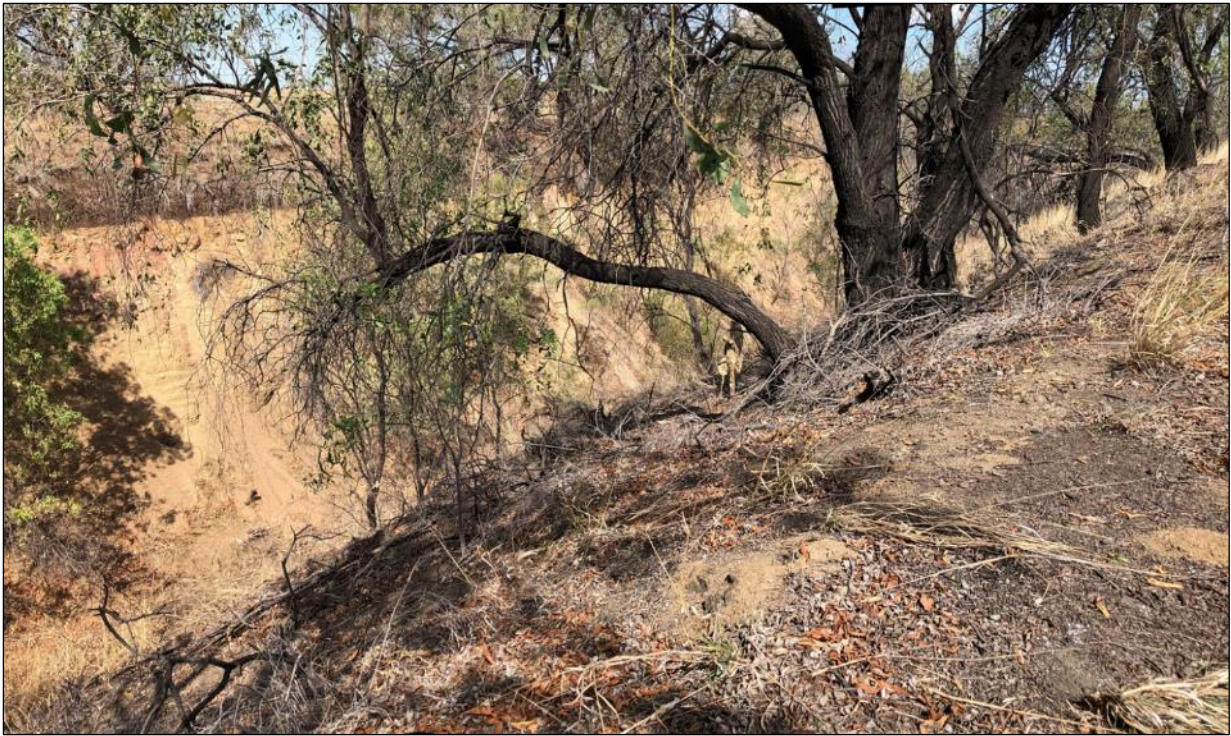
The southeast channel cut is characterised by localised, generally minor sheet and gully erosion and there were no indications of significant build-up of erosion products at the channel floor that could compromise hydraulic effectiveness. The current vegetation growth was providing some reinforcement of the more soil-like materials within the upper slope adjacent to the channel bank crest lines.

*Figure 11-8 - Southeast channel cut in weathered basalt with nominal 2v:1h batters (view downstream towards southeast)*

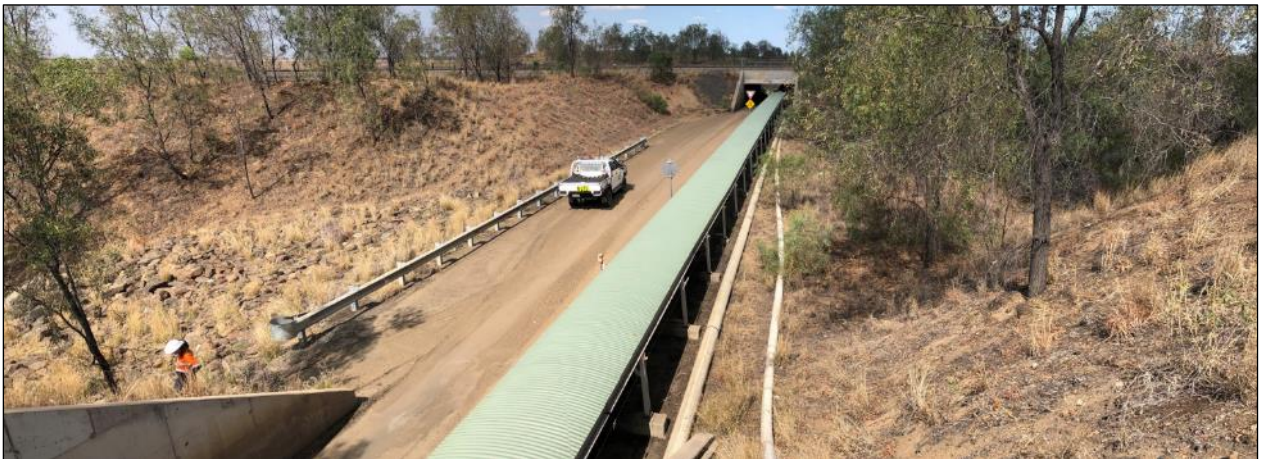
A culvert structure (**Figure 11-9**) carries the overland conveyor (OLC) and maintenance access road across the southeast channel cut at the immediate north side of the lease boundary. The culvert consists of twin corrugated metal pipes (CMPs) contained within an embankment having relatively steep lower side slopes, protected by shotcrete covers with drain holes, and gently sloping upper side slopes protected by basalt rock fill.

*Figure 11-9 - Culvert crossing of southeast channel cut by overland conveyor (OLC) and access road, with upper side slopes protected by basalt rock fill*

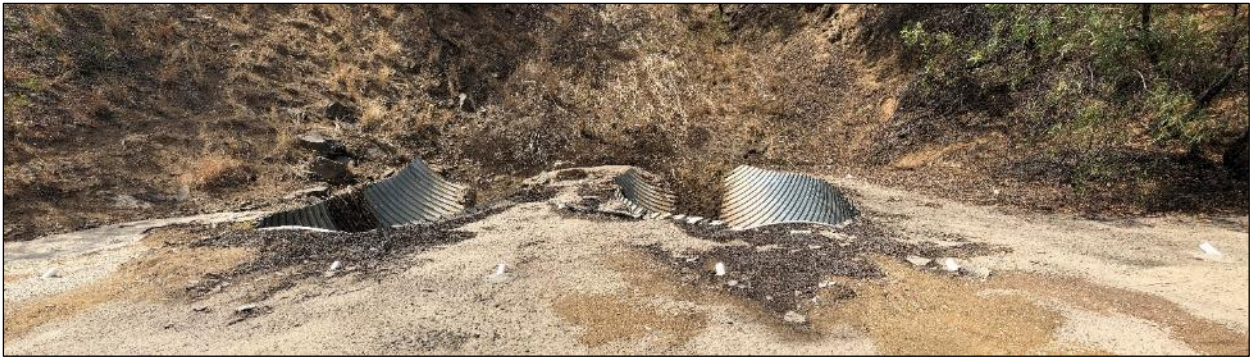
**Figure 11-10** and **Figure 11-11** respectively show the north and south lower side slopes of the culvert crossing. There were no indications of significant erosion of the culvert structure or of the flow transition zones at each side slope. There was also no evidence of a flood debris “tideline” on the north side that would be indicative of partial CMP intake blockage during a significant flow event.

*Figure 11-10 - Upstream (north) side of access road culvert with twin CMPs and lower side slope protected by shotcrete cover*

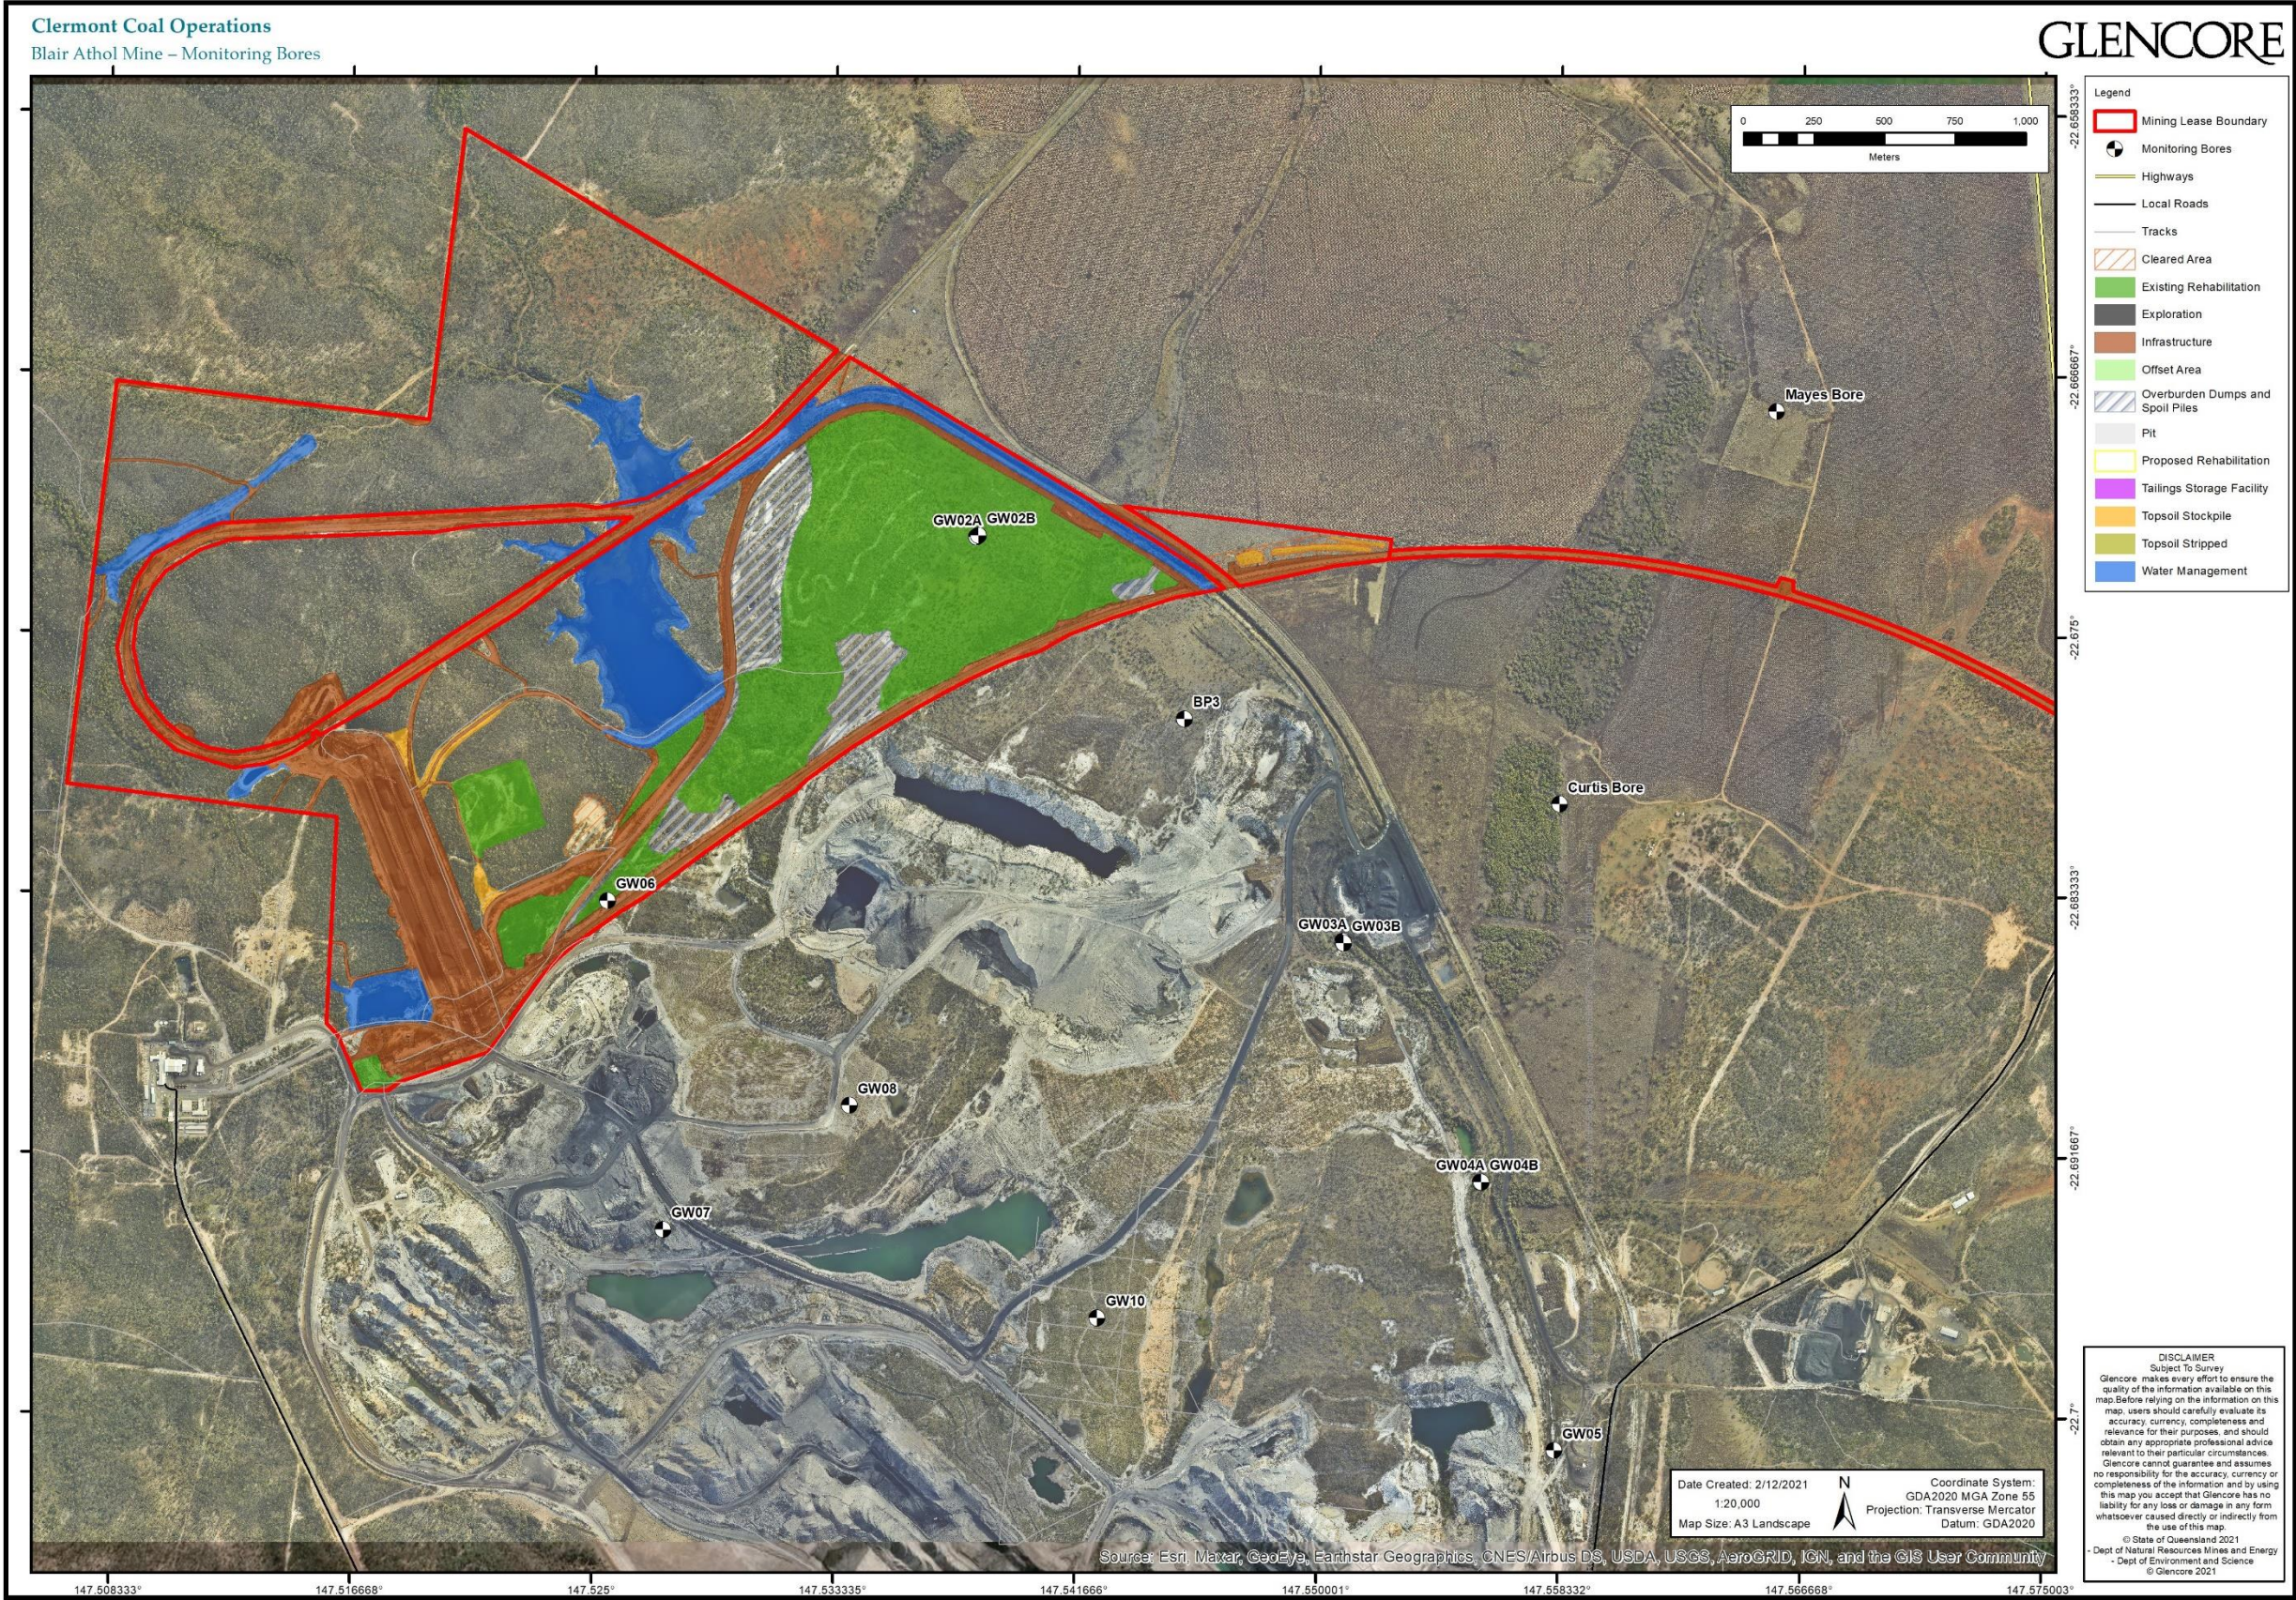
Limited groundwater monitoring data exists in the TLO area. Four groundwater monitoring bores lie within the TLO area, including GW02A, GW02B, GW06 and RN89427 (old name 1277R) (**Figure 2-2**). The bores are no longer active. Bores GW02A, GW02B and RN89427 are located within the present rehabilitation area and GW06 is located in the Ramp 2a waste dump area.

Figure 2-2 - Location of Groundwater Bores in the TLO area

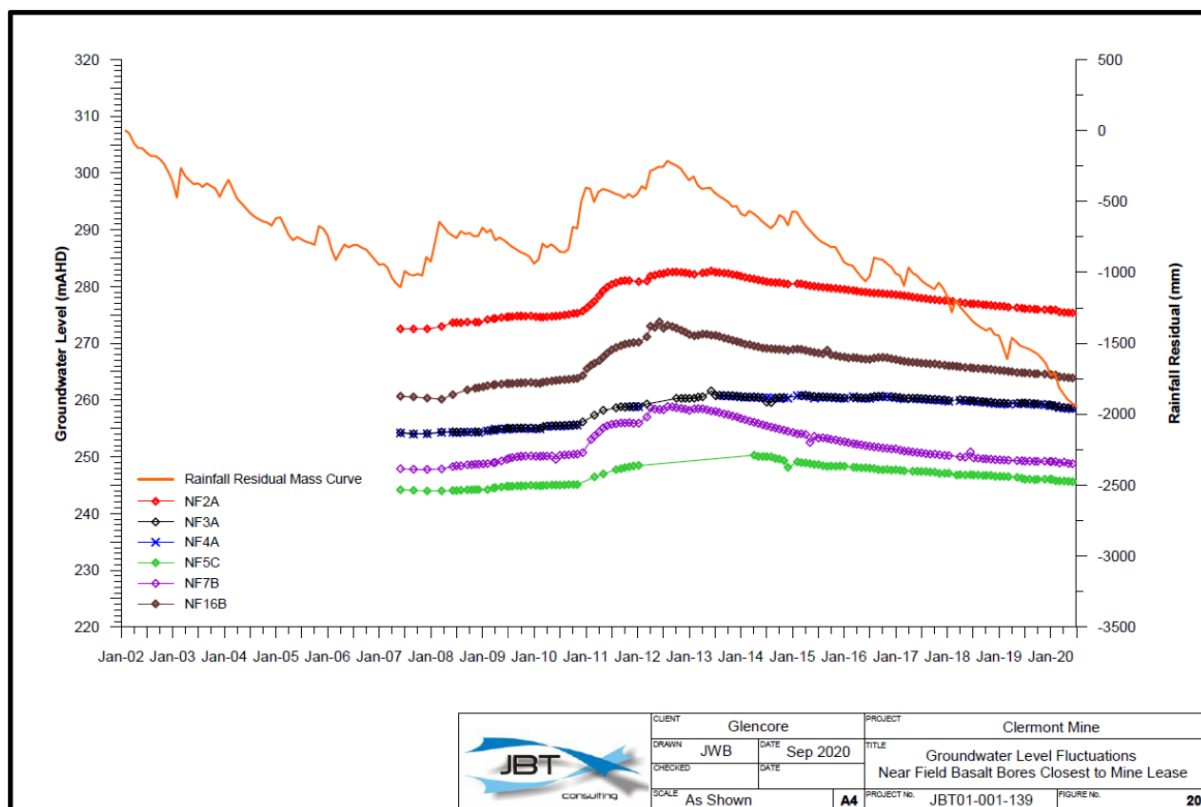
- Water level trend data as compiled 2008 to June 2020 for near mine bores (**Figure 2-3**) regional (**Figure 2-4**) and show a general correlation with the cumulative residual rainfall trend; and
- Basalt groundwater levels close to the mine, for example NF4A (**Figure 2-3**), have higher groundwater levels as of Dec 2020 compared to early 2008 despite a protracted dry climate period since mid-2012. This demonstrates the ability of the basalt aquifer to recharge.

Figure 2-3 - Near Mine Basalt Groundwater Level trends

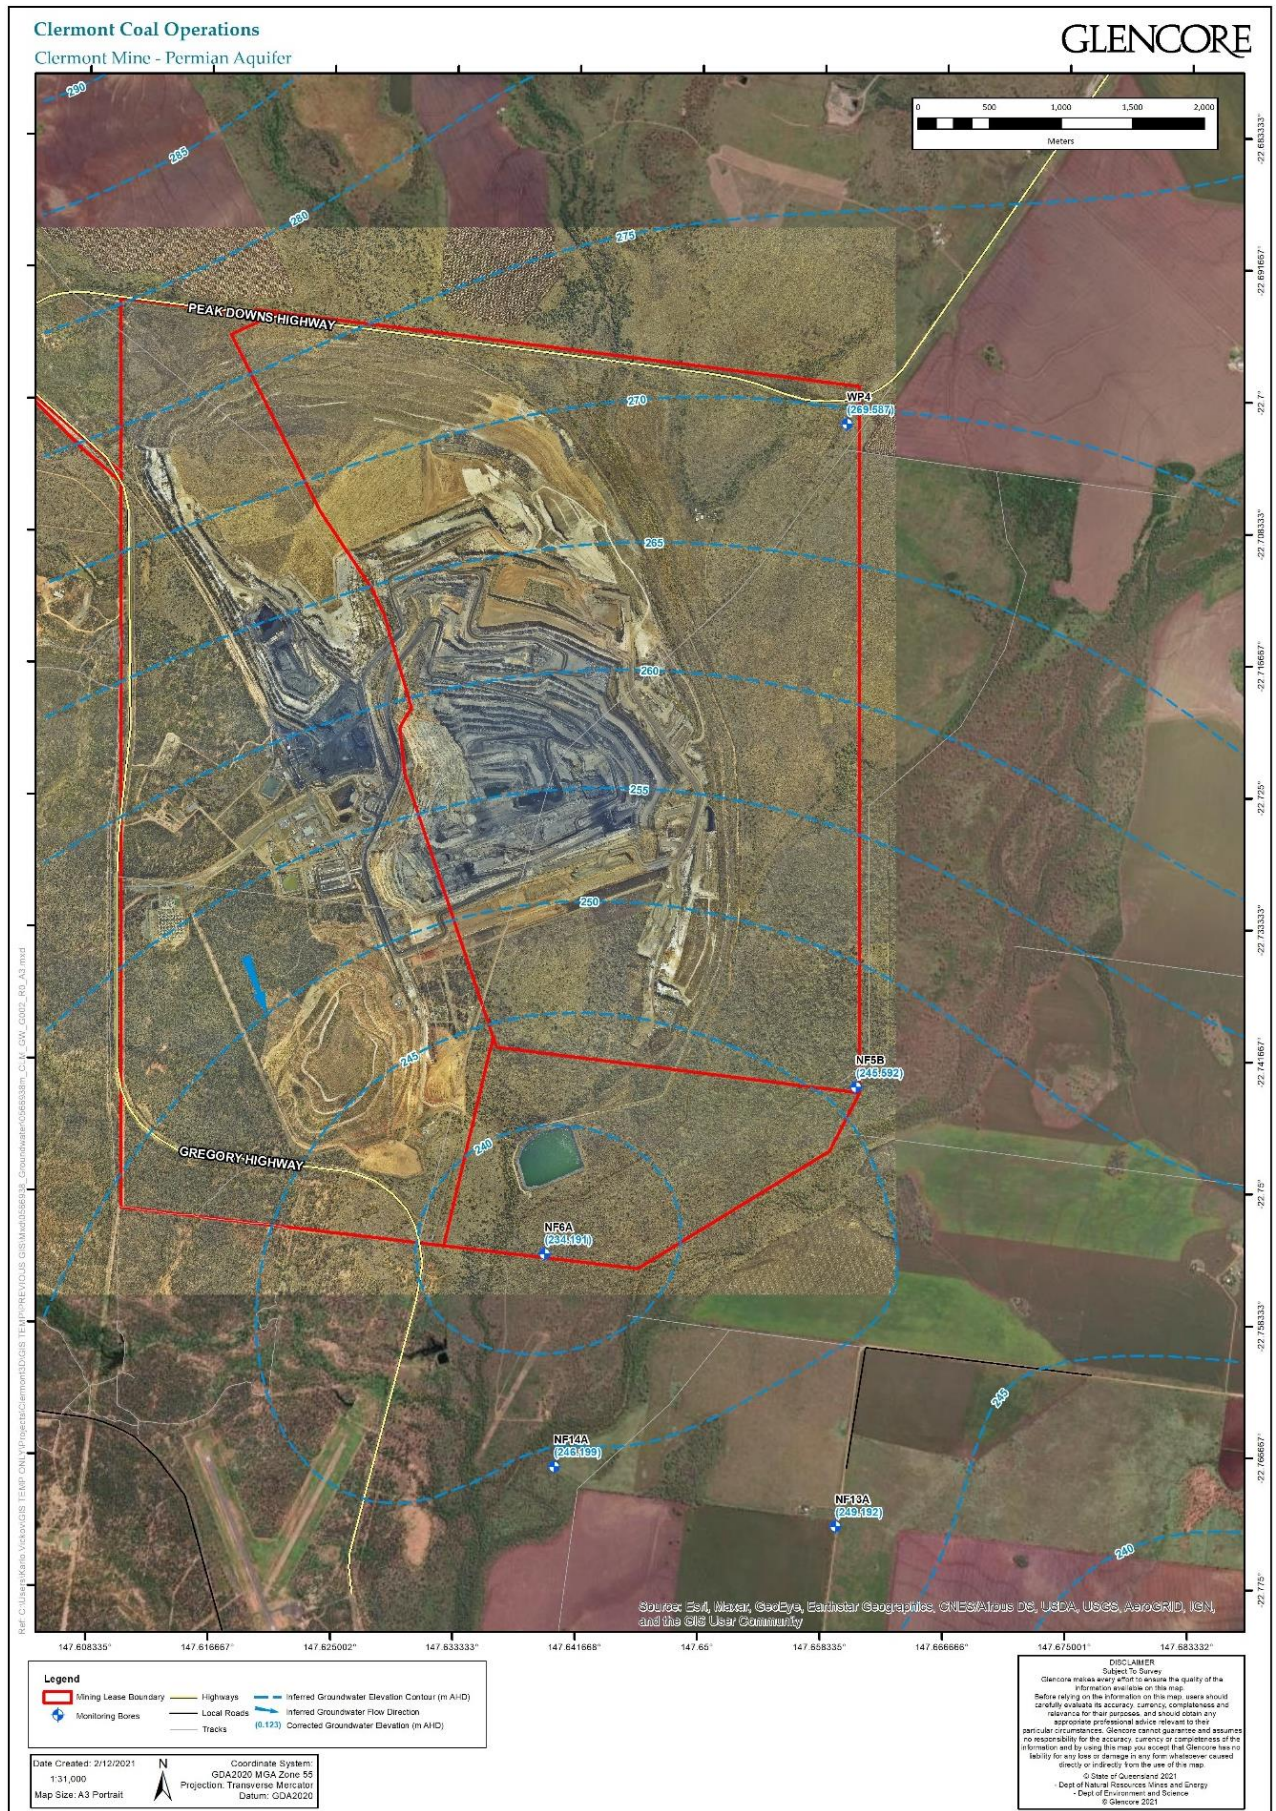
Figure 2-6- June 2020 Permian Aquifer Groundwater Piezometric Contours

The Permian groundwater piezometric levels for June 2020 area presented in **Figure 2-6** below.

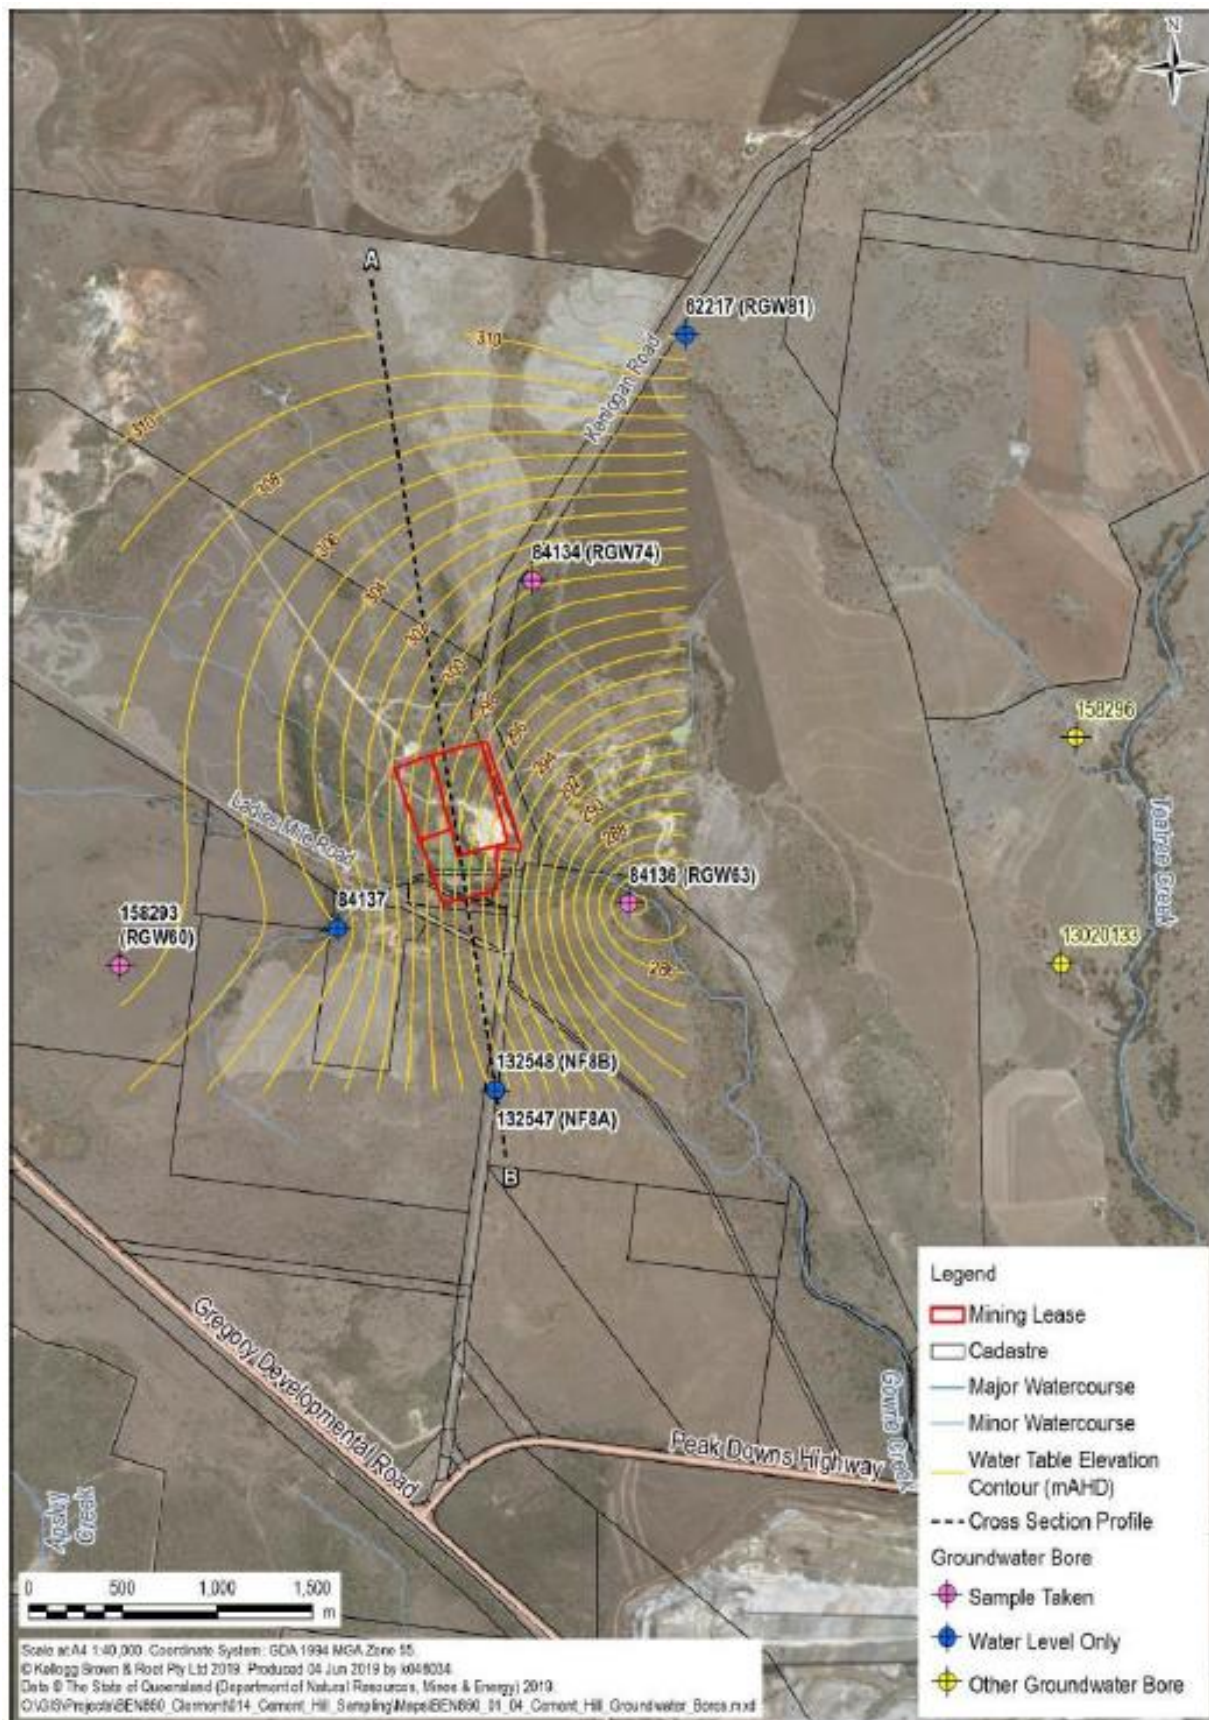
Figure 2-7 - Basalt aquifer groundwater contours for 2019

A south-easterly groundwater gradient has been shown from groundwater level monitoring data (**Figure 2-7**) which corresponds with the topographic / drainage system.

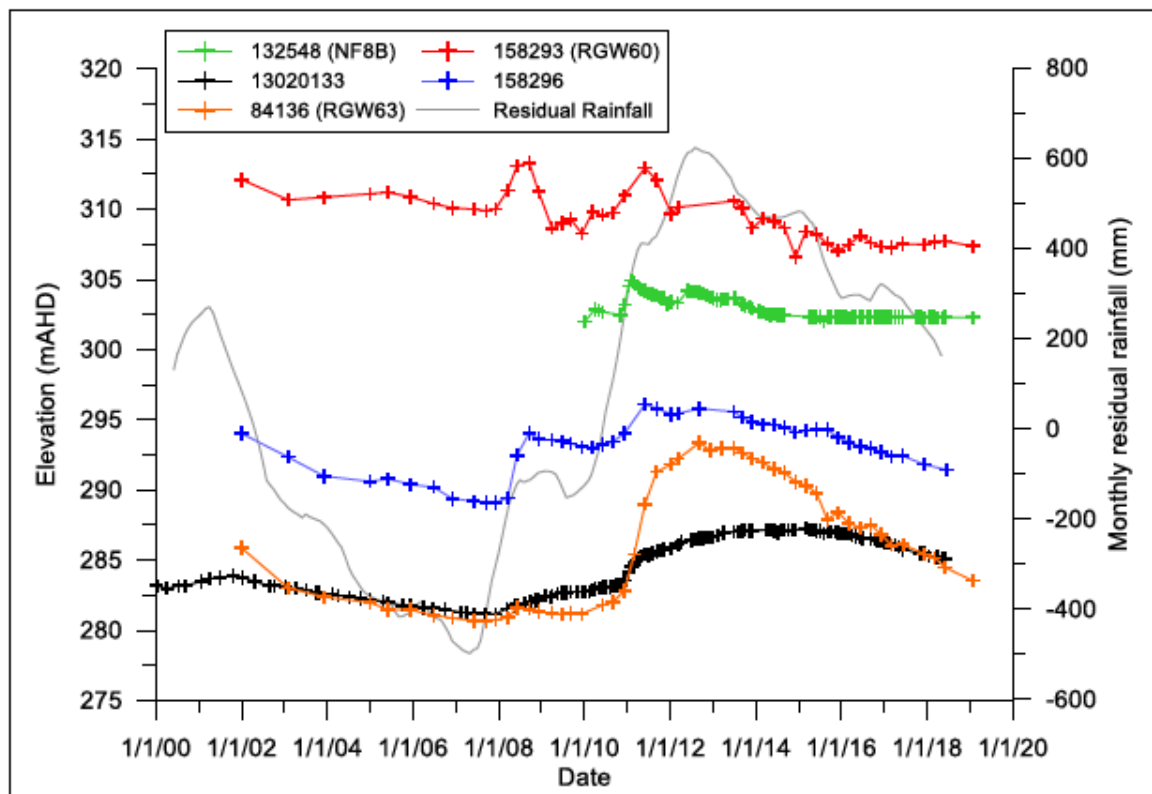
Figure 2-8 - Long term water table elevation records with monthly residual rainfall

The groundwater level data is presented in **Figure 2-8**, along with monthly residual rainfall data. This plot shows a period typified by low rainfall from the early 2000's to around 2007. From around 2008 to 2013, monthly residual rainfall increased to positive values (i.e. above average rainfall conditions) before returning to persistent below average conditions from 2013 (KBR, 2019).

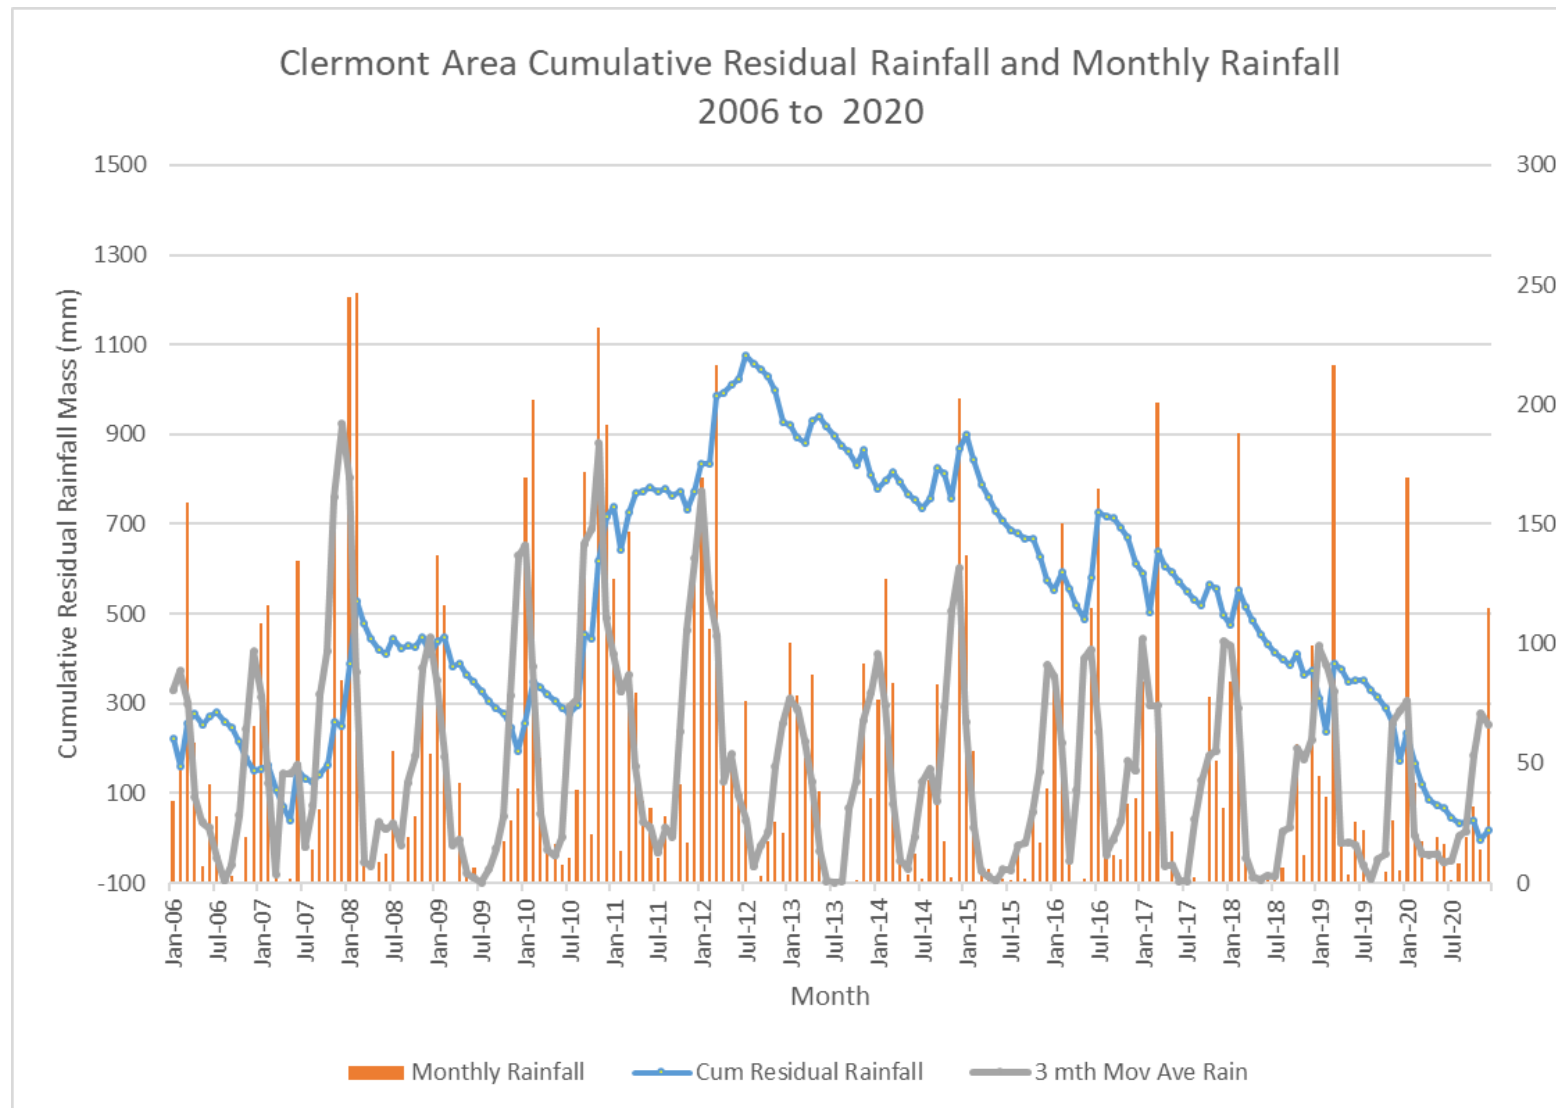
Figure 3-1 - Monthly rainfall from SILO database (Lat -22.7, Long 147.6) 2006-2020

- The period from 2006 to mid-2012 shows a general wetter climate trend as demonstrated from the rising cumulative residual rainfall mass curve with the September 2010-March 2011. The early onset of the wet season in September provided enhanced conditions for groundwater recharge, as the ground was already saturated from the rain in September when the wet season rainfall began;
- The 2011-2012 wet season was also above average, due mainly to high rainfall recorded during January and March 2012; and
- The rainfall trend has essentially been in a dry climate trend since mid-2012. This falling trend over the past eight years indicates a potential for longer-term falling groundwater levels, especially for shallow aquifers (such as the Tertiary basalt aquifer) where water levels are, in some cases, strongly influenced by rainfall.

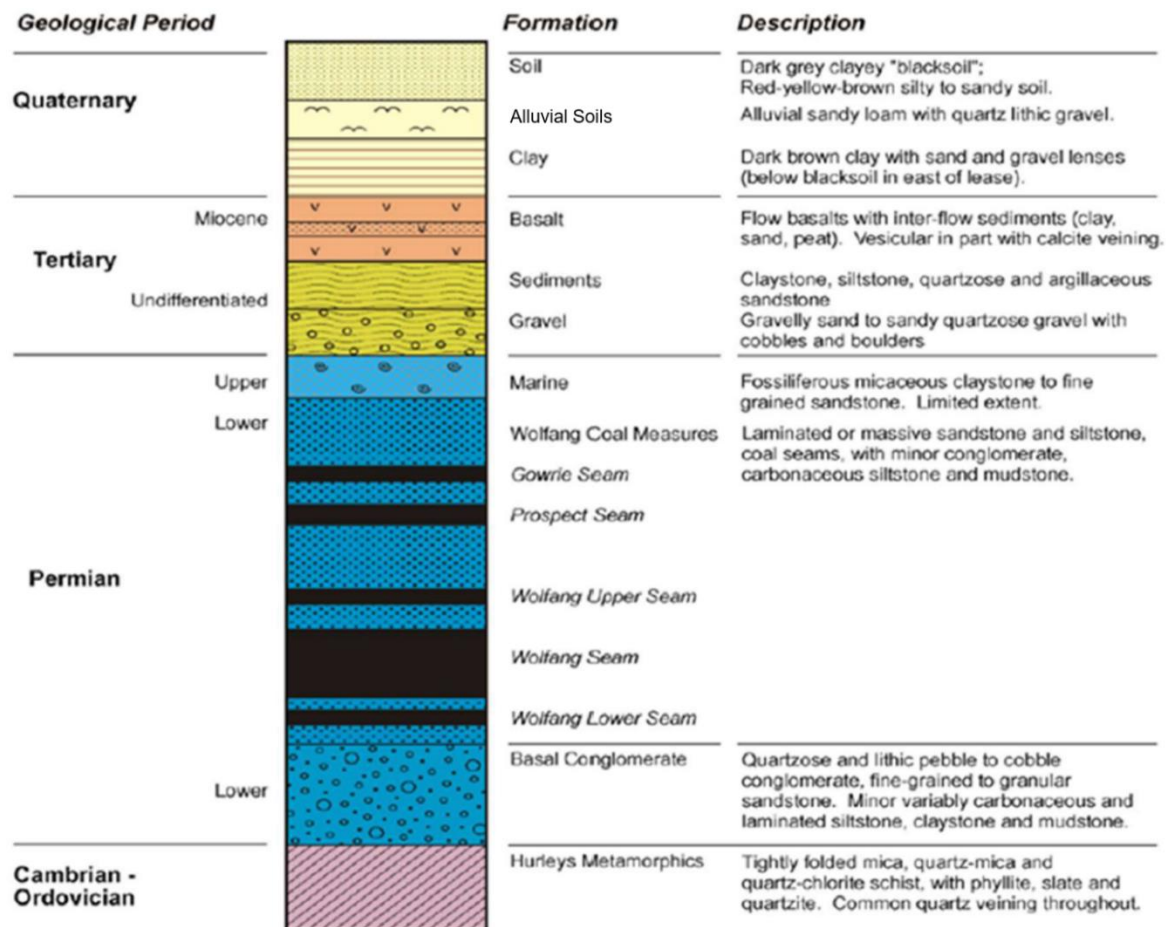
Figure 3-3 - Typical Stratigraphic Sequence at the CCO site

Permian sediments lie under the surface geology of Quaternary sediments, Tertiary sediments and Tertiary basalt (**Figure 3-2** and **Figure 3-3**), formed in a graben basin during the Early Permian following a tectonic extension episode. The western margin of the Clermont main deposit represents the up-thrust side of the graben and is locally referred to as the 'Western Wall Fault'. Glacial sediments form the lower basal conglomerate of the Permian sequence in the graben structure, with subsequent sedimentation of finer sediments forming the coal and interburden layers of the Wolfgang coal measures in the Clermont main deposit area. The Permian sediments in the Clermont main deposit area and east of the active mine area can range in thickness from 80 m to 290 m.

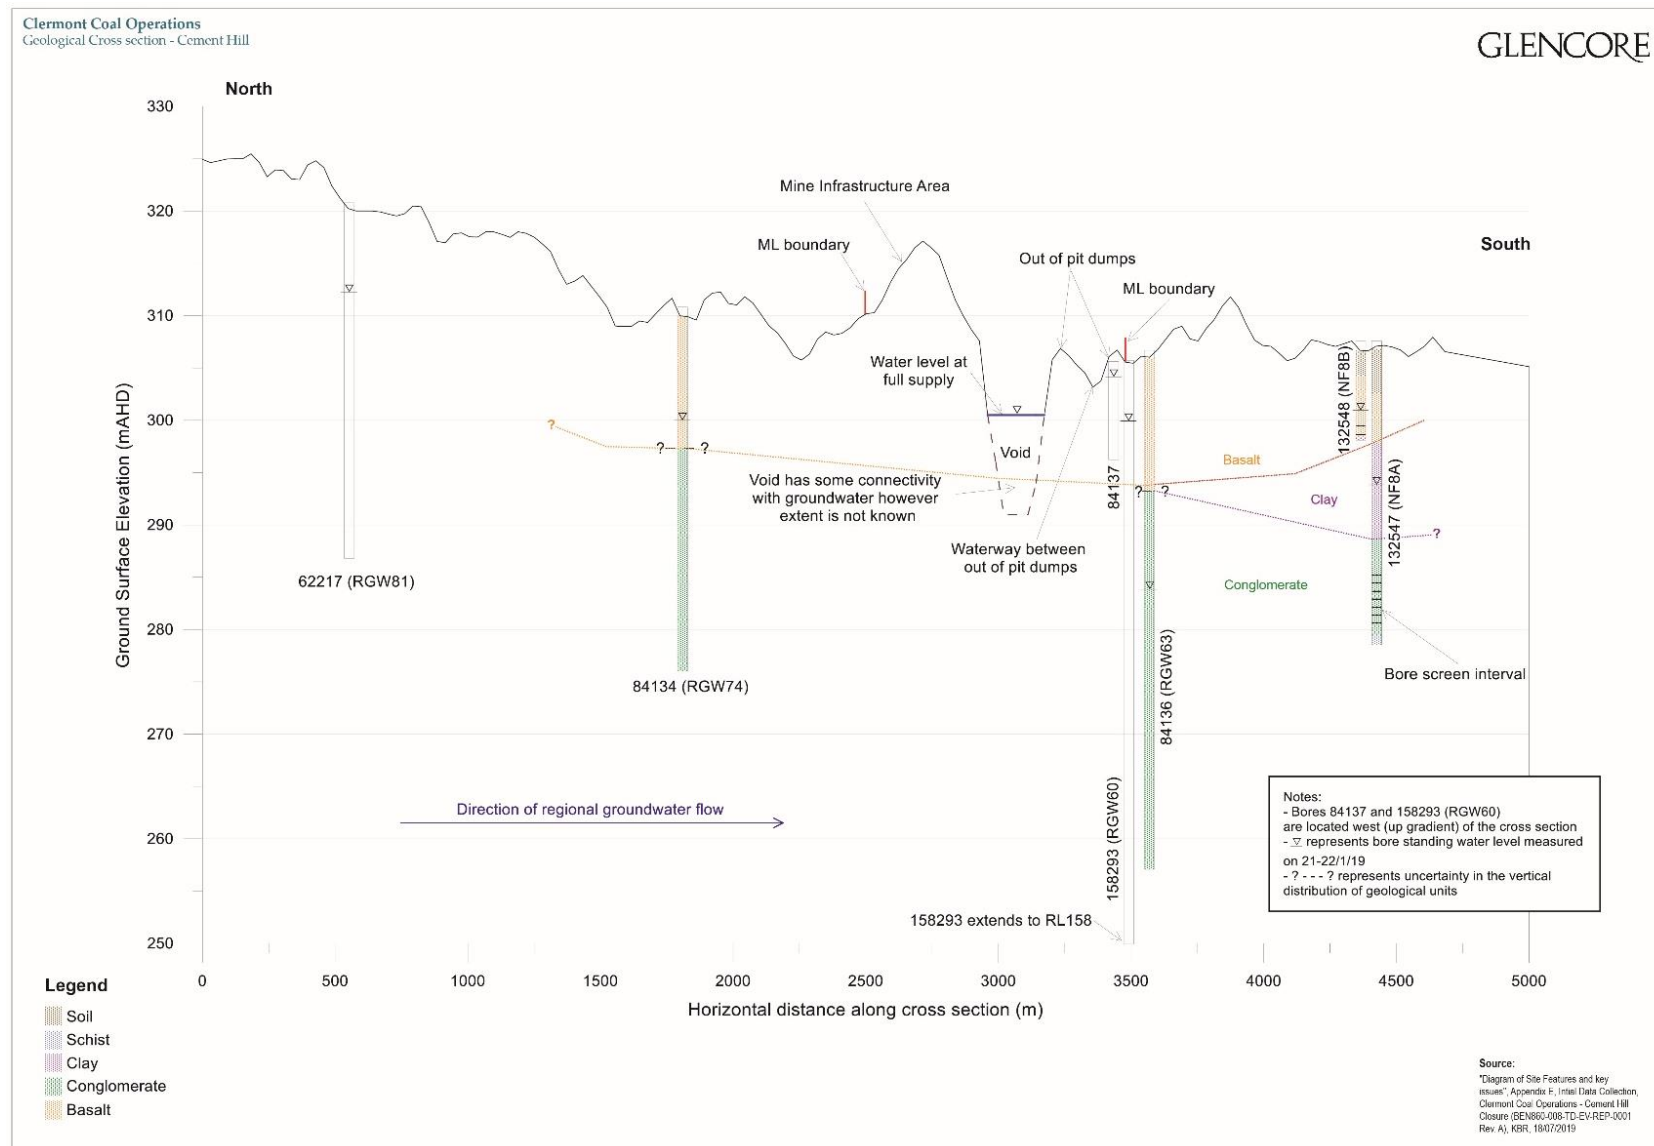
Local drill hole data suggests that in the local area, a 10-20 m thick layer of basalt overlies a conglomerate sequence of greater than 50 m depth, across most of the site, except in the south, where a 10 m thick layer of clay occurs between the conglomerate and the basalt (refer to *Figure 3-4* below).

Figure 3-4 Geology Cross Cement Hill Area

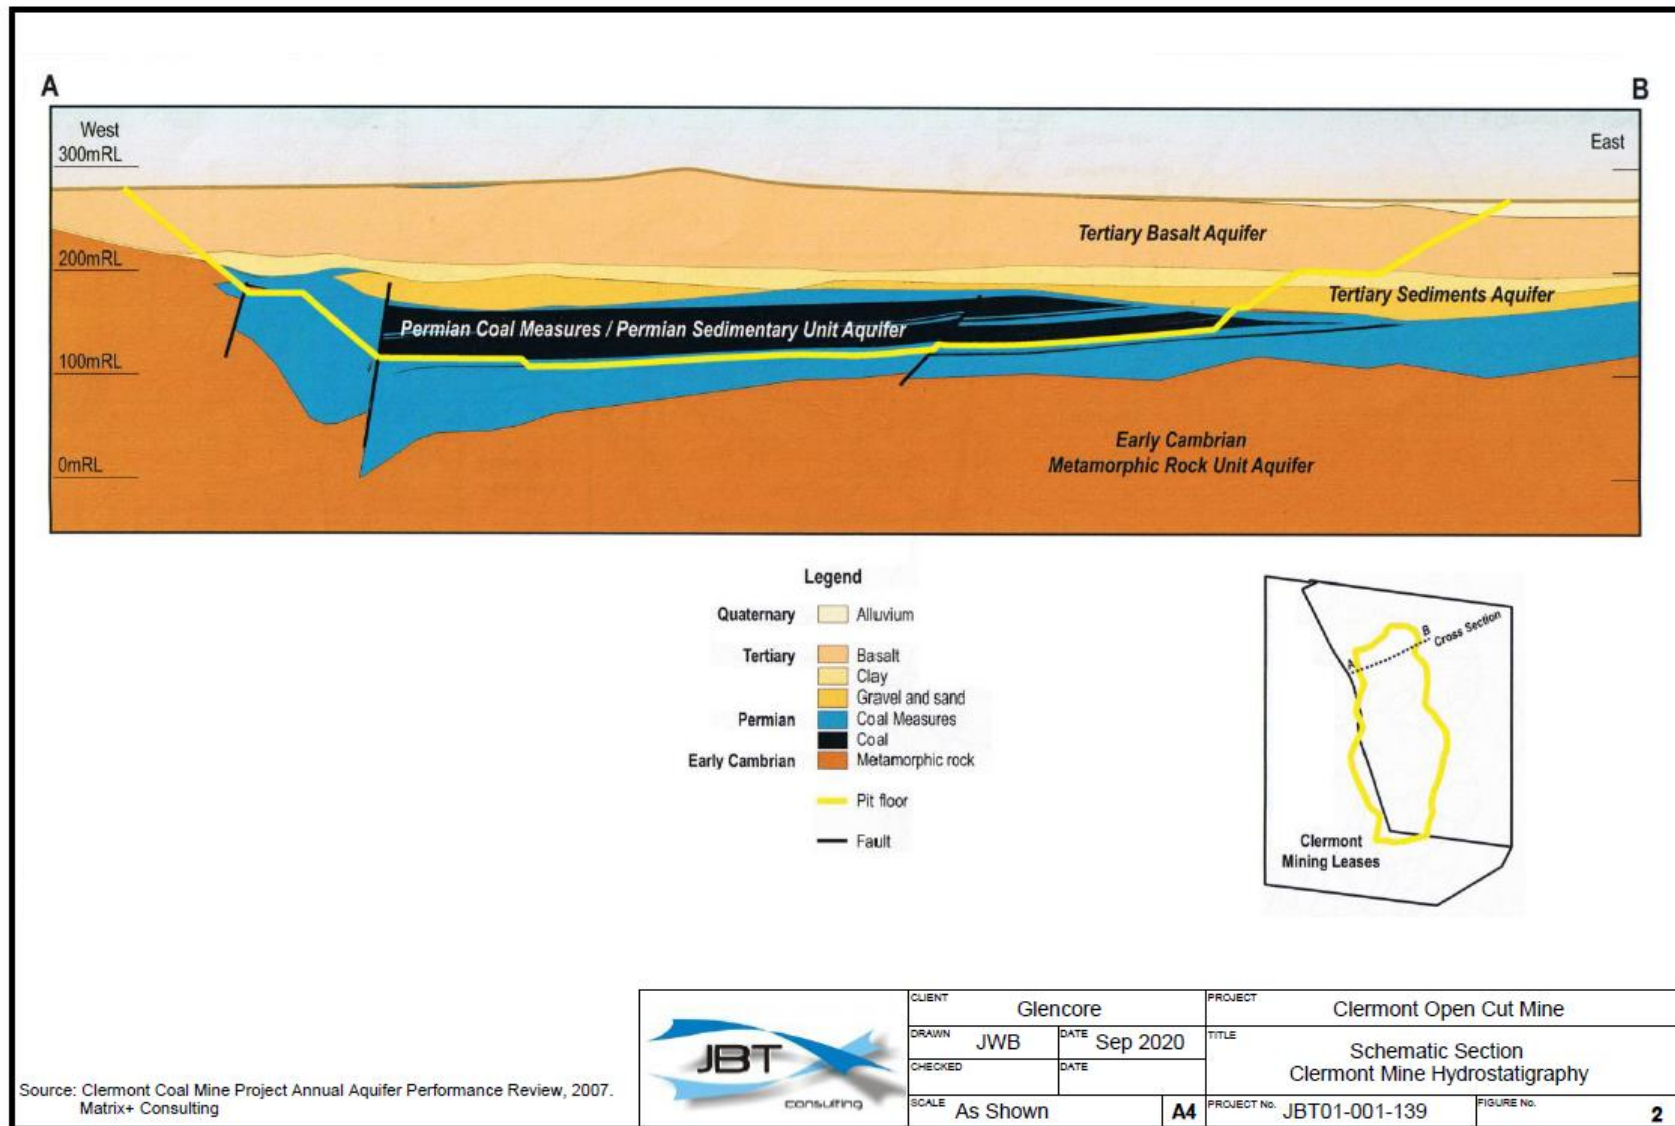
Figure 3-6 - Hydro stratigraphic cross section of Clermont

*Figure 3-6* provides a schematic hydro stratigraphic cross section through the mine area, which identifies the units described above and their associated depths.

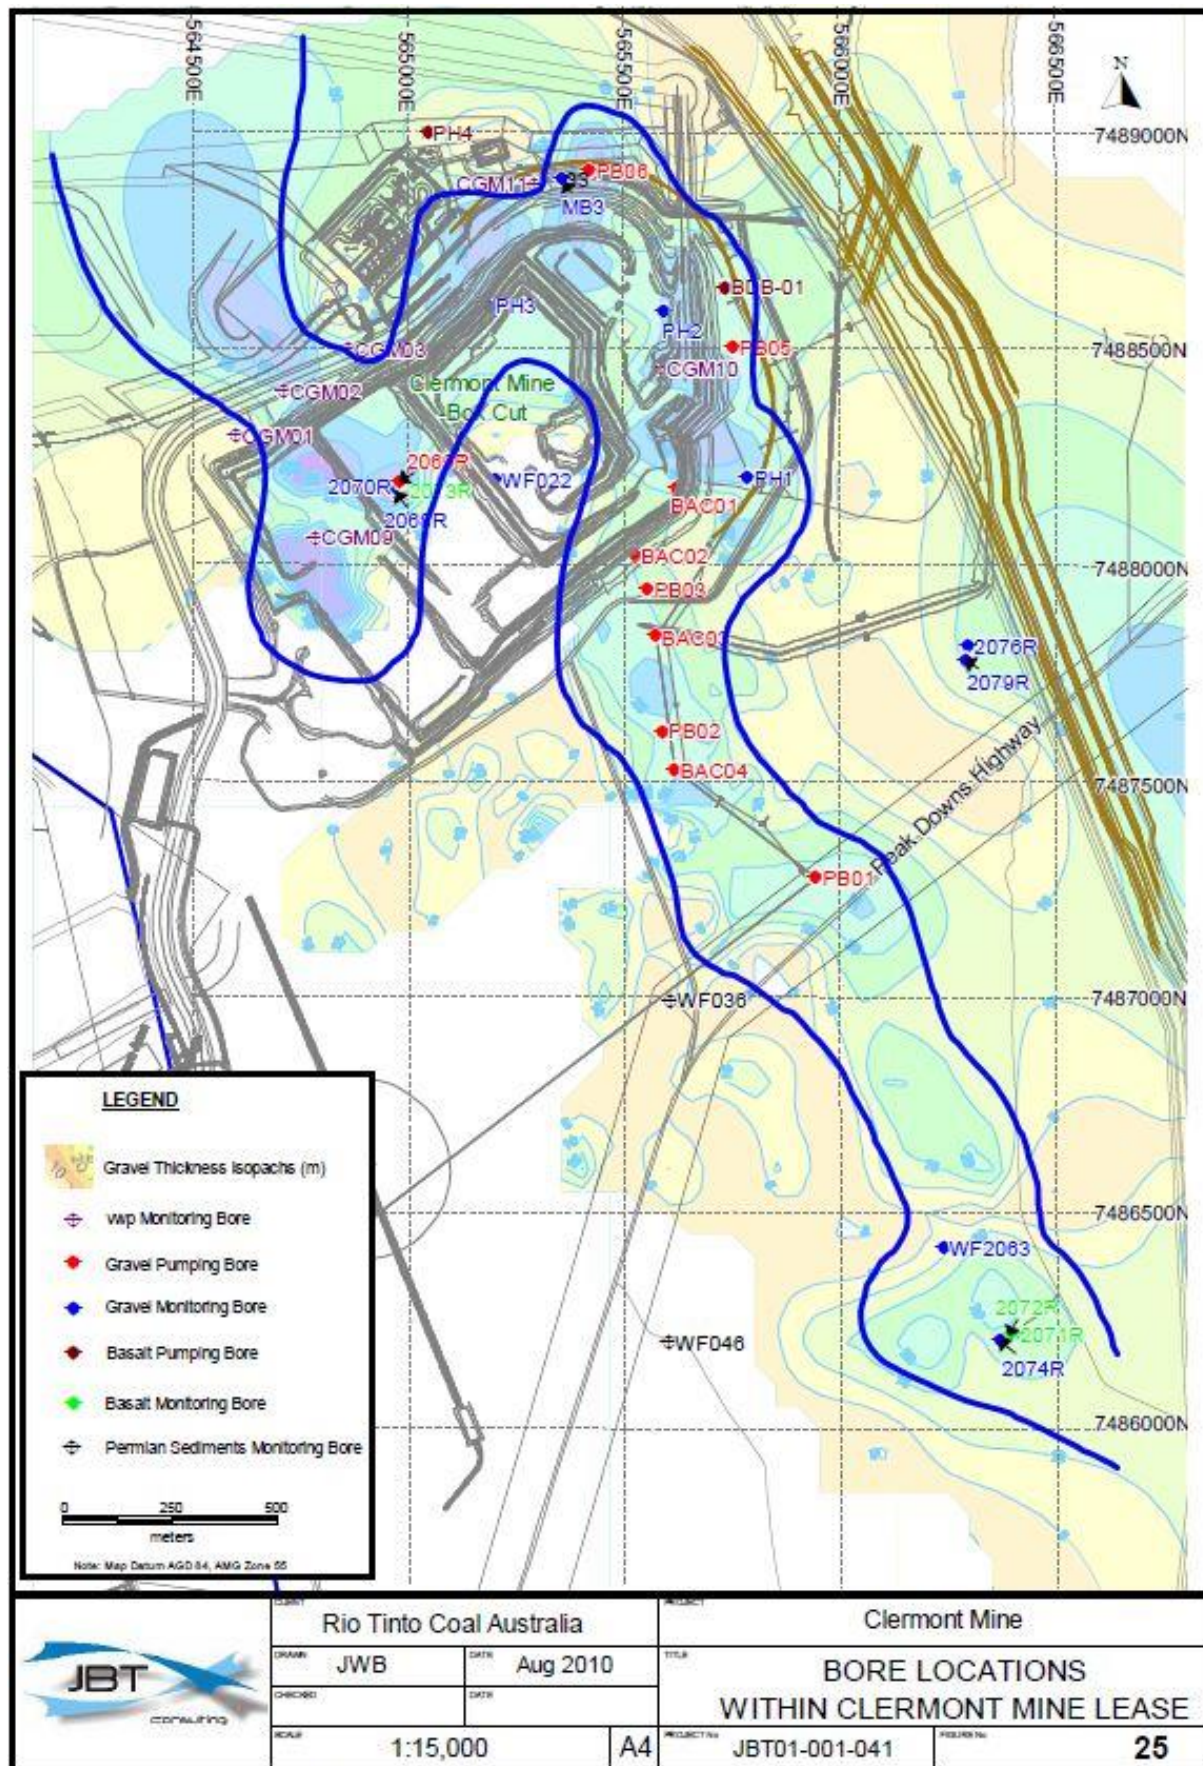
Figure 3-8 - Tertiary Gravel Aquifer Thickness map

Considerable water has been extracted from the Tertiary gravel aquifer as part of the dewatering process to access the coal reserves. The aquifer is for the most part, a confined aquifer. The gravel aquifer has limited aerial extent as outlined in blue in **Figure 3-8**, having deposited in eroded valleys within the top of the Permian sedimentary package. The lateral extent of the gravel aquifer in the CCO area is approximately 4 km in strike length by 250 m wide and up to 30 m thick in the deeper section. The aquifer has been drained by the earlier advanced dewatering and subsequent in pit seepage to the mine void. The impact of mine dewatering is shown in **Figure 3-9**, where the groundwater levels rapidly drawdown over an initial 12 month period followed by steady decline.
