CLERMONT

GLENCORE

# Progressive Rehabilitation and Closure Plan (PRC Plan)

January 2023

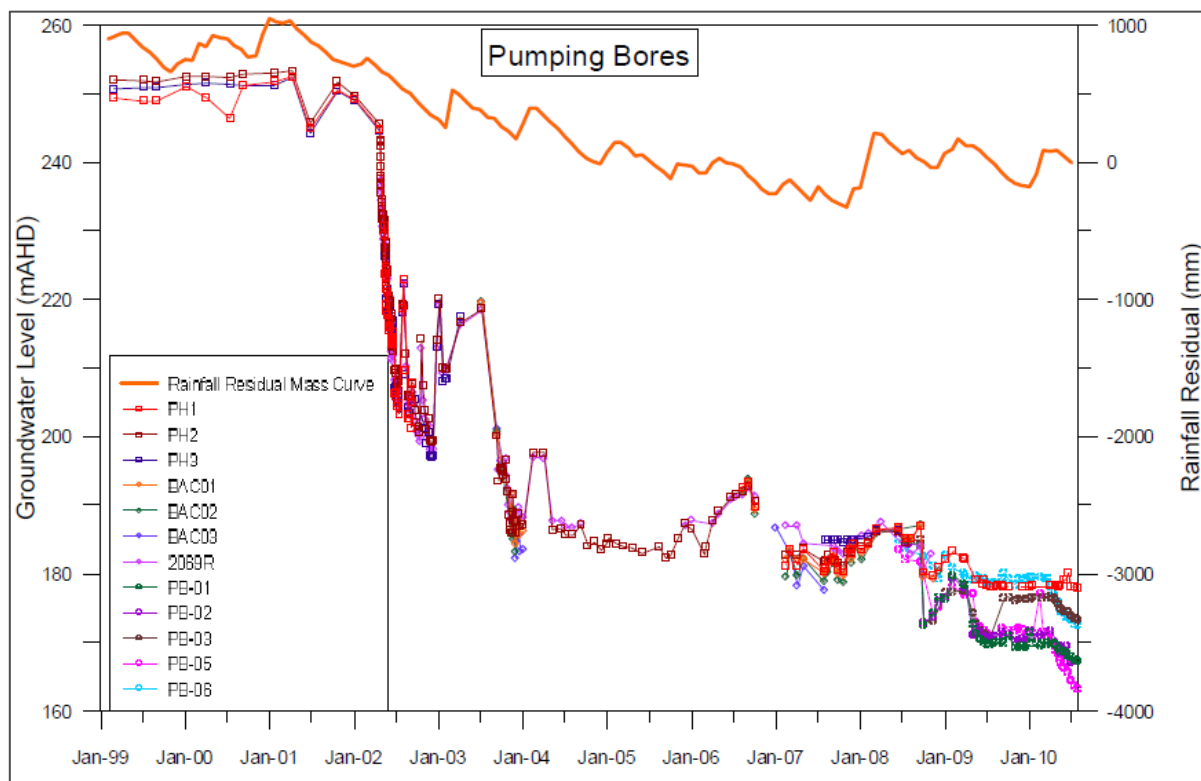
Figure 3-9 - Groundwater drawdown of Tertiary Gravel Aquifer

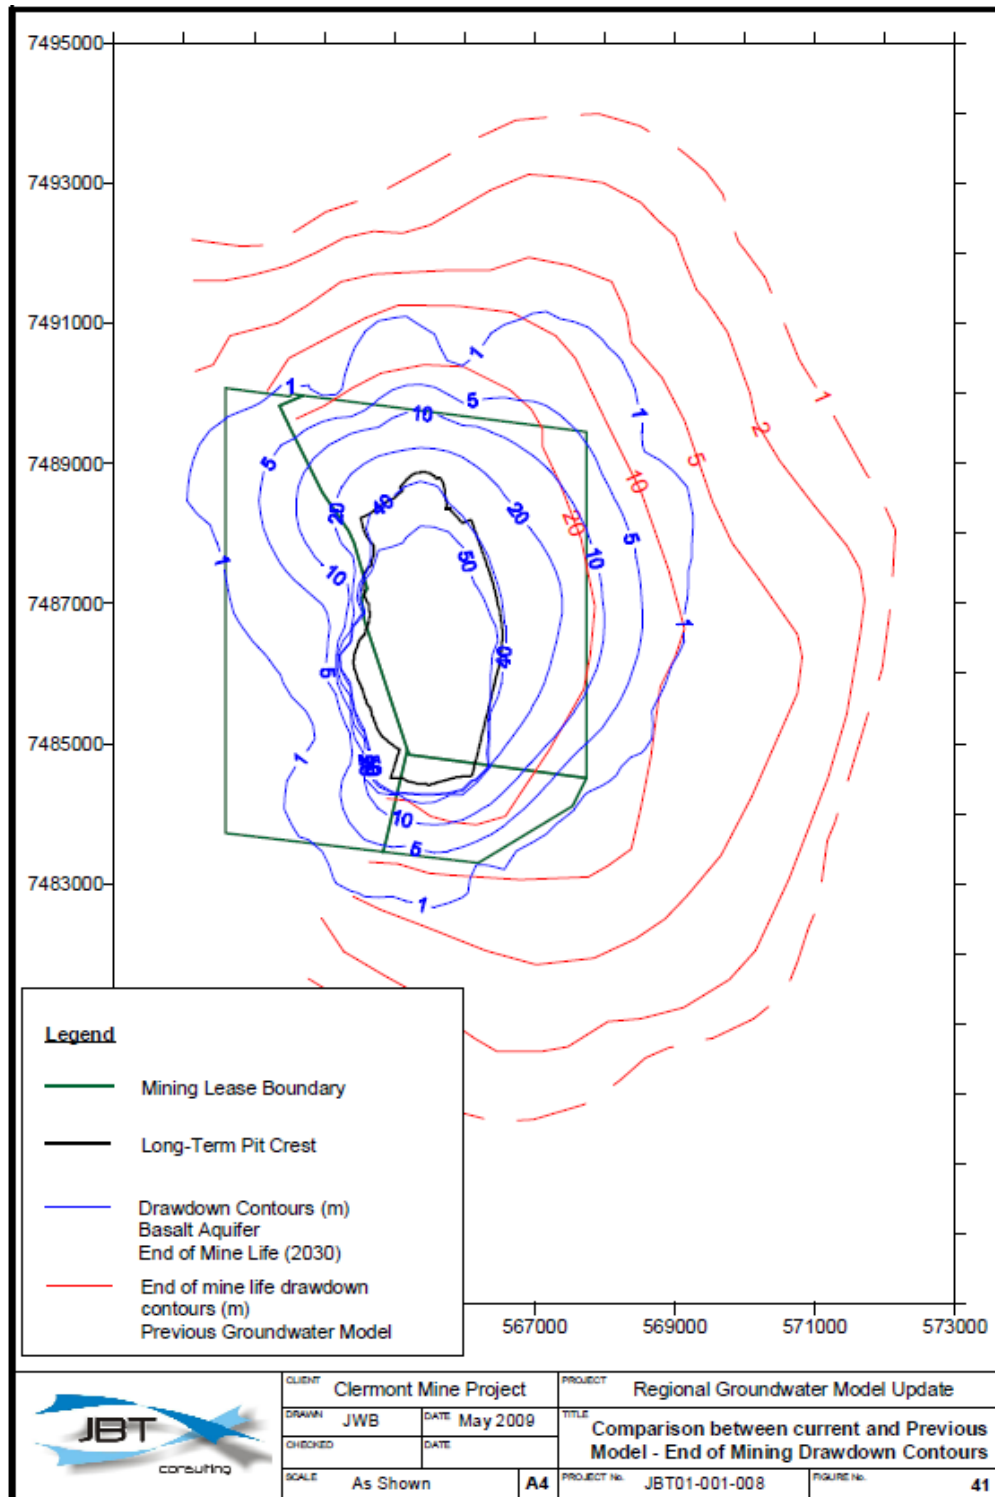
Figure 4-1 - 2009 Basalt groundwater drawdown prediction versus 2004 model prediction

The main potential impacts from mining is the local drawdown of groundwater levels in the basalt aquifer, which has been shown to be limited in extent with groundwater monitoring data providing

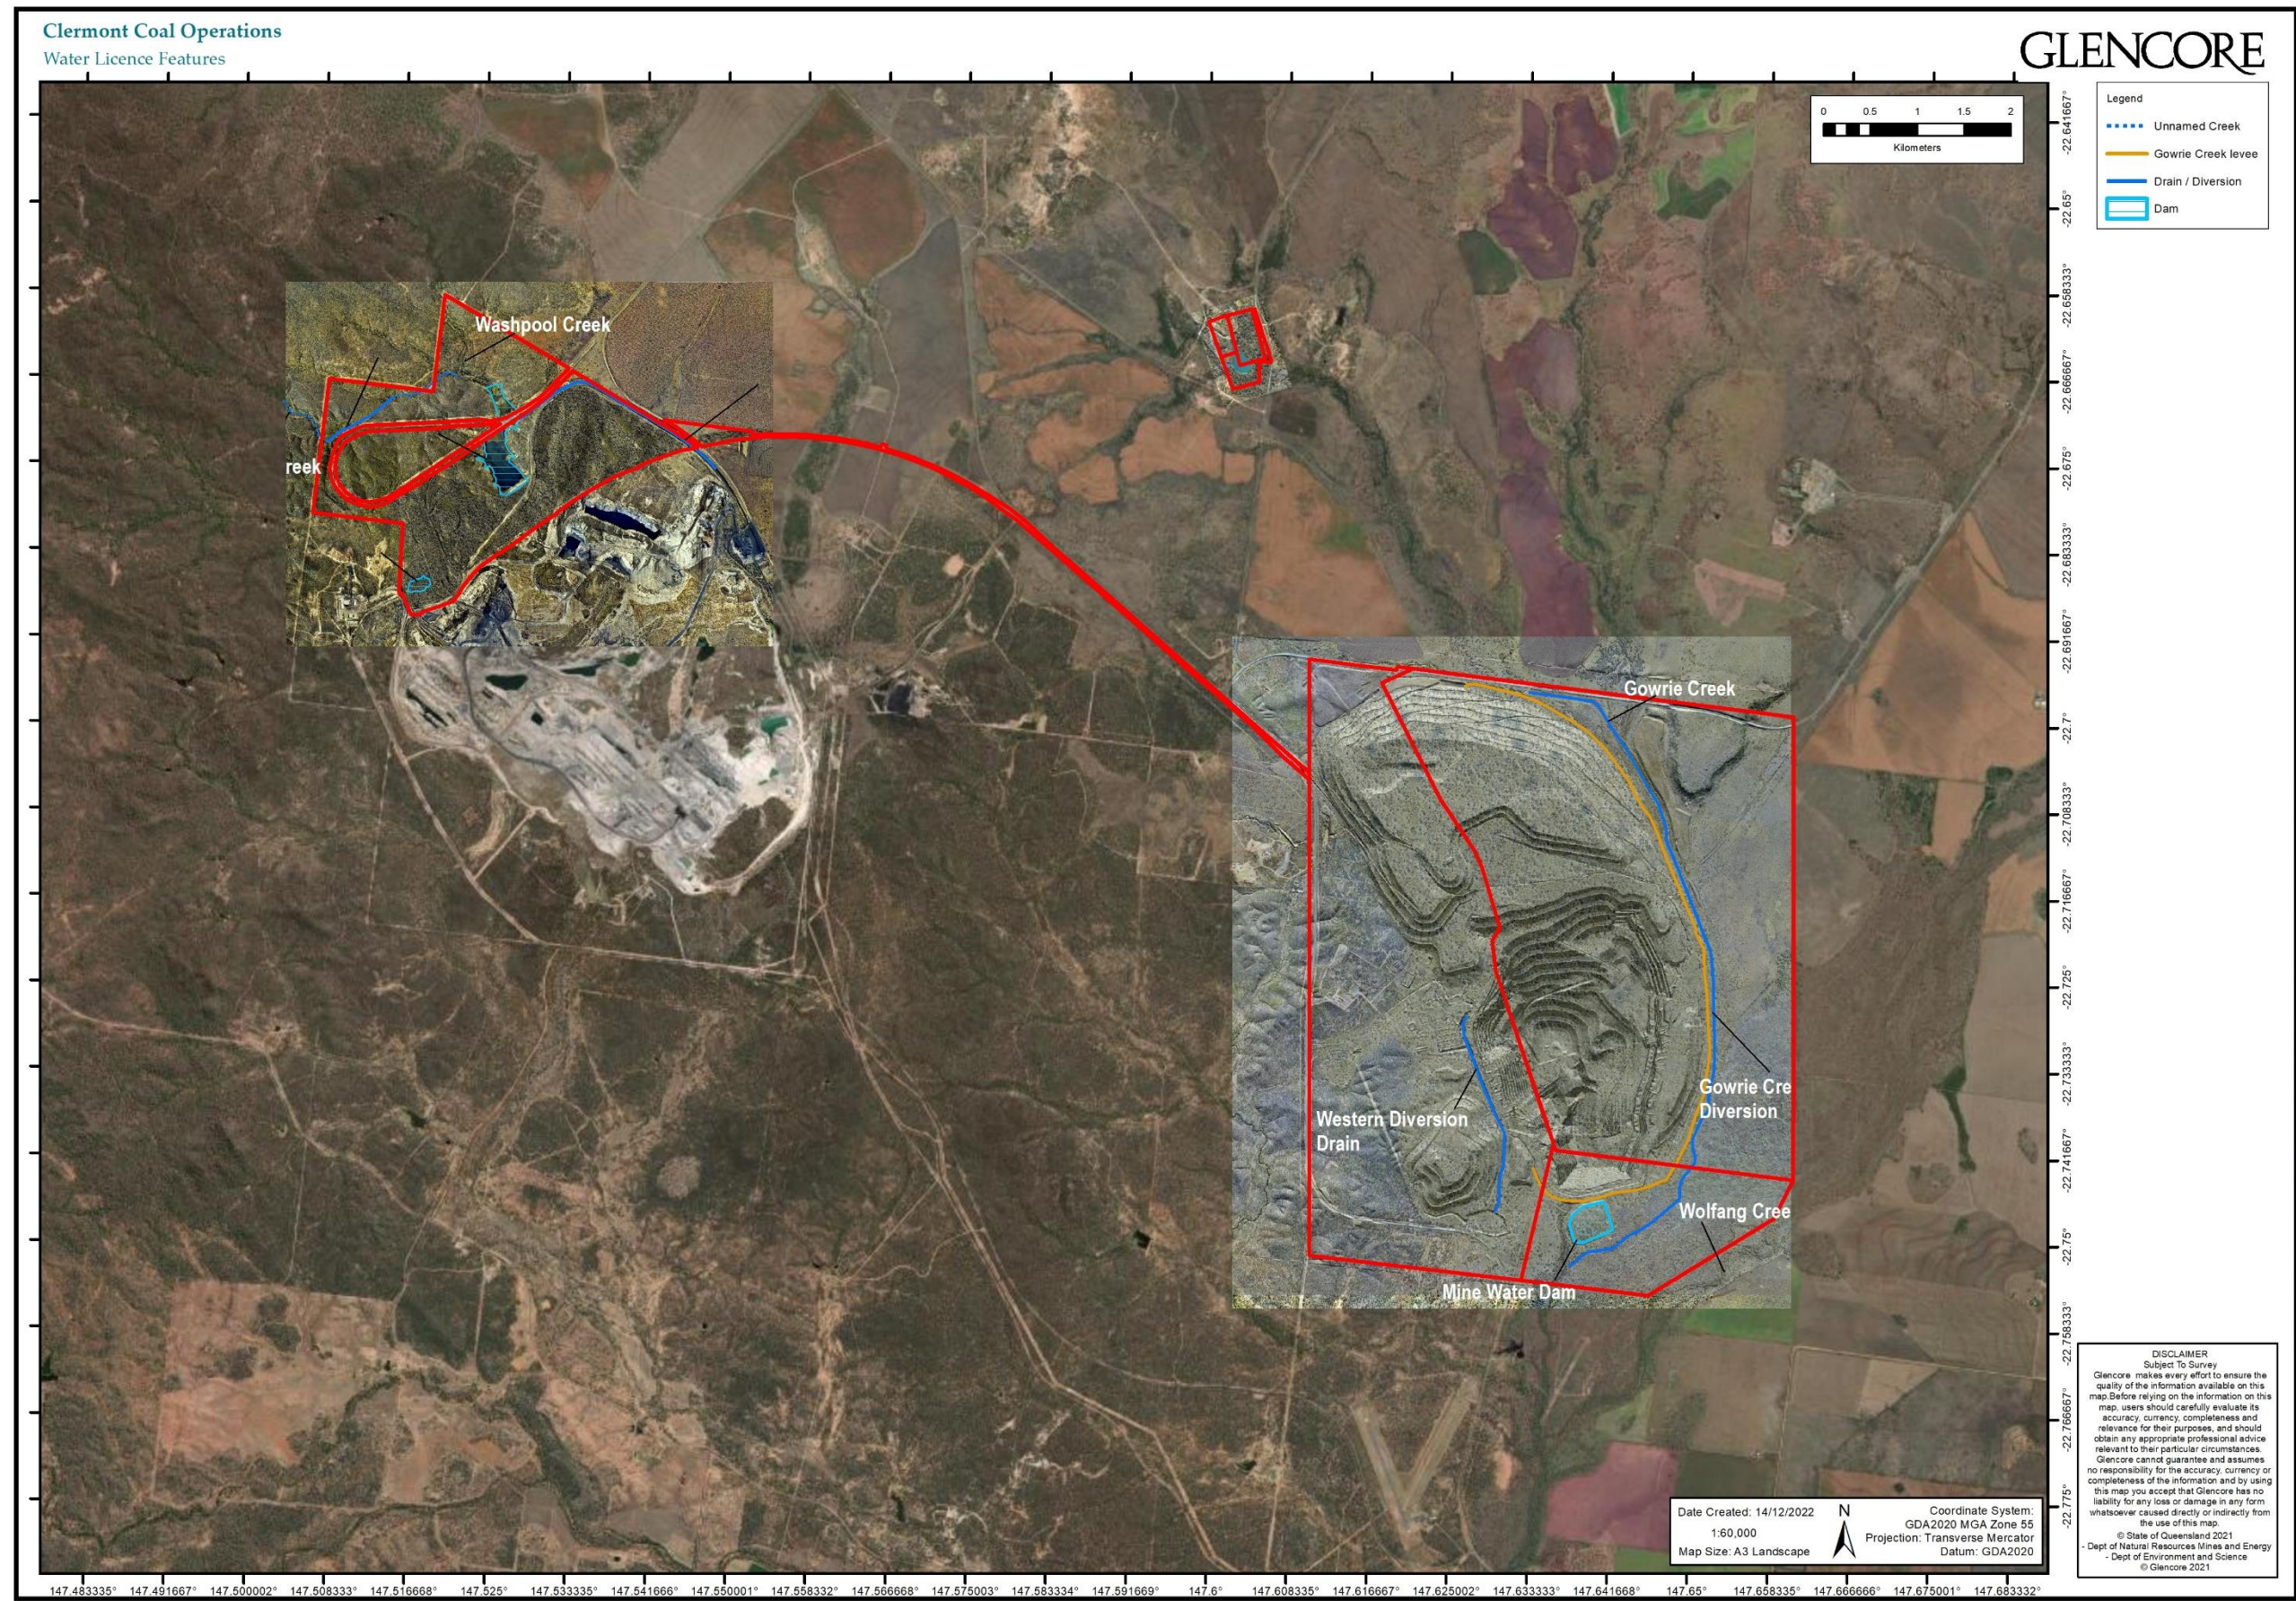
Figure 2-2 - Water Licence Features

As detailed in **Table 2-1** and **Table 2-2**, there are multiple structures and diversions that influence flow. These are (**Figure 2-2**):

- Clermont Mine:
  - Gowrie Creek diversion and levee – permanent diversion of Gowrie Creek to the east of Clermont void;
  - Western diversion drain – drainage feature immediately west of Clermont void;
- Train Load Out:
  - Rail loop diversion – temporary diversion away from the rail loop and towards West Dam; and
  - West Dam and diversion – storage and diversion around the eastern side of Blair Athol. Consists of a number of segments of which the Northern Boundary Diversion is located within the TLO, with segments further downstream (on Terracom land) including the Eastern Diversion and the South Eastern Diversion.

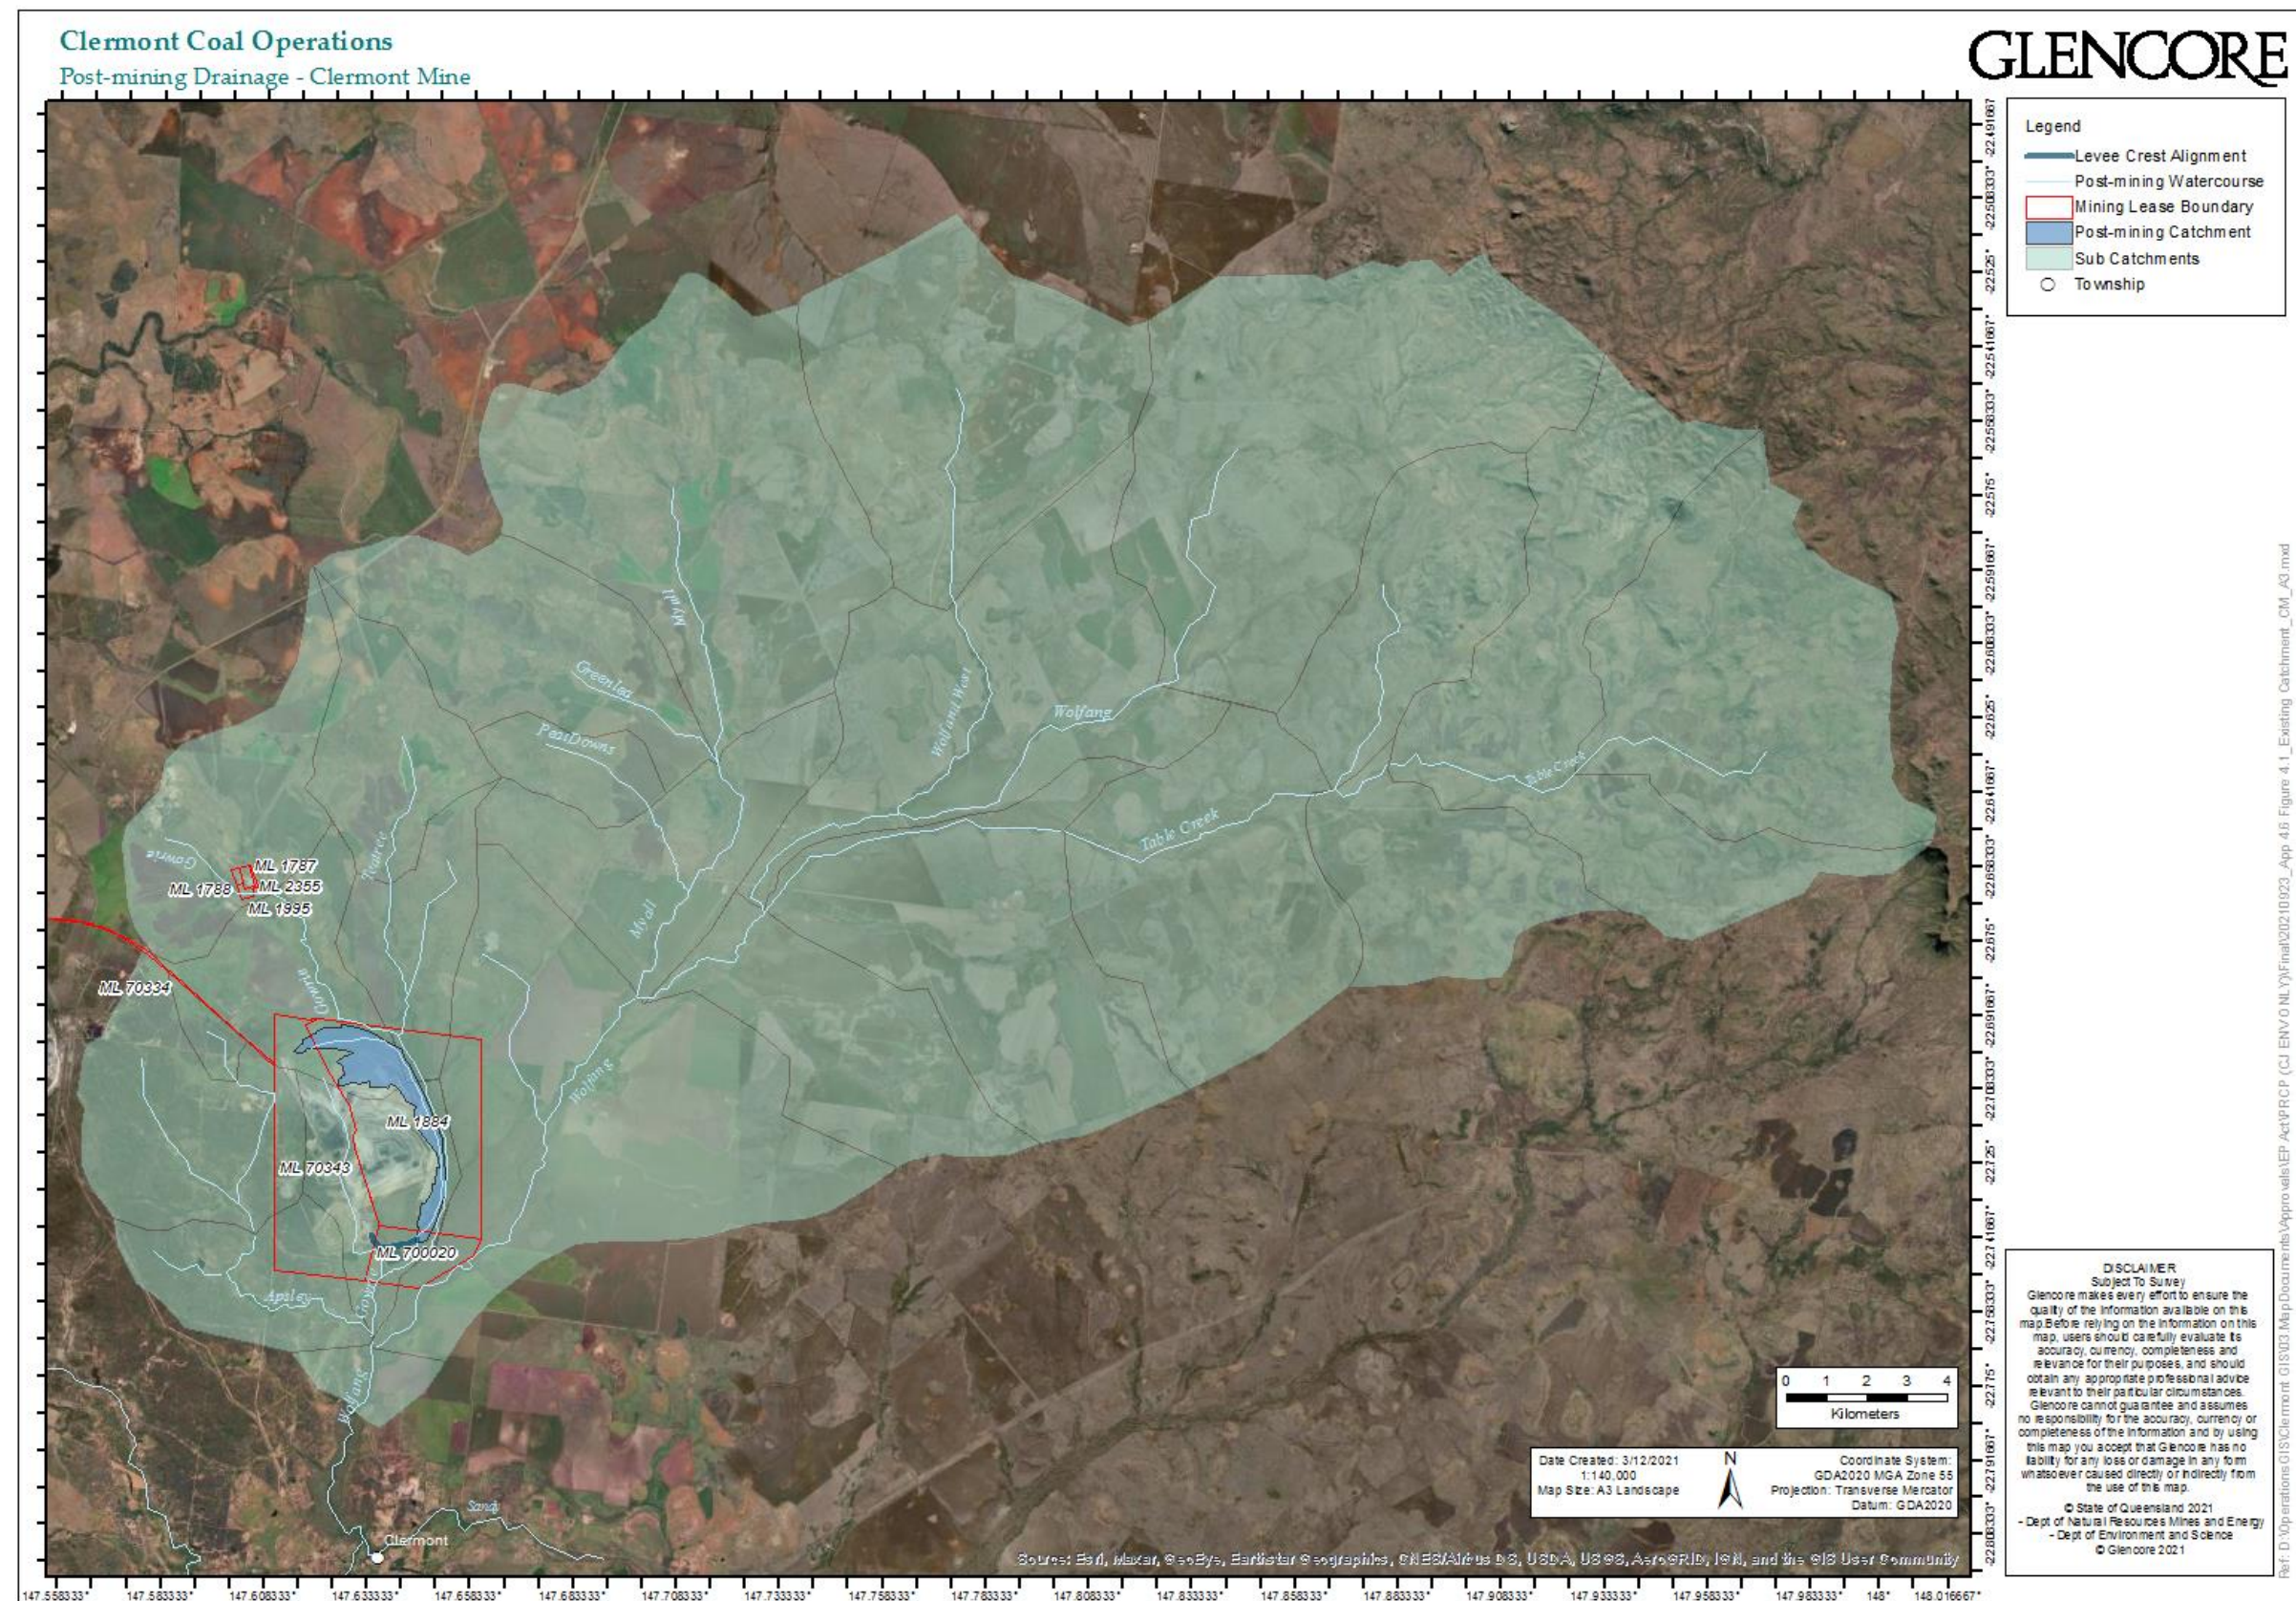
Figure 3-1 - Existing mine catchments delineation

The Gowrie Creek diversion and surrounding creeks are shown in **Figure 3-1**. The hydrology surrounding CM will be largely unchanged from the current regime under active mining. The rehabilitation of the northern WRD to a vegetated and outward draining surface is not expected to substantially alter the local hydrological response. Incorporation of the eastern levee into the final landform provides a robust and sustainable landform moving through closure and into the future.

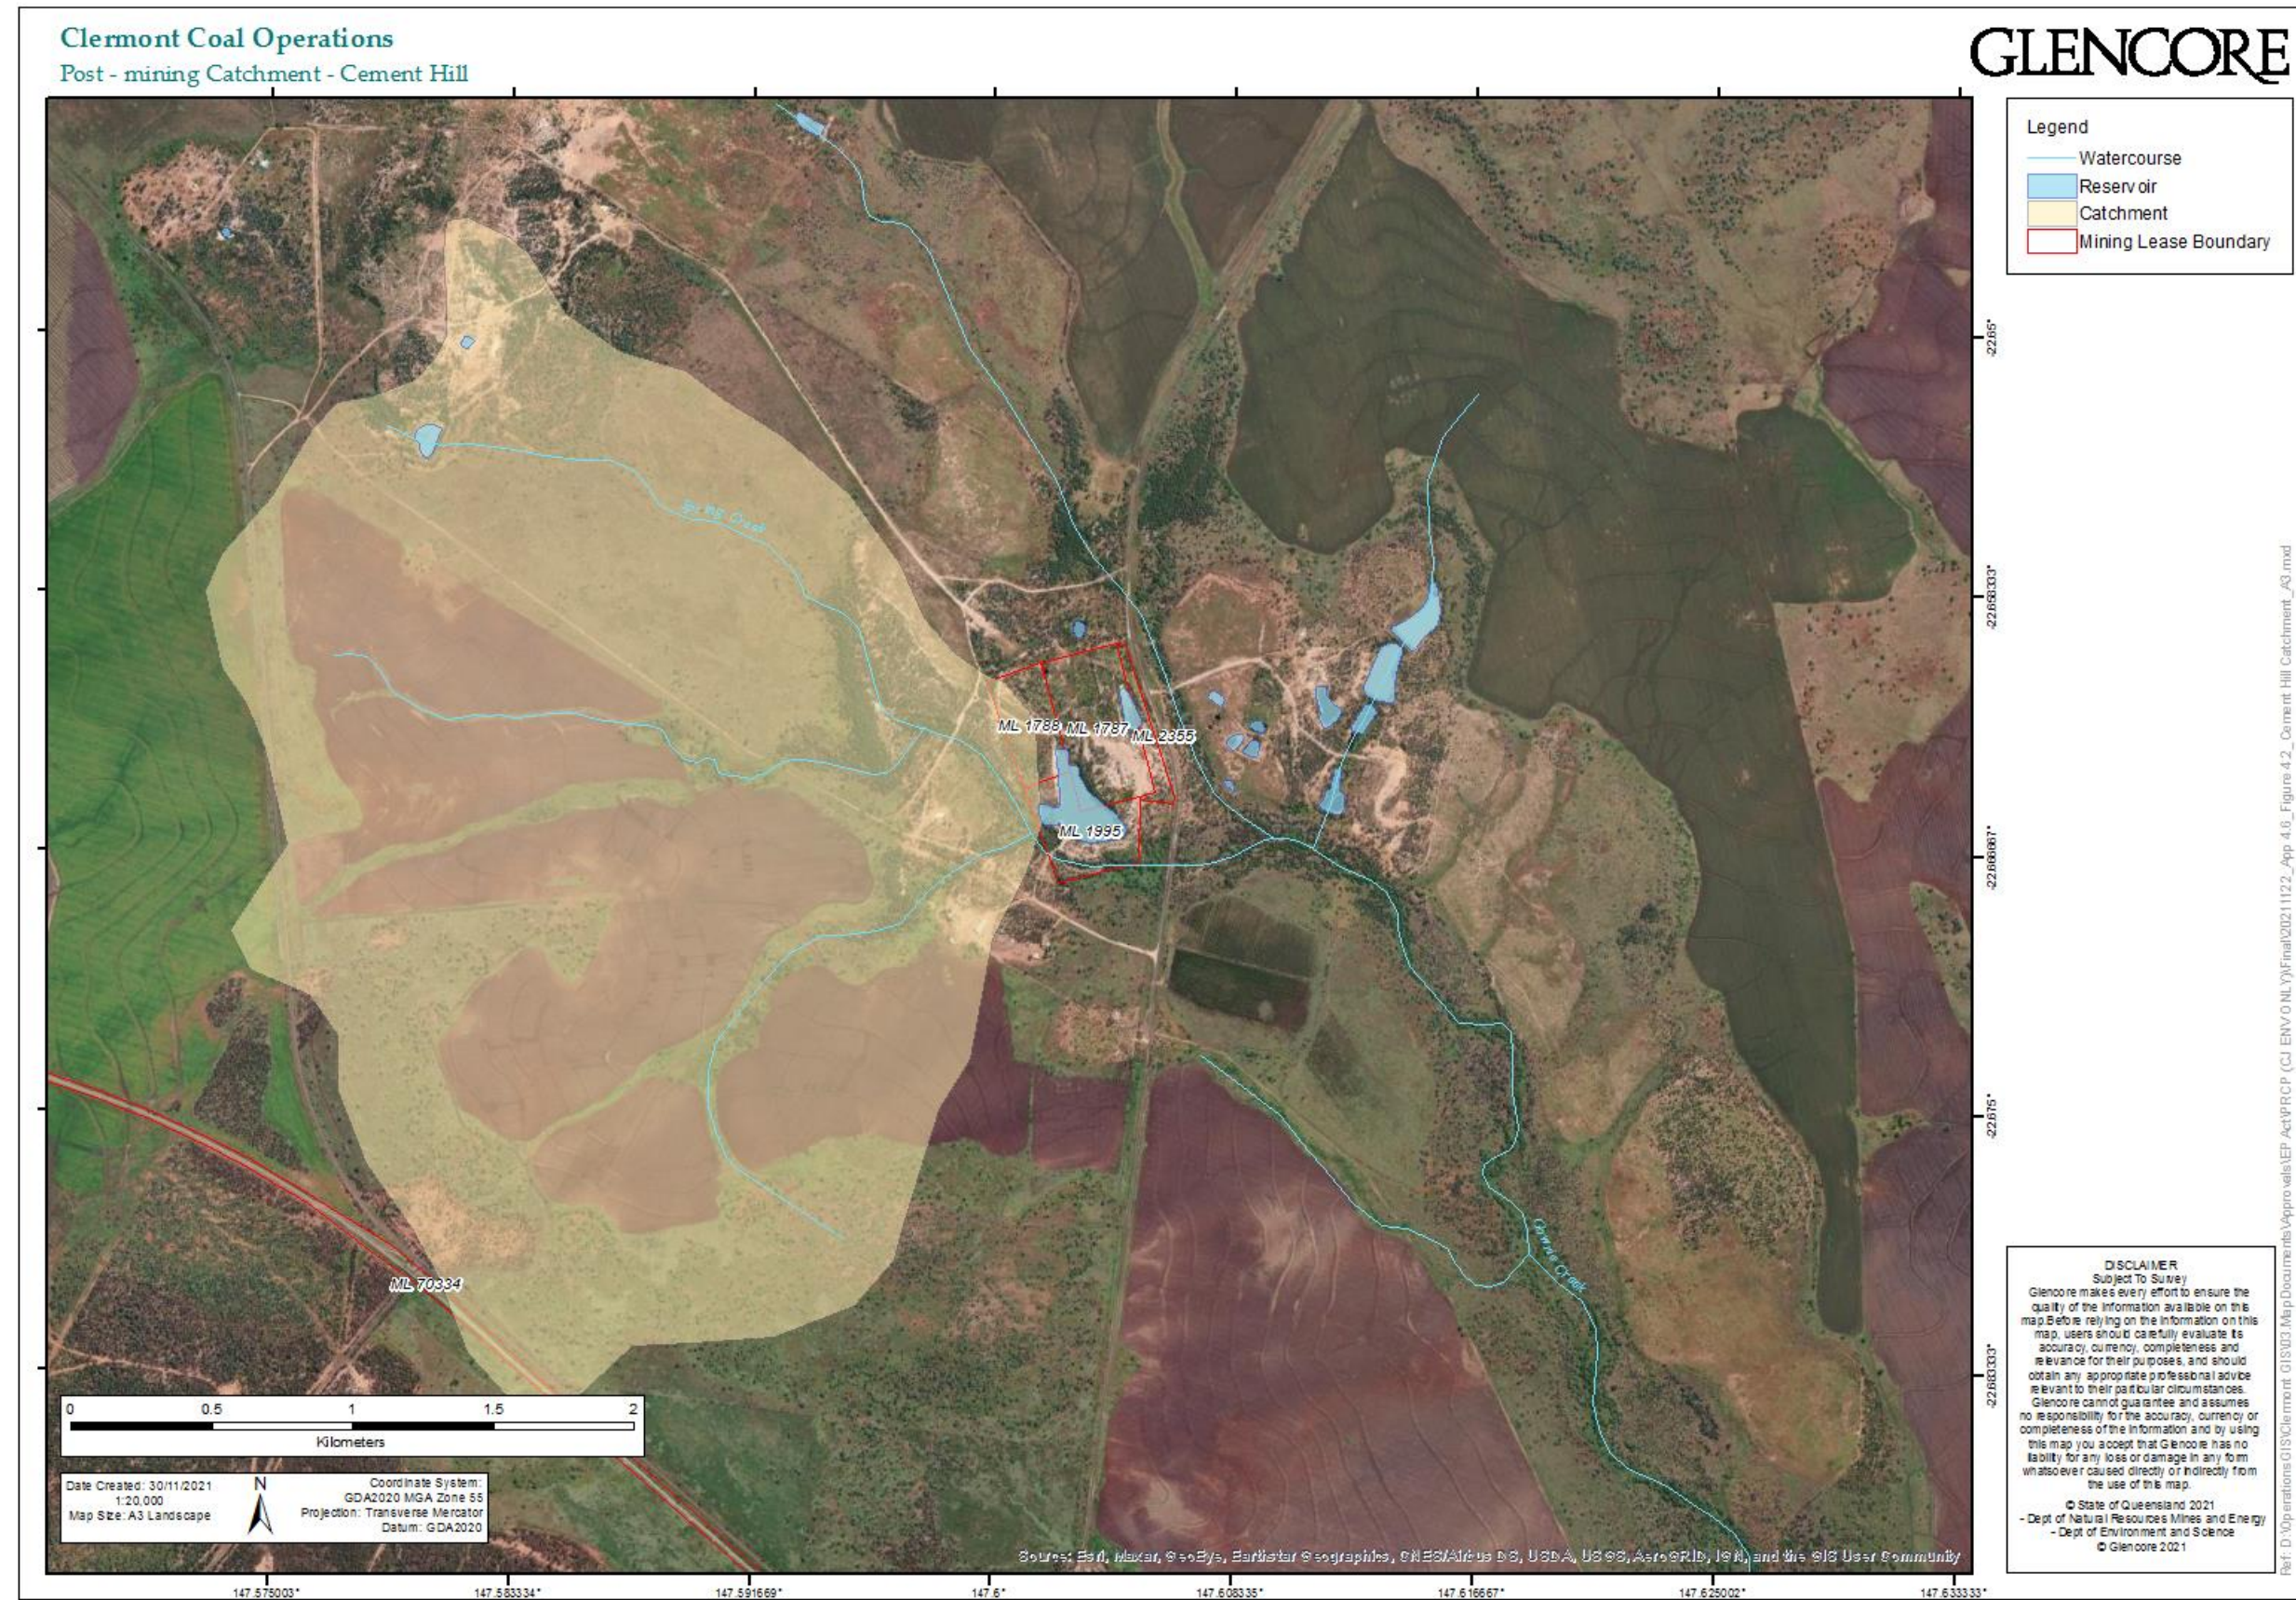
Figure 3-2 - Cement Hill catchment delineation

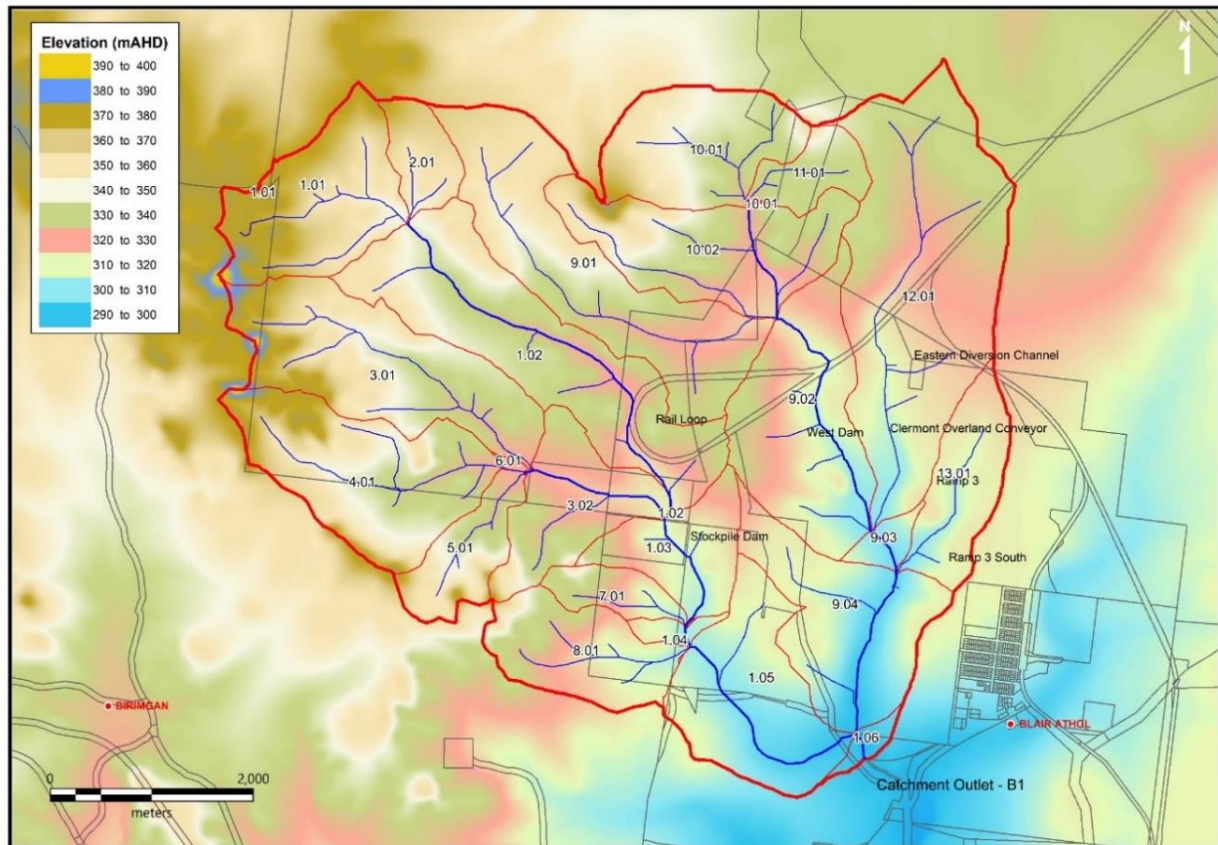
Figure 3-3 - Delineated pre-mining flow path and catchment boundaries

Pre-mining topography comprising the Study Area was obtained from the Queensland Spatial Catalogue - QSpatial. **Figure 3-3** shows the delineated pre-mining flow path mapping and catchment boundaries based on available topographical data. The original flow path of the Western Creek is to the south, just west of the rail loop before it enters the Blair Athol (BA) mine lease, owned and operated by Terracom.

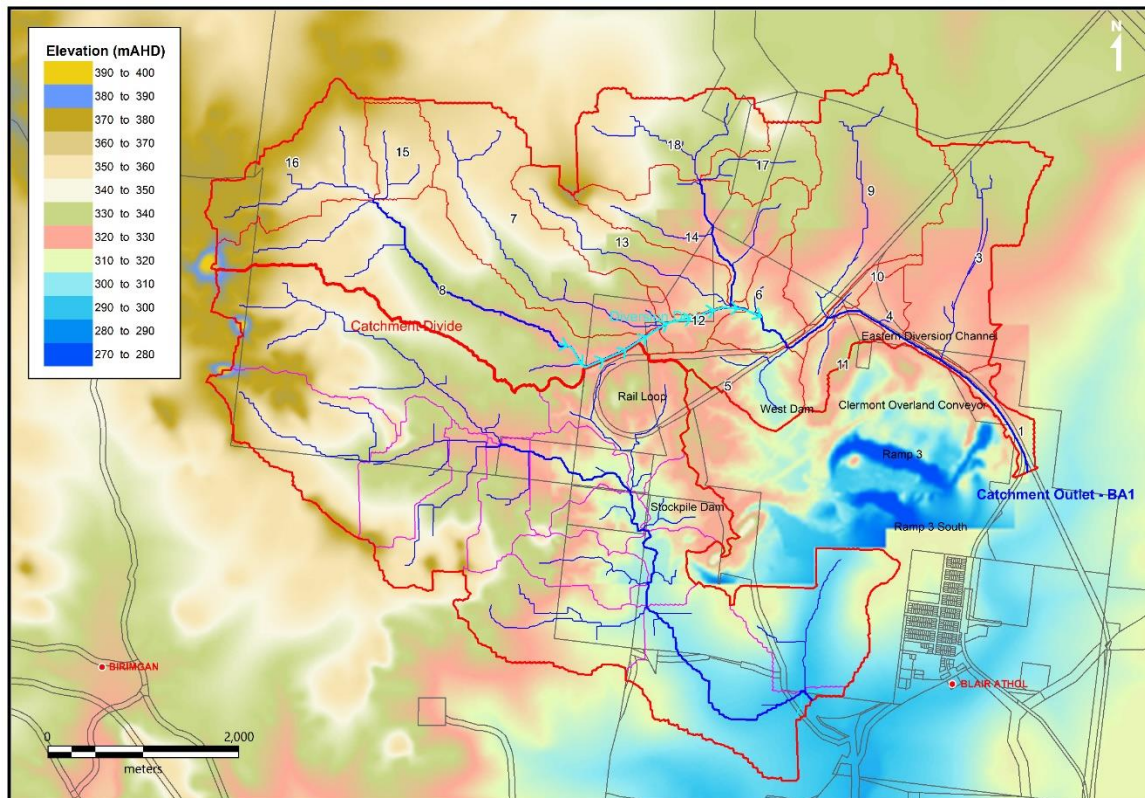
Figure 3-4 - Delineated post mining flow path and catchment boundaries

The current topography dataset was derived by stamping the Study Area LiDAR data on the pre-mining topography on **Figure 3-3**. Flow path mapping and catchment delineation was undertaken using the derived topography. The delineation of the hydrologic sub-catchment boundaries was important for simulating appropriate routing, especially given the location of West Dam for the estimation of flow entering via the Rail Loop diversion. The Rail Loop diversion contribution to West Dam was implemented with a hydraulic control feature. **Figure 3-4** shows the delineated catchment boundaries to West Dam and the downstream Northern Boundary diversion.

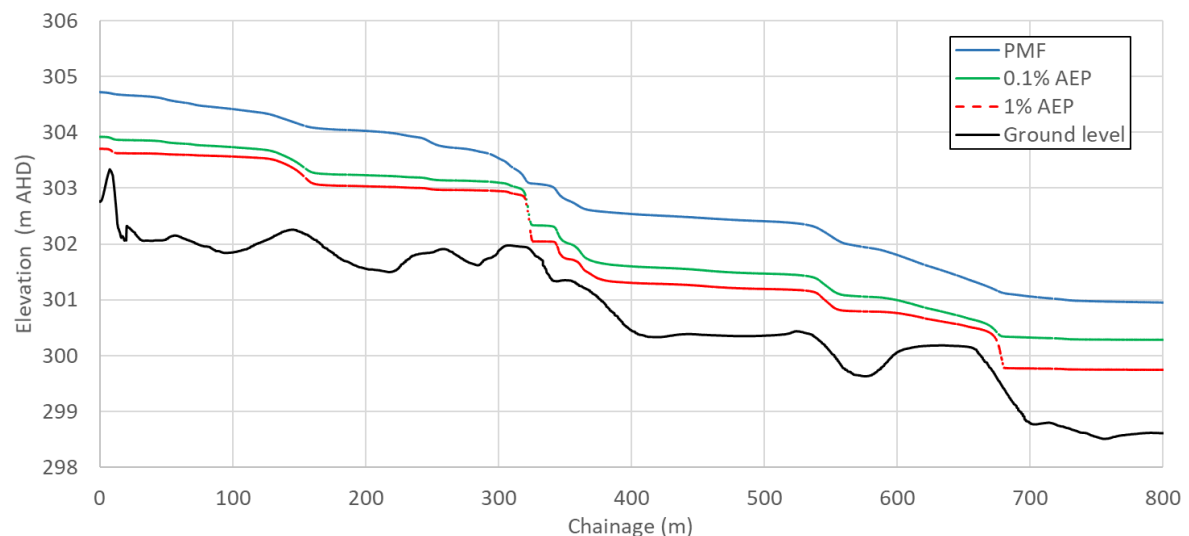
Figure 4-4 - Design flood events at Cement Hill

The water surface elevation in the main channel adjacent to the void for the 1% AEP, 0.1% AEP and PMF flood events is shown in **Figure 4-4**.

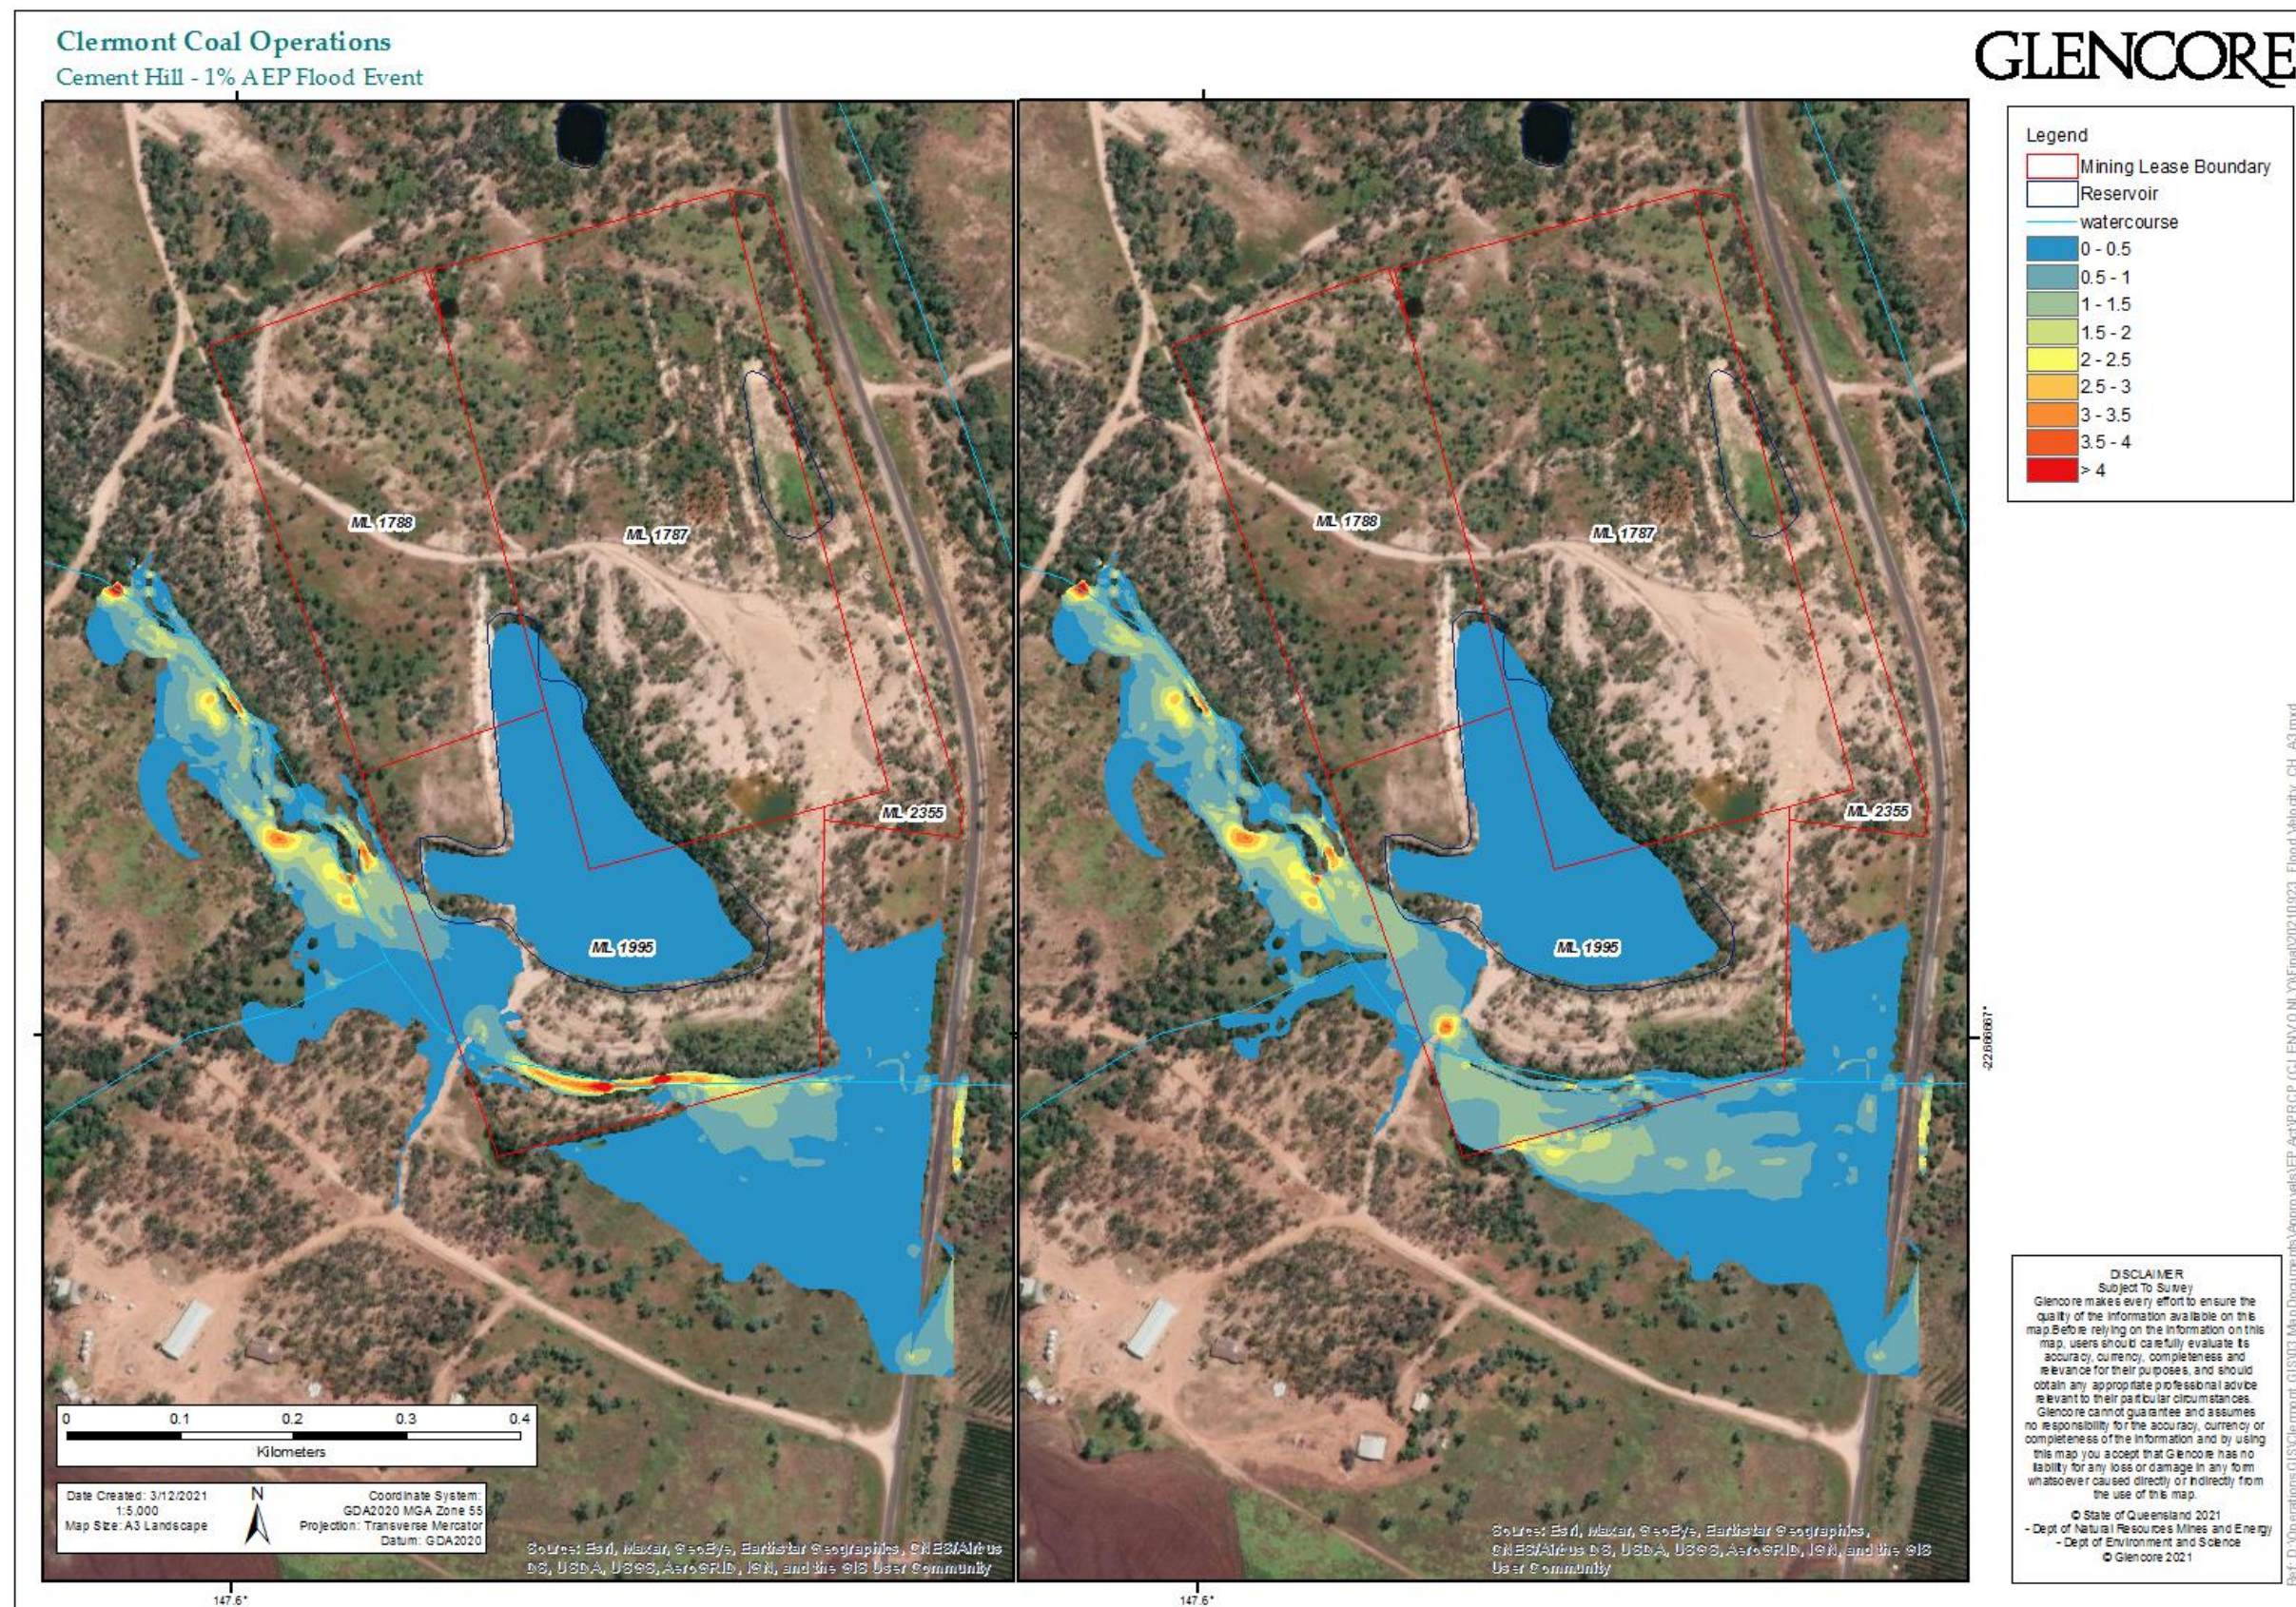
Figure 4-5 - 1% AEP velocity prior to and after final landform

Given that the CH void is connected to the flood plain via a weir, void flood immunity is not relevant and therefore the effect of extreme flood events such as 0.1% AEP and PMF is less significant at this location. The 1% AEP event is presented in **Figure 4-5** as this is the event of most relevance from an erosion perspective associated with a major flood event. The flood extent and velocity profile of the current situation shows a constriction to flow between the southern WRD and a satellite WRD placed in stream. Peak velocity in the location reaches 6 m/s and is likely to result in bed erosion and scour of the waste rock margins.

To address this scour risk, Glencore have committed to relocating the satellite WRD, thereby reinstating a flood plain to the south of the southern WRD. The effect of these proposed works within the floodplain was assessed in the hydraulic model and the results are shown in the post-rehabilitation scenario depicted on **Figure 4-5**. The peak velocity is reduced substantially to less than 2 m/s, which adequately addresses the toe scour risk and is equivalent to other sections of the floodplain upstream of the ML.

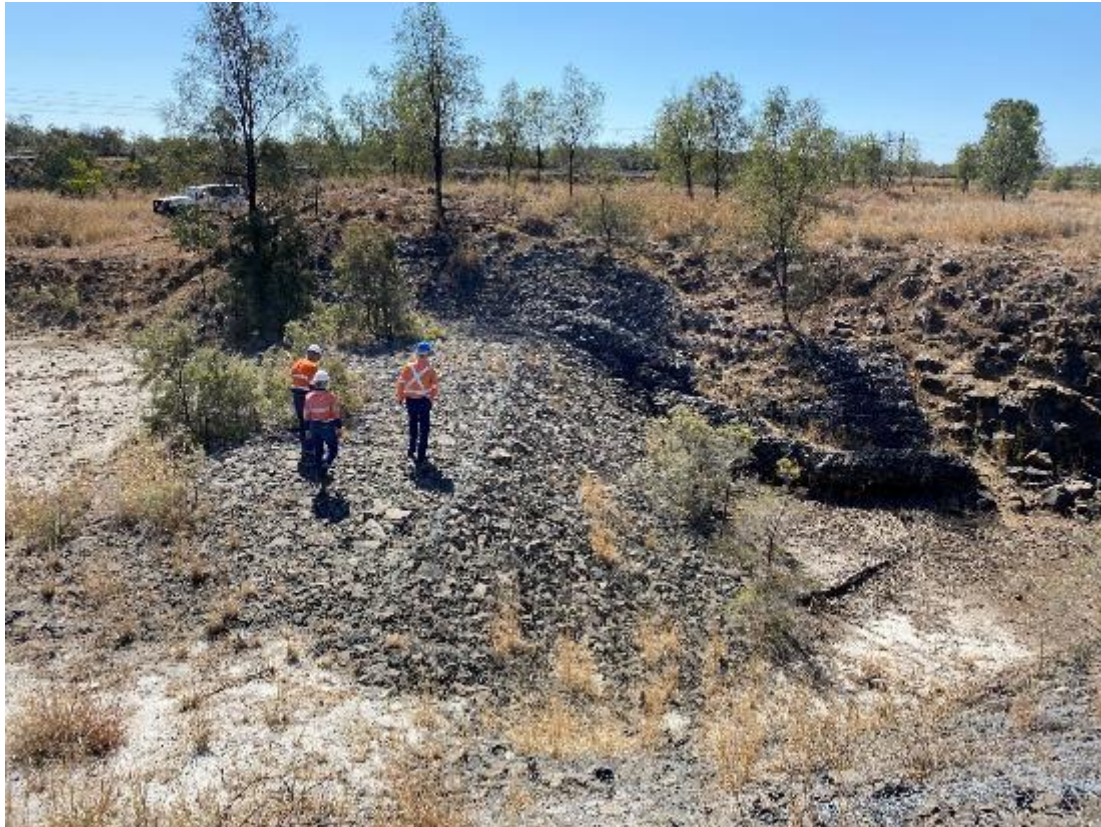
*Figure 4-7 - Scour and instability at the diversion bywash*

- The existing bywash is causing a hydraulic constraint and localised high velocity, shear stress and stream power. This is confirmed by field observations revealing scour of the gabion baskets, as shown in *Figure 4-7*;
- The culverts under the overland conveyor and access road is causing a hydraulic constraint, leading to backwater effects propagating up the majority of the diversion. This is exacerbated by the very low gradient on the diversion channel; and
- The diversion does not cater for 0.1% AEP flooding containment in two locations: immediately upstream of the culvert and adjacent to West Dam bywash.
