CLERMONT

GLENCORE

# Progressive Rehabilitation and Closure Plan (PRC Plan)

January 2023

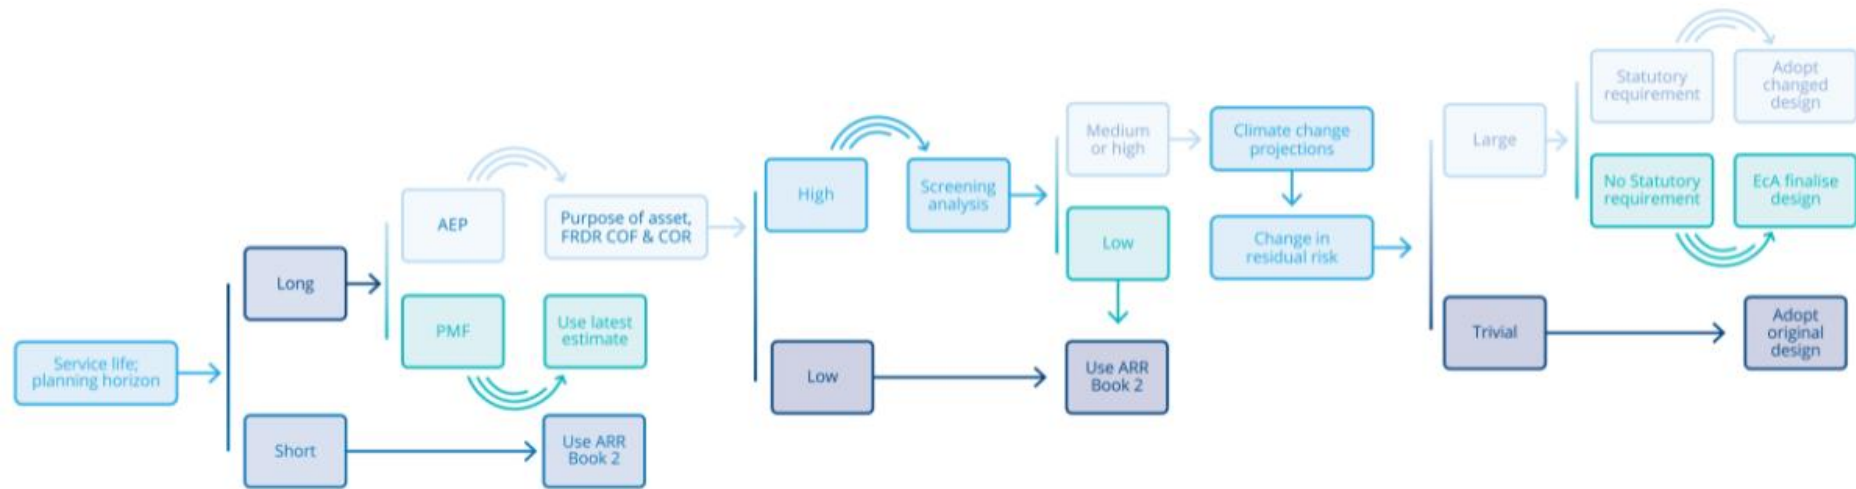
Figure 5-1 - AR&R 2019 climate change incorporation decision tree

A six-step process is used to incorporate climate change risks into decisions involving the estimation of design flood characteristics. The process uses a decision tree approach that enables the practitioner to define the nature of the information needed for a particular problem and to reach an appropriate course of action. The decision process is shown in *Figure 5-1*.

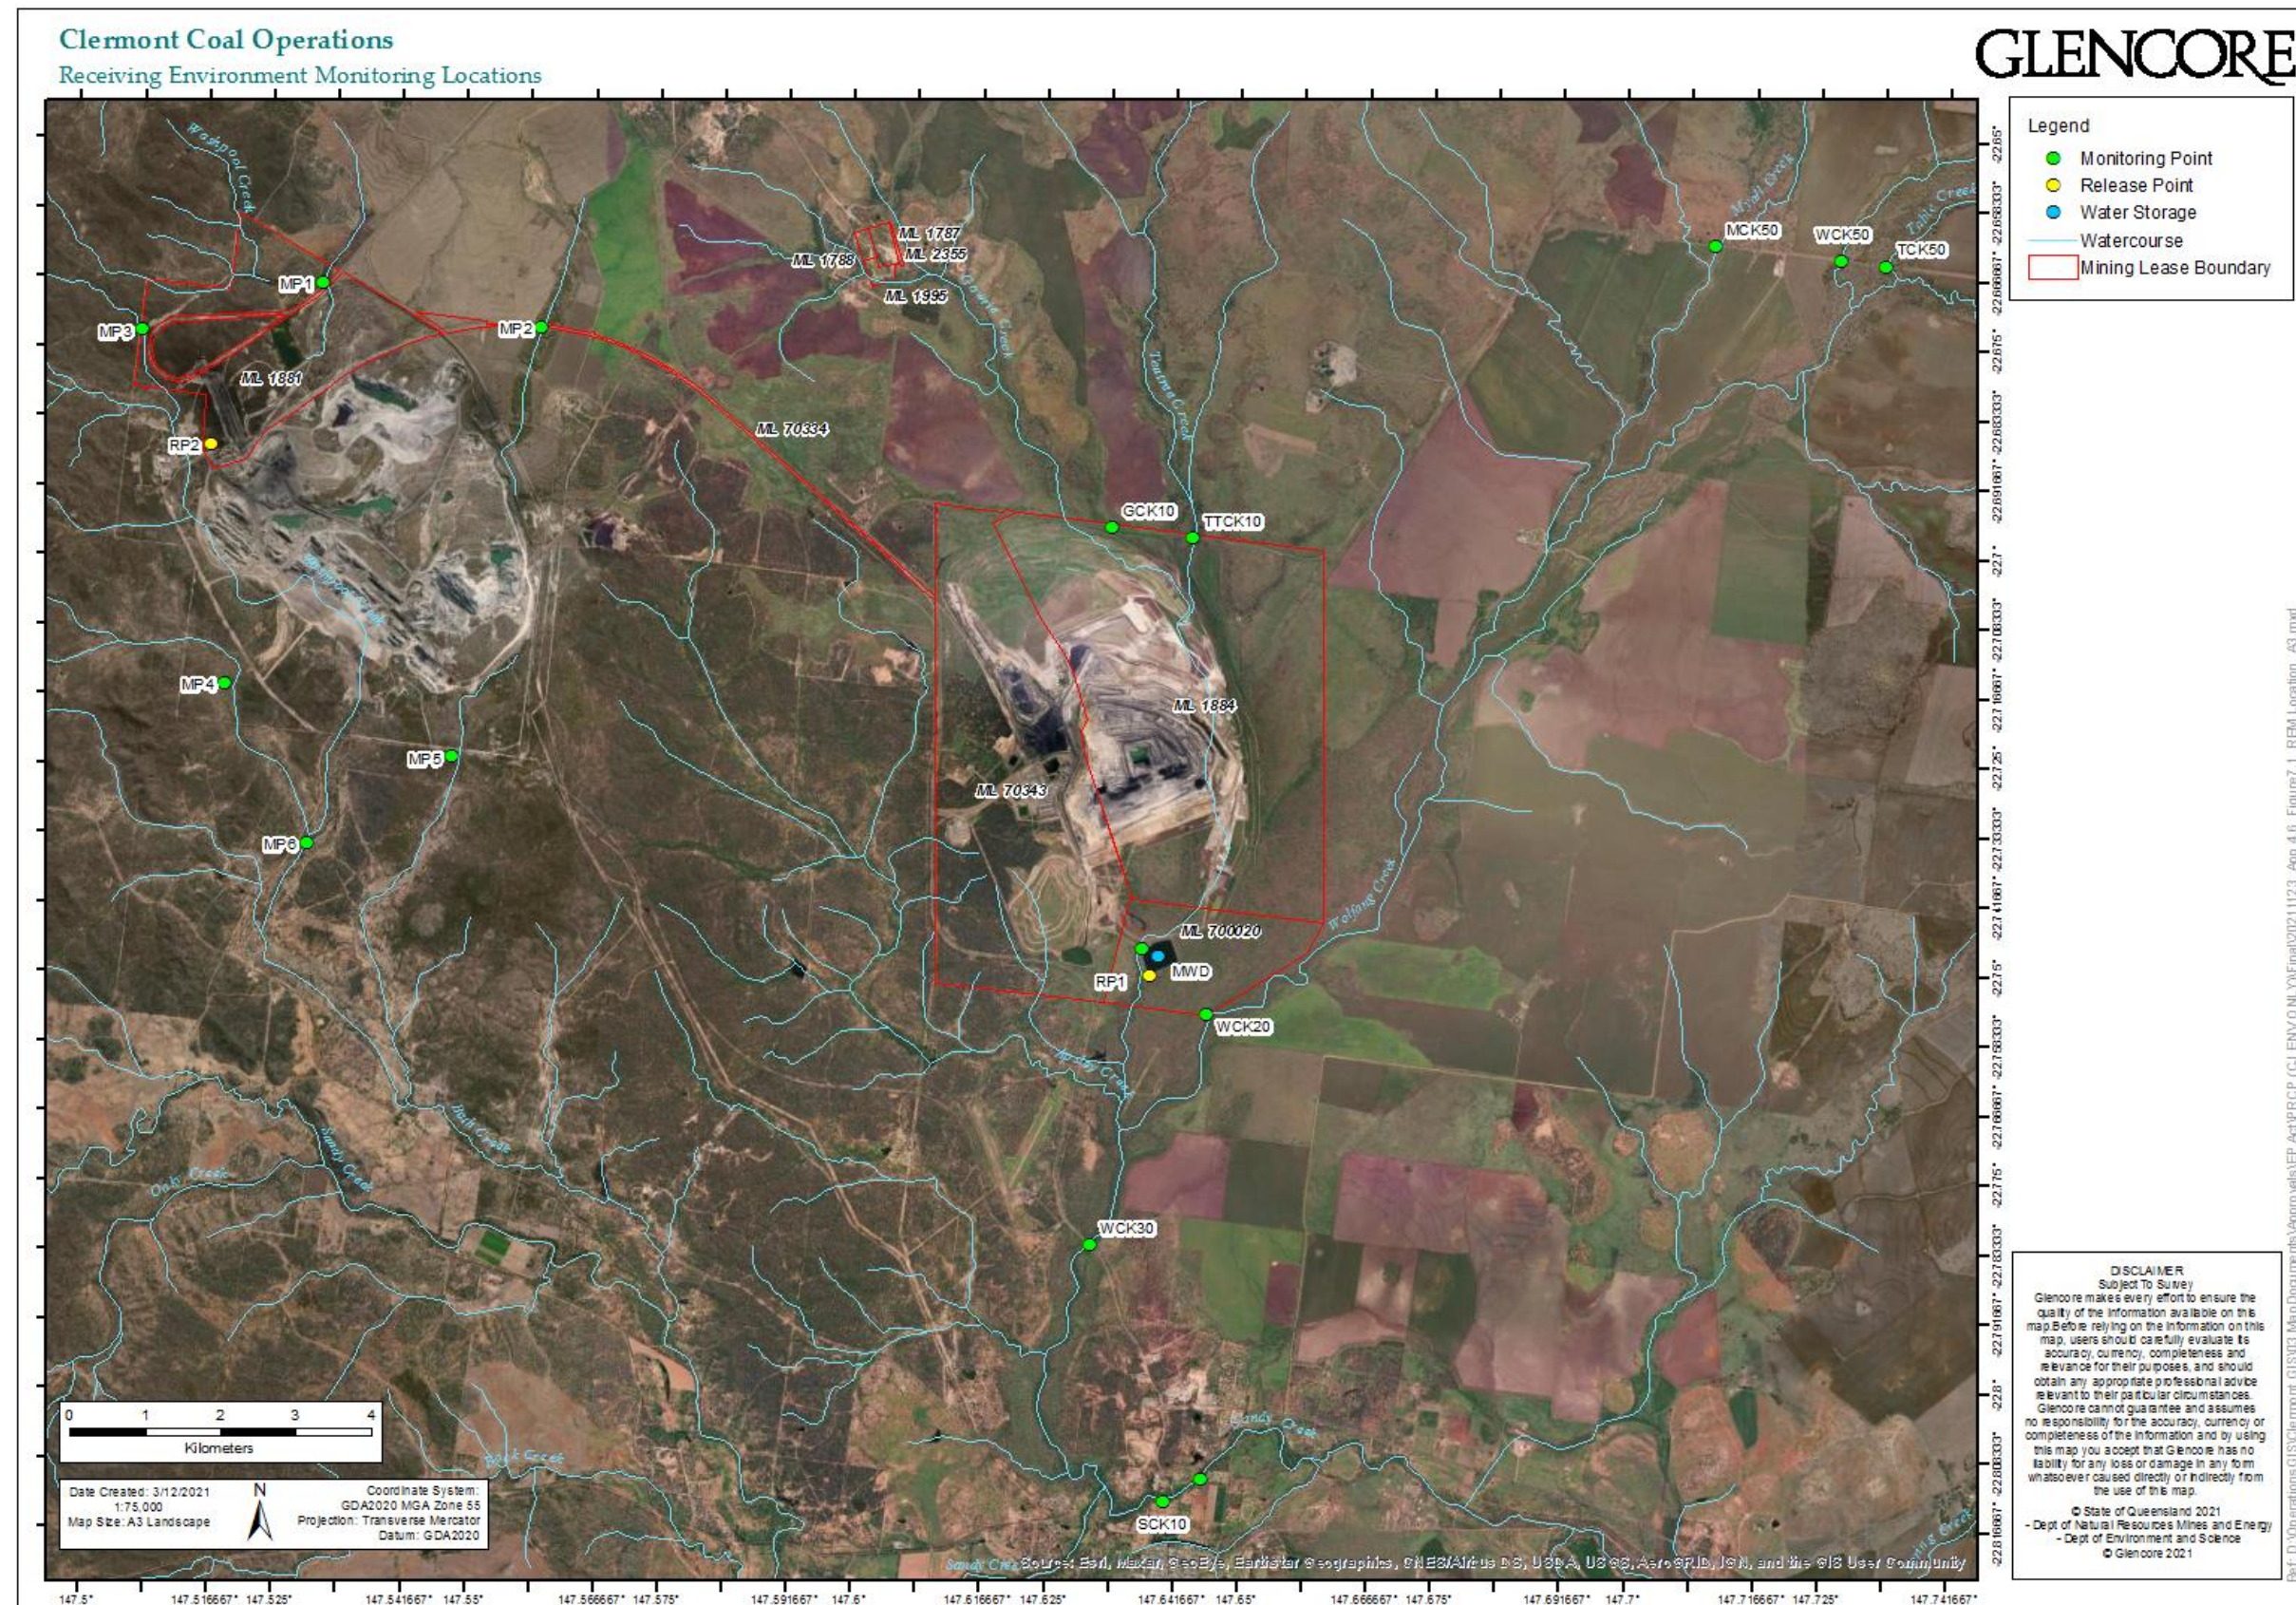
Figure 6-1 - Receiving environment monitoring locations

Water can be released from CCO to surrounding waterways (the receiving environment) in accordance with the conditions in Environmental Authority EPML006341131 (the EA), and from two authorised release points (RP1 and RP2, refer to **Figure 6-1**). The receiving environment for the purposes of the environmental values (EVs) and water quality objectives (WQOs) is the water of the Wolfgang Creek, Bath Creek and connected waterways within 15 km downstream of the release points (FRC, 2020).

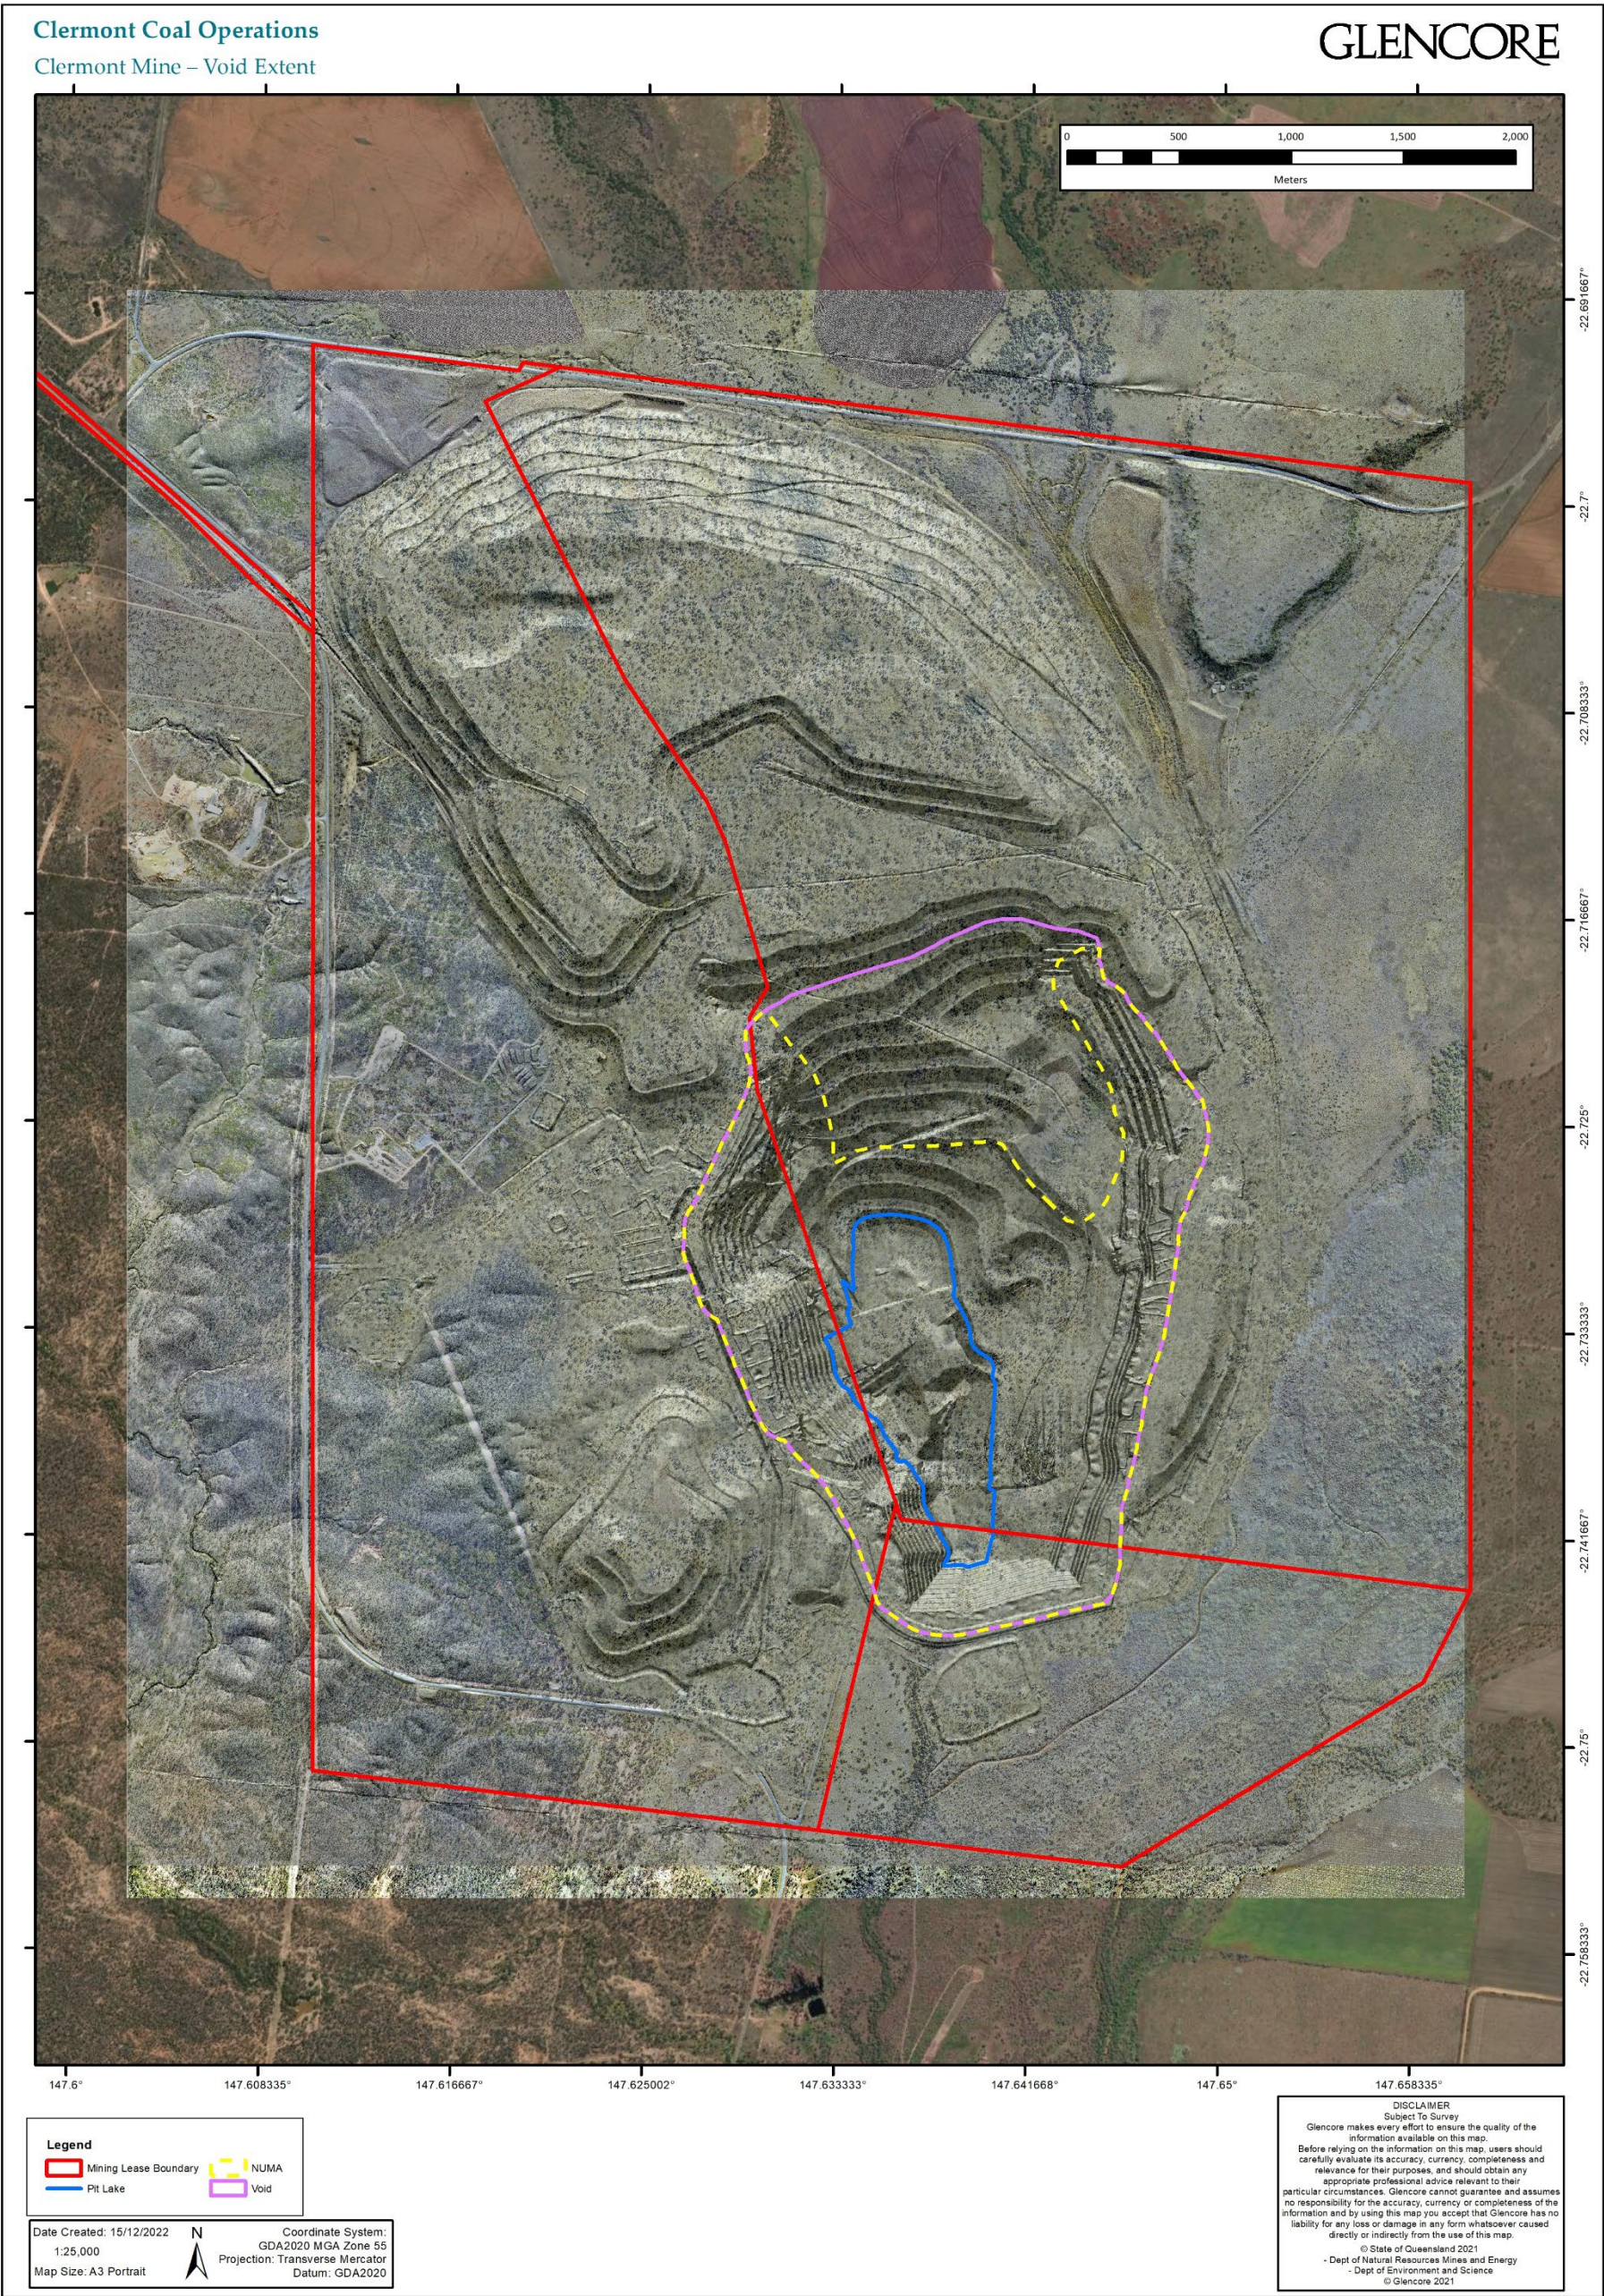
Figure 3-1 - Clermont void location and extent

The extent of the void has been minimised to the maximum extent possible within the constraints of the mine plan. A key focus for the landform design was to maximise the usable area at natural surface, and this has resulted in a substantial shift of the northern extent of the void to the south.

The LODs identify that the void will have no use (NUMA), GCAA have committed to an extensive rehabilitation program within the void, which will aim to minimise the extent of the no use area (NUMA). This involves re-contouring, topsoiling and seeding the entire low wall down to the pit floor.

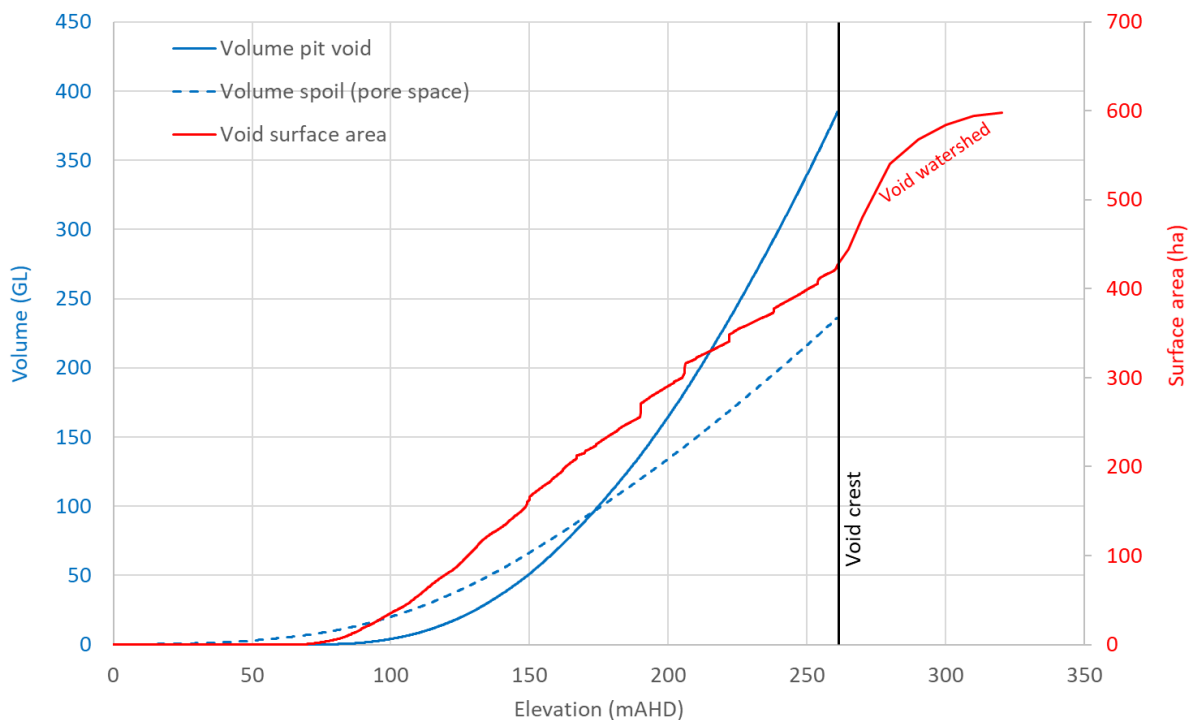
Figure 3-2 - Stage Storage relationship - Clermont void

The final void geometry determines the ponded surface area and volume of water at different water levels. The geometry affects evaporation, incident rainfall and surface water inflow and therefore the steady state water level that will eventually occur in the final void is determined predominately by the geometry.

The stage-storage curve (i.e. relationship between water level and volume and water level and surface area) of the rehabilitated void design is presented in **Figure 3-2**.

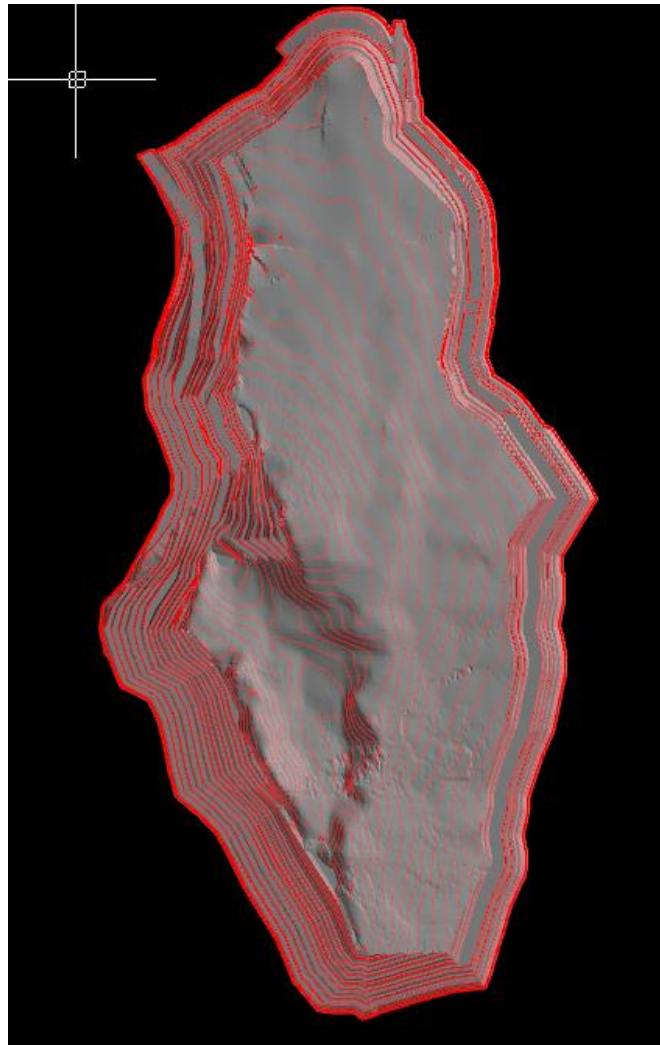
*Figure 3-3 - Pit shell (i.e. mined extent excluding in pit spoil)*

Given that the coal deposit has a dipping floor, a considerable volume of backfill exists below the final pit floor. The pit floor (excluding spoil) is shown in **Figure 3-3**. This will have an important influence on the water level recovery immediately following mining, as water will initially accumulate in the spoil rather than the final void. The spoil storage relationship has been estimated based on the pit shell (floor levels prior to backfill). The porosity was estimated using the site-derived swell factor of 16%, which is regularly tested and verified by site. The effective porosity at some other Glencore coal mines has been measured at less than 16%, as low as 6% at one site. In the event that the porosity is lower than expected at Clermont, this would increase the rate of water level rise in the final void, but would not alter the elevation of the predicted steady state water level.

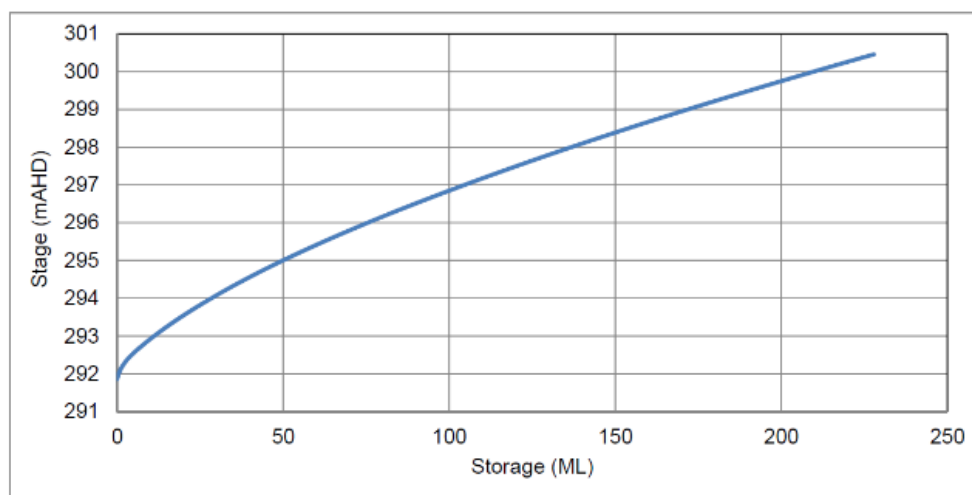
Figure 3-4 - Storage stage relationship – Cement Hill void

The void currently acts as a water storage feature, receiving inflows from surface water and groundwater. Surface water inflows originate from immediate runoff from the spoil reporting to the void and from periodic inflows during flow events in the adjacent drainage feature. The water level within the void varies based on climatic sequence however typically contains water. The inlet in the south western corner of the void controls the void maximum water level which is around 300.5 mAHD. At maximum water level, surface water runoff collected in the tributary which drains towards the inlet bypasses the void via the drainage feature to the south of the void (located between the two out of pit dumps). The ponded area of the void at full supply level (at the elevation of 300.5 mAHD) is around 4.7 ha and occupies a volume of approximately 228 ML. The stage-storage relationship is shown in **Figure 3-4**.

The void as shown in **Figure 3-4** covers an area of approximately 4.7 ha. The ground surface elevation at the top of the western wall sits at around 310 mAHD and the floor has an approximate elevation of around 291 mAHD. The northern, eastern and southern boundaries contain batter slopes with gradients ranging from around 35% in the north and south to around 50-55% along the eastern batter.

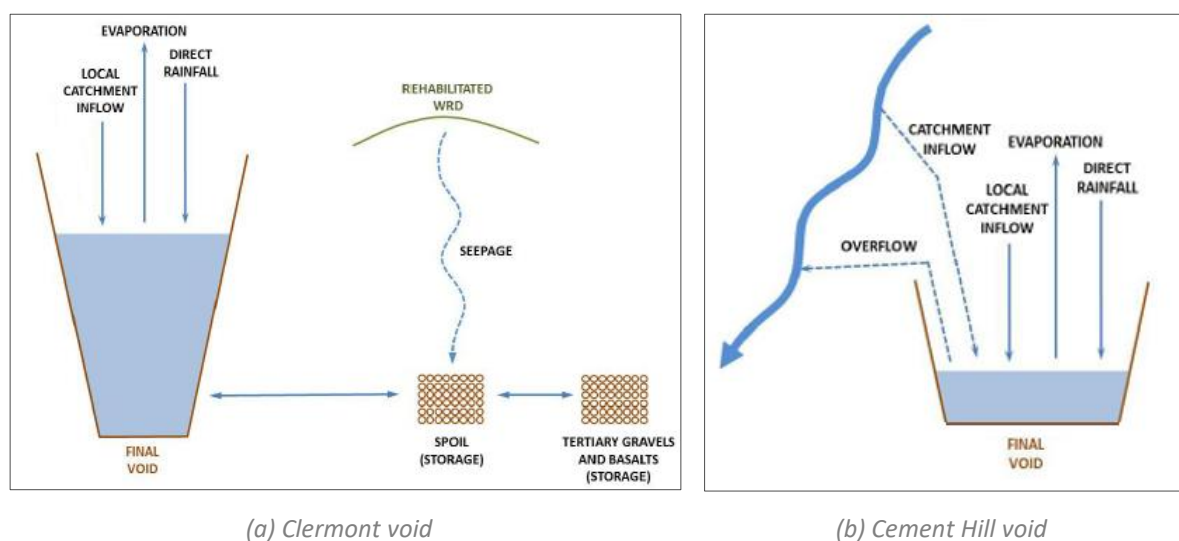
Figure 6-1 - Hydrological Conceptual Model

- Inflows:
  - Local surface water catchments (pit wall, rehabilitated spoil);
  - External catchment inputs (Cement Hill only);
  - Seepage through rehabilitated spoil;
  - Direct rainfall; and
  - Groundwater inflows;
- Storage:
  - Void storage; and
  - Spoil storage;
- Outflows:
  - Evaporation;
  - Groundwater outflows; and
  - Overflows to external catchments.

The conceptual model for both voids is shown in **Figure 6-1**.

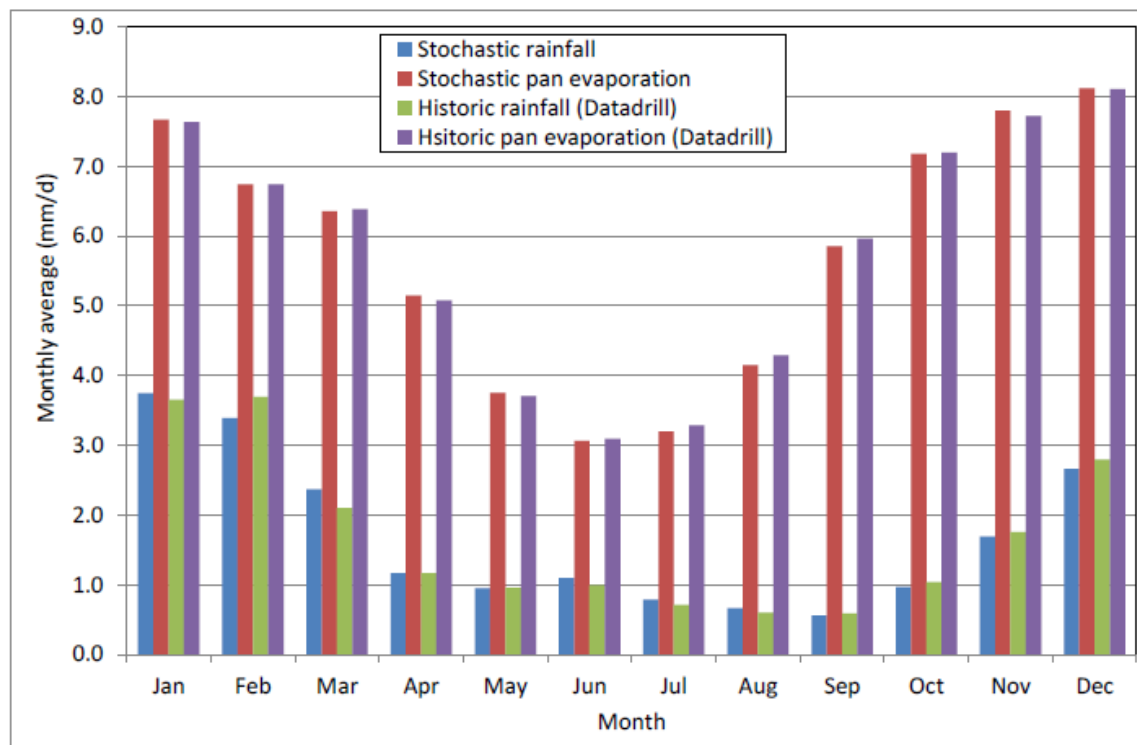
Figure 6-2 - Stochastic and Historic Data Comparison

**Figure 6-2** presents a comparison between the input historical data (Datadrill) and the output stochastic data from SCL. The results show a good comparison, with the resulting monthly averages of the datasets mostly within 0.1 mm of each other.

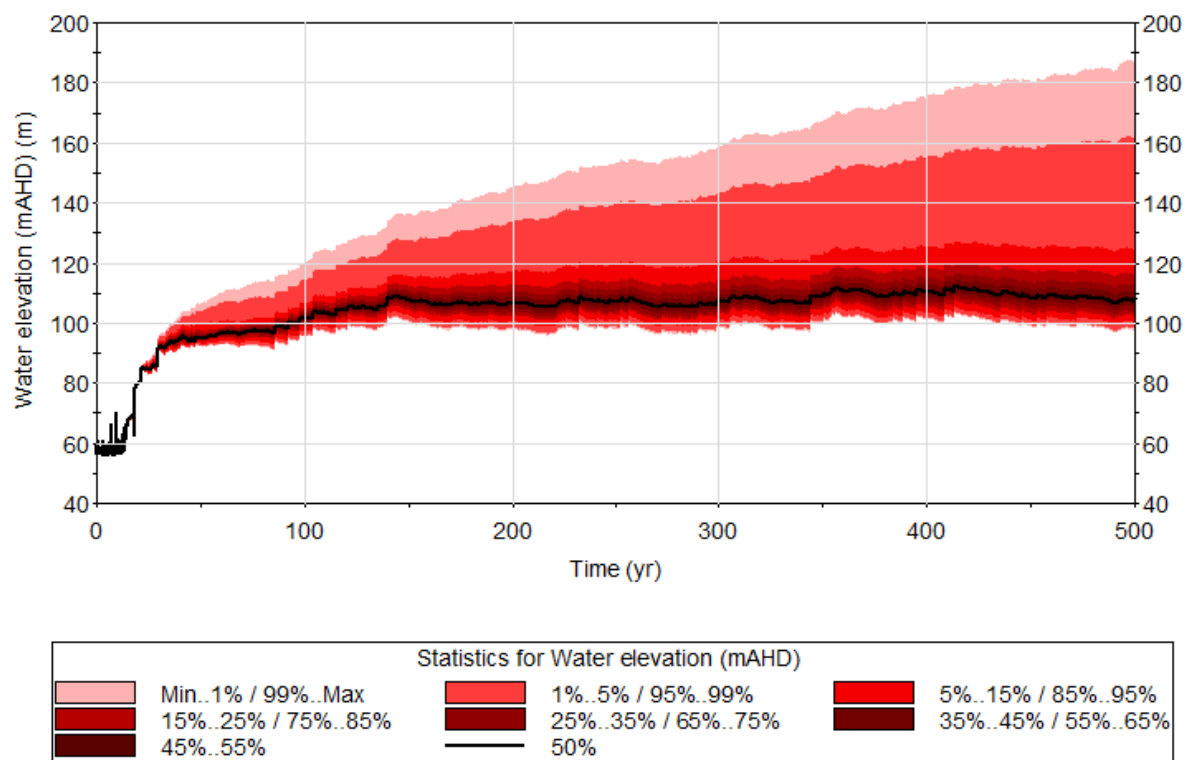
Figure 6-3 - Predicted final void level

The Clermont void model predicts that eventually (over many years) the water level in the pit void will reach a quasi-steady state condition as shown in **Figure 6-3**. This occurs when the inflows from rainfall, run-off and groundwater balance the outflows, mainly evaporation. As these fluxes are climate dependent, there will be some small variability in water level each year.

The lake will result in a depth of approximately 40-50 m. Once steady state is achieved, the water level typically varies around 2.5 m in elevation as a result of climatic variation.

Another important observation is that the formation of a pit lake is not expected to form until around 15-20 years post closure. The final void is not located in the lowest part of the pit shell and therefore water entering the final void can transfer through the permeable spoil and accumulate at the lowest point (in the spoil). A shallow lake (several metres deep) may form during the wet season due to blinding of the bed and sides of the final void by fine particles.

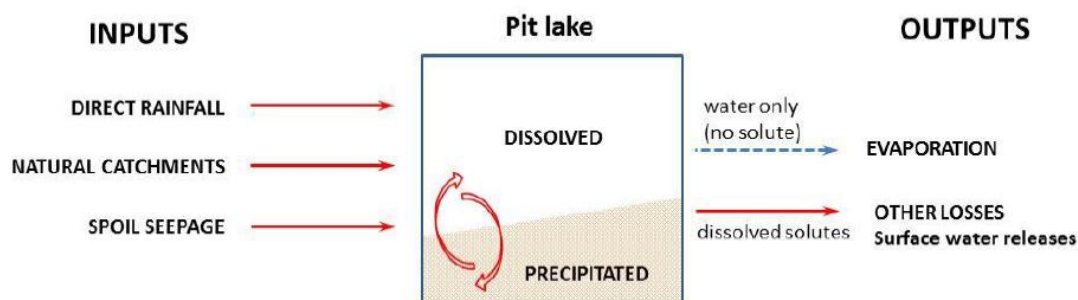
*Figure 7-1 - Geochemical Model Structure*

The geochemical model is built in the PHREEQC platform, a widely applied equilibrium geochemical model produced by USGS. The model considers speciation and assesses the saturation state of mineral phases within input waters. The structure of the model is shown in *Figure 7-1*.

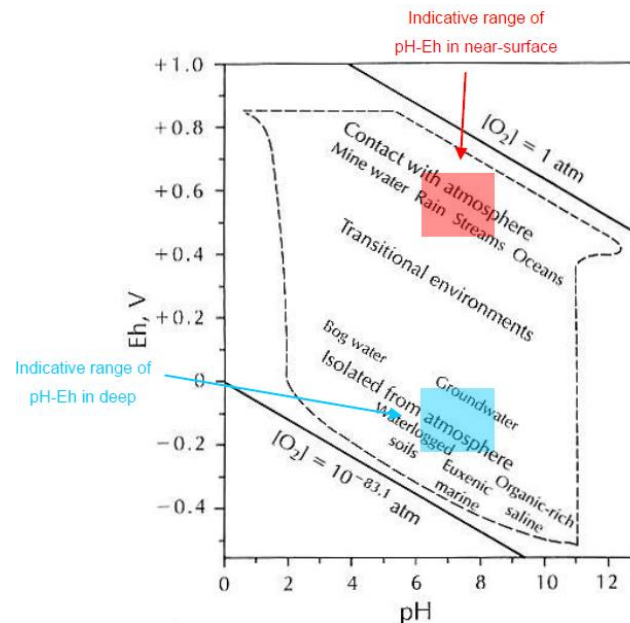
Figure 7-2 - Range of Eh-pH Conditions in Natural Environments

A range of redox conditions are anticipated within the pit lake. It is expected that near surface layers in contact with atmosphere would be relatively well mixed and remain oxygenated, primarily as a result of wind induced turbulence. The extent to which the oxygen is distributed vertically within the water column is dependent on whether stratification occurs, and the strength and duration of the stratification. Deeper layers are more likely to be oxygen depleted, especially during stratification events. **Figure 7-2** shows the relationship between pH and Eh for various environments.

Based on **Figure 7-2**, Eh is expected to lie in the range +400 to +600 mV within the near-surface horizons of the pit lake. Based on Manahan (2005)  $Eh \text{ (mV)} = 59.2pe$  (at 25°C), a pe range of +6.8 to +10.1 is expected. pe is the logarithm of electron concentration in a solution, as opposed to pH which is the logarithm of hydrogen ion concentration in a solution. pe is directly proportional to the redox potential.

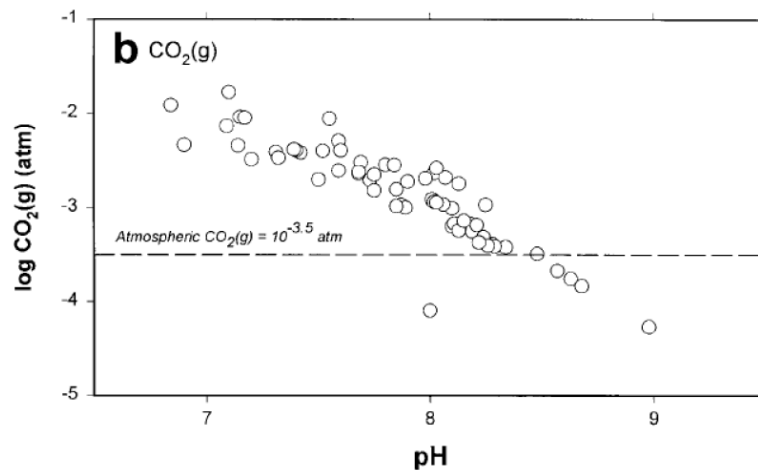
Figure 7-3 - Saturation Indices in Hard Rock Pit Lakes for Equilibrium Partial Pressures of CO<sub>2</sub> (Gas)

Carbon dioxide is an important gas in lakes. As carbon dioxide dissolves in water, it forms a series of compounds, including carbonic acid, bicarbonate, and carbonate that effect pH. The equilibrium condition that is established with CO<sub>2</sub> (gas) varies with temperature, biological activity and mixing processes. A review of various mine voids around the world was completed by Eary (1999) and the relationship between pH and carbon dioxide shown in **Figure 7-3** was derived. This indicates that the likely range of CO<sub>2</sub> (g) partial pressures varies from 10<sup>-2</sup> atm to 10<sup>-3.5</sup> atm (atmospheric carbon dioxide partial pressure). A sensitivity analysis was conducted over this range to assess the effect of this variable.

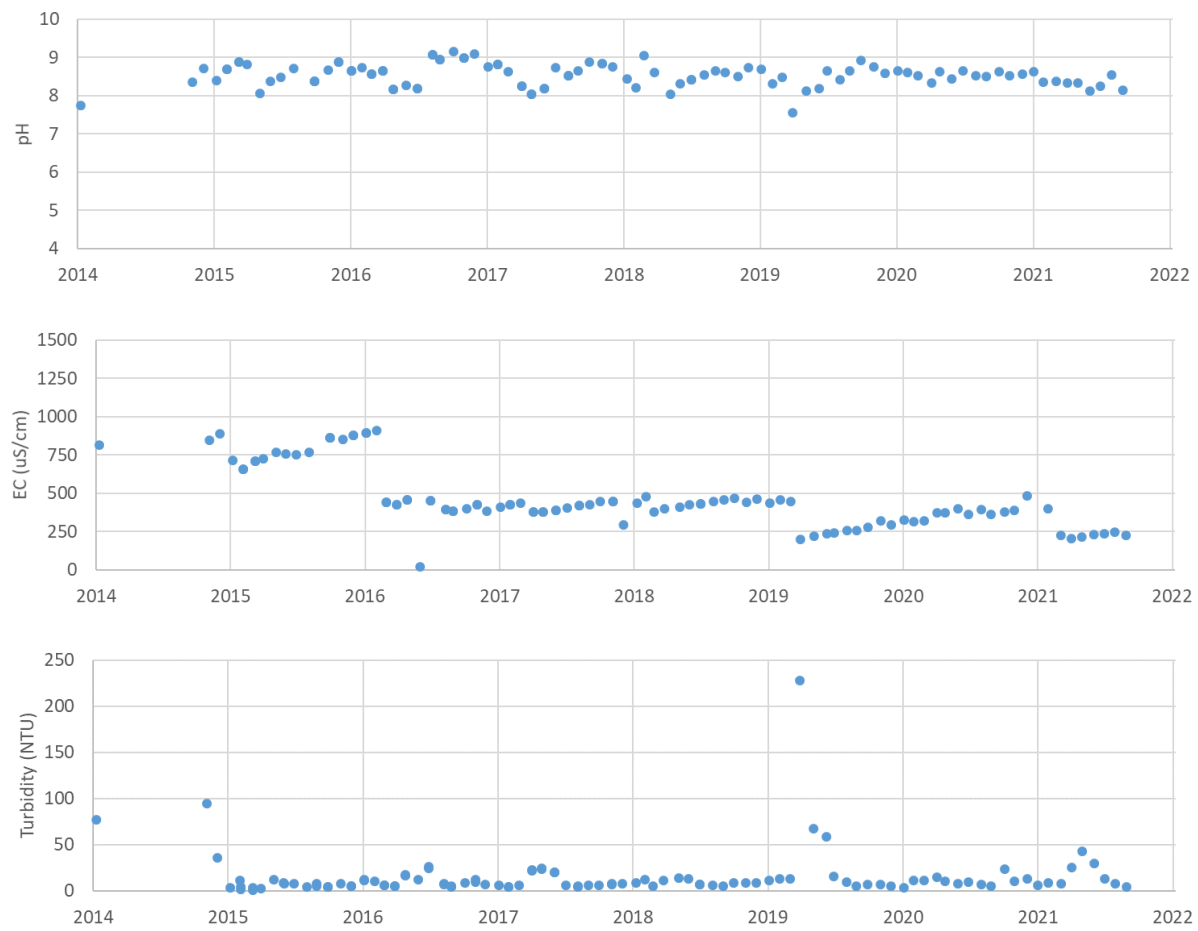
Figure 7-5 - Cement Hill void water quality observations

The long term physicochemical parameters are shown in **Figure 7-5**. This reveals a slightly alkaline pH ranging 8-9, low electrical conductivity indicating fresh water and low turbidity routinely less than 20 NTU. The EC trend shows the effect of some significant recharge events and interspersed with slow evapoconcentration. The periodic connection to the external drainage feature prevents any long term concentrating processes. The waterbody appears to function as any natural water storage would.

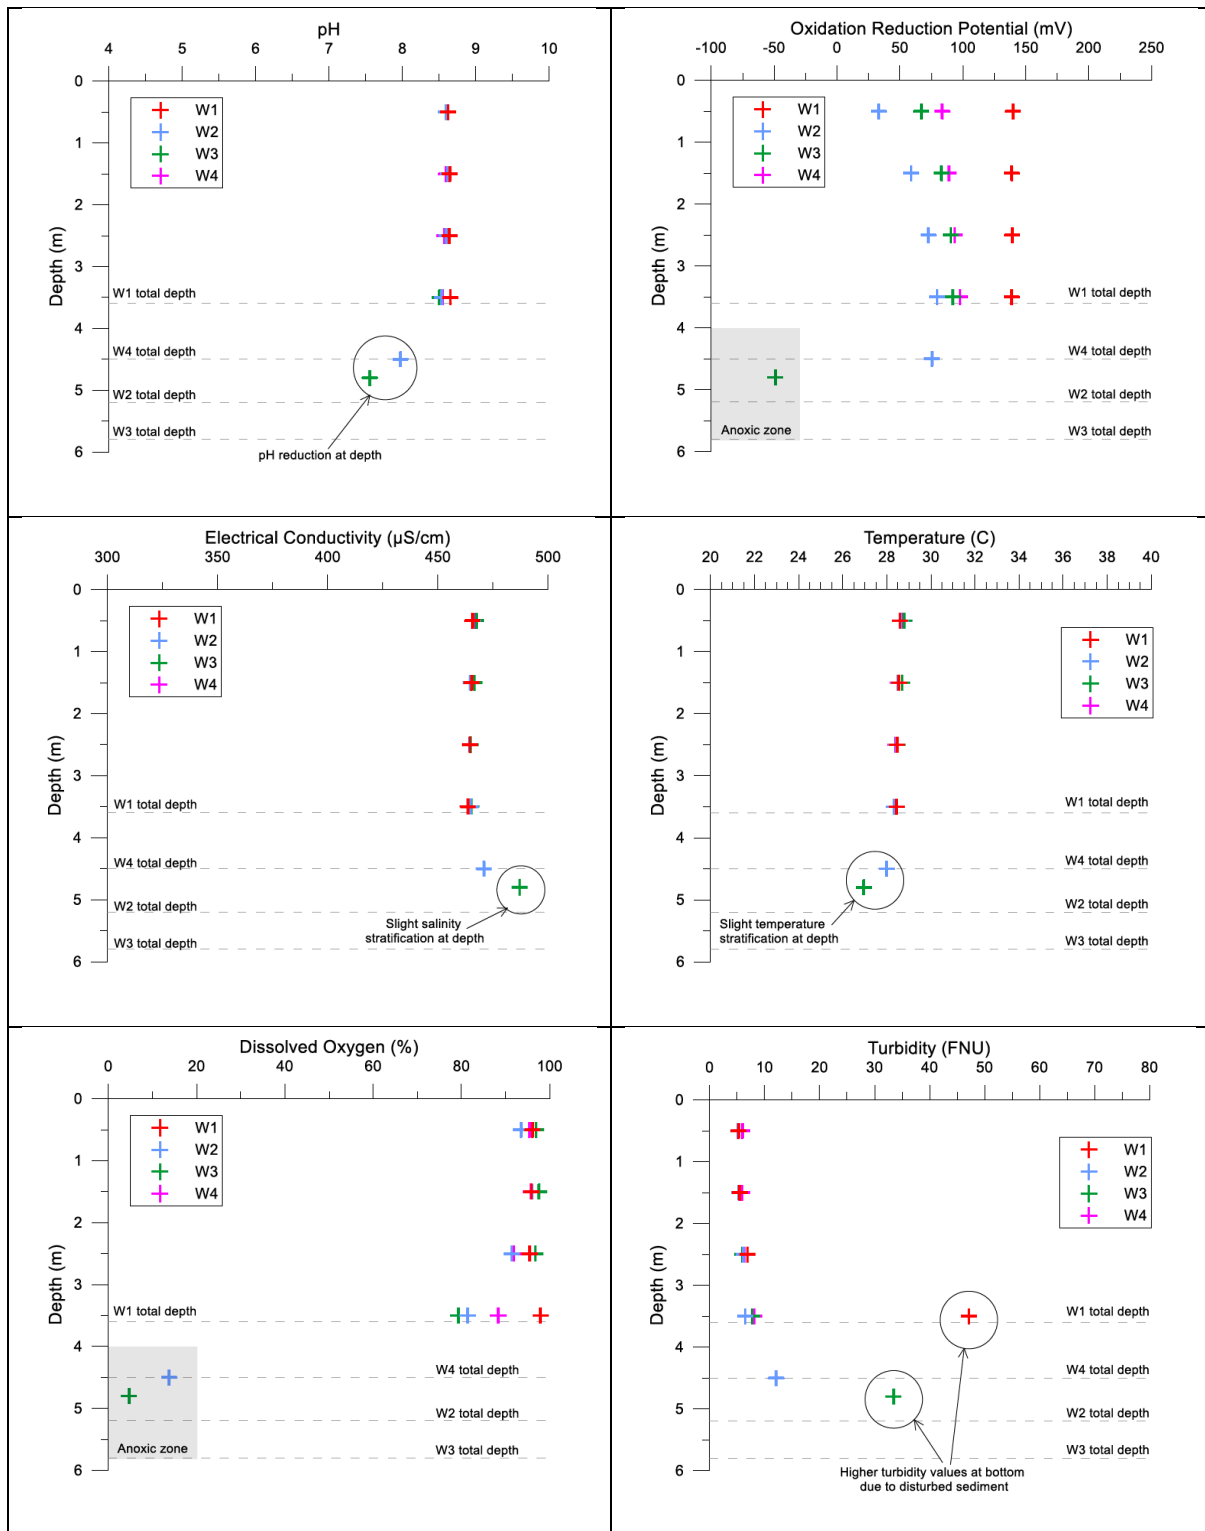
Figure 7-6 - Cement Hill void – depth profile (January 2019)

Depth profiling undertaken in summer of 2019 (*Figure 7-6*) shows a consistent water chemistry throughout the profile, with some mild stratification in the deeper parts of the waterbody. pH values are in the alkaline range throughout the water column (around pH 8.5), with lower pH values (pH 7.5-8.0) recorded at depth (from 4 m). ORP values were positive throughout much of the water column at all locations, with negative values (representing an anoxic zone) recorded in the deeper zone (at around 4.8 m depth) at one location only

Temperature was consistent throughout much of the water column (values around 28.5°C), with slightly lower temperatures (between 27 and 28°C) recorded in deeper sections of the void, representing a slight thermal stratification at depth

Turbidity values were low (<10 FNU) throughout much of the water column, with these values in the range generally acceptable for aquatic ecosystems. Higher values were recorded at depth which is likely a function of where the water quality instrument disturbed the fine sediment on the base of the void.
