CLERMONT

GLENCORE

# Progressive Rehabilitation and Closure Plan (PRC Plan)

January 2023

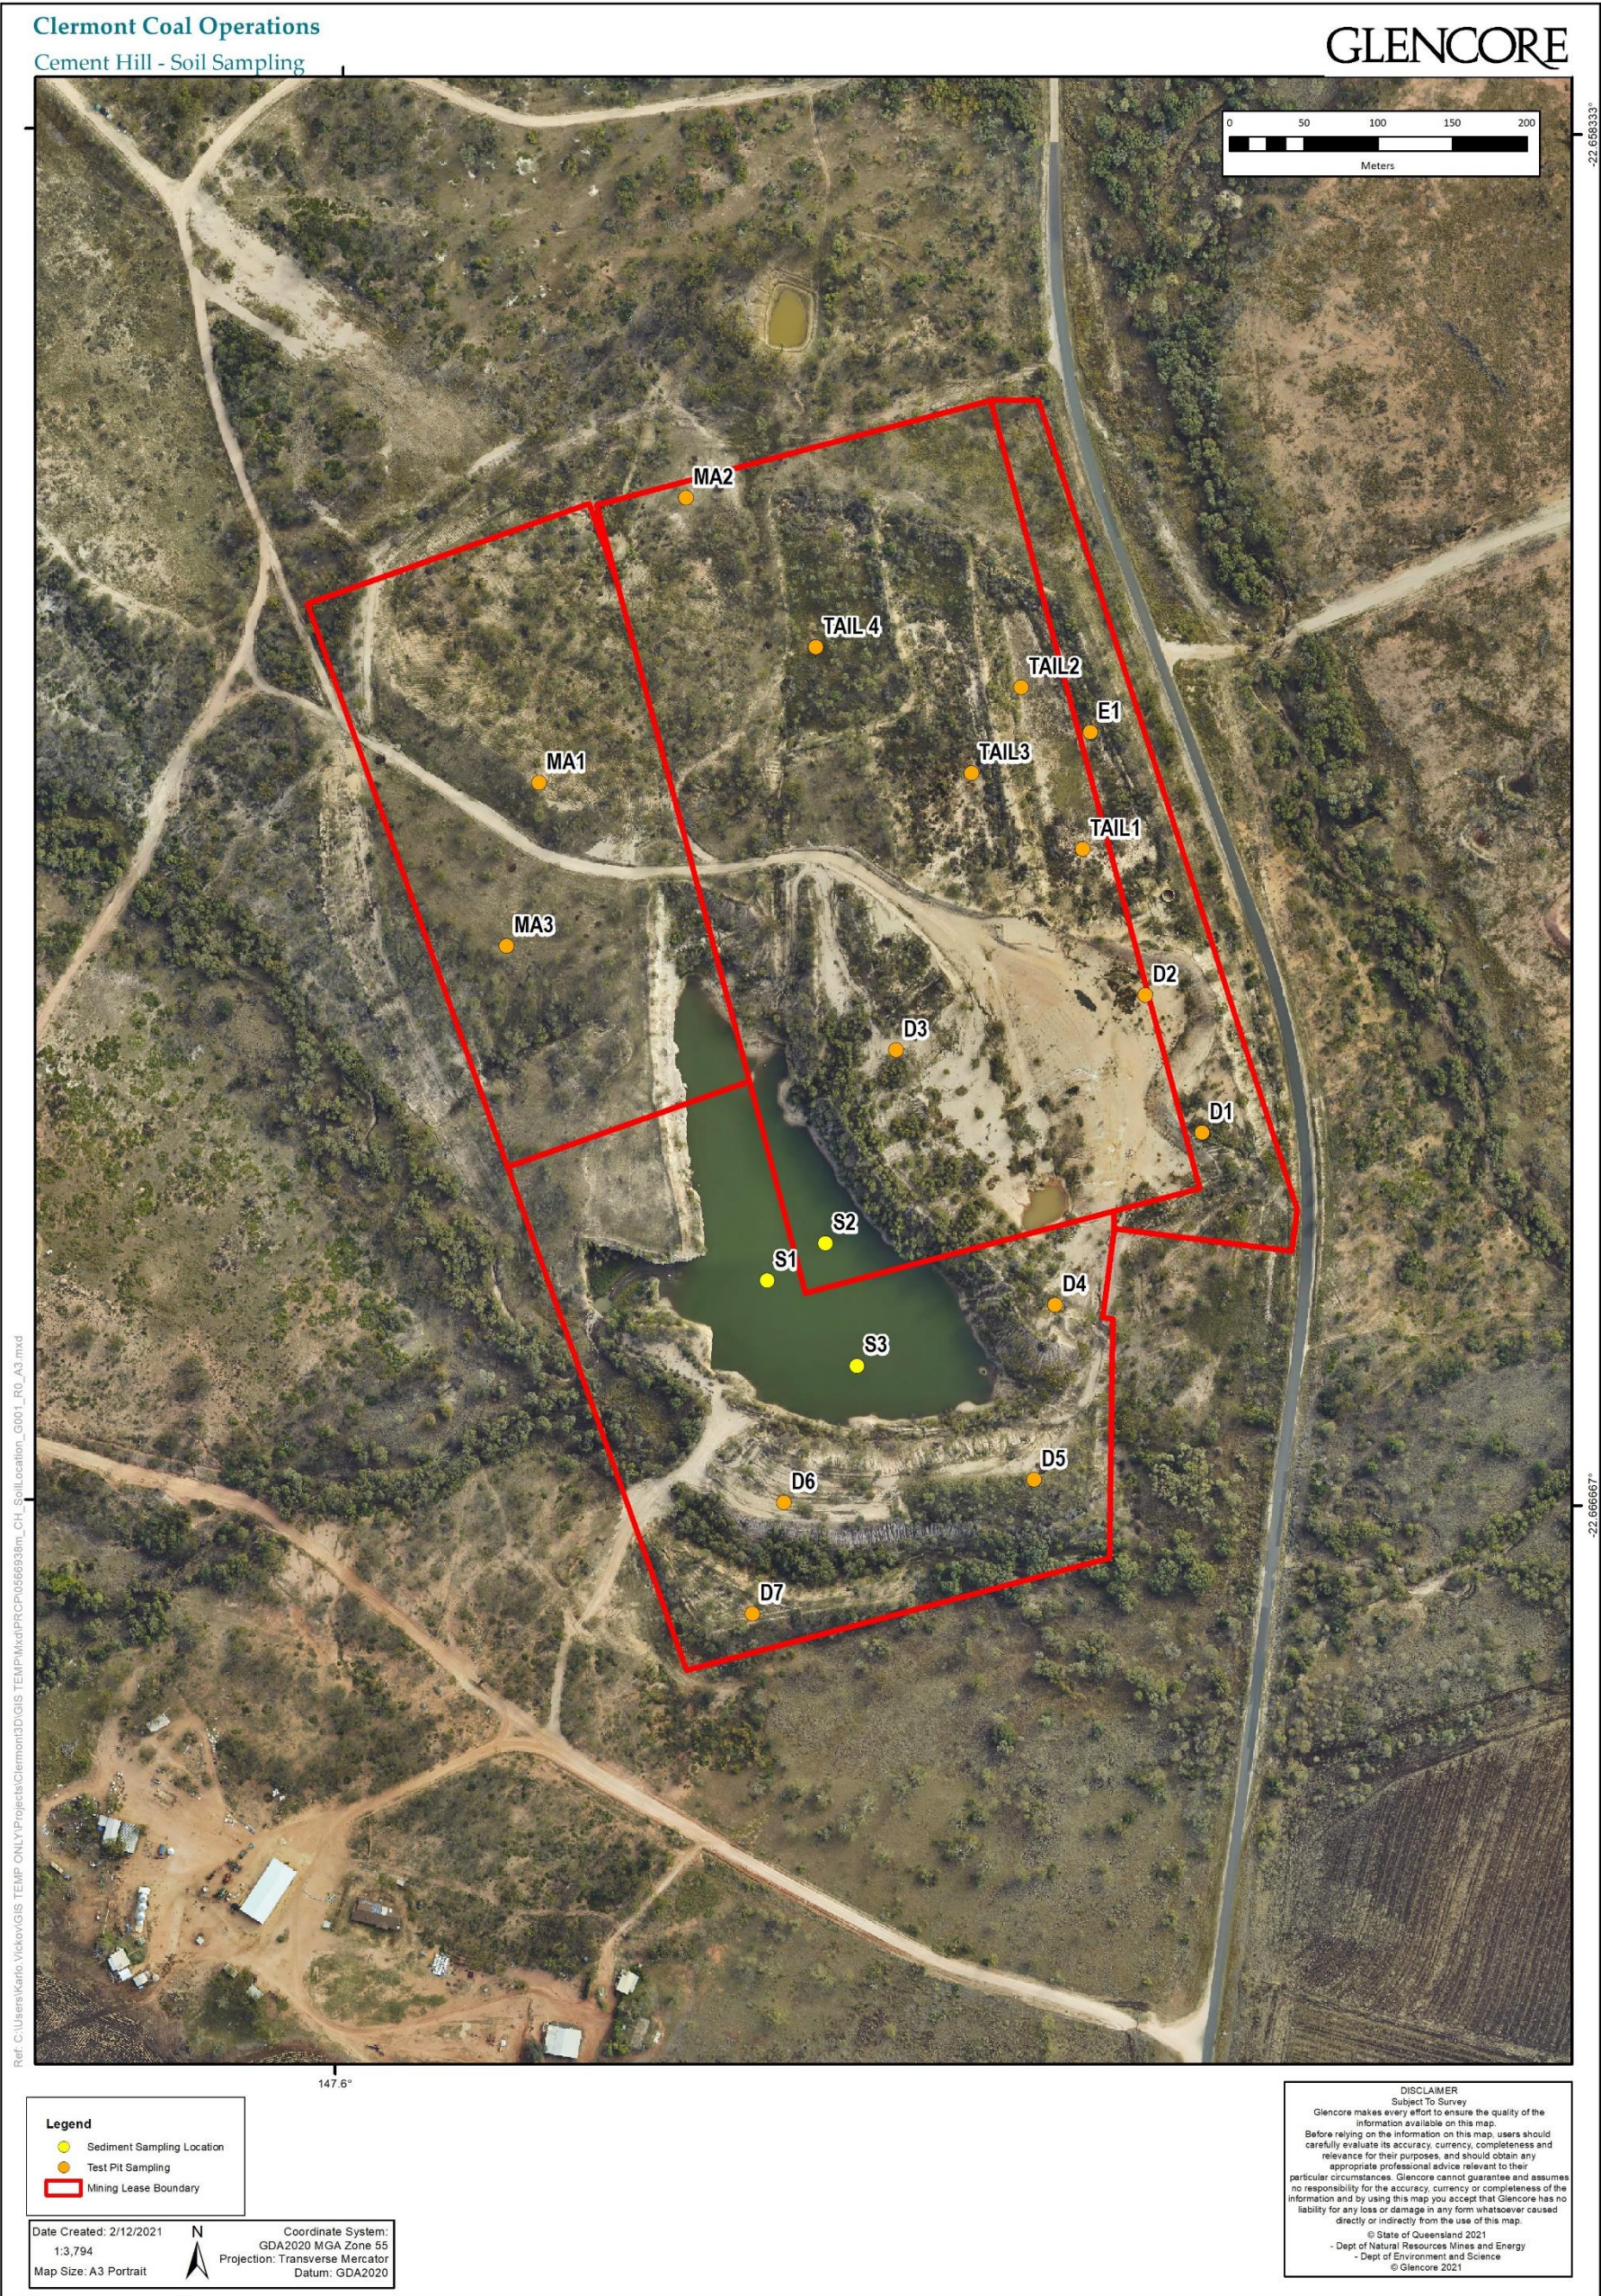
Figure 3-1 - Location of soil test pits

The TLO is located in a landscape which consists of gently sloping country derived from metamorphosed sedimentary rocks intersected by volcanic intrusions mostly to the north of the mining leases. Soil sampling in this area has generally been conducted as a component of CCO's rehabilitation monitoring, and so is viewed in the context of supporting vegetation. Highlands Environmental (2020) collected 63 samples from 31 sites across all the rehabilitation areas in TLO. Soil profiles were excavated by hand auger to a total depth of 90 cm or refusal on rock or gravel. Depending on excavation depth, soil samples were taken from up to five depth increments (0 to 10 cm, 20 to 30 cm, 40 to 50 cm, 60 to 70 cm and 80 to 90 cm depth).

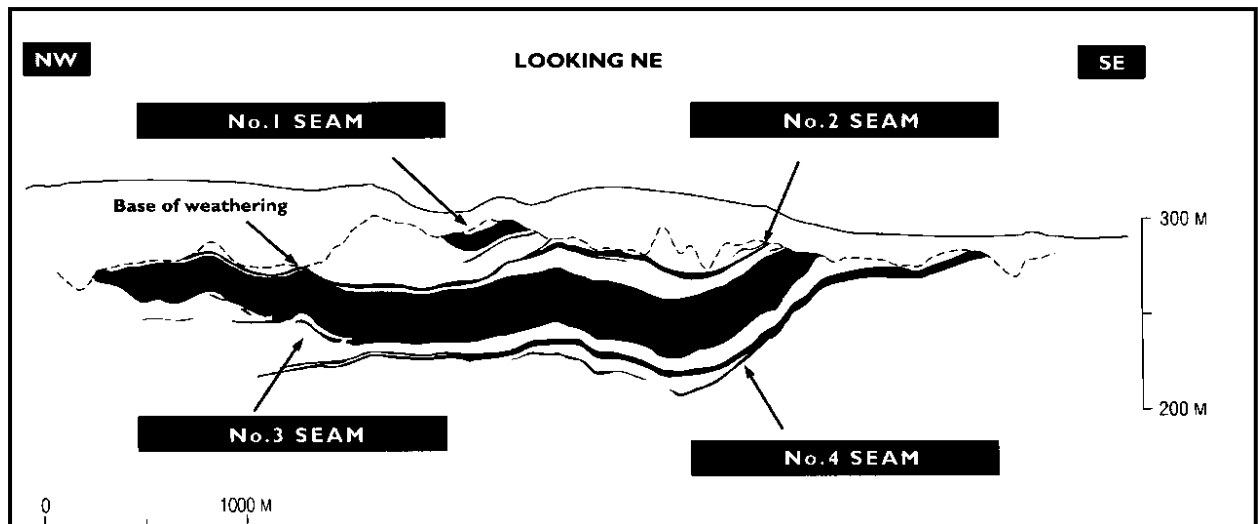
Figure 2-2 - Typical Stratigraphic Sequence at BA

At Blair Athol (BA) mine (where the TLO is located), the coal bearing sequence consists of sandstone, siltstone, mudstone, conglomerate and four significant coal seams (identified as Seams No. 1, 2, 3 and 4) (refer **Figure 2-2**). The sequence overlies a basement of Anakie Metamorphics and a basal conglomerate consisting of coarse sandstone and minor carbonaceous shales with stony coal seams.

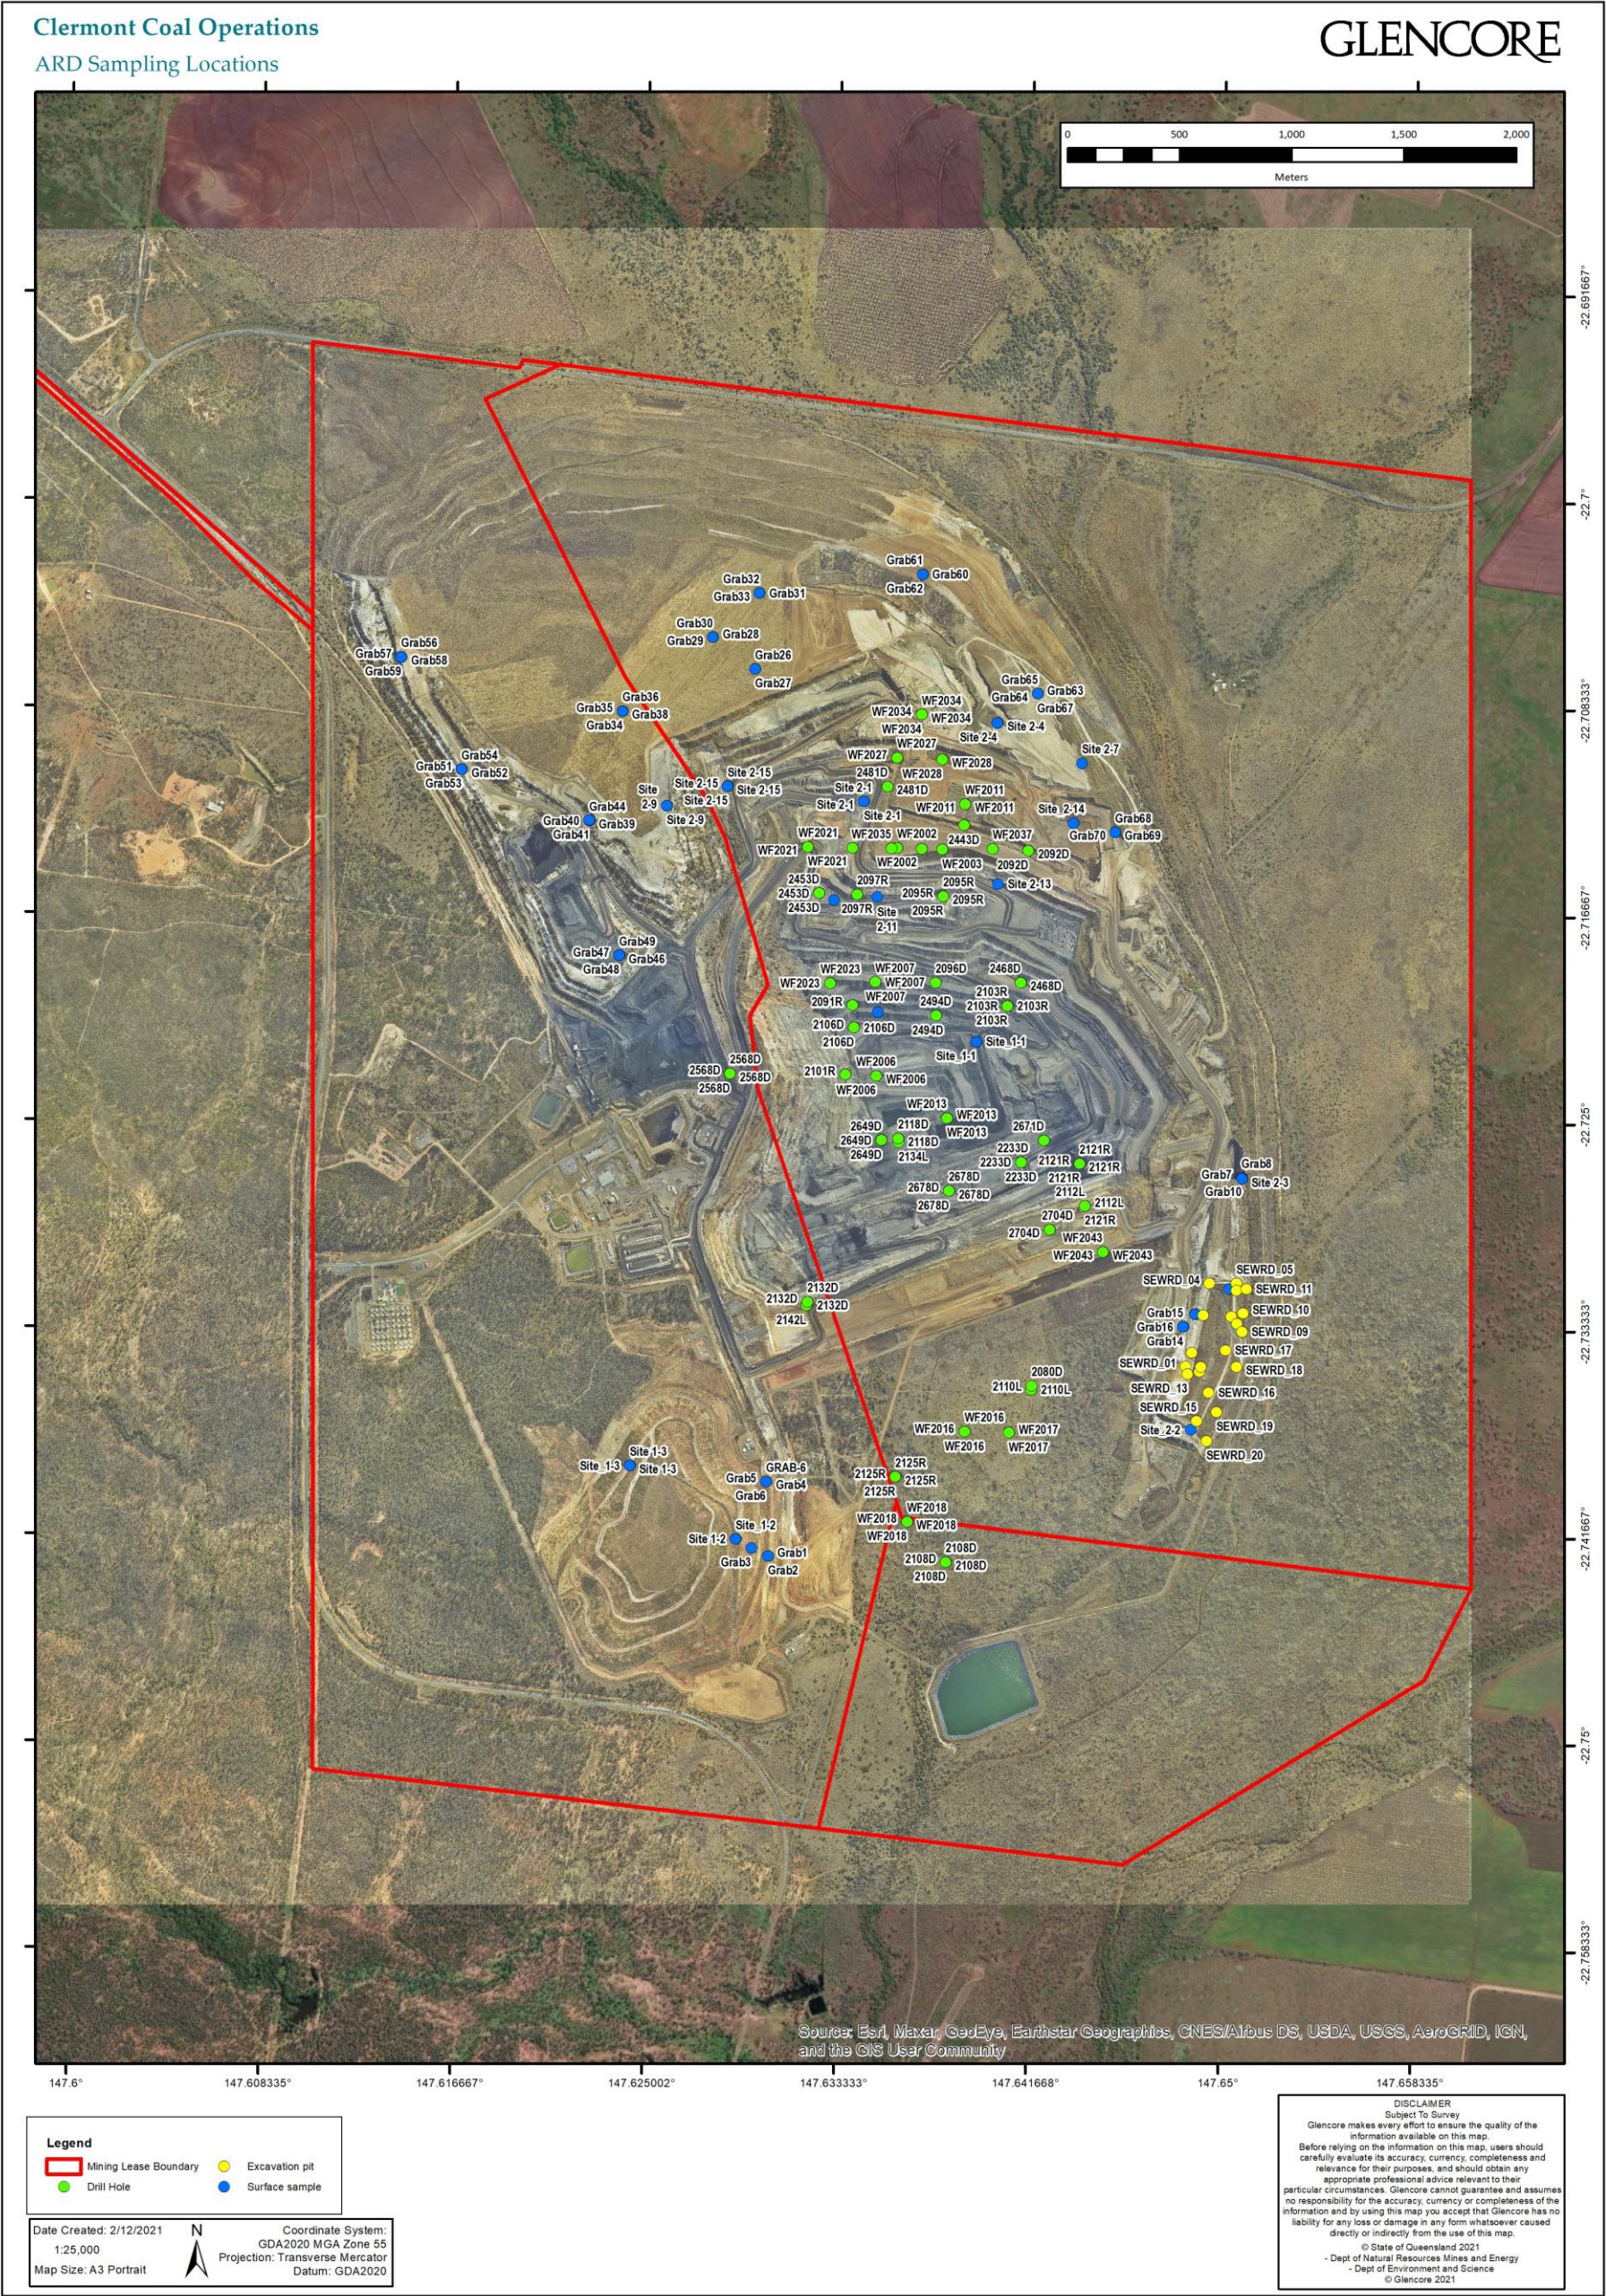
Figure 3-1 - Distribution of previous geochemistry samples at CM

Characterisation of mineral waste from the Blair Athol operation (the wider operation on which the TLO section of the lease sits) has been undertaken through various geochemical assessments over the life of the operation, and categorised in accordance with its acid mine drainage (AMD) potential, in line with the current classification for CCO. A range of overburden and interburden types were tested by Dames and Moore (1983), with further AMD analysis of waste material performed as part of exploration drilling as well as operational sampling campaigns between 2006 and 2016.

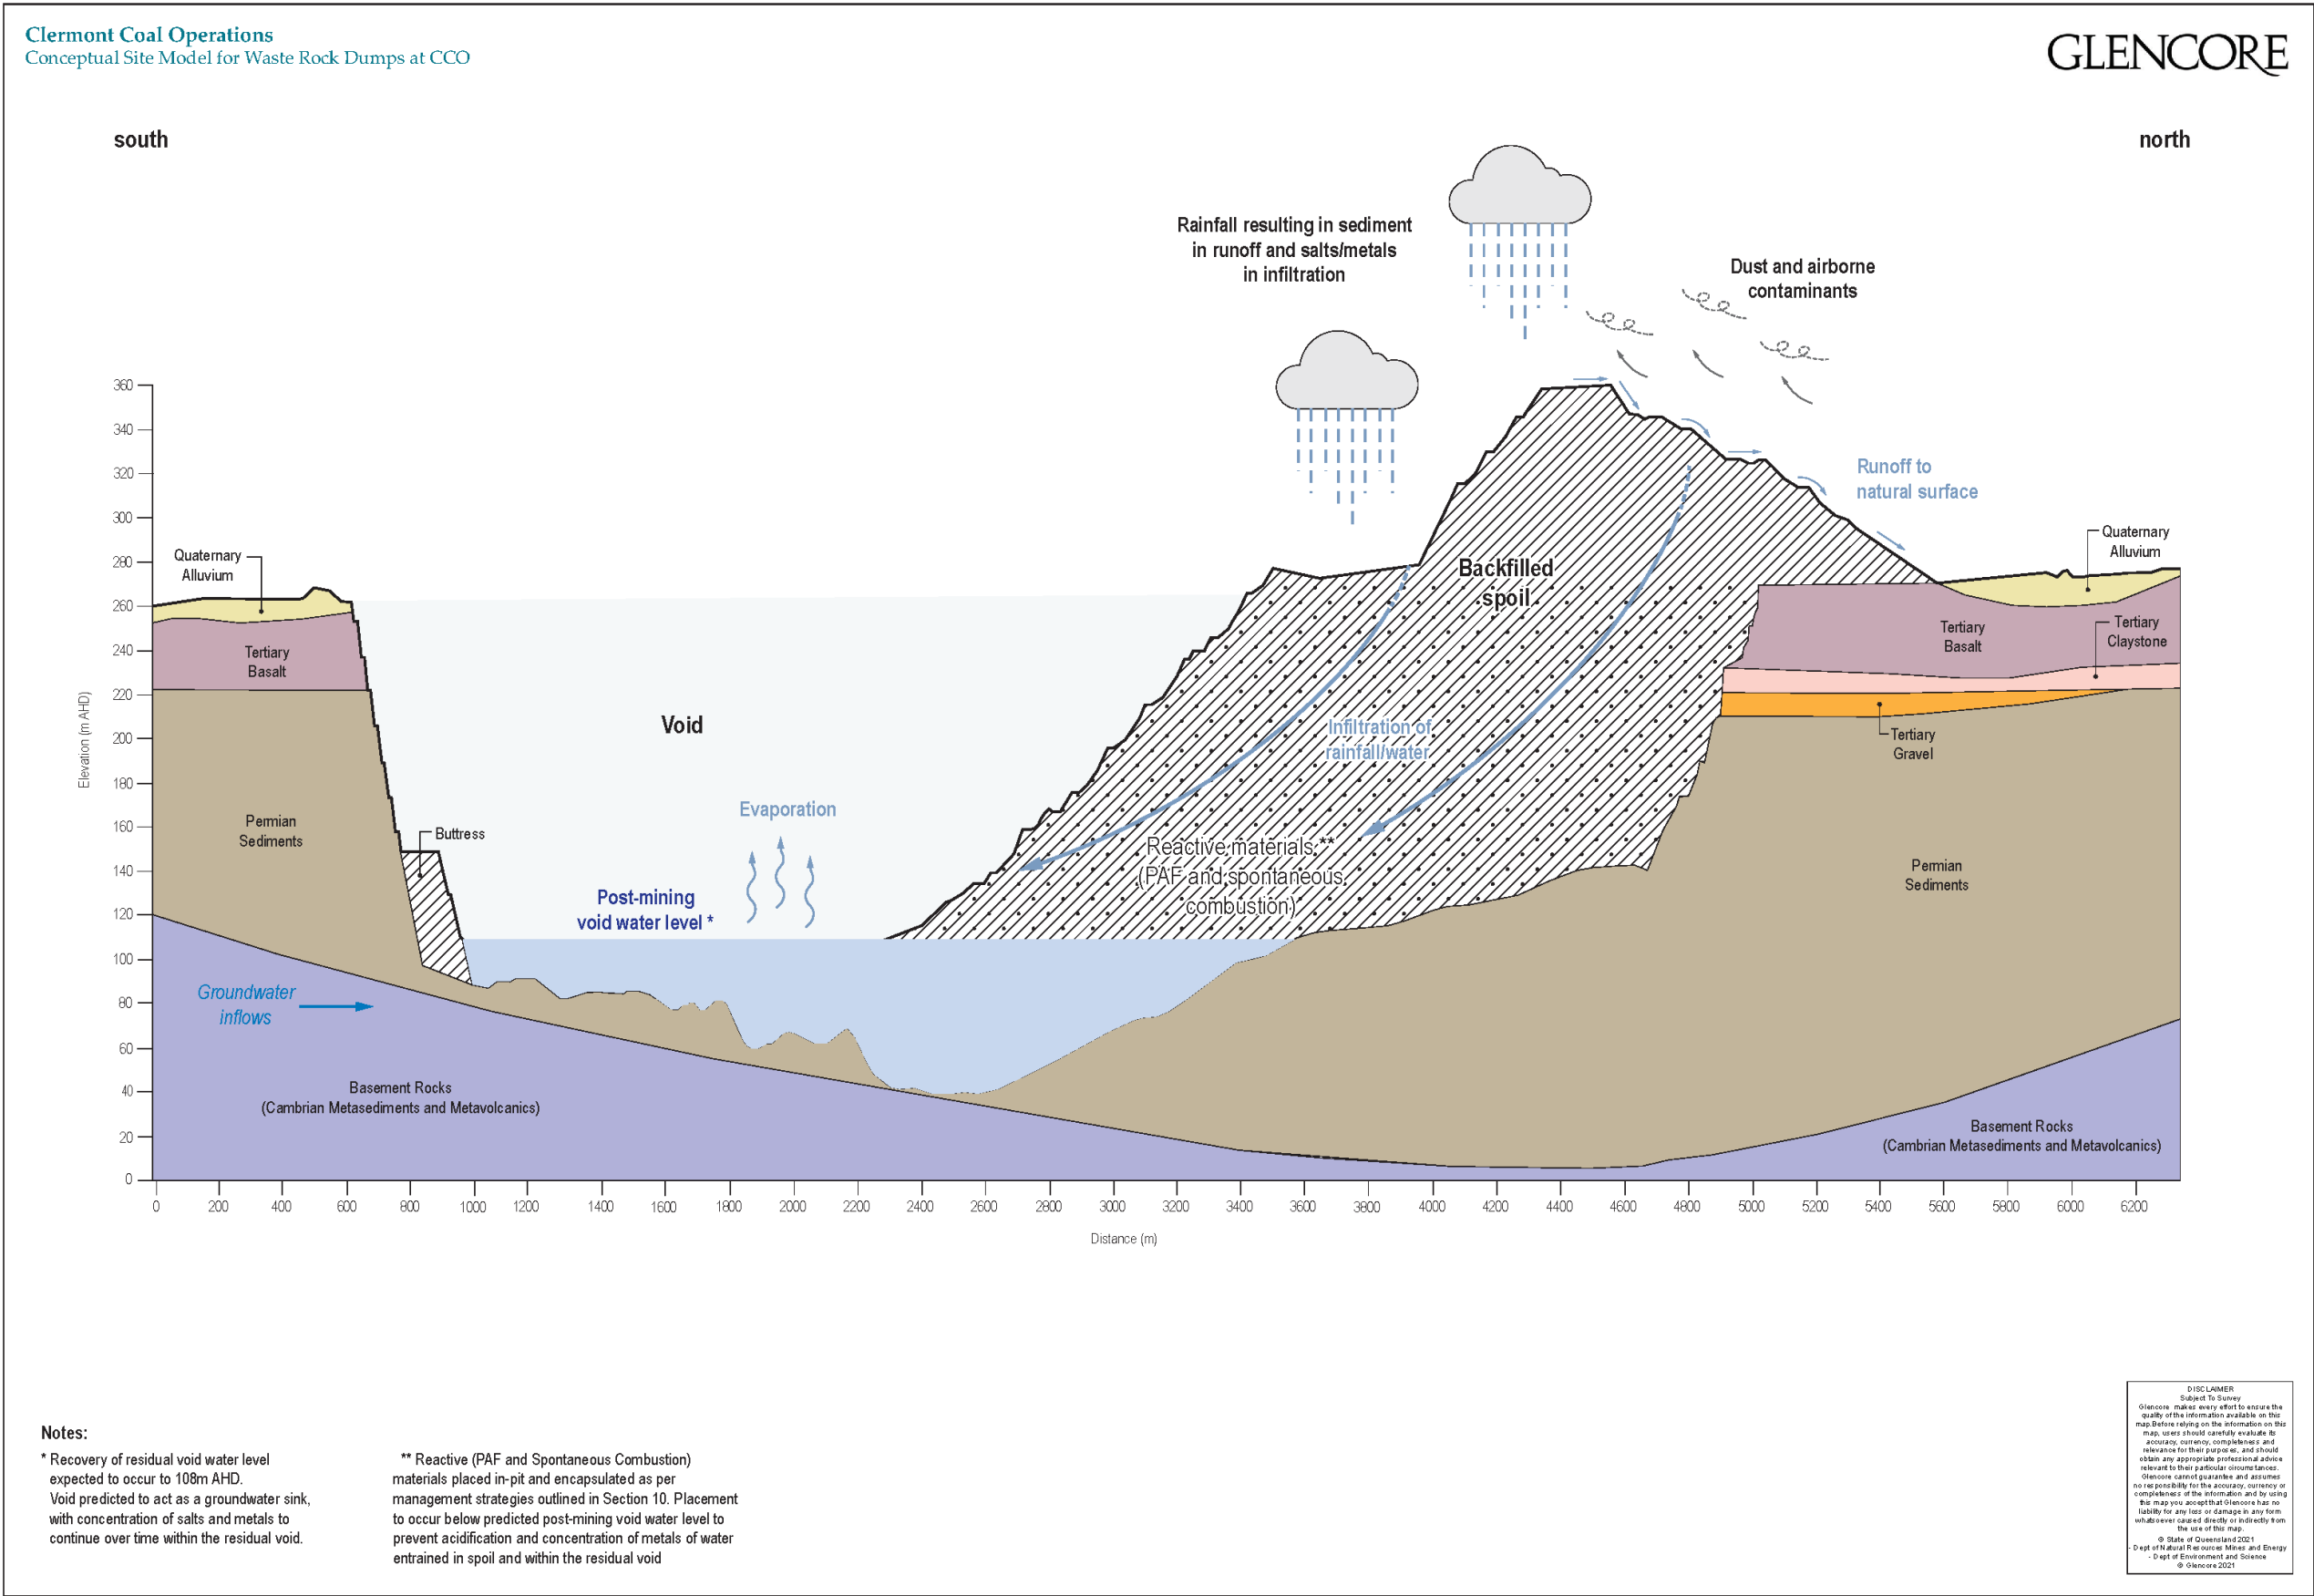
Figure 7-2 - Conceptual site model for waste rock dumps at CCO

The conceptual model provided below forms both a summary table (**Table 7-2**) and a schematic diagram to show key interactions between the WRD and surrounding environment. The summary table considers the source-pathway-receptor linkages and highlights key geochemical risks as well as management controls and interventions required. Further, the schematic (**Figure 9-2**) presents the boundary conditions, site topography and climate, the in situ distribution and location of reactive materials and illustrates key hydrological and hydrogeological pathways.

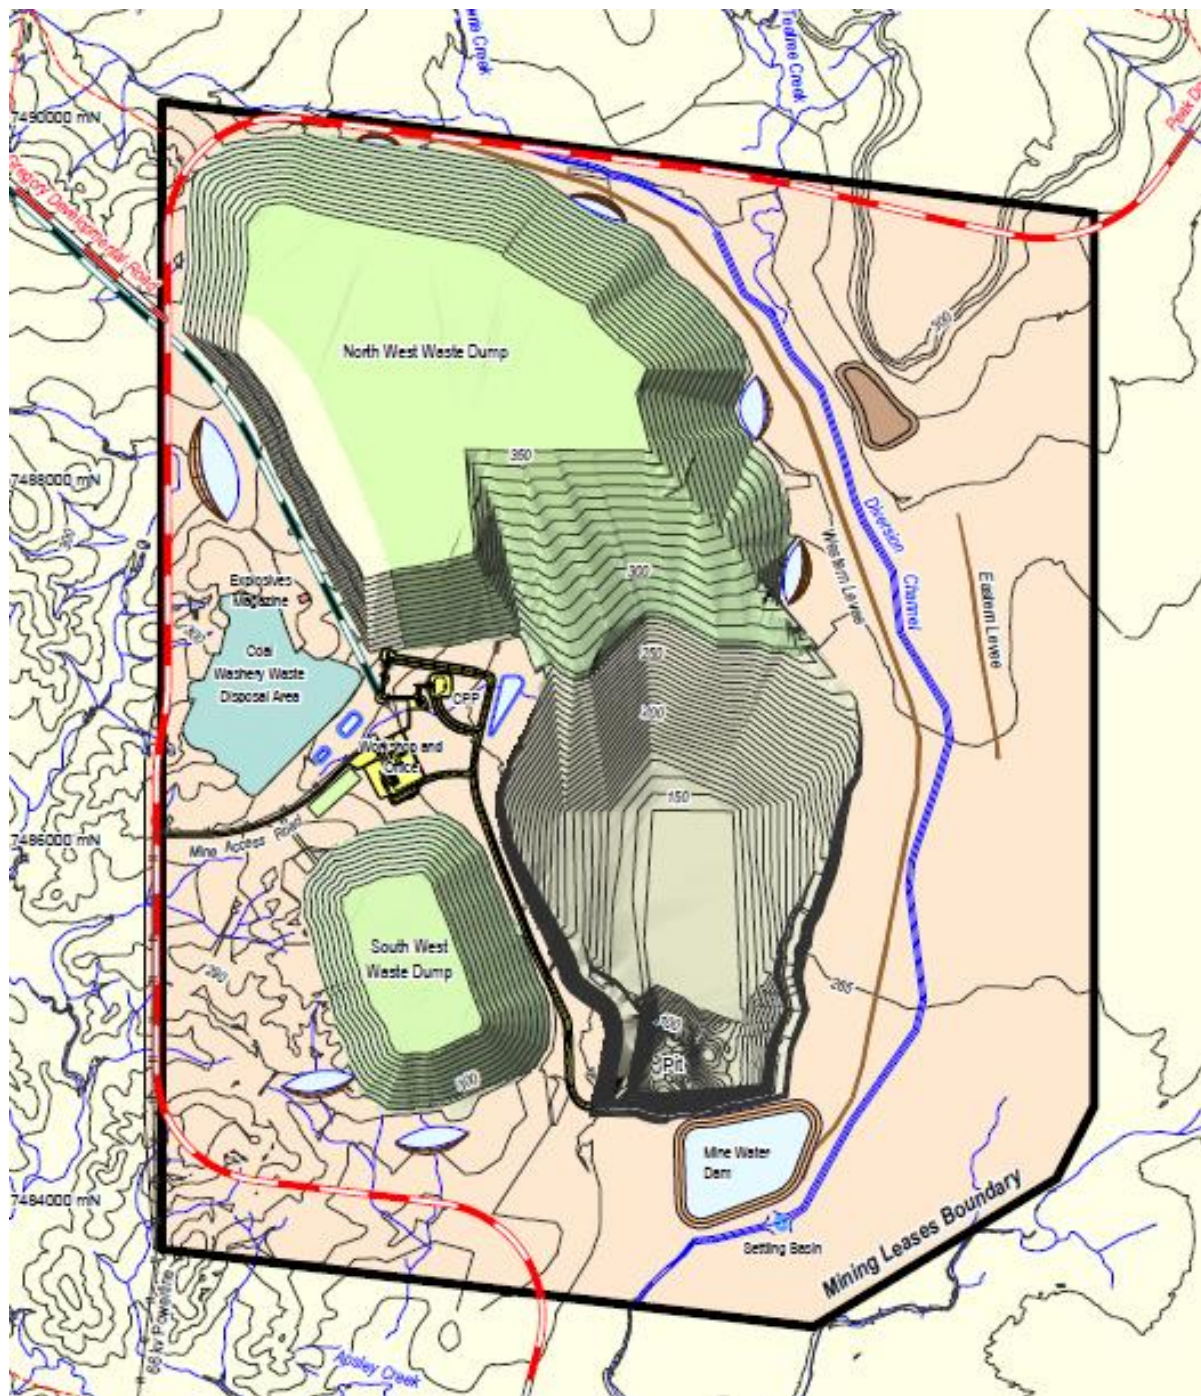
Figure 2-1 - Initial proposed Coal Washery Waste Disposal Area (RTCA, 2004a)

The initial reject management solution proposed for CM was for coarse coal rejects to be wet co-disposed with tailings in a 'Coal Washery Waste Disposal Area'. This was initially to be located to the west of the CHPP, located within in a designated ex-pit facility, as shown in **Figure 2-1** below. A total footprint of ~60 ha was expected to be required to contain the waste generated for the life of the operation. The liquid portion was to be disposed to a series of cells, which would result in the materials in each cell being stable and able to be trafficked after a 'relatively short period of time' (RTCA, 2004a).

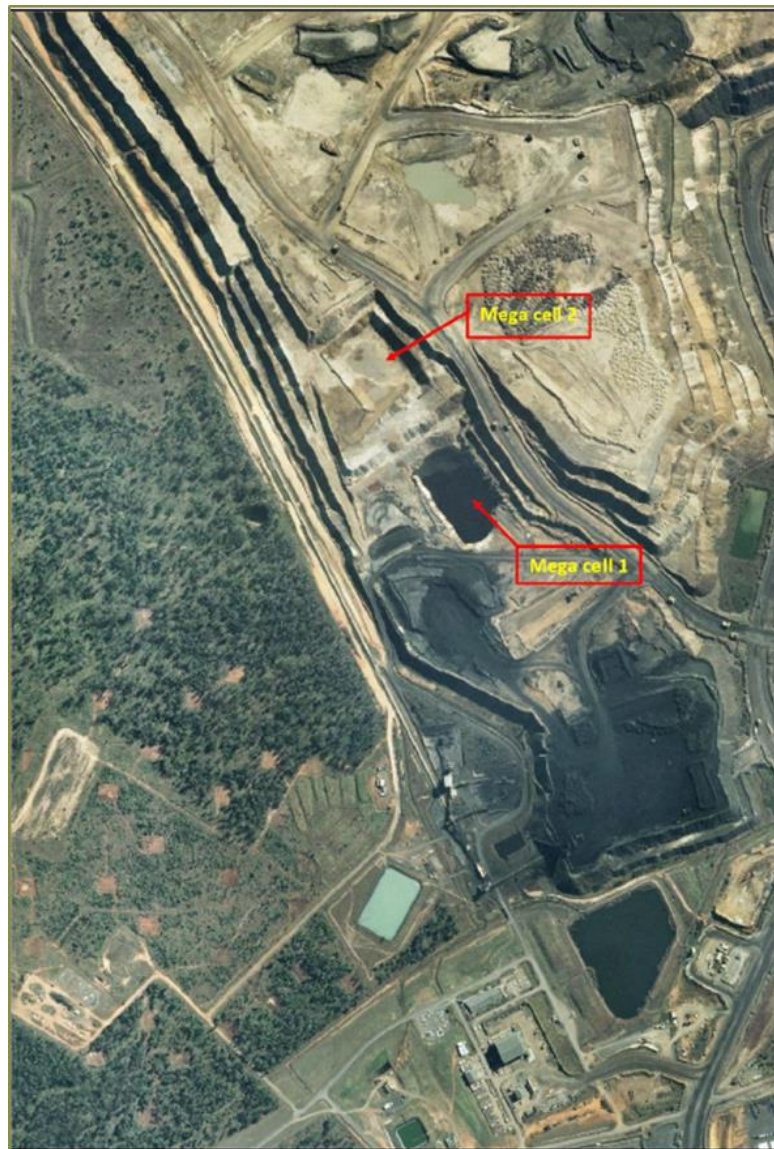
*Figure 2-2 – Megacell 1 at completion and prior to encapsulation (circa 2013)*

CCO has utilised two Megacells during its existing operational life, which represent an approximate combined area of less than 10 ha. Both Megacells are located to the north of the Processing Plant and ROM coal stockpiles, adjacent to the Secondary ROM Stockpile, as shown in **Figure 2-2**. The Megacells contain all of the CCO tailings generated up to 2021. They are surrounded on all sides by spoil dumps, with an embankment to the west also constructed utilising mine spoil.

Megacell 1 was commissioned in 2010 at the commencement of coal production and Megacell 2 was commissioned in 2012 as the washing needs of the operation continued. During the initial period of operation Megacell 1 received co-disposed tailings and coarse rejects, however due to the low proportion of washing at CM (5-10%) the operation of the Megacells changed from that initially planned. The proportion of coarse rejects co-disposed with the tailings declined and the extended

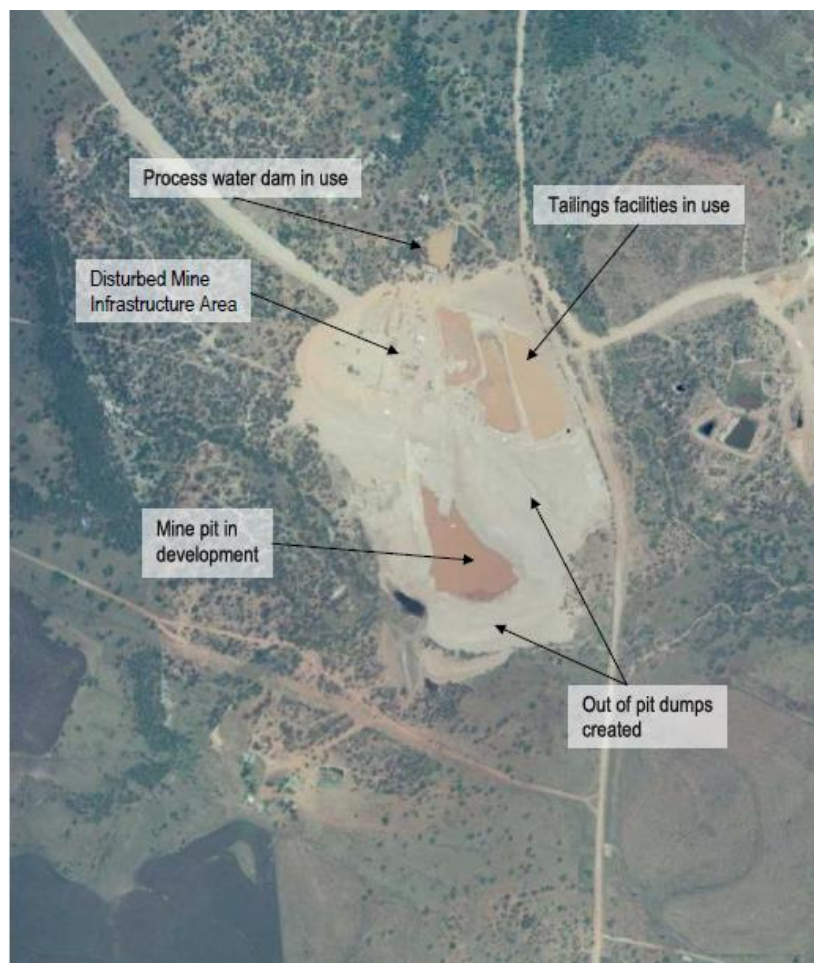
Figure 2-4 - Location of historic TSFs at CH

At CH, a historic tailings area is located in the north-eastern portion of the site (as per *Figure 2-4*) and occupies an area of approximately 6.6 ha, and consists of three main cells. It is known that the previous operation was an alluvial gold mine, whereby the tailings process was limited to washing. No evidence of metal or contaminant concentration is present, with material sampling indicating a high percentage of fine material (silt and clay) from the base of the tailings cells (KBR, 2019).

The third cell (at the western extent of the area) is generally flat, and around 4 m higher again in elevation from the secondary cell. This area is also reasonably well vegetated, with evidence of grazing activity.

There is an above ground circular concrete tank located in the south-eastern corner of the primary tailings cell. Apart from that, no other physical infrastructure of remains from the former mining operation (KBR, 2019).

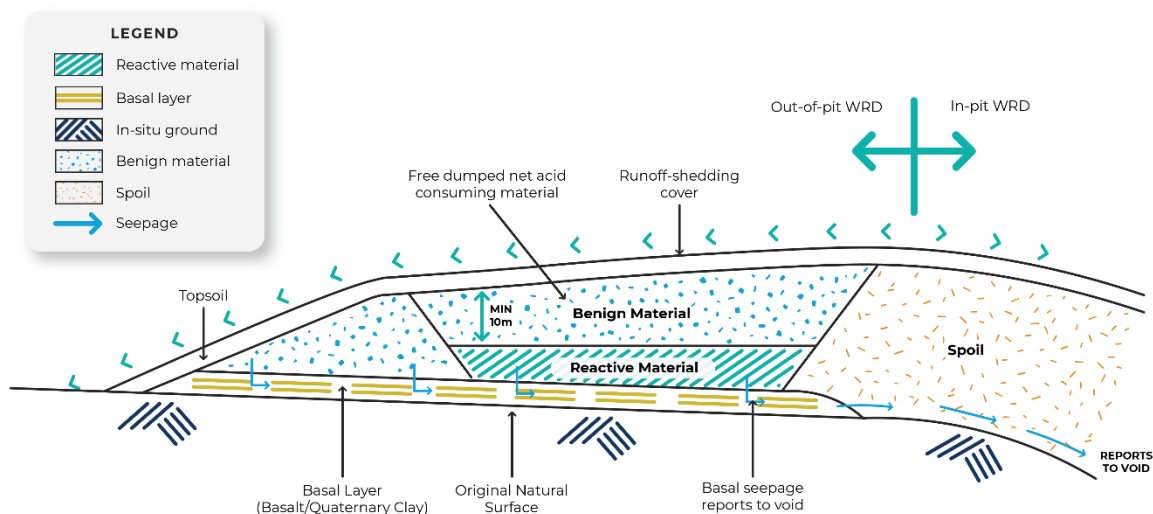
Figure 4-1 - Encapsulation Diagram for Reactive Tailings

Encapsulation of the tailings within the Megacells will occur in accordance with the schematic shown in **Figure 4-1**.

The criteria for encapsulating reactive tailings materials is as follows:

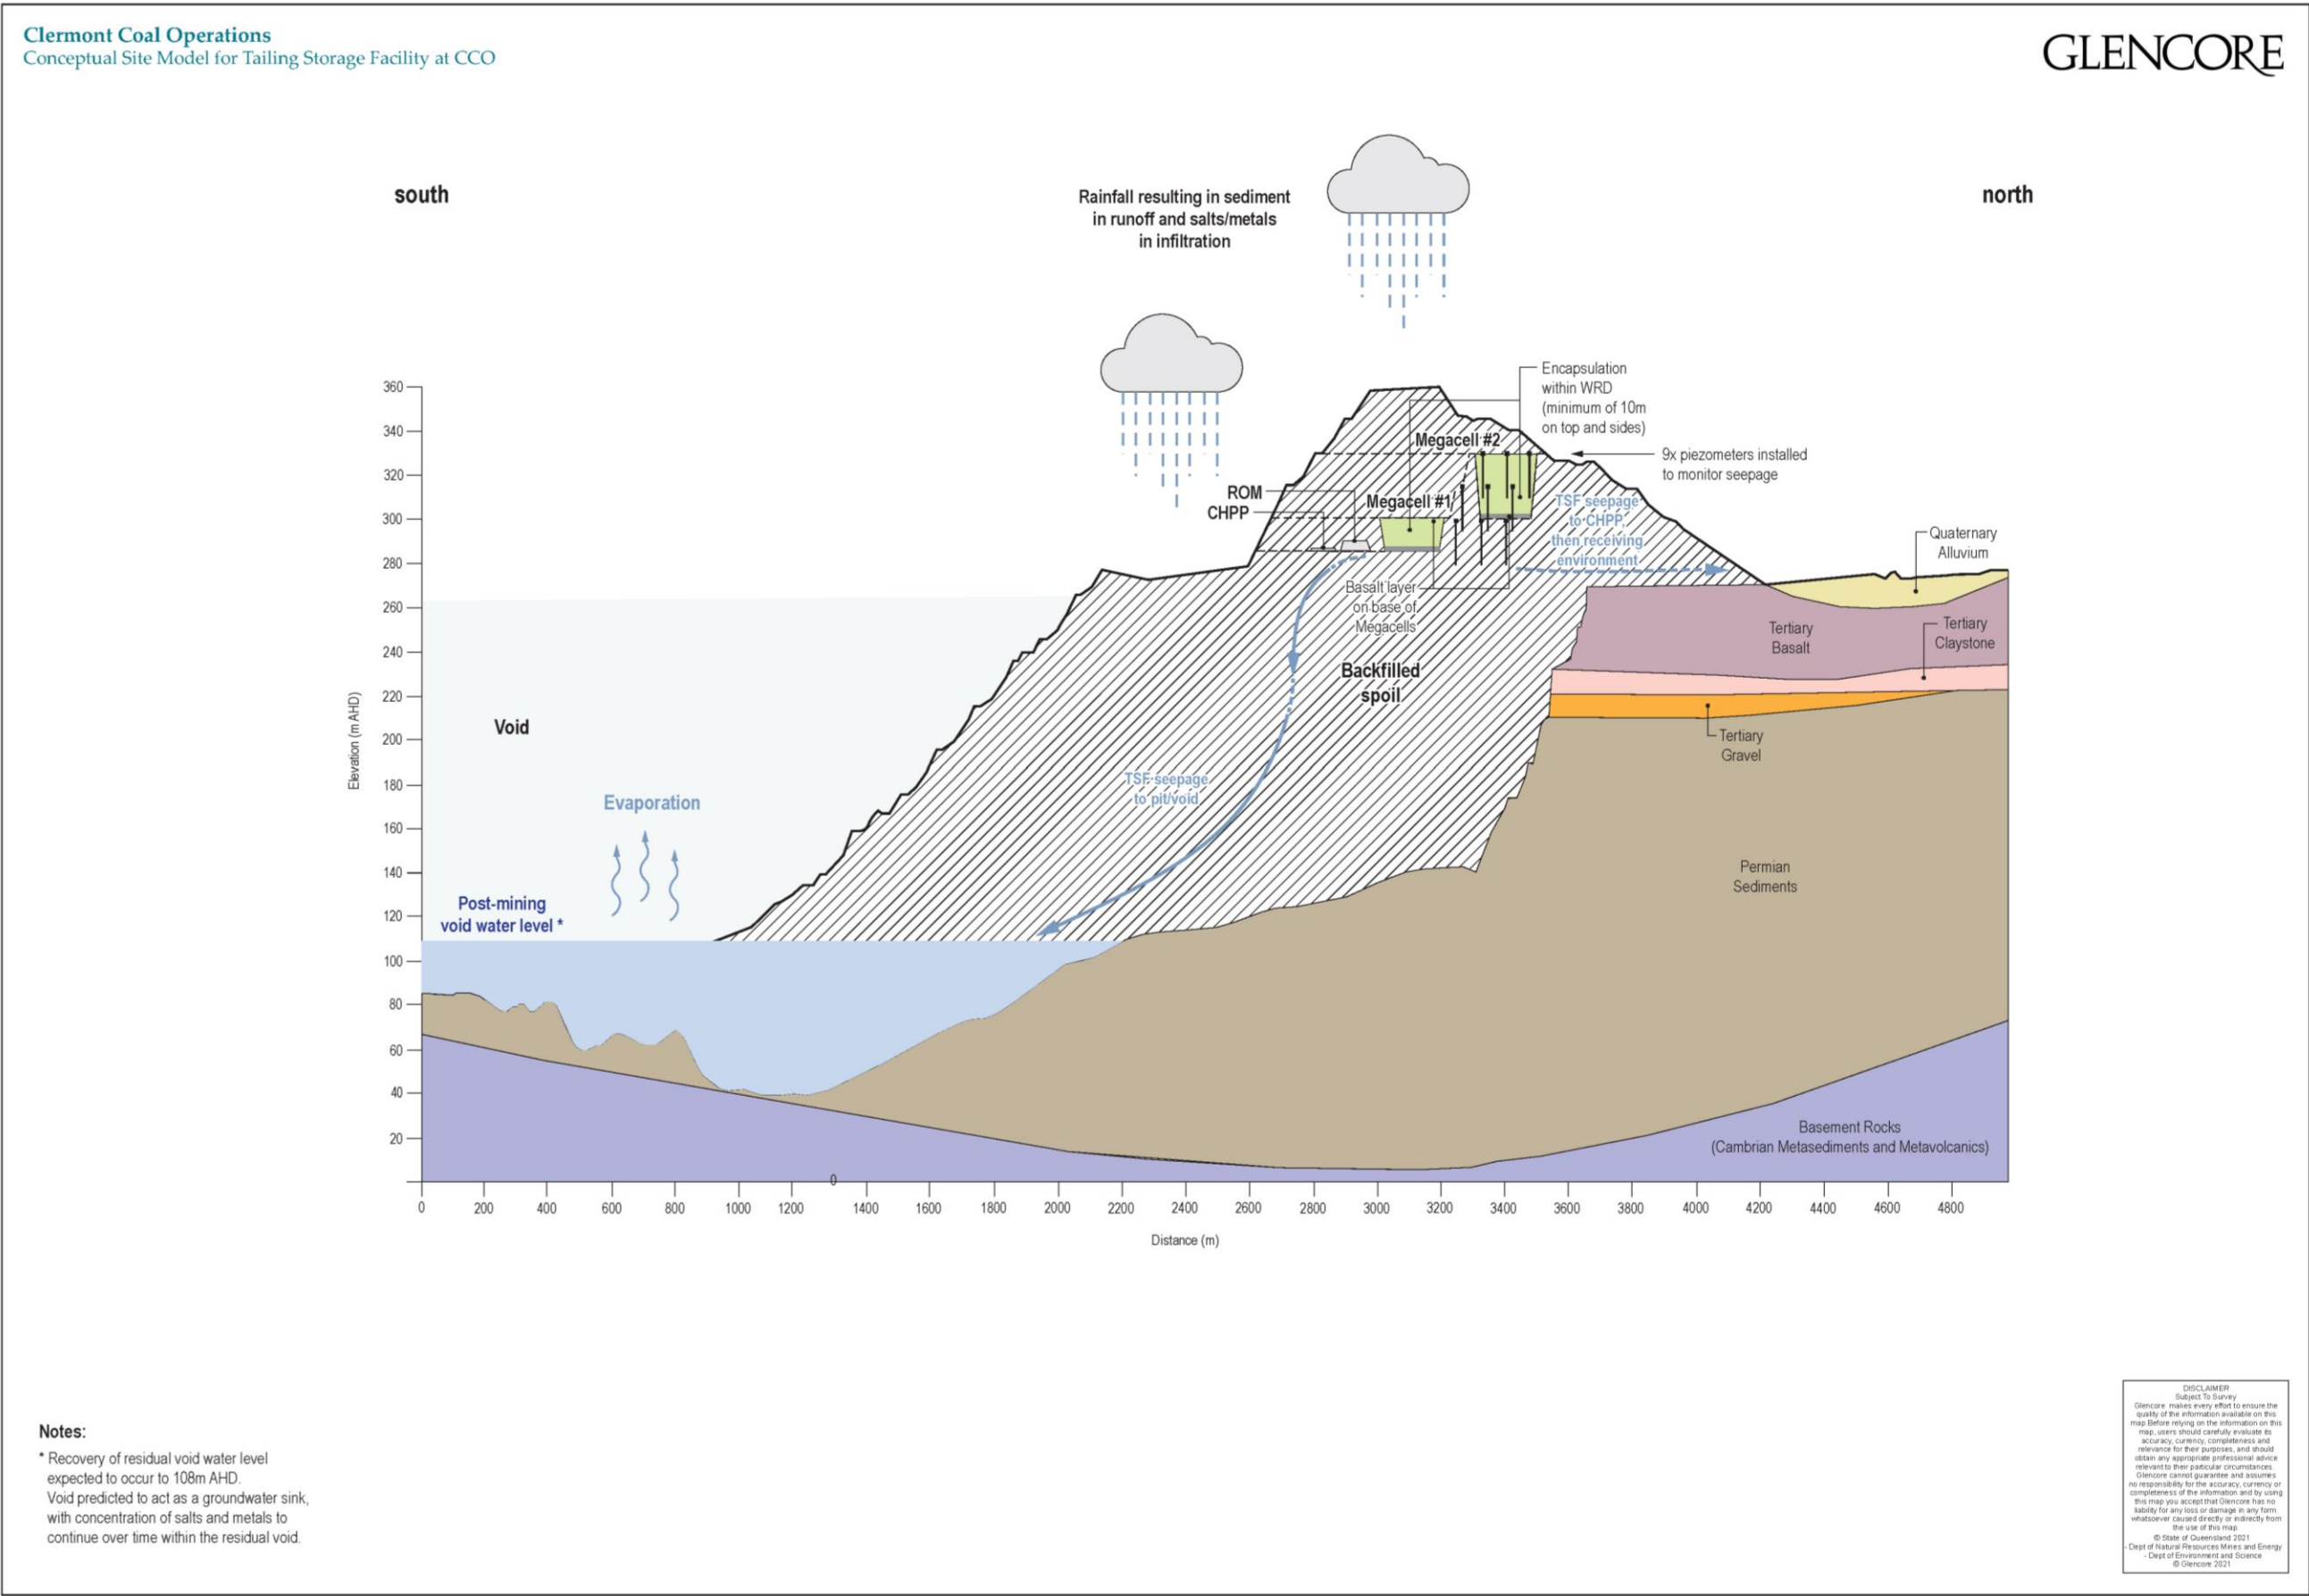
Figure 5-1 - Conceptual site model for tailings at CCO

The conceptual model provided below forms both a summary table (**Table 5-1**) and a schematic diagram to show key interactions between the TSFs and surrounding environment. The summary table considers the source-pathway-receptor linkages and highlights key geochemical risks as well as management controls and interventions required. Further, the schematic (provided as **Figure 5-1**) presents the boundary conditions, site topography and climate, the in situ distribution and location of reactive materials and illustrates key hydrological and hydrogeological pathways.

Nine piezometers have been installed to the south west of Megacell 2, with the purpose and intent of measuring seepage levels to the nearest 0.01 m (AHD). The location of the nine piezometers are as shown on the conceptual site model (*Figure 5-1*). These piezometers will be monitored on a monthly basis and will inform the performance of the Megacell against TARP trigger values.
