CLERMONT

GLENCORE

# Progressive Rehabilitation and Closure Plan (PRC Plan)

January 2023

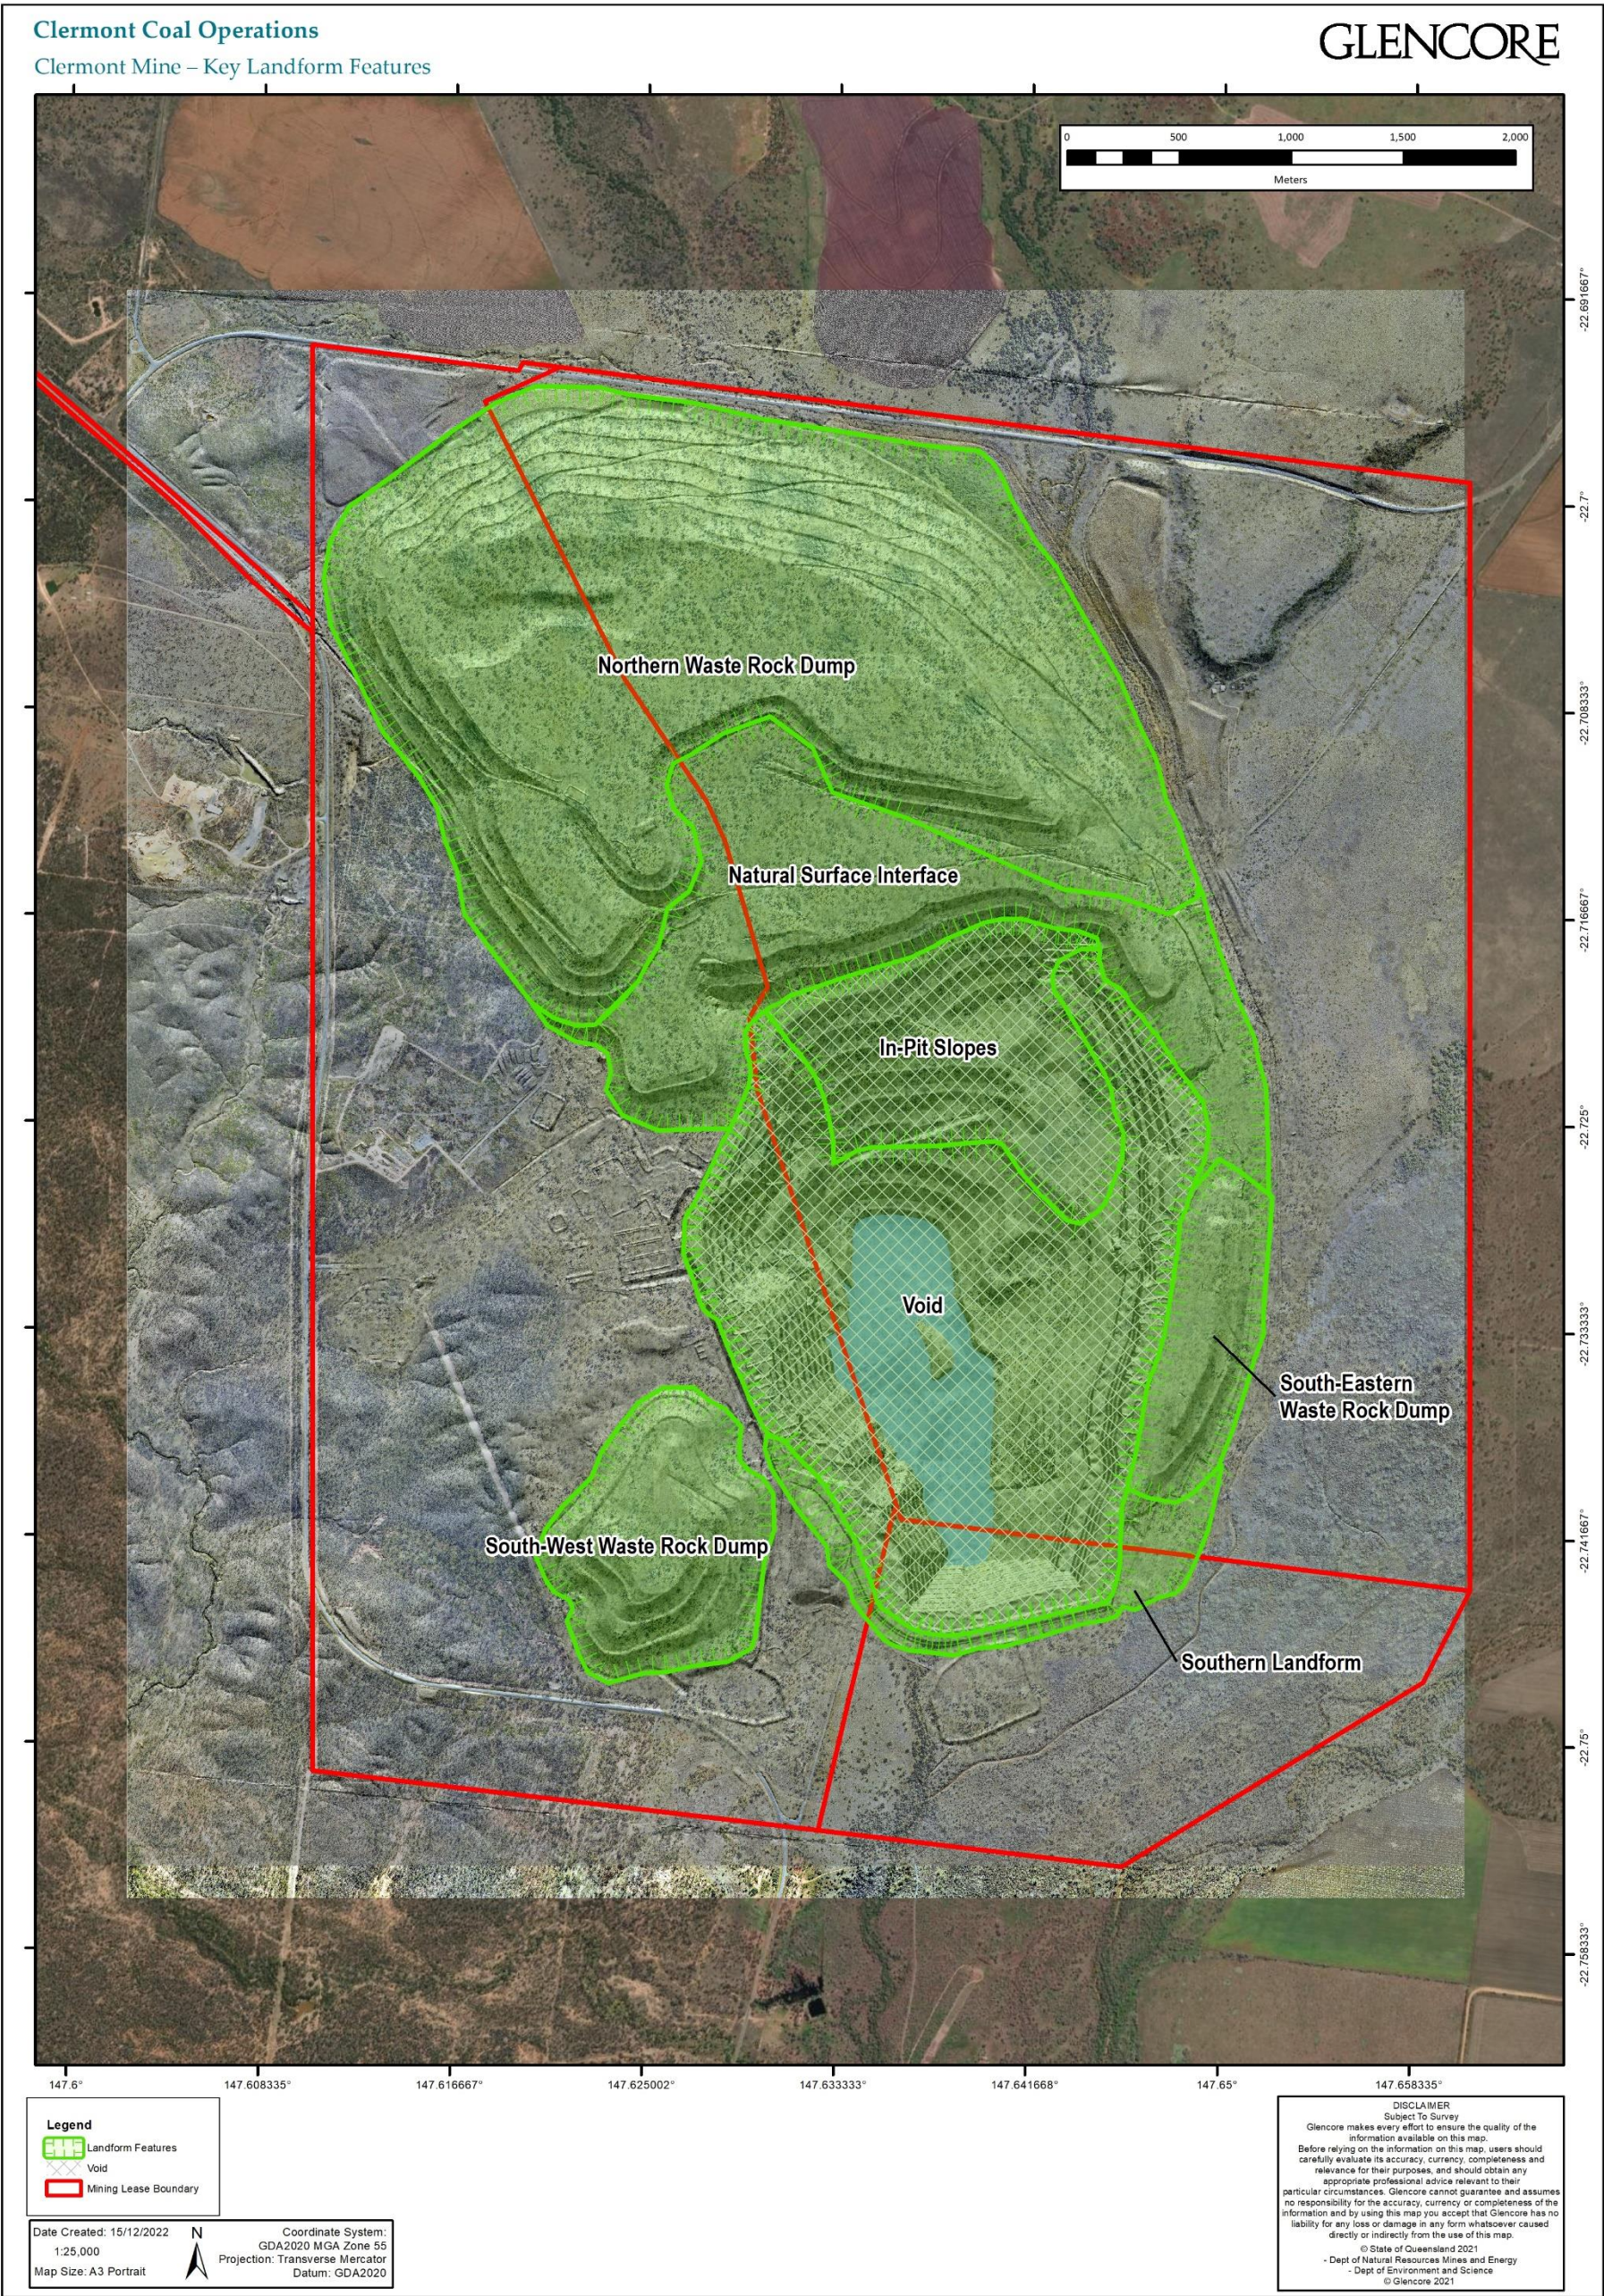
Figure 5-1 - Key landform features for CM area

Landform design characteristics are detailed in **Figure 5-1** for each landform area within the CM area. The main landforms relevant to the CM area include the Northern Waste Rock Dump (NWRD); South-West Rock Dump (SWRD); South-Eastern Waste Rock Dump (SEWRD); Natural Surface Interface (NSI); In-Pit Slopes; Void and the Southern Landform. **Table 5-1** details the key features of each landform for the CM area and is reflective of the final design concept. A view of the 3D design work has been included for each feature.

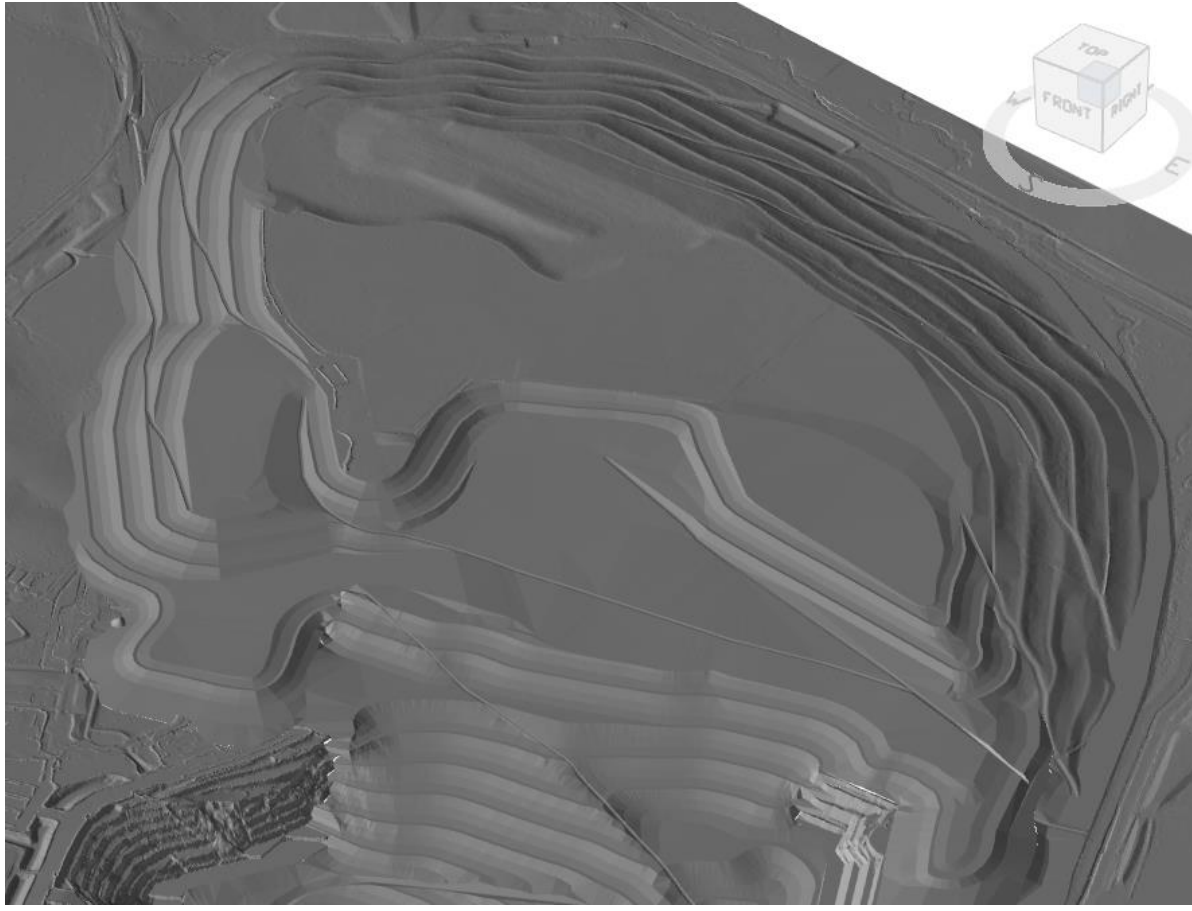
| Northern Waste Rock Dump | Dimensions |
|---|---|
| Landform footprint | 654 ha |
| Landform height | 360 m AHD, ~75 m high from natural ground |
| Key design constraints and considerations | <p>Highway at northern toe, visual impacts of concern. Significant landform overall size and height</p> <p>Need to manage local catchment runoff effectively.</p> <p>Ensure toe to north and east ties into existing operational levee, with permanent landform to be extended to top of levee and levee structure retained intact to provide toe protection during flood events.</p> |

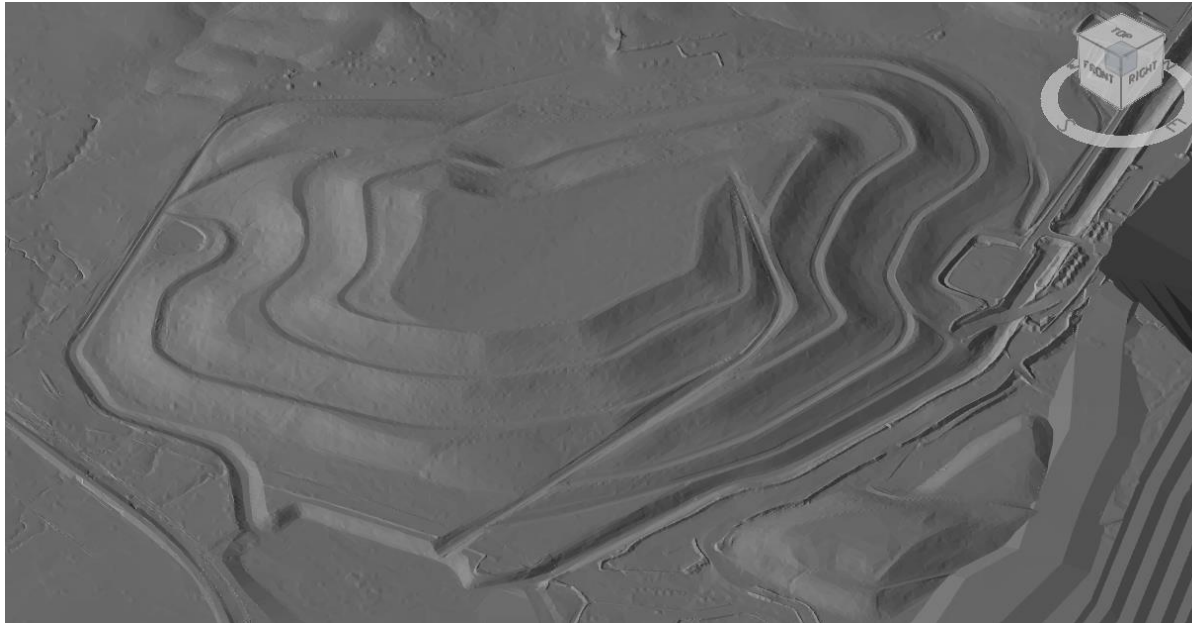
| South-West Rock Dump | Dimensions |

| South-West Rock Dump | Dimensions |
|---|---|
| Landform footprint | 98 ha |
| Landform height | 310 m AHD, ~40 m high from natural ground |
| Key design constraints and considerations | <p><i>This is an existing rehabilitated area.</i></p> <p>Highway to south of WRD, visual impacts of concern.</p> <p>Constrained by surface drainage features to the west.</p> |

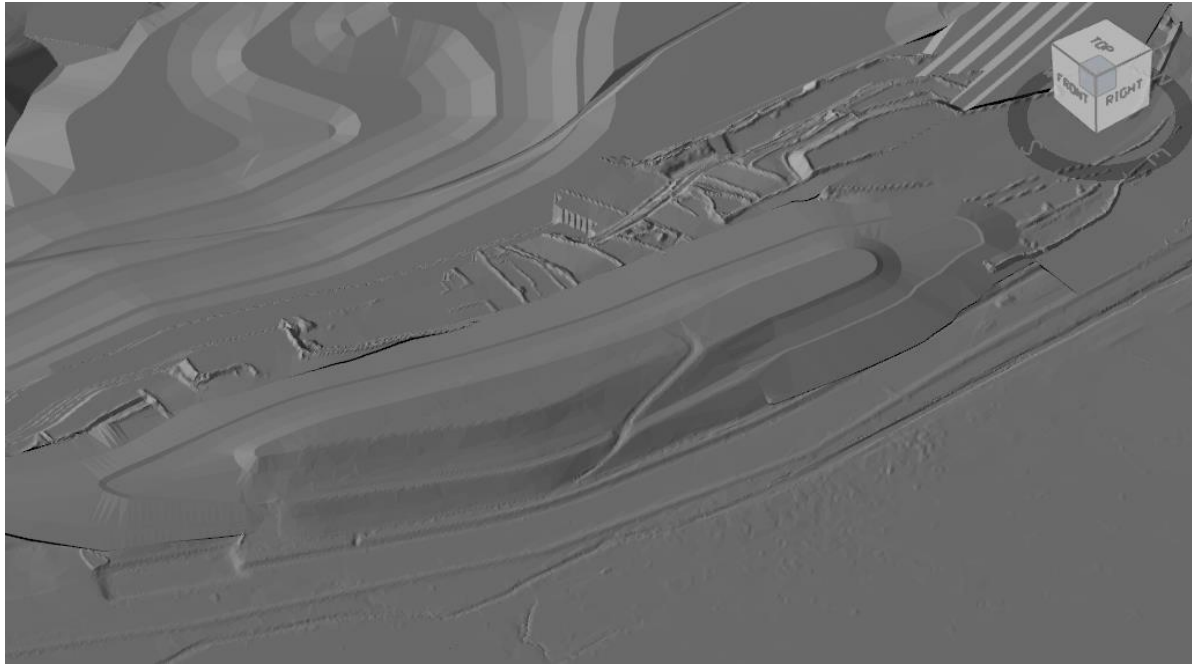
| South-Eastern Waste Rock Dump | Dimensions |
|---|---|
| Landform footprint | 60 ha |
| Landform height | 295 m AHD, ~250 m high from natural ground |
| Key design constraints and considerations | Ensure toe to east ties into and incorporates the existing operational levee. The landform is to be extended to the crest of the levee, and the levee structure retained intact, to provide toe protection during flood events. |

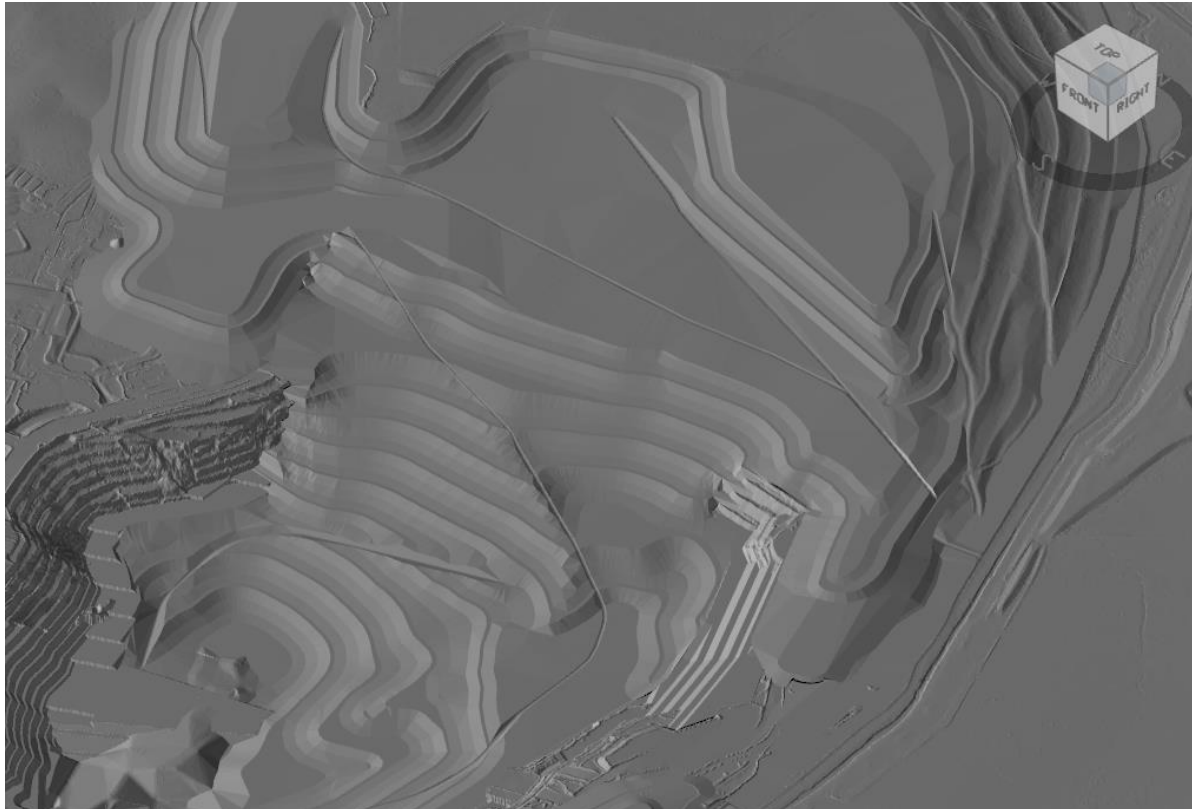
| Natural Surface Interface | Dimensions |
|---|---|
| Landform footprint | 198 ha |
| Landform height | <p>Between 270 – 325 m AHD, sloping down to natural ground surface ~270 m AHD</p> <p>Up to 55 m high from natural ground</p> |
| Key design constraints and considerations | <p>Tie into natural surface to east and west</p> <p>Maximise ex-pit drainage and ensure slope grade to support catchment functionality</p> <p>Provide areas with access to top of NWRD plateau for livestock grazing</p> |

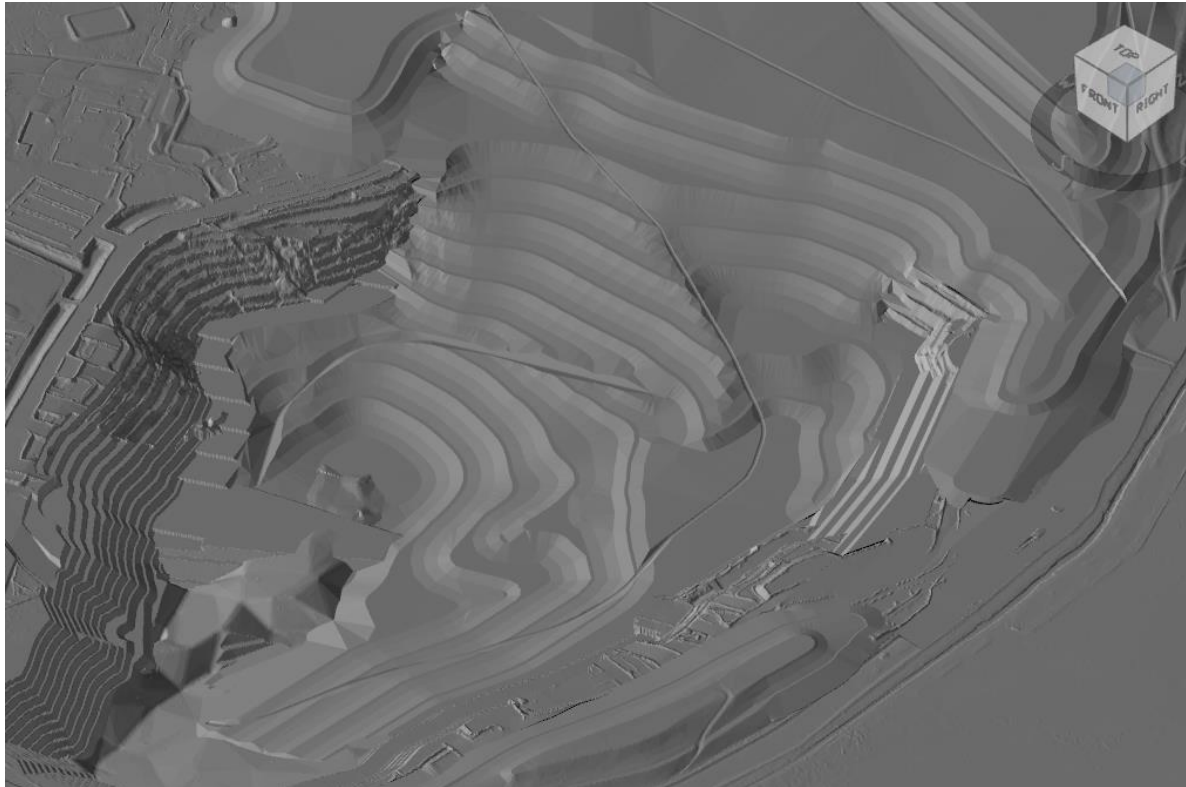
| In-Pit Slopes | Dimensions |

| In-Pit Slopes | Dimensions |
|---|---|
| Landform footprint | 149 ha |
| Landform height | From natural ground surface ~270 m AHD down to ~100 m AHD<br>~170 m high from base of slopes to natural ground |
| Key design constraints and considerations | Significant in pit catchment/backfilled material<br>Ensure adequate surface water management with chute concept |

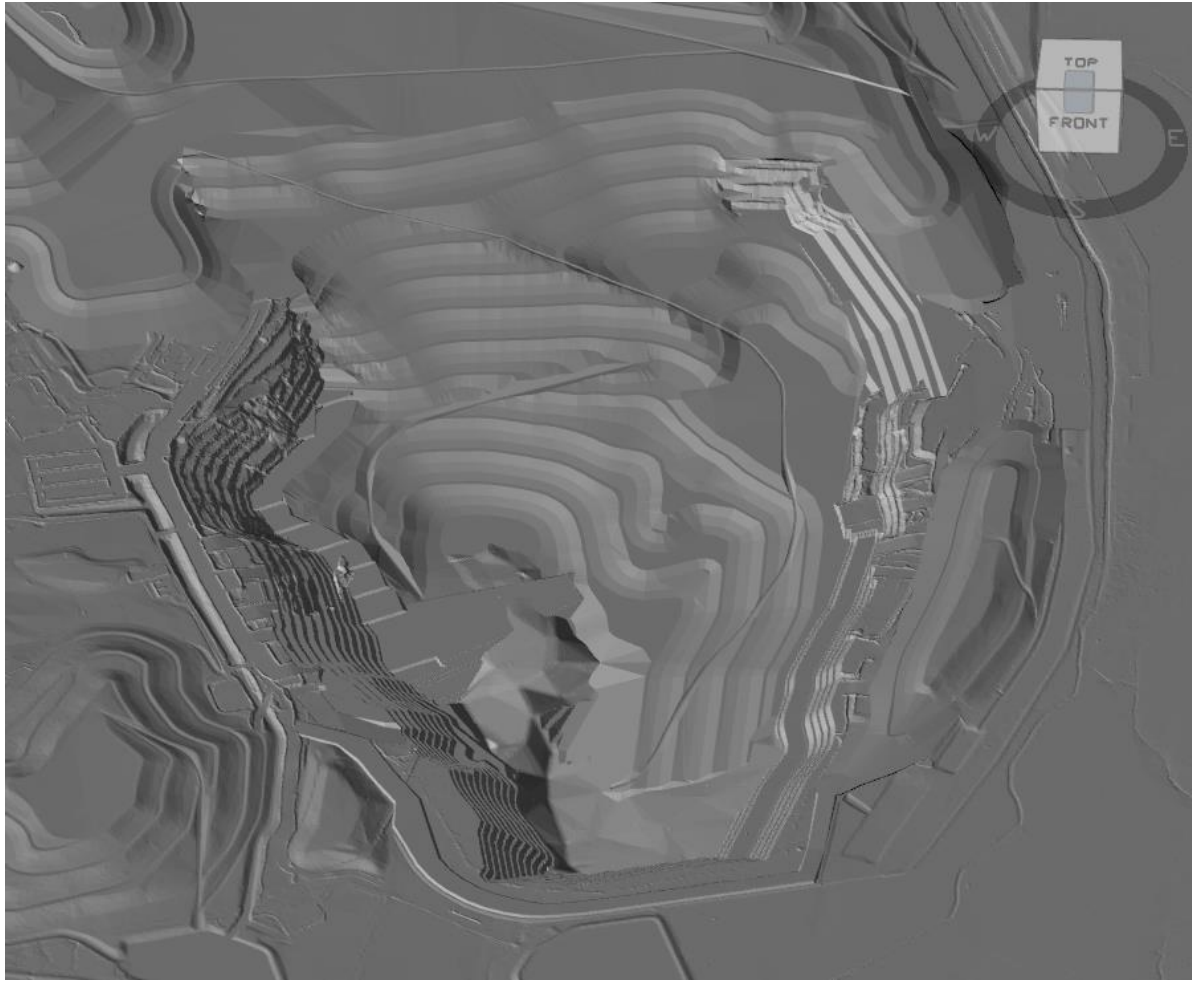
| Void | Dimensions |

| Void | Dimensions |
|---|---|
| Landform footprint | 582 ha |
| Landform height | From natural ground surface ~270 m AHD down to ~ 75 m AHD<br>~195 m high from base of void to natural ground |

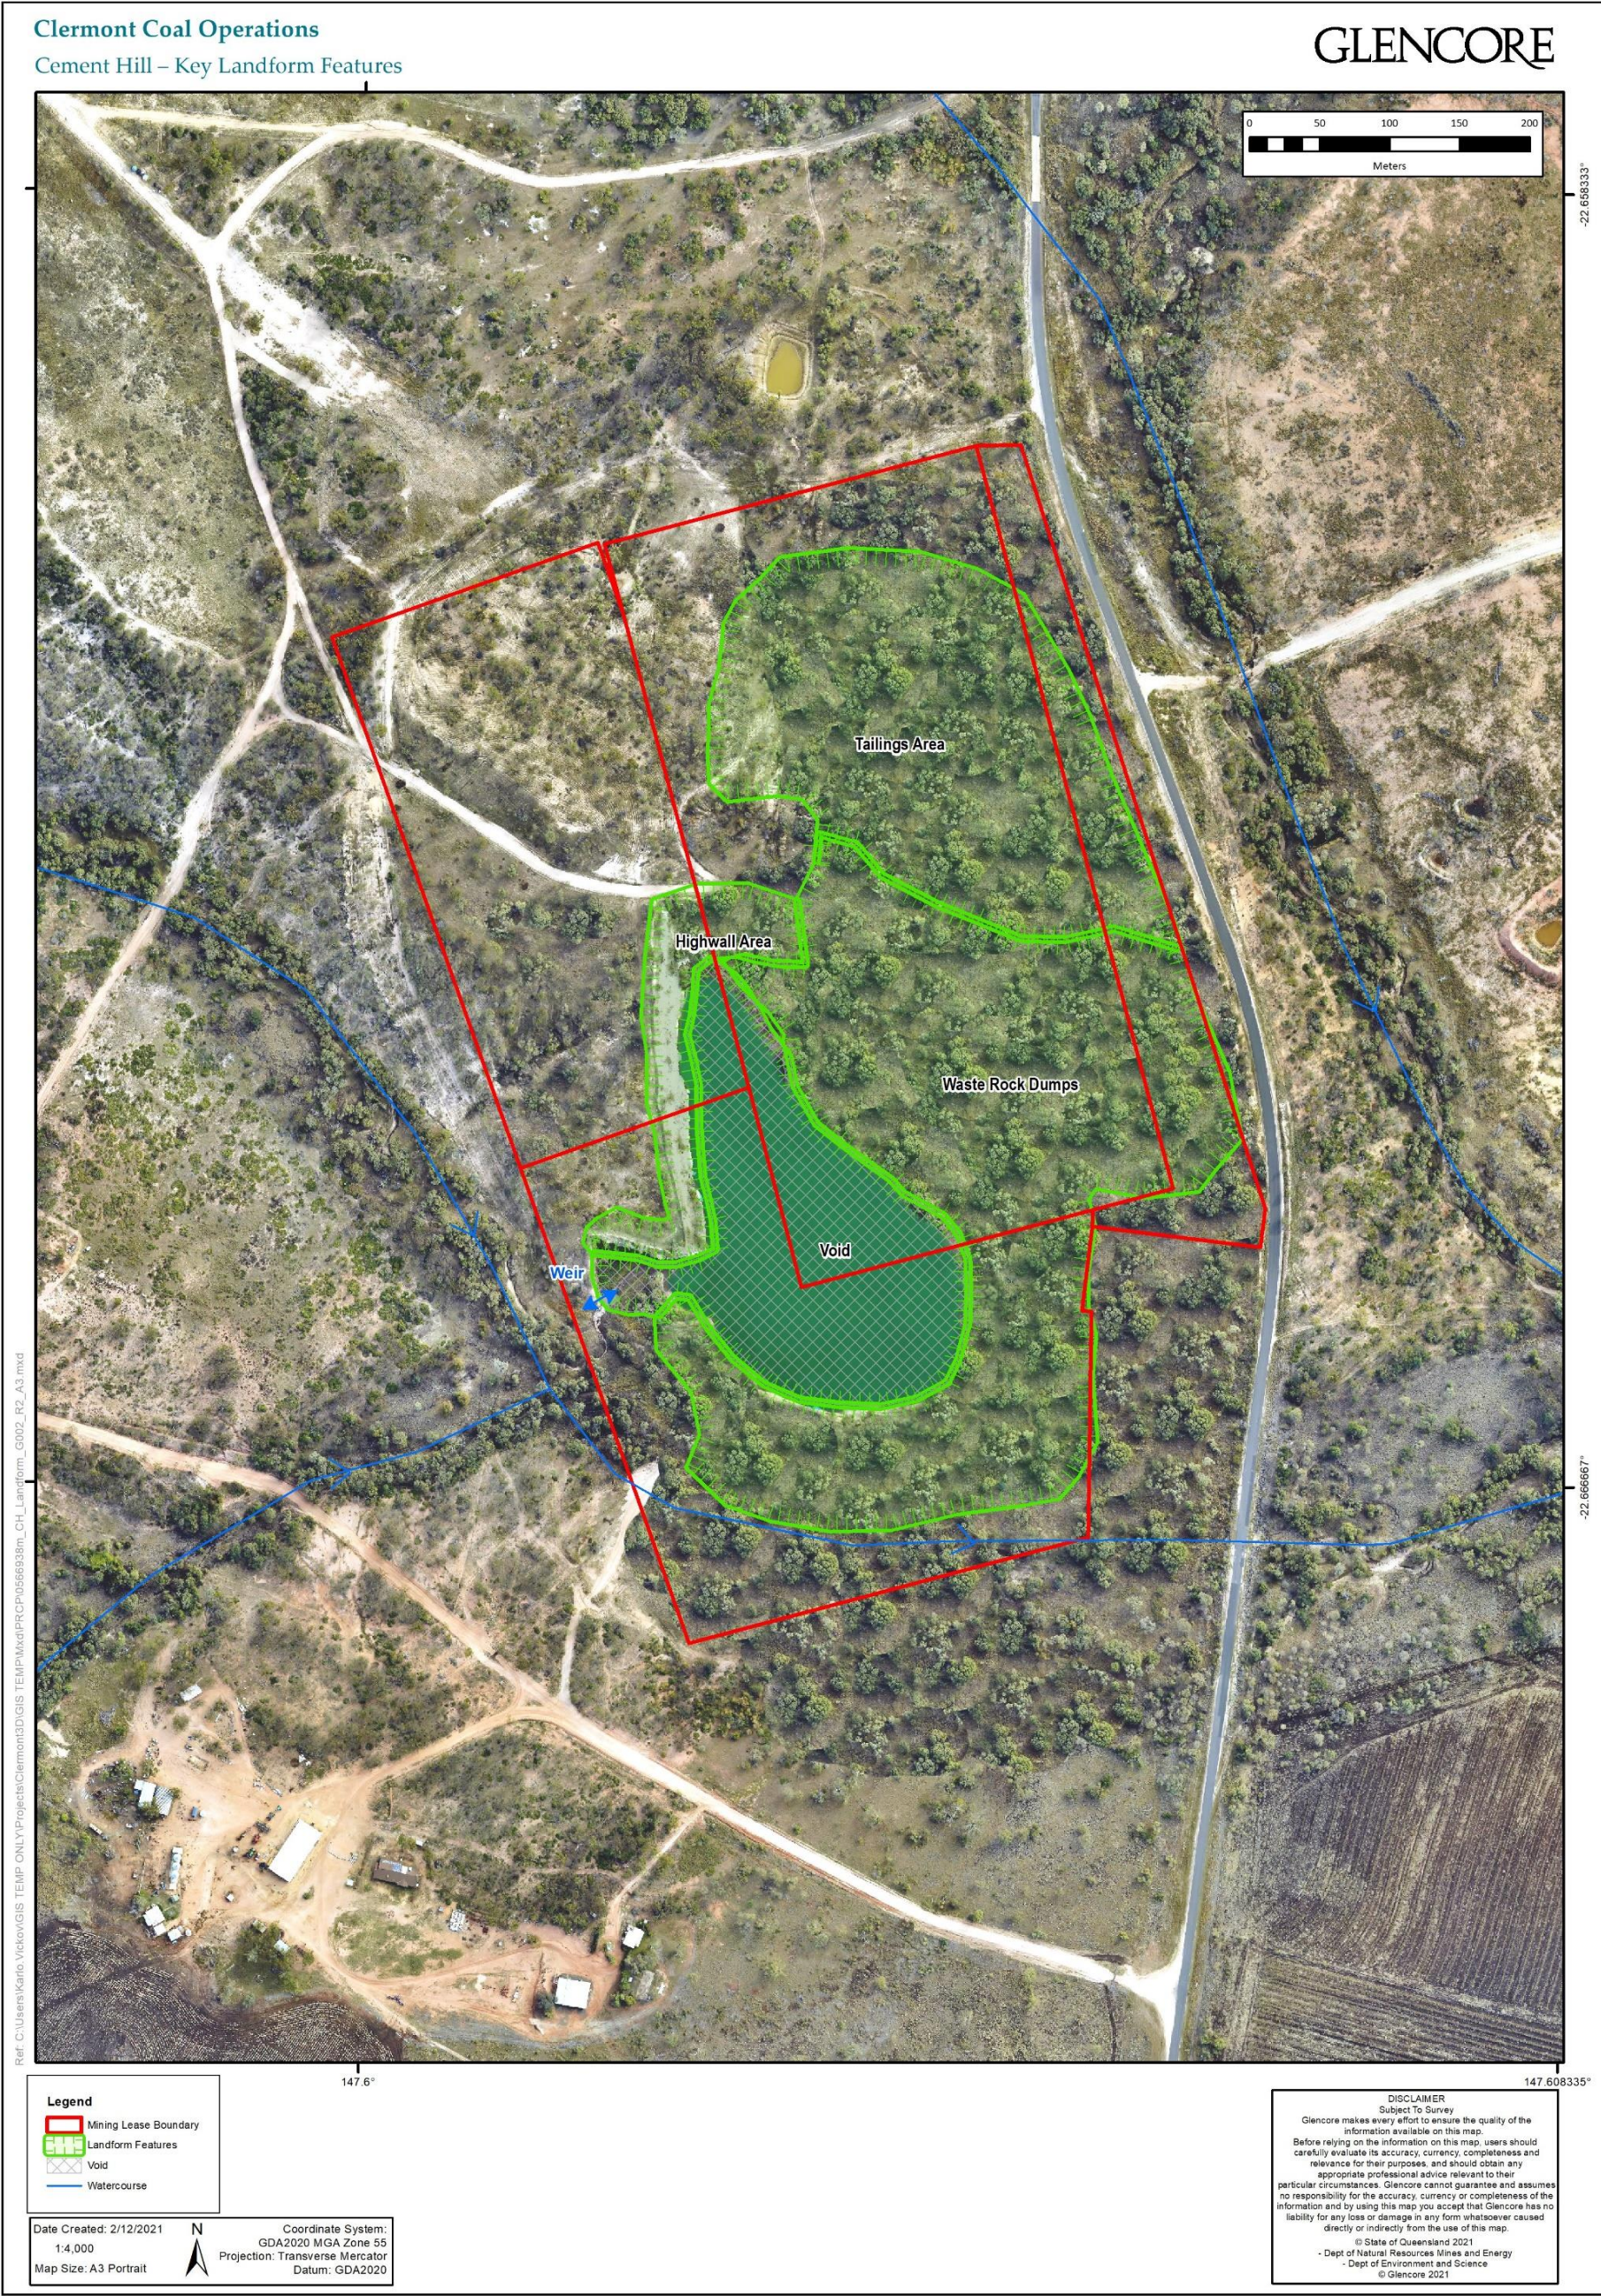
Figure 5-2 - Key landform features for CH area

Landform design characteristics have been detailed in **Figure 5-2** for each landform area within the CH area. Key features of each of the rehabilitated landforms is as identified, including landform footprint and height, as well as a range of other relevant factors. CCO has sought to optimise the long term rehabilitation outcomes for the site. The key design decisions, constraints and considerations have also been summarised, these represent the aspects that have influenced the landform design at each location.

The main landforms relevant to the CH area include the Waste Rock Dumps (WRDs); Tailings Area (TA); the High Wall (HW) and the Void. The following **Table 5-3** details the key features of each landform for the CH area and are reflective of the final design concept. A view of the 3D design work has been included for each feature, positioned so as to best show the nature of each landform feature.

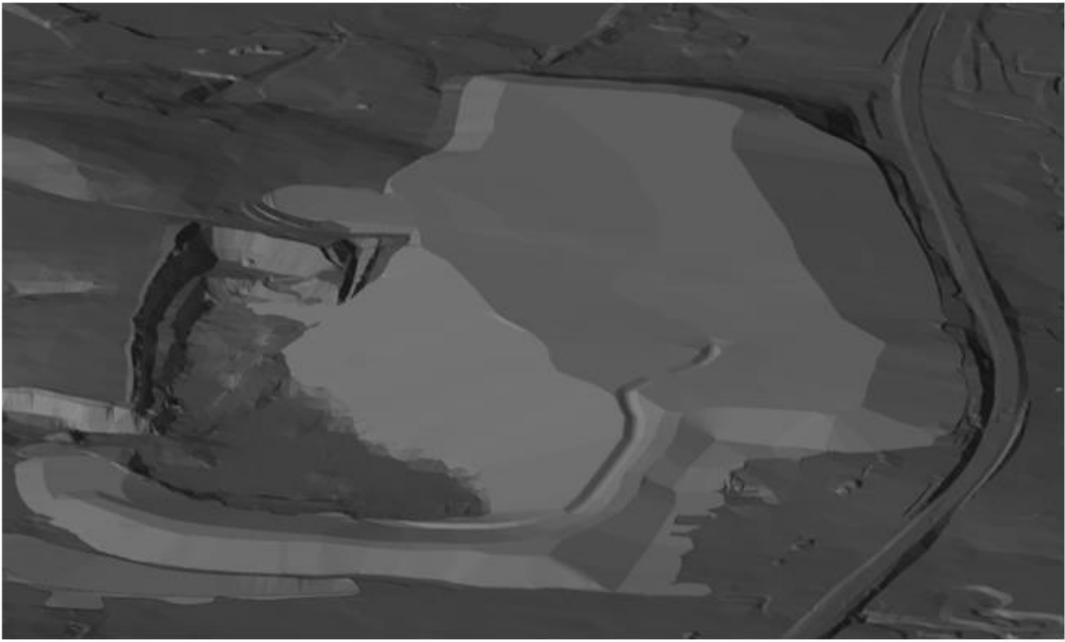
| Waste Rock Dumps | Dimensions |
|---|---|
| Landform footprint | 16 ha |
| Landform height | (RL or Z = ~314) and ~14m high from natural ground. |
| Key design constraints and considerations | <p>Highway at eastern extent, and previous dump footprint encroached beyond ML boundary</p> <p>Maintain void capacity for water storage and supply</p> <p>Ensure saline/compacted area on top of previous surface was reshaped</p> <p>Floodplain interactions to the south impacted on position of southern WRDs</p> |

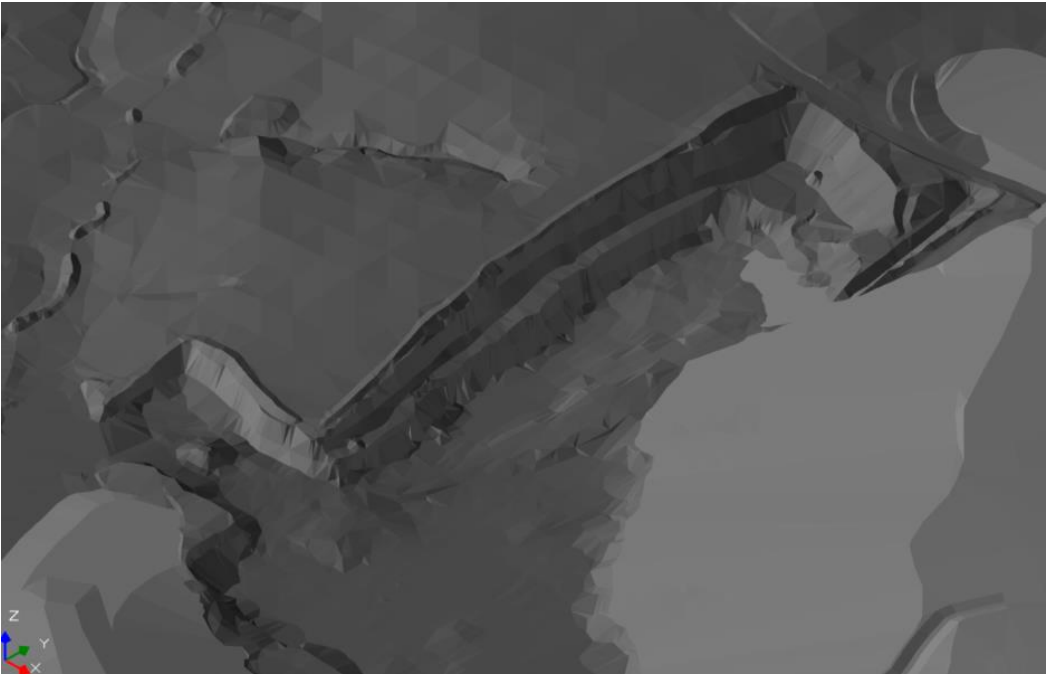
| High wall Area | Dimensions |

| High wall Area | Dimensions |
|---|---|
| Landform footprint | 1 ha |
| Landform height | 318 RL top of highwall to 295 RL bottom of highwall. (with water level ~300 RL) |
| Key design constraints and considerations | Geotechnically considered acceptable to remain as is, without modification or layback |

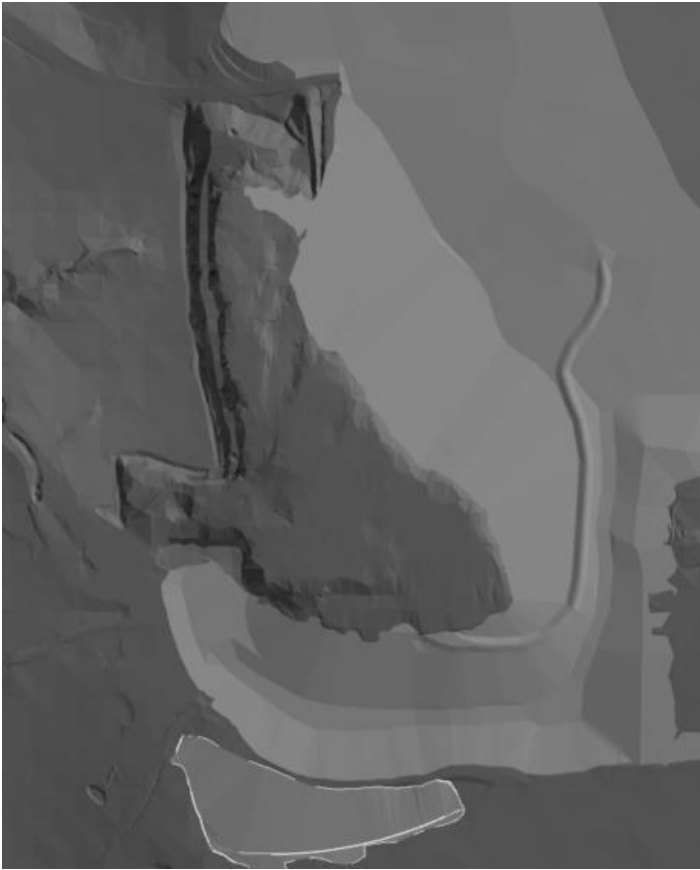
| Final Void | Dimensions |
|---|---|
| Landform footprint | 3 ha |
| Landform height | Base of void at ~292 RL, compared to natural ground surface ~300 RL (8 m deep). |

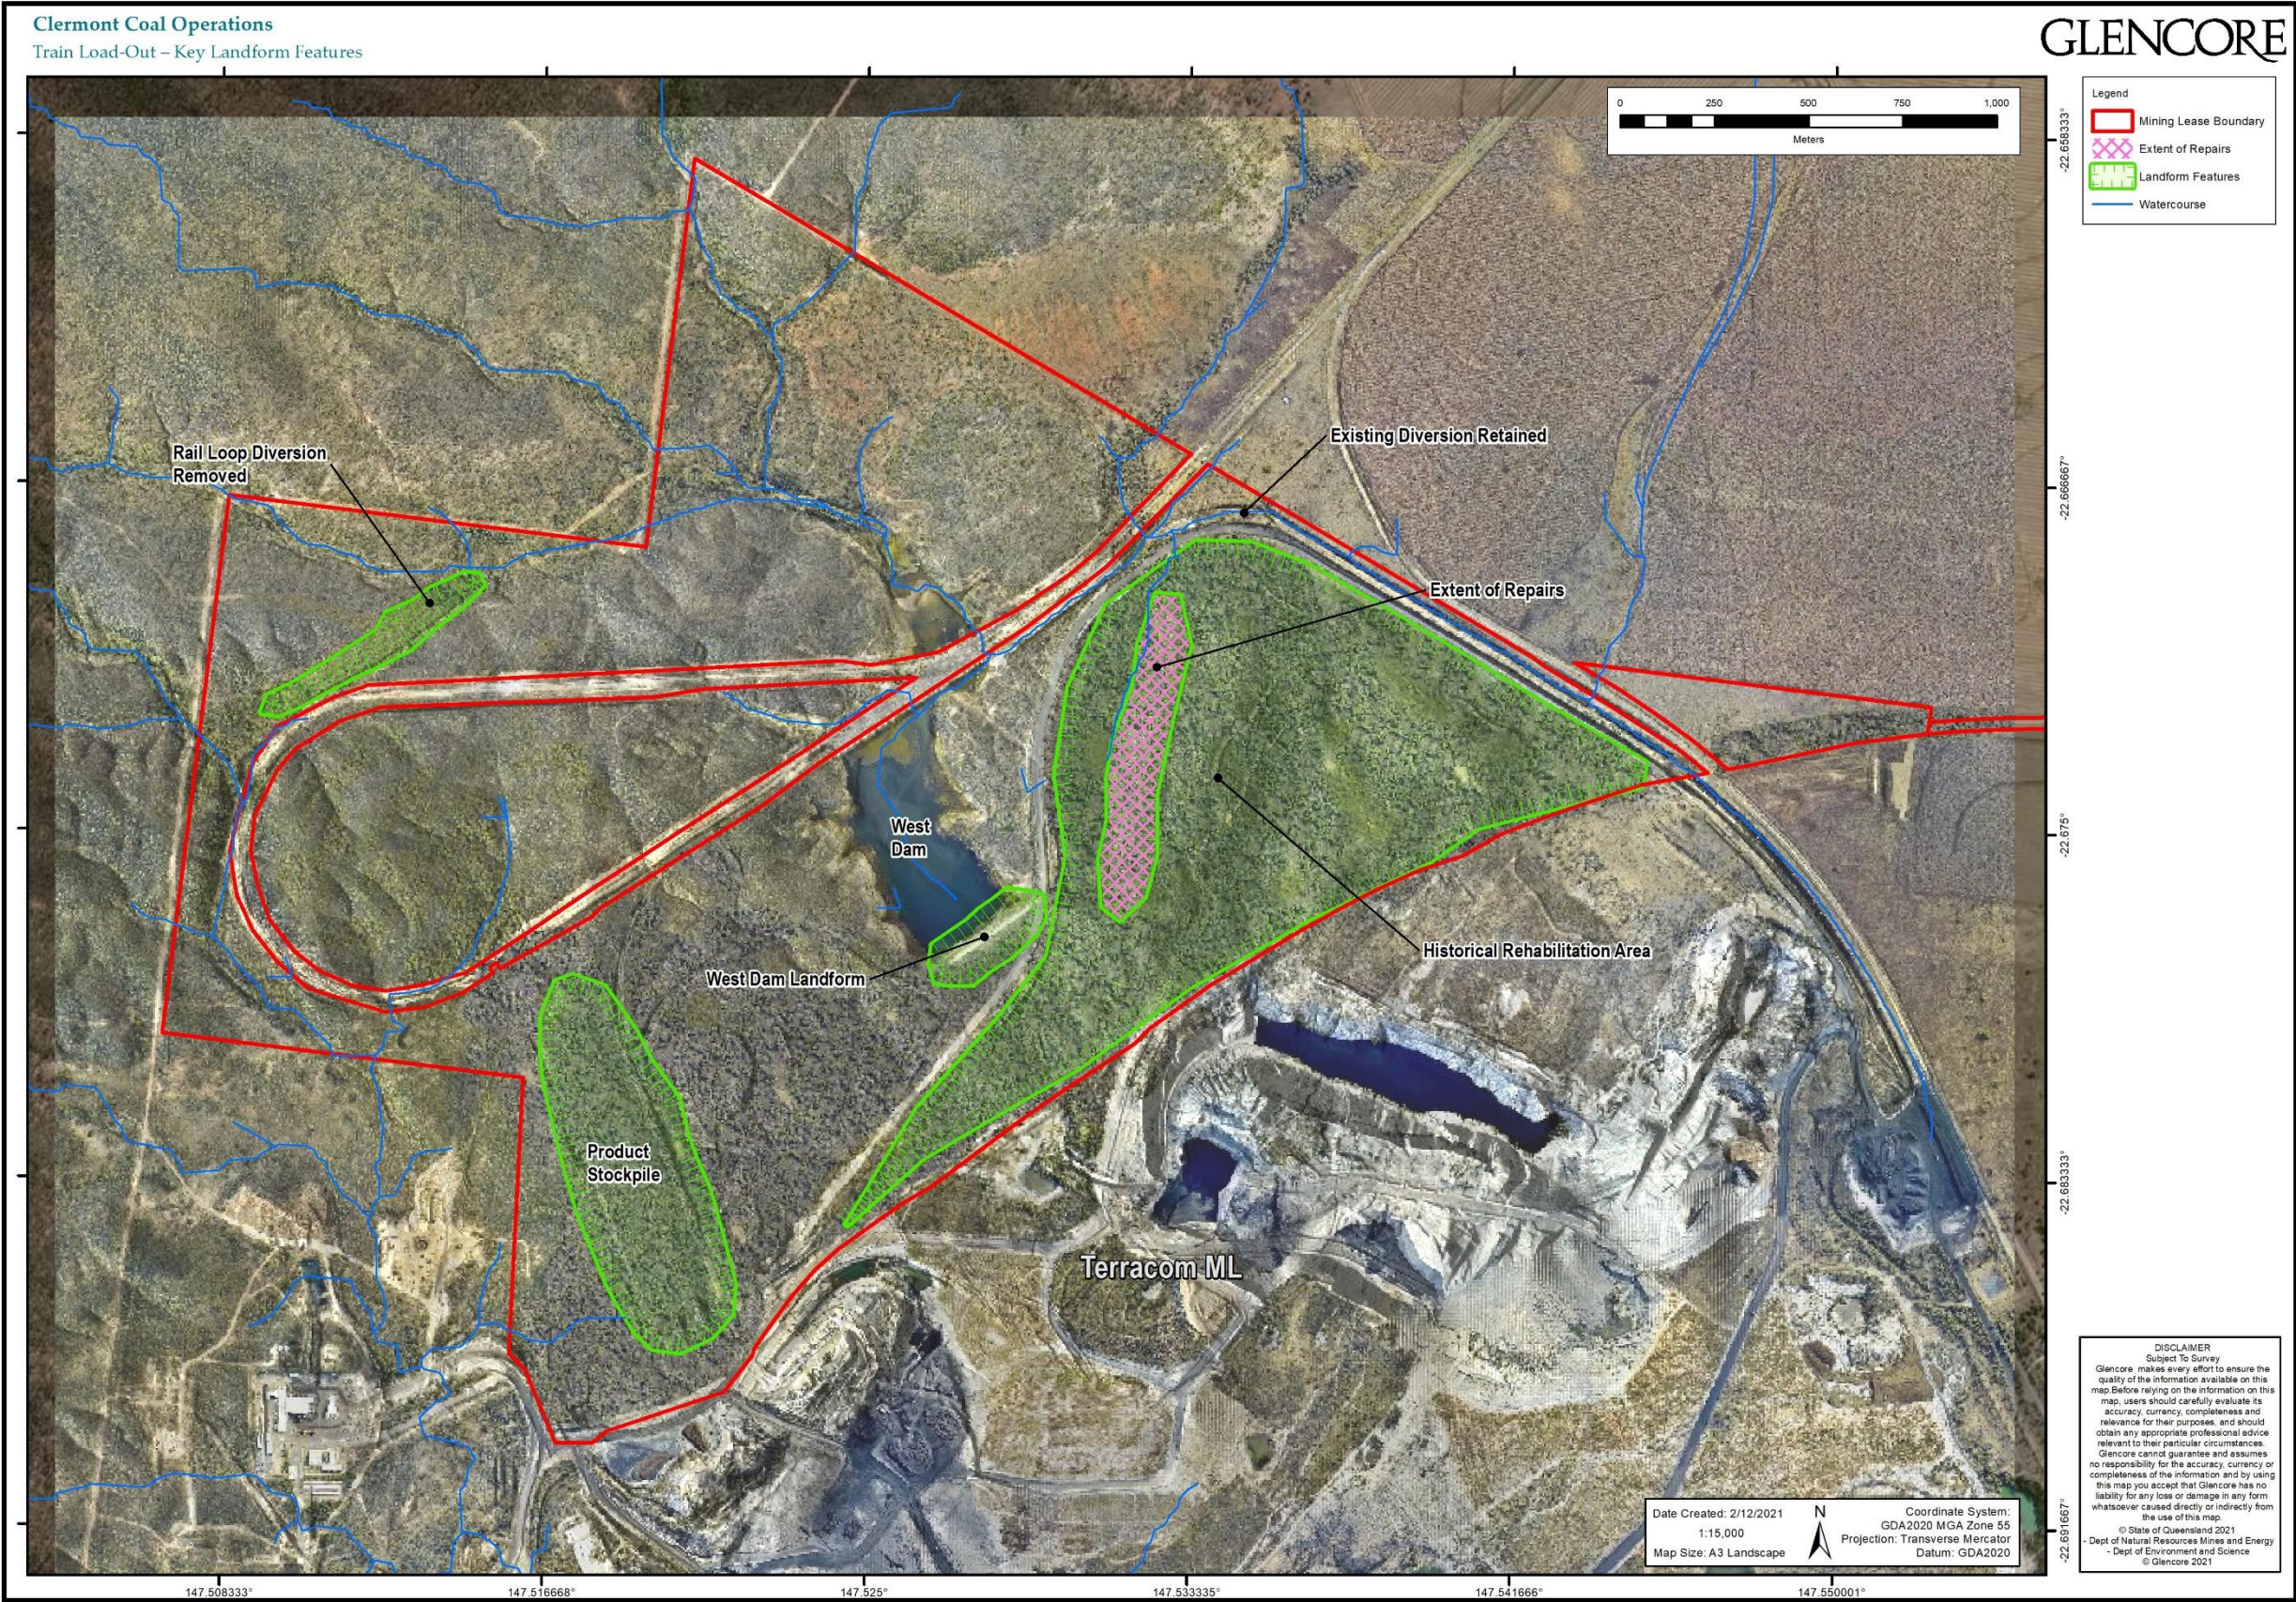
Figure 5-4 - Key Landform Features for TLO area

Landform design characteristics have been detailed in **Figure 5-4** for each landform area within the TLO area. Key features of each of the rehabilitated landforms is as identified, including landform footprint and height, as well as a range of other relevant factors. The key design decisions, constraints and considerations have also been summarised, these represent the aspects that have influenced the landform design at each location.

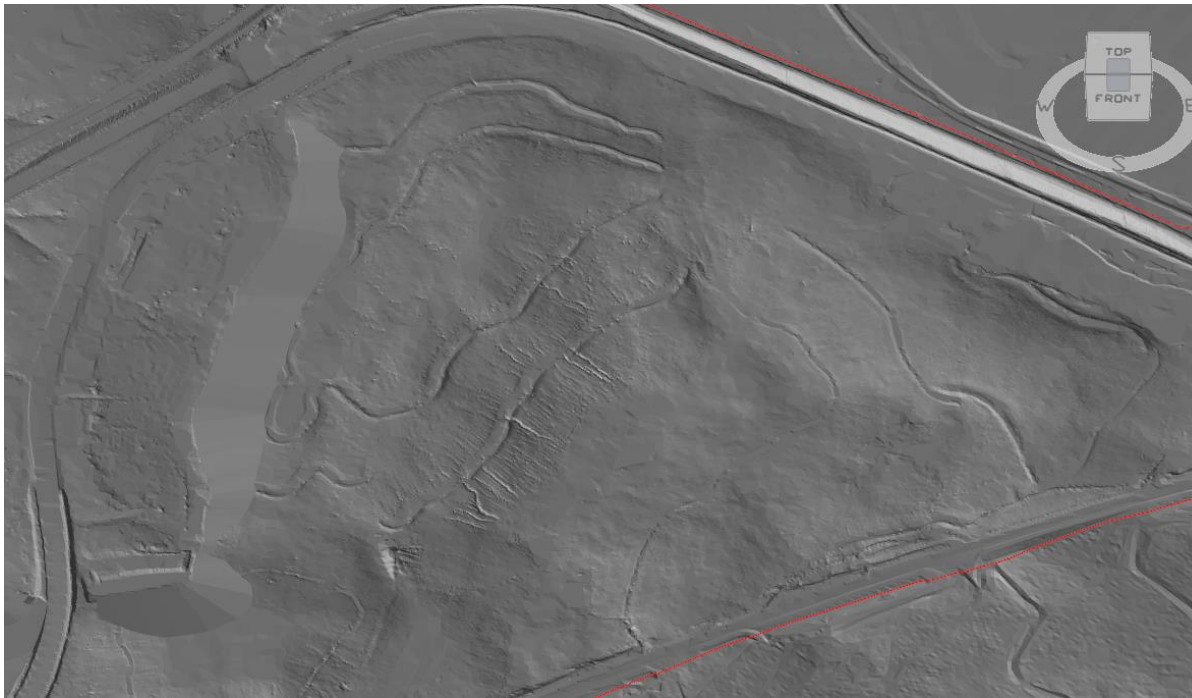
| Historic Rehabilitation Area | Dimensions |
|---|---|
| Landform footprint | 125 ha (Extent of repairs = 10 ha) |
| Landform height | 340 m AHD, ~15 m high from natural ground |
| Key design constraints and considerations | <p>Need to repair historic erosion features</p> <p>Previous contour arrangement did not support water shedding landform, need to re-establish drainage concept</p> <p>Aim to retain as much existing revegetated area as possible</p> |

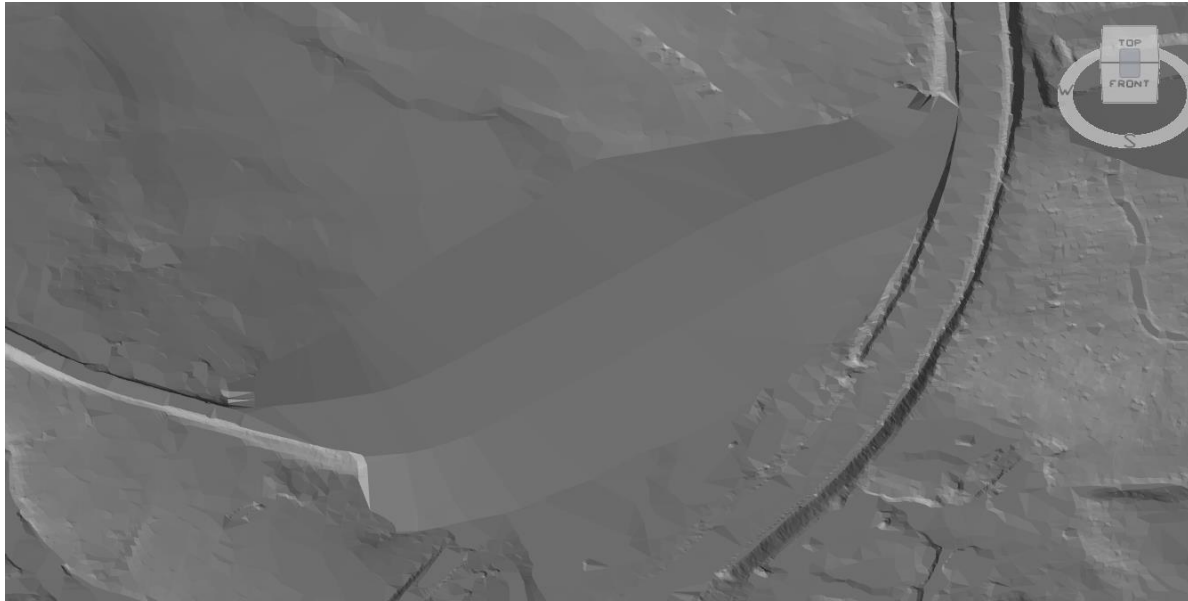
| West Dam Landform | Dimensions |

| West Dam Landform | Dimensions |
|---|---|
| Landform footprint | 4 ha |
| Landform height | 335 m AHD, ~10 m high from natural ground |
