CLERMONT

GLENCORE

# Progressive Rehabilitation and Closure Plan (PRC Plan)

January 2023

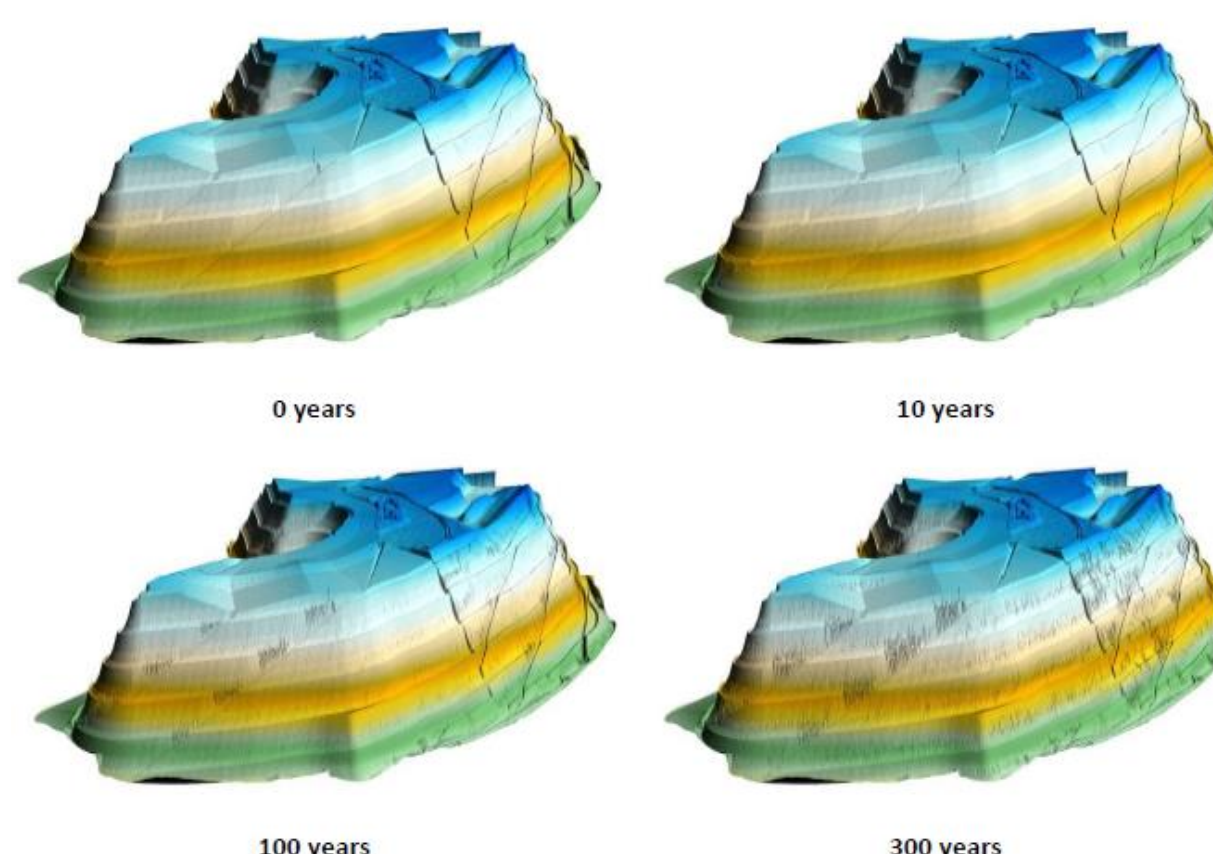
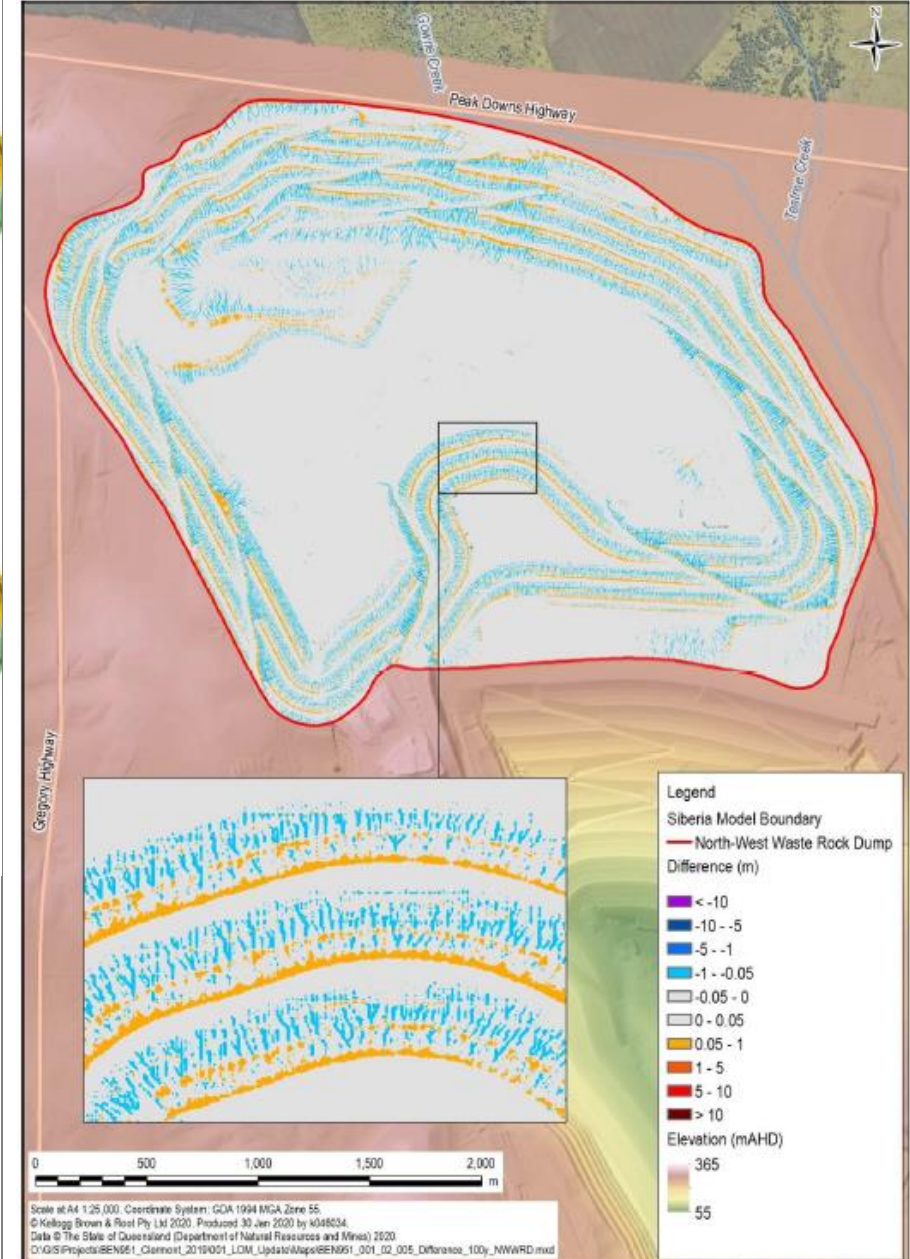
| Landform as it transforms from 0 years (design) to 300 years | 'Difference' map comparing the 100 year surface to the 0 year surface | Description |
|---|---|---|
| <div><p>Northern Waste Rock Dump</p><p>0 years      10 years</p><p>100 years      300 years</p><p>5 x vertical exaggeration has been applied</p></div> | <div><p>Northern Waste Rock Dump erosion and deposition at 100 years</p><p>Orange zones indicate deposition and blue indicates erosion.</p></div> | <div><p>Tri-linear slope concept performs well.</p><p>Erosion begins to develop around the 100 year point but is stable overall.</p><p>There is a loss from the trilinear slope sections upslope of the benches of between 5-100 cm, which is then deposited locally in the benches below.</p><p>Net erosion from the landform falls within the benchmarked target erosion rate.</p></div> |

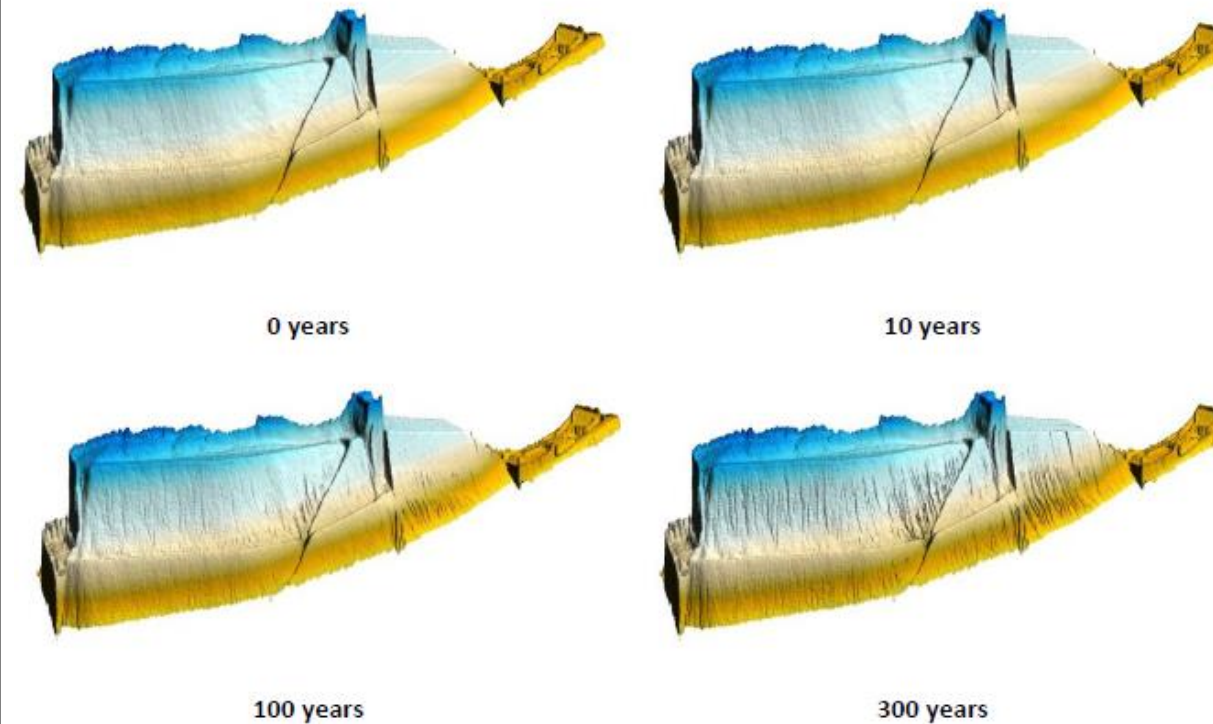
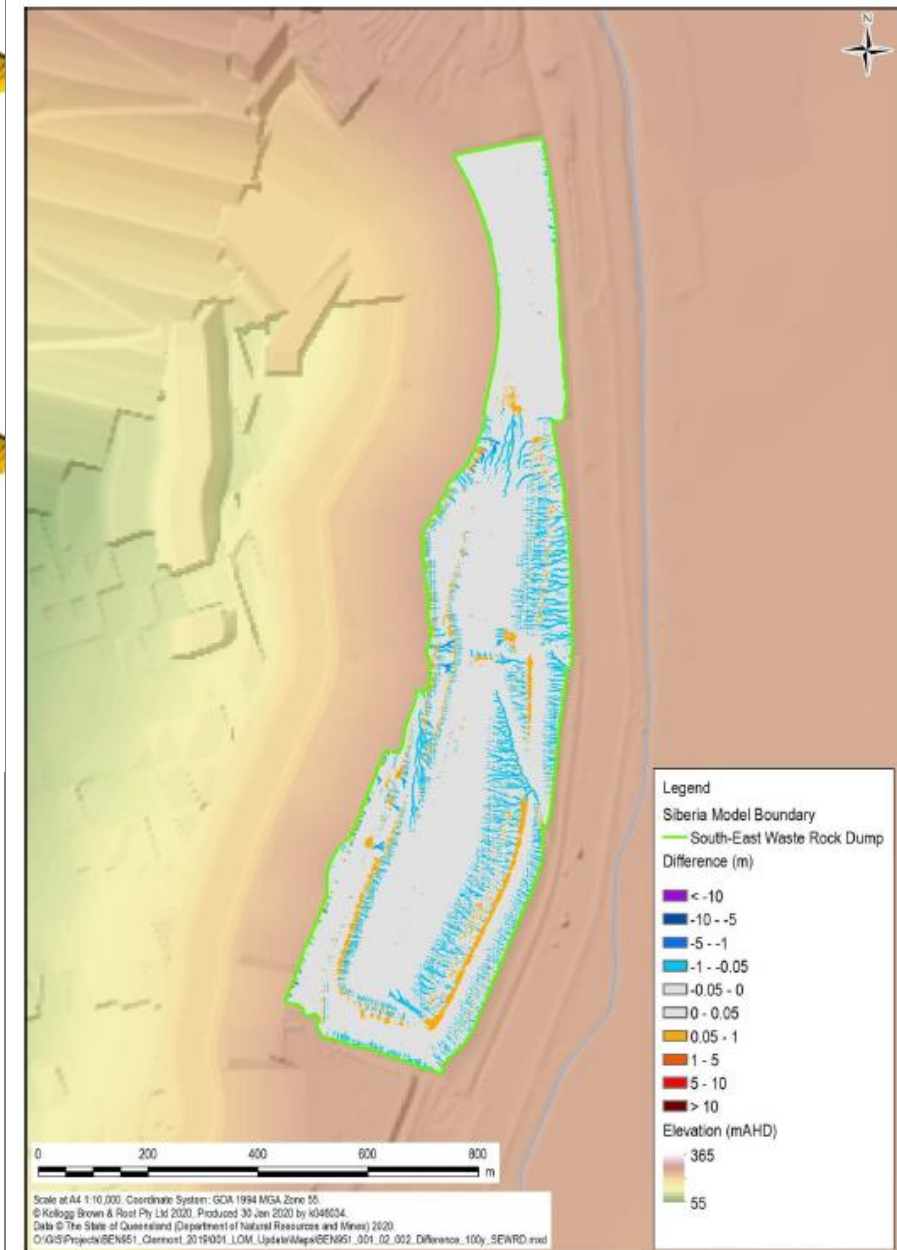
| Landform as it transforms from 0 years (design) to 300 years | 'Difference' map comparing the 100 year surface to the 0 year surface | Description |
|---|---|---|
| <div><div><div><div><div>South-east Waste Rock Dump</div><div><div>0 years10 years100 years300 years</div></div><div>5 x vertical exaggeration has been applied</div></div></div></div><div><div>South-east Waste Rock Dump erosion and deposition at 100 years</div><div><div>Orange zones indicate deposition and blue indicates erosion.</div></div></div><div><div>Modelling was run on the eastern face of the SEWRD, as shown.</div><div>The eastern face is approximately 30 m high with a single bench, which conforms to the general concept design (15 m lifts). However, given that the landform elevation is less than a typical tri-linear section, the overall slope is 20% vs the average tri-linear slope of approximately 18% (30%, 20% and 10%).</div><div>The tri-linear slope concept performs well under simulation, with a rate of soil loss of 5-100 cm over 100 years. The sediment is deposited locally in the bench below.</div><div>Net erosion from the landform falls within the benchmarked target erosion rate.</div></div></div> | | |

| Landform as it transforms from 0 years (design) to 300 years | 'Difference' map comparing the 100 year surface to the 0 year surface | Description |

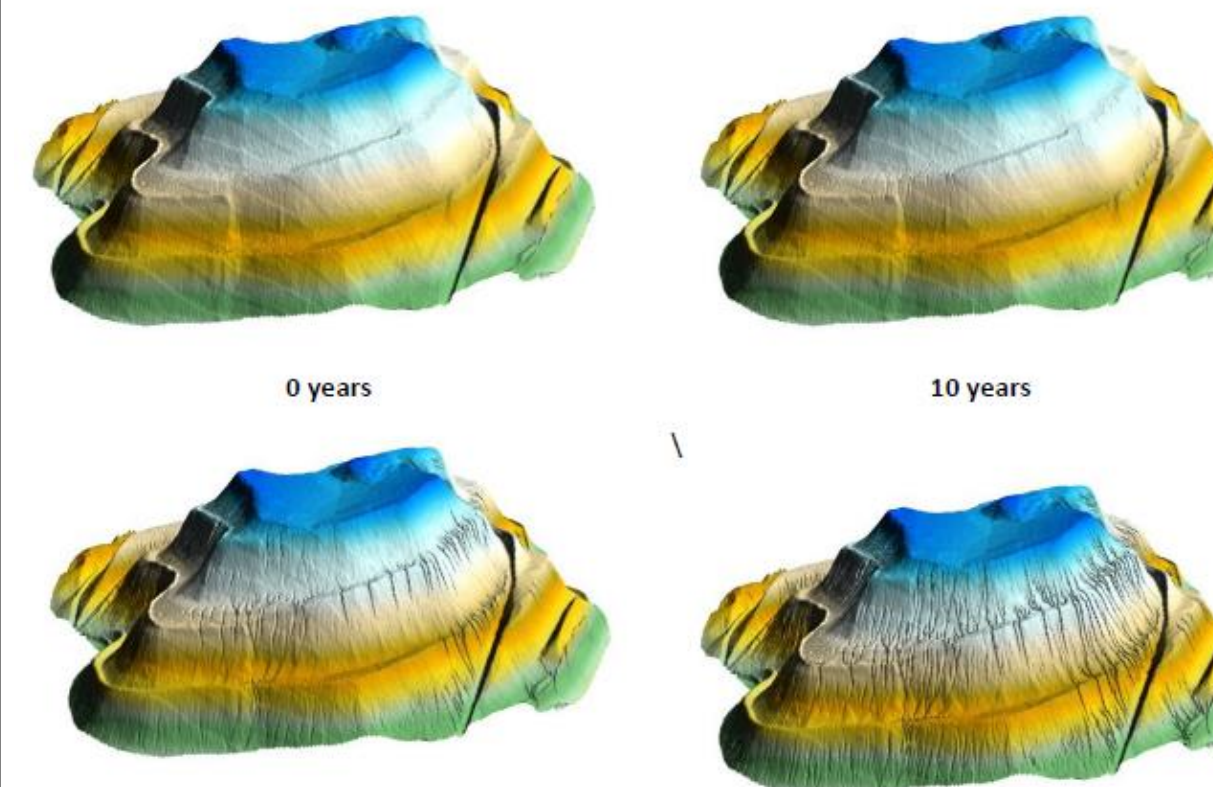
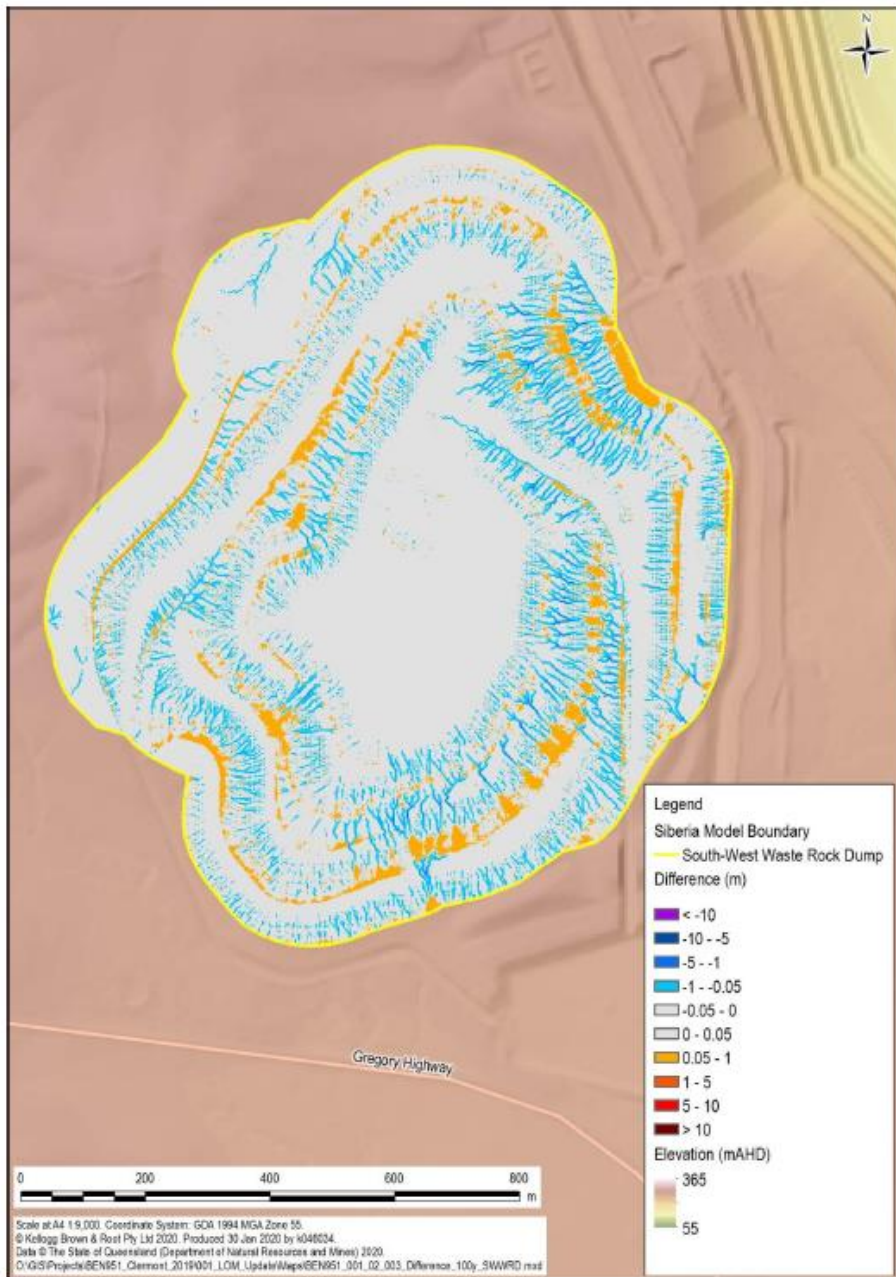
| Landform as it transforms from 0 years (design) to 300 years | 'Difference' map comparing the 100 year surface to the 0 year surface | Description |
|---|---|---|
| <div><div><div>South-west Waste Rock Dump</div><div><div><div>0 years</div><div>10 years</div><div>100 years</div><div>300 years</div></div></div><div><div>5 x vertical exaggeration has been applied</div></div></div></div> | <div><div>South-west Waste Rock Dump erosion and deposition at 100 years</div><div><div>Orange zones indicate deposition and blue indicates erosion.</div></div></div> | <div><div>The tri-linear design has been applied to the SWRD.</div><div>The tri-linear slope concept performs well under simulation, with a rate of soil loss of 5-100 cm over 100 years. The sediment is deposited locally in the bench below.</div><div>Net erosion from the landform falls within the benchmarked target erosion rate.</div></div> |
