## **Environmental authority P-EA-100121435**

| Environmentally relevant activities | Locations |
|---|---|
| ERA 63 - Sewage Treatment 1(e) - Operating sewage treatment works, other than no-release works, with a total daily peak design capacity of more than 10,000 but not more than 50,000EP | Lots 2 and 3 Plan RP223470; Lot 1 Plan SL3427; Lot 254 Plan S31102; and Lots 83, 84, 86, 255, 256, 257 and 259 on Plan S312432. |

SOUTHERN REDLAND BAY WASTEWATER TREATMENT PLANT  
CONCEPT REHABILITATION PLAN - DETAIL SHEET 05

R01v05\_20020099\_Southern\_Redland\_Bay\_Stage\_3\_Assessments

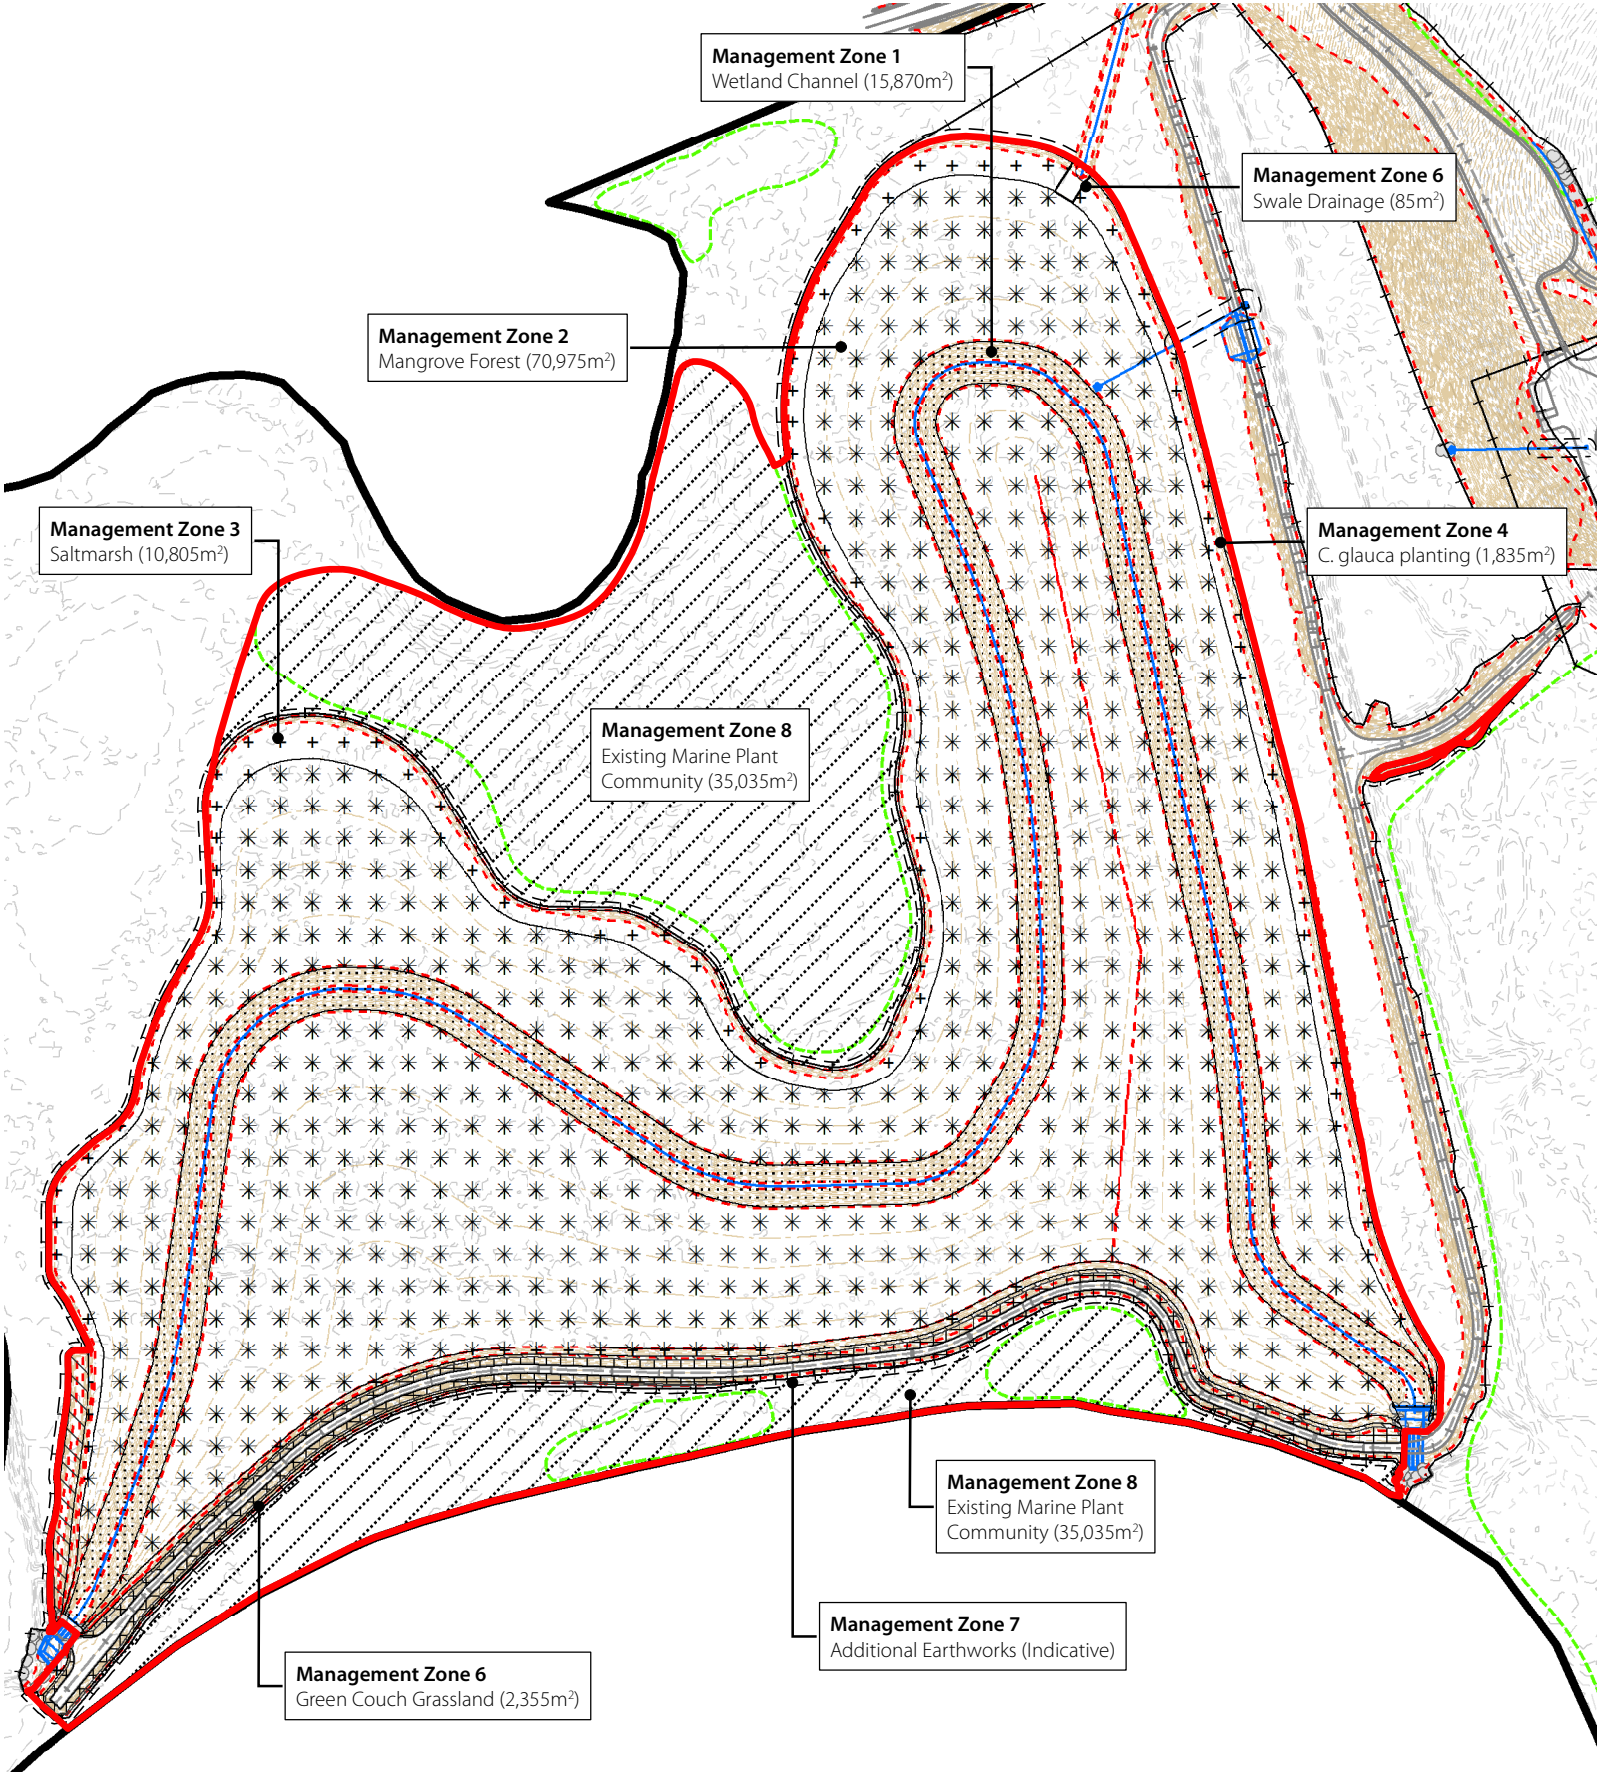
CONCEPT REHABILITATION PLAN - MANAGEMENT ZONES

In accordance with the SEQERF, the rehabilitation design comprising distinct management zones, provides assessment managers, clients and contractors a clear methodology to assist creation of the new mangrove wetland / saltmarsh. The management zones are described in detail below. This zoning has been informed by site assessments, preliminary advice from other consultants and individuals, the Queensland Government’s Fish Habitat Guidelines and SEQERF, EMR Protocol and previous rehabilitation project experience. Refer to Rehabilitation notes for additional details, plant species and densities.

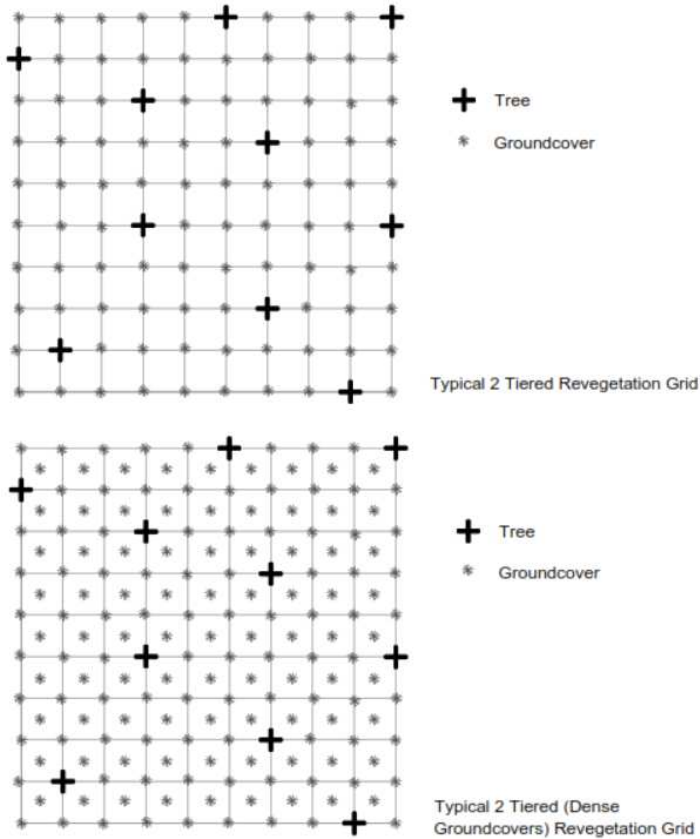
Planting locations shall be generally set out in accordance with a typical random grid pattern as shown below. Various typical densities shown. Refer to plant schedule for species and planting densities.

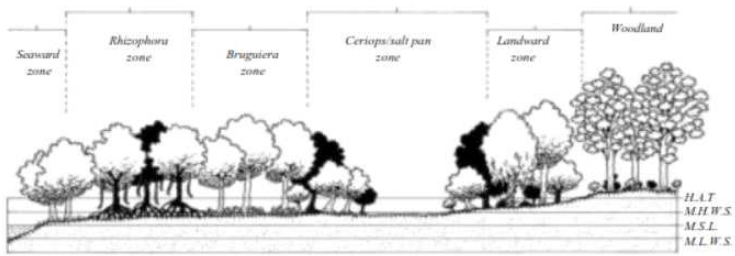
Mangrove planting set out should also consider the tidal character of the site to increase the success rate of plant community establishment. If the site is at the outer edge of the mangrove fringe along a foreshore, then the use of appropriate pioneering species (e.g. *Avicennia* spp. and *Rhizophora* spp.) that are most likely to be able to sustain higher tidal inundation is recommended. If the area to be planted is a disturbance path through the tidal profile (e.g. a transect from the foreshore to the landward edge of the mangrove area), then a variety of species according to their typical occurrence in the tidal range is recommended. A typical zonation arrangement for mangroves in SEQ is shown below.

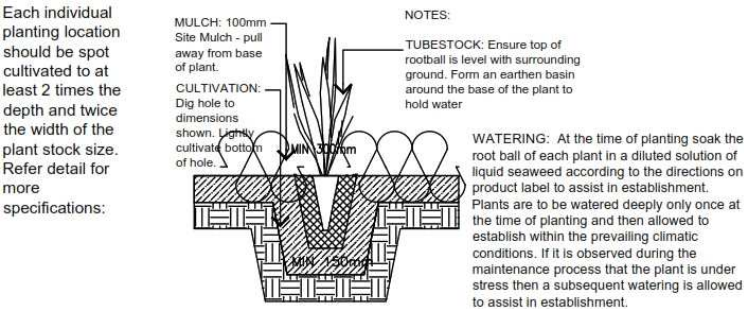
Typical planting details as below for standard medium mulch installation and jute netting. Refer to manufacturer's recommendations for detailed jute netting installation including pinning, etc.

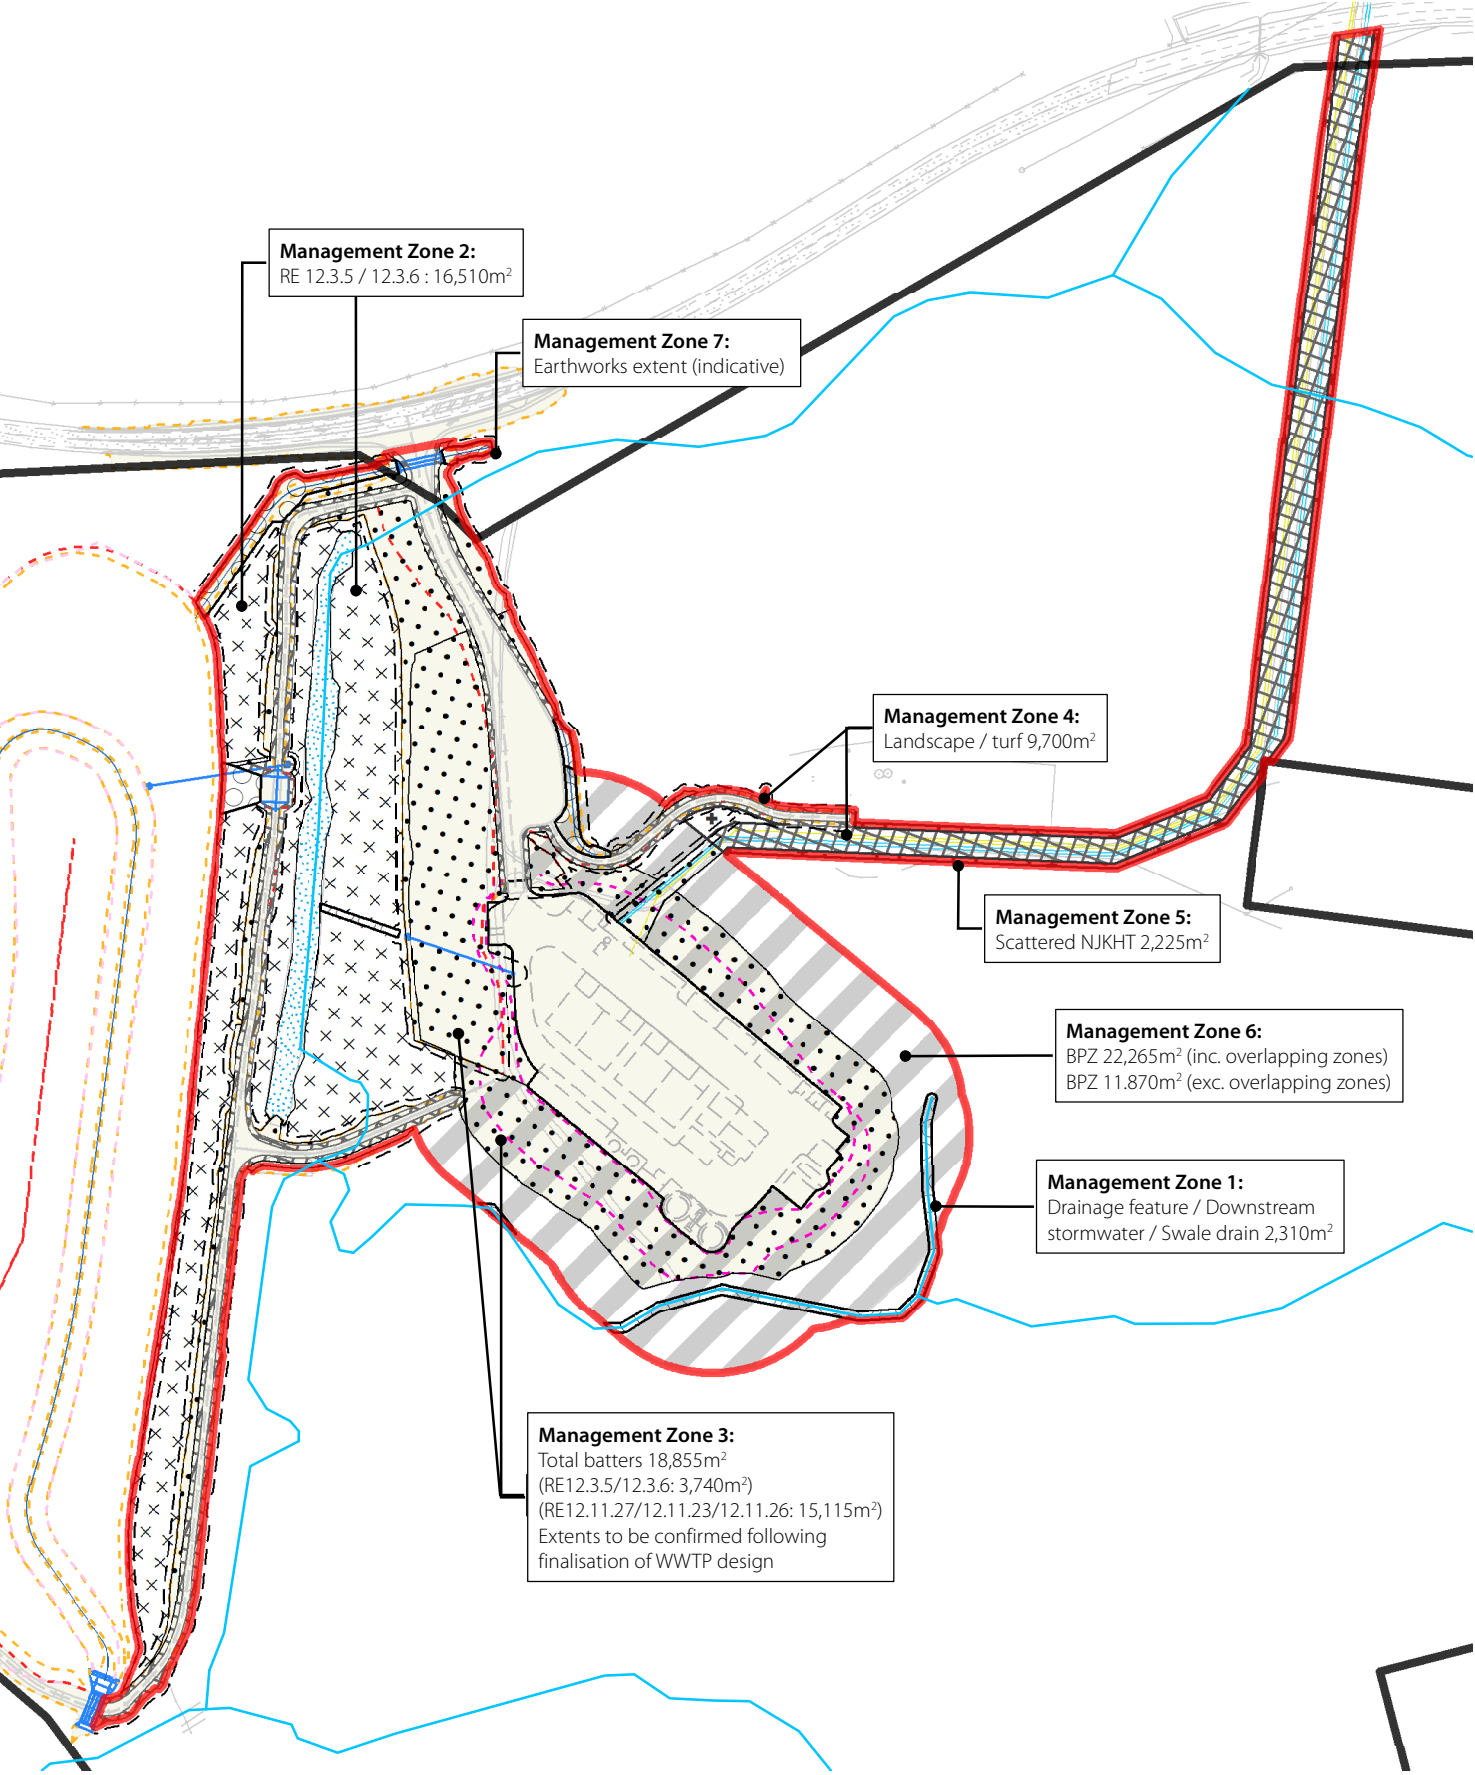
CONCEPT REHABILITATION PLAN - MANAGEMENT ZONES

Management Zone 1: Drainage feature / Downstream stormwater outlet / swale drain (Fabrication)

Zone to be finalised by civil contractor appropriately prior to rehabilitation works, including, but not limited to: cultivation and scarification to media, installation of final media profile to approved levels / depths, and conducting all tests (flow, conductivity etc.) as required by the assessment manager.

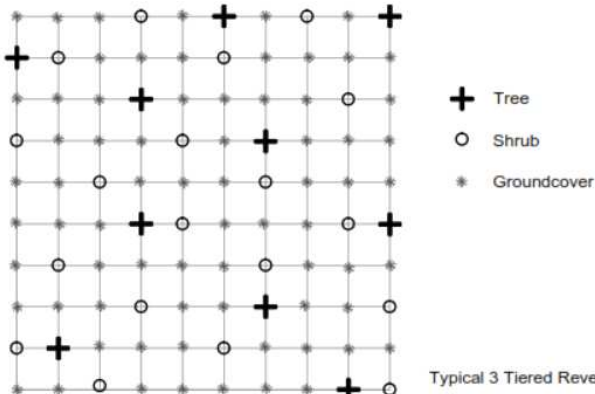
Typical 3 Tiered Revegetation Grid

Revegetation planting locations shall be generally set out in accordance with a typical random grid pattern as shown below. Various typical densities shown. Refer to plant schedule for species and planting densities.

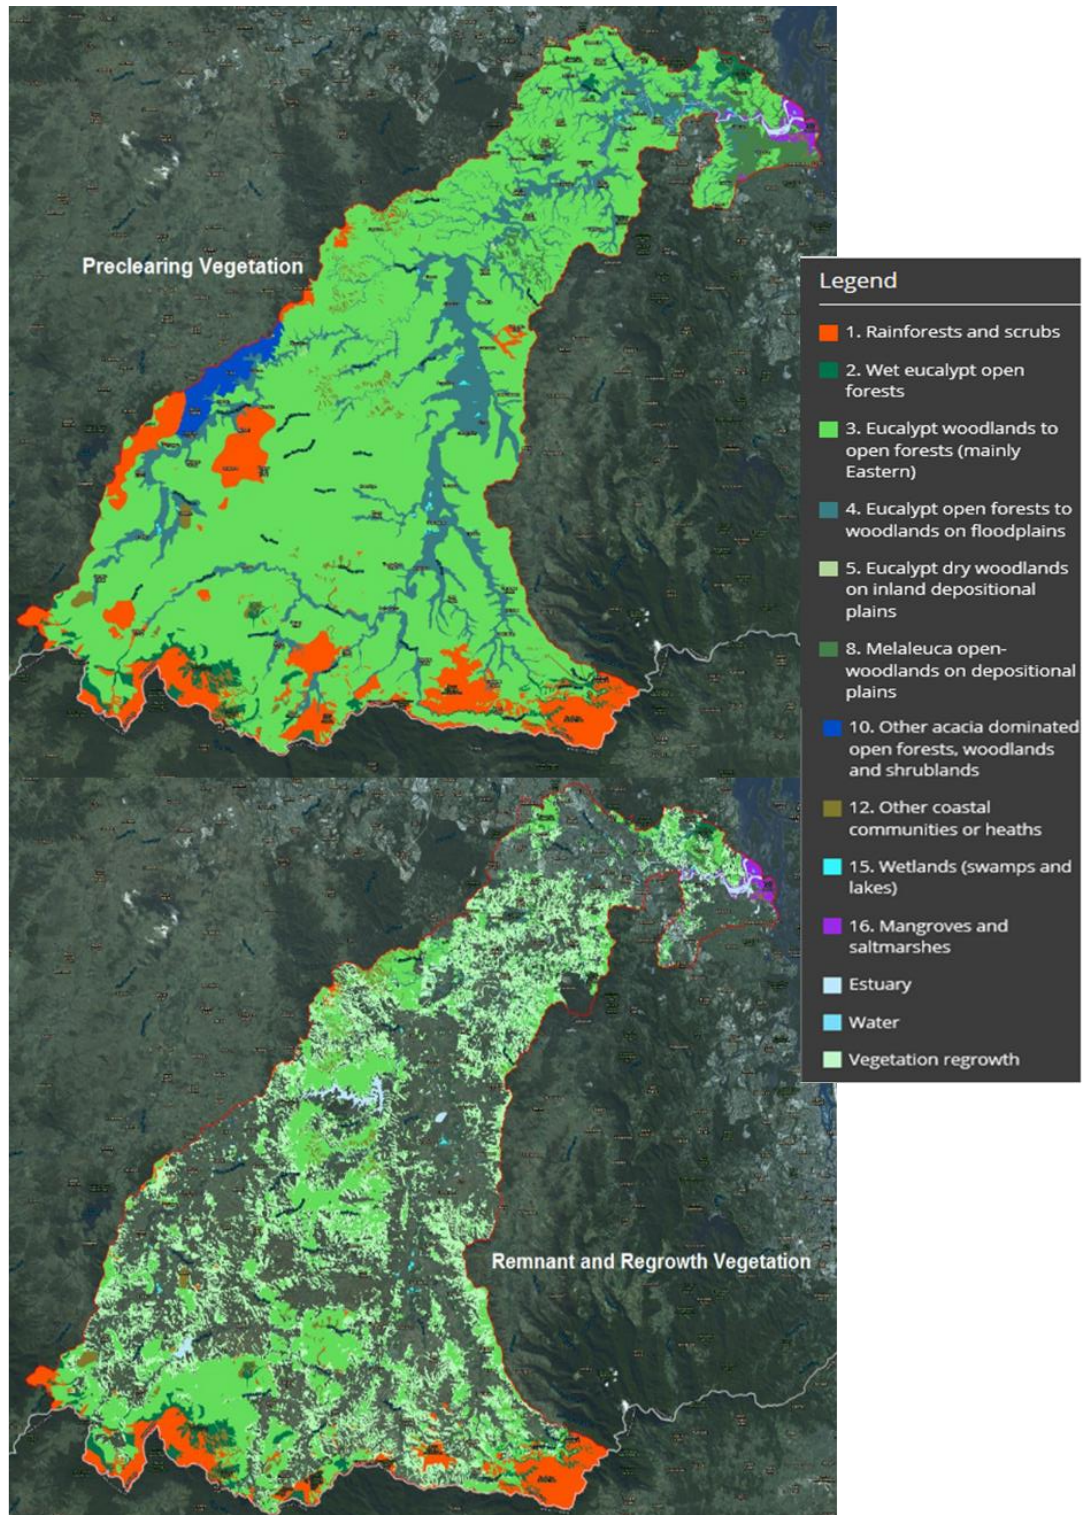
**FIGURE 2-2 PRECLEARING VS EXISTING STATE OF VEGETATION COVERAGE IN THE LOGAN CATCHMENT**  
(SOURCE: WETLAND INFO, DES)

Historically, most of the headwaters of the Logan catchment comprised large areas of rainforest and scrub, together with wet eucalypt forests. The lower catchment area (where the site is located) comprised large areas of melaleuca woodlands, together with wet eucalypt and mangrove forests, which made up the preclearing vegetation condition of the region (Figure 2-2).

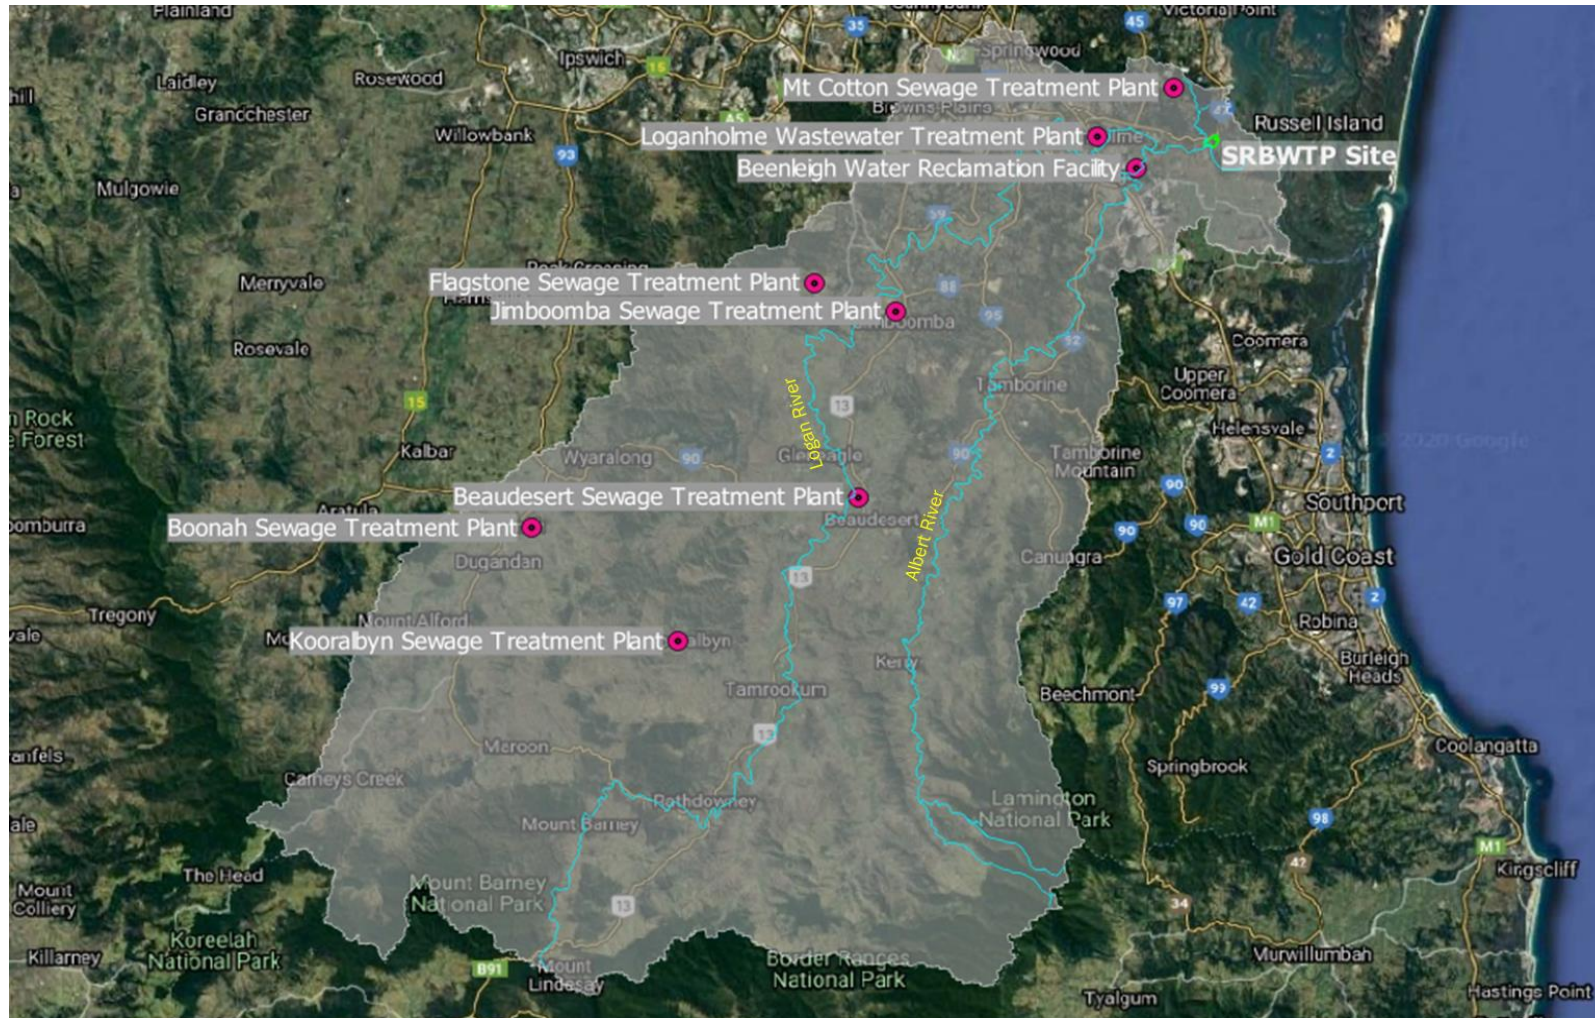
FIGURE 2-3 SEWAGE TREATMENT FACILITIES UPSTREAM OF THE SRBWTP SITE

In the Lower Logan sub-catchment, water quality is heavily influenced by land use, including stormwater runoff. Water quality is also heavily influenced by point source inputs such as sewage treatment plants, septic tank seepage and stormwater discharge. In the overall Logan sub-catchment, there are several sewage treatment plants, including Kooralbyn, Boonah, Beaudesert, Flagstone, Jimboomba, Eagleby, Loganholme and Mount Cotton, all of which discharge directly or indirectly into the Logan River (Figure 2-3 and Table 2-2). Of these, the Lower Logan sub-catchment treatment plants at Loganholme (> 100,000 EP capacity) and Mount Cotton (10,000 – 50,000 EP capacity) discharge into the Logan River and the Beenleigh Water Reclamation Facility (50,000 – 100,000 EP capacity) discharges into the Albert River. Although DES reports that the Loganholme STP alone services >100,000 EP, according to Logan City Council factsheets the capacity of the treatment plant is as follows:

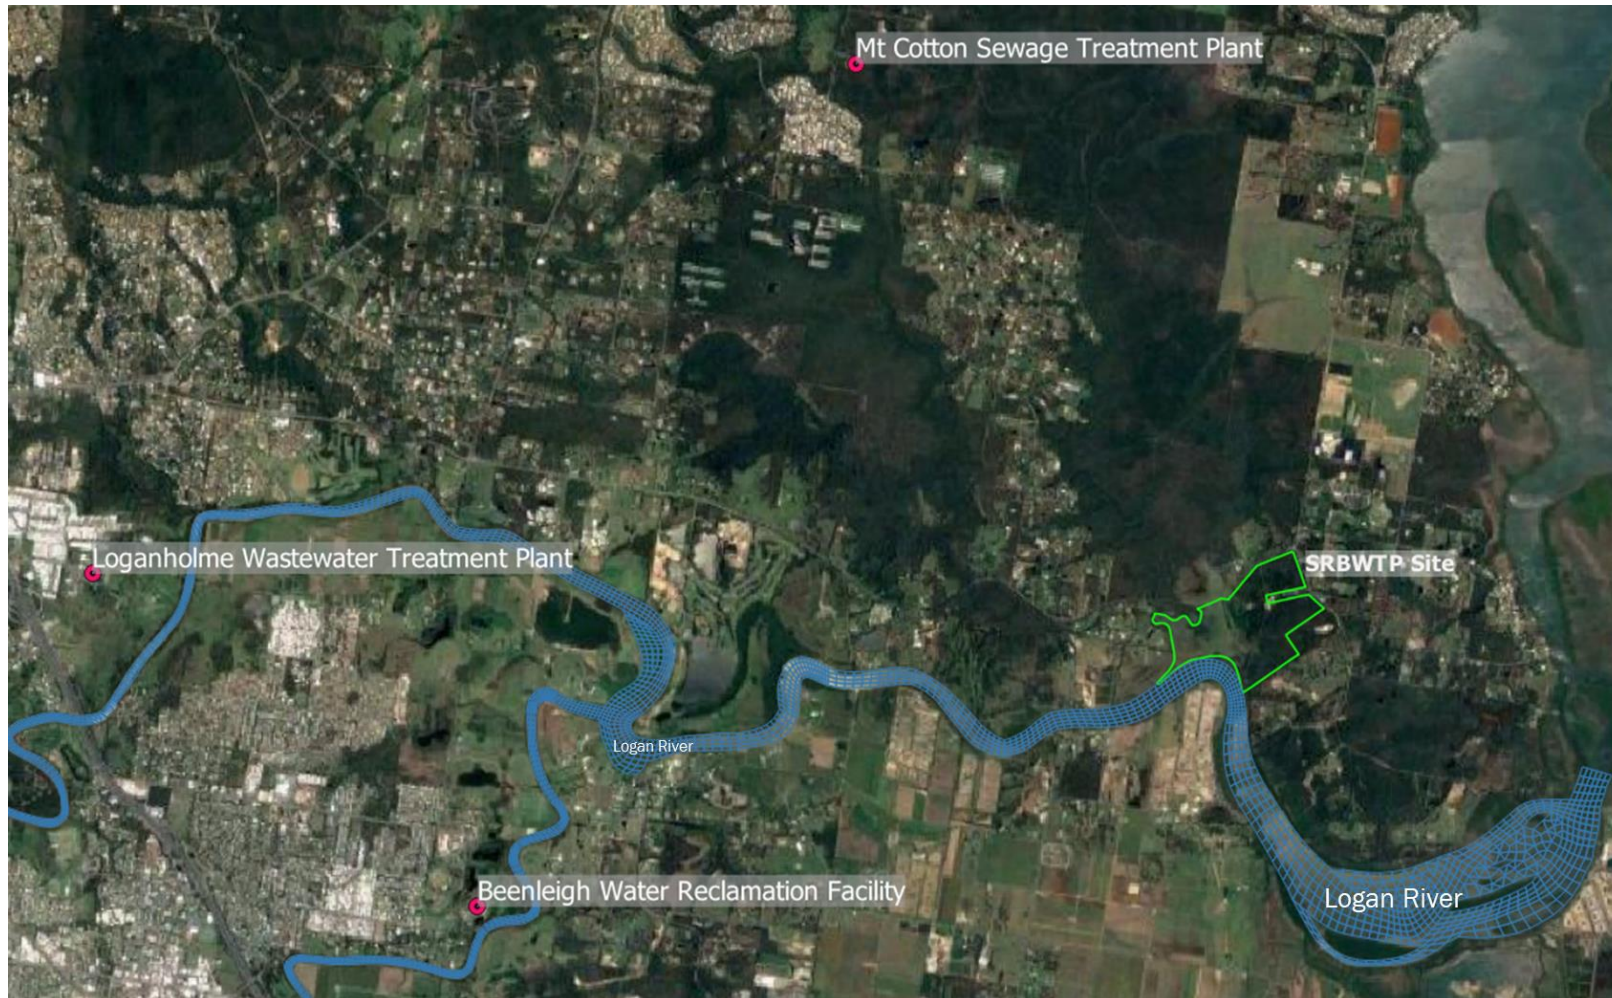
FIGURE 2-4 SRBWTP SITE ALONG THE LOGAN RIVER

The proposed SRBWWTP site is located to the south of 38 Longland Road, Redland Bay, on an outer bend of the Logan River, about 7.5 km upstream from the mouth of the river (Figure 2-4). The site is approximately 75 hectares (ha) in area and extends over four (4) lots within the Redland City Council, bearing lot numbers 3RP223470, 2RP223470, 254S31102 and 1SL3427. It is proposed that the project will consist of a Mangrove Offset Area (MOA) and Freshwater Storage Lagoon (FSL), and an adjacent WWTP to the east of the site. Adjacent to the lots, on the western side, is Logan City Council, at the southern end is the Logan River, rural property is on the eastern side and the northern side of the area is adjacent to the Beenleigh Redland Bay Road. The Southern Redland Bay WWTP will service 13,500 EP, this being some 5% of the population **already** being serviced by existing sewage treatment facilities in the Lower Logan sub-catchment, without considering the five other facilities elsewhere in the catchment.

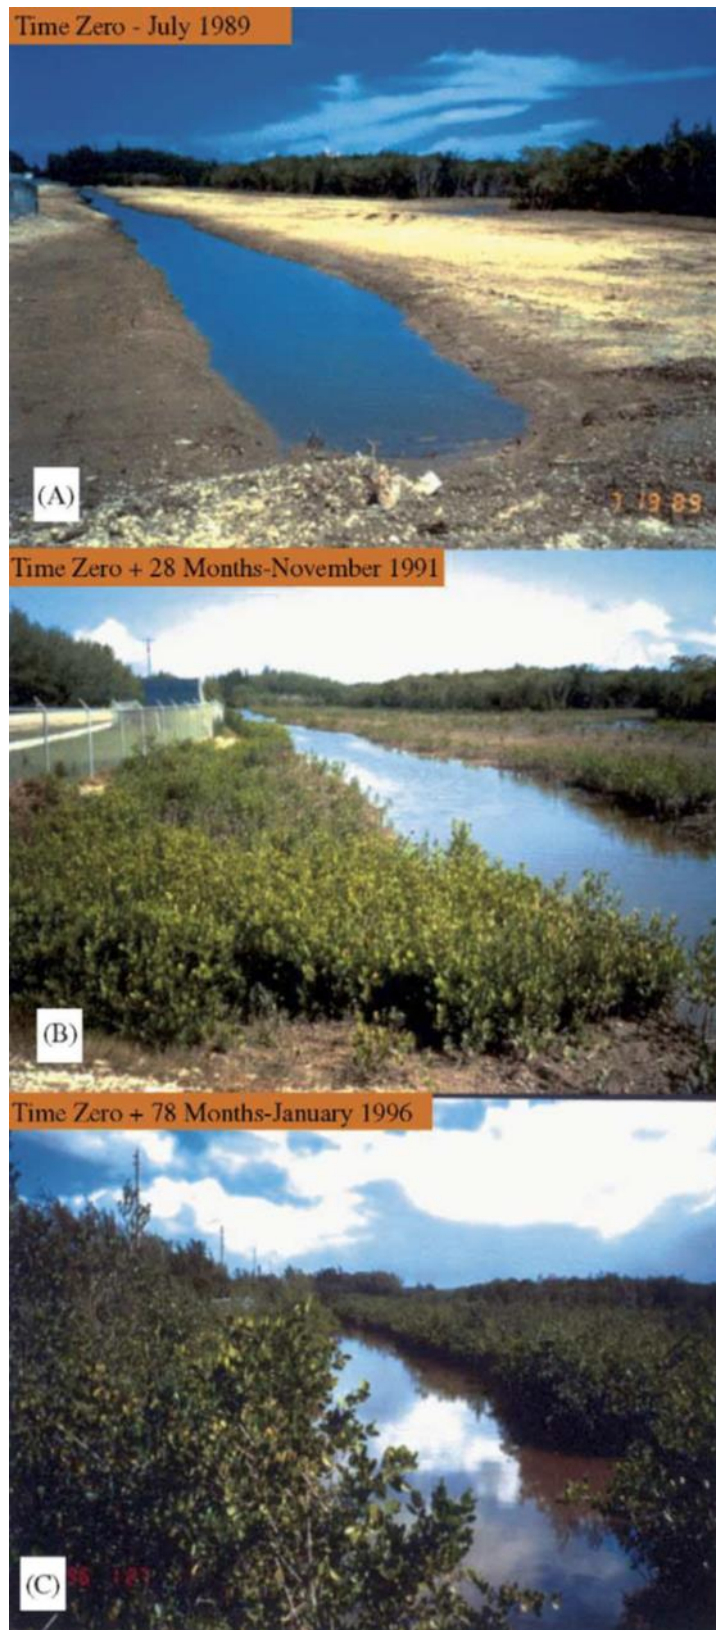
**FIGURE 3-1 HYDROLOGIC MANGROVE RESTORATION PROJECT AT WEST LAKE PARK, HOLLYWOOD, FL, USA (A) JULY 1989 (B) NOVEMBER 1991 AND (C) JANUARY 1996. NO PLANTING OF MANGROVES OCCURRED**

**West Lake, Florida** - Figure 3-1 shows a time sequence over a period of 78 months from the completion of a portion of the hydrologic restoration of a 500 ha mangrove restoration site at West Lake near Fort Lauderdale, Florida. The procedure involved the excavation of historically filled-in mangrove wetlands. Success resulted from using the adjacent undisturbed forest as a reference site to achieve final constructed grades (elevations). Extensive constructed tidal creeks were also added to the original plans, which had been designed without them. No planting of mangroves took place or was necessary. The hydrologic restoration reconnected impounded mangroves to normal tidal influence (Lewis III, R.R., 2005).

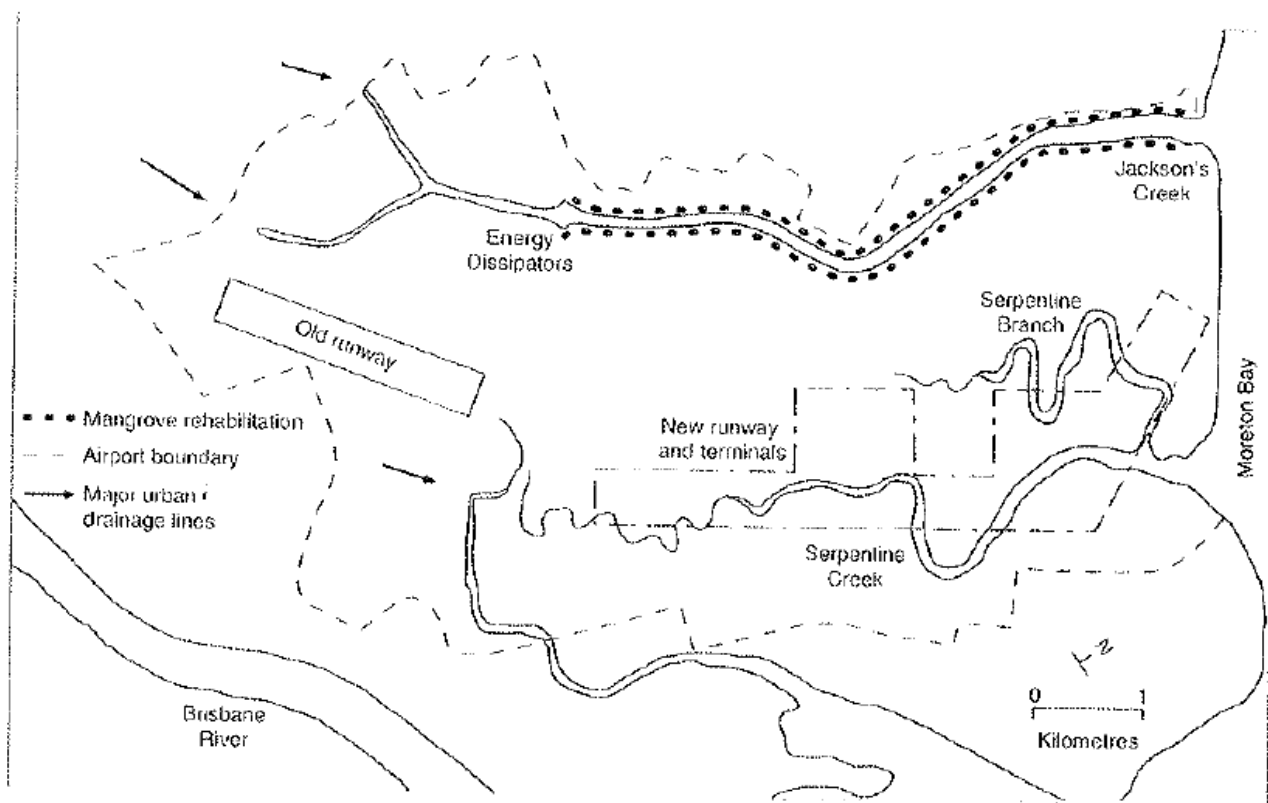
**FIGURE 3-2 LOCALITY MAP SHOWING THE MANGROVE REHABILITATION AREA AND FORMER SERPENTINE CREEK IN THE AREA OF THE NEW BRISBANE AIRPORT (SOURCE: SAENGER, 1996)**

**Brisbane Airport, Brisbane** - Closer to home, similar focused attention to the topographic grade relative to adjacent natural mangroves in constructed mangrove wetlands was shown to be the key to success in a project at the Brisbane International Airport (Saenger, 1996). The rehabilitation process involved hydrologic restoration by channel digging and subsequent reforestation. Emeritus Professor Peter Saenger was contacted by email for further insights into this development and its success. Prof. Saenger provided references to his prior work at the Brisbane Airport and confirmed that most of the work involved 'moving' Serpentine Creek (See Figure 3-2, not to be confused with Serpentine Creek in proximity to the proposed MOA site) by excavating a new drainage line and stabilising it with mangroves (which was also the cheapest option at the time). Survival rates of the mangroves were monitored and reported from the time of initial planting (1981) until twelve years later (1993) which showed that the survival and growth rates of the plants were good and that within four to five years, natural recruitment was apparent. Consequently, a self-maintaining mangrove system had become established. He is also in support of improving the EMR protocols.

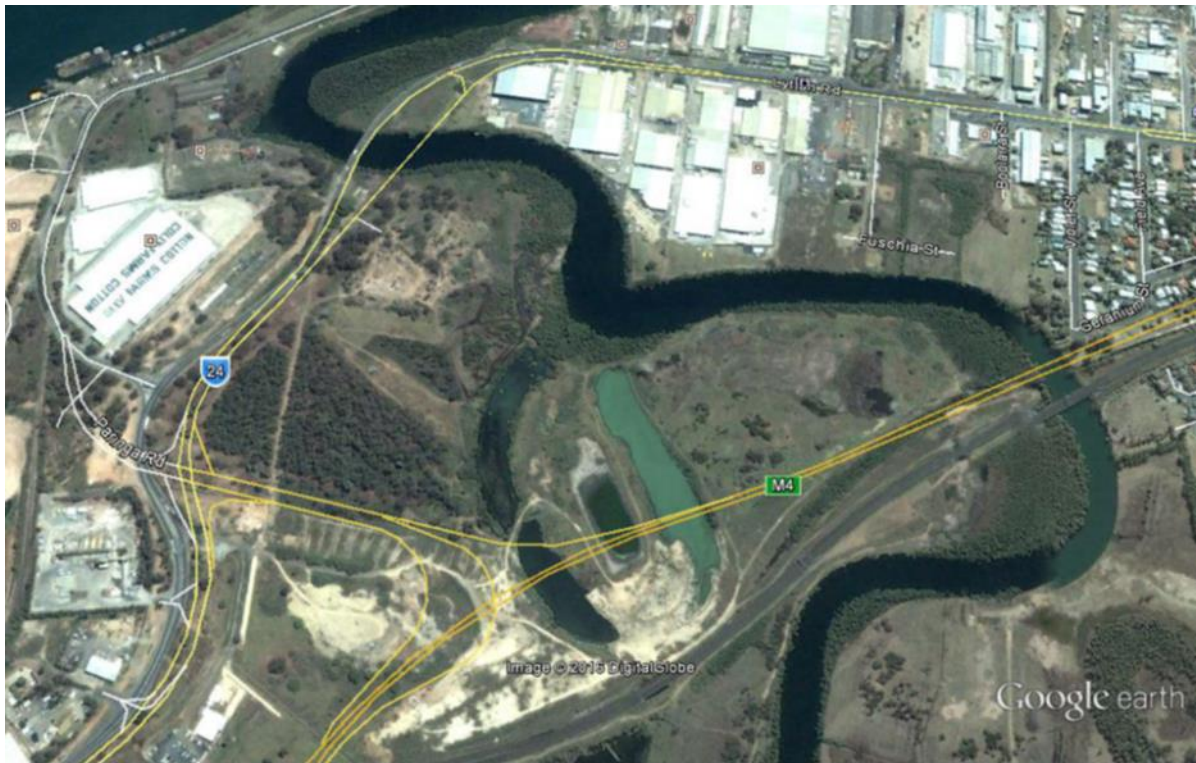
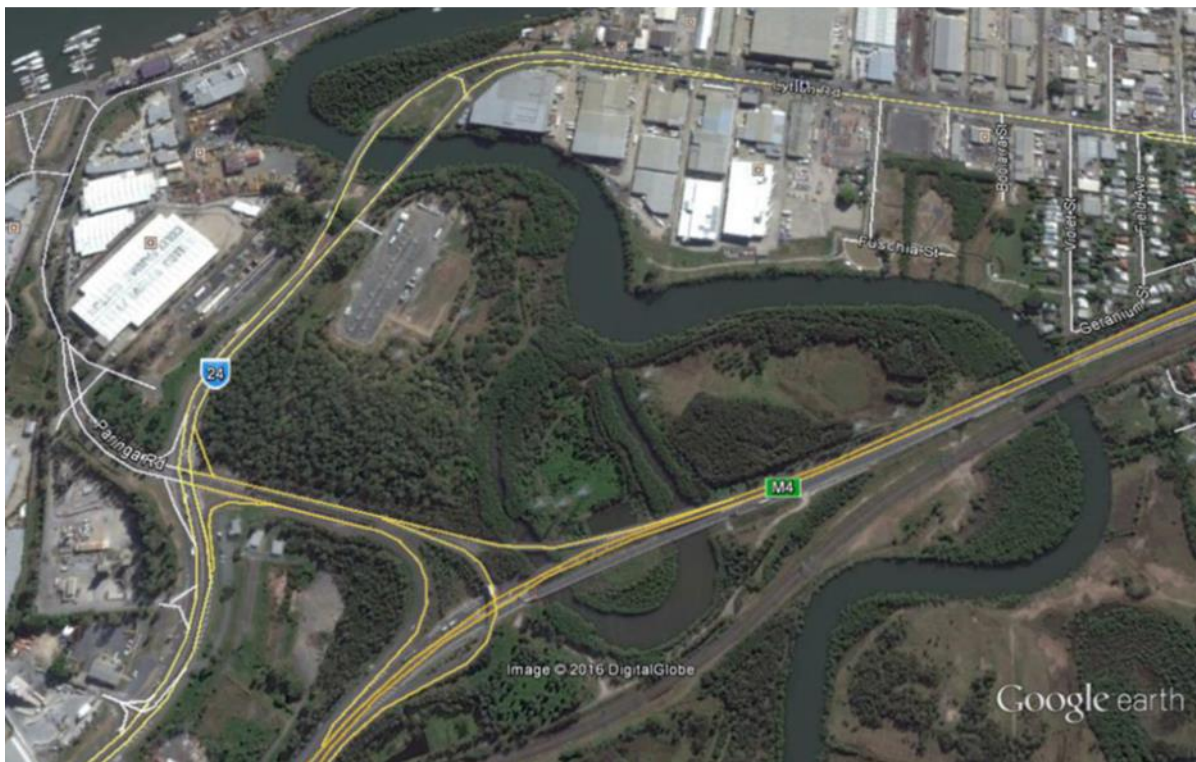
**FIGURE 3-3 BULIMBA-OXBOW MANGROVE REHABILITATION PROJECT PROGRESS - AERIALS OF THE SITE IN 2010 (TOP) AND 2017 (BOTTOM)**

**Oxbow to Bulimba Creek, Brisbane** - Another example of successful mangrove establishment in the Brisbane region is the innovative hydraulic rehabilitation undertaken to open up the Oxbow to Bulimba Creek and laser-controlled levelling of the site to enable significant recovery of extensive tidal wetlands including saltmarsh and mangroves (Figure 3-3). The Bulimba Creek Catchment Coordinating Committee's saltmarsh project is involved in ongoing restoration of Bulimba Creek that began in the year 2000 as an offset to the Port of Brisbane Motorway construction. This long-term project has been studied extensively and has been recognised with at least eight awards (Knight, 2018).

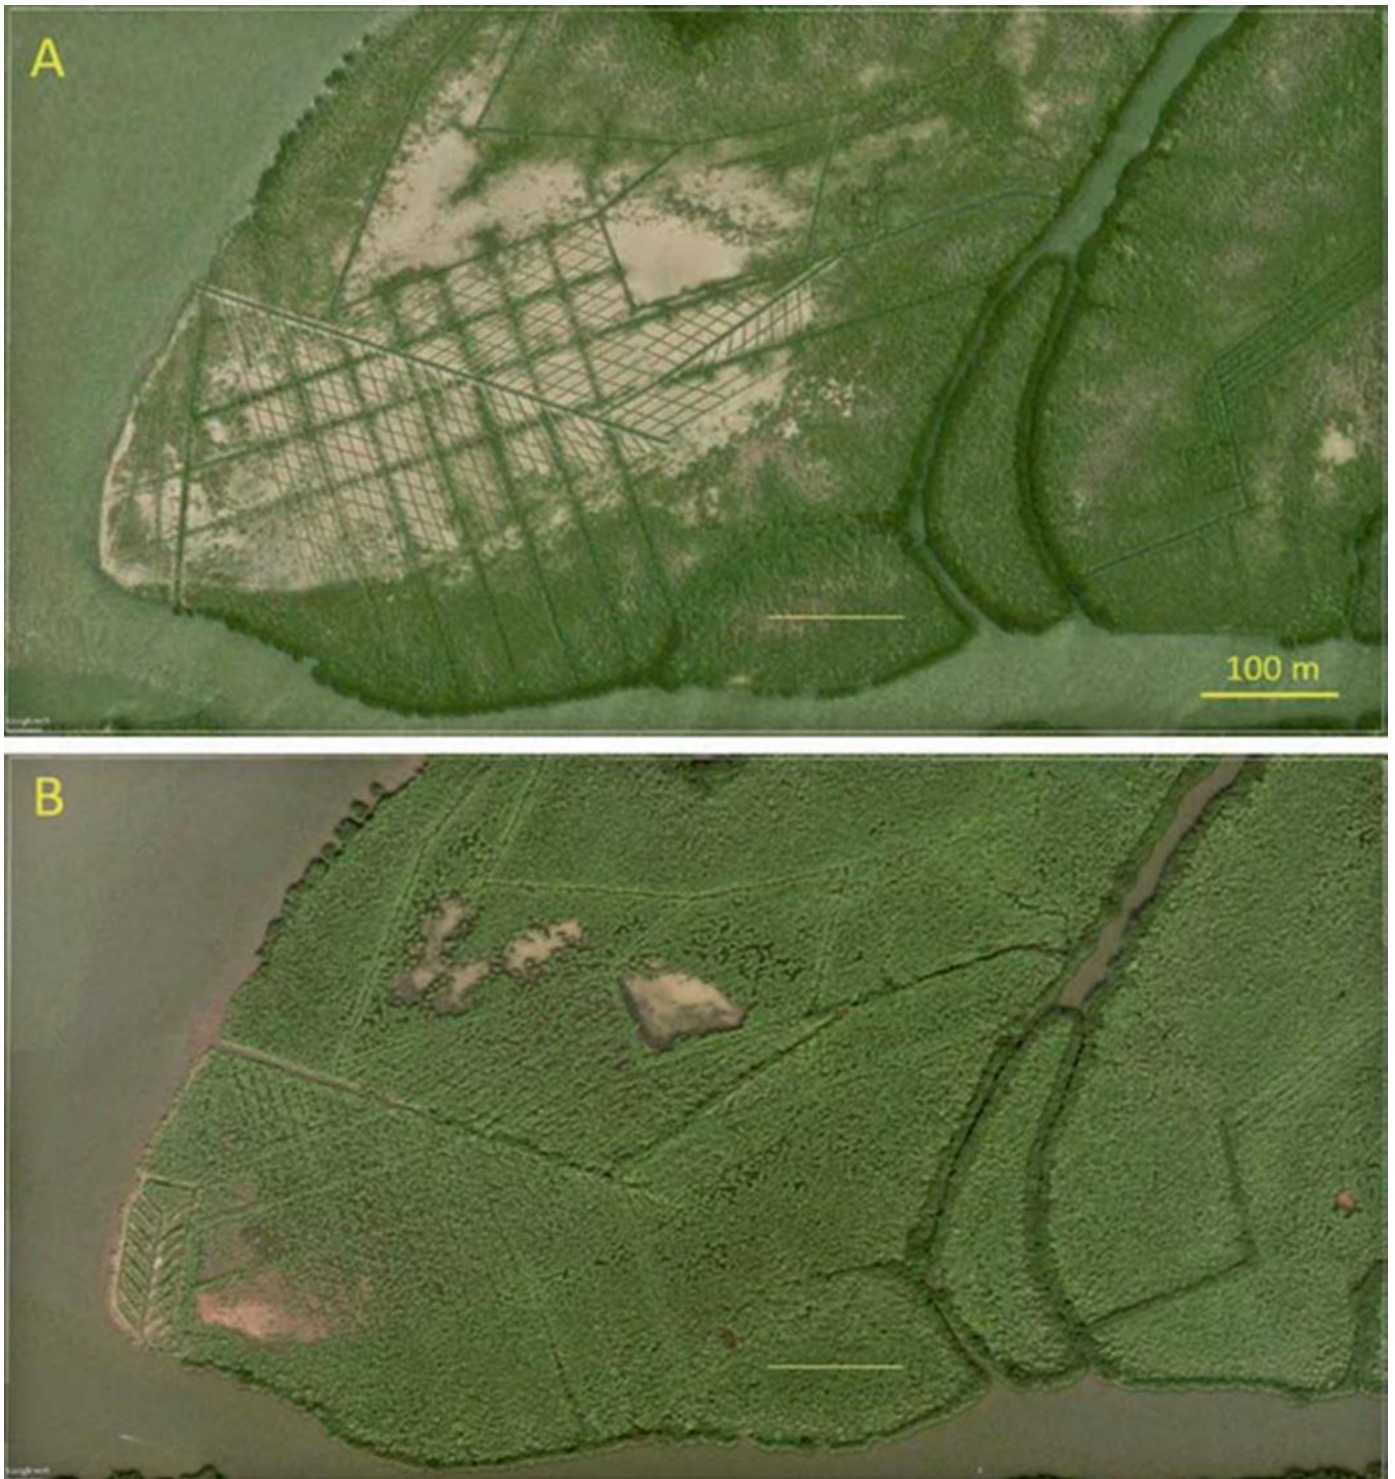
**FIGURE 3-4 HYDROLOGICAL RESTORATION IMPLEMENTED IN TAMIL NADU, INDIA, SHOWING ORIGINAL MAIN AND FEEDER CHANNELS EXCAVATED CIRCA 1996. SITE IN MARCH 2003 (ABOVE) AND SITE IN JANUARY 2016 (BELOW) (SOURCE: GOOGLE EARTH)**

**Southern States, India** - The states of Tamil Nadu and Andhra Pradesh in India constructed artificial channels through excavations (1 m deep, 1.5 m wide at the base and 3 m wide at the soil surface) and connections to natural adjacent channels (Figure 3-4). Feeder channels (0.75 m deep, 0.6 wide at the base, and 1.5 m wide at the soil surface) were also excavated throughout the die-back mangrove area, following a "fish bone" spatial pattern (Figure 3-4). The excavated sediments were deposited next to the channels, increasing soil relative elevation. This strategy was designed to re-establish water exchange between the mangrove die-back areas and the natural channels with the goal of increasing the survival rate of planted and naturally established seedlings. The technique (i.e., feeder channels) was first tested around 1996 in a pilot study involving 10 ha of dead mangrove wetland and resulted in the recovery of an extensive mangrove forest area (Figure 3-4). After it was demonstrated to be successful, it was used in other areas covering at least 1,200 ha of impacted mangrove sites in the region (Selvam et al., 2005, López-Portillo et al., 2017).

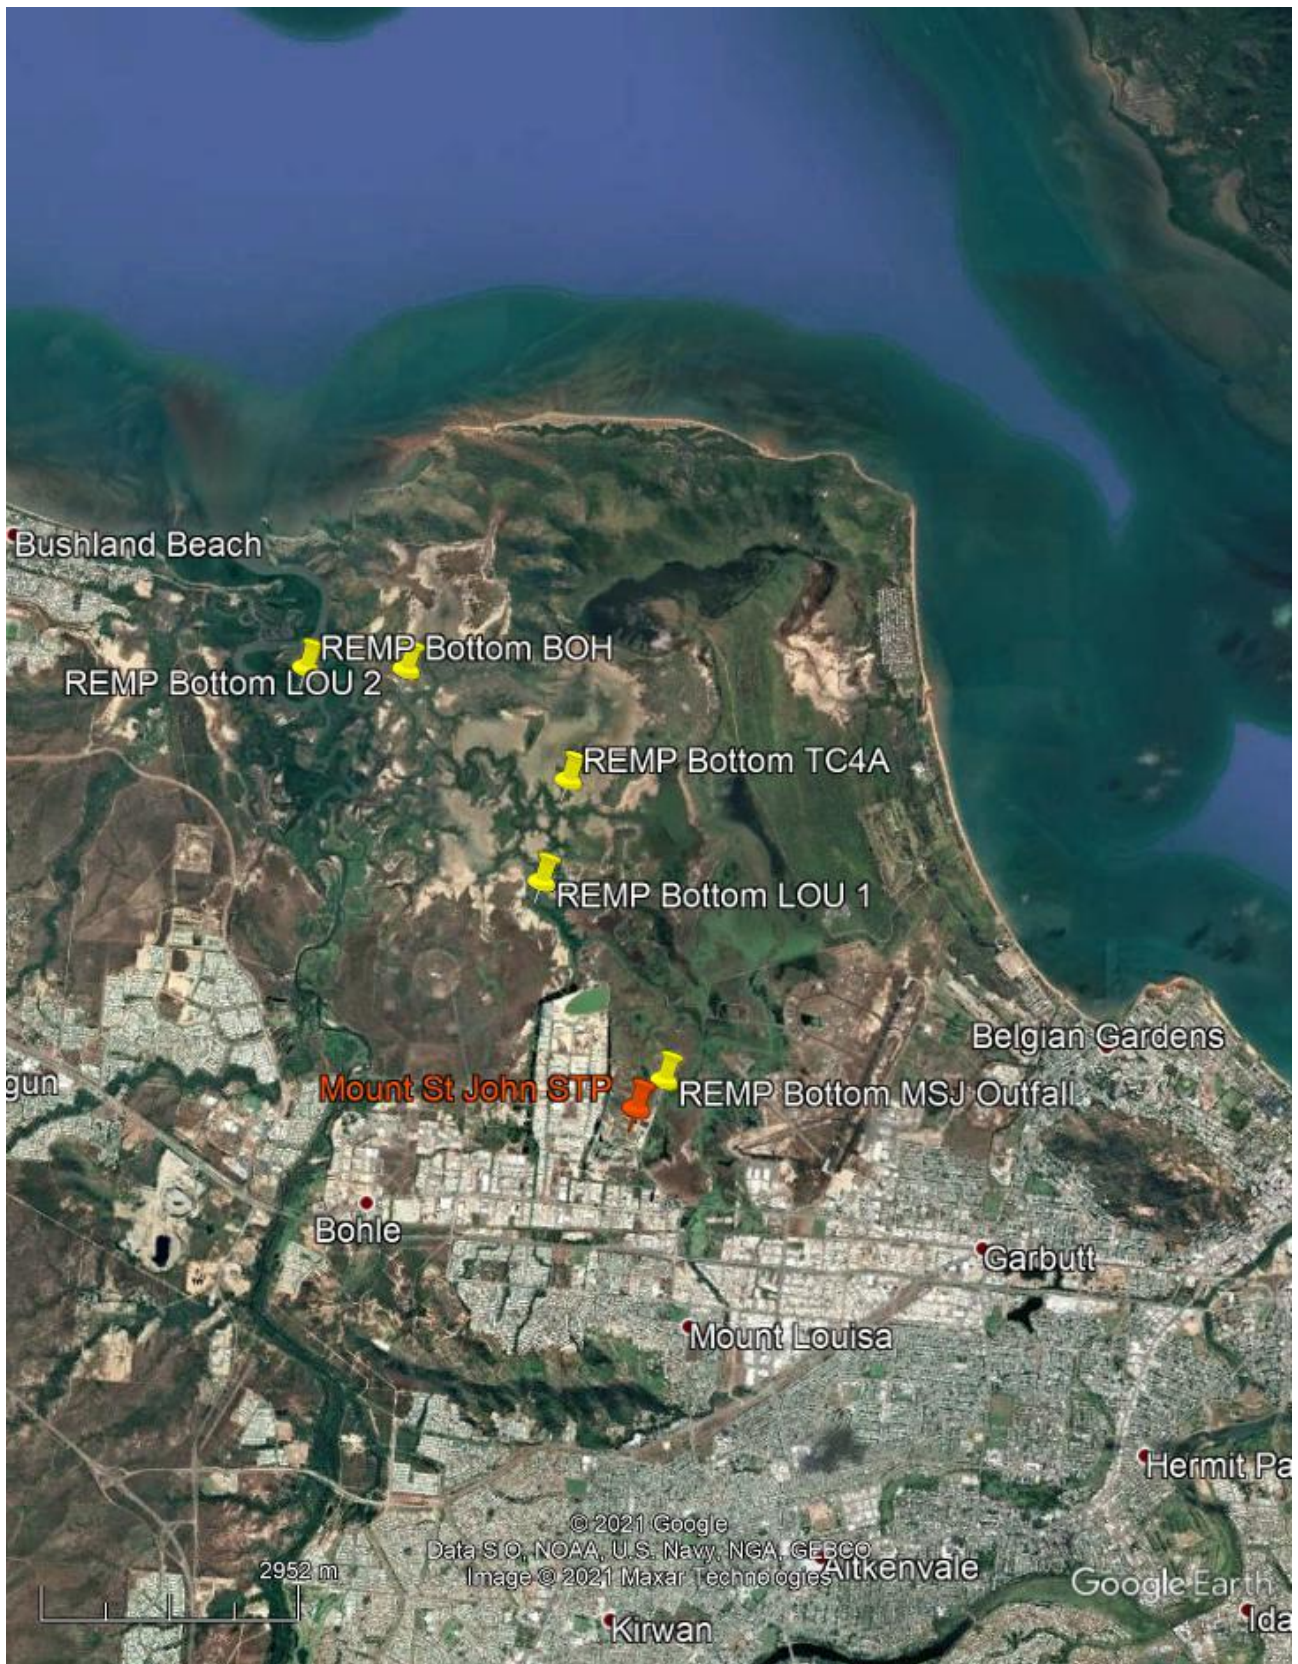
FIGURE 3-5 MOUNT ST JOHN REMP SITES

The treated effluent discharge via an outfall to Snaggy Creek is of special interest to this project in support of the due diligence assessments being undertaken. Snaggy Creek is a tributary of the Bohle River which discharges into Halifax Bay near Bushland Beach, before emptying into the Coral Sea. The catchment area of the river occupies 368 square kilometres of which an area of 26 square kilometres is composed of estuarine (mangrove) wetlands (Figure 3-5).
