## **Environmental authority P-EA-100121435**

| Environmentally relevant activities | Locations |
|---|---|
| ERA 63 - Sewage Treatment 1(e) - Operating sewage treatment works, other than no-release works, with a total daily peak design capacity of more than 10,000 but not more than 50,000EP | Lots 2 and 3 Plan RP223470; Lot 1 Plan SL3427; Lot 254 Plan S31102; and Lots 83, 84, 86, 255, 256, 257 and 259 on Plan S312432. |

SOUTHERN REDLAND BAY WASTEWATER TREATMENT PLANT  
CONCEPT REHABILITATION PLAN - DETAIL SHEET 05

R01v05\_20020099\_Southern\_Redland\_Bay\_Stage\_3\_Assessments

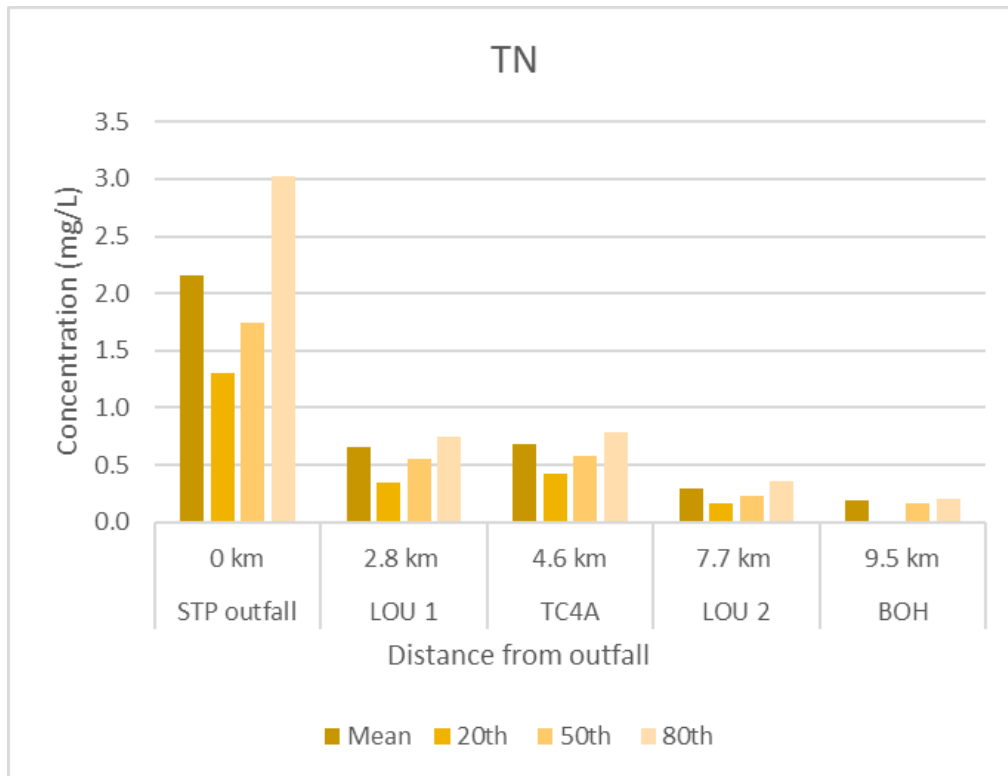
**FIGURE 3-6 TN CONCENTRATIONS IN THE RECEIVING ENVIRONMENT OF MOUNT ST JOHN STP**

The contaminant release limits at the location of the Mt St John STP outfall to the discharge channel to Snaggy Creek are 5 mg/L TN and 1 mg/L TP (long-term 50th percentile). Townsville City Council supplied Water Technology with monthly/sub-monthly REMP data (from June 2014 to December 2018) for 5 (five) monitored sites within the receiving environments of the STP discharge. The sampling sites for the REMP monitoring are shown in Figure 3-5. The nutrient concentrations downstream of the STP outfall are presented in Figure 3-6 and Figure 3-7. The decrease in concentration of nutrients between the STP outfall and the monitoring station in closest proximity (LOU 1, located immediately after the connected wetland area) is significant. Further downstream (LOU 2 and BOH, located well into the mangrove coverage area), the measured TN and TP concentrations were also noticeably lower.

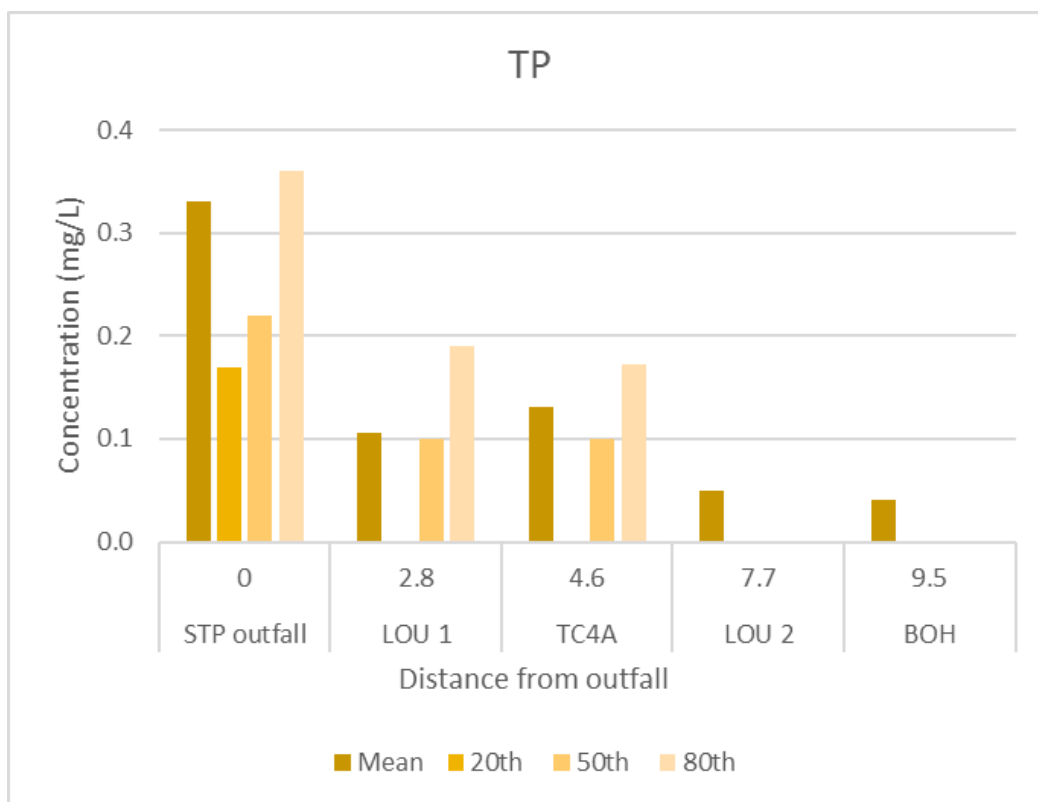
FIGURE 3-7 TP CONCENTRAITONS IN THE RECEIVING ENVIRONMENT OF MOUTN ST JOHN STP

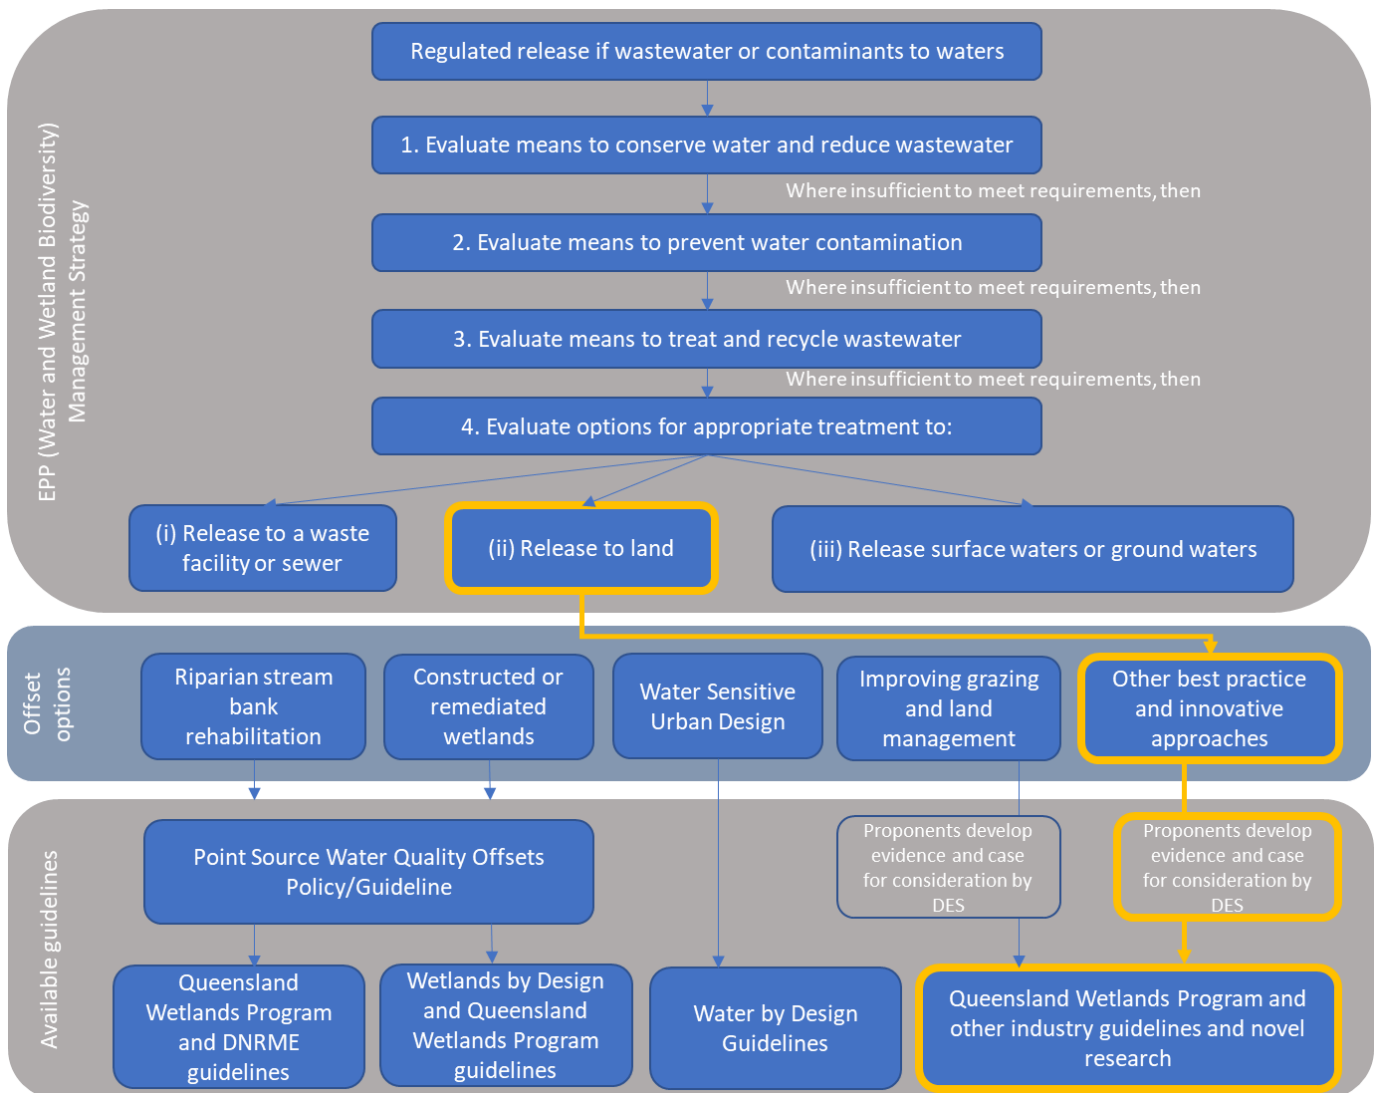
**FIGURE 3-8 OFFSET OPTIONS BASED ON THE ENVIRONMENTAL PROTECTION (WATER AND WETLAND BIODIVERSITY) POLICY 2019<sup>4</sup>.**

Based on the offset options in the context of the Environmental Protection (Water and Wetland Biodiversity) Policy 2019 and as outlined in the Point Source Water Quality Offsets Policy 2019, the proposed MOA classifies as an “Other Best Practice and Innovative Approach” (see Figure 3-8). In support of this classification, we note that the proposed offset option is a novel and sustainable approach to managing a wastewater discharge to a receiving environment and is guided by the Queensland Wetlands Program<sup>2</sup>. The Queensland Wetlands Program recommends several practical rehabilitation techniques which are applicable to the proposed project, including the following:

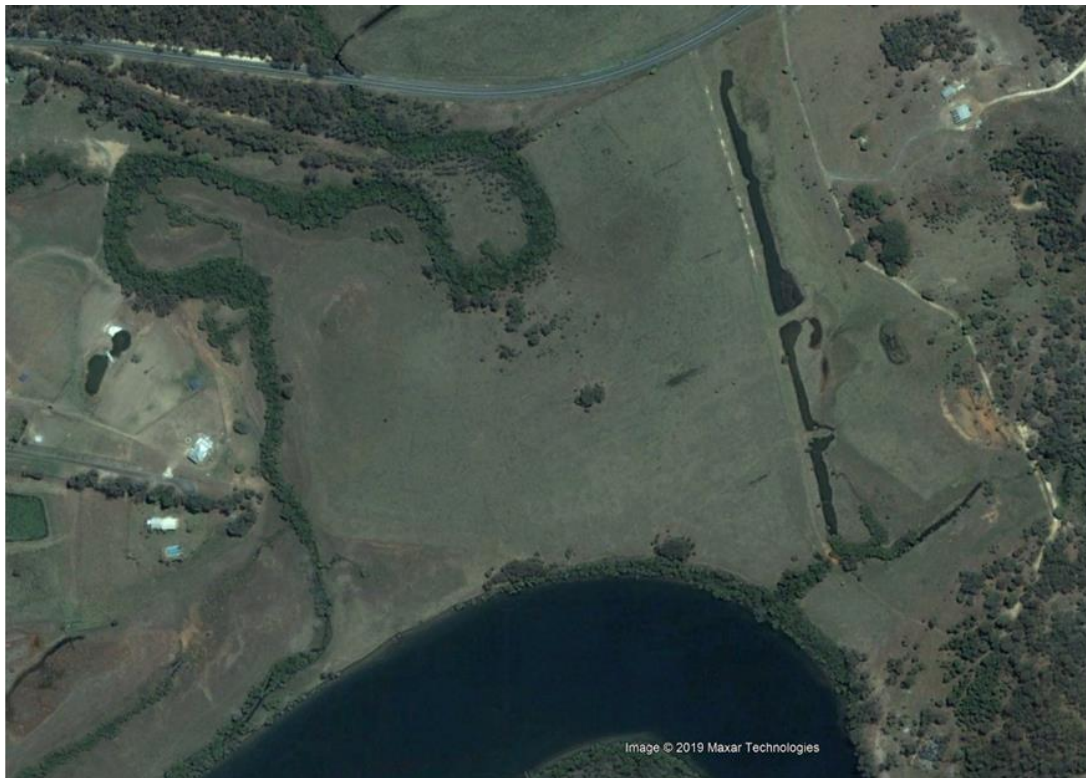
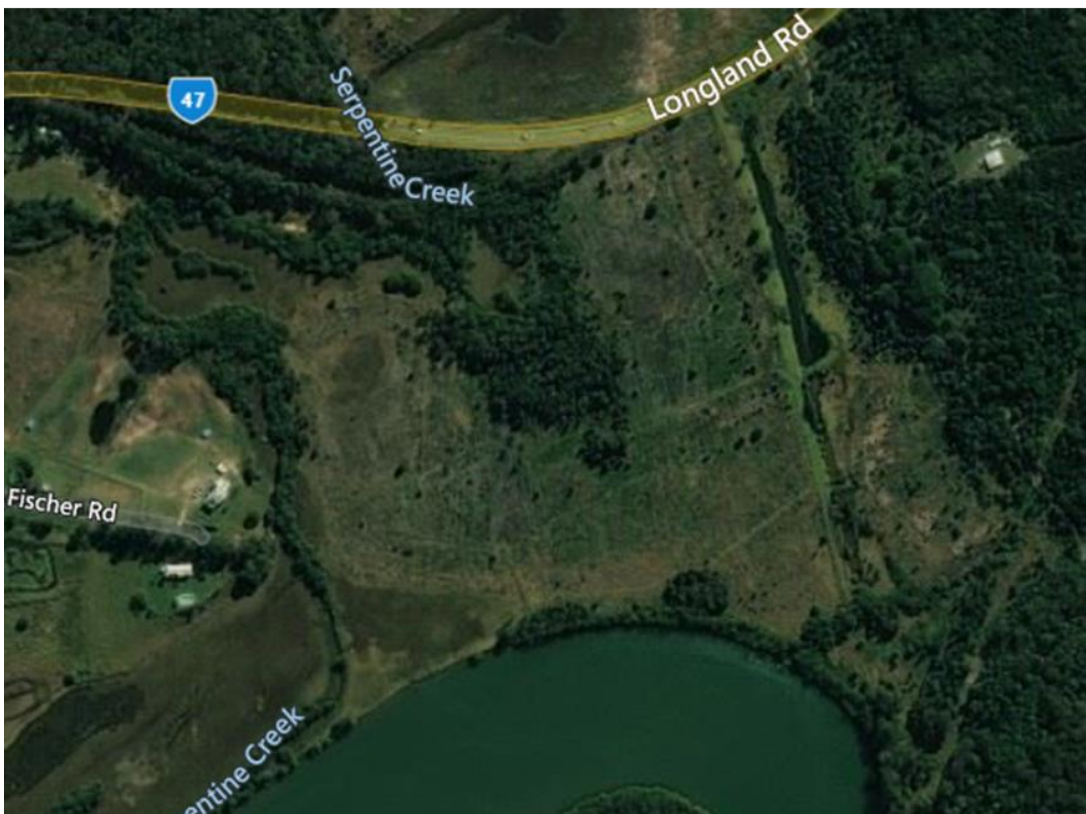
**FIGURE 3-9 PROPOSED SITE FOR MANGROVE ESTABLISHMENT CIRCA 2004 (TOP) AND 2019 (BOTTOM) SHOWING NATURAL MANGROVE PROPAGATION (SOURCE: GOOGLE MAPS)**

- Fortunately, the proposed project site is known to be in proximity to existing mangrove environments. Figure 3-9 shows the natural mangrove propagation along Serpentine Creek, the northern bank of the Logan River and to the east of the site over the past decade. Issues such as ensuring long-term access to and conservation of the site will be dealt with at a later stage by Lendlease.

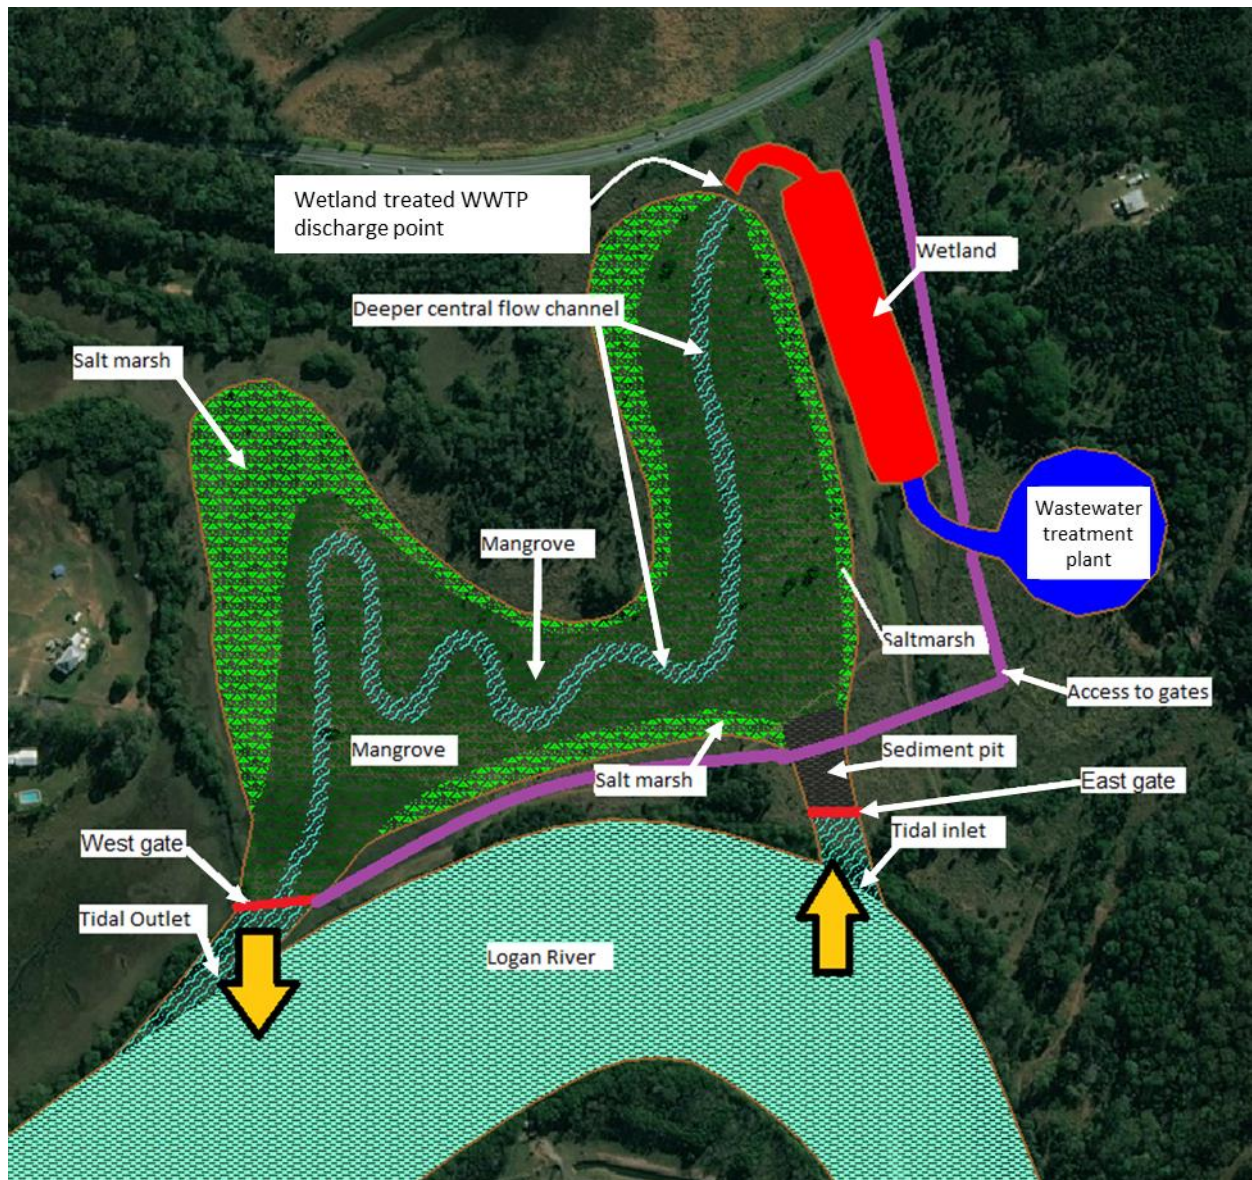
**FIGURE 3-10 SRBWWTP MANGROVE CONCEPTUAL DESIGN PLAN (NOTE: THIS FIGURE IS ILLUSTRATIVE ONLY)**

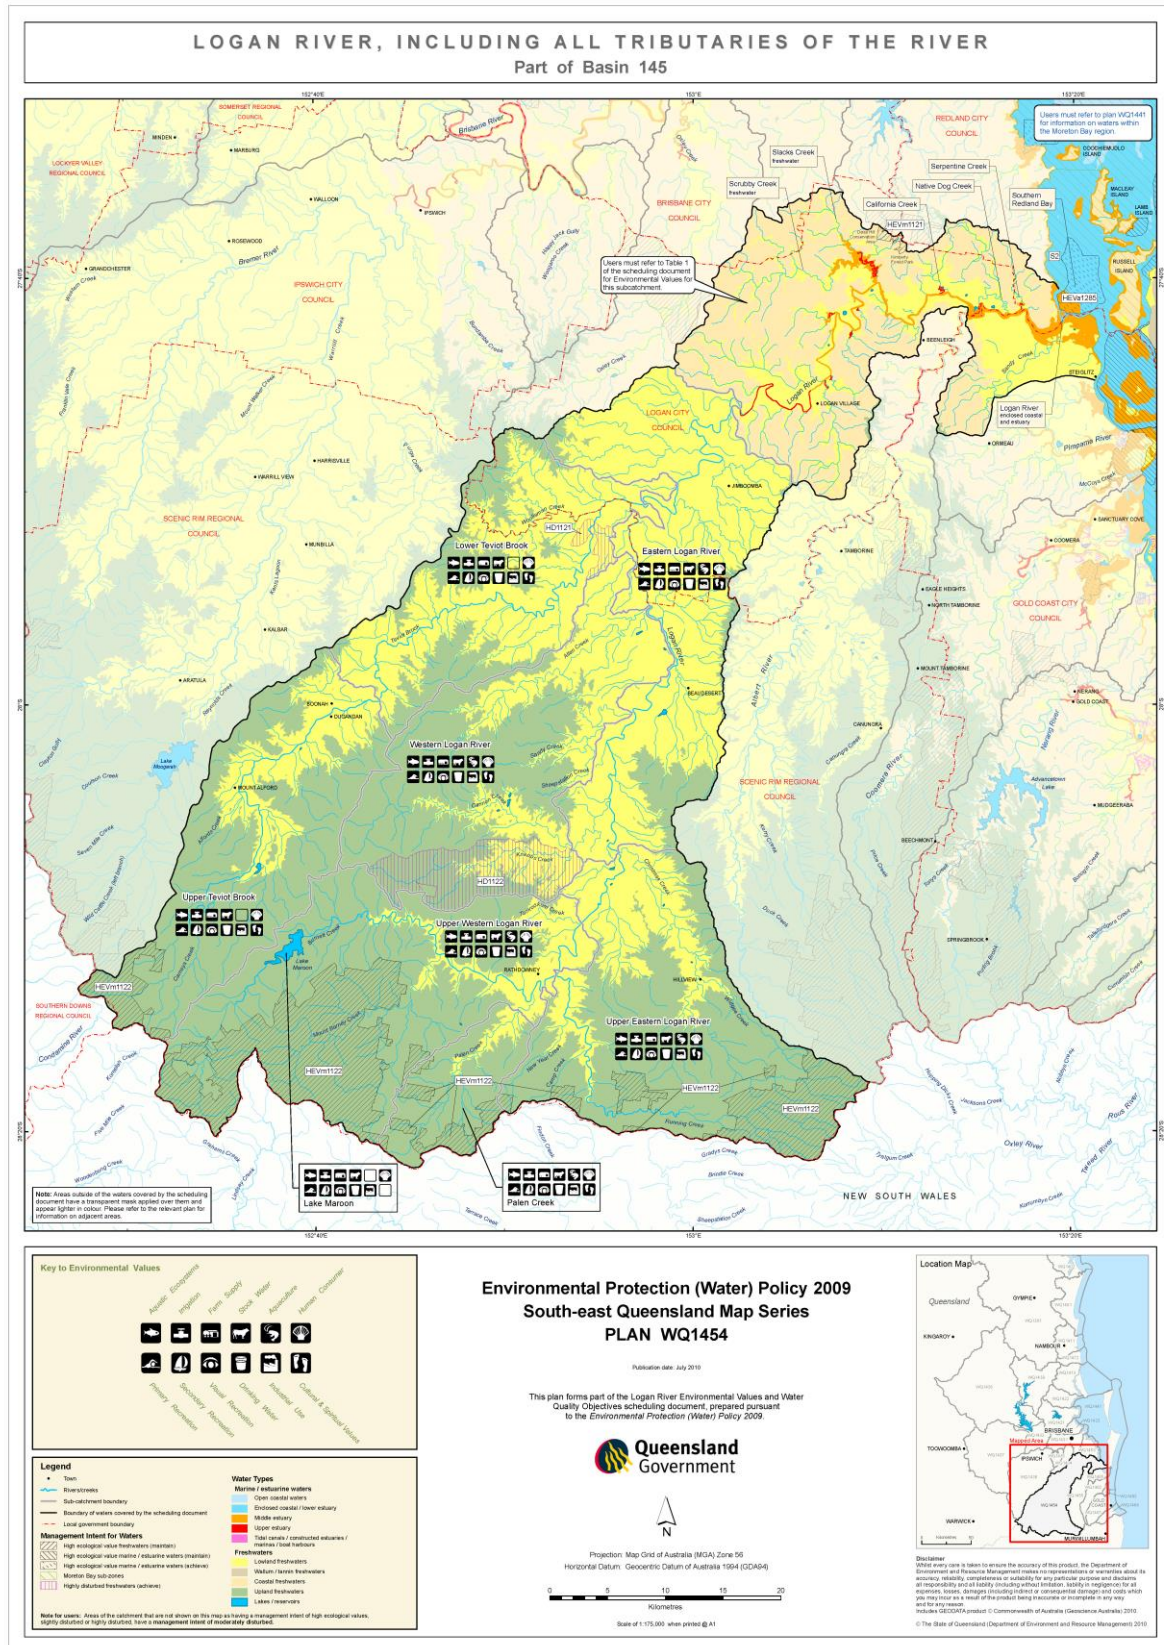
**FIGURE 4-2 ENVIRONMENTAL PROTECTION (WATER) POLICY 2009 – LOGAN RIVER AND TRIBUTARIES**

The EVs and WQOs for the SRBWWTP are governed by the EPP (Water) 2009 and apply to fresh, estuarine and marine surface waters and groundwaters draining the Logan River catchment, as indicated in the accompanying plan (WQ1454) (Figure 4-2 and Figure 4-3). Plan WQ1454 shows that the site can be mapped in the following zones:

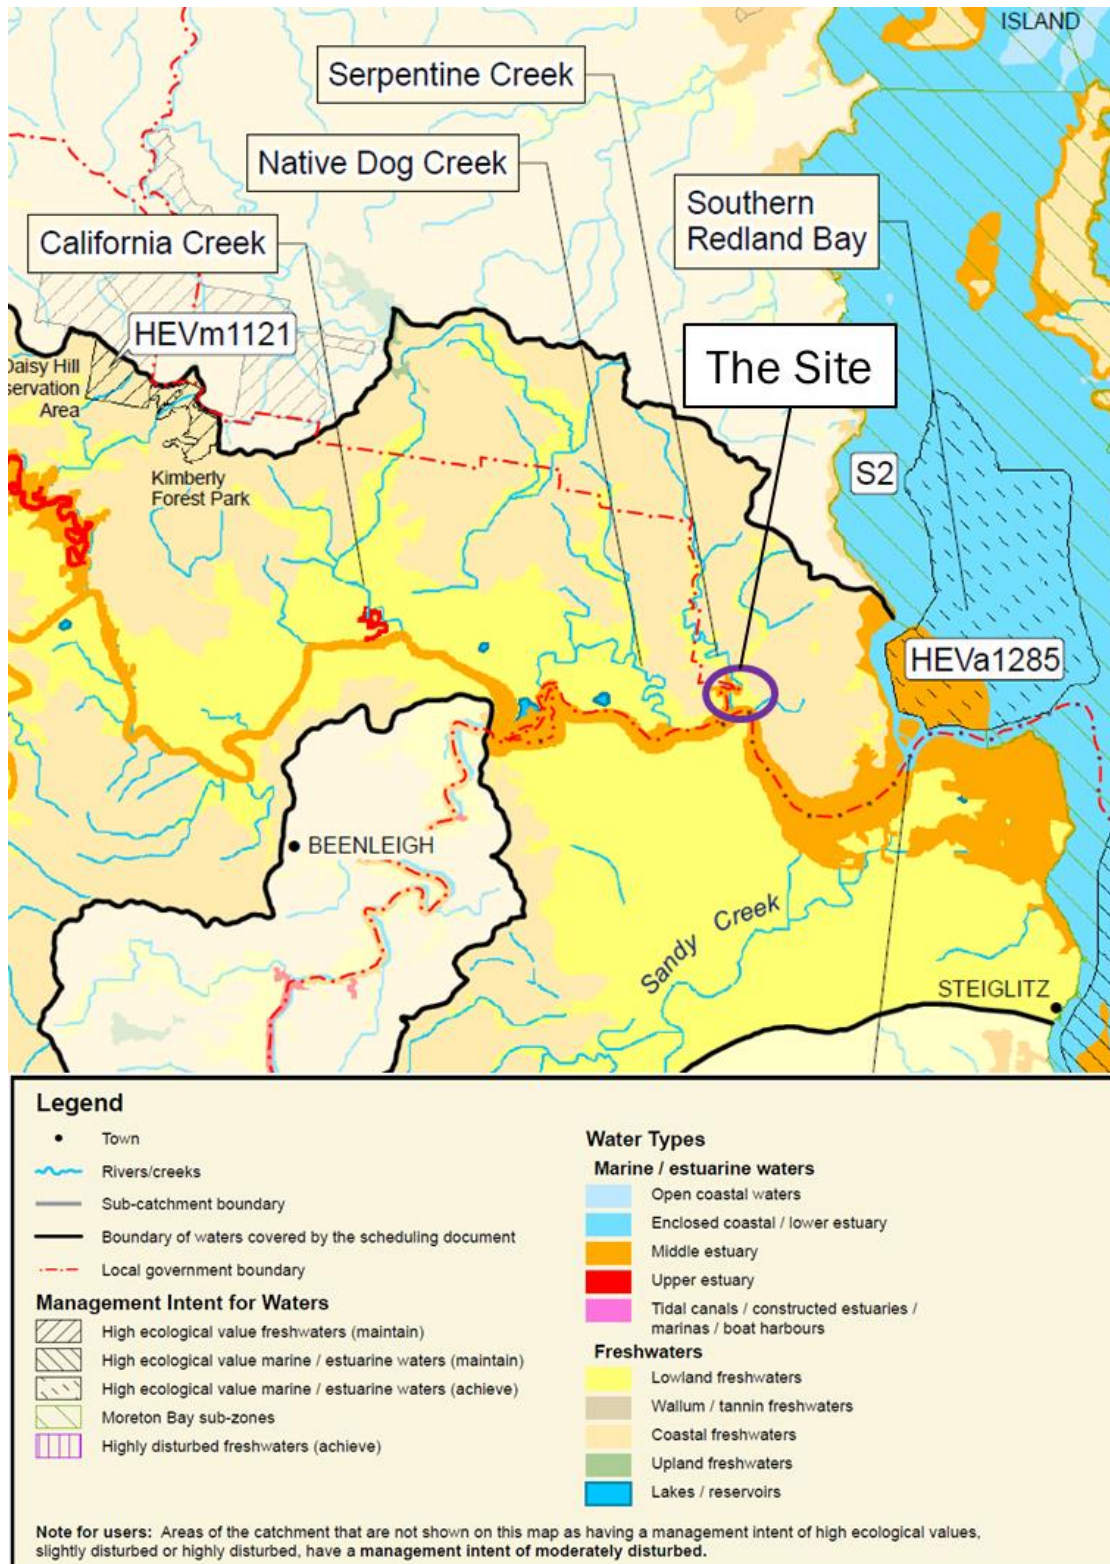
FIGURE 4-3 ENVIRONMENTAL PROTECTION (WATER) POLICY 2009 (EXTRACT) – THE SITE

The SRBWWTP site is located 5.5 km upstream of the mouth of the Logan River Estuary. The site has no frontage to High Ecological Value (HEV) sites in Southern Redland Bay (Figure 4-3). Changes to hydrology and water quality due to the proposed SRBWWTP have the potential to affect the ecological and water quality characteristics of:

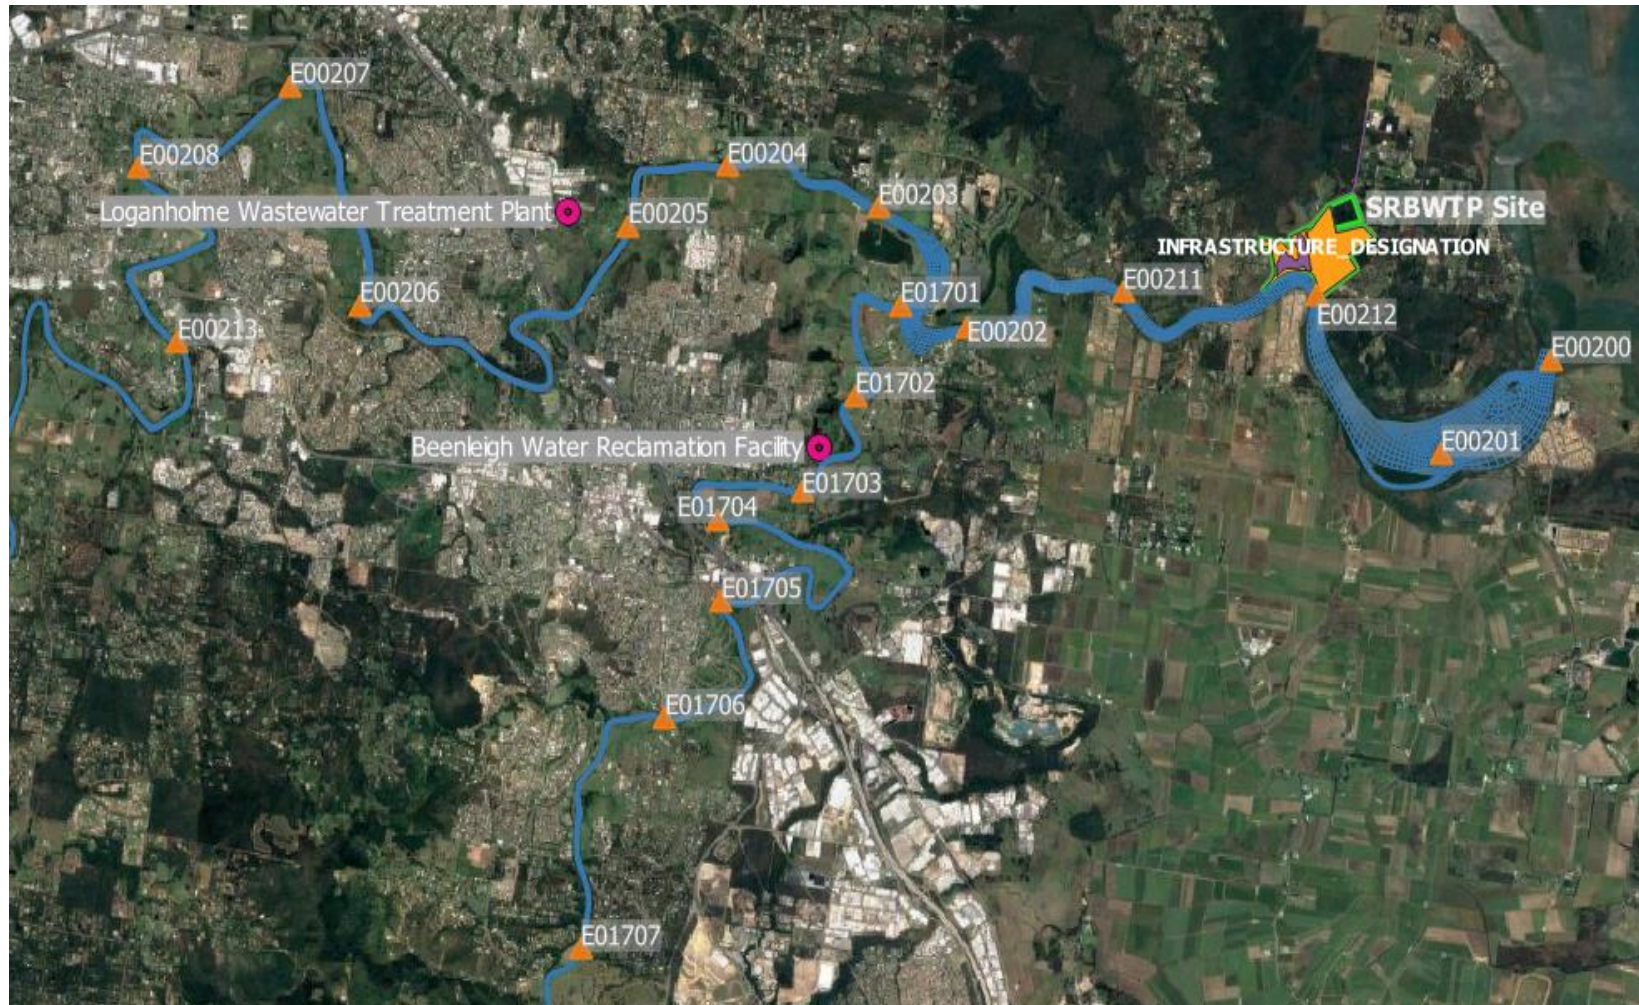
FIGURE 6-1 EHMP SITES IN THE LOGAN RIVER CATCHMENT (MARKED AS ORANGE TRIANGLES)

Using data collected for the EHMP (See Figure 6-1), HLW has overseen the development of state-of-the-art catchment pollutant models (Source) and three dimensional hydrodynamic and water quality models (TUFLOW-FV) that are used to calculate the HLW Report Card each year. The Source modelling framework is used to simulate how catchment land uses and climate variables such as rainfall affect sediment and nutrient generation in SEQ catchments. The outputs from HLW's Source models provide input data on pollutant loads for the Receiving Water Quality Models (RWQM) which are subsequently used to predict annual water quality medians for each estuarine and marine reporting zone.

In addition to monitoring in the MOA and FSL, it is recommended that water quality data from the Healthy Land and Water (HLW) Ecosystem Health Monitoring Program (EHMP) be used to assess any changes in ambient water quality in the Logan Estuary. EHMP site E00212 is in close proximity to the Logan River – Serpentine Creek junction which is the proposed location of the MOA tidal outlet (see Figure 6-1 and Figure 6-2).

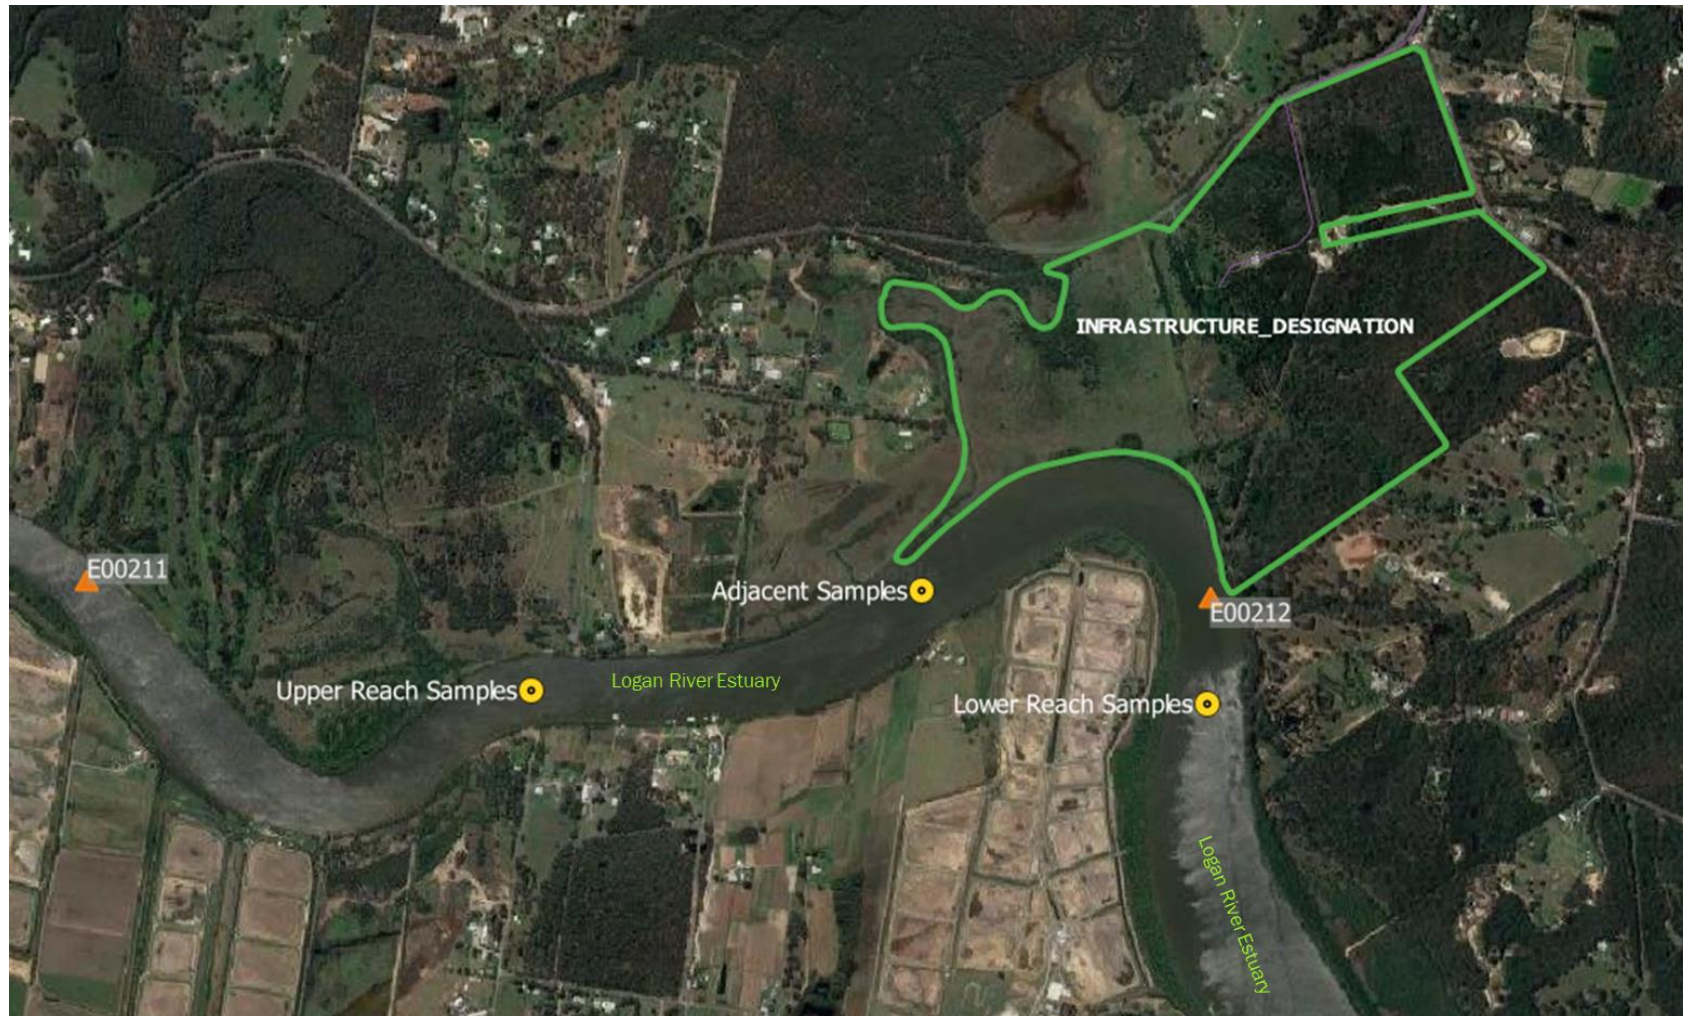
FIGURE 6-2 SRBWWTP WATER QUALITY MONITORING SITES IN RELATION TO EHMP SITES

The sites sampled were located in proximity to EHMP sites E00212 and E00211 (See Figure 6-2).

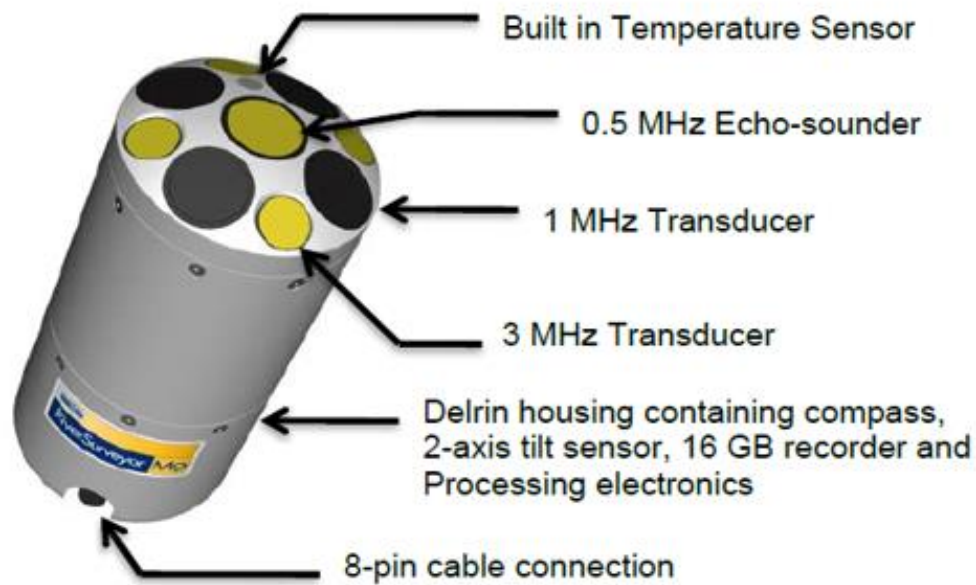
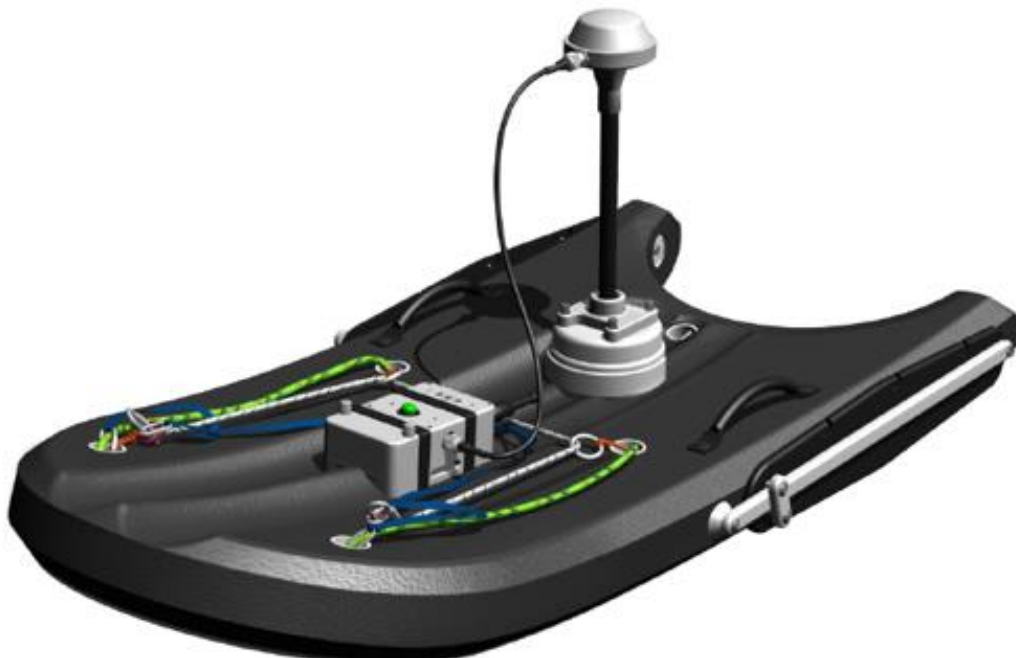
FIGURE 6-3 M9 UNIT (UPPER) AND M9 PLACED IN THE HYDROBOARD (SOURCE: SONTEK 2018)

During deployment, the system was mounted on a flotation device (hydroboard) and towed at slow speed across predefined transects (Figure 6-3 and Figure 6-4).

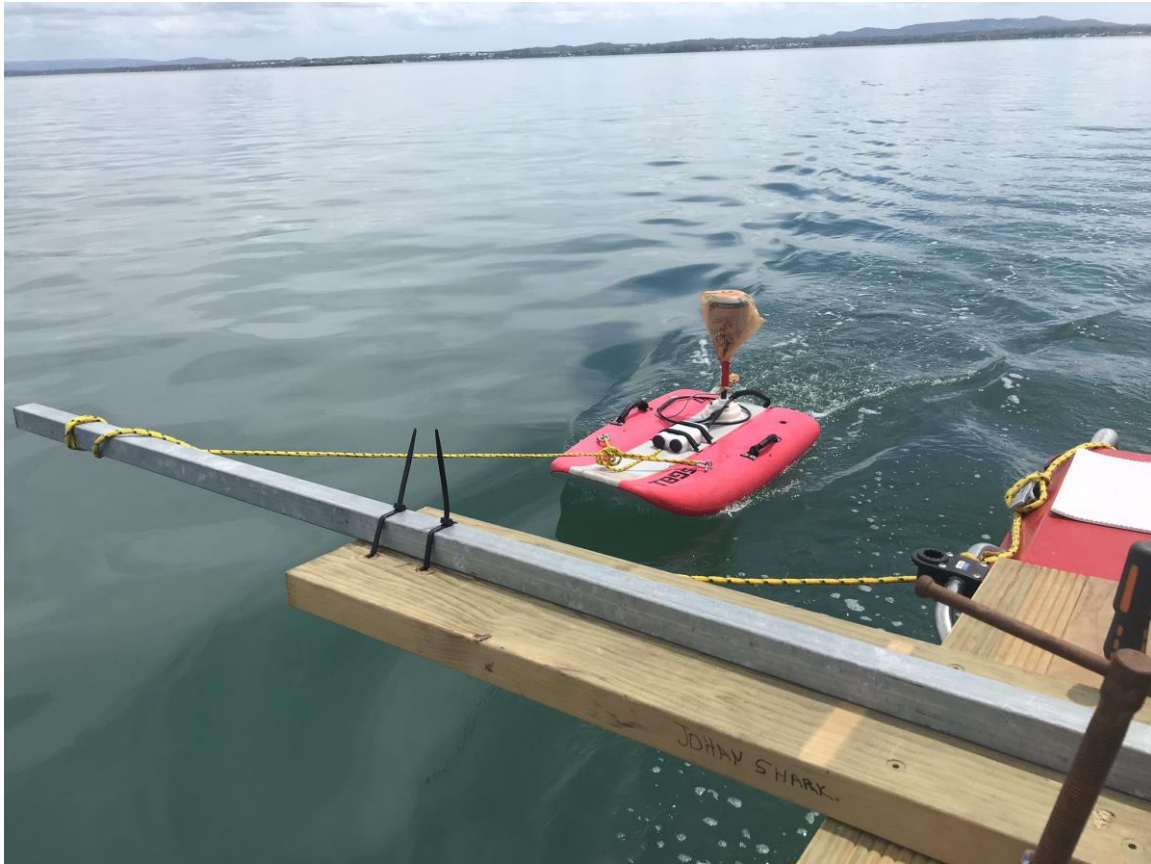
FIGURE 6-4 ADCP M9 UNIT DURING DATA COLLECTION (EXAMPLE)

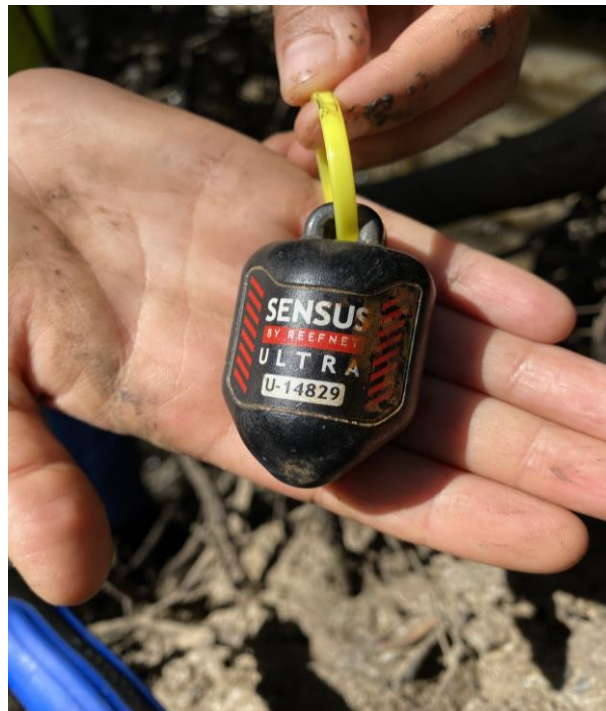
FIGURE 6-5 SENSUS ULTRA DIVE LOGGING DEVICE

Water elevation data was collected using Sensus Ultra dive logging devices. These devices are 3cm x 4cm (Figure 6-5) and are capable of recording depth and temperature data at a resolution of ~1.3cm and 0.01°C, respectively. For this study, four (4) instruments were deployed to capture tidal level and temperature data in the inlet and outlet areas of the proposed Mangrove Offset Area.

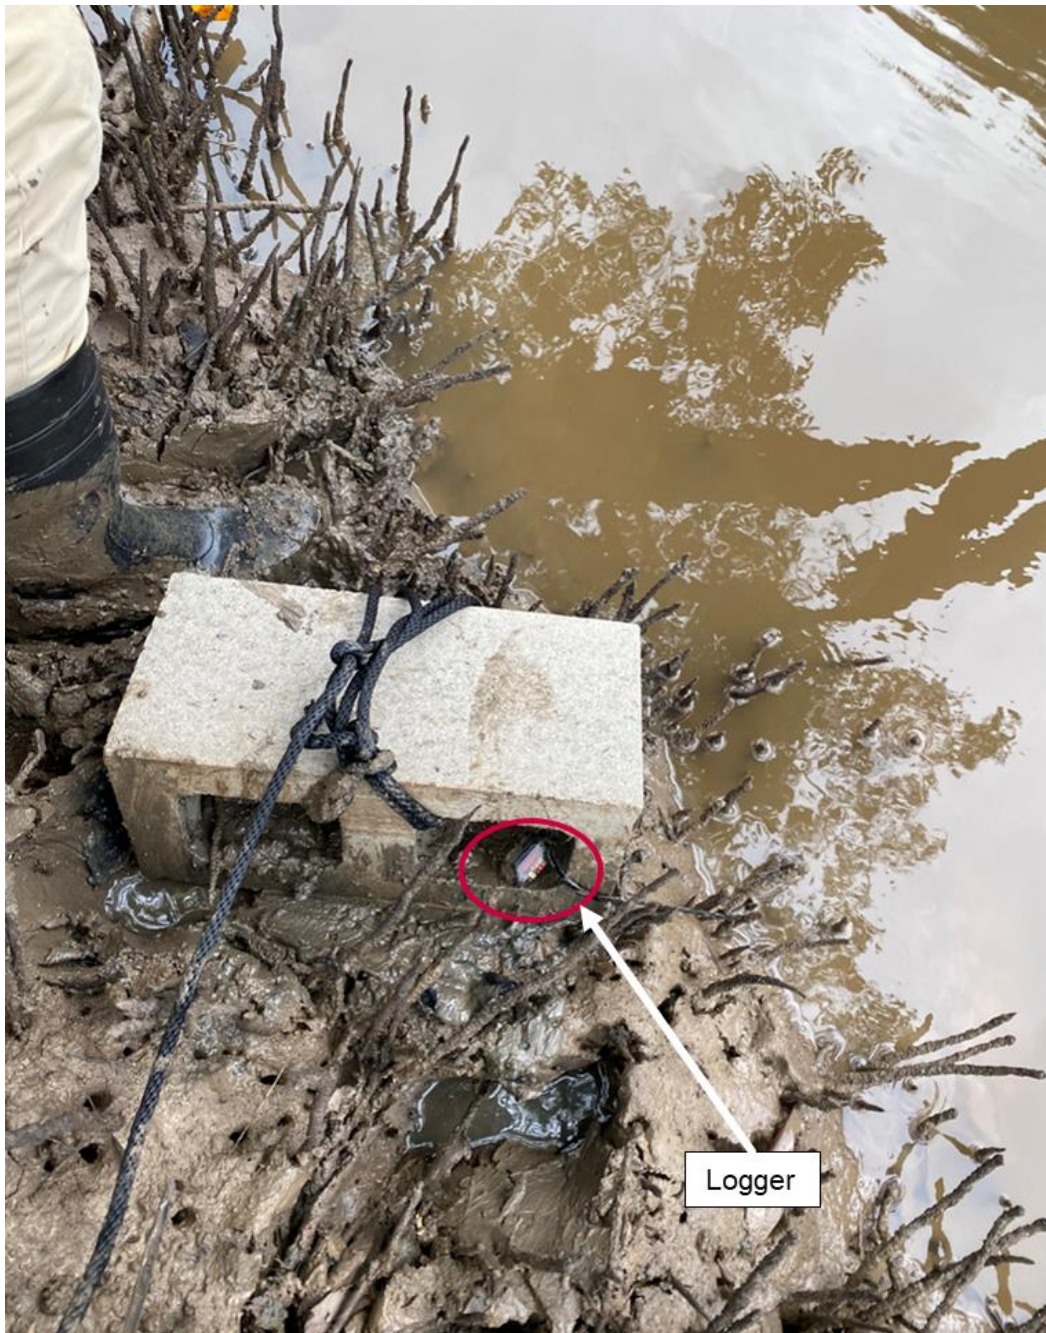
Prior to deployment, each instrument was securely mounted onto a Besser brick which was tethered to a surface float (Figure 6-6).

FIGURE 6-6 WATER LEVEL LOGGER MOUNTED ONTO BESSER BRICK

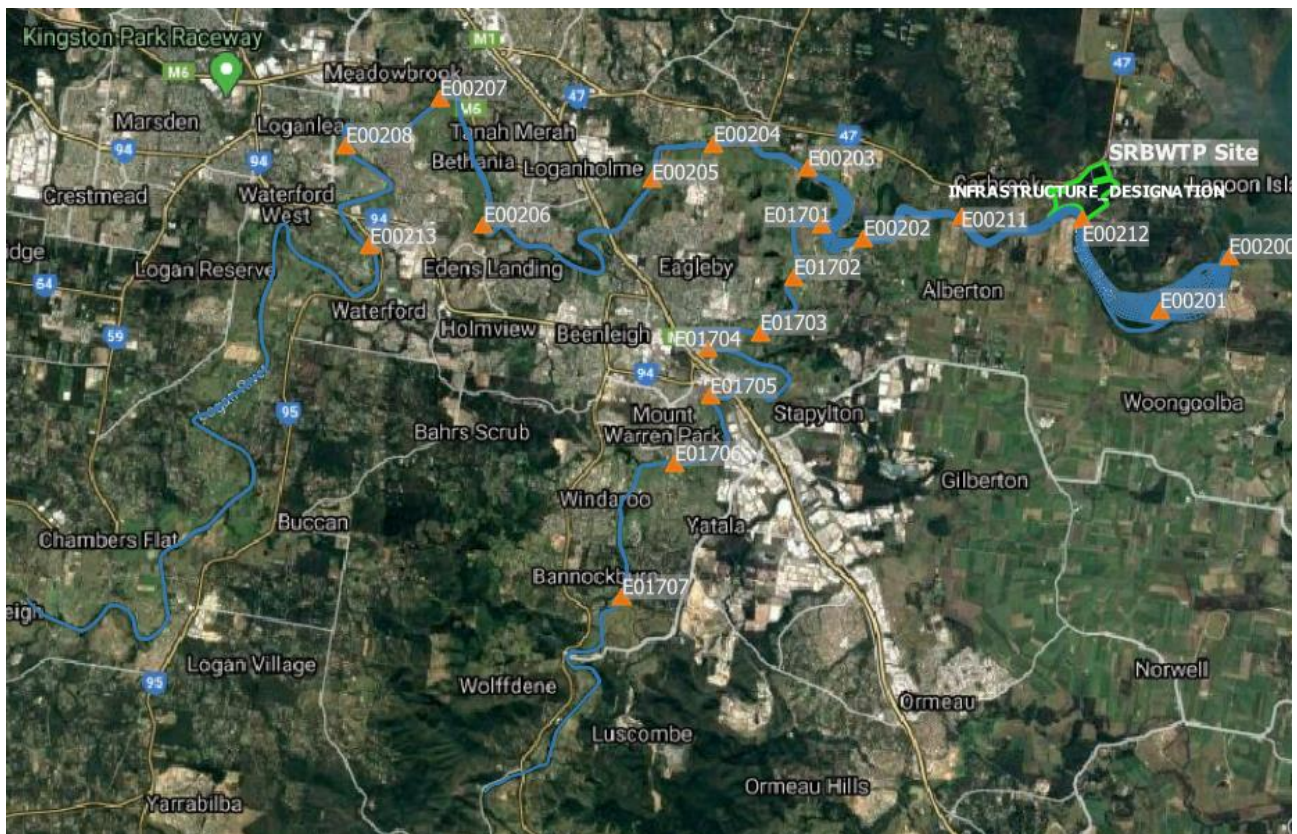
FIGURE 8-1 TUFLOW FV MODEL MESH FOR THE LOGAN RIVER

The existing HLW model mesh was refined to better resolve the complex bathymetric features and flow patterns in the Logan-Albert River system. To assess the refined model's performance, model results have been compared to measurements collected during the data collection portion of the study. Figure 8-1 depicts the refined mesh (in blue) in Logan-Albert River and the locations (orange triangles) of the measurements used to demonstrate model's performance.

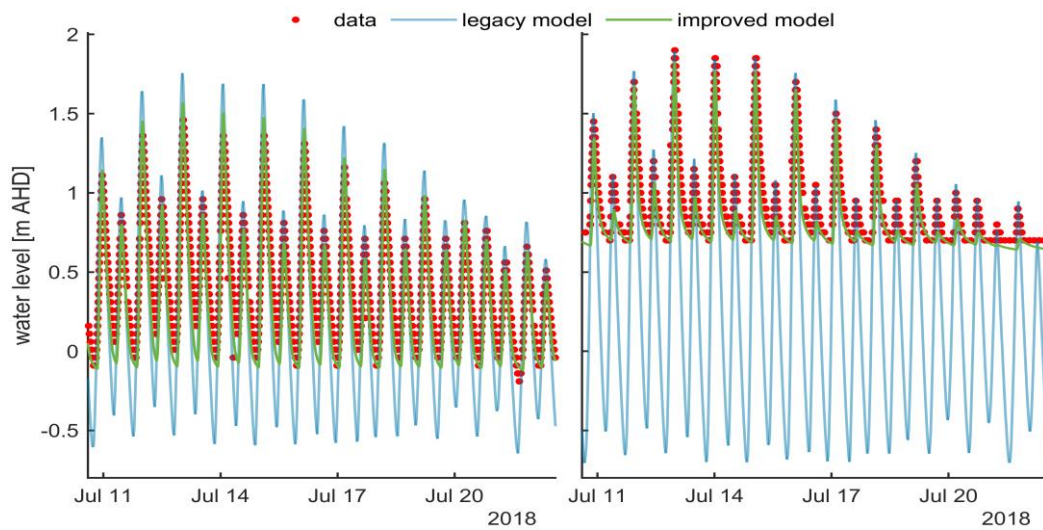
In late 2019, the bathymetry of the Logan-Albert Estuary was surveyed. These latest measurements were incorporated into the model during this study. Numerous refinements to the model's mesh were also required to adequately resolve bathymetric features. Figure 8-2 illustrates that the improved model is far more capable of simulating water levels in the upper reaches of the estuary.

**FIGURE 8-2 COMPARISON OF THE LEGACY AND IMPROVED NUMERICAL MODELS AGAINST MEASUREMENTS IN THE UPPER LOGAN ESTUARY AT LOGAN VILLAGE (LEFT) AND THE UPPER ALBERT ESTUARY AT WOLFFDENE (RIGHT)**

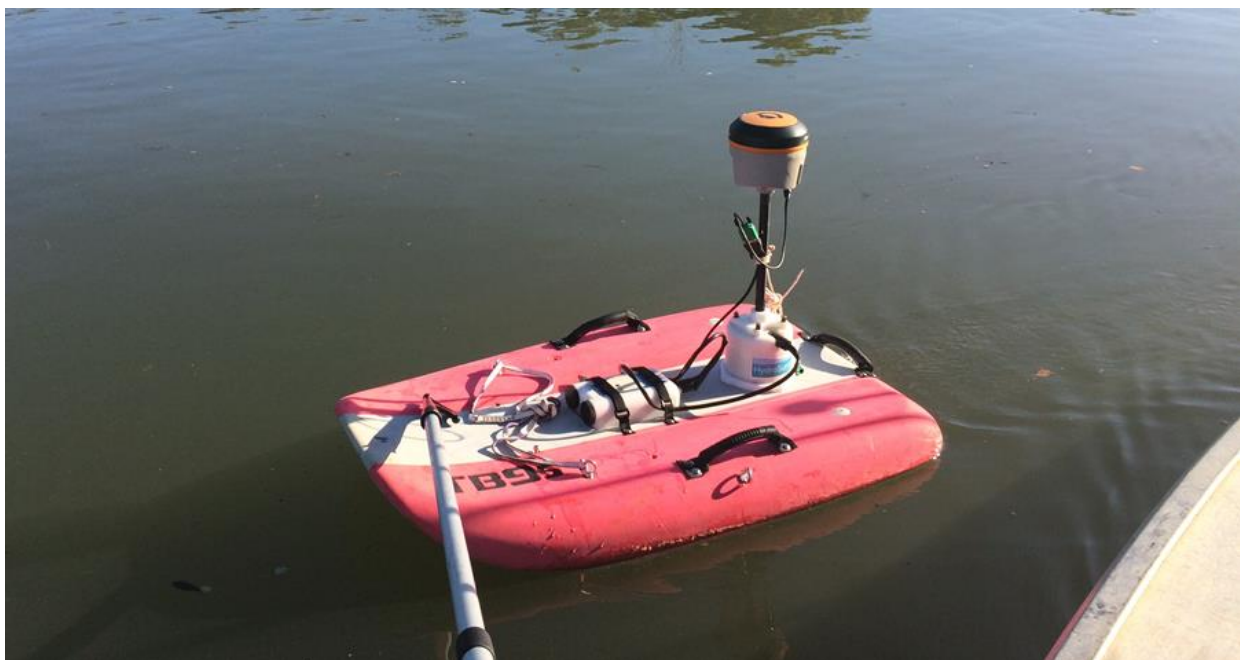
To further demonstrate the model's ability to simulate the hydrodynamics within the Logan River Estuary, comparisons between measured and modelled flows and currents adjacent the MOA were undertaken. The measurements were collected using a downward facing Acoustic Doppler Current Profiler (ADCP) (See Section 6.3). The ADCP was attached to a small unmanned vessel and towed alongside the crewed field boat as depicted in Figure 8-3. The ADCP was continuously towed across the estuary throughout the ebb-flood cycle (10+ hours) during both neap and spring tides.

**FIGURE 8-3 DOWNWARD FACING ADCP MOUNTED ON AN UNMANNED VESSEL AND TOWED ALONGSIDE A FIELD BOAT**

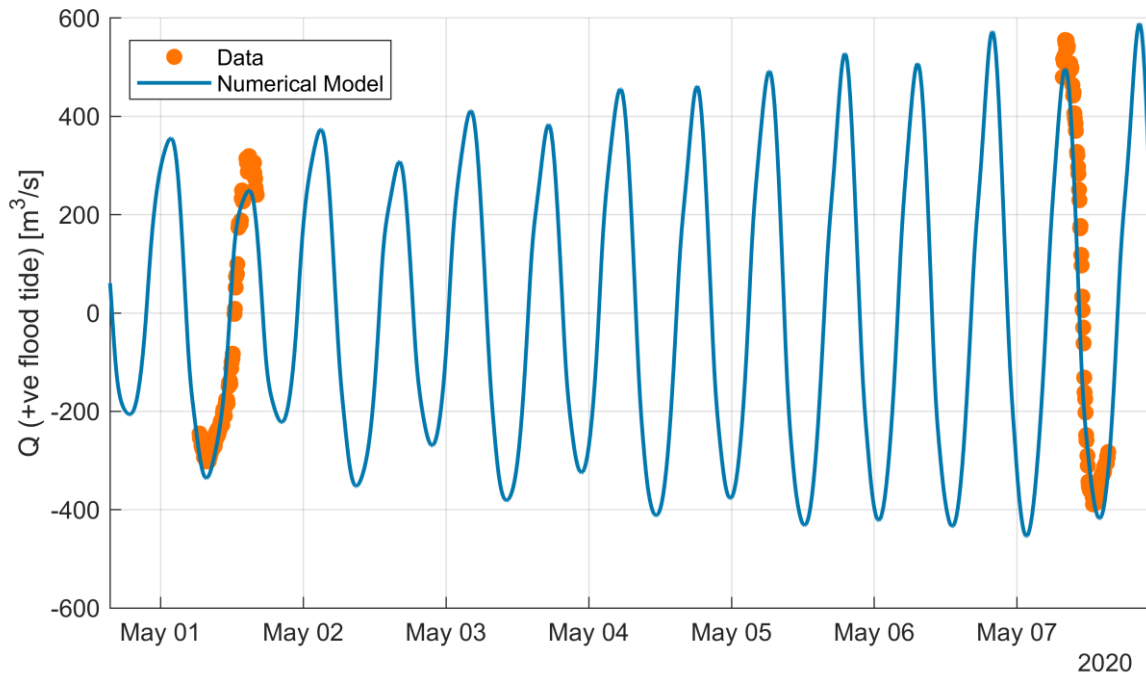
Measured and modelled flows through the Logan River Estuary adjacent the MOA are presented together in Figure 8-4. The figure demonstrates how the model adequately simulates the flows during ebb-flood and spring-neap tides, with a slight overprediction in the peak flood-tide flows and a slight under prediction in the peak ebb-tide flows.

**FIGURE 8-4 COMPARISON BETWEEN MEASURED AND MODELLED FLOWS THROUGH THE LOGAN RIVER ESTUARY ADJACENT TO THE MOA**

Figure 8-4 presents a comparison between the measured ADCP tidal flow data in the Logan estuary and the predictions made by the TUFLOW FV model. This shows that the model is doing an excellent job of reproducing tidal flows.
