## **Environmental authority P-EA-100121435**

| Environmentally relevant activities | Locations |
|---|---|
| ERA 63 - Sewage Treatment 1(e) - Operating sewage treatment works, other than no-release works, with a total daily peak design capacity of more than 10,000 but not more than 50,000EP | Lots 2 and 3 Plan RP223470; Lot 1 Plan SL3427; Lot 254 Plan S31102; and Lots 83, 84, 86, 255, 256, 257 and 259 on Plan S312432. |

SOUTHERN REDLAND BAY WASTEWATER TREATMENT PLANT  
CONCEPT REHABILITATION PLAN - DETAIL SHEET 05

R01v05\_20020099\_Southern\_Redland\_Bay\_Stage\_3\_Assessments

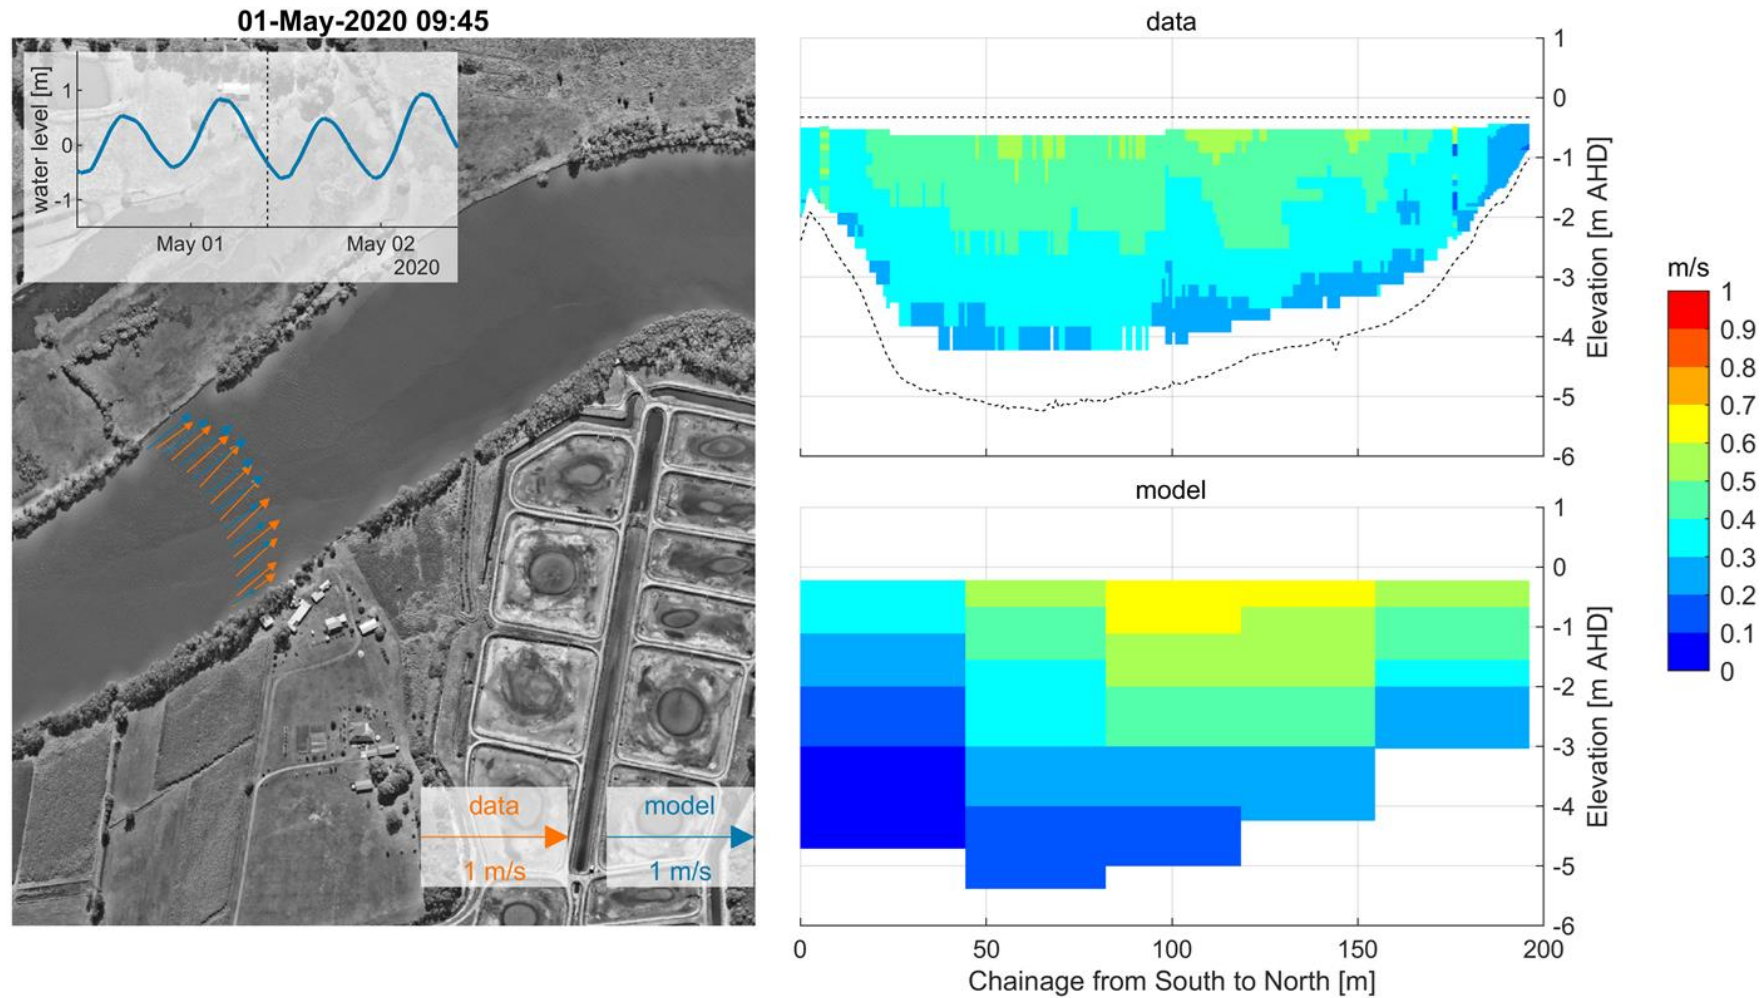
**FIGURE 8-5 COMPARISON BETWEEN MEASURED AND MODELLED EBB TIDE CURRENTS ADJACENT TO THE MOA DURING NEAP TIDES**

The first panels in Figure 8-5 to Figure 8-8 indicate how the magnitude and direction of the depth averaged currents across the estuary are consistent between those measured and those modelled for various stages within the ebb-flood and spring-neap tidal cycles. The second and third panels in the figures indicate how the measured and modelled currents are distributed equivalently throughout the water column and across the transect.

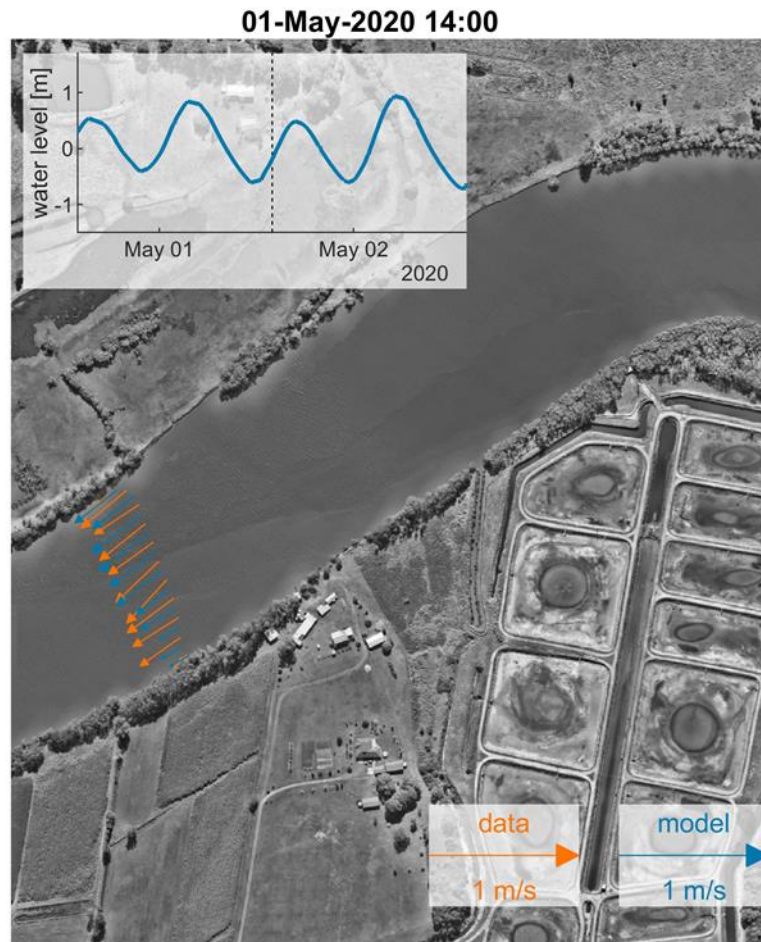
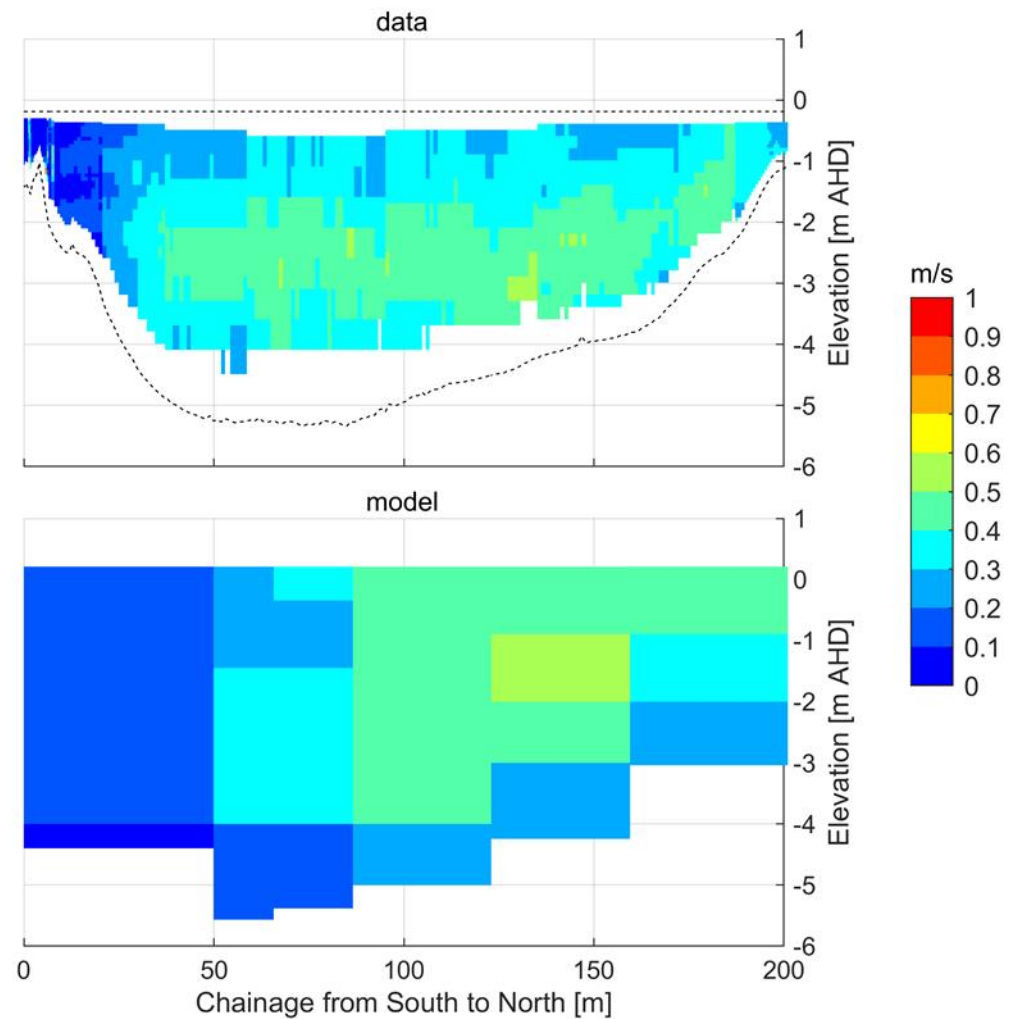
**FIGURE 8-6 COMPARISON BETWEEN MEASURED AND MODELLED FLOOD-TIDE CURRENTS ADJACENT TO THE MOA DURING NEAP-TIDES**

Measured and modelled currents through the Logan River Estuary adjacent the MOA are presented together in Figure 8-5 to Figure 8-8. The figures consist of three panels.

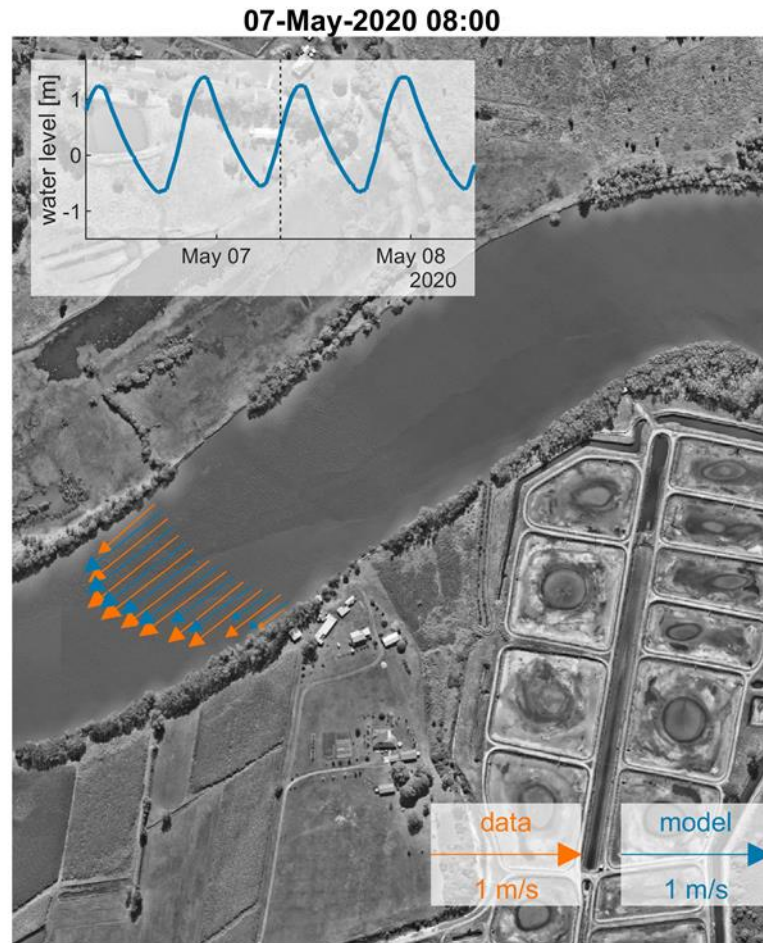
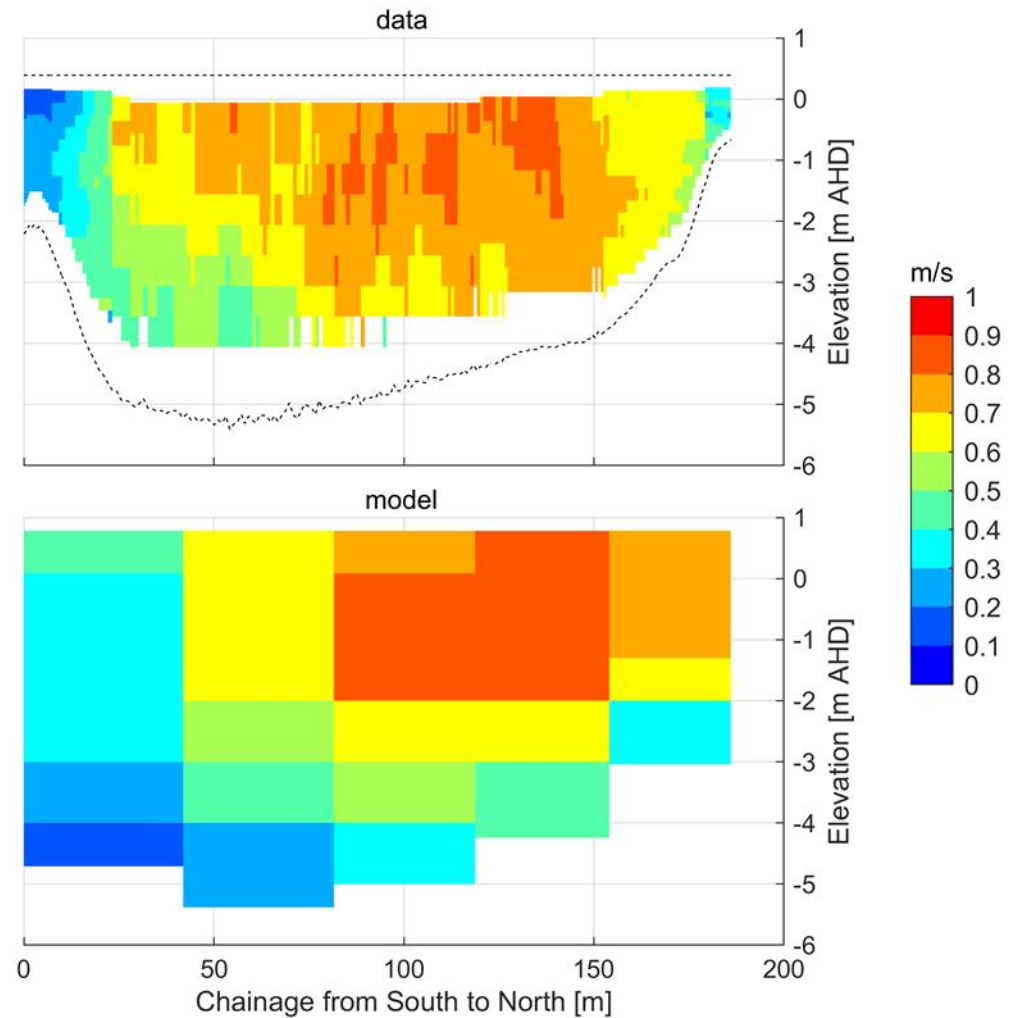
**FIGURE 8-7 COMPARISON BETWEEN MEASURED AND MODELLED FLOOD-TIDE CURRENTS ADJACENT TO THE MOA DURING SPRING-TIDES**

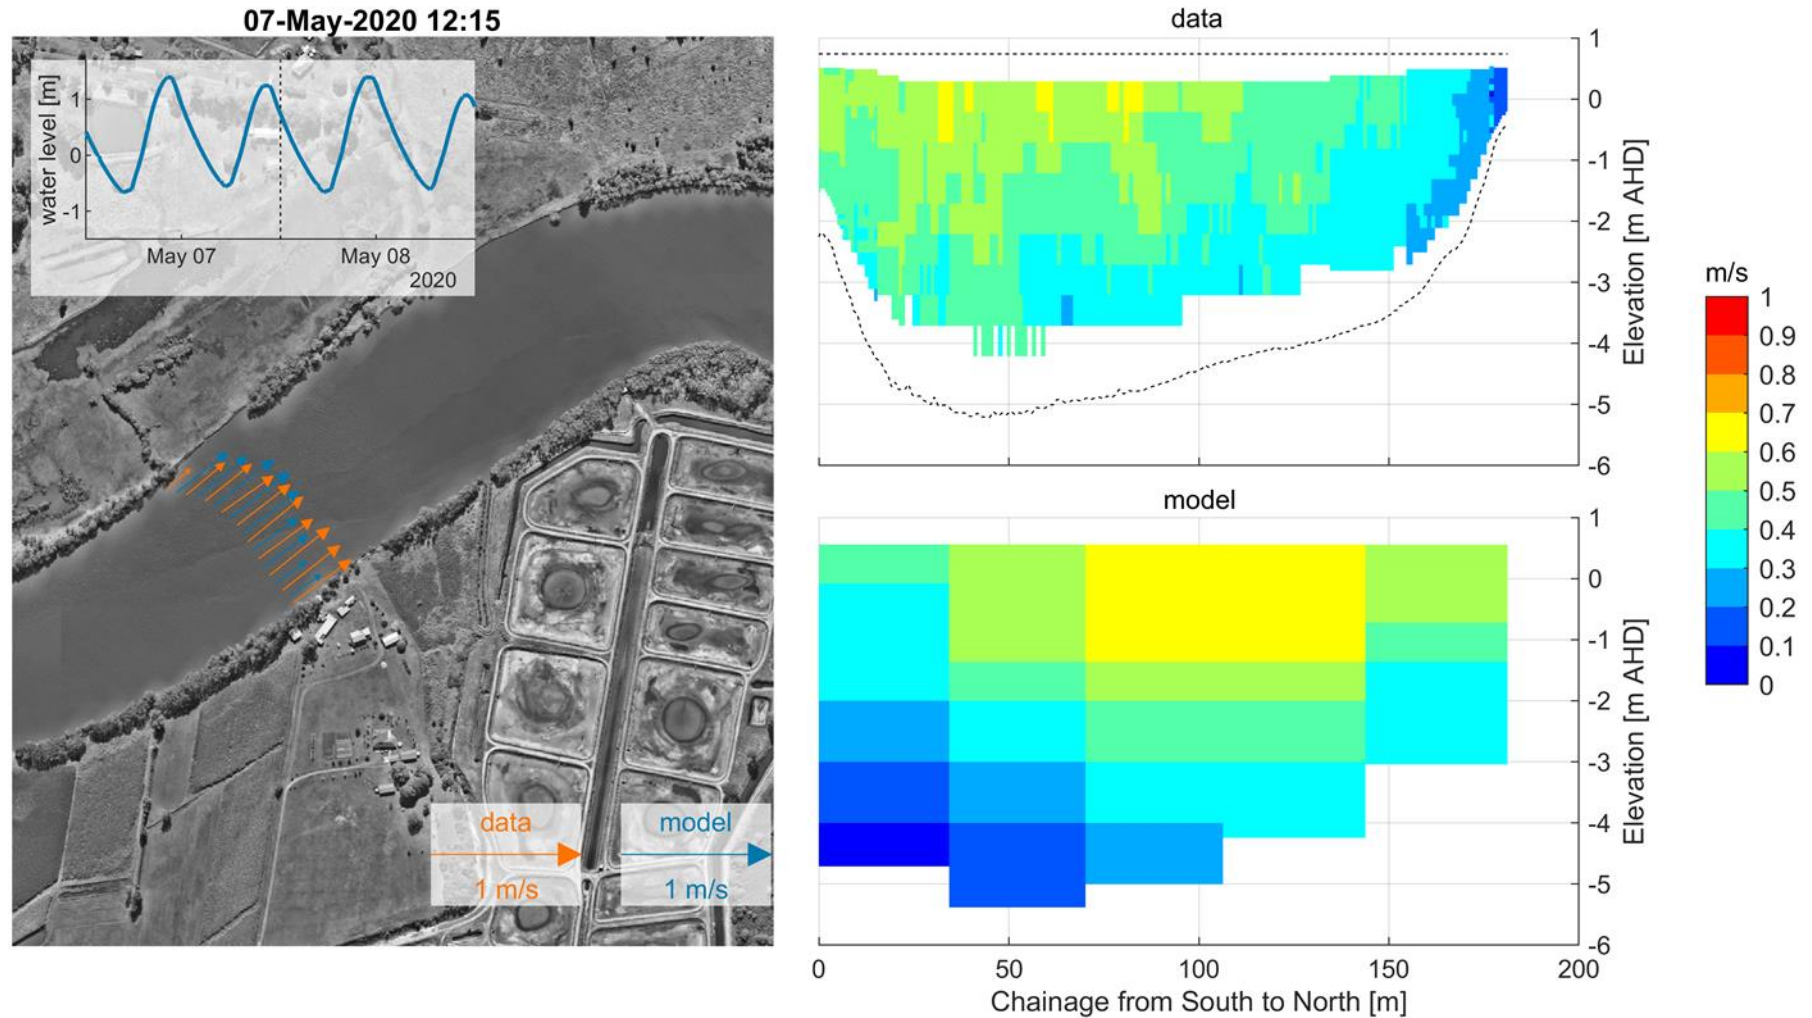
**FIGURE 8-8 COMPARISON BETWEEN MEASURED AND MODELLED EBB-TIDE CURRENTS ADJACENT TO THE MOA DURING SPRING-TIDES**

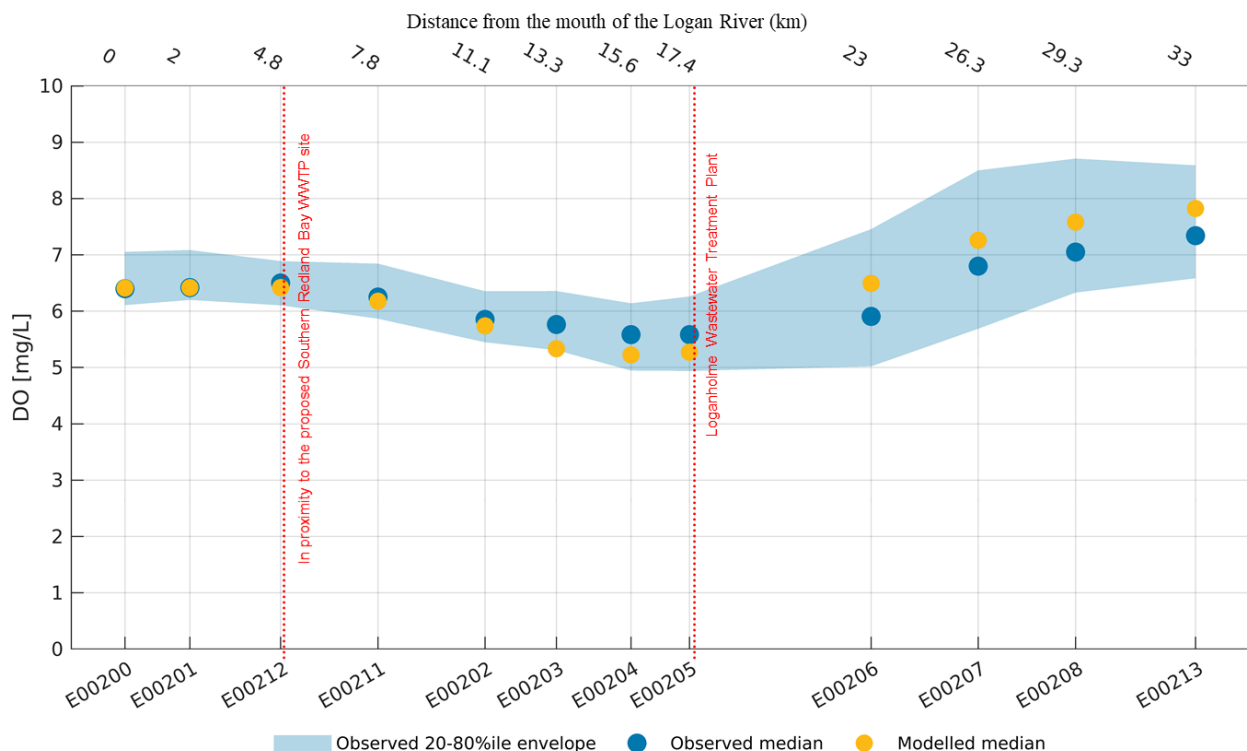
**FIGURE 8-9 OBSERVED (EHMP) AND MODELLED DO IN THE LOGAN ESTUARY, 2018-2019**

Figure 8-9 - Figure 8-21 are plots depicting the respective longitudinal distributions of dissolved oxygen, total nitrogen and total phosphorus in the Logan Estuary. The observations were collected as part of the Environmental Health Monitoring Program. Water Technology performed the numerical modelling as part of the 2018-2019 Healthy Land and Water report carding initiative. The plots indicate how the location of the Loganholme Wastewater Treatment Plant generally coincides with the minima in dissolved oxygen and the maxima in nutrient concentrations. It is understood that these concentrations are reflective of the sheer volume of discharge from the Loganholme treatment plant (67 ML/day). Note that the proposed MOA is located between the EHMP sites E00212 and E00211 (See Figure 6-2).

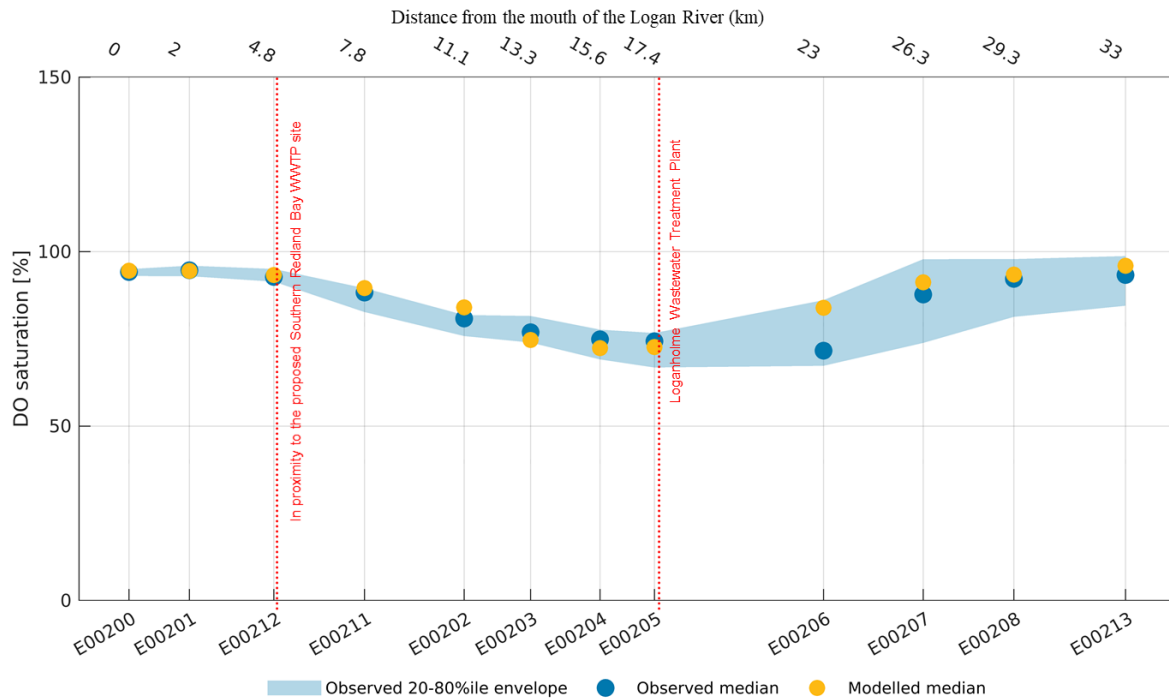
**FIGURE 8-10 OBSERVED (EHMP) AND MODELLED DO SATURATION IN THE LOGAN ESTUARY (2018-2019)**

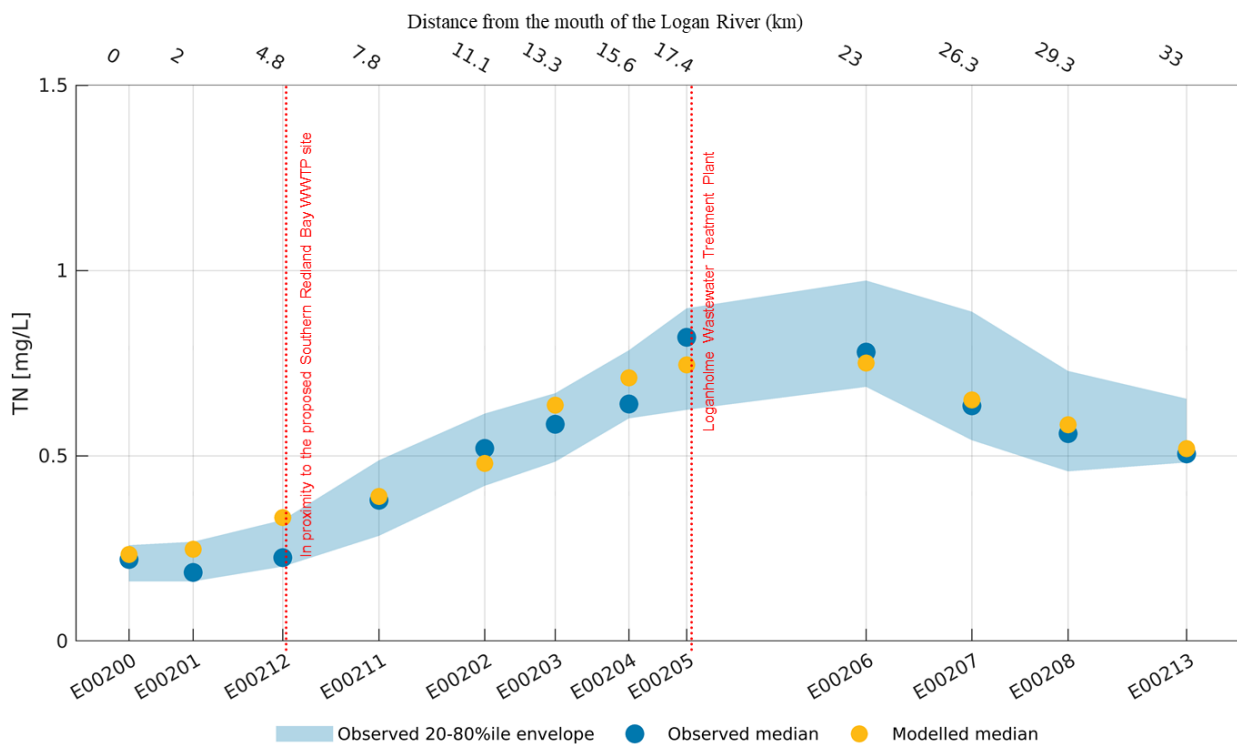
**FIGURE 8-11 OBSERVED (EHMP) AND MODELLED TOTAL NITROGEN IN THE LOGAN ESTUARY (2018-2019)**

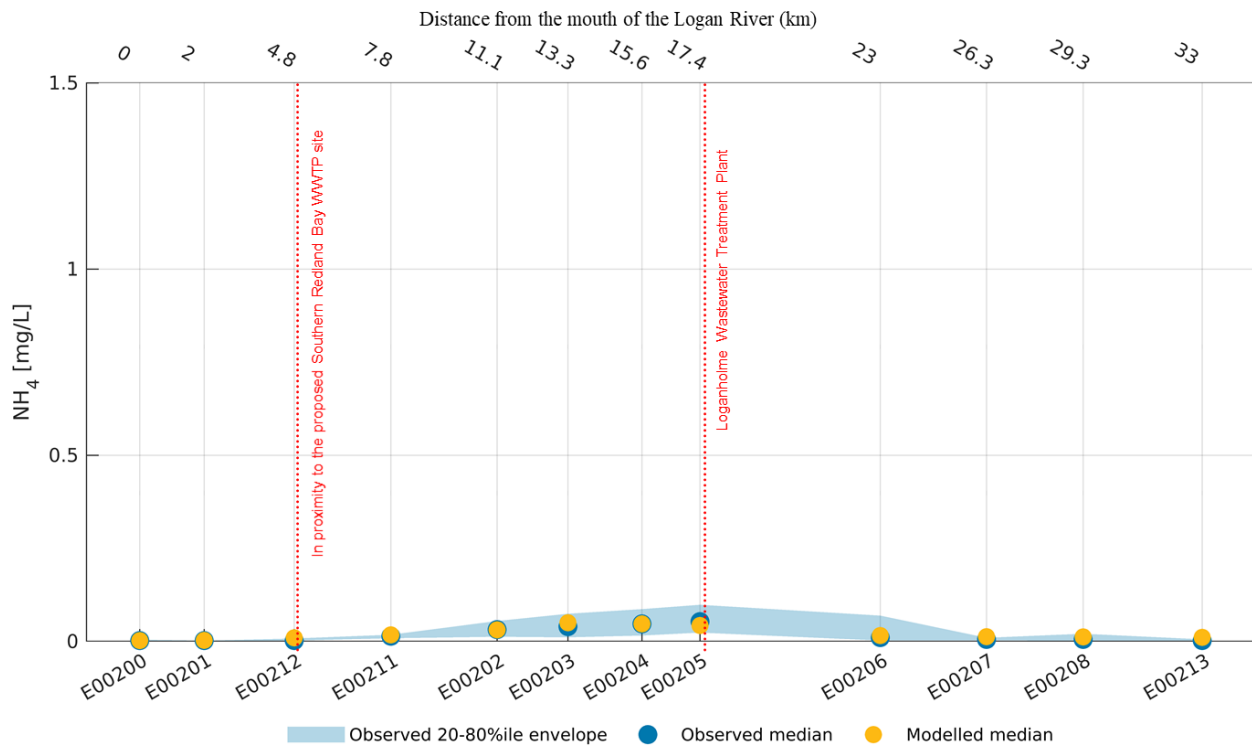
FIGURE 8-12 OBSERVED (EHMP) AND MODELLED AMMONIA IN THE LOGAN ESTUARY (2018-2019)

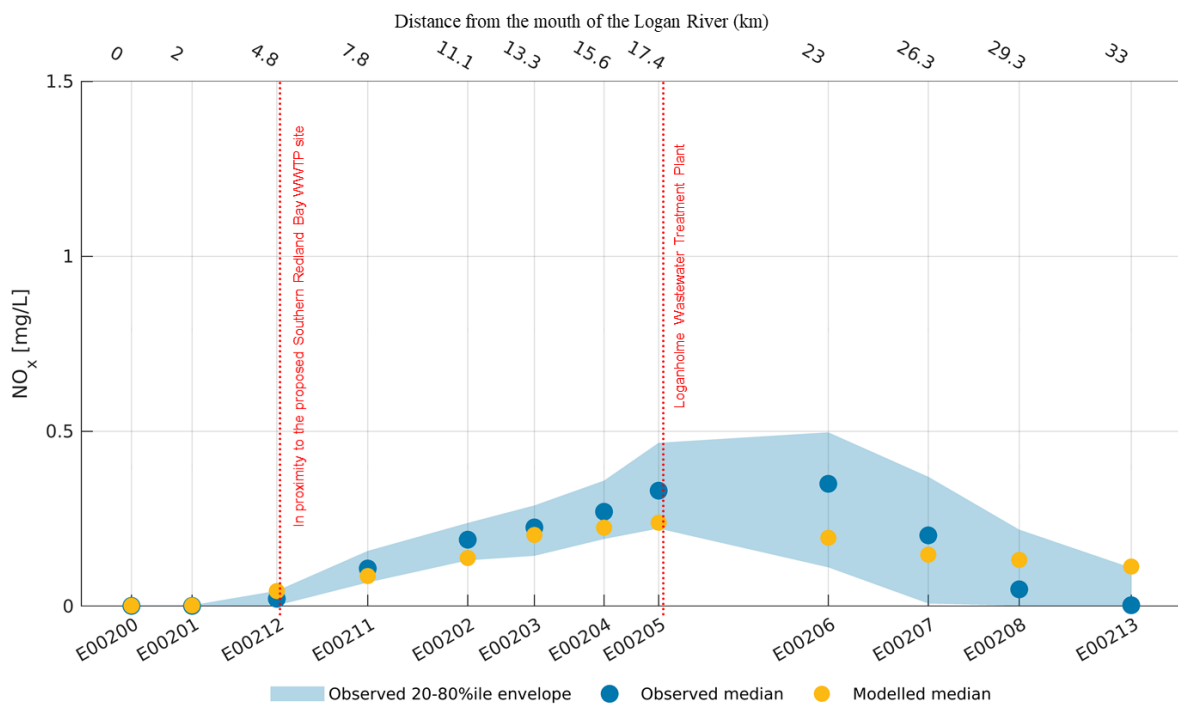
FIGURE 8-13 OBSERVED (EHMP) AND MODELLED NOX IN THE LOGAN ESTUARY (2018-2019)

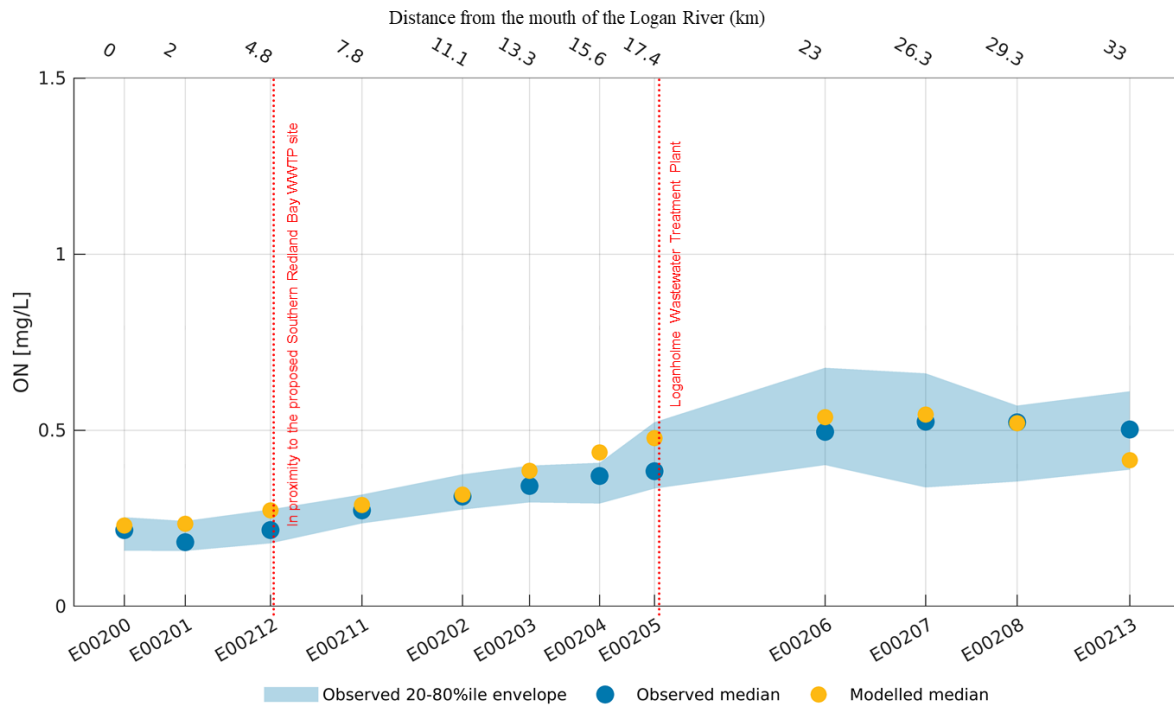
**FIGURE 8-14 OBSERVED (EHMP) AND MODELLED ON IN THE LOGAN ESTUARY (2018-2019)**

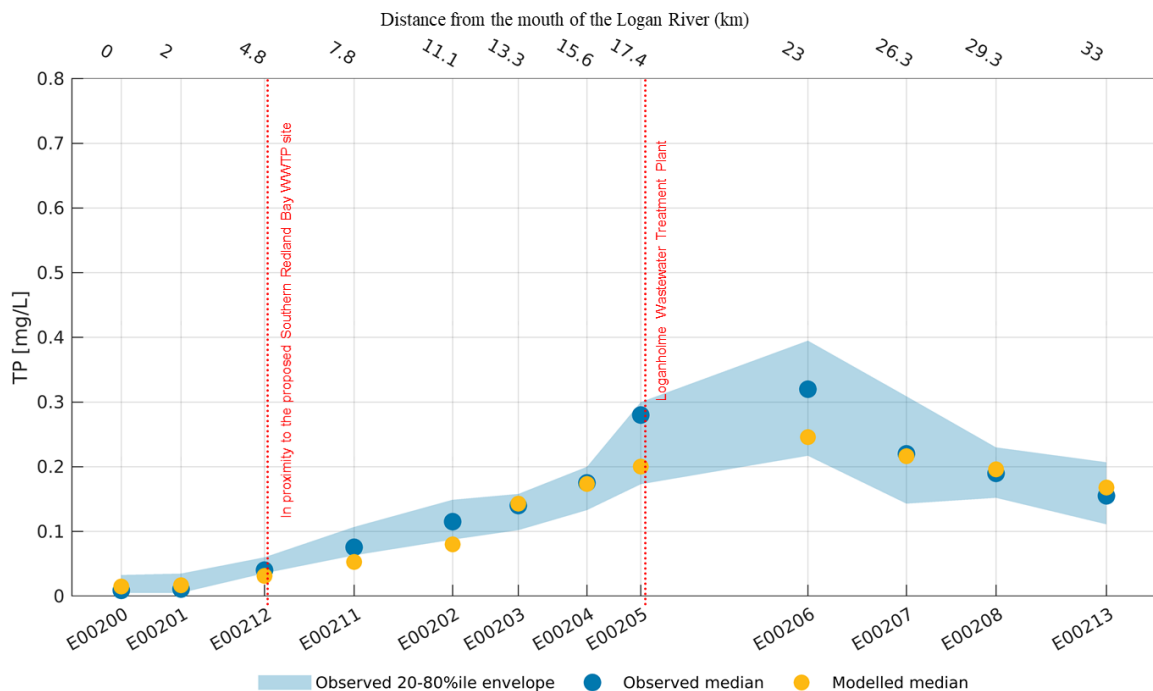
**FIGURE 8-15 OBSERVED (EHMP) AND MODELLED TOTAL PHOSPHORUS IN THE LOGAN ESTUARY, 2018-2019**

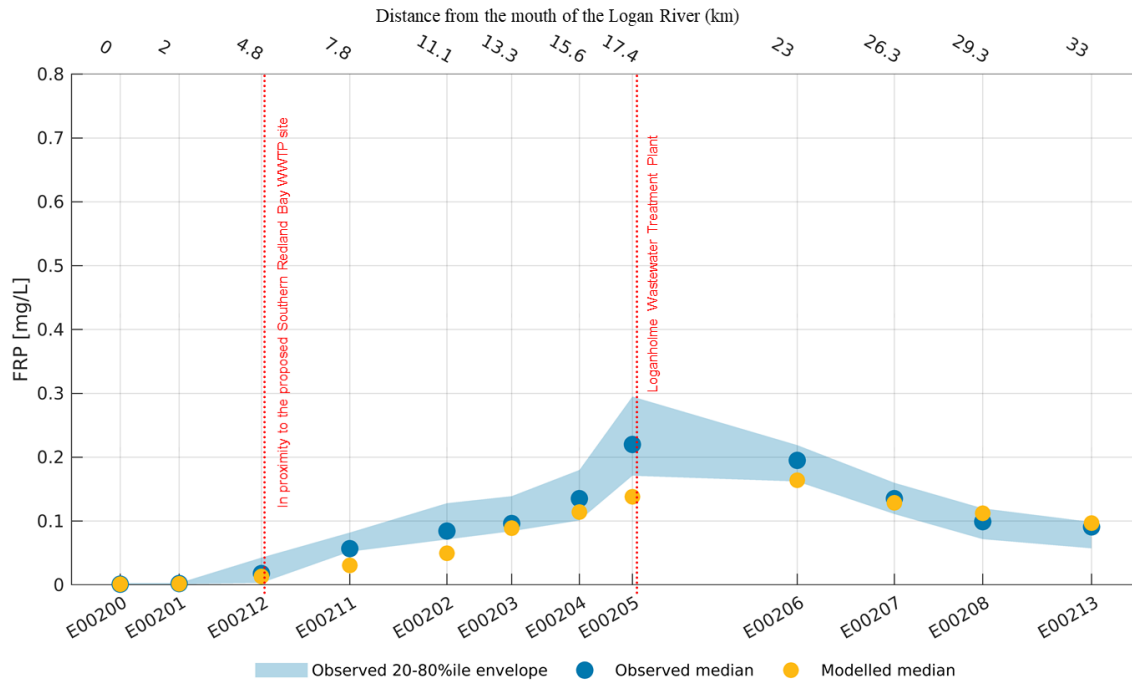
**FIGURE 8-16 OBSERVED (EHMP) AND MODELLED FRP IN THE LOGAN ESTUARY (2018-2019)**

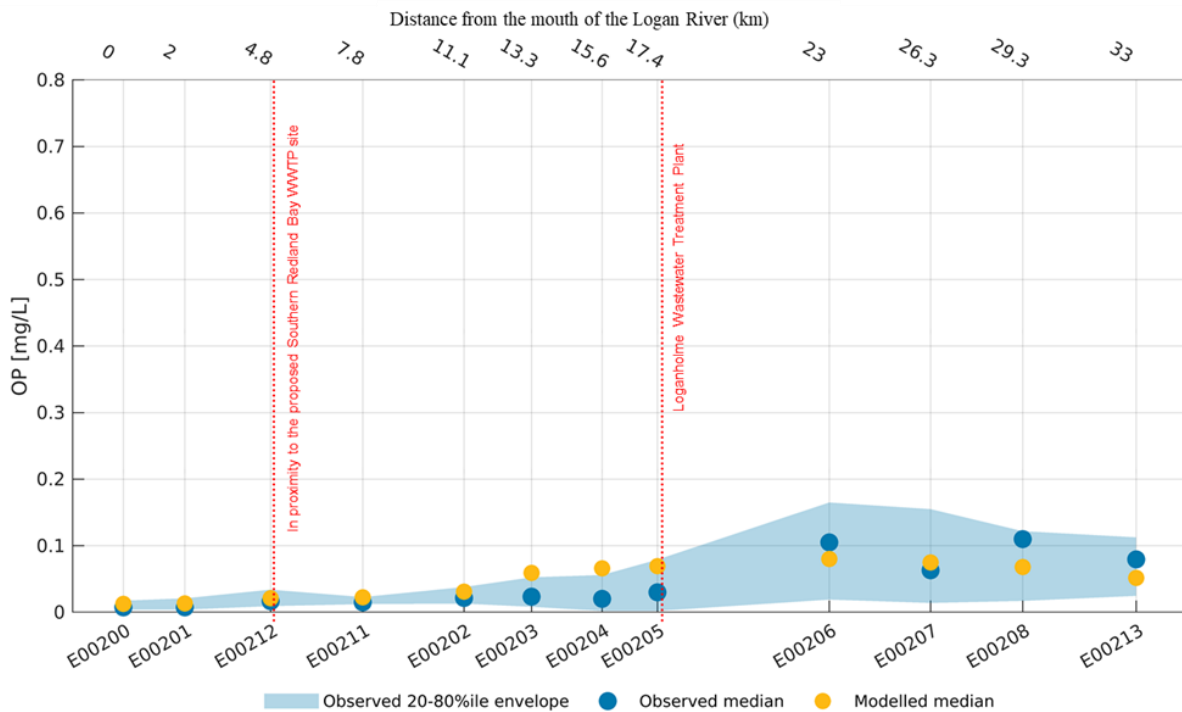
**FIGURE 8-17 OBSERVED (EHMP) AND MODELLED OP IN THE LOGAN ESTUARY (2018-2019)**

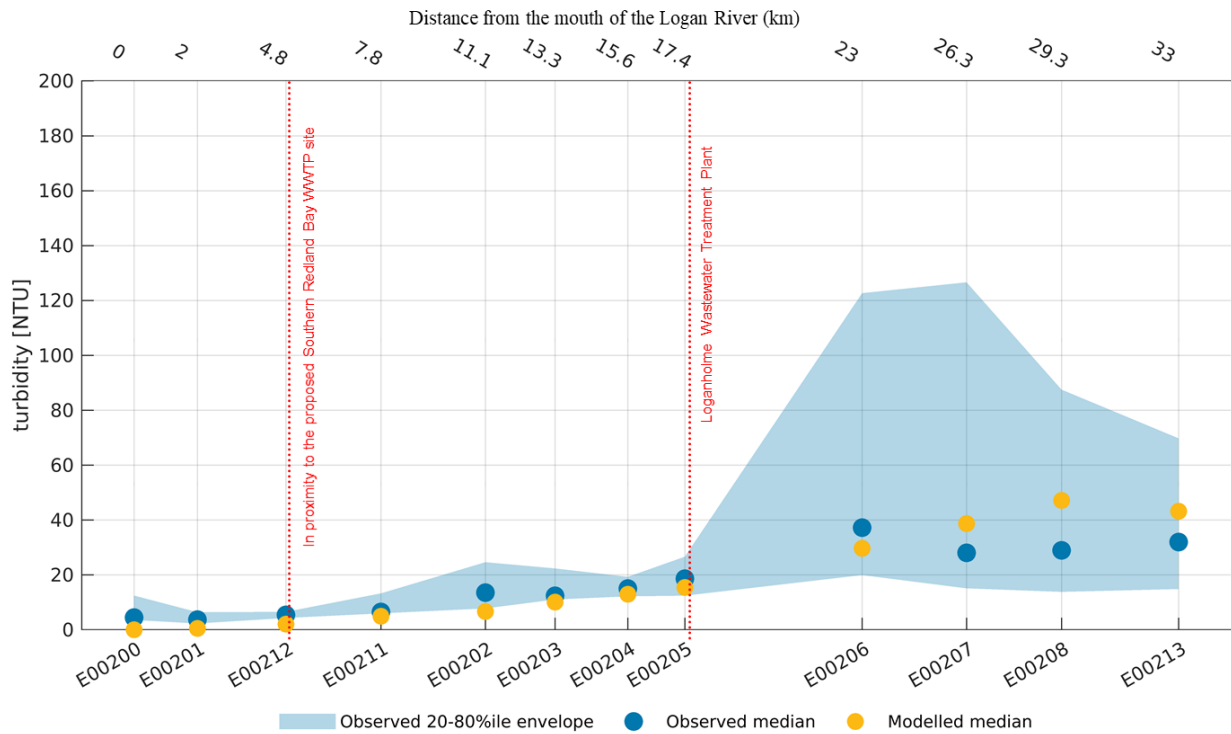
**FIGURE 8-18 OBSERVED (EHMP) AND MODELLED TURBIDITY IN THE LOGAN ESTUARY (2018-2019)**

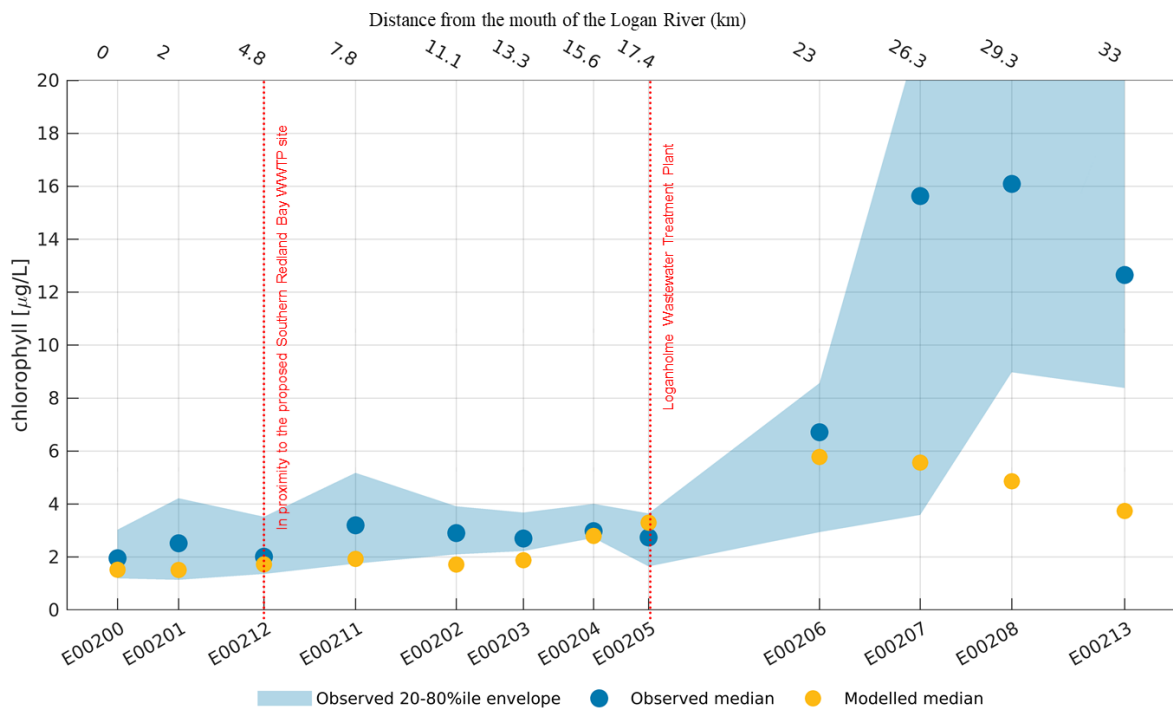
**FIGURE 8-19 OBSERVED (EHMP) AND MODELLED CHLOROPHYLL-A IN THE LOGAN ESTUARY (2018-2019)**

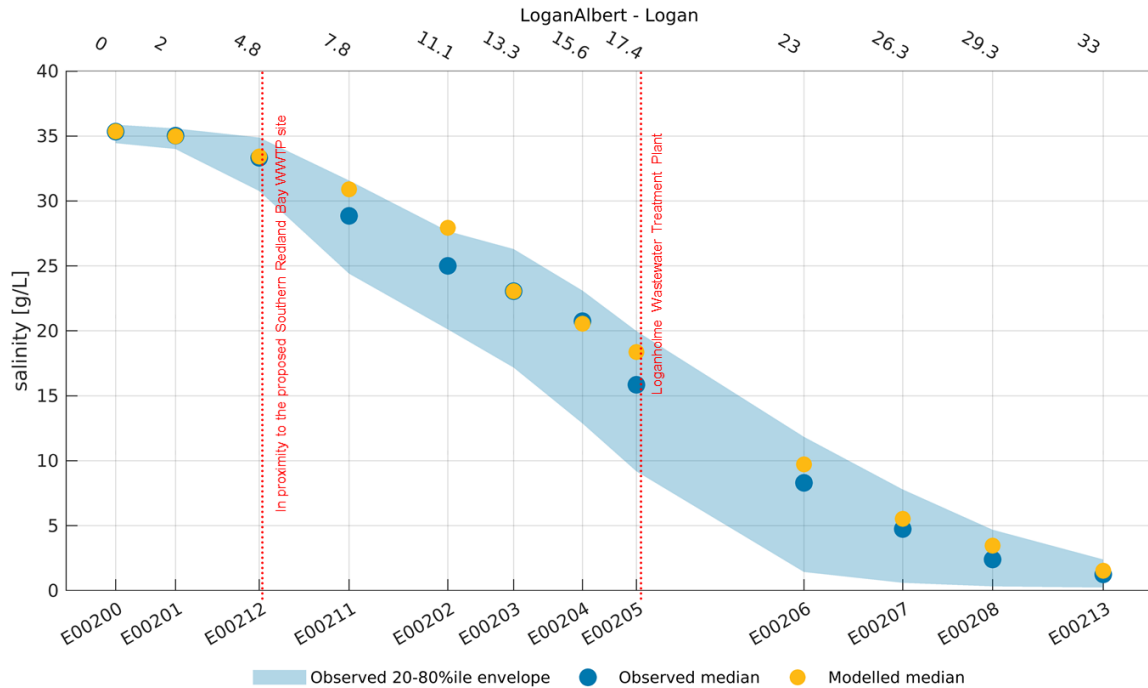
**FIGURE 8-20 OBSERVED (EHMP) AND MODELLED SALINITY IN THE LOGAN ESTUARY (2018-2019)**

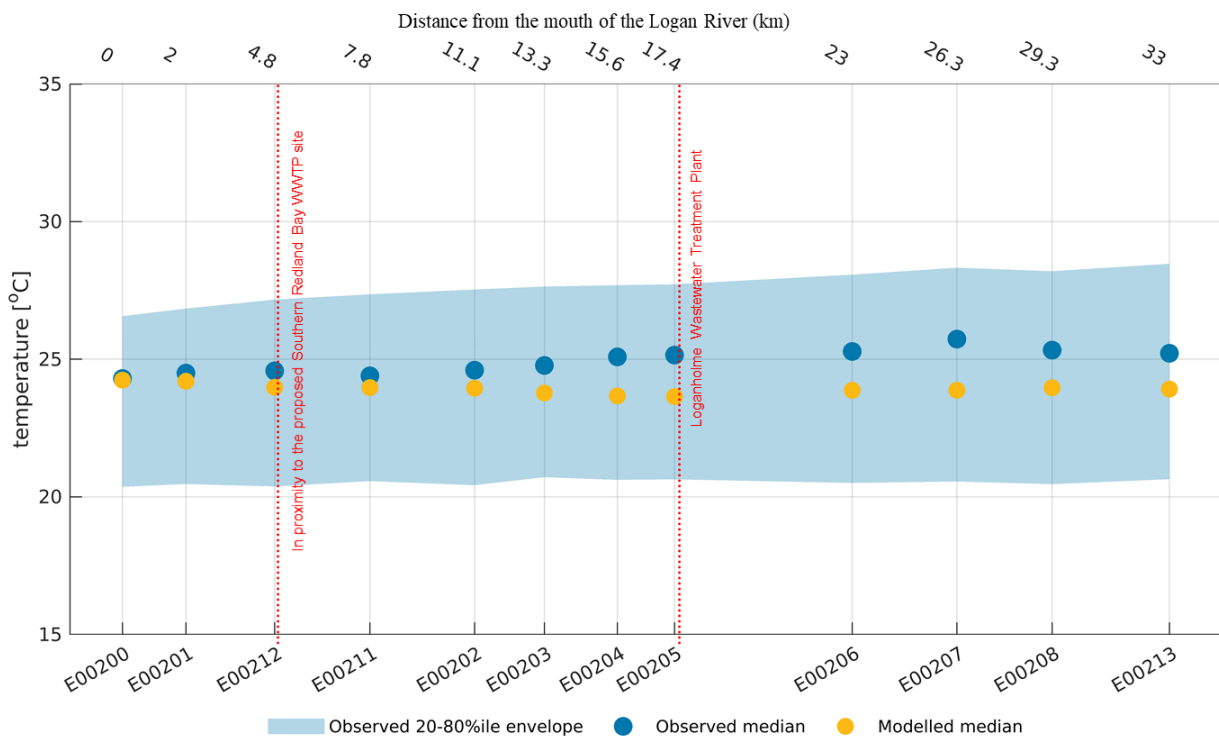
**FIGURE 8-21 OBSERVED (EHMP) AND MODELLED TEMPERATURE IN THE LOGAN ESTUARY (2018-2019)**

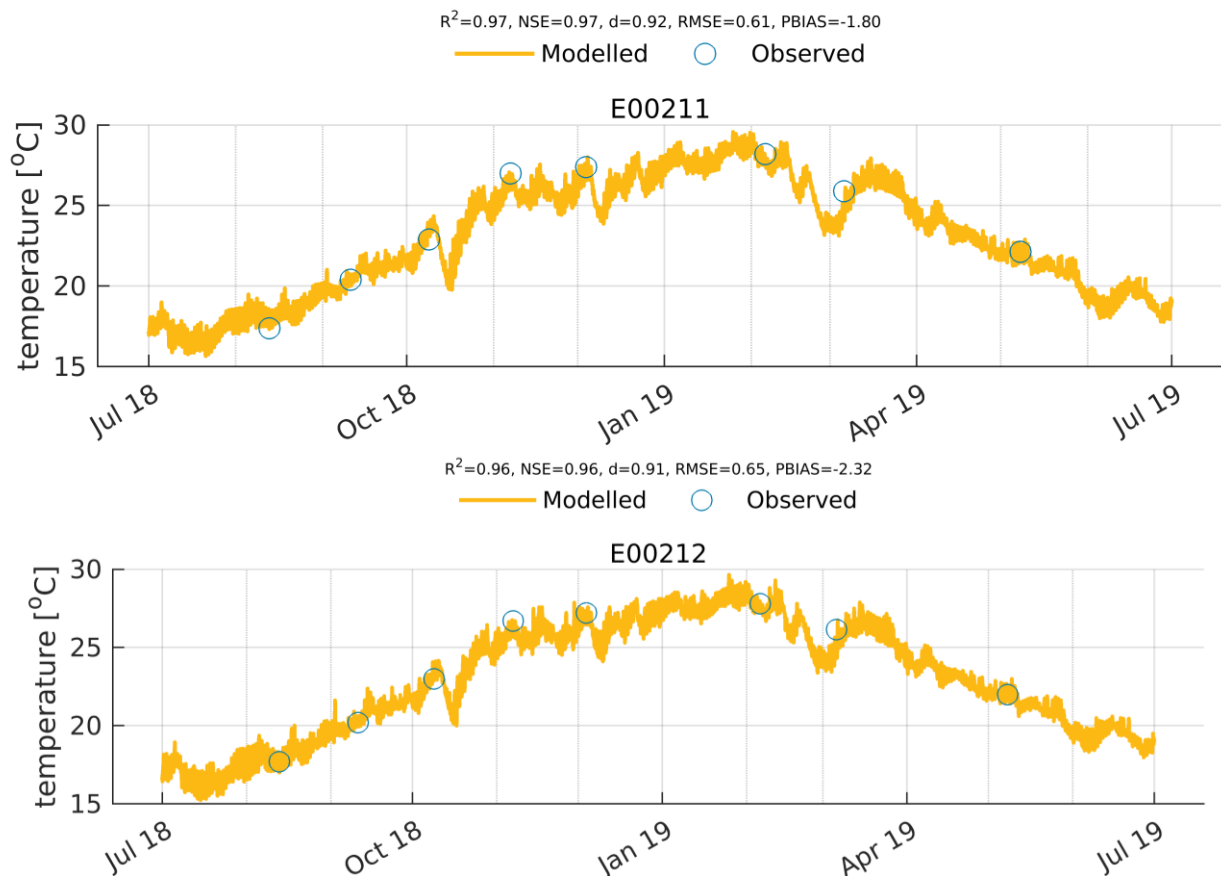
The comparison between simulated and measured temperature at the two selected EHMP locations is presented in Figure 8-22. The figure demonstrates that the model accurately simulates water temperature during warm and cool periods.

FIGURE 8-22 COMPARISON BETWEEN SIMULATED AND MEASURED TEMPERATURE

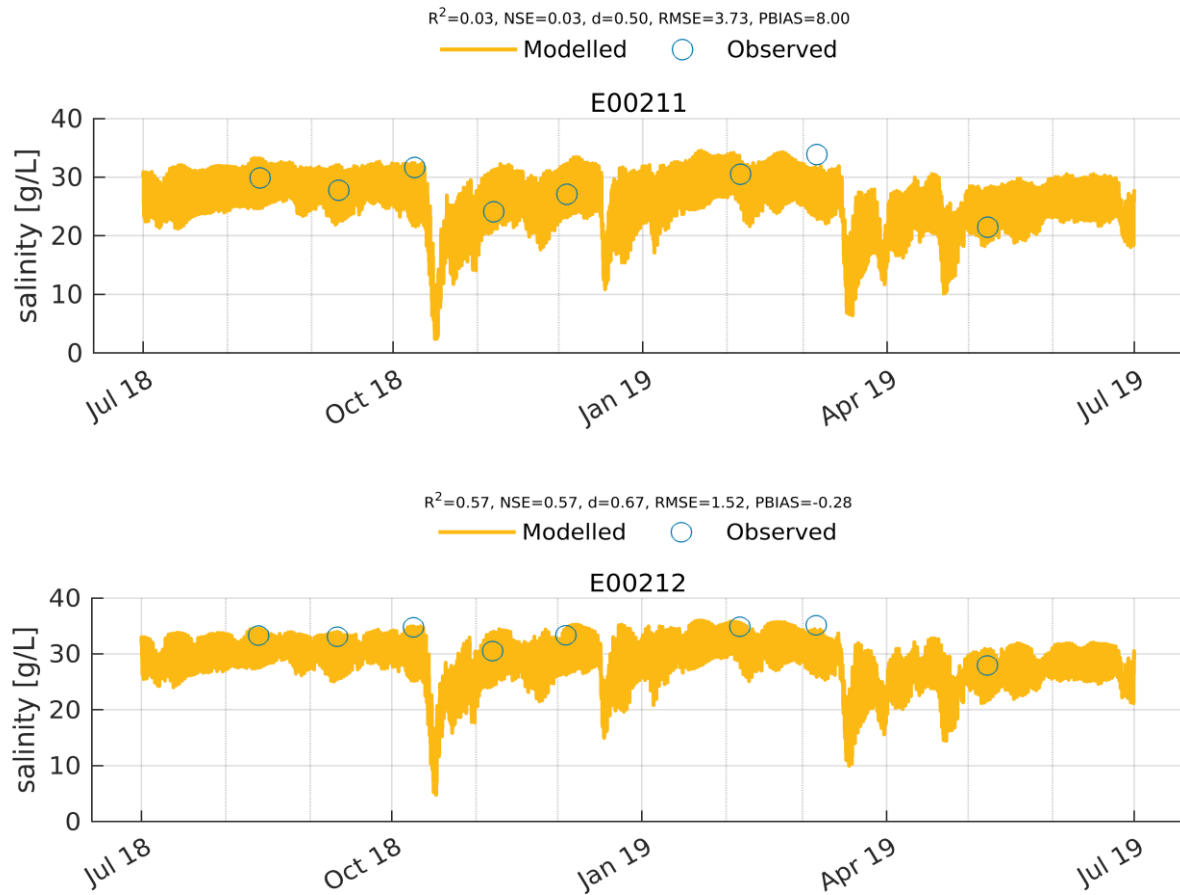
The comparison between simulated and measured salinity at the two chosen EHMP sites is presented in Figure 8-23. The high measurement in March is likely spurious. The prediction of salinity was an accurate representation of reality.

FIGURE 8-23 COMPARISON BETWEEN SIMULATED AND MEASURED SALINITY

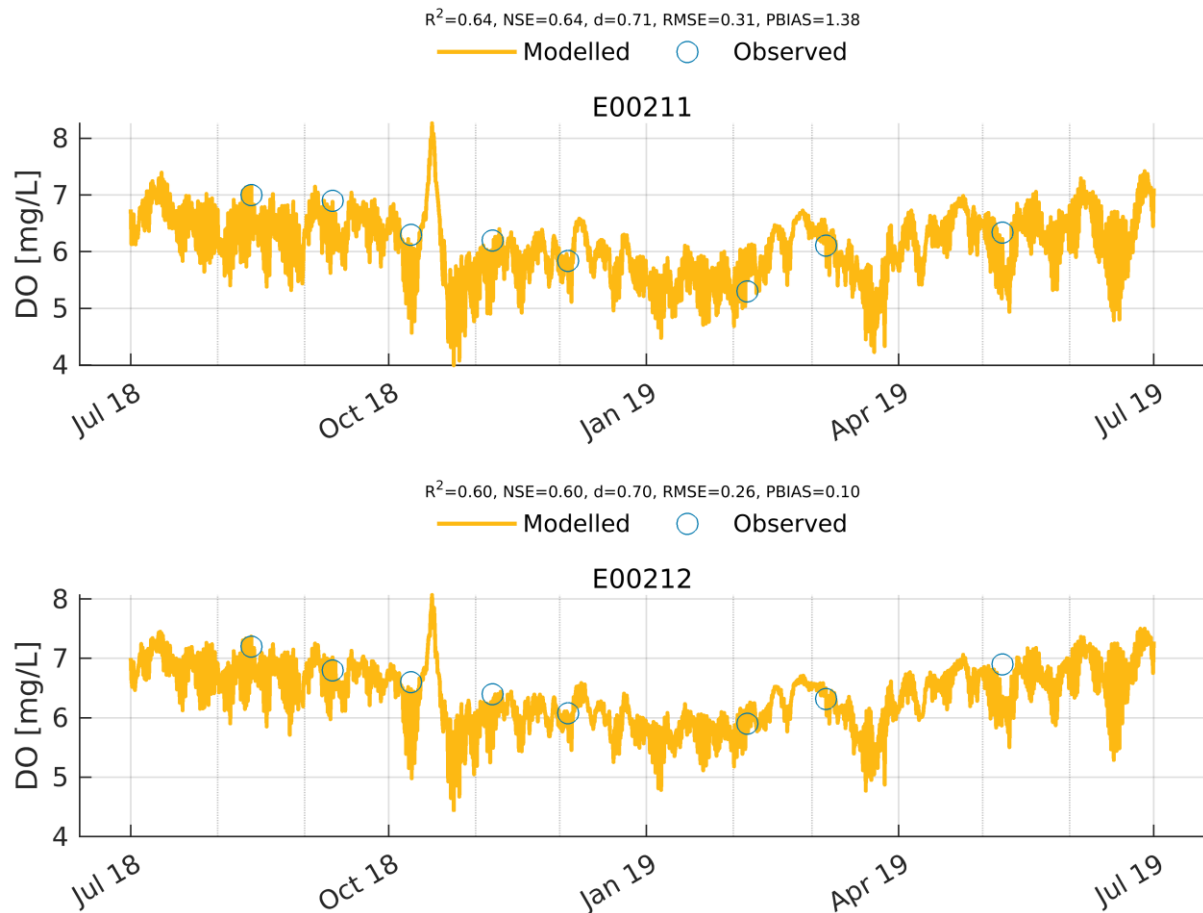
The comparison between the simulated and measured dissolved oxygen at the two chosen sites is presented in Figure 8-24. The slight discrepancies are attributable to minor misrepresentations of the oxygen contributions from photosynthesizing organisms within suspension and on the bed. In general, the prediction of DO was an accurate representation of reality.

**FIGURE 8-24 COMPARISON BETWEEN SIMULATED AND MEASURED DISSOLVED OXYGEN**
