## **Environmental authority P-EA-100121435**

| Environmentally relevant activities | Locations |
|---|---|
| ERA 63 - Sewage Treatment 1(e) - Operating sewage treatment works, other than no-release works, with a total daily peak design capacity of more than 10,000 but not more than 50,000EP | Lots 2 and 3 Plan RP223470; Lot 1 Plan SL3427; Lot 254 Plan S31102; and Lots 83, 84, 86, 255, 256, 257 and 259 on Plan S312432. |

SOUTHERN REDLAND BAY WASTEWATER TREATMENT PLANT  
CONCEPT REHABILITATION PLAN - DETAIL SHEET 05

R01v05\_20020099\_Southern\_Redland\_Bay\_Stage\_3\_Assessments

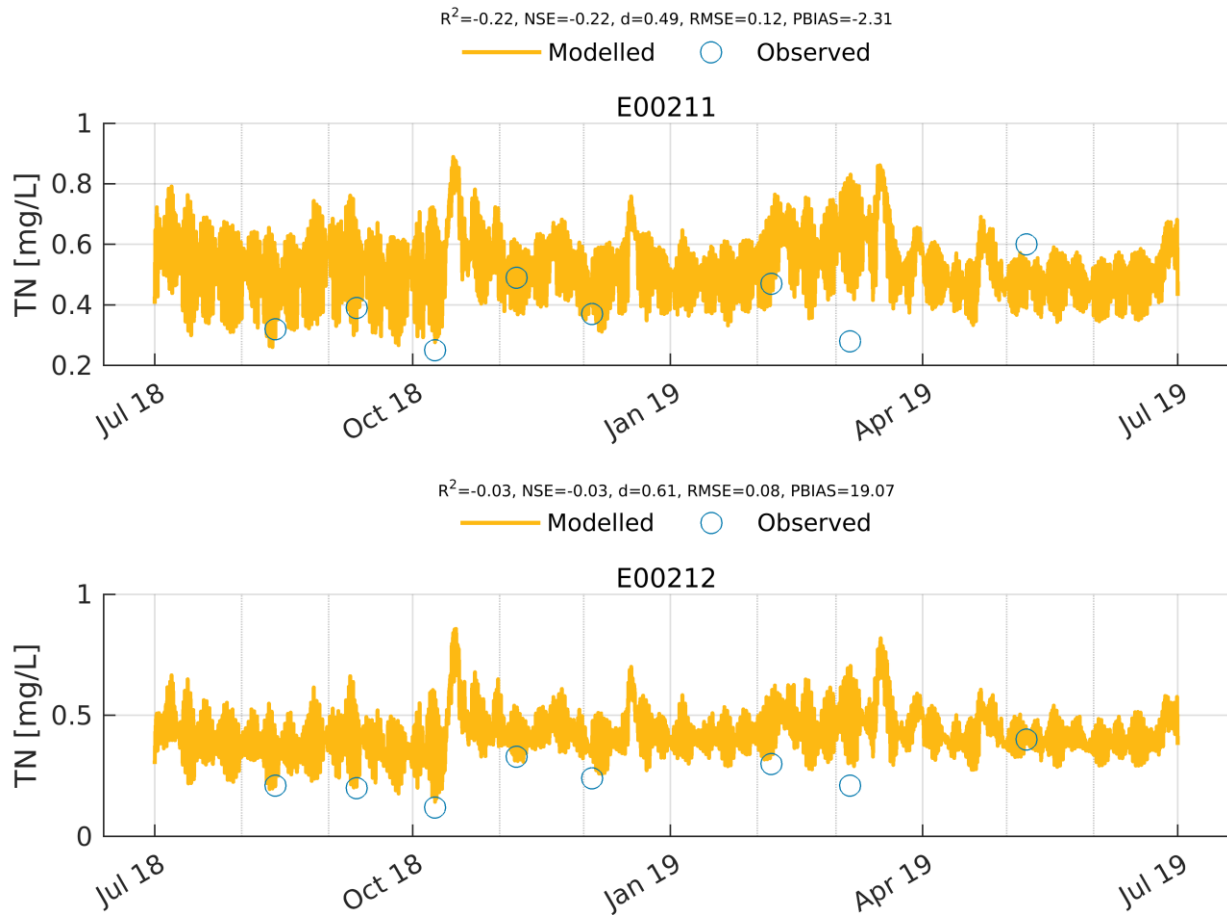
The comparisons between the simulated and measured total nitrogen at the EHMP sites are presented in Figure 8-25. The model slightly overpredicts the total nitrogen trend, especially in the month of March.

FIGURE 8-25 COMPARISON BETWEEN SIMULATED AND MEASURED TOTAL NITROGEN

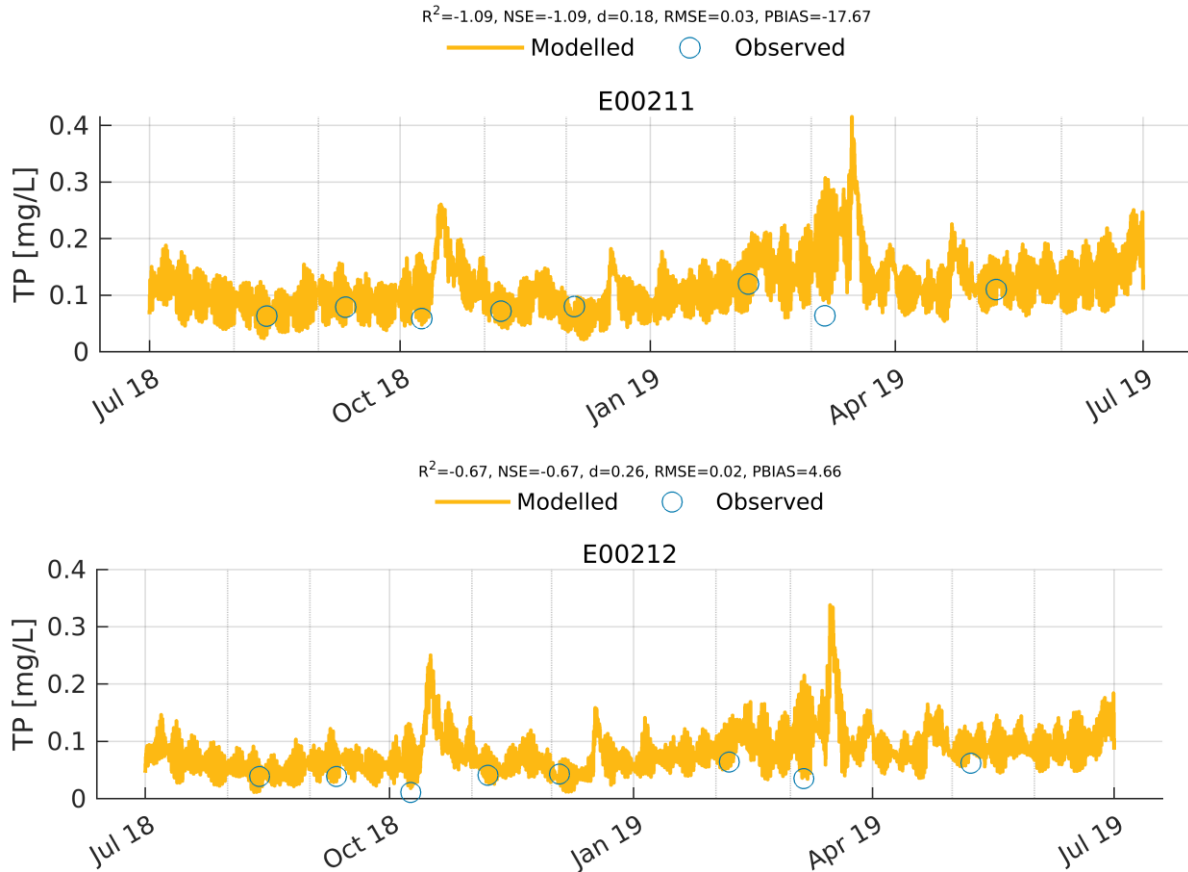
The comparisons between simulated and measured total phosphorus at the chosen EHMP sites are presented in Figure 8-26. The model reproduces the general trend of total phosphorus through the year, but slightly overpredicts concentrations in March.

**FIGURE 8-26 COMPARISON BETWEEN SIMULATED AND MEASURED TOTAL PHOSPHORUS**

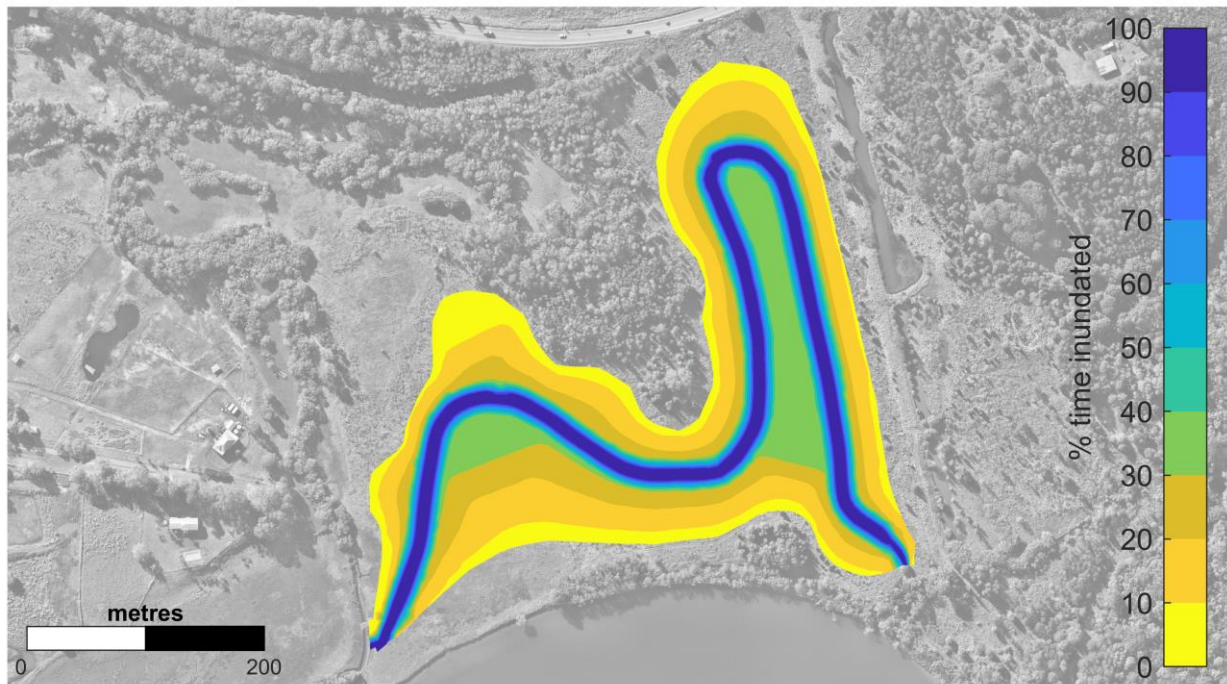
**FIGURE 9-1 MODELLED INUNDATION TIMES (PERCENTAGE) WITHIN THE MOA. INUNDATION TIMES BEYOND THE MOA HAVE NOT BEEN MAPPED**

The assessment was performed by extending the existing TUFLOWFV estuary model, described previously in Section 8, to include the proposed MOA. The inlet and outlet structures and the excavated bathymetry within the MOA had been designed to facilitate the colonisation by mangroves over the designated areas (See 'Hydrodynamic Modelling for Culvert Sizing' report). The percentage of time for which the various areas of the MOA are expected to be inundated is presented in Figure 9-1. The values were derived by analysing a one (1) month modelled period. As evident in the figure, the percentage times inundated are amenable to mangrove colonisation, and in the upper regions, salt marsh colonisation. The ground elevations and the time varying water levels, which are dependent on the configuration of the inlet and outlet culverts, were carefully considered during the culvert design works (See Hydrodynamic Modelling for Culvert Sizing report by Water Technology). The percentage inundation times which are amenable to the colonisation by locally native species were derived from the surveyed extents of existing intertidal vegetation and measured water levels within the adjacent Logan River Estuary.

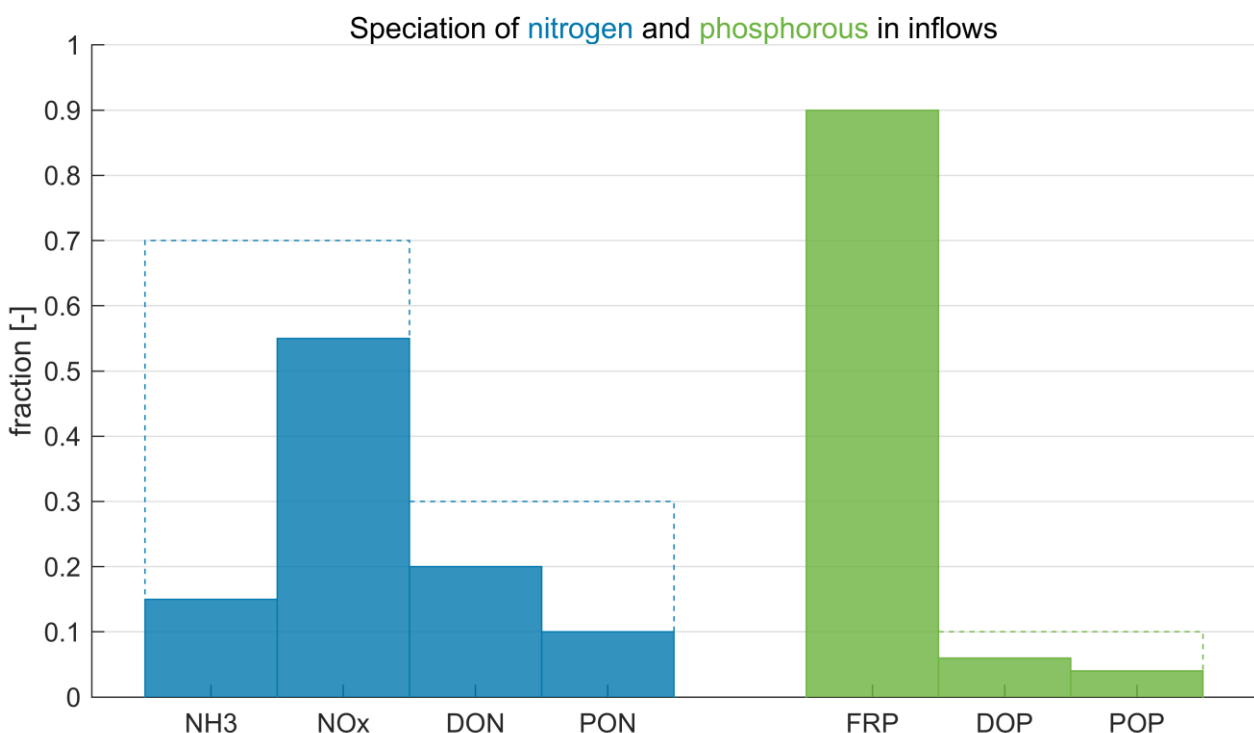
3 mg/L and 1 mg/L, resulting in loads of 7.2 kg/day for nitrogen and 2.4 kg/day for phosphorus. The values are consistent with those presented in Table 3-1. As presented in Figure 9-2, the modelled discharged nutrients consisted principally of the inorganic fractions. Whilst the speciation of the nutrients discharged from the proposed WWTP will likely, to an extent, vary temporally, the values adopted (Figure 9-2) are assumed representative of the future operations and are consistent with those provided by Stantec's 'Southern Redland Bay (Shoreline) WWTP – Effluent Characterisation Technical Memorandum'. According to Stantec's memorandum, whilst the short term 50th percentile value for TN is assumed to be 3 mg/L as N as a discharge permit condition, speciation is applied as follows:

**FIGURE 9-2 SPECIATION OF NUTRIENTS WITHIN THE MODELLED DISCHARGES OF THE PROPOSED WASTEWATER TREATMENT PLANT. INORGANIC NUTRIENTS ARE GROUPED AND PLOTTED TO THE LEFT OF THE RESPECTIVE ORGANIC NUTRIENTS.**

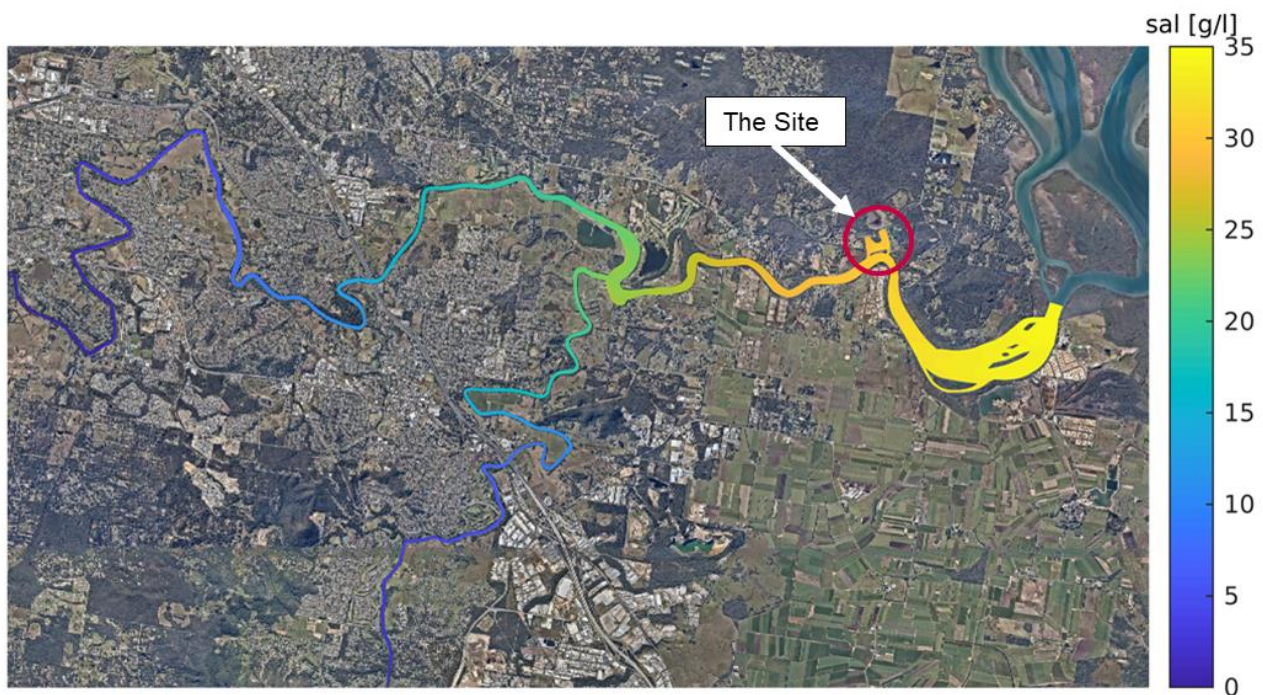
**FIGURE 9-3 MEDIAN SALINITY DISTRIBUTION IN THE LOGAN RIVER – EXISTING (UNDEVELOPED) CASE**

Impacts may arise from changes in salinity influenced by the proposed recycled water discharge into the MOA which could subsequently influence mangrove growth and salinity in the Logan River. Existing salinity levels for the Logan River were incorporated into the Logan-Albert River model to provide a base case (Figure 9-3). Salinity levels within the proposed mangrove area (without recycled water discharge) were estimated to be to the order of ~ 30 g/L, which aligns with the levels in the adjacent Logan River.

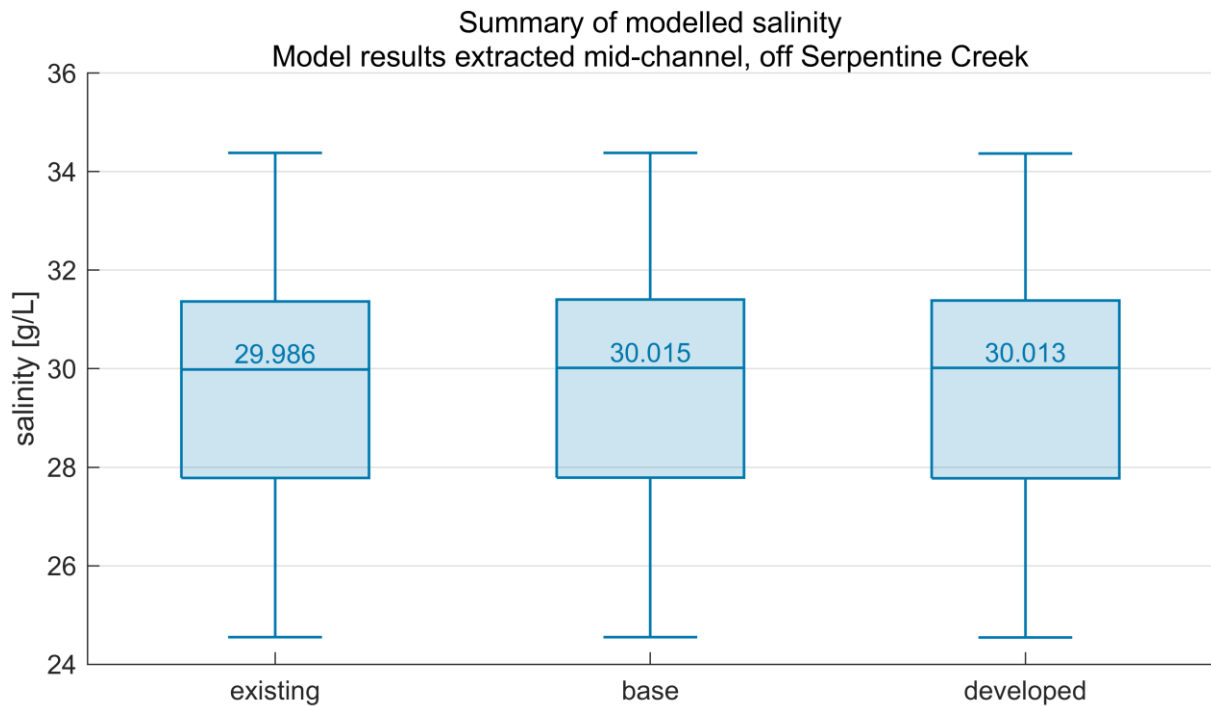
The expected changes to salinity within the Logan River Estuary in the vicinity of, and attributable to, the MOA are provided in Figure 9-4. It is evident that no significant change in salinity is expected when contextualised within the variation experienced throughout the tidal cycle during a month of dry weather.

FIGURE 9-4 BOX PLOT OF MODELLED SALINITY

Results from the modelling showed minimal impacts from the proposed recycled water discharge into the MOA (Figure 9-5). The median salinity (~ 25 g/L) **within the mangroves** showed a slight decrease in the areas immediately surrounding the point of entry of recycled water. The slight decrease will not affect the establishment of mangroves or salt marsh. The discharge had **negligible impacts on salinity levels in the Logan River**, which were shown to remain at ~ 30 g/L (See Figure 9-4).

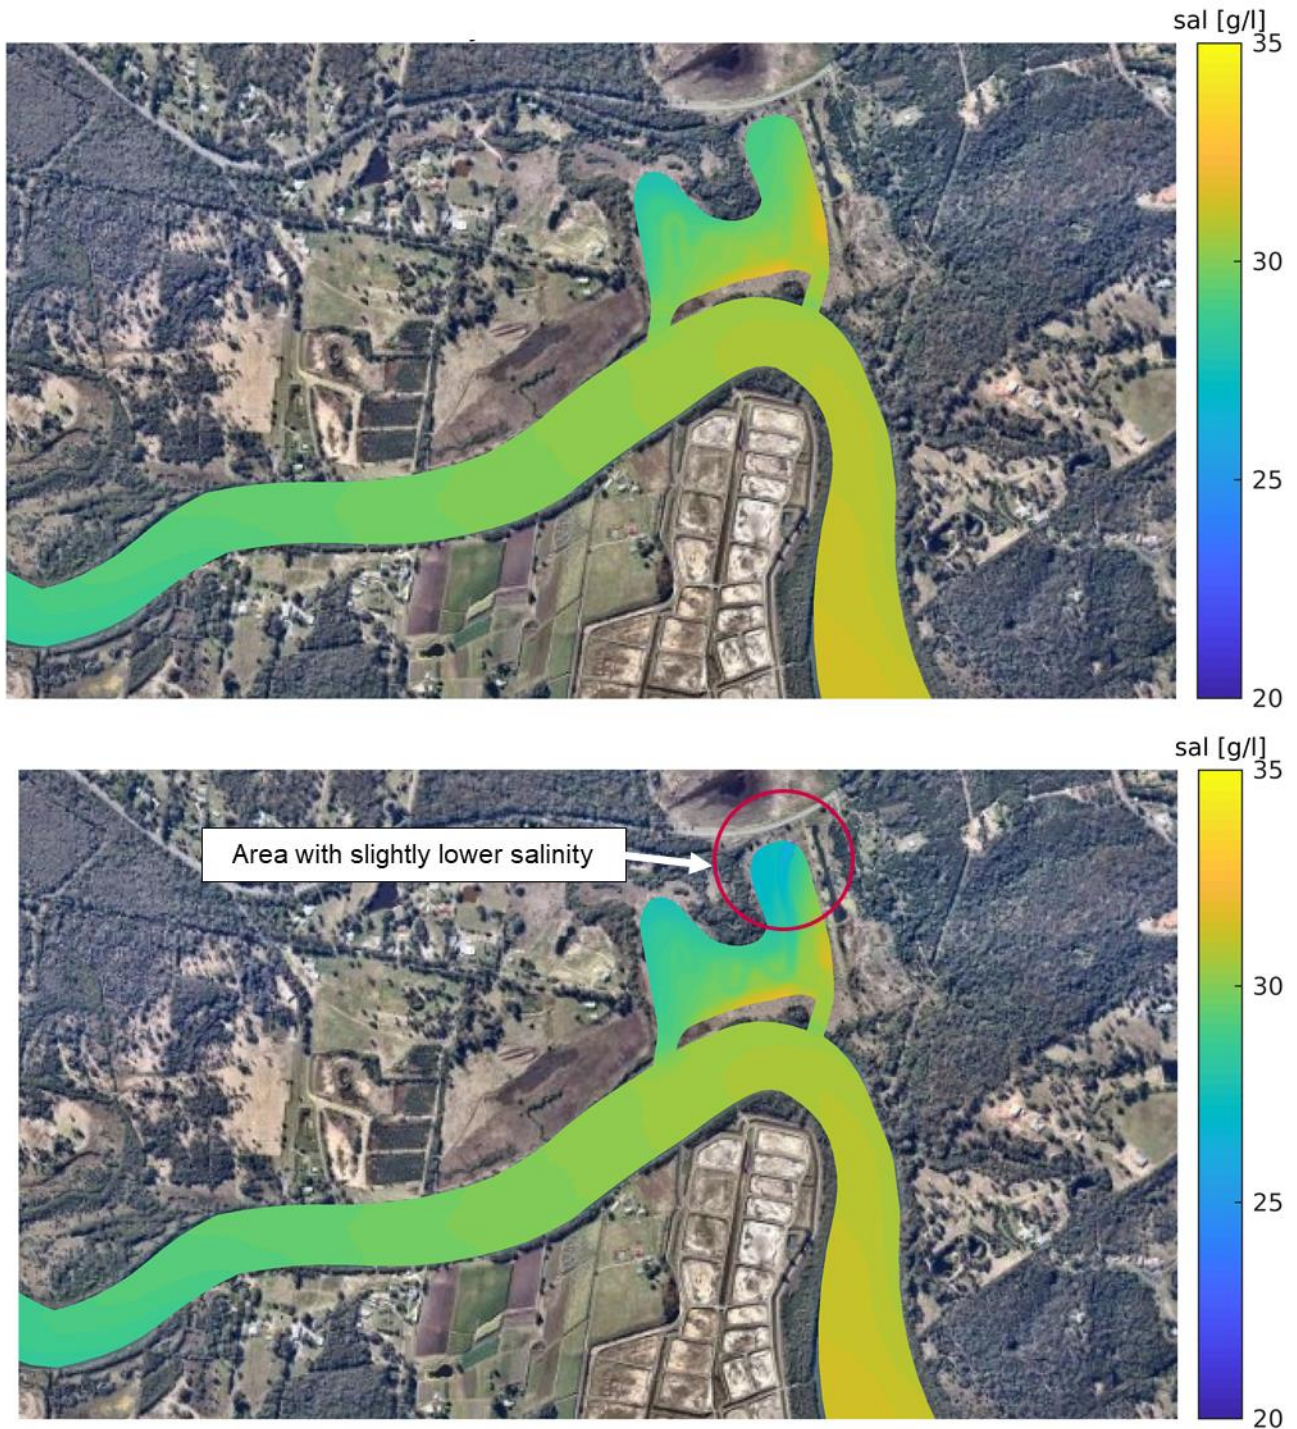
FIGURE 9-5 MEDIAN SALINITY DISTRIBUTION – ABOVE: BASE CASE (NO RECYCLED WATER DISCHARGE), BELOW: DEVELOPED CASE (WITH RECYCLED WATER DISCHARGE)

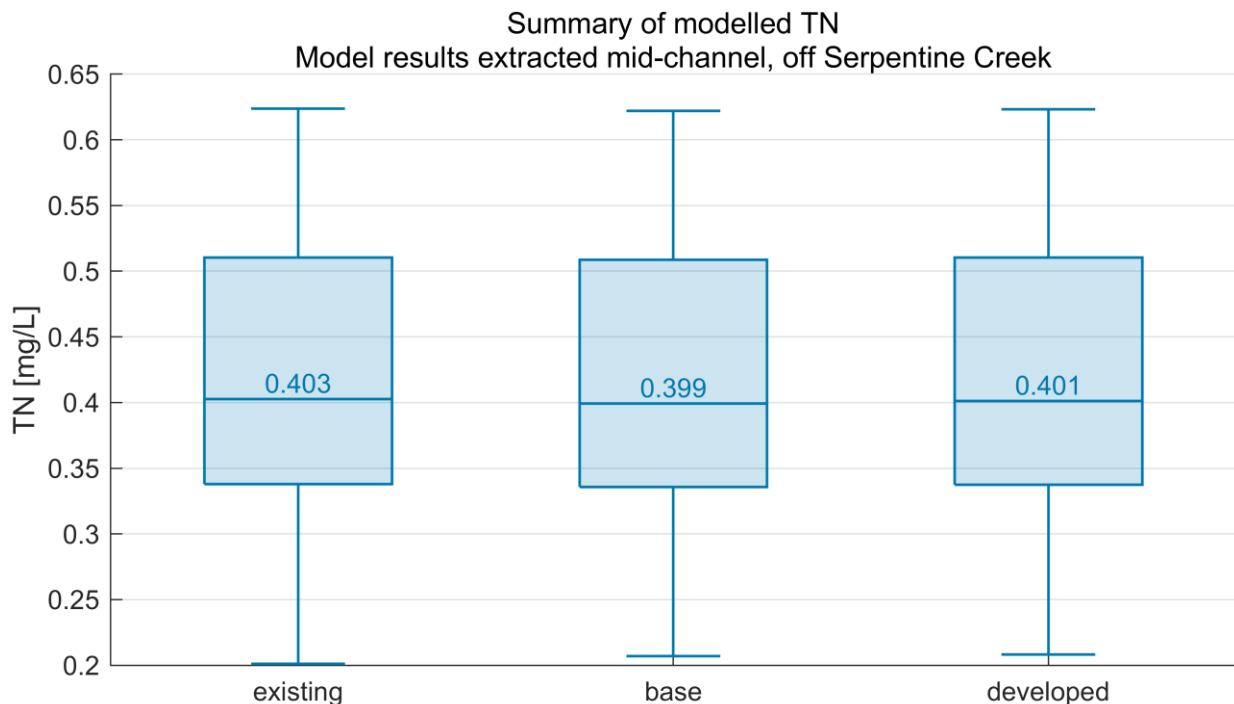
The expected changes to Total Nitrogen (TN) within the Logan River Estuary in the vicinity of, and attributable to, the MOA are provided in Figure 9-6. It is evident that no significant change in TN is expected when contextualised within the variation experienced throughout the tidal cycle during a month of dry weather. The slight differences in the minimum TN between the existing and base cases is reflective of a subtle variation in

**FIGURE 9-6 BOX PLOT OF MODELLED TOTAL NITROGEN**

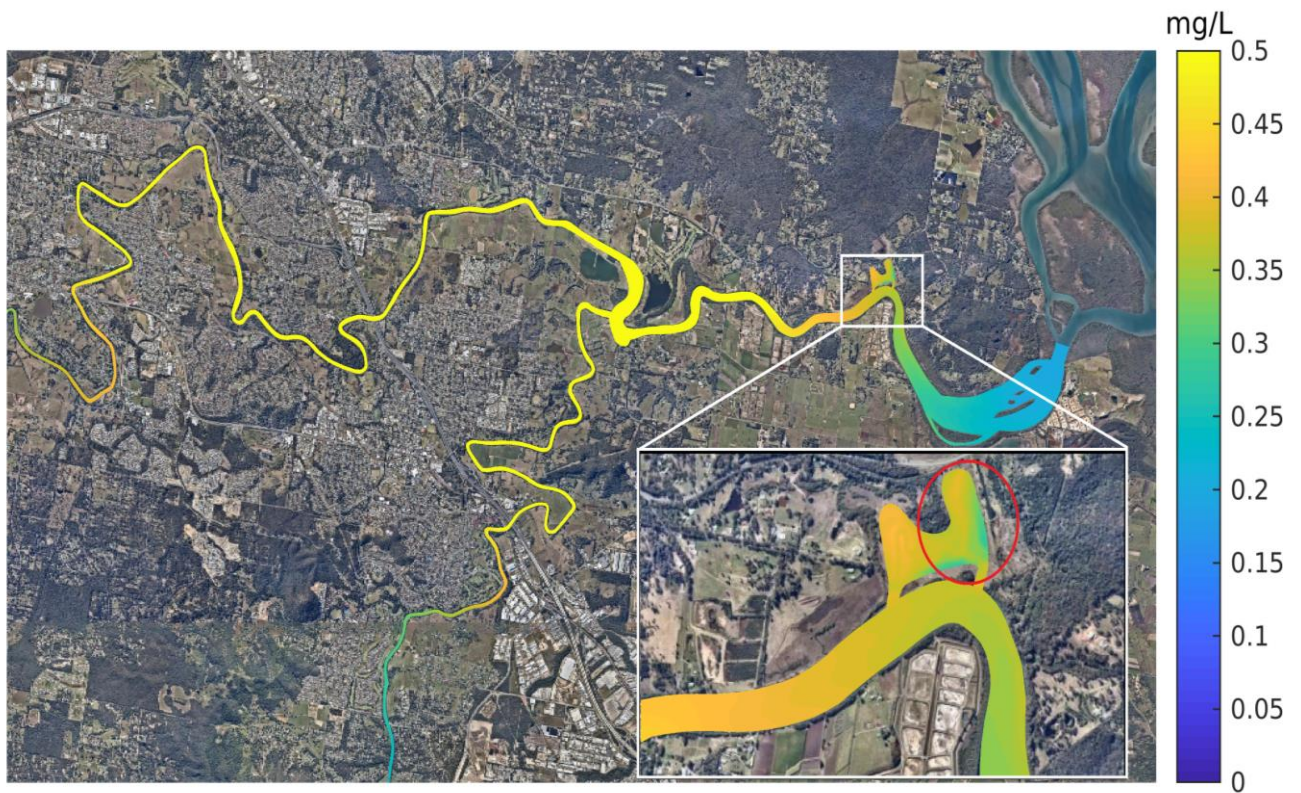
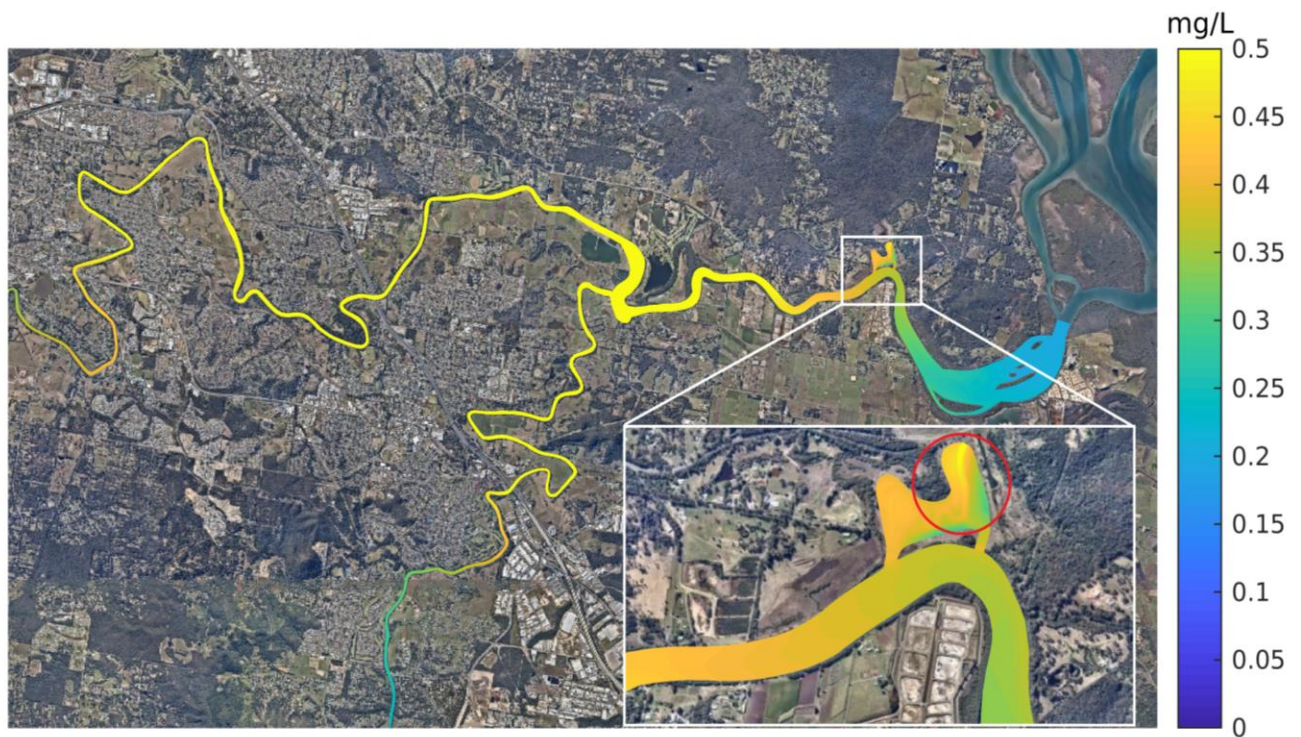
A comparison of the base case and developed case scenarios **within the MOA** showed that changes in water levels/volumes were influenced by the recycled water discharge in addition to tidal influence from the Logan River. As expected, the levels of TN **within the MOA** were also influenced by the recycled water discharge. Figure 9-7 shows the median distribution of TN for the base case and developed case scenarios. An apparent increase in the median TN concentration **within the MOA** at the recycled water discharge point north-east of the proposed mangrove site is seen. However, impacts in the Logan Estuary from TN in the recycled water discharge in the MOA are negligible and of no concern.

**FIGURE 9-7 MEDIAN TOTAL NITROGEN DISTRIBUTION – ABOVE: BASE CASE WITH NO RECYCLED WATER DISCHARGE IN THE MOA; BELOW: DEVELOPED CASE WITH RECYCLED WATER DISCHARGE IN THE MOA**

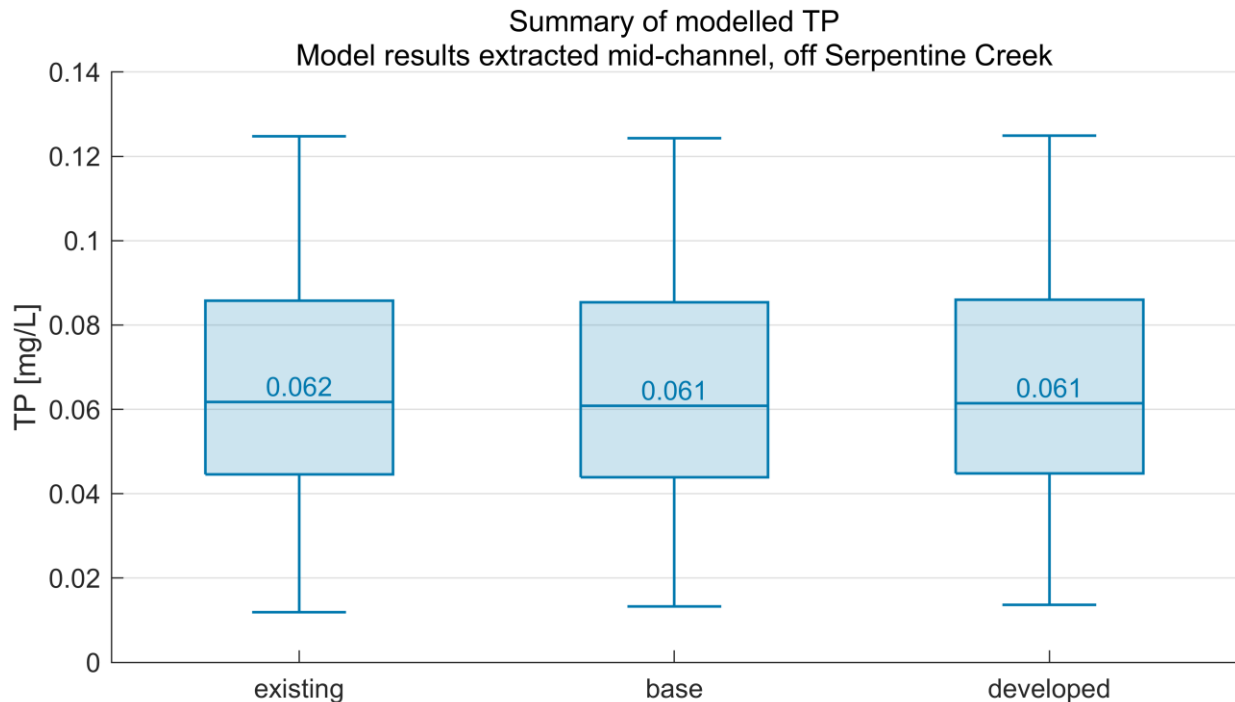
The expected changes to the Total Phosphorus (TP) within the Logan River Estuary in the vicinity of, and attributable to, the MOA are provided in Figure 9-8. It is evident that the median TP decreases slightly from the existing case to the base case. Once discharges from the wastewater treatment plant are included however (developed case), the TP concentrations are again equivalent to those of the existing case. Therefore, the discharge had negligible impacts on the levels of TP in the Logan River.

FIGURE 9-8 BOX PLOT OF MODELLED TOTAL PHOSPHORUS

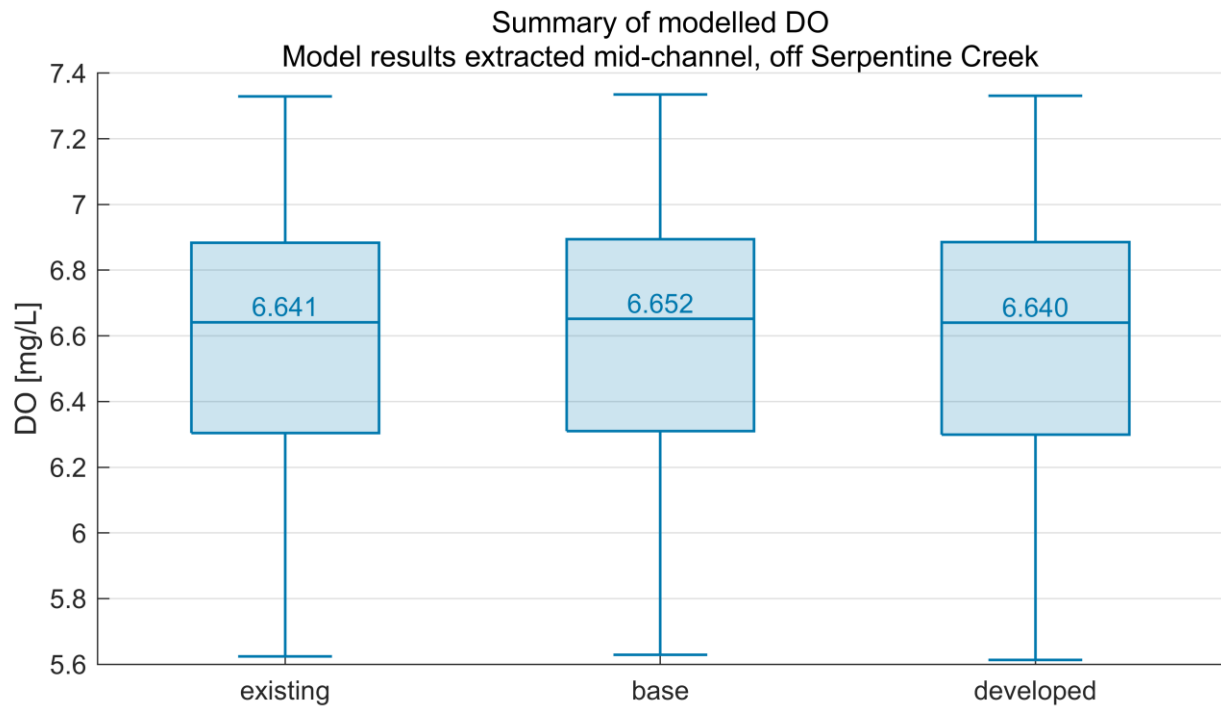
The expected changes to the Dissolved Oxygen (DO) within the Logan River Estuary in the vicinity of, and attributable to, the MOA are provided in Figure 9-9. It is evident that the median DO increases slightly from the existing case to the base case. Once the discharges from the wastewater treatment plant are included however (developed case), the DO concentrations are again equivalent to those of the existing case. Therefore, the discharge had negligible impacts on the levels of DO in the Logan River.

FIGURE 9-9 BOX PLOT OF MODELLED DISSOLVED OXYGEN

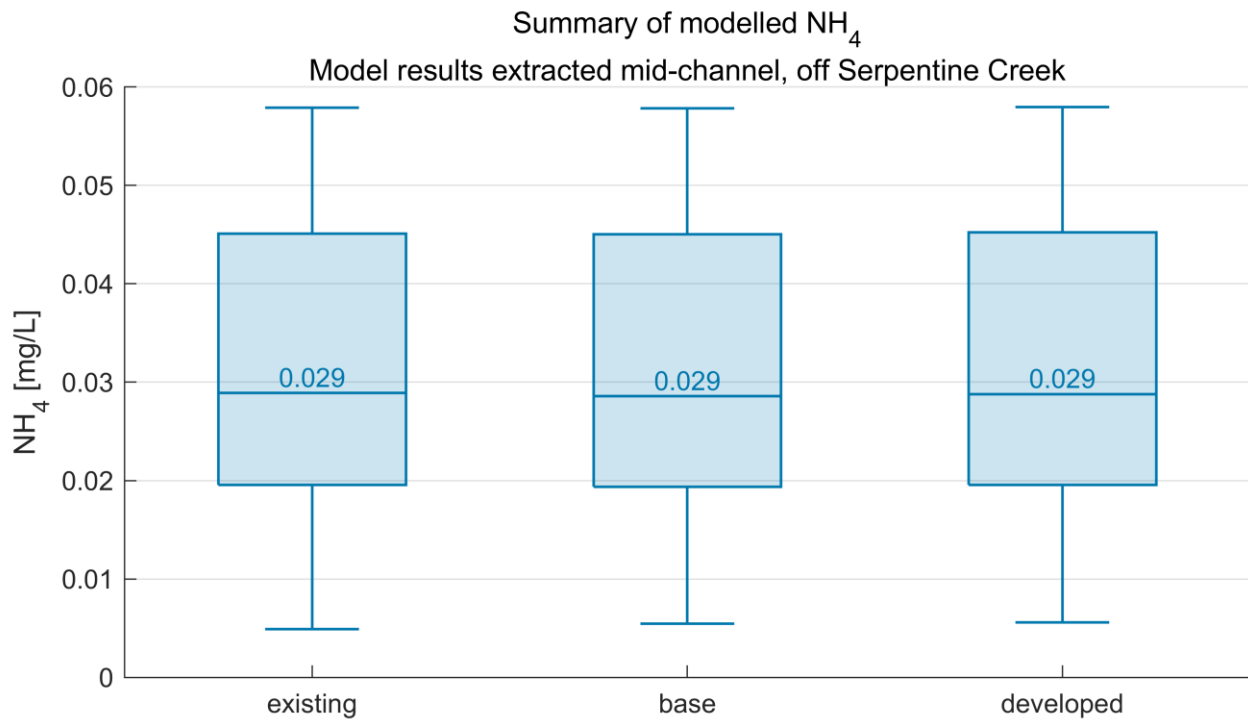
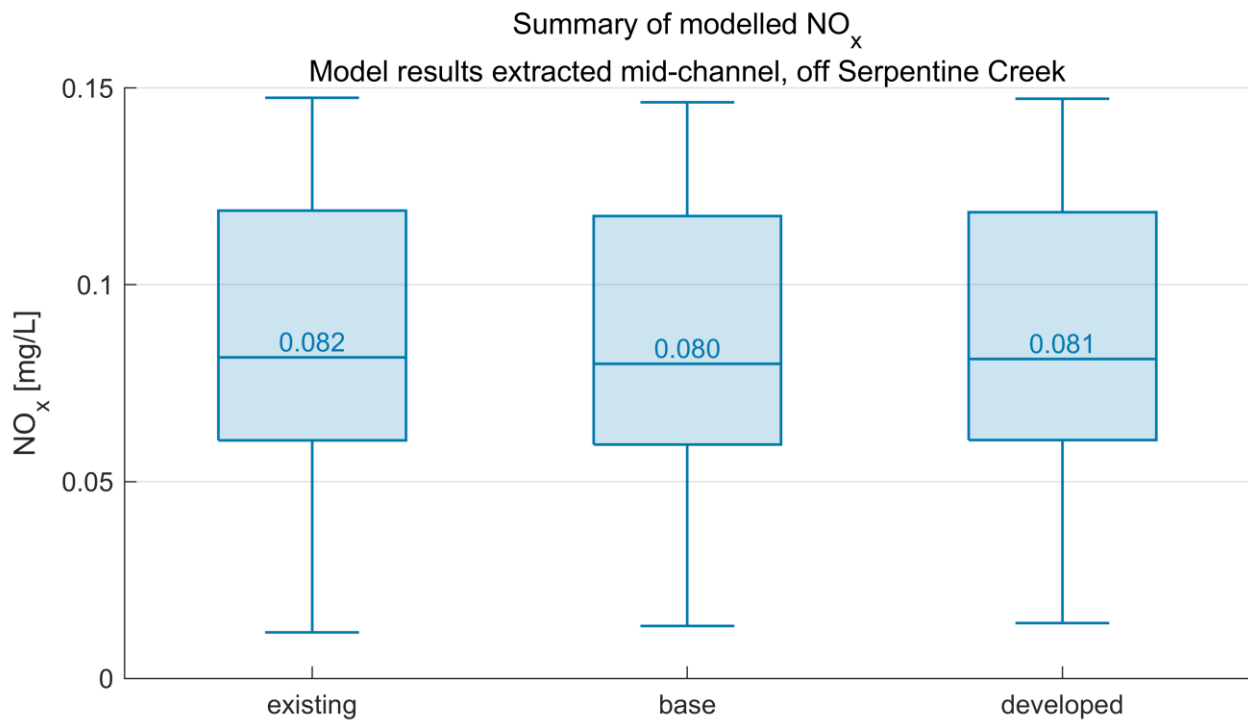
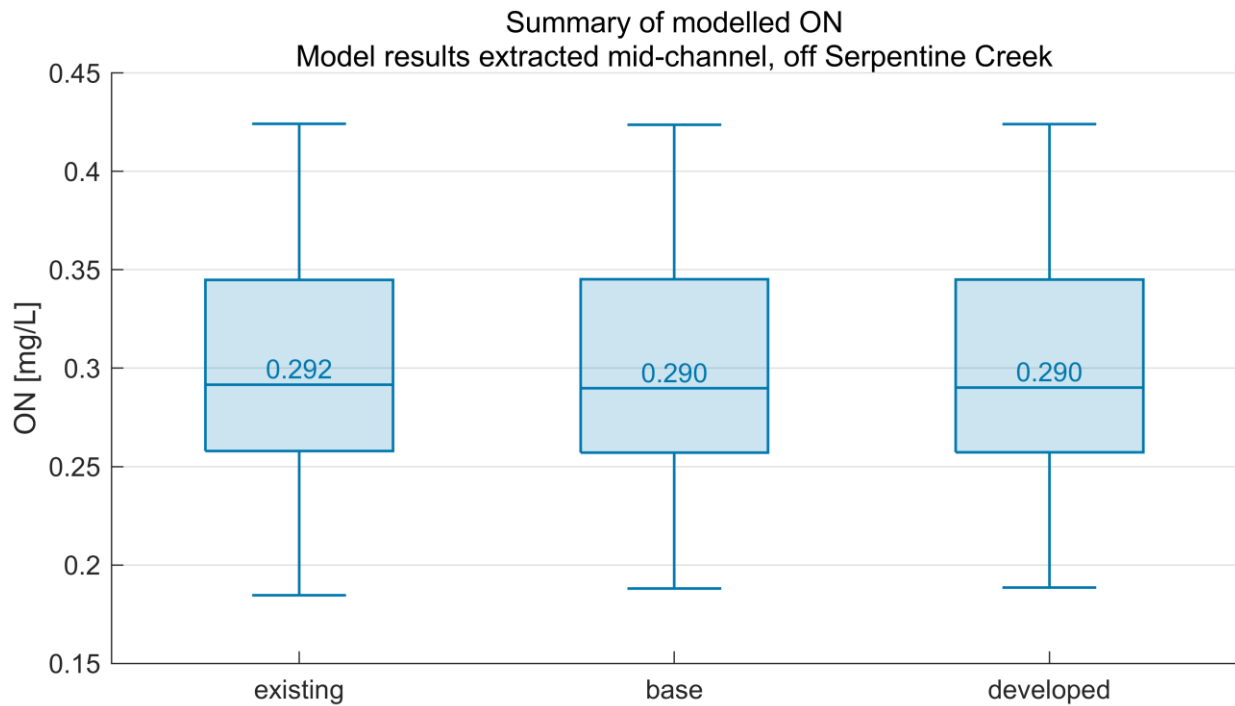
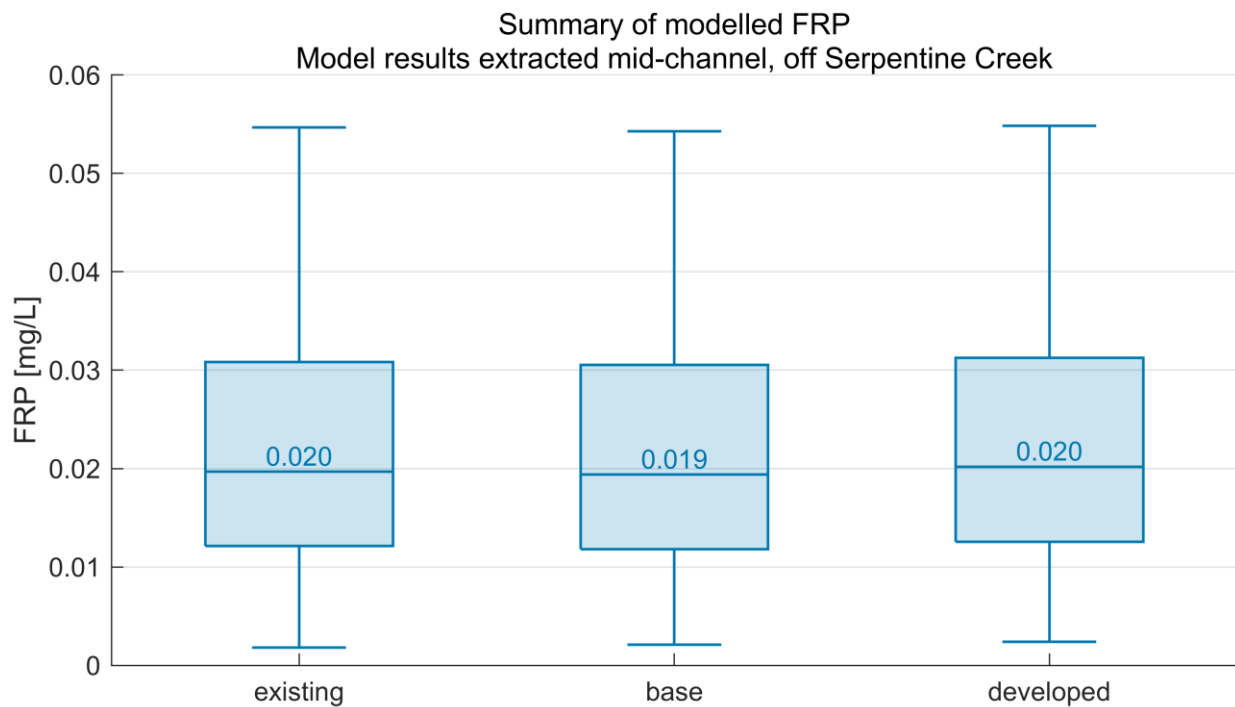
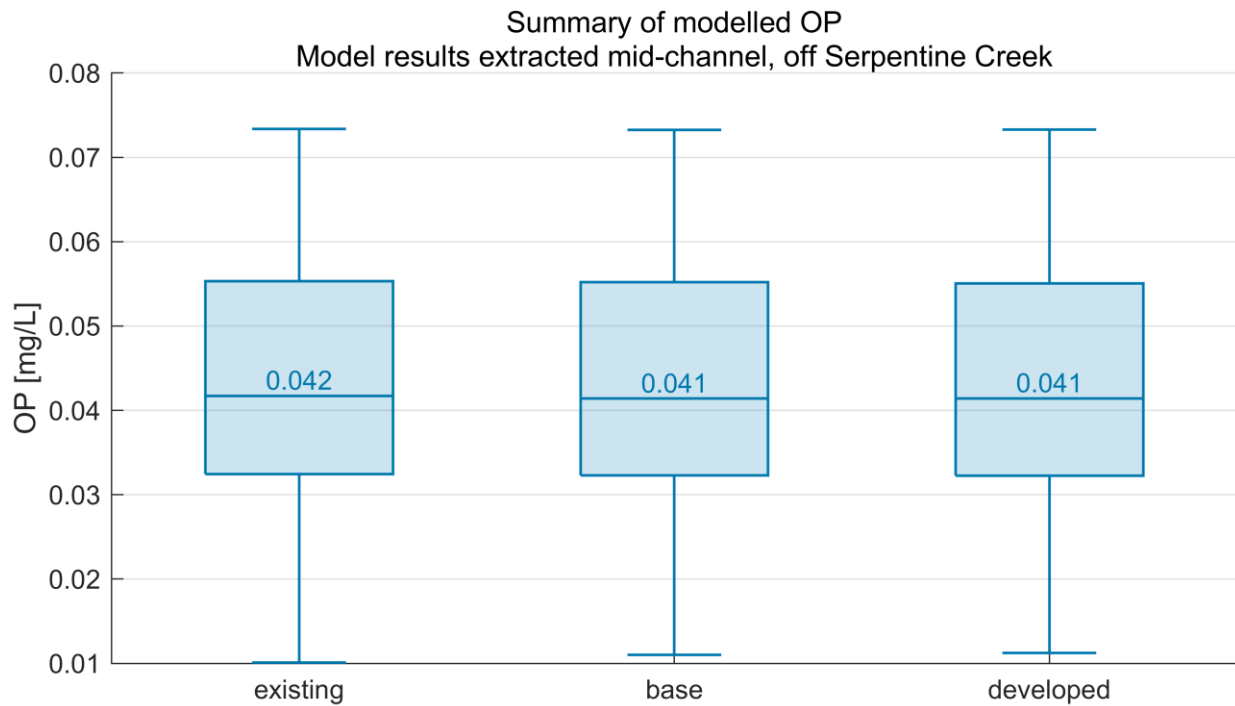
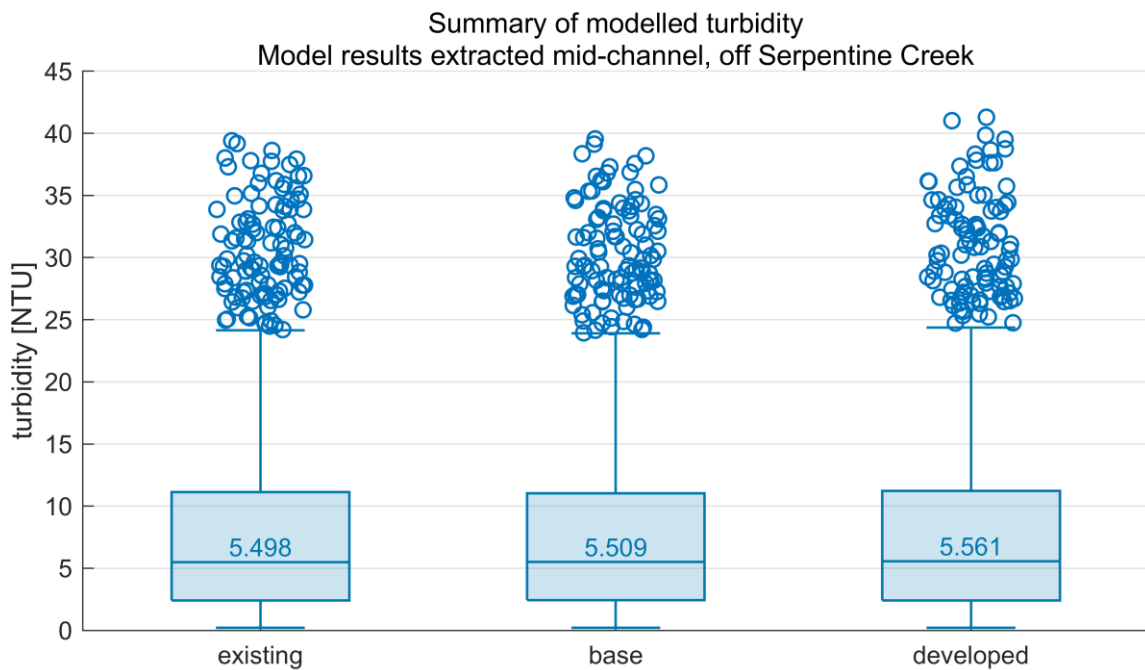
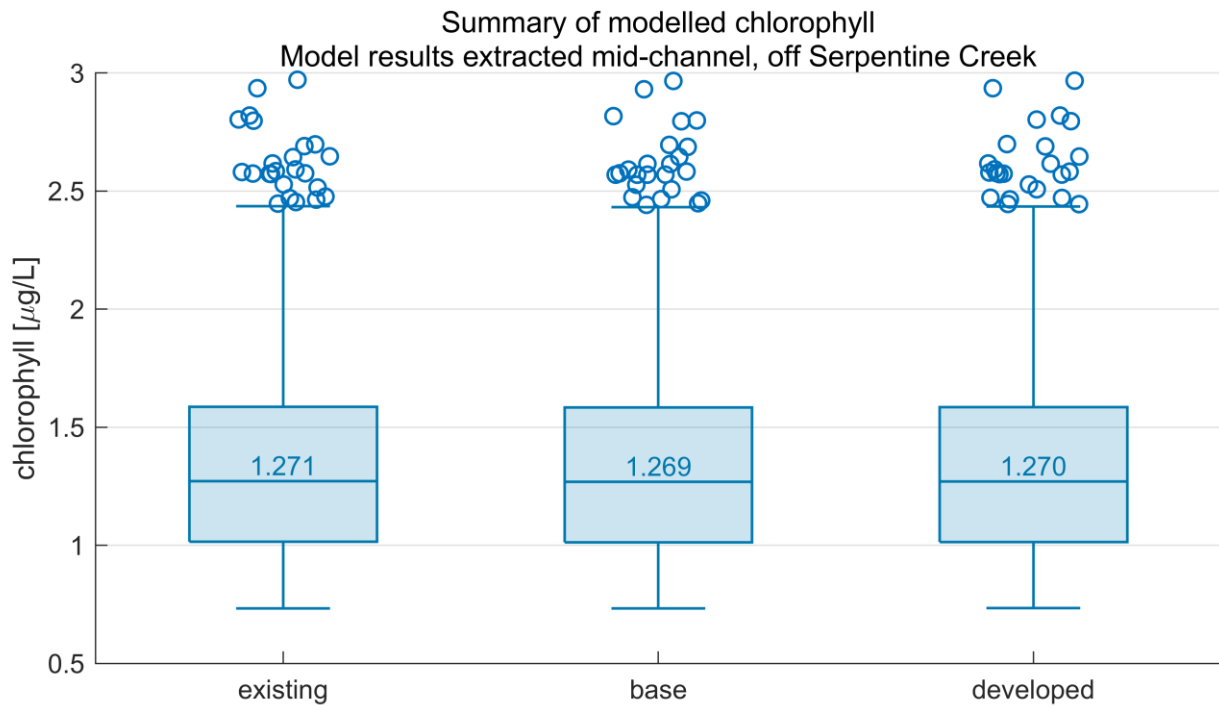
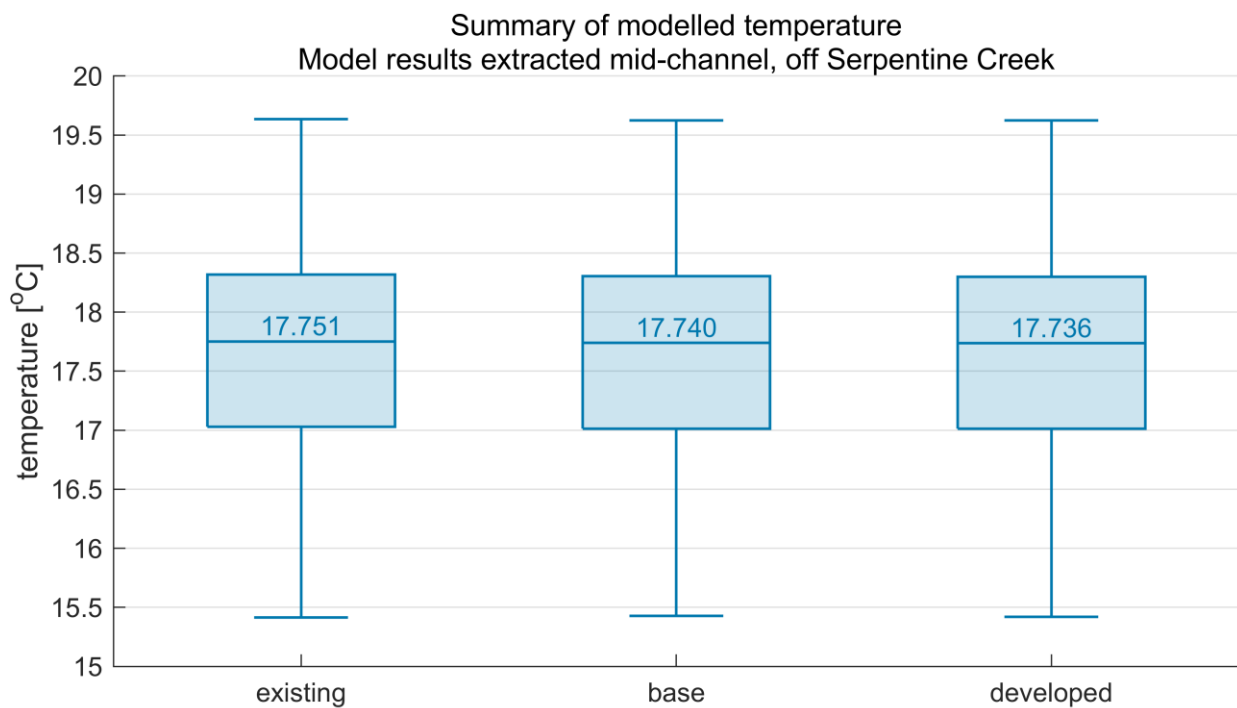
The expected changes in speciated nutrient concentrations (Ammonia, Nitrous Oxide, Organic Nitrogen, Filterable Reactive Phosphorus and Orthophosphate), Turbidity, Chlorophyll-a and Temperature within the Logan River Estuary in the vicinity of, and attributable to, the MOA are provided in Figure 9-10 to Figure 9-17. It is evident that the changes in median values from existing to base case scenarios are miniscule for all parameters. Once the discharges from the wastewater treatment plant are included however (developed case), the concentrations still remain similar to those of the base and existing cases. Therefore, the discharge had negligible impacts on the levels of the modelled parameters in the Logan River.

FIGURE 9-10 BOX PLOT OF MODELLED AMMONIA

FIGURE 9-11 BOX PLOT OF MODELLED NITRATE AND NITRITE N ( $\text{NO}_x$ )

FIGURE 9-12 BOX PLOT OF MODELLED ORGANIC NITROGEN (ON)

FIGURE 9-13 BOX PLOT OF MODELLED FILTERABLE REACTIVE PHOSPHORUS (FRP)

FIGURE 9-14 BOX PLOT OF MODELLED ORTHOPHOSPHATE (OP)

FIGURE 9-15 BOX PLOT OF MODELLED TURBIDITY<sup>7</sup>

FIGURE 9-16 BOX PLOT OF MODELLED CHLOROPHYLL-A<sup>1</sup>

FIGURE 9-17 BOX PLOT OF MODELLED TEMPERATURE

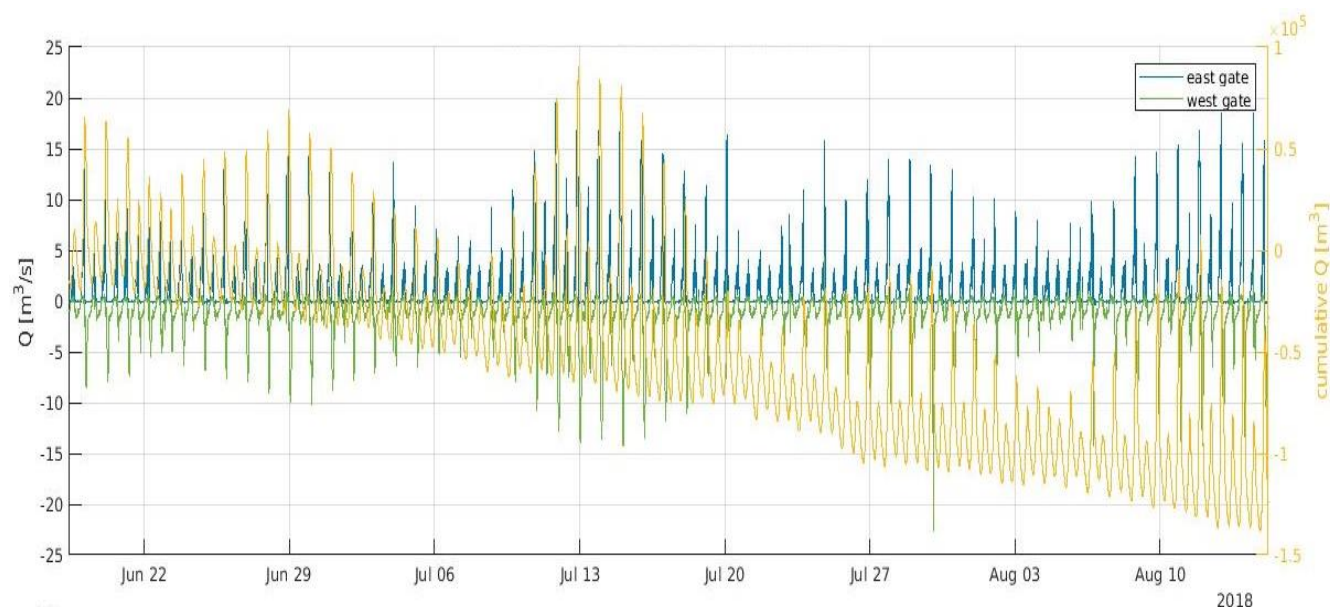
In Figure 9-18, the flow of the incoming tide (at the inlet culvert) is represented in blue and the flow of the outgoing tide (ebb tide) is represented in green. Note that the outgoing tide from the MOA also includes the recycled water contributions (for a fully established development case) into the mangroves, which would consequently be discharged (during the ebb tide) into the Logan River. The estimated cumulative volume of water leaving the mangroves over a two-month period is also shown in Figure 9-18 (marked in yellow).

Based on the Southern Redland Bay WWTP Recycled Water Strategy (see Section 3.2), the estimated daily recycled water discharge (at full capacity) into the MOA was assumed to be at 200 L/EP/day or equivalent to 2.4 ML/day (2.4 x 10<sup>3</sup> m<sup>3</sup> per day). The volume of water which flows into the MOA through the inflow structure during a neap flood tide is 30 x 10<sup>3</sup> m<sup>3</sup>. Similarly, for a spring tide, the volume of water which flows into the MOA is 150 x 10<sup>3</sup> m<sup>3</sup>. Therefore, the recycled water discharge into the MOA will only account for 1.7% and 0.3% shift in volumes during neap and spring tides, respectively. These recycled water (freshwater) discharges will have a small effect on the salinity level in the mangroves (see Section 9.1.2). This change will not however impact the growth and propagation of the mangroves.

**FIGURE 9-18 FLOWS (+VE INTO MANGROVE SITE) FOR THE PROPOSED MOA WITH WWTP RECYCLED WATER DISCHARGE (DEVELOPMENT CASE)**
